# SEQU

## WIP Report

### NPS Retaining Wall Inventory Program Sequoia National Park

**Data Collection Date: August 2007  
Report Date: December 2015**

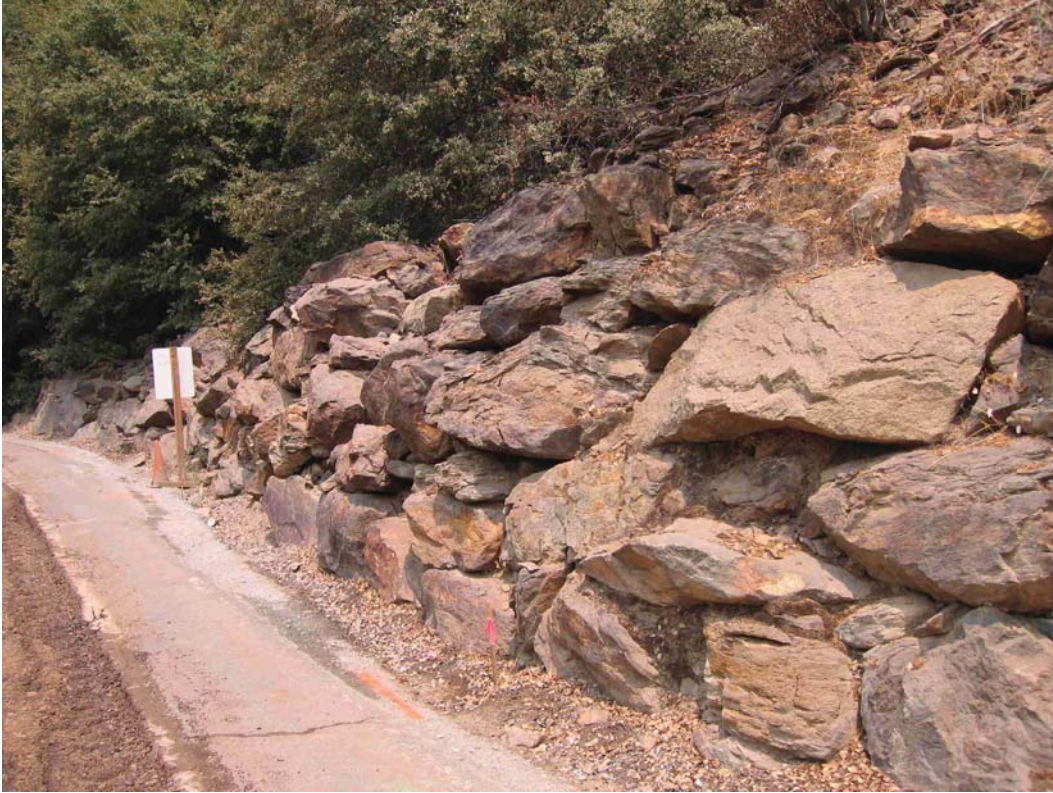
**SEQU\_0010\_10.625\_R\_1.jpg**

<b>Wall ID:</b>	SEQU-0010-10.625-R		
<b>Route Name:</b>	GENERALS HIGHWAY HISTORIC		
<b>Inspection Date:</b>	August 16, 2007	<b>Approximate Year Built:</b>	Unknown
<b>*Wall Rating:</b>	68	<b>Maintenance Action:</b>	No Action

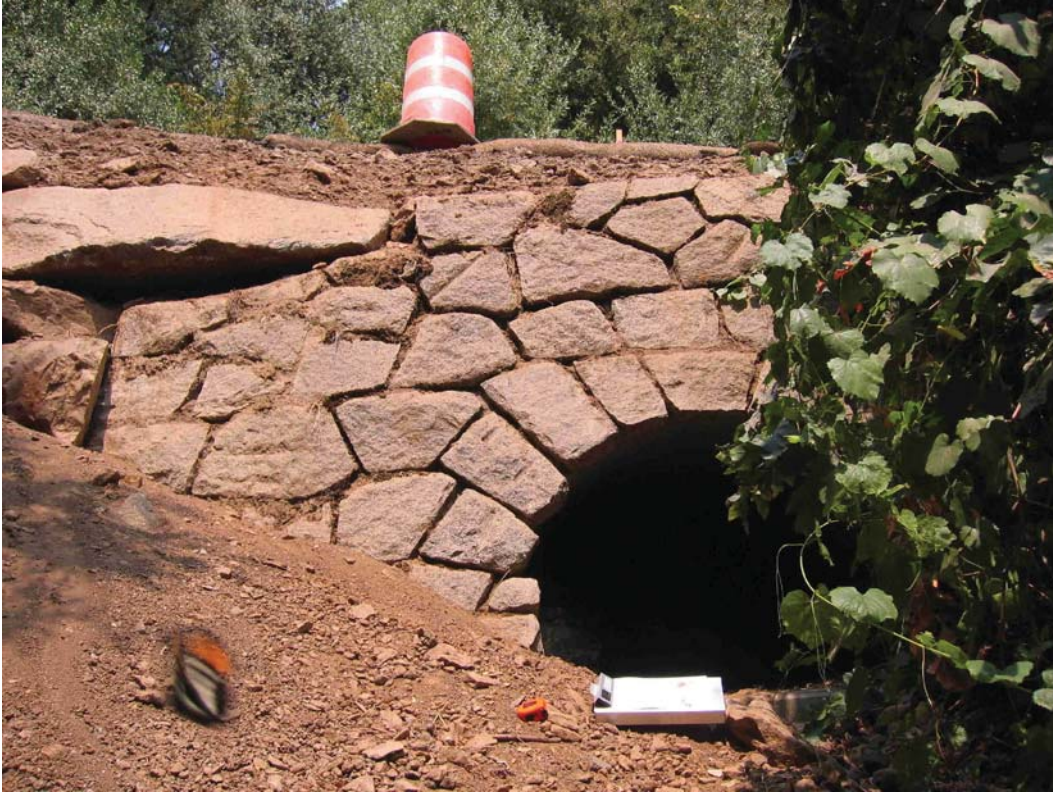
**SEQU\_0010\_10.645\_L\_1.jpg**

<b>Wall ID:</b>	SEQU-0010-10.645-L		
<b>Route Name:</b>	GENERALS HIGHWAY HISTORIC		
<b>Inspection Date:</b>	August 16, 2007	<b>Approximate Year Built:</b>	Unknown
<b>*Wall Rating:</b>	83	<b>Maintenance Action:</b>	No Action

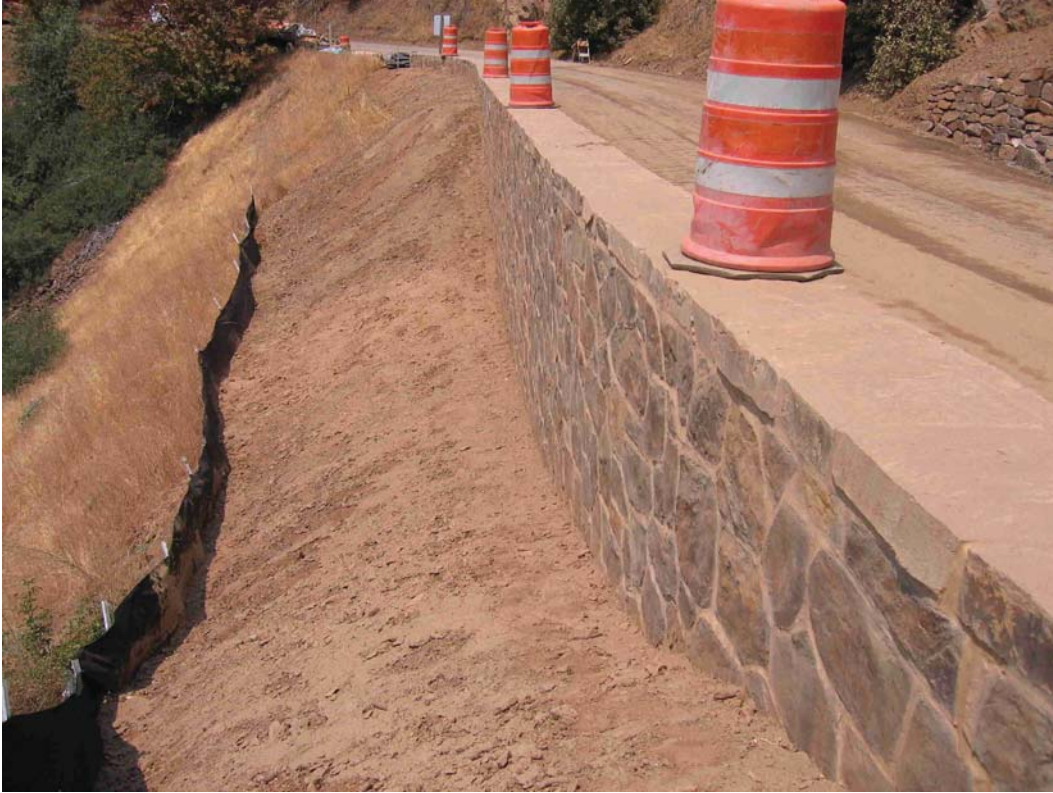
**SEQU\_0010\_10.895\_L\_1.jpg**

<b>Wall ID:</b>	SEQU-0010-10.895-L		
<b>Route Name:</b>	GENERALS HIGHWAY HISTORIC		
<b>Inspection Date:</b>	August 16, 2007	<b>Approximate Year Built:</b>	2007
<b>*Wall Rating:</b>	93	<b>Maintenance Action:</b>	No Action

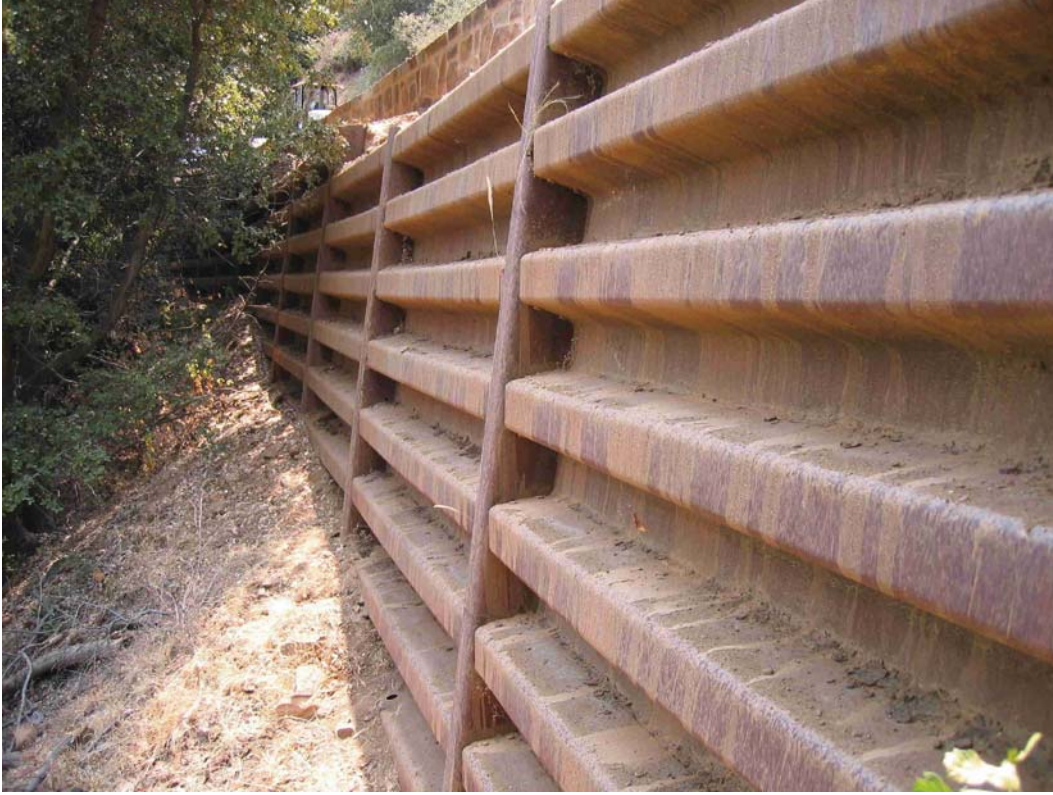
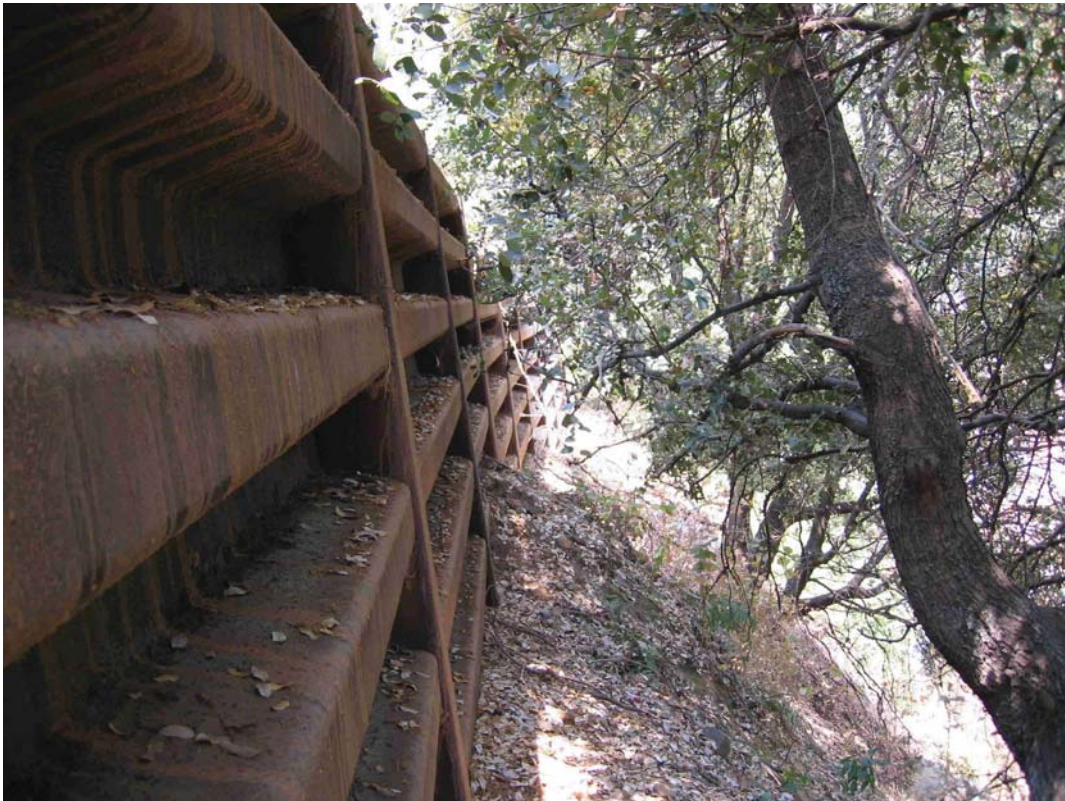
**SEQU\_0010\_11.046\_L\_1.jpg**

<b>Wall ID:</b>	SEQU-0010-11.046-L		
<b>Route Name:</b>	GENERALS HIGHWAY HISTORIC		
<b>Inspection Date:</b>	August 16, 2007	<b>Approximate Year Built:</b>	1970
<b>*Wall Rating:</b>	83	<b>Maintenance Action:</b>	No Action

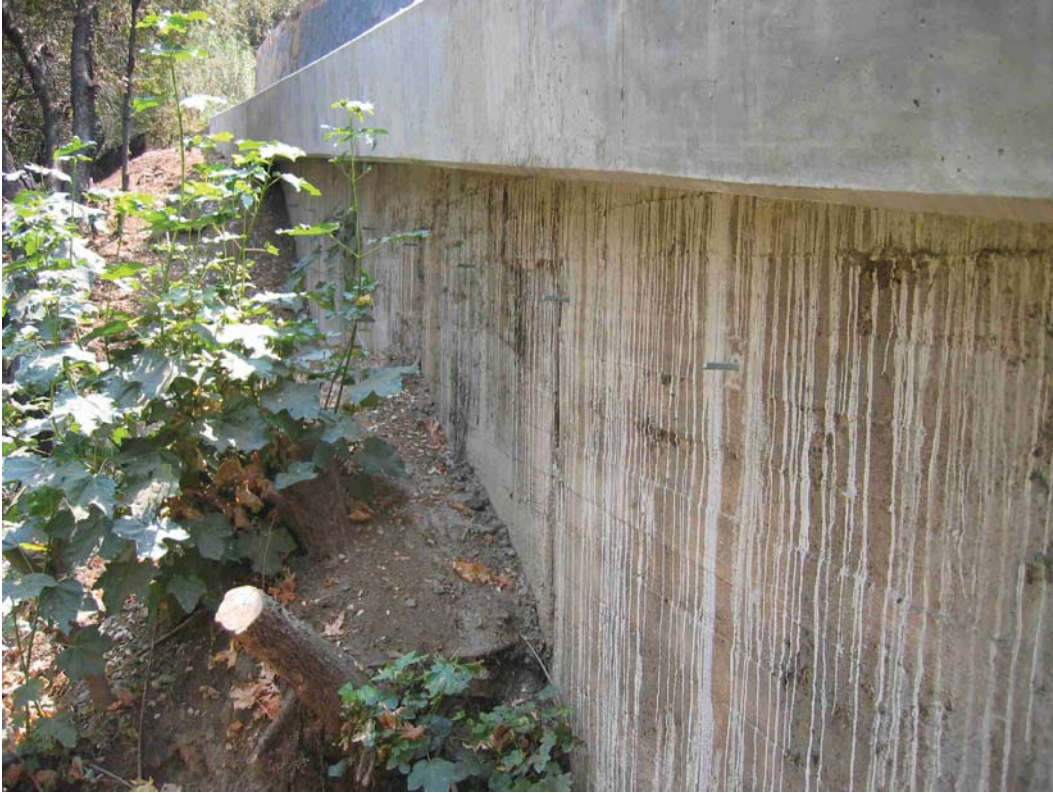
**SEQU\_0010\_11.101\_L\_1.jpg**

<b>Wall ID:</b>	SEQU-0010-11.101-L		
<b>Route Name:</b>	GENERALS HIGHWAY HISTORIC		
<b>Inspection Date:</b>	August 16, 2007	<b>Approximate Year Built:</b>	1960
<b>*Wall Rating:</b>	80	<b>Maintenance Action:</b>	No Action

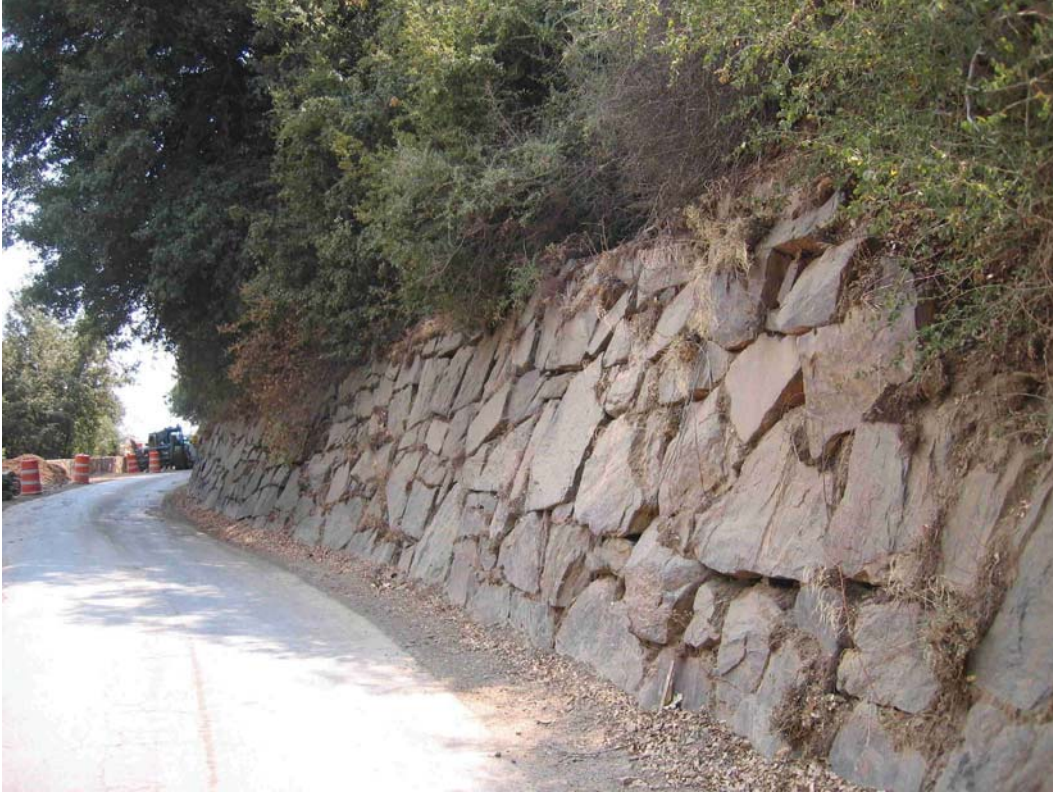
**SEQU\_0010\_11.108\_R\_1.jpg**

<b>Wall ID:</b>	SEQU-0010-11.108-R		
<b>Route Name:</b>	GENERALS HIGHWAY HISTORIC		
<b>Inspection Date:</b>	August 16, 2007	<b>Approximate Year Built:</b>	Unknown
<b>*Wall Rating:</b>	80	<b>Maintenance Action:</b>	No Action

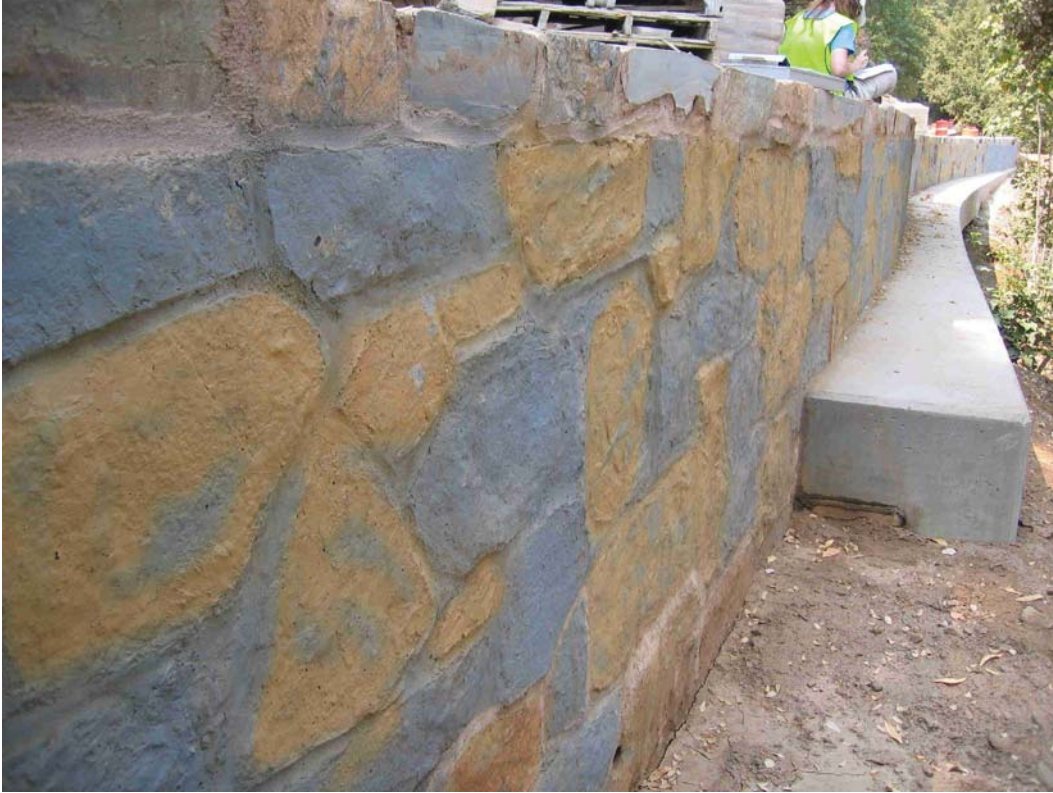
**SEQU\_0010\_11.123\_L\_1.jpg**

<b>Wall ID:</b>	SEQU-0010-11.123-L		
<b>Route Name:</b>	GENERALS HIGHWAY HISTORIC		
<b>Inspection Date:</b>	August 16, 2007	<b>Approximate Year Built:</b>	2007
<b>*Wall Rating:</b>	96	<b>Maintenance Action:</b>	No Action

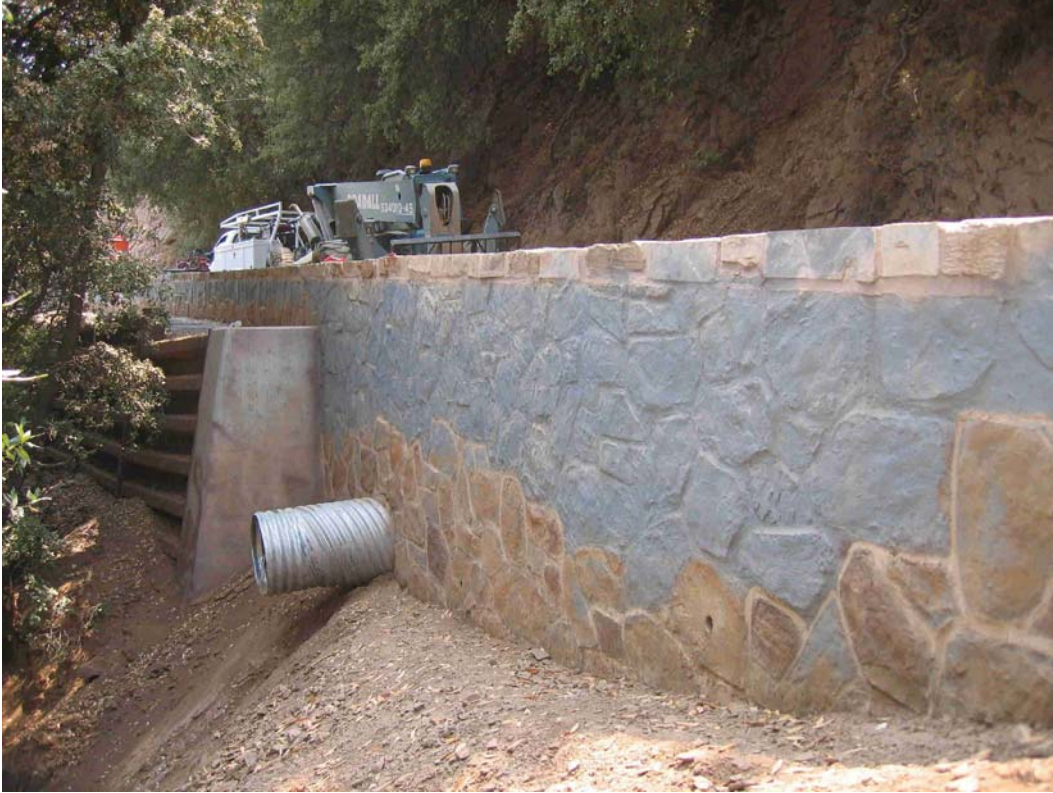
**SEQU\_0010\_11.136\_L\_1.jpg**

<b>Wall ID:</b>	SEQU-0010-11.136-L		
<b>Route Name:</b>	GENERALS HIGHWAY HISTORIC		
<b>Inspection Date:</b>	August 16, 2007	<b>Approximate Year Built:</b>	2007
<b>*Wall Rating:</b>	96	<b>Maintenance Action:</b>	No Action

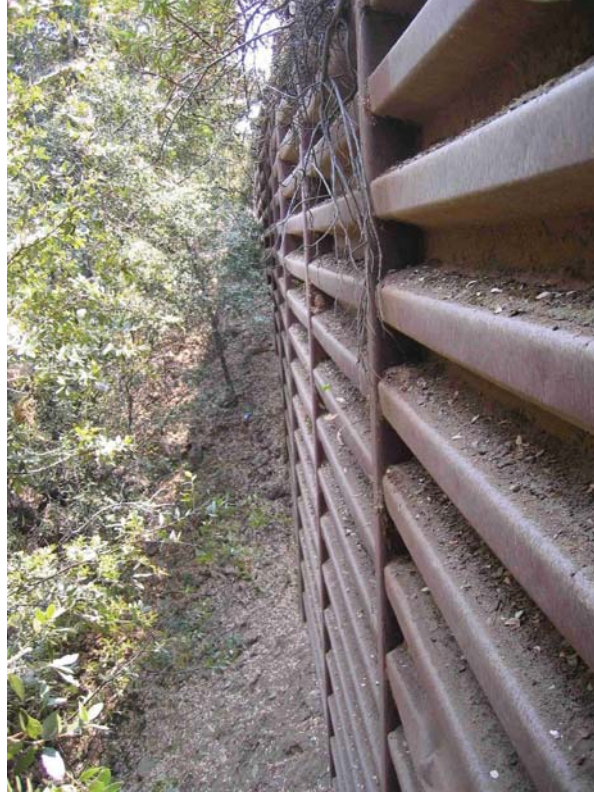
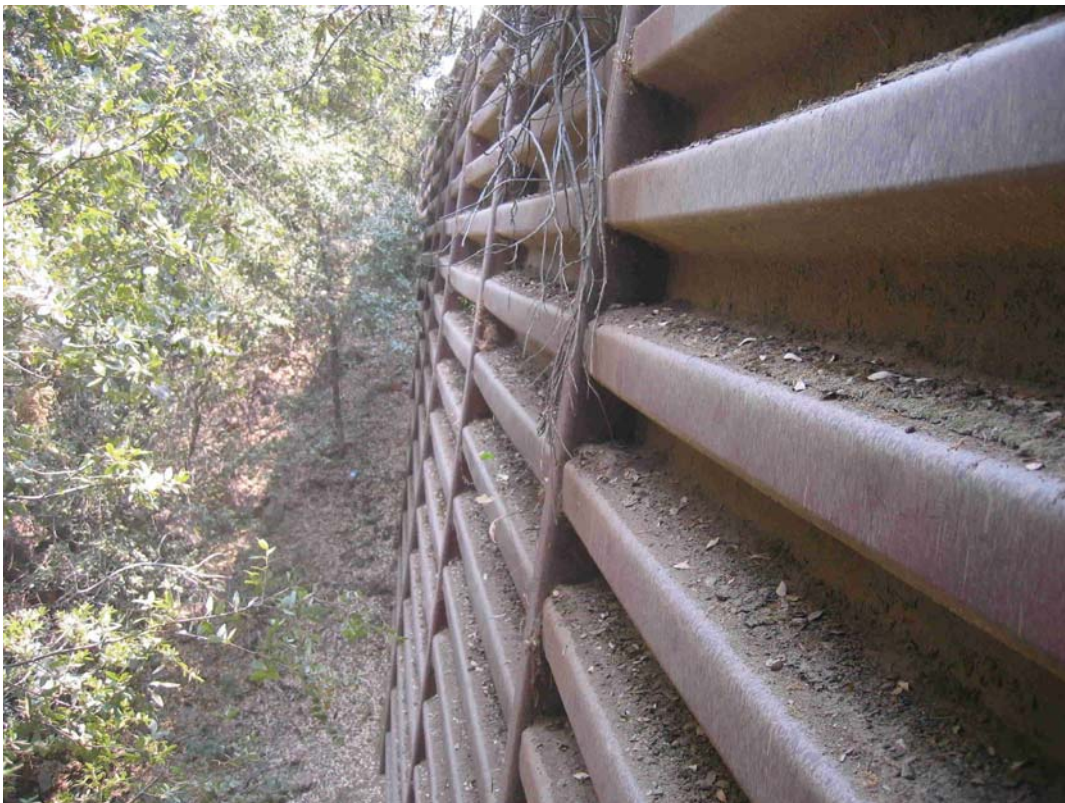
**SEQU\_0010\_11.142\_L\_1.jpg**

<b>Wall ID:</b>	SEQU-0010-11.142-L		
<b>Route Name:</b>	GENERALS HIGHWAY HISTORIC		
<b>Inspection Date:</b>	August 16, 2007	<b>Approximate Year Built:</b>	2007
<b>*Wall Rating:</b>	86	<b>Maintenance Action:</b>	No Action

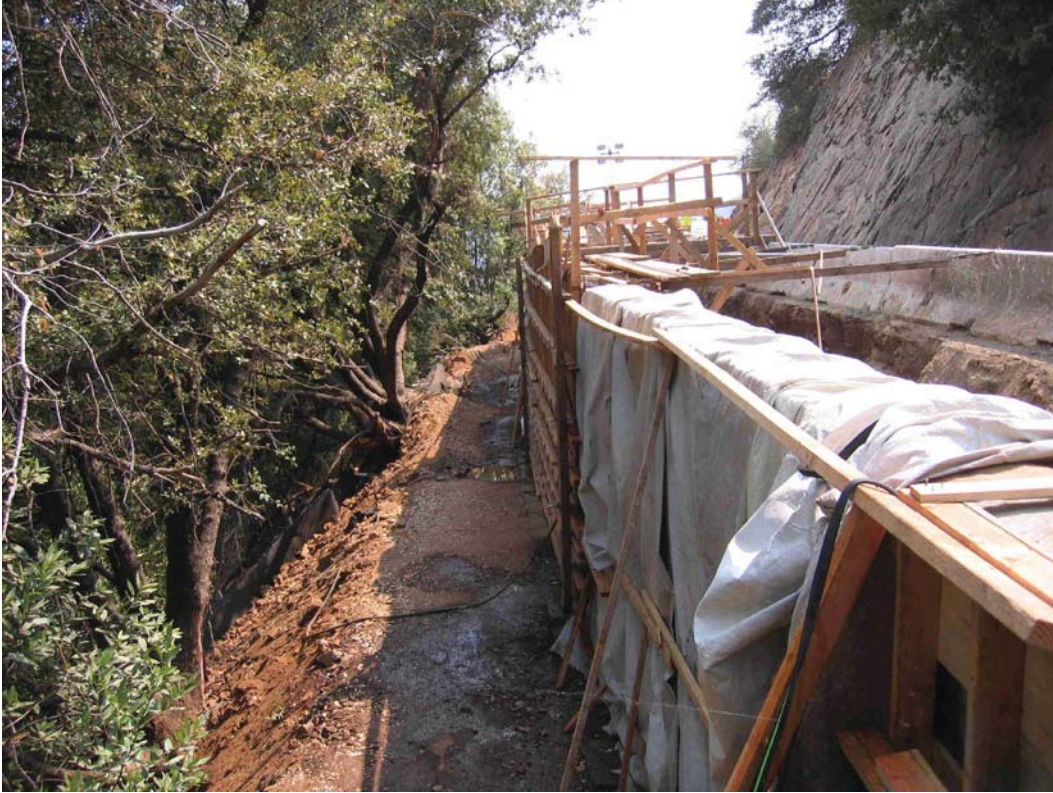
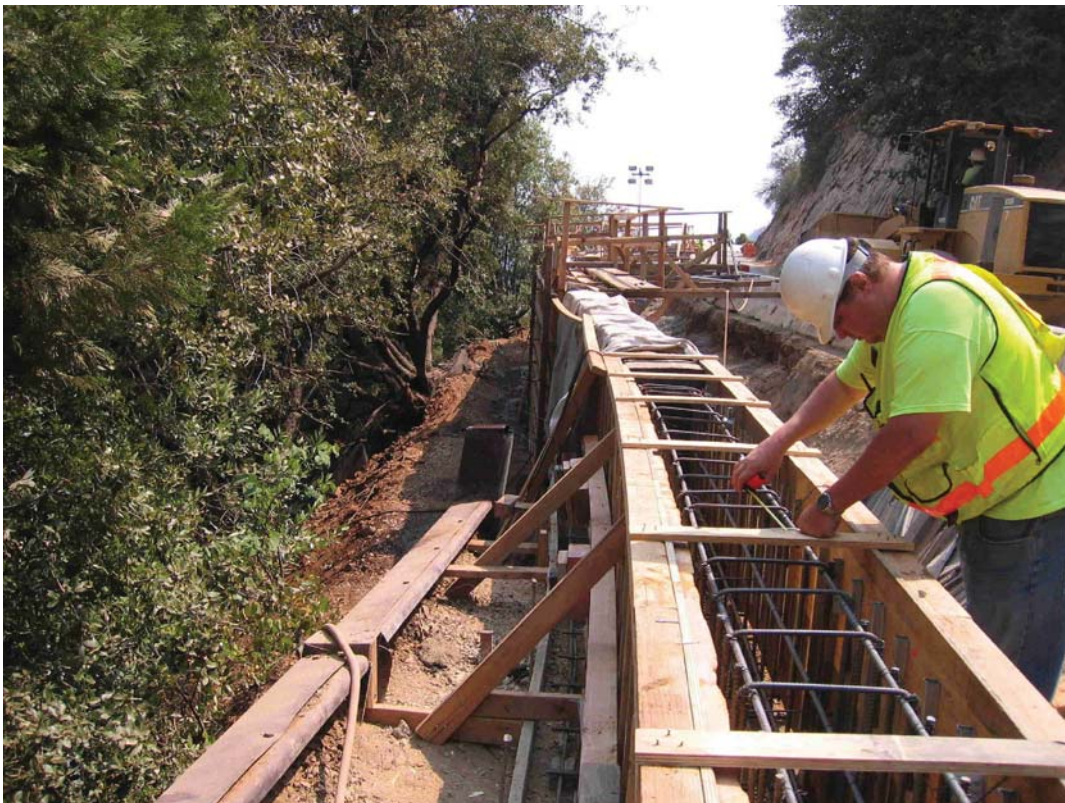
**SEQU\_0010\_11.175\_L\_1.jpg**

<b>Wall ID:</b>	SEQU-0010-11.175-L		
<b>Route Name:</b>	GENERALS HIGHWAY HISTORIC		
<b>Inspection Date:</b>	August 16, 2007	<b>Approximate Year Built:</b>	2007
<b>*Wall Rating:</b>	96	<b>Maintenance Action:</b>	No Action

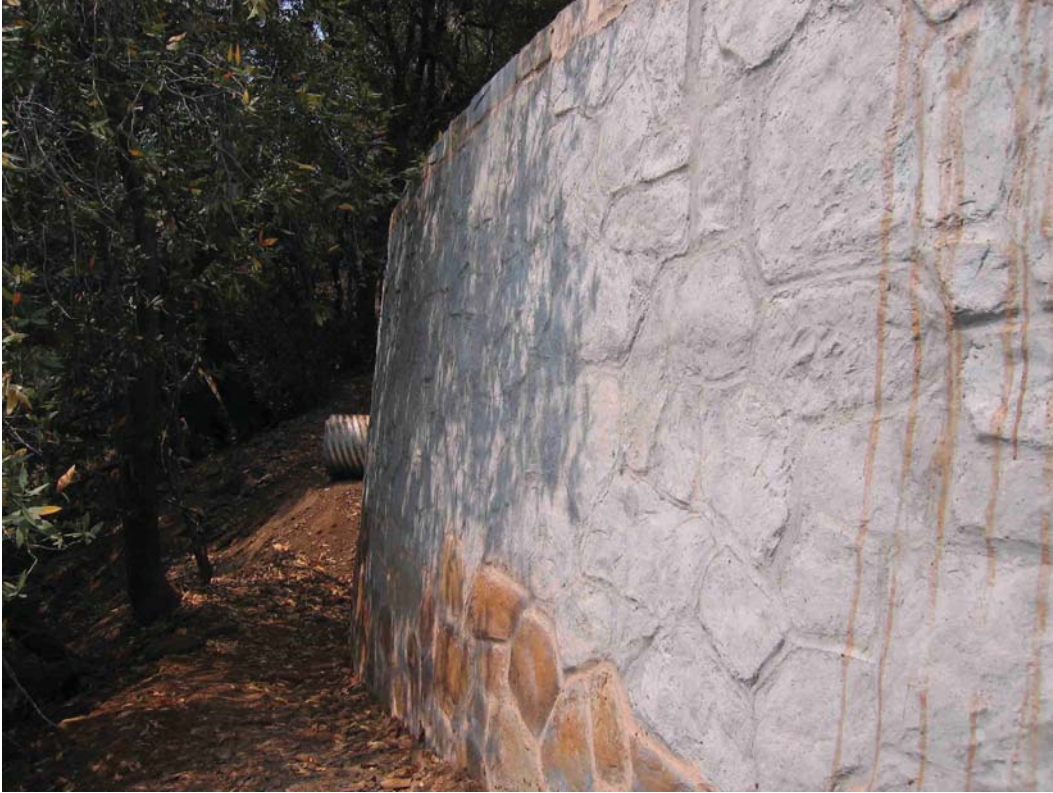
**SEQU\_0010\_11.266\_L\_1.jpg**

<b>Wall ID:</b>	SEQU-0010-11.266-L		
<b>Route Name:</b>	GENERALS HIGHWAY HISTORIC		
<b>Inspection Date:</b>	August 16, 2007	<b>Approximate Year Built:</b>	2007
<b>*Wall Rating:</b>	96	<b>Maintenance Action:</b>	No Action

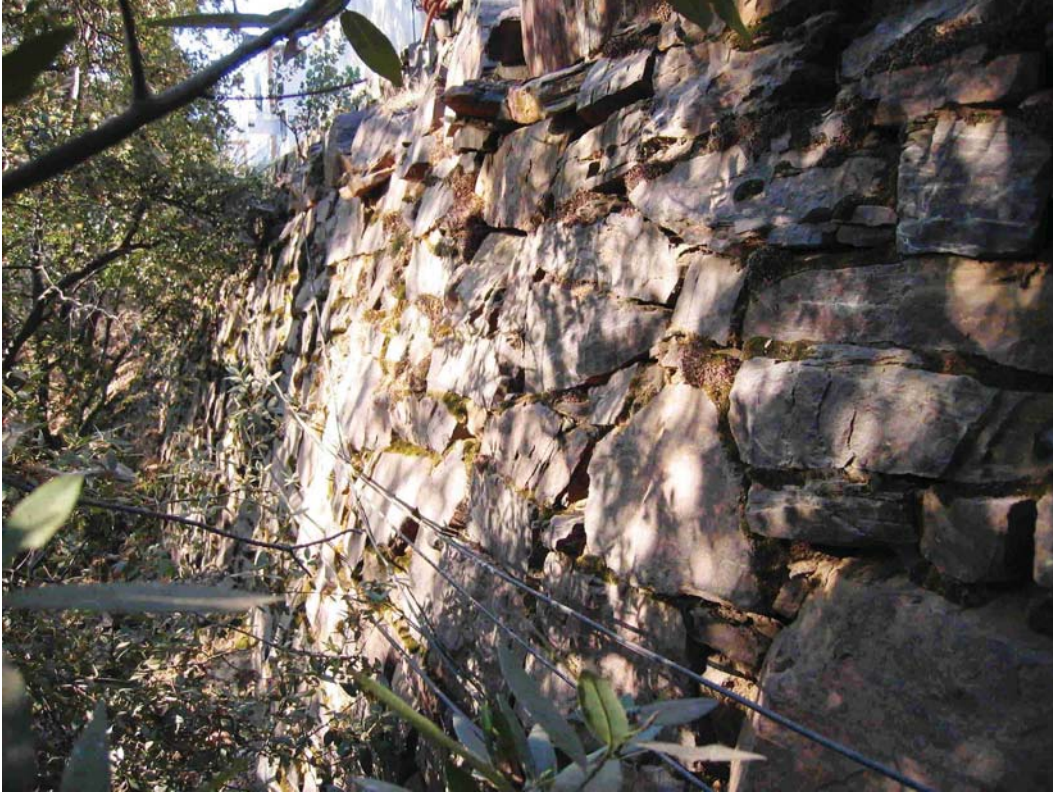
**SEQU\_0010\_11.350\_R\_1.jpg**

<b>Wall ID:</b>	SEQU-0010-11.350-R		
<b>Route Name:</b>	GENERALS HIGHWAY HISTORIC		
<b>Inspection Date:</b>	August 17, 2007	<b>Approximate Year Built:</b>	Unknown
<b>*Wall Rating:</b>	48	<b>Maintenance Action:</b>	Replace Elements

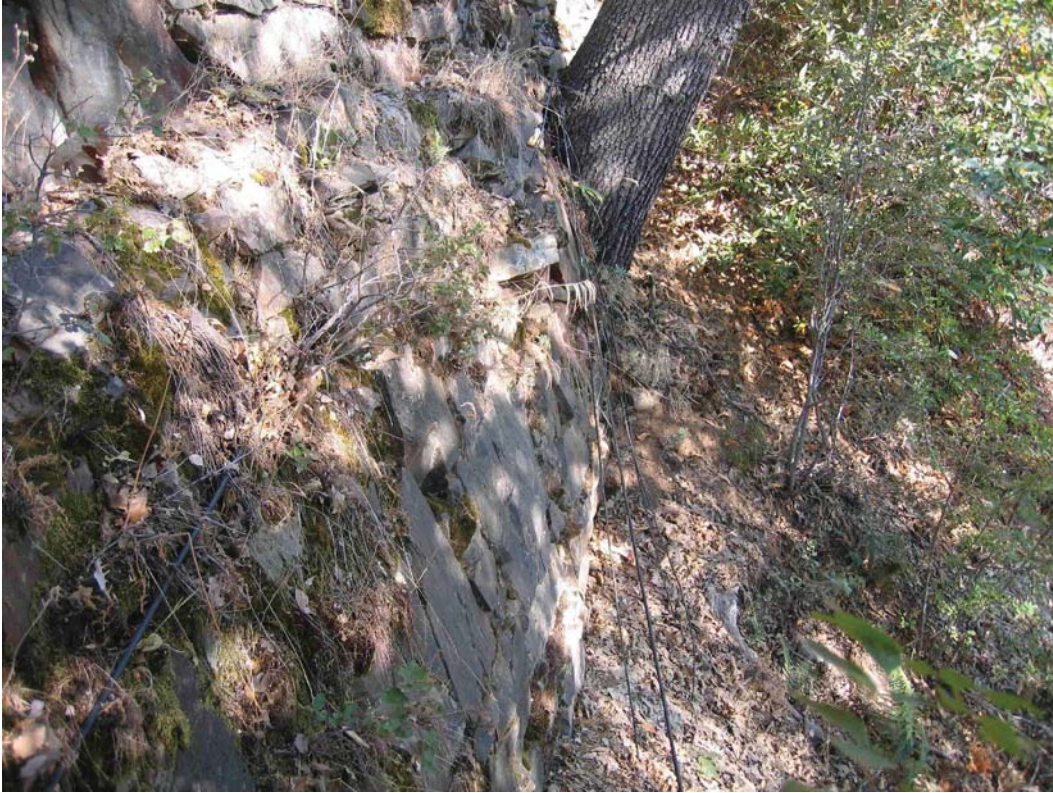
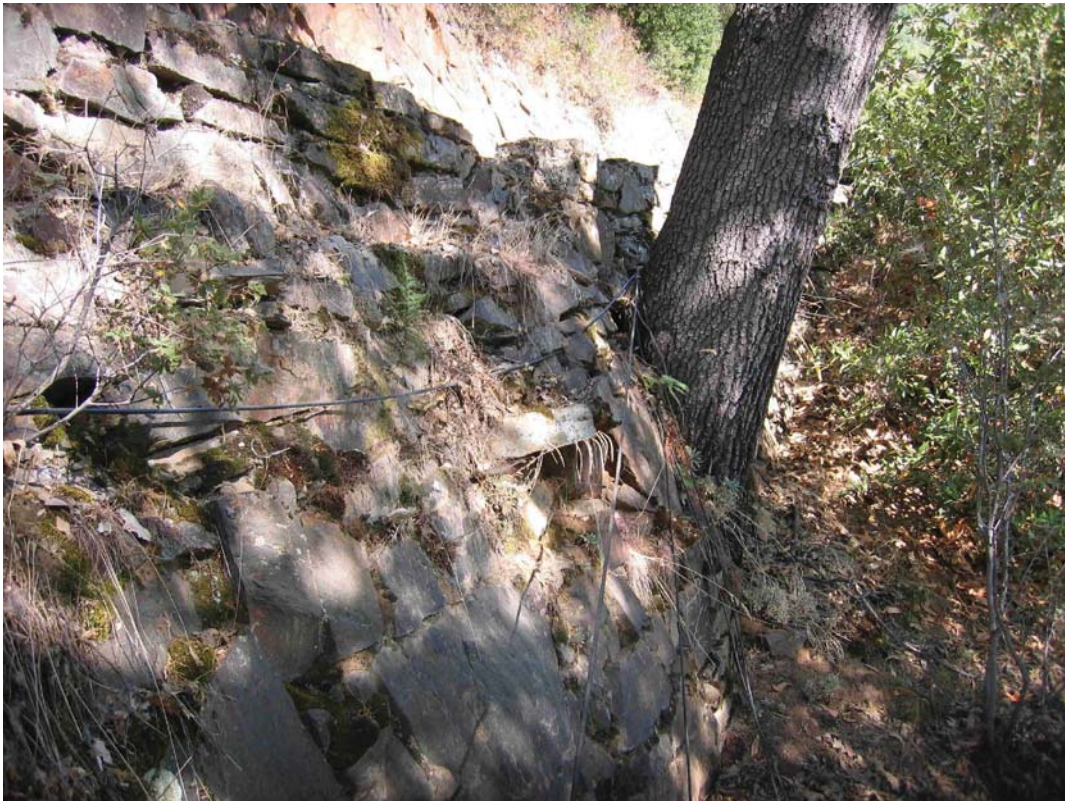
**SEQU\_0010\_11.440\_R\_1.jpg**

<b>Element (Weighting Factor)</b>	<b>Narrative</b>	<b>Condition Rating (0 - 10)</b>
PERFORMANCE 8.00	Poor performance. Wall is failed in segment and bulging.	4
WALL FOUNDATION MATERIAL 8.00	Loose fill, very steep 0.75H:1V slope. The bottom of wall is embedded.	6
PLACED STONE 8.00	Stones are schist moderately weathered and fractured. Missing elements, elements moved, and wall rotated.	4
ROAD/SIDEWALK/SHOULDER 1.00	Cracks and distress caused by wall movement.	4
DOWNSLOPE 1.00	Very steep, 0.75H:1V with loose fill.	5
LATERAL SLOPE 1.00	Very steep, 0.75H:1V with minor erosion	5
WALL DRAINS 1.00	No wall drains are visible.	7
TRAFFIC BARRIER/FENCE 5.00	Schist guardwall. Missing elements or fractured. Bad condition.	3
VEGETATION 5.00	A large tree is growing in all and affecting the wall stability and integrity (Need to be removed)	3

<b>Failure Consequence:</b>	HIGH
<b>Recommendation Narrative:</b>	Rebuild wall \$100 ft <sup>2</sup> at \$50/ft <sup>2</sup> = \$5000 Remove tree - Labor (8 hrs) @ \$55/hr = \$240 Rebuild guardwall 80 ft at \$705 = \$56400
<b>Repair Cost:</b>	\$61,640

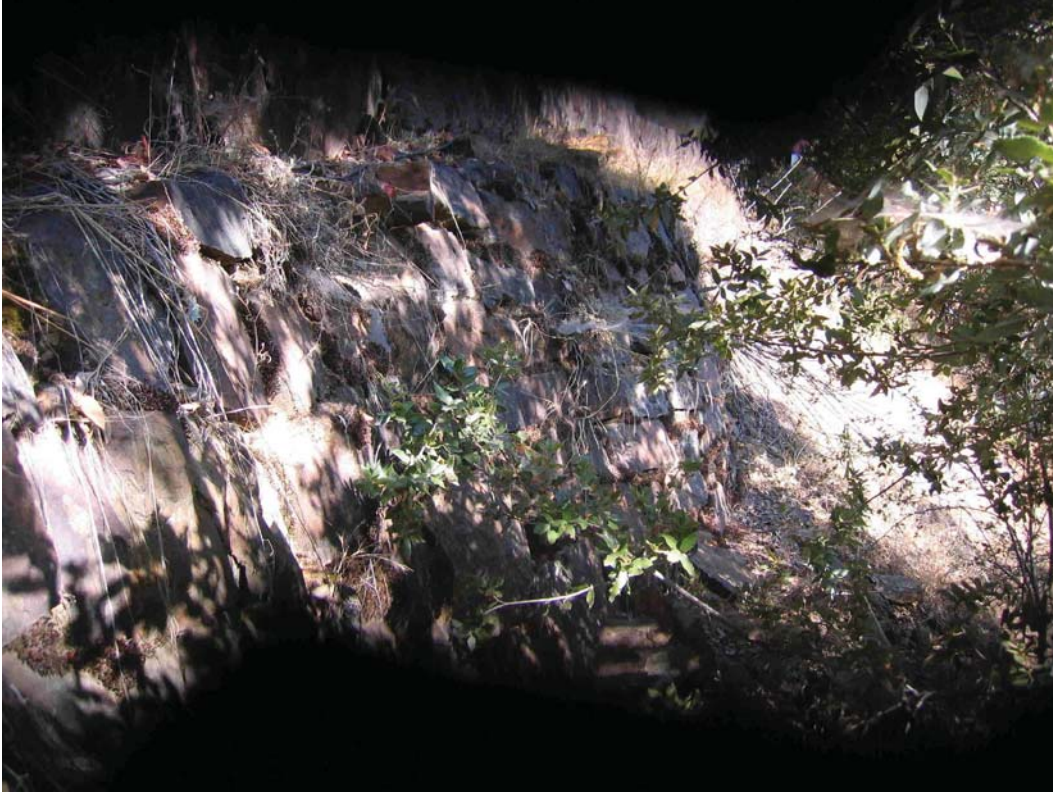
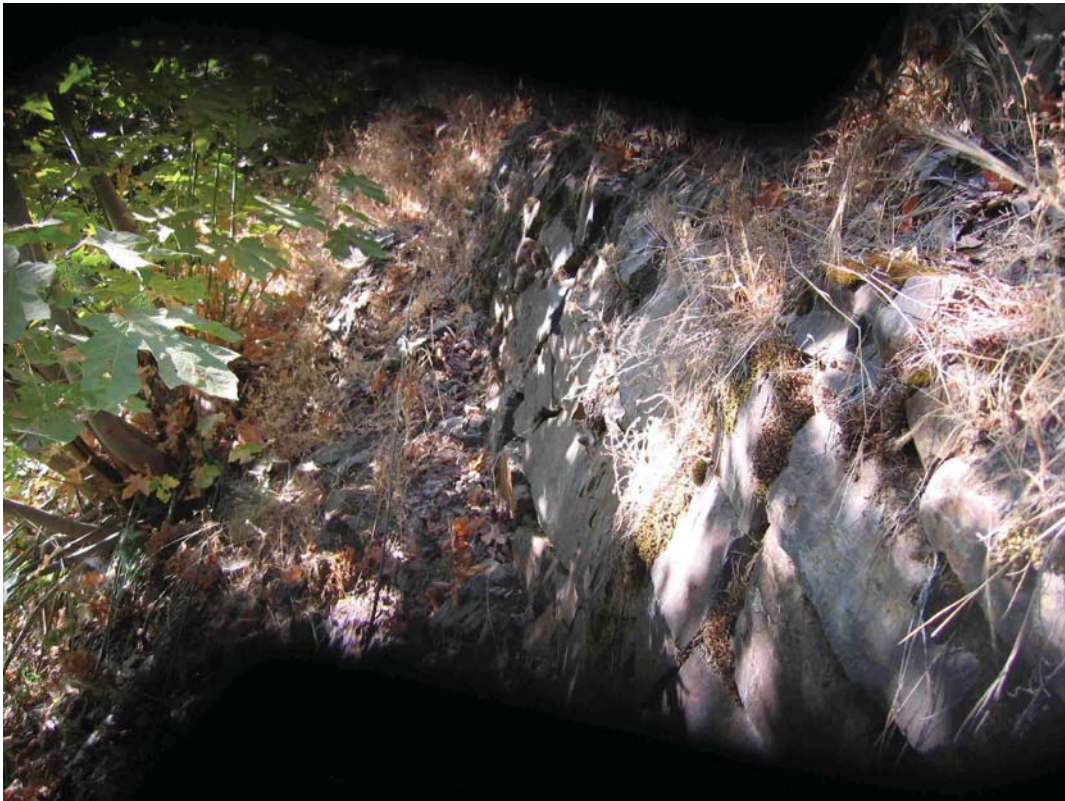
**SEQU\_0010\_11.494\_L\_1.jpg**

<b>Element (Weighting Factor)</b>	<b>Narrative</b>	<b>Condition Rating (0 - 10)</b>
PERFORMANCE 8.00	Poor performance. Signs of rotation, settlement, and failed segments.	4
WALL FOUNDATION MATERIAL 8.00	Fill with rock 3 ft bench and sufficient to support wall.	8
PLACED STONE 8.00	Moderately weathered schist with some cracks, missing elements, failed segment.	4
LATERAL SLOPE 1.00	Fill with rock slope. Steep 1H:1V slope with minor erosion.	5
DOWNSLOPE 1.00	Fill with rock, grass and large trees. Steep 1H:1V with moderate erosion.	6
VEGETATION 1.00	Minor vegetation is on wall face and not affecting wall stability.	7
WALL DRAINS 1.00	No wall drains are visible.	7
ROAD/SIDEWALK/SHOULDER 5.00	Half moon failure with 2 inch depression caused by wall rotation and movement.	3
TRAFFIC BARRIER/FENCE 5.00	Schist, highly weathered and cracked. Severely settled with only 2 inch above grade.	3

<b>Failure Consequence:</b>	HIGH
<b>Recommendation Narrative:</b>	Rebuild schist wall = 60 ft2 at \$50 = \$3000 Rebuild guardwall = 200 ft at \$705 = \$141000
<b>Repair Cost:</b>	\$144,000

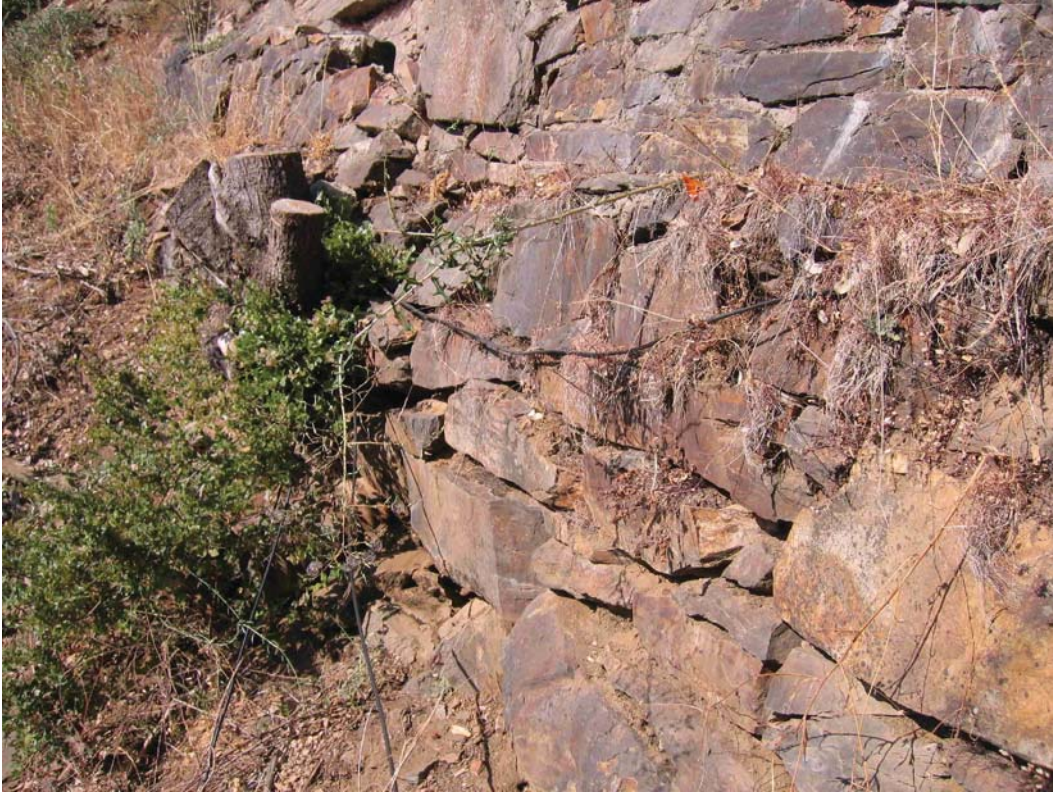
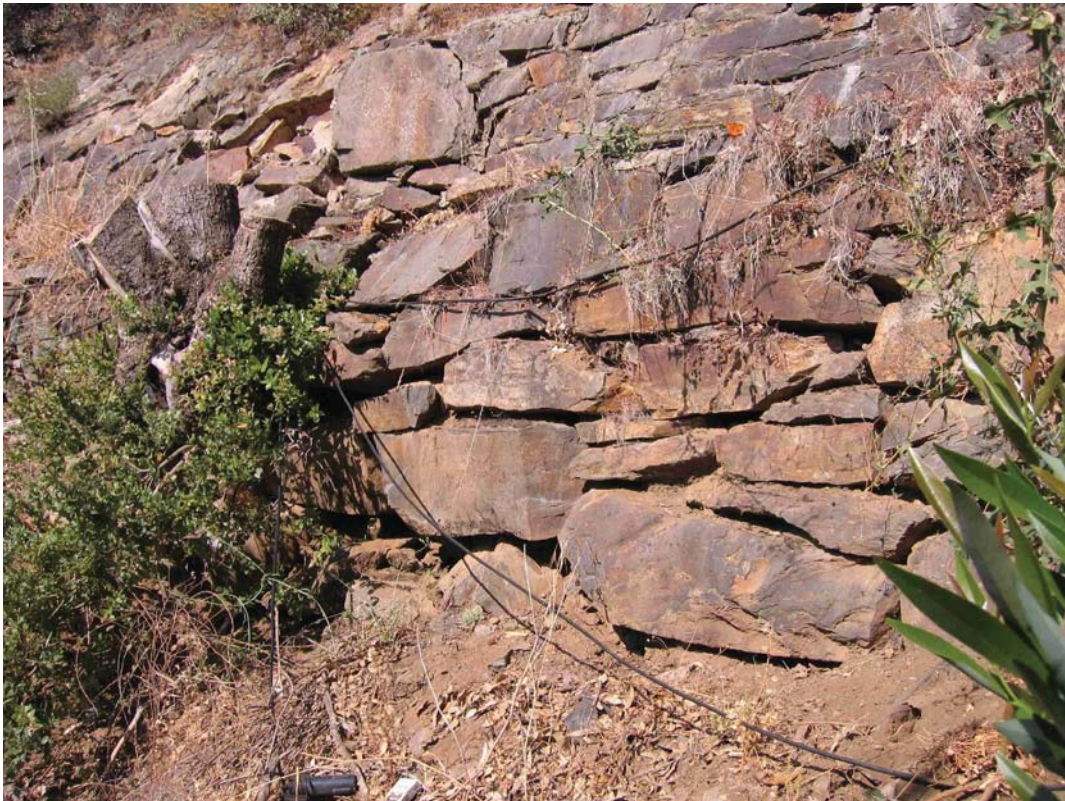
**SEQU\_0010\_11.600\_R\_1.jpg**

<b>Element (Weighting Factor)</b>	<b>Narrative</b>	<b>Condition Rating (0 - 10)</b>
PERFORMANCE 8.00	Poor performance. Failed foundation and rotated wall, settlement and global failure evident.	4
WALL FOUNDATION MATERIAL 8.00	Undermined by the culvert. Not sufficient to support wall. Immediate attention needed.	3
PLACED STONE 8.00	Schist moderately weathered, cracked, bulging, missing elements.	4
CULVERT 1.00	12 in CMP culvert washing foundation from under wall.	4
ROAD/SIDEWALK/SHOULDER 1.00	Cracking and depression due to wall settlement.	4
VEGETATION 1.00	Large tree stump and affecting wall stability.	4
DOWNSLOPE 1.00	Very steep. Loose 0.75H:1V with trees and bushes with moderate eroded.	6
LATERAL SLOPE 1.00	Very steep, compacted fill with grass and bushes. Severe erosion.	6
WALL DRAINS 1.00	No drains were visible in wall.	7

<b>Failure Consequence:</b>	HIGH
<b>Recommendation Narrative:</b>	Rebuild wall 130 ft at \$50 = \$6,500 Rebuild guardwall 180 ft at \$705 = \$126,900
<b>Repair Cost:</b>	\$133,400

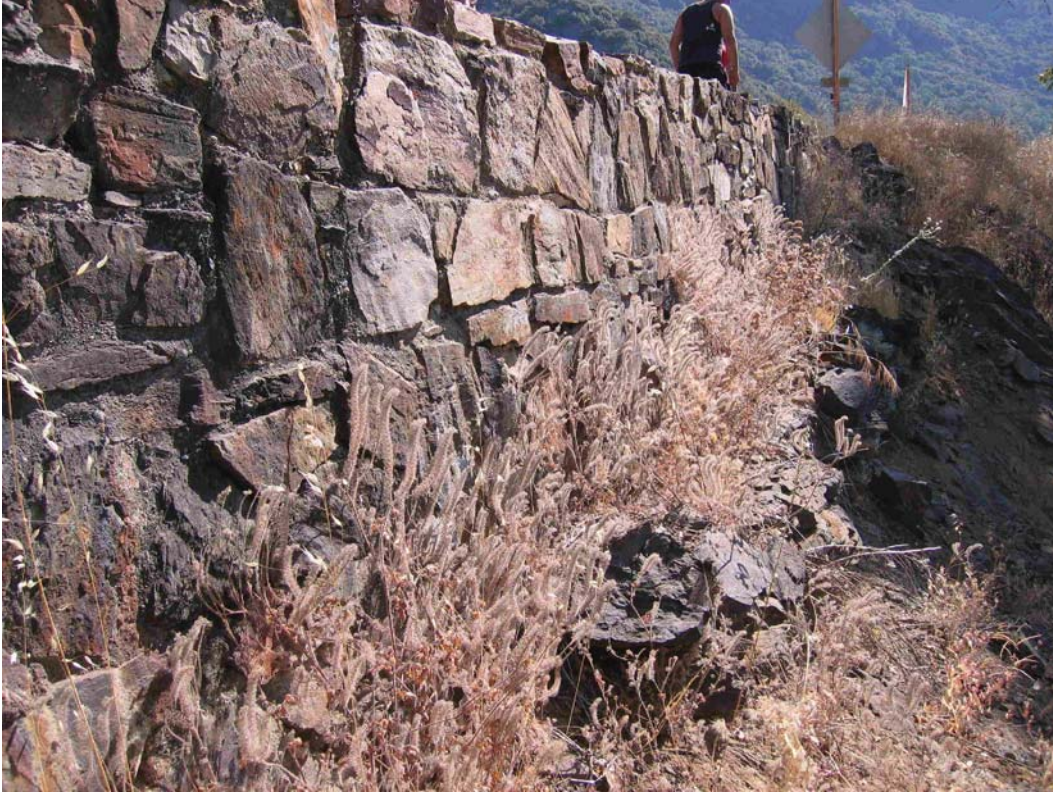
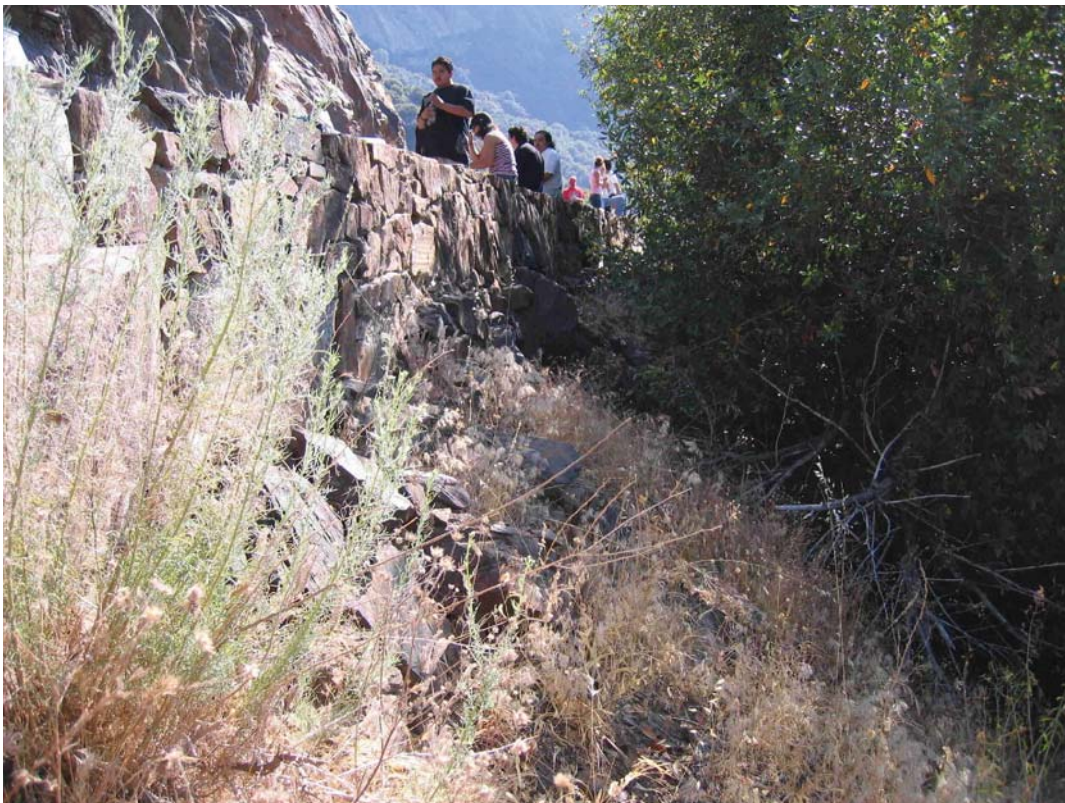
**SEQU\_0010\_11.662\_R\_1.jpg**

<b>Element (Weighting Factor)</b>	<b>Narrative</b>	<b>Condition Rating (0 - 10)</b>
PERFORMANCE 8.00	Poor performance, moderate settlement and rotation are evident.	6
WALL FOUNDATION MATERIAL 8.00	Compacted fill with boulders and 5 ft bench.	7
MORTAR 8.00	Mortar is showing signs of cracking and shrinkage. Some missing sections.	6
STONE MASONRY 8.00	Slightly weathered schist and missing elements.	6
ROAD/SIDEWALK/SHOULDER 1.00	Cracks caused by wall settlement and rotation.	4
TRAFFIC BARRIER/FENCE 1.00	Guardwall with mortared schist stone. Poor condition, weathered, cracked, moved and missing elements.	4
DOWNSLOPE 1.00	Very steep 1H:1V slope with bedrock, weathered rock, trees and bushes.	7
LATERAL SLOPE 1.00	Minor erosion and steep slope.	7
VEGETATION 1.00	Minor vegetation on wall but not affecting wall stability	7

<b>Failure Consequence:</b>	HIGH
<b>Recommendation Narrative:</b>	Reset elements (mortared stone) = 20 ft2 at \$160 = \$3200
<b>Repair Cost:</b>	\$3,200

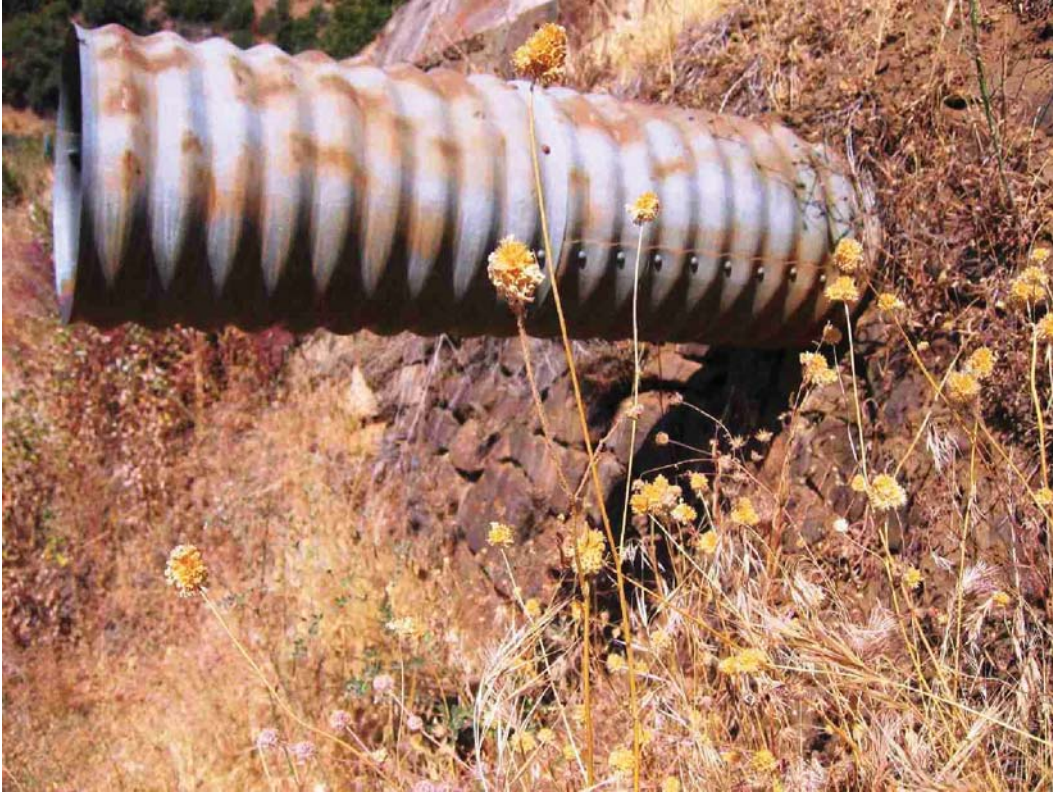
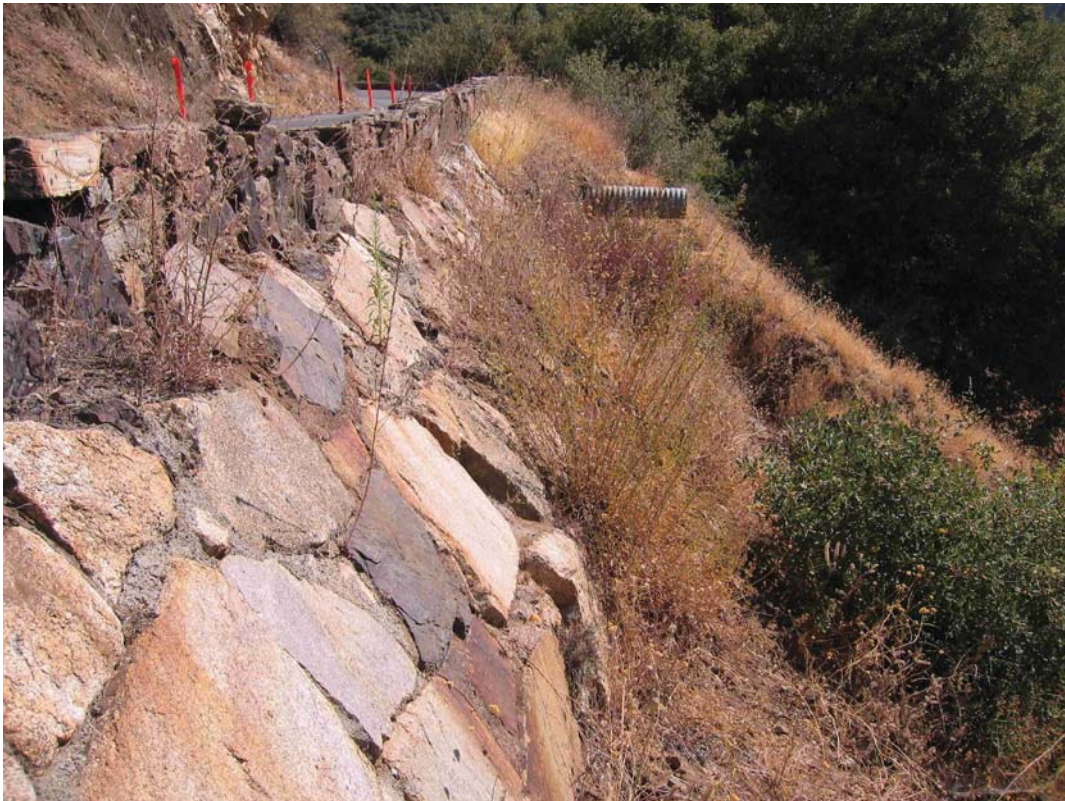
**SEQU\_0010\_11.715\_R\_1.jpg**

<b>Element (Weighting Factor)</b>	<b>Narrative</b>	<b>Condition Rating (0 - 10)</b>
PERFORMANCE 8.00	Good performance. Intact but slight rotation and settlement	6
WALL FOUNDATION MATERIAL 8.00	Compacted fill and bedrock. Steep-washed out near the culvert	6
MORTAR 8.00	Slightly weathered, shrinkage, missing sections.	6
PLACED STONE 8.00	Granite/schist show some weathering	6
ROAD/SIDEWALK/SHOULDER 1.00	Cracked and distressed, settlement due to wall movement	4
TRAFFIC BARRIER/FENCE 1.00	Guardwall with schist mortared cut stone - Bad condition.	4
DOWNSLOPE 1.00	Weathered bedrock 0.5H:1V with bushes. Erosion beneath pipe.	5
LATERAL SLOPE 1.00	Weathered bedrock. Very steep and eroded	5
CULVERT 1.00	One 18" culvert. Performing as intended.	7

<b>Failure Consequence:</b>	HIGH
<b>Recommendation Narrative:</b>	Replace guardwall 160 ft long @ \$705 = \$112,800
<b>Repair Cost:</b>	\$112,800
