# SEQU

## WIP Report

### NPS Retaining Wall Inventory Program Sequoia National Park

**Data Collection Date: August 2007  
Report Date: December 2015**

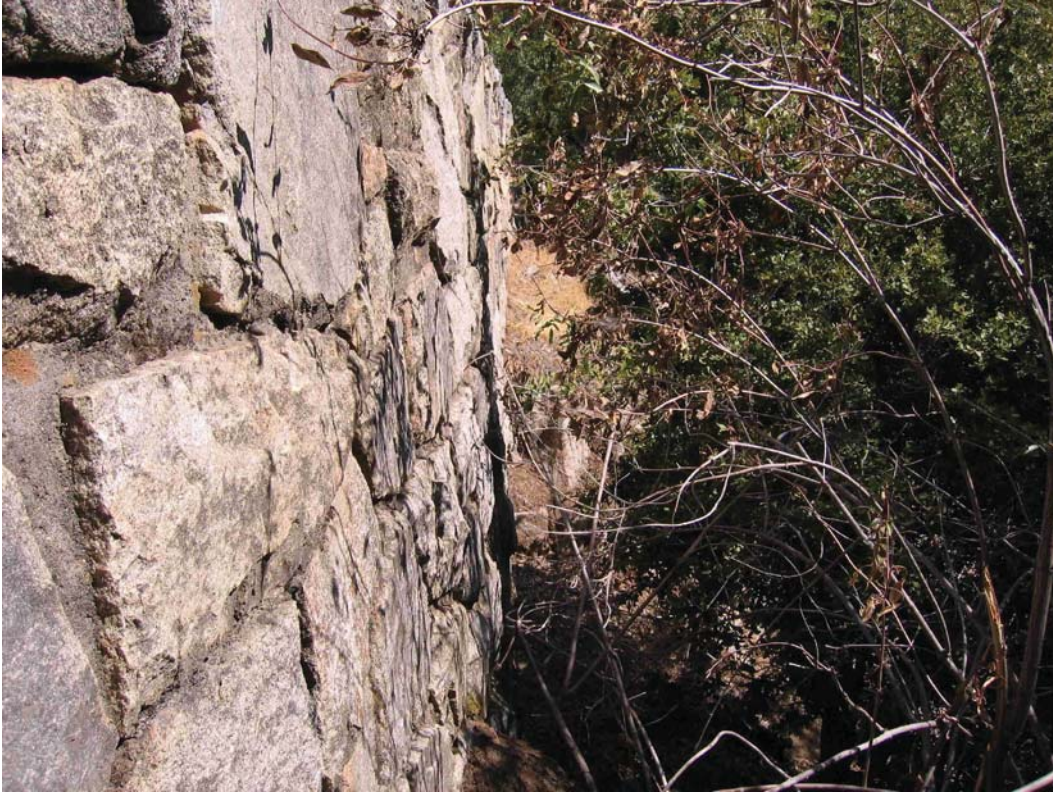
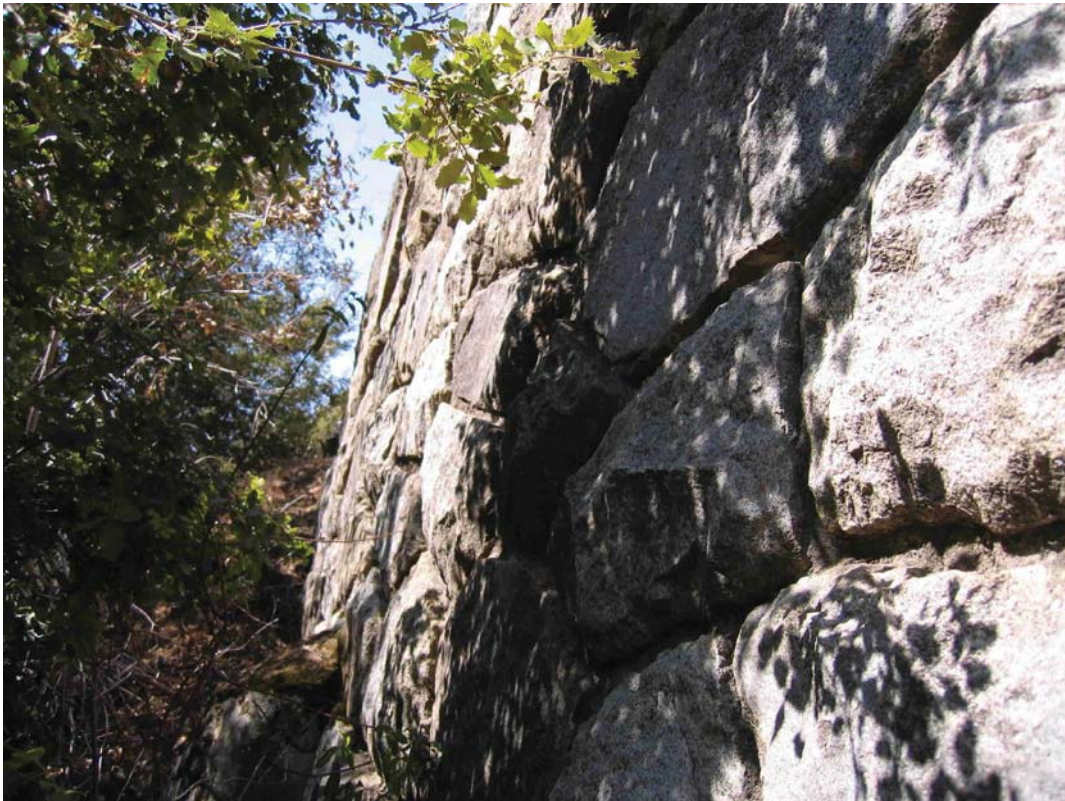
**SEQU\_0010\_11.752\_R\_1.jpg**

<b>Element (Weighting Factor)</b>	<b>Narrative</b>	<b>Condition Rating (0 - 10)</b>
PERFORMANCE 8.00	Good performance. No signs of rotation, global instability or settlement	8
WALL FOUNDATION MATERIAL 8.00	Granite bedrock and 5 ft bench.	8
MORTAR 8.00	Some cracking and missing sections.	7
STONE MASONRY 8.00	Strong, competent granite. No weathering or cracking	8
DOWNSLOPE 0.50	Bedrock, strong competent granite with large trees stable.	8
LATERAL SLOPE 0.50	Minor erosion and steep slope. One end at rock outcrop	8
ROAD/SIDEWALK/SHOULDER 0.50	Some cracking but not related to wall movement.	8
TRAFFIC BARRIER/FENCE 0.50	Intact granite, strong and competent.	8
WALL DRAINS 1.00	No drains visible	7

<b>Failure Consequence:</b>	HIGH
<b>Recommendation Narrative:</b>	Repair a cracked section ( 50 ft2) at \$130/ft2 = \$6500 at beginning of wall
<b>Repair Cost:</b>	\$6,500

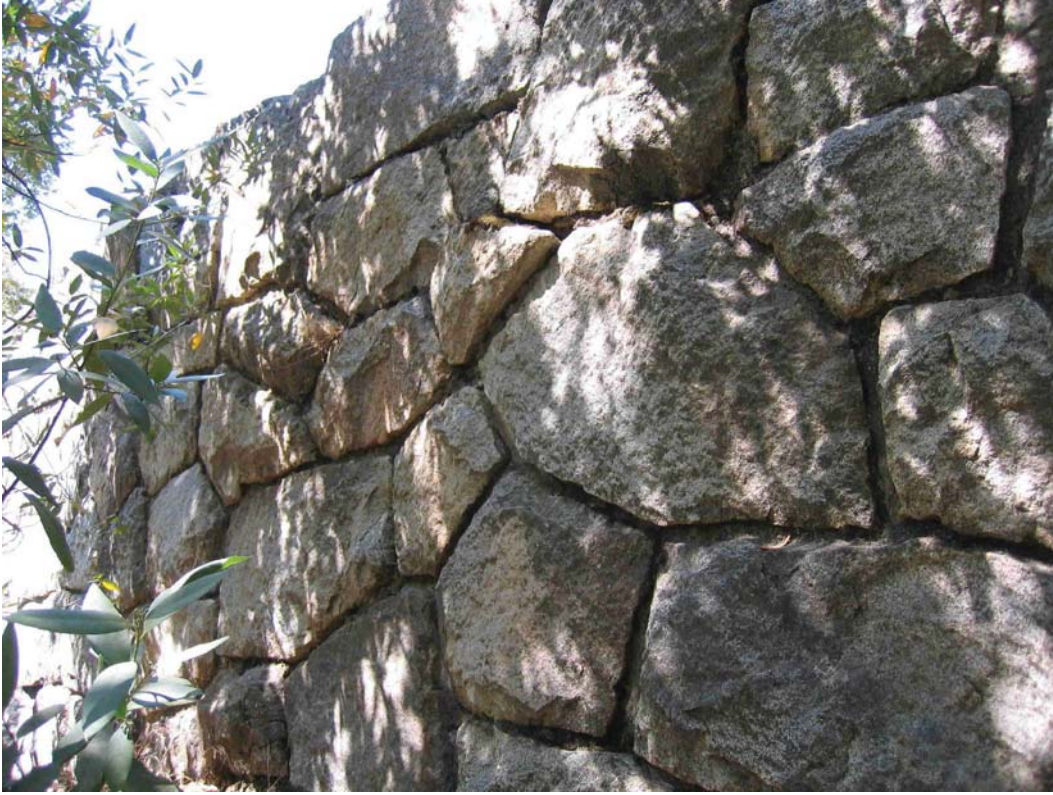
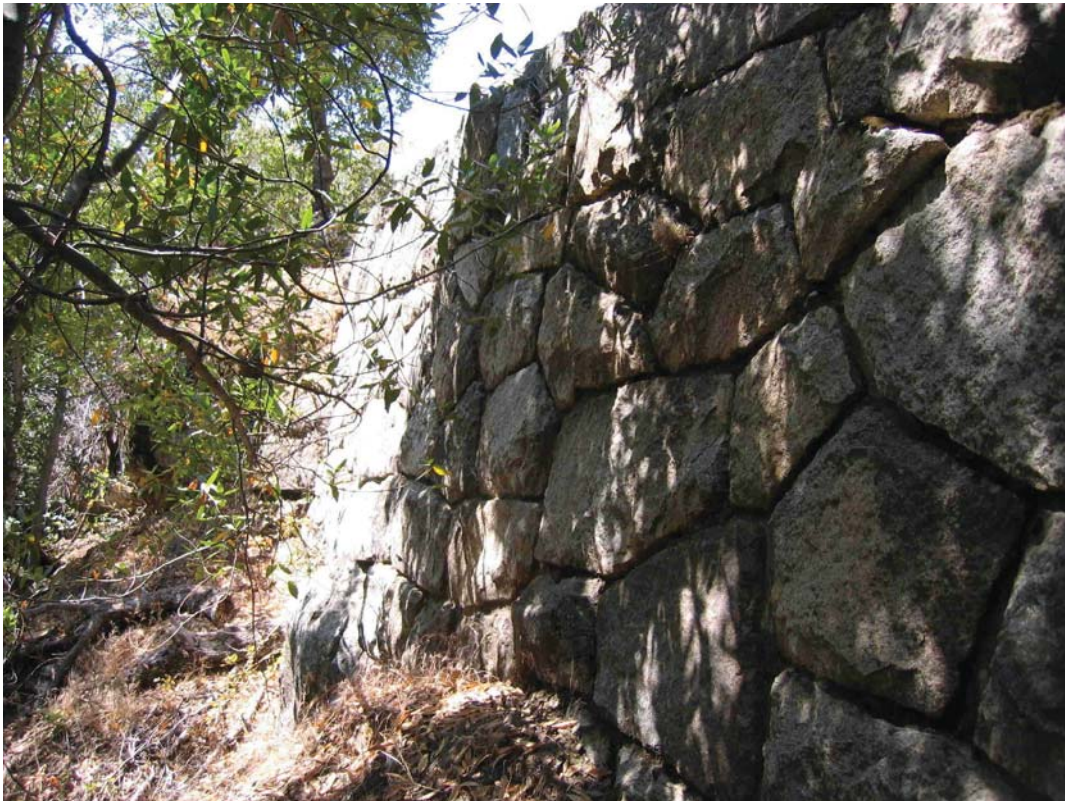
**SEQU\_0010\_11.774\_R\_1.jpg**

<b>Element (Weighting Factor)</b>	<b>Narrative</b>	<b>Condition Rating (0 - 10)</b>
PERFORMANCE 8.00	Good performance. Wall appears to be hit by traffic and shifted at midpoint.	6
WALL FOUNDATION MATERIAL 8.00	Bedrock, granite, strong and competent	8
MORTAR 8.00	Mortar is generally in good condition. Missing segments and some cracking. A large crack in mid wall. (Requires repair)	6
STONE MASONRY 8.00	Strong competent, granite stone. No weathering, some missing elements, a large cracked segment.	6
DOWNSLOPE 0.50	Strong, competent bedrock	8
LATERAL SLOPE 0.50	Minor erosion and steep slope next to rock outcrop.	8
ROAD/SIDEWALK/SHOULDER 1.00	Some cracking due to settlement.	6
TRAFFIC BARRIER/FENCE 1.00	Generally competent and intact. One shifted movement in midpoint.	6
WALL DRAINS 1.00	No wall drains were visible.	7

<b>Failure Consequence:</b>	HIGH
<b>Recommendation Narrative:</b>	Repair a cracked section at mid point of wall (50 ft2) at \$130/ft2 = \$6500
<b>Repair Cost:</b>	\$6,500

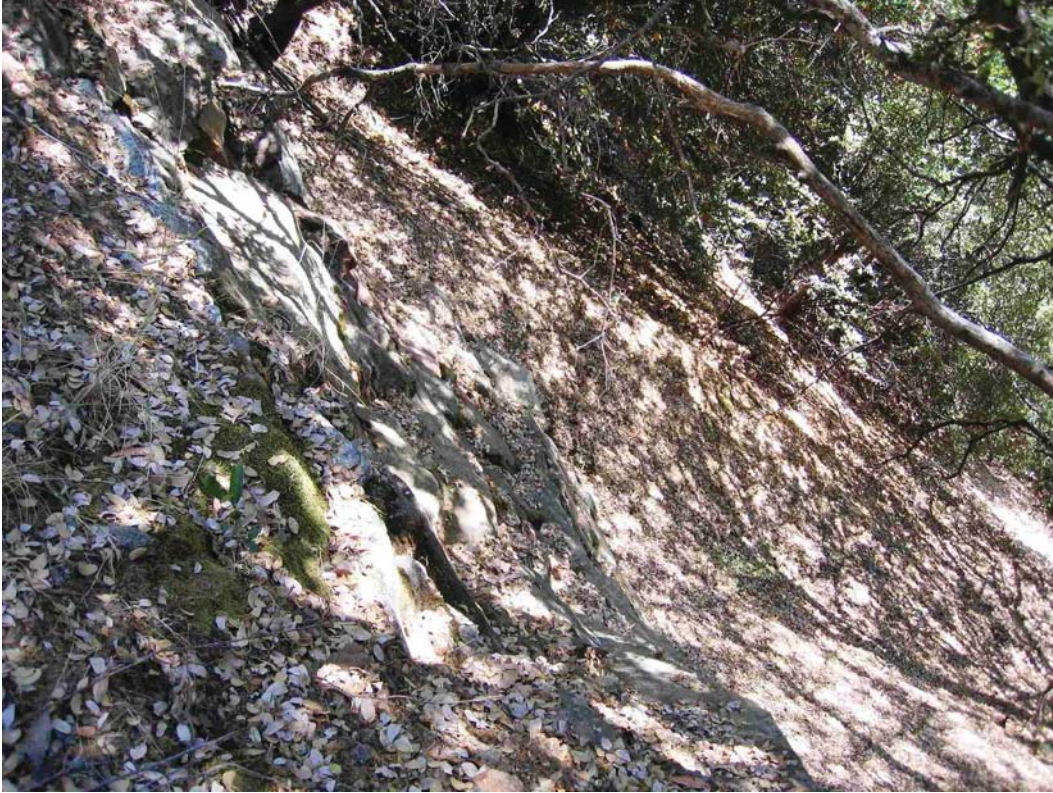
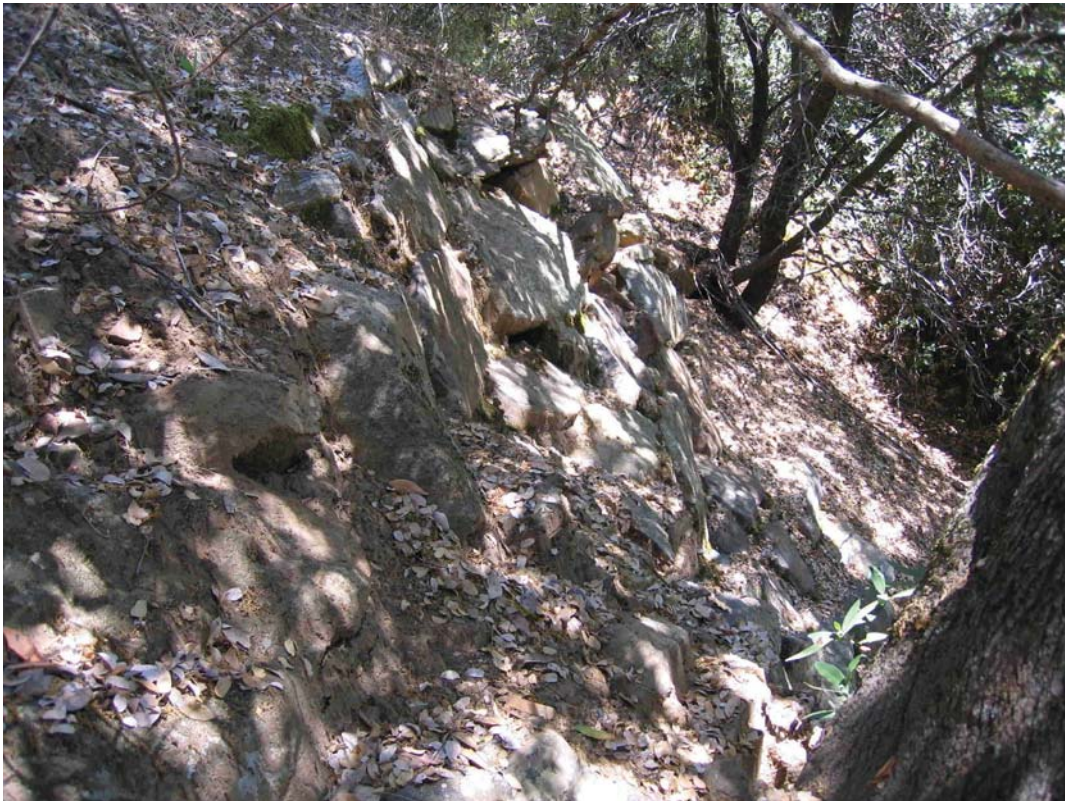
**SEQU\_0010\_11.985\_R\_1.jpg**

<b>Element (Weighting Factor)</b>	<b>Narrative</b>	<b>Condition Rating (0 - 10)</b>
PERFORMANCE 8.00	Good performance. No signs or settlement, rotation or global instability	6
WALL FOUNDATION MATERIAL 8.00	Competent strong fill on bedrock. Very steep .75H:1V some erosion	6
PLACED STONE 8.00	Schist with some weathering.	6
DOWNSLOPE 1.00	Very steep .75H:1V moderate erosion	5
LATERAL SLOPE 1.00	Bedrock will loose fill and eroded	5
ROAD/SIDEWALK/SHOULDER 1.00	Crack due to settlement	5
VEGETATION 1.00	Minor vegetation on wall but not affecting stability	5
WALL DRAINS 1.00	No wall drains were visible	6

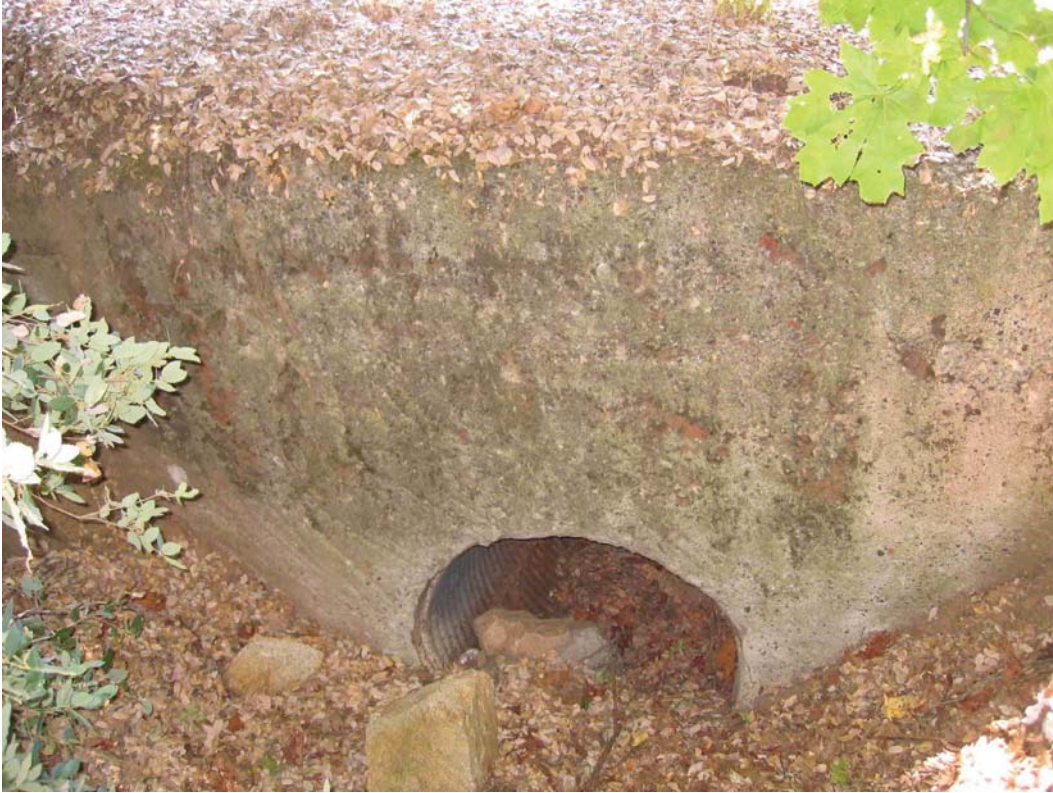
**SEQU\_0010\_12.023\_L\_1.jpg**

<b>Element (Weighting Factor)</b>	<b>Narrative</b>	<b>Condition Rating (0 - 10)</b>
PERFORMANCE 8.00	Good performance. No signs of settlement or movement.	7
WALL FOUNDATION MATERIAL 8.00	Fill with boulders	7
CONCRETE 8.00	Concrete is severely weathered. Aggregate and rebar exposed	5
LATERAL SLOPE 0.50	Bedrock schist with some weathering	8
UPSLOPE 0.50	Bedrock, schist. Good condition.	8
VEGETATION 0.50	No vegetation affecting culvert	8
CULVERT 1.00	4' CMP in moderate condition with some rust but generally good	7
WALL DRAINS 1.00	No drains are visible.	7

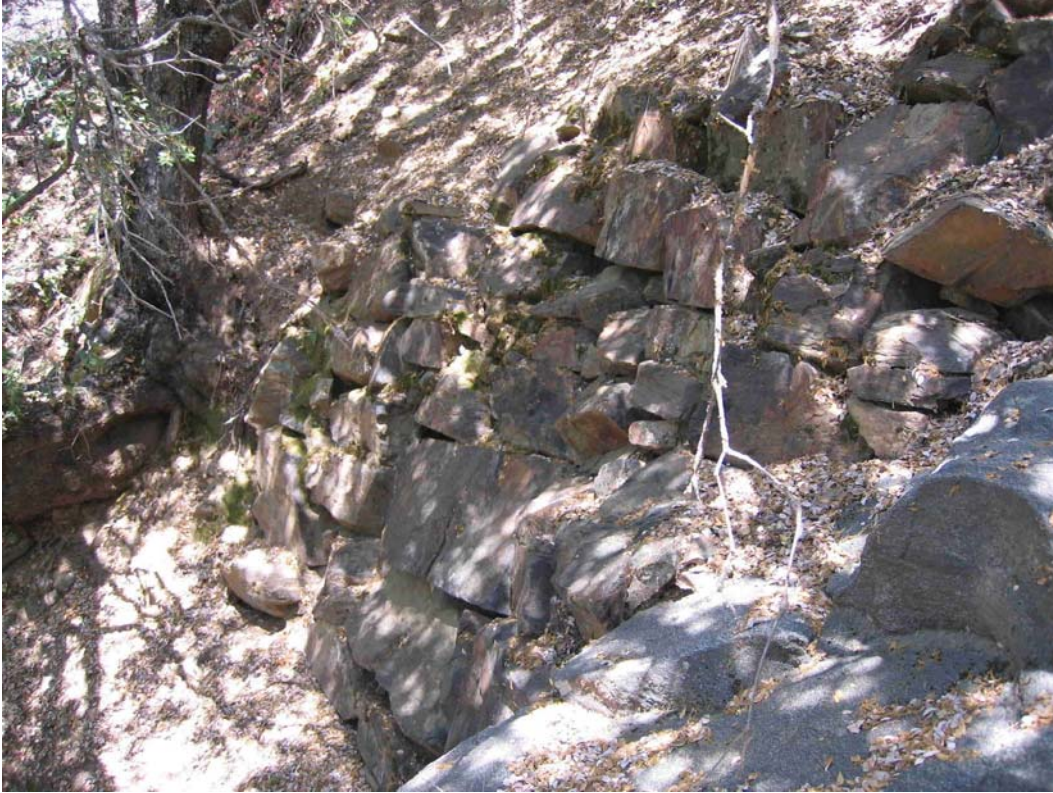
**SEQU\_0010\_12.057\_R\_1.jpg**

<b>Element (Weighting Factor)</b>	<b>Narrative</b>	<b>Condition Rating (0 - 10)</b>
PERFORMANCE 8.00	Good performance. No settlement or rotation.	7
WALL FOUNDATION MATERIAL 8.00	Granite bedrock, strong competent	8
PLACED STONE 8.00	Schist stone, competent strong, slightly weathered.	7
DOWNSLOPE 0.50	Loose materials on bedrock. 1H:1V slope with some erosion.	8
LATERAL SLOPE 0.50	Granite bedrock, strong, competent.	8
VEGETATION 0.50	No vegetation on wall face.	8
CULVERT 1.00	One CMP next to wall in good condition. Not a headwall.	7
WALL DRAINS 1.00	No wall drains were visible.	7

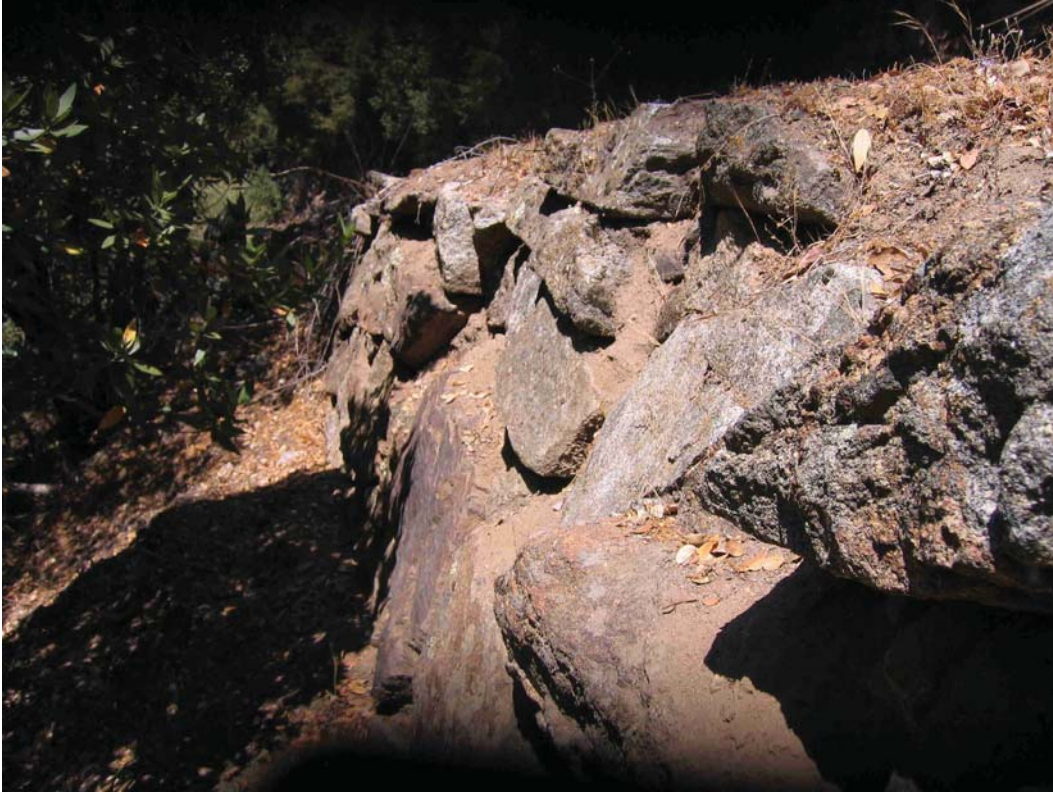
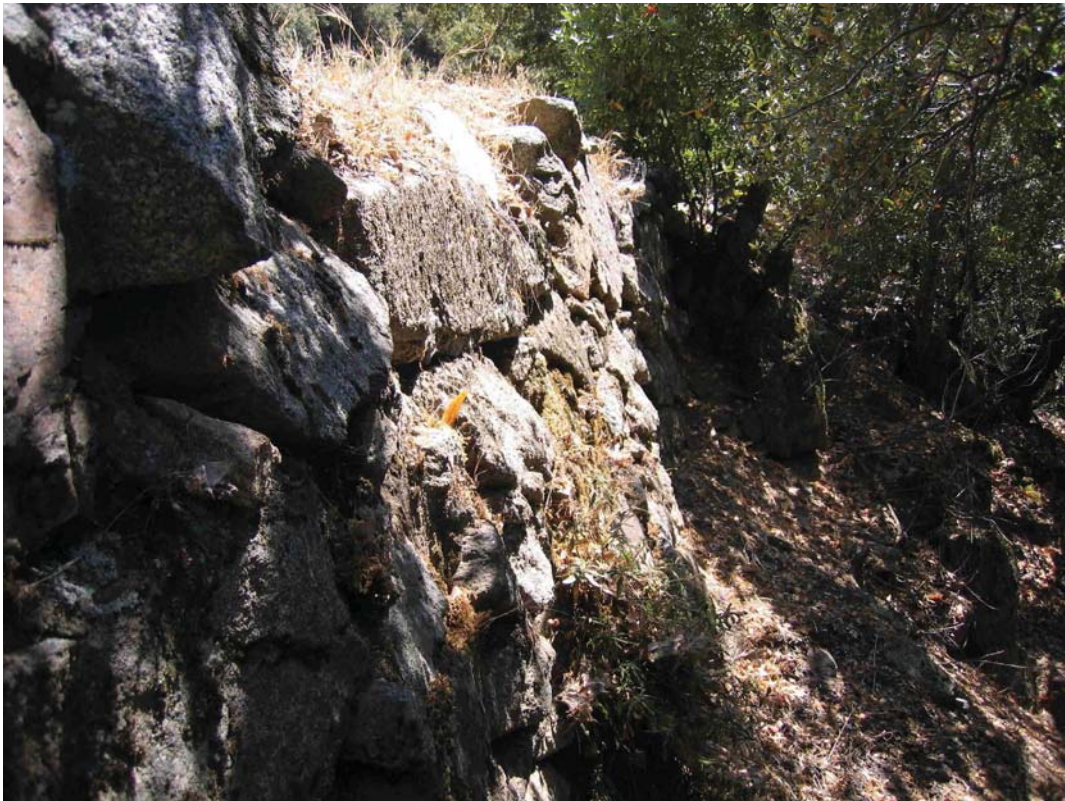
**SEQU\_0010\_12.089\_R\_1.jpg**

<b>Element (Weighting Factor)</b>	<b>Narrative</b>	<b>Condition Rating (0 - 10)</b>
PERFORMANCE 8.00	Good performance. Minor rotation and settlement are observed.	7
WALL FOUNDATION MATERIAL 8.00	Loose fill material will boulder sufficient to support wall.	7
PLACED STONE 8.00	Granite stone, strong competent rock. No weathering or cracking, missing element.	6
LATERAL SLOPE 0.50	Large boulders and bedrock. Minor weathering.	8
DOWNSLOPE 1.00	Loose fill on bedrock steep 1H:1V	7
VEGETATION 1.00	Some vegetation is in the wall. Not affecting all performance.	7
WALL DRAINS 1.00	No wall drains were evident.	7

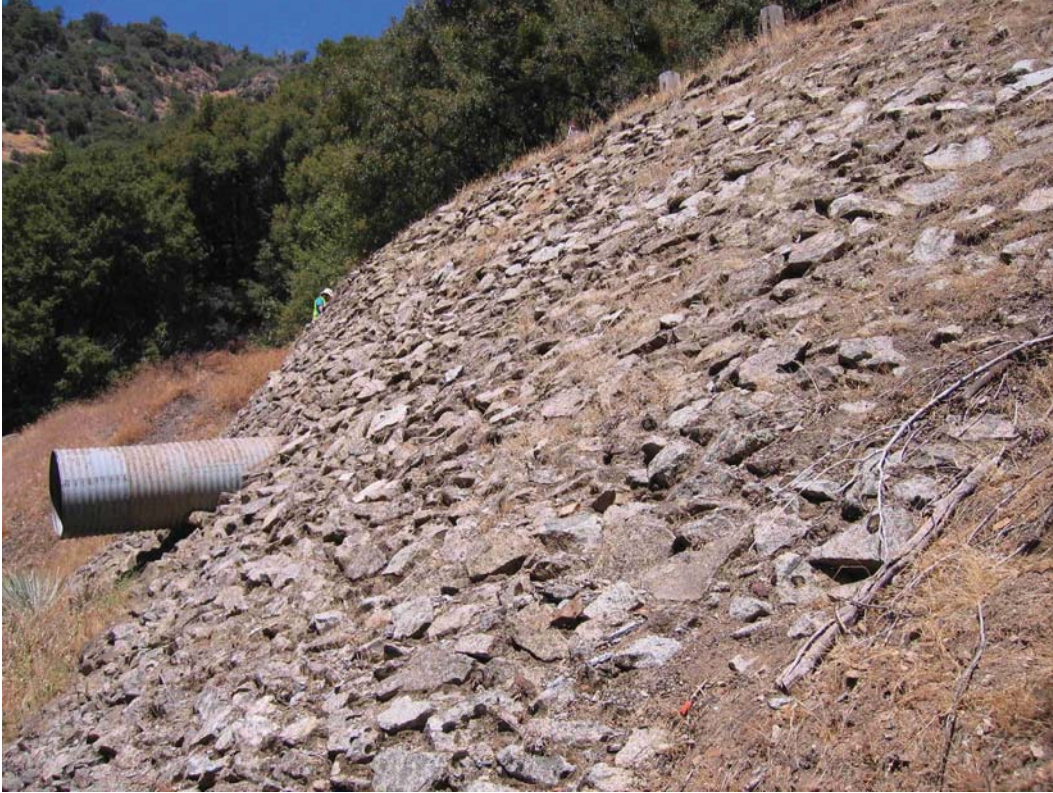
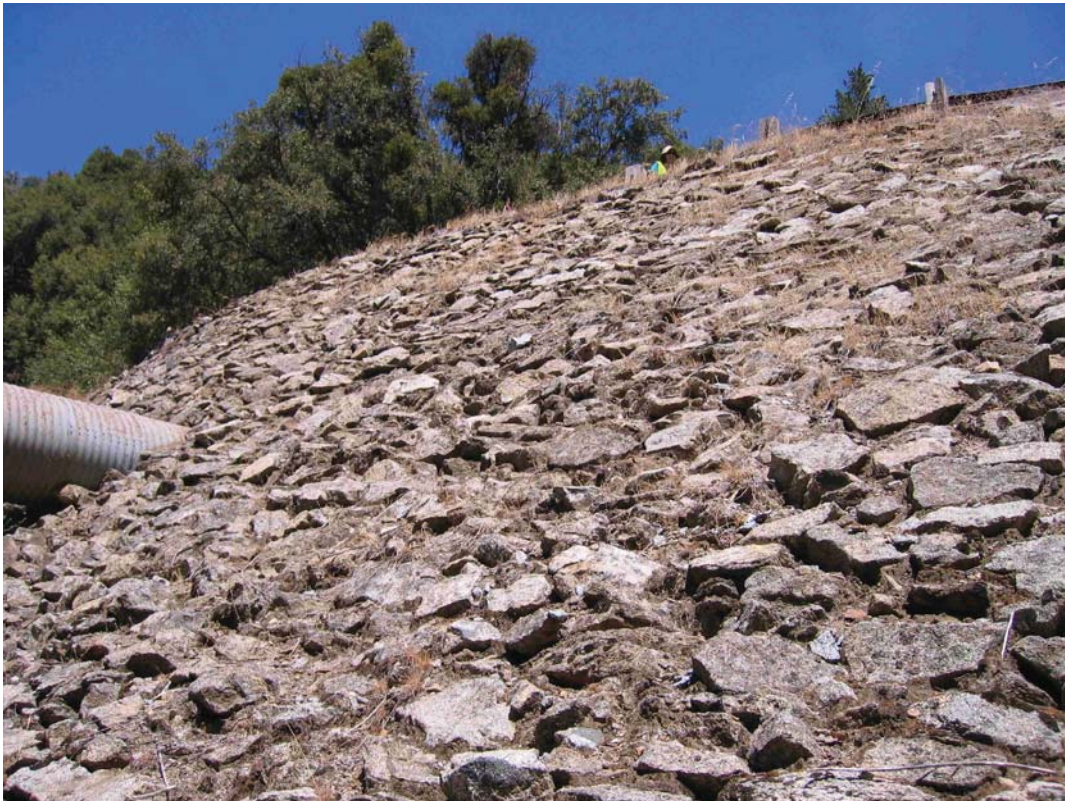
**SEQU\_0010\_12.144\_R\_1.jpg**

<b>Element (Weighting Factor)</b>	<b>Narrative</b>	<b>Condition Rating (0 - 10)</b>
PERFORMANCE 8.00	Good performance. No movement is observed. Strong, competent are light against slopes.	7
WALL FOUNDATION MATERIAL 8.00	Fill is boulders over bedrock.	8
PLACED STONE 8.00	Granite stone slope protection. Strong competent stones, lightly packed against slope. Slightly bulging and missing very few elements.	7
TRAFFIC BARRIER/FENCE 1.00	Guard rail is damaged.	5
CULVERT 1.00	One 24" CMP. Fair condition. Culvert is clean and functional.	7
DOWNSLOPE 1.00	Boulders, drainage relatively flat.	7
LATERAL SLOPE 1.00	Some erosion on one side. Fill material other granite bedrock.	7
ROAD/SIDEWALK/SHOULDER 1.00	Minor transverse cracking. Good condition.	7
WALL DRAINS 1.00	No drains are visible.	7

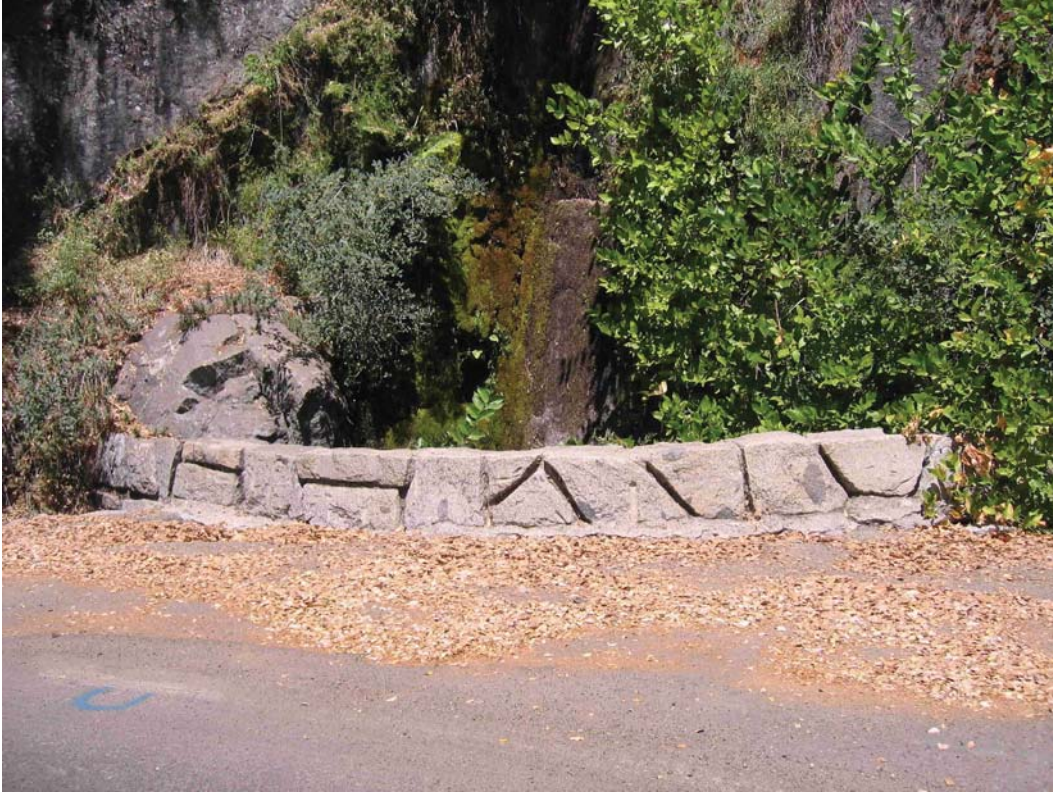
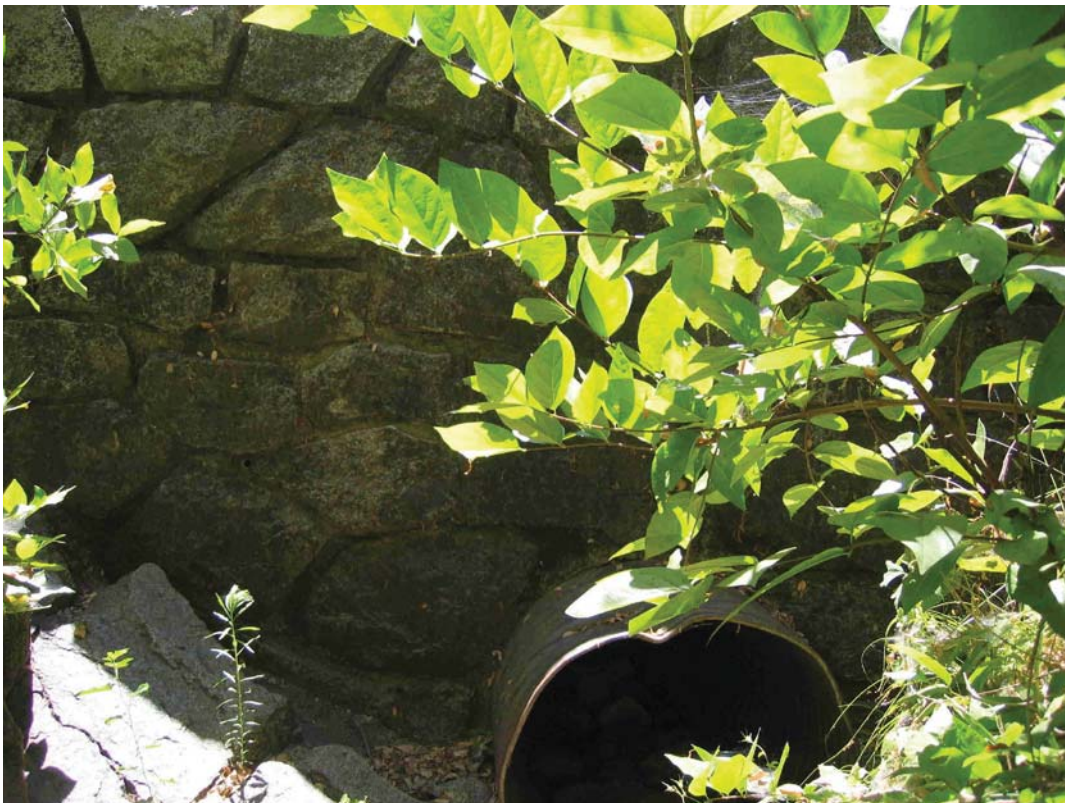
**SEQU\_0010\_12.172\_R\_1.jpg**

<b>Element (Weighting Factor)</b>	<b>Narrative</b>	<b>Condition Rating (0 - 10)</b>
PERFORMANCE 8.00	Excellent performance. No signs of global instability or settlement.	8
WALL FOUNDATION MATERIAL 8.00	Granite bedrock. Strong and competent.	9
MORTAR 8.00	Mortar showed moderate shrinkage.	7
STONE MASONRY 8.00	Granite, strong, competent. No weathering or cracking.	8
ROAD/SIDEWALK/SHOULDER 0.50	No cracking or distress	8
TRAFFIC BARRIER/FENCE 0.50	Mortared masonry granite barrier. Good condition.	8
LATERAL SLOPE 0.50	Bedrock granite. Strong and competent. No erosion.	9
UPSLOPE 0.50	Bedrock Cliff (Granite)	9
WALL DRAINS 1.00	No drains are visible. One pipe in the wall, not sure if used for drainage.	7

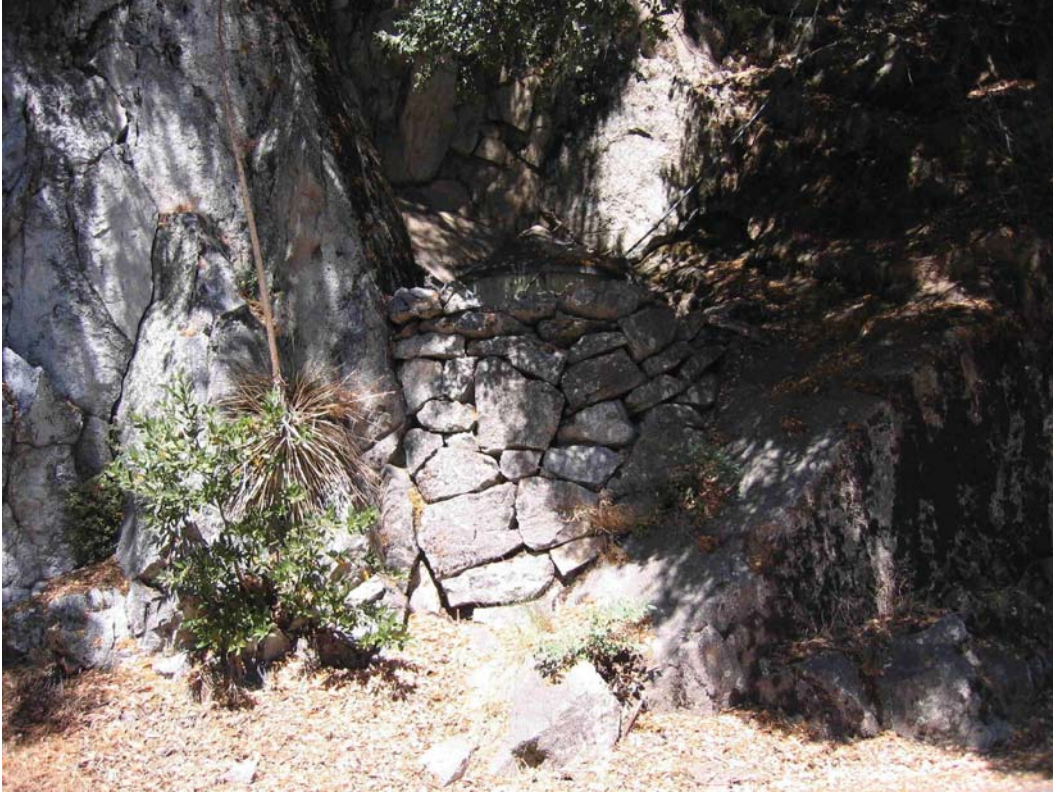
**SEQU\_0010\_12.183\_R\_1.jpg**

<b>Element (Weighting Factor)</b>	<b>Narrative</b>	<b>Condition Rating (0 - 10)</b>
PERFORMANCE 8.00	Excellent performance. Not retaining soil. No movement or global instability exist.	8
WALL FOUNDATION MATERIAL 8.00	Granite bedrock, strong	9
PLACED STONE 8.00	Strong competent granite stone. No weathering or cracking.	8
DOWNSLOPE 0.50	Paved.	8
LATERAL SLOPE 0.50	Bedrock, granite, massive.	8
UPSLOPE 0.50	Bedrock granite massive.	8
VEGETATION 0.50	No vegetation exist on wall face.	8
WALL DRAINS 1.00	No drains are visible.	7

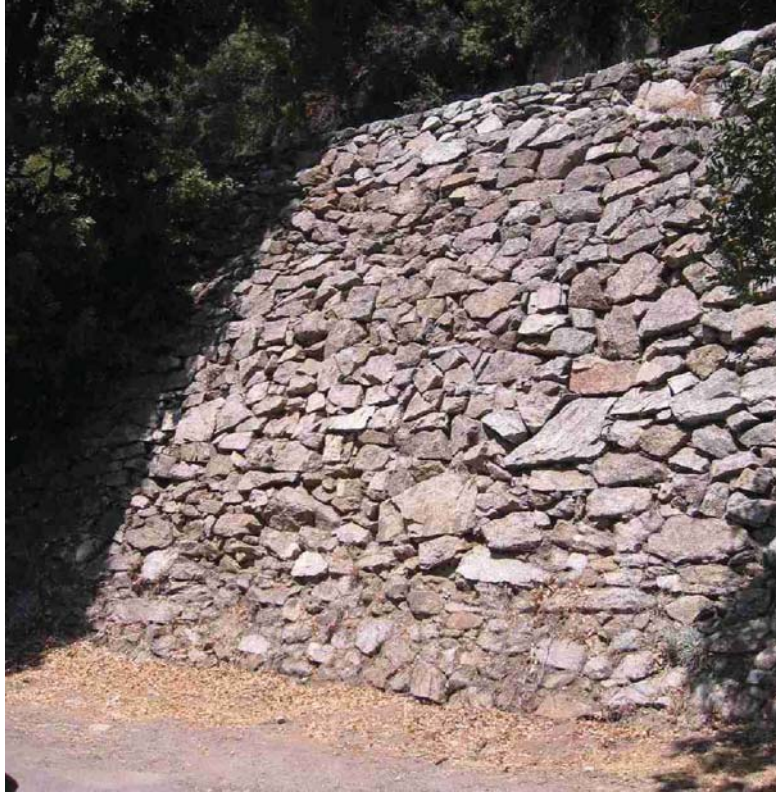
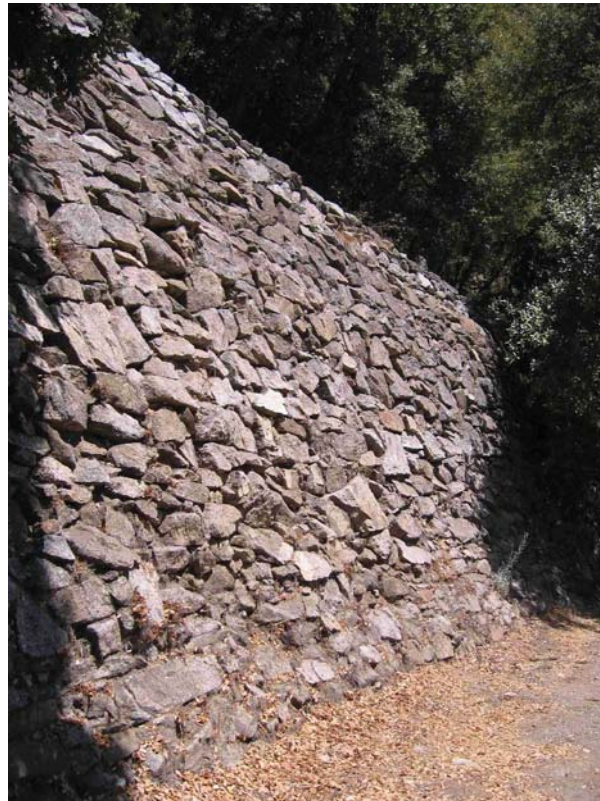
**SEQU\_0010\_12.192\_L\_1.jpg**

<b>Element (Weighting Factor)</b>	<b>Narrative</b>	<b>Condition Rating (0 - 10)</b>
PERFORMANCE 8.00	Good performance. No major rotation, settlement or global failure.	8
WALL FOUNDATION MATERIAL 8.00	Compacted road base with rocks, strong. Sufficient to support wall.	9
PLACED STONE 8.00	Granite, competent, strong, strong. No weathering or cracking. No missing elements. Slight bulging is observed.	7
DOWNSLOPE 0.50	Paved.	8
UPSLOPE 0.50	Paved.	8
LATERAL SLOPE 0.50	Granite bedrock, strong, competent.	9
TRAFFIC BARRIER/FENCE 1.00	Granite guardwall with mortared granite stones. Damage and missing stones.	6
WALL DRAINS 1.00	No wall drains are visible.	7

<b>Failure Consequence:</b>	HIGH
<b>Recommendation Narrative:</b>	Repair parapet 30 lft at \$705 = \$21,150
<b>Repair Cost:</b>	\$21,150

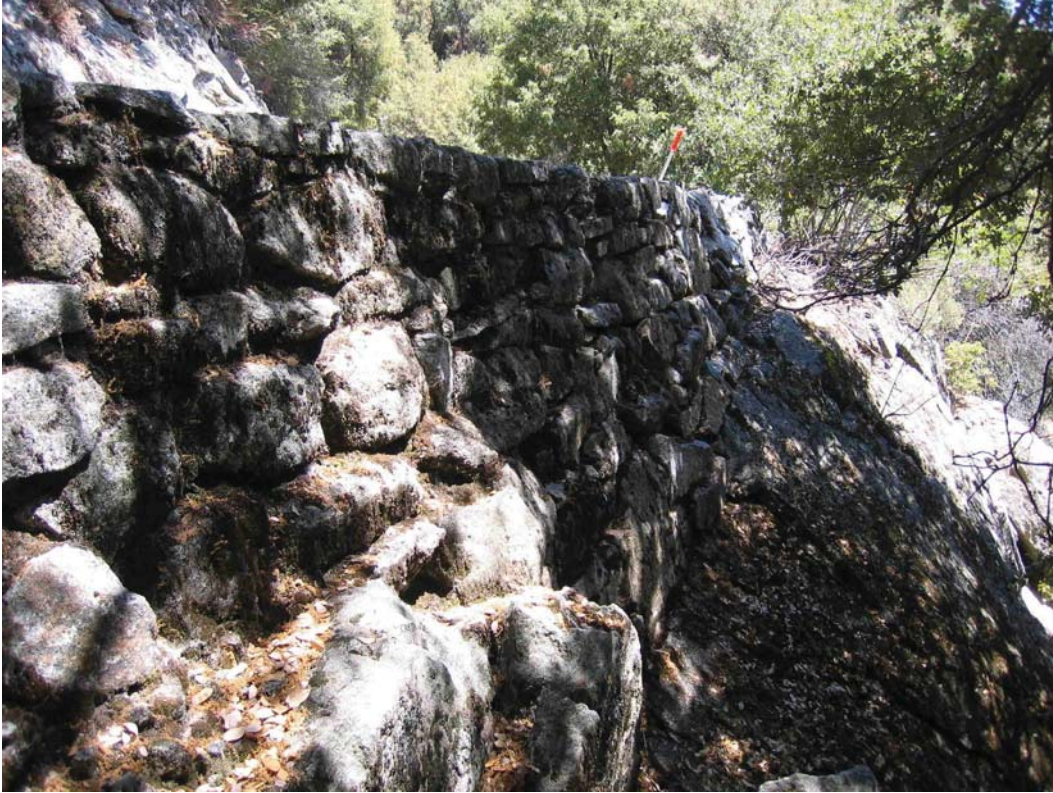
**SEQU\_0010\_12.220\_L\_1.jpg**

<b>Element (Weighting Factor)</b>	<b>Narrative</b>	<b>Condition Rating (0 - 10)</b>
PERFORMANCE 8.00	Good performance.	8
WALL FOUNDATION MATERIAL 8.00	Granite, strong, competent bedrock.	9
MORTAR 8.00	Mortar is in good condition. Not visible due to mold (moss)	7
STONE MASONRY 8.00	Competent, strong granite. No weathering or cracking.	8
ROAD/SIDEWALK/SHOULDER 0.50	No crack or distress caused by wall.	8
TRAFFIC BARRIER/FENCE 0.50	Good condition. Mortared and granite stain.	8
VEGETATION 0.50	No vegetation growing in wall face.	8
DOWNSLOPE 0.50	Granite bedrock, no erosion.	9
LATERAL SLOPE 0.50	Granite bedrock, no erosion.	9

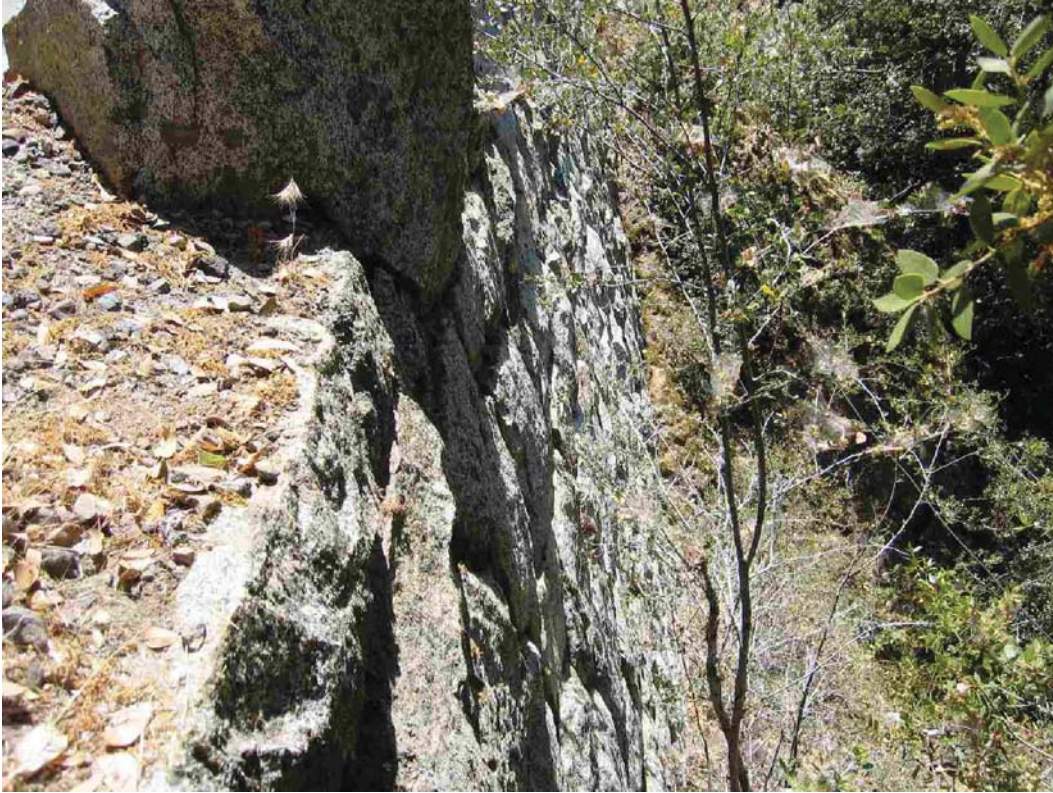
**SEQU\_0010\_12.887\_L\_1.jpg**

<b>Wall ID:</b>	SEQU-0010-12.887-L		
<b>Route Name:</b>	GENERALS HIGHWAY HISTORIC		
<b>Inspection Date:</b>	August 13, 2007	<b>Approximate Year Built:</b>	Unknown
<b>*Wall Rating:</b>	89	<b>Maintenance Action:</b>	No Action

<b>Wall Function:</b>	Fill Wall	<b>Primary Wall Type:</b>	Gravity - Mortared Stone
<b>Surface Treatment:</b>		<b>Secondary Wall Type:</b>	
<b>Secondary Surface Treatment:</b>		<b>Architectural Facing:</b>	
<b>General Description:</b>	Mortared masonry stone wall in excellent condition.

<b>Element (Weighting Factor)</b>	<b>Narrative</b>	<b>Condition Rating (0 - 10)</b>
PERFORMANCE 8.00	Excellent, like new wall.	9
WALL FOUNDATION MATERIAL 8.00	Bedrock and rock fill, very stable.	9
MORTAR 8.00	Good condition, no cracking or shrinking.	8
STONE MASONRY 8.00	Excellent condition, hard, fresh granite, no weathering or distress.	10
LATERAL SLOPE 0.50	Well vegetated, stable soil, no erosion.	8
WALL DRAINS 0.50	None visible but wall appears to be draining well.	8
TRAFFIC BARRIER/FENCE 0.50	Placed boulders near road edge, no wall related distress.	9
ROAD/SIDEWALK/SHOULDER 1.00	Significant settlement and patching is evident.	6

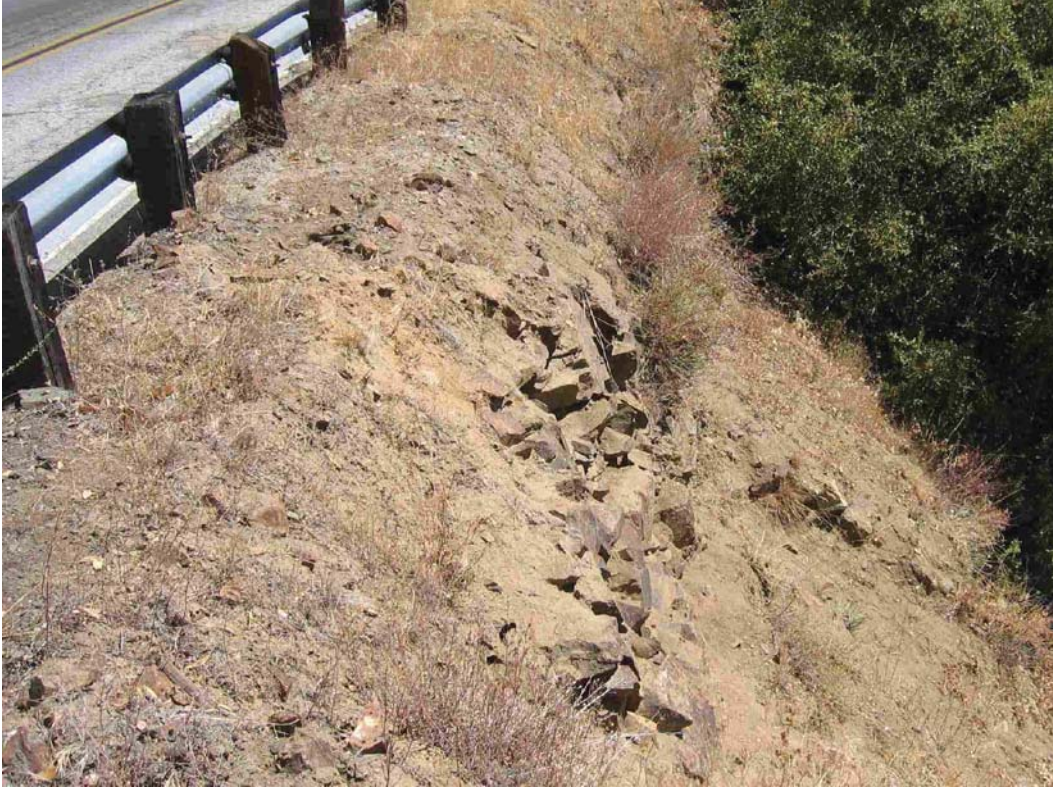
**SEQU\_0010\_12.905\_L\_1.jpg**

<b>Wall ID:</b>	SEQU-0010-12.905-L		
<b>Route Name:</b>	GENERALS HIGHWAY HISTORIC		
<b>Inspection Date:</b>	August 13, 2007	<b>Approximate Year Built:</b>	Unknown
<b>*Wall Rating:</b>	89	<b>Maintenance Action:</b>	No Action

<b>Wall Function:</b>	Fill Wall	<b>Primary Wall Type:</b>	Gravity - Mortared Stone
<b>Surface Treatment:</b>		<b>Secondary Wall Type:</b>	
<b>Secondary Surface Treatment:</b>		<b>Architectural Facing:</b>	
<b>General Description:</b>	Mortared masonry stone wall in excellent condition.

<b>Element (Weighting Factor)</b>	<b>Narrative</b>	<b>Condition Rating (0 - 10)</b>
PERFORMANCE 8.00	Excellent condition, no significant signs of distress.	9
WALL FOUNDATION MATERIAL 8.00	Rock fill and bedrock. No signs of distress.	9
MORTAR 8.00	Good condition, no cracking or shrinking.	8
STONE MASONRY 8.00	Excellent condition, hard, fresh granite, no weathering or distress.	10
LATERAL SLOPE 0.50	Heavily vegetated, no signs of erosion.	8
TRAFFIC BARRIER/FENCE 0.50	Placed boulders on shoulder area.	9
WALL DRAINS 0.50	None visible but wall appears to be draining well.	9
ROAD/SIDEWALK/SHOULDER 1.00	Minor settlement in roadway.	7
VEGETATION 1.00	Brushes growing out of wall.	7

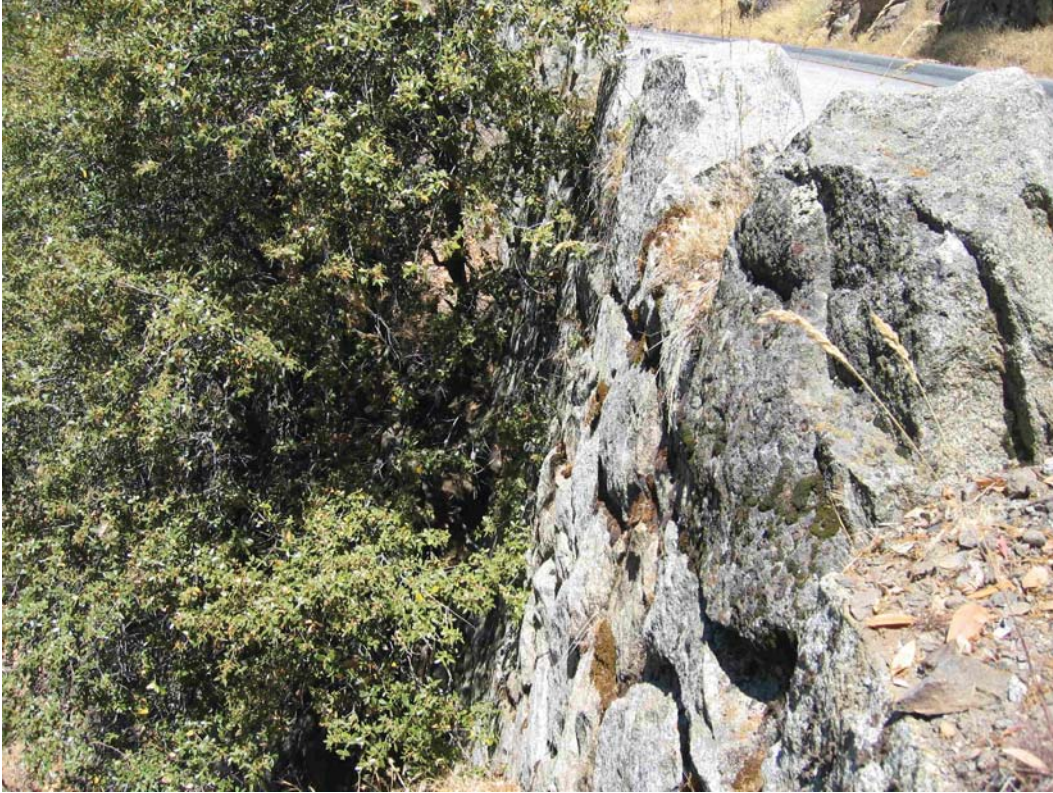
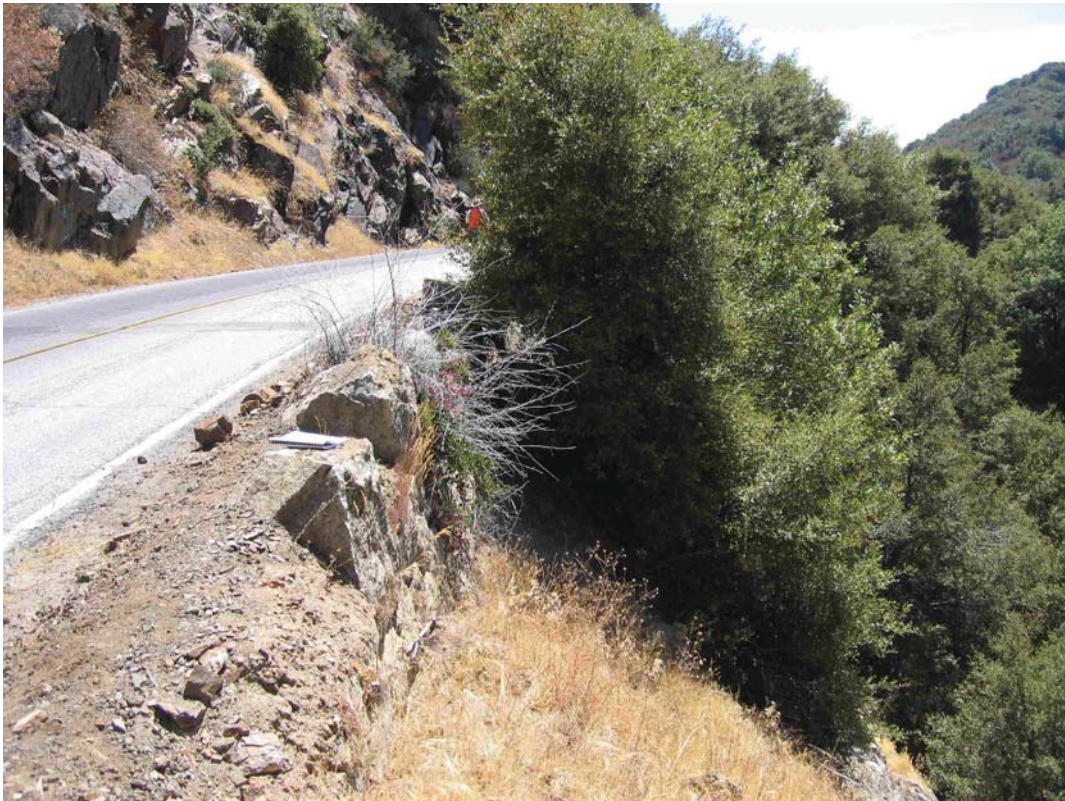
**SEQU\_0010\_12.910\_L\_1.jpg**

<b>Wall ID:</b>	SEQU-0010-12.910-L		
<b>Route Name:</b>	GENERALS HIGHWAY HISTORIC		
<b>Inspection Date:</b>	August 13, 2007	<b>Approximate Year Built:</b>	Unknown
<b>*Wall Rating:</b>	89	<b>Maintenance Action:</b>	Maintenance

<b>Wall Function:</b>	Fill Wall	<b>Primary Wall Type:</b>	Gravity - Mortared Stone
<b>Surface Treatment:</b>		<b>Secondary Wall Type:</b>	
<b>Secondary Surface Treatment:</b>		<b>Architectural Facing:</b>	
<b>General Description:</b>	Mortared masonry stone wall in excellent condition.

<b>Element (Weighting Factor)</b>	<b>Narrative</b>	<b>Condition Rating (0 - 10)</b>
PERFORMANCE 8.00	Excellent overall condition, no signs of distress.	9
WALL FOUNDATION MATERIAL 8.00	Rock fill and bedrock. No signs of distress.	9
MORTAR 8.00	Good condition, no cracking or shrinking.	8
STONE MASONRY 8.00	Excellent condition, hard, fresh granite, no weathering or distress.	10
LATERAL SLOPE 0.50	Heavily vegetated, no signs of erosion.	8
TRAFFIC BARRIER/FENCE 0.50	Placed boulders on shoulder area.	9
WALL DRAINS 0.50	None visible but wall appears to be draining well.	9
ROAD/SIDEWALK/SHOULDER 1.00	Minor settlement in roadway.	7
VEGETATION 1.00	Brush growing out of top of wall.	7

<b>Failure Consequence:</b>	HIGH
<b>Recommendation Narrative:</b>	Remove brush from top of wall: Labor (1 hr) @ \$55.00/hr = \$55.00
<b>Repair Cost:</b>	\$55

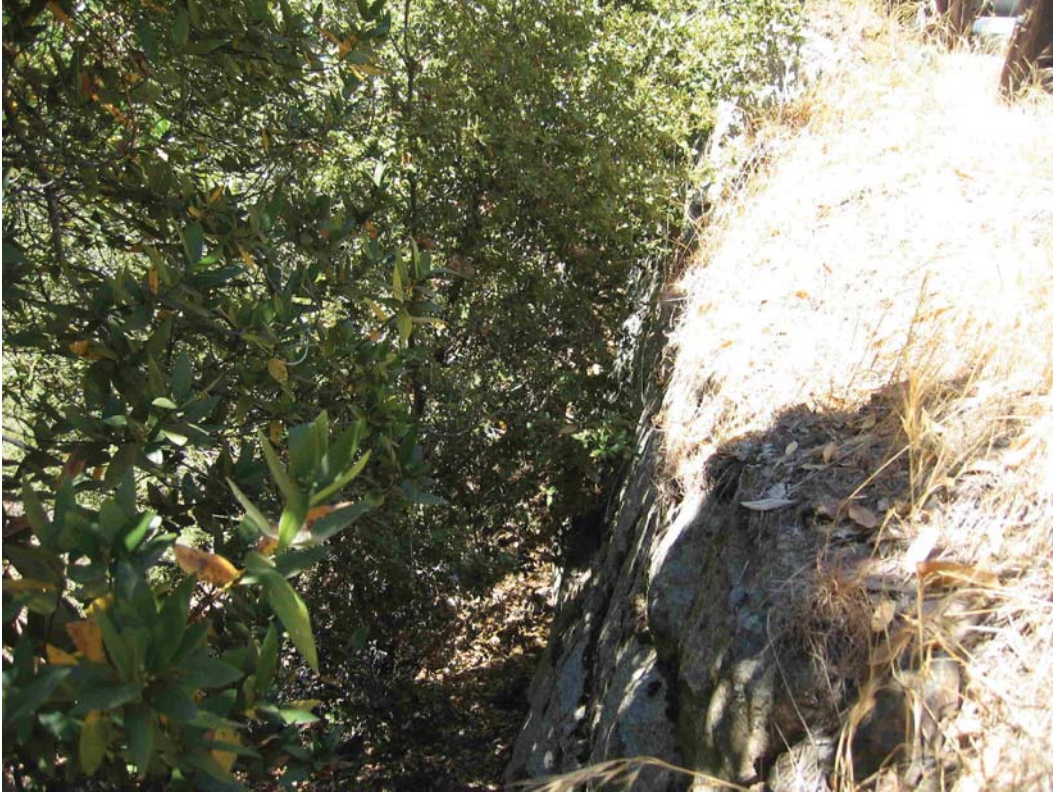
**SEQU\_0010\_13.015\_L\_1.jpg**

<b>Wall ID:</b>	SEQU-0010-13.015-L		
<b>Route Name:</b>	GENERALS HIGHWAY HISTORIC		
<b>Inspection Date:</b>	August 13, 2007	<b>Approximate Year Built:</b>	Unknown
<b>*Wall Rating:</b>	71	<b>Maintenance Action:</b>	Maintenance

<b>Element (Weighting Factor)</b>	<b>Narrative</b>	<b>Condition Rating (0 - 10)</b>
PERFORMANCE 8.00	Wall is showing signs of distress and some stones are missing.	7
WALL FOUNDATION MATERIAL 8.00	Bedrock, some minor erosion.	8
PLACED STONE 8.00	Durable rock, but several missing stones and some were poorly placed.	7
LATERAL SLOPE 0.50	Anchored by big tree on one side. No signs of major distress.	8
TRAFFIC BARRIER/FENCE 0.50	Steel guardrail in good condition.	9
WALL DRAINS 0.50	None visible but wall appears to be draining well.	9
DOWNSLOPE 1.00	Very steep with moderate signs of erosion.	5
ROAD/SIDEWALK/SHOULDER 1.00	Significant cracking, patching, and settlement in the roadway.	6

<b>Failure Consequence:</b>	HIGH
<b>Recommendation Narrative:</b>	Remove brush from wall face: Labor (2 hrs) @ \$55/hr = \$110.00
<b>Repair Cost:</b>	\$110
