# SEQU

## WIP Report

### NPS Retaining Wall Inventory Program Sequoia National Park

**Data Collection Date: August 2007  
Report Date: December 2015**

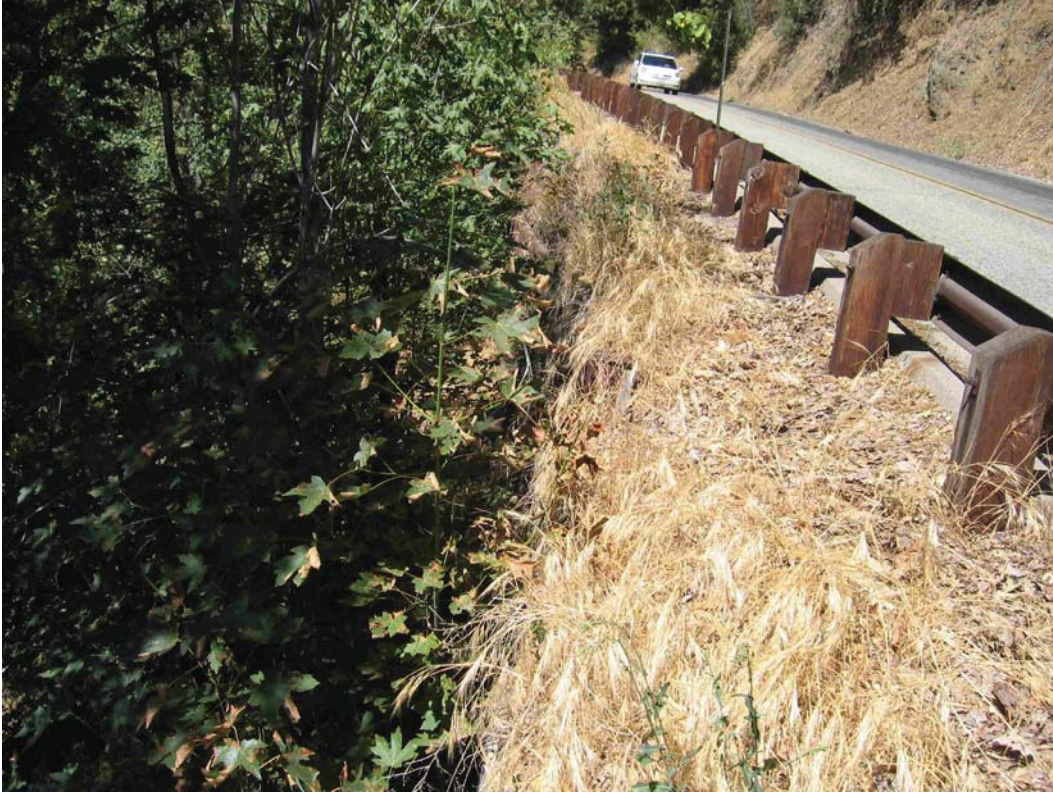
**SEQU\_0010\_13.088\_L\_1.jpg**

<b>Wall ID:</b>	SEQU-0010-13.088-L		
<b>Route Name:</b>	GENERALS HIGHWAY HISTORIC		
<b>Inspection Date:</b>	August 13, 2007	<b>Approximate Year Built:</b>	Unknown
<b>*Wall Rating:</b>	79	<b>Maintenance Action:</b>	No Action

<b>Wall Function:</b>	Fill Wall	<b>Primary Wall Type:</b>	Bin - Metal
<b>Surface Treatment:</b>	Stain	<b>Secondary Wall Type:</b>	
<b>Secondary Surface Treatment:</b>		<b>Architectural Facing:</b>	
<b>General Description:</b>	Metal bin wall, functioning well.

<b>Element (Weighting Factor)</b>	<b>Narrative</b>	<b>Condition Rating (0 - 10)</b>
PERFORMANCE 8.00	Good, no significant signs of distress.	8
WALL FOUNDATION MATERIAL 8.00	Rock fill, stable, no signs of settlement.	8
BIN OR CRIB 8.00	All bins are intact. Minor corrosion, no breaking or cracking, no significant distortion or settlement.	8
DOWNSLOPE 0.50	Moderately vegetated, stable soil.	8
LATERAL SLOPE 0.50	Moderately vegetated, stable soil.	8
TRAFFIC BARRIER/FENCE 0.50	Guardwall, no wall related stress.	8
WALL DRAINS 0.50	None visible but wall appears to be draining well.	9
CURB/BERM/DITCH 1.00	Wall settlement cracking is evident in the asphalt curb.	7
ROAD/SIDEWALK/SHOULDER 1.00	Significant settlement in roadway, some patching of road surface.	7

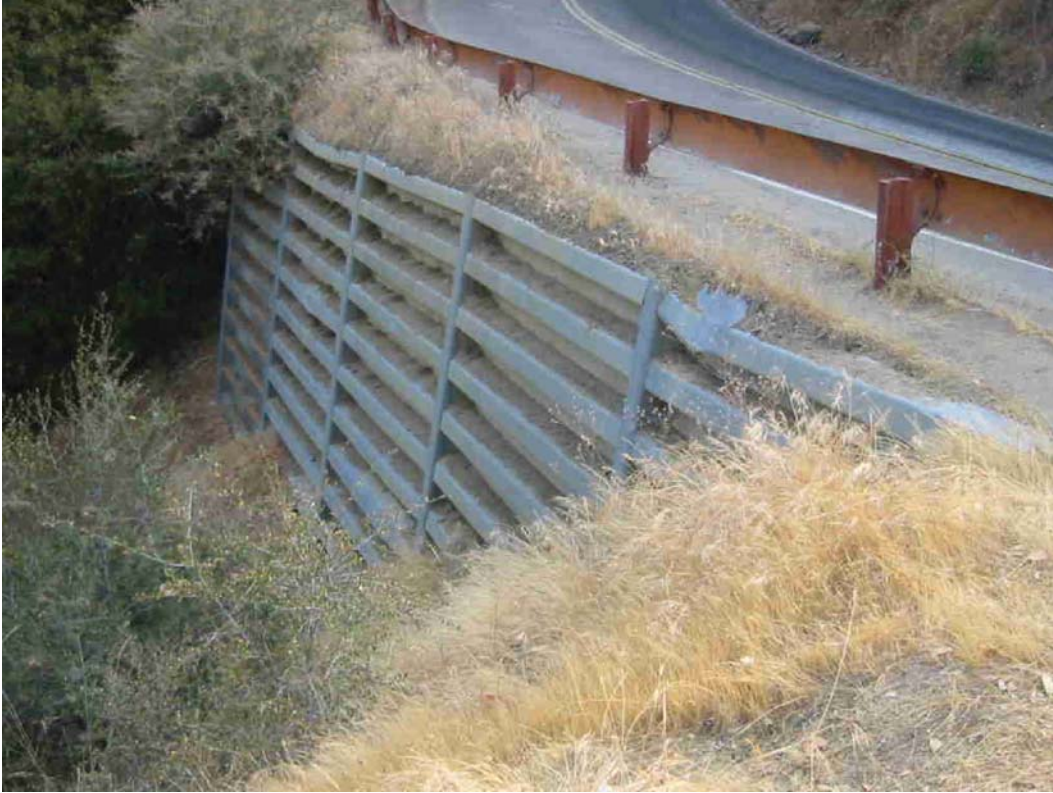
**SEQU\_0010\_13.271\_L\_1.jpg**

<b>Wall ID:</b>	SEQU-0010-13.271-L		
<b>Route Name:</b>	GENERALS HIGHWAY HISTORIC		
<b>Inspection Date:</b>	August 14, 2007	<b>Approximate Year Built:</b>	Unknown
<b>*Wall Rating:</b>	81	<b>Maintenance Action:</b>	Maintenance

<b>Element (Weighting Factor)</b>	<b>Narrative</b>	<b>Condition Rating (0 - 10)</b>
PERFORMANCE 8.00	Good wall, no significant signs of distress.	8
WALL FOUNDATION MATERIAL 8.00	Stable soil, no distress or erosion.	8
BIN OR CRIB 8.00	All bins are intact but there are several dents in the wall beams.	8
ROAD/SIDEWALK/SHOULDER 0.50	Some settlement in the roadway, some patching of road surface.	8
DOWNSLOPE 0.50	Stable soils, no erosion evident.	9
LATERAL SLOPE 0.50	Heavily vegetated, stable soil.	9
TRAFFIC BARRIER/FENCE 0.50	Steel guardrail, no wall related stress.	9
WALL DRAINS 0.50	None visible but wall appears to be draining well.	9

<b>Failure Consequence:</b>	HIGH
<b>Recommendation Narrative:</b>	Remove large bushes and other vegetation from top of wall and wall face areas. Labor (3 hrs) @ \$55.00/hr = \$165.00
<b>Repair Cost:</b>	\$165

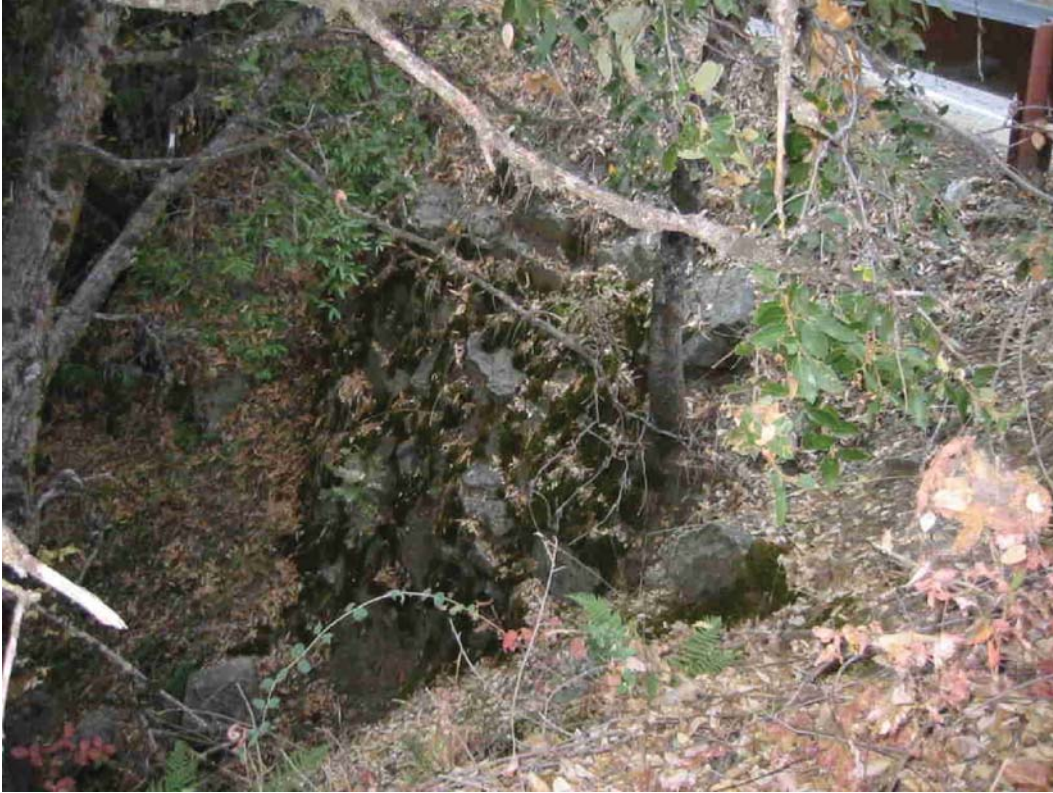
**SEQU\_0010\_13.297\_L\_1.jpg**

<b>Wall ID:</b>	SEQU-0010-13.297-L		
<b>Route Name:</b>	GENERALS HIGHWAY HISTORIC		
<b>Inspection Date:</b>	August 14, 2007	<b>Approximate Year Built:</b>	Unknown
<b>*Wall Rating:</b>	65	<b>Maintenance Action:</b>	No Action

<b>Wall Function:</b>	Fill Wall	<b>Primary Wall Type:</b>	Gravity - Dry Stone
<b>Surface Treatment:</b>		<b>Secondary Wall Type:</b>	
<b>Secondary Surface Treatment:</b>		<b>Architectural Facing:</b>	
<b>General Description:</b>	Old, dry laid stone wall, heavily vegetated, moss covered. Suggest foundation be monitored.

<b>Element (Weighting Factor)</b>	<b>Narrative</b>	<b>Condition Rating (0 - 10)</b>
PERFORMANCE 8.00	Good wall overall for its age, but minor foundation issues; recommend monitoring foundation.	7
WALL FOUNDATION MATERIAL 8.00	Eroding soil at foundation.	5
PLACED STONE 8.00	No significant distress and no movement evident, but some stones are missing.	7
ROAD/SIDEWALK/SHOULDER 0.50	Some settlement in the roadway, some patching of road surface.	8
TRAFFIC BARRIER/FENCE 0.50	Steel guardrail, no wall related distress.	8
WALL DRAINS 0.50	None visible but wall appears to be draining well.	8
LATERAL SLOPE 0.50	Stable soils, no signs of erosion or movement.	9

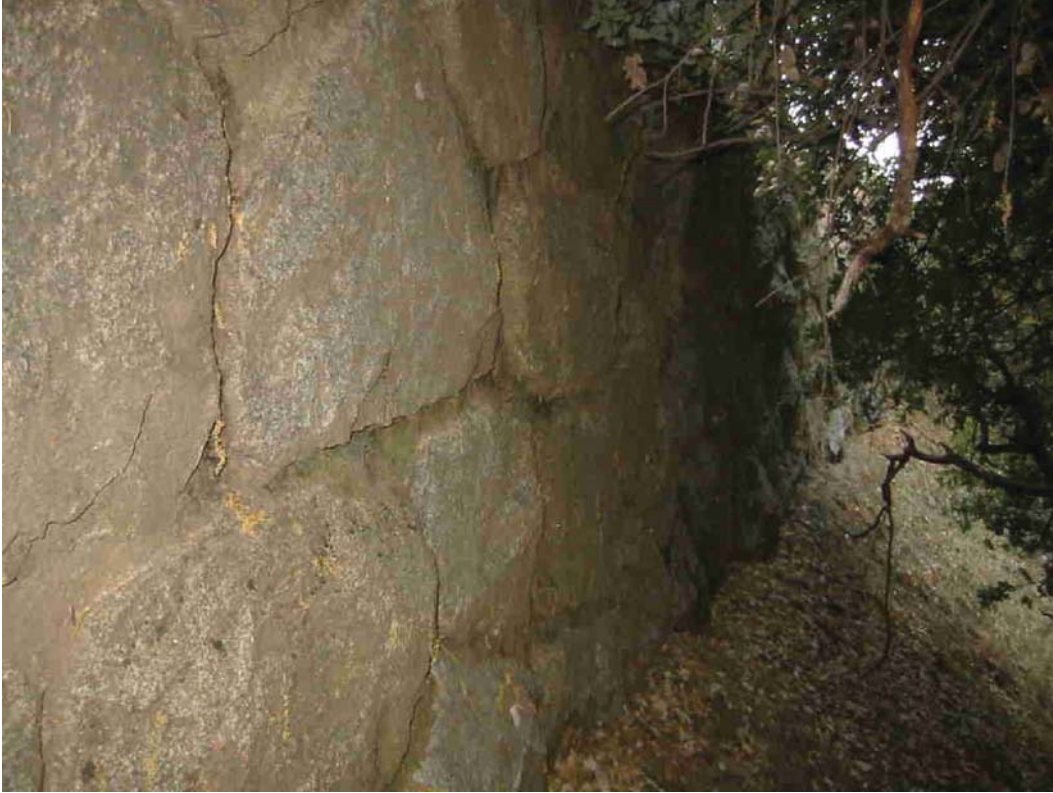
**SEQU\_0010\_13.302\_L\_1.jpg**

<b>Wall ID:</b>	SEQU-0010-13.302-L		
<b>Route Name:</b>	GENERALS HIGHWAY HISTORIC		
<b>Inspection Date:</b>	August 14, 2007	<b>Approximate Year Built:</b>	Unknown
<b>*Wall Rating:</b>	85	<b>Maintenance Action:</b>	No Action

<b>Wall Function:</b>	Fill Wall	<b>Primary Wall Type:</b>	Gravity - Mortared Stone
<b>Surface Treatment:</b>		<b>Secondary Wall Type:</b>	
<b>Secondary Surface Treatment:</b>		<b>Architectural Facing:</b>	
<b>General Description:</b>	Mortared, stone wall in good condition.

<b>Element (Weighting Factor)</b>	<b>Narrative</b>	<b>Condition Rating (0 - 10)</b>
PERFORMANCE 8.00	Good performing wall, no significant distress.	9
WALL FOUNDATION MATERIAL 8.00	Stable soil, no signs of movement or distress.	8
MANUFACTURED BLOCK/BRICK 8.00	Good condition, minor weathering, no signs of distress	8
MORTAR 8.00	Mortar in good condition, no signs of shrinking or cracking.	9
ROAD/SIDEWALK/SHOULDER 0.50	Some settlement in the roadway.	8
LATERAL SLOPE 0.50	Stable slope, no signs of distress, no erosion evident.	9
TRAFFIC BARRIER/FENCE 0.50	Large stones placed intermittently in roadway shoulder area. No signs of distress.	9
WALL DRAINS 0.50	None visible but wall appears to be draining well.	9

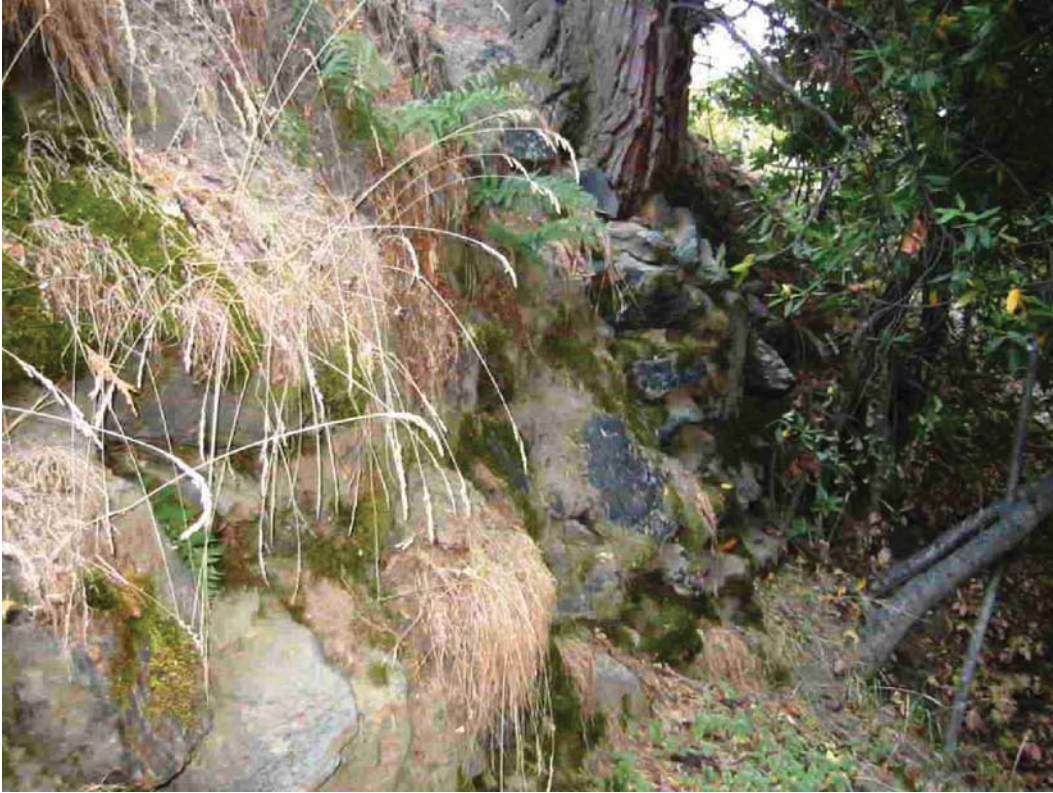
**SEQU\_0010\_13.480\_L\_1.jpg**

<b>Wall ID:</b>	SEQU-0010-13.480-L		
<b>Route Name:</b>	GENERALS HIGHWAY HISTORIC		
<b>Inspection Date:</b>	August 14, 2007	<b>Approximate Year Built:</b>	Unknown
<b>*Wall Rating:</b>	71	<b>Maintenance Action:</b>	No Action

<b>Element (Weighting Factor)</b>	<b>Narrative</b>	<b>Condition Rating (0 - 10)</b>
PERFORMANCE 8.00	Good overall, but the voids in the wall face should be monitored.	7
WALL FOUNDATION MATERIAL 8.00	Stable soil, no signs of distress.	8
PLACED STONE 8.00	Stones in good condition, but covered with soil and vegetation. Some voids in wall face.	6
ROAD/SIDEWALK/SHOULDER 0.50	Minor roadway settlement, some patching of road surface.	8
WALL DRAINS 0.50	None visible but wall appears to be draining well.	8
LATERAL SLOPE 0.50	Moderately vegetated, stable soil. No signs of wall-related stress.	9

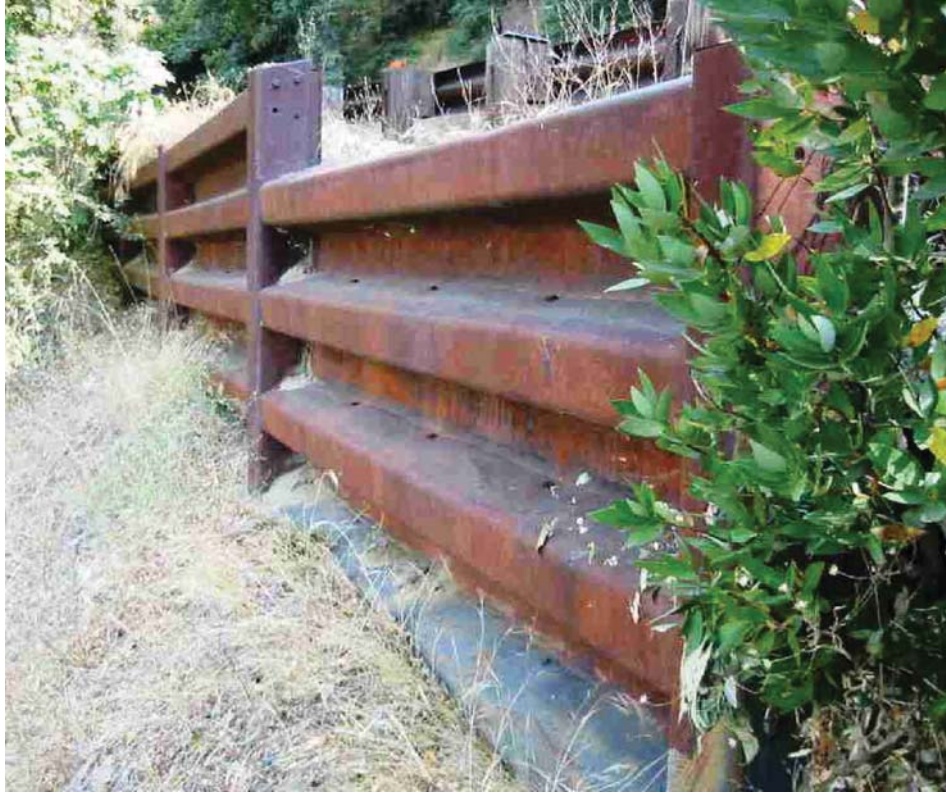
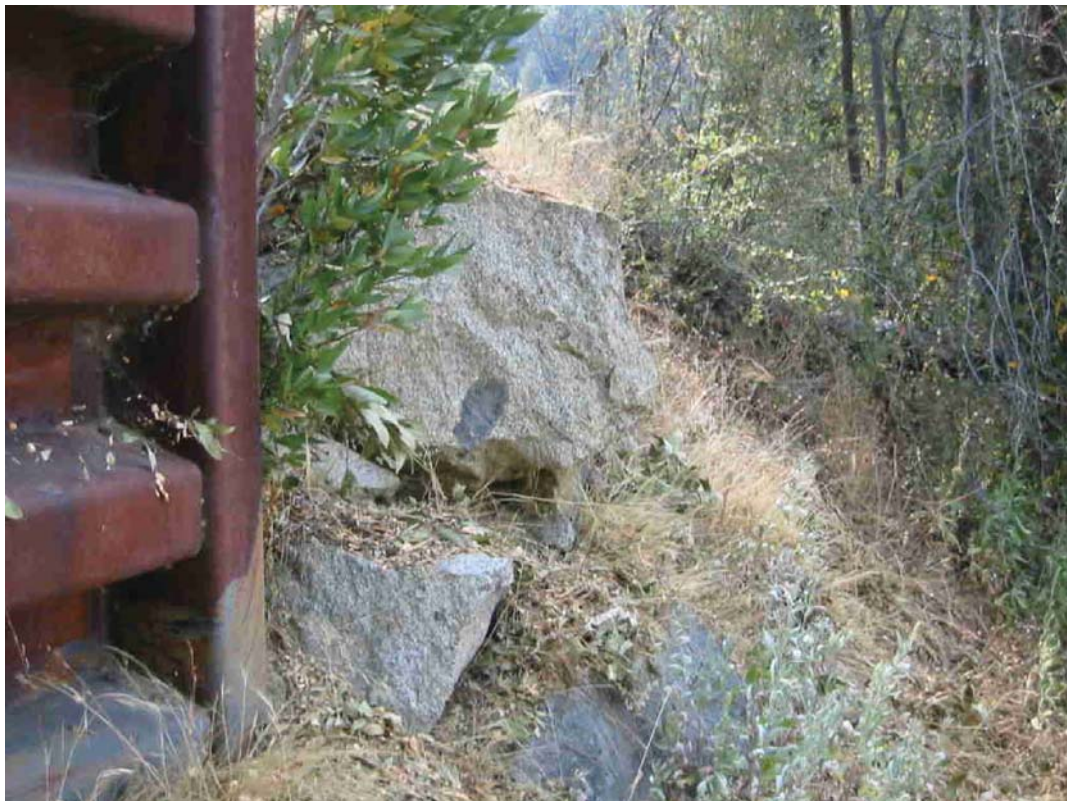
**SEQU\_0010\_13.580\_L\_1.jpg**

<b>Wall ID:</b>	SEQU-0010-13.580-L		
<b>Route Name:</b>	GENERALS HIGHWAY HISTORIC		
<b>Inspection Date:</b>	August 14, 2007	<b>Approximate Year Built:</b>	Unknown
<b>*Wall Rating:</b>	80	<b>Maintenance Action:</b>	No Action

<b>Wall Function:</b>	Fill Wall	<b>Primary Wall Type:</b>	Bin - Metal
<b>Surface Treatment:</b>	Stain	<b>Secondary Wall Type:</b>	
<b>Secondary Surface Treatment:</b>		<b>Architectural Facing:</b>	
<b>General Description:</b>	Steel bin wall in good condition

<b>Element (Weighting Factor)</b>	<b>Narrative</b>	<b>Condition Rating (0 - 10)</b>
PERFORMANCE 8.00	Very good, slight settlement of road to centerline.	8
WALL FOUNDATION MATERIAL 8.00	Stable soil, no distress.	8
BIN OR CRIB 8.00	All bins are intact and in good condition.	8
LATERAL SLOPE 0.50	Good, stable soil; at wall begin stones placed to maintain lateral slope stability (4' H x 6' W).	8
UPSLOPE 0.50	Paved partially at wall begin and end.	8
WALL DRAINS 0.50	None visible but wall appears to be draining well.	8
DOWNSLOPE 0.50	Heavily vegetated, stable soil.	9

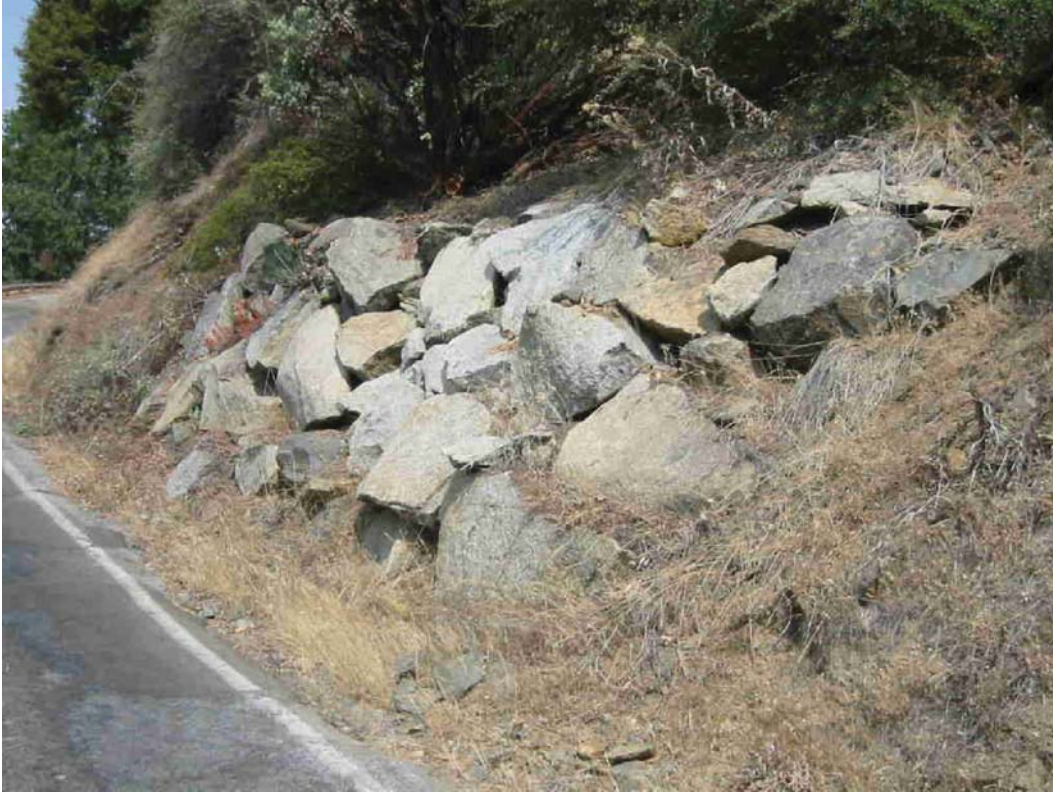
**SEQU\_0010\_13.667\_R\_1.jpg**

<b>Wall ID:</b>	SEQU-0010-13.667-R		
<b>Route Name:</b>	GENERALS HIGHWAY HISTORIC		
<b>Inspection Date:</b>	August 14, 2007	<b>Approximate Year Built:</b>	Unknown
<b>*Wall Rating:</b>	90	<b>Maintenance Action:</b>	No Action

<b>Wall Function:</b>	Cut Wall	<b>Primary Wall Type:</b>	Gravity - Dry Stone
<b>Surface Treatment:</b>		<b>Secondary Wall Type:</b>	
<b>Secondary Surface Treatment:</b>		<b>Architectural Facing:</b>	
<b>General Description:</b>	Dry laid rockery cut wall in excellent condition.

<b>Element (Weighting Factor)</b>	<b>Narrative</b>	<b>Condition Rating (0 - 10)</b>
PERFORMANCE 8.00	Performing well as designed.	9
WALL FOUNDATION MATERIAL 8.00	Stable bedrock and roadway.	9
PLACED STONE 8.00	Excellent condition.	9
LATERAL SLOPE 0.50	Stable, no signs of erosion.	9
ROAD/SIDEWALK/SHOULDER 0.50	No wall induced stress.	9
UPSLOPE 0.50	Stable soils, no signs of erosion.	9
WALL DRAINS 0.50	None visible but wall appears to be draining well.	10

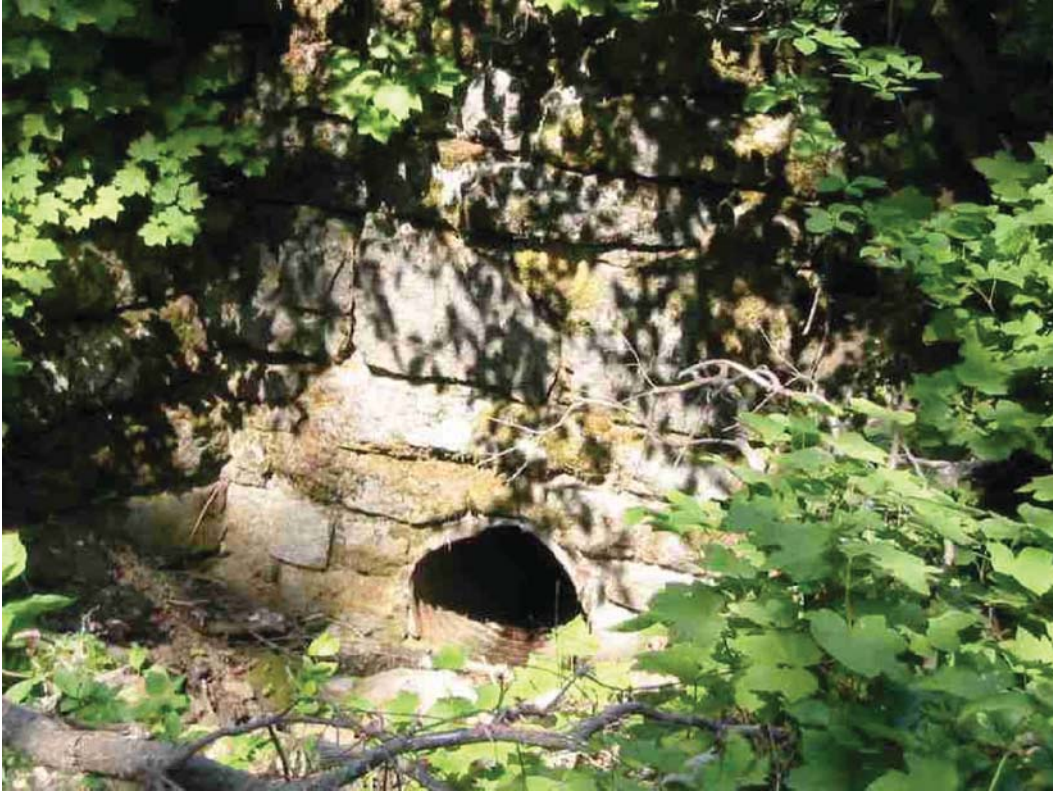
**SEQU\_0010\_15.945\_R\_1.jpg**

<b>Wall ID:</b>	SEQU-0010-15.945-R		
<b>Route Name:</b>	GENERALS HIGHWAY HISTORIC		
<b>Inspection Date:</b>	August 14, 2007	<b>Approximate Year Built:</b>	Unknown
<b>*Wall Rating:</b>	90	<b>Maintenance Action:</b>	No Action

<b>Wall Function:</b>	Head Wall	<b>Primary Wall Type:</b>	Gravity - Mortared Stone
<b>Surface Treatment:</b>		<b>Secondary Wall Type:</b>	
<b>Secondary Surface Treatment:</b>		<b>Architectural Facing:</b>	
<b>General Description:</b>	Mortared stone culvert head wall with wing walls at a pullout in good condition.

<b>Element (Weighting Factor)</b>	<b>Narrative</b>	<b>Condition Rating (0 - 10)</b>
PERFORMANCE 8.00	Excellent wall, performing as designed.	9
WALL FOUNDATION MATERIAL 8.00	Very good, stable soil and rock.	9
MORTAR 8.00	Good condition, no signs of shrinking or cracking, a few small voids.	9
PLACED STONE 8.00	Good condition, no signs of weathering or corrosion.	9
CULVERT 0.50	Very rusty culvert, but not critical.	8
ARCHITECTURAL FACING 0.50	Not visible, but wall appears to be draining well.	9
LATERAL SLOPE 0.50	No signs of distress, no erosion, stable soil.	9
WALL DRAINS 0.50	None visible but wall appears to be draining well.	9

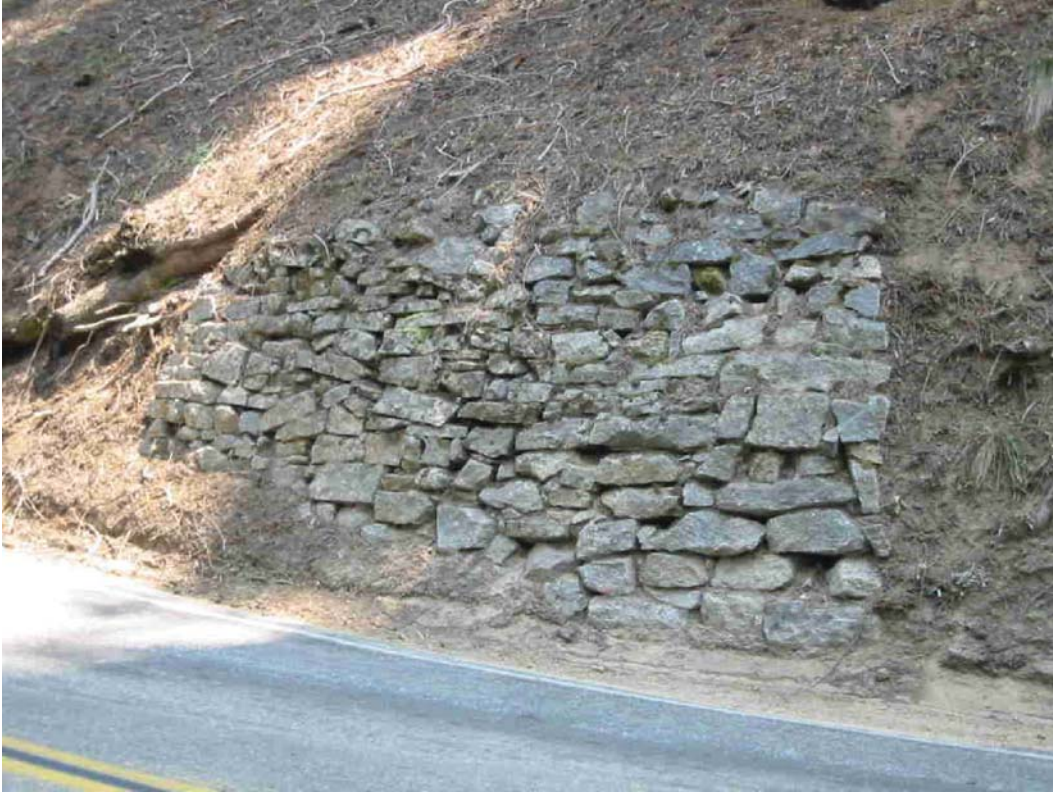
**SEQU\_0010\_18.813\_R\_1.jpg**

<b>Wall ID:</b>	SEQU-0010-18.813-R		
<b>Route Name:</b>	GENERALS HIGHWAY HISTORIC		
<b>Inspection Date:</b>	August 14, 2007	<b>Approximate Year Built:</b>	1933
<b>*Wall Rating:</b>	83	<b>Maintenance Action:</b>	No Action

<b>Element (Weighting Factor)</b>	<b>Narrative</b>	<b>Condition Rating (0 - 10)</b>
PERFORMANCE 8.00	Good condition, no signs of bulging, no voids, no signs of unsettling.	8
WALL FOUNDATION MATERIAL 8.00	Stable soil foundation.	9
PLACED STONE 8.00	Hand placed stones, minor settling, no major distress.	8
LATERAL SLOPE 0.50	Stable soil and decomposed rock, no signs of erosion.	8
WALL DRAINS 0.50	None visible, but wall appears to be draining well.	8

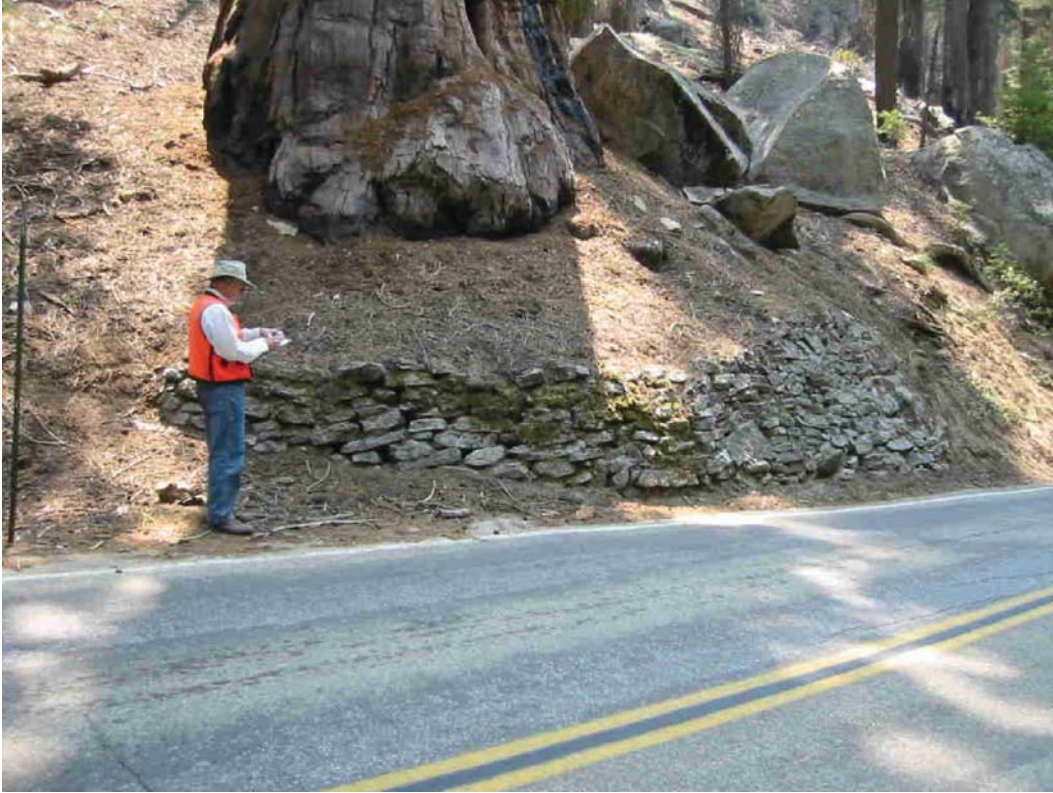
**SEQU\_0010\_18.913\_R\_1.jpg**

<b>Wall ID:</b>	SEQU-0010-18.913-R		
<b>Route Name:</b>	GENERALS HIGHWAY HISTORIC		
<b>Inspection Date:</b>	August 14, 2007	<b>Approximate Year Built:</b>	1933
<b>*Wall Rating:</b>	83	<b>Maintenance Action:</b>	No Action

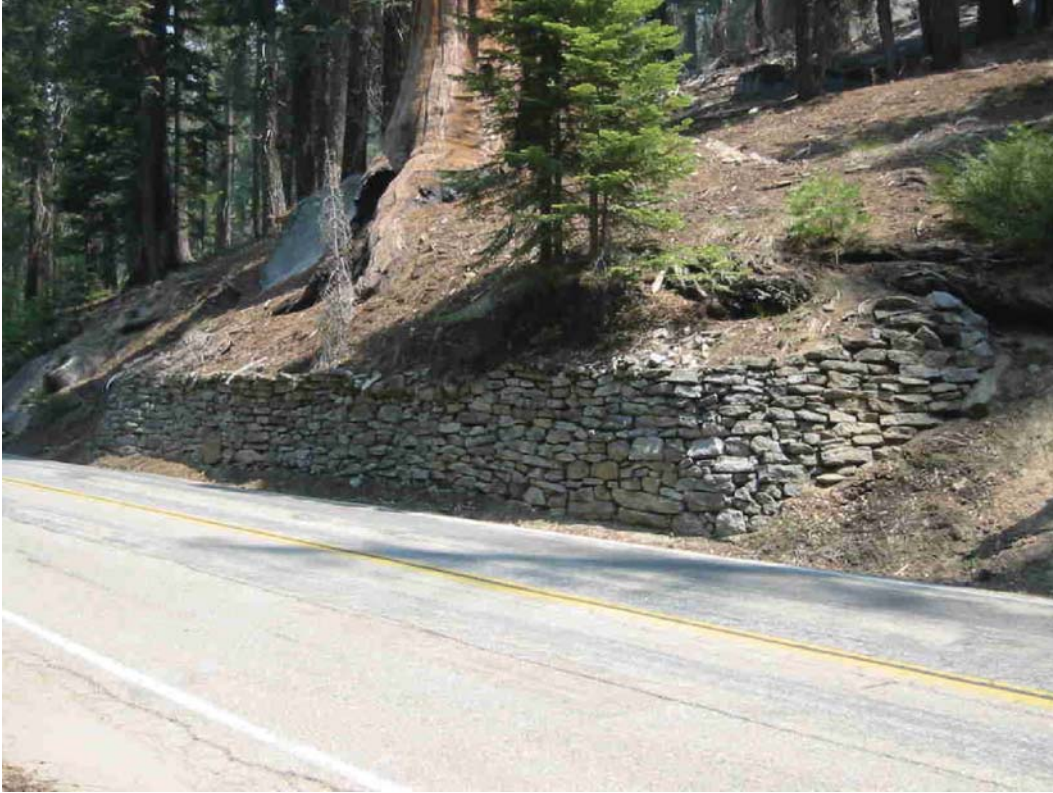
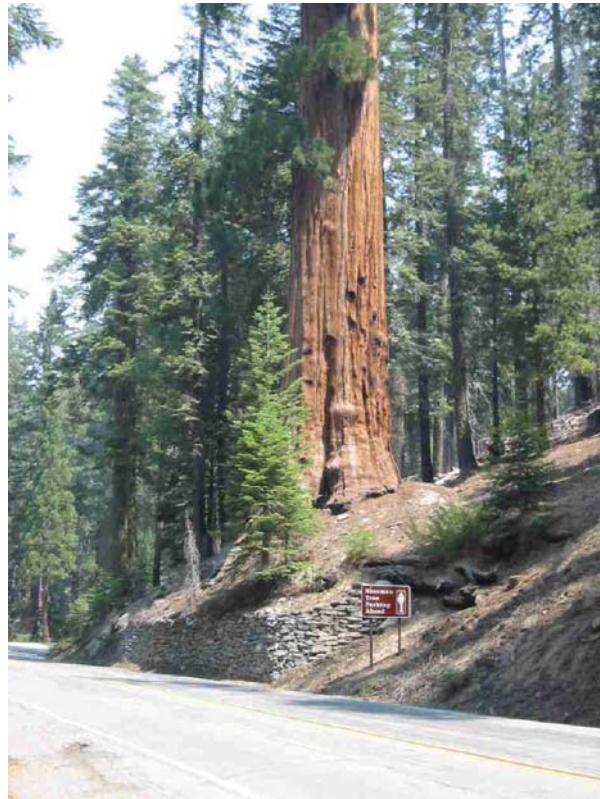
**SEQU\_0010\_18.974\_R\_1.jpg**

<b>Wall ID:</b>	SEQU-0010-18.974-R		
<b>Route Name:</b>	GENERALS HIGHWAY HISTORIC		
<b>Inspection Date:</b>	August 14, 2007	<b>Approximate Year Built:</b>	1933
<b>*Wall Rating:</b>	77	<b>Maintenance Action:</b>	No Action

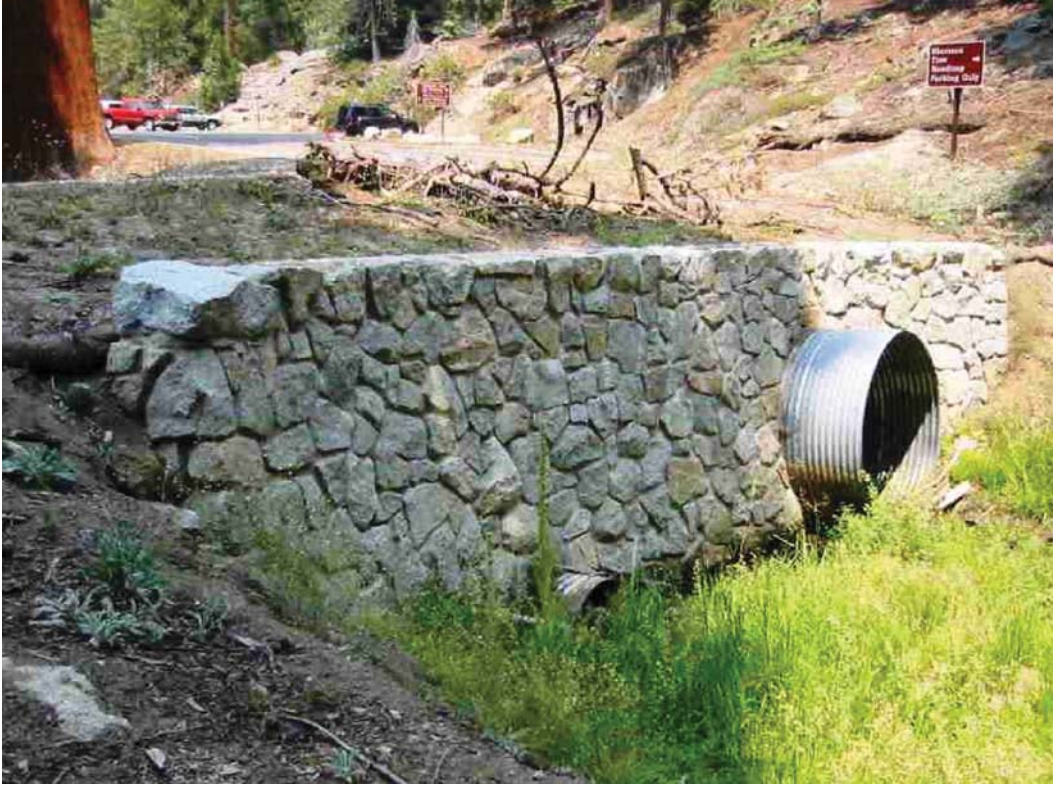
**SEQU\_0010\_19.070\_L\_1.jpg**

<b>Wall ID:</b>	SEQU-0010-19.070-L		
<b>Route Name:</b>	GENERALS HIGHWAY HISTORIC		
<b>Inspection Date:</b>	August 14, 2007	<b>Approximate Year Built:</b>	Unknown
<b>*Wall Rating:</b>	74	<b>Maintenance Action:</b>	No Action

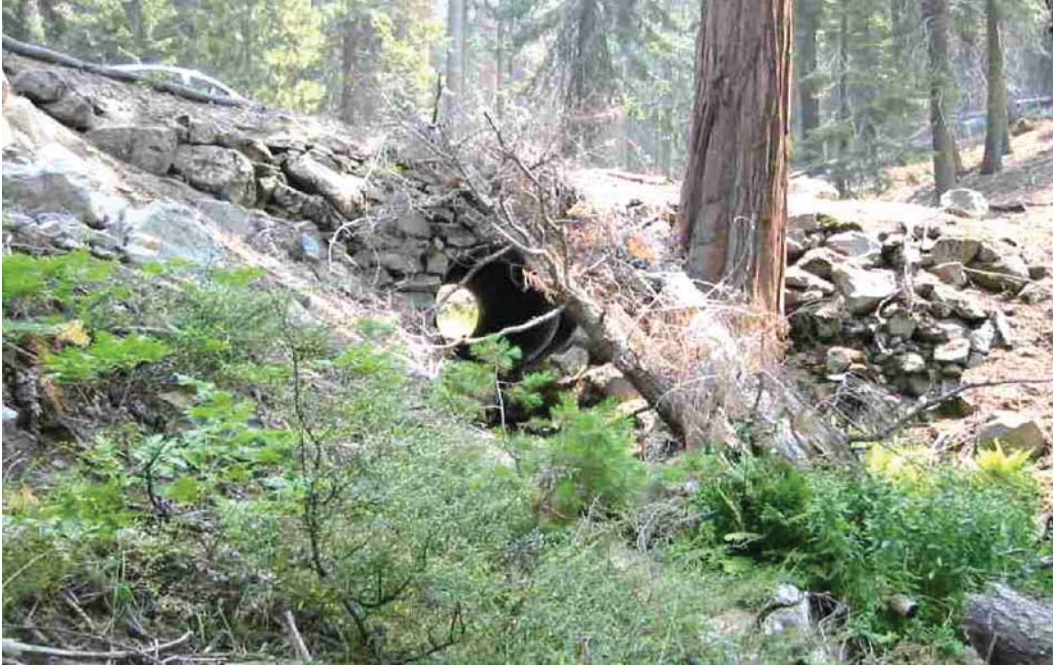
**SEQU\_0010\_19.070\_R\_1.jpg**

<b>Wall ID:</b>	SEQU-0010-19.070-R		
<b>Route Name:</b>	GENERALS HIGHWAY HISTORIC		
<b>Inspection Date:</b>	August 14, 2007	<b>Approximate Year Built:</b>	Unknown
<b>*Wall Rating:</b>	97	<b>Maintenance Action:</b>	No Action

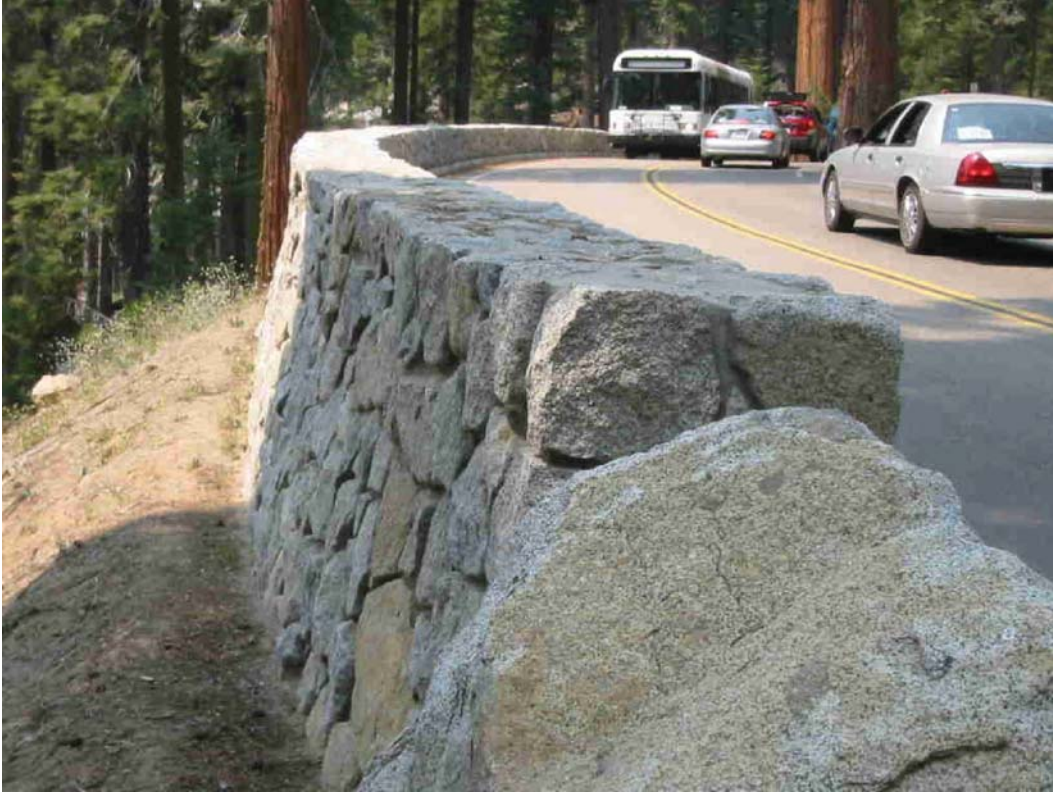
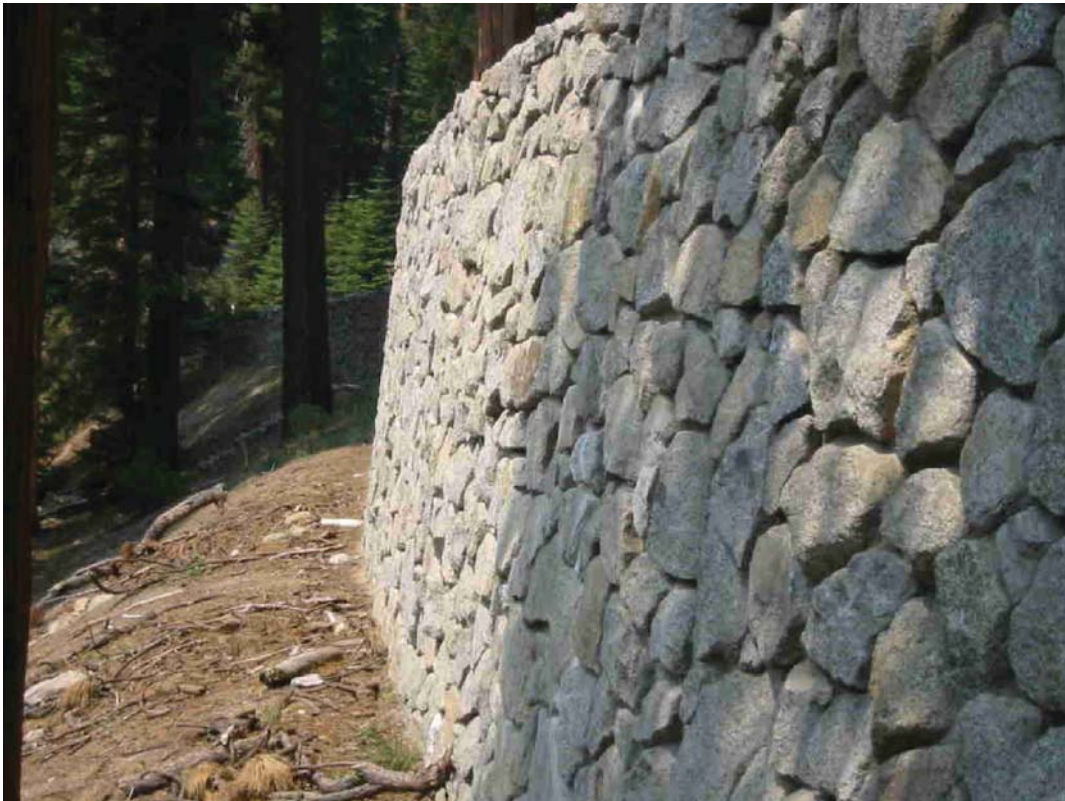
**SEQU\_0010\_19.110\_L\_1.jpg**

<b>Wall ID:</b>	SEQU-0010-19.110-L		
<b>Route Name:</b>	GENERALS HIGHWAY HISTORIC		
<b>Inspection Date:</b>	August 14, 2007	<b>Approximate Year Built:</b>	2003
<b>*Wall Rating:</b>	89	<b>Maintenance Action:</b>	No Action

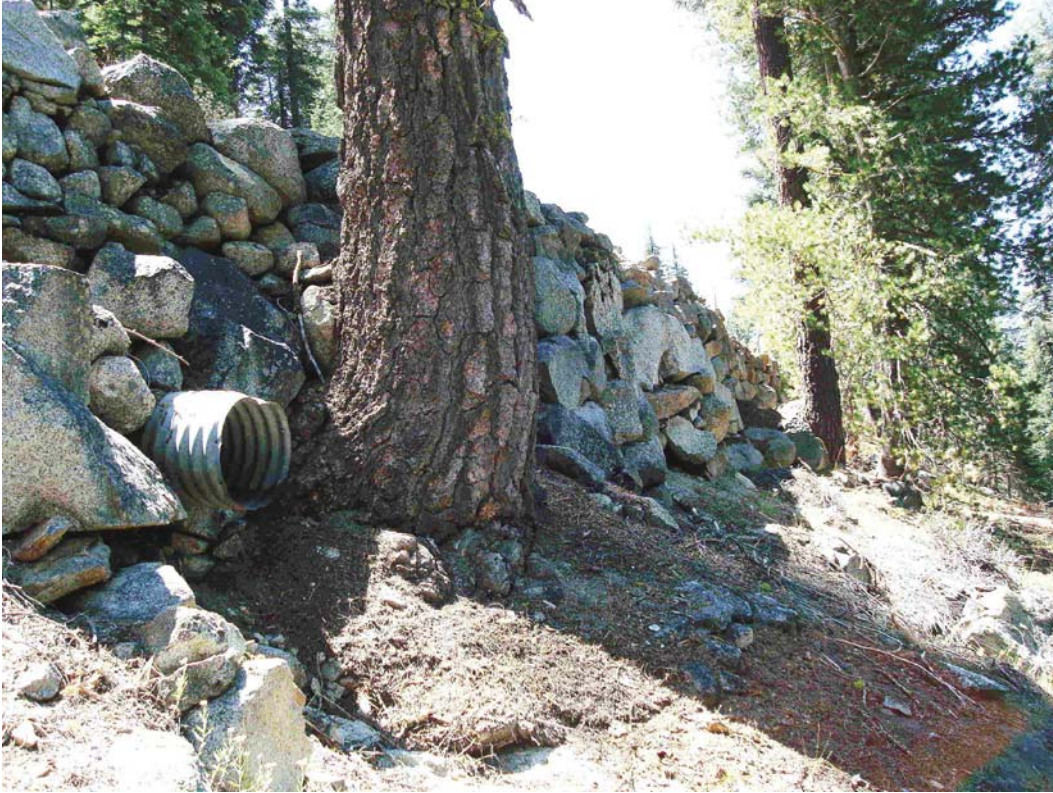
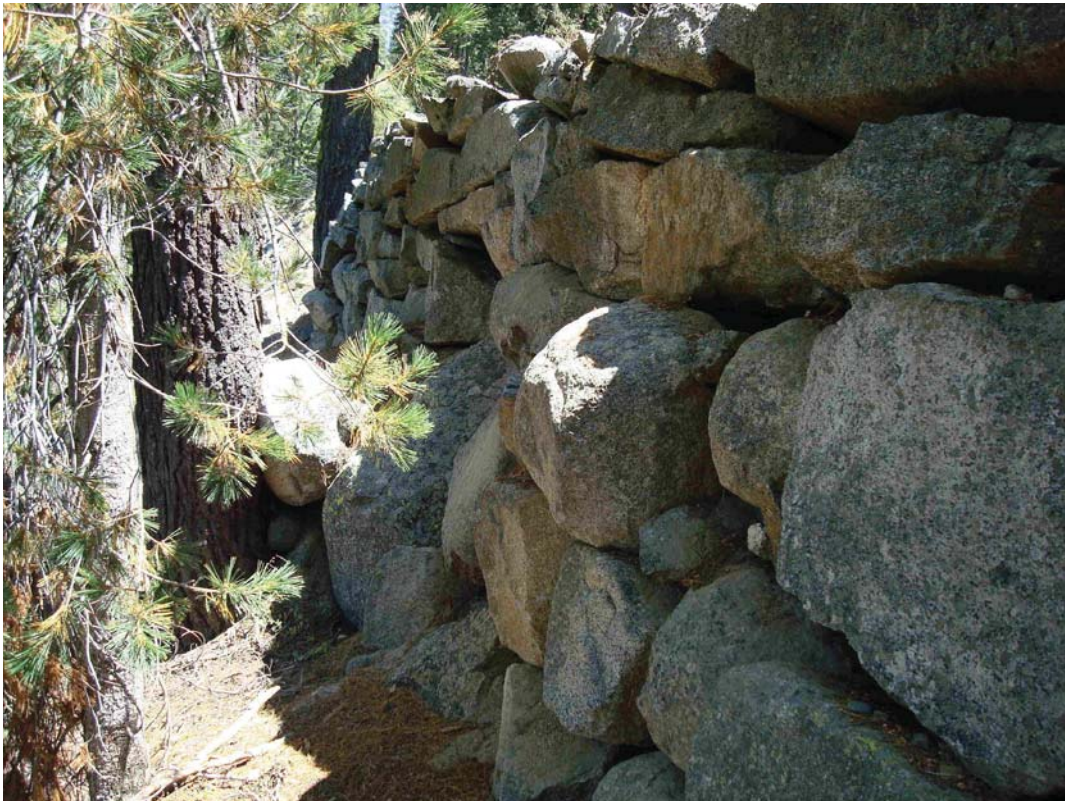
**SEQU\_0010\_20.930\_L\_1.jpg**

<b>Wall ID:</b>	SEQU-0010-20.930-L		
<b>Route Name:</b>	GENERALS HIGHWAY HISTORIC		
<b>Inspection Date:</b>	August 17, 2007	<b>Approximate Year Built:</b>	Unknown
<b>*Wall Rating:</b>	80	<b>Maintenance Action:</b>	No Action

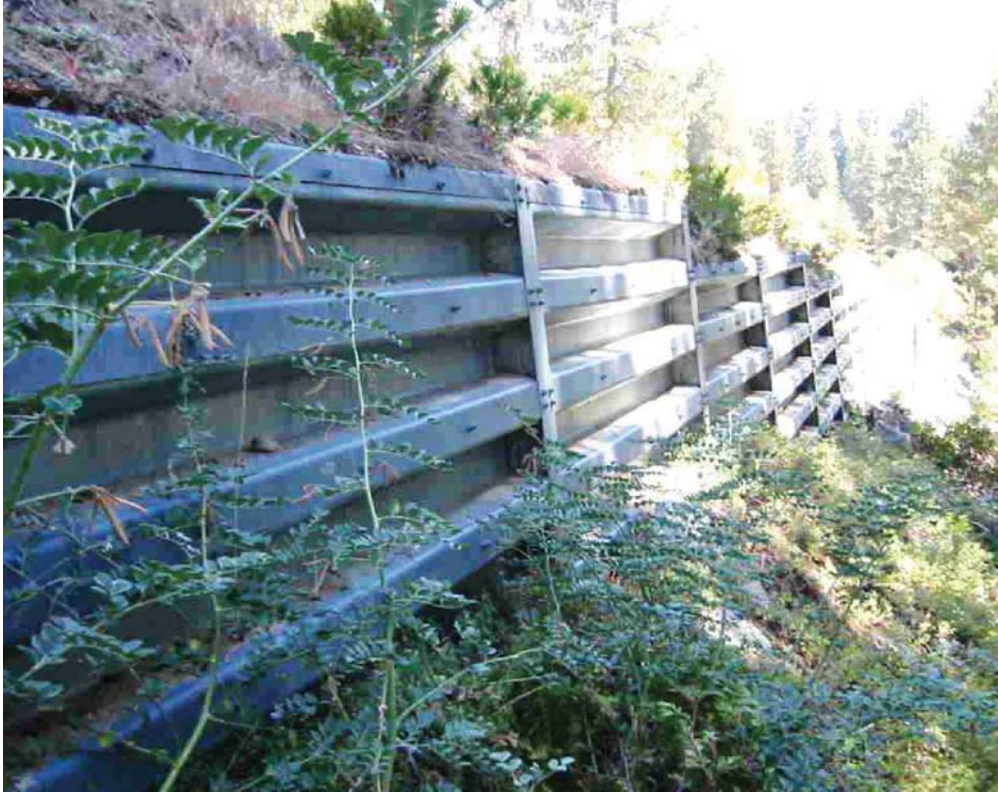
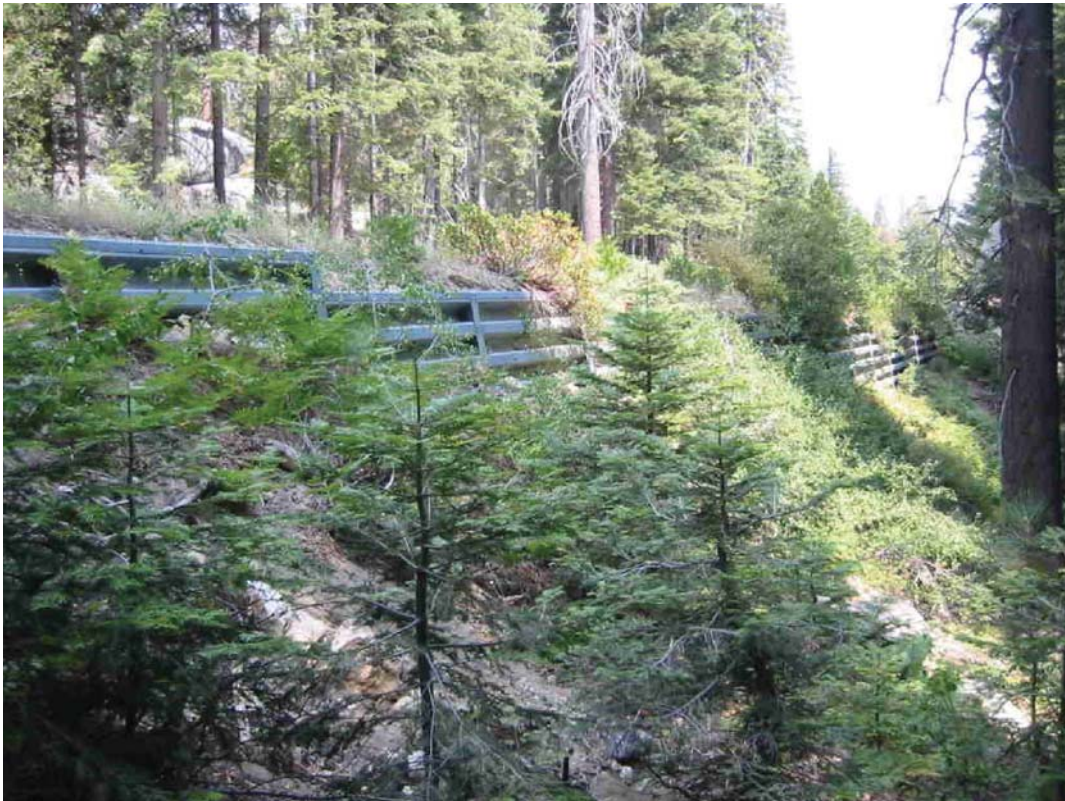
**SEQU\_0010\_22.903\_L\_1.jpg**

<b>Wall ID:</b>	SEQU-0010-22.903-L		
<b>Route Name:</b>	GENERALS HIGHWAY HISTORIC		
<b>Inspection Date:</b>	August 16, 2007	<b>Approximate Year Built:</b>	Unknown
<b>*Wall Rating:</b>	90	<b>Maintenance Action:</b>	No Action

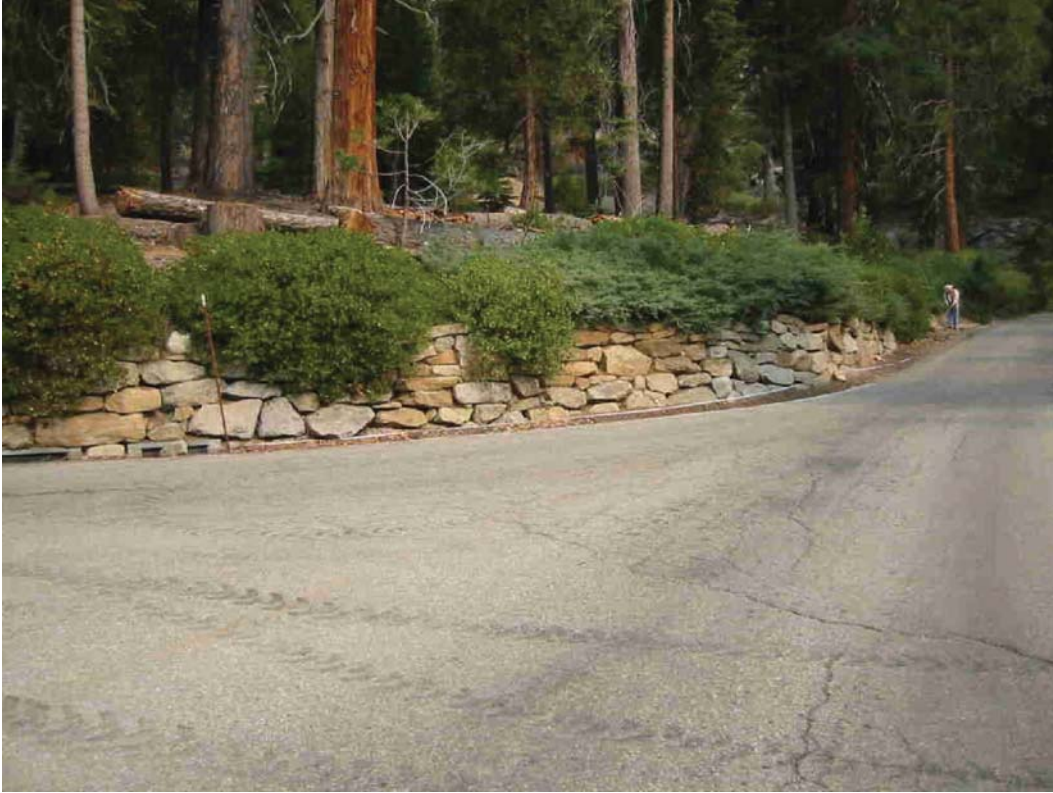
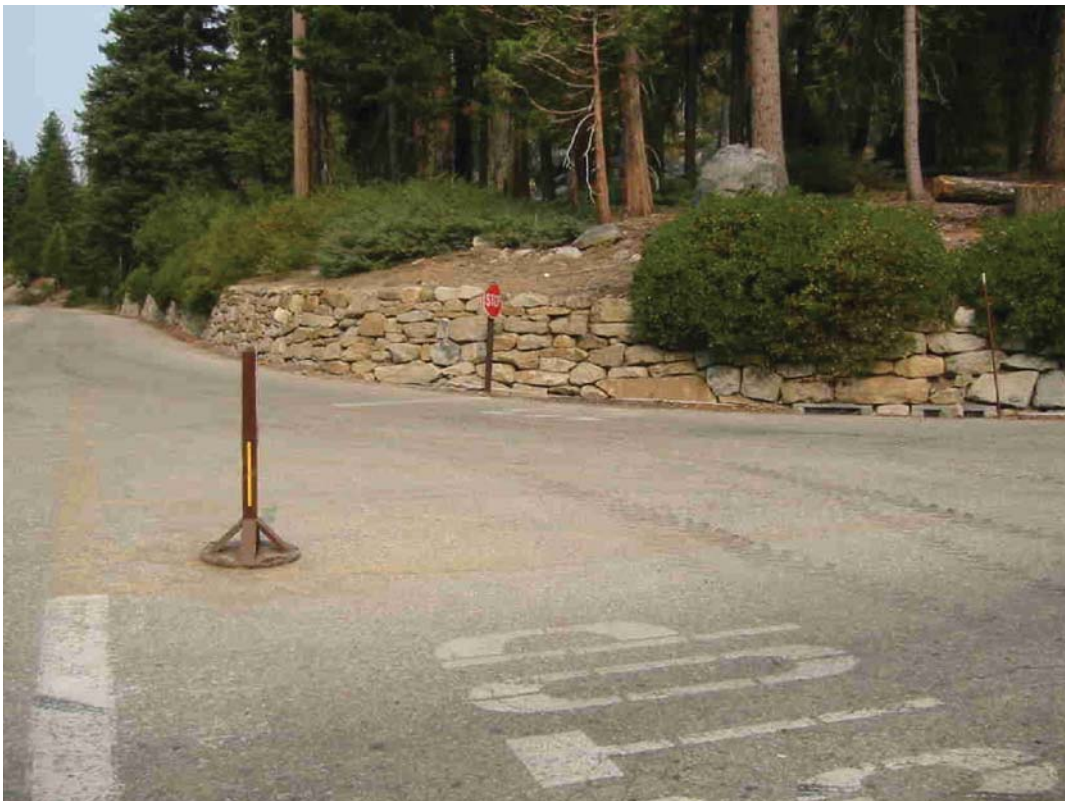
**SEQU\_0010\_22.980\_R\_1.jpg**

<b>Wall ID:</b>	SEQU-0010-22.980-R		
<b>Route Name:</b>	GENERALS HIGHWAY HISTORIC		
<b>Inspection Date:</b>	August 16, 2007	<b>Approximate Year Built:</b>	1999
<b>*Wall Rating:</b>	86	<b>Maintenance Action:</b>	No Action
