# SEQU

## WIP Report

### NPS Retaining Wall Inventory Program Sequoia National Park

**Data Collection Date: August 2007  
Report Date: December 2015**

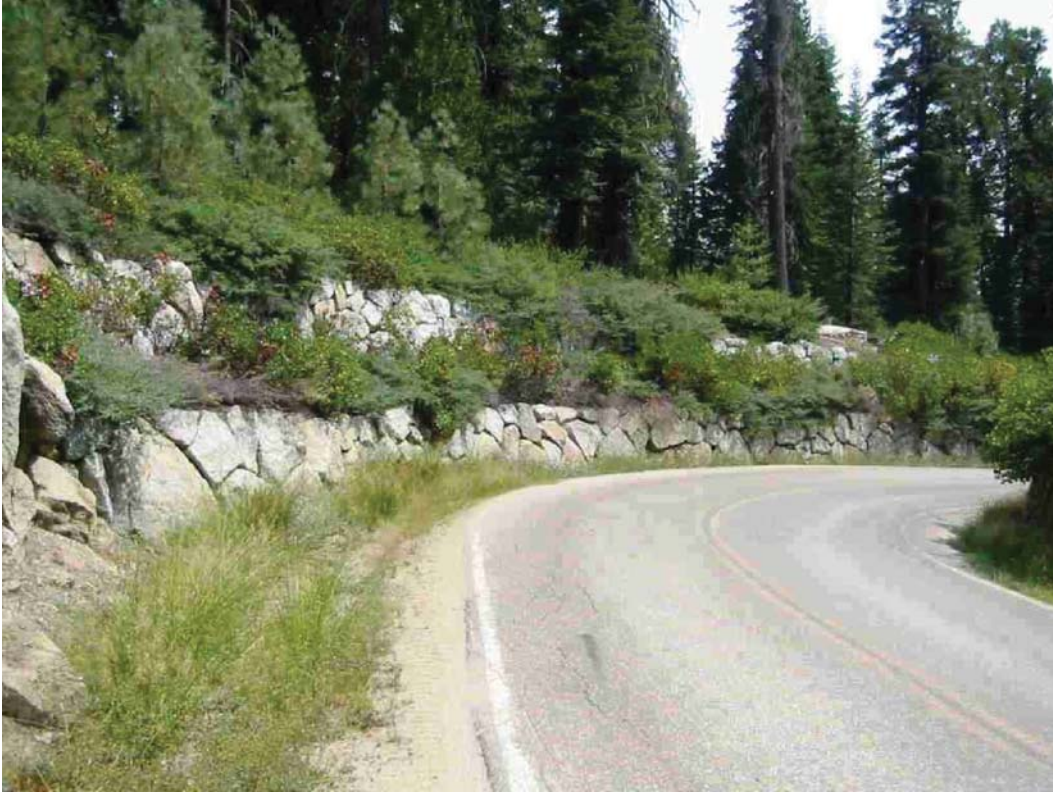
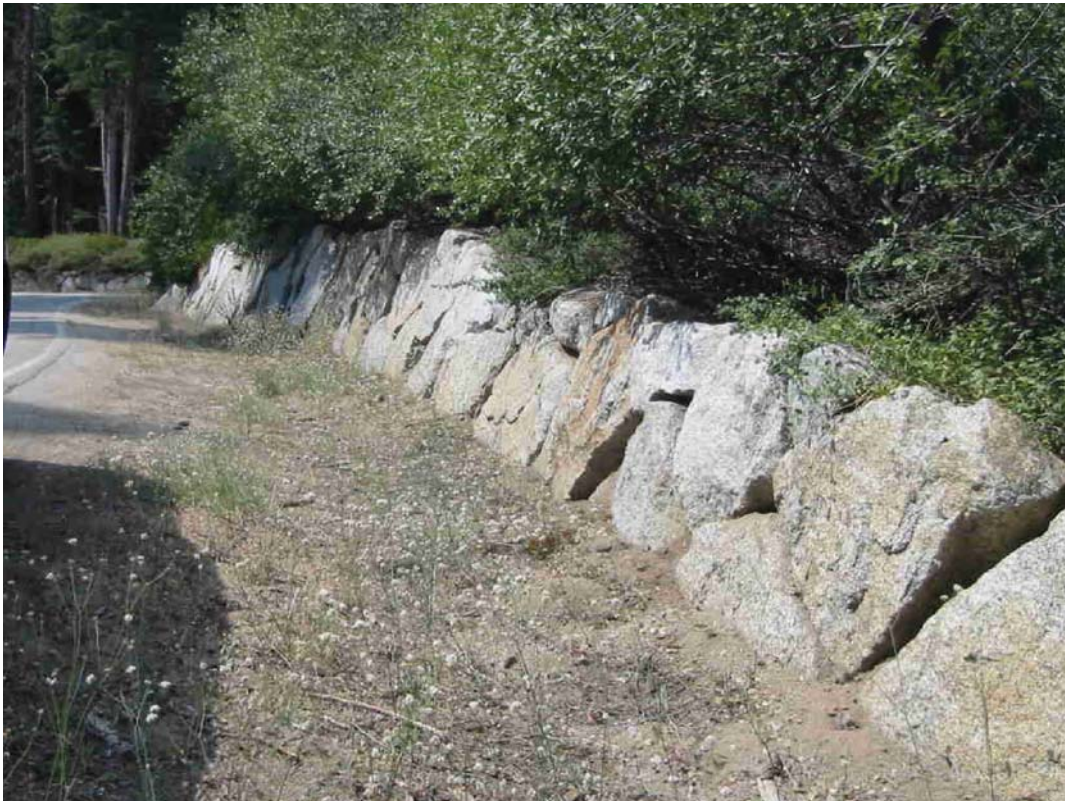
**SEQU\_0010\_23.367\_R\_1.jpg**

<b>Wall ID:</b>	SEQU-0010-23.367-R		
<b>Route Name:</b>	GENERALS HIGHWAY HISTORIC		
<b>Inspection Date:</b>	August 16, 2007	<b>Approximate Year Built:</b>	Unknown
<b>*Wall Rating:</b>	89	<b>Maintenance Action:</b>	No Action

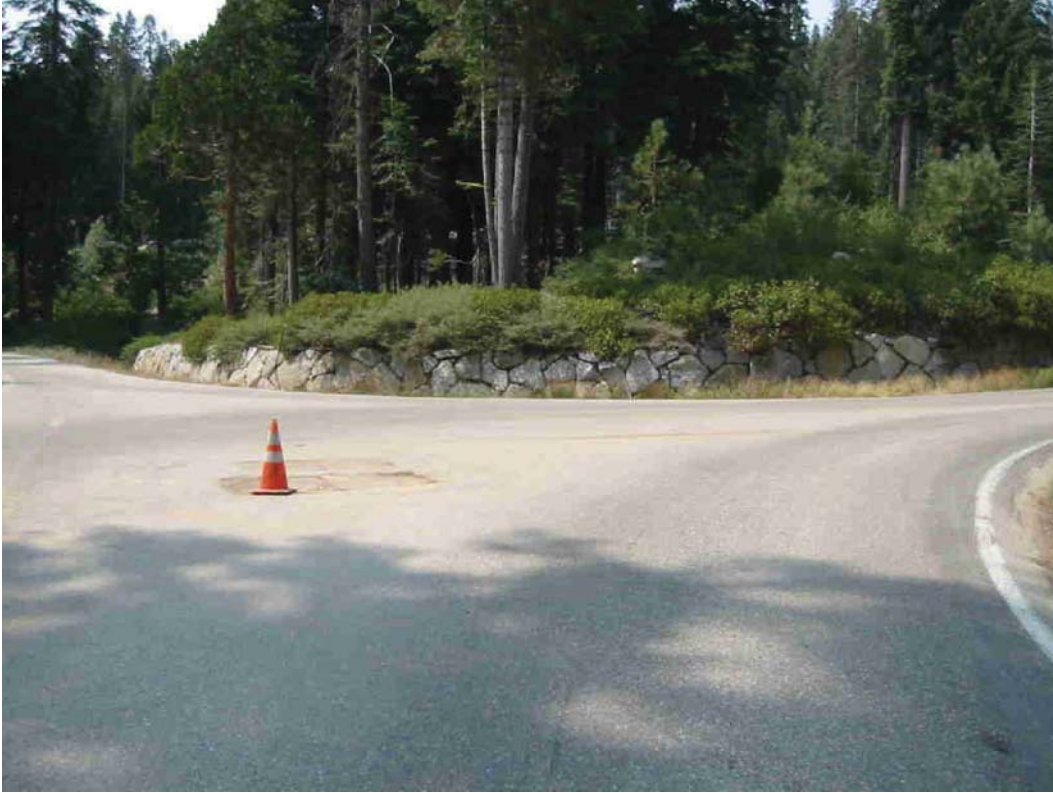
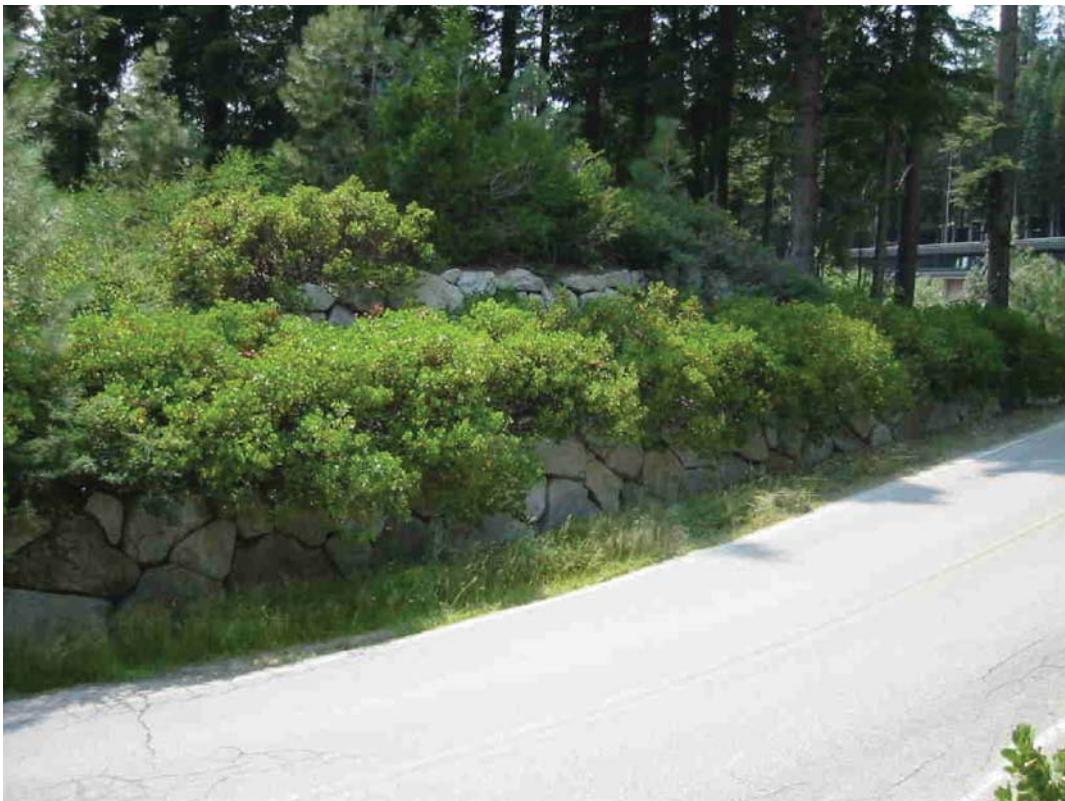
**SEQU\_0010\_23.410\_R\_1.jpg**

<b>Wall ID:</b>	SEQU-0010-23.410-R		
<b>Route Name:</b>	GENERALS HIGHWAY HISTORIC		
<b>Inspection Date:</b>	August 16, 2007	<b>Approximate Year Built:</b>	1999
<b>*Wall Rating:</b>	89	<b>Maintenance Action:</b>	No Action

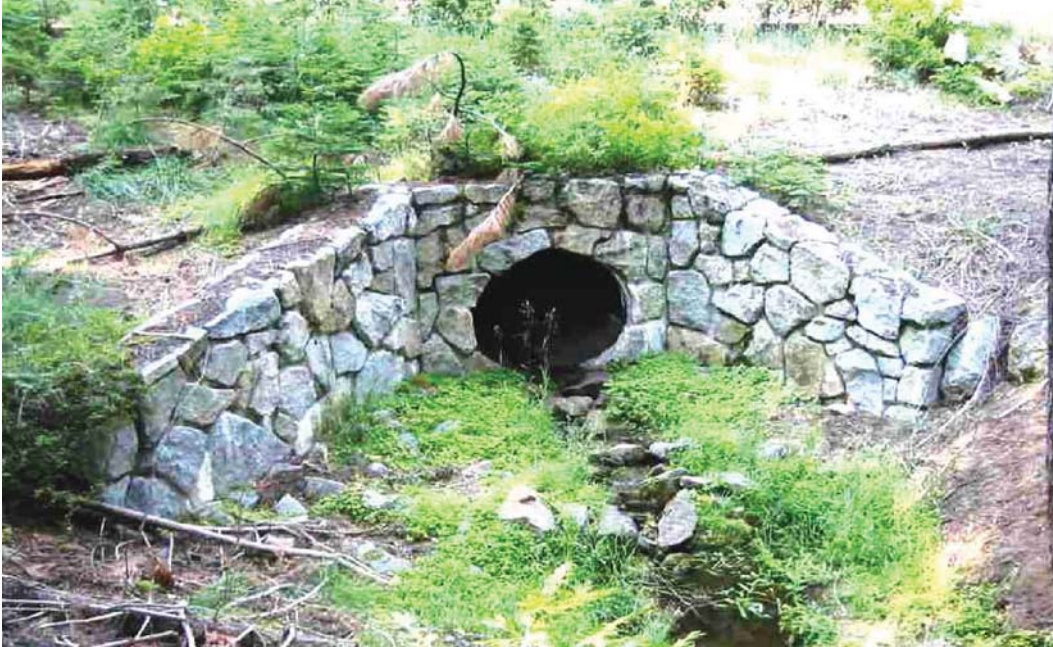
**SEQU\_0010\_23.423\_L\_1.jpg**

<b>Wall ID:</b>	SEQU-0010-23.423-L		
<b>Route Name:</b>	GENERALS HIGHWAY HISTORIC		
<b>Inspection Date:</b>	August 16, 2007	<b>Approximate Year Built:</b>	Unknown
<b>*Wall Rating:</b>	87	<b>Maintenance Action:</b>	No Action

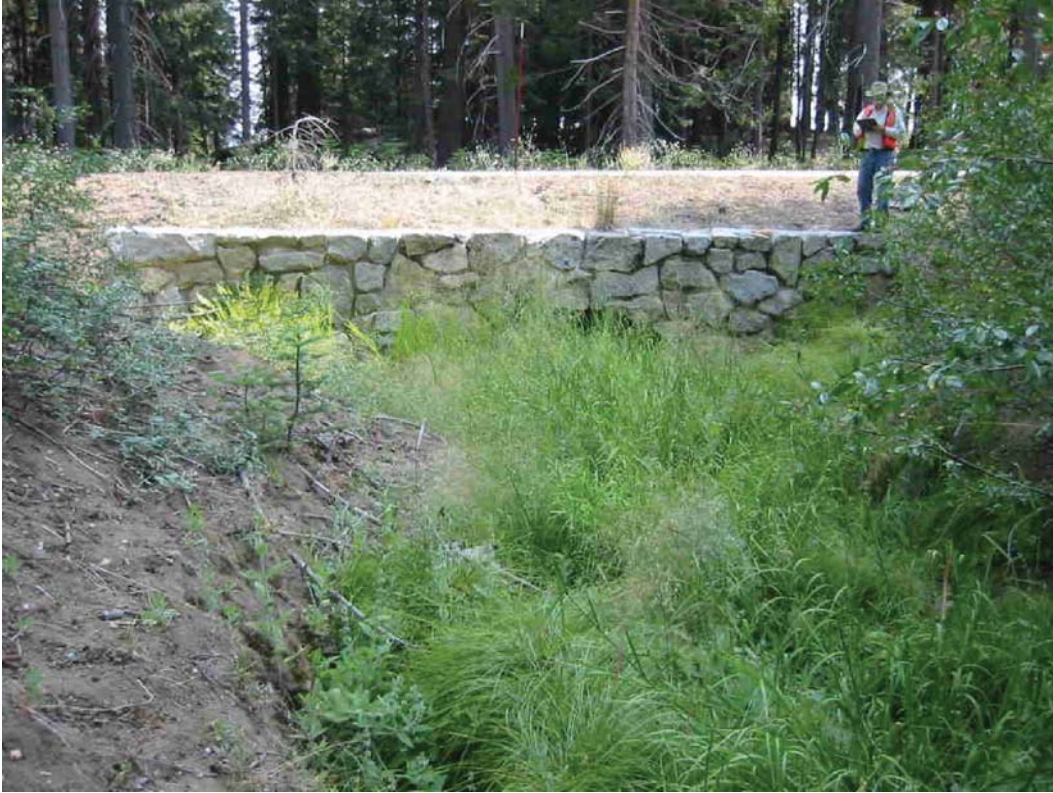
**SEQU\_0010\_23.426\_R\_1.jpg**

<b>Wall ID:</b>	SEQU-0010-23.426-R		
<b>Route Name:</b>	GENERALS HIGHWAY HISTORIC		
<b>Inspection Date:</b>	August 16, 2007	<b>Approximate Year Built:</b>	Unknown
<b>*Wall Rating:</b>	87	<b>Maintenance Action:</b>	No Action

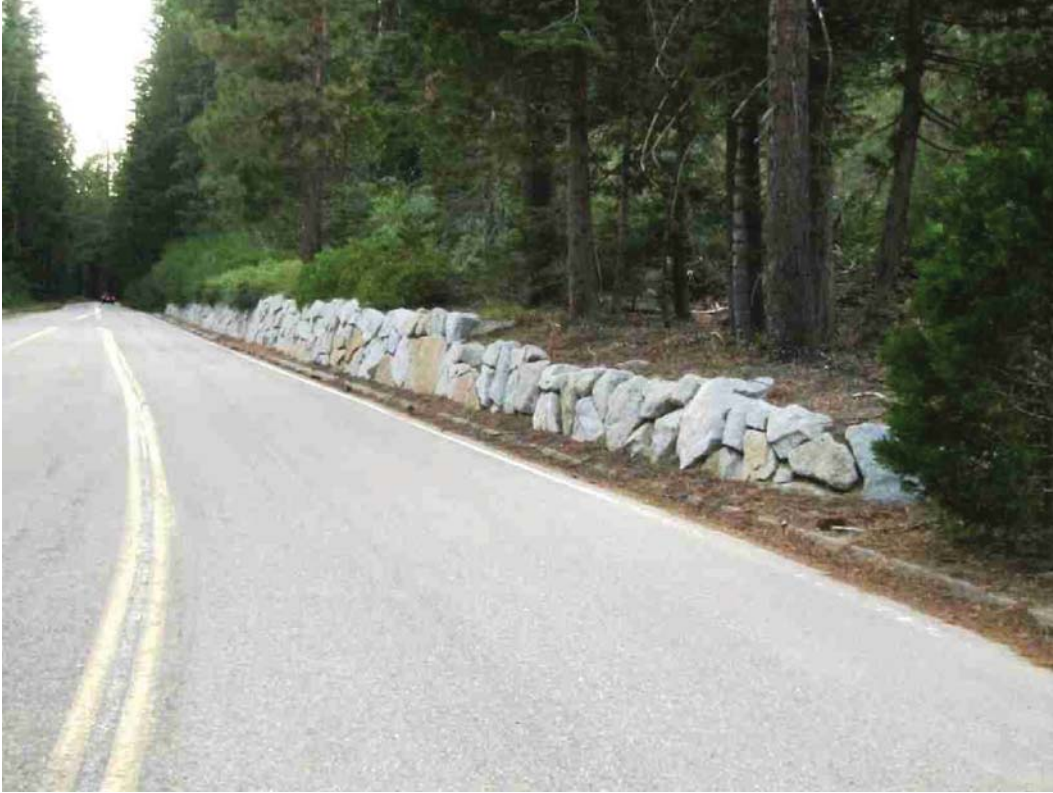
**SEQU\_0010\_23.449\_R\_1.jpg**

<b>Wall ID:</b>	SEQU-0010-23.449-R		
<b>Route Name:</b>	GENERALS HIGHWAY HISTORIC		
<b>Inspection Date:</b>	August 18, 2007	<b>Approximate Year Built:</b>	1990
<b>*Wall Rating:</b>	90	<b>Maintenance Action:</b>	No Action

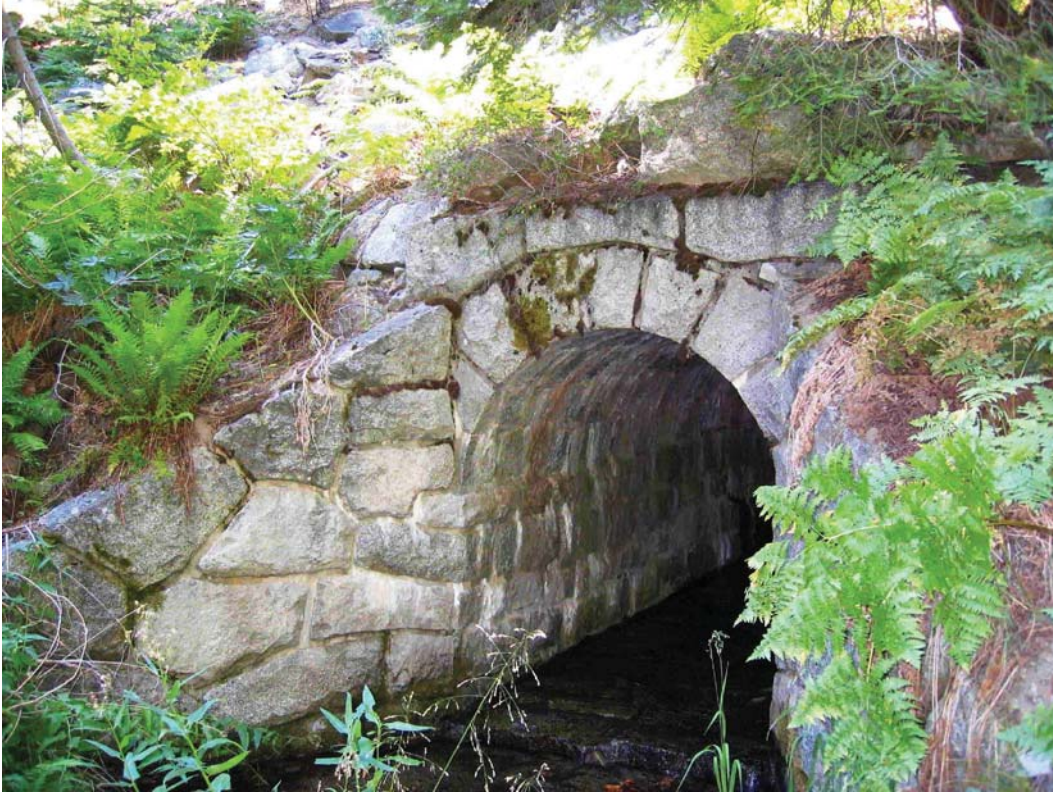
**SEQU\_0010\_26.399\_L\_1.jpg**

<b>Wall ID:</b>	SEQU-0010-26.399-L		
<b>Route Name:</b>	GENERALS HIGHWAY HISTORIC		
<b>Inspection Date:</b>	August 23, 2007	<b>Approximate Year Built:</b>	Unknown
<b>*Wall Rating:</b>	78	<b>Maintenance Action:</b>	No Action

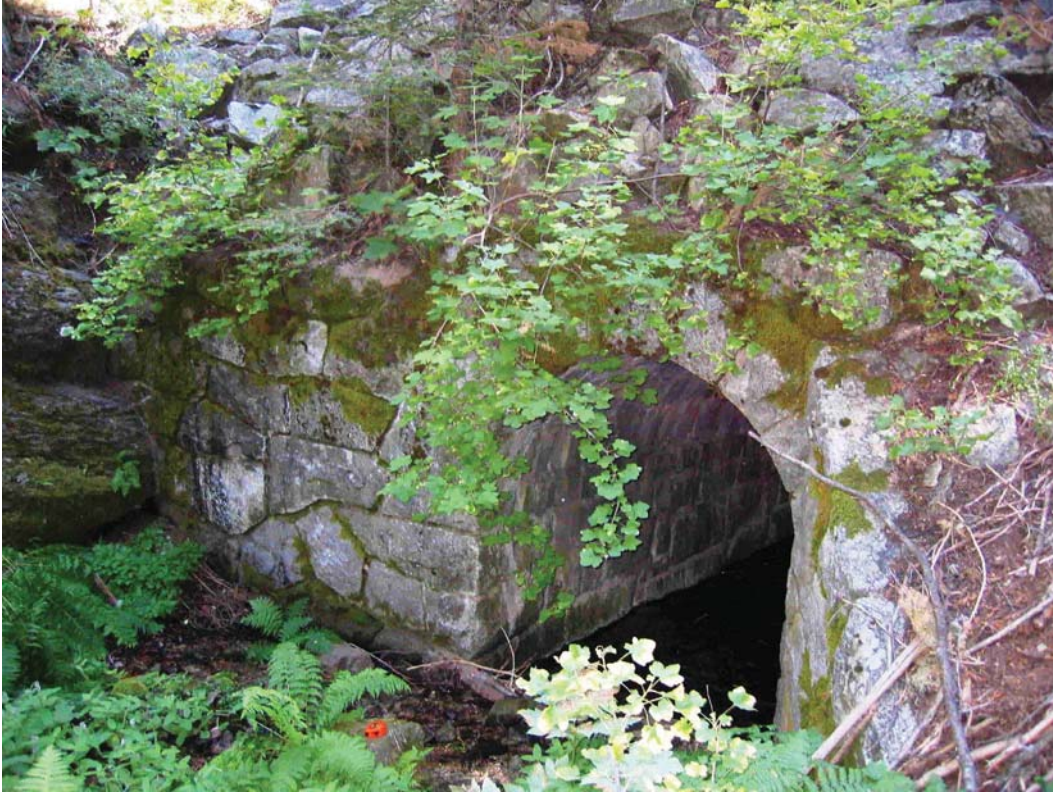
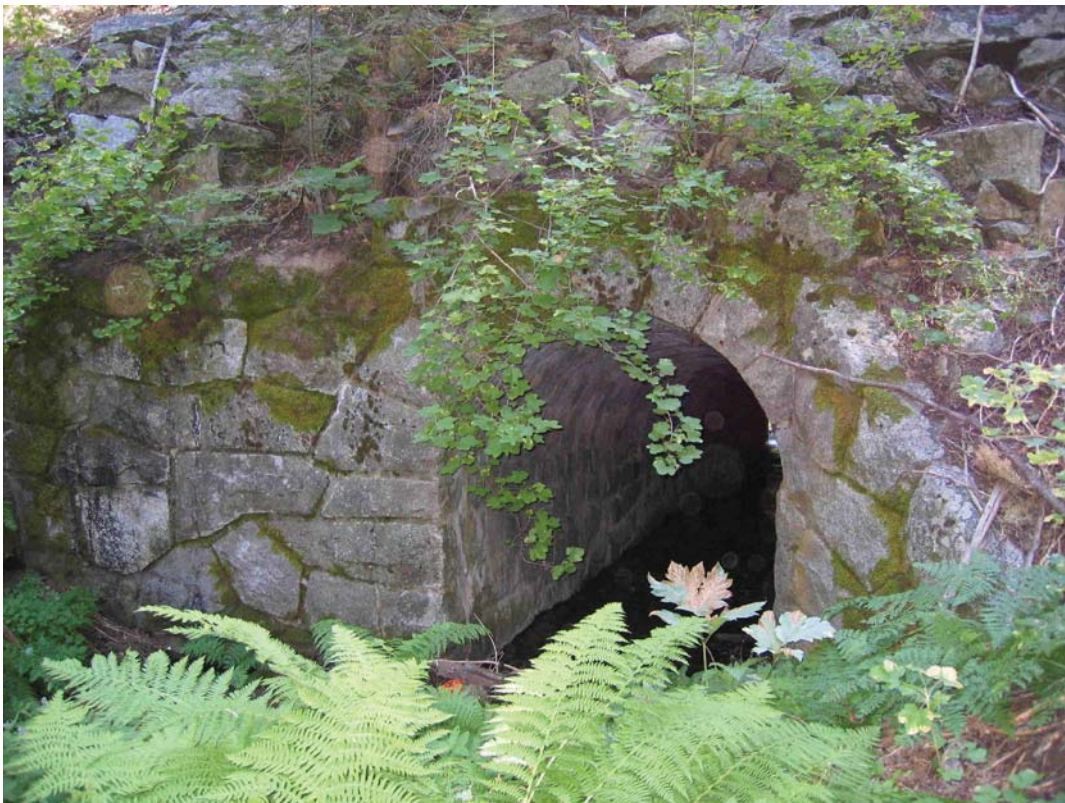
**SEQU\_0010\_26.399\_R\_1.jpg**

<b>Wall ID:</b>	SEQU-0010-26.399-R		
<b>Route Name:</b>	GENERALS HIGHWAY HISTORIC		
<b>Inspection Date:</b>	August 23, 2007	<b>Approximate Year Built:</b>	Unknown
<b>*Wall Rating:</b>	77	<b>Maintenance Action:</b>	No Action

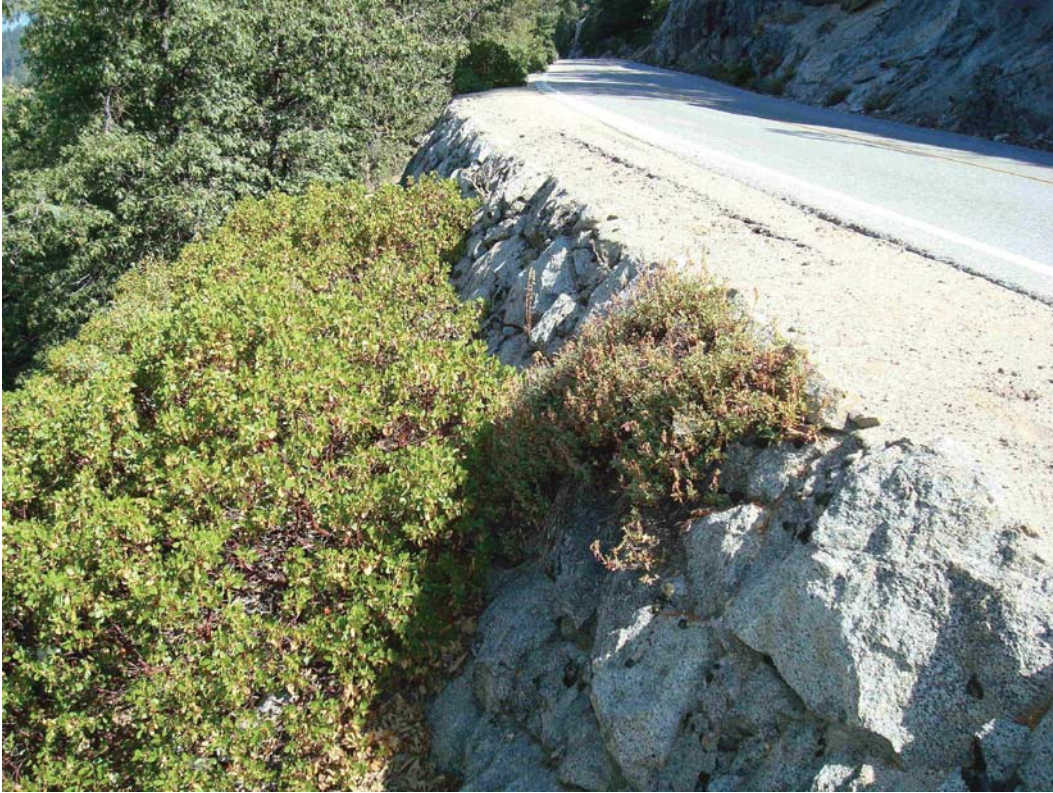
**SEQU\_0010\_27.212\_L\_1.jpg**

<b>Wall ID:</b>	SEQU-0010-27.212-L		
<b>Route Name:</b>	GENERALS HIGHWAY HISTORIC		
<b>Inspection Date:</b>	August 17, 2007	<b>Approximate Year Built:</b>	Unknown
<b>*Wall Rating:</b>	80	<b>Maintenance Action:</b>	Maintenance

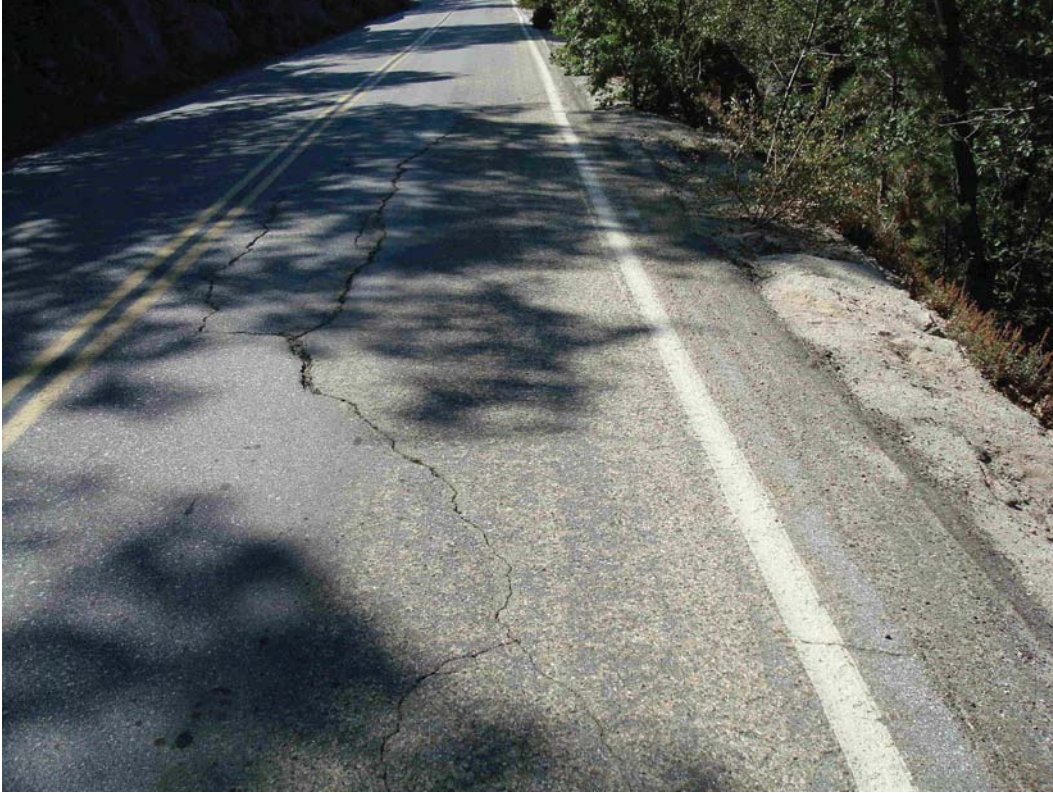
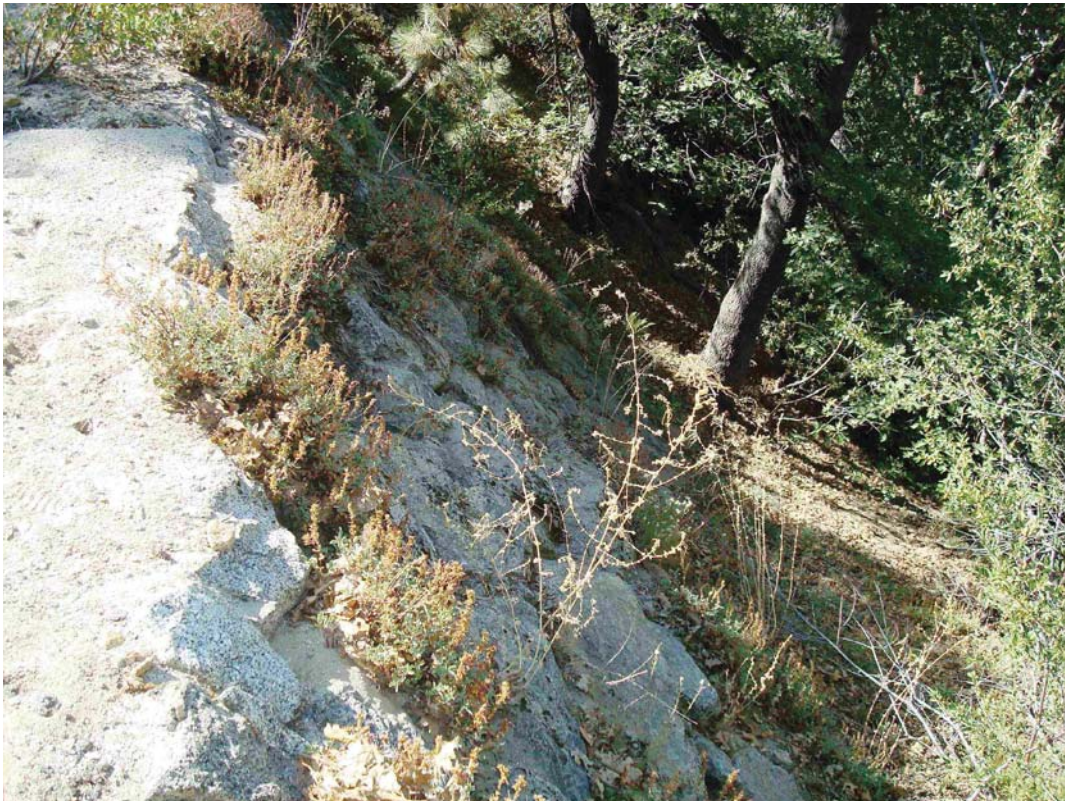
<b>Wall ID:</b>	SEQU-0010-27.269-L		
<b>Route Name:</b>	GENERALS HIGHWAY HISTORIC		
<b>Inspection Date:</b>	August 17, 2007	<b>Approximate Year Built:</b>	Unknown
<b>*Wall Rating:</b>	80	<b>Maintenance Action:</b>	Maintenance

<b>Element (Weighting Factor)</b>	<b>Narrative</b>	<b>Condition Rating (0 - 10)</b>
PERFORMANCE 8.00	Wall is in good condition.	8
WALL FOUNDATION MATERIAL 8.00	Soil, boulders and bedrock outcrop.	8
PLACED STONE 8.00	Dry stacked granite stones in good condition.	8
DOWNSLOPE 0.50	Steep bouldery slope with vegetation.	8
LATERAL SLOPE 0.50	No issues.	8
ROAD/SIDEWALK/SHOULDER 0.50	No settlement or cracks in roadway.	8
VEGETATION 0.50	Small amount on wall face.	8
WALL DRAINS 0.50	No drainage issues.	8

<b>Failure Consequence:</b>	HIGH
<b>Recommendation Narrative:</b>	Remove small trees and bushes from wall face and roadway shoulder. Labor and mobilization = \$100.00
<b>Repair Cost:</b>	\$100

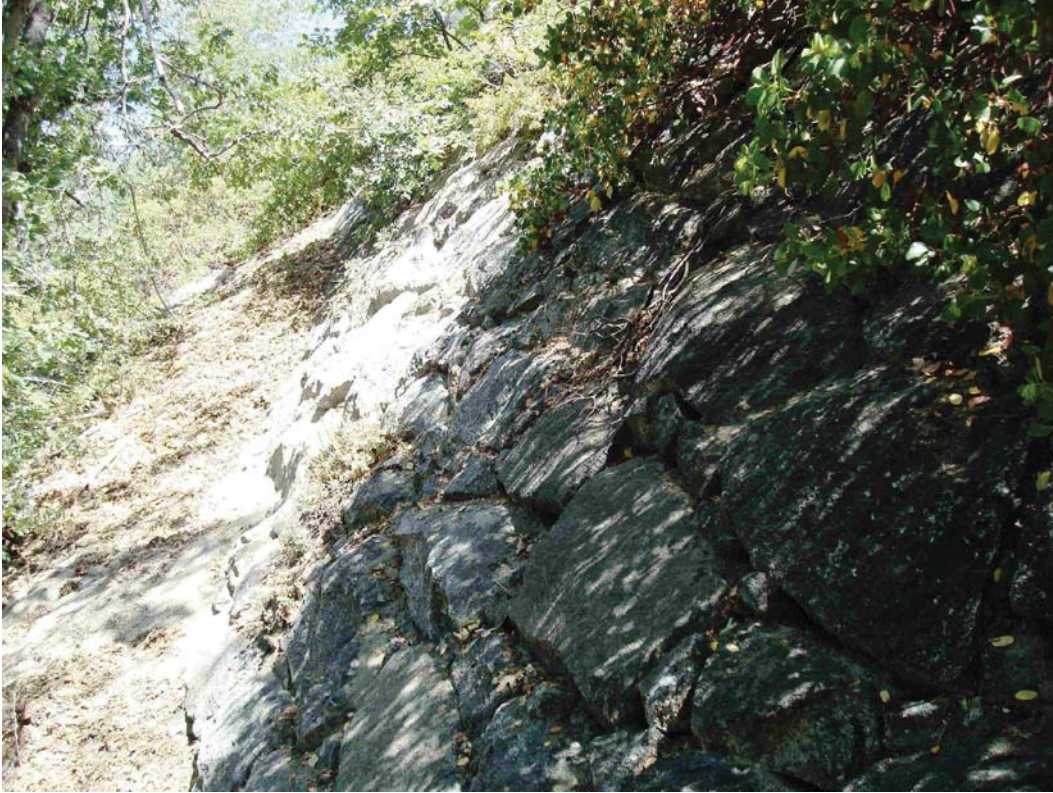
**SEQU\_0010\_27.316\_L\_1.jpg**

<b>Wall ID:</b>	SEQU-0010-27.316-L		
<b>Route Name:</b>	GENERALS HIGHWAY HISTORIC		
<b>Inspection Date:</b>	August 17, 2007	<b>Approximate Year Built:</b>	Unknown
<b>*Wall Rating:</b>	80	<b>Maintenance Action:</b>	Maintenance

<b>Wall Function:</b>	Fill Wall	<b>Primary Wall Type:</b>	Gravity - Dry Stone
<b>Surface Treatment:</b>		<b>Secondary Wall Type:</b>	
<b>Secondary Surface Treatment:</b>		<b>Architectural Facing:</b>	
<b>General Description:</b>	Dry stacked stone fill wall at edge of roadway in good condition.

<b>Element (Weighting Factor)</b>	<b>Narrative</b>	<b>Condition Rating (0 - 10)</b>
PERFORMANCE 8.00	Good condition.	8
WALL FOUNDATION MATERIAL 8.00	Steep bedrock, boulders and soil with vegetation.	8
PLACED STONE 8.00	Dry stacked granite stone in good condition.	8
DOWNSLOPE 0.50	Very steep bedrock and boulders.	8
LATERAL SLOPE 0.50	No issues.	8
VEGETATION 0.50	Small trees and bushes on wall face.	8
WALL DRAINS 0.50	No issues.	8

<b>Failure Consequence:</b>	HIGH
<b>Recommendation Narrative:</b>	Remove vegetation and trees from wall face and top of wall. Labor and mobilization = \$100.00
<b>Repair Cost:</b>	\$100

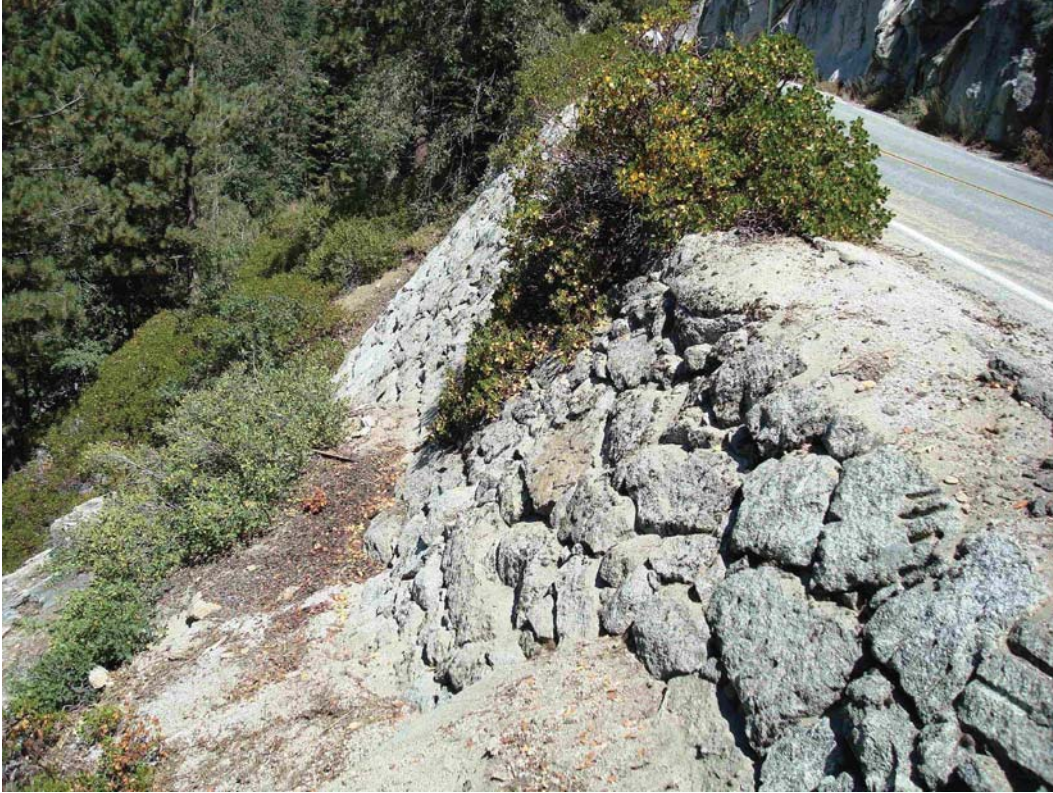
**SEQU\_0010\_27.336\_L\_1.jpg**

<b>Wall ID:</b>	SEQU-0010-27.336-L		
<b>Route Name:</b>	GENERALS HIGHWAY HISTORIC		
<b>Inspection Date:</b>	August 17, 2007	<b>Approximate Year Built:</b>	Unknown
<b>*Wall Rating:</b>	80	<b>Maintenance Action:</b>	Maintenance

<b>Wall Function:</b>	Fill Wall	<b>Primary Wall Type:</b>	Gravity - Dry Stone
<b>Surface Treatment:</b>		<b>Secondary Wall Type:</b>	
<b>Secondary Surface Treatment:</b>		<b>Architectural Facing:</b>	
<b>General Description:</b>	Dry stack stone wall at edge of roadway in good condition.

<b>Element (Weighting Factor)</b>	<b>Narrative</b>	<b>Condition Rating (0 - 10)</b>
PERFORMANCE 8.00	Good condition.	8
WALL FOUNDATION MATERIAL 8.00	Mostly bedrock with competent solid foundation zones.	8
PLACED STONE 8.00	Granite stones are in good condition.	8
DOWNSLOPE 0.50	Very steep bedrock and boulders slope with vegetation.	8
LATERAL SLOPE 0.50	NO issues.	8
ROAD/SIDEWALK/SHOULDER 0.50	Good condition no AC pavement settlement or cracks.	8
VEGETATION 0.50	Some small trees and brush on wall face and at top of wall.	8
WALL DRAINS 0.50	No drainage issues.	8

<b>Failure Consequence:</b>	HIGH
<b>Recommendation Narrative:</b>	Remove small trees and bushes from wall face. Labor and mobilization = \$100.00
<b>Repair Cost:</b>	\$100

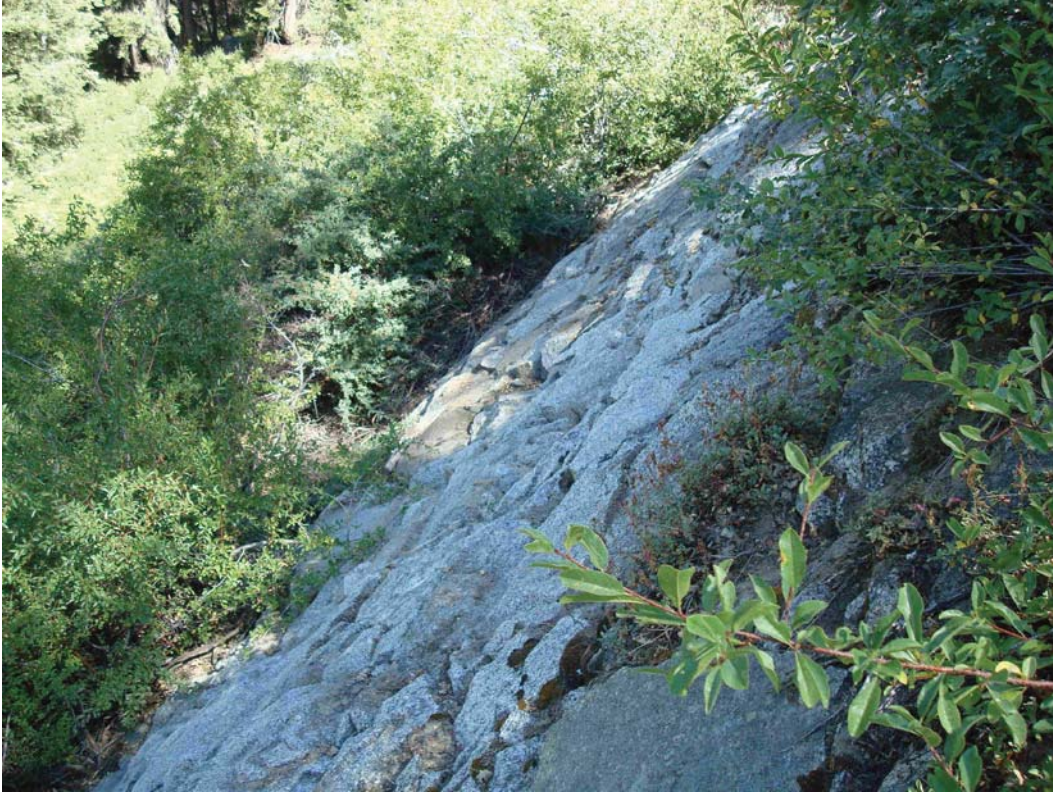
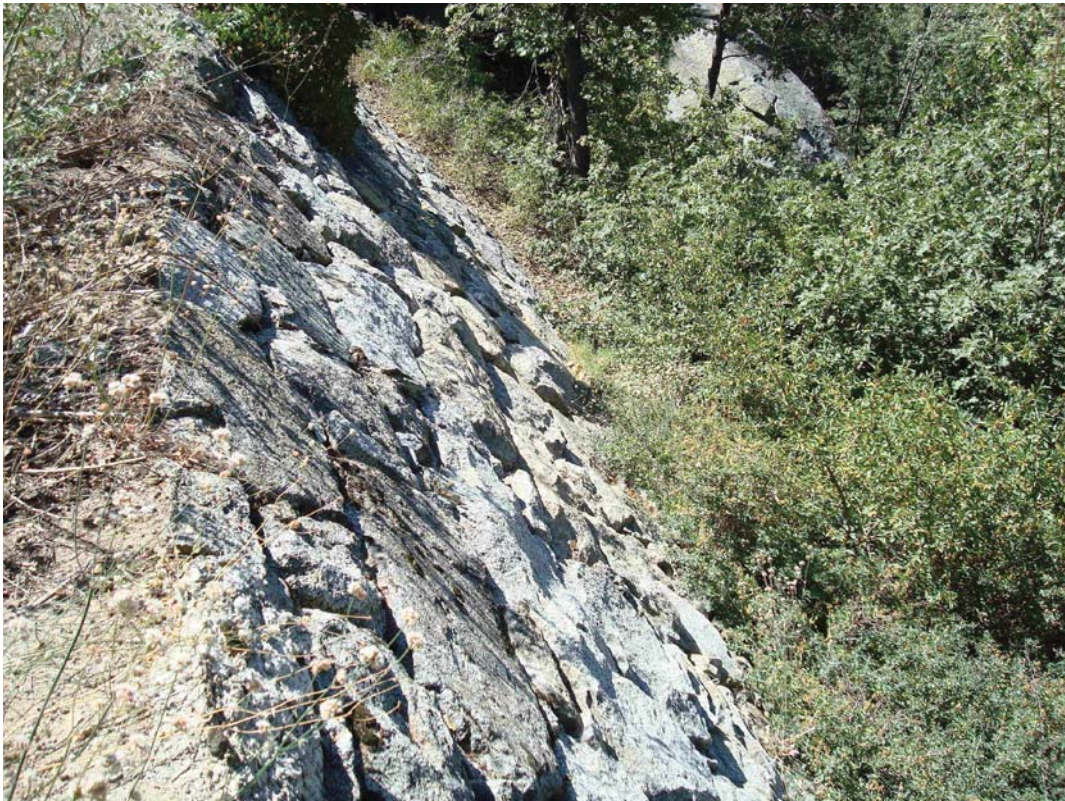
<b>Wall ID:</b>	SEQU-0010-27.498-L		
<b>Route Name:</b>	GENERALS HIGHWAY HISTORIC		
<b>Inspection Date:</b>	August 17, 2007	<b>Approximate Year Built:</b>	Unknown
<b>*Wall Rating:</b>	76	<b>Maintenance Action:</b>	Maintenance

<b>Element (Weighting Factor)</b>	<b>Narrative</b>	<b>Condition Rating (0 - 10)</b>
PERFORMANCE 8.00	Wall in good condition except fore one spot that could be slightly bulging.	8
WALL FOUNDATION MATERIAL 8.00	Competent soil, boulders and bedrock outcrop.	8
PLACED STONE 8.00	Durable granite stone with drainage problem at one spot causing settlement and cracks.	7
LATERAL SLOPE 0.50	No issues	8
DOWNSLOPE 1.00	Steep wooded and vegetated slope	7
VEGETATION 1.00	Some small trees and bushes on wall face.	7
WALL DRAINS 1.00	Wall drainage good. Surface drainage at one spot causing slight wall movement and settlement.	7

<b>Failure Consequence:</b>	HIGH
<b>Recommendation Narrative:</b>	Remove small trees and bushes from within wall face and top of wall. Clear ditch on opposite side of settled roadway in order to limit surface runoff on wall face. Labor and mobilization = \$200.00
<b>Repair Cost:</b>	\$200

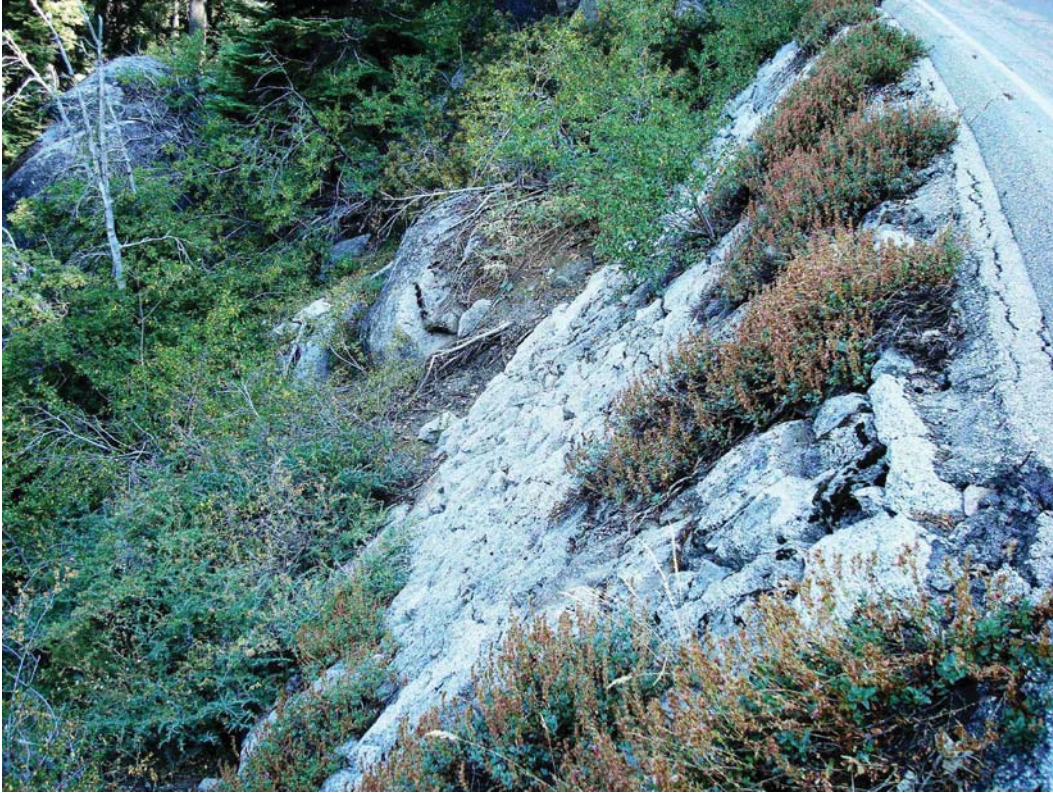
**SEQU\_0010\_27.505\_L\_1.jpg**

<b>Wall ID:</b>	SEQU-0010-27.505-L		
<b>Route Name:</b>	GENERALS HIGHWAY HISTORIC		
<b>Inspection Date:</b>	August 17, 2007	<b>Approximate Year Built:</b>	Unknown
<b>*Wall Rating:</b>	67	<b>Maintenance Action:</b>	Repair Elements

<b>Element (Weighting Factor)</b>	<b>Narrative</b>	<b>Condition Rating (0 - 10)</b>
PERFORMANCE 8.00	Wall performing good with erosion problem.	7
WALL FOUNDATION MATERIAL 8.00	Boulders and soil with severe erosion.	6
PLACED STONE 8.00	Dry stacked stones in fair to good condition. Stones durable.	7
VEGETATION 0.50	Some vegetation growth on wall face.	8
LATERAL SLOPE 1.00	Steep to very steep boulders and rock with some erodable material.	6
WALL DRAINS 1.00	Drainable wall with erosion problem.	6
ROAD/SIDEWALK/SHOULDER 1.00	Small longitudinal cracks parallel to curb.	7

<b>Failure Consequence:</b>	HIGH
<b>Recommendation Narrative:</b>	Grout bottom eroded 1 to 2 feet of the wall. Grouting could be combined with minor excavation, placement of additional stones. Also remove brush at edges of wall. Material and labor estimated at \$5,000.00.
<b>Repair Cost:</b>	\$5,000

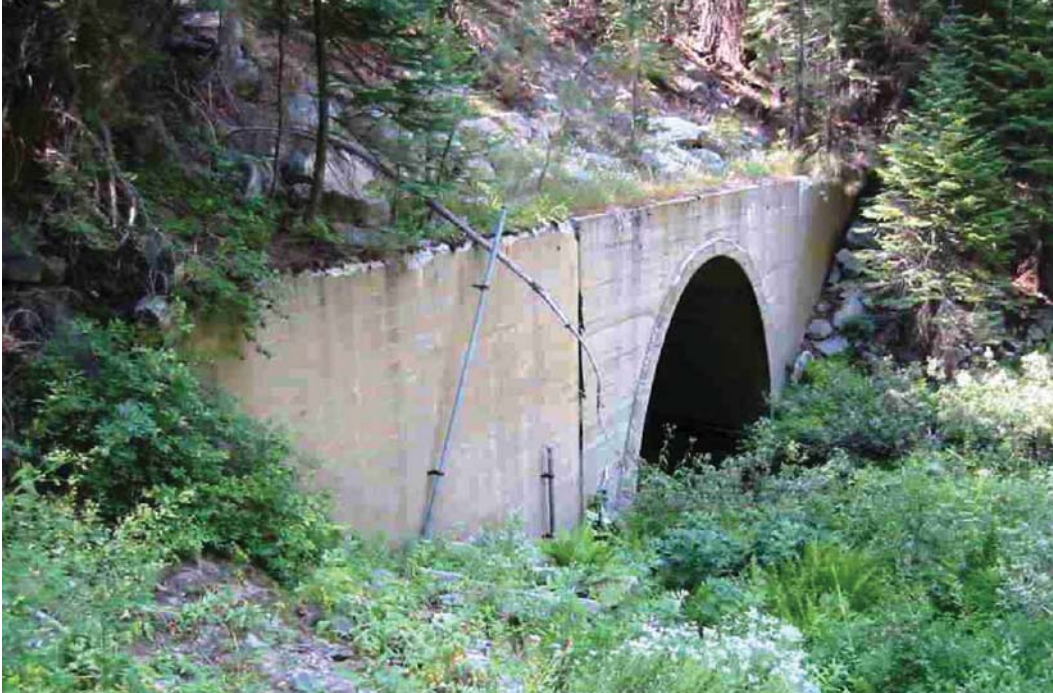
**SEQU\_0010\_30.310\_R\_1.jpg**

<b>Wall ID:</b>	SEQU-0010-30.310-R		
<b>Route Name:</b>	GENERALS HIGHWAY HISTORIC		
<b>Inspection Date:</b>	August 15, 2007	<b>Approximate Year Built:</b>	Unknown
<b>*Wall Rating:</b>	83	<b>Maintenance Action:</b>	No Action

<b>Element (Weighting Factor)</b>	<b>Narrative</b>	<b>Condition Rating (0 - 10)</b>
PERFORMANCE 8.00	Very good, performing as intended.	8
WALL FOUNDATION MATERIAL 8.00	Stable stream bed, no signs of distress	9
CONCRETE 8.00	Cast-in-place concrete in good condition, no leaching, very minor spalling on cap ends.	8
CULVERT 0.50	CIP concrete with arch, good condition.	8
LATERAL SLOPE 0.50	Stable, vegetated soil, no erosion evident.	8
UPSLOPE 0.50	Trees, loose stable sandy soil embankment.	8
WALL DRAINS 0.50	None visible, but no signs of drain related stress.	8

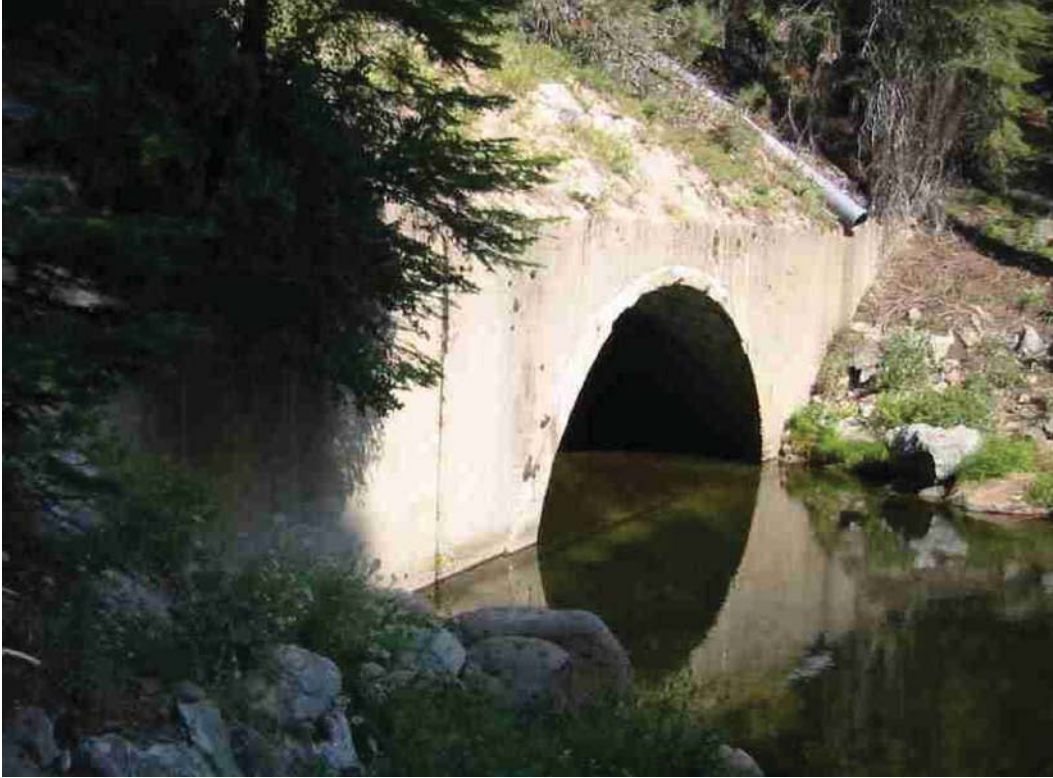
**SEQU\_0010\_30.321\_L\_1.jpg**

<b>Wall ID:</b>	SEQU-0010-30.321-L		
<b>Route Name:</b>	GENERALS HIGHWAY HISTORIC		
<b>Inspection Date:</b>	August 15, 2007	<b>Approximate Year Built:</b>	Unknown
<b>*Wall Rating:</b>	83	<b>Maintenance Action:</b>	No Action

<b>Wall Function:</b>	Head Wall	<b>Primary Wall Type:</b>	Cantilever - Concrete
<b>Surface Treatment:</b>		<b>Secondary Wall Type:</b>	
<b>Secondary Surface Treatment:</b>		<b>Architectural Facing:</b>	
<b>General Description:</b>	Cast in-place concrete headwall, outlet in good condition. 14 foot high concrete CIP arch culvert.

<b>Element (Weighting Factor)</b>	<b>Narrative</b>	<b>Condition Rating (0 - 10)</b>
PERFORMANCE 8.00	Very good, performing as intended	8
WALL FOUNDATION MATERIAL 8.00	Stable stream bed, no signs of distress	9
CONCRETE 8.00	CIP concrete with arch, good condition.	8
CULVERT 0.50	CIP concrete arch culvert in good condition.	8
LATERAL SLOPE 0.50	Stable vegetated soil, no erosion evident.	8
UPSLOPE 0.50	Trees, loose, stable sandy soil embankment.	8
WALL DRAINS 0.50	None visible, but no signs of drain related stress.	8

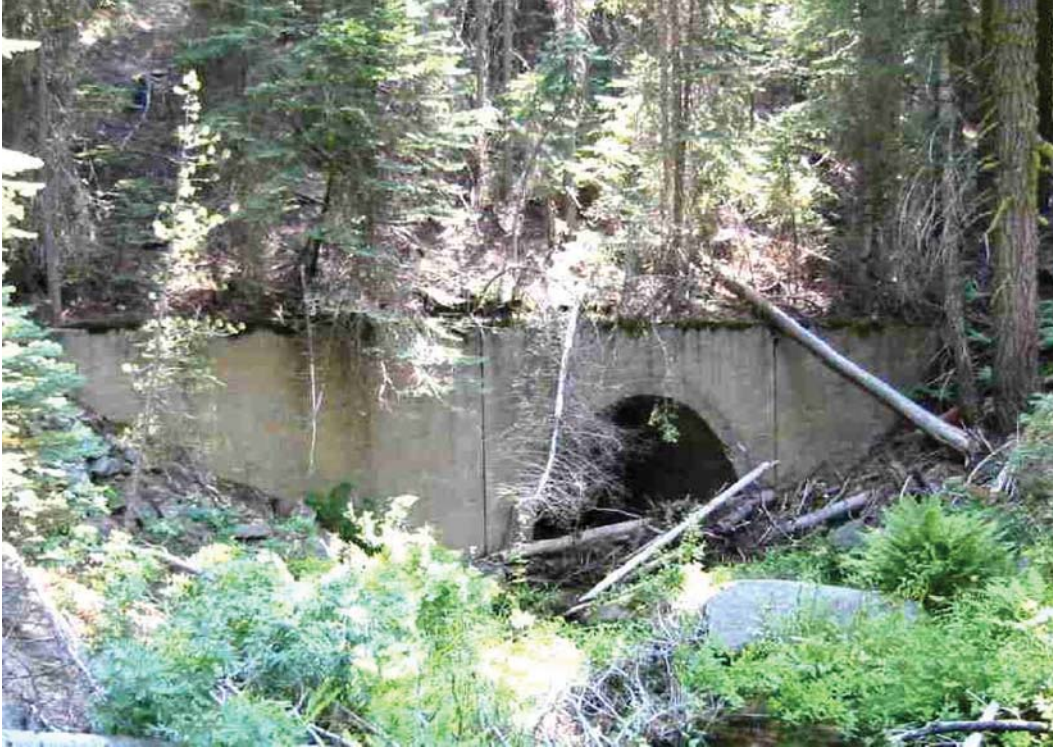
**SEQU\_0010\_31.052\_L\_1.jpg**

<b>Wall ID:</b>	SEQU-0010-31.052-L		
<b>Route Name:</b>	GENERALS HIGHWAY HISTORIC		
<b>Inspection Date:</b>	August 15, 2007	<b>Approximate Year Built:</b>	Unknown
<b>*Wall Rating:</b>	83	<b>Maintenance Action:</b>	Maintenance

<b>Wall Function:</b>	Head Wall	<b>Primary Wall Type:</b>	Cantilever - Concrete
<b>Surface Treatment:</b>		<b>Secondary Wall Type:</b>	
<b>Secondary Surface Treatment:</b>		<b>Architectural Facing:</b>	
<b>General Description:</b>	Concrete cantilever cast in-place culvert headwall in good condition.

<b>Element (Weighting Factor)</b>	<b>Narrative</b>	<b>Condition Rating (0 - 10)</b>
PERFORMANCE 8.00	Very good overall performing wall, no signs of distress, but trees in culvert inlet need to be removed.	8
WALL FOUNDATION MATERIAL 8.00	Stable massive bedrock foundation.	9
CONCRETE 8.00	Cast-in-place concrete in good condition, some spalling on outlet collar and one short piece of rebar is exposed. Wings in good condition.	8
LATERAL SLOPE 0.50	Stable soil, trees and bushes.	8
UPSLOPE 0.50	Stable soil, vegetated by trees and bushes.	8
WALL DRAINS 0.50	None visible, but no signs of drain related stress.	8

<b>Failure Consequence:</b>	HIGH
<b>Recommendation Narrative:</b>	Remove large felled tree trunks and other debris from culvert opening: Labor (4 hours) @ \$55.00/hr = \$220.00
<b>Repair Cost:</b>	\$220

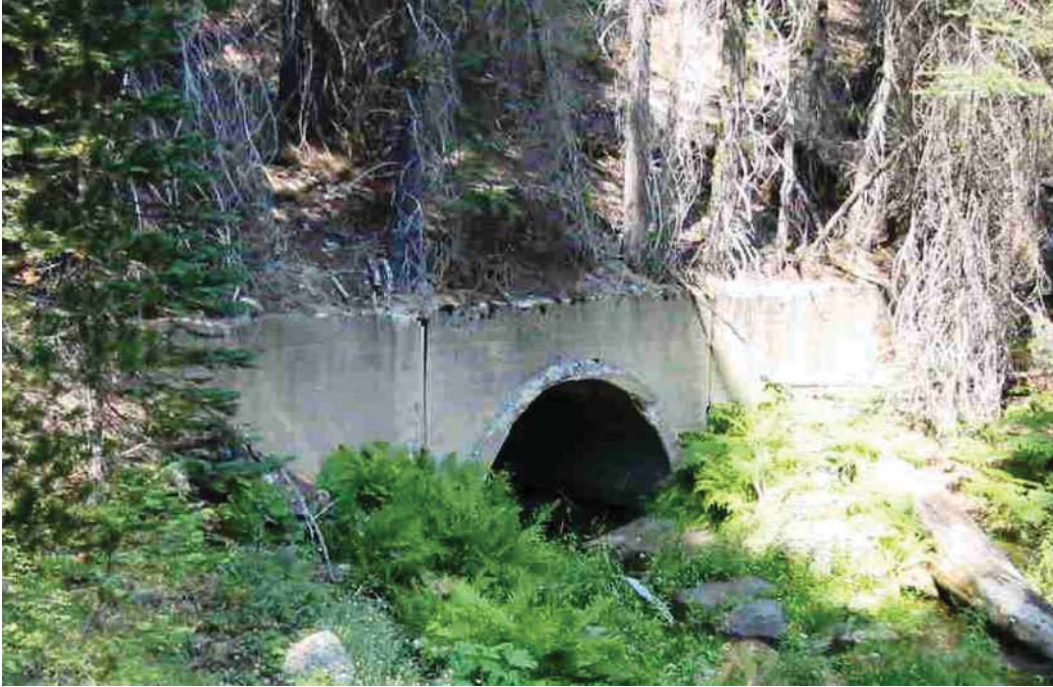
**SEQU\_0010\_31.052\_R\_1.jpg**

<b>Wall ID:</b>	SEQU-0010-31.052-R		
<b>Route Name:</b>	GENERALS HIGHWAY HISTORIC		
<b>Inspection Date:</b>	August 15, 2007	<b>Approximate Year Built:</b>	Unknown
<b>*Wall Rating:</b>	83	<b>Maintenance Action:</b>	No Action

<b>Wall Function:</b>	Head Wall	<b>Primary Wall Type:</b>	Cantilever - Concrete
<b>Surface Treatment:</b>		<b>Secondary Wall Type:</b>	
<b>Secondary Surface Treatment:</b>		<b>Architectural Facing:</b>	
<b>General Description:</b>	Cantilever, cast in-place concrete culvert head wall in good condition.

<b>Element (Weighting Factor)</b>	<b>Narrative</b>	<b>Condition Rating (0 - 10)</b>
PERFORMANCE 8.00	Very good overall performing wall, no signs of distress.	8
WALL FOUNDATION MATERIAL 8.00	Stable massive bedrock foundation.	9
CONCRETE 8.00	Cast-in-place concrete in good condition, some spalling on outlet collar and one short piece of rebar is exposed. Wings in good condition.	8
LATERAL SLOPE 0.50	Stable soil, trees and bushes.	8
UPSLOPE 0.50	Stable soil, vegetated by trees and bushes.	8
WALL DRAINS 0.50	None visible, but no signs of drain related stress.	8
