# SEQU

## WIP Report

### NPS Retaining Wall Inventory Program Sequoia National Park

**Data Collection Date: August 2007  
Report Date: December 2015**

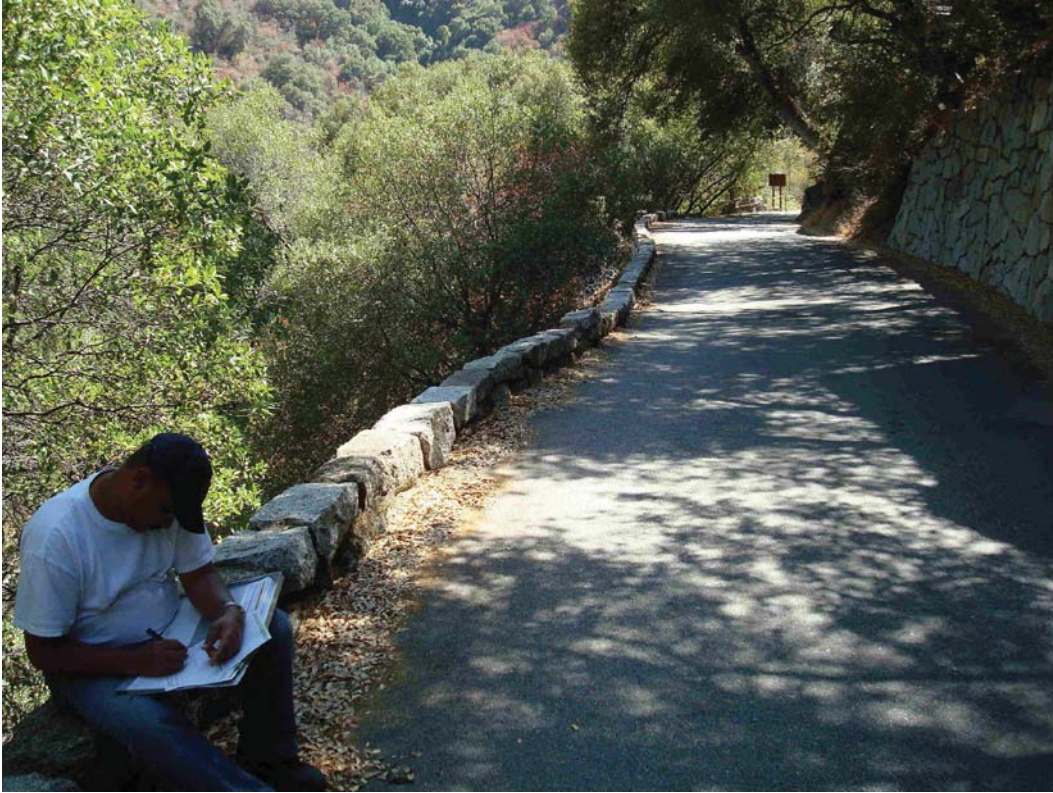
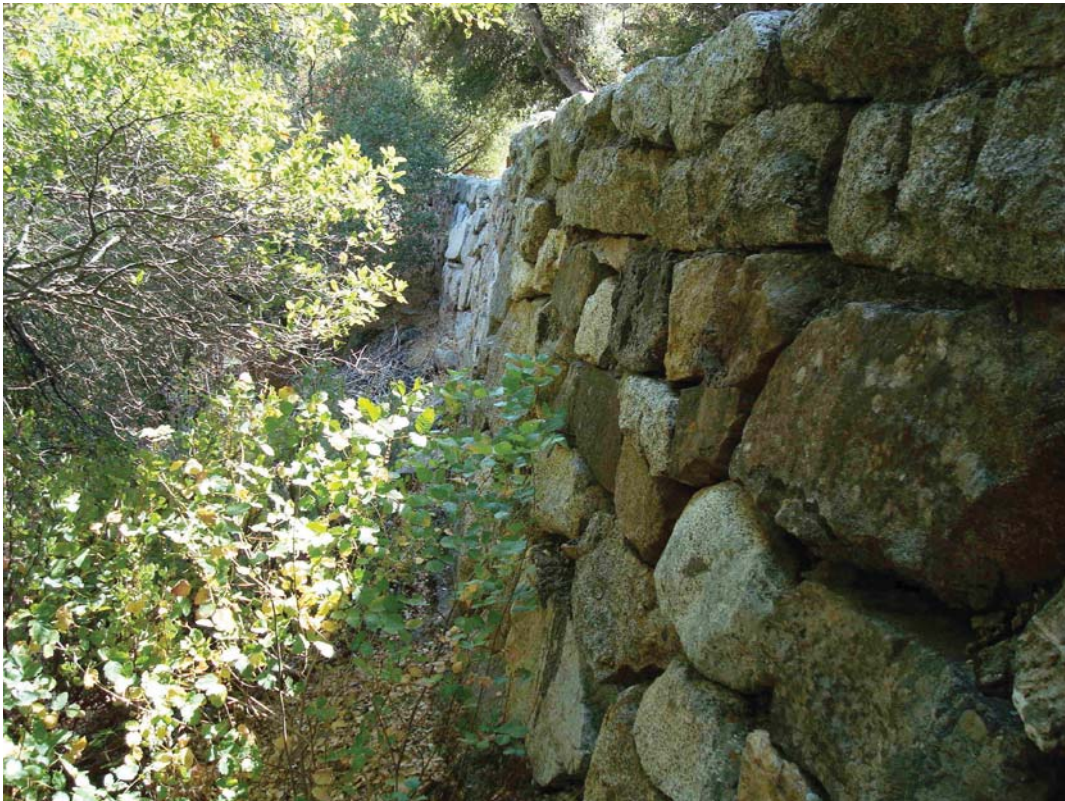
<b>Wall ID:</b>	SEQU-0203-0.000-R		
<b>Route Name:</b>	BUCKEYE FLAT ROAD		
<b>Inspection Date:</b>	August 17, 2007	<b>Approximate Year Built:</b>	Unknown
<b>*Wall Rating:</b>	76	<b>Maintenance Action:</b>	Maintenance
<b>Wall Description</b>			
<b>Wall Function:</b>	Fill Wall	<b>Primary Wall Type:</b>	Gravity - Dry Stone
<b>Surface Treatment:</b>		<b>Secondary Wall Type:</b>	
<b>Secondary Surface Treatment:</b>		<b>Architectural Facing:</b>	
<b>General Description:</b>	Dry stacked granite stone fill wall located at edge of pavement with a 1 foot stone guardwall parapet.		
<b>Wall Measurements</b>			
<b>Wall Length (ft.):</b>	230	<b>Face Area (sq.):</b>	1215
<b>Average Wall Height (ft.):</b>	5	<b>Face Angle (deg.):</b>	80
<b>Maximum Wall Height (ft.):</b>	12	<b>Vertical Offset (ft.):</b>	0
<b>Assessed Elements</b>			
<b>Element (Weighting Factor)</b>	<b>Narrative</b>		<b>Condition Rating (0 - 10)</b>
PERFORMANCE 8.00	Good condition with some drainage problem.		7
