#### Federal Lands Highway Road Inventory Program

Road Inventory and Condition Assessment

#### Charles Young Buffalo Soldiers National Monument CHYO

**Cycle 5 Report**

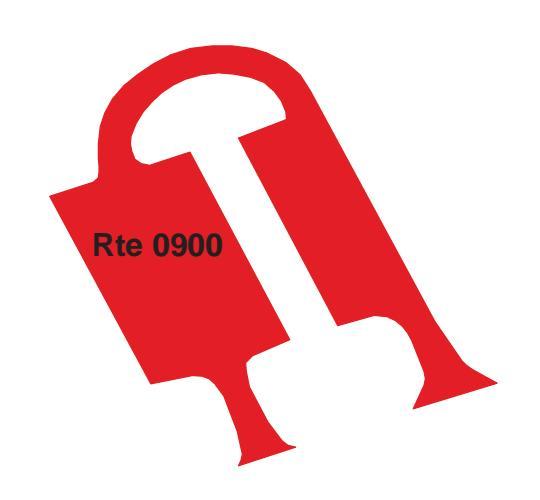
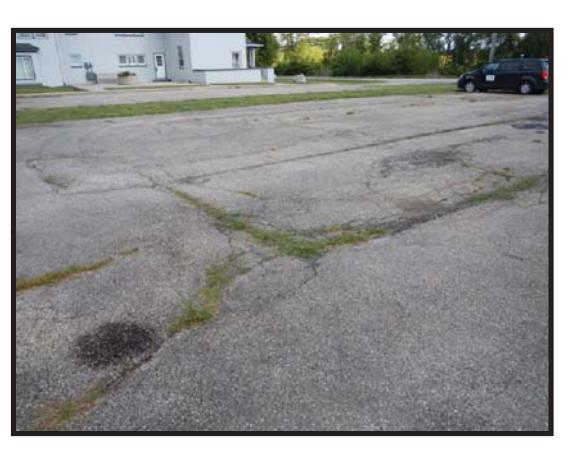
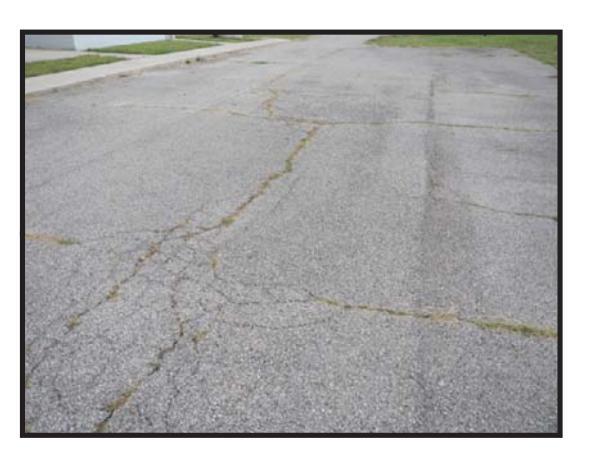
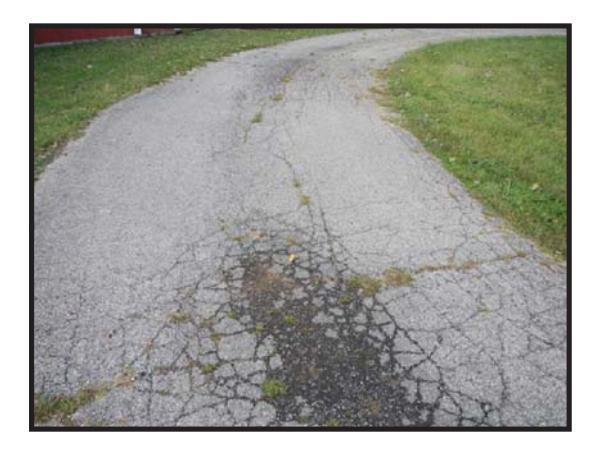
#### CHARLES YOUNG BUFFALO SOLDIERS NATIONAL MONUMENT Route 0900

HORSESHOE PARKING LOT FROM U.S. HIGHWAY 42 TO U.S. HIGHWAY 42

Route	Public /				
Number	NonPublic	Date Visited	Area (sq ft)	Lane Miles *	Surface Type
0900	PUBLIC	9/21/2013	9,615	0.17	AS
Culverts	<b>Drop Inlets</b>	Gates	Curb & Gutter	Curb	PCR
			NO CURB AND		
2	0	0	GUTTER	NO CURB	POOR/45
