The Road Inventory of Blue Ridge Parkway BLRI – 5140 Volume 1

Road Inventory Program

Prepared By:
Federal Highway Administration
Eastern Federal Lands Highway Division
Cycle 3

Blue Ridge Parkway in North Carolina

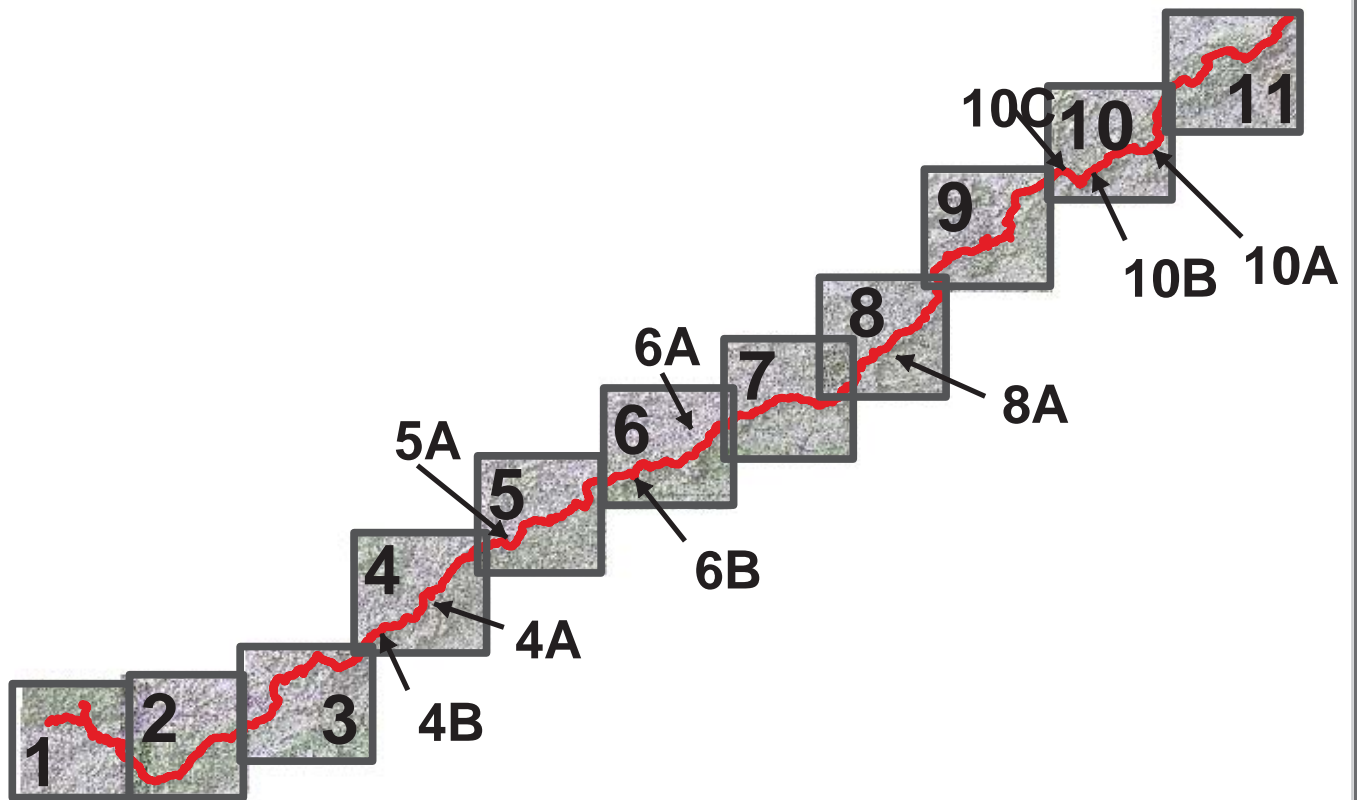
Blue Ridge Parkway Route Location Key Map

Park Owned Routes

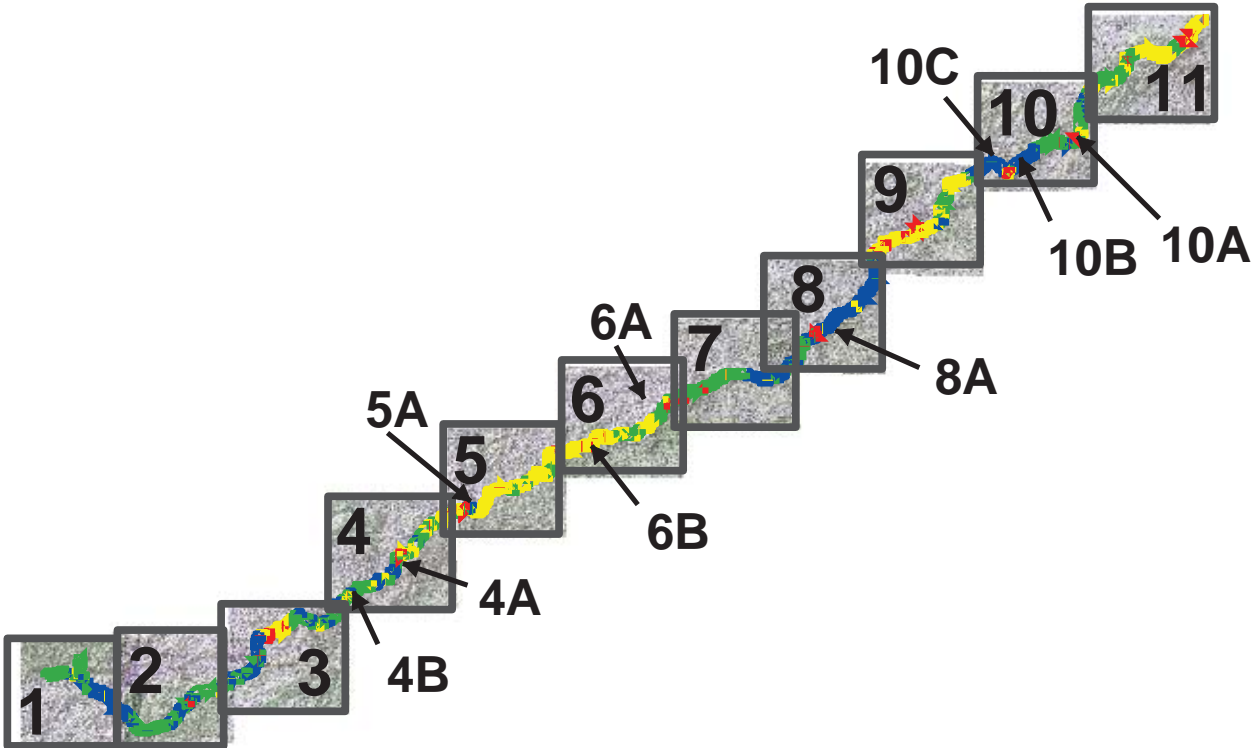
Blue Ridge Parkway Route Condition Key Map PCR - Mile by Mile

PCR	Poor		Fair		Good		Excellent	
		(<=60)		(61 - 84)		(85 - 94)		(95 - 100)

* If the PCR rating is not available for a section, the SCR rating will be displayed. See appendix for definitions and formulas.

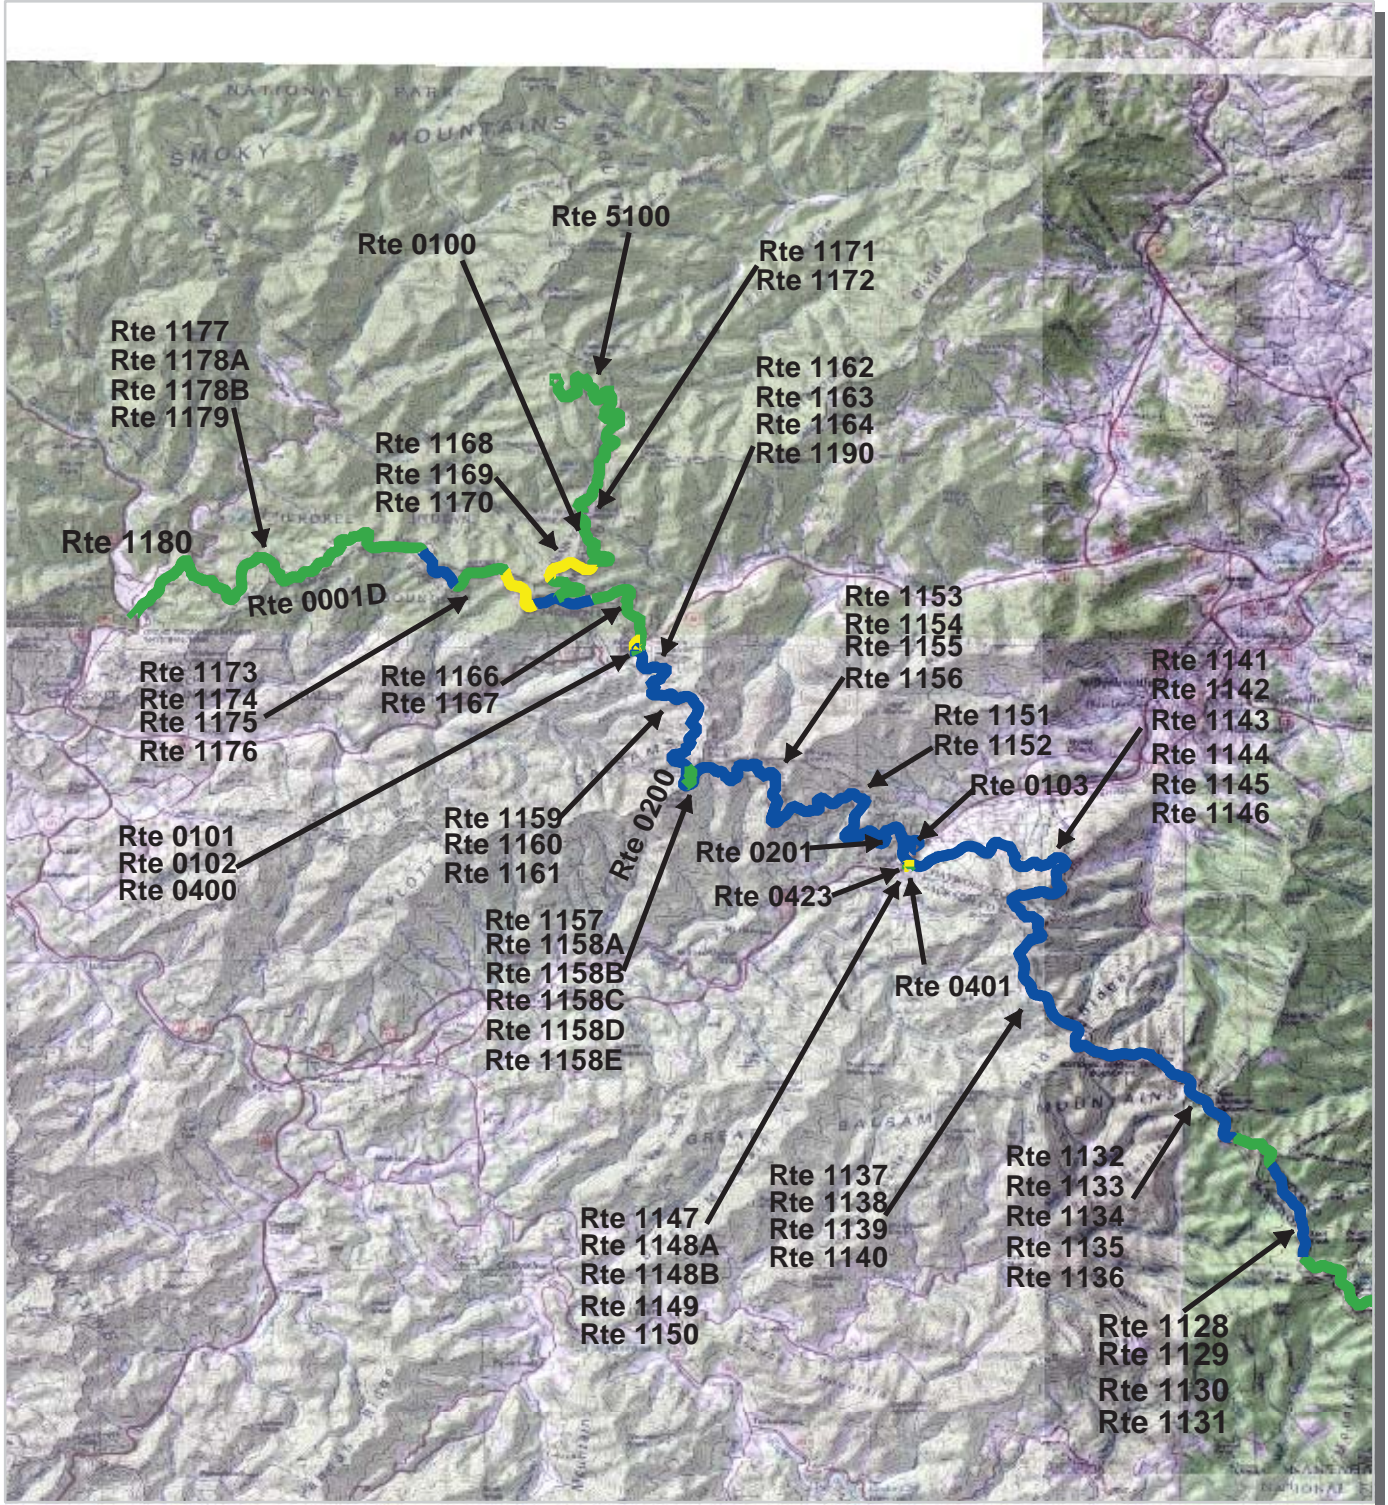
Blue Ridge Parkway Route Condition Area Map 1 PCR - Mile by Mile

PCR	Poor	Fair	Good	Excellent

(<=60)	(61 - 84)	(85 - 94)	(95 - 100)

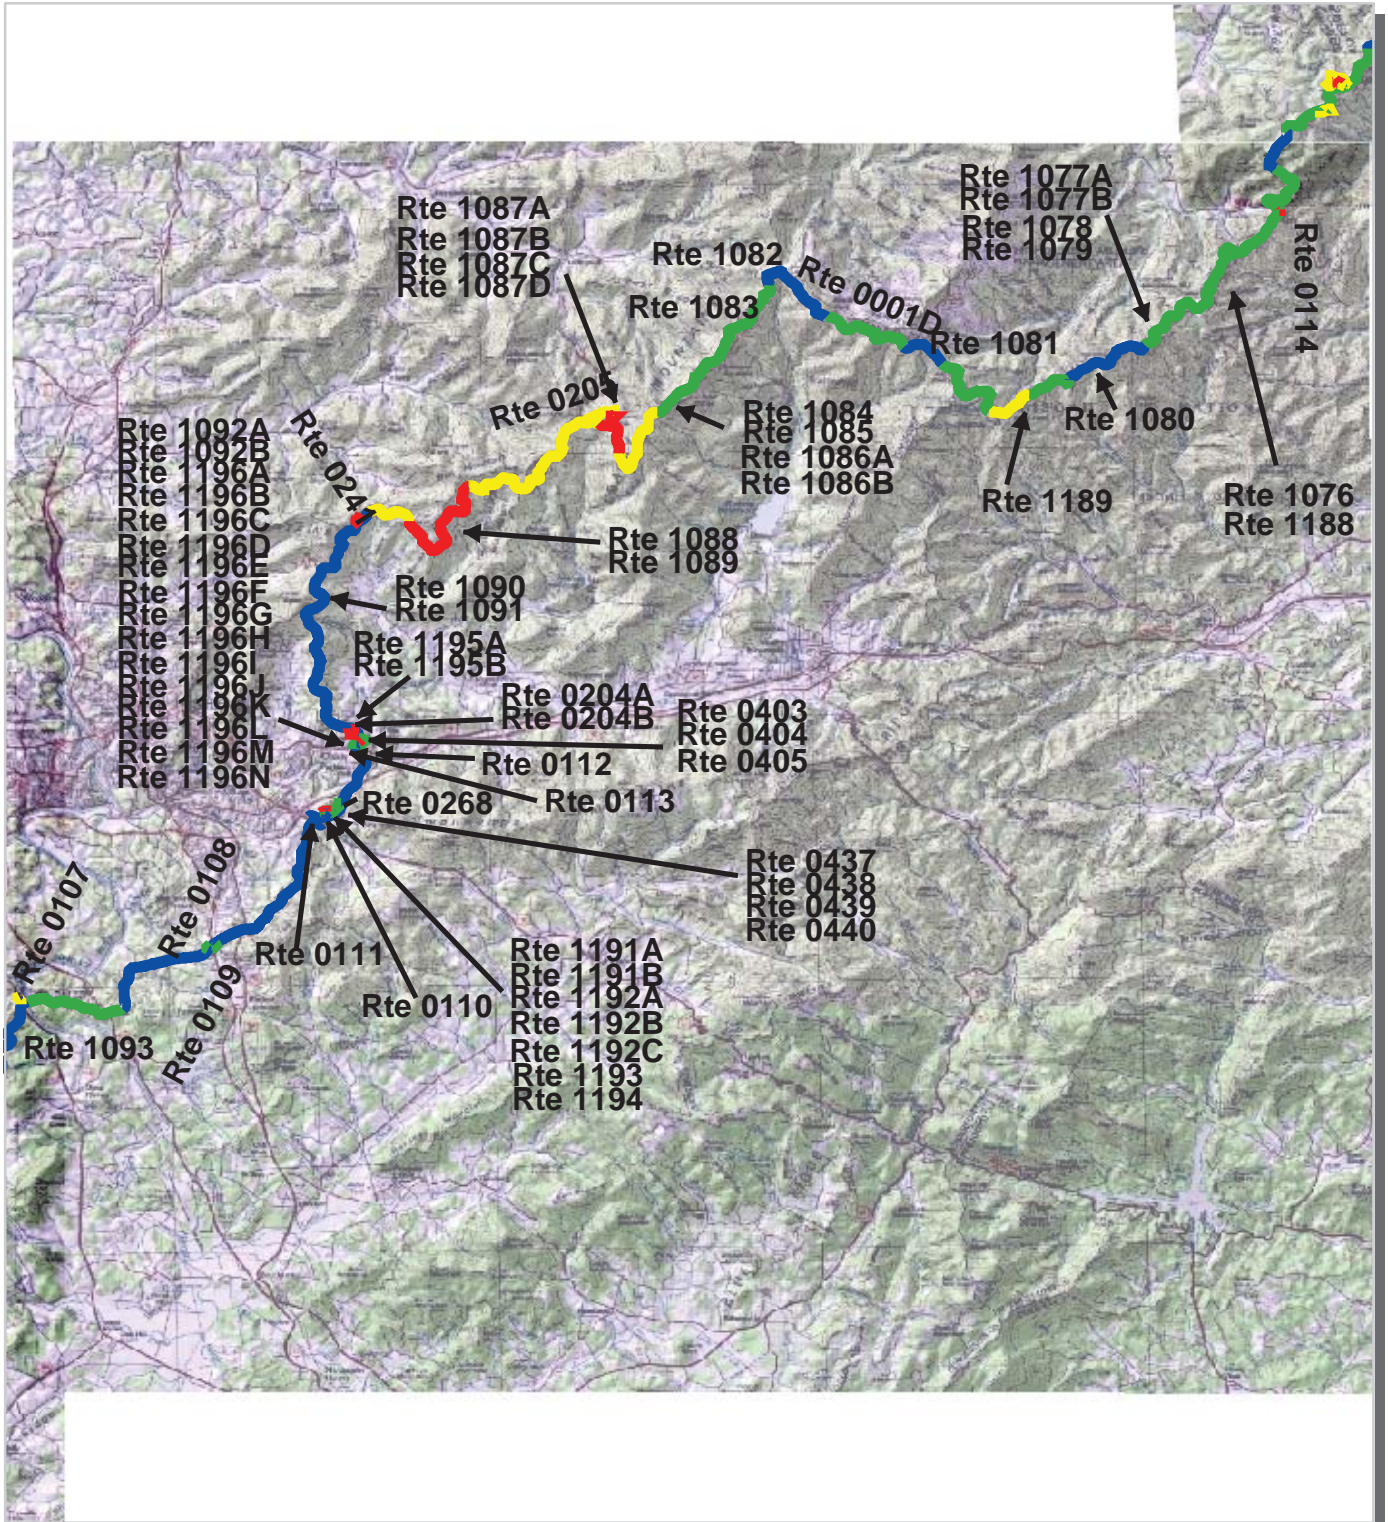
Blue Ridge Parkway Route Condition Area Map 3 PCR - Mile by Mile

PCR Poor ■ Fair ■ Good ■ Excellent ■
 (≤60) (61 - 84) (85 - 94) (95 - 100)

* If the PCR rating is not available for a section, the SCR rating will be displayed. See appendix for definitions and formulas.

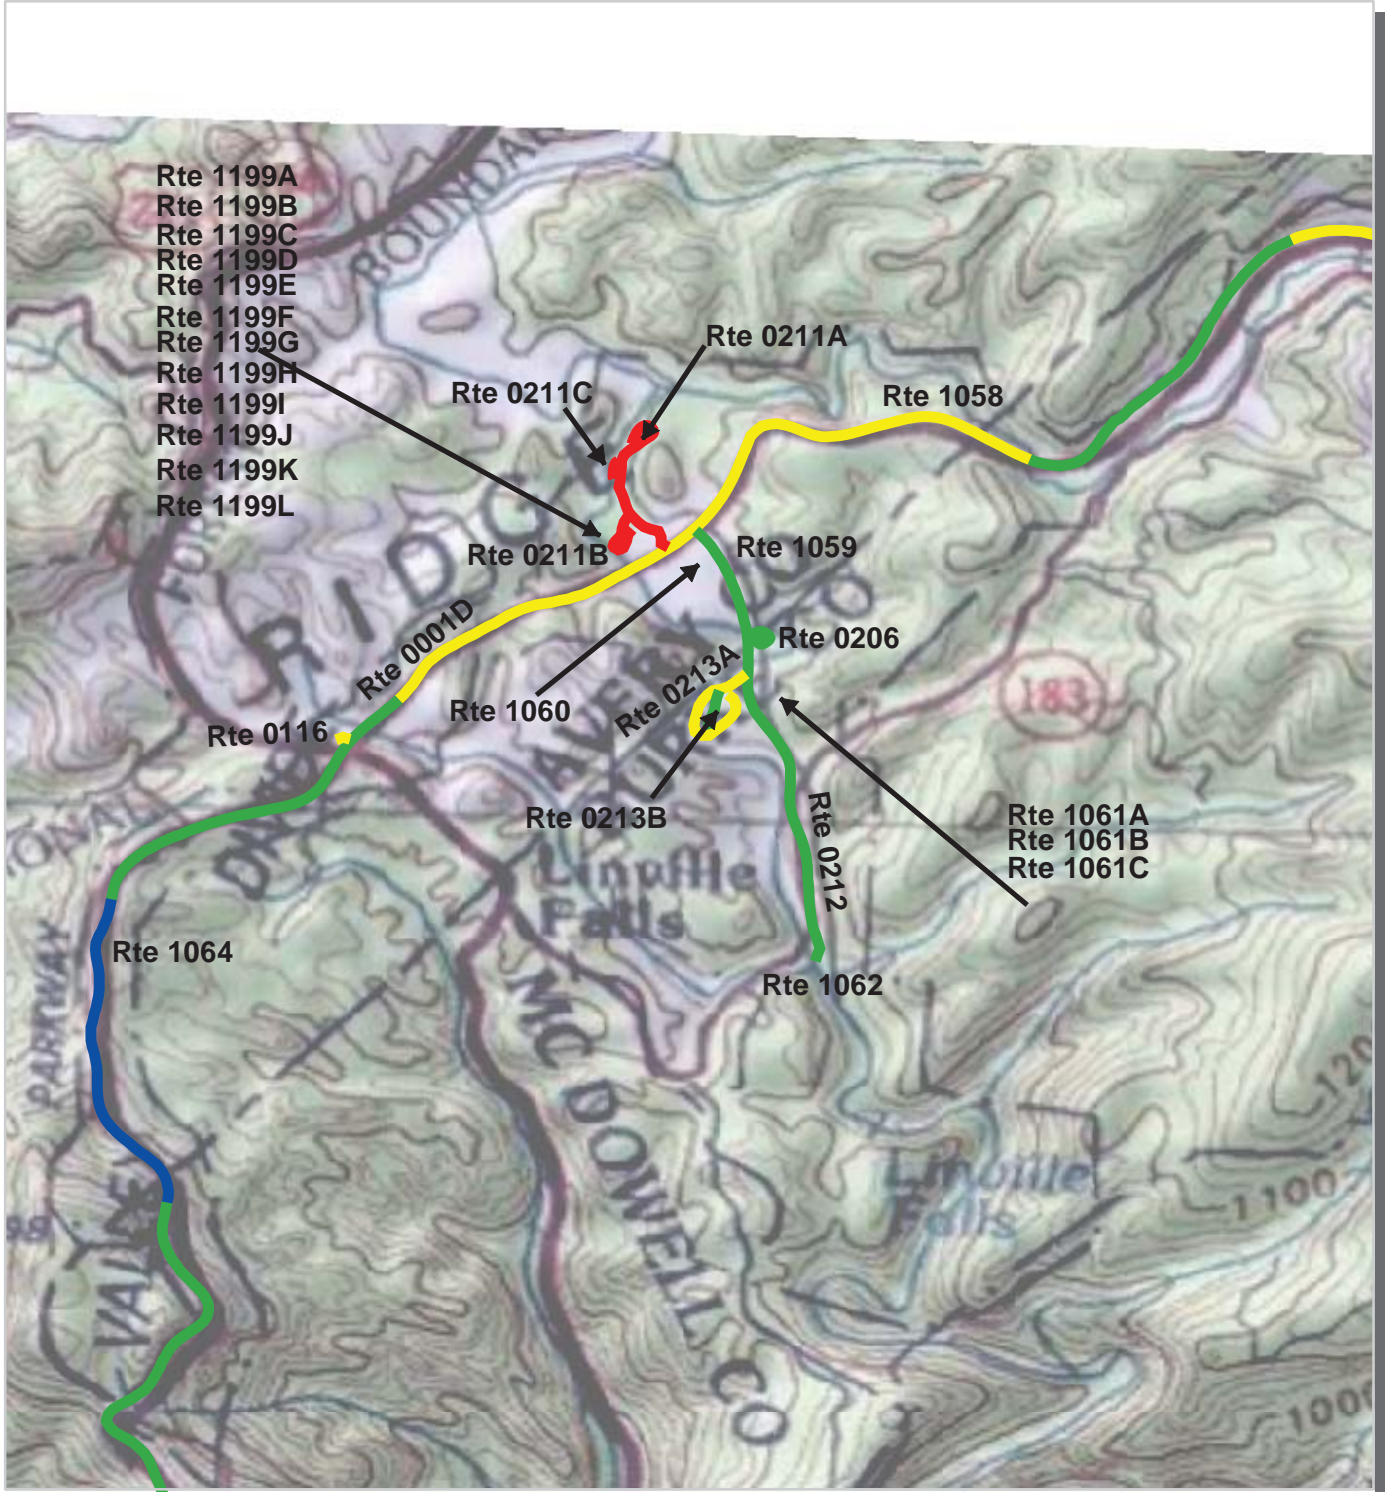
Blue Ridge Parkway Route Condition Area Map 4A PCR - Mile by Mile

PCR	Poor		Fair		Good		Excellent	
	(<=60)		(61 - 84)	(85 - 94)	(95 - 100)

* If the PCR rating is not available for a section, the SCR rating will be displayed. See appendix for definitions and formulas.

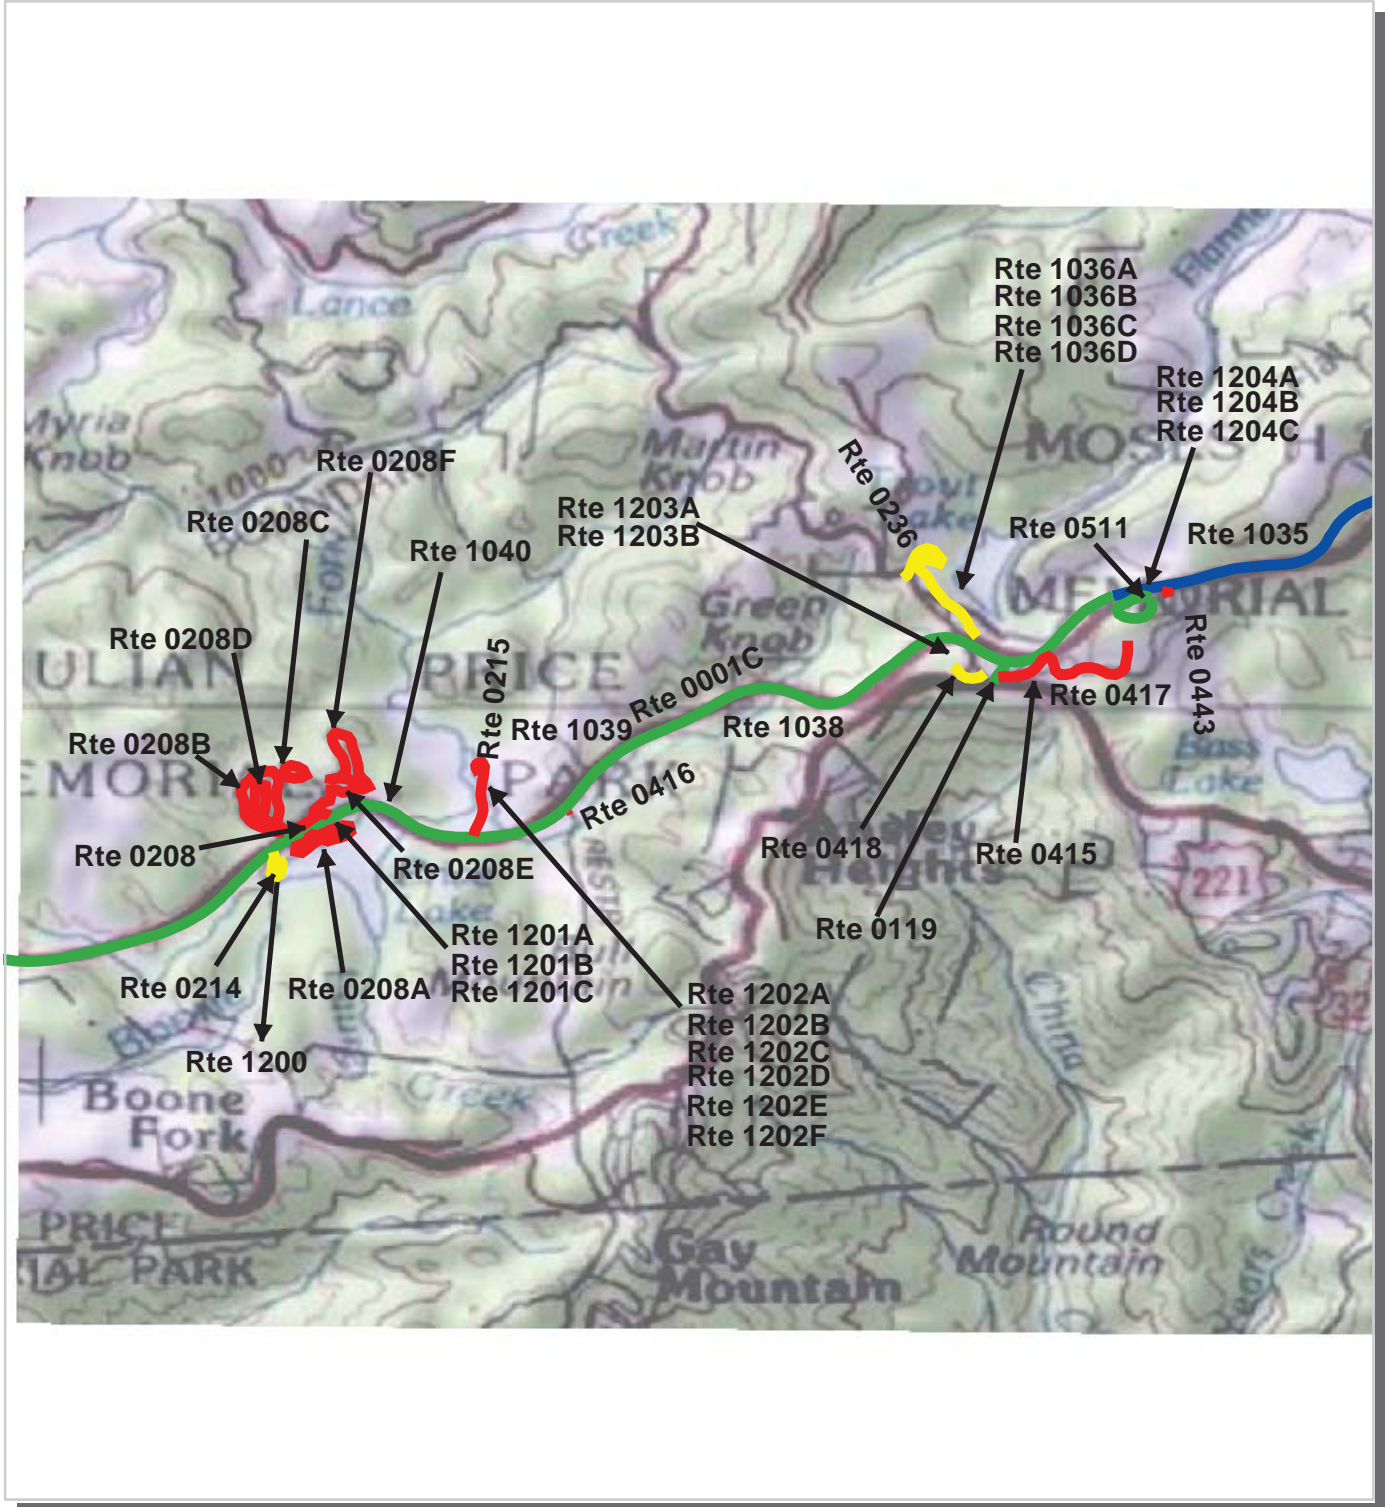
Blue Ridge Parkway Route Condition Area Map 5A PCR - Mile by Mile

PCR	Poor █ (≤ 60)	Fair █ (61 - 84)	Good █ (85 - 94)	Excellent █ (95 - 100)
-----	---	--	---	--

* If the PCR rating is not available for a section, the SCR rating will be displayed. See appendix for definitions and formulas.

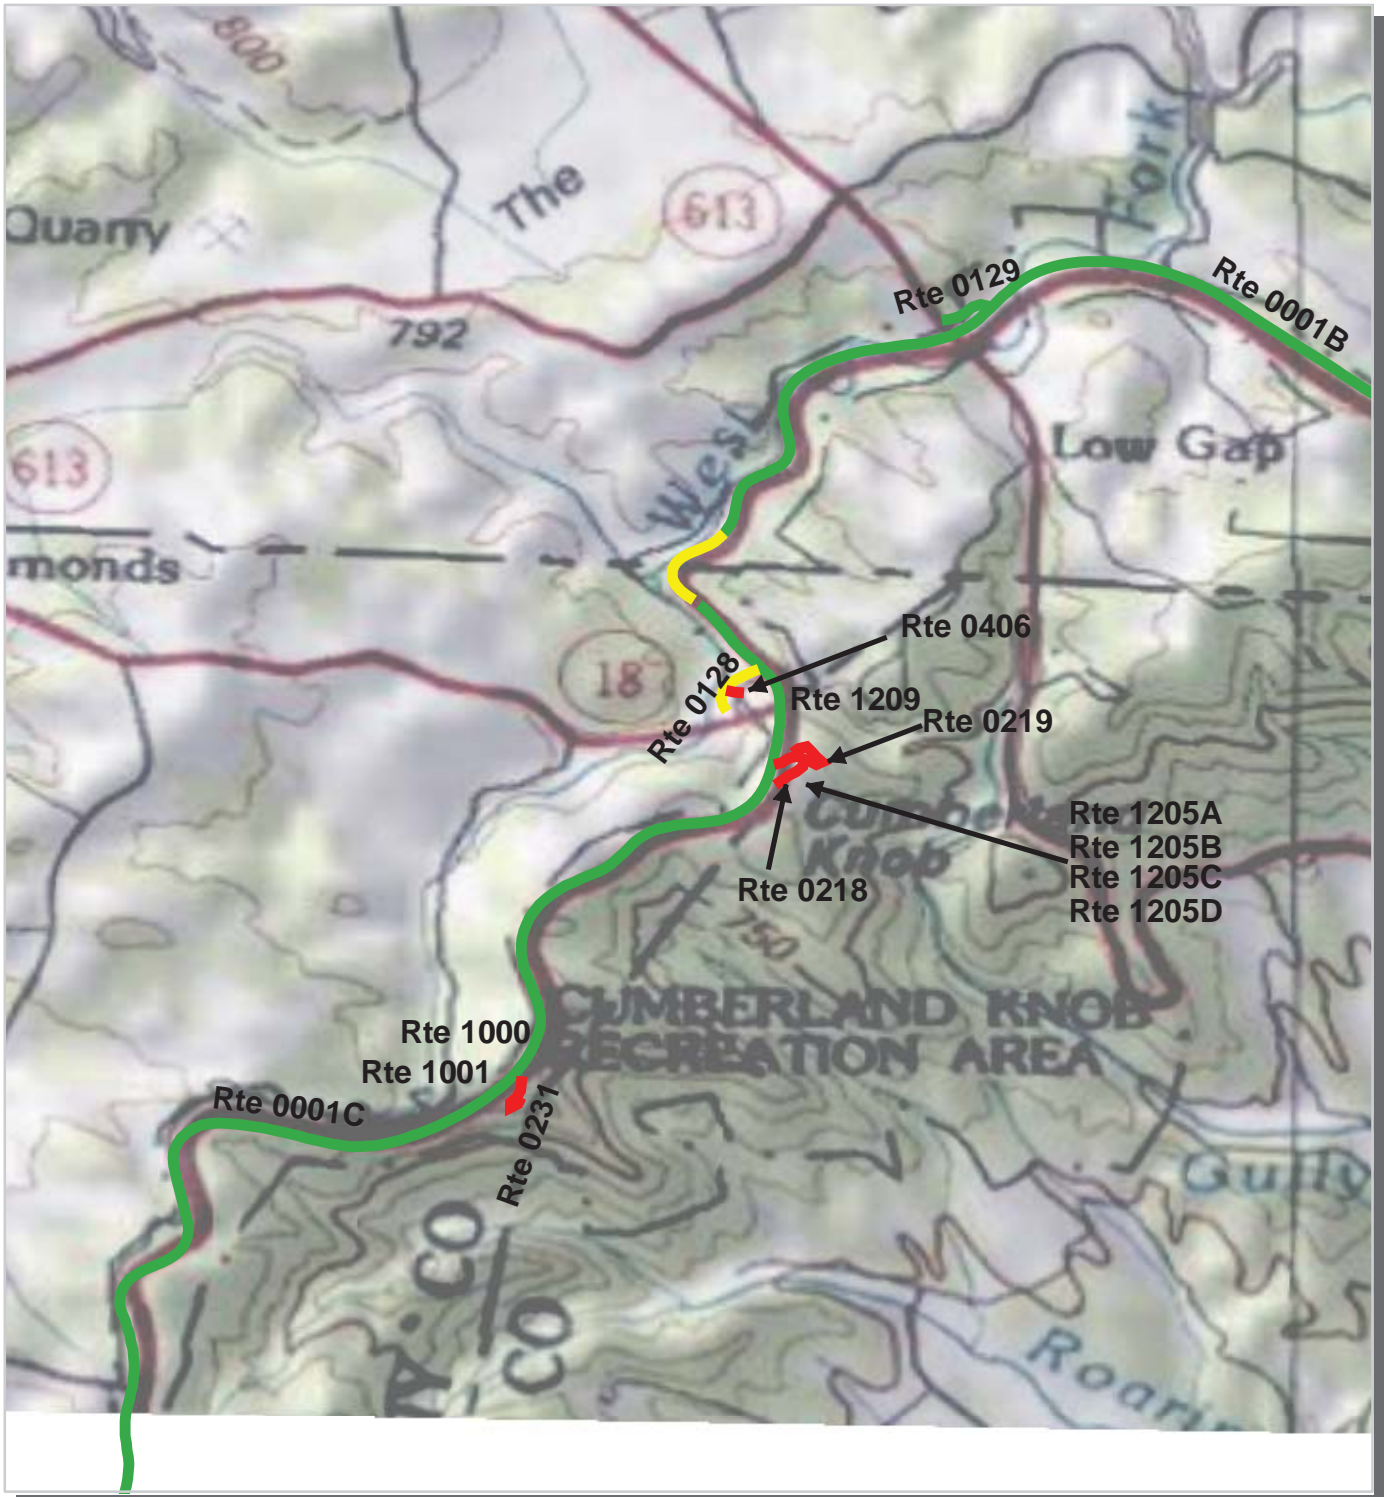
Blue Ridge Parkway Route Condition Area Map 6A PCR - Mile by Mile

PCR	Poor		Fair		Good		Excellent	
		(<=60)		(61 - 84)		(85 - 94)		(95 - 100)

* If the PCR rating is not available for a section, the SCR rating will be displayed. See appendix for definitions and formulas.

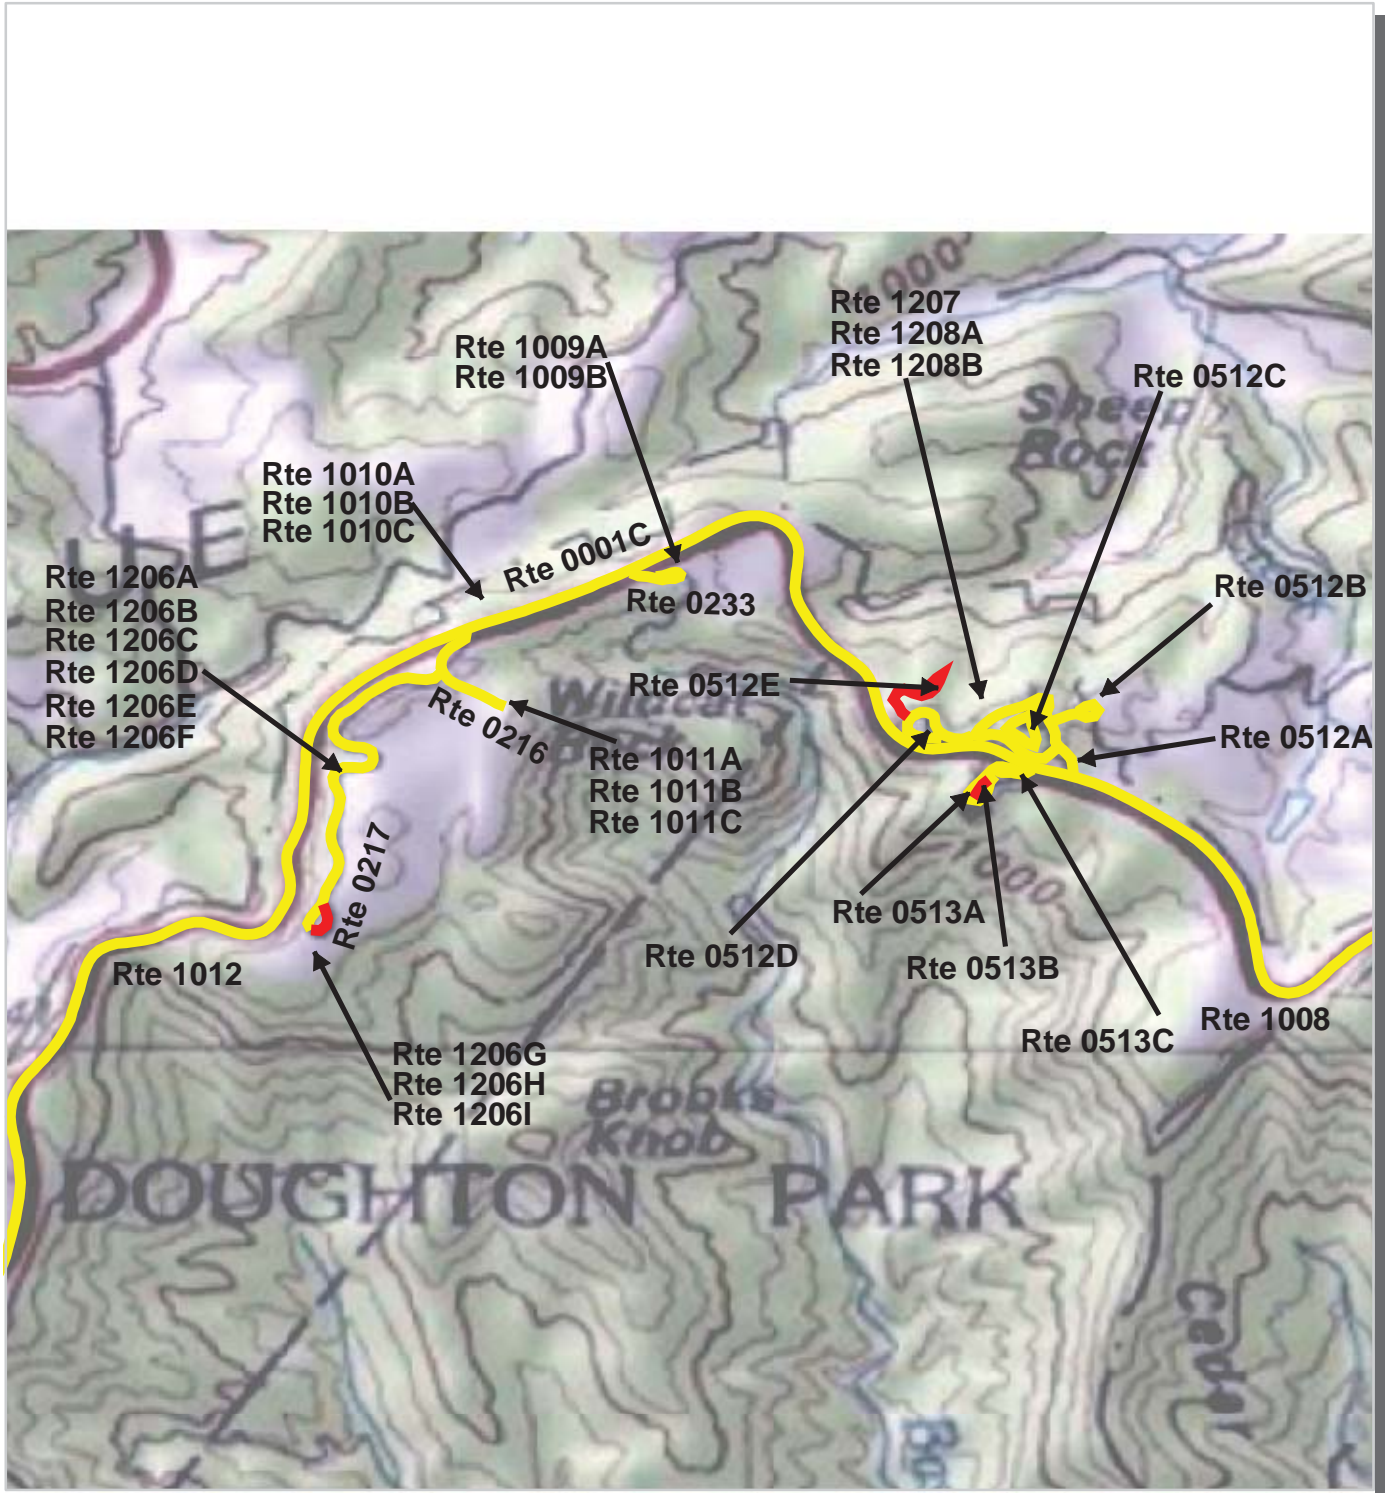
Blue Ridge Parkway Route Condition Area Map 6B PCR - Mile by Mile

PCR Poor ■ Fair ■ Good ■ Excellent ■
 (≤60) (61 - 84) (85 - 94) (95 - 100)

† If the PCR rating is not available for a section, the SCR rating will be displayed. See appendix for definitions and formulas.

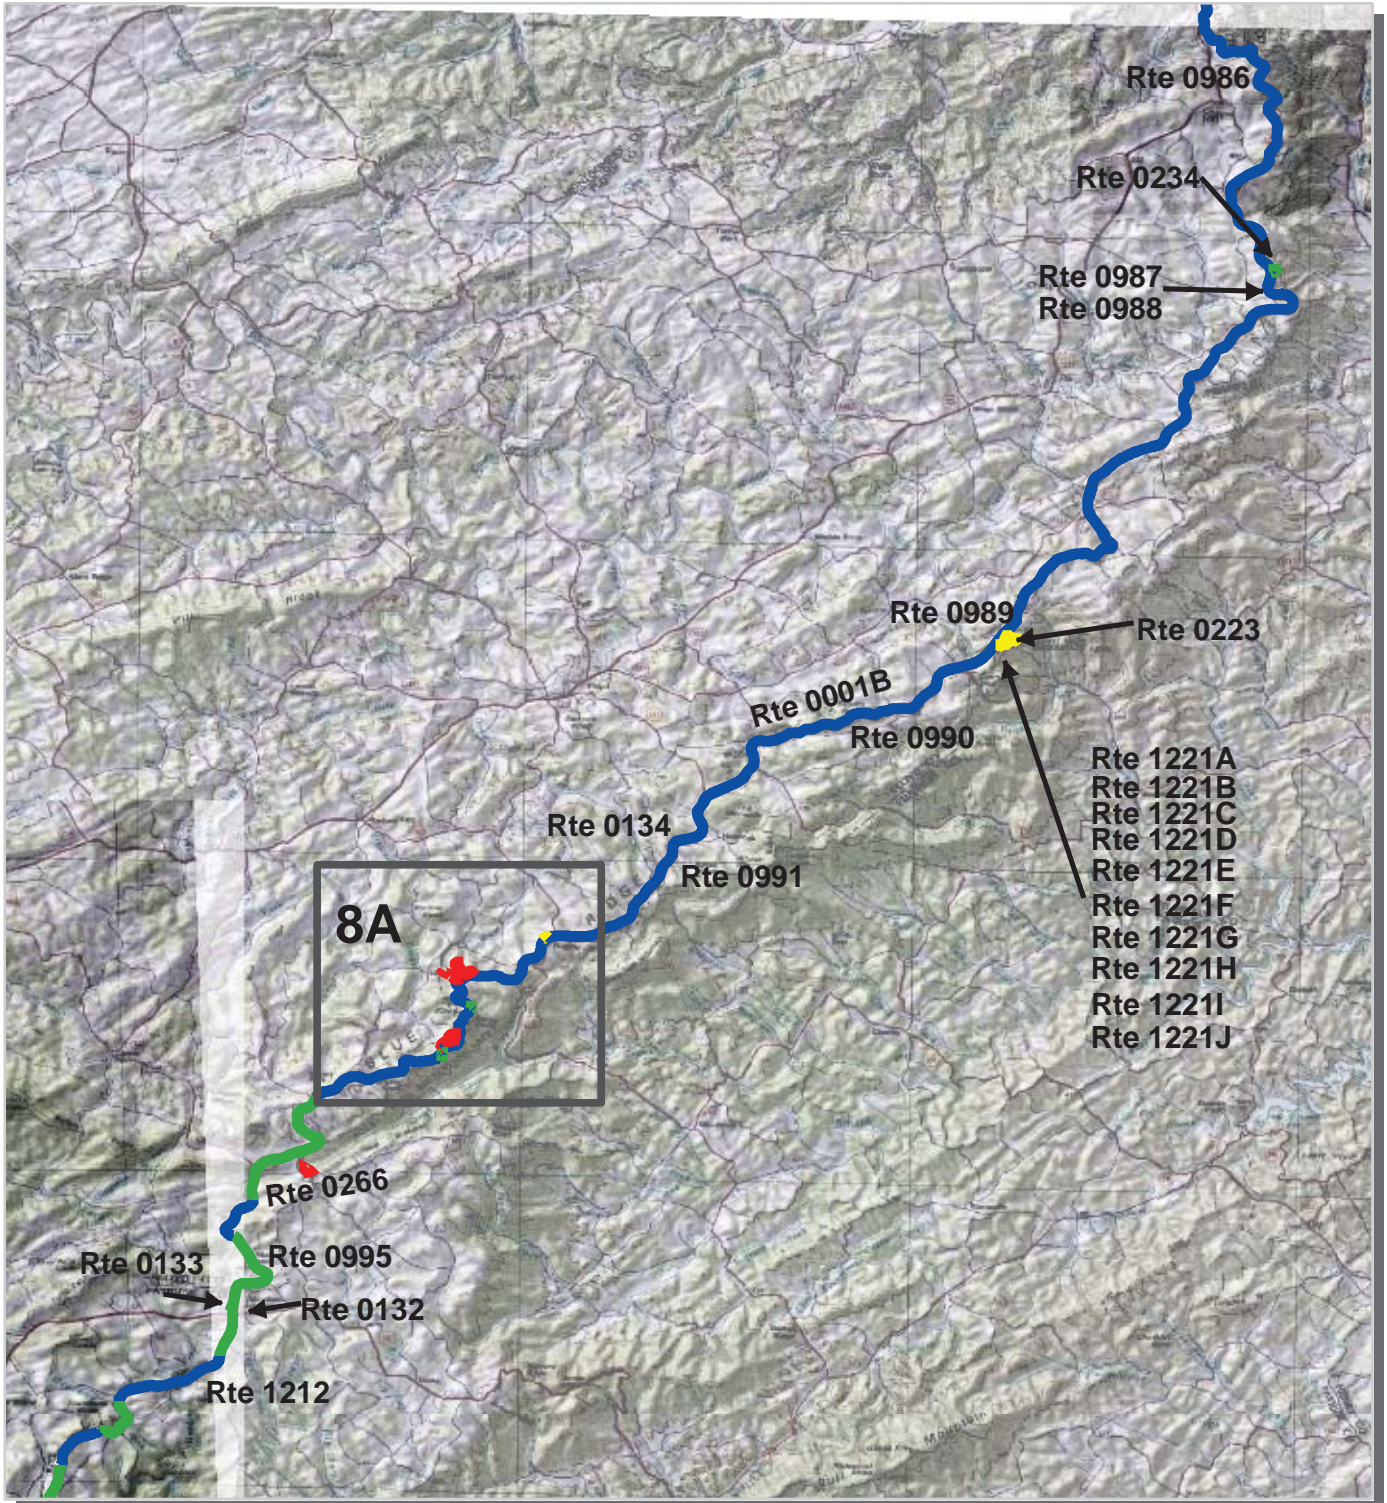
Blue Ridge Parkway Route Condition Area Map 8 PCR - Mile by Mile

PCR Poor ■ Fair ■ Good ■ Excellent ■
 (<=60) (61 - 84) (85 - 94) (95 - 100)

* If the PCR rating is not available for a section, the SCR rating will be displayed. See appendix for definitions and formulas.

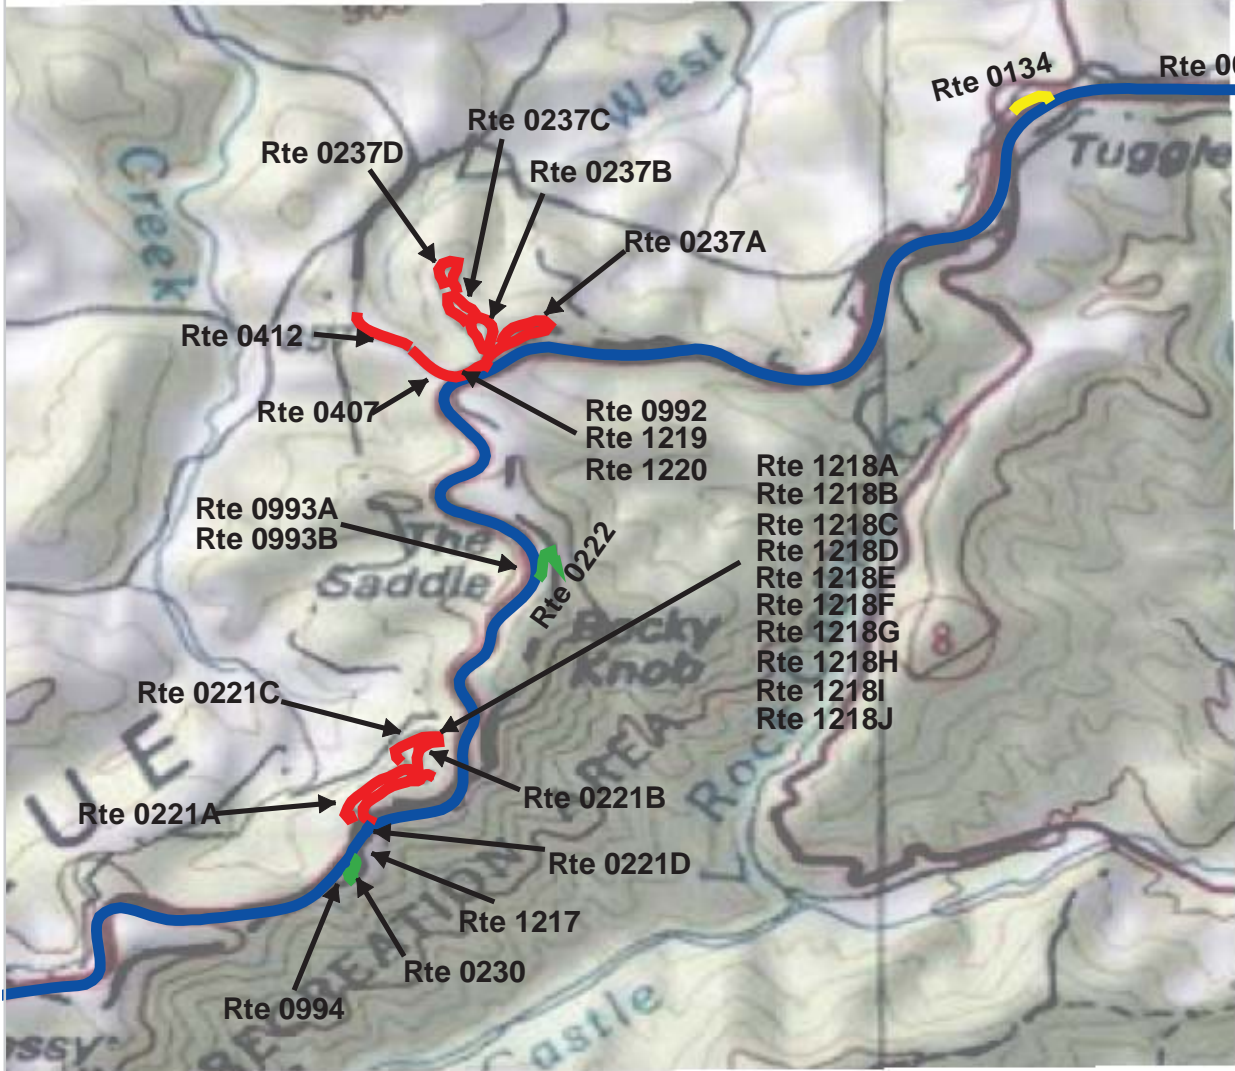
Blue Ridge Parkway Route Condition Area Map 8A PCR - Mile by Mile

PCR	Poor (<=60)	Fair (61 - 84)	Good (85 - 94)	Excellent (95 - 100)
* If the PCR rating is not available for a section, the SCR rating will be displayed. See appendix for definitions and formulas.

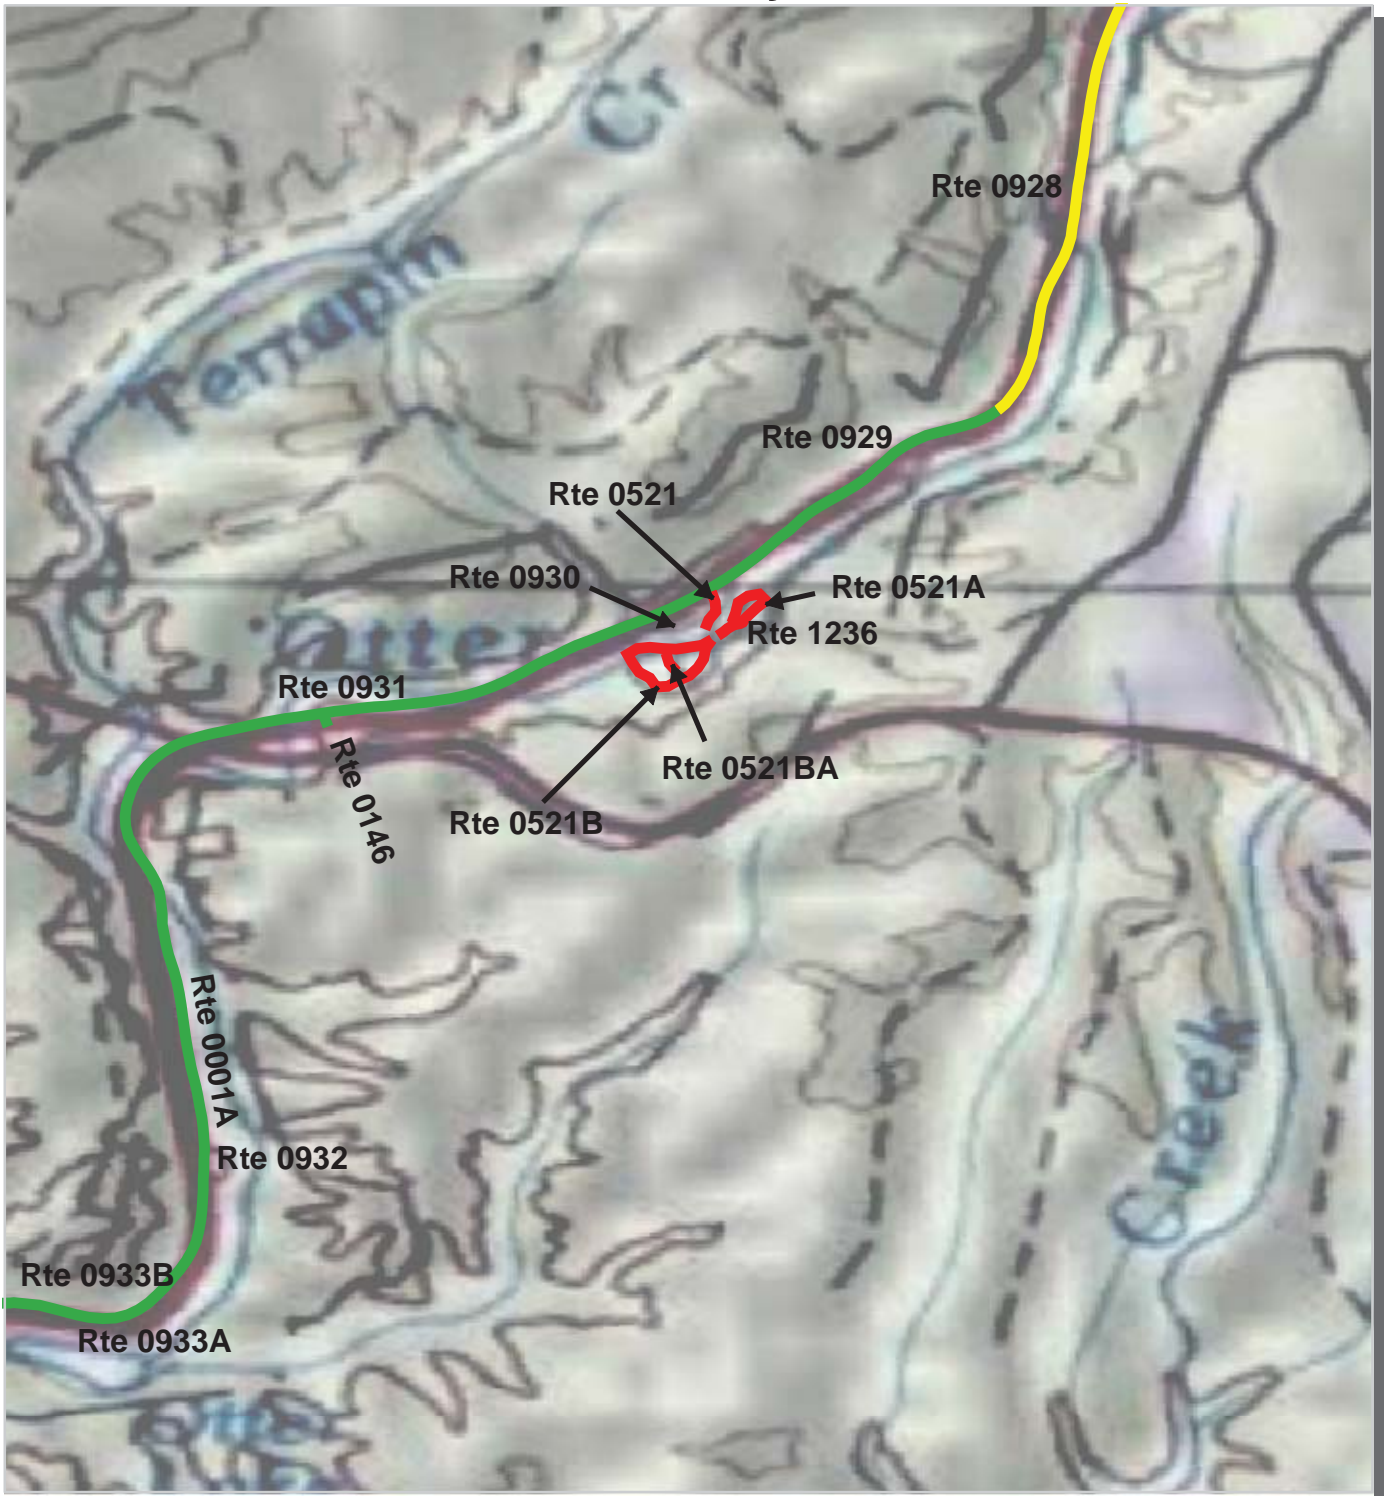
Blue Ridge Parkway Route Condition Area Map 10A PCR - Mile by Mile

PCR	Poor		Fair		Good		Excellent	
	(<=60)		(61 - 84)		(85 - 94)		(95 - 100)

* If the PCR rating is not available for a section, the SCR rating will be displayed. See appendix for definitions and formulas.

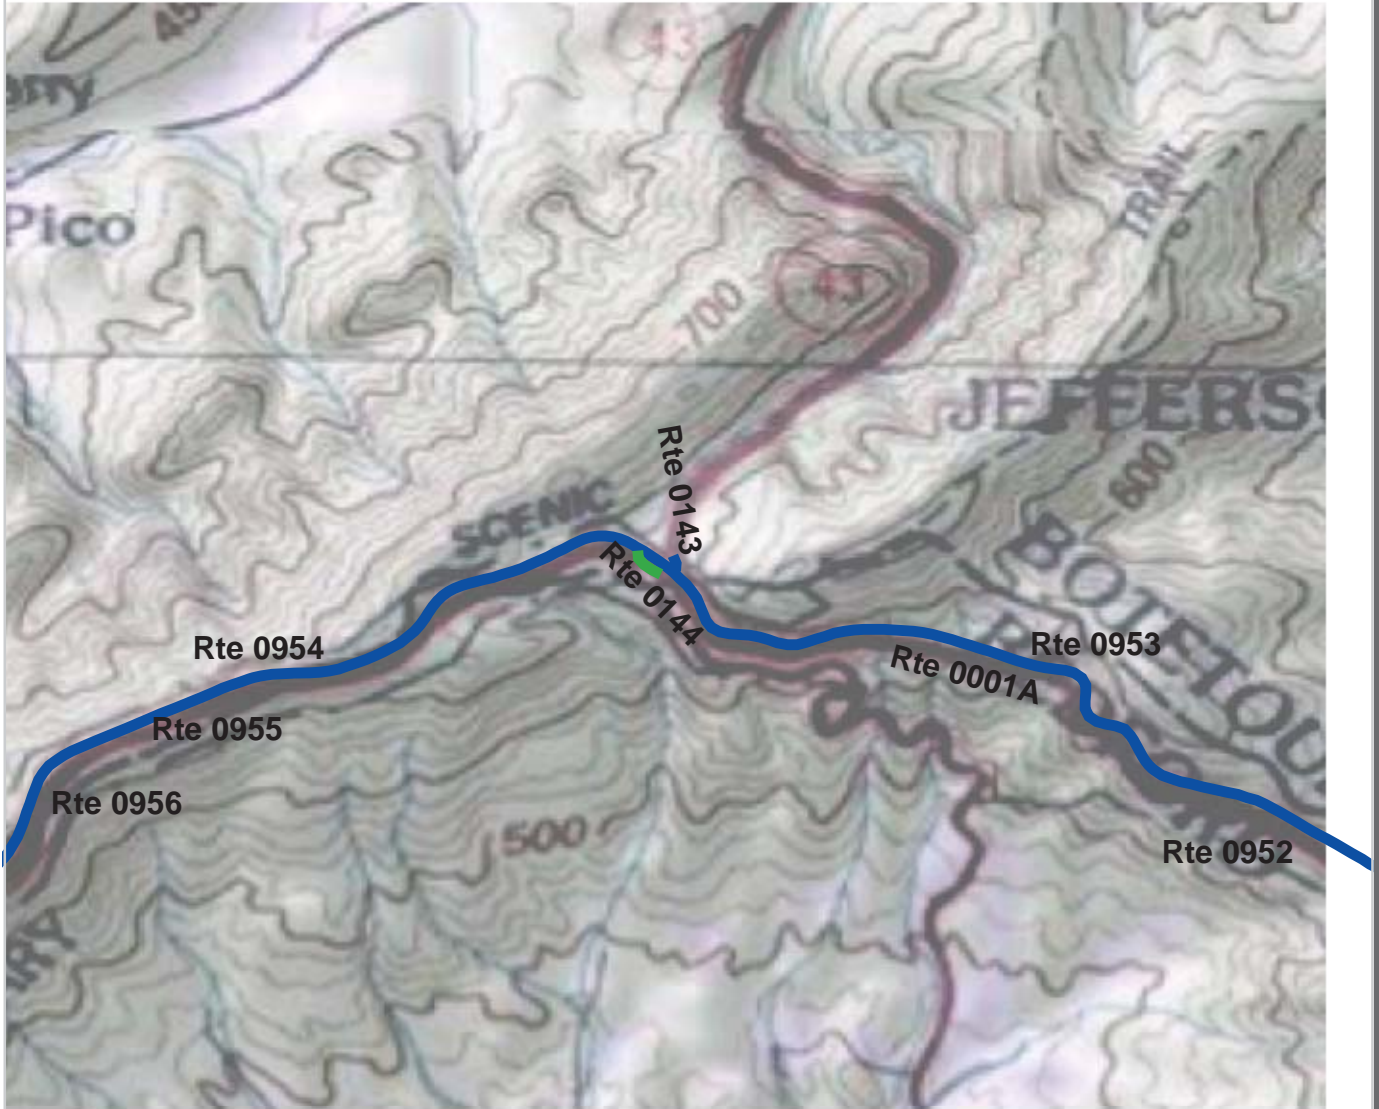
Blue Ridge Parkway Route Condition Area Map 10C PCR - Mile by Mile

PCR	Poor		Fair		Good		Excellent	
		(<=60)		(61 - 84)		(85 - 94)		(95 - 100)

† If the PCR rating is not available for a section, the SCR rating will be displayed. See appendix for definitions and formulas.
