The Road Inventory of Blue Ridge Parkway BLRI – 5140 Volume 1

Road Inventory Program

Prepared By:
Federal Highway Administration
Eastern Federal Lands Highway Division
Cycle 3

Blue Ridge Parkway in North Carolina

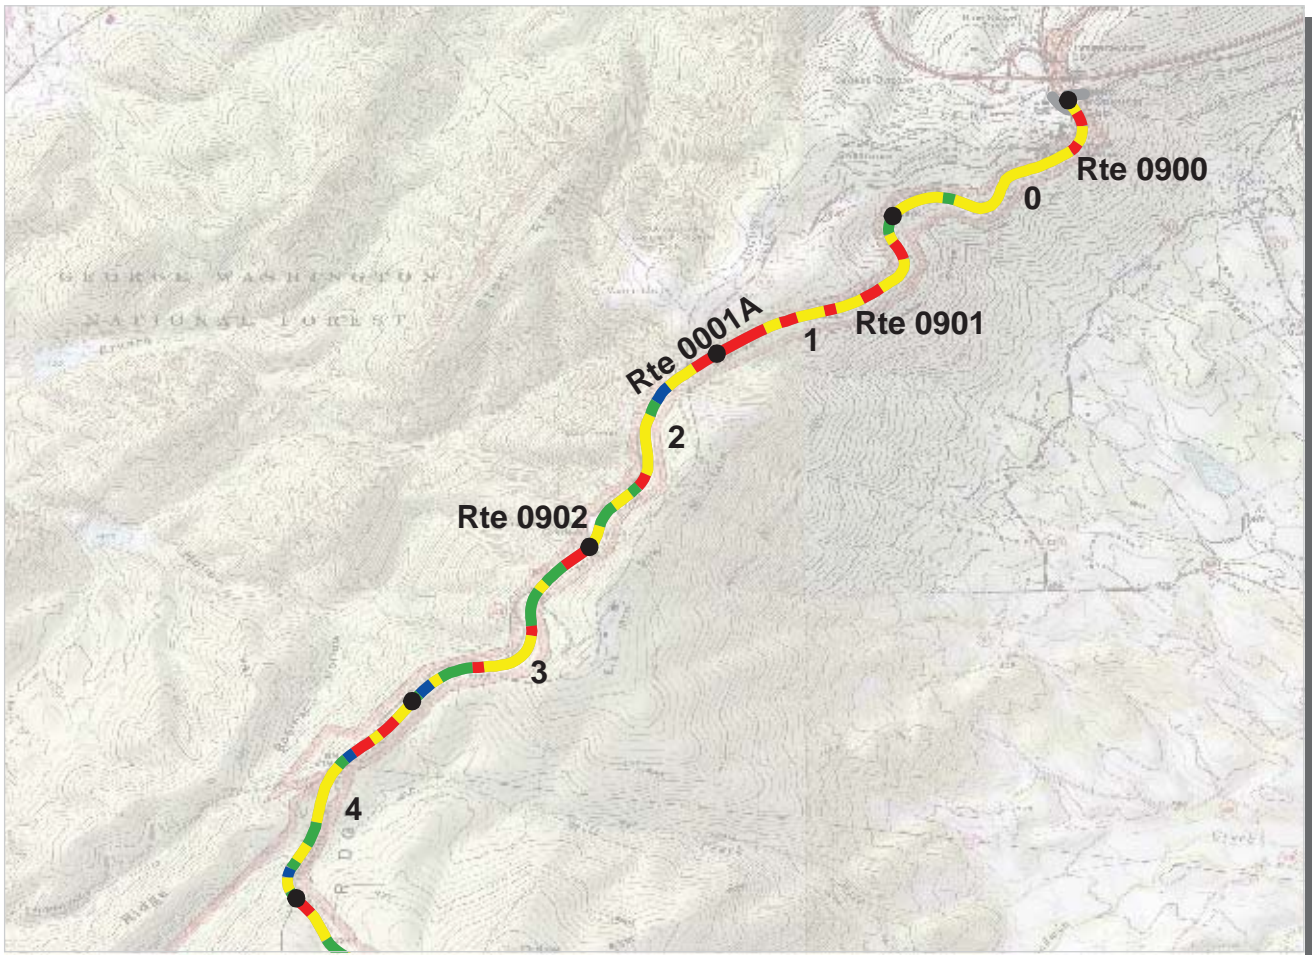
ROUTE: 0001A Blue Ridge Parkway, Maintenance District 1 TOTAL LENGTH: 105.65 Miles

Section Number	0	1	2	3	4
Section Length (mi)	1.00	1.00	1.00	1.00	1.00
AADT	**				
SADT	**				
ADT Date	**				
Cross Section Information					
Number of Lanes	2	2	2	2	2
Paved Width (ft)	20	19	20	21	19
Lane Width (ft)	10	10	10	10	9
Shoulder Width (ft)	5	5	4	3	6
Roadway Condition Information					
PCR (Pavement Condition Rating)	69	63	71	72	77
RCI (Roughness Condition Index)	95	95	94	93	97
SCR (Surface Condition Rating)	52	41	56	58	64
Alligator Cracking Index	93	95	92	94	98
Rutting Index	92	89	90	85	92
Patching Index	100	100	100	100	100
Transverse Cracking Index	77	71	82	86	83
Longitudinal Cracking Index	87	85	89	90	90
Shoulder Condition Rating	GOOD	GOOD	GOOD	GOOD	GOOD
Drainage Condition Rating	GOOD	GOOD	GOOD	GOOD	GOOD

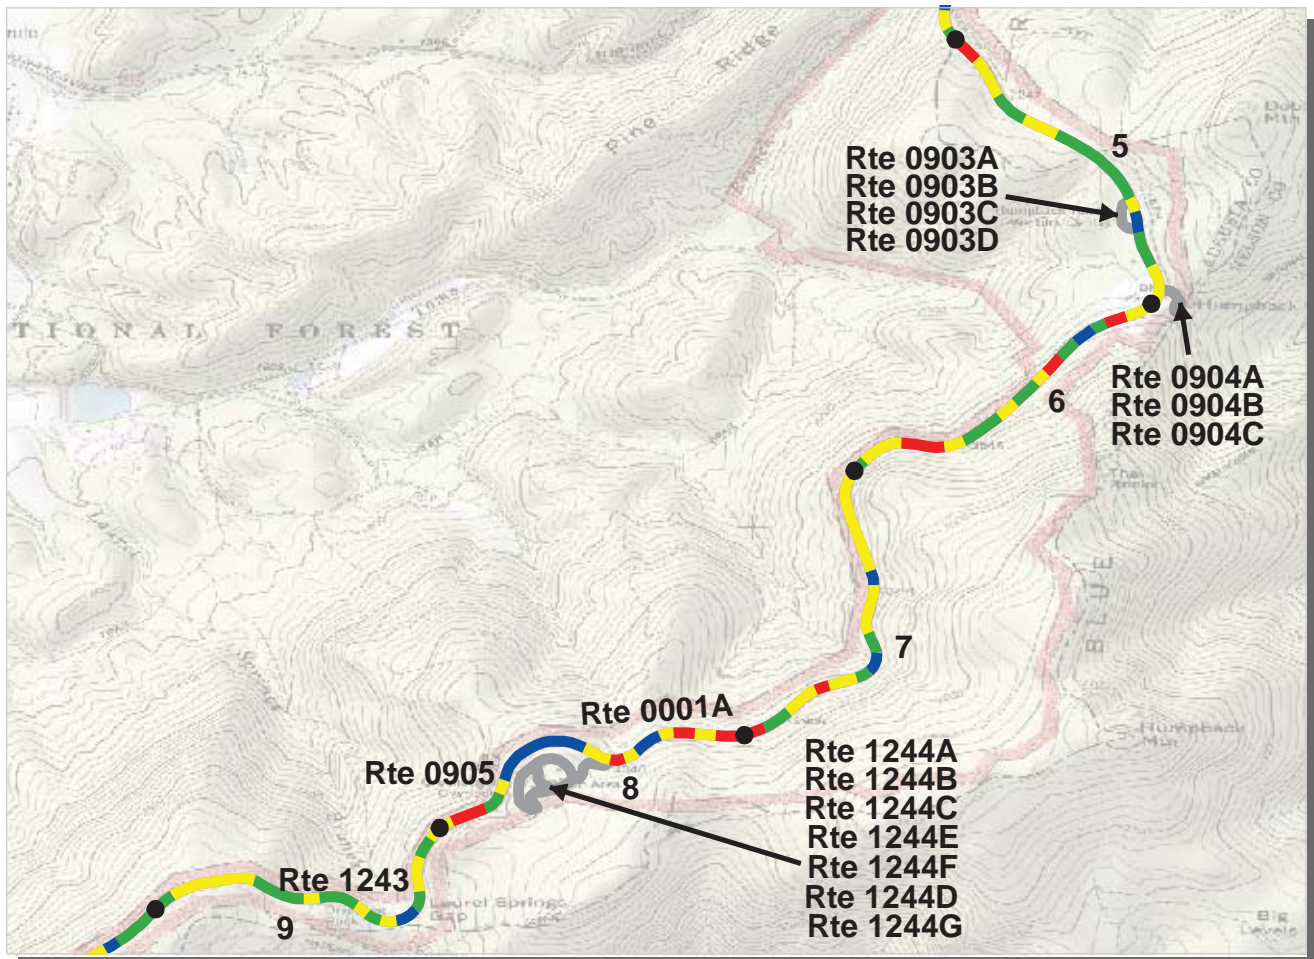
ROUTE: 0001A Blue Ridge Parkway, Maintenance District 1 TOTAL LENGTH: 105.65 Miles

Section Number	5	6	7	8	9
Section Length (mi)	1.00	1.00	1.00	1.00	1.00
AADT	**				
SADT	**				
ADT Date	**				
Cross Section Information					
Number of Lanes	2	2	2	2	2
Paved Width (ft)	19	21	20	21	21
Lane Width (ft)	10	10	11	11	11
Shoulder Width (ft)	5	6	4	6	6
Roadway Condition Information					
PCR (Pavement Condition Rating)	83	73	78	70	84
RCI (Roughness Condition Index)	97	93	94	91	93
SCR (Surface Condition Rating)	73	59	68	56	79
Alligator Cracking Index	97	82	92	76	99
Rutting Index	91	89	88	84	85
Patching Index	100	99	100	100	100
Transverse Cracking Index	94	94	94	94	97
Longitudinal Cracking Index	89	90	92	94	97
Shoulder Condition Rating	GOOD	GOOD	GOOD	GOOD	GOOD
Drainage Condition Rating	GOOD	GOOD	GOOD	GOOD	GOOD

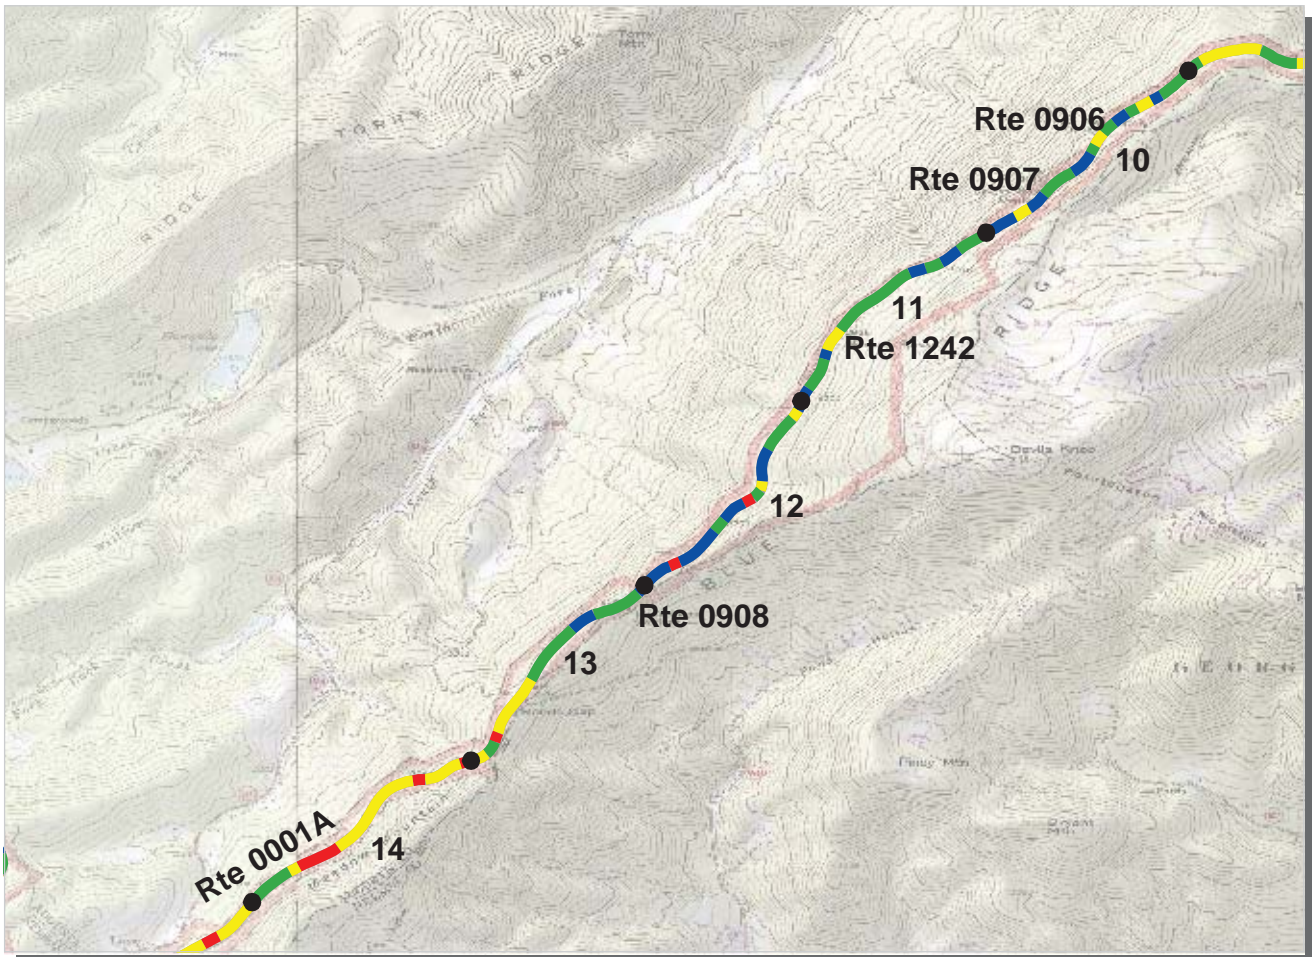
ROUTE: 0001A Blue Ridge Parkway, Maintenance District 1 TOTAL LENGTH: 105.65 Miles

Section Number	10	11	12	13	14
Section Length (mi)	1.00	1.00	1.00	1.00	1.00
AADT	**				
SADT	**				
ADT Date	**				
Cross Section Information					
Number of Lanes	2	2	2	2	2
Paved Width (ft)	21	20	20	20	20
Lane Width (ft)	11	10	10	10	10
Shoulder Width (ft)	5	5	6	7	7
Roadway Condition Information					
PCR (Pavement Condition Rating)	88	88	87	81	72
RCI (Roughness Condition Index)	95	96	94	95	88
SCR (Surface Condition Rating)	82	83	83	72	61
Alligator Cracking Index	96	98	97	96	94
Rutting Index	91	89	93	87	78
Patching Index	100	100	100	99	99
Transverse Cracking Index	96	97	96	93	96
Longitudinal Cracking Index	97	98	96	95	91
Shoulder Condition Rating	GOOD	GOOD	GOOD	GOOD	GOOD
Drainage Condition Rating	GOOD	GOOD	GOOD	GOOD	GOOD

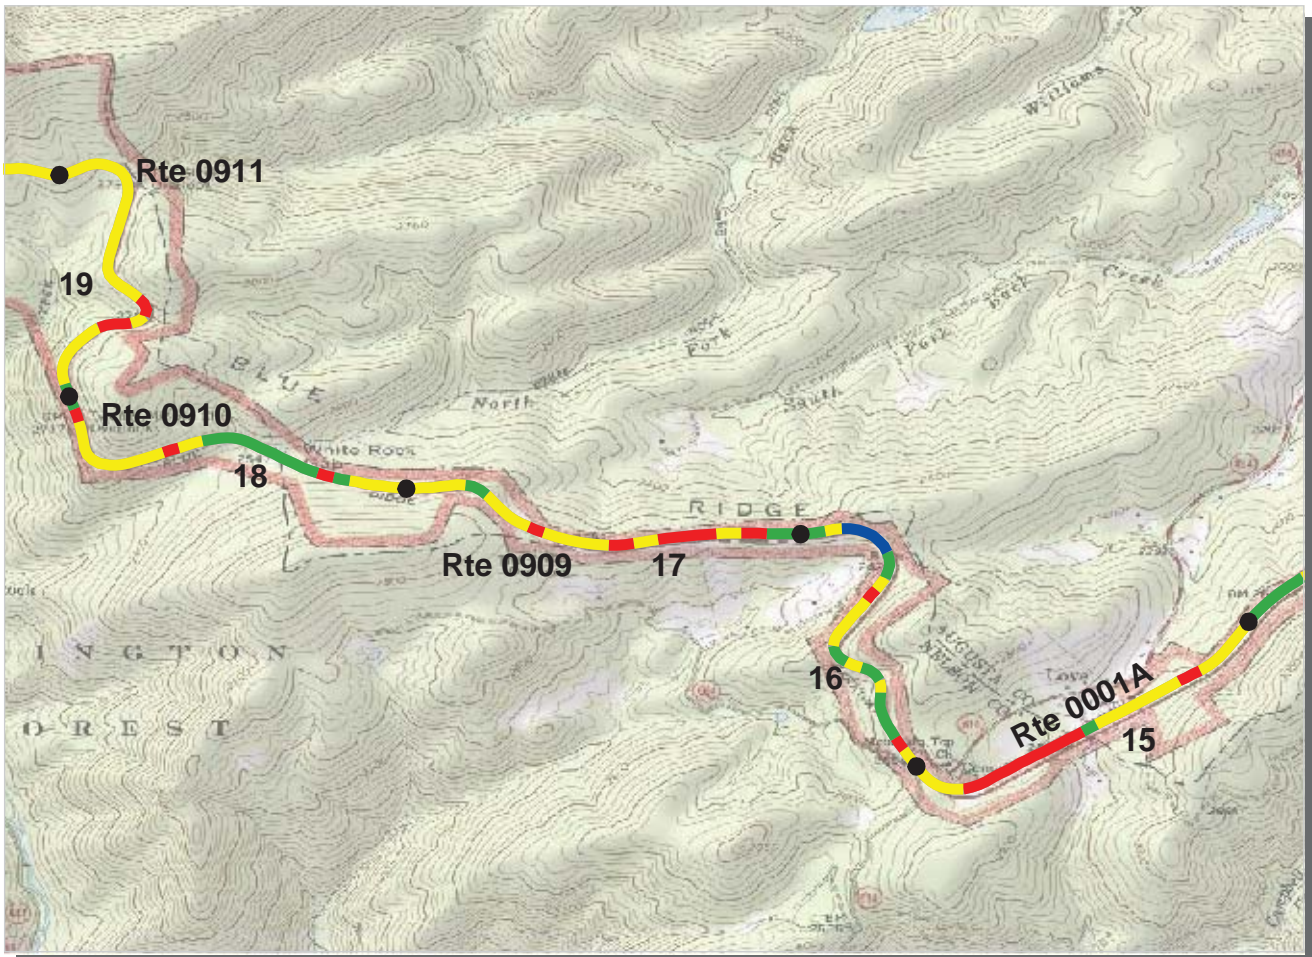
ROUTE: 0001A Blue Ridge Parkway, Maintenance District 1 TOTAL LENGTH: 105.65 Miles

Section Number	15	16	17	18	19
Section Length (mi)	1.00	1.00	1.00	1.00	1.00
AADT	**				
SADT	**				
ADT Date	**				
Cross Section Information					
Number of Lanes	2	2	2	2	2
Paved Width (ft)	20	22	20	19	21
Lane Width (ft)	10	11	11	9	10
Shoulder Width (ft)	7	4	5	5	3
Roadway Condition Information					
PCR (Pavement Condition Rating)	63	79	65	74	69
RCI (Roughness Condition Index)	87	96	87	85	88
SCR (Surface Condition Rating)	47	68	51	66	56
Alligator Cracking Index	86	89	91	93	90
Rutting Index	76	86	80	85	82
Patching Index	99	99	99	99	99
Transverse Cracking Index	92	95	88	92	91
Longitudinal Cracking Index	87	95	90	94	91
Shoulder Condition Rating	GOOD	GOOD	GOOD	GOOD	GOOD
Drainage Condition Rating	GOOD	GOOD	GOOD	GOOD	GOOD

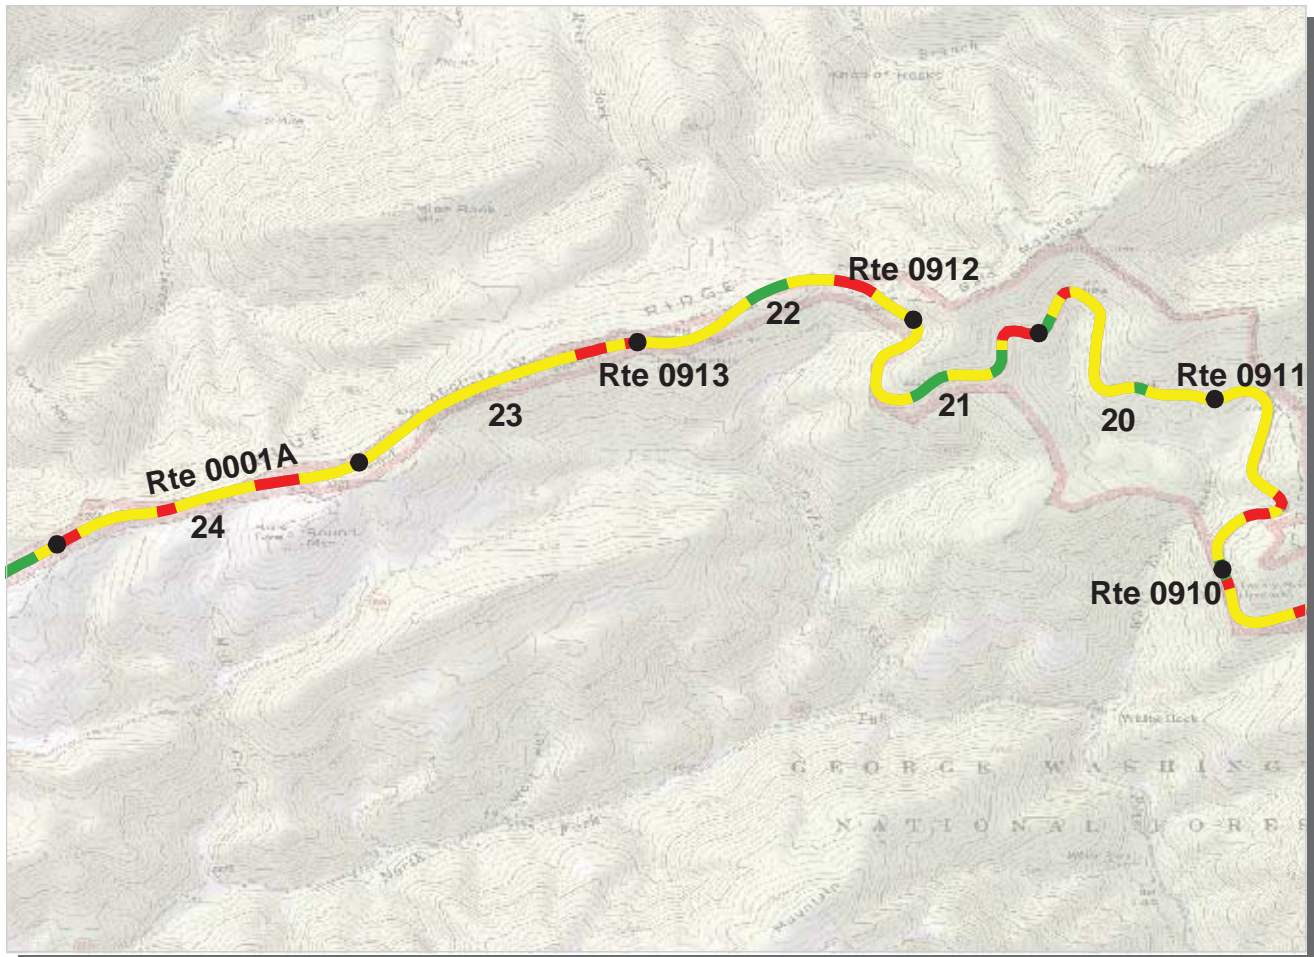
ROUTE: 0001A Blue Ridge Parkway, Maintenance District 1 TOTAL LENGTH: 105.65 Miles

Section Number	20	21	22	23	24
Section Length (mi)	1.00	1.00	1.00	1.00	1.00
AADT	**				
SADT	**				
ADT Date	**				
Cross Section Information					
Number of Lanes	2	2	2	2	2
Paved Width (ft)	21	20	18	19	18
Lane Width (ft)	10	11	9	10	9
Shoulder Width (ft)	4	5	4	5	5
Roadway Condition Information					
PCR (Pavement Condition Rating)	73	73	70	66	65
RCI (Roughness Condition Index)	89	88	89	92	86
SCR (Surface Condition Rating)	63	64	58	49	50
Alligator Cracking Index	96	94	96	92	84
Rutting Index	84	84	78	70	75
Patching Index	100	100	99	99	99
Transverse Cracking Index	90	91	90	92	90
Longitudinal Cracking Index	91	91	92	92	92
Shoulder Condition Rating	GOOD	GOOD	GOOD	GOOD	GOOD
Drainage Condition Rating	GOOD	GOOD	GOOD	GOOD	GOOD

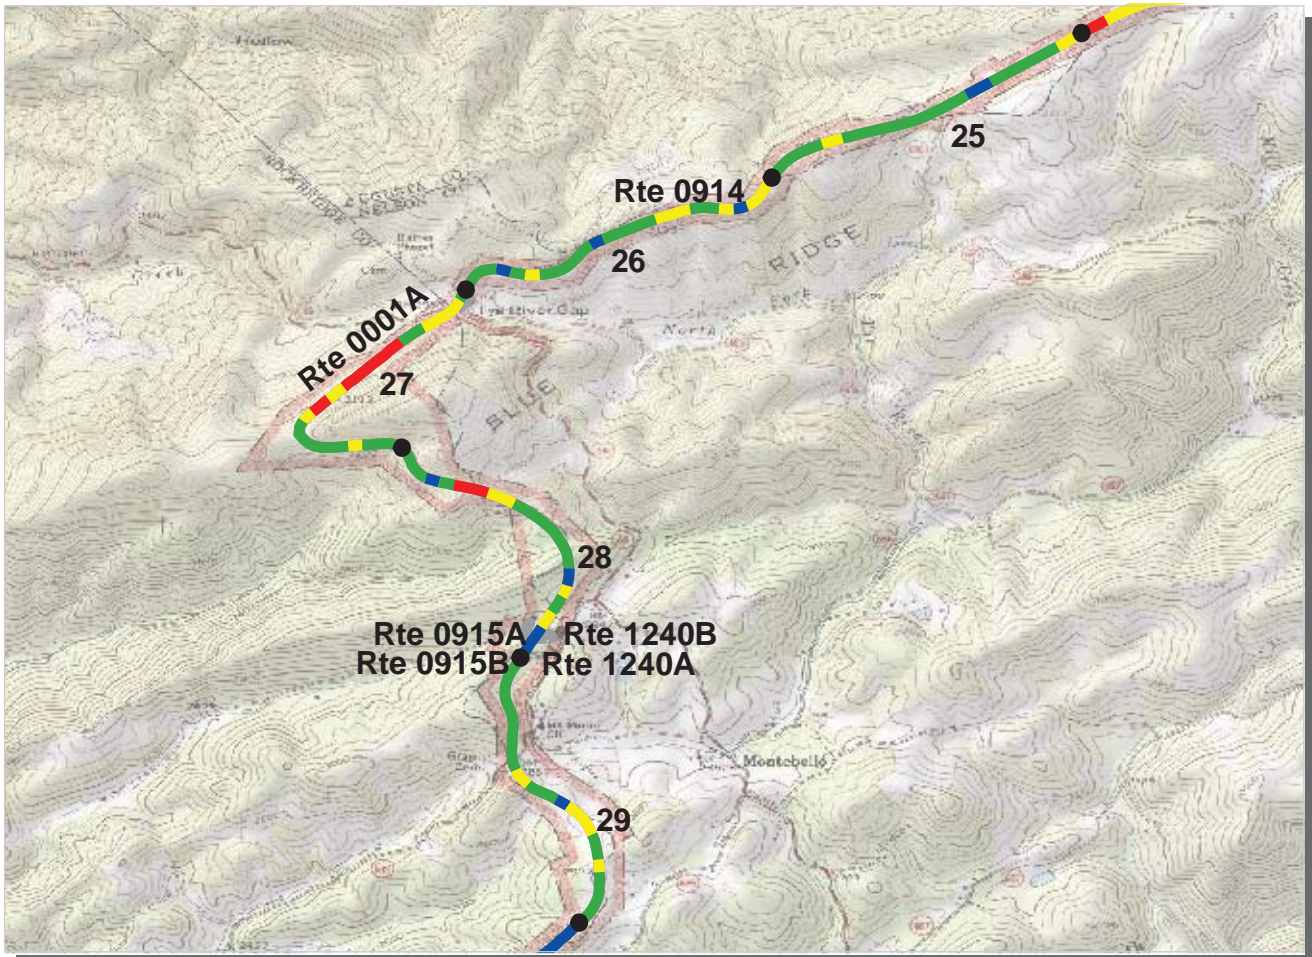
ROUTE: 0001A Blue Ridge Parkway, Maintenance District 1 TOTAL LENGTH: 105.65 Miles

Section Number	25	26	27	28	29
Section Length (mi)	1.00	1.00	1.00	1.00	1.00
AADT	**				
SADT	**				
ADT Date	**				
Cross Section Information					
Number of Lanes	2	2	2	2	2
Paved Width (ft)	19	20	20	19	19
Lane Width (ft)	10	10	10	9	9
Shoulder Width (ft)	4	8	5	6	4
Roadway Condition Information					
PCR (Pavement Condition Rating)	86	87	71	85	88
RCI (Roughness Condition Index)	94	95	95	96	98
SCR (Surface Condition Rating)	81	82	55	78	82
Alligator Cracking Index	99	99	81	99	100
Rutting Index	86	86	79	84	85
Patching Index	100	99	99	99	100
Transverse Cracking Index	96	96	95	96	97
Longitudinal Cracking Index	98	99	94	98	98
Shoulder Condition Rating	GOOD	GOOD	GOOD	GOOD	GOOD
Drainage Condition Rating	GOOD	GOOD	GOOD	GOOD	GOOD

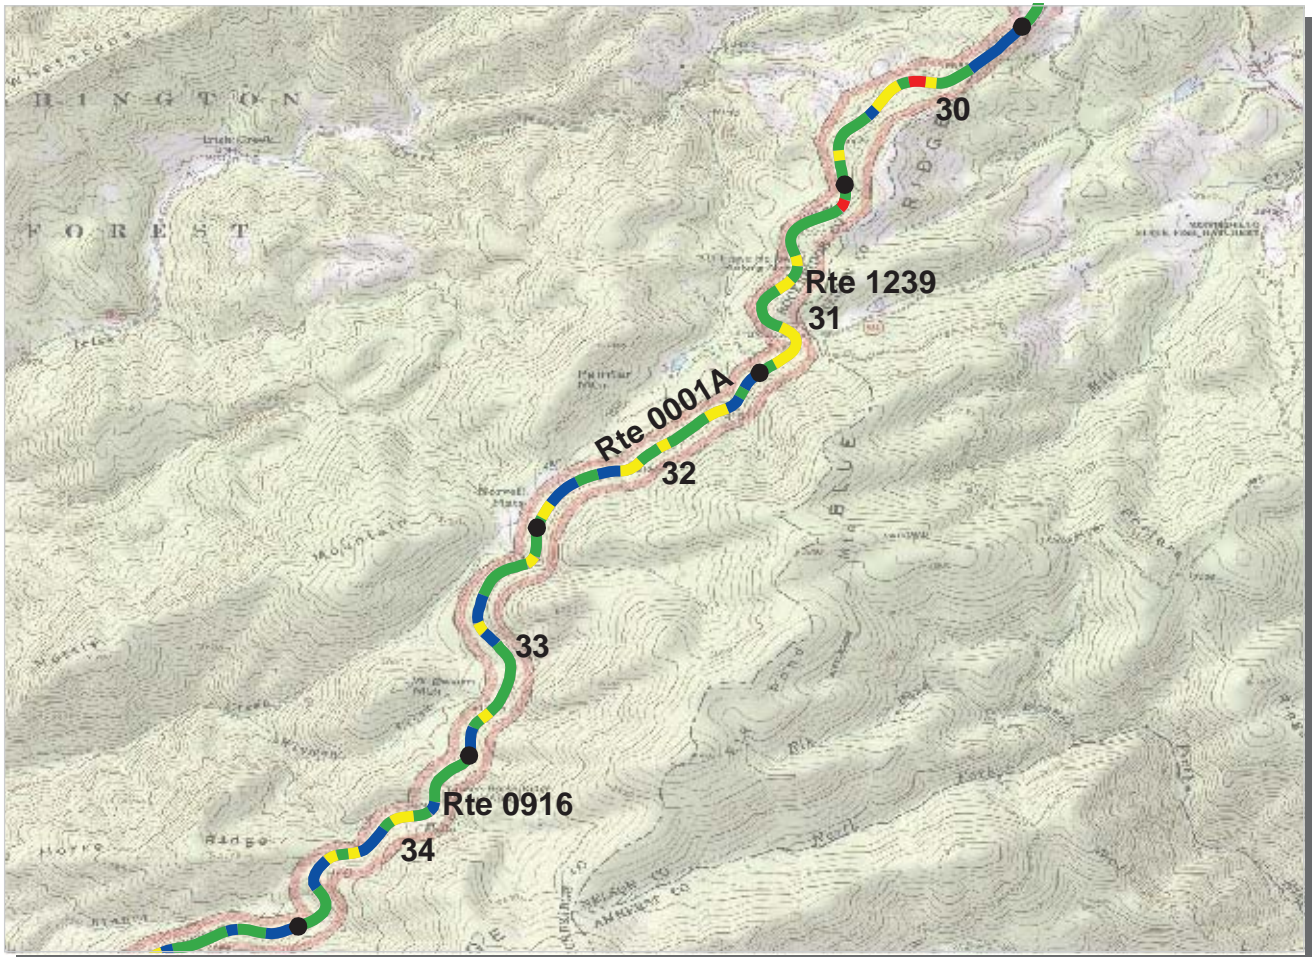
ROUTE: 0001A Blue Ridge Parkway, Maintenance District 1 TOTAL LENGTH: 105.65 Miles

Section Number	30	31	32	33	34
Section Length (mi)	1.00	1.00	1.00	1.00	1.00
AADT	**				
SADT	**				
ADT Date	**				
Cross Section Information					
Number of Lanes	2	2	2	2	2
Paved Width (ft)	14	21	21	20	19
Lane Width (ft)	5	11	11	9	10
Shoulder Width (ft)	4	6	6	5	6
Roadway Condition Information					
PCR (Pavement Condition Rating)	86	83	88	89	87
RCI (Roughness Condition Index)	96	95	94	95	95
SCR (Surface Condition Rating)	79	74	84	85	82
Alligator Cracking Index	97	98	99	100	99
Rutting Index	83	77	86	86	84
Patching Index	100	100	100	100	100
Transverse Cracking Index	99	99	99	99	99
Longitudinal Cracking Index	98	98	99	99	98
Shoulder Condition Rating	GOOD	GOOD	GOOD	GOOD	GOOD
Drainage Condition Rating	GOOD	GOOD	GOOD	GOOD	GOOD

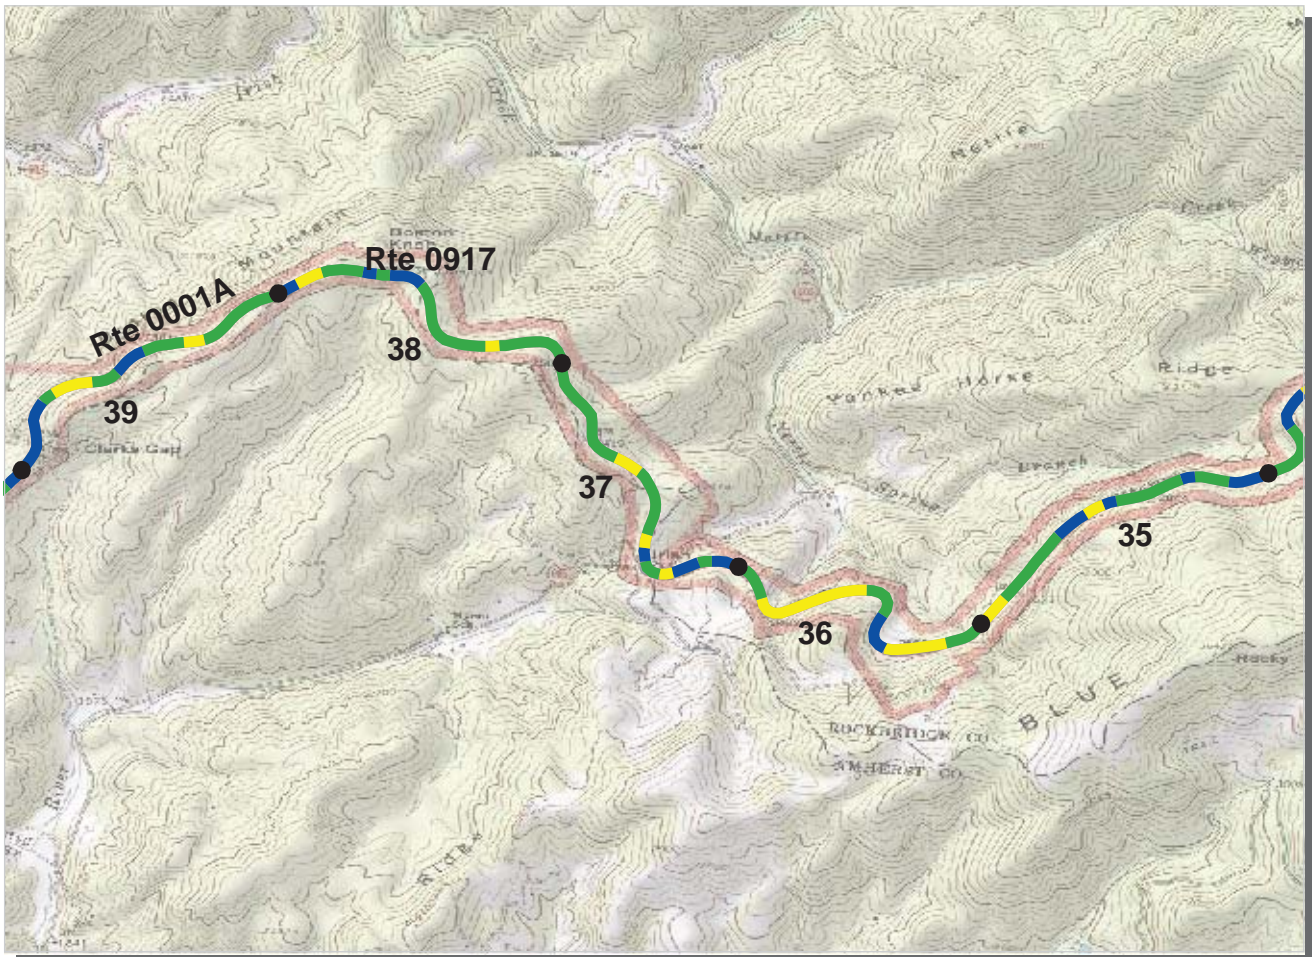
ROUTE: 0001A Blue Ridge Parkway, Maintenance District 1 TOTAL LENGTH: 105.65 Miles

Section Number	35	36	37	38	39
Section Length (mi)	1.00	1.00	1.00	1.00	1.00
AADT	**				
SADT	**				
ADT Date	**				
Cross Section Information					
Number of Lanes	2	2	2	2	2
Paved Width (ft)	21	19	19	19	19
Lane Width (ft)	11	10	10	10	9
Shoulder Width (ft)	9	7	6	7	7
Roadway Condition Information					
PCR (Pavement Condition Rating)	89	81	88	91	90
RCI (Roughness Condition Index)	95	92	98	98	96
SCR (Surface Condition Rating)	85	74	83	86	86
Alligator Cracking Index	100	100	100	100	100
Rutting Index	86	75	84	86	86
Patching Index	100	100	100	100	100
Transverse Cracking Index	99	99	99	99	99
Longitudinal Cracking Index	99	99	99	99	100
Shoulder Condition Rating	GOOD	GOOD	GOOD	GOOD	GOOD
Drainage Condition Rating	GOOD	GOOD	GOOD	GOOD	GOOD

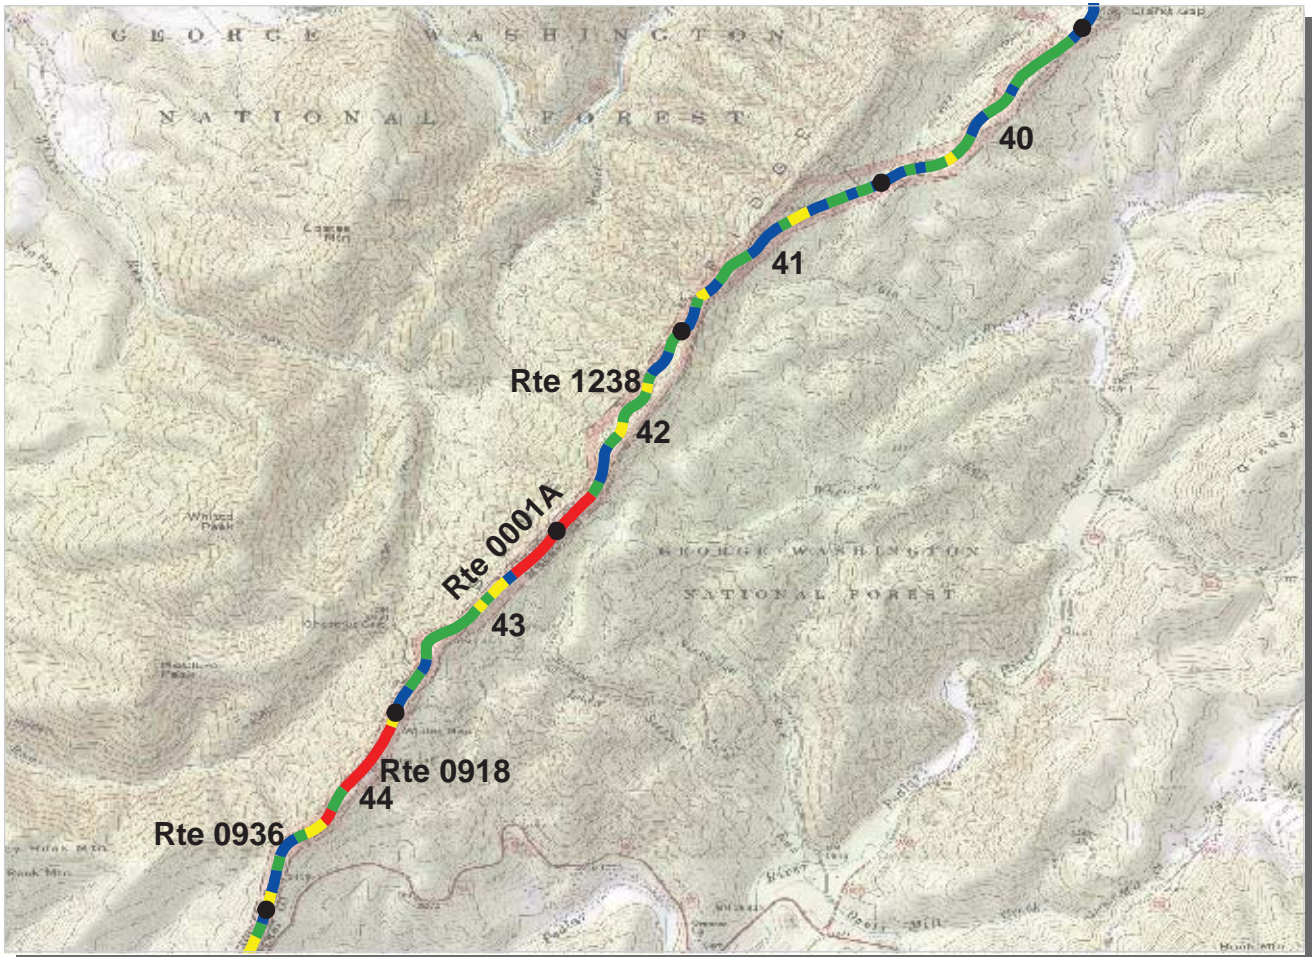
ROUTE: 0001A Blue Ridge Parkway, Maintenance District 1 TOTAL LENGTH: 105.65 Miles

Section Number	40	41	42	43	44
Section Length (mi)	1.00	1.00	1.00	1.00	1.00
AADT	**				
SADT	**				
ADT Date	**				
Cross Section Information					
Number of Lanes	2	2	2	2	2
Paved Width (ft)	20	21	19	20	18
Lane Width (ft)	10	10	10	11	9
Shoulder Width (ft)	4	6	6	6	6
Roadway Condition Information					
PCR (Pavement Condition Rating)	92	92	83	75	63
RCI (Roughness Condition Index)	99	98	91	88	83
SCR (Surface Condition Rating)	88	89	77	68	55
Alligator Cracking Index	99	100	100	100	100
Rutting Index	89	90	77	69	56
Patching Index	100	100	100	100	100
Transverse Cracking Index	99	99	99	99	99
Longitudinal Cracking Index	99	99	99	99	99
Shoulder Condition Rating	GOOD	GOOD	GOOD	GOOD	GOOD
Drainage Condition Rating	GOOD	GOOD	GOOD	GOOD	GOOD

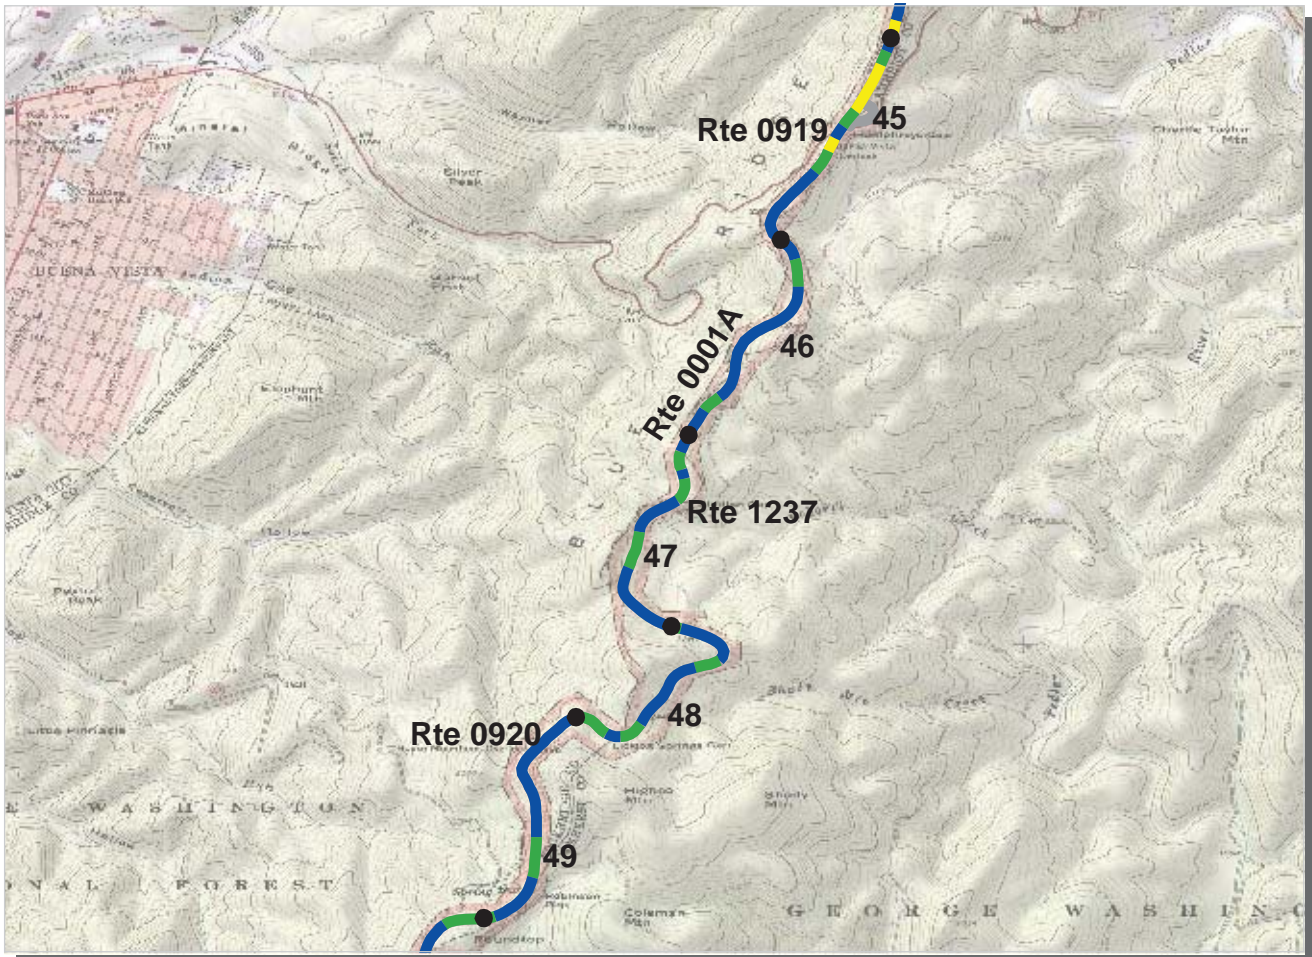
ROUTE: 0001A Blue Ridge Parkway, Maintenance District 1 TOTAL LENGTH: 105.65 Miles

Section Number	45	46	47	48	49
Section Length (mi)	1.00	1.00	1.00	1.00	1.00
AADT	**				
SADT	**				
ADT Date	**				
Cross Section Information					
Number of Lanes	2	2	2	2	2
Paved Width (ft)	19	21	19	20	20
Lane Width (ft)	9	11	9	10	10
Shoulder Width (ft)	6	6	6	7	6
Roadway Condition Information					
PCR (Pavement Condition Rating)	87	95	95	94	96
RCI (Roughness Condition Index)	93	99	99	98	99
SCR (Surface Condition Rating)	82	93	92	91	94
Alligator Cracking Index	99	100	100	100	100
Rutting Index	84	93	92	91	95
Patching Index	100	100	100	100	100
Transverse Cracking Index	99	99	99	99	99
Longitudinal Cracking Index	99	99	99	99	99
Shoulder Condition Rating	GOOD	GOOD	GOOD	GOOD	GOOD
Drainage Condition Rating	GOOD	GOOD	GOOD	GOOD	GOOD

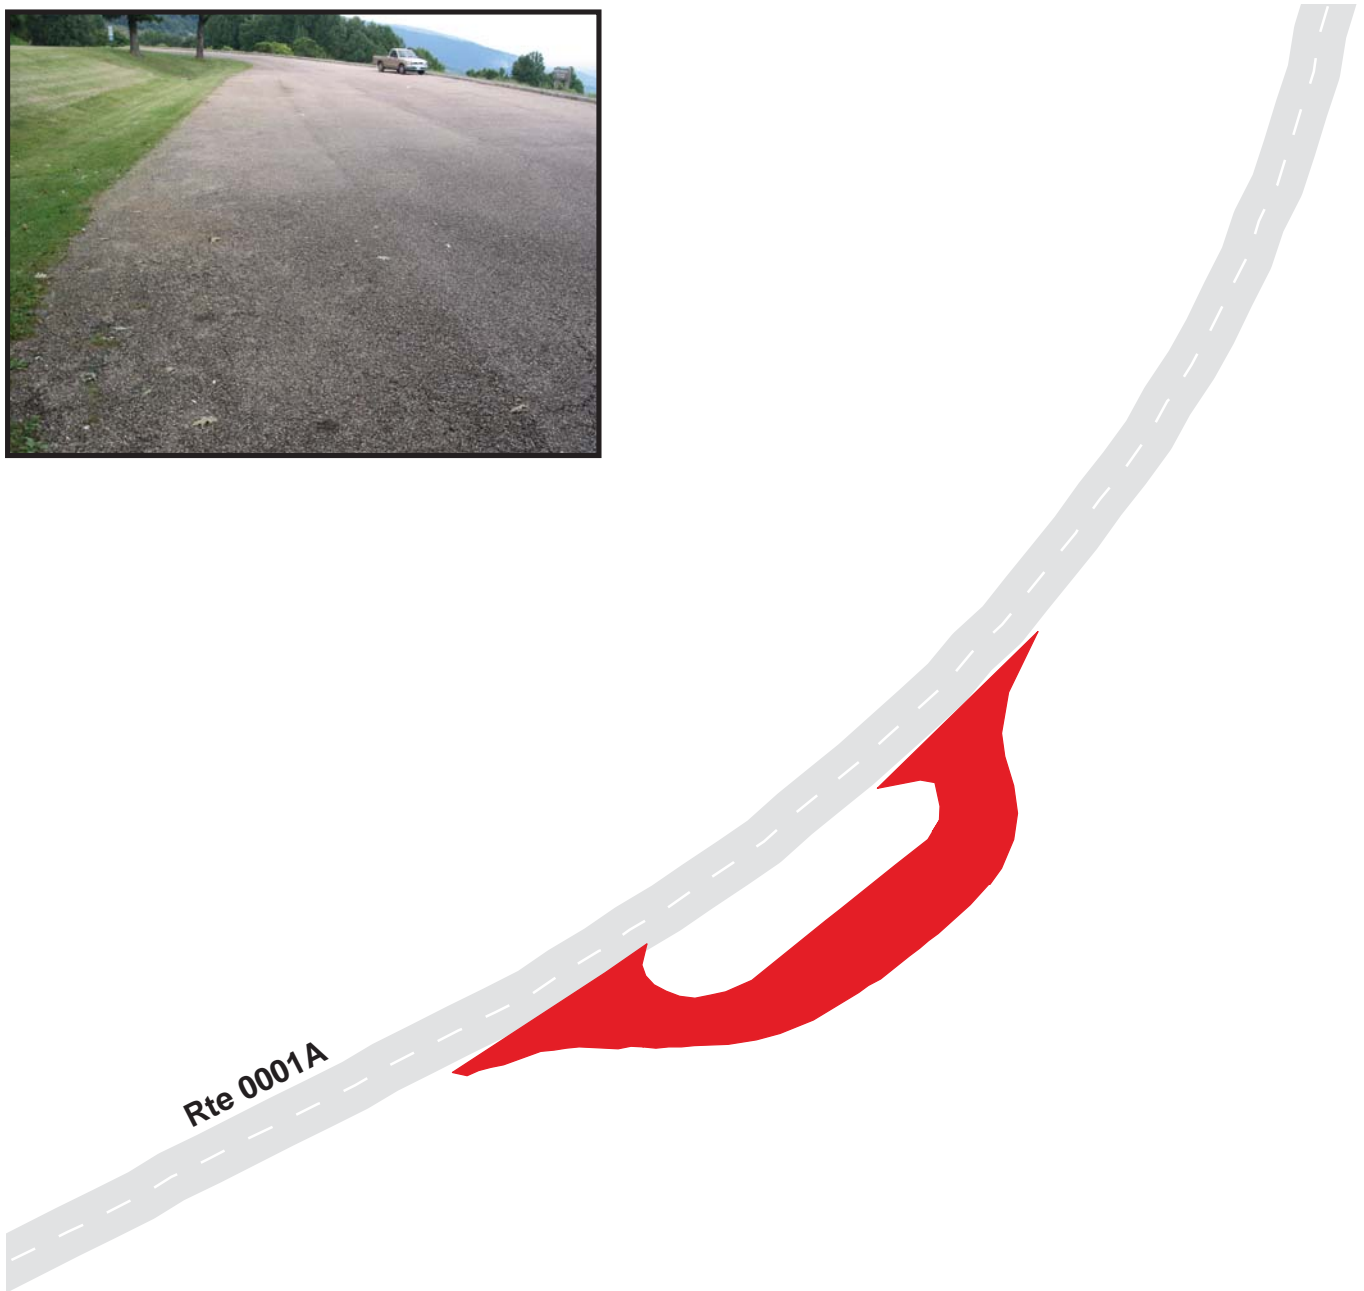
Route	Public / NonPublic	Date Visited	Area (sq ft)	Lane Miles *	Surface Type	Condition / PCR
0900	Public	9/10/2003	7915	0.14	AS	POOR / 45

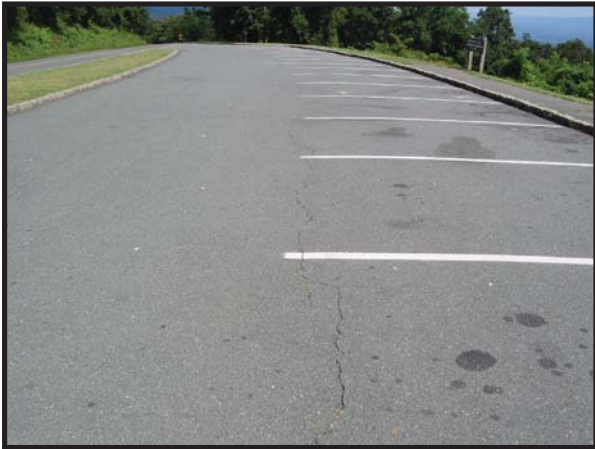
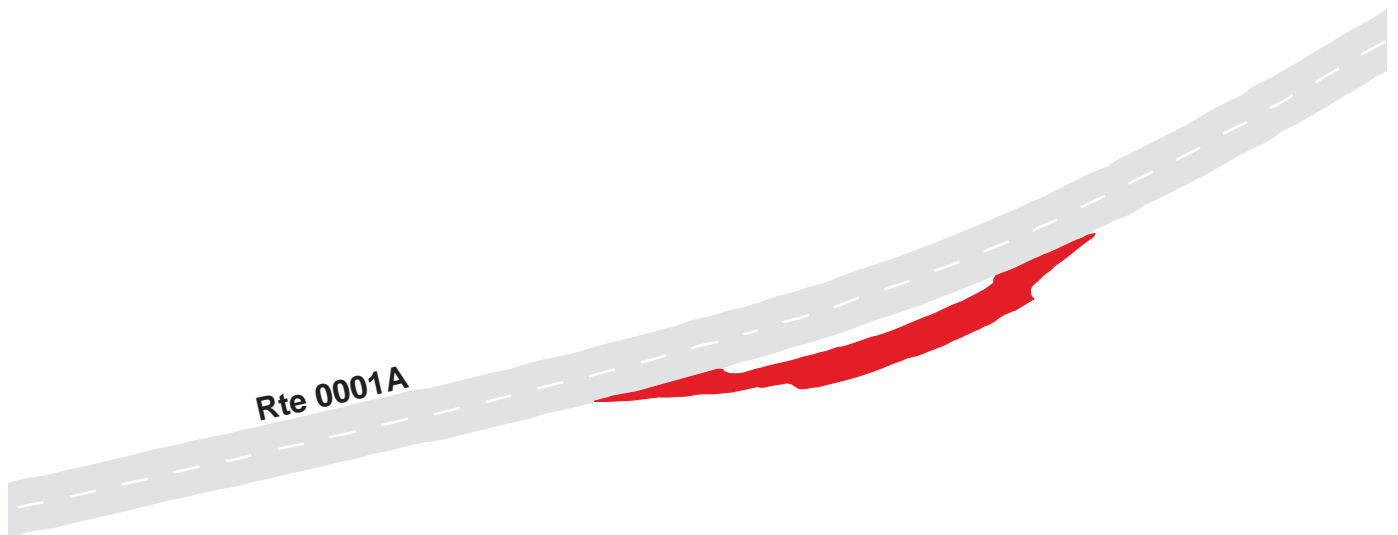
Route	Public / NonPublic	Date Visited	Area (sq ft)	Lane Miles *	Surface Type	Condition / PCR
0901	Public	9/10/2003	10789	0.19	AS	FAIR / 73

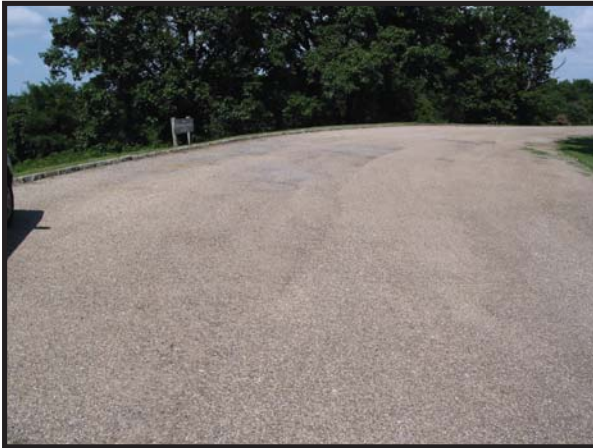
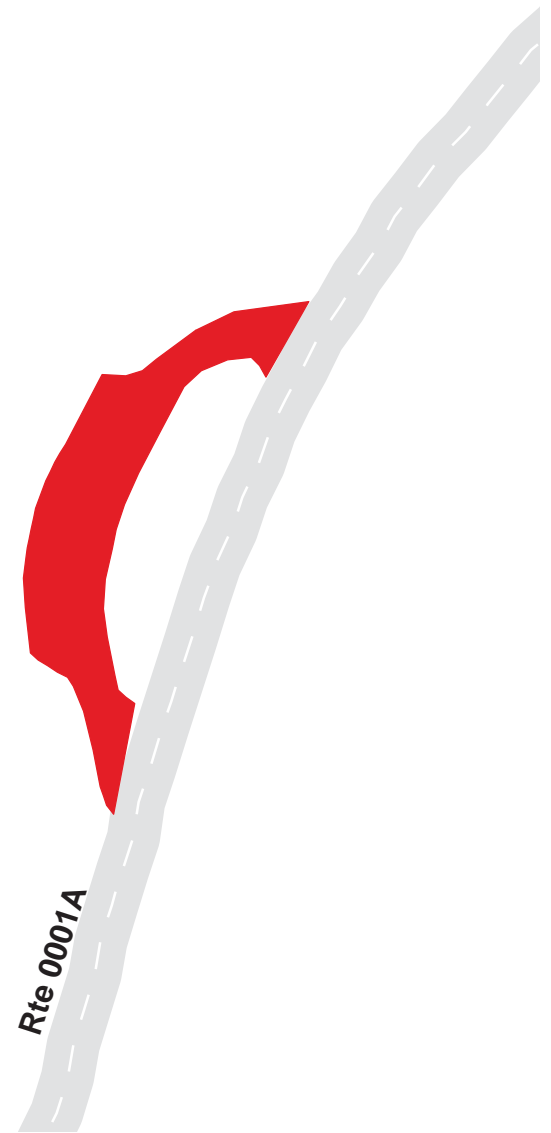
Route 0902

Route	Public / NonPublic	Date Visited	Area (sq ft)	Lane Miles *	Surface Type	Condition / PCR
0902	Public	9/10/2003	7387	0.13	AS	POOR / 45

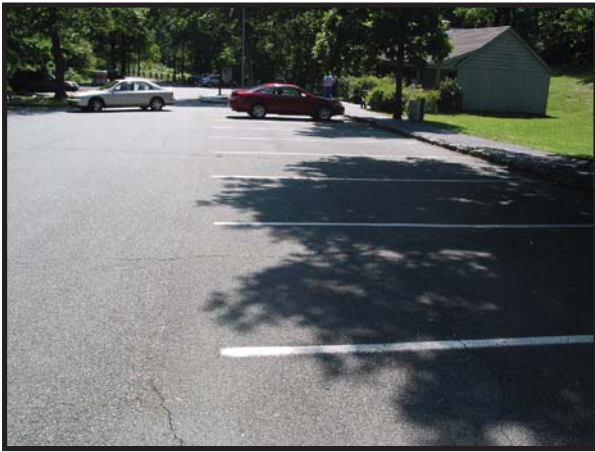
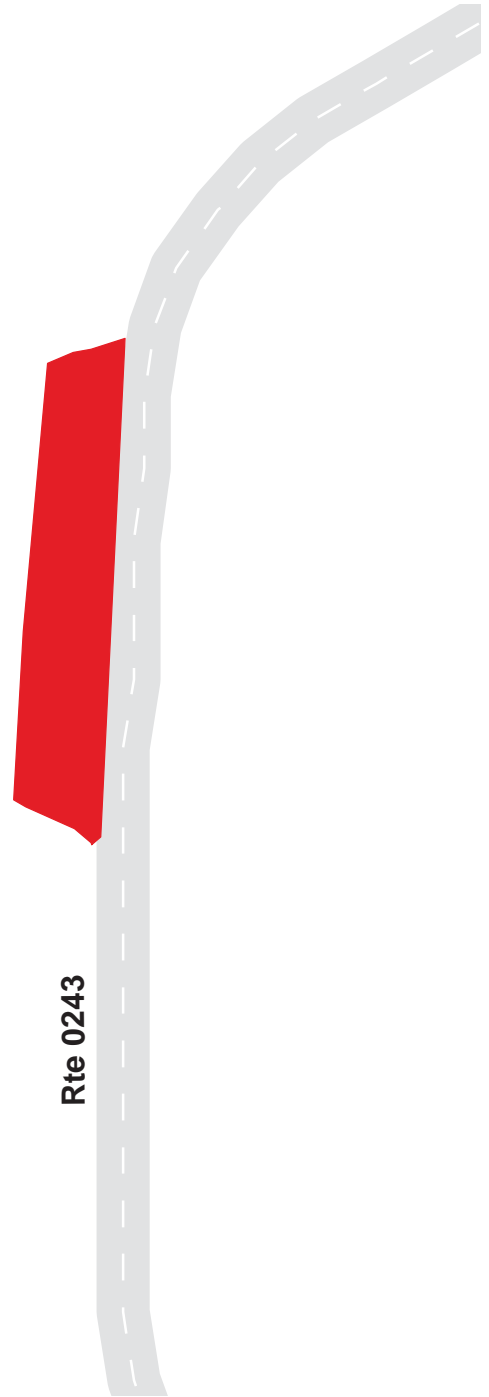
Route 0903A

Route	Public / NonPublic	Date Visited	Area (sq ft)	Lane Miles *	Surface Type	Condition / PCR
0903A	Public	9/10/2003	2180	0.04	AS	FAIR / 73

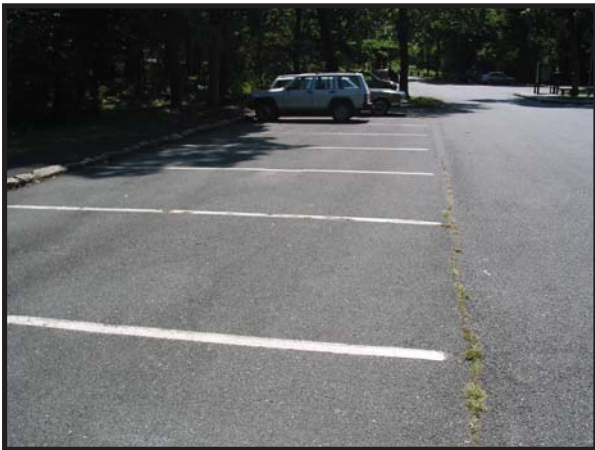
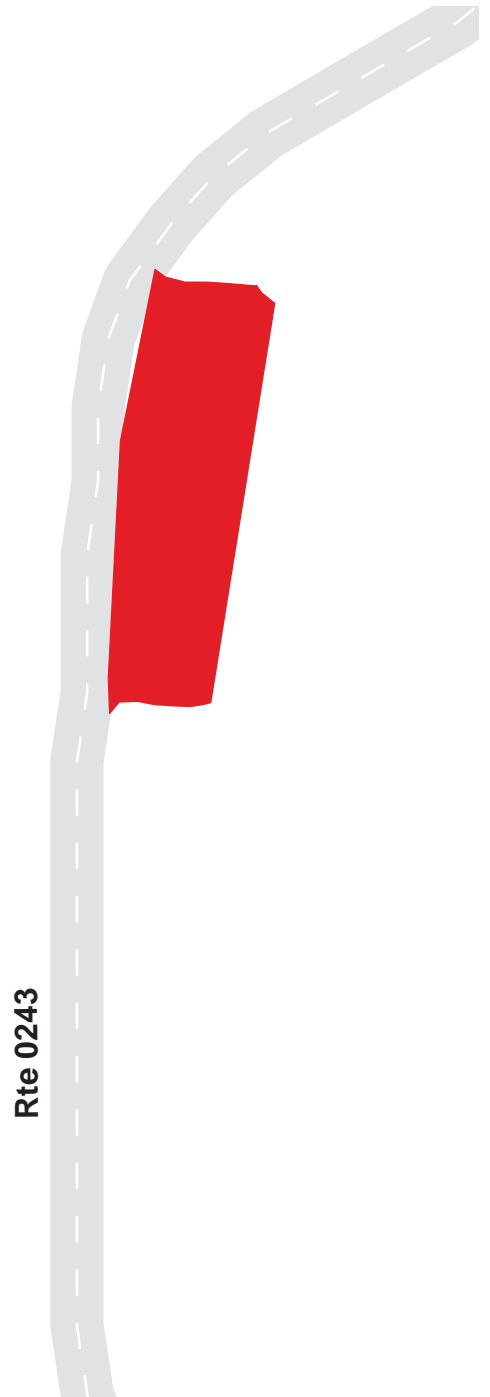
Route 0903B

Route	Public / NonPublic	Date Visited	Area (sq ft)	Lane Miles *	Surface Type	Condition / PCR
0903B	Public	9/10/2003	2818	0.05	AS	FAIR / 73

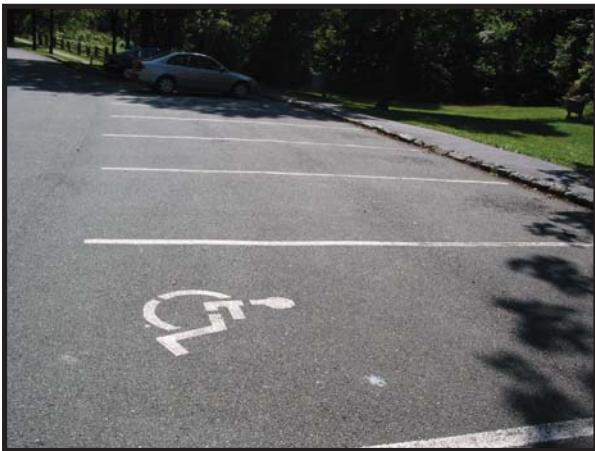
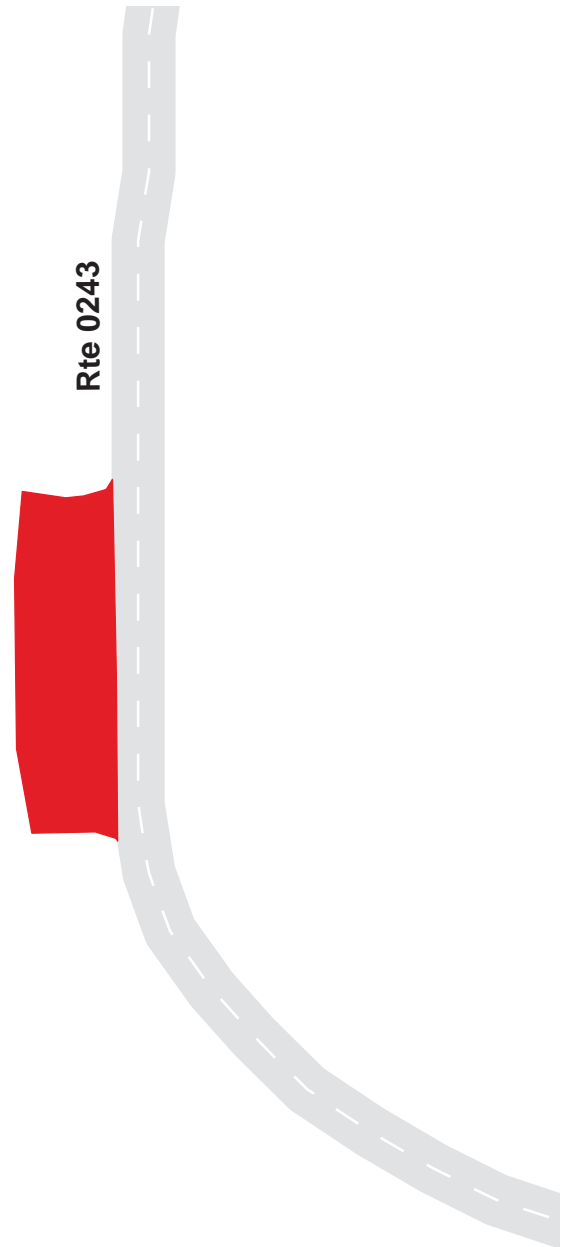
Route 0903C

Route	Public / NonPublic	Date Visited	Area (sq ft)	Lane Miles *	Surface Type	Condition / PCR
0903C	Public	9/10/2003	1812	0.03	AS	FAIR / 73

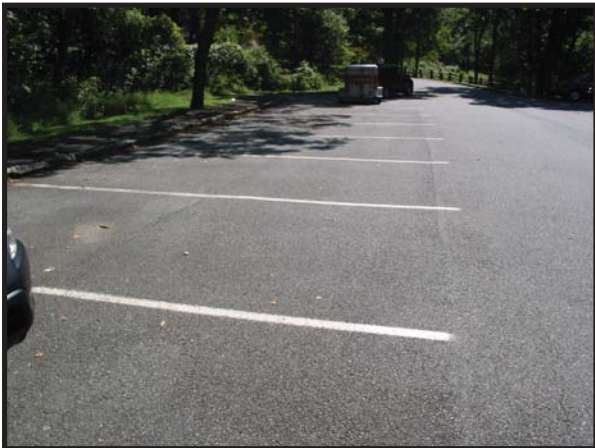
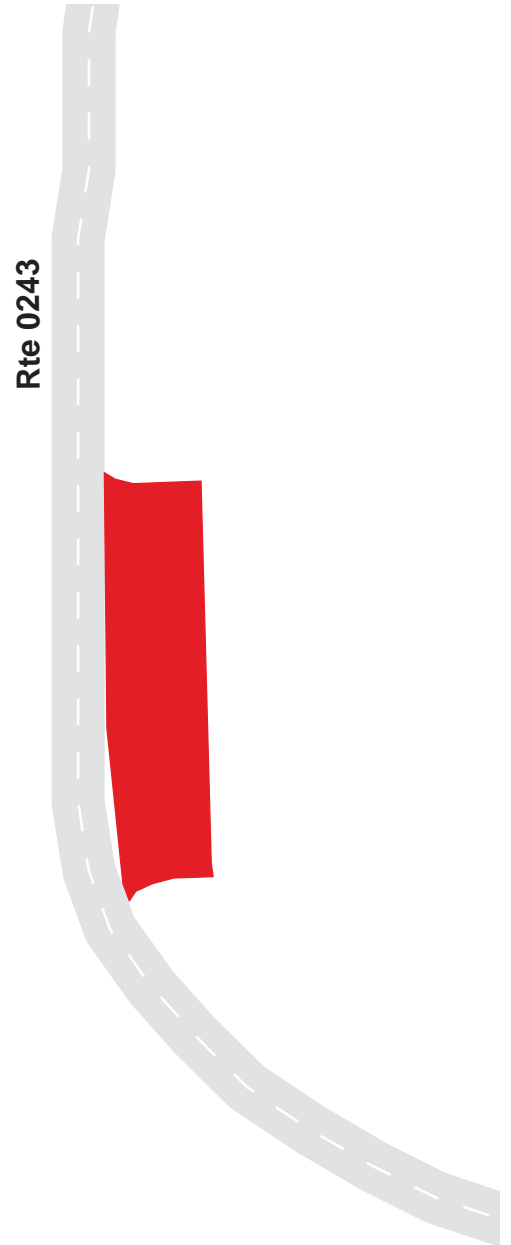
Route 0903D

Route	Public / NonPublic	Date Visited	Area (sq ft)	Lane Miles *	Surface Type	Condition / PCR
0903D	Public	9/10/2003	2145	0.04	AS	FAIR / 73
