The Road Inventory of Blue Ridge Parkway BLRI – 5140 Volume 1

Road Inventory Program

Prepared By:
Federal Highway Administration
Eastern Federal Lands Highway Division
Cycle 3

Blue Ridge Parkway in North Carolina

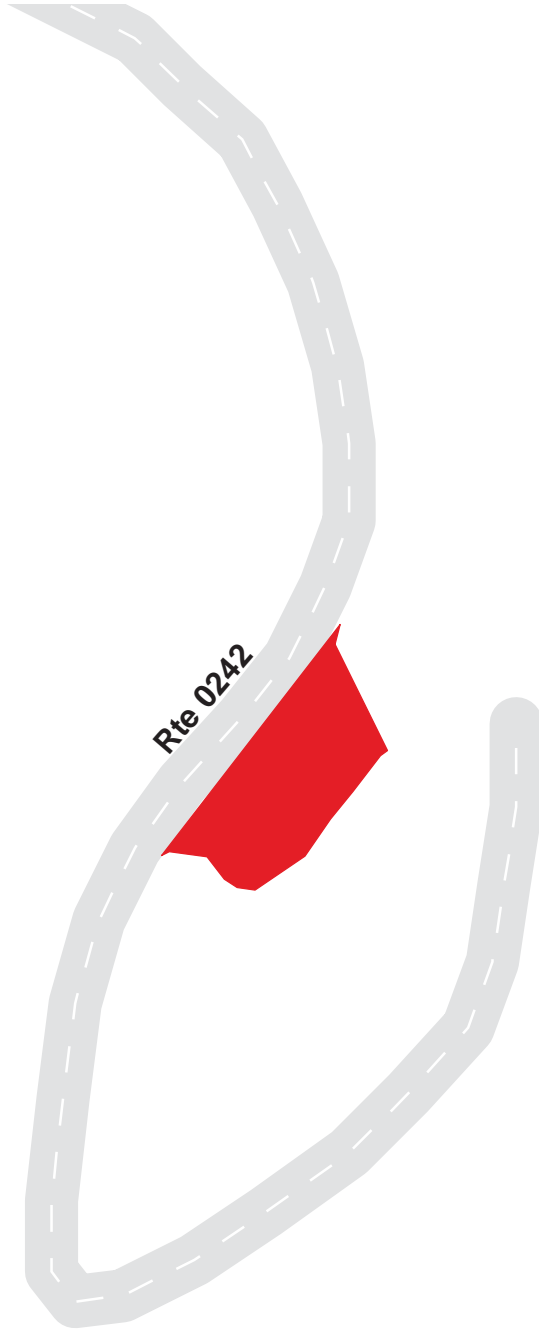
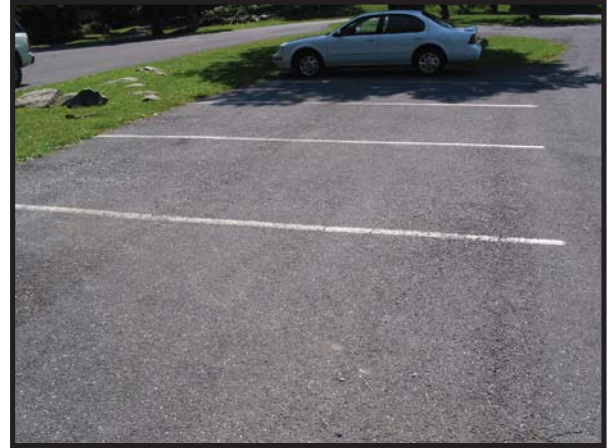
Route 0904A

Route	Public / NonPublic	Date Visited	Area (sq ft)	Lane Miles *	Surface Type	Condition / PCR
0904A	Public	9/10/2003	1084	0.02	AS	GOOD / 90

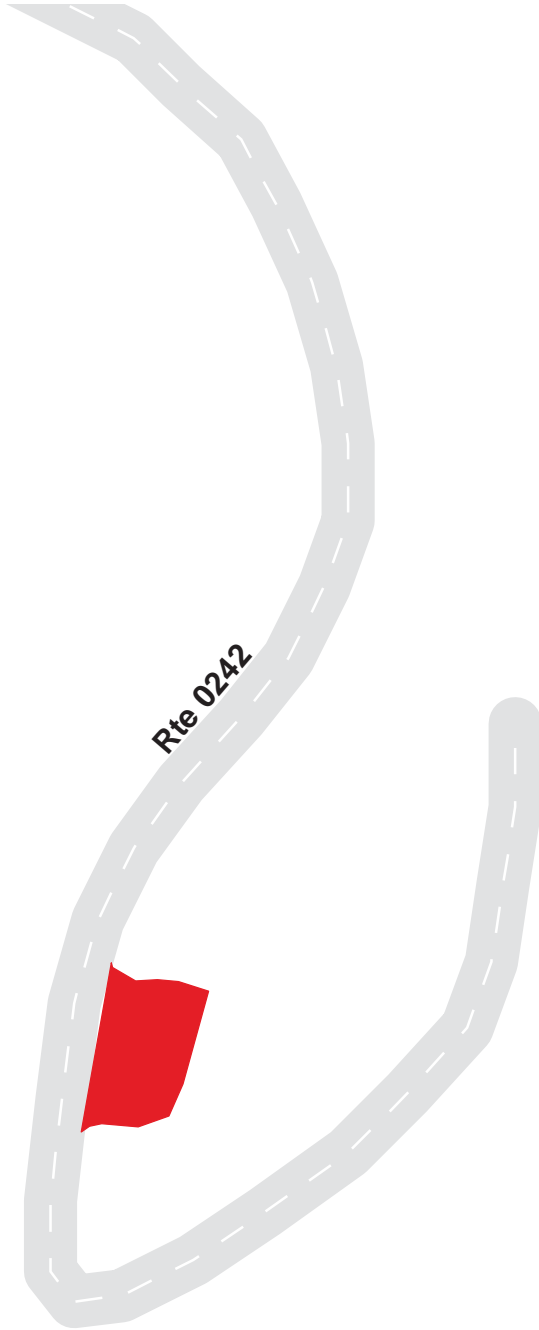
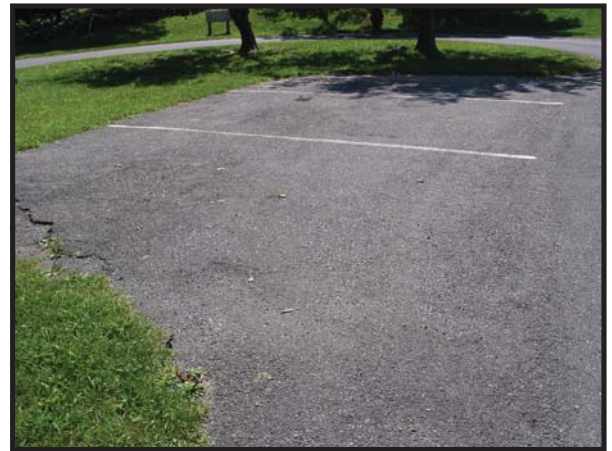
Route 0904B

Route	Public / NonPublic	Date Visited	Area (sq ft)	Lane Miles *	Surface Type	Condition / PCR
0904B	Public	9/10/2003	591	0.01	AS	FAIR / 73

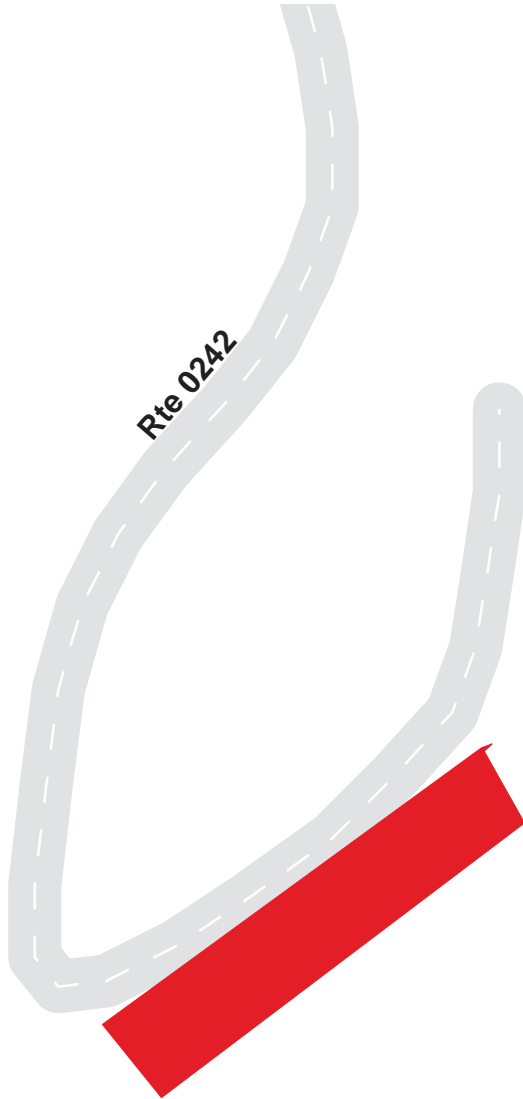
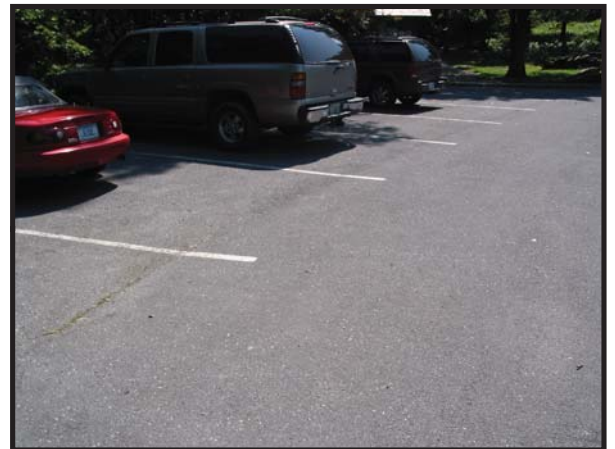
Route 0904C

Route	Public / NonPublic	Date Visited	Area (sq ft)	Lane Miles *	Surface Type	Condition / PCR
0904C	Public	9/10/2003	1789	0.03	AS	GOOD / 90

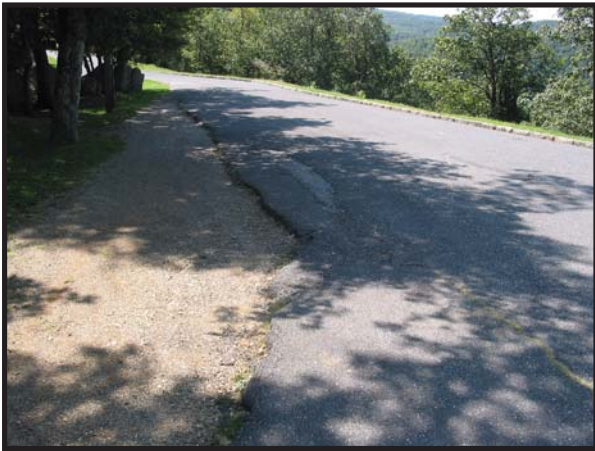
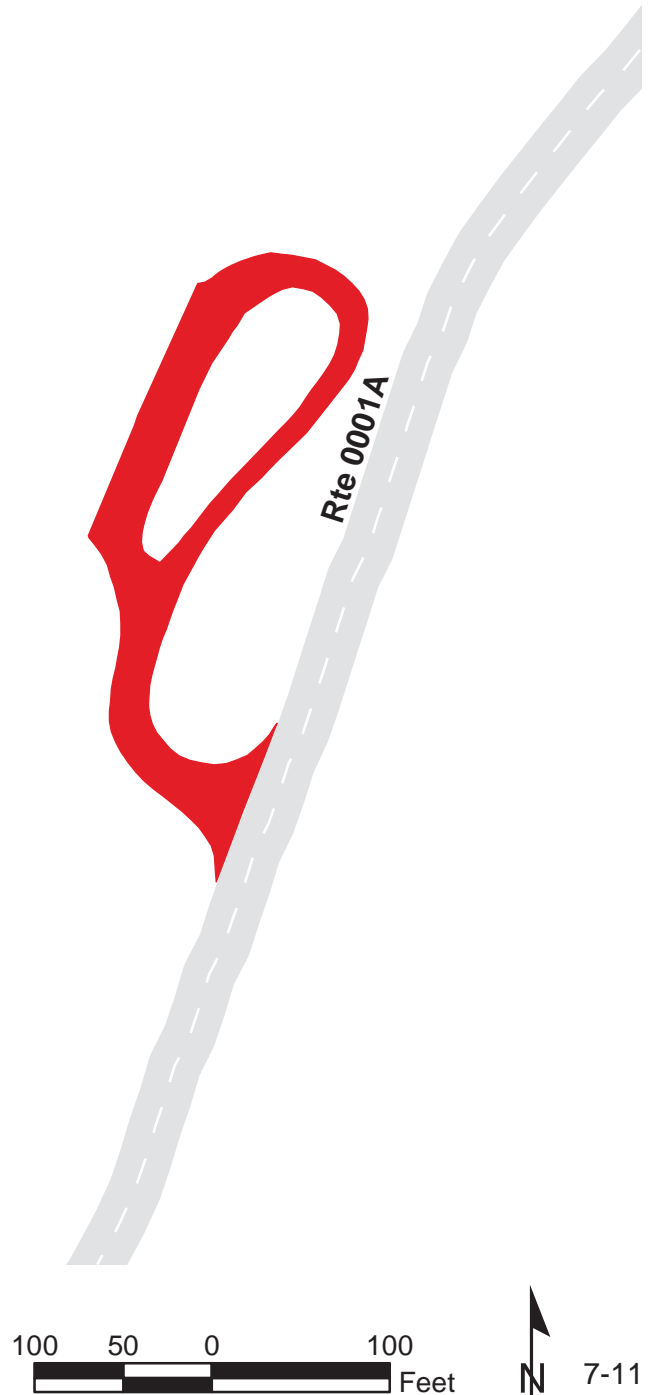
Route 0905

Route	Public / NonPublic	Date Visited	Area (sq ft)	Lane Miles *	Surface Type	Condition / PCR
0905	Public	9/10/2003	10700	0.18	AS	GOOD / 90

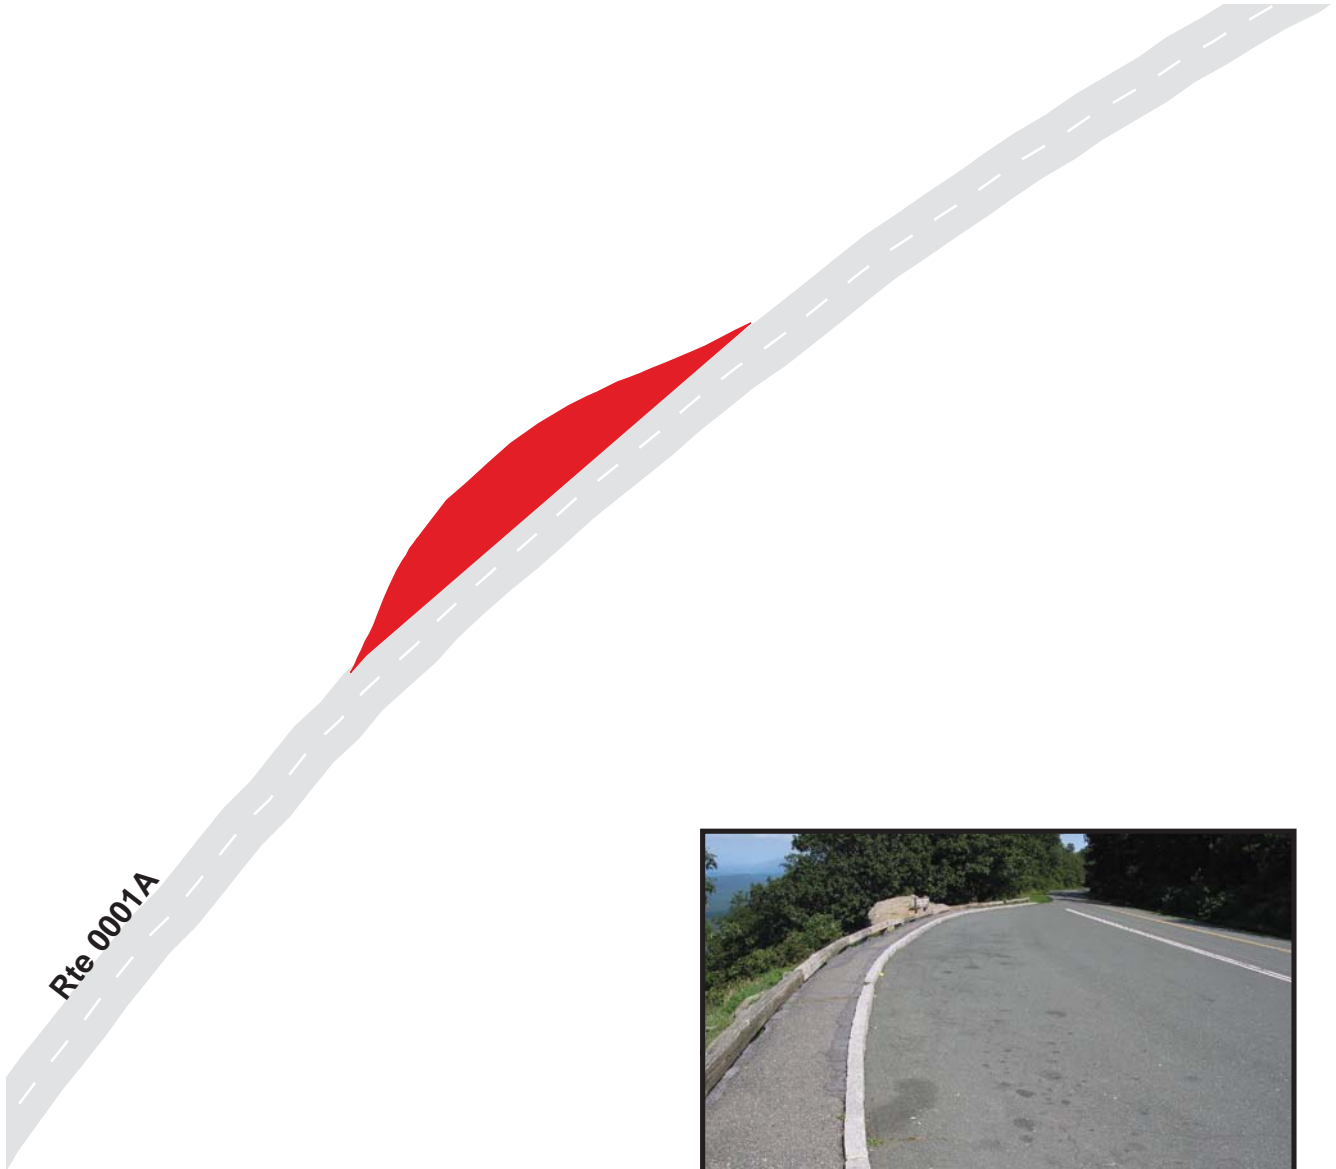
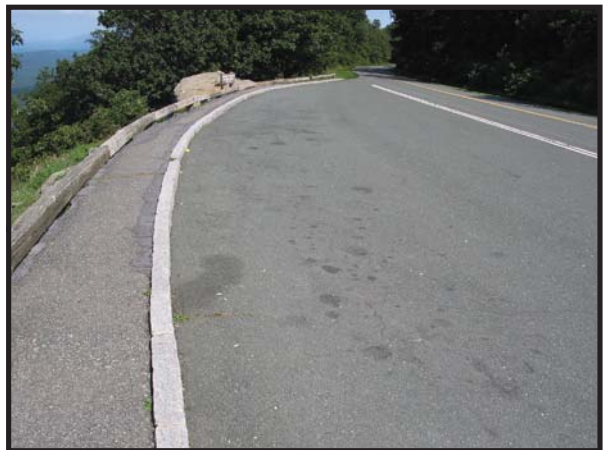
Route 0906

Route	Public / NonPublic	Date Visited	Area (sq ft)	Lane Miles *	Surface Type	Condition / PCR
0906	Public	9/10/2003	4479	0.08	AS	GOOD / 90

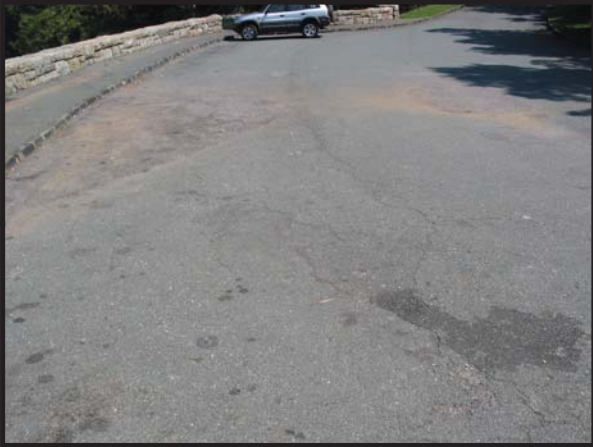
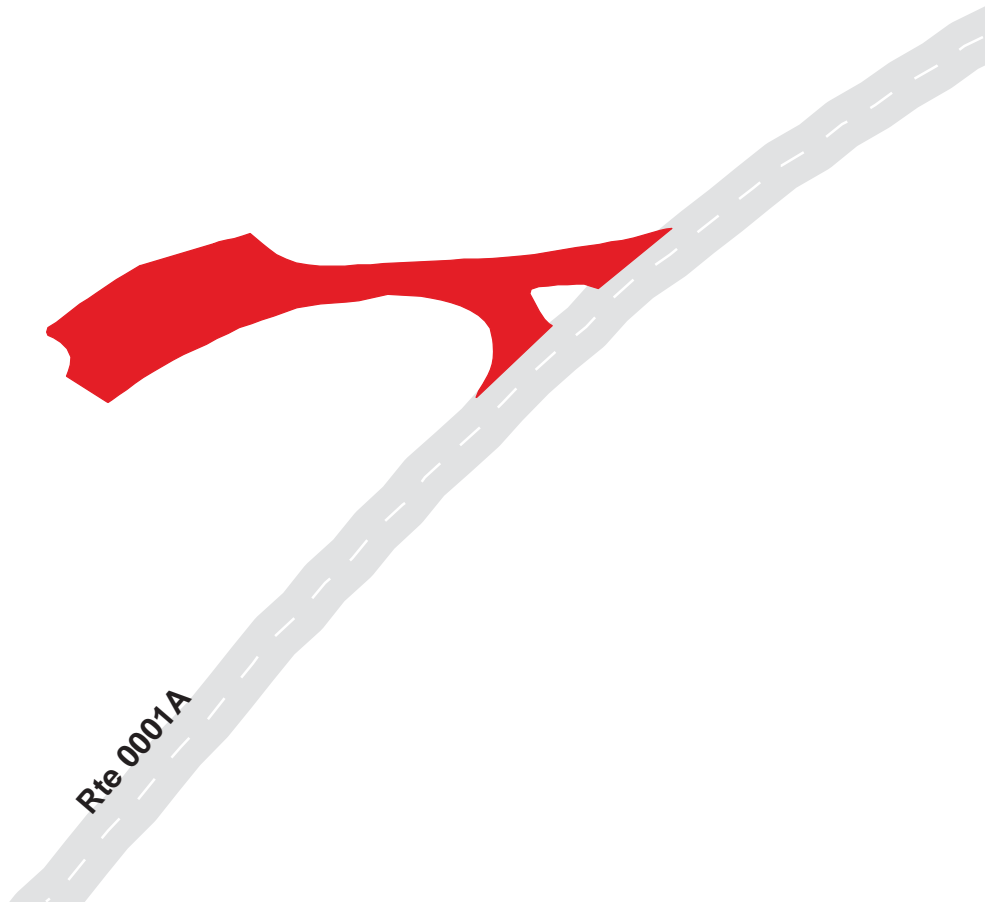
Route 0907

Route	Public / NonPublic	Date Visited	Area (sq ft)	Lane Miles *	Surface Type	Condition / PCR
0907	Public	9/10/2003	7582	0.13	AS	GOOD / 90

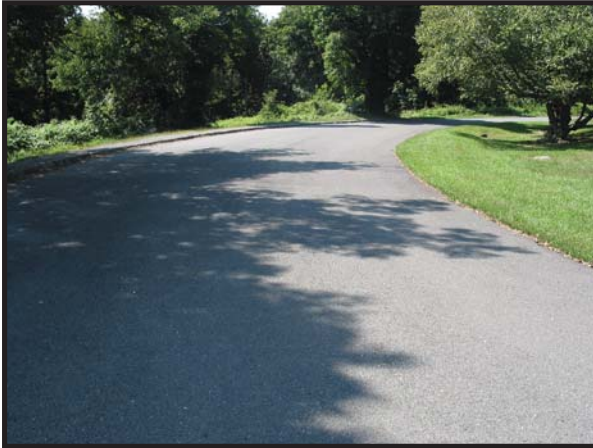
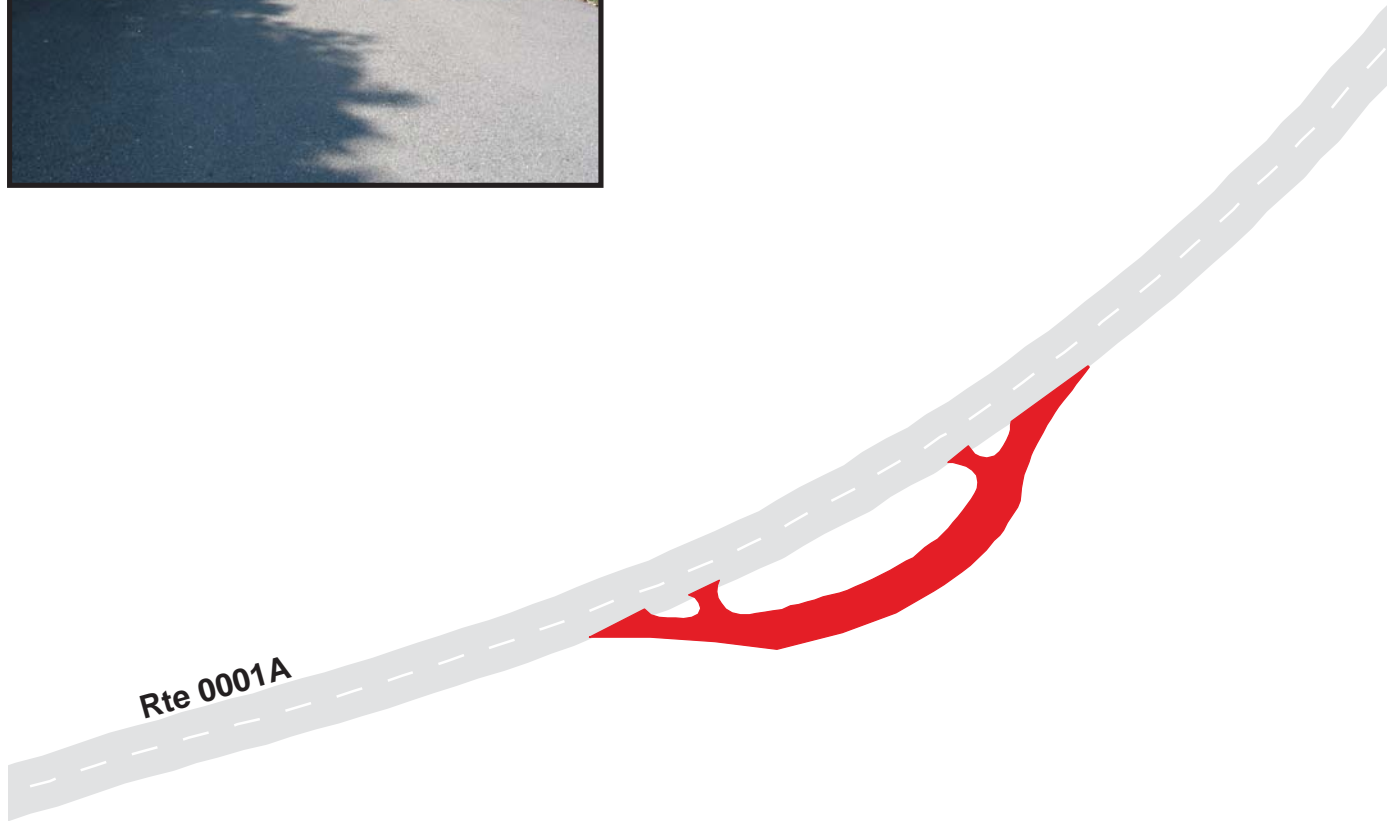
Route 0908

Route	Public / NonPublic	Date Visited	Area (sq ft)	Lane Miles *	Surface Type	Condition / PCR
0908	Public	9/10/2003	8805	0.15	AS	GOOD / 90

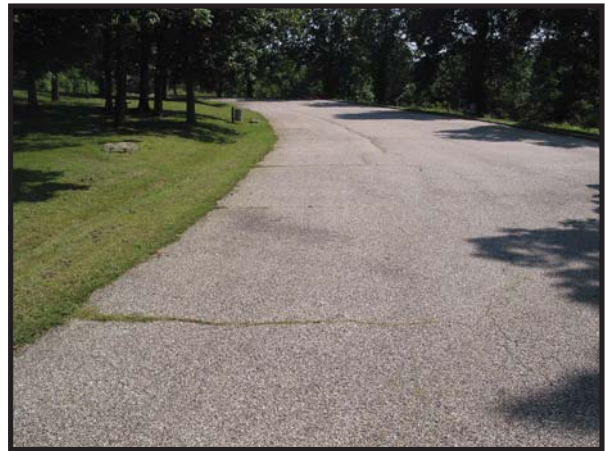
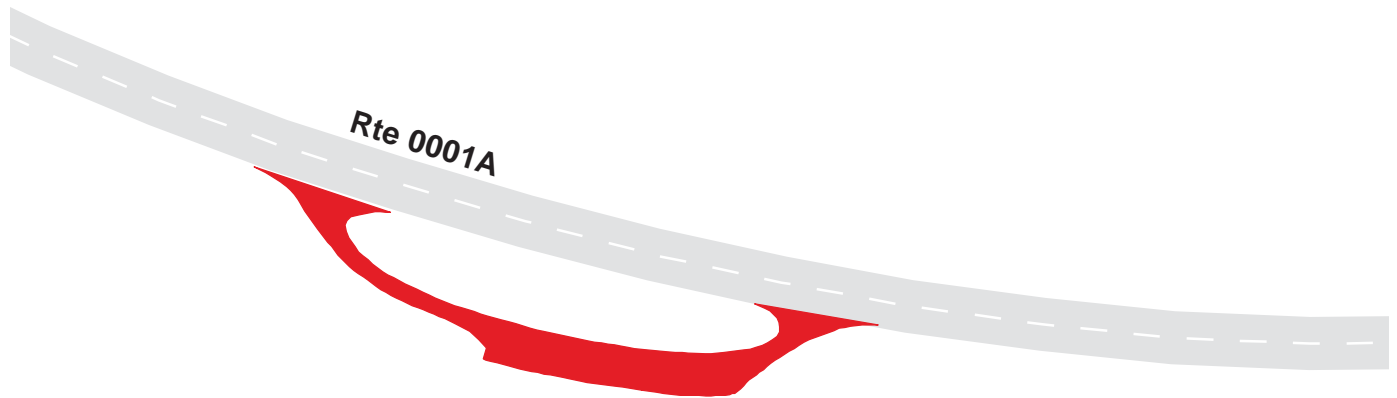
Route 0909

Route	Public / NonPublic	Date Visited	Area (sq ft)	Lane Miles *	Surface Type	Condition / PCR
0909	Public	9/10/2003	15342	0.26	AS	FAIR / 73

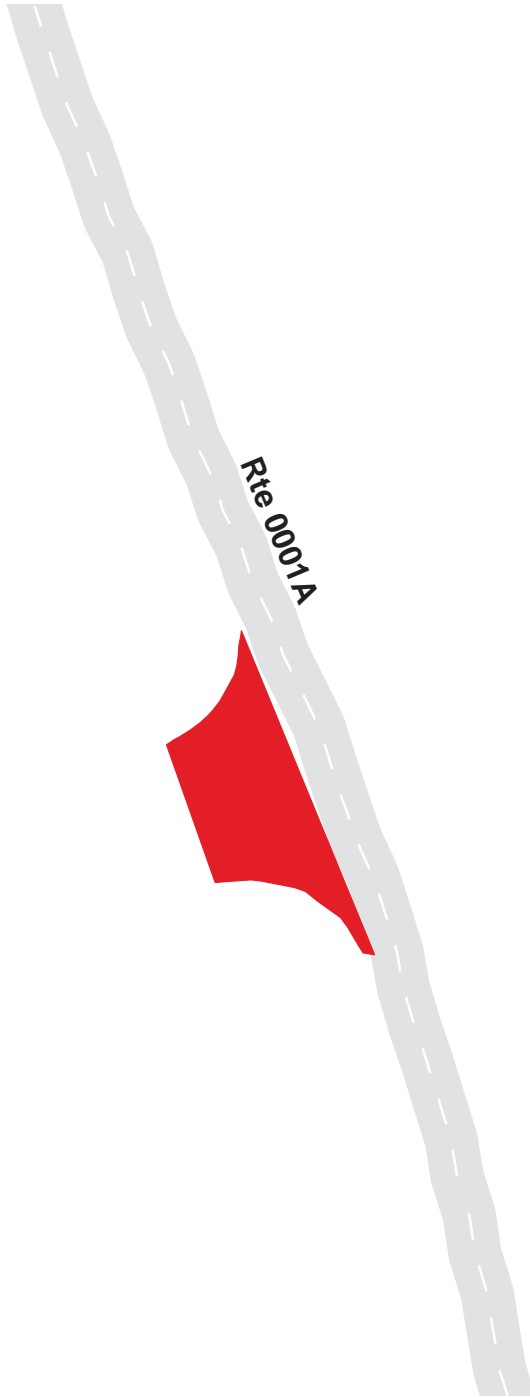
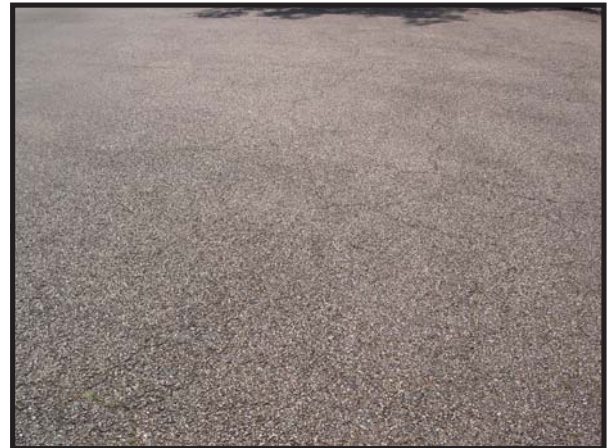
Route 0910

Route	Public / NonPublic	Date Visited	Area (sq ft)	Lane Miles *	Surface Type	Condition / PCR
0910	Public	9/10/2003	4096	0.07	AS	FAIR / 73

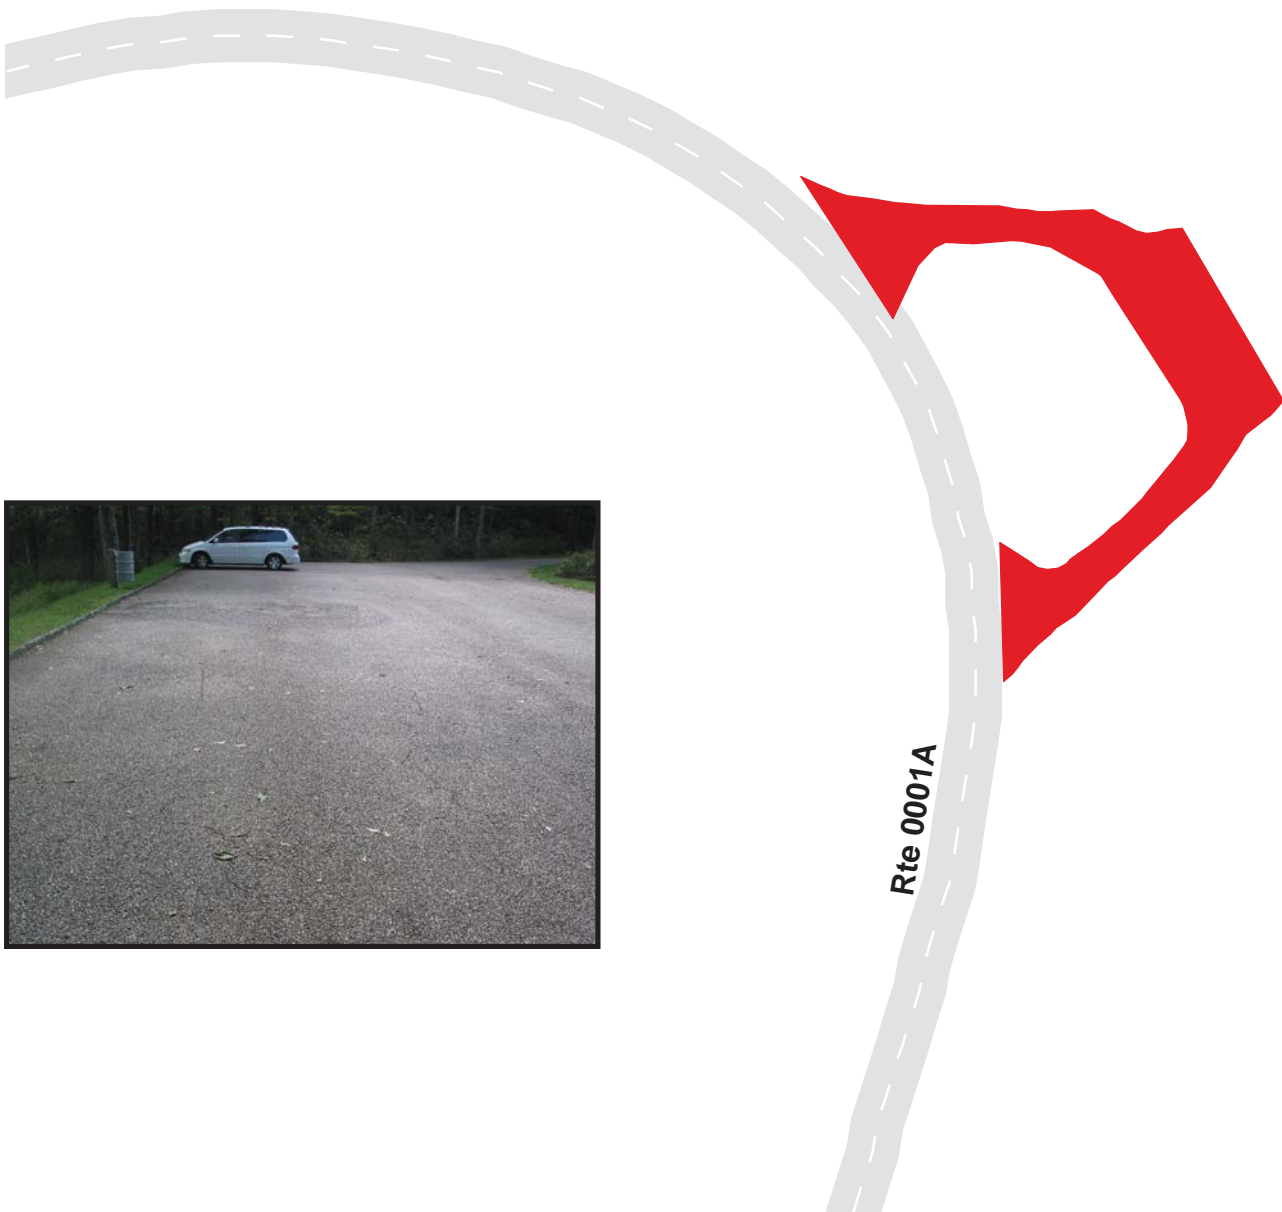
Route 0911

Route	Public / NonPublic	Date Visited	Area (sq ft)	Lane Miles *	Surface Type	Condition / PCR
0911	Public	9/10/2003	16563	0.29	AS	FAIR / 73

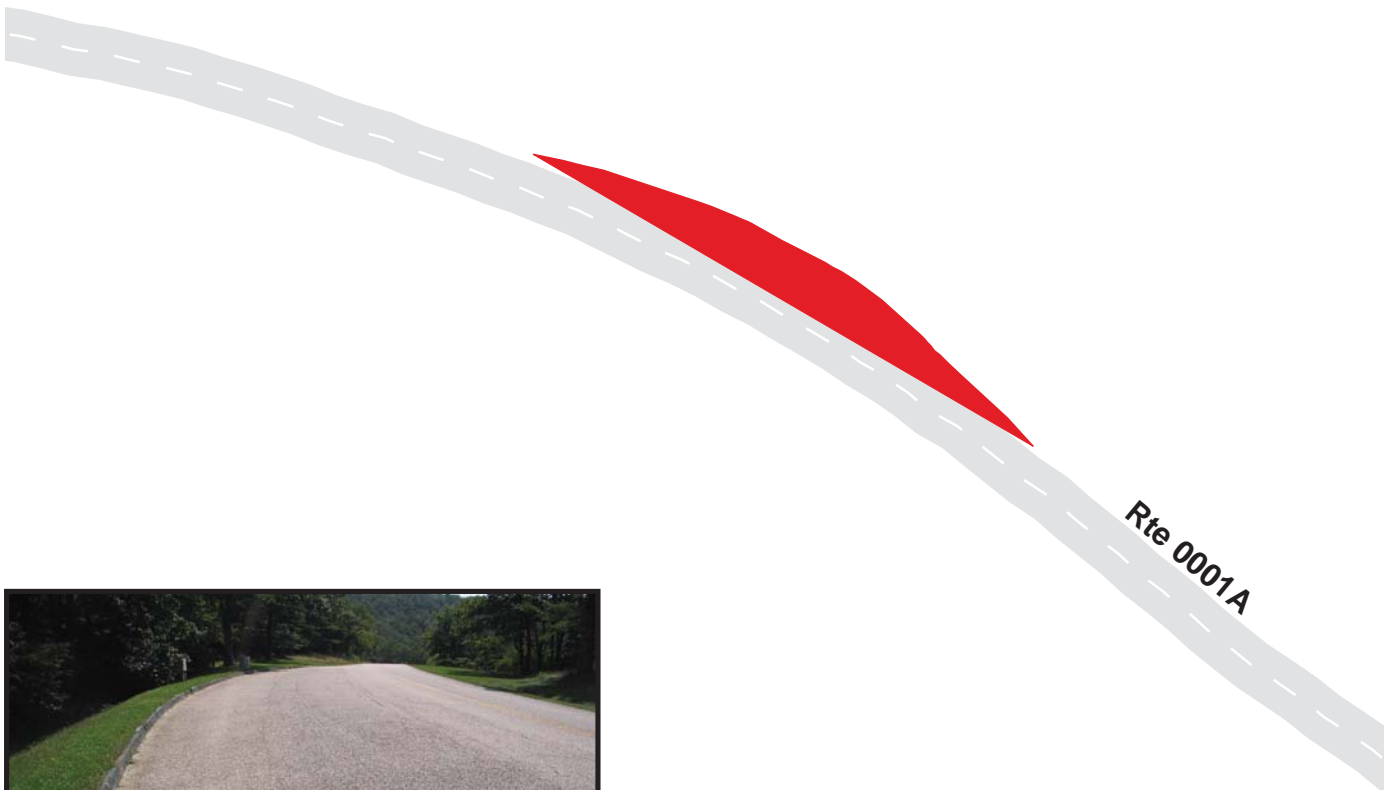
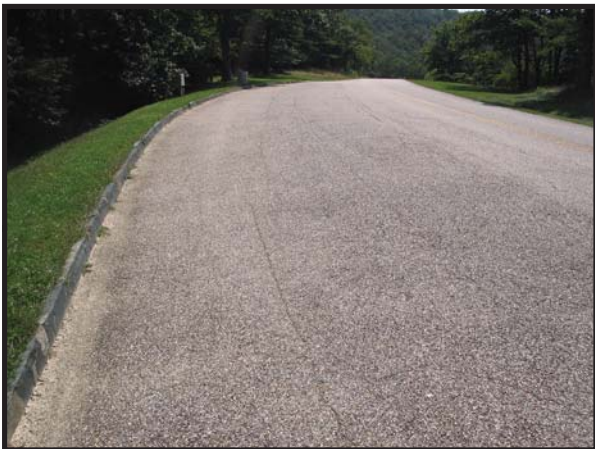
Route 0912

Route	Public / NonPublic	Date Visited	Area (sq ft)	Lane Miles *	Surface Type	Condition / PCR
0912	Public	9/10/2003	5984	0.10	AS	FAIR / 73

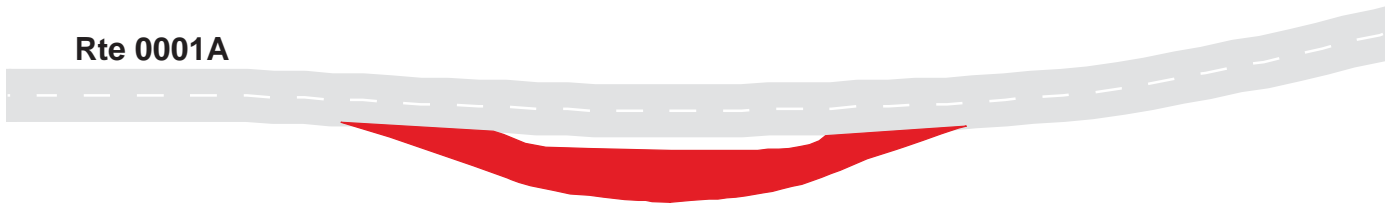
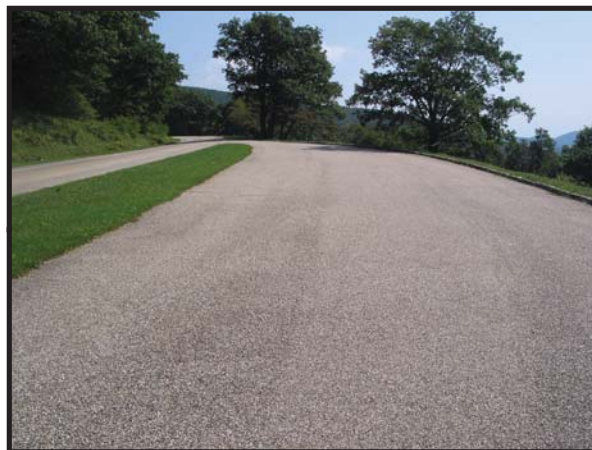
Blue Ridge Parkway
Route 0913
 Fork Mountain
 From Route 0001A at MP 22.88 on Left

Route	Public / NonPublic	Date Visited	Area (sq ft)	Lane Miles *	Surface Type	Condition / PCR
0913	Public	9/10/2003	6390	0.11	AS	FAIR / 73

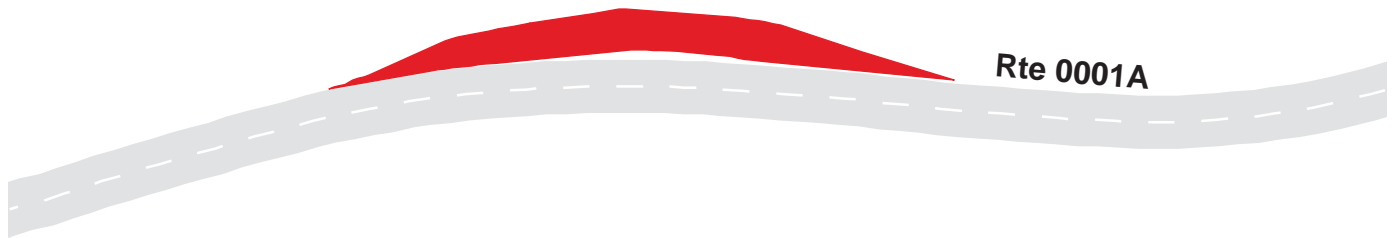
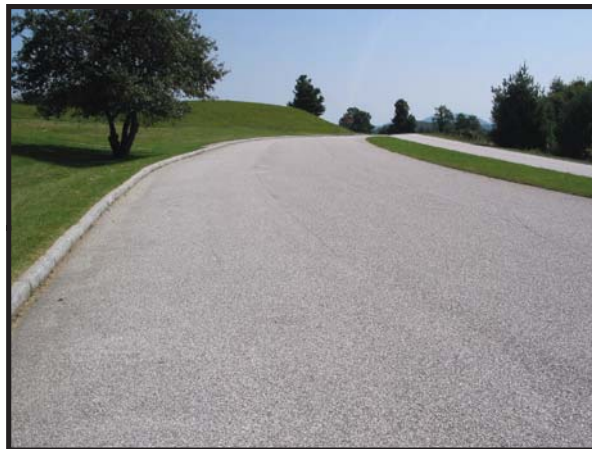
Route 0914

Route	Public / NonPublic	Date Visited	Area (sq ft)	Lane Miles *	Surface Type	Condition / PCR
0914	Public	9/10/2003	11649	0.20	AS	FAIR / 73

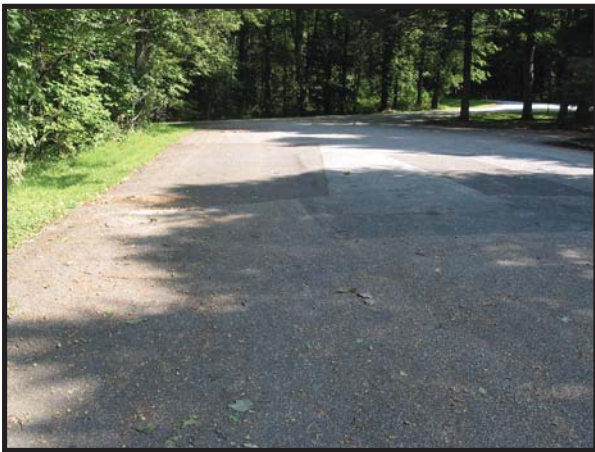
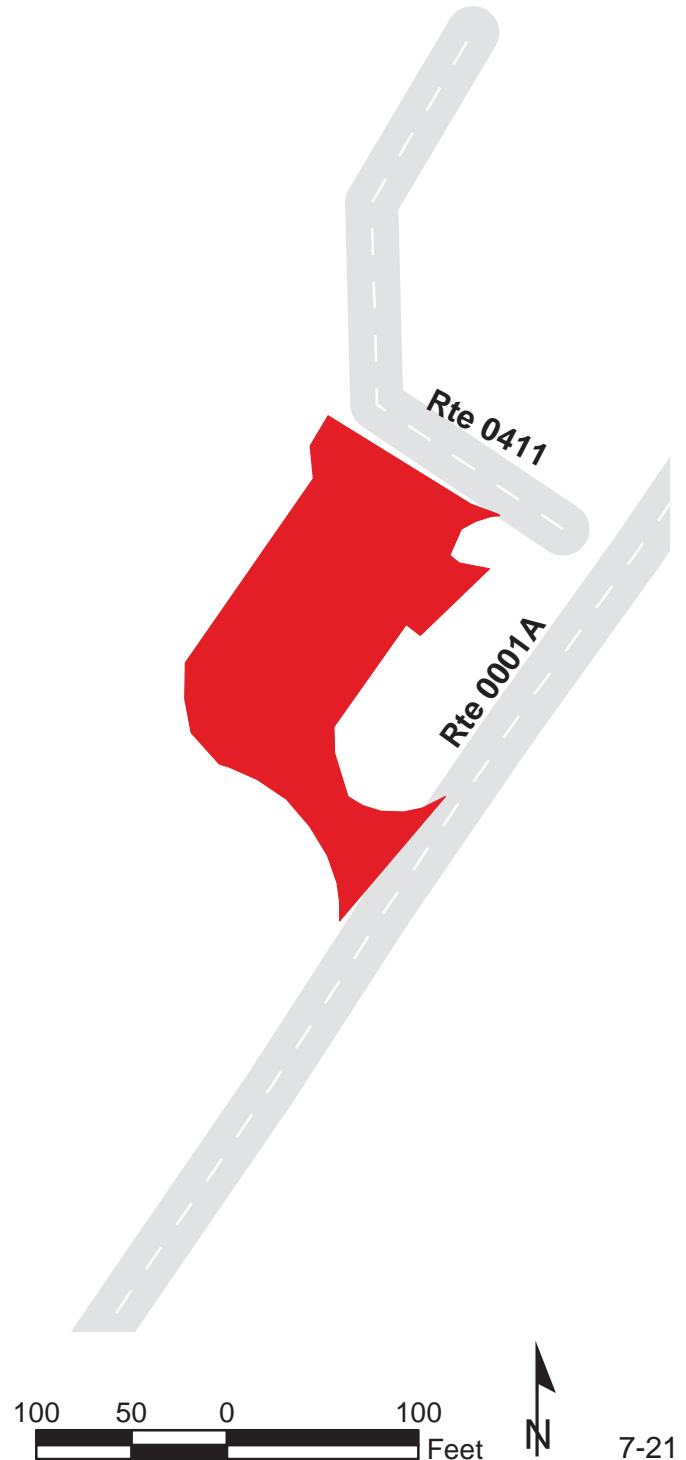
Blue Ridge Parkway Route 0915A

Route	Public / NonPublic	Date Visited	Area (sq ft)	Lane Miles *	Surface Type	Condition / PCR
0915A	Public	9/10/2003	14471	0.25	AS	GOOD / 90

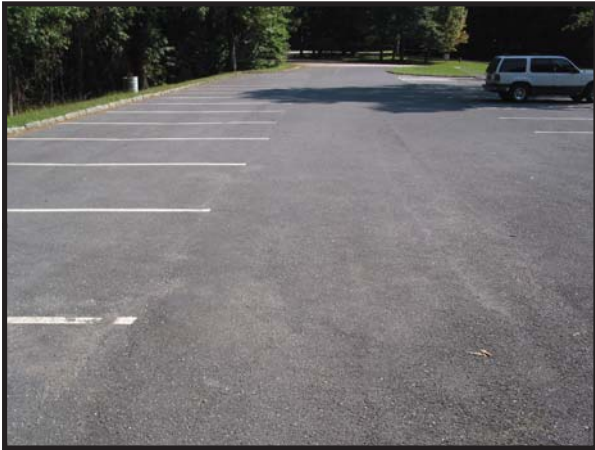
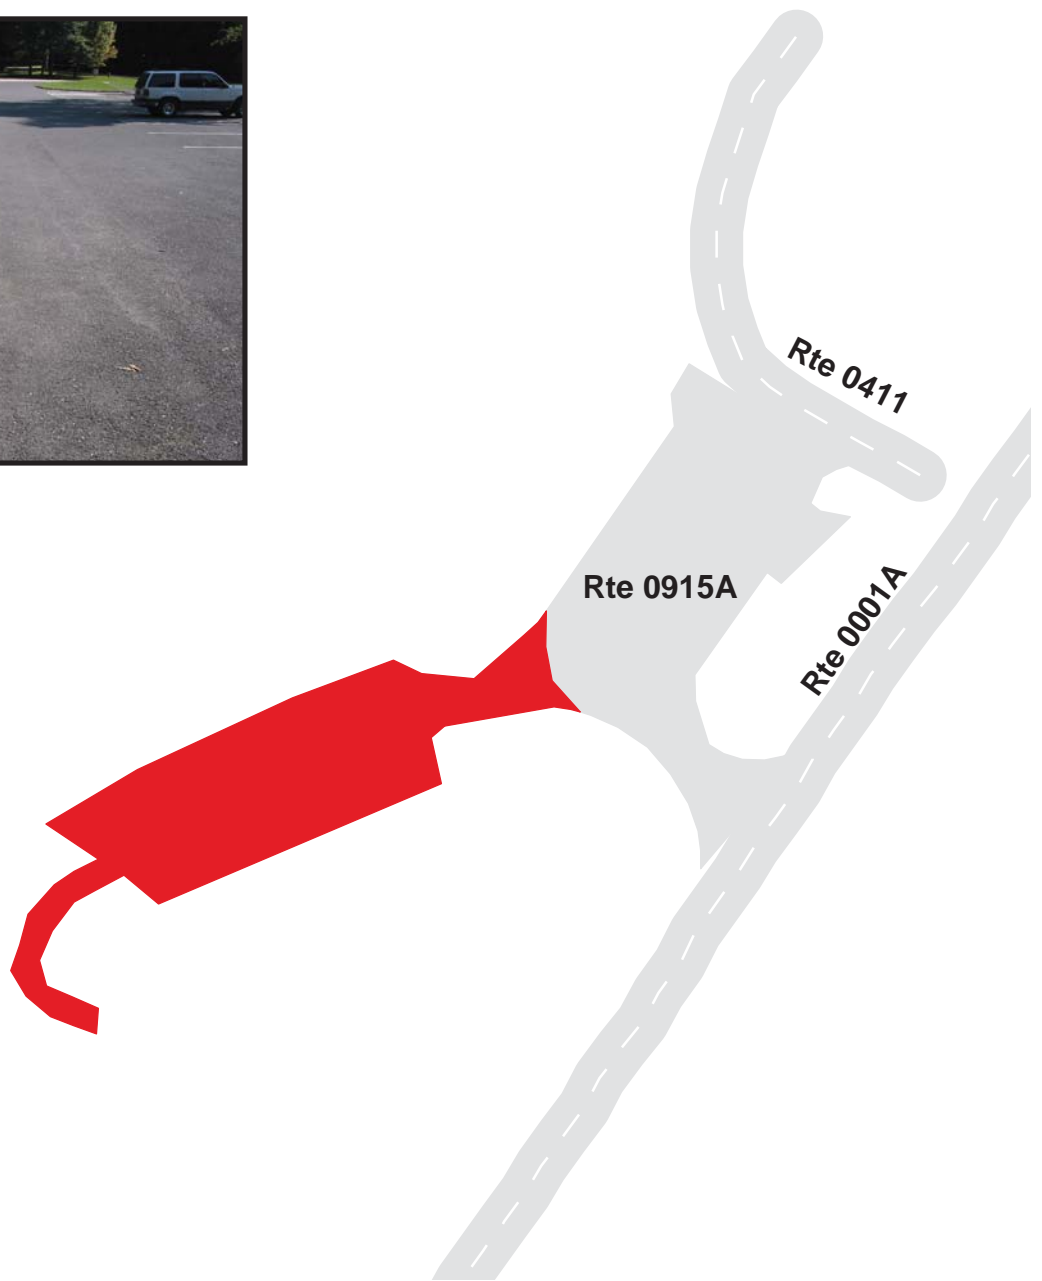
Route	Public / NonPublic	Date Visited	Area (sq ft)	Lane Miles *	Surface Type	Condition / PCR
0915B	Public	9/10/2003	13243	0.23	AS	GOOD / 90

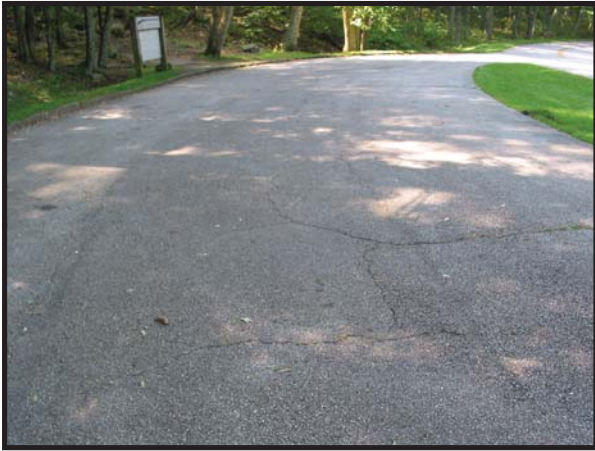
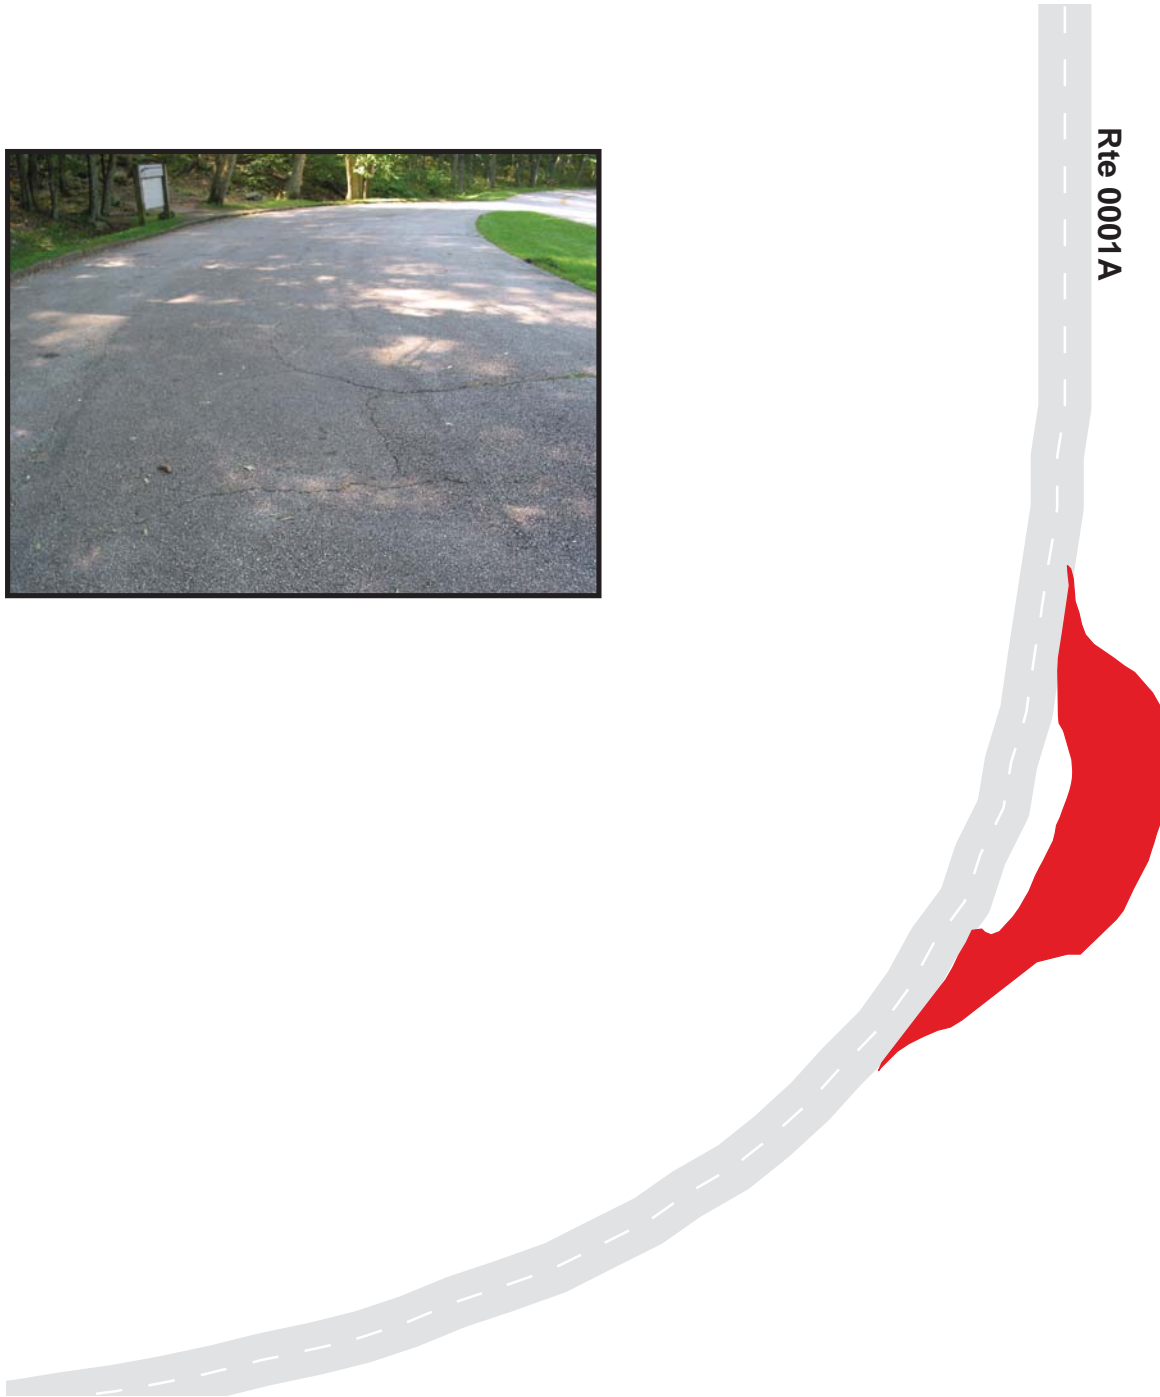
Route 0916

Route	Public / NonPublic	Date Visited	Area (sq ft)	Lane Miles *	Surface Type	Condition / PCR
0916	Public	9/10/2003	3742	0.06	AS	FAIR / 73

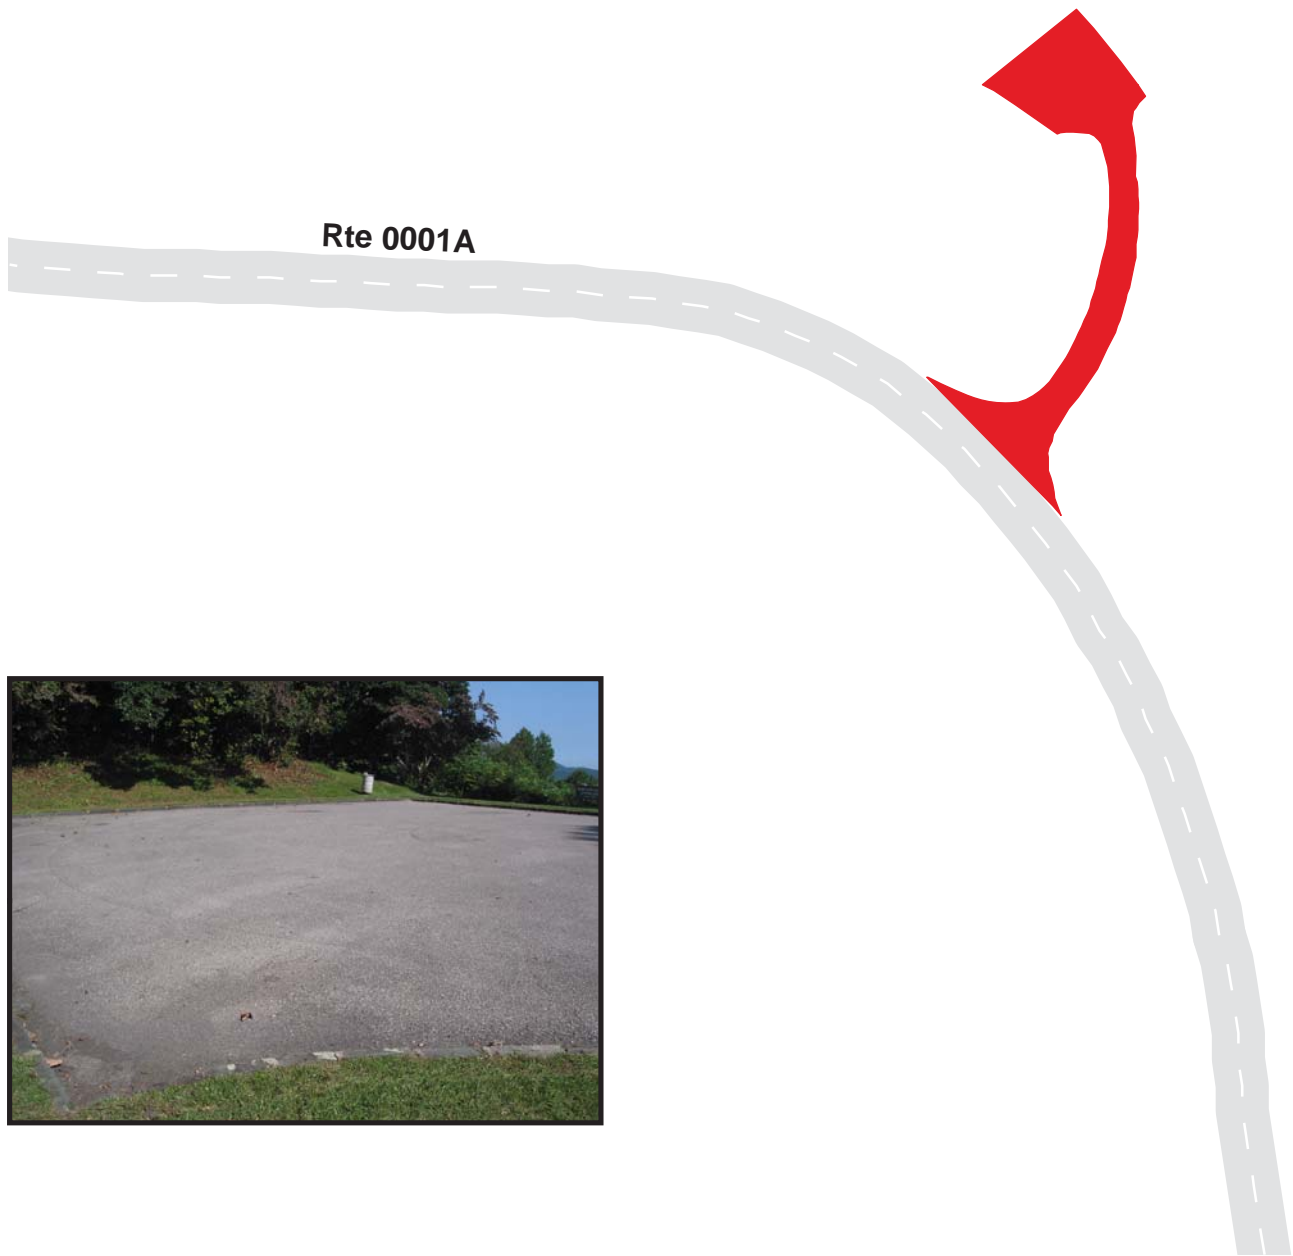
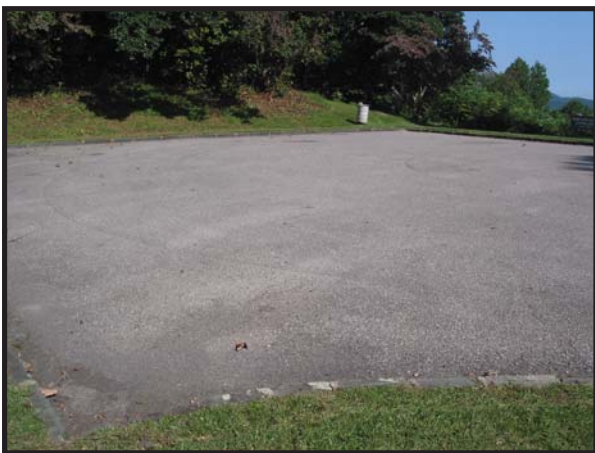
Route 0917

Route	Public / NonPublic	Date Visited	Area (sq ft)	Lane Miles *	Surface Type	Condition / PCR
0917	Public	9/10/2003	10925	0.19	AS	GOOD / 90
