The Road Inventory of Blue Ridge Parkway BLRI – 5140 Volume 1

Road Inventory Program

Prepared By:
Federal Highway Administration
Eastern Federal Lands Highway Division
Cycle 3

Blue Ridge Parkway in North Carolina

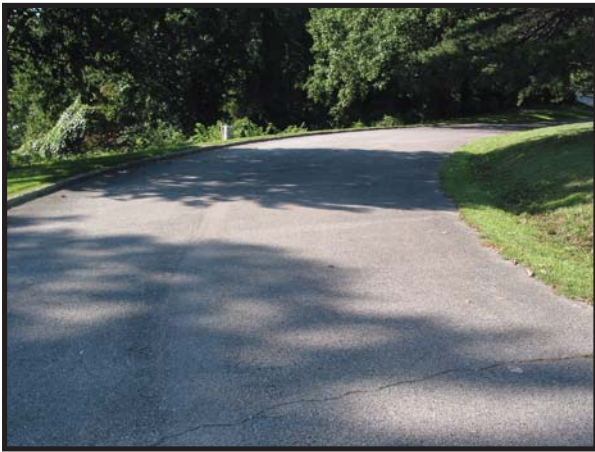
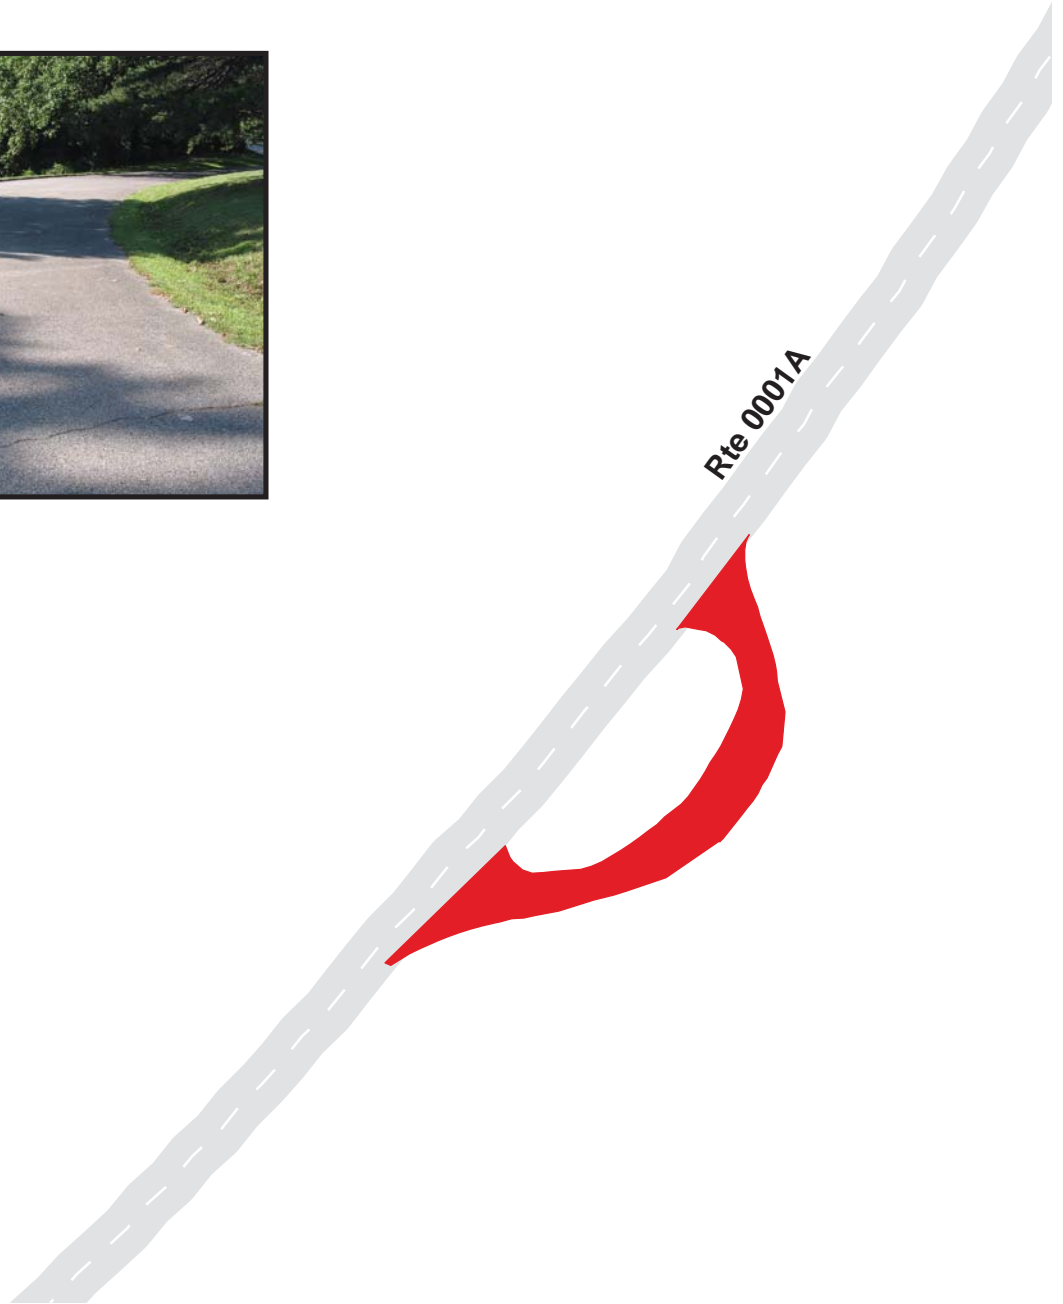
Route 0918

Route	Public / NonPublic	Date Visited	Area (sq ft)	Lane Miles *	Surface Type	Condition / PCR
0918	Public	9/10/2003	6712	0.12	AS	GOOD / 90

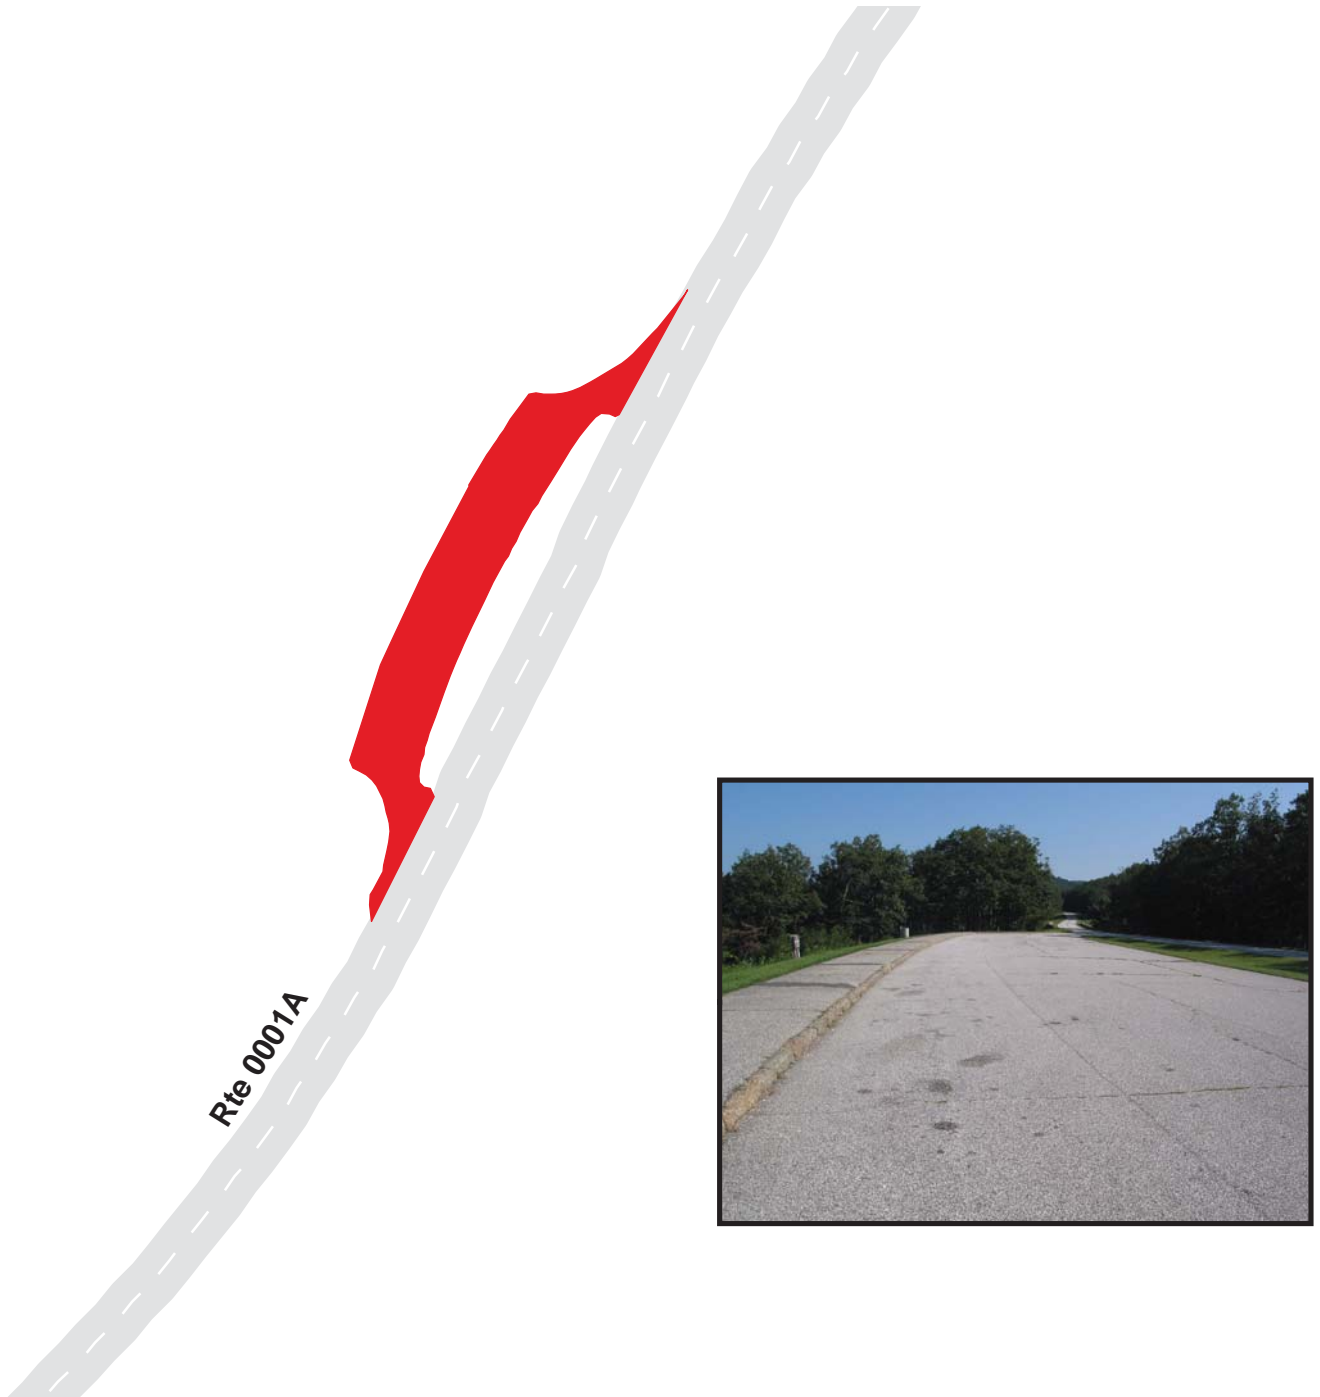
Route	Public / NonPublic	Date Visited	Area (sq ft)	Lane Miles *	Surface Type	Condition / PCR
0919	Public	9/10/2003	12700	0.22	AS	POOR / 45

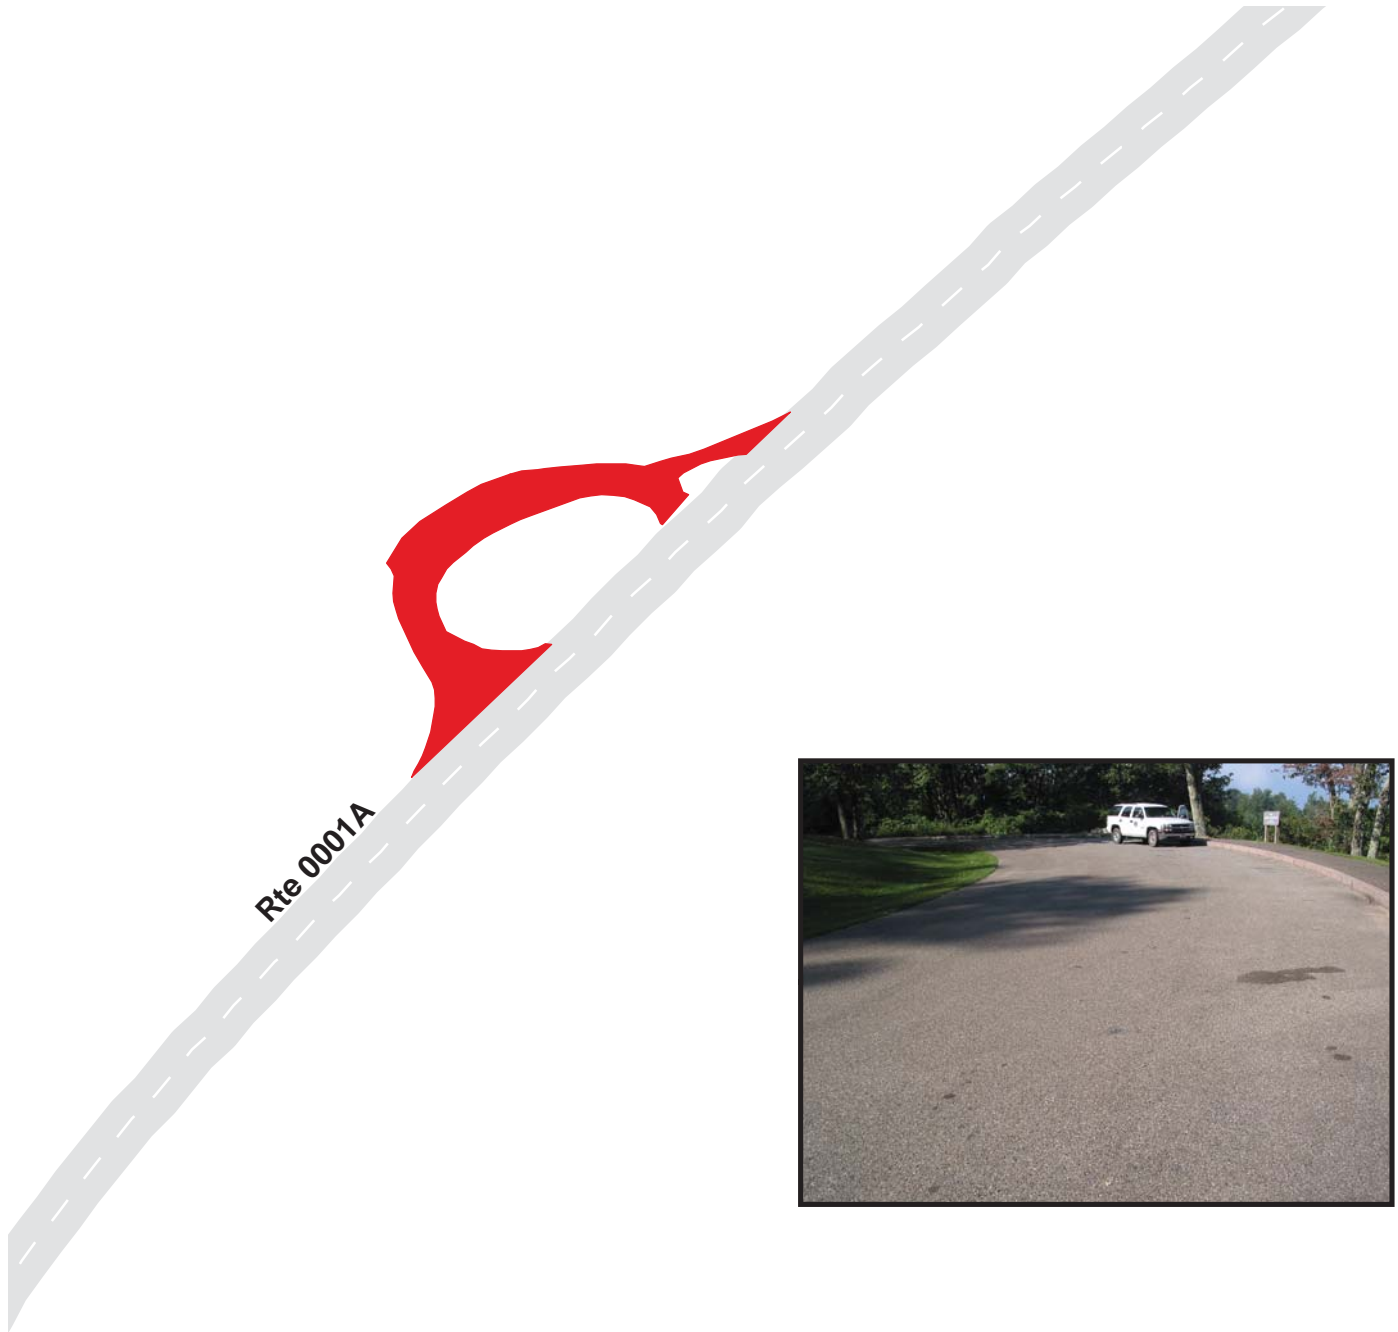
Route	Public / NonPublic	Date Visited	Area (sq ft)	Lane Miles *	Surface Type	Condition / PCR
0920	Public	9/10/2003	7238	0.12	AS	GOOD / 90

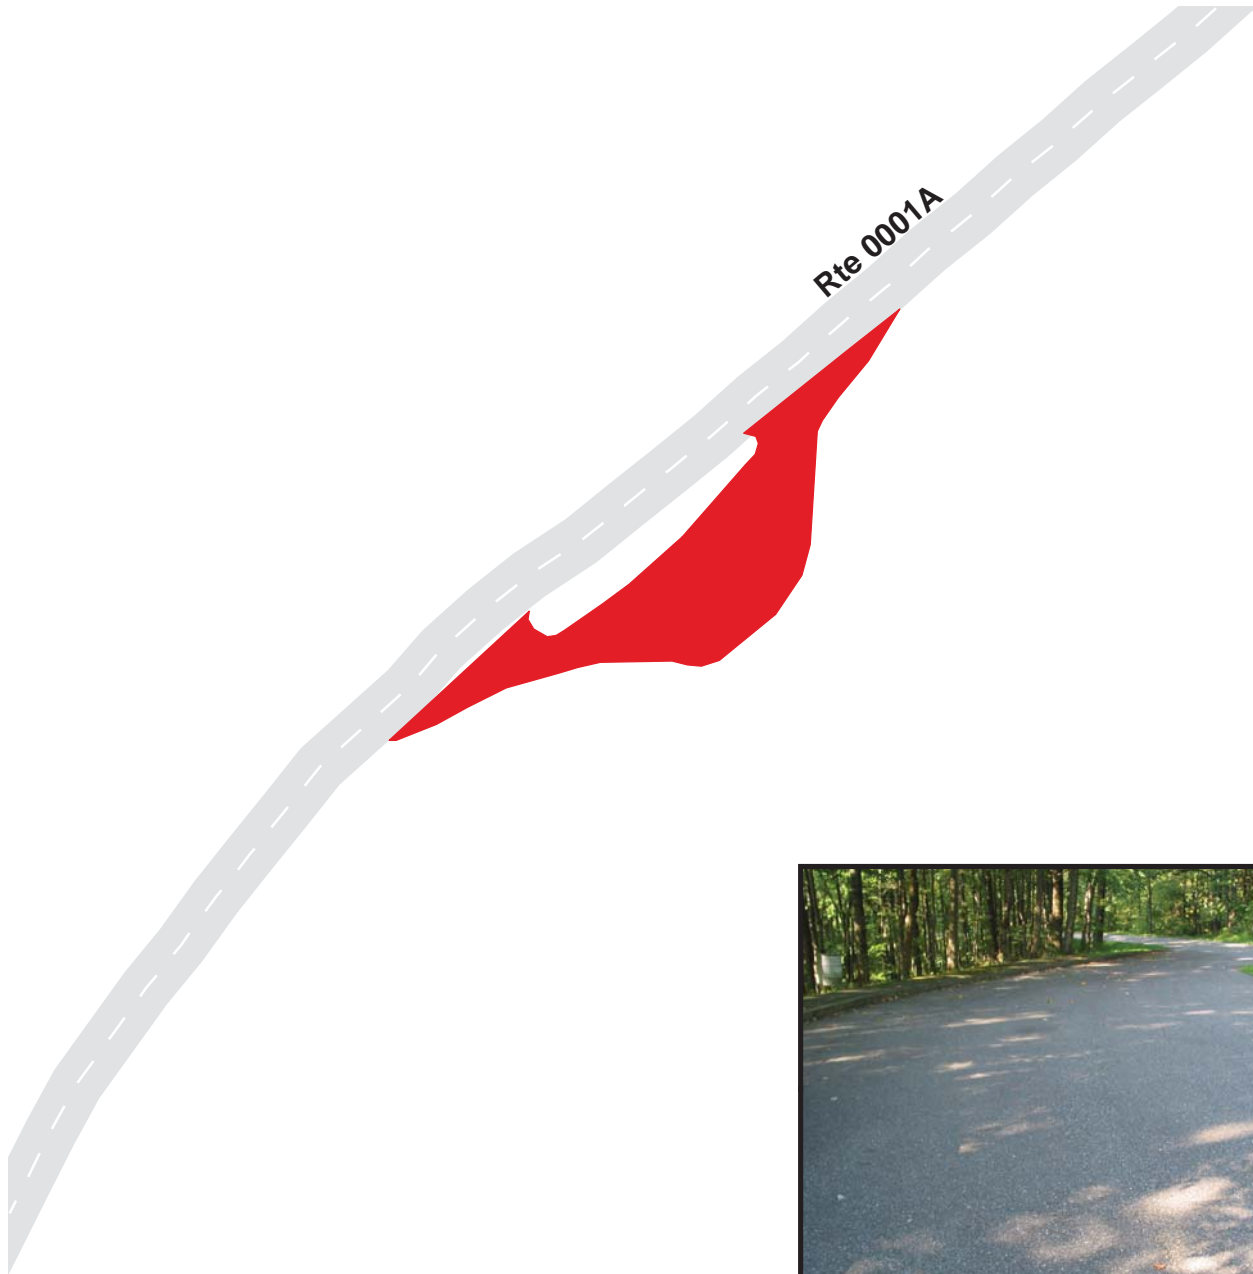
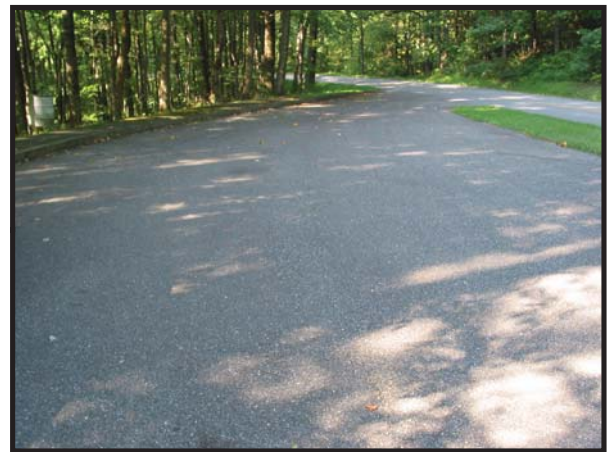
Route	Public / NonPublic	Date Visited	Area (sq ft)	Lane Miles *	Surface Type	Condition / PCR
0921	Public	9/10/2003	3358	0.06	AS	GOOD / 90

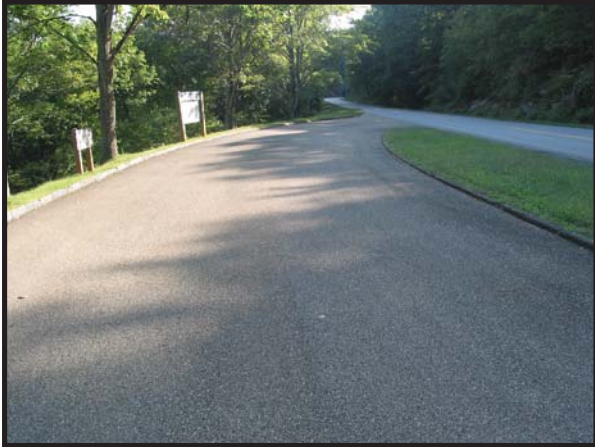
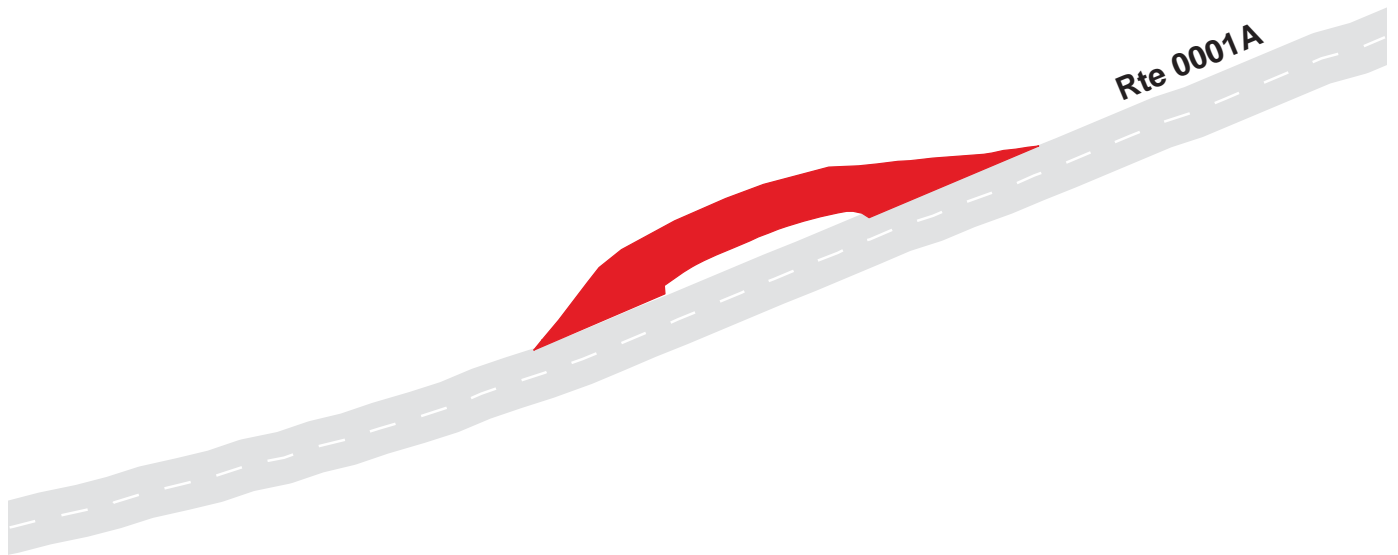
Route 0922

Route	Public / NonPublic	Date Visited	Area (sq ft)	Lane Miles *	Surface Type	Condition / PCR
0922	Public	9/10/2003	4458	0.08	AS	GOOD / 90

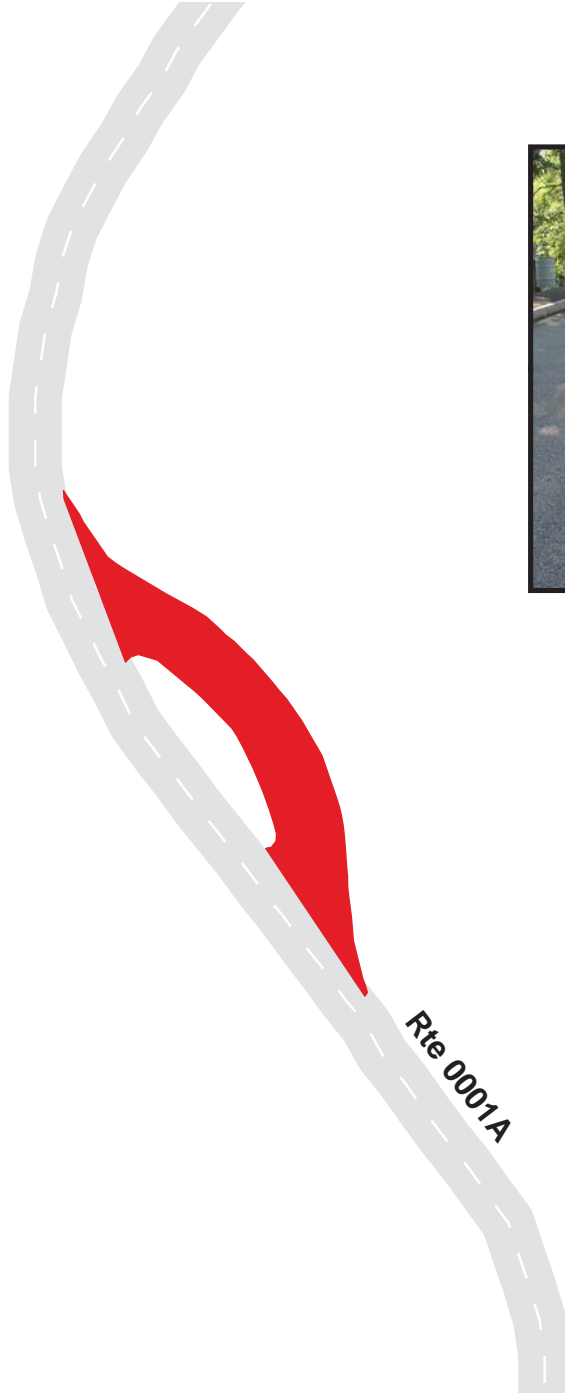
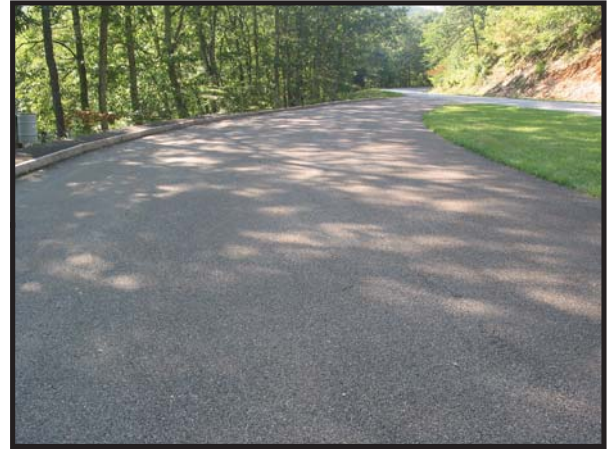
Route 0923

Route	Public / NonPublic	Date Visited	Area (sq ft)	Lane Miles *	Surface Type	Condition / PCR
0923	Public	9/10/2003	6479	0.11	AS	GOOD / 90

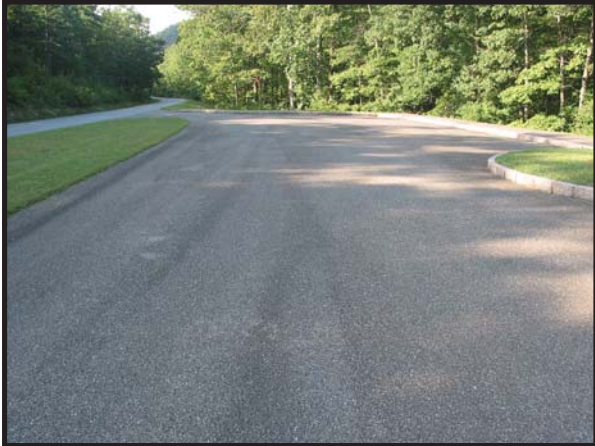
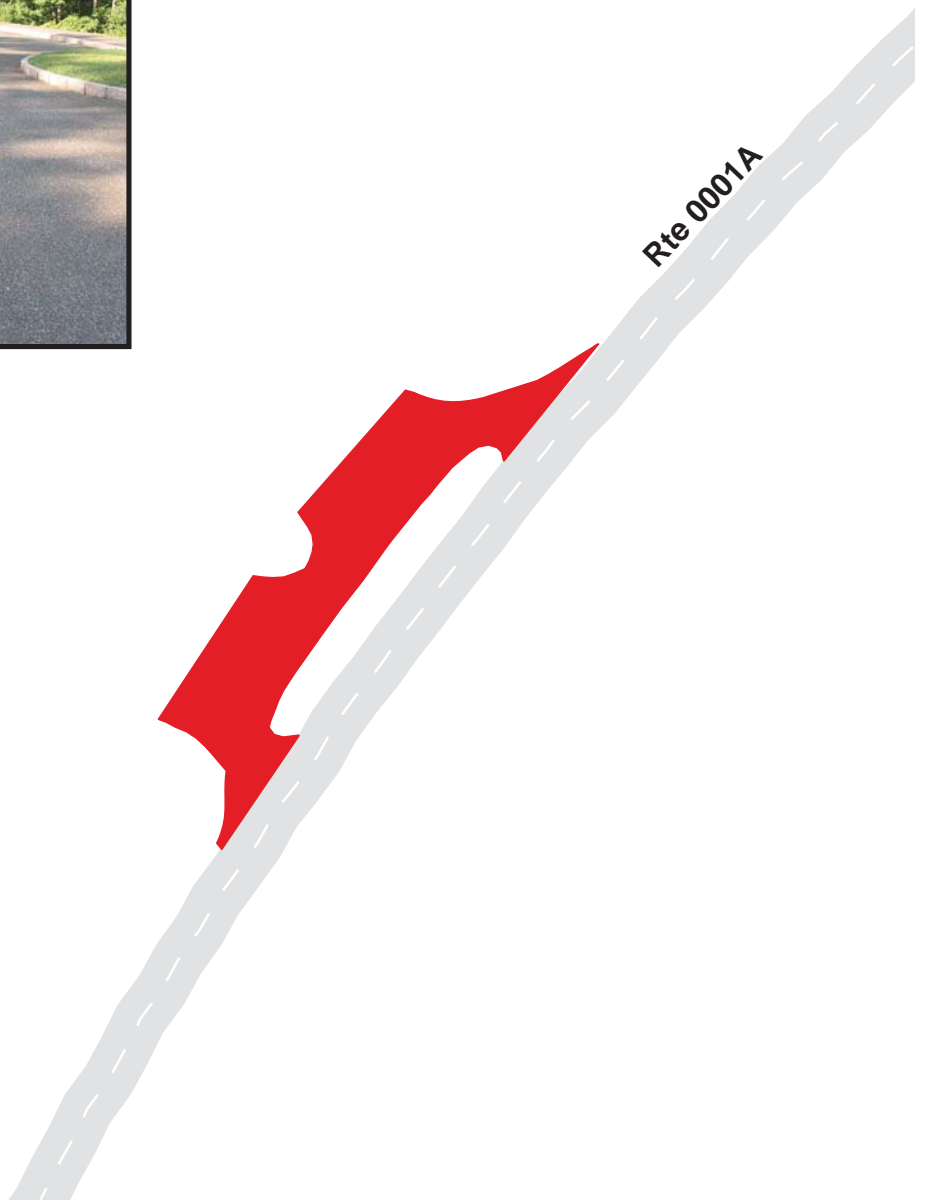
Route 0924

Route	Public / NonPublic	Date Visited	Area (sq ft)	Lane Miles *	Surface Type	Condition / PCR
0924	Public	9/10/2003	9456	0.16	AS	GOOD / 90

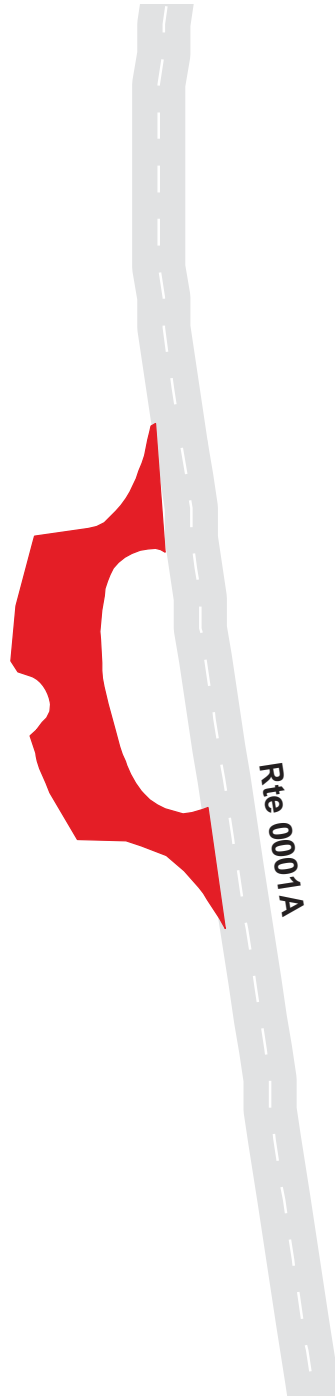
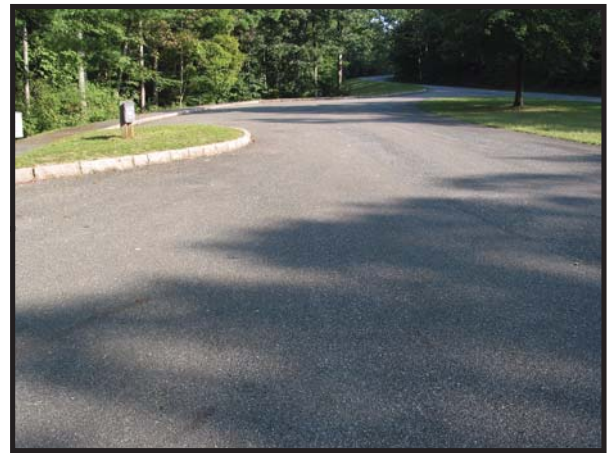
Route 0925

Route	Public / NonPublic	Date Visited	Area (sq ft)	Lane Miles *	Surface Type	Condition / PCR
0925	Public	9/10/2003	9656	0.17	AS	GOOD / 90

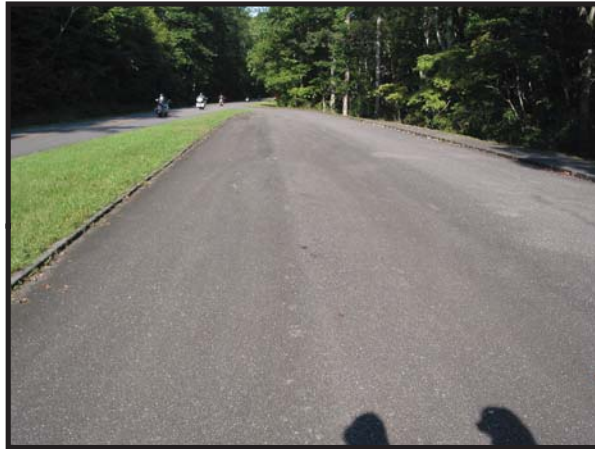
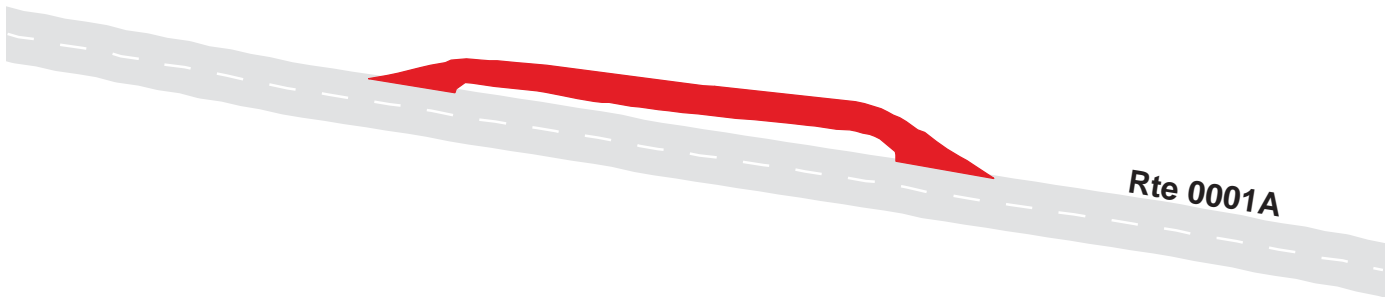
Route 0926

Route	Public / NonPublic	Date Visited	Area (sq ft)	Lane Miles *	Surface Type	Condition / PCR
0926	Public	9/10/2003	9812	0.17	AS	GOOD / 90

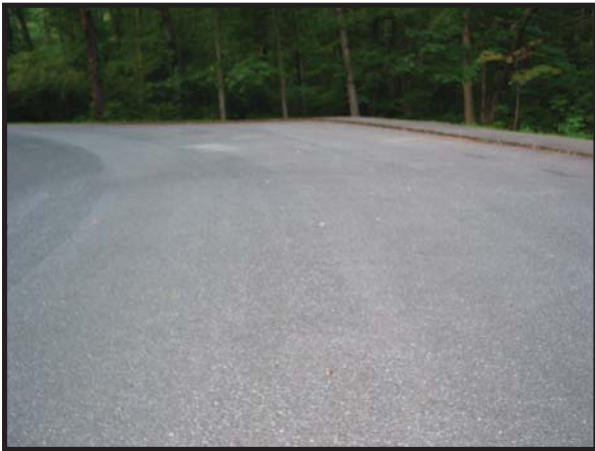
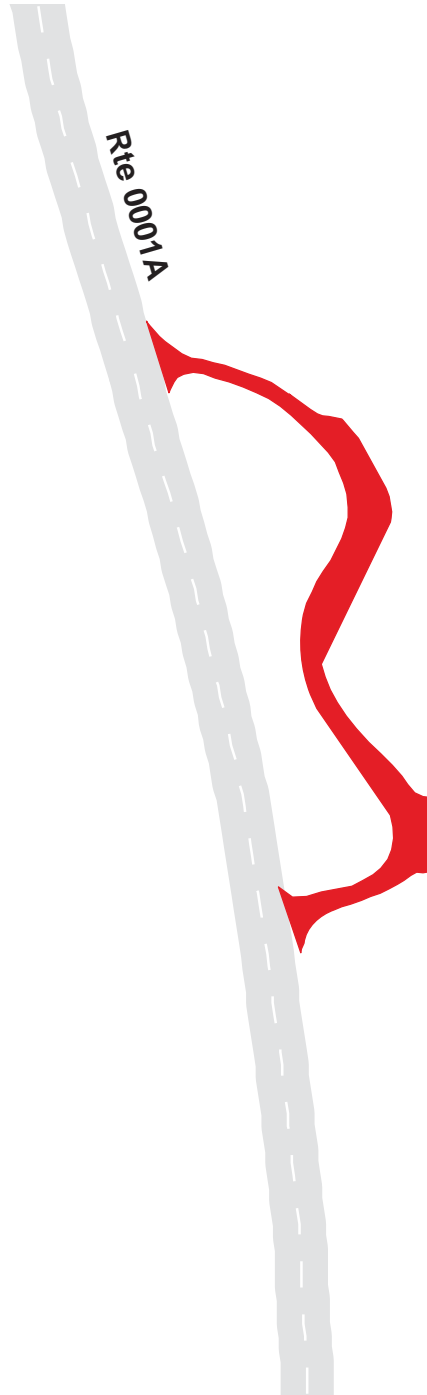
Route 0927

Route	Public / NonPublic	Date Visited	Area (sq ft)	Lane Miles *	Surface Type	Condition / PCR
0927	Public	9/9/2003	39189	0.67	AS	GOOD / 90

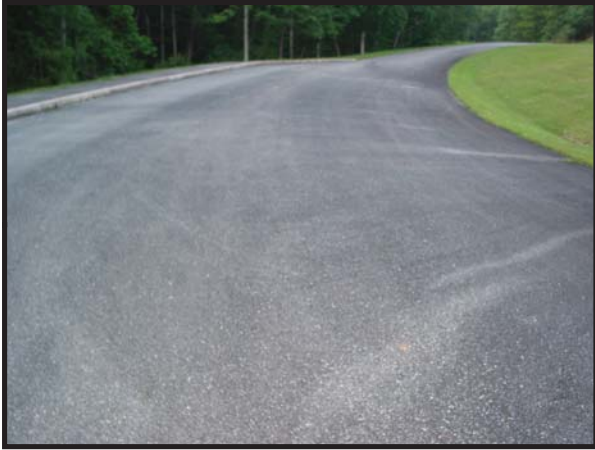
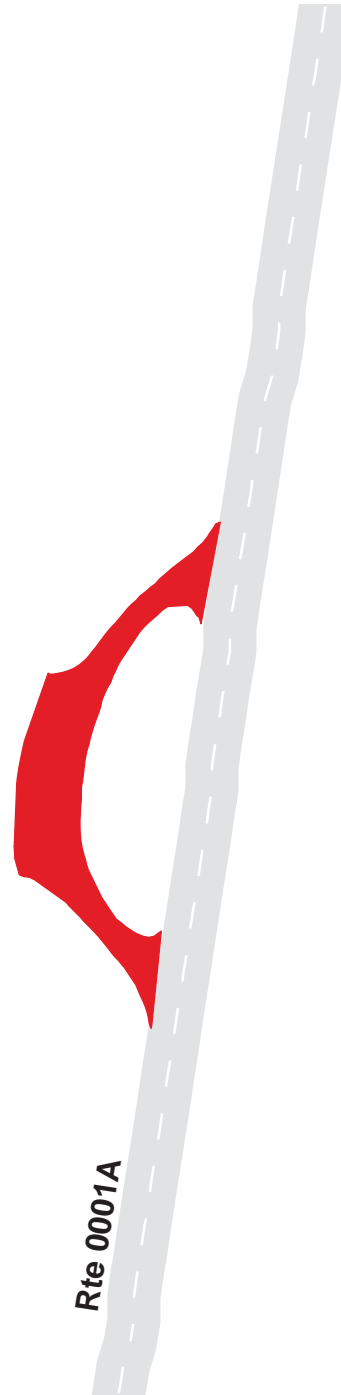
Route 0928

Route	Public / NonPublic	Date Visited	Area (sq ft)	Lane Miles *	Surface Type	Condition / PCR
0928	Public	9/9/2003	11592	0.20	AS	GOOD / 90

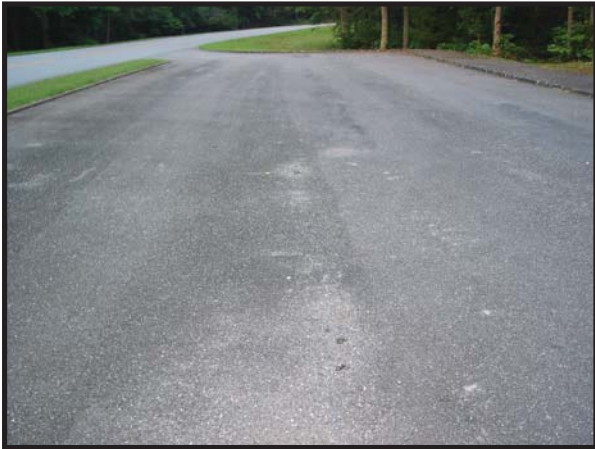
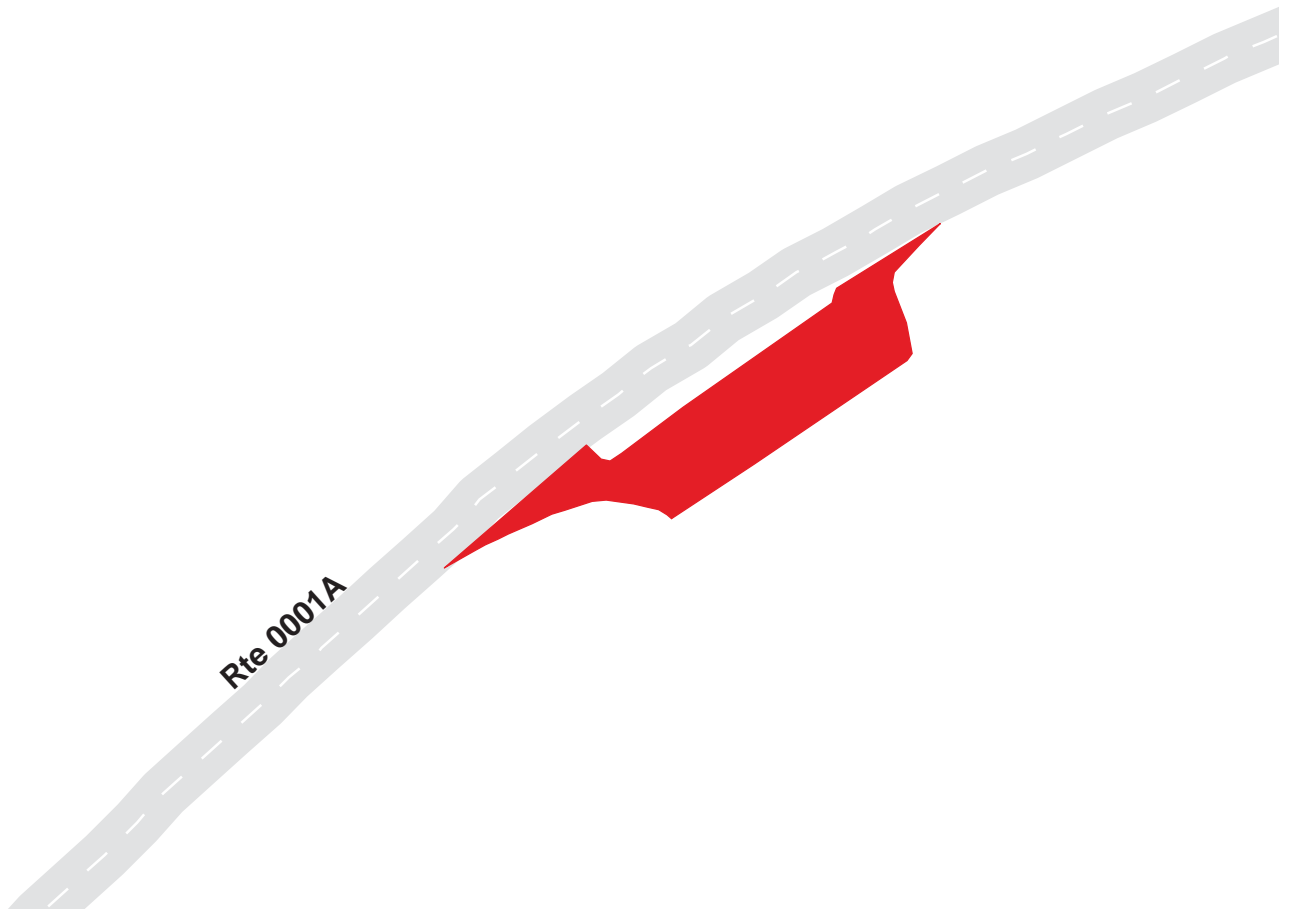
Route 0929

Route	Public / NonPublic	Date Visited	Area (sq ft)	Lane Miles *	Surface Type	Condition / PCR
0929	Public	9/9/2003	4892	0.08	AS	GOOD / 90

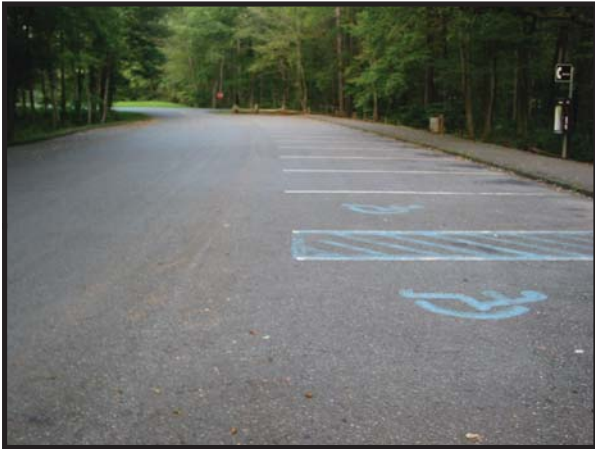
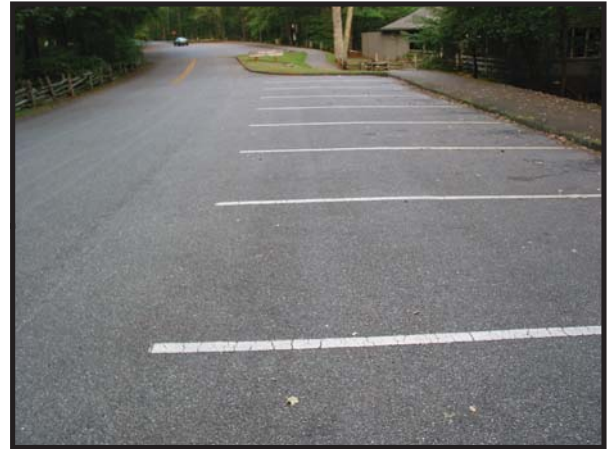
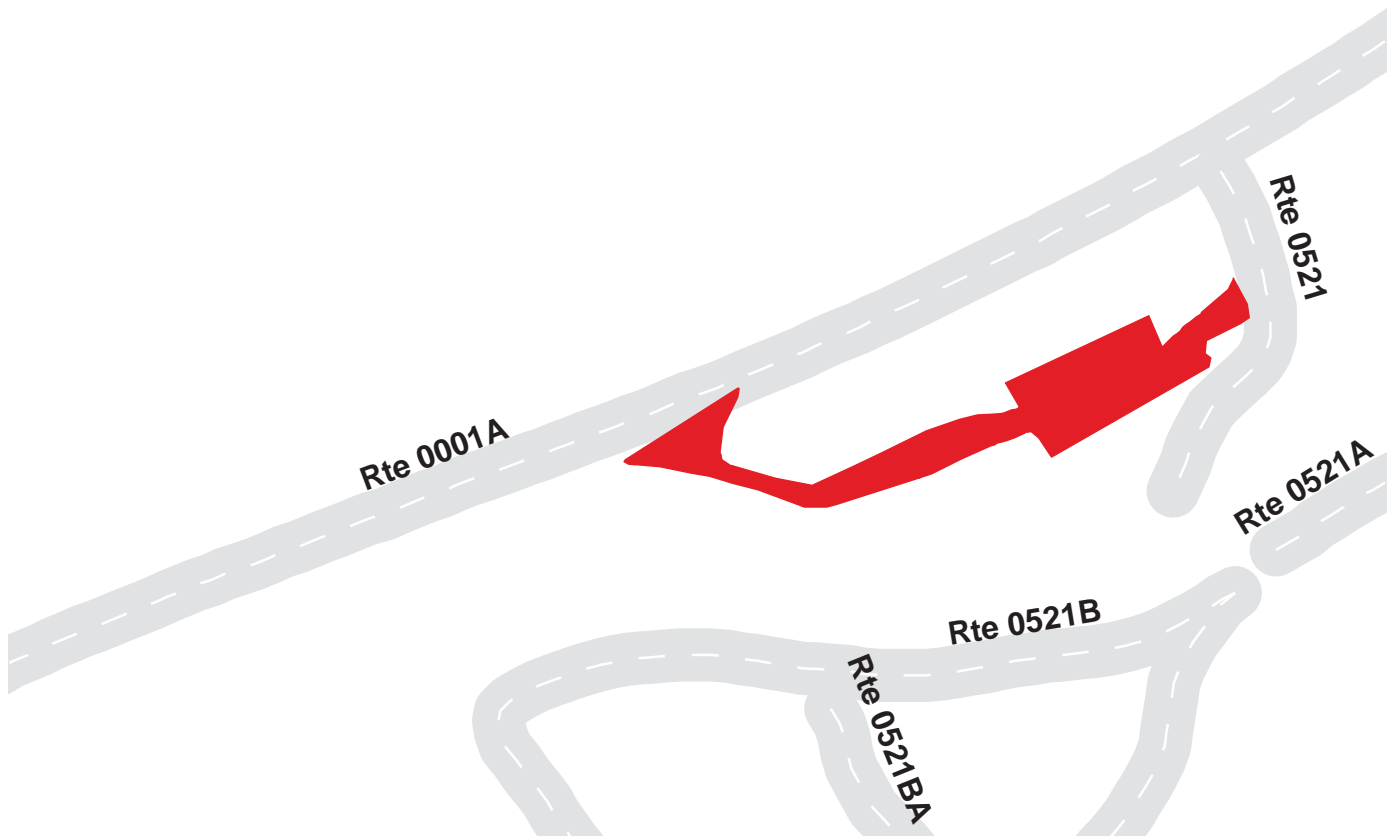
Route 0930

Route	Public / NonPublic	Date Visited	Area (sq ft)	Lane Miles *	Surface Type	Condition / PCR
0930	Public	9/9/2003	32706	0.56	AS	GOOD / 90

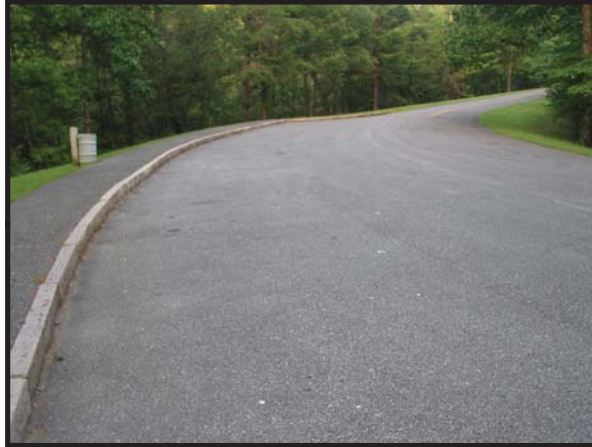
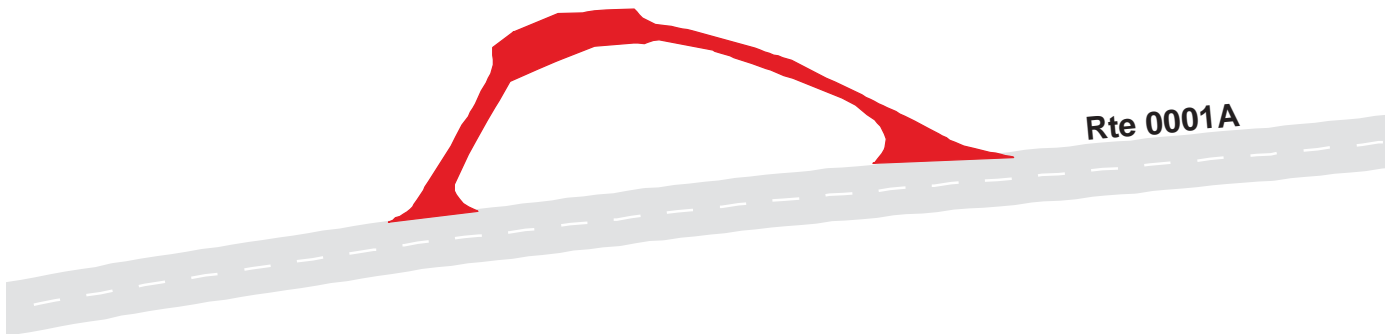
Route 0931

Route	Public / NonPublic	Date Visited	Area (sq ft)	Lane Miles *	Surface Type	Condition / PCR
0931	Public	9/9/2003	19171	0.33	AS	GOOD / 90

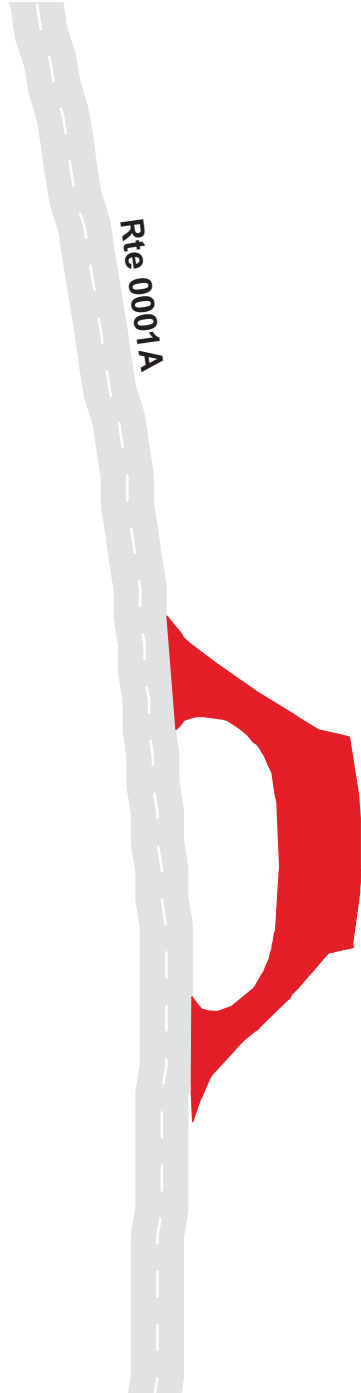
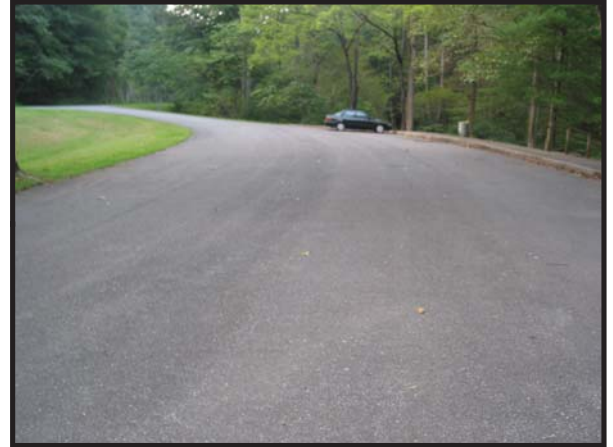
Route 0932

Route	Public / NonPublic	Date Visited	Area (sq ft)	Lane Miles *	Surface Type	Condition / PCR
0932	Public	9/9/2003	10453	0.18	AS	GOOD / 90

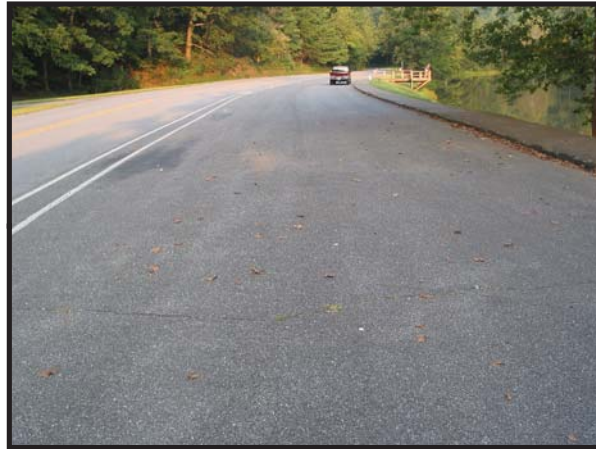
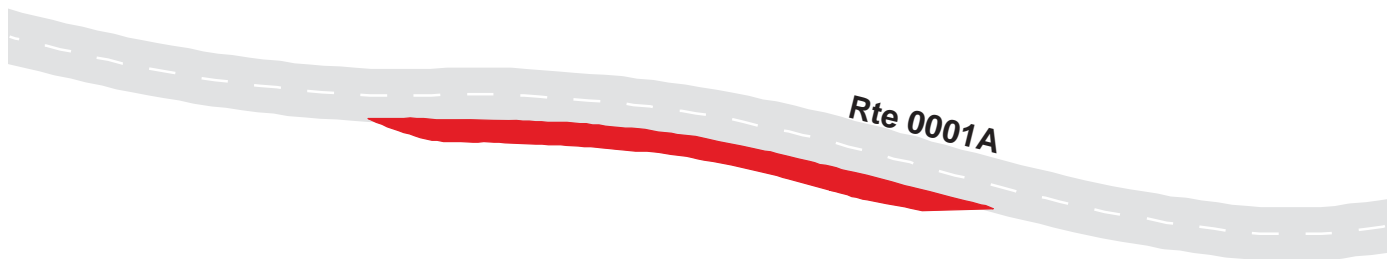
Route 0933A

Route	Public / NonPublic	Date Visited	Area (sq ft)	Lane Miles *	Surface Type	Condition / PCR
0933A	Public	9/9/2003	13445	0.23	AS	GOOD / 90

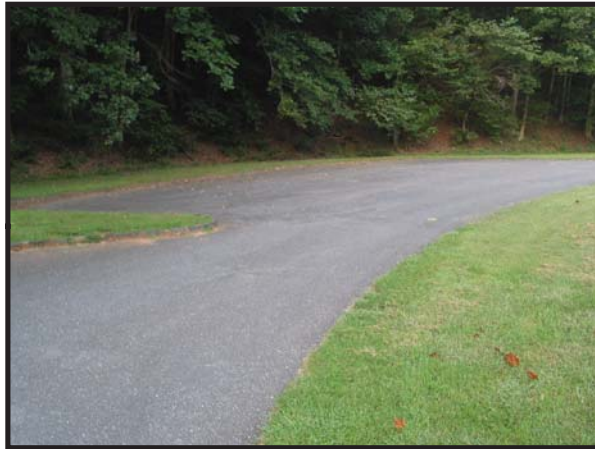
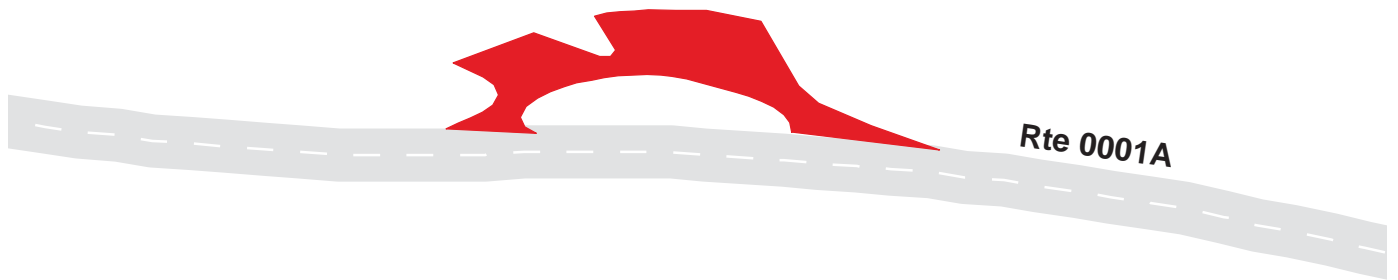
Route 0933B

Route	Public / NonPublic	Date Visited	Area (sq ft)	Lane Miles *	Surface Type	Condition / PCR
0933B	Public	9/9/2003	4493	0.08	AS	GOOD / 90

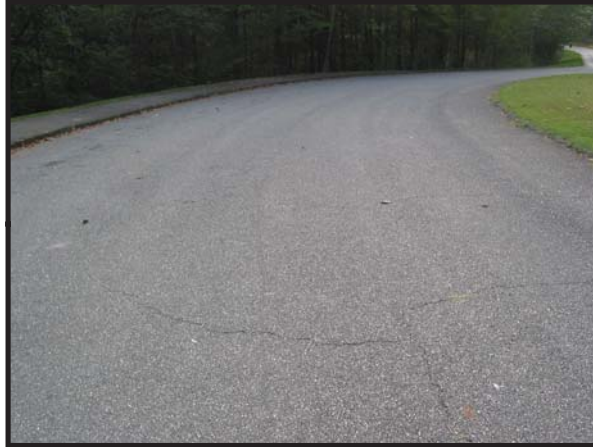
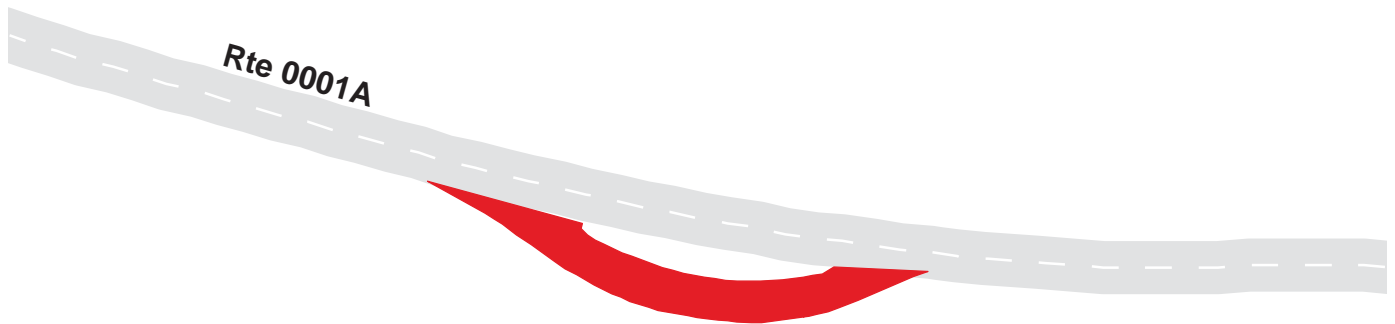
Route 0933C

Route	Public / NonPublic	Date Visited	Area (sq ft)	Lane Miles *	Surface Type	Condition / PCR
0933C	Public	9/9/2003	5253	0.09	AS	GOOD / 90

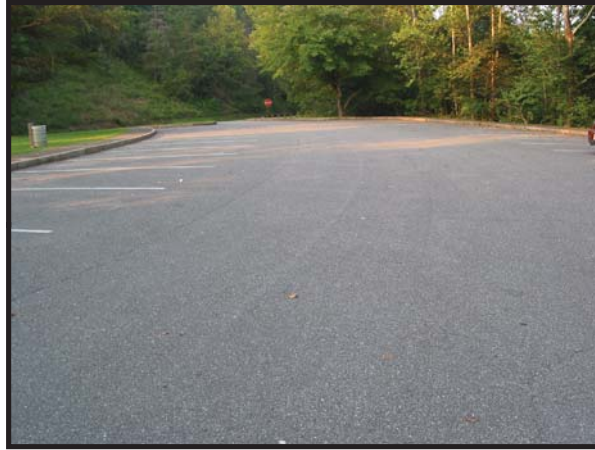
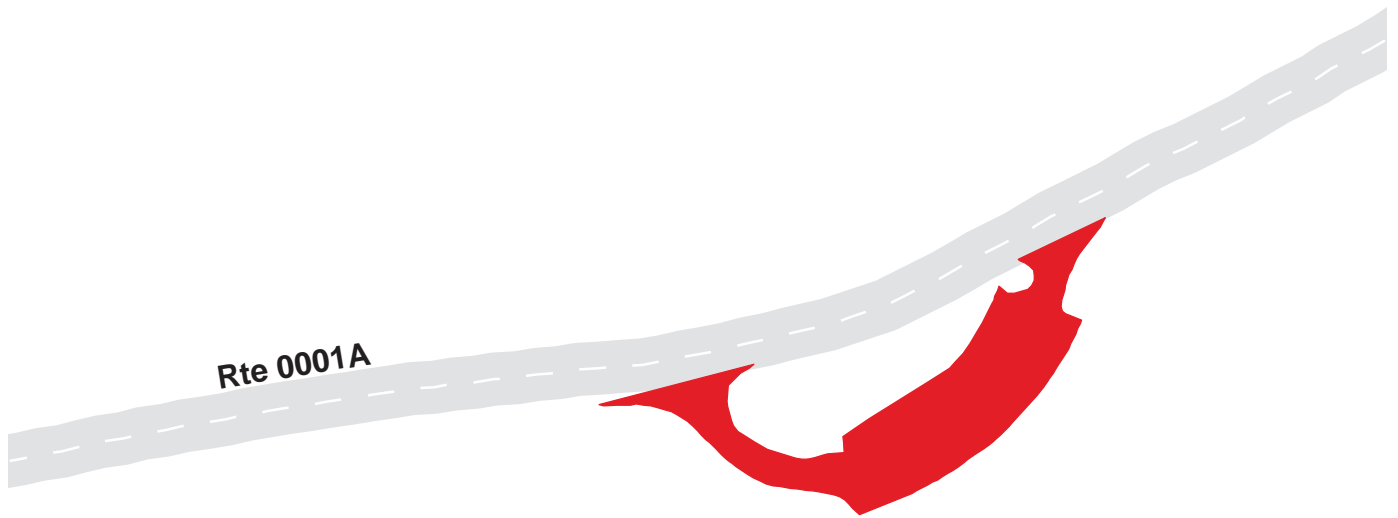
Route 0935A

Route	Public / NonPublic	Date Visited	Area (sq ft)	Lane Miles *	Surface Type	Condition / PCR
0935A	NonPublic	9/9/2003	24724	0.43	AS	GOOD / 90
