The Road Inventory of Blue Ridge Parkway BLRI – 5140 Volume 1

Road Inventory Program

Prepared By:
Federal Highway Administration
Eastern Federal Lands Highway Division
Cycle 3

Blue Ridge Parkway in North Carolina

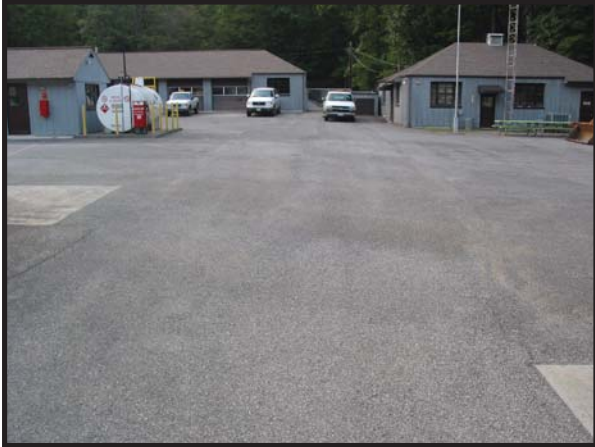
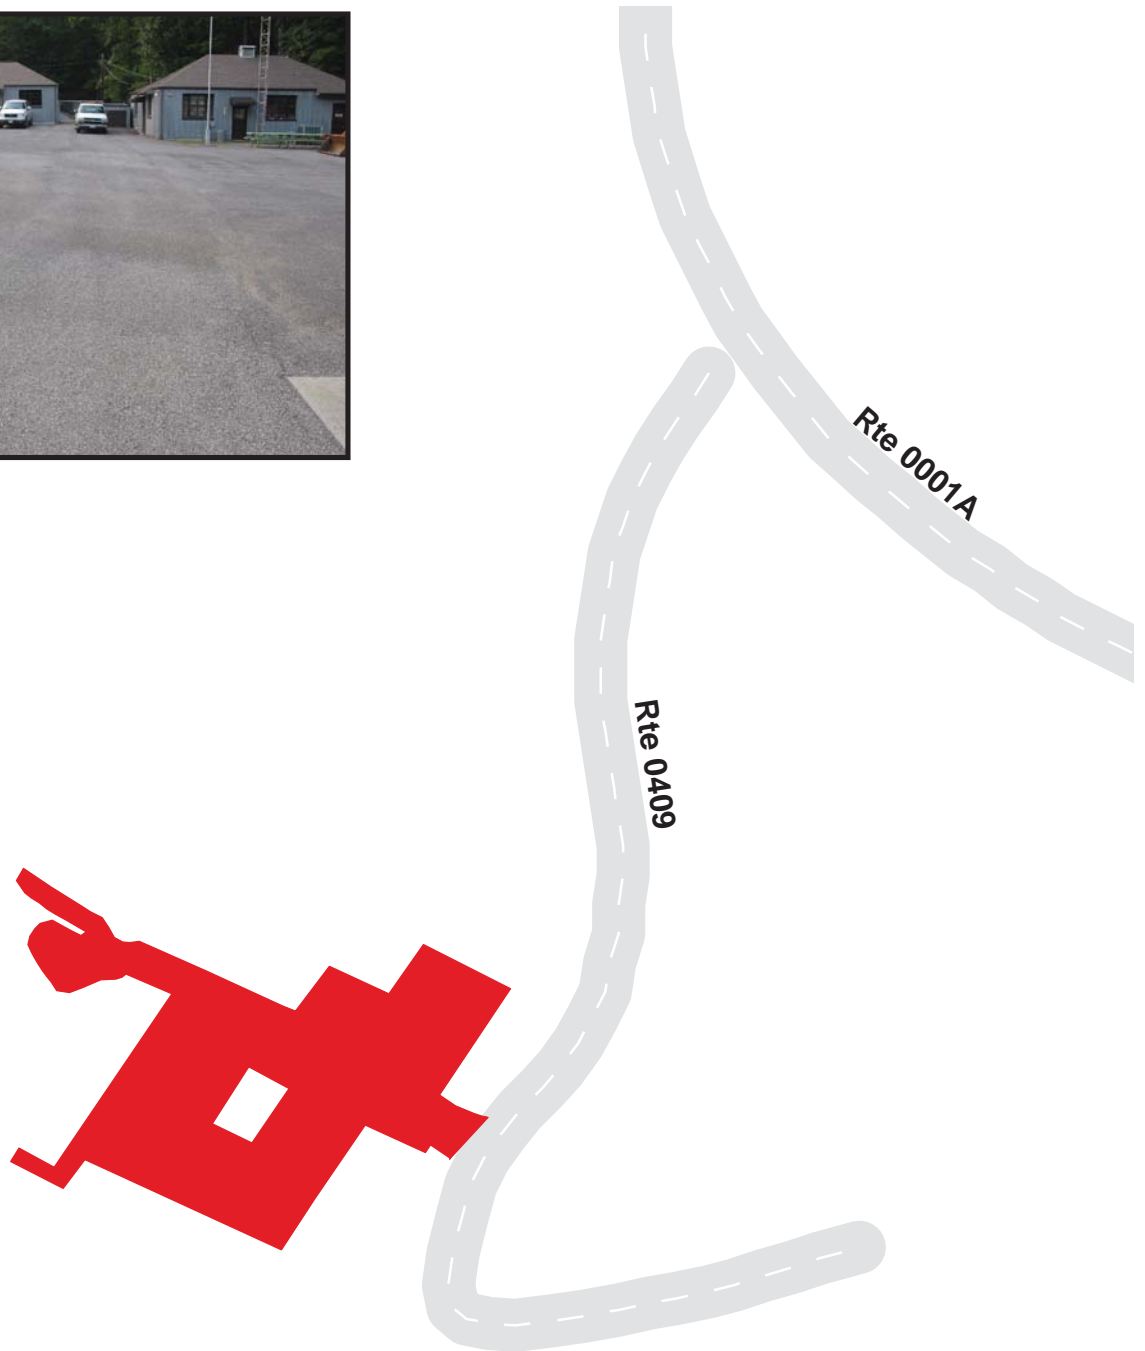
Blue Ridge Parkway Route 0935B

James River Maintenance Yard
Adjacent to Route 0935A

Route	Public / NonPublic	Date Visited	Area (sq ft)	Lane Miles *	Surface Type	Condition / PCR
0935B	Public	9/9/2003	790	0.01	AS	GOOD / 90

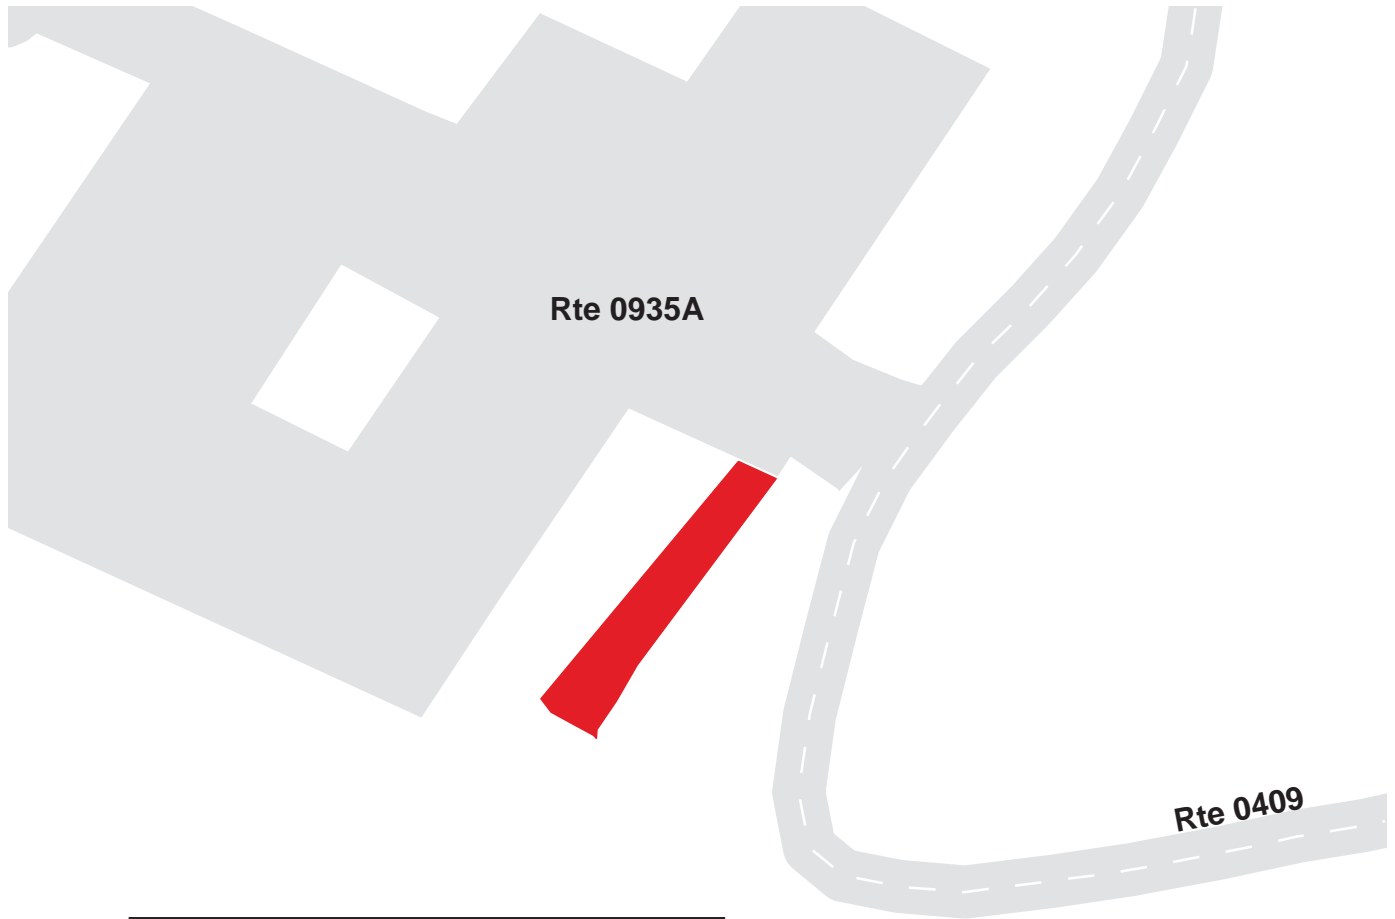
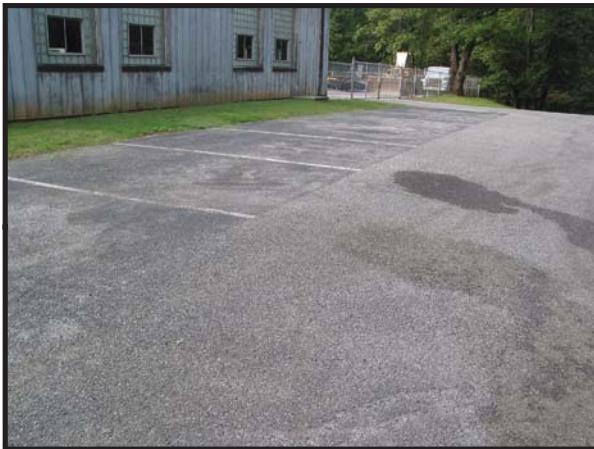
Route 0936

Route	Public / NonPublic	Date Visited	Area (sq ft)	Lane Miles *	Surface Type	Condition / PCR
0936	Public	9/10/2003	2798	0.05	AS	POOR / 45

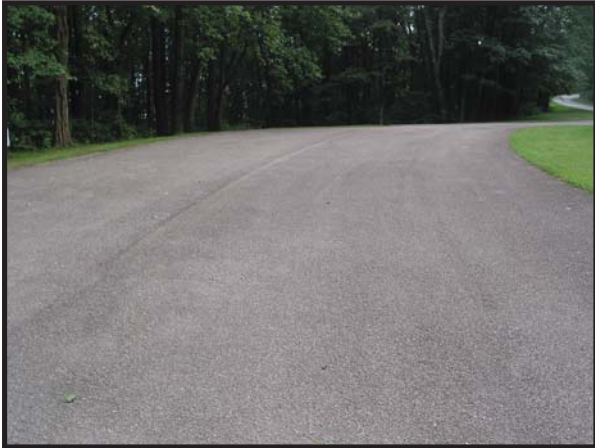
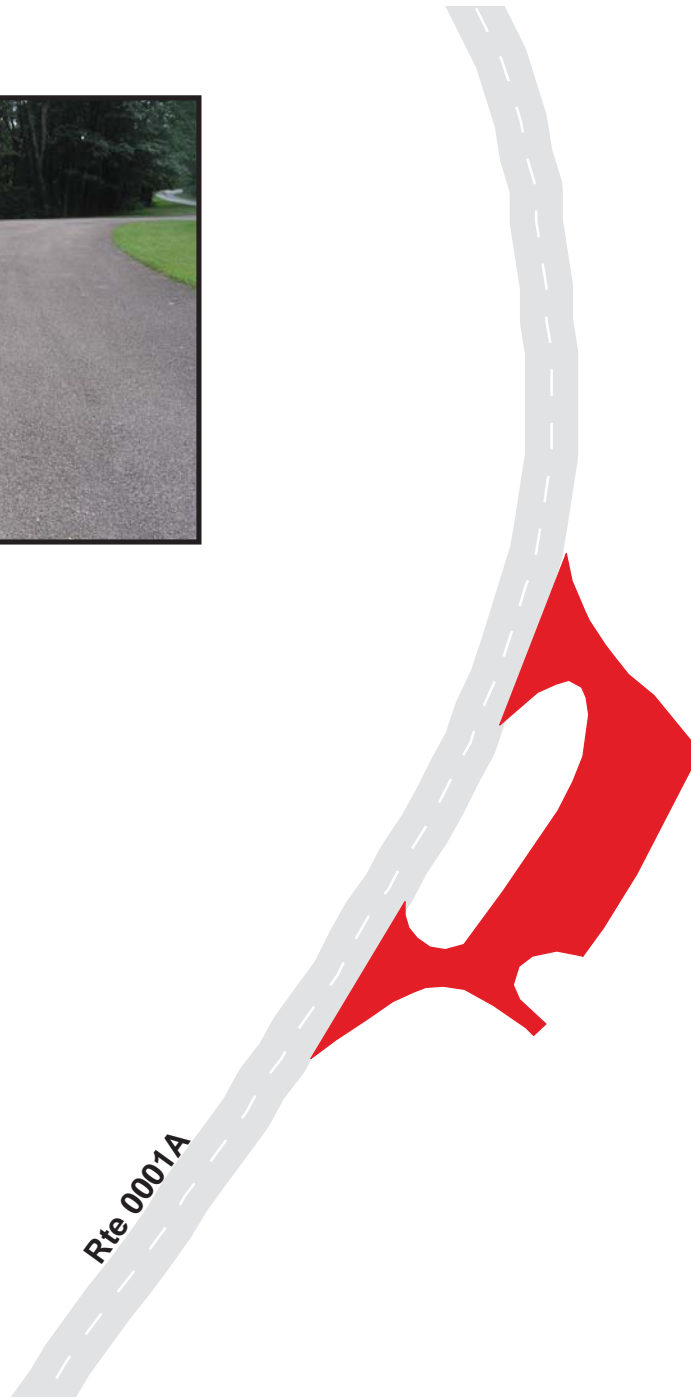
Route 0937

Route	Public / NonPublic	Date Visited	Area (sq ft)	Lane Miles *	Surface Type	Condition / PCR
0937	Public	9/9/2003	5283	0.09	AS	GOOD / 90

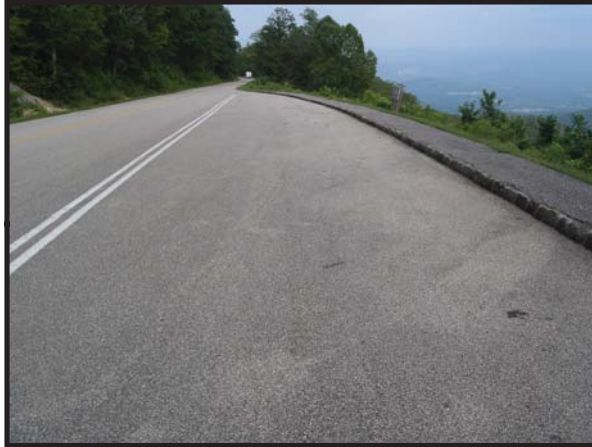
Route 0938

Route	Public / NonPublic	Date Visited	Area (sq ft)	Lane Miles *	Surface Type	Condition / PCR
0938	Public	9/9/2003	22432	0.39	AS	GOOD / 90

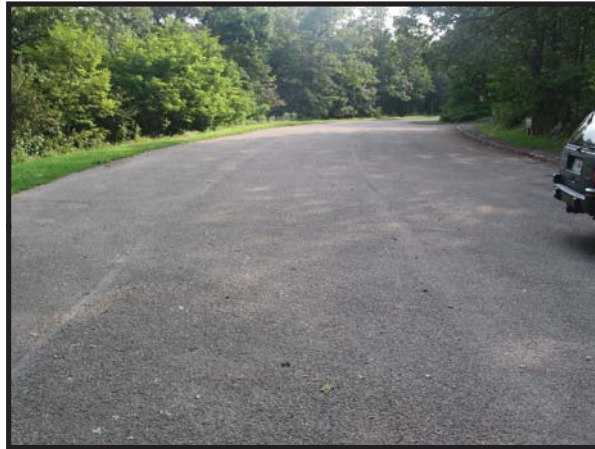
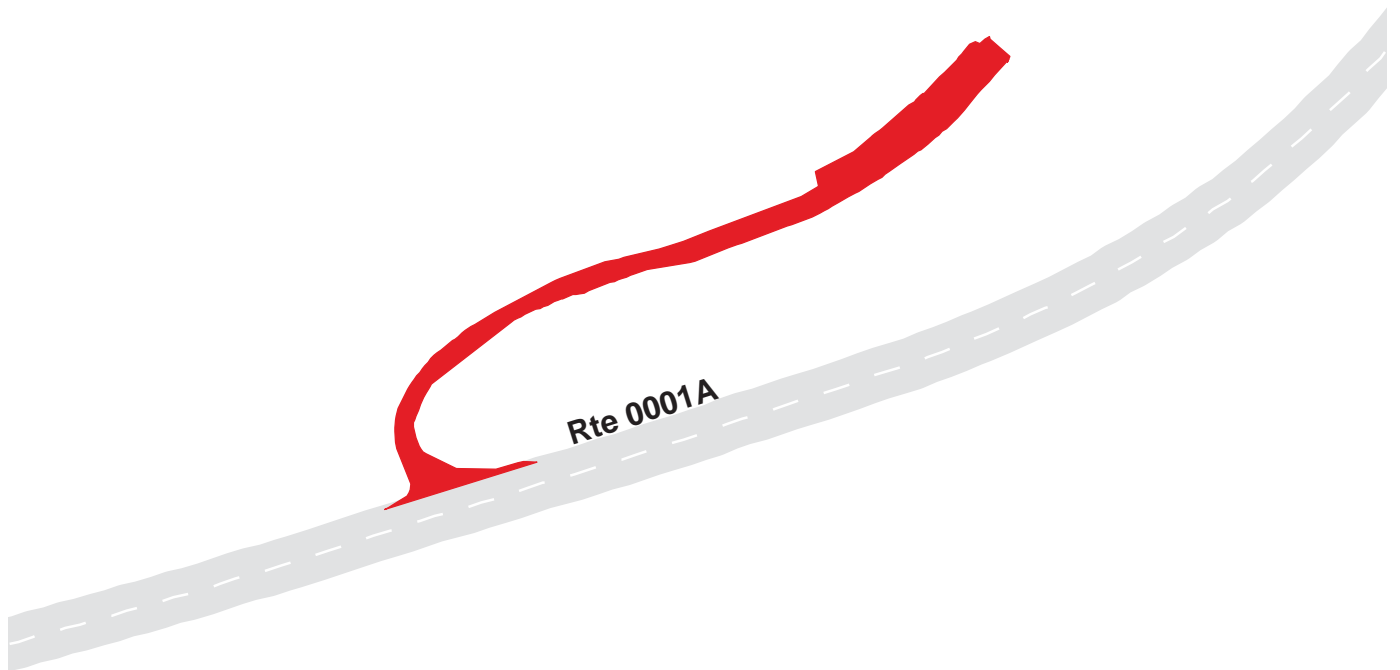
Route 0939

Route	Public / NonPublic	Date Visited	Area (sq ft)	Lane Miles *	Surface Type	Condition / PCR
0939	Public	9/9/2003	1872	0.03	AS	GOOD / 90

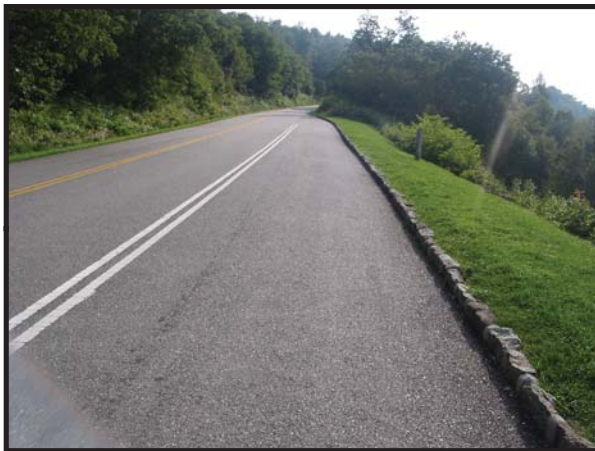
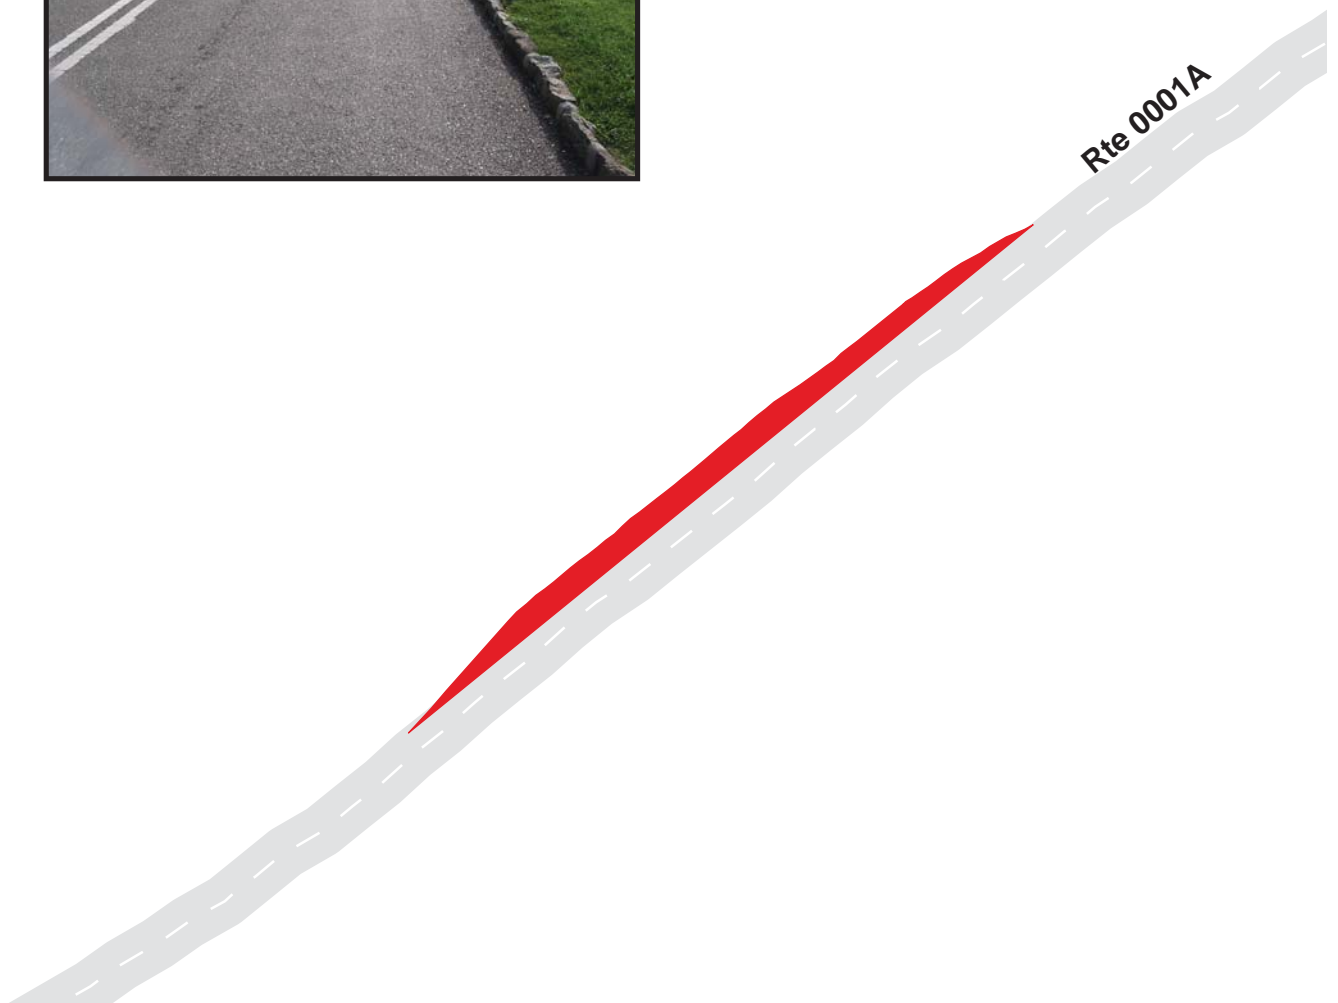
Route 0941

Route	Public / NonPublic	Date Visited	Area (sq ft)	Lane Miles *	Surface Type	Condition / PCR
0941	Public	9/9/2003	11685	0.20	AS	GOOD / 90

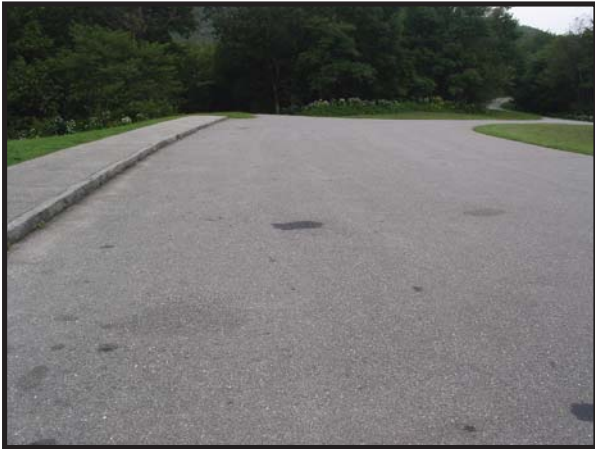
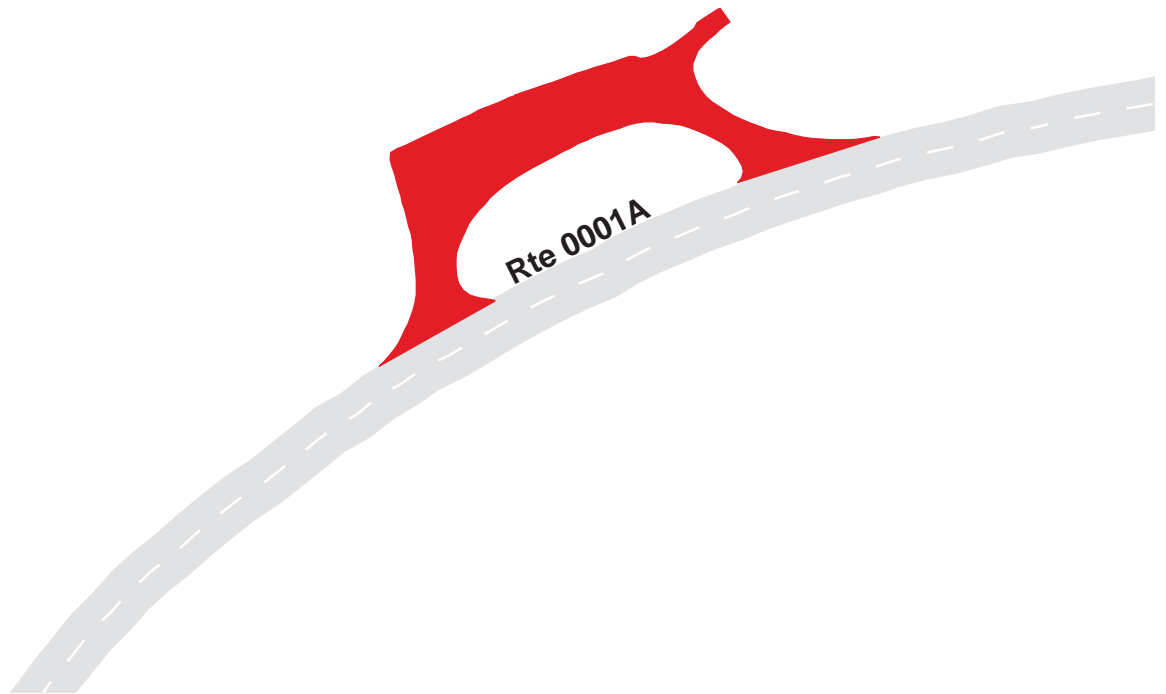
Route 0942

Route	Public / NonPublic	Date Visited	Area (sq ft)	Lane Miles *	Surface Type	Condition / PCR
0942	Public	9/9/2003	7345	0.13	AS	GOOD / 90

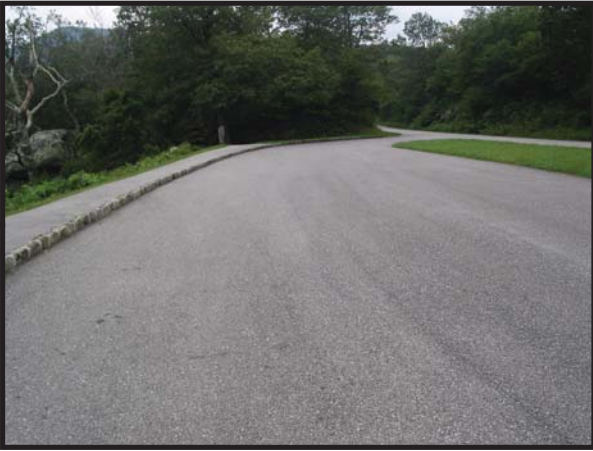
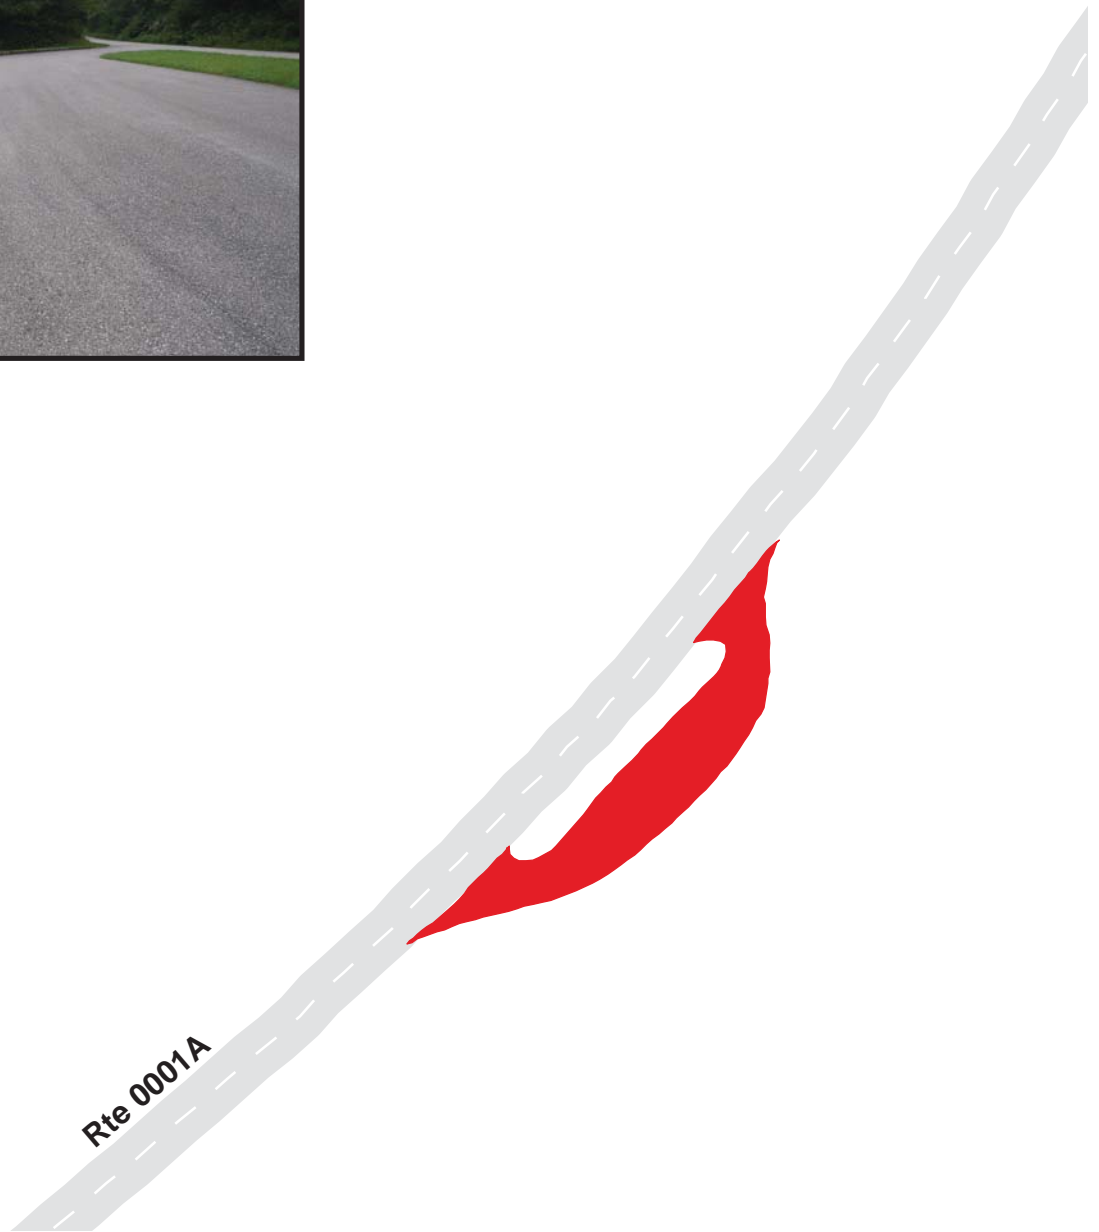
Route 0943

Route	Public / NonPublic	Date Visited	Area (sq ft)	Lane Miles *	Surface Type	Condition / PCR
0943	Public	9/9/2003	3315	0.06	AS	GOOD / 90

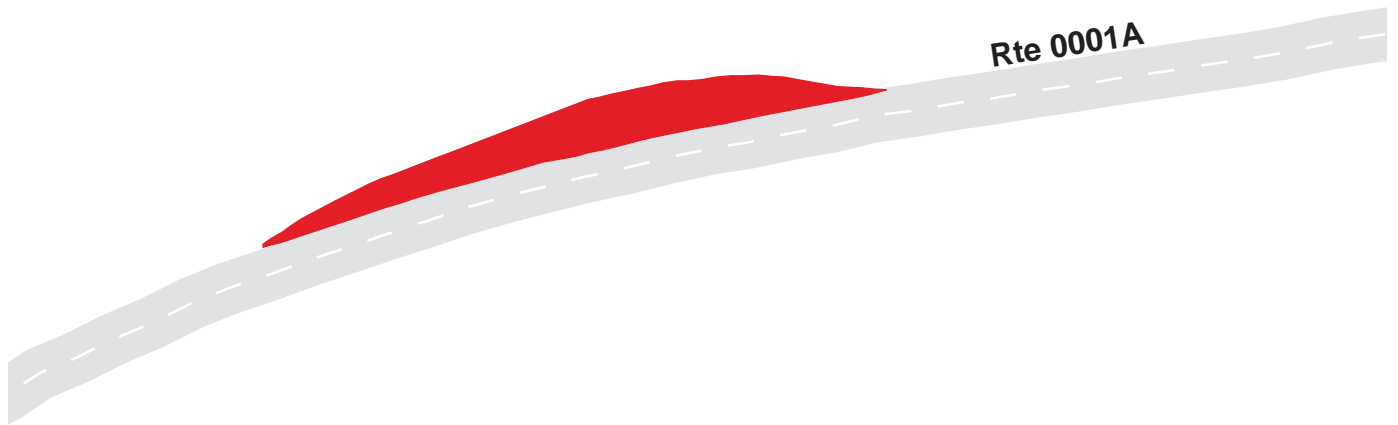
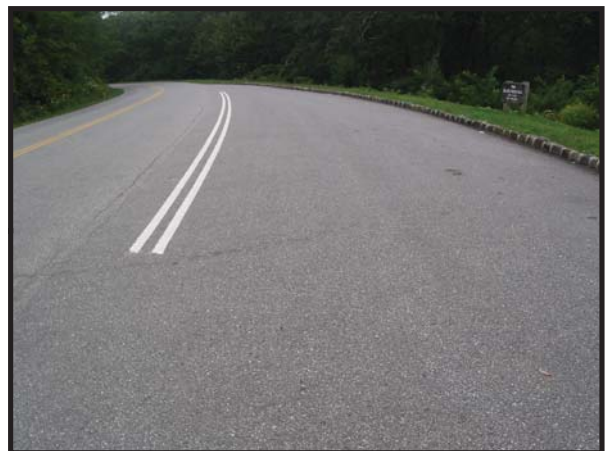
Route 0944

Route	Public / NonPublic	Date Visited	Area (sq ft)	Lane Miles *	Surface Type	Condition / PCR
0944	Public	9/9/2003	3363	0.06	AS	GOOD / 90

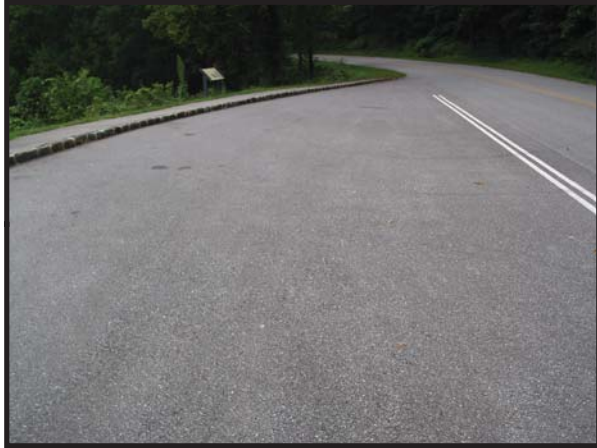
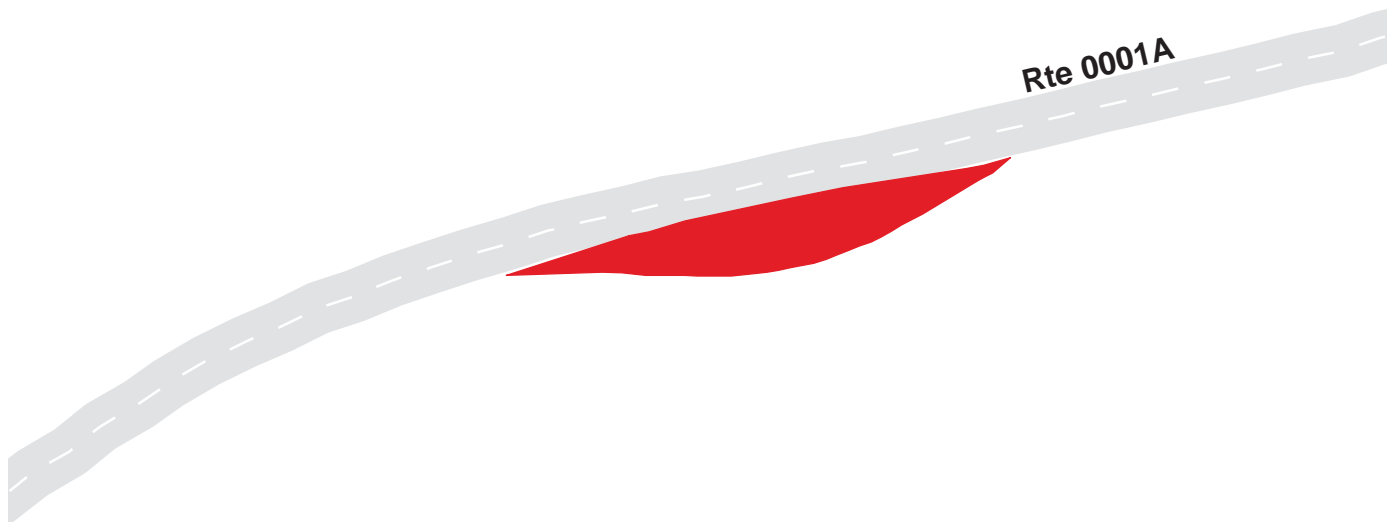
Route 0945

Route	Public / NonPublic	Date Visited	Area (sq ft)	Lane Miles *	Surface Type	Condition / PCR
0945	Public	9/9/2003	10639	0.18	AS	GOOD / 90

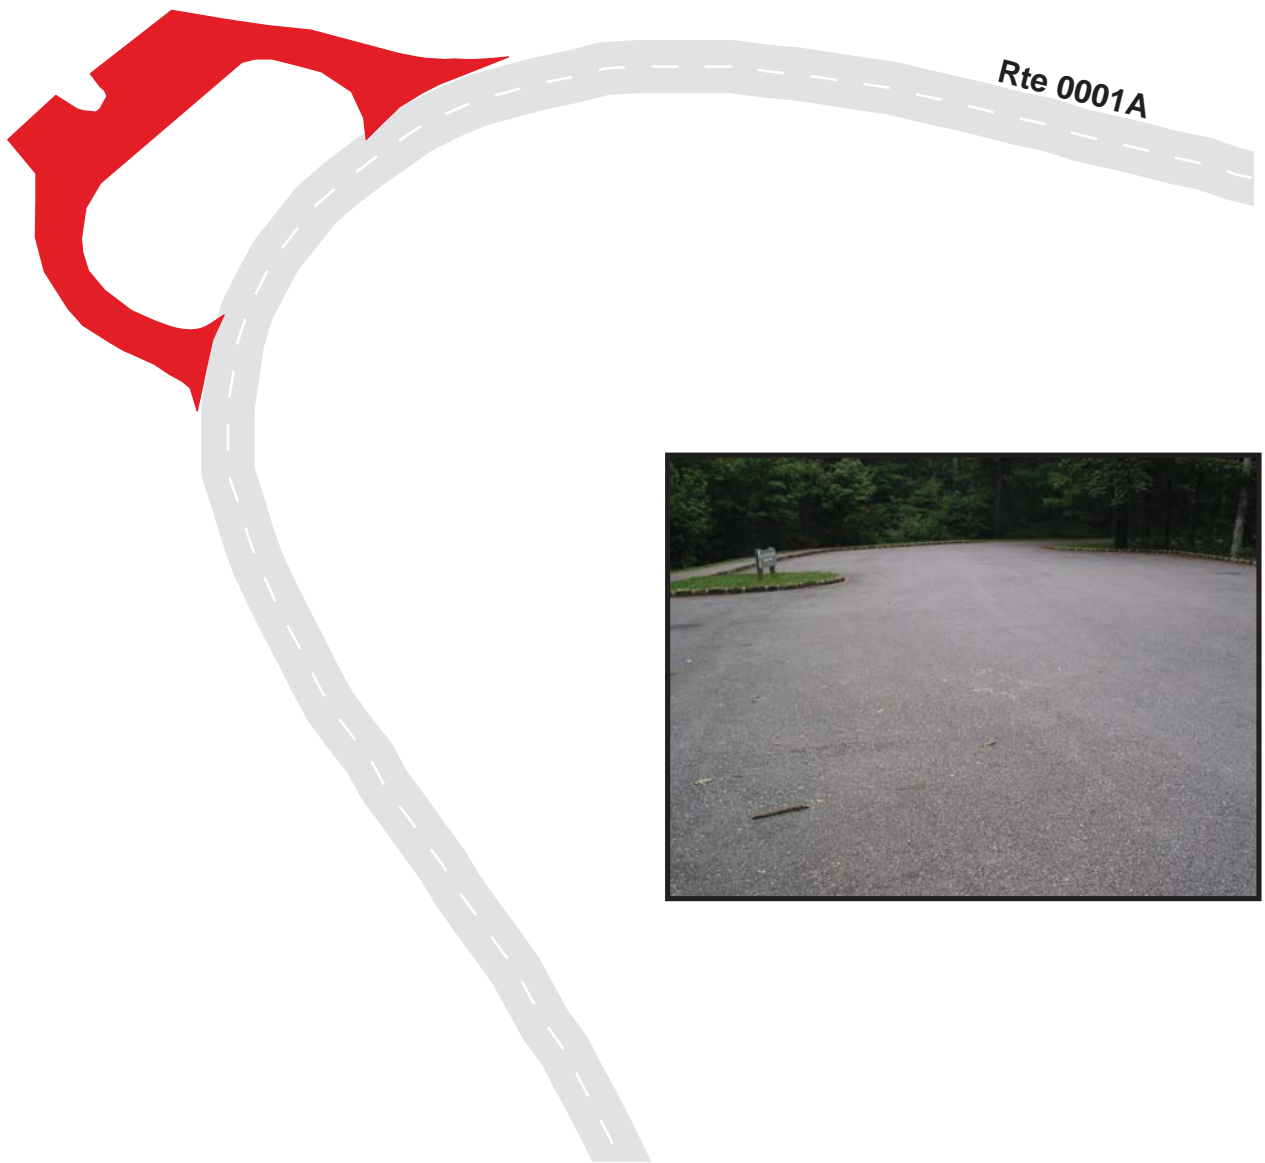
Route 0946

Route	Public / NonPublic	Date Visited	Area (sq ft)	Lane Miles *	Surface Type	Condition / PCR
0946	Public	9/9/2003	4398	0.08	AS	GOOD / 90

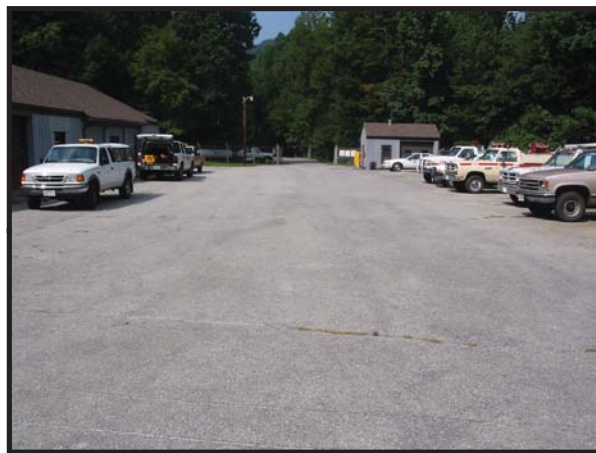
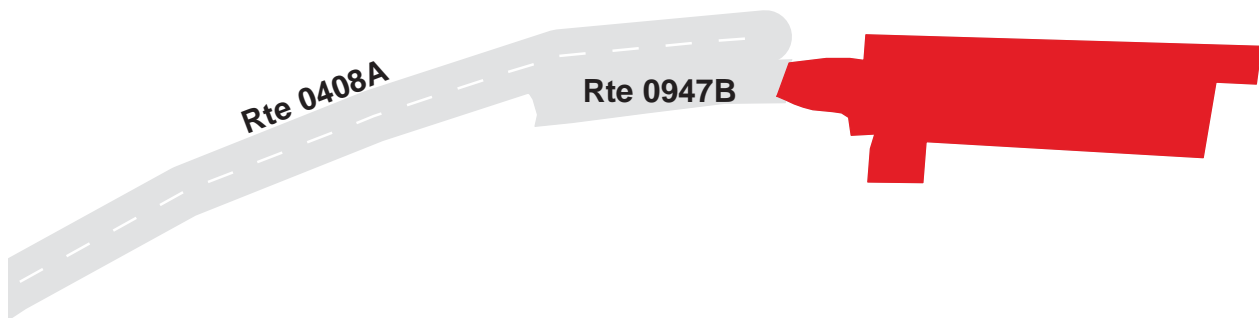
Route 0947B

Route	Public / NonPublic	Date Visited	Area (sq ft)	Lane Miles *	Surface Type	Condition / PCR
0947B	Public	9/9/2003	3503	0.06	AS	FAIR / 73

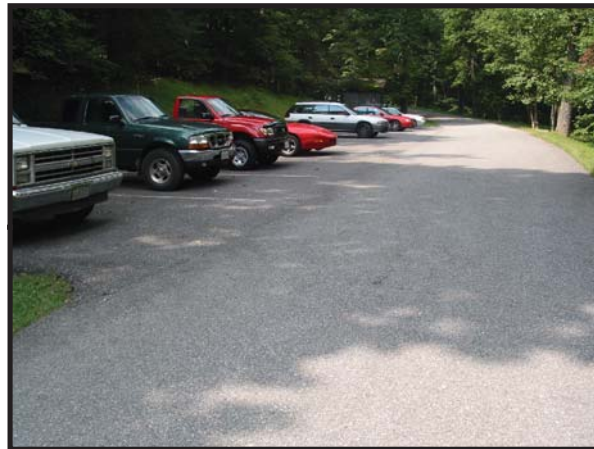
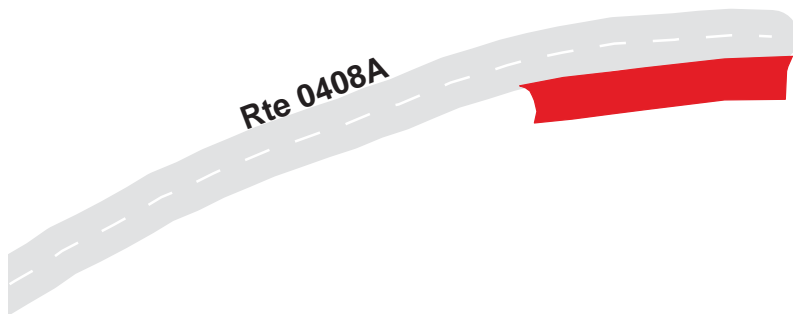
Route 0947C

Route	Public / NonPublic	Date Visited	Area (sq ft)	Lane Miles *	Surface Type	Condition / PCR
0947C	Public	9/9/2003	930	0.02	AS	GOOD / 90

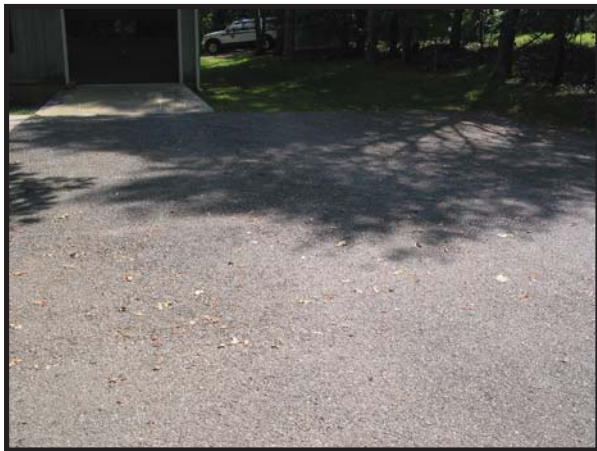
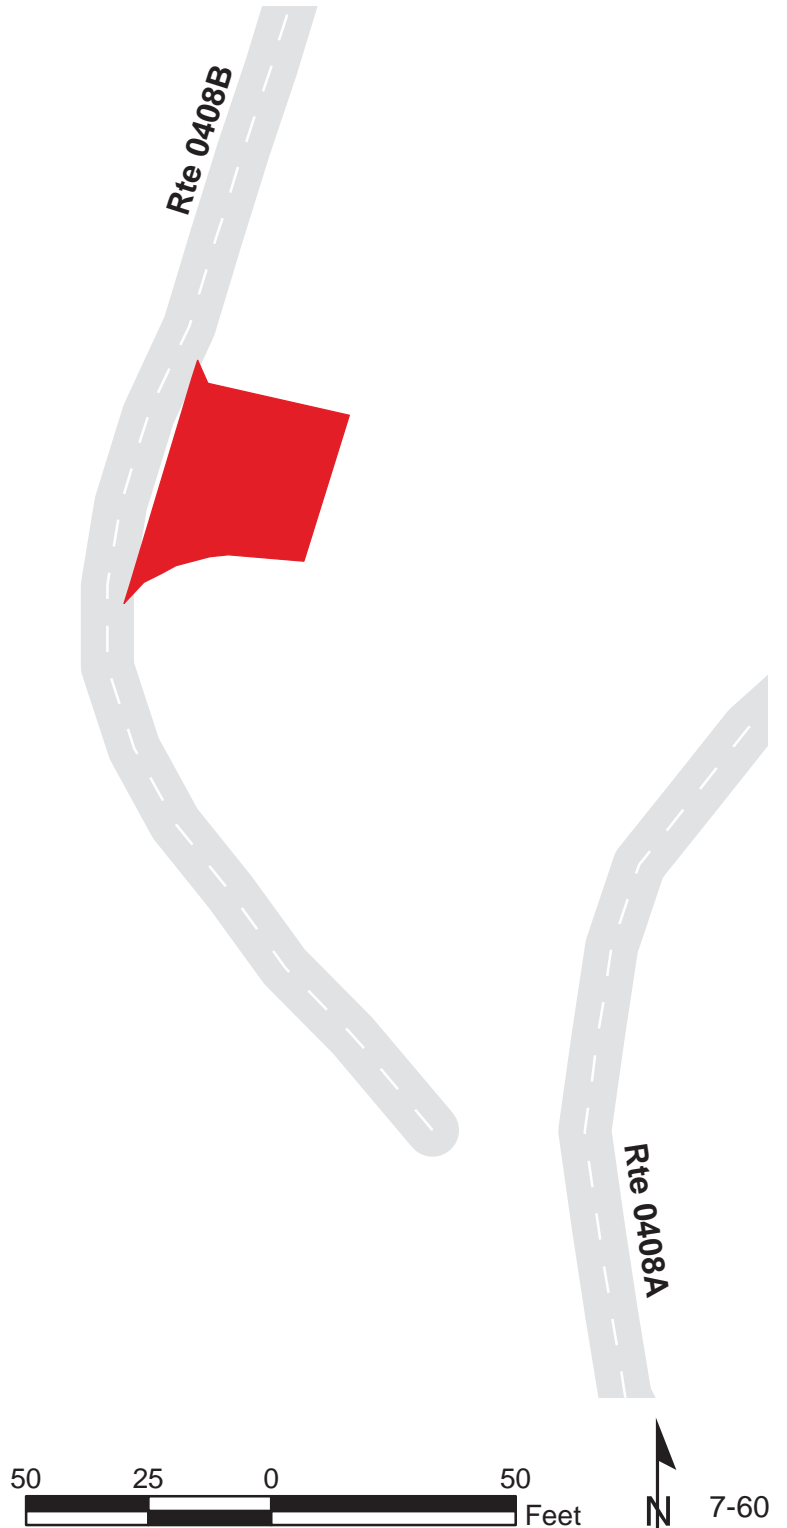
Route 0950A

Route	Public / NonPublic	Date Visited	Area (sq ft)	Lane Miles *	Surface Type	Condition / PCR
0950A	Public	9/8/2003	16842	0.29	AS	GOOD / 90

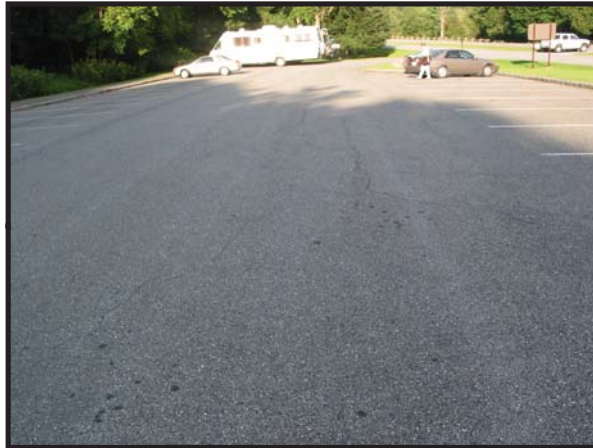
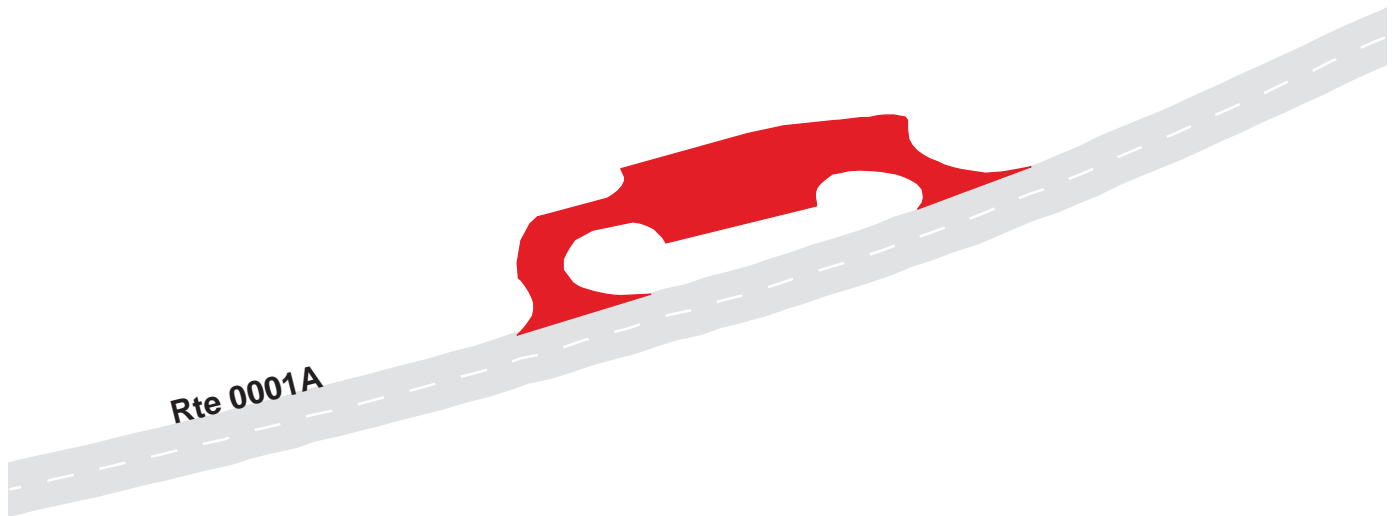
Route 0950B

Route	Public / NonPublic	Date Visited	Area (sq ft)	Lane Miles *	Surface Type	Condition / PCR
0950B	Public	9/8/2003	11042	0.19	AS	GOOD / 90

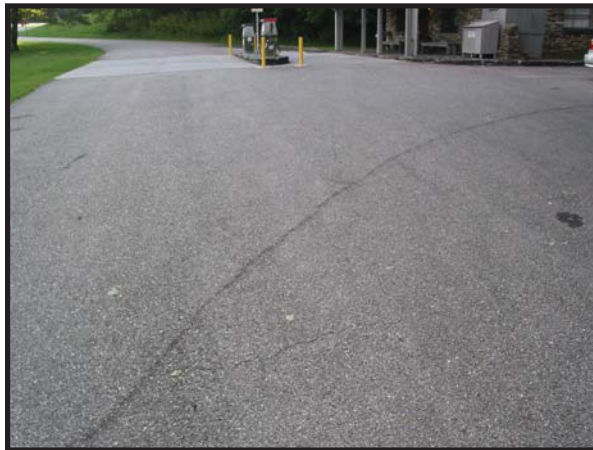
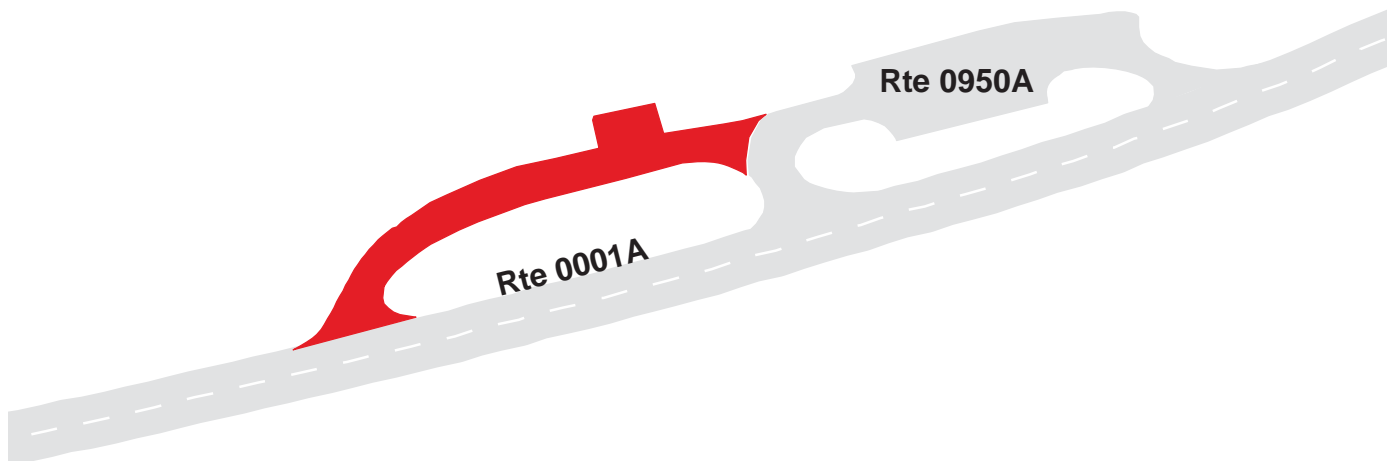
Route 0951A

Route	Public / NonPublic	Date Visited	Area (sq ft)	Lane Miles *	Surface Type	Condition / PCR
0951A	Public	9/8/2003	2320	0.04	AS	GOOD / 90

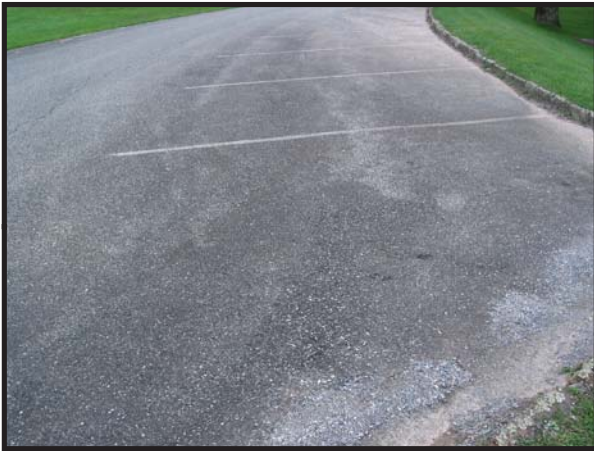
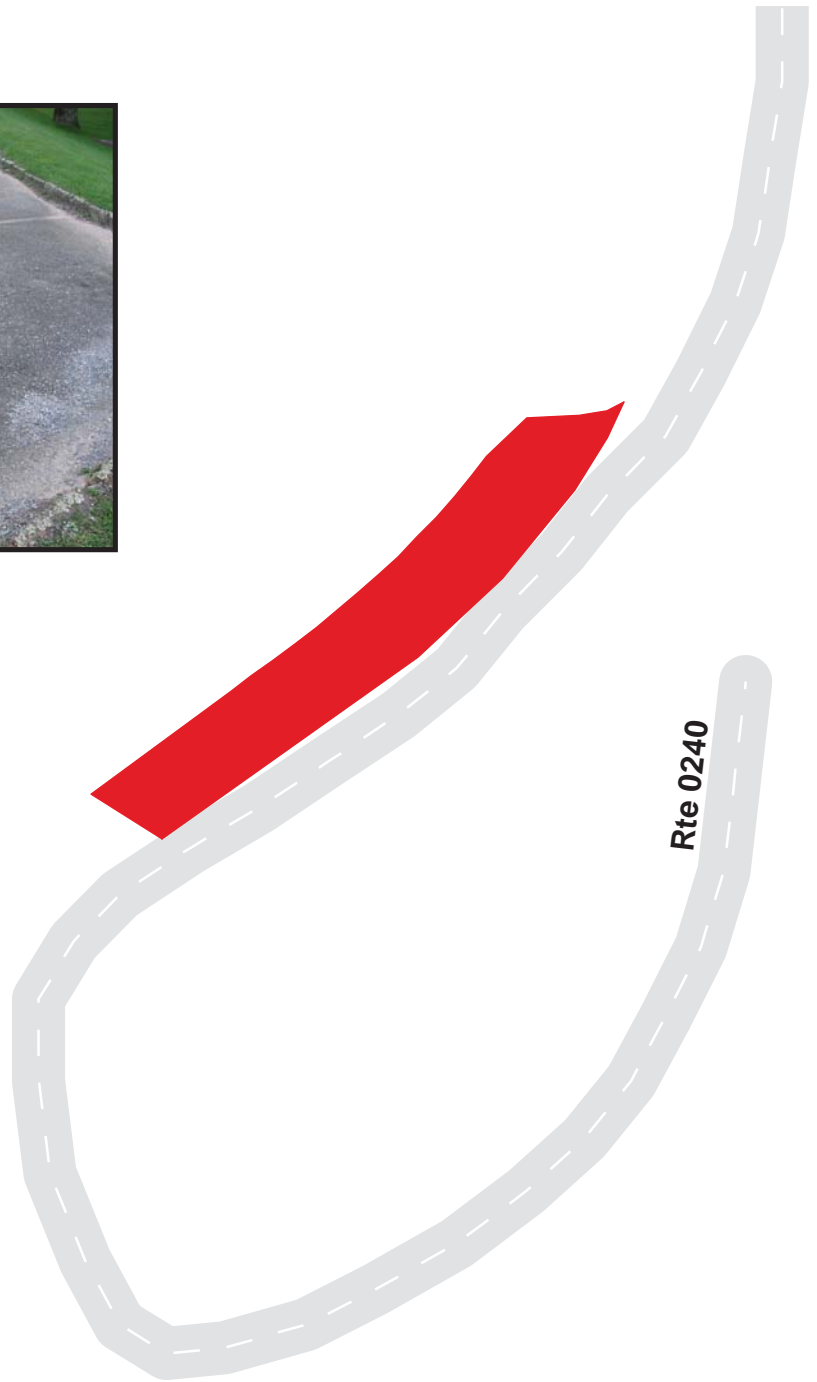
Route 0951B

Route	Public / NonPublic	Date Visited	Area (sq ft)	Lane Miles *	Surface Type	Condition / PCR
0951B	Public	9/8/2003	1327	0.02	AS	GOOD / 90

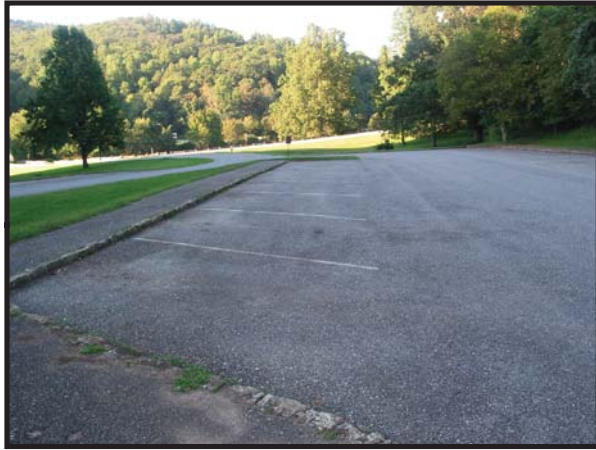
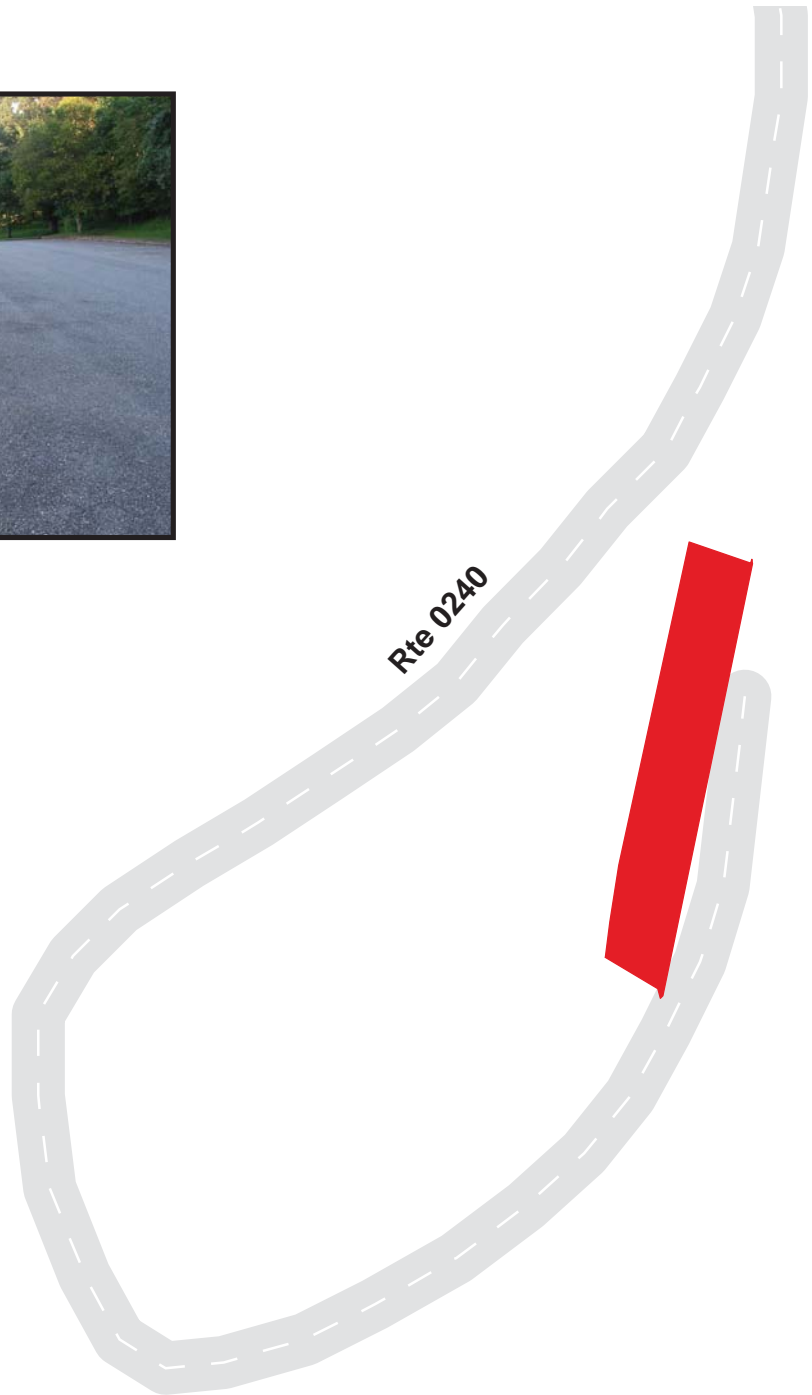
Route 0951C

Route	Public / NonPublic	Date Visited	Area (sq ft)	Lane Miles *	Surface Type	Condition / PCR
0951C	Public	9/8/2003	4870	0.08	AS	GOOD / 90
