The Road Inventory of Blue Ridge Parkway BLRI – 5140 Volume 1

Road Inventory Program

Prepared By:
Federal Highway Administration
Eastern Federal Lands Highway Division
Cycle 3

Blue Ridge Parkway in North Carolina

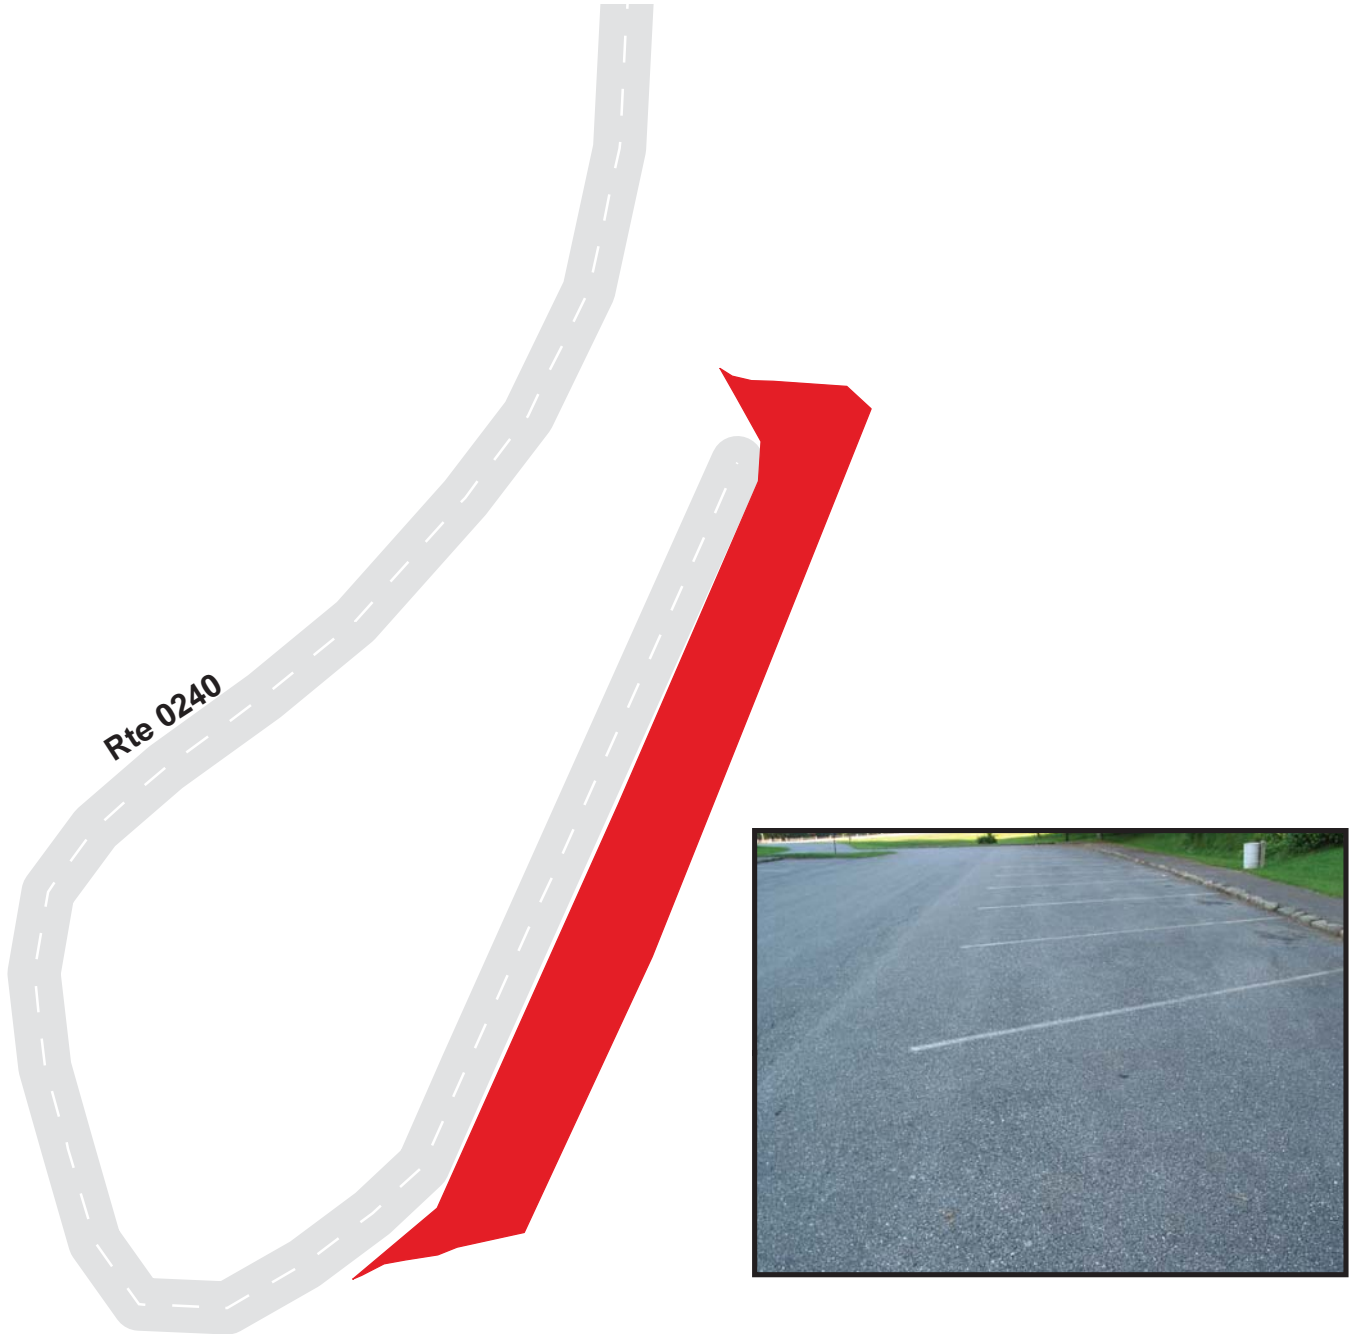
Route 0952

Route	Public / NonPublic	Date Visited	Area (sq ft)	Lane Miles *	Surface Type	Condition / PCR
0952	Public	9/8/2003	2996	0.05	AS	GOOD / 90

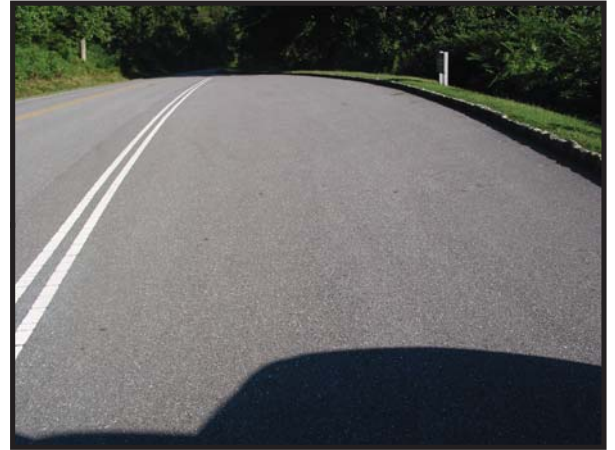
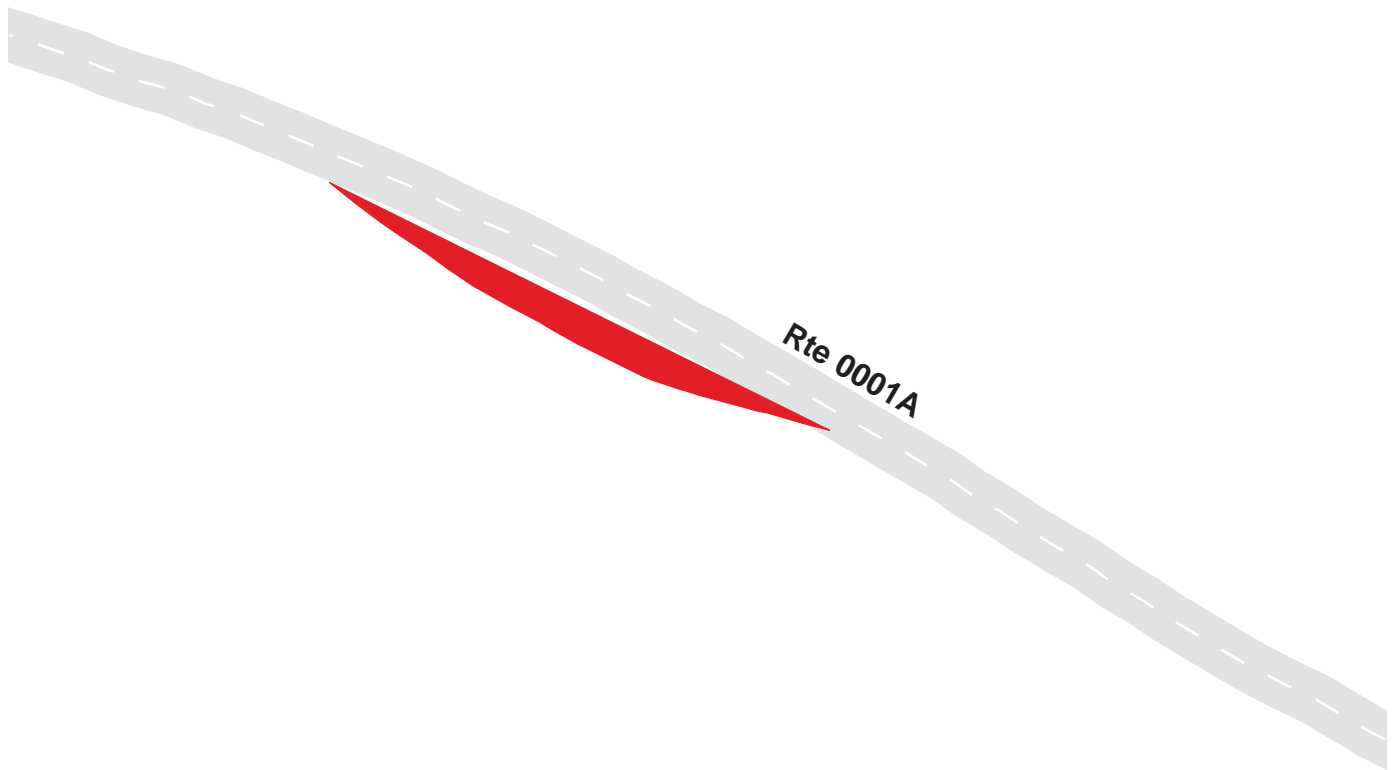
Route 0953

Route	Public / NonPublic	Date Visited	Area (sq ft)	Lane Miles *	Surface Type	Condition / PCR
0953	Public	9/8/2003	9829	0.17	AS	GOOD / 90

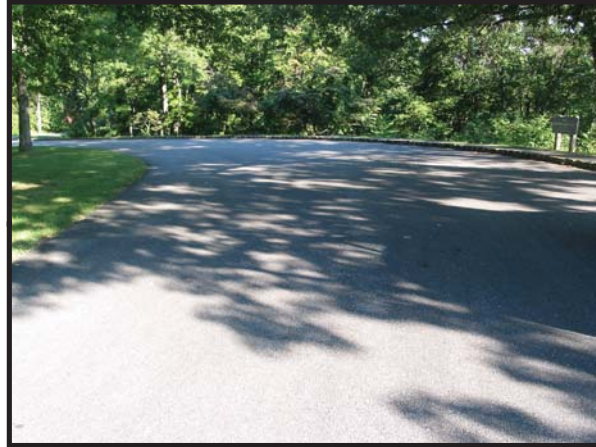
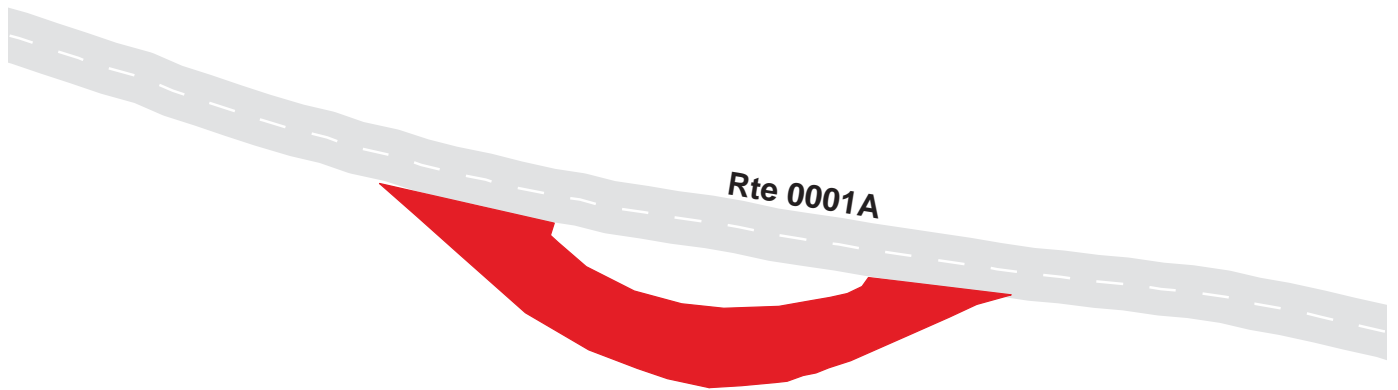
Route 0954

Route	Public / NonPublic	Date Visited	Area (sq ft)	Lane Miles *	Surface Type	Condition / PCR
0954	Public	9/8/2003	11368	0.20	AS	GOOD / 90

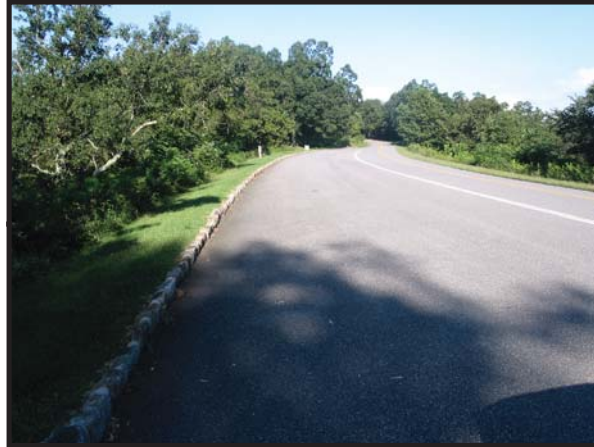
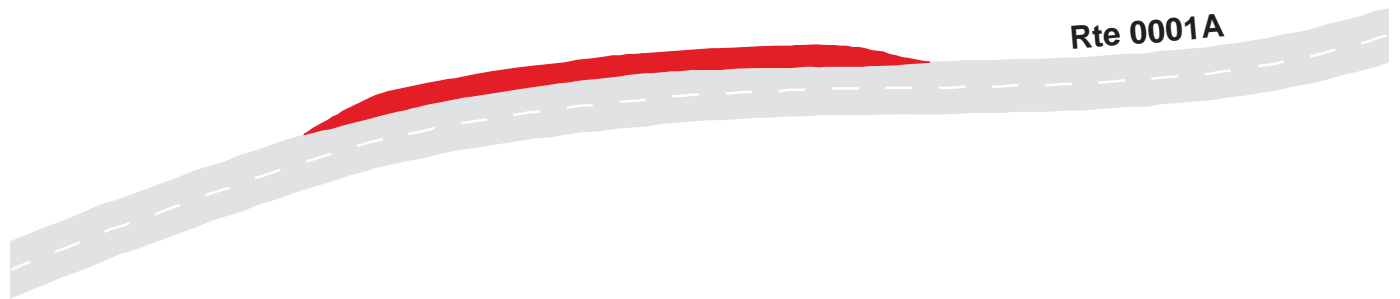
Route 0955

Route	Public / NonPublic	Date Visited	Area (sq ft)	Lane Miles *	Surface Type	Condition / PCR
0955	Public	9/8/2003	7275	0.13	AS	GOOD / 90

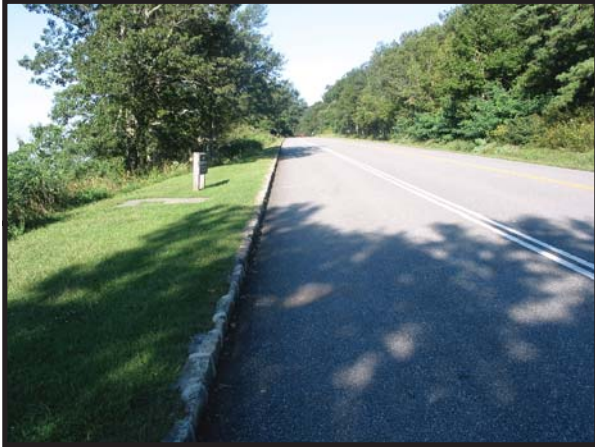
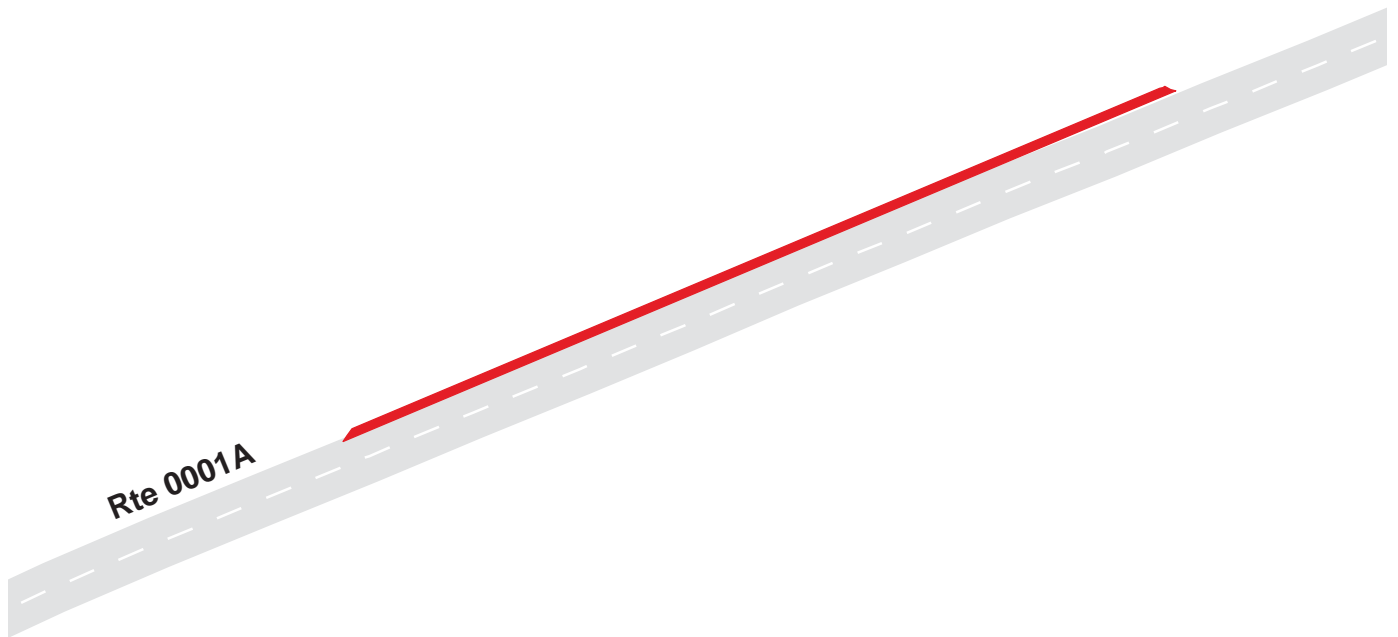
Route 0956

Route	Public / NonPublic	Date Visited	Area (sq ft)	Lane Miles *	Surface Type	Condition / PCR
0956	Public	9/8/2003	4348	0.07	AS	GOOD / 90

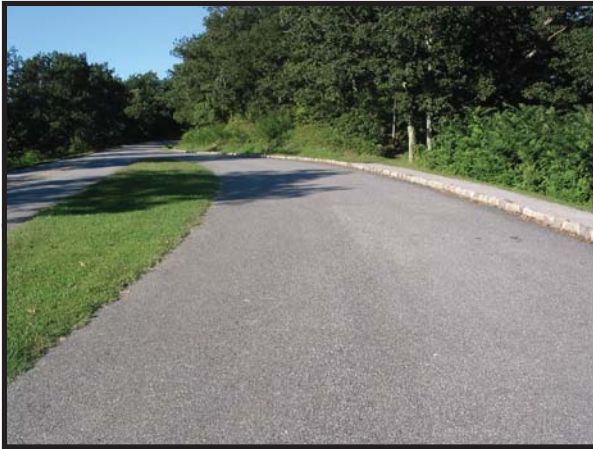
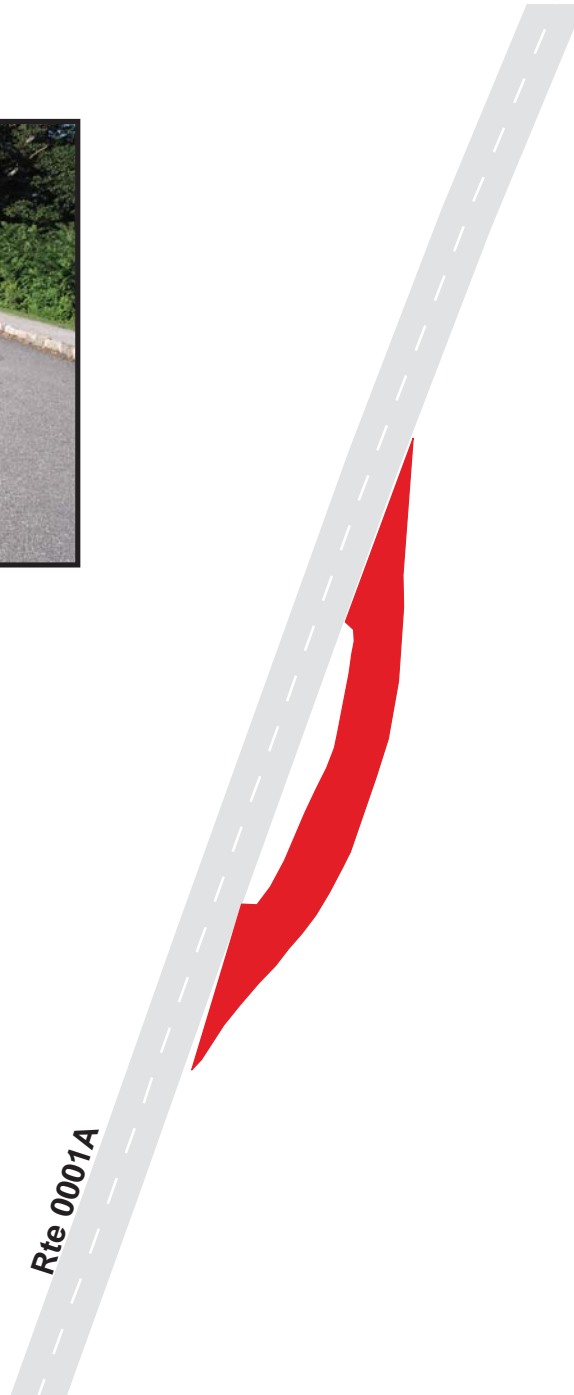
Route 0957

Route	Public / NonPublic	Date Visited	Area (sq ft)	Lane Miles *	Surface Type	Condition / PCR
0957	Public	9/8/2003	9684	0.17	AS	GOOD / 90

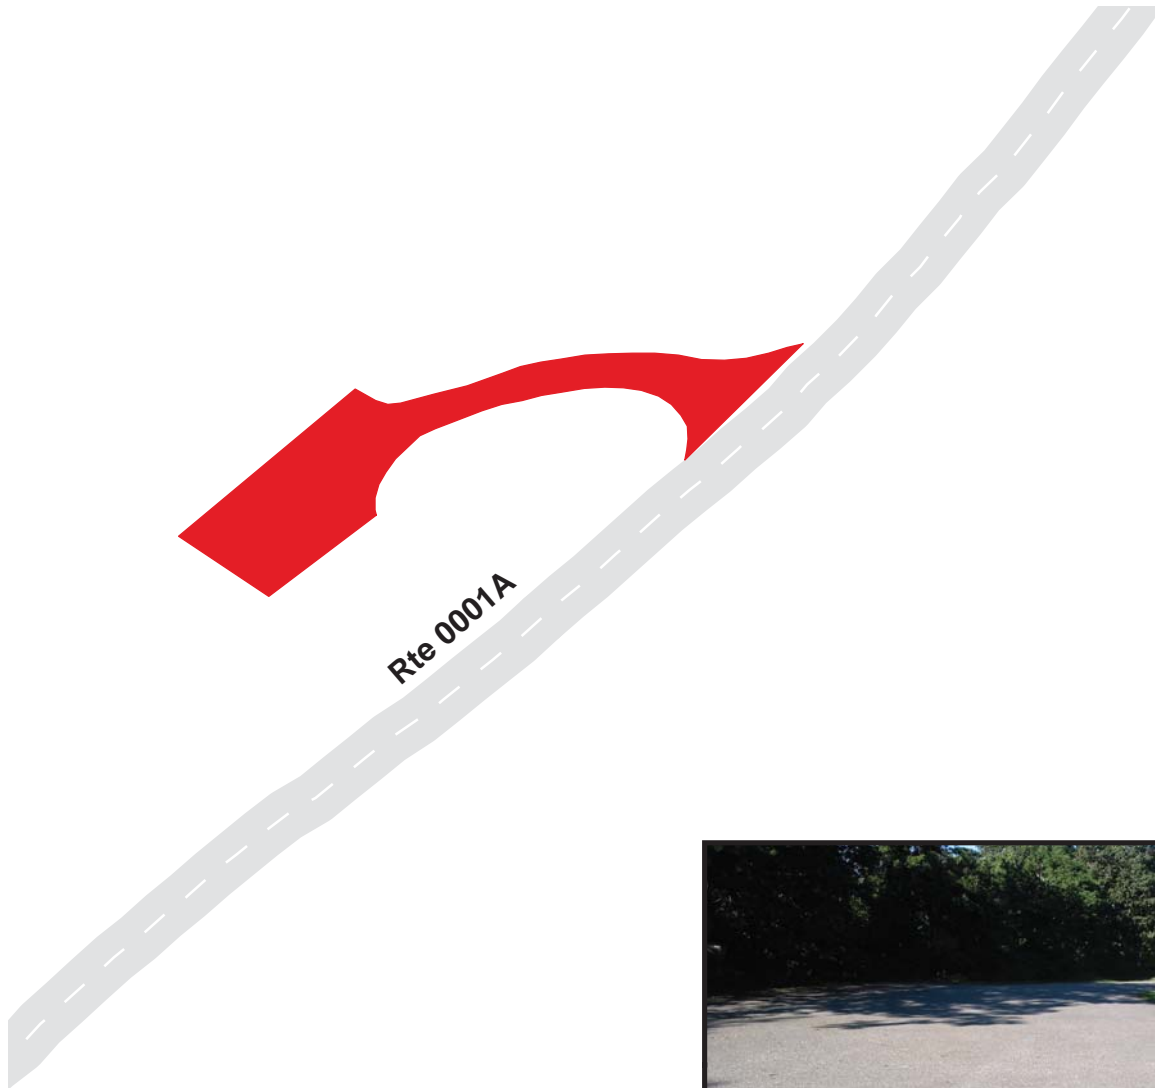
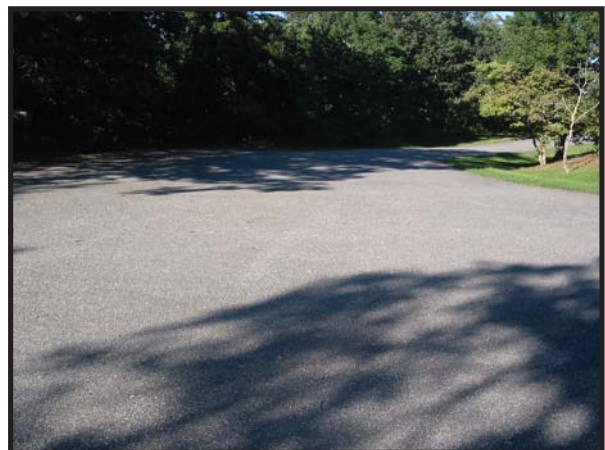
Route 0958

Route	Public / NonPublic	Date Visited	Area (sq ft)	Lane Miles *	Surface Type	Condition / PCR
0958	Public	9/8/2003	3596	0.06	AS	GOOD / 90

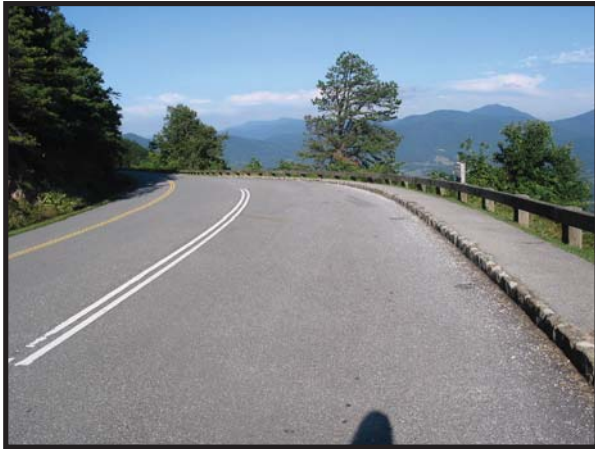
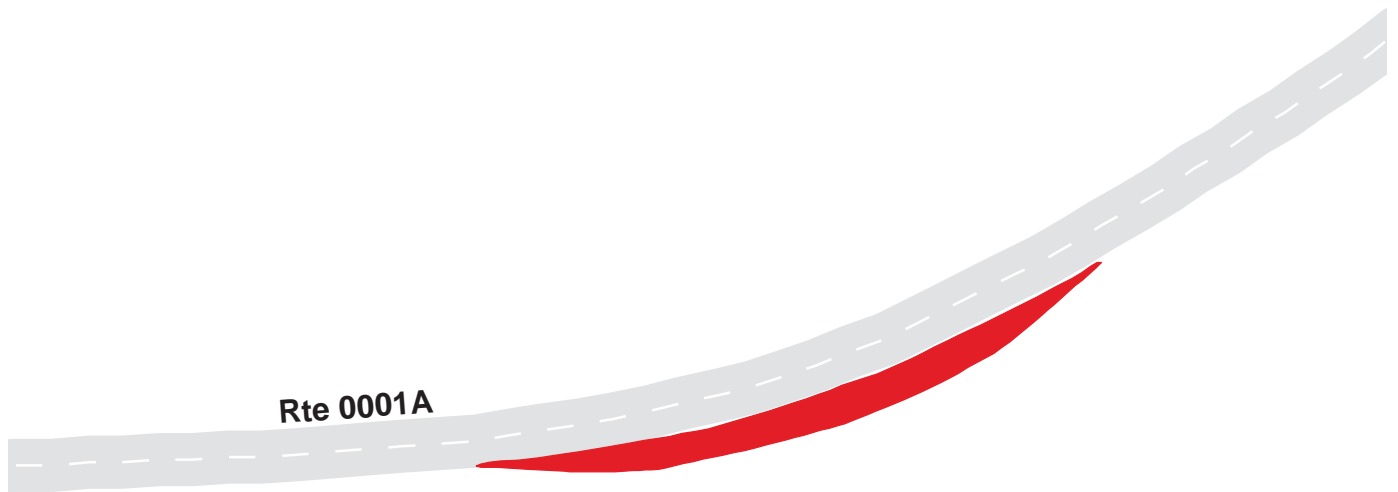
Blue Ridge Parkway
Route 0959
 Harveys Knob
 From Route 0001A at MP 95.00 on Right

Route	Public / NonPublic	Date Visited	Area (sq ft)	Lane Miles *	Surface Type	Condition / PCR
0959	Public	9/8/2003	13445	0.23	AS	GOOD / 90

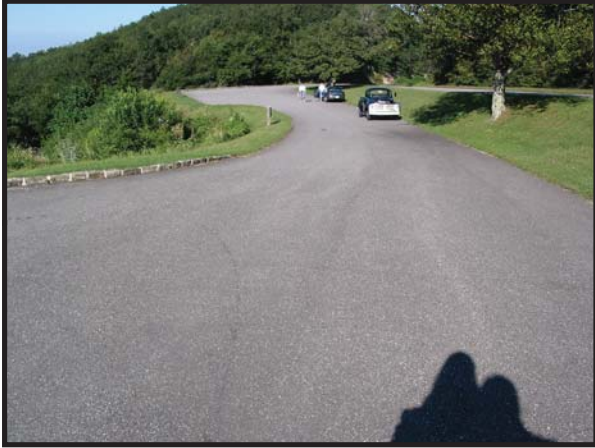
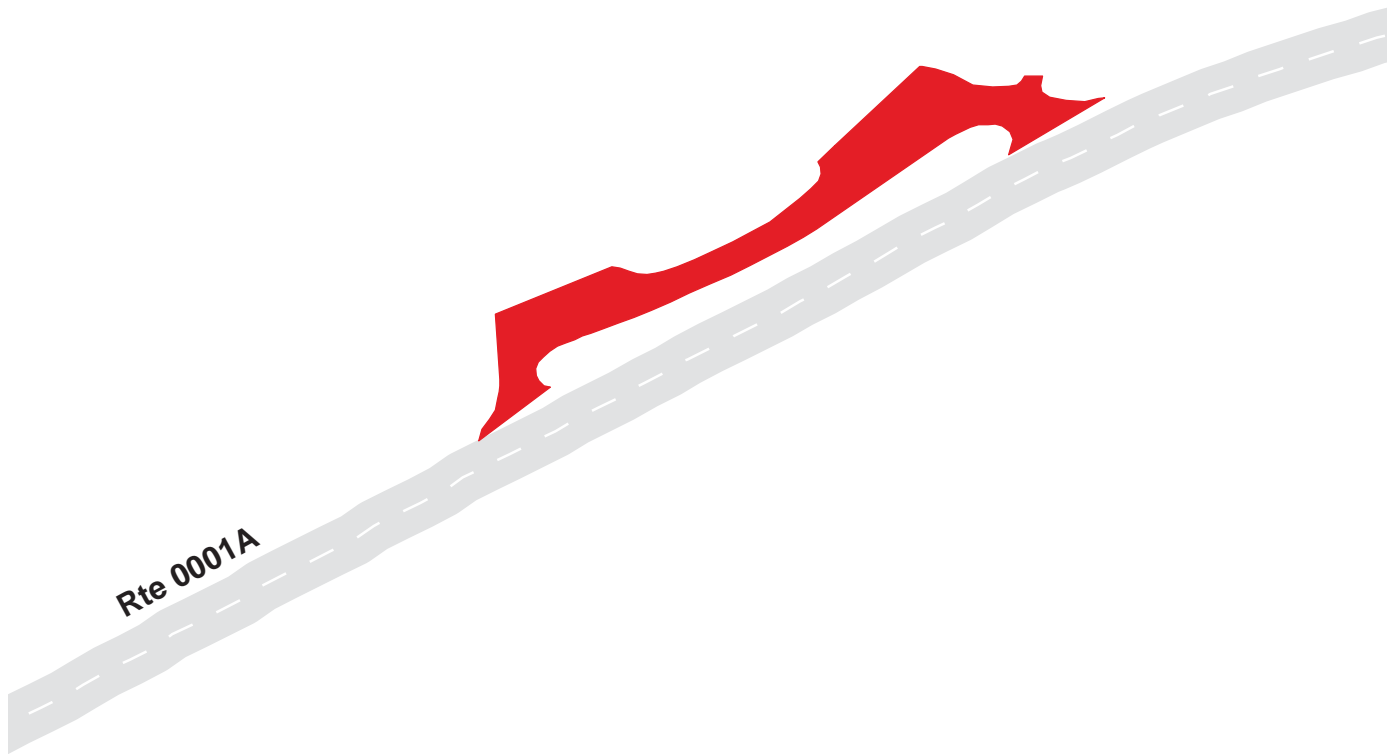
Route 0960

Route	Public / NonPublic	Date Visited	Area (sq ft)	Lane Miles *	Surface Type	Condition / PCR
0960	Public	9/8/2003	12015	0.21	AS	GOOD / 90

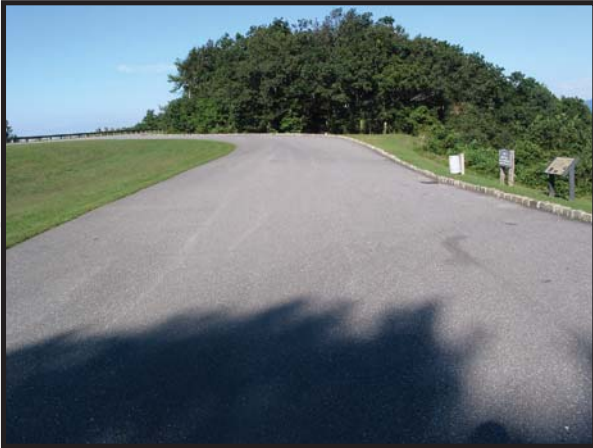
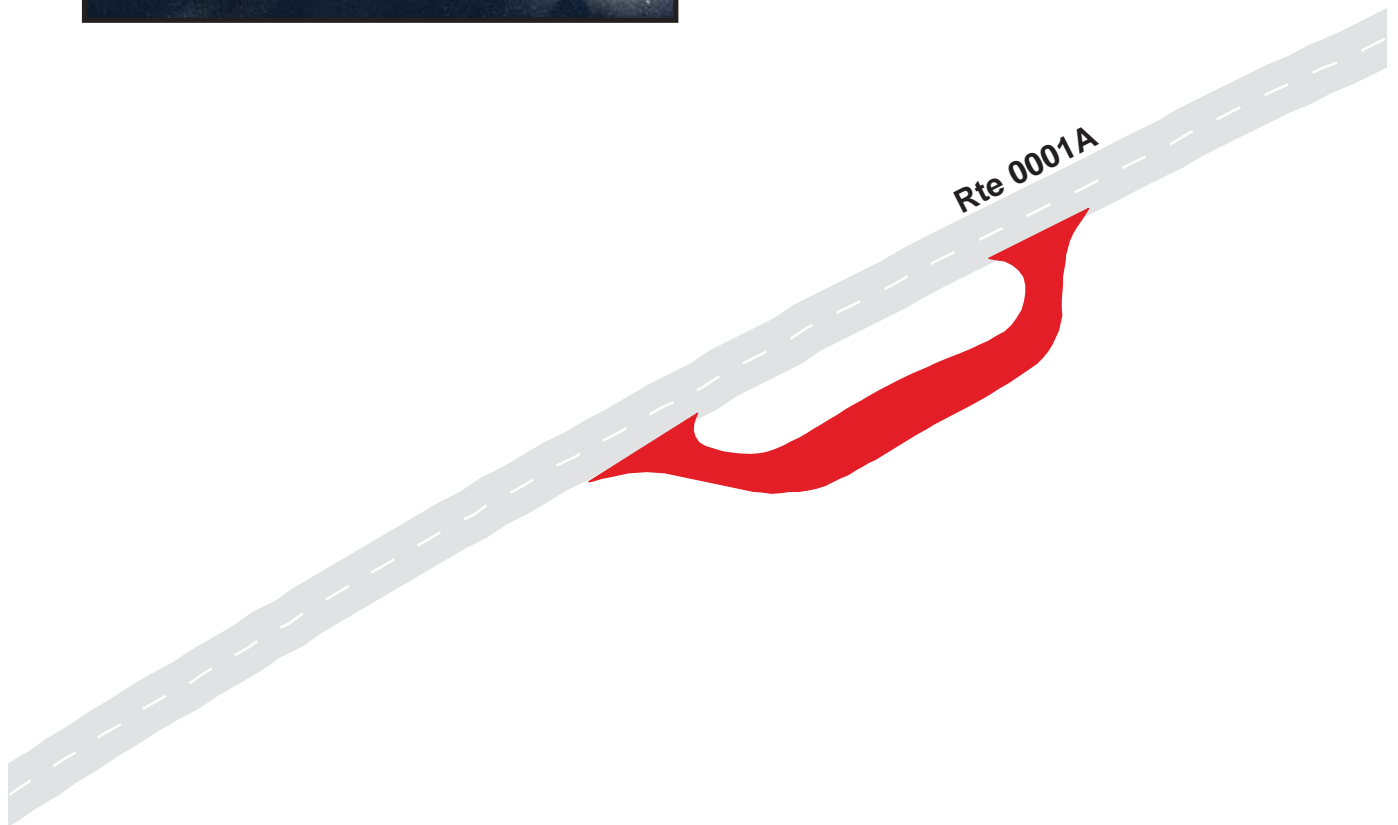
Route 0961

Route	Public / NonPublic	Date Visited	Area (sq ft)	Lane Miles *	Surface Type	Condition / PCR
0961	Public	9/8/2003	2320	0.04	AS	GOOD / 90

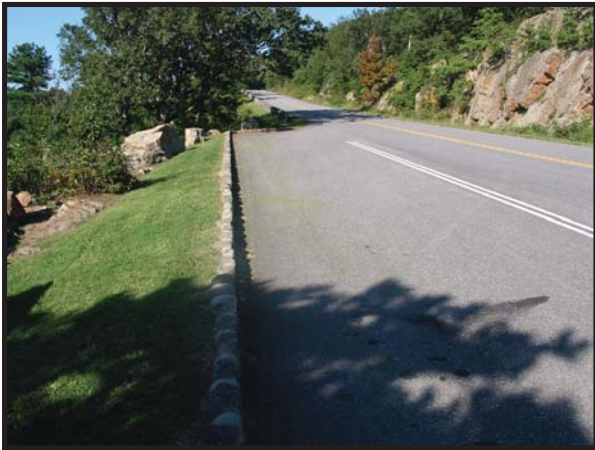
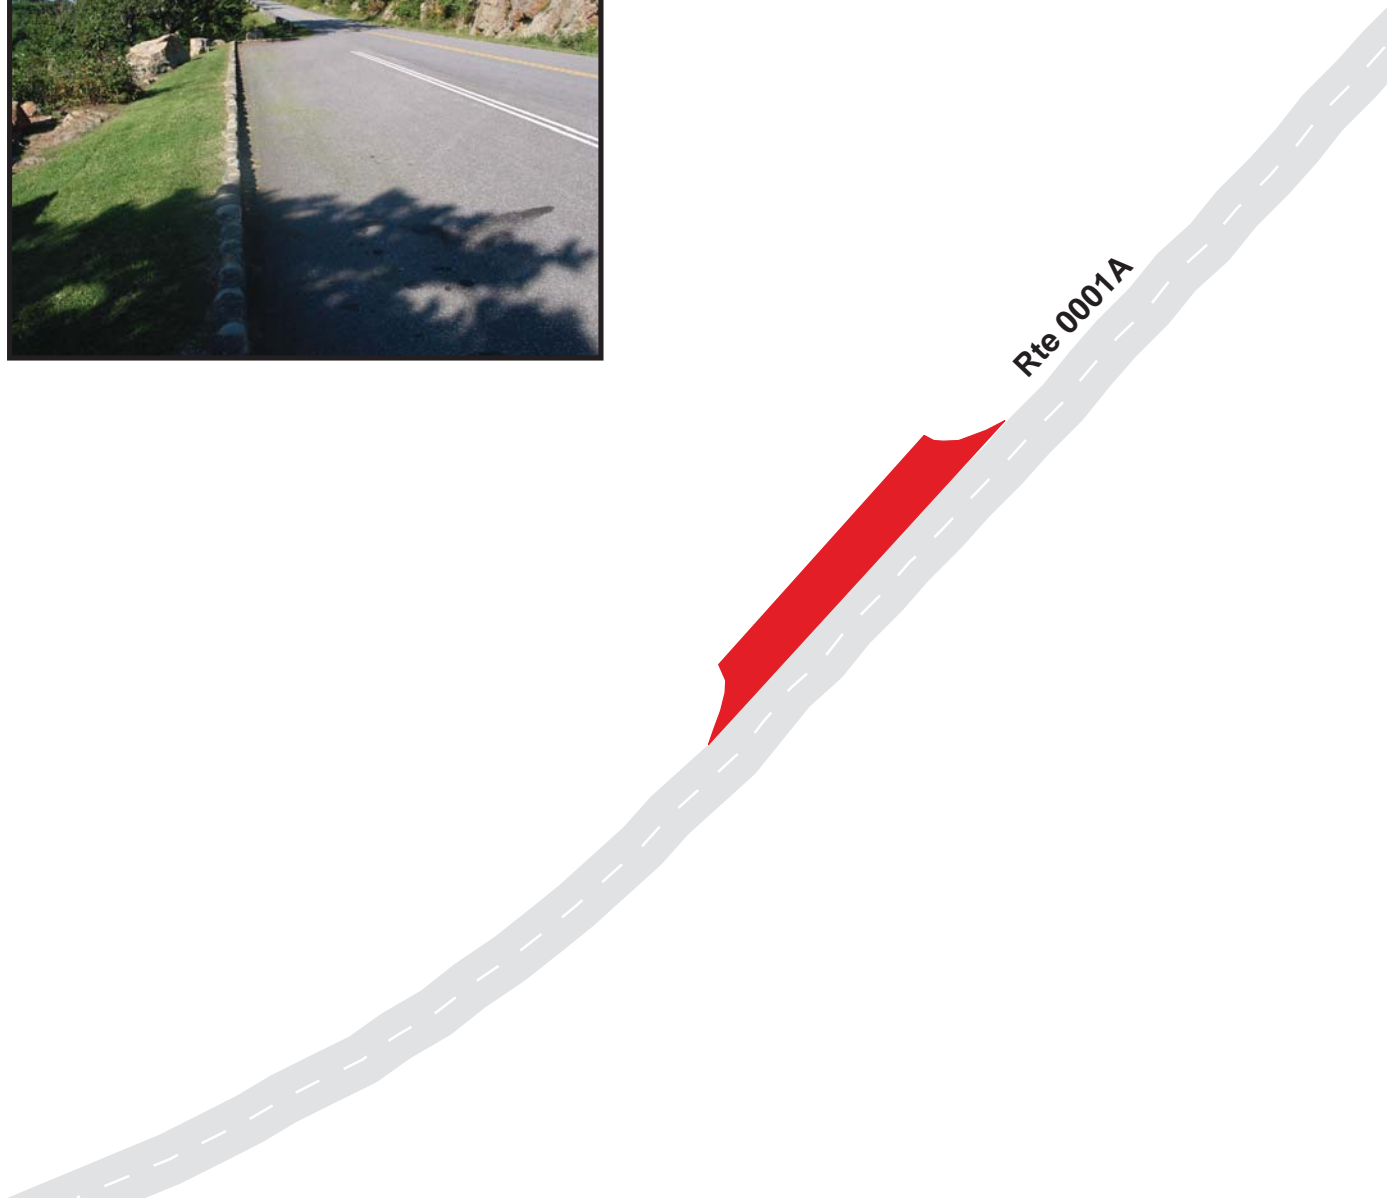
Route 0962

Route	Public / NonPublic	Date Visited	Area (sq ft)	Lane Miles *	Surface Type	Condition / PCR
0962	Public	9/8/2003	2728	0.05	AS	GOOD / 90

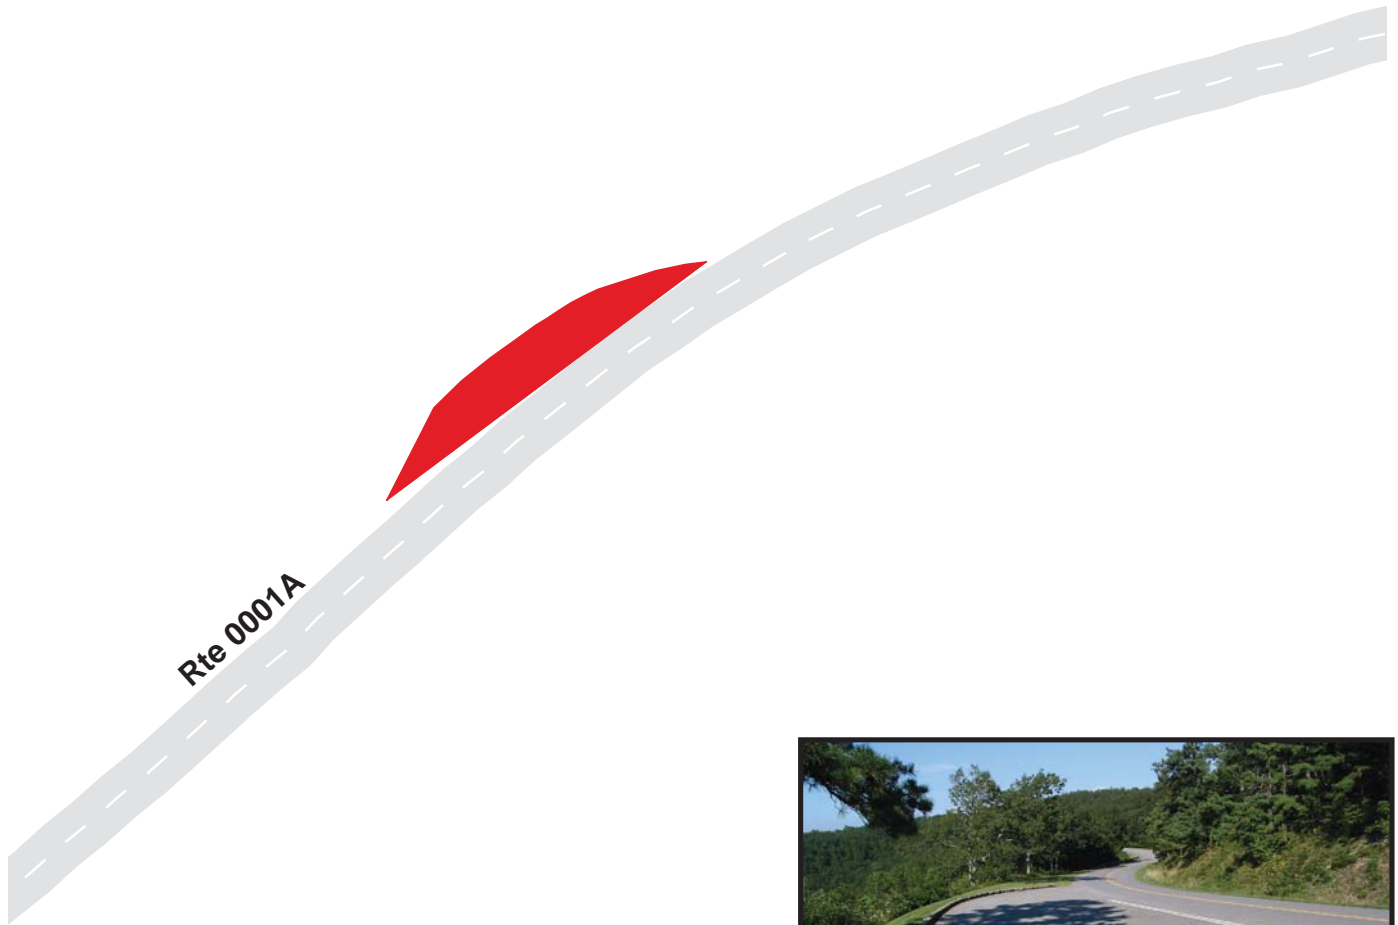
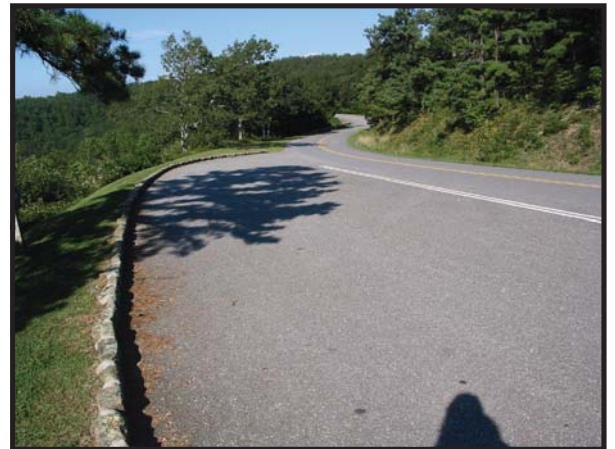
Route 0963

Route	Public / NonPublic	Date Visited	Area (sq ft)	Lane Miles *	Surface Type	Condition / PCR
0963	Public	9/8/2003	14179	0.24	AS	GOOD / 90

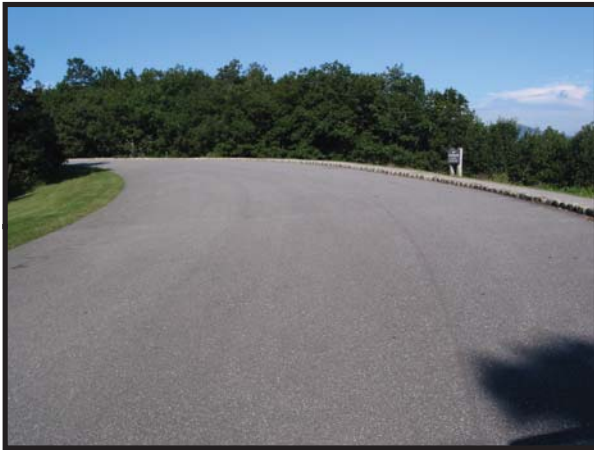
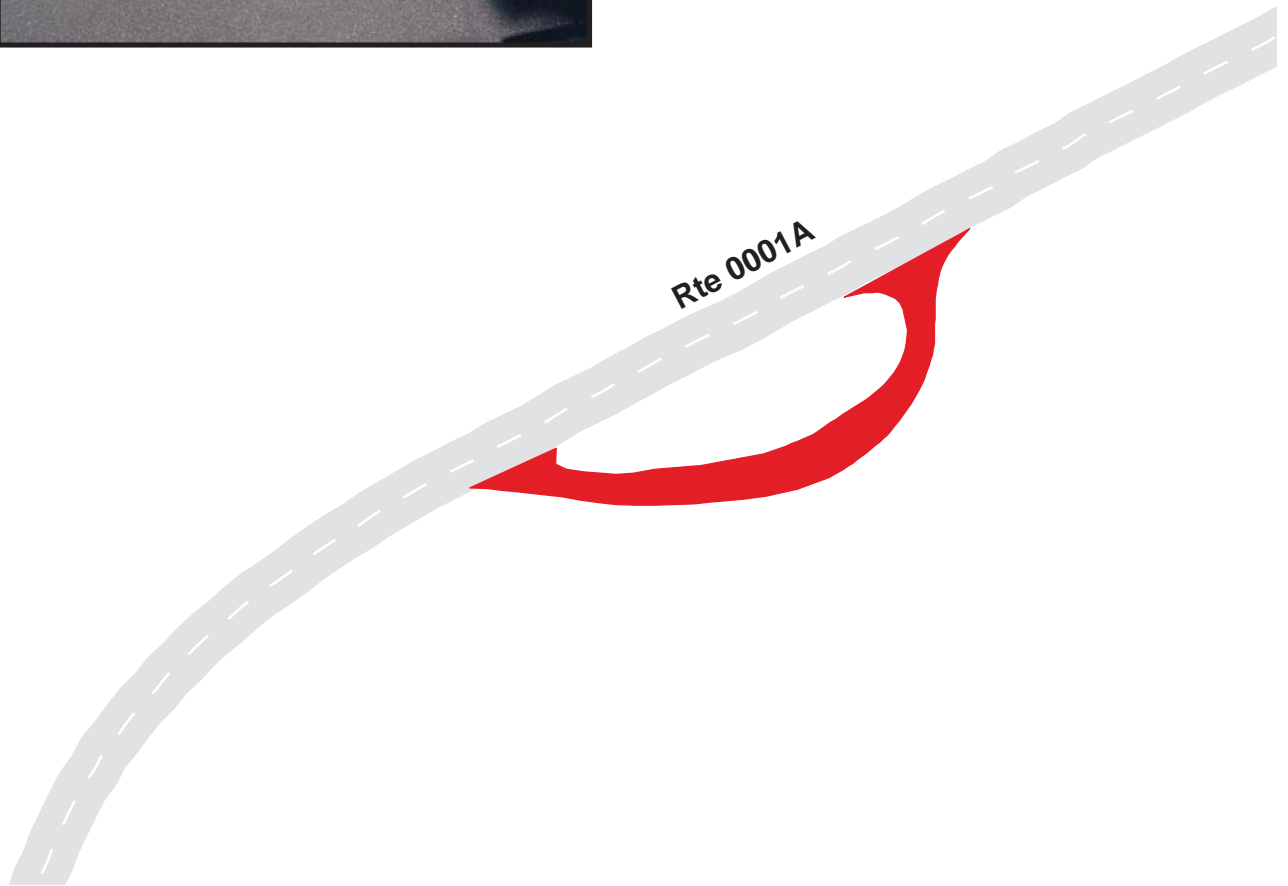
Route 0964

Route	Public / NonPublic	Date Visited	Area (sq ft)	Lane Miles *	Surface Type	Condition / PCR
0964	Public	9/8/2003	8272	0.14	AS	FAIR / 73

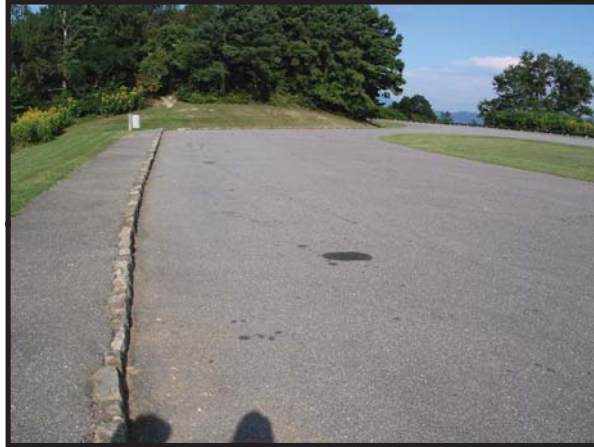
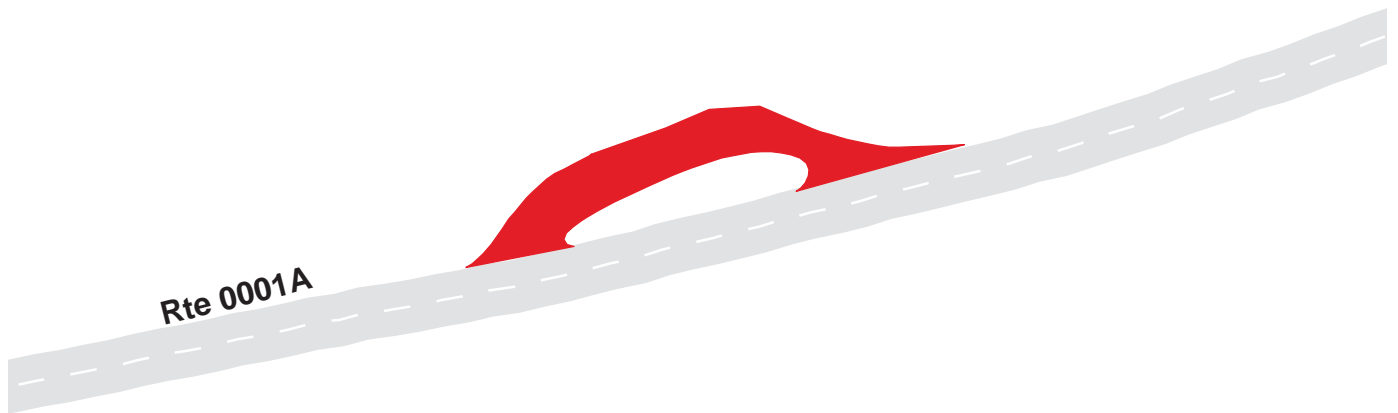
Route 0965

Route	Public / NonPublic	Date Visited	Area (sq ft)	Lane Miles *	Surface Type	Condition / PCR
0965	Public	9/8/2003	9276	0.16	AS	FAIR / 73

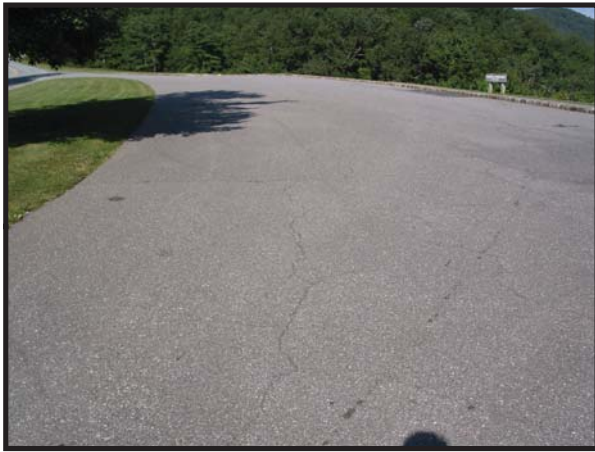
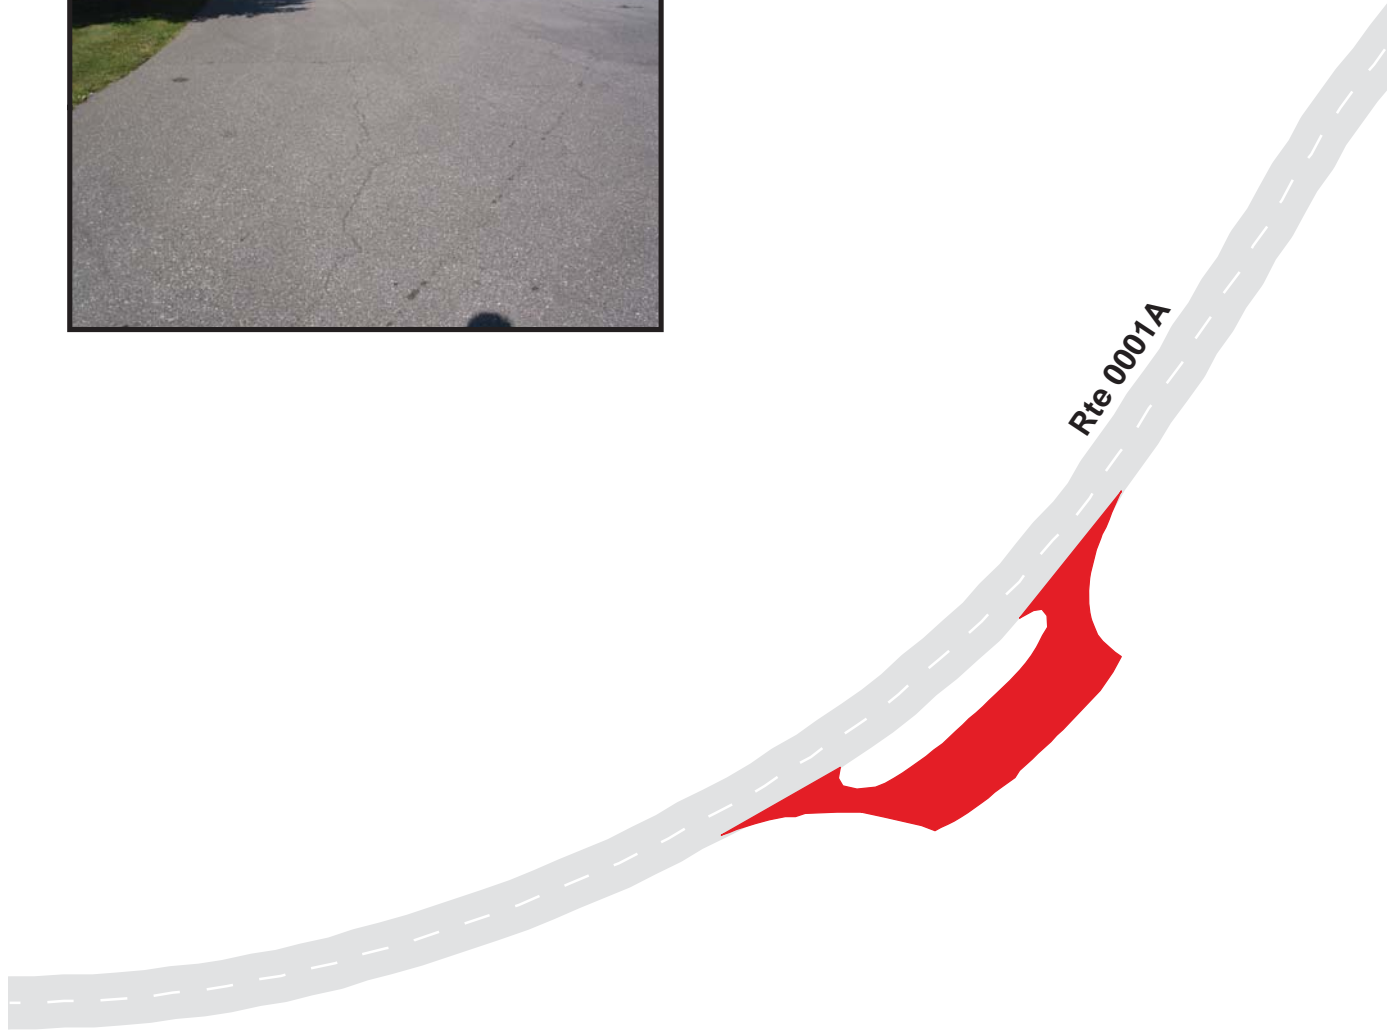
Route 0966

Route	Public / NonPublic	Date Visited	Area (sq ft)	Lane Miles *	Surface Type	Condition / PCR
0966	Public	9/8/2003	14992	0.26	AS	GOOD / 90

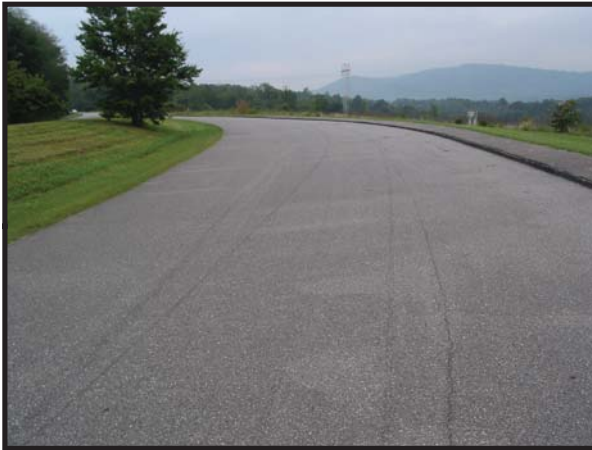
Blue Ridge Parkway
Route 0967
Coyner Mountain
From Route 0001B at MP 106.66 on Right

Route	Public / NonPublic	Date Visited	Area (sq ft)	Lane Miles *	Surface Type	Condition / PCR
0967	Public	9/8/2003	24558	0.42	AS	FAIR / 73

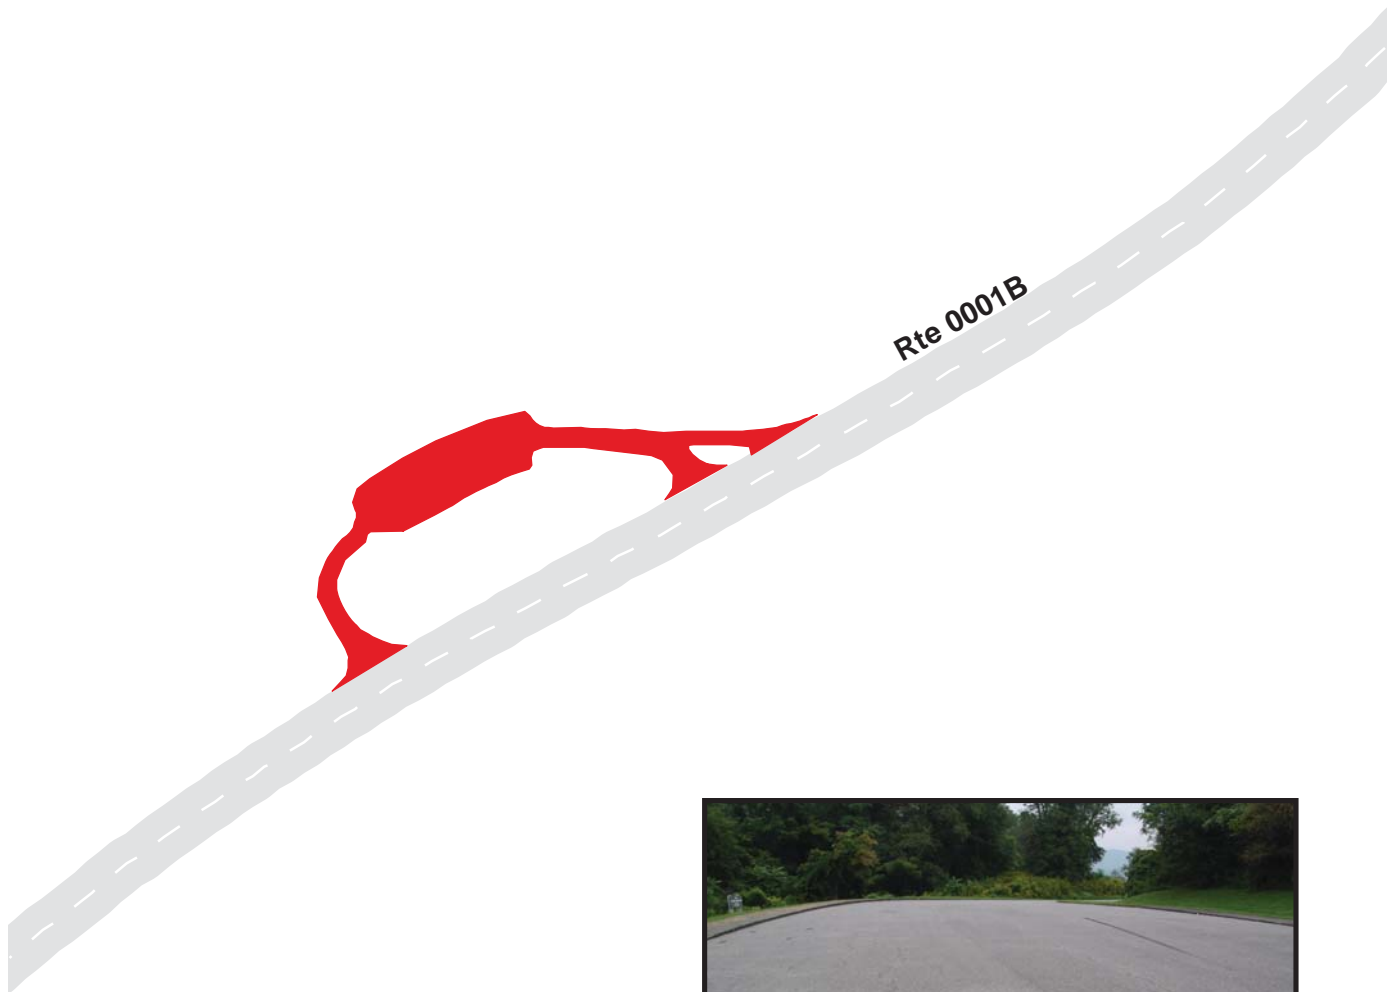
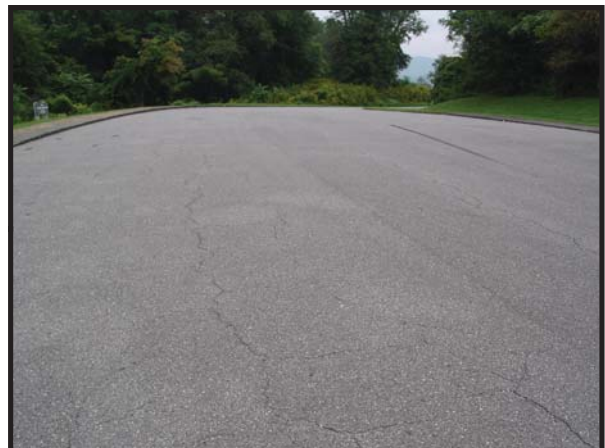
Route 0968

Route	Public / NonPublic	Date Visited	Area (sq ft)	Lane Miles *	Surface Type	Condition / PCR
0968	Public	9/8/2003	16736	0.29	AS	GOOD / 90
