The Road Inventory of Blue Ridge Parkway BLRI – 5140 Volume 1

Road Inventory Program

Prepared By:
Federal Highway Administration
Eastern Federal Lands Highway Division
Cycle 3

Blue Ridge Parkway in North Carolina

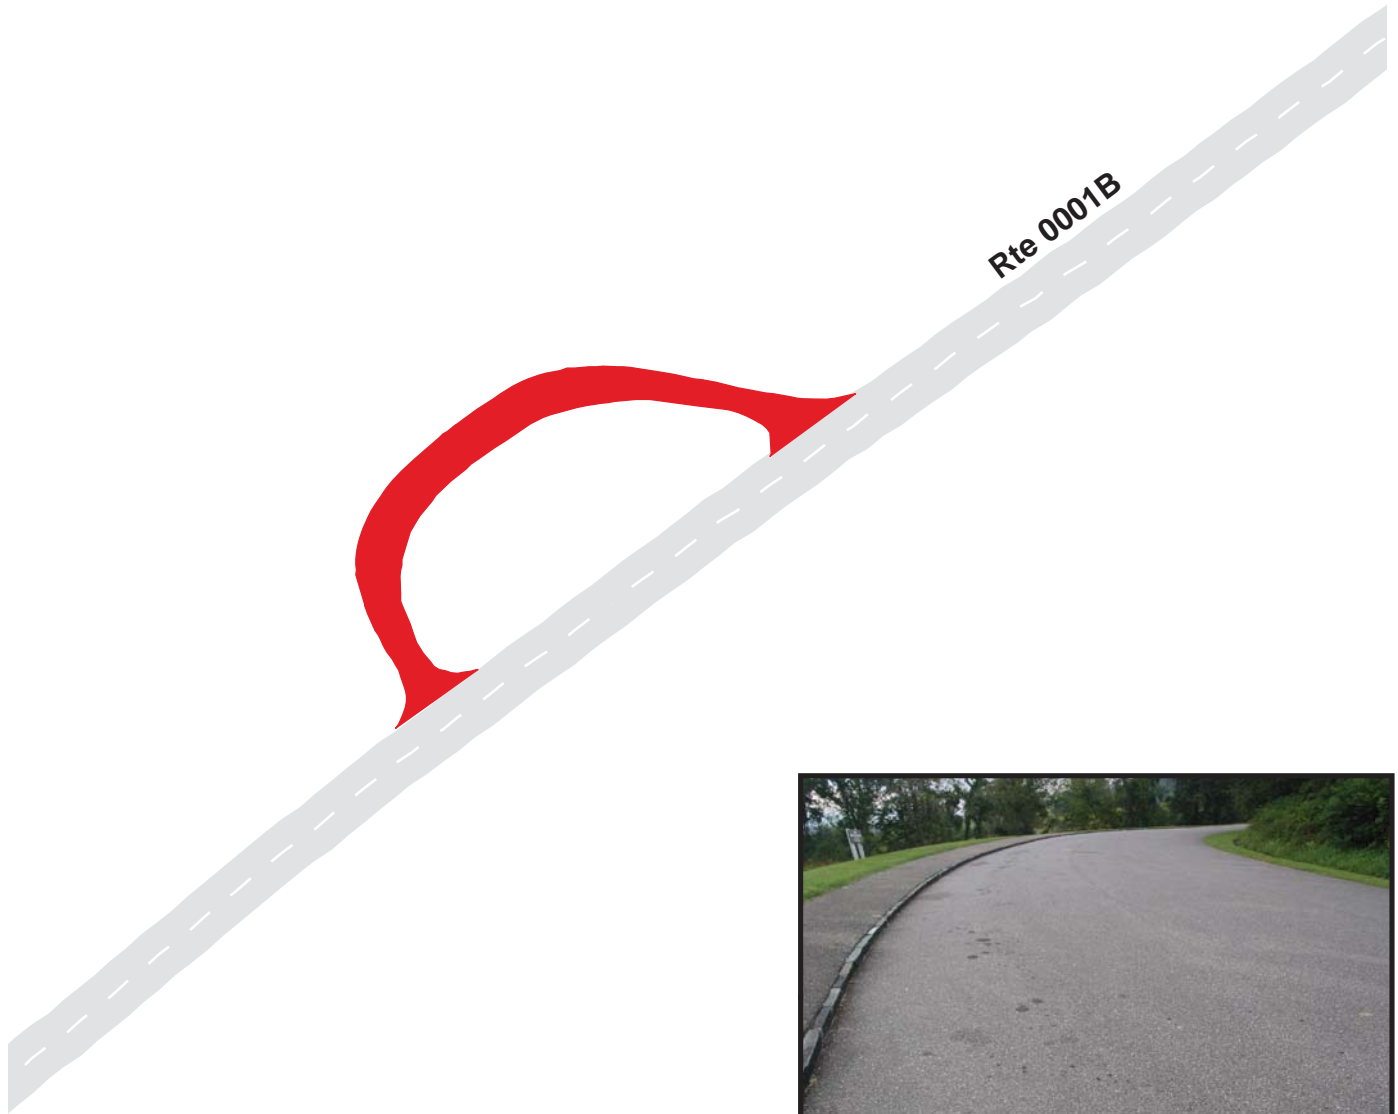
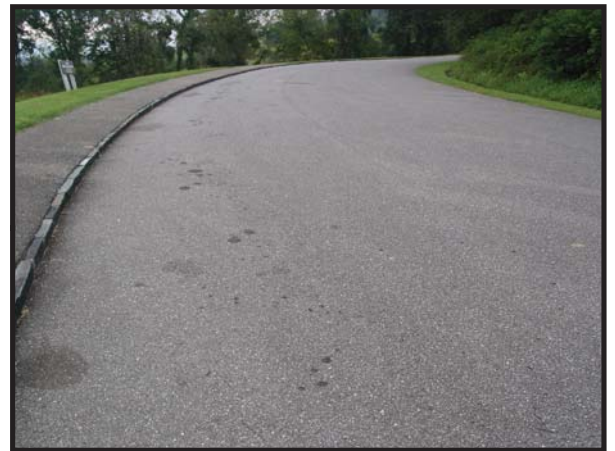
Route 0969

Route	Public / NonPublic	Date Visited	Area (sq ft)	Lane Miles *	Surface Type	Condition / PCR
0969	Public	9/8/2003	26190	0.45	AS	GOOD / 90

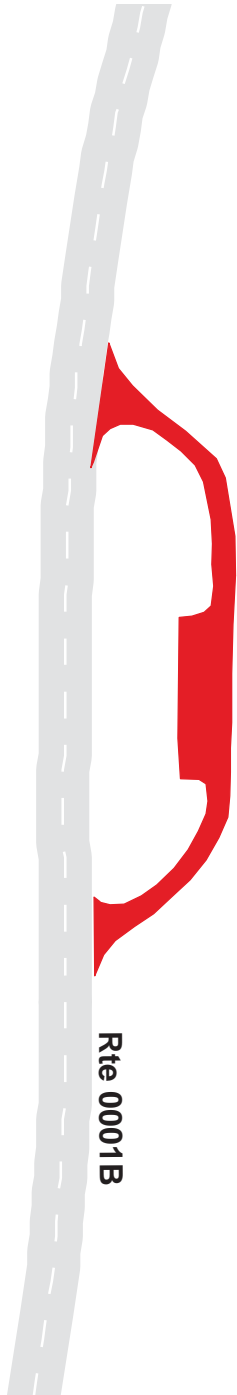
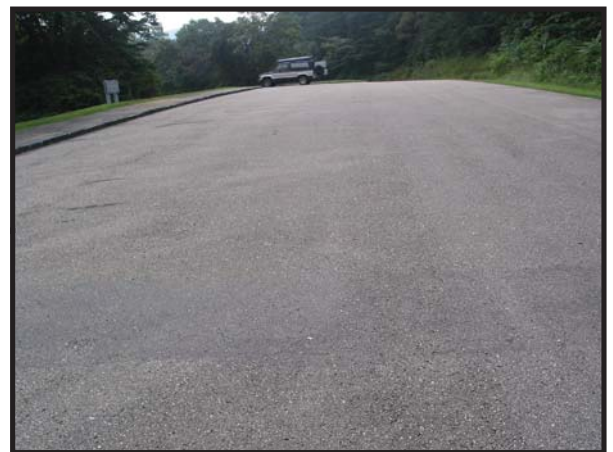
Route 0970

Route	Public / NonPublic	Date Visited	Area (sq ft)	Lane Miles *	Surface Type	Condition / PCR
0970	Public	9/8/2003	15987	0.28	AS	FAIR / 73

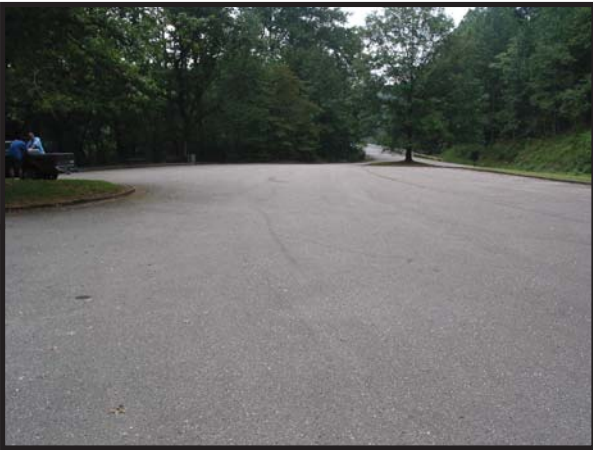
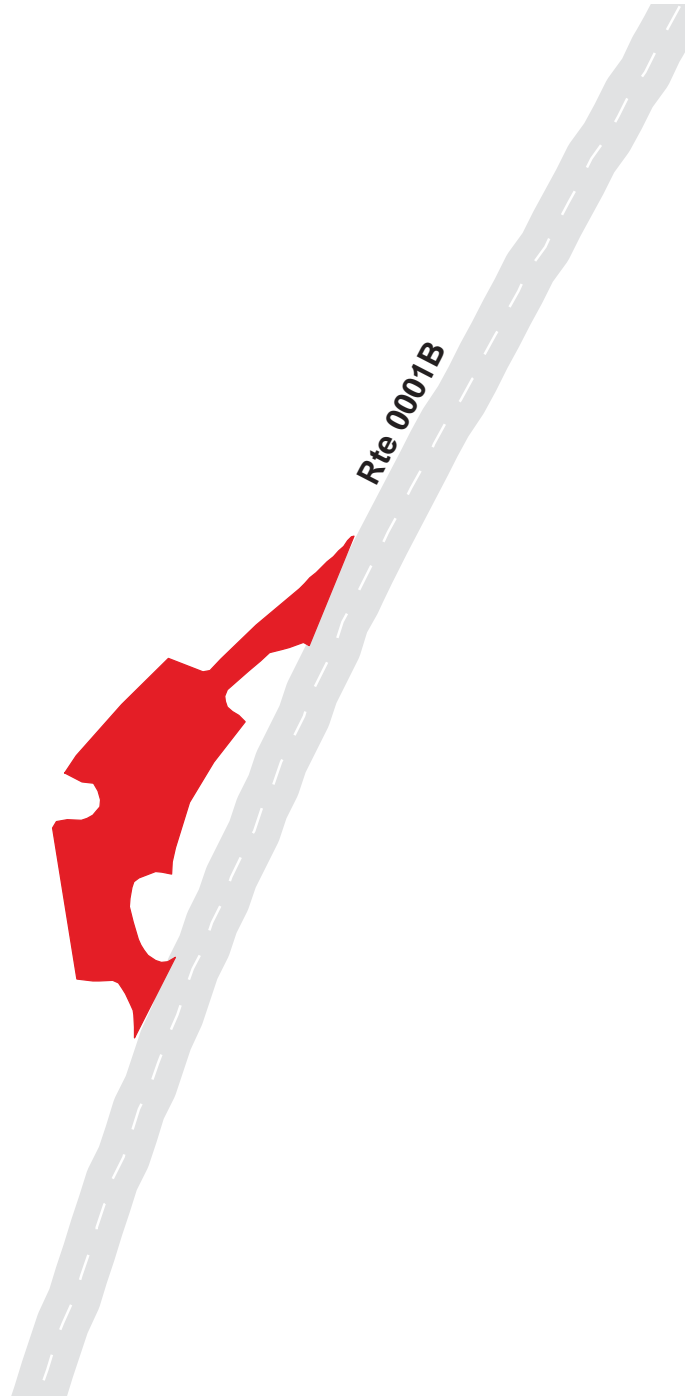
Blue Ridge Parkway
Route 0971
 Mill Mountain
 From Route 0518 at MP 1.04 on Left

Route	Public / NonPublic	Date Visited	Area (sq ft)	Lane Miles *	Surface Type	Condition / PCR
0971	Public	9/7/2003	6458	0.11	AS	GOOD / 90

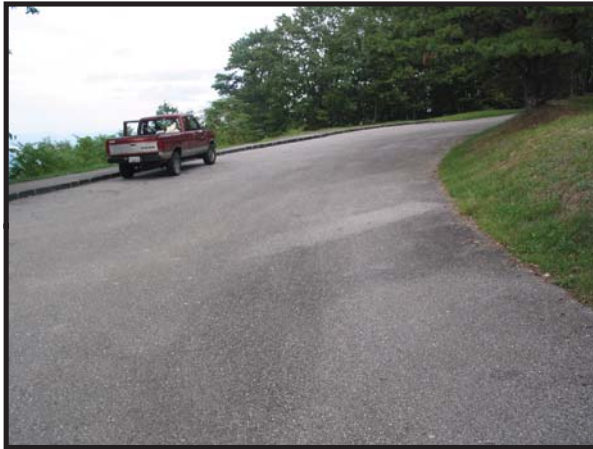
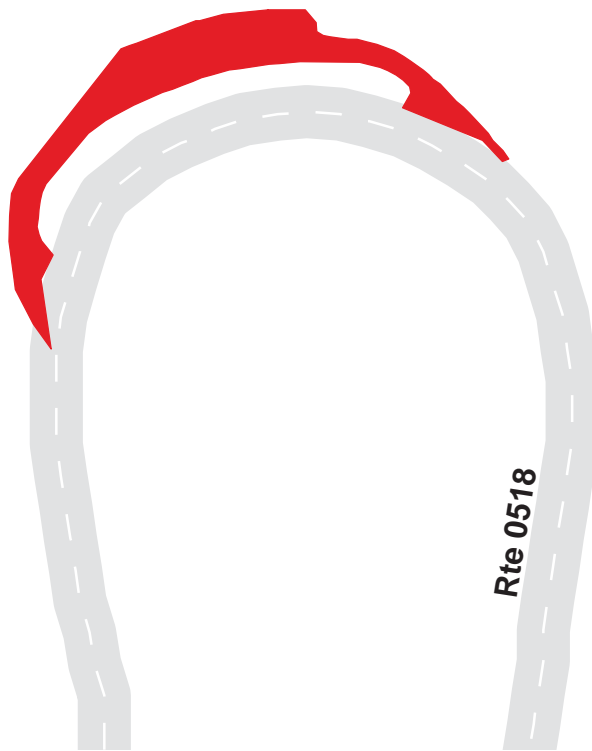
Route 0972

Route	Public / NonPublic	Date Visited	Area (sq ft)	Lane Miles *	Surface Type	Condition / PCR
0972	Public	9/7/2003	4298	0.07	AS	GOOD / 90

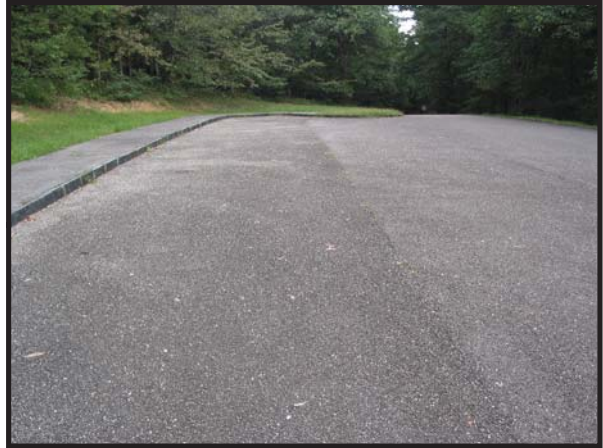
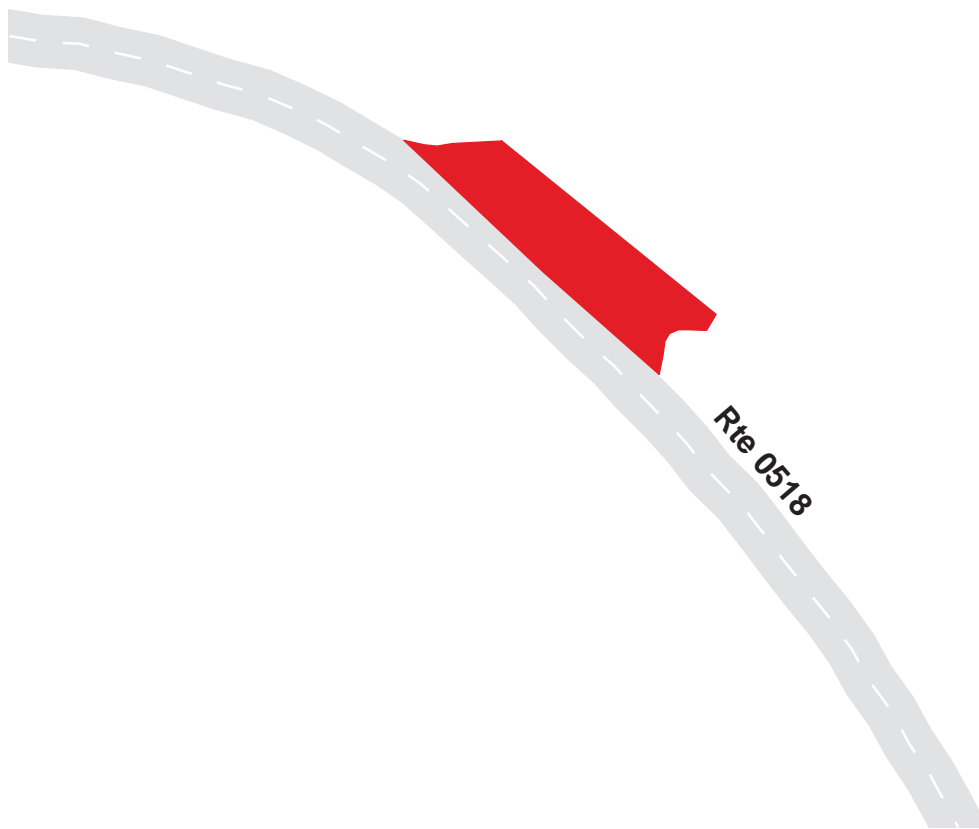
Route 0973

Route	Public / NonPublic	Date Visited	Area (sq ft)	Lane Miles *	Surface Type	Condition / PCR
0973	Public	9/7/2003	9415	0.16	AS	GOOD / 90

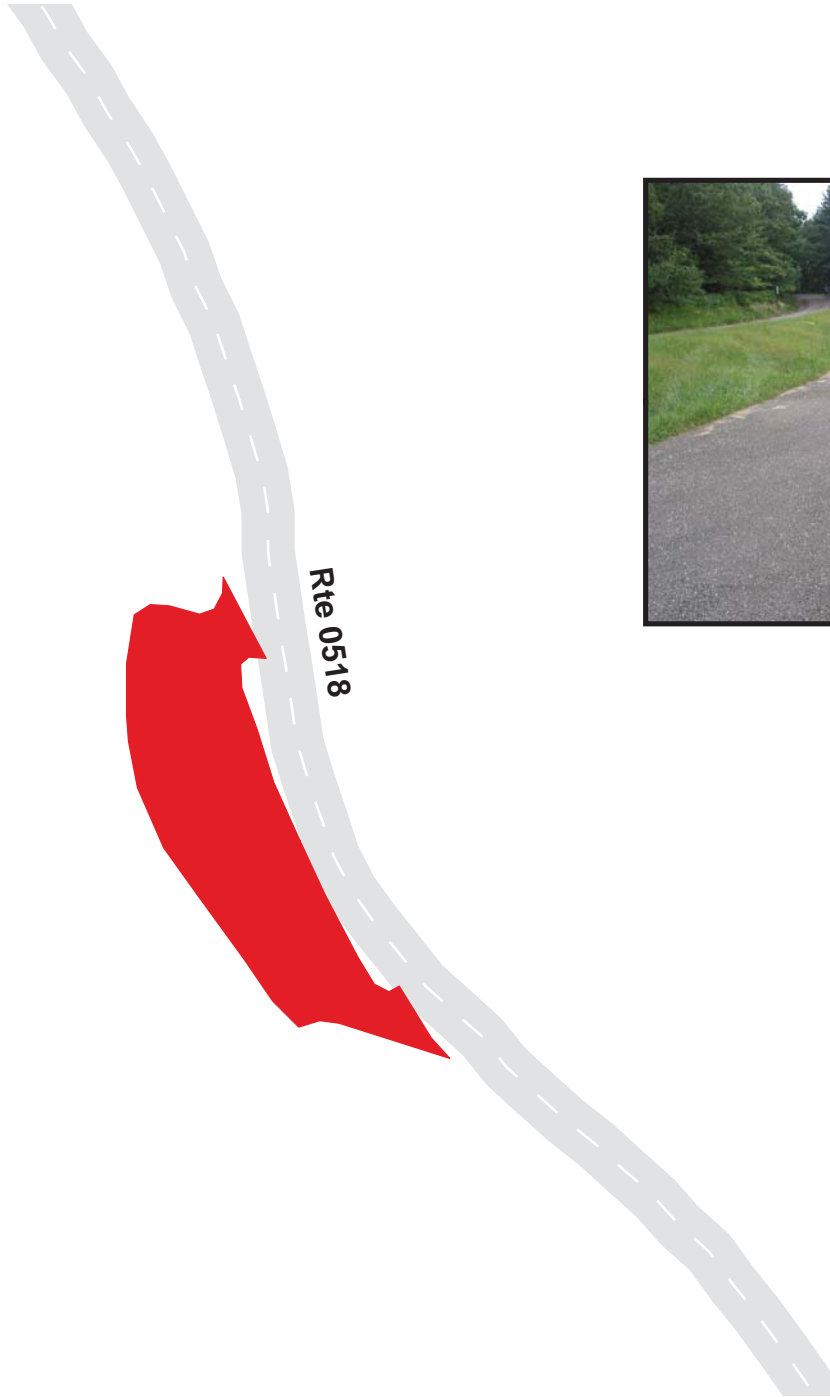
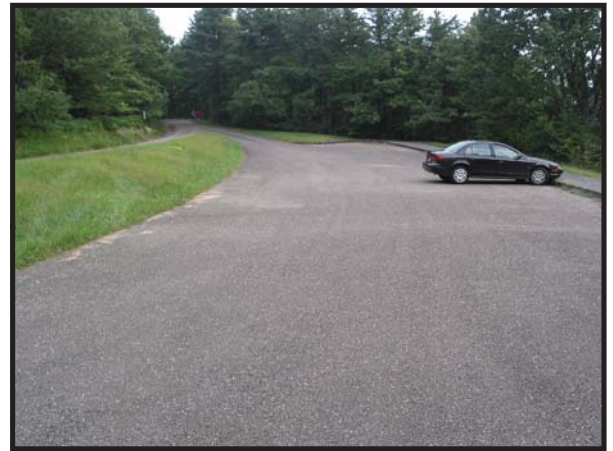
Route 0974A

Route	Public / NonPublic	Date Visited	Area (sq ft)	Lane Miles *	Surface Type	Condition / PCR
0974A	Public	9/7/2003	4072	0.07	AS	GOOD / 90

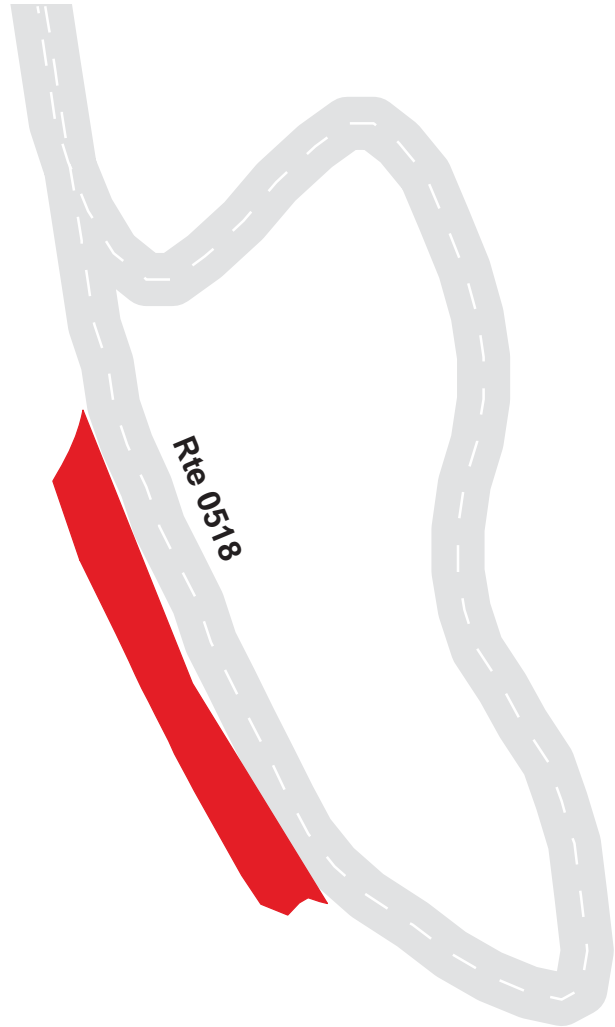
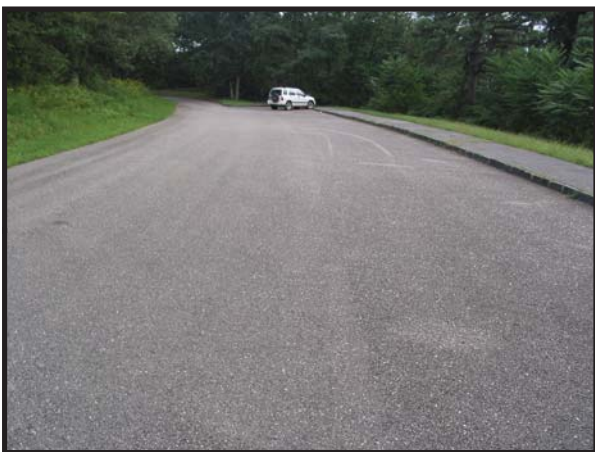
Route 0974B

Route	Public / NonPublic	Date Visited	Area (sq ft)	Lane Miles *	Surface Type	Condition / PCR
0974B	Public	9/7/2003	1921	0.03	AS	GOOD / 90

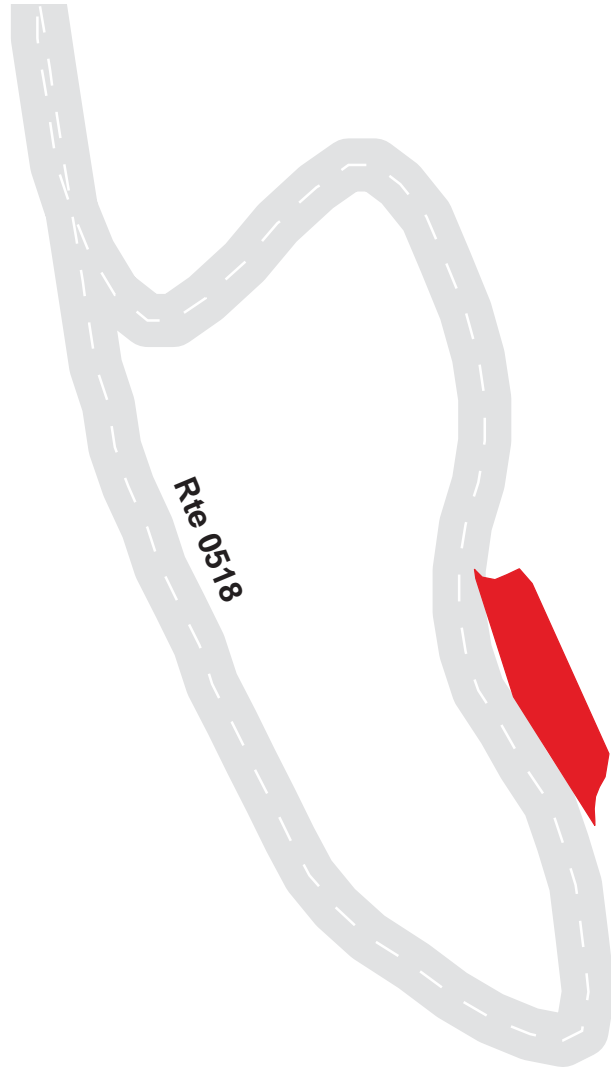
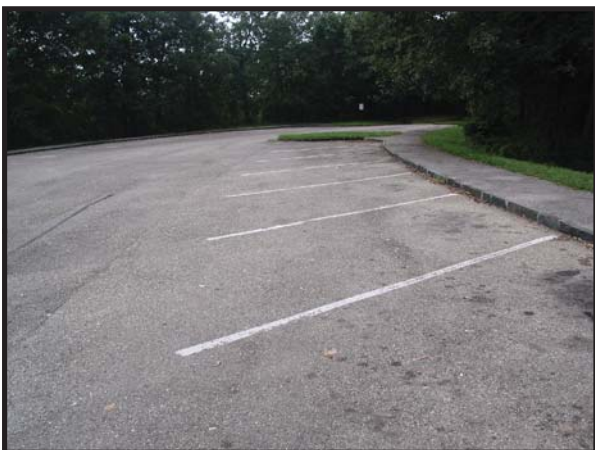
Route 0974C

Route	Public / NonPublic	Date Visited	Area (sq ft)	Lane Miles *	Surface Type	Condition / PCR
0974C	Public	9/7/2003	5283	0.09	AS	GOOD / 90

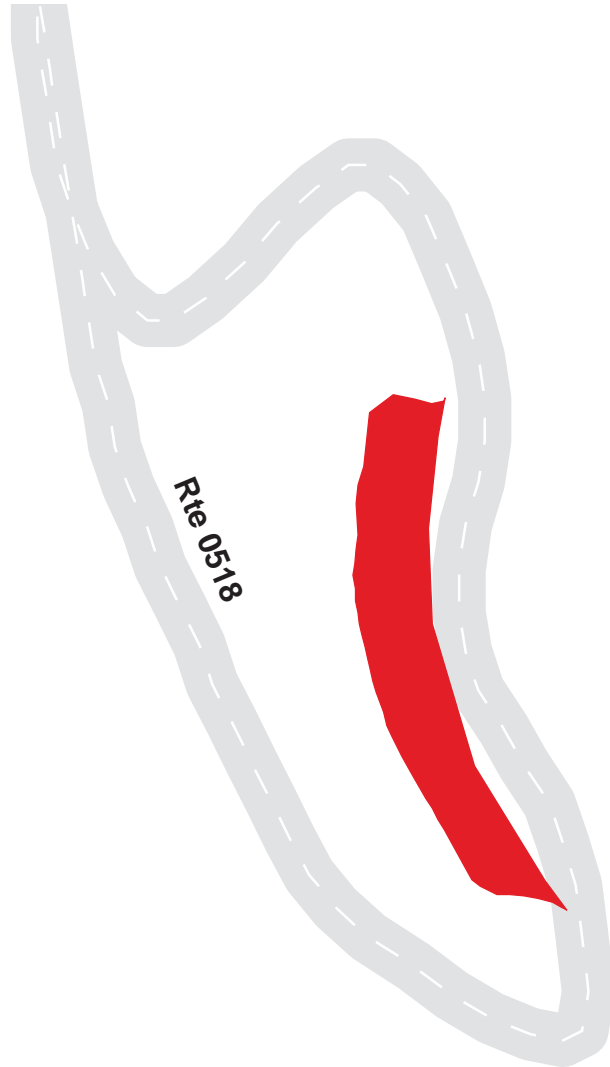
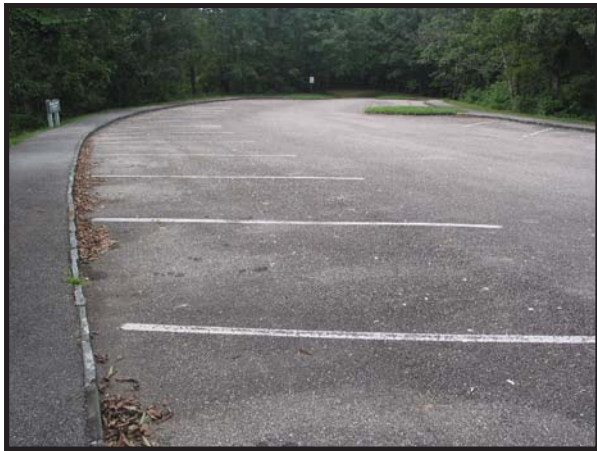
Route 0974D

Route	Public / NonPublic	Date Visited	Area (sq ft)	Lane Miles *	Surface Type	Condition / PCR
0974D	Public	9/7/2003	1969	0.03	AS	GOOD / 90

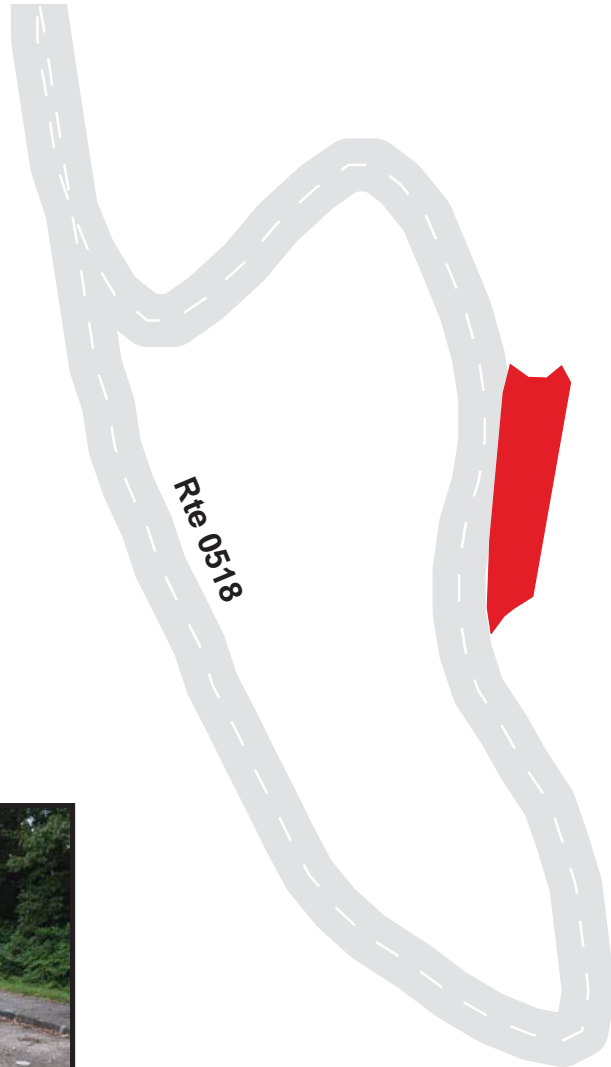
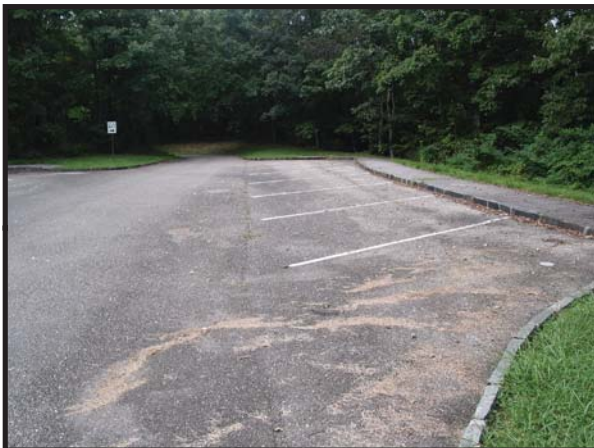
Route 0975

Route	Public / NonPublic	Date Visited	Area (sq ft)	Lane Miles *	Surface Type	Condition / PCR
0975	Public	9/7/2003	4251	0.07	AS	GOOD / 90

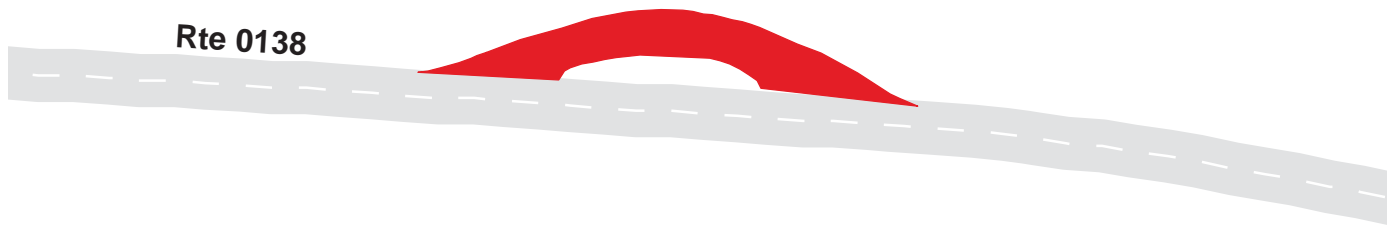
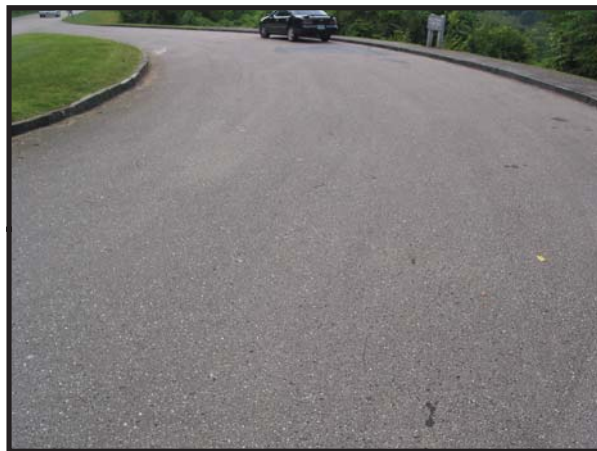
Route 0976

Route	Public / NonPublic	Date Visited	Area (sq ft)	Lane Miles *	Surface Type	Condition / PCR
0976	Public	9/7/2003	7166	0.12	AS	GOOD / 90

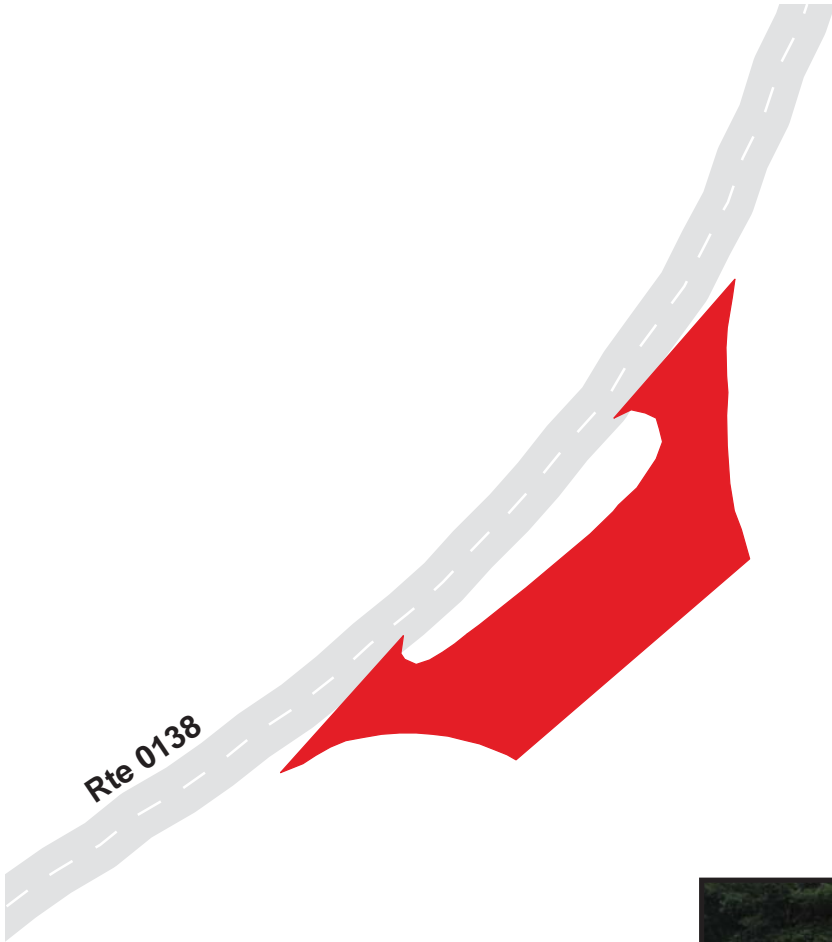
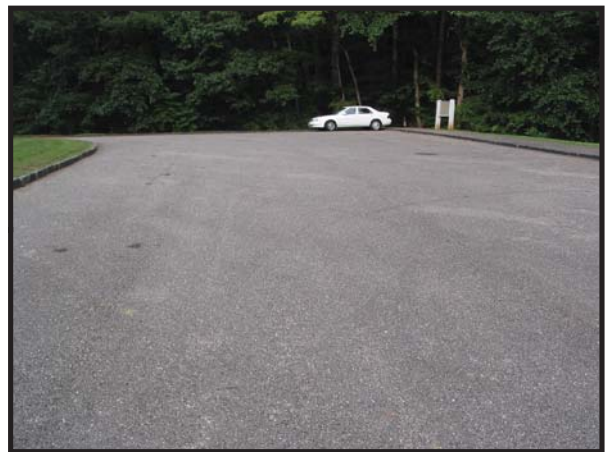
Route 0977

Route	Public / NonPublic	Date Visited	Area (sq ft)	Lane Miles *	Surface Type	Condition / PCR
0977	Public	9/7/2003	7570	0.13	AS	POOR / 45

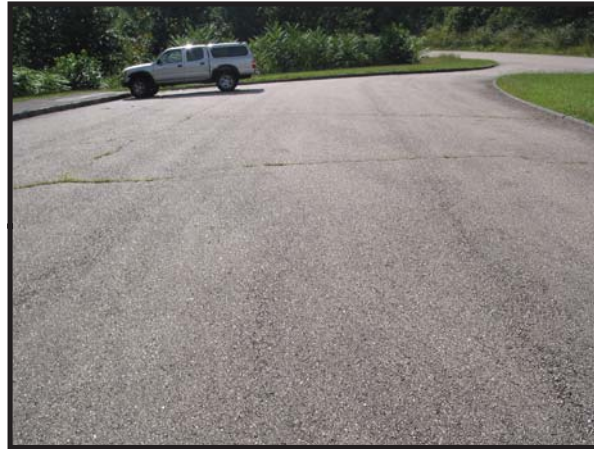
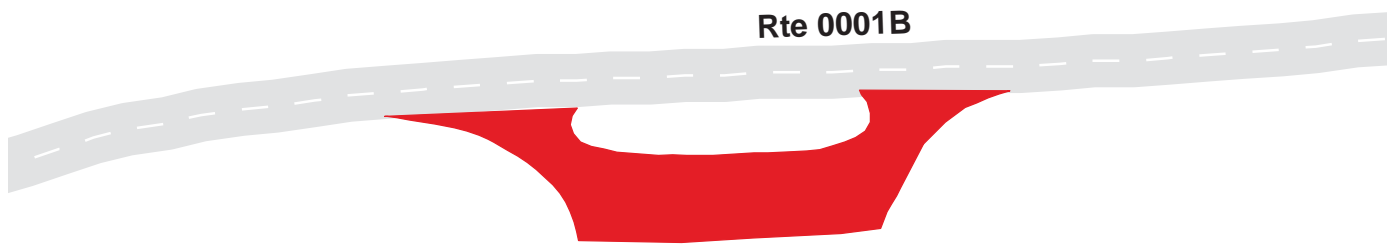
Route 0978

Route	Public / NonPublic	Date Visited	Area (sq ft)	Lane Miles *	Surface Type	Condition / PCR
0978	Public	9/7/2003	18996	0.33	AS	POOR / 45

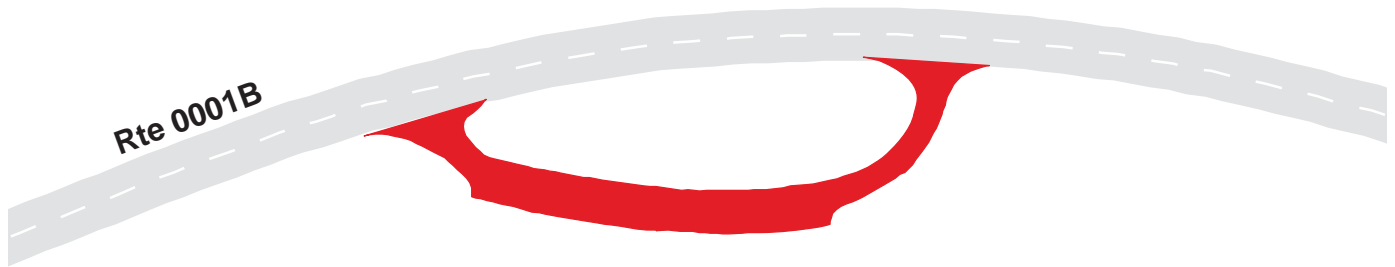
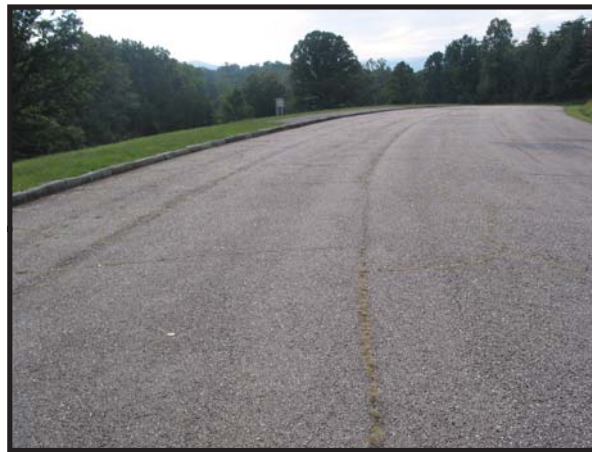
Route 0979

Route	Public / NonPublic	Date Visited	Area (sq ft)	Lane Miles *	Surface Type	Condition / PCR
0979	Public	9/7/2003	10263	0.18	AS	FAIR / 73

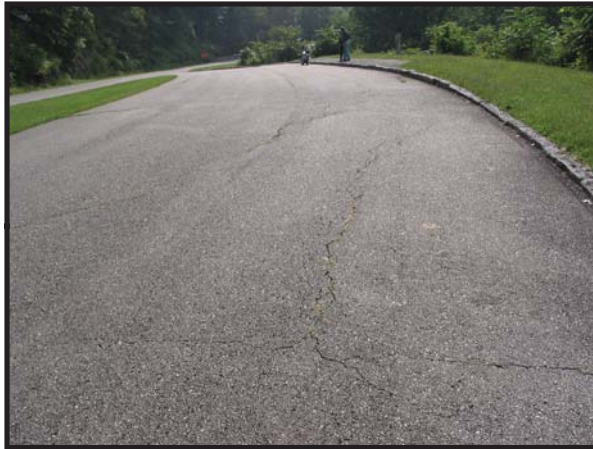
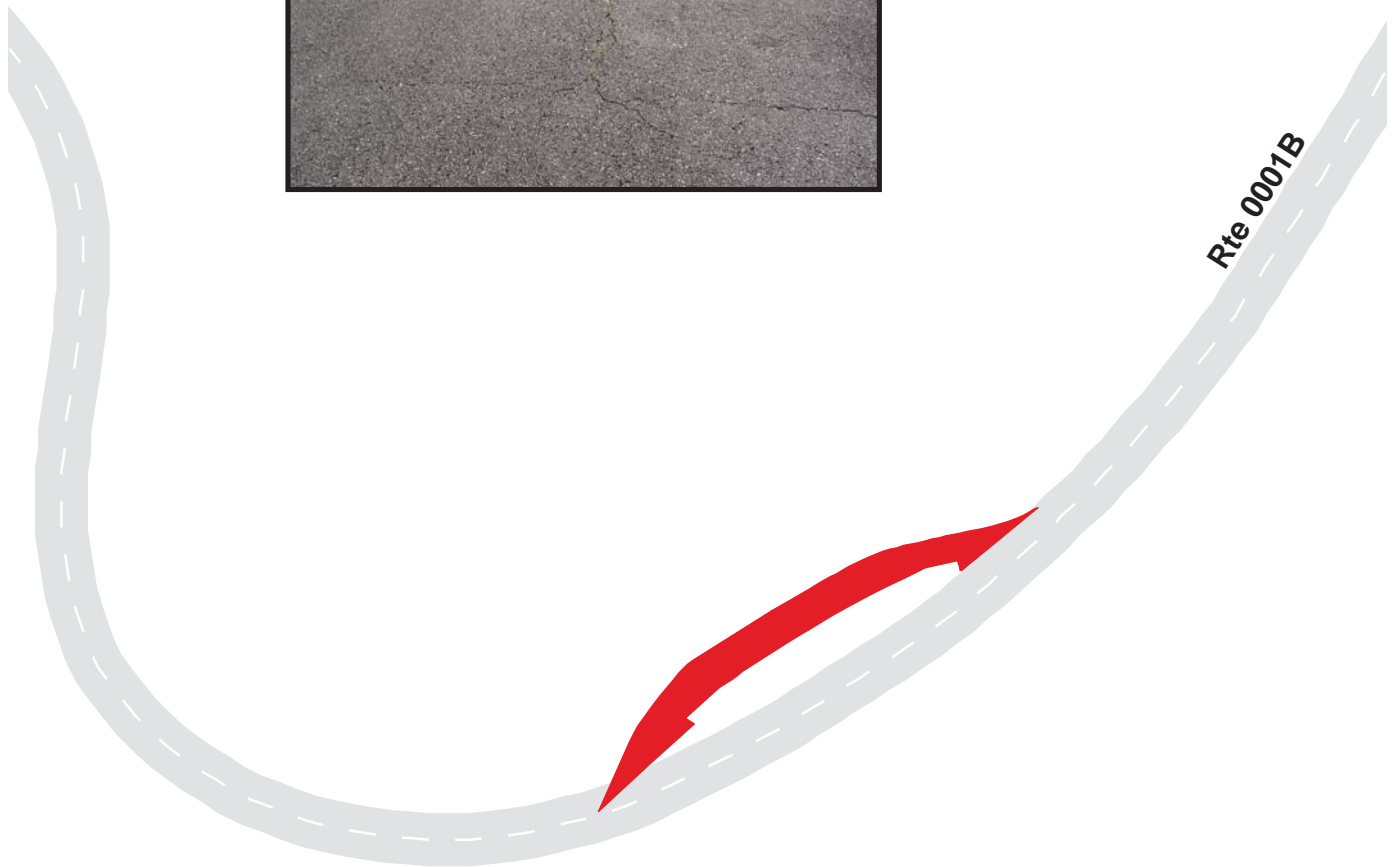
Route 0980

Route	Public / NonPublic	Date Visited	Area (sq ft)	Lane Miles *	Surface Type	Condition / PCR
0980	Public	9/7/2003	11719	0.20	AS	FAIR / 73

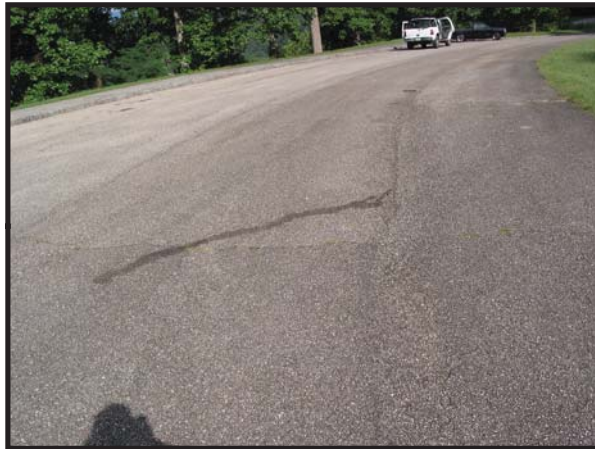
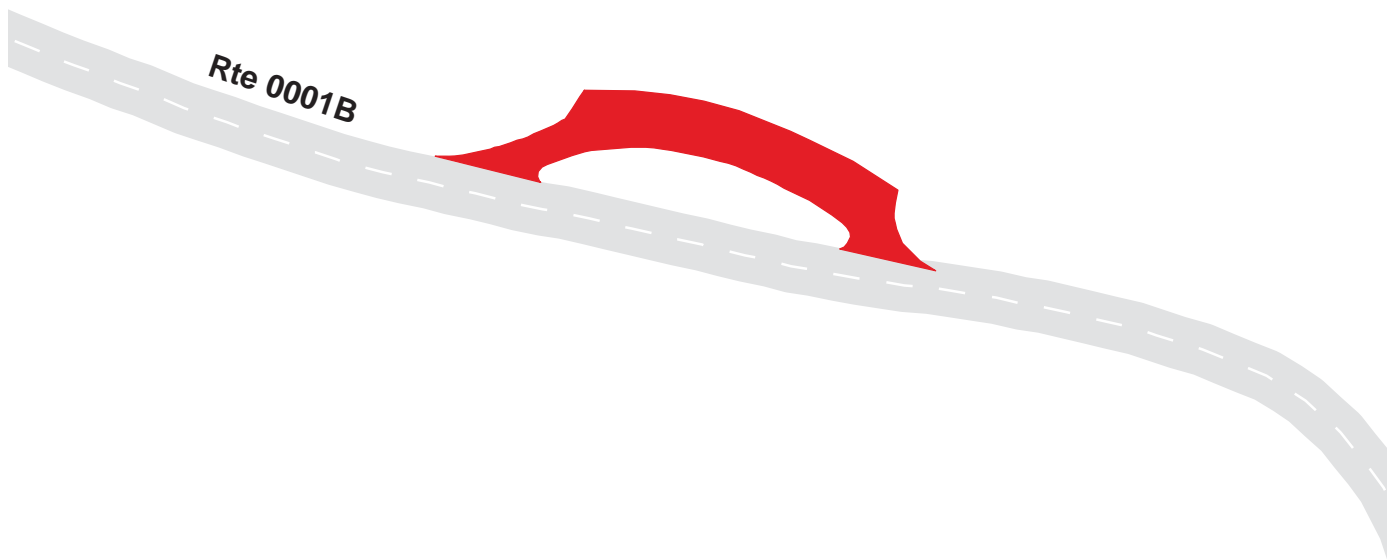
Route 0981

Route	Public / NonPublic	Date Visited	Area (sq ft)	Lane Miles *	Surface Type	Condition / PCR
0981	Public	9/7/2003	7169	0.12	AS	GOOD / 90

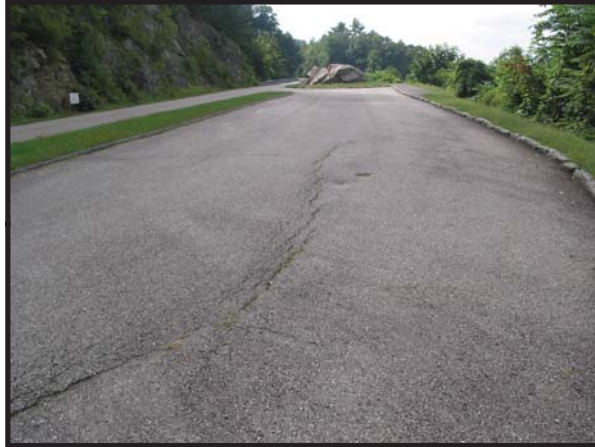
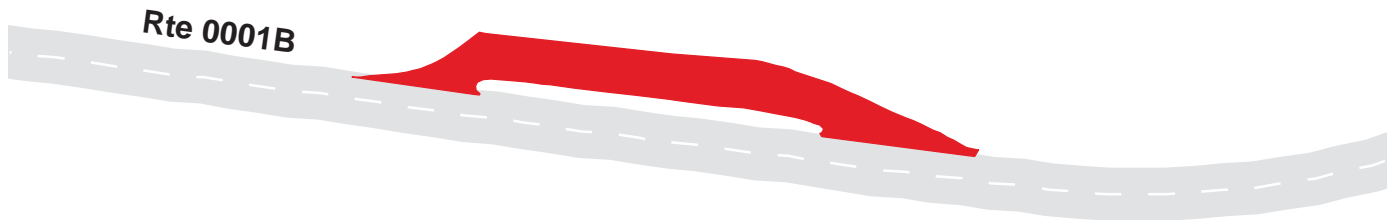
Route 0982

Route	Public / NonPublic	Date Visited	Area (sq ft)	Lane Miles *	Surface Type	Condition / PCR
0982	Public	9/7/2003	5760	0.10	AS	GOOD / 90

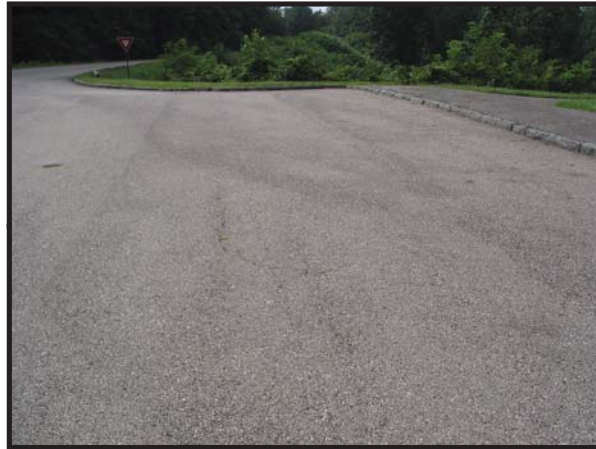
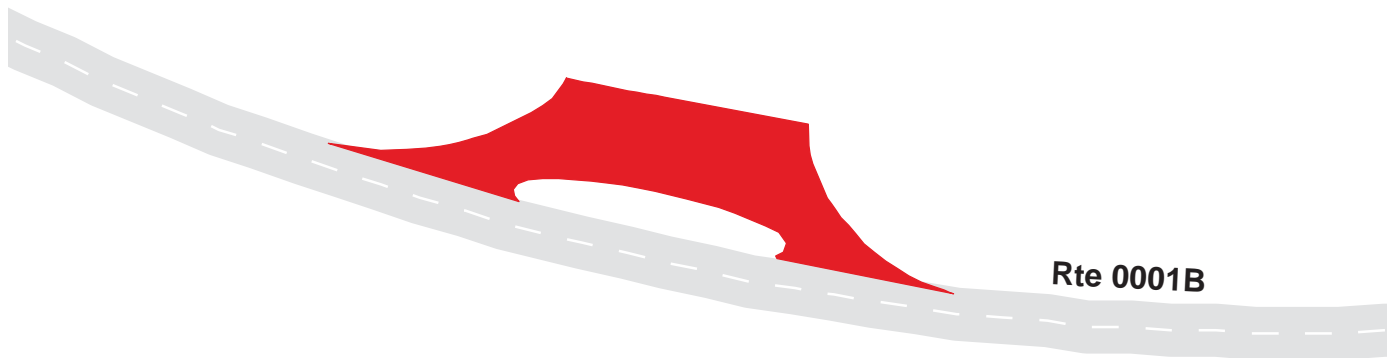
Route 0983

Route	Public / NonPublic	Date Visited	Area (sq ft)	Lane Miles *	Surface Type	Condition / PCR
0983	Public	9/7/2003	7477	0.13	AS	FAIR / 73

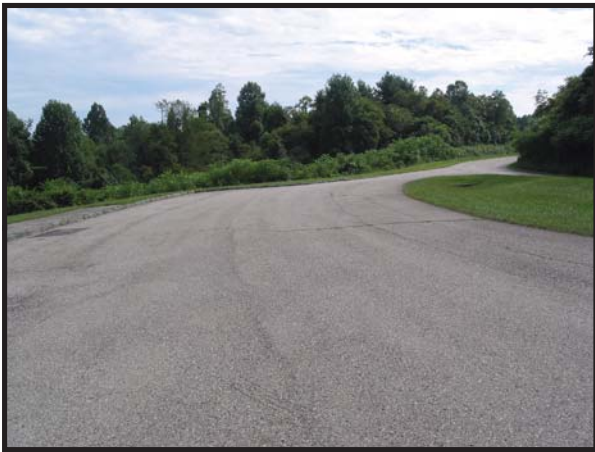
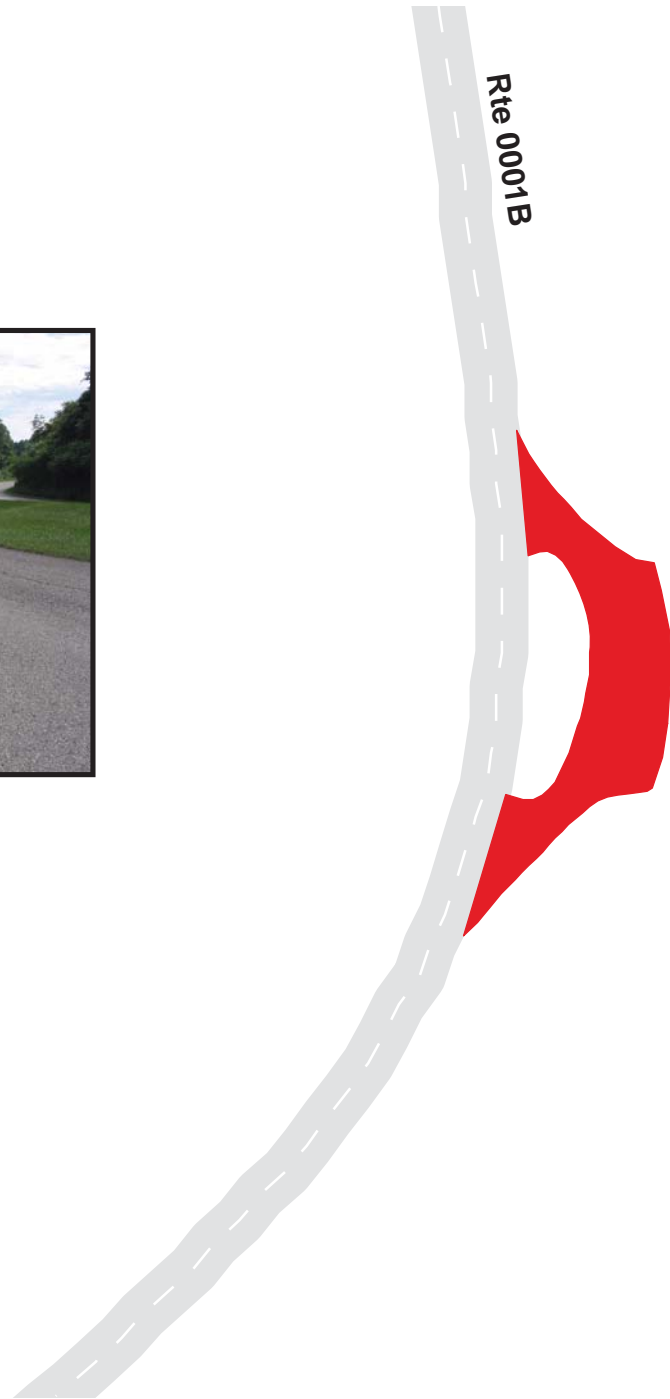
Route 0984

Route	Public / NonPublic	Date Visited	Area (sq ft)	Lane Miles *	Surface Type	Condition / PCR
0984	Public	9/7/2003	13317	0.23	AS	GOOD / 90

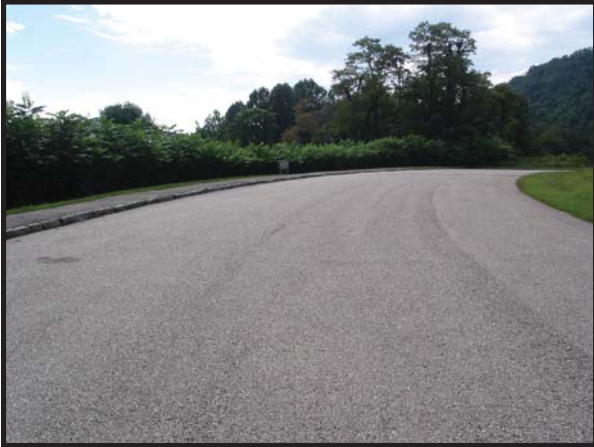
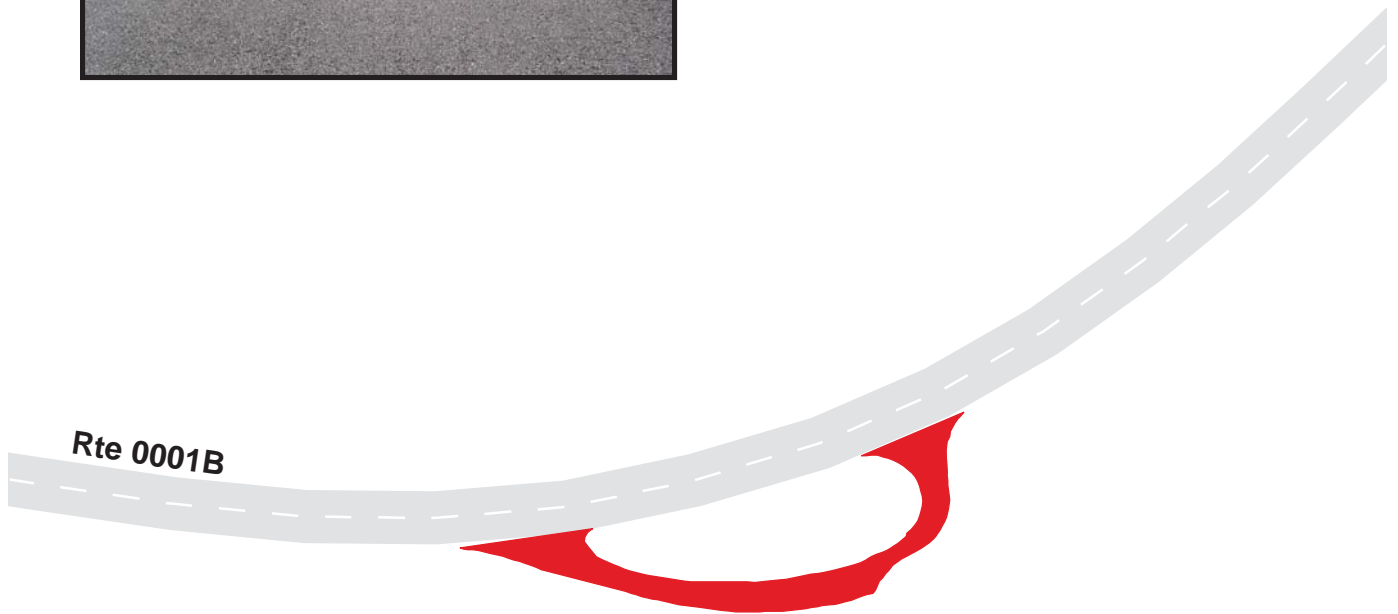
Route 0985

Route	Public / NonPublic	Date Visited	Area (sq ft)	Lane Miles *	Surface Type	Condition / PCR
0985	Public	9/7/2003	8971	0.15	AS	GOOD / 90

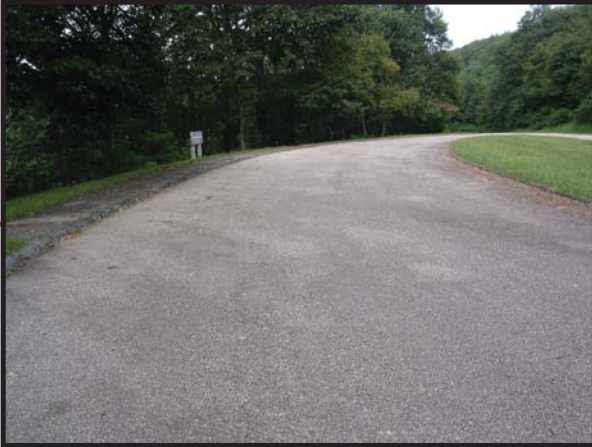
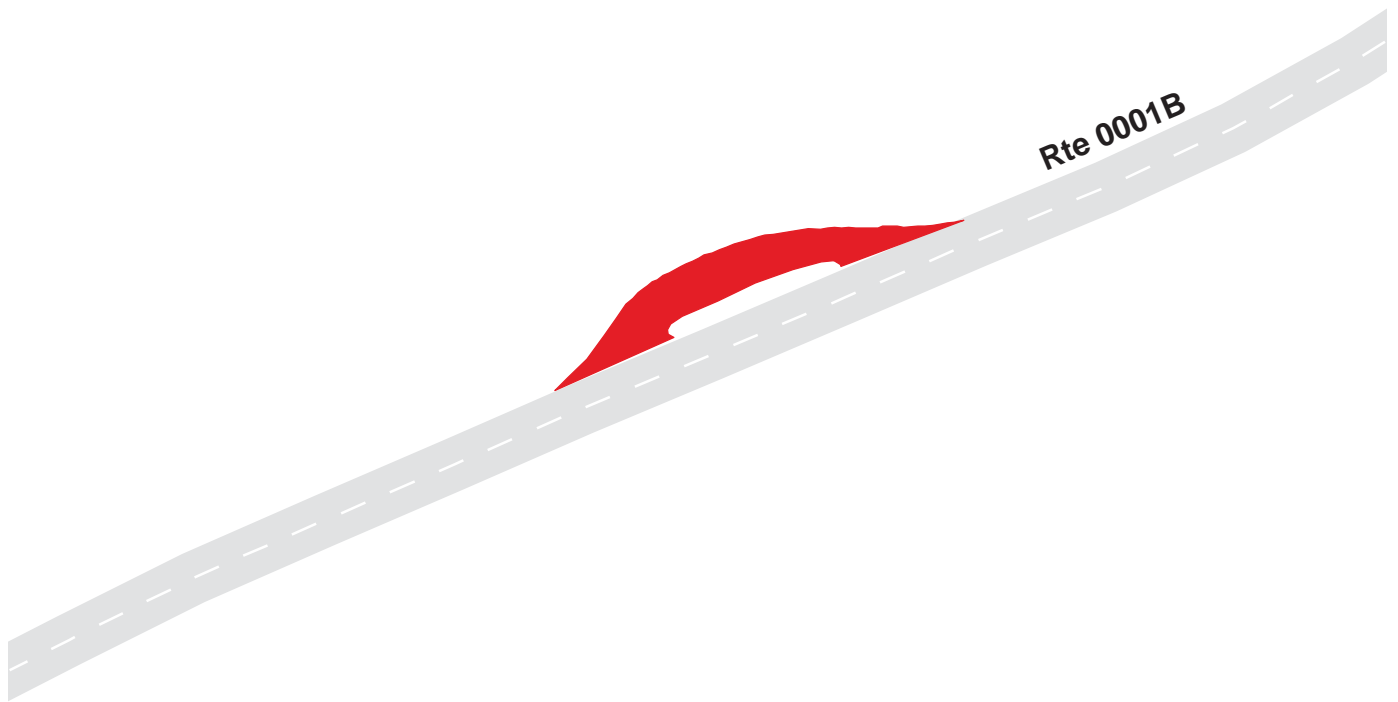
Route 0986

Route	Public / NonPublic	Date Visited	Area (sq ft)	Lane Miles *	Surface Type	Condition / PCR
0986	Public	9/7/2003	17294	0.30	AS	GOOD / 90
