The Road Inventory of Blue Ridge Parkway BLRI – 5140 Volume 1

Road Inventory Program

Prepared By:
Federal Highway Administration
Eastern Federal Lands Highway Division
Cycle 3

Blue Ridge Parkway in North Carolina

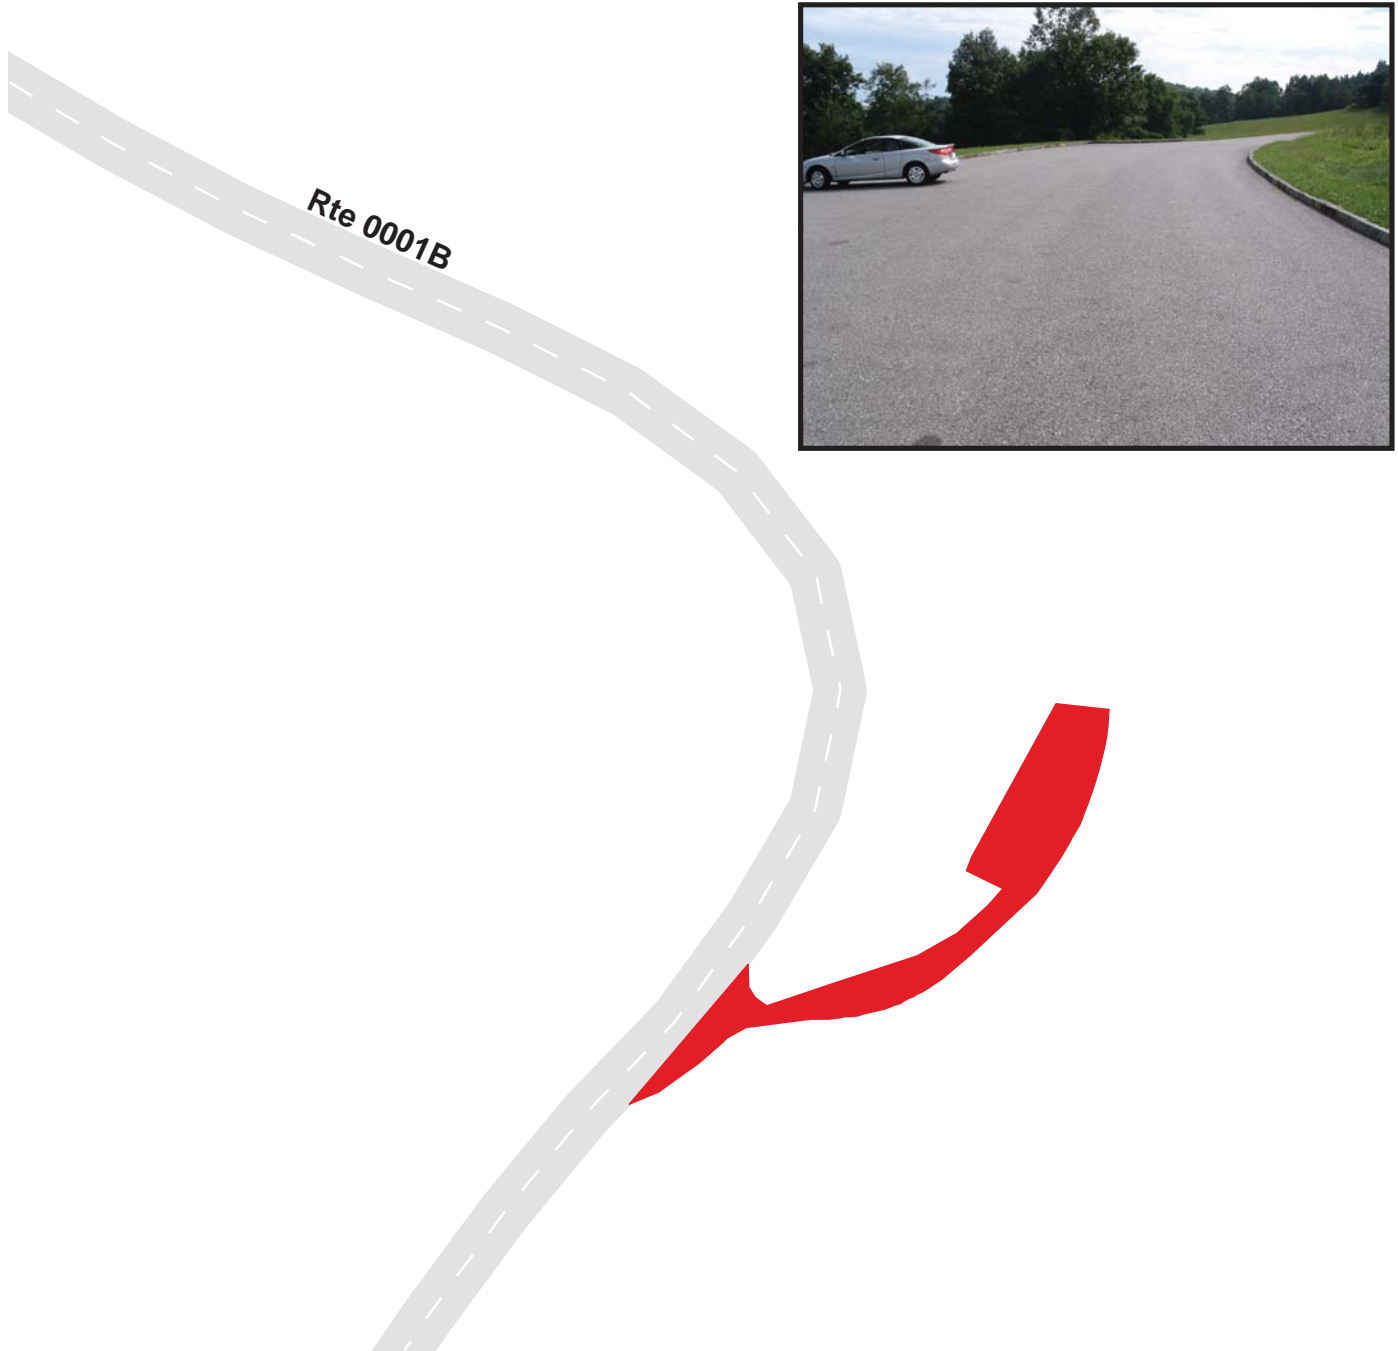
Blue Ridge Parkway
Route 0987
Devils Backbone
From Route 0234 at 0.08 on Right

Route	Public / NonPublic	Date Visited	Area (sq ft)	Lane Miles *	Surface Type	Condition / PCR
0987	Public	9/7/2003	5555	0.10	AS	GOOD / 90

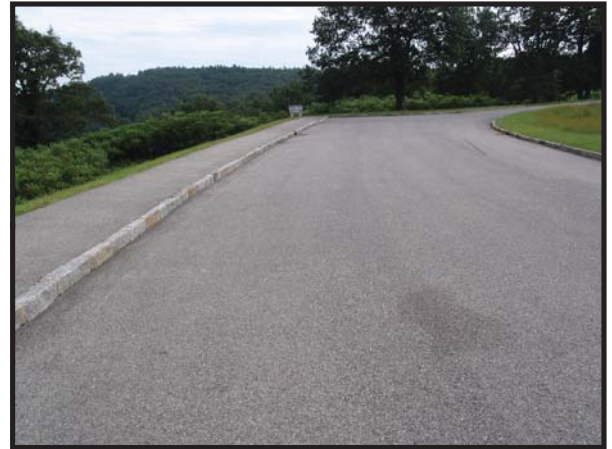
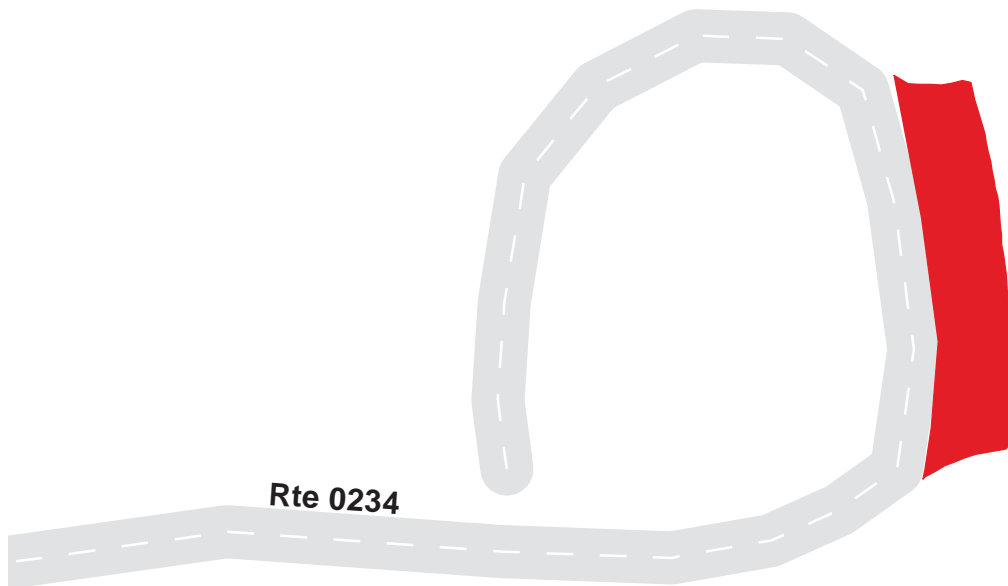
Route 0988

Route	Public / NonPublic	Date Visited	Area (sq ft)	Lane Miles *	Surface Type	Condition / PCR
0988	Public	9/7/2003	20881	0.36	AS	GOOD / 90

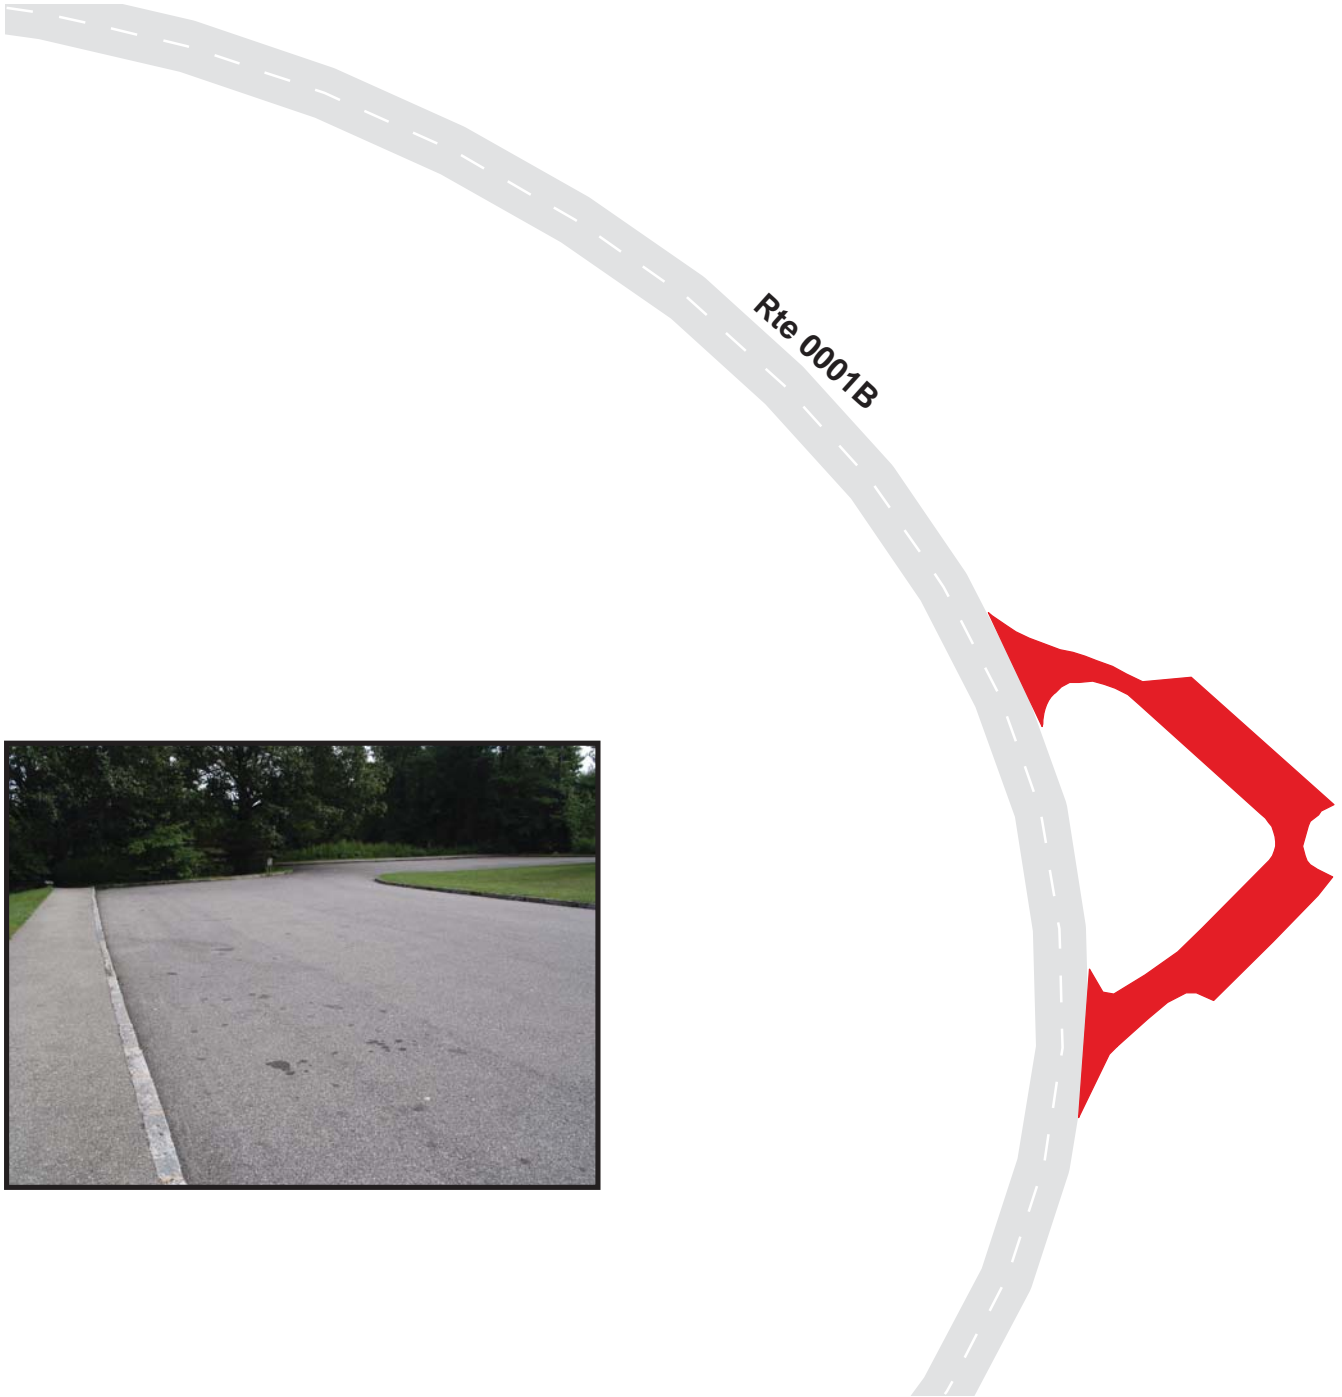
Route 0989

Route	Public / NonPublic	Date Visited	Area (sq ft)	Lane Miles *	Surface Type	Condition / PCR
0989	Public	9/7/2003	16388	0.28	AS	GOOD / 90

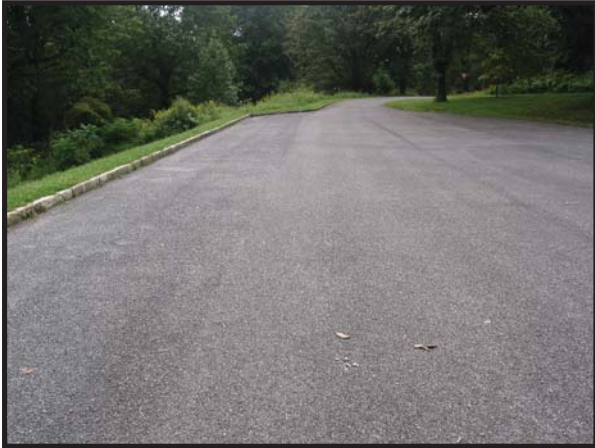
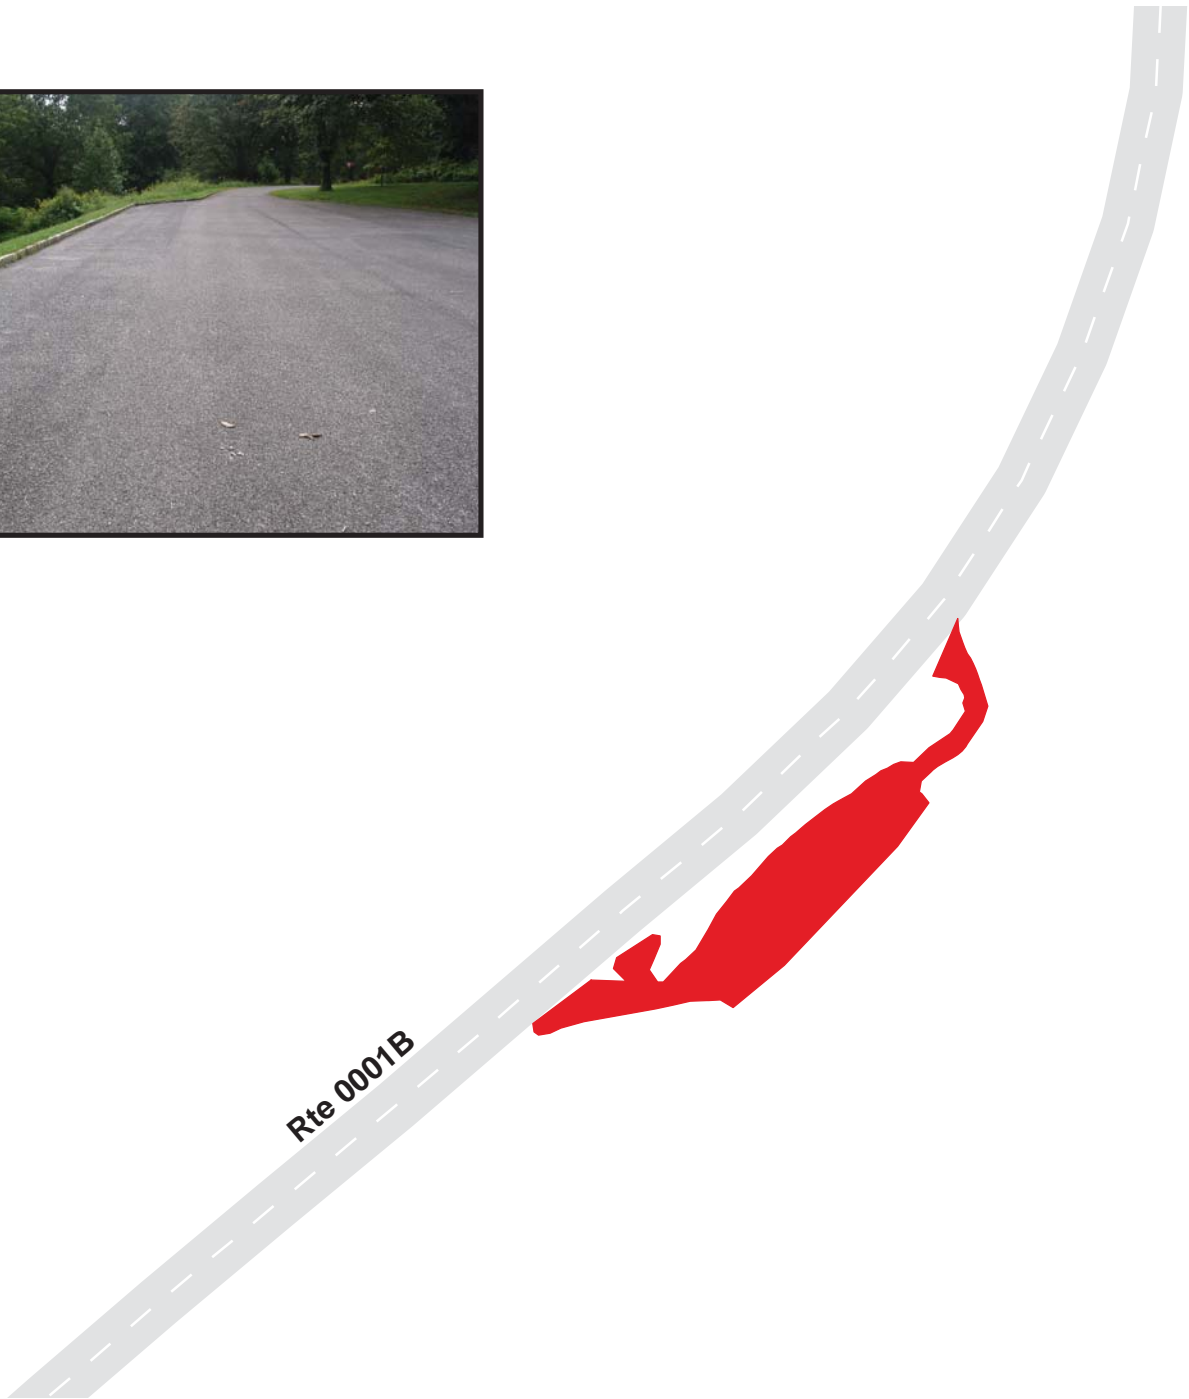
Route 0990

Route	Public / NonPublic	Date Visited	Area (sq ft)	Lane Miles *	Surface Type	Condition / PCR
0990	Public	9/7/2003	7500	0.13	AS	GOOD / 90

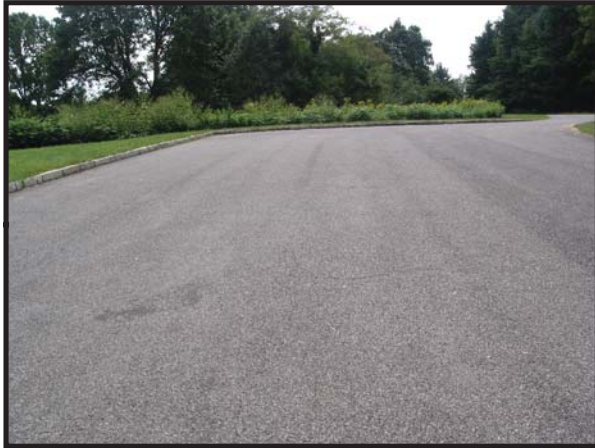
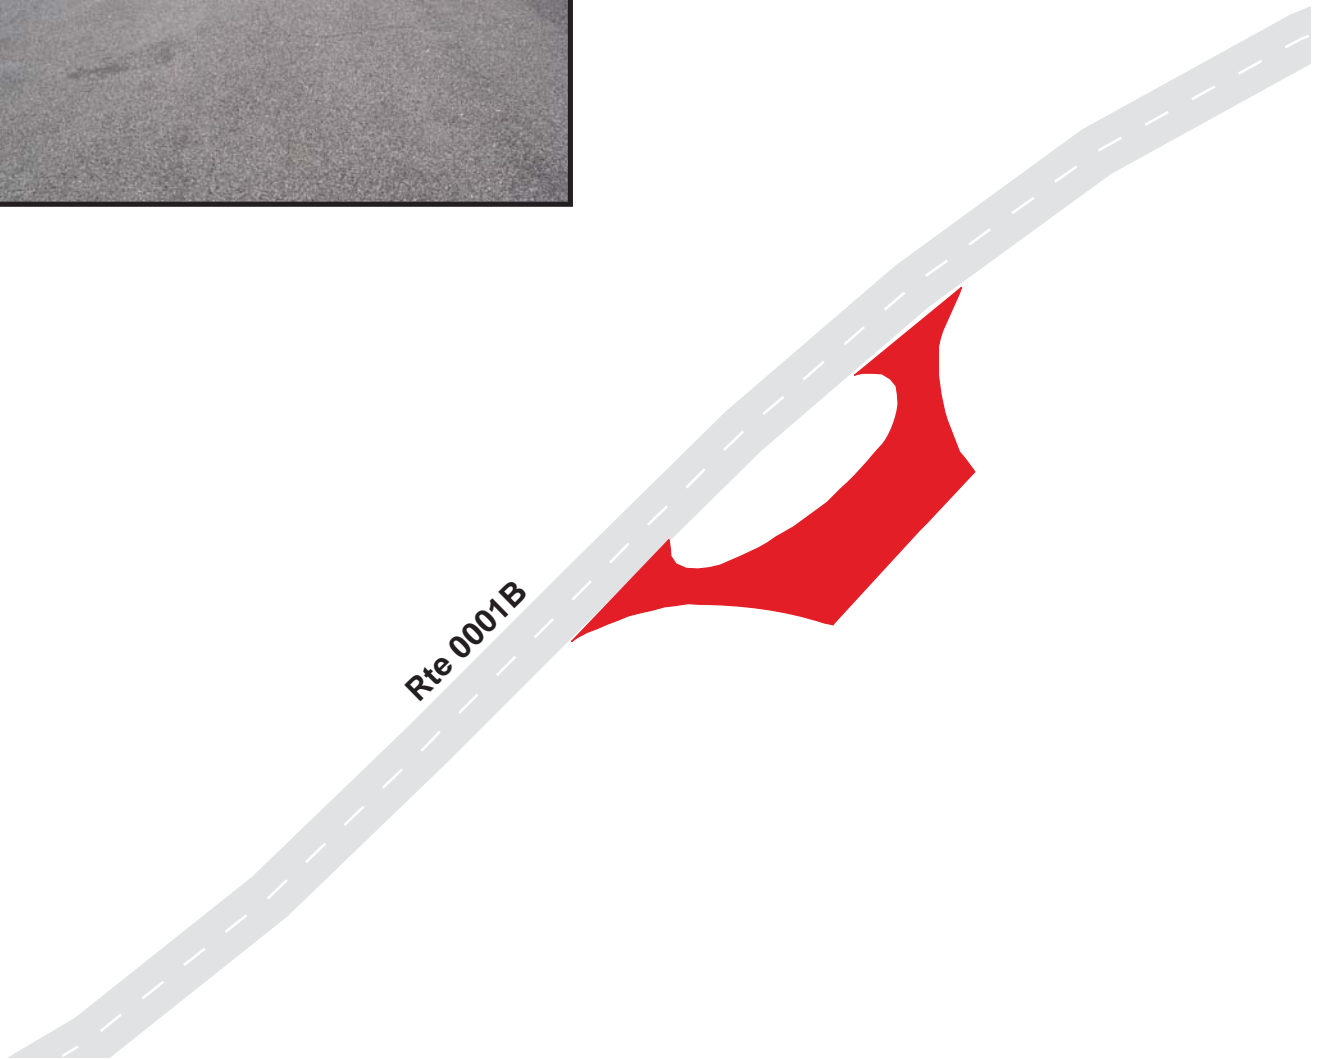
Route 0991

Route	Public / NonPublic	Date Visited	Area (sq ft)	Lane Miles *	Surface Type	Condition / PCR
0991	Public	9/7/2003	5915	0.10	AS	GOOD / 90

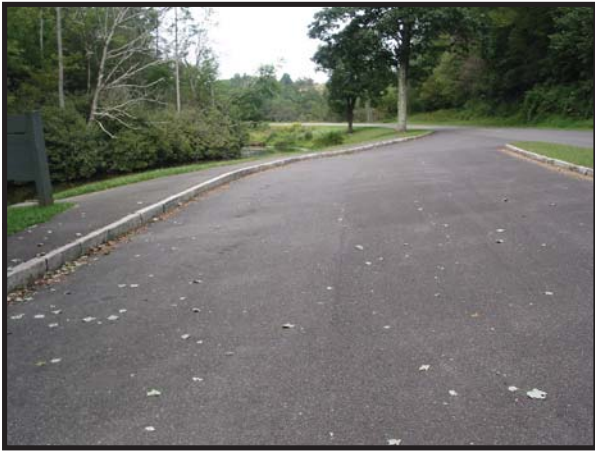
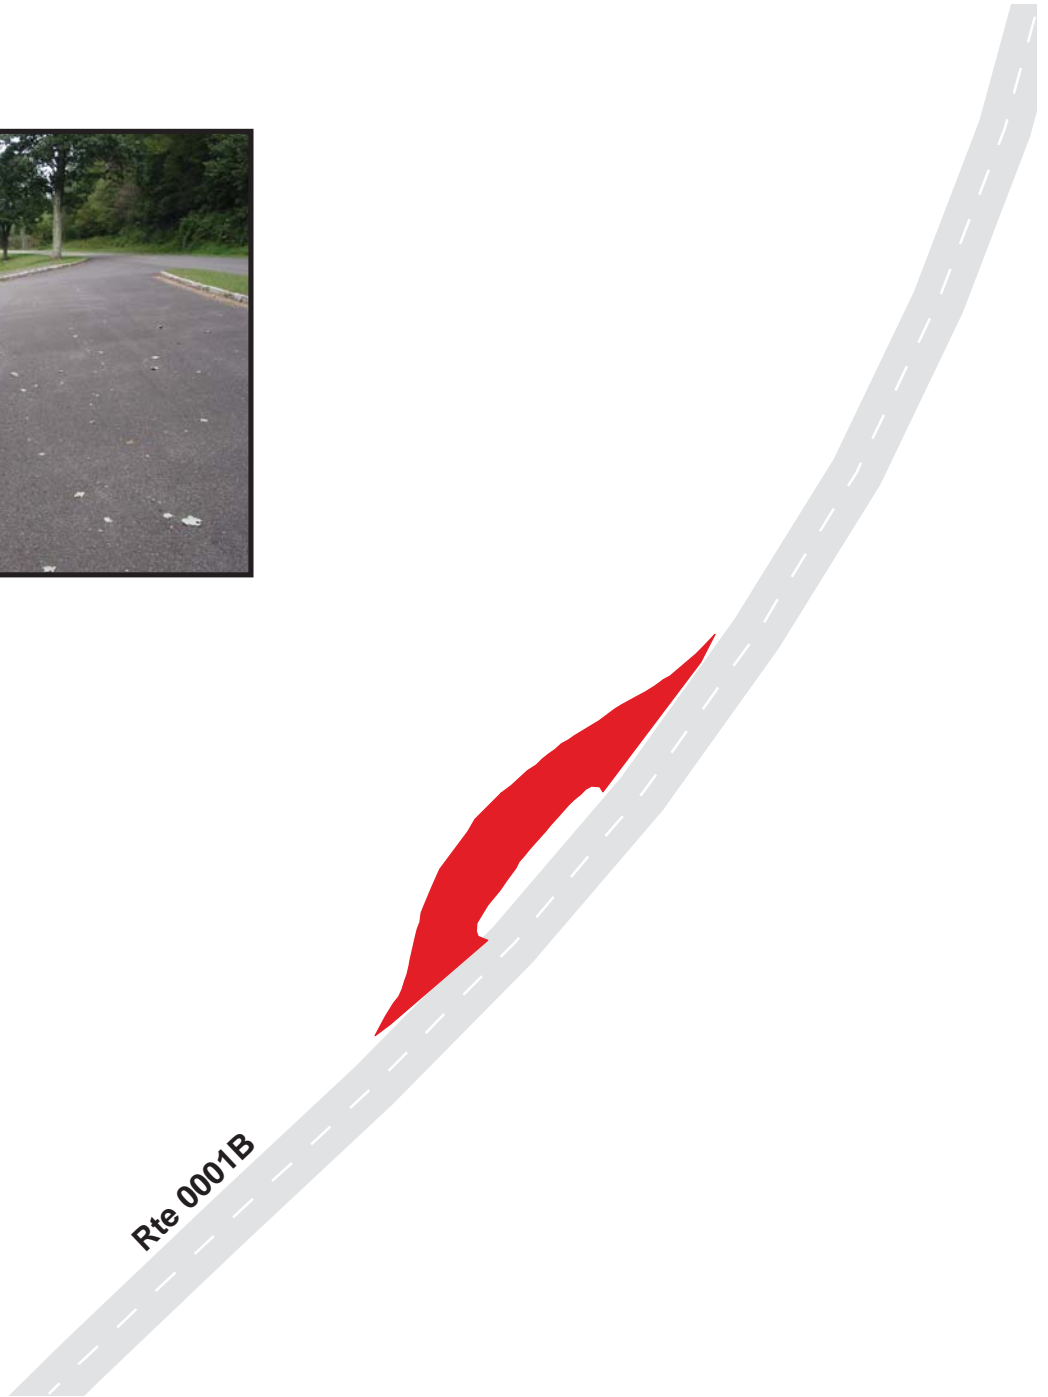
Route 0992

Route	Public / NonPublic	Date Visited	Area (sq ft)	Lane Miles *	Surface Type	Condition / PCR
0992	Public	9/7/2003	40101	0.69	AS	FAIR / 73

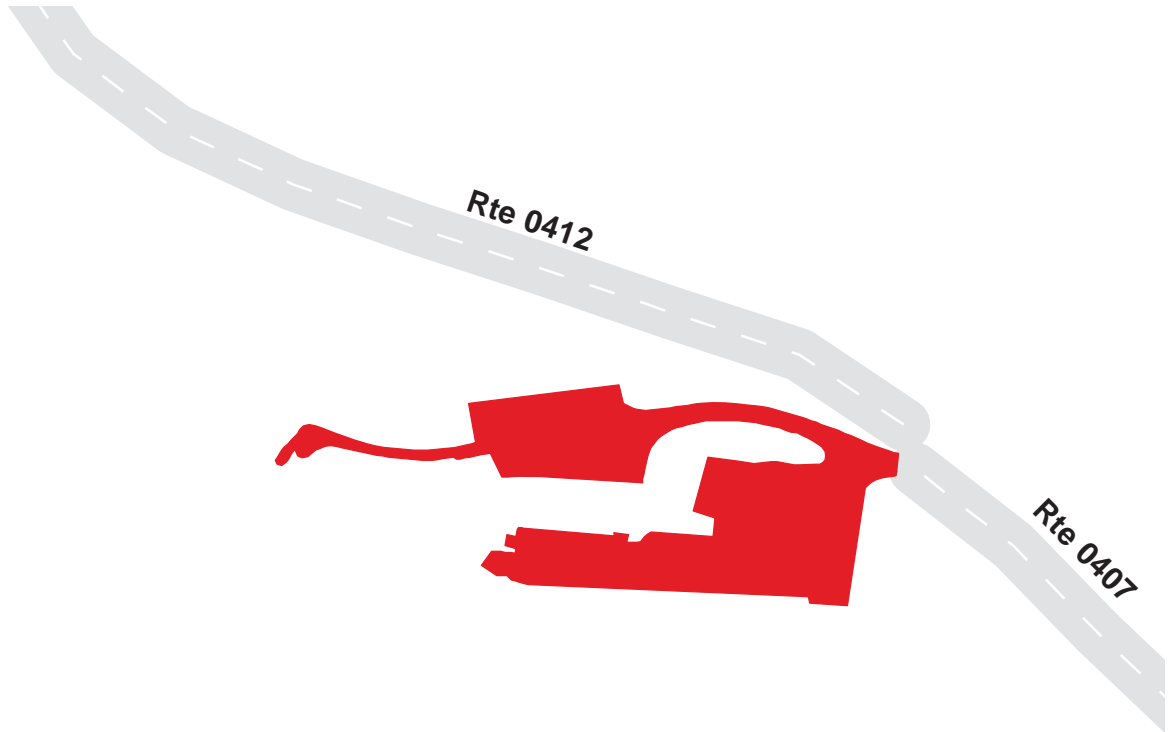
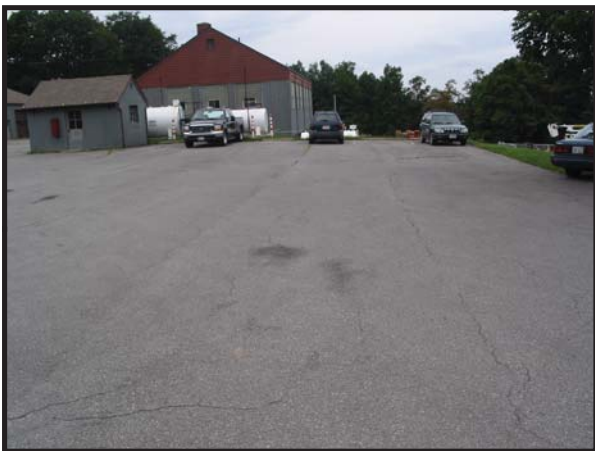
Route 0993A

Route	Public / NonPublic	Date Visited	Area (sq ft)	Lane Miles *	Surface Type	Condition / PCR
0993A	NonPublic	9/7/2003	3097	0.05	AS	GOOD / 90

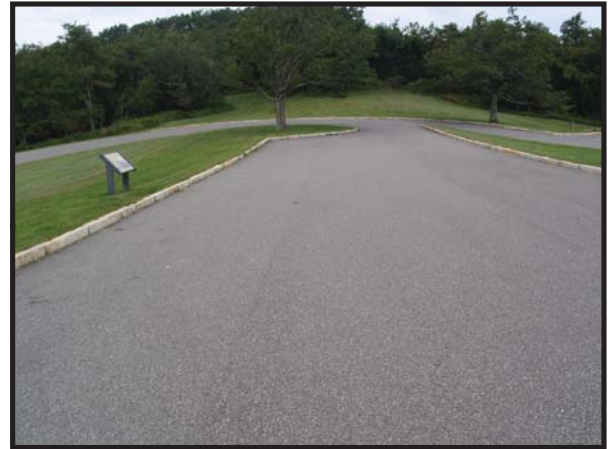
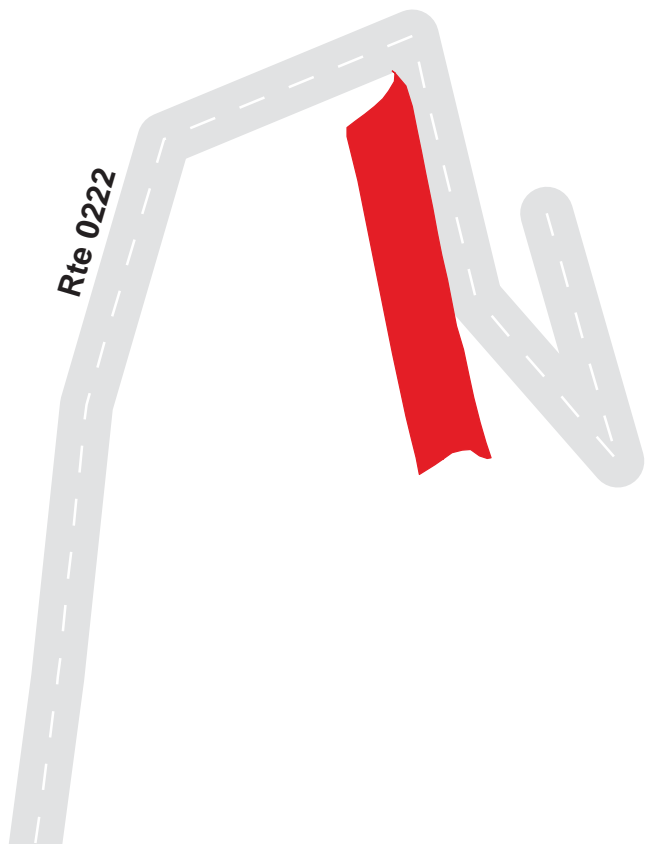
Route 0993B

Route	Public / NonPublic	Date Visited	Area (sq ft)	Lane Miles *	Surface Type	Condition / PCR
0993B	Public	9/7/2003	2696	0.05	AS	GOOD / 90

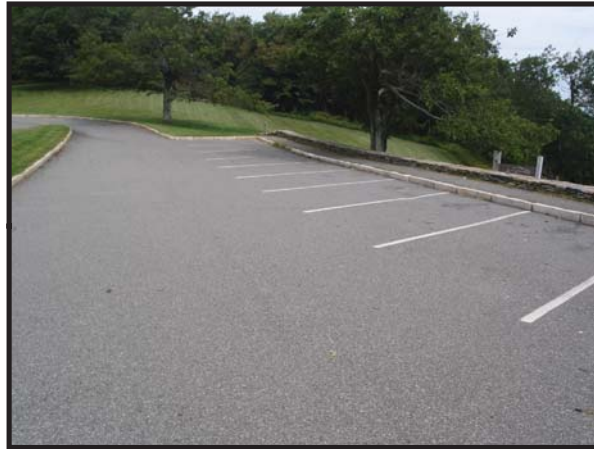
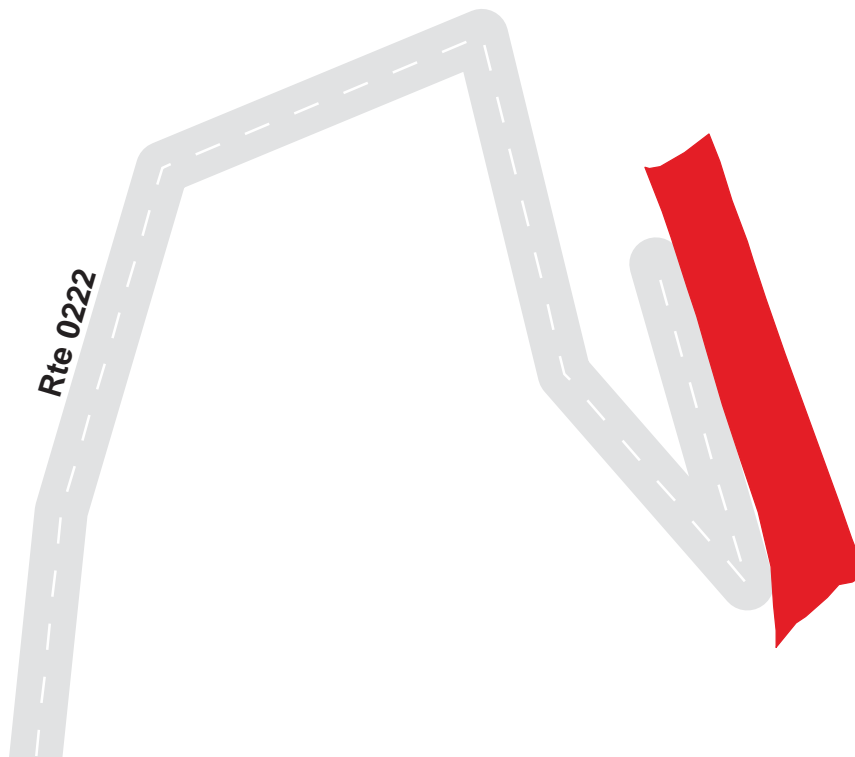
Route 0994

Route	Public / NonPublic	Date Visited	Area (sq ft)	Lane Miles *	Surface Type	Condition / PCR
0994	Public	9/7/2003	9485	0.16	AS	GOOD / 90

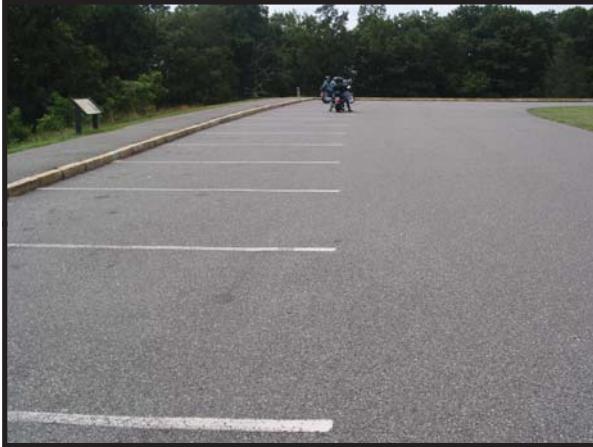
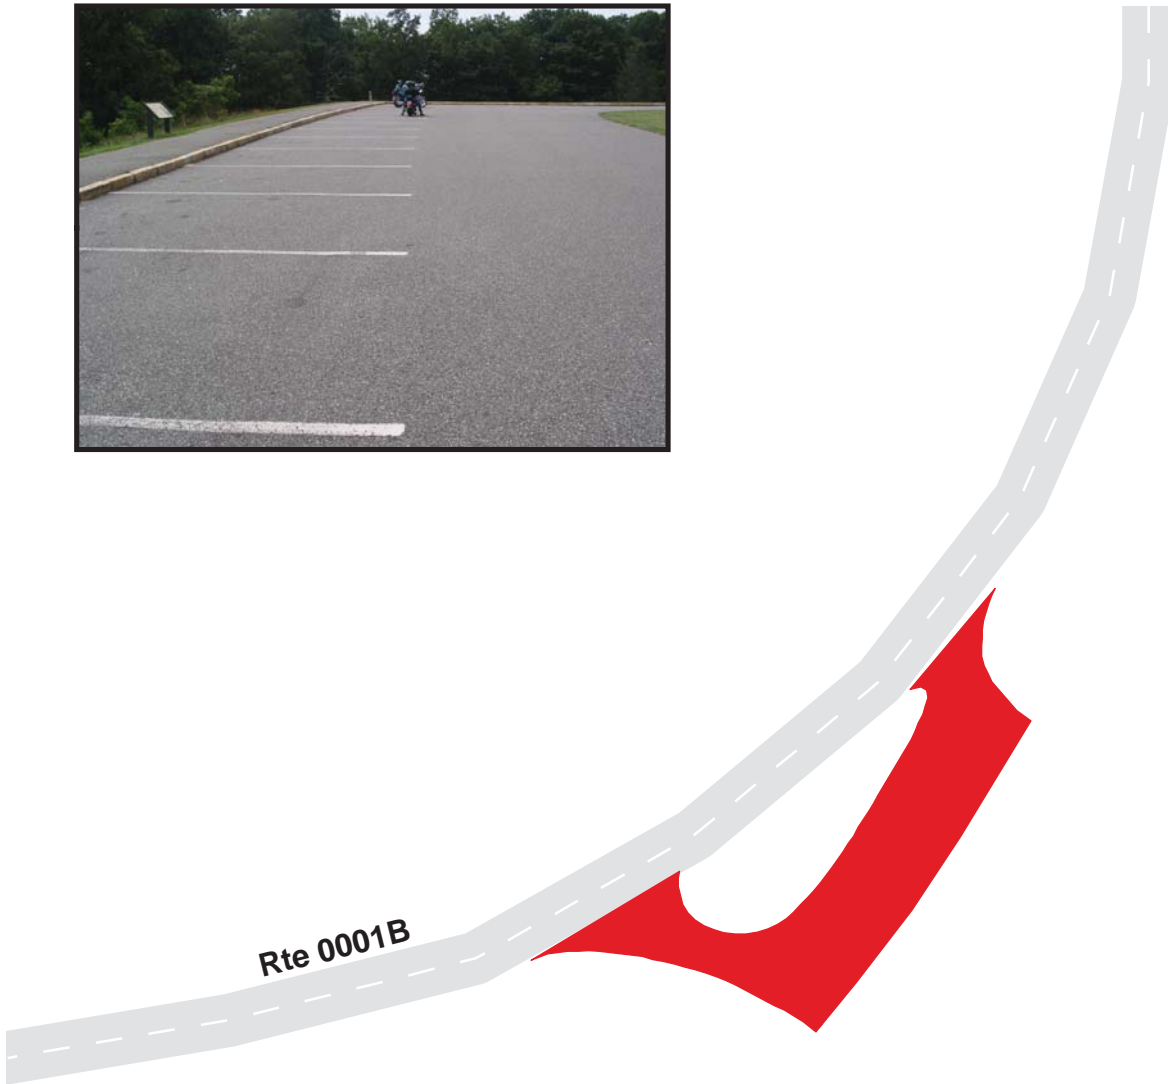
Route 0995

Route	Public / NonPublic	Date Visited	Area (sq ft)	Lane Miles *	Surface Type	Condition / PCR
0995	Public	9/5/2003	26122	0.45	AS	GOOD / 90

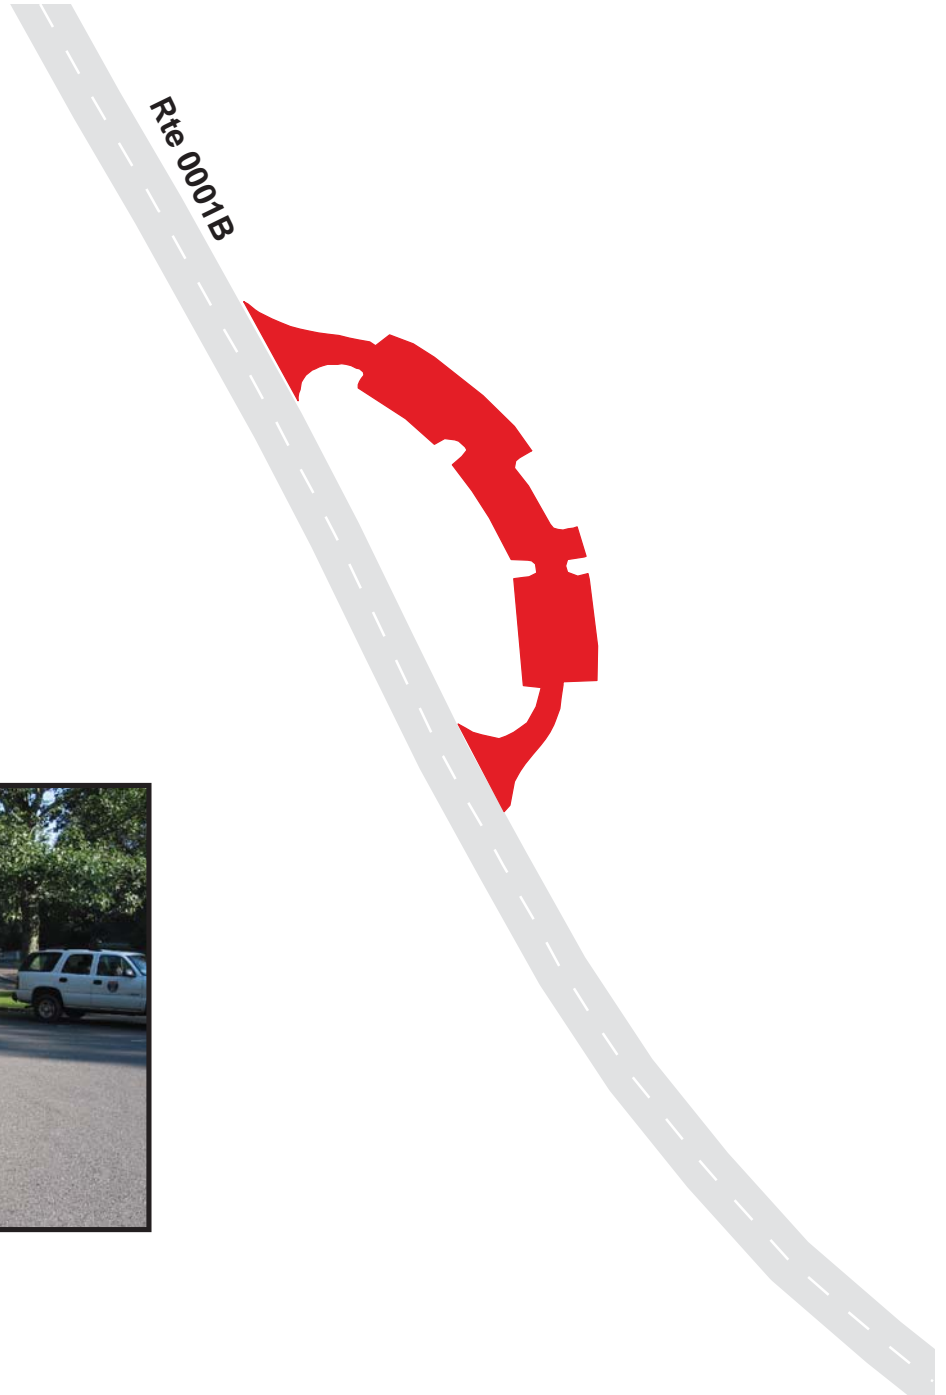
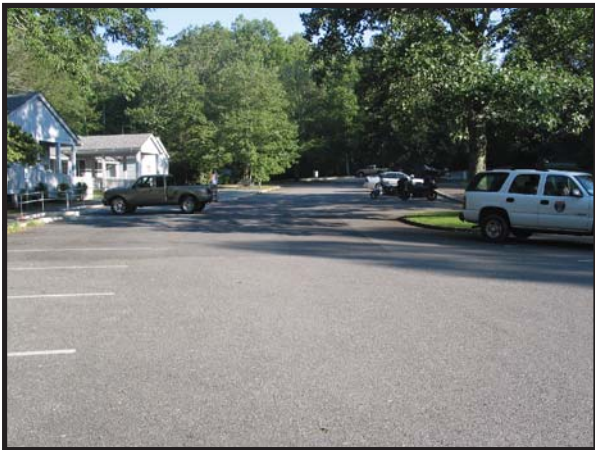
Route 0996

Route	Public / NonPublic	Date Visited	Area (sq ft)	Lane Miles *	Surface Type	Condition / PCR
0996	Public	9/5/2003	7208	0.12	AS	GOOD / 90

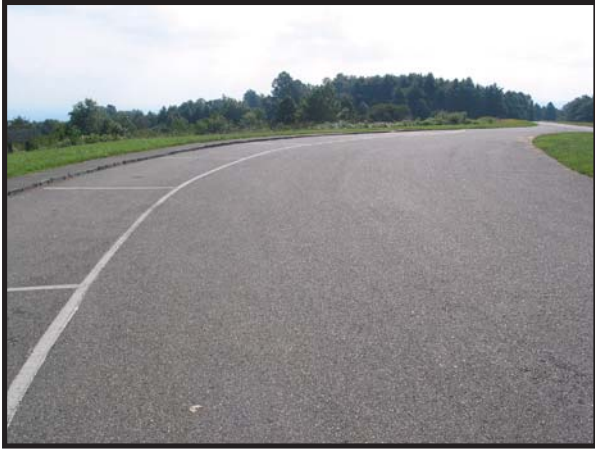
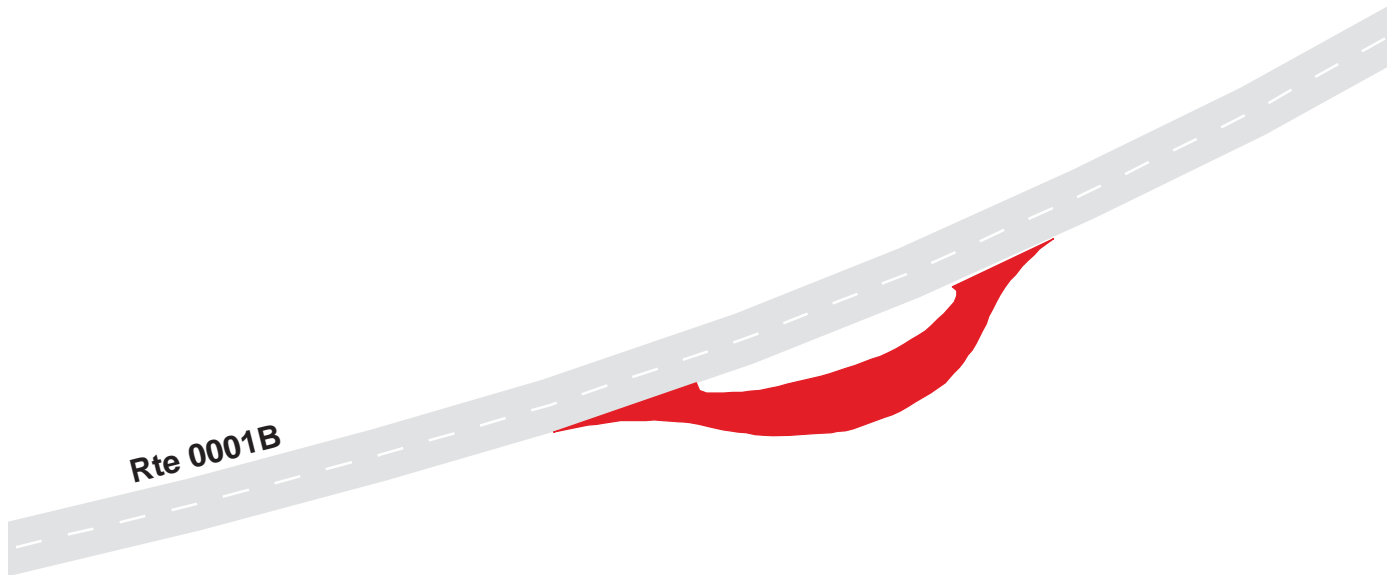
Route 0997

Route	Public / NonPublic	Date Visited	Area (sq ft)	Lane Miles *	Surface Type	Condition / PCR
0997	Public	9/5/2003	2633	0.05	AS	GOOD / 90

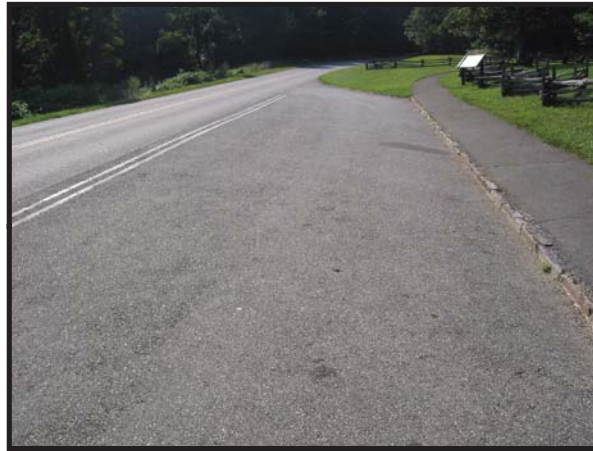
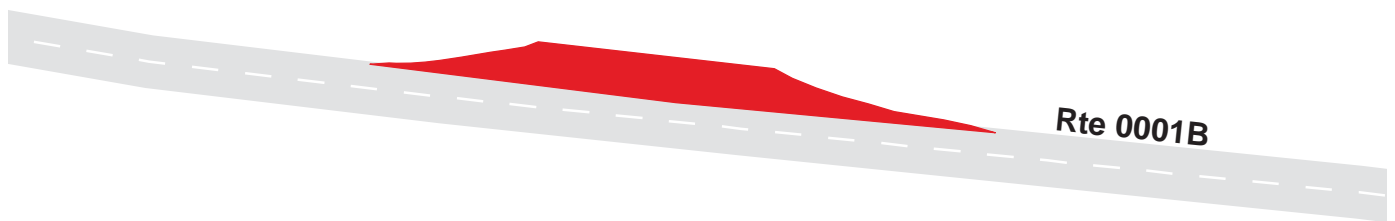
Route 0998

Route	Public / NonPublic	Date Visited	Area (sq ft)	Lane Miles *	Surface Type	Condition / PCR
0998	Public	9/5/2003	21511	0.37	AS	GOOD / 90

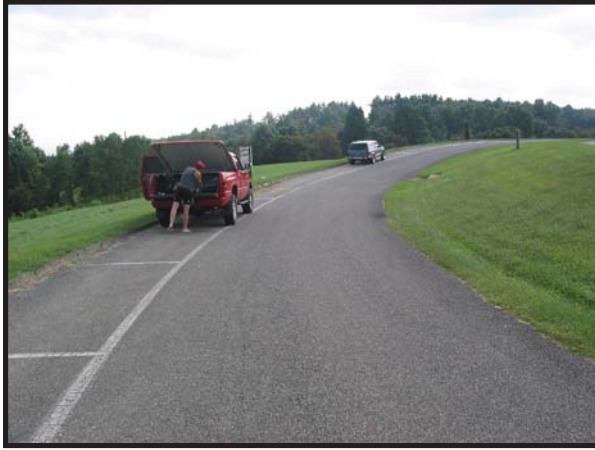
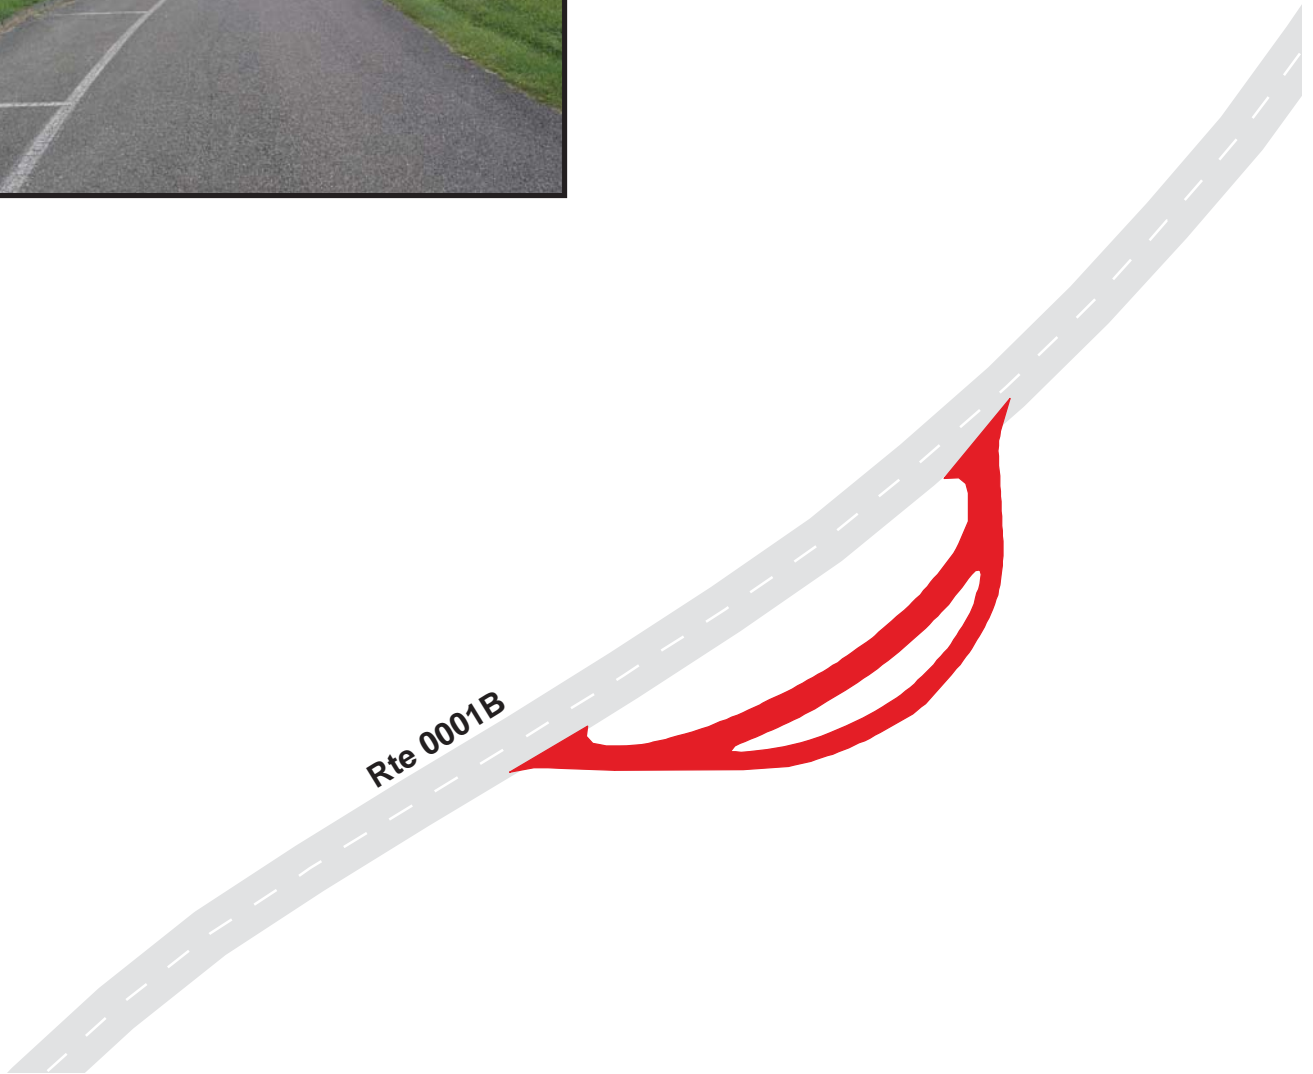
Route 0999

Route	Public / NonPublic	Date Visited	Area (sq ft)	Lane Miles *	Surface Type	Condition / PCR
0999	Public	9/5/2003	11504	0.20	AS	GOOD / 90

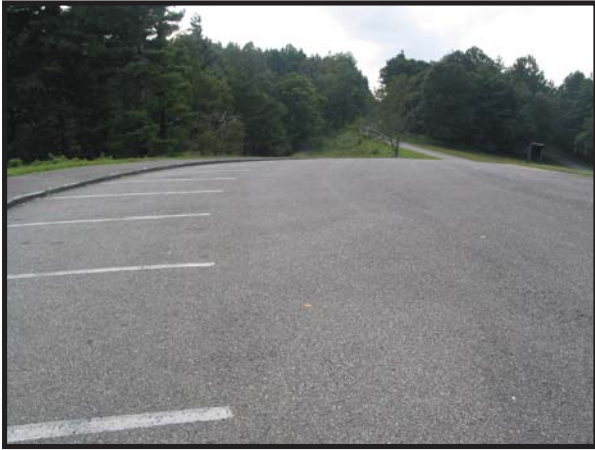
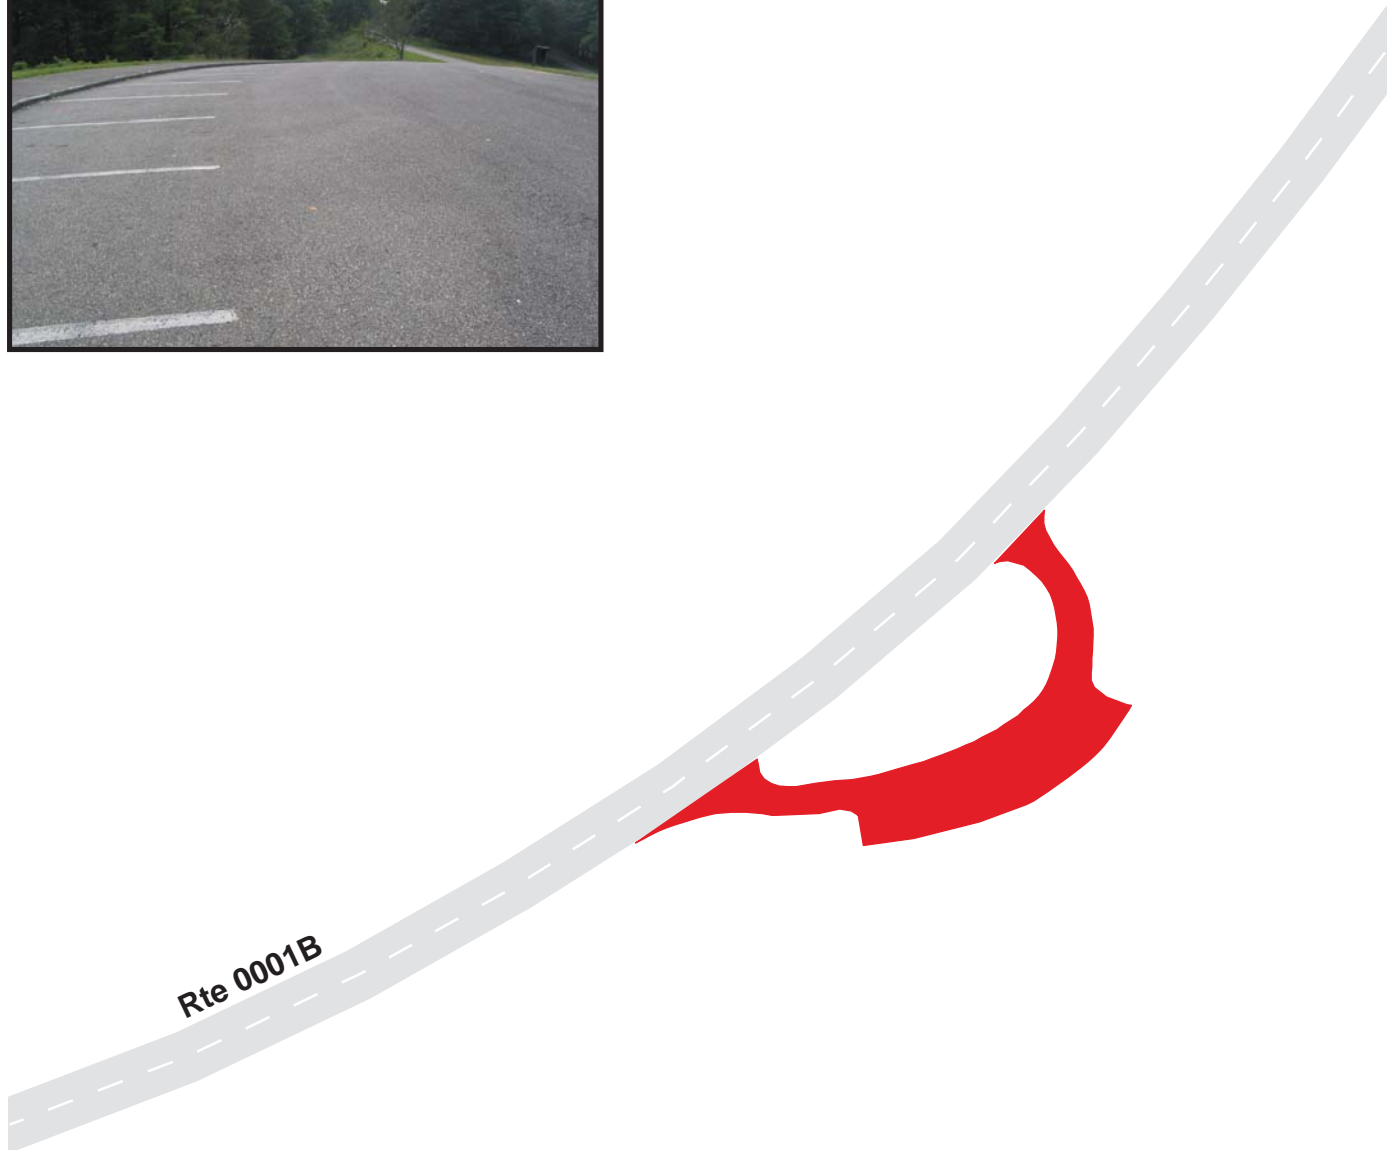
Route 1000

Route	Public / NonPublic	Date Visited	Area (sq ft)	Lane Miles *	Surface Type	Condition / PCR
1000	Public	9/4/2003	11721	0.20	AS	FAIR / 73
