The Road Inventory of Blue Ridge Parkway BLRI – 5140 Volume 1

Road Inventory Program

Prepared By:
Federal Highway Administration
Eastern Federal Lands Highway Division
Cycle 3

Blue Ridge Parkway in North Carolina

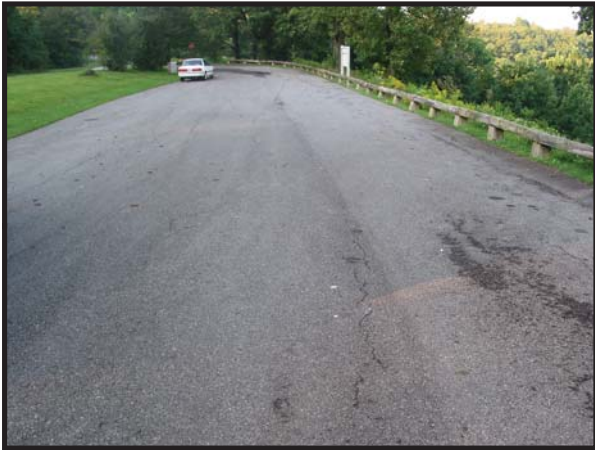
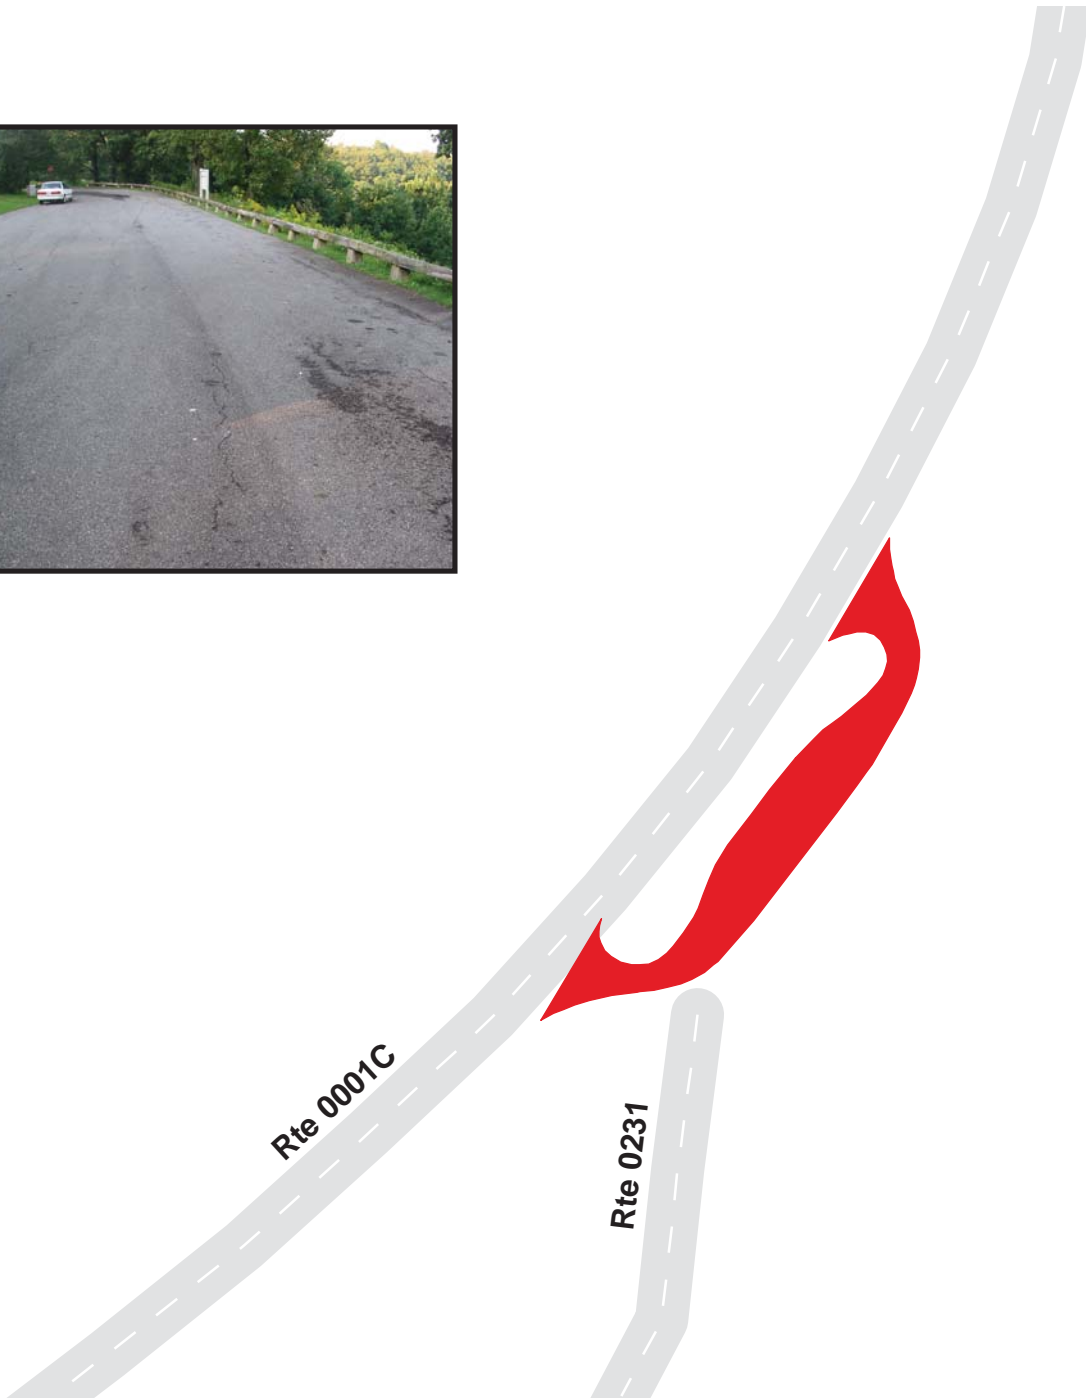
Blue Ridge Parkway Route 1001

Fox Hunter Picnic Area
Adjacent to Route 0231 at MP 0.12 on Right

Route	Public / NonPublic	Date Visited	Area (sq ft)	Lane Miles *	Surface Type	Condition / PCR
1001	Public	9/4/2003	3149	0.05	AS	GOOD / 90

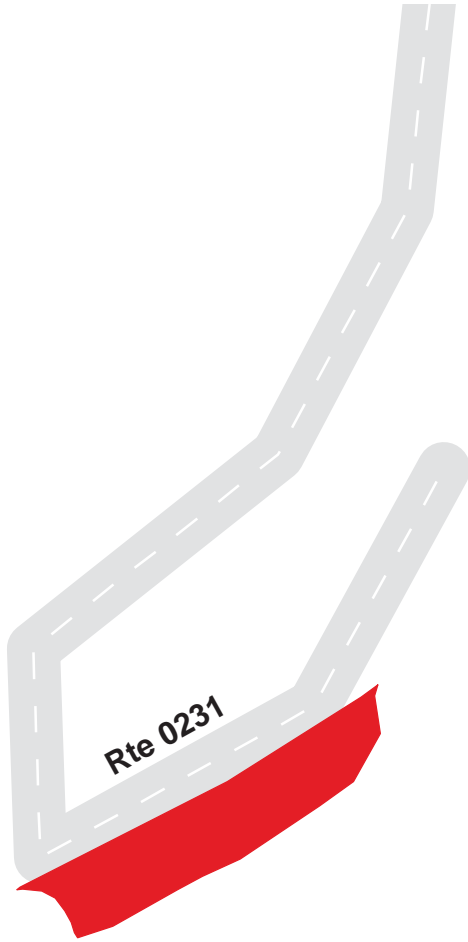
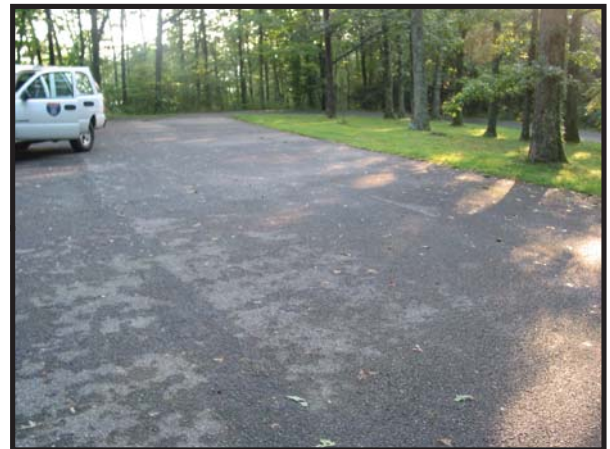
Route 1002

Route	Public / NonPublic	Date Visited	Area (sq ft)	Lane Miles *	Surface Type	Condition / PCR
1002	Public	9/5/2003	4247	0.07	AS	FAIR / 73

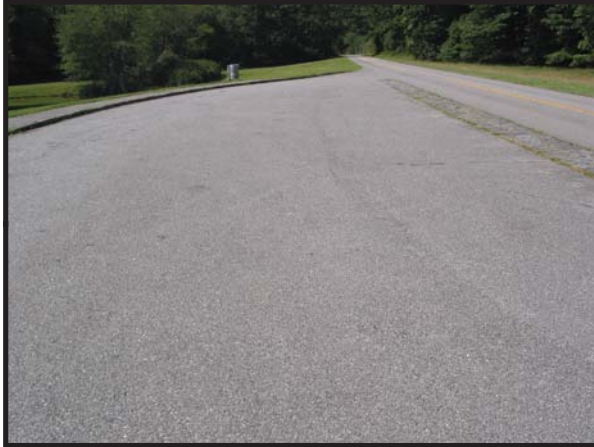
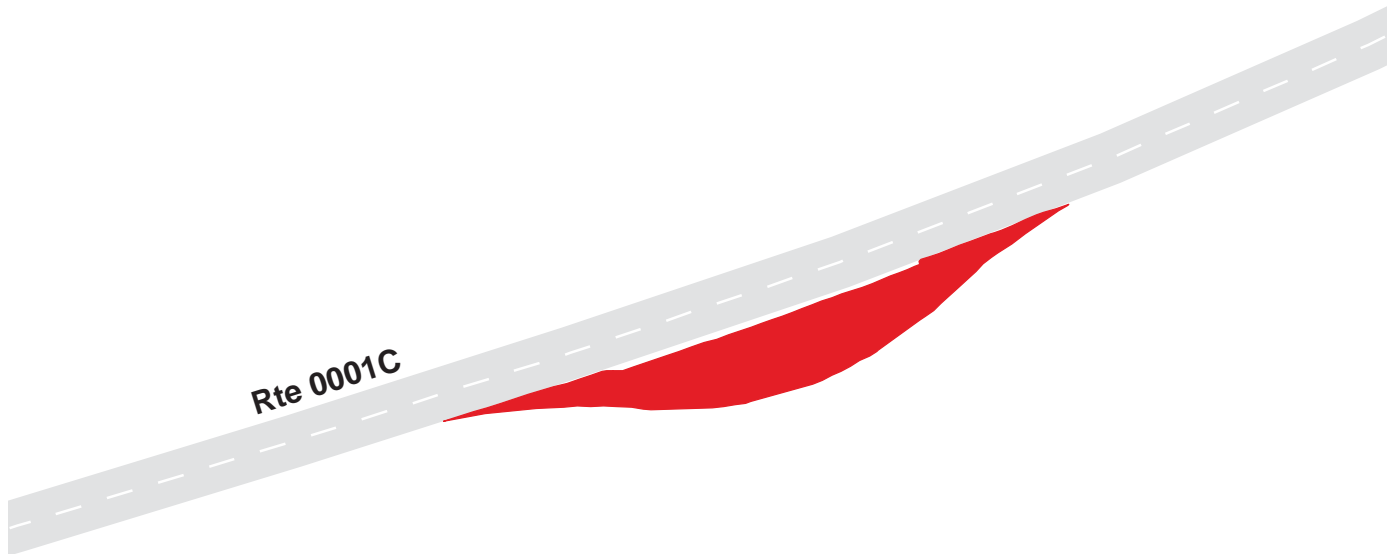
Route 1003

Route	Public / NonPublic	Date Visited	Area (sq ft)	Lane Miles *	Surface Type	Condition / PCR
1003	Public	9/5/2003	18042	0.31	AS	FAIR / 73

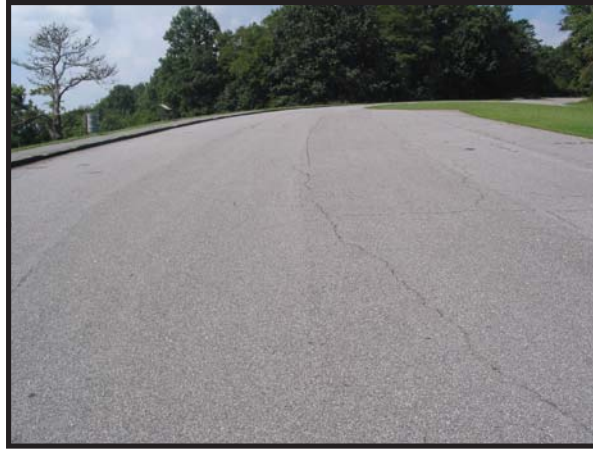
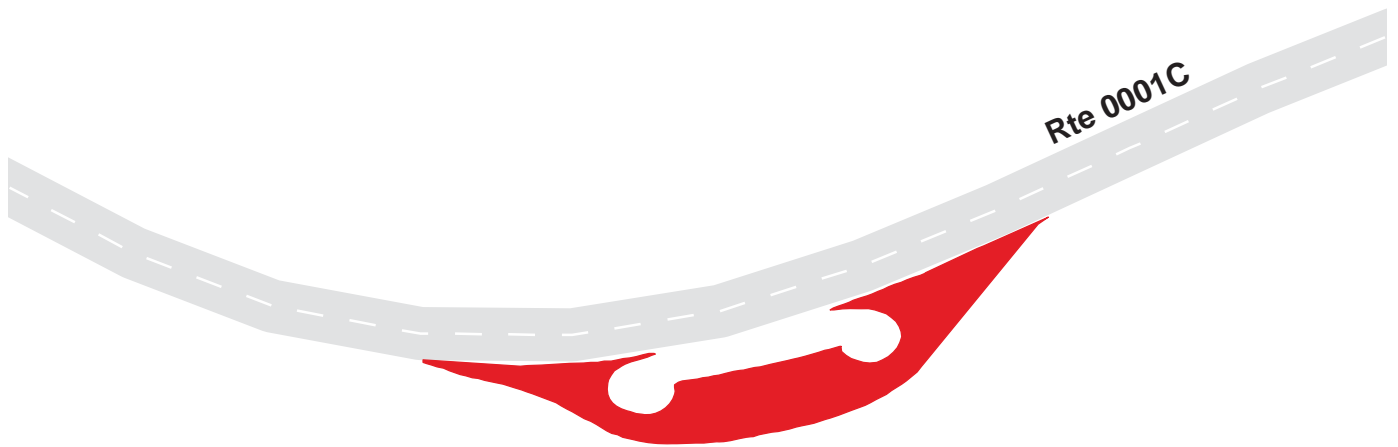
Route 1004

Route	Public / NonPublic	Date Visited	Area (sq ft)	Lane Miles *	Surface Type	Condition / PCR
1004	Public	9/5/2003	3313	0.06	AS	GOOD / 90

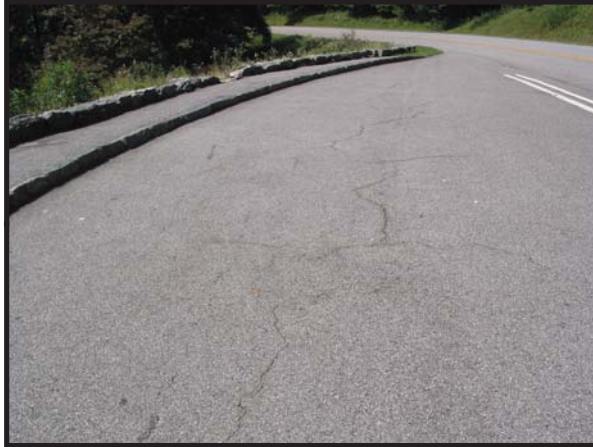
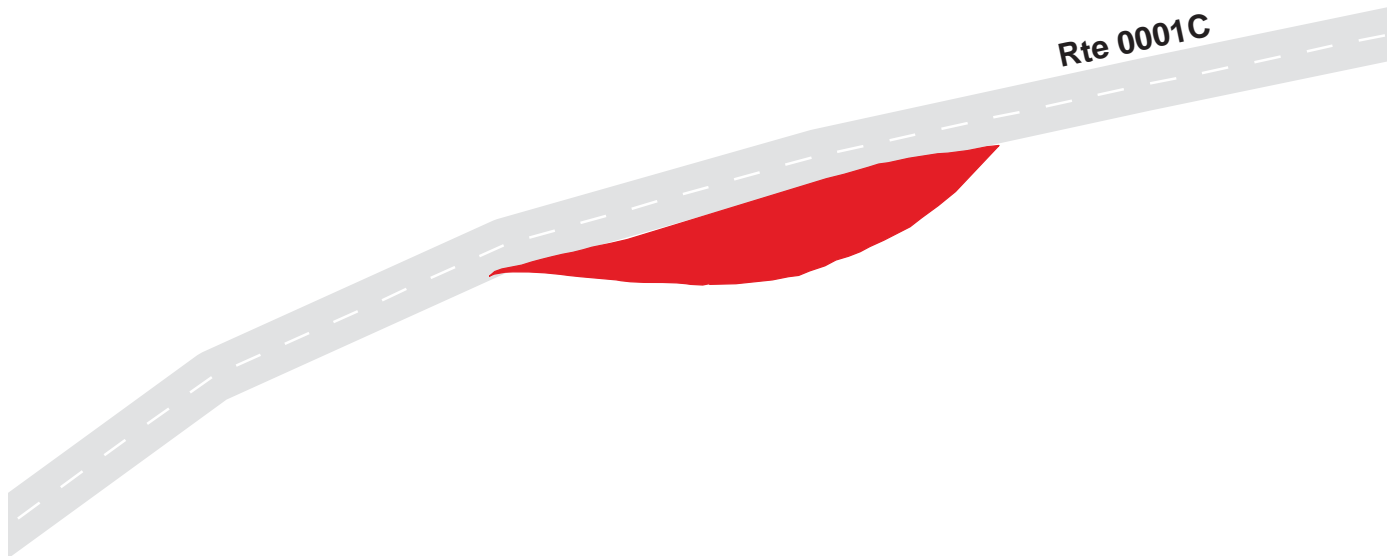
Route 1005

Route	Public / NonPublic	Date Visited	Area (sq ft)	Lane Miles *	Surface Type	Condition / PCR
1005	Public	9/5/2003	13534	0.23	AS	GOOD / 90

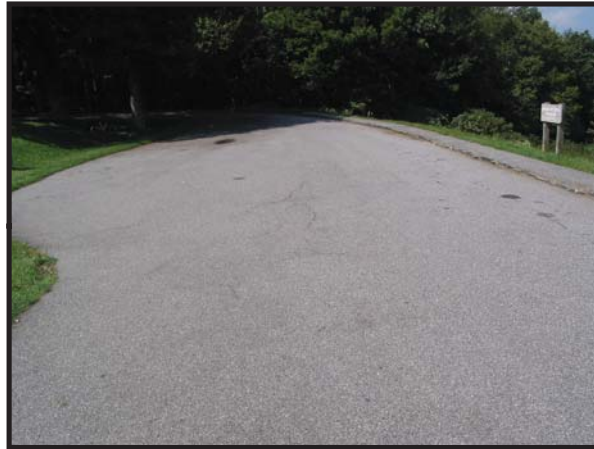
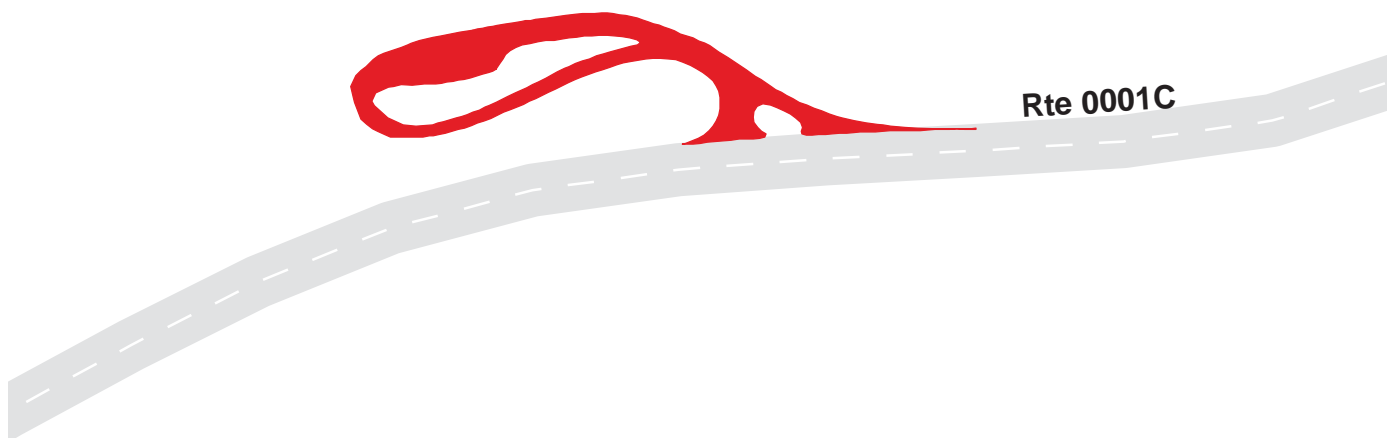
Route 1006

Route	Public / NonPublic	Date Visited	Area (sq ft)	Lane Miles *	Surface Type	Condition / PCR
1006	Public	9/5/2003	10630	0.18	AS	GOOD / 90

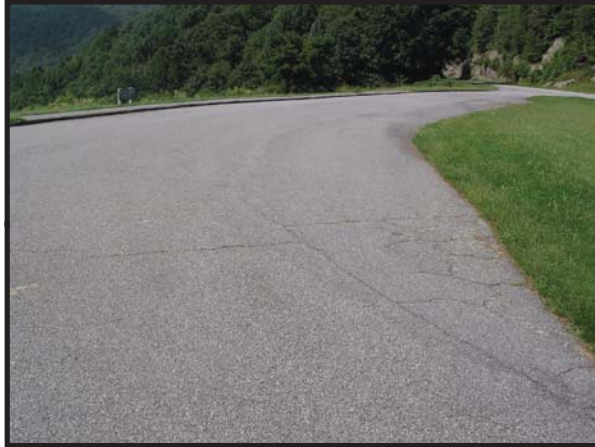
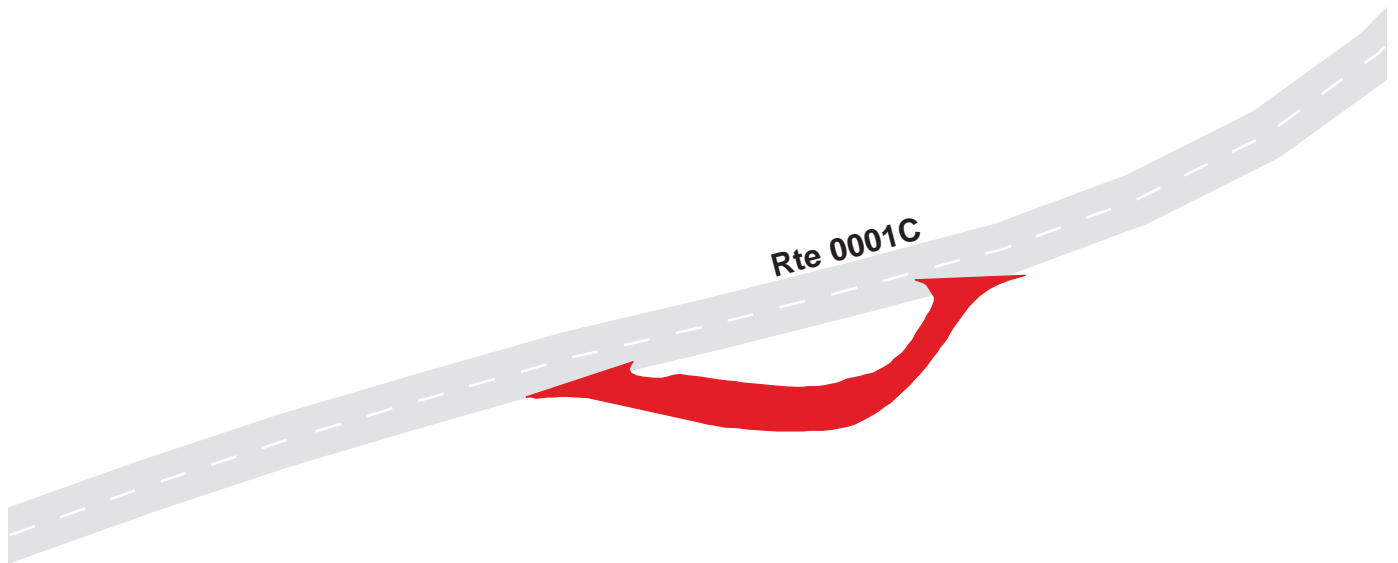
Route 1007

Route	Public / NonPublic	Date Visited	Area (sq ft)	Lane Miles *	Surface Type	Condition / PCR
1007	Public	9/5/2003	16921	0.29	AS	GOOD / 90

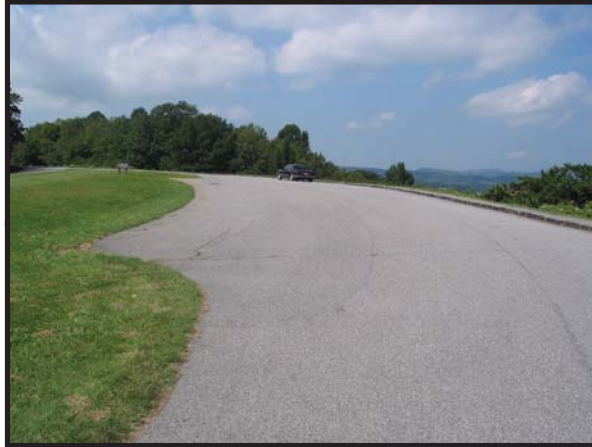
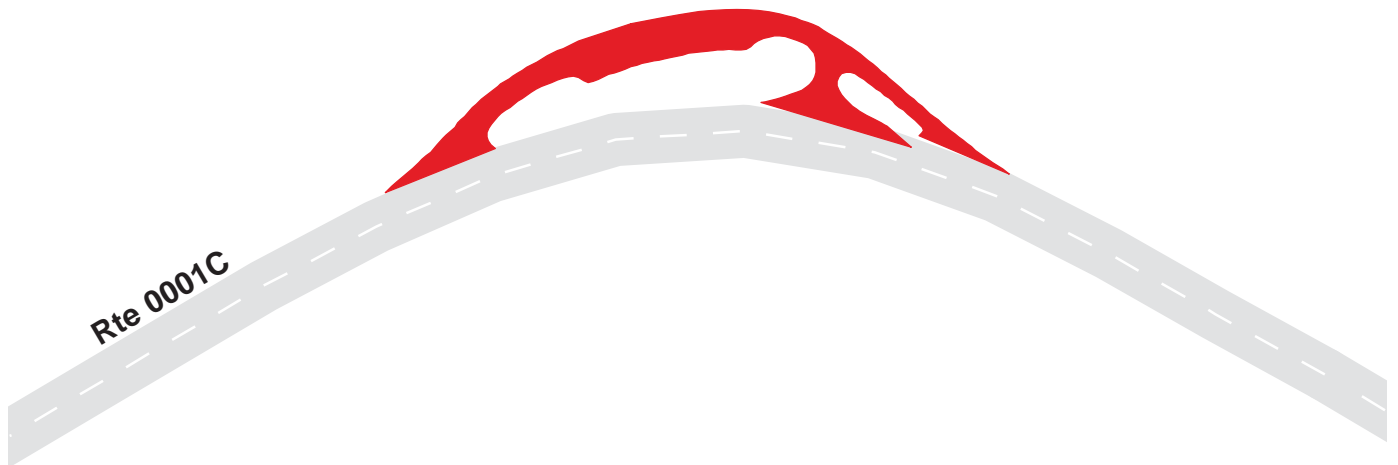
Route 1008

Route	Public / NonPublic	Date Visited	Area (sq ft)	Lane Miles *	Surface Type	Condition / PCR
1008	Public	9/5/2003	11712	0.20	AS	FAIR / 73

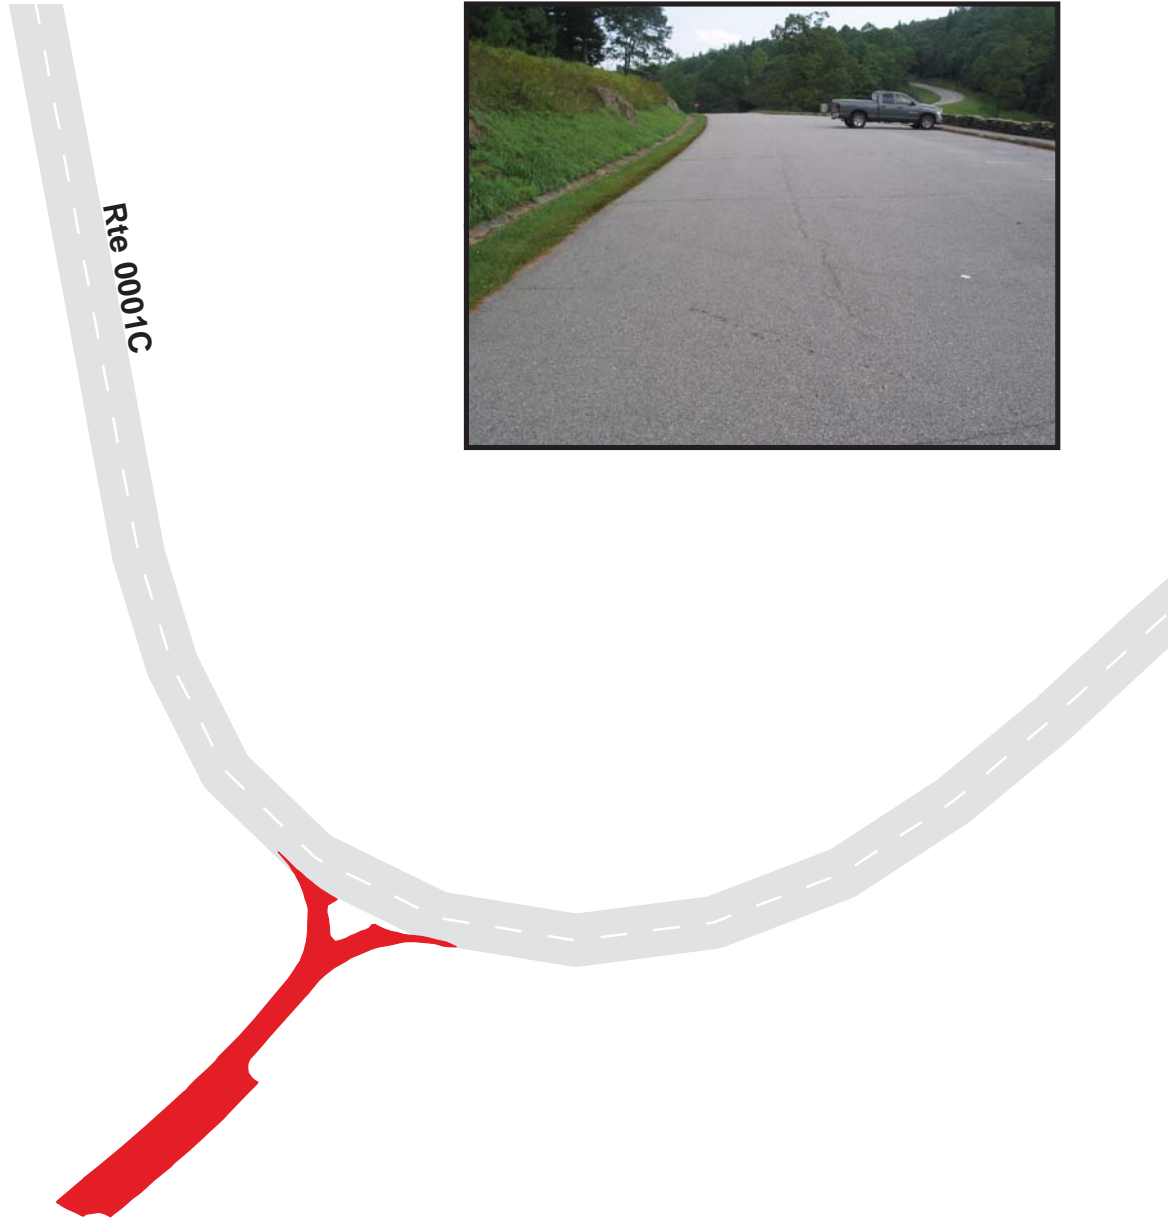
Blue Ridge Parkway Route 1009A

Fodders Stack Parking Area A
Adjacent to Route 0233 at MP 0.10 on Right

Route	Public / NonPublic	Date Visited	Area (sq ft)	Lane Miles *	Surface Type	Condition / PCR
1009A	Public	9/5/2003	2888	0.05	AS	GOOD / 90

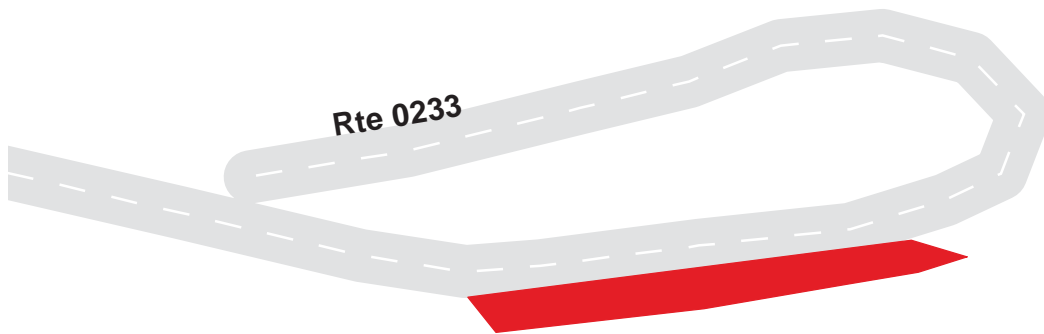
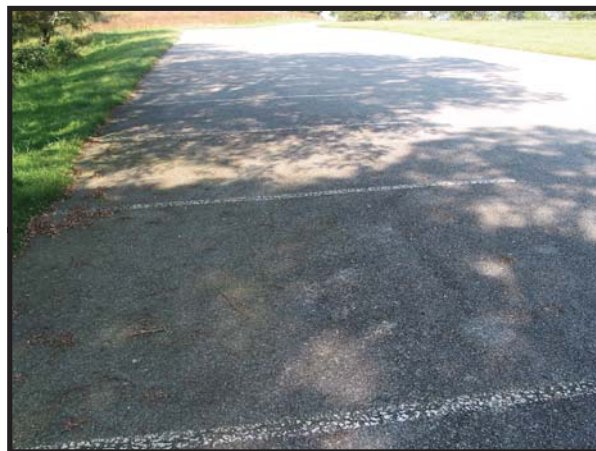
Blue Ridge Parkway Route 1009B

Fodders Stack Parking Area B
Adjacent to Route 0233 at MP 0.08 on Left

Route	Public / NonPublic	Date Visited	Area (sq ft)	Lane Miles *	Surface Type	Condition / PCR
1009B	Public	9/5/2003	2759	0.05	AS	GOOD / 90

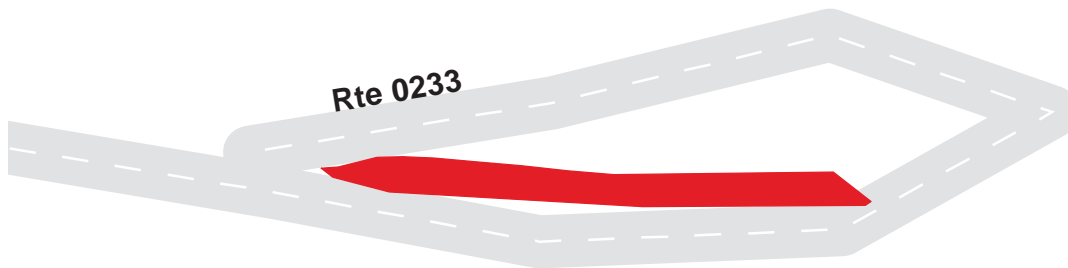
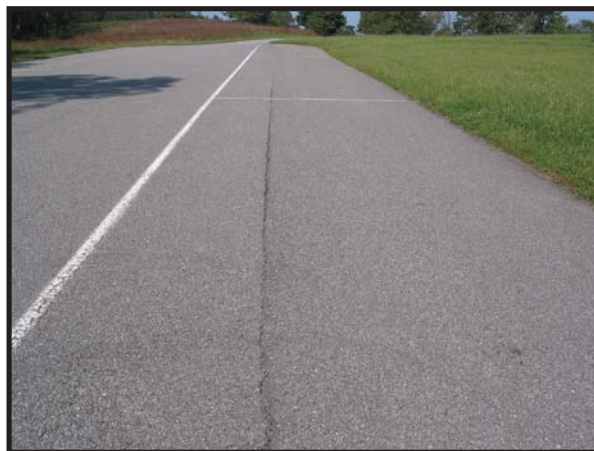
Route 1010A

Route	Public / NonPublic	Date Visited	Area (sq ft)	Lane Miles *	Surface Type	Condition / PCR
1010A	Public	9/5/2003	21555	0.37	AS	FAIR / 73

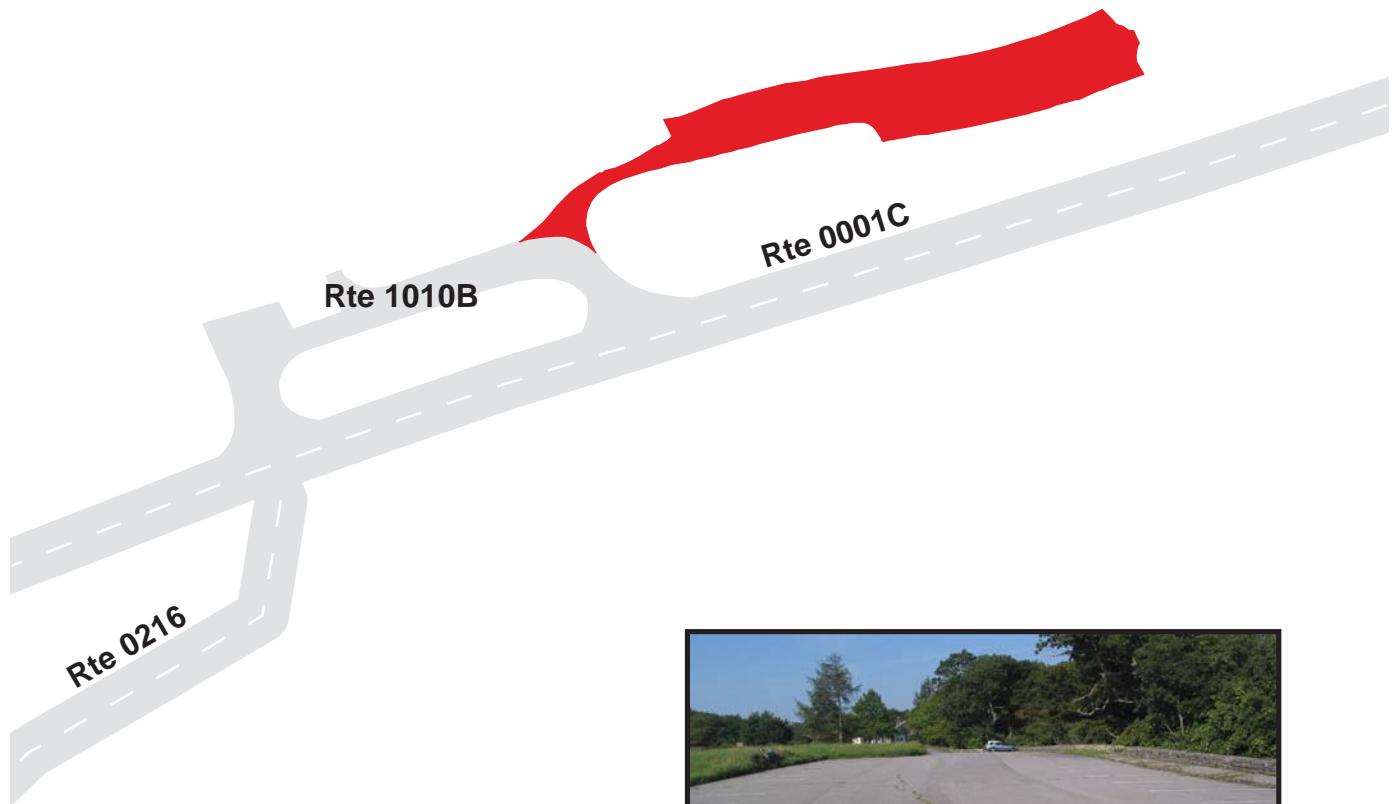
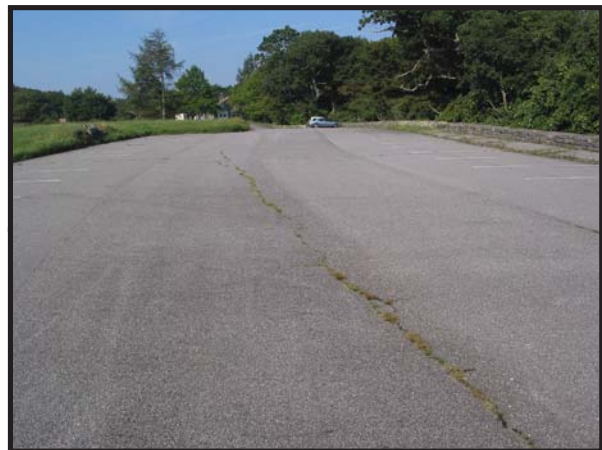
Route 1010B

Route	Public / NonPublic	Date Visited	Area (sq ft)	Lane Miles *	Surface Type	Condition / PCR
1010B	Public	9/5/2003	17463	0.30	AS	GOOD / 90

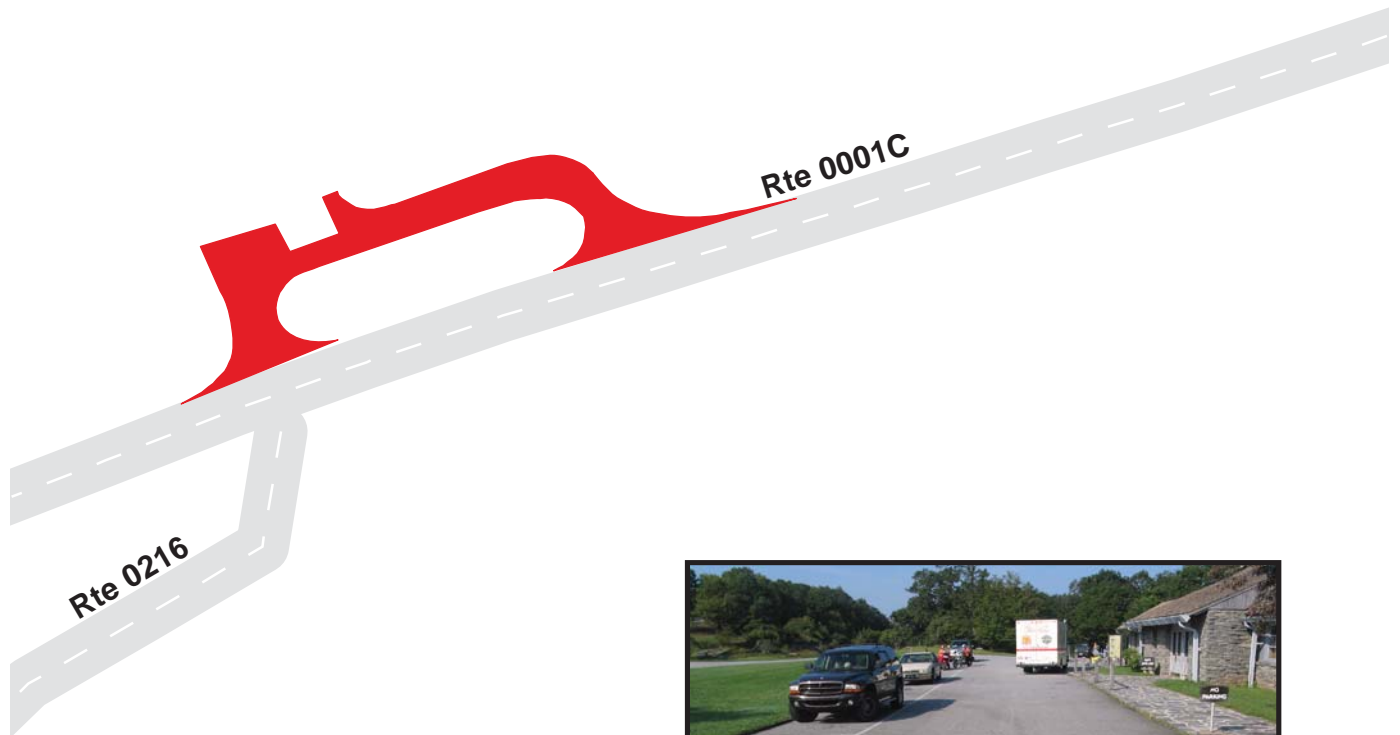
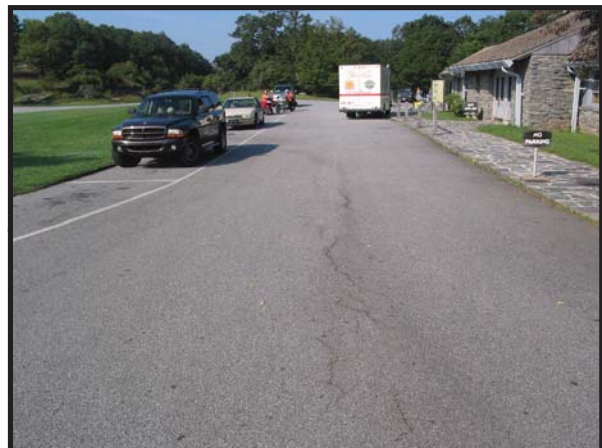
**Blue Ridge Parkway
Route 1010C**
Bluffs Gas Parking
Adjacent to Route 1010B on Left

Route	Public / NonPublic	Date Visited	Area (sq ft)	Lane Miles *	Surface Type	Condition / PCR
1010C	Public	9/5/2003	10849	0.19	AS	GOOD / 90

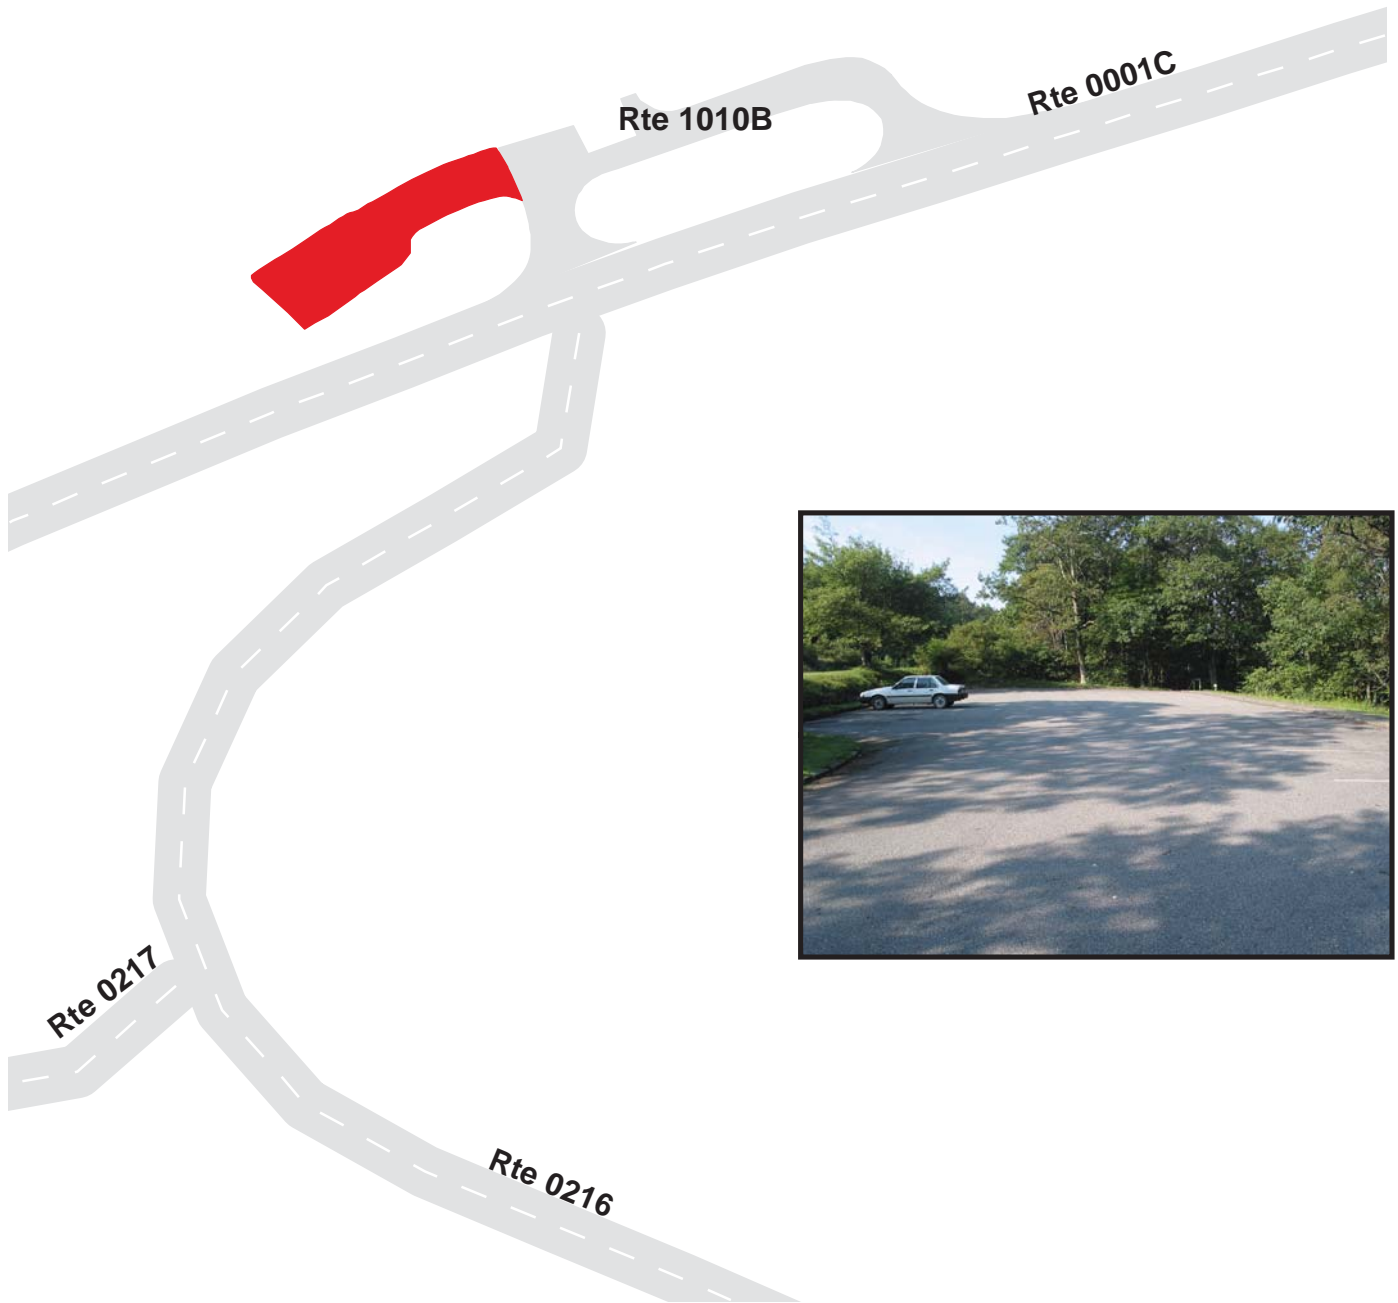
Route 1011A

Route	Public / NonPublic	Date Visited	Area (sq ft)	Lane Miles *	Surface Type	Condition / PCR
1011A	Public	9/5/2003	21712	0.37	AS	FAIR / 73

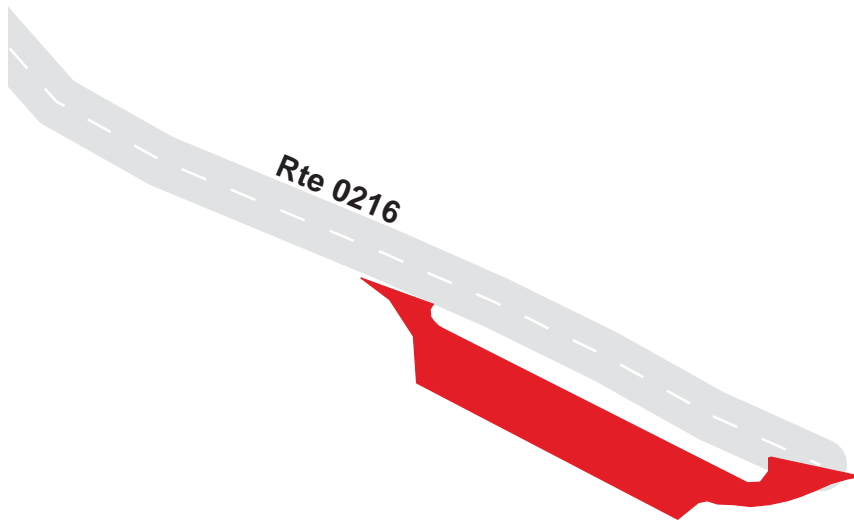
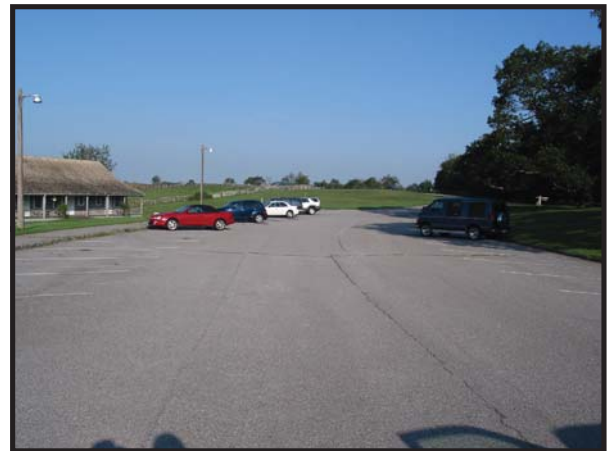
Route 1011B

Route	Public / NonPublic	Date Visited	Area (sq ft)	Lane Miles *	Surface Type	Condition / PCR
1011B	Public	9/5/2003	4757	0.08	AS	GOOD / 90

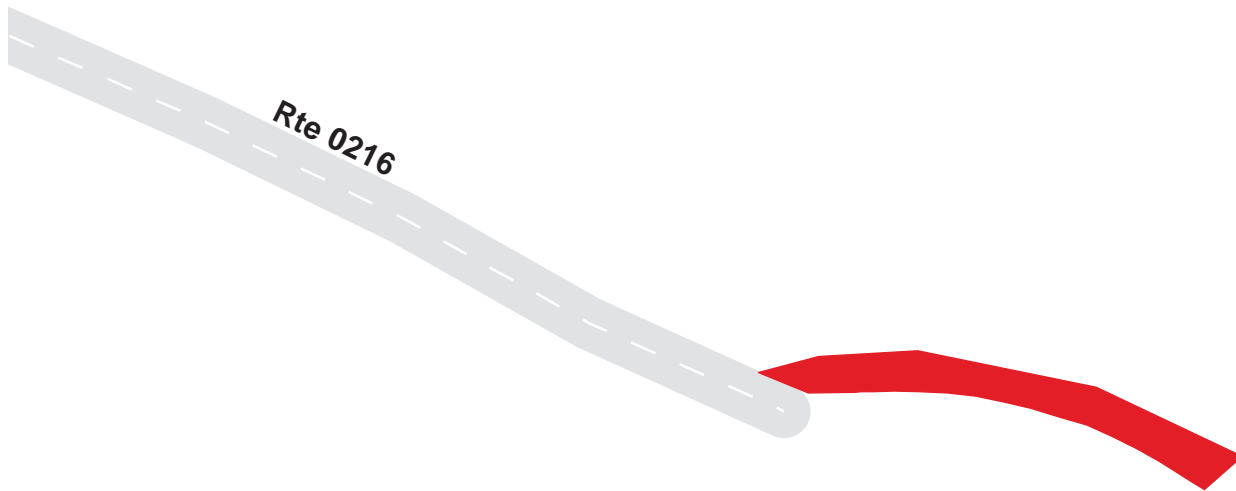
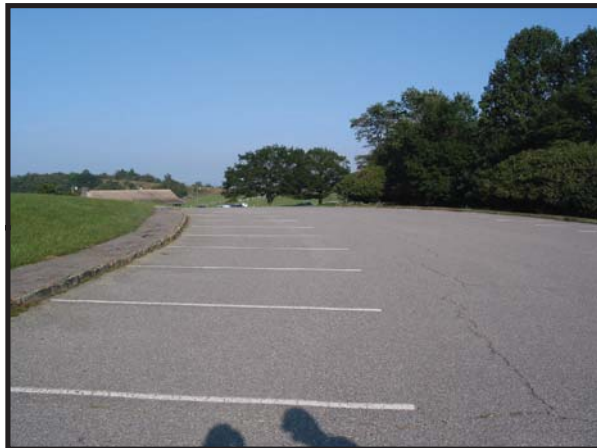
Route 1011C

Route	Public / NonPublic	Date Visited	Area (sq ft)	Lane Miles *	Surface Type	Condition / PCR
1011C	Public	9/5/2003	4501	0.08	AS	GOOD / 90

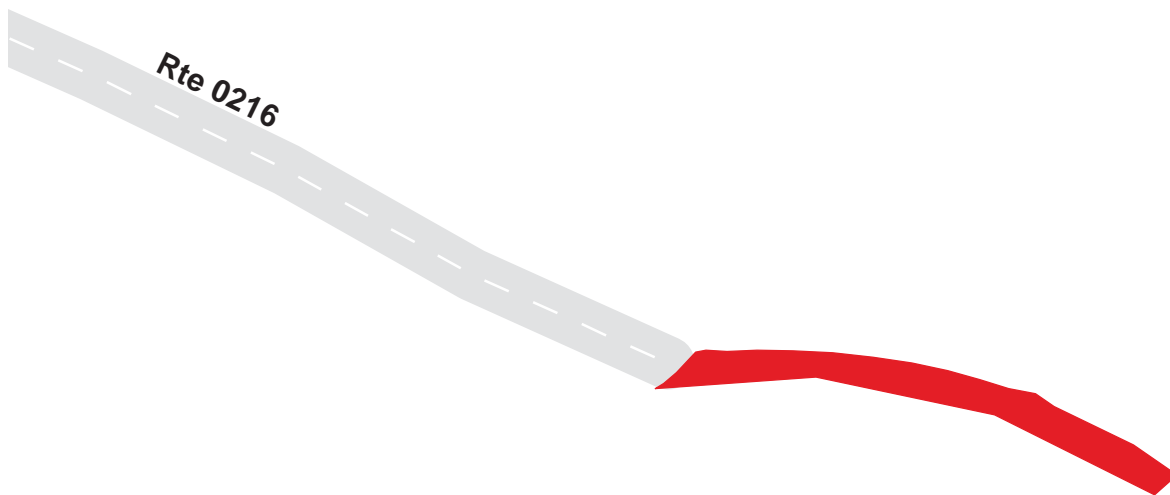
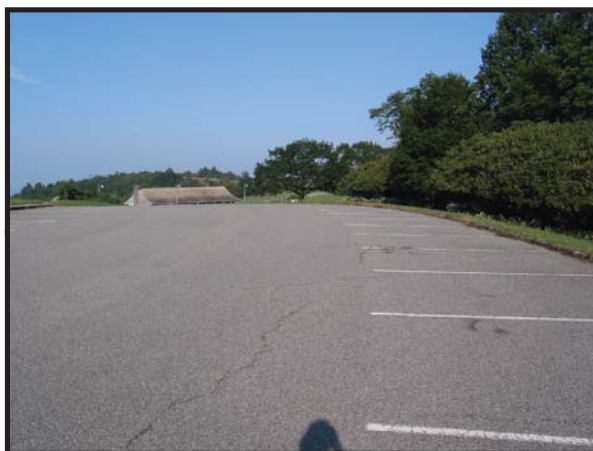
Route 1012

Route	Public / NonPublic	Date Visited	Area (sq ft)	Lane Miles *	Surface Type	Condition / PCR
1012	Public	9/5/2003	17607	0.30	AS	FAIR / 73

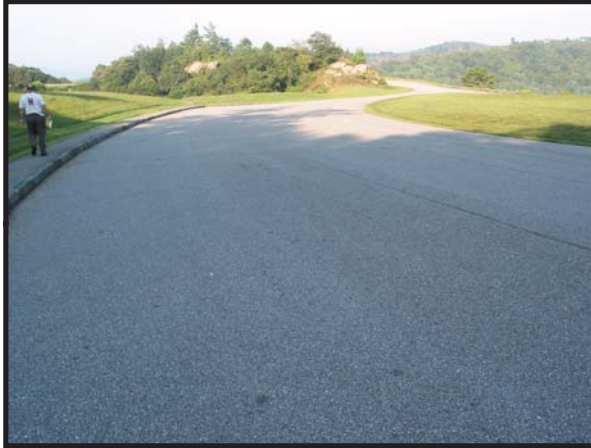
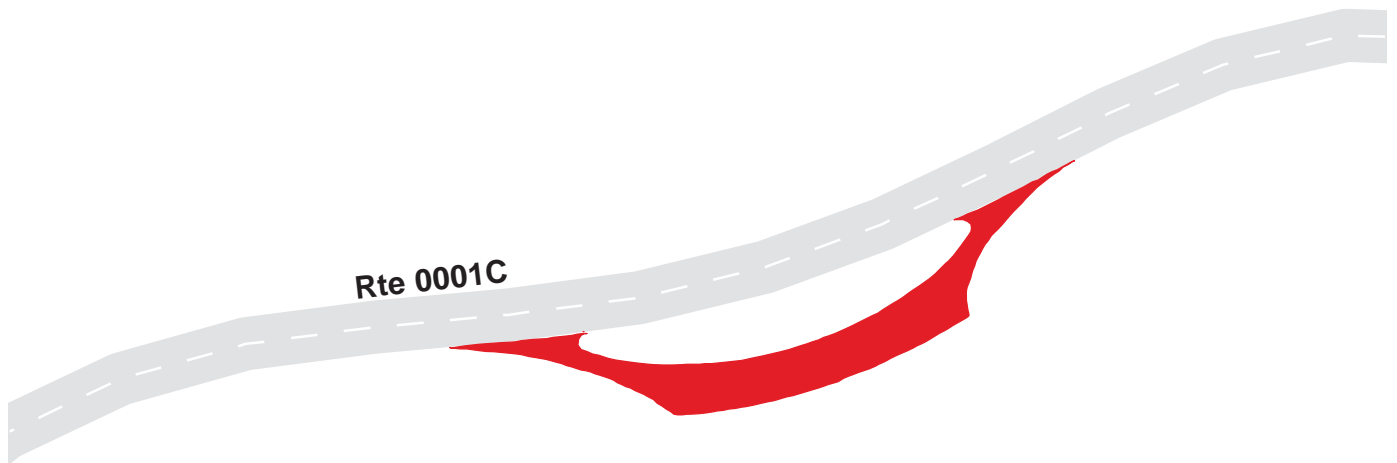
Route 1013

Route	Public / NonPublic	Date Visited	Area (sq ft)	Lane Miles *	Surface Type	Condition / PCR
1013	Public	9/5/2003	8015	0.14	AS	FAIR / 73

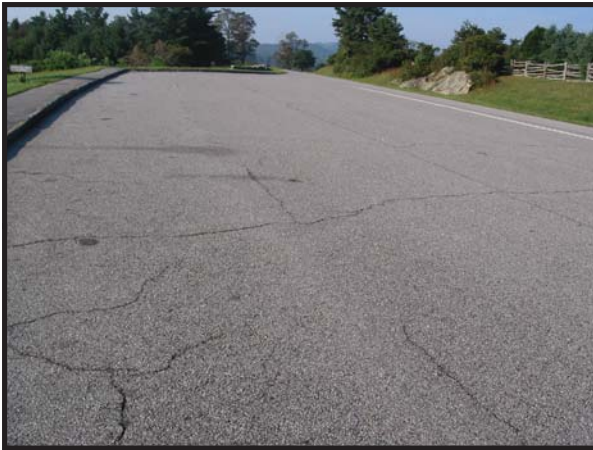
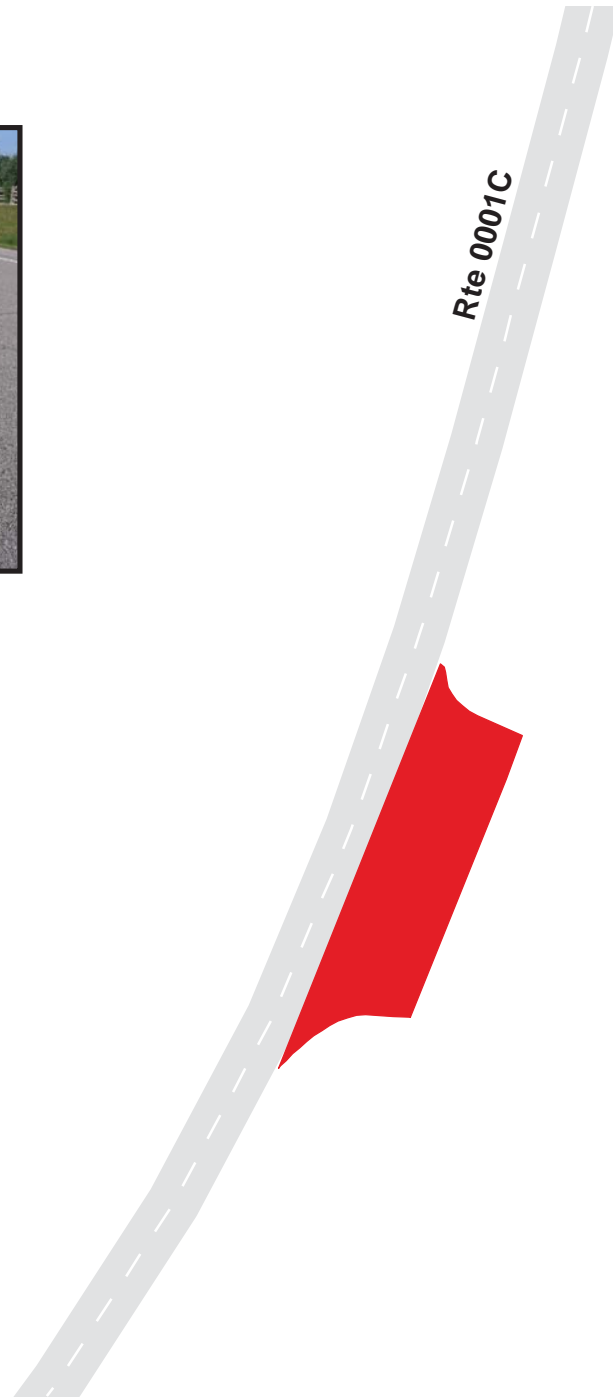
Route 1014

Route	Public / NonPublic	Date Visited	Area (sq ft)	Lane Miles *	Surface Type	Condition / PCR
1014	Public	9/5/2003	12784	0.22	AS	FAIR / 73

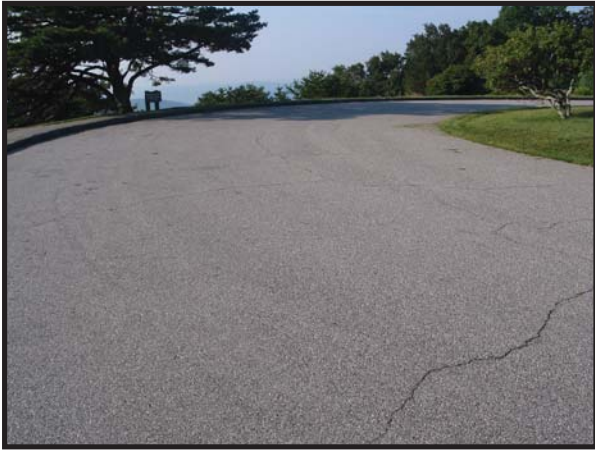
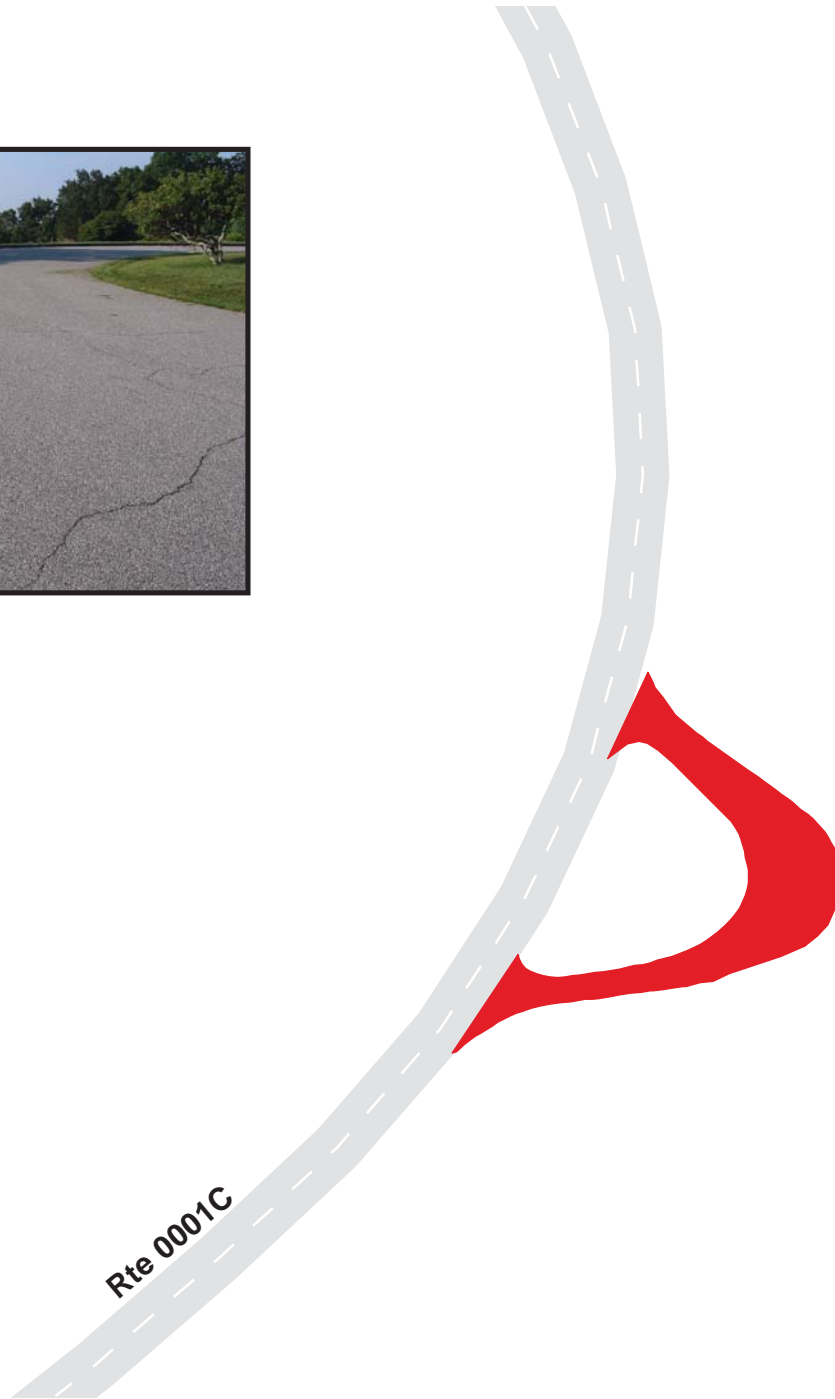
Route 1015

Route	Public / NonPublic	Date Visited	Area (sq ft)	Lane Miles *	Surface Type	Condition / PCR
1015	Public	9/3/2003	48893	0.84	AS	POOR / 45
