The Road Inventory of Blue Ridge Parkway BLRI – 5140 Volume 1

Road Inventory Program

Prepared By:
Federal Highway Administration
Eastern Federal Lands Highway Division
Cycle 3

Blue Ridge Parkway in North Carolina

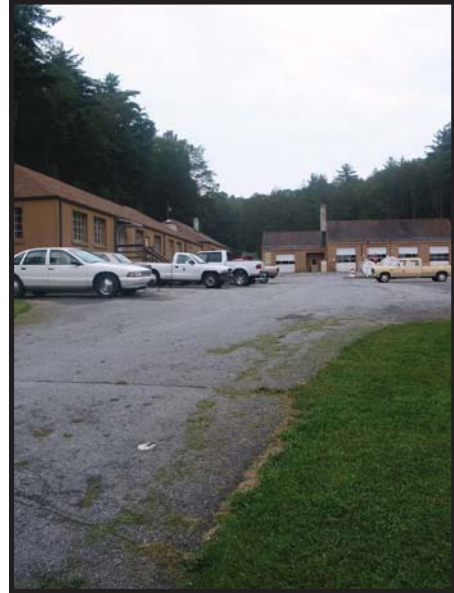
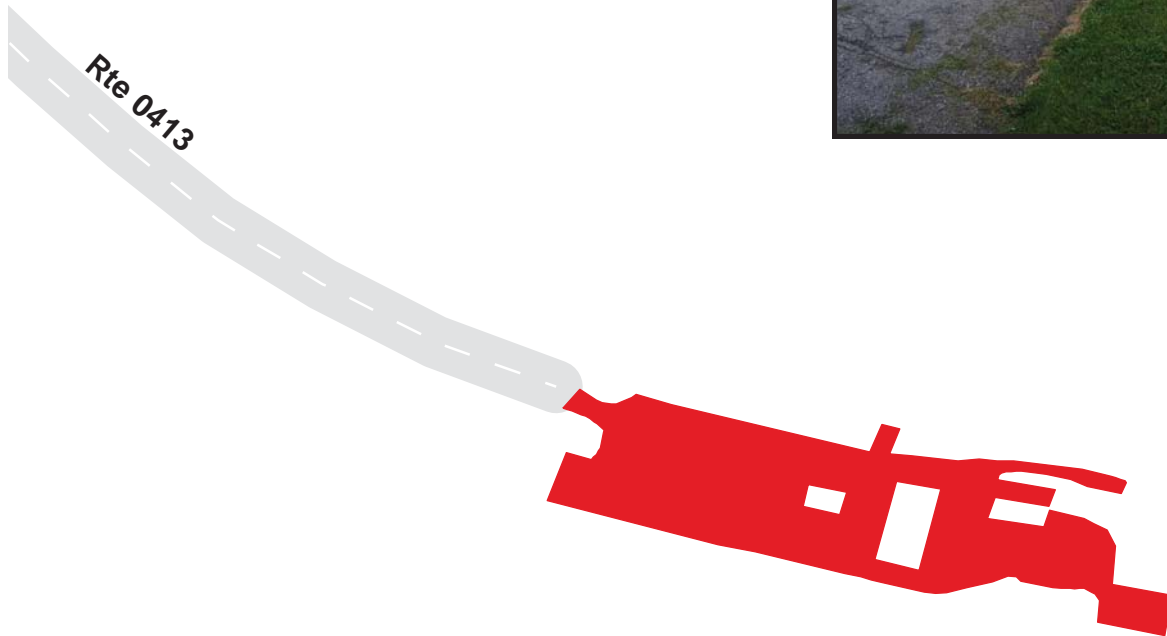
Route 1016

Route	Public / NonPublic	Date Visited	Area (sq ft)	Lane Miles *	Surface Type	Condition / PCR
1016	Public	9/3/2003	19110	0.33	AS	GOOD / 90

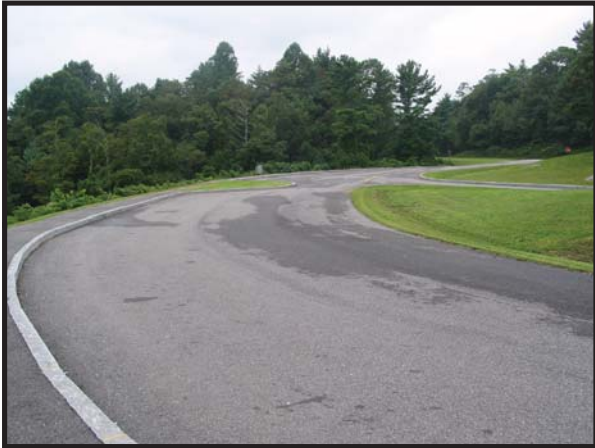
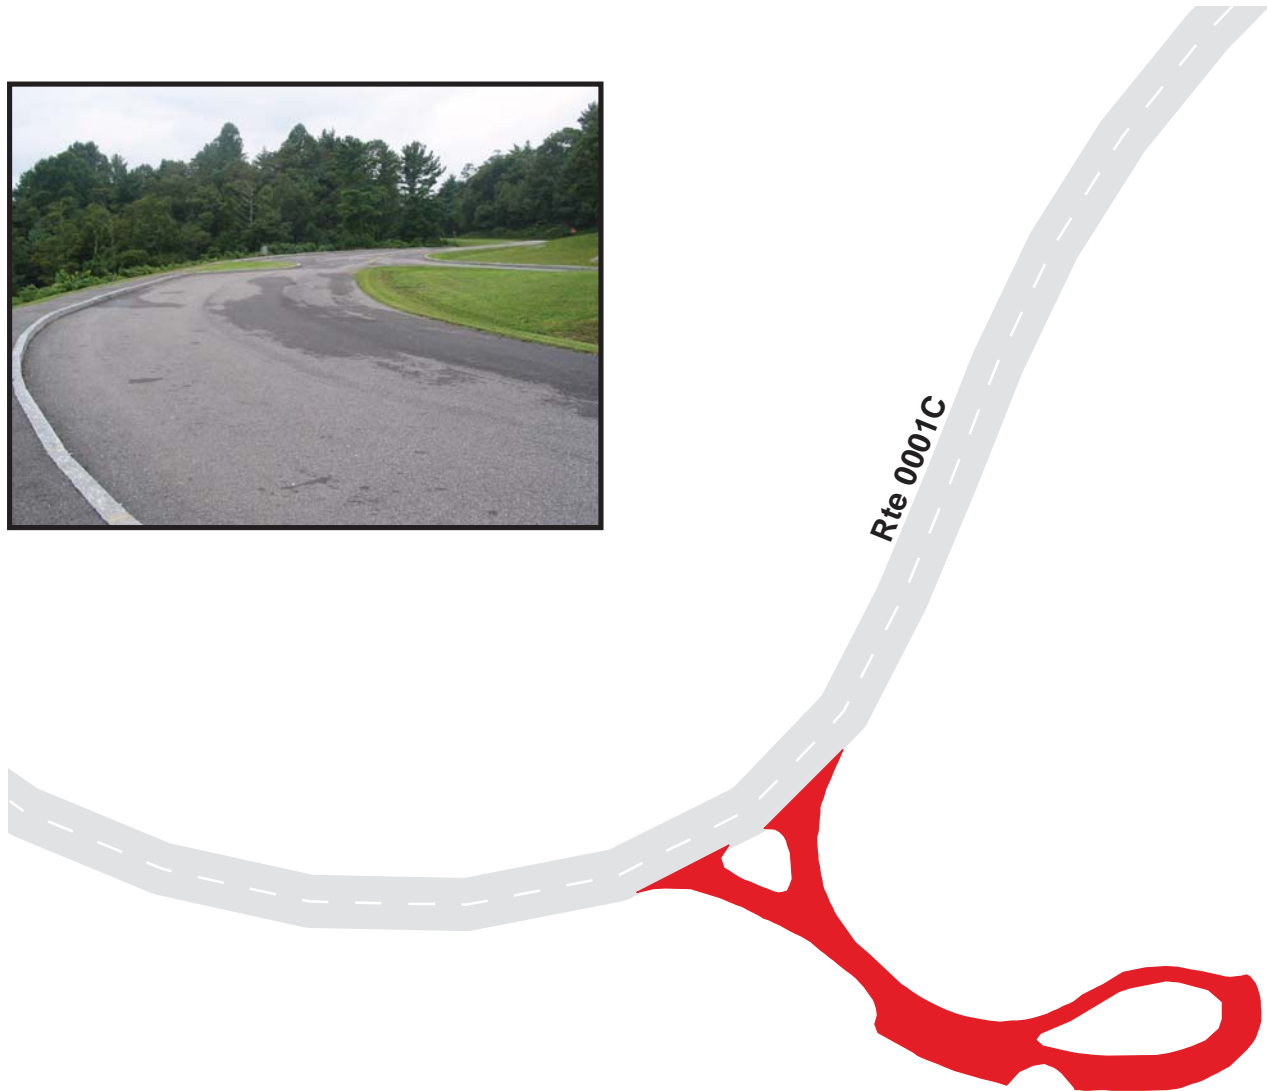
Route 1017

Route	Public / NonPublic	Date Visited	Area (sq ft)	Lane Miles *	Surface Type	Condition / PCR
1017	Public	9/3/2003	15176	0.26	AS	GOOD / 90

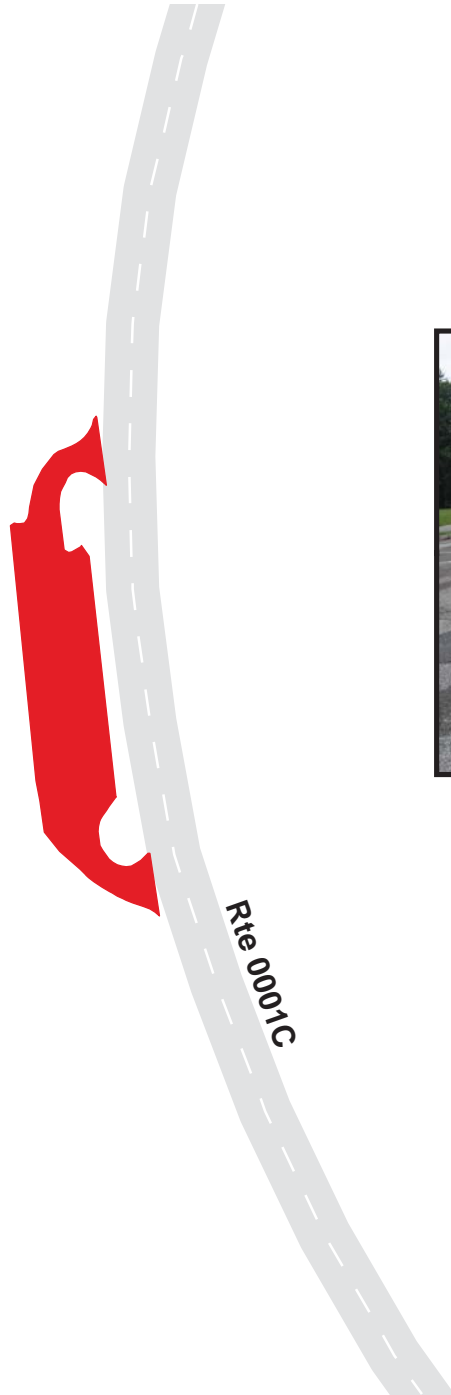
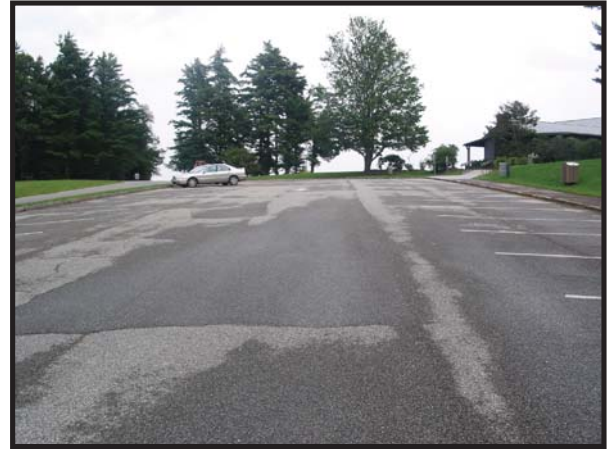
Route 1018

Route	Public / NonPublic	Date Visited	Area (sq ft)	Lane Miles *	Surface Type	Condition / PCR
1018	Public	9/3/2003	8385	0.14	AS	GOOD / 90

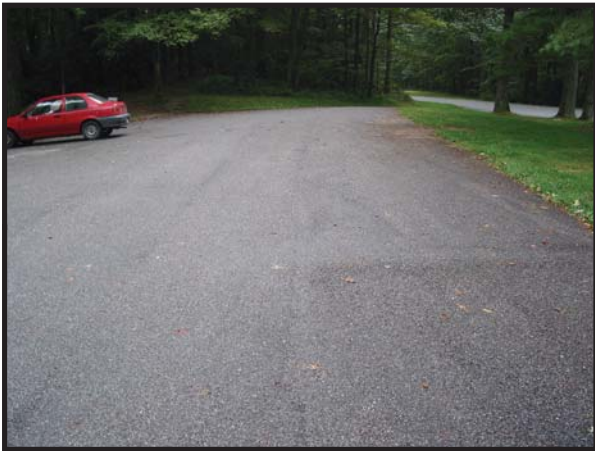
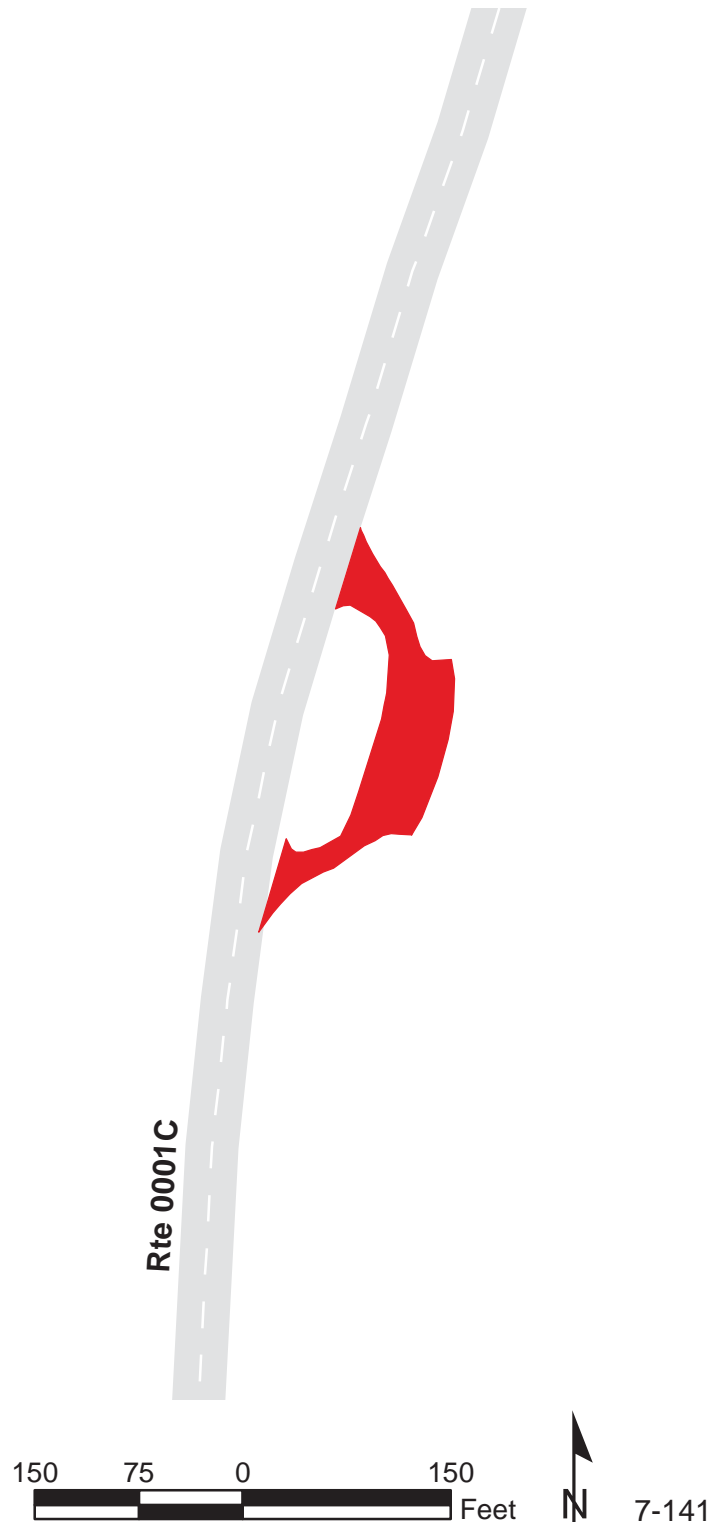
Route 1019

Route	Public / NonPublic	Date Visited	Area (sq ft)	Lane Miles *	Surface Type	Condition / PCR
1019	Public	9/3/2003	17087	0.29	AS	FAIR / 73

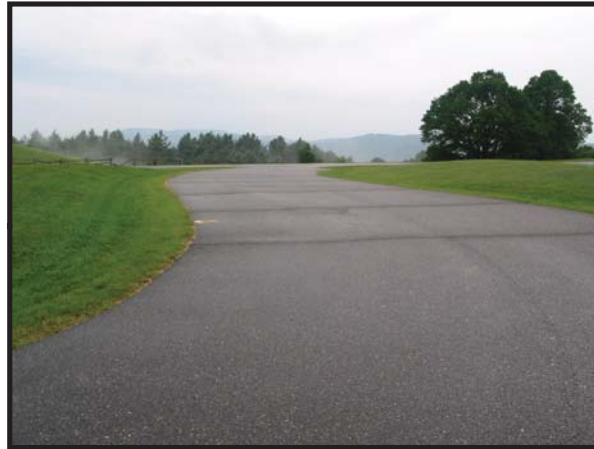
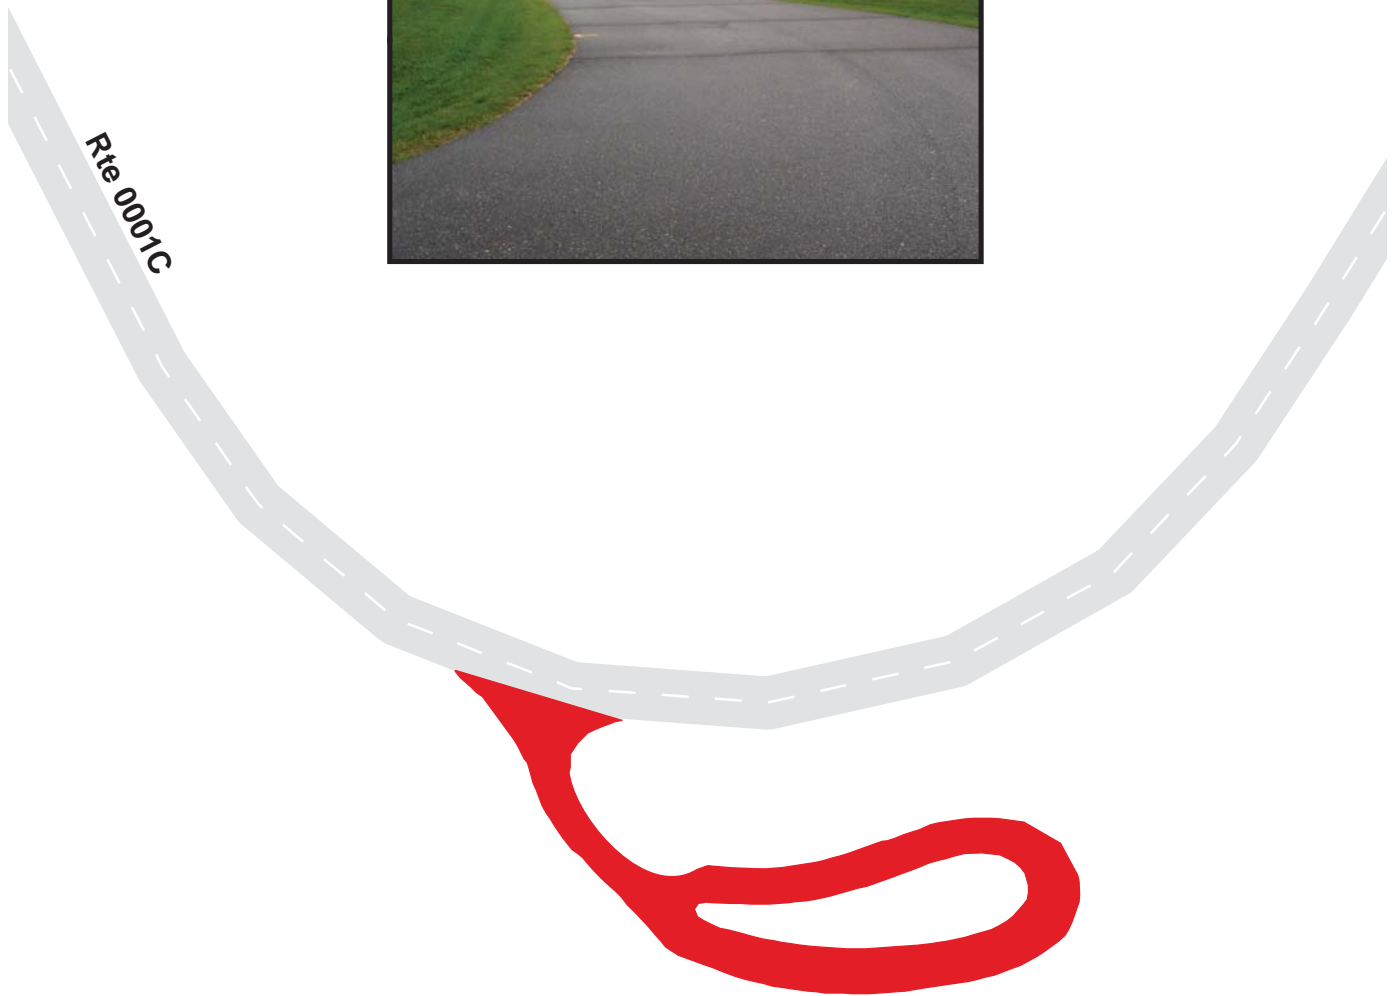
Route 1020

Route	Public / NonPublic	Date Visited	Area (sq ft)	Lane Miles *	Surface Type	Condition / PCR
1020	Public	9/3/2003	4163	0.07	AS	FAIR / 73

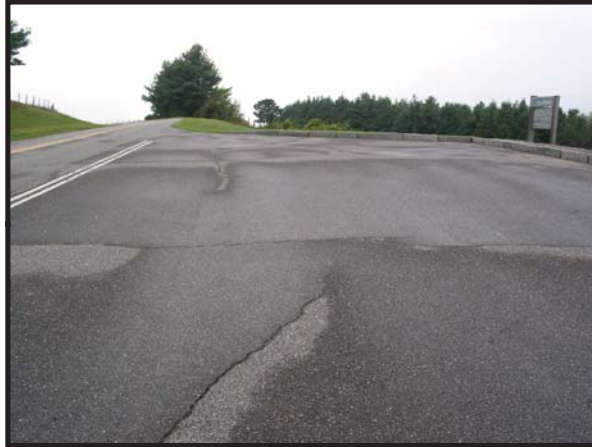
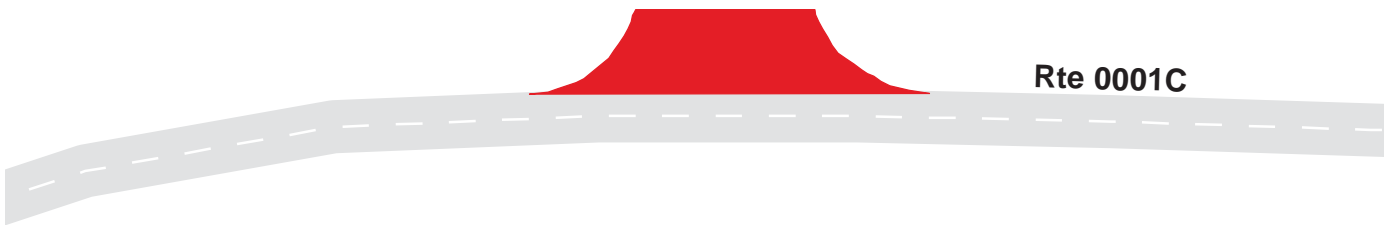
Route 1021

Route	Public / NonPublic	Date Visited	Area (sq ft)	Lane Miles *	Surface Type	Condition / PCR
1021	Public	9/3/2003	1207	0.02	AS	GOOD / 90

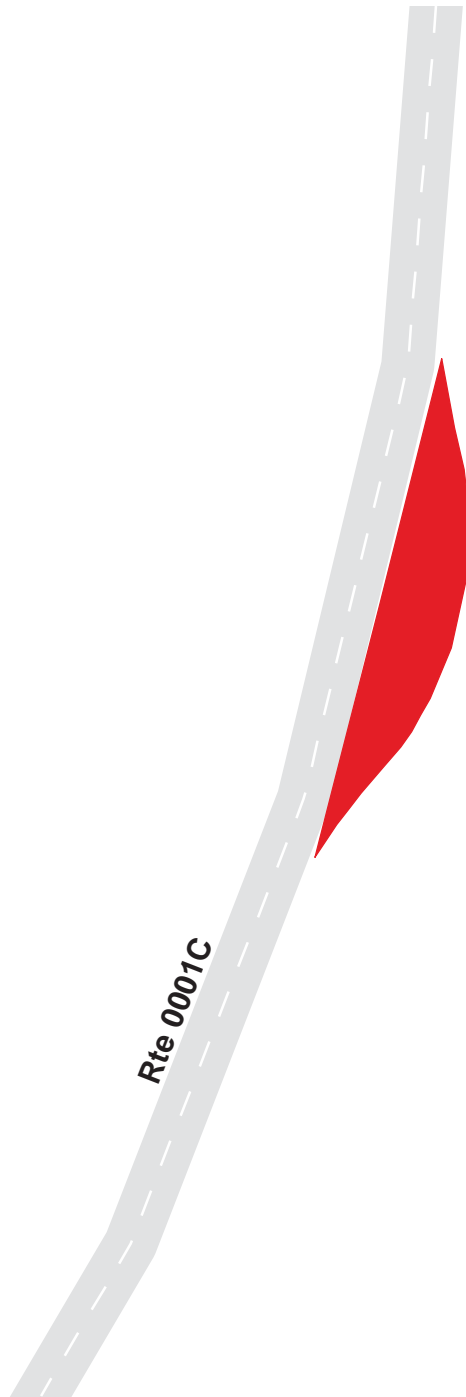
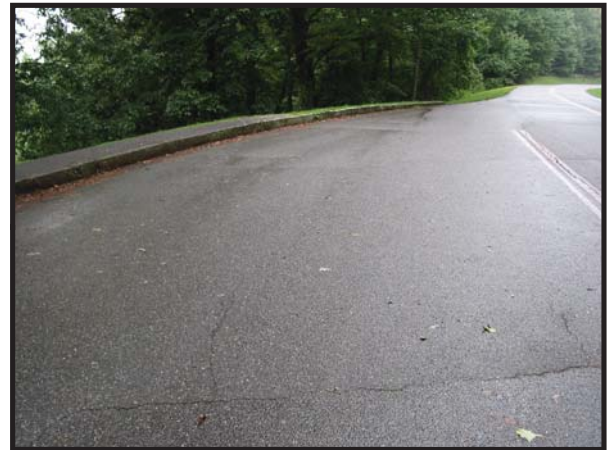
**Blue Ridge Parkway
Route 1022**
Benge Maintenance Yard
Adjacent to SR 1163 on Right

Route	Public / NonPublic	Date Visited	Area (sq ft)	Lane Miles *	Surface Type	Condition / PCR
1022	Public	9/3/2003	5570	0.10	AS	POOR / 45

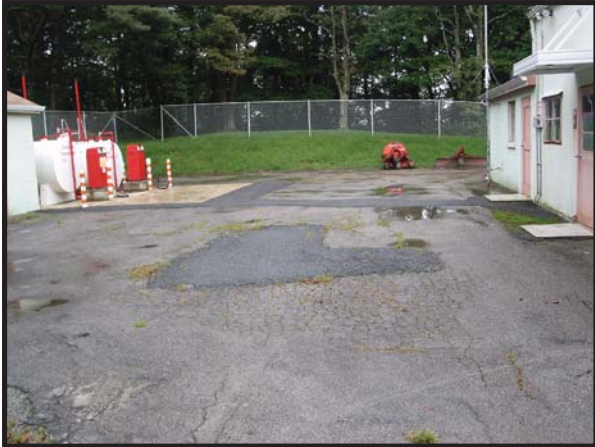
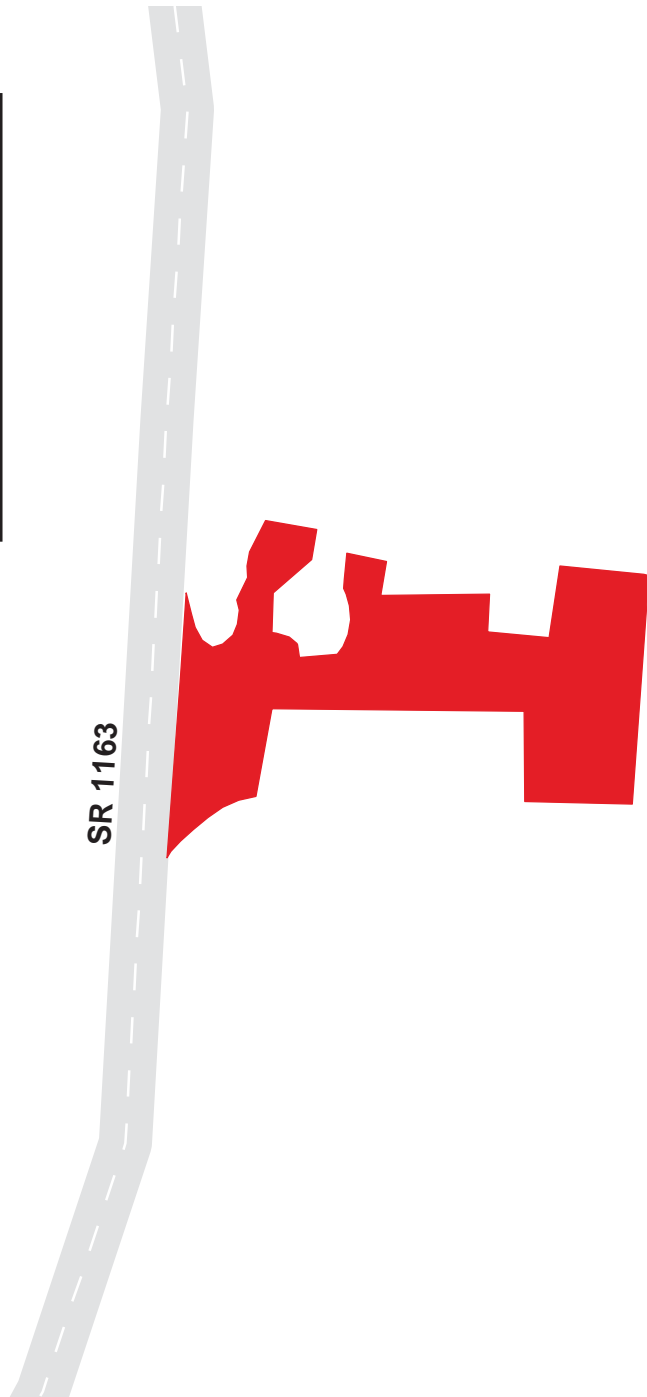
Route 1023

Route	Public / NonPublic	Date Visited	Area (sq ft)	Lane Miles *	Surface Type	Condition / PCR
1023	Public	9/3/2003	7889	0.14	AS	GOOD / 90

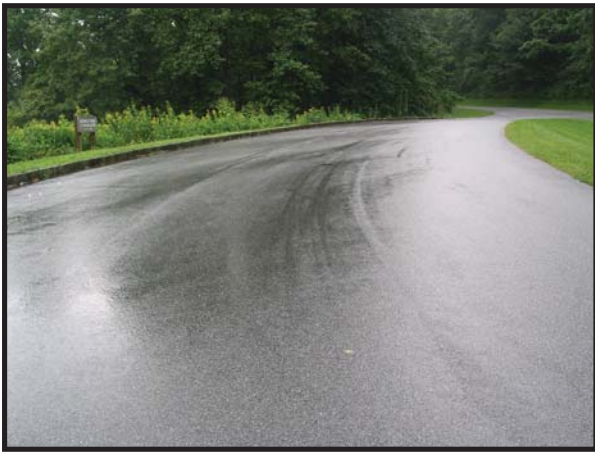
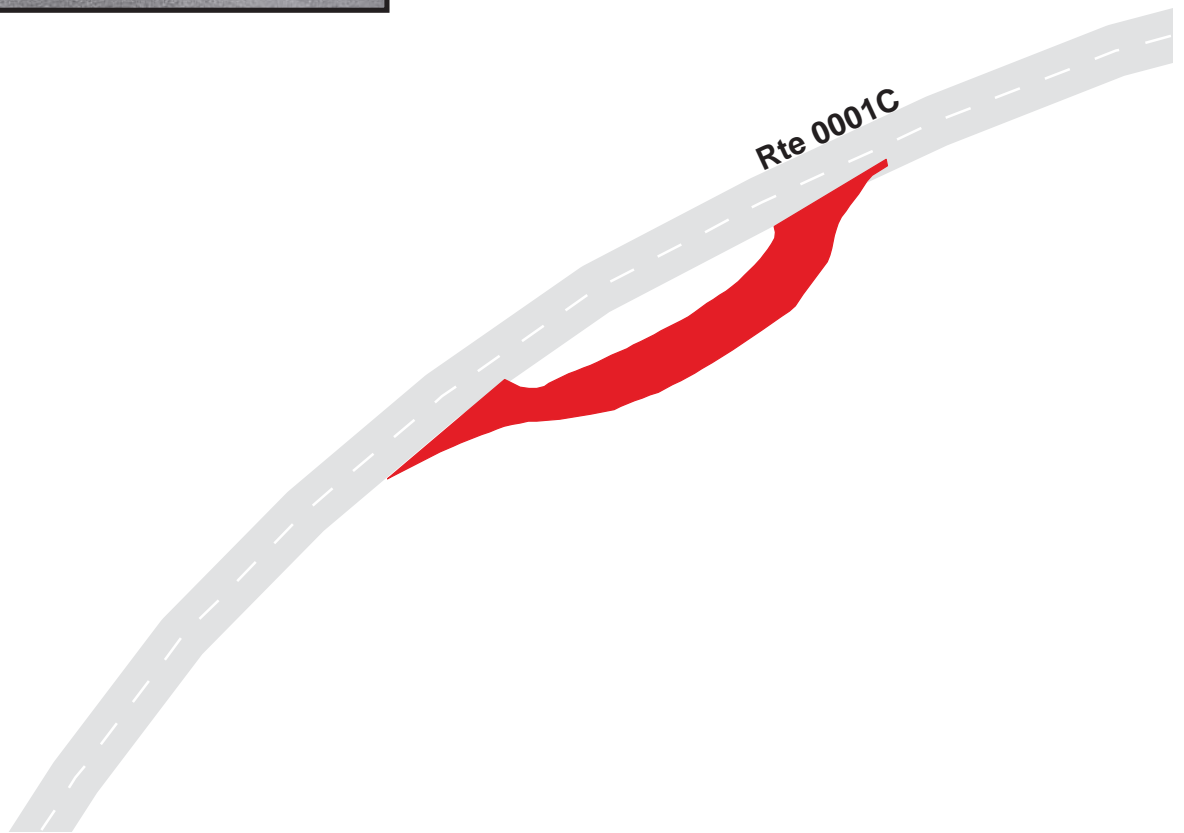
Route 1024

Route	Public / NonPublic	Date Visited	Area (sq ft)	Lane Miles *	Surface Type	Condition / PCR
1024	Public	9/3/2003	23418	0.40	AS	GOOD / 90

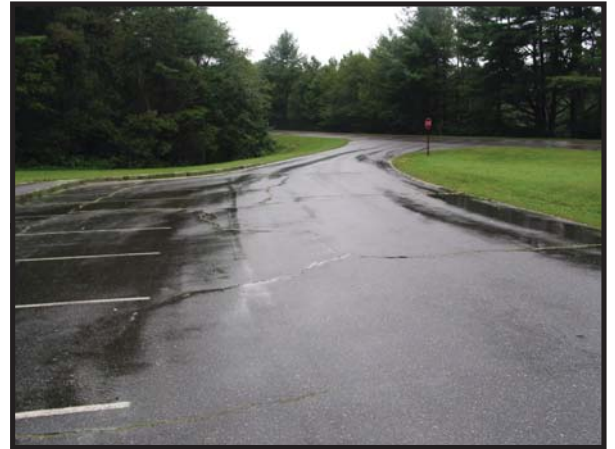
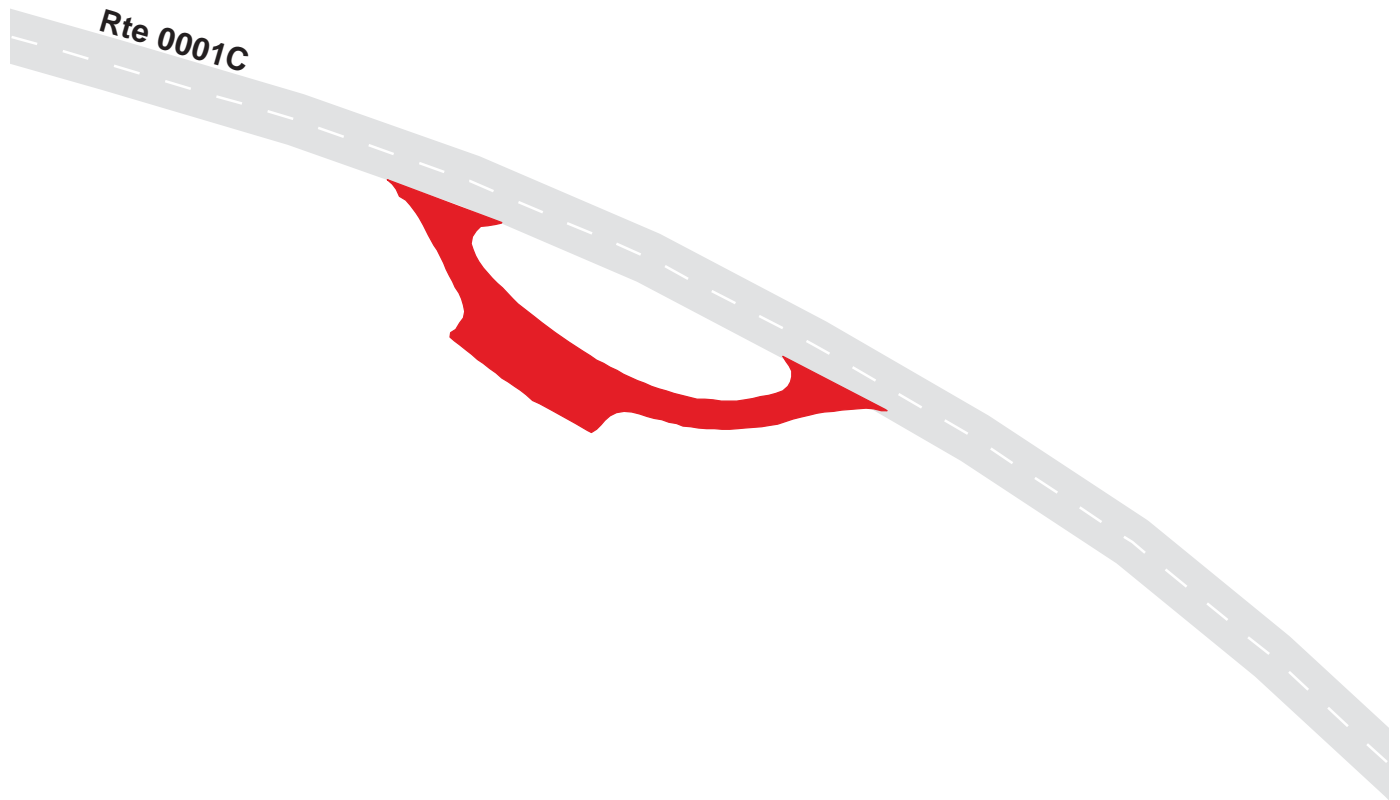
Route 1025

Route	Public / NonPublic	Date Visited	Area (sq ft)	Lane Miles *	Surface Type	Condition / PCR
1025	Public	9/3/2003	8404	0.14	AS	FAIR / 73

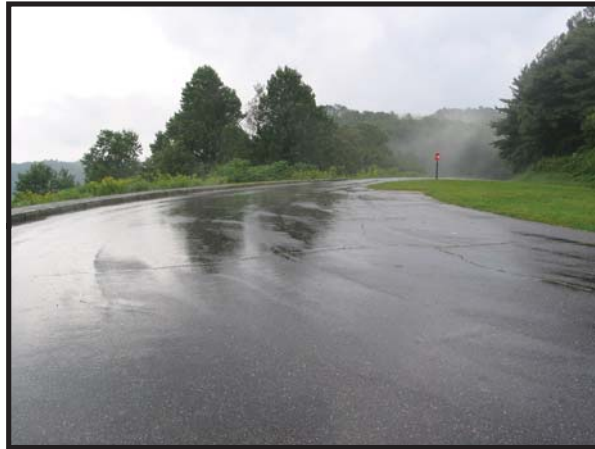
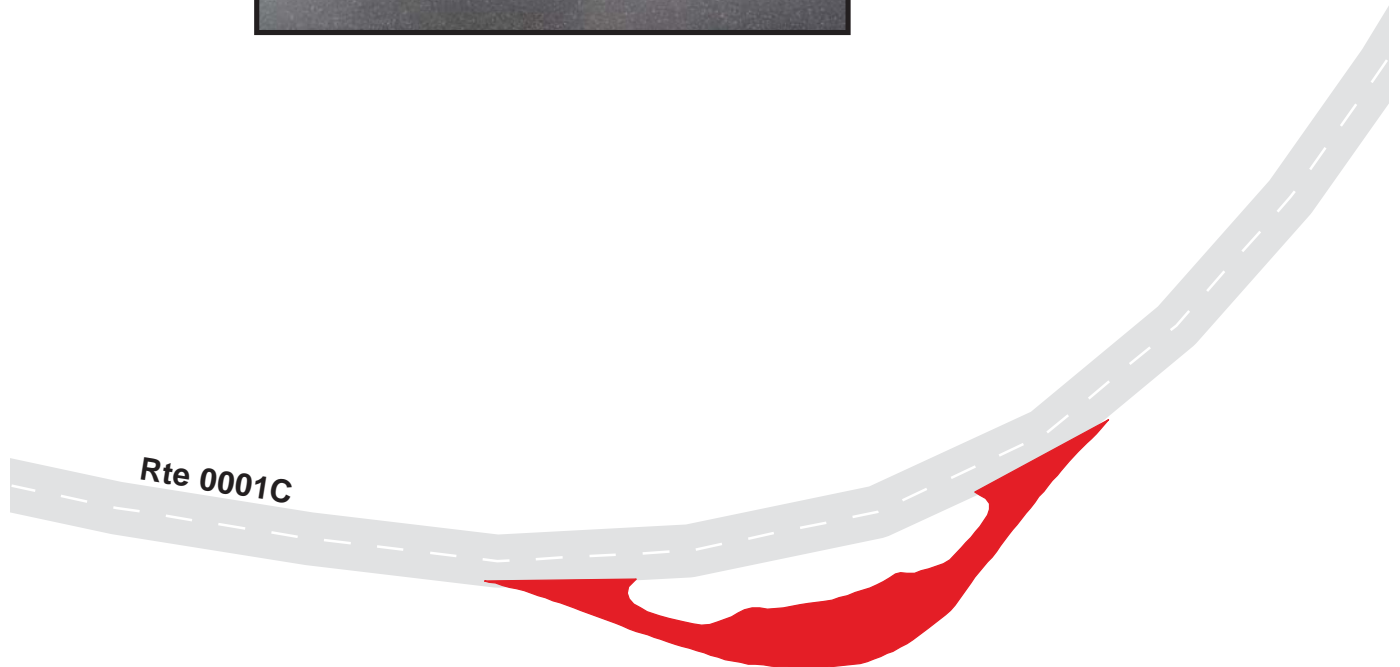
Route 1026

Route	Public / NonPublic	Date Visited	Area (sq ft)	Lane Miles *	Surface Type	Condition / PCR
1026	Public	9/3/2003	9748	0.17	AS	FAIR / 73

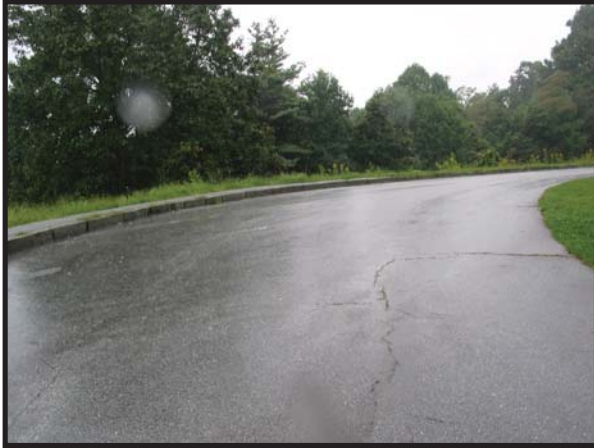
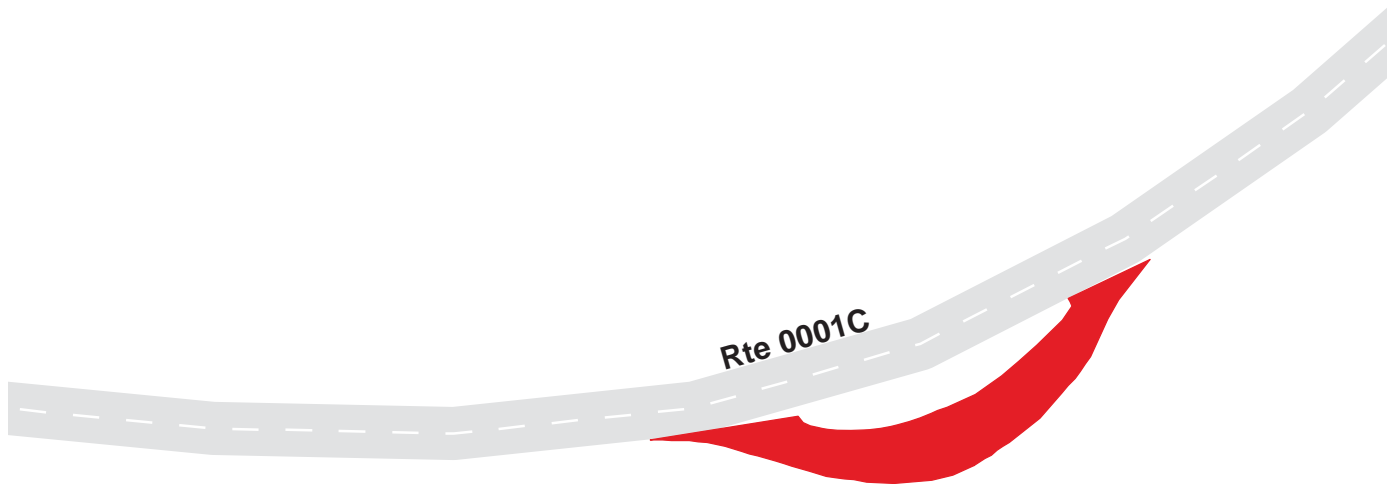
Route 1027

Route	Public / NonPublic	Date Visited	Area (sq ft)	Lane Miles *	Surface Type	Condition / PCR
1027	Public	9/3/2003	5589	0.10	AS	FAIR / 73

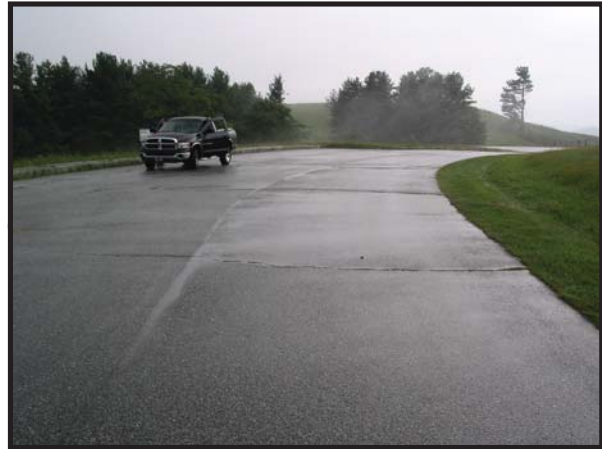
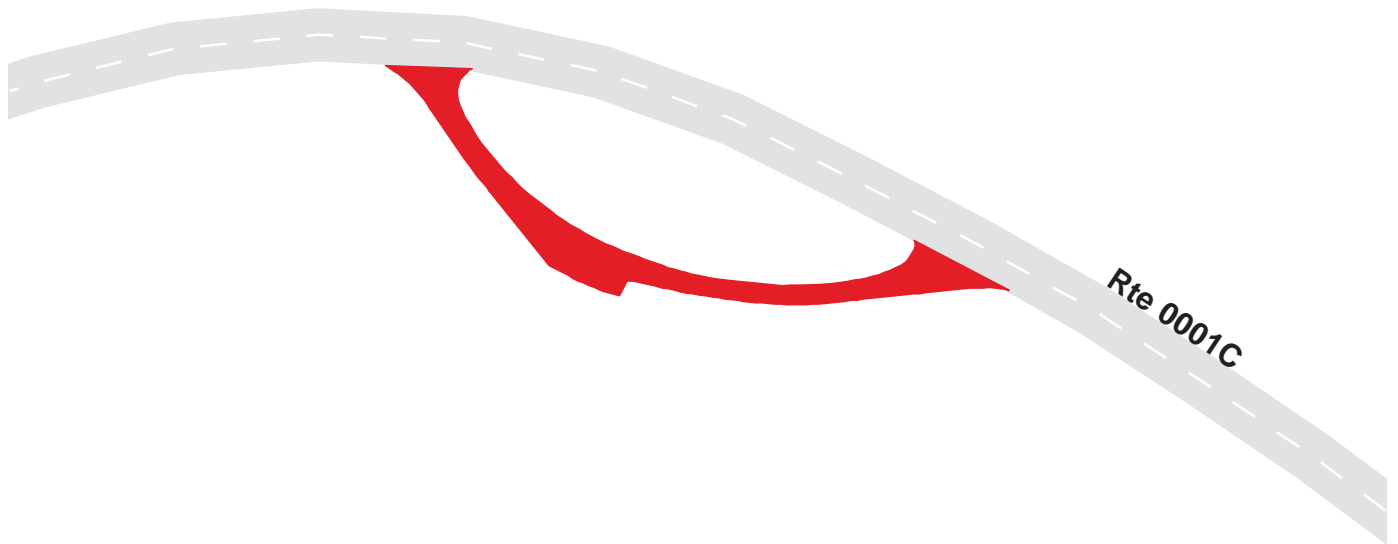
Blue Ridge Parkway Route 1028

Osborne Mountain Overlook
From Route 0001C at MP 276.72 on Left

Route	Public / NonPublic	Date Visited	Area (sq ft)	Lane Miles *	Surface Type	Condition / PCR
1028	Public	9/3/2003	12659	0.22	AS	FAIR / 73

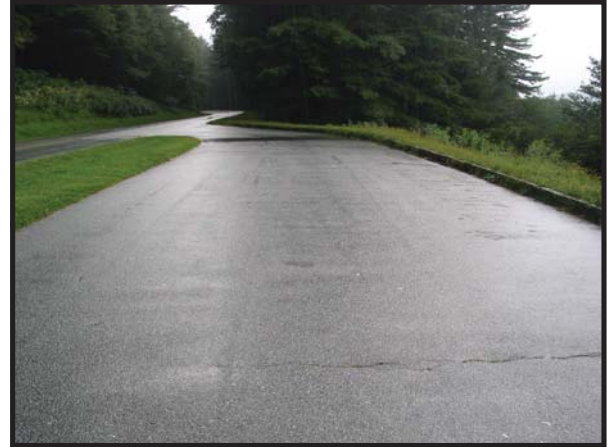
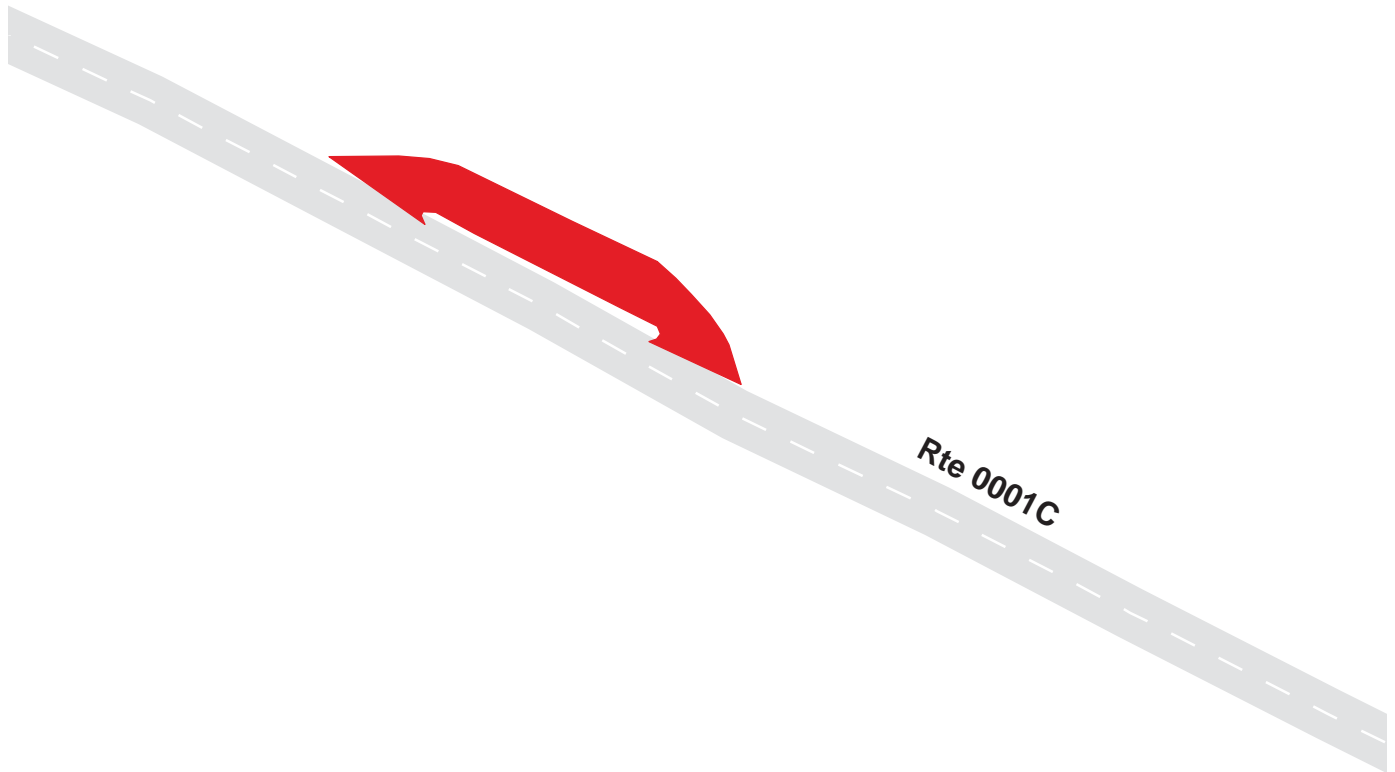
Route 1029

Route	Public / NonPublic	Date Visited	Area (sq ft)	Lane Miles *	Surface Type	Condition / PCR
1029	Public	9/3/2003	5649	0.10	AS	GOOD / 90

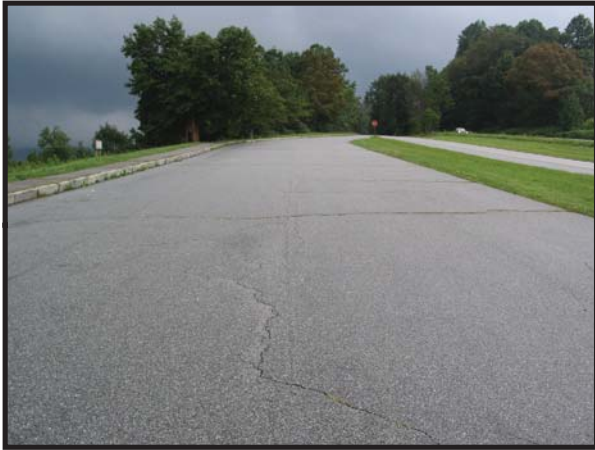
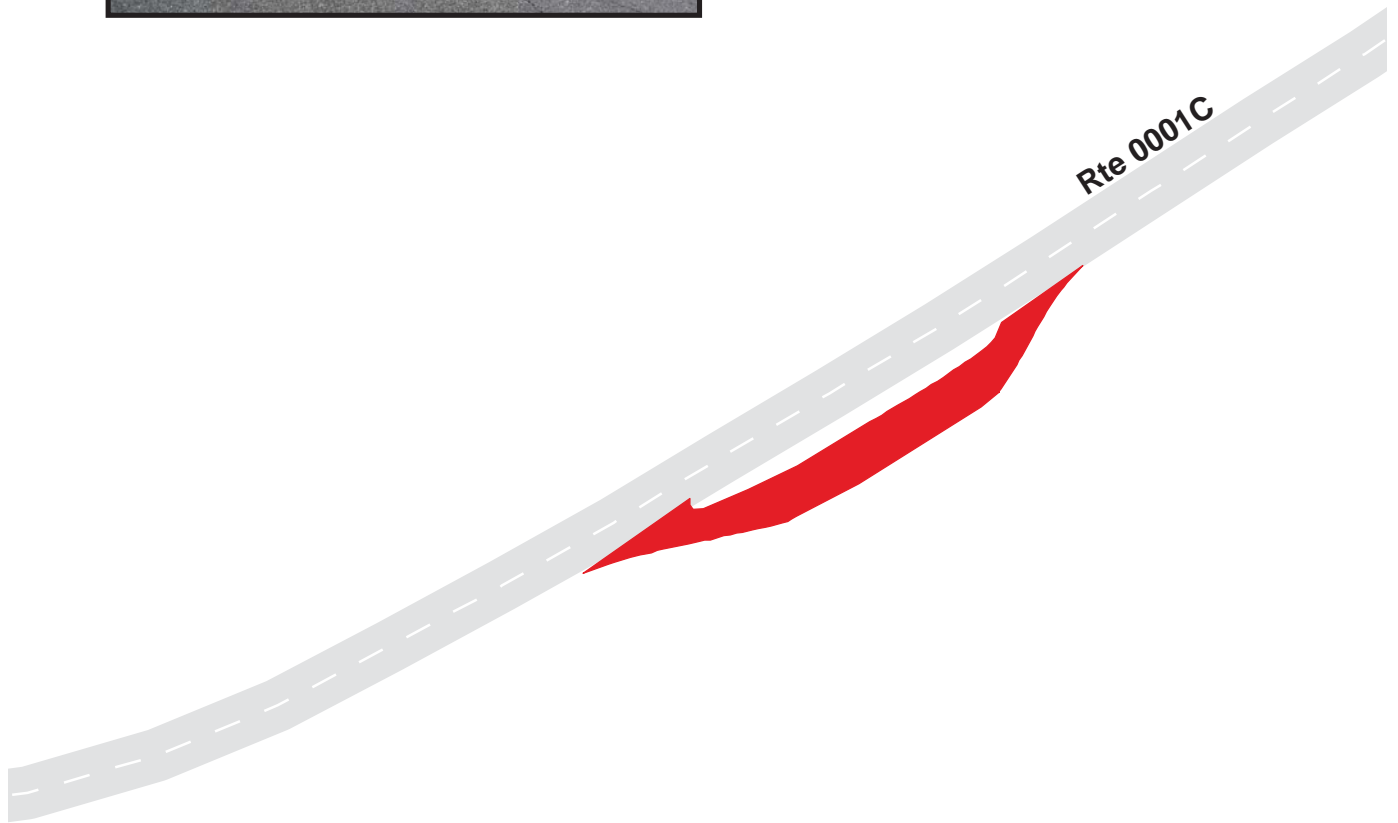
Route 1030

Route	Public / NonPublic	Date Visited	Area (sq ft)	Lane Miles *	Surface Type	Condition / PCR
1030	Public	9/3/2003	15080	0.26	AS	FAIR / 73

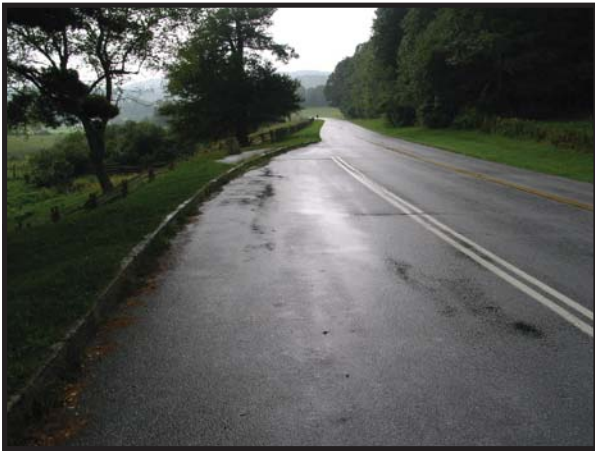
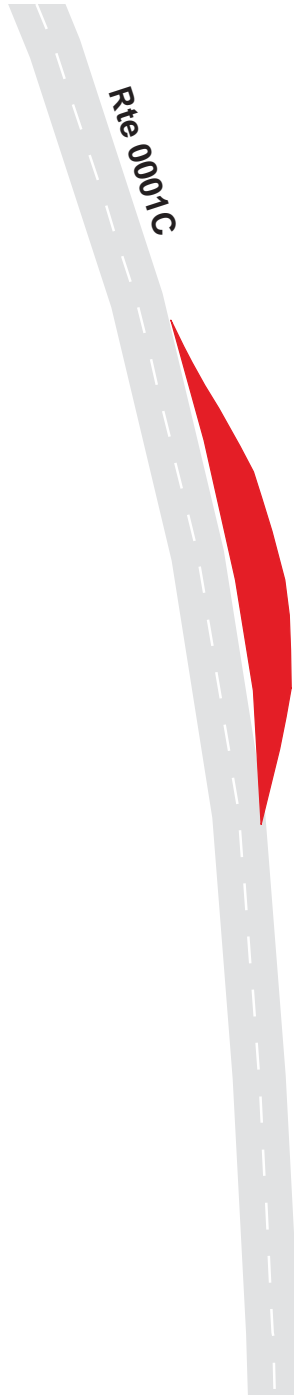
Blue Ridge Parkway
Route 1031
 Boones Trace
 From Route 0001C at MP 283.96 on Left

Route	Public / NonPublic	Date Visited	Area (sq ft)	Lane Miles *	Surface Type	Condition / PCR
1031	Public	9/3/2003	2116	0.04	AS	GOOD / 90

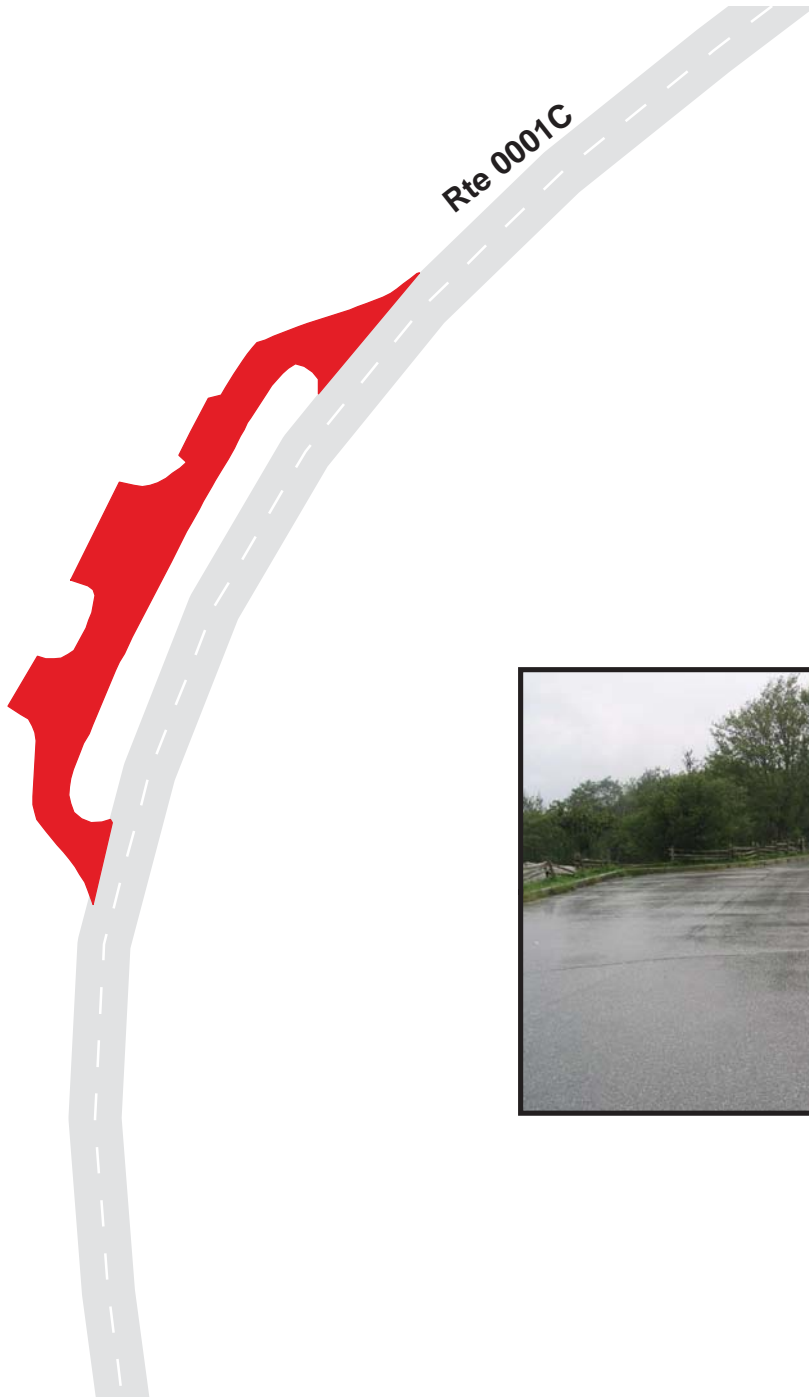
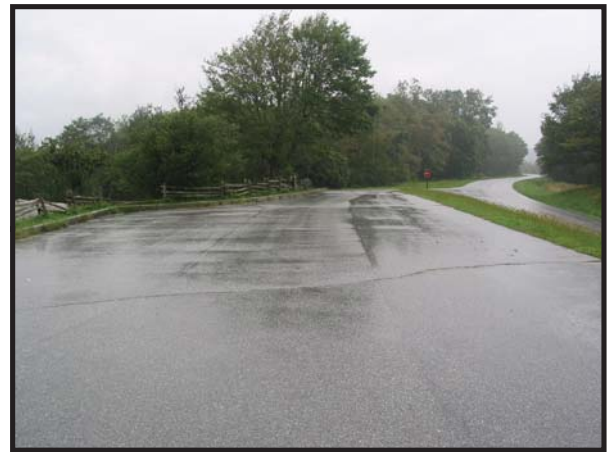
Route 1032

Route	Public / NonPublic	Date Visited	Area (sq ft)	Lane Miles *	Surface Type	Condition / PCR
1032	Public	9/3/2003	11131	0.19	AS	GOOD / 90

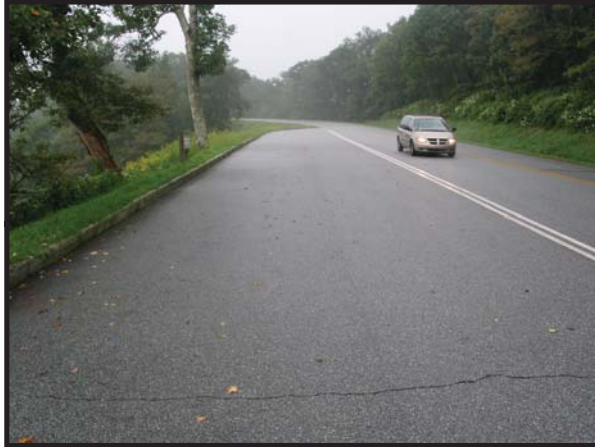
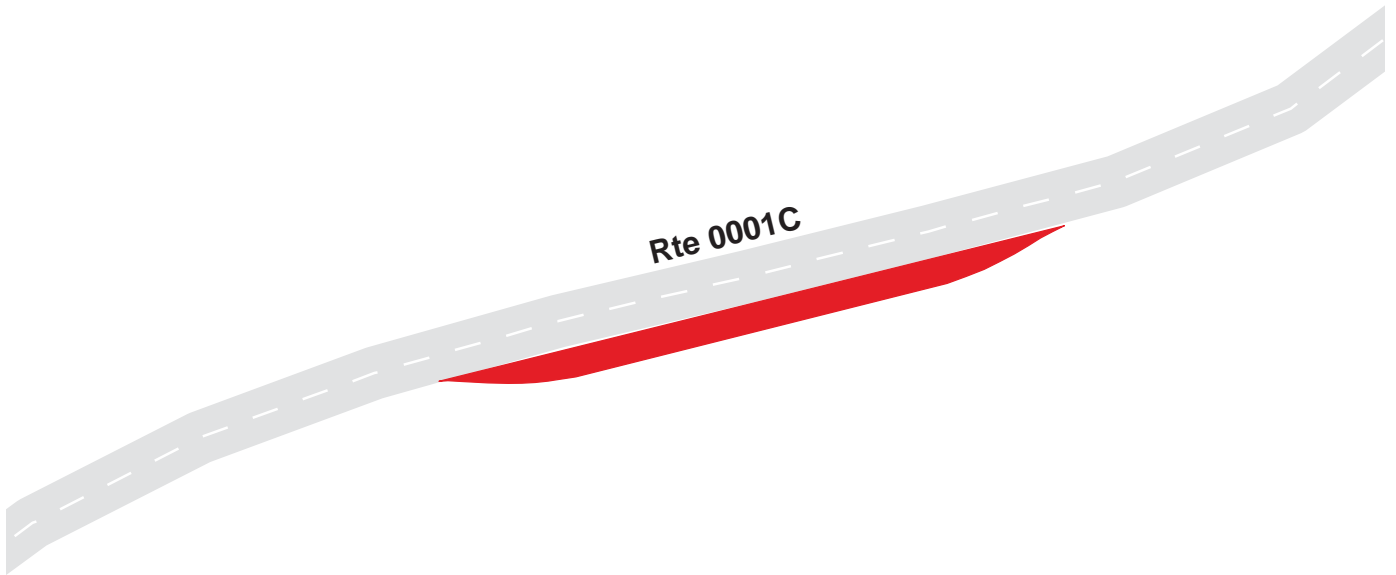
Route 1033

Route	Public / NonPublic	Date Visited	Area (sq ft)	Lane Miles *	Surface Type	Condition / PCR
1033	Public	9/3/2003	5479	0.09	AS	GOOD / 90

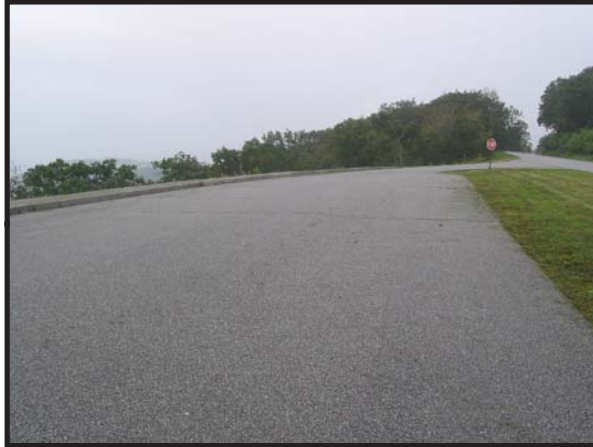
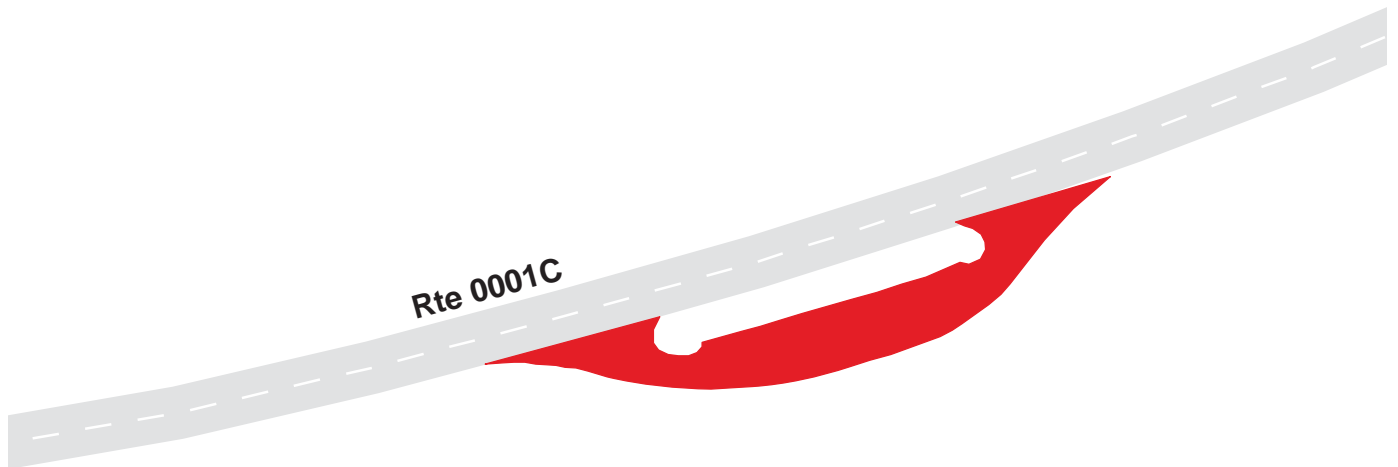
Route 1034

Route	Public / NonPublic	Date Visited	Area (sq ft)	Lane Miles *	Surface Type	Condition / PCR
1034	Public	9/3/2003	10074	0.17	AS	FAIR / 73
