The Road Inventory of Blue Ridge Parkway BLRI – 5140 Volume 1

Road Inventory Program

Prepared By:
Federal Highway Administration
Eastern Federal Lands Highway Division
Cycle 3

Blue Ridge Parkway in North Carolina

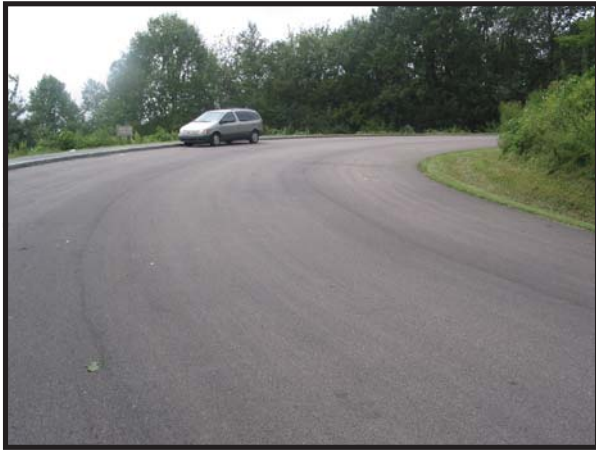
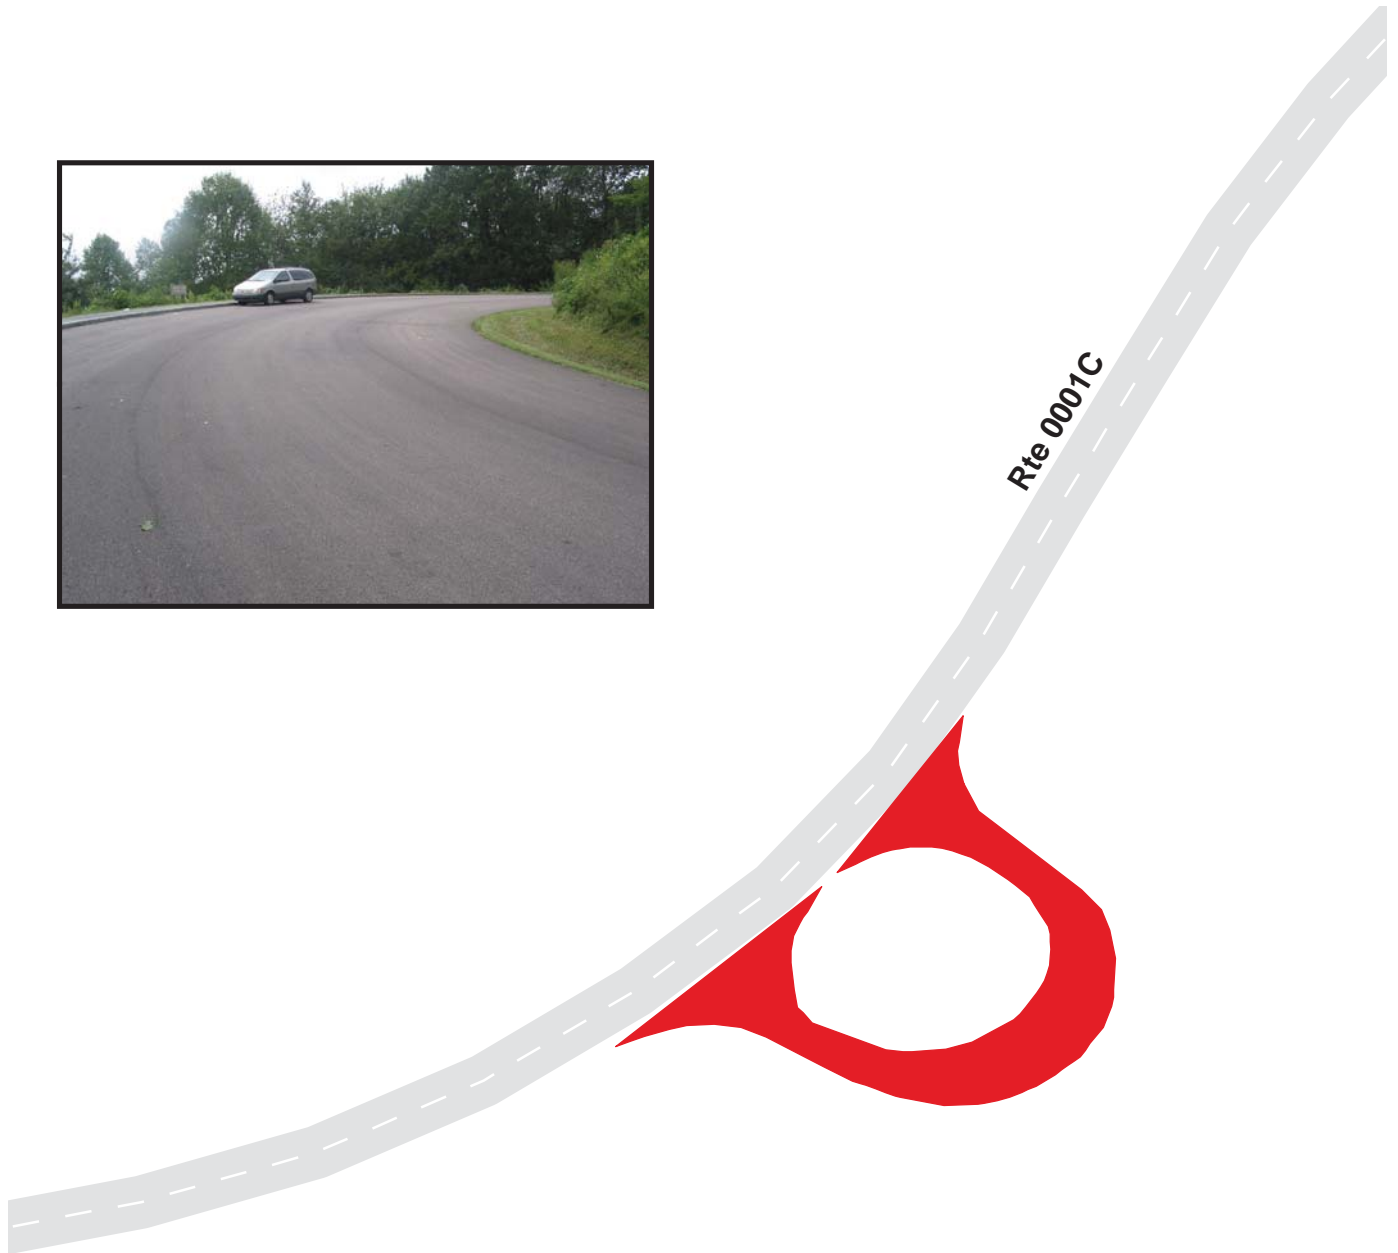
Route 1035

Route	Public / NonPublic	Date Visited	Area (sq ft)	Lane Miles *	Surface Type	Condition / PCR
1035	Public	9/3/2003	18292	0.31	AS	GOOD / 90

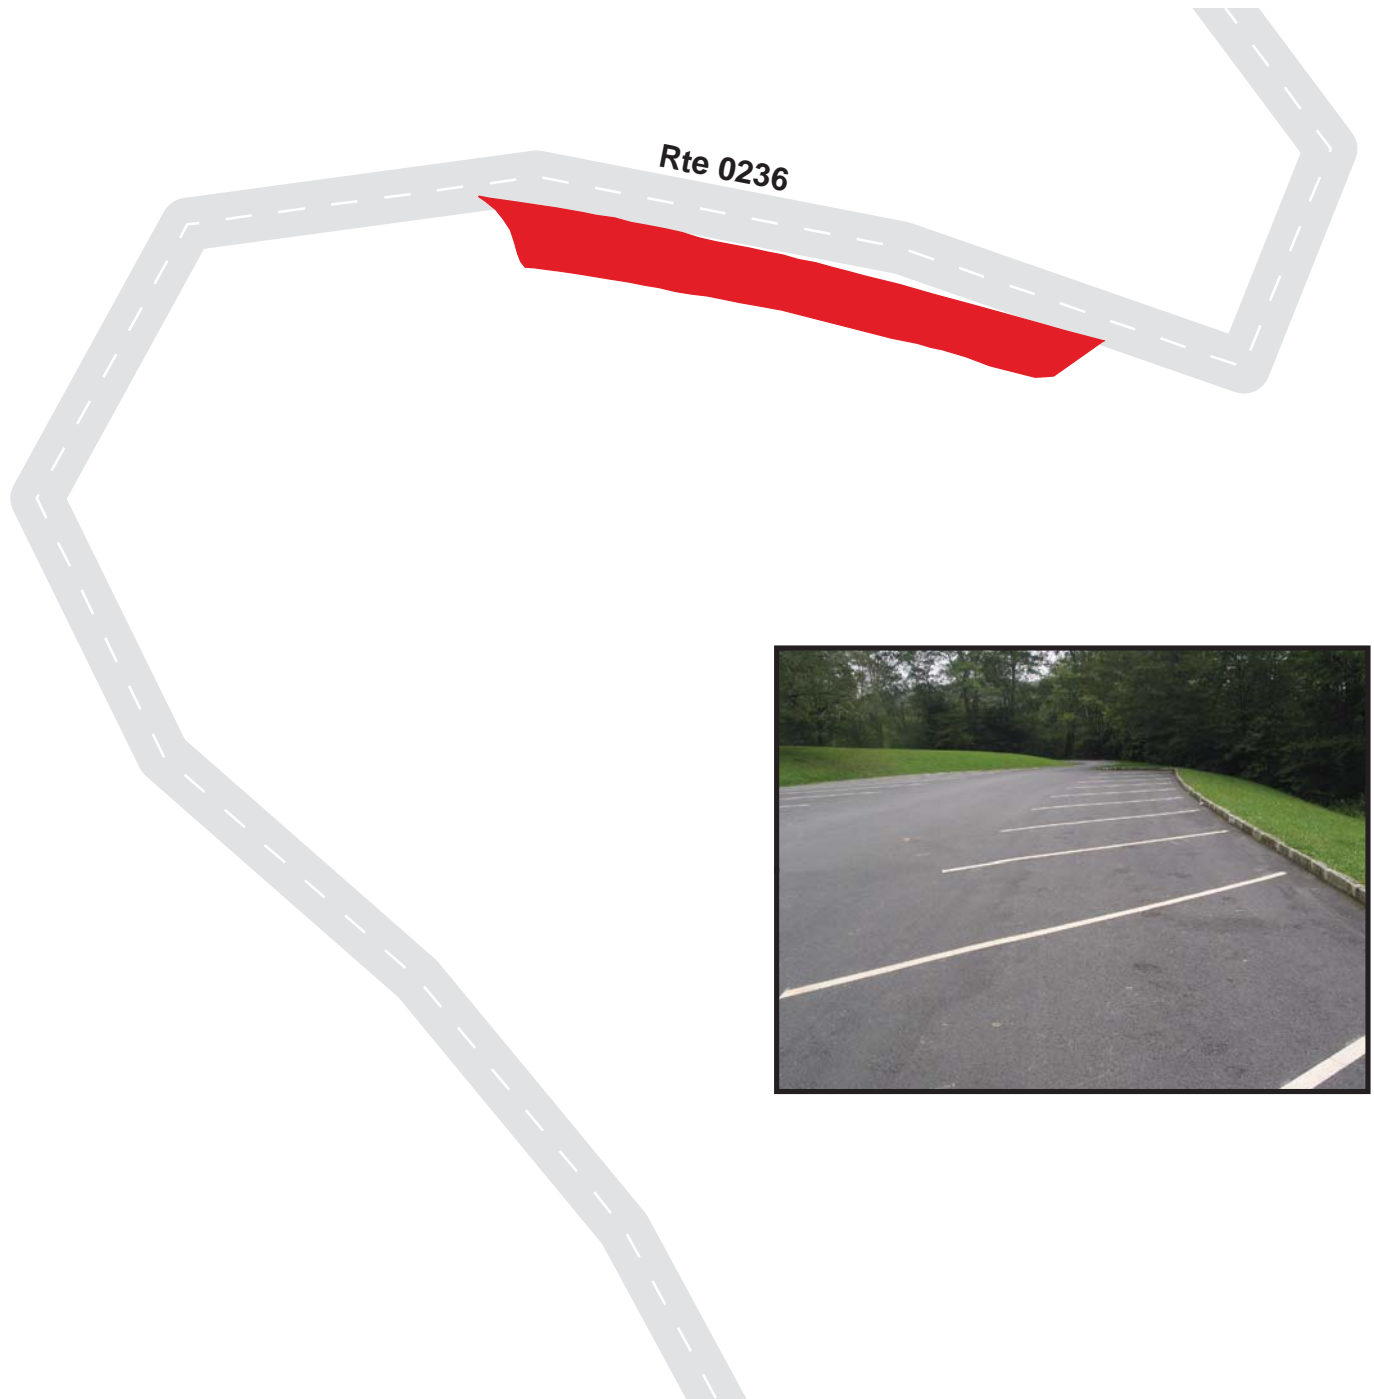
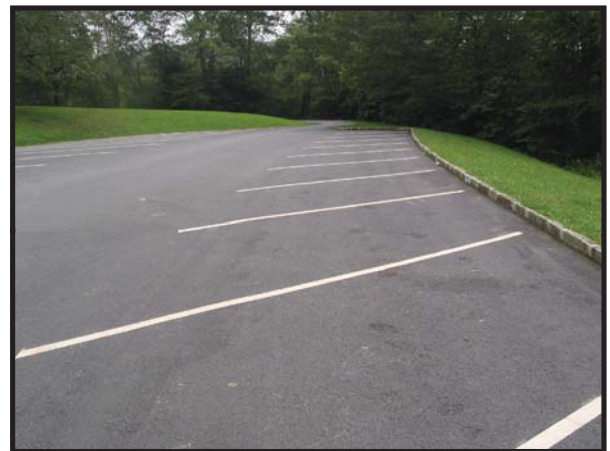
Route 1036A

Route	Public / NonPublic	Date Visited	Area (sq ft)	Lane Miles *	Surface Type	Condition / PCR
1036A	Public	9/3/2003	3218	0.06	AS	GOOD / 90

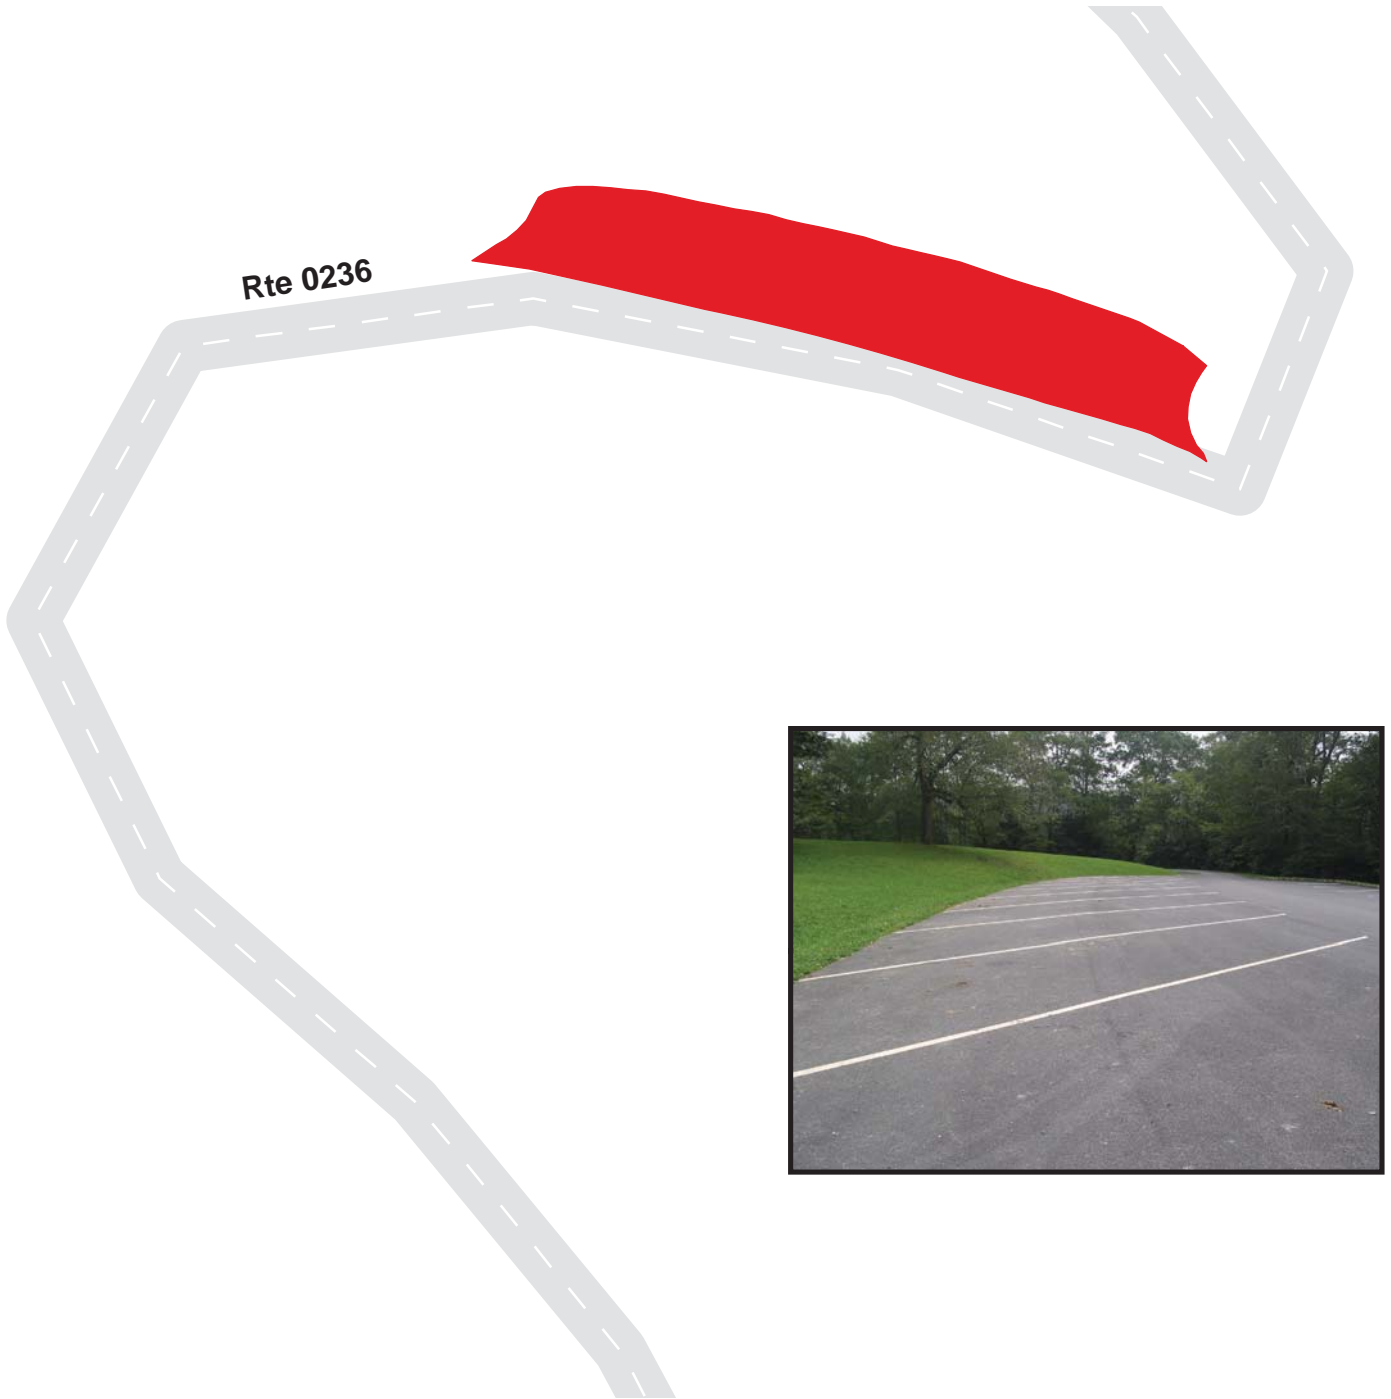
Blue Ridge Parkway Route 1036B

Trout Lake Parking B
Adjacent to Route 0236 at MP 0.36 on Left

Route	Public / NonPublic	Date Visited	Area (sq ft)	Lane Miles *	Surface Type	Condition / PCR
1036B	Public	9/3/2003	7173	0.12	AS	GOOD / 90

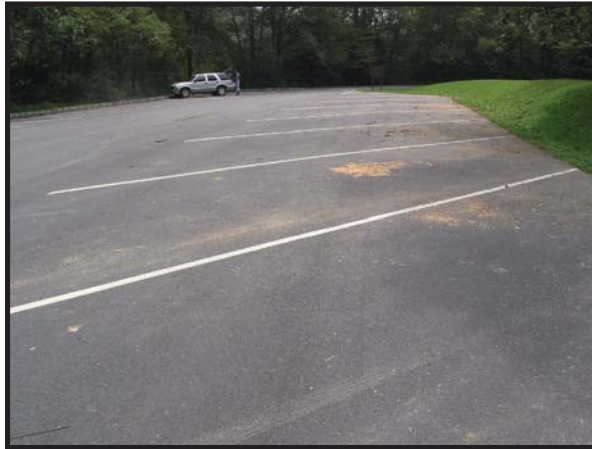
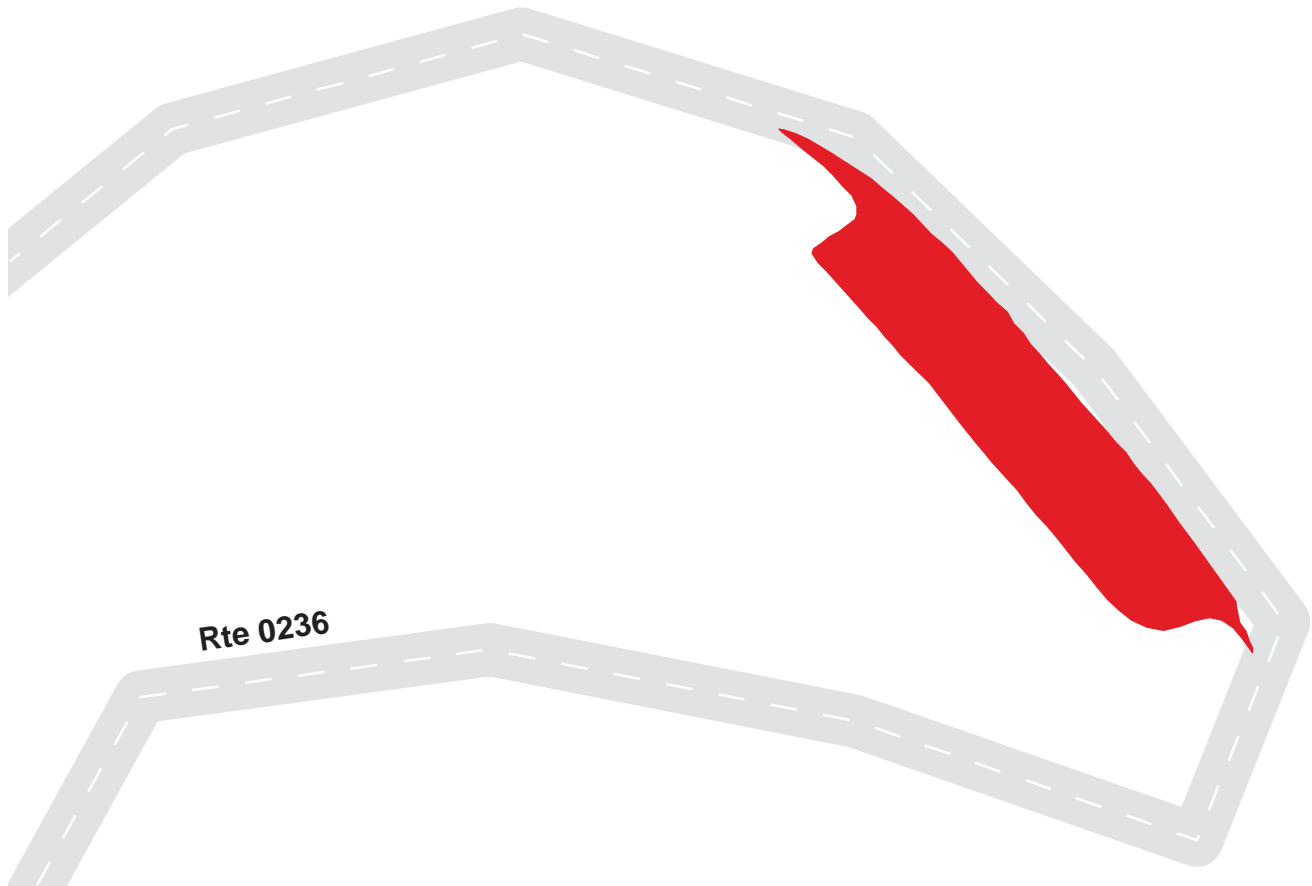
Route 1036C

Route	Public / NonPublic	Date Visited	Area (sq ft)	Lane Miles *	Surface Type	Condition / PCR
1036C	Public	9/3/2003	5646	0.10	AS	GOOD / 90

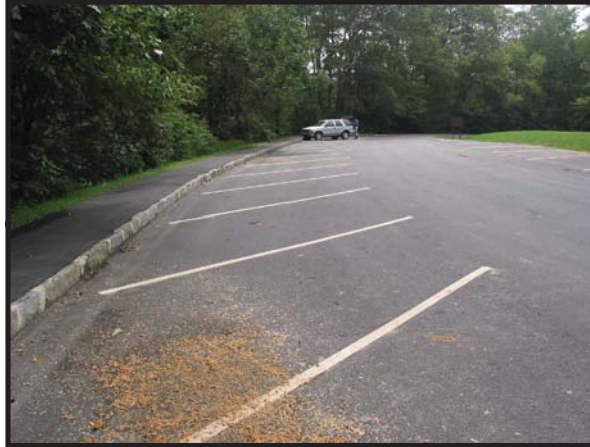
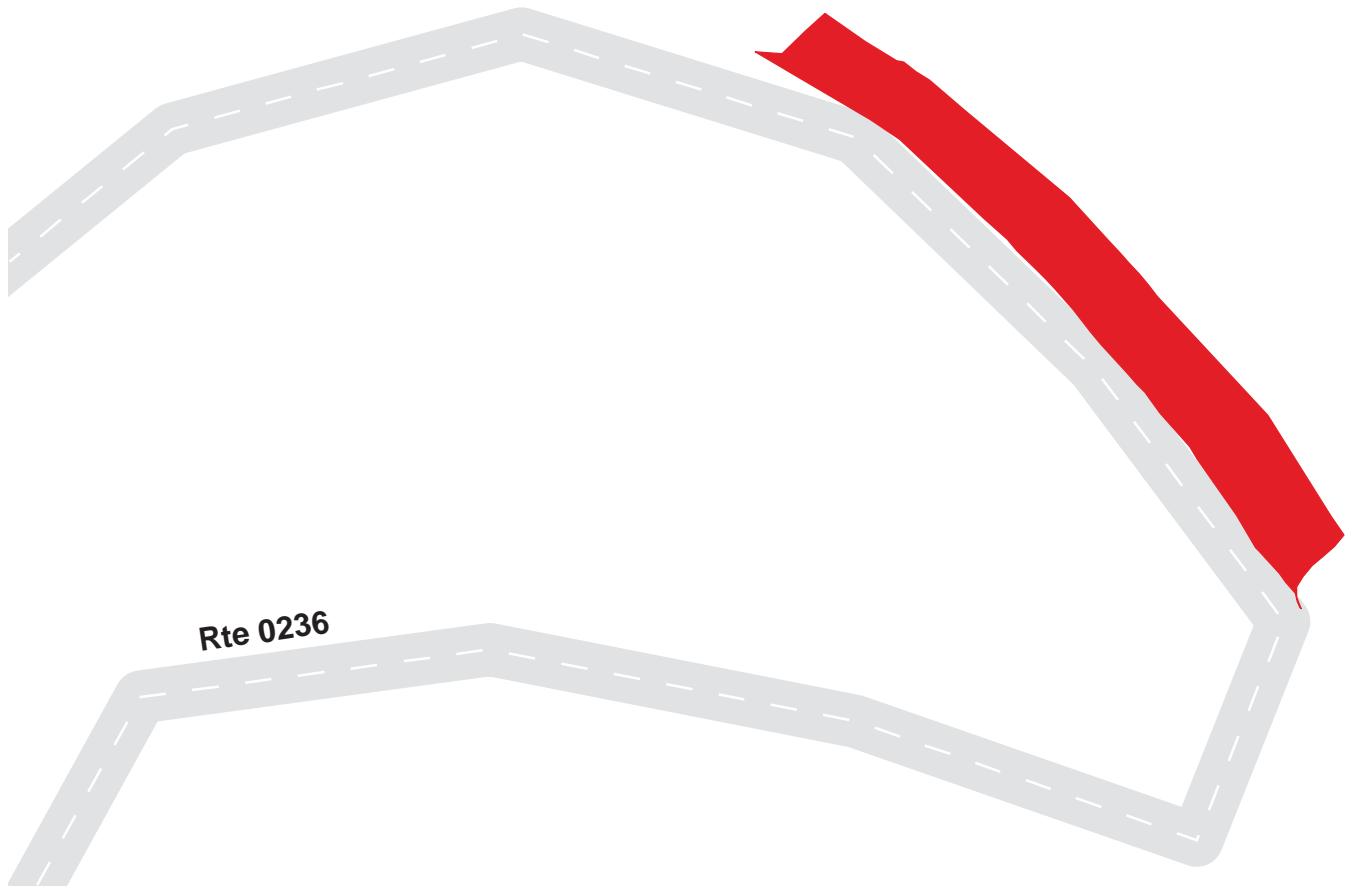
Route 1036D

Route	Public / NonPublic	Date Visited	Area (sq ft)	Lane Miles *	Surface Type	Condition / PCR
1036D	Public	9/3/2003	5387	0.09	AS	GOOD / 90

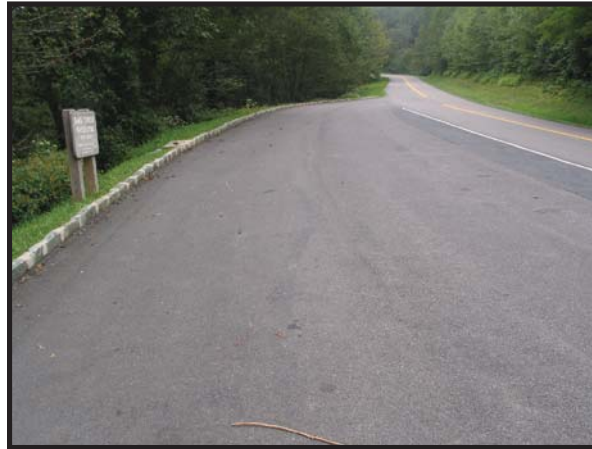
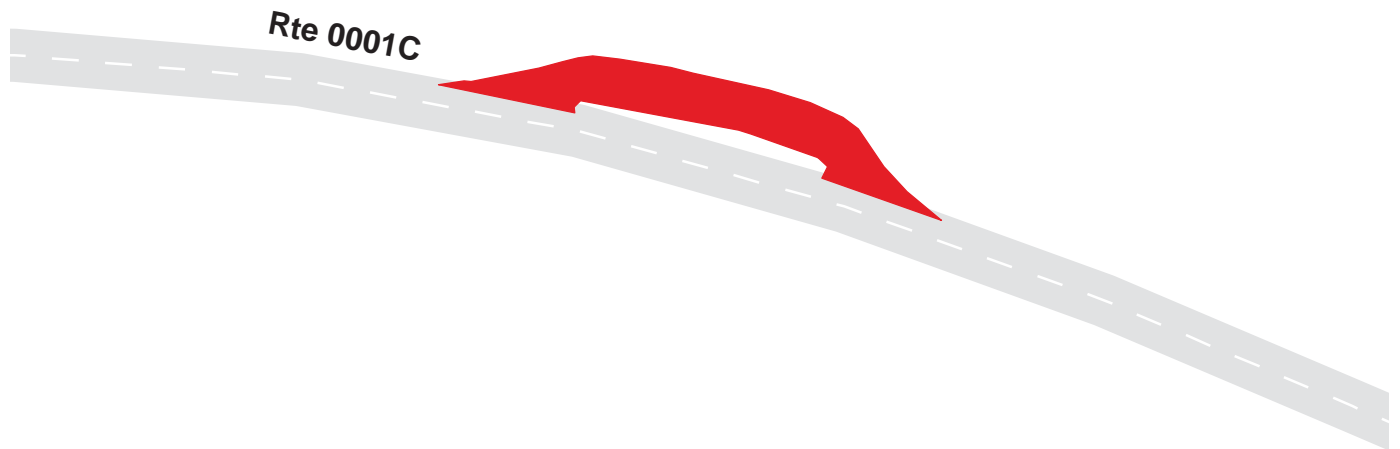
Route 1038

Route	Public / NonPublic	Date Visited	Area (sq ft)	Lane Miles *	Surface Type	Condition / PCR
1038	Public	9/3/2003	3422	0.06	AS	GOOD / 90

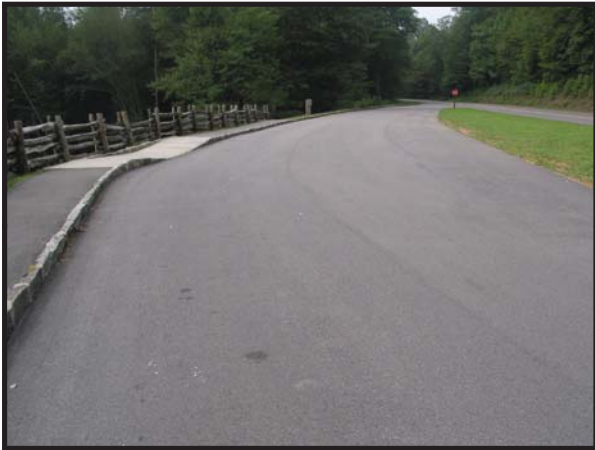
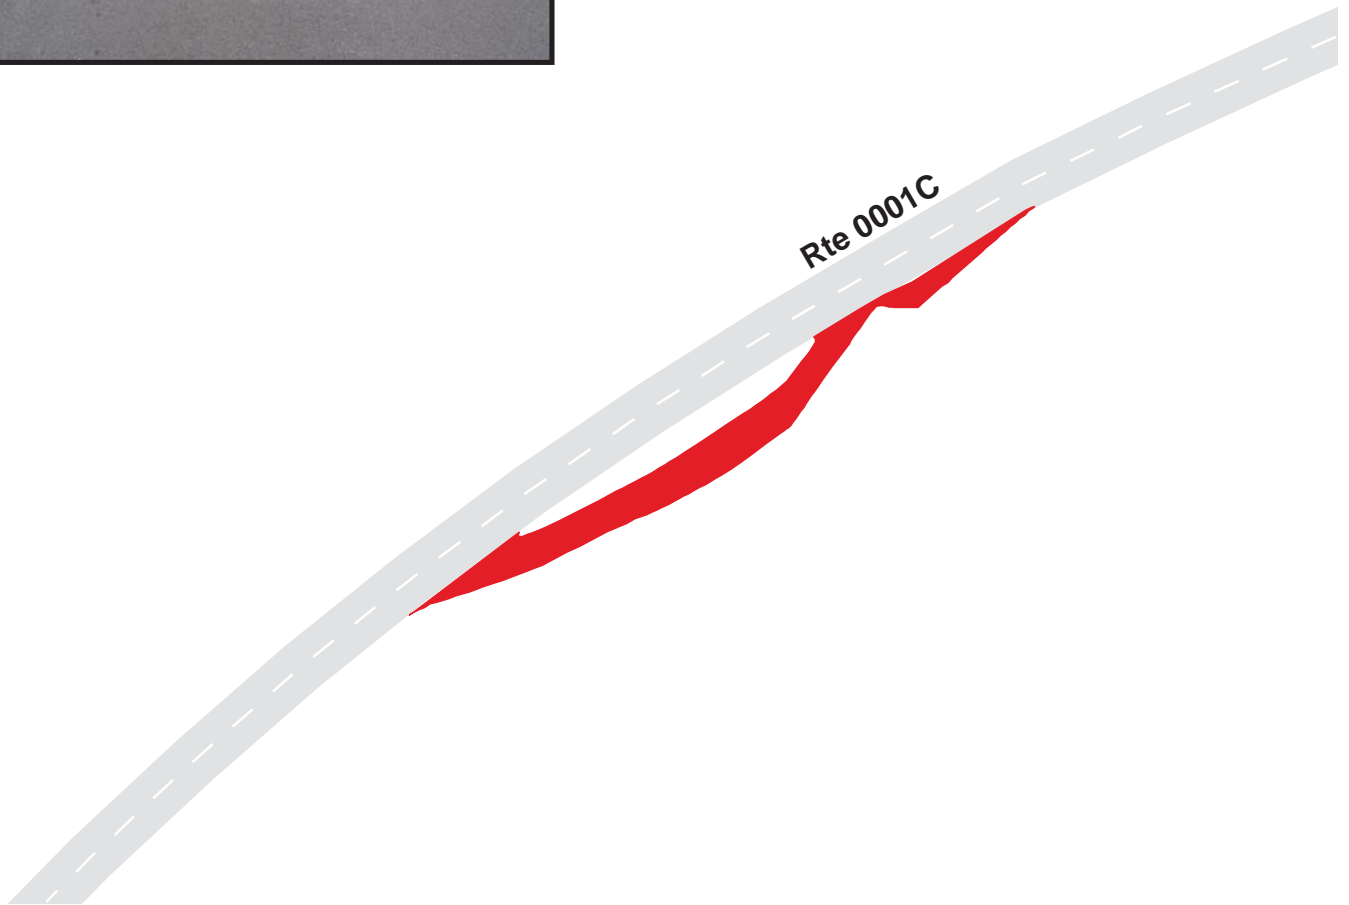
Route 1039

Route	Public / NonPublic	Date Visited	Area (sq ft)	Lane Miles *	Surface Type	Condition / PCR
1039	Public	9/3/2003	10660	0.18	AS	GOOD / 90

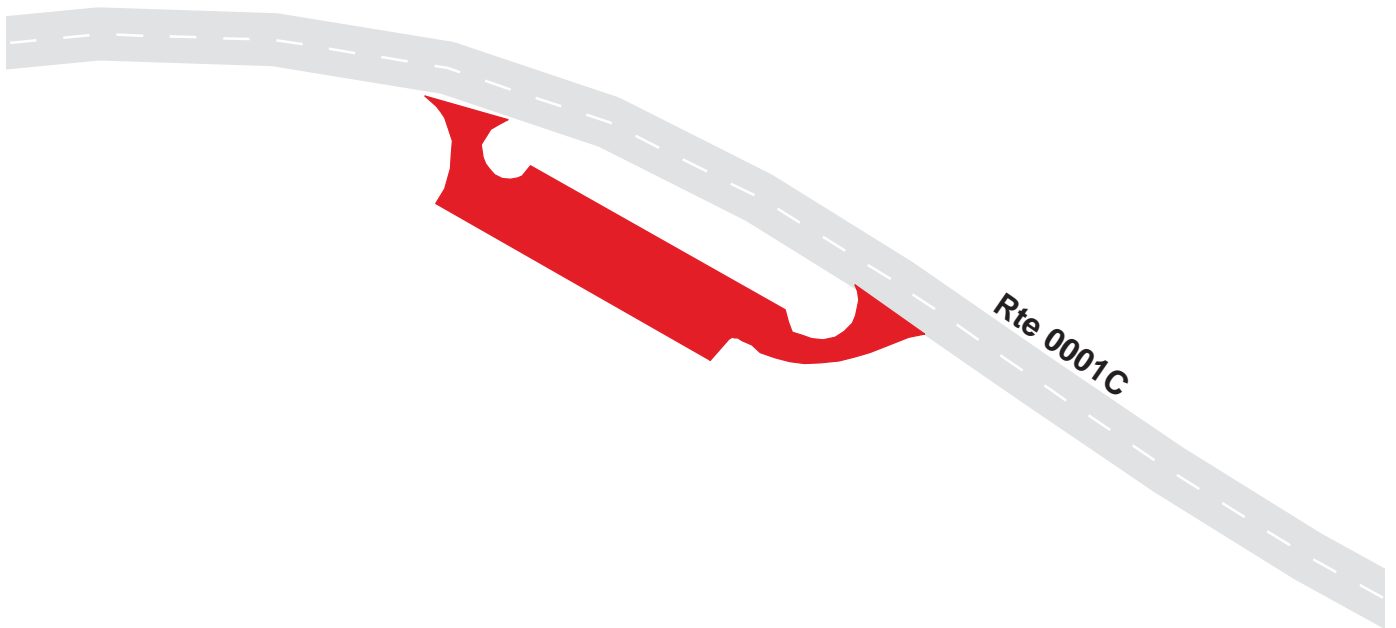
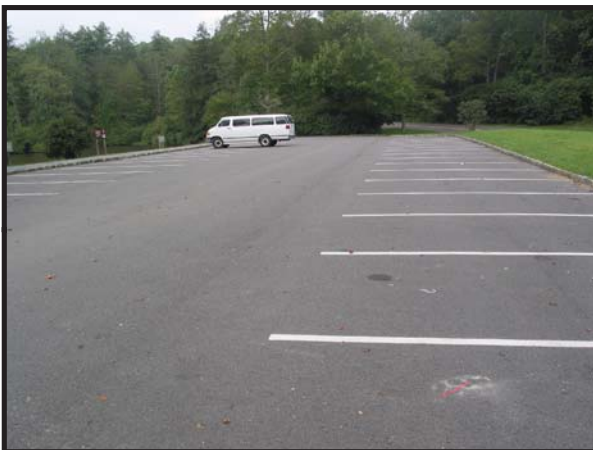
Route 1040

Route	Public / NonPublic	Date Visited	Area (sq ft)	Lane Miles *	Surface Type	Condition / PCR
1040	Public	9/3/2003	14774	0.25	AS	GOOD / 90

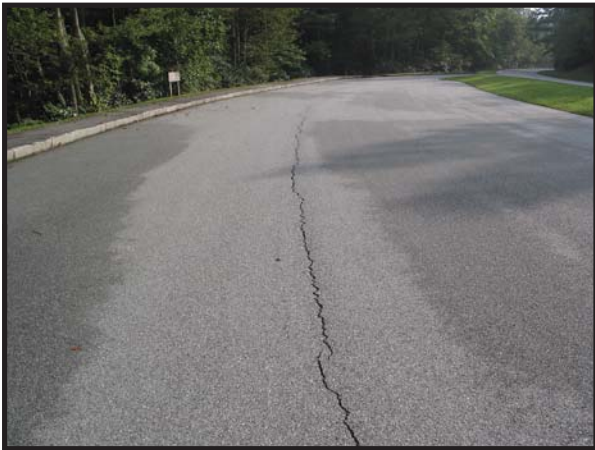
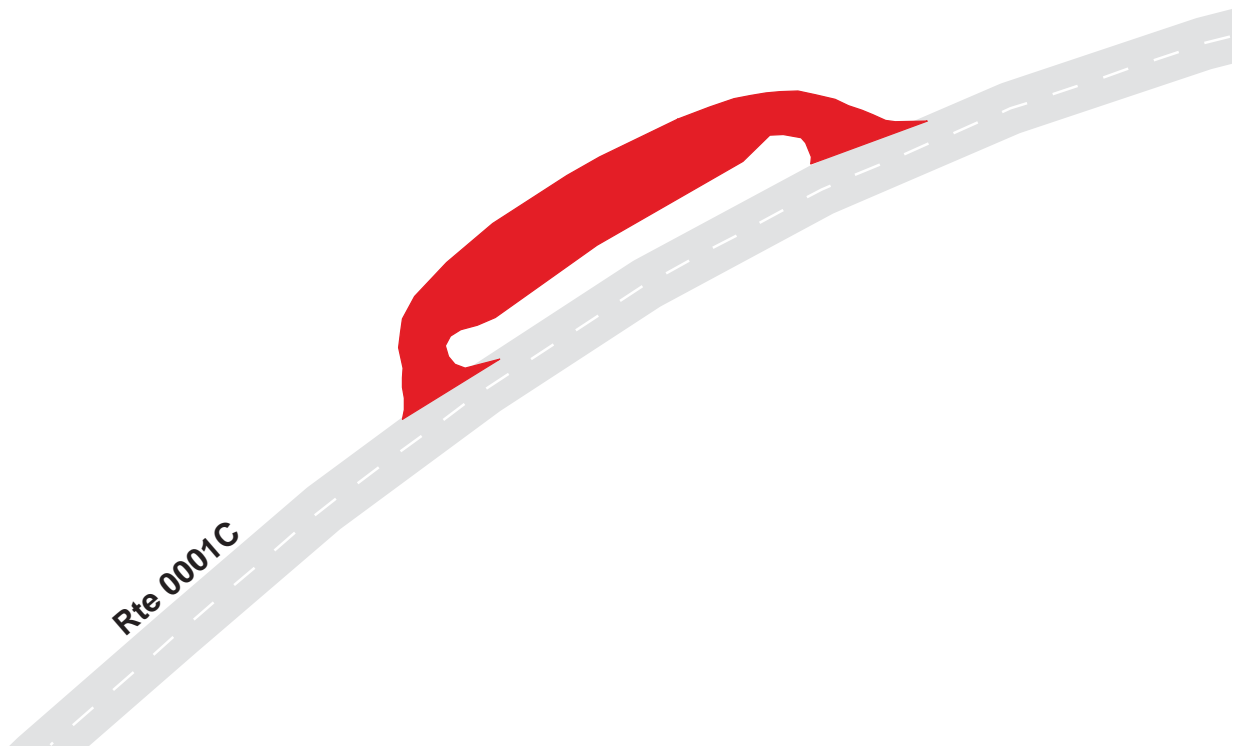
Route 1041

Route	Public / NonPublic	Date Visited	Area (sq ft)	Lane Miles *	Surface Type	Condition / PCR
1041	Public	9/3/2003	11772	0.20	AS	FAIR / 73

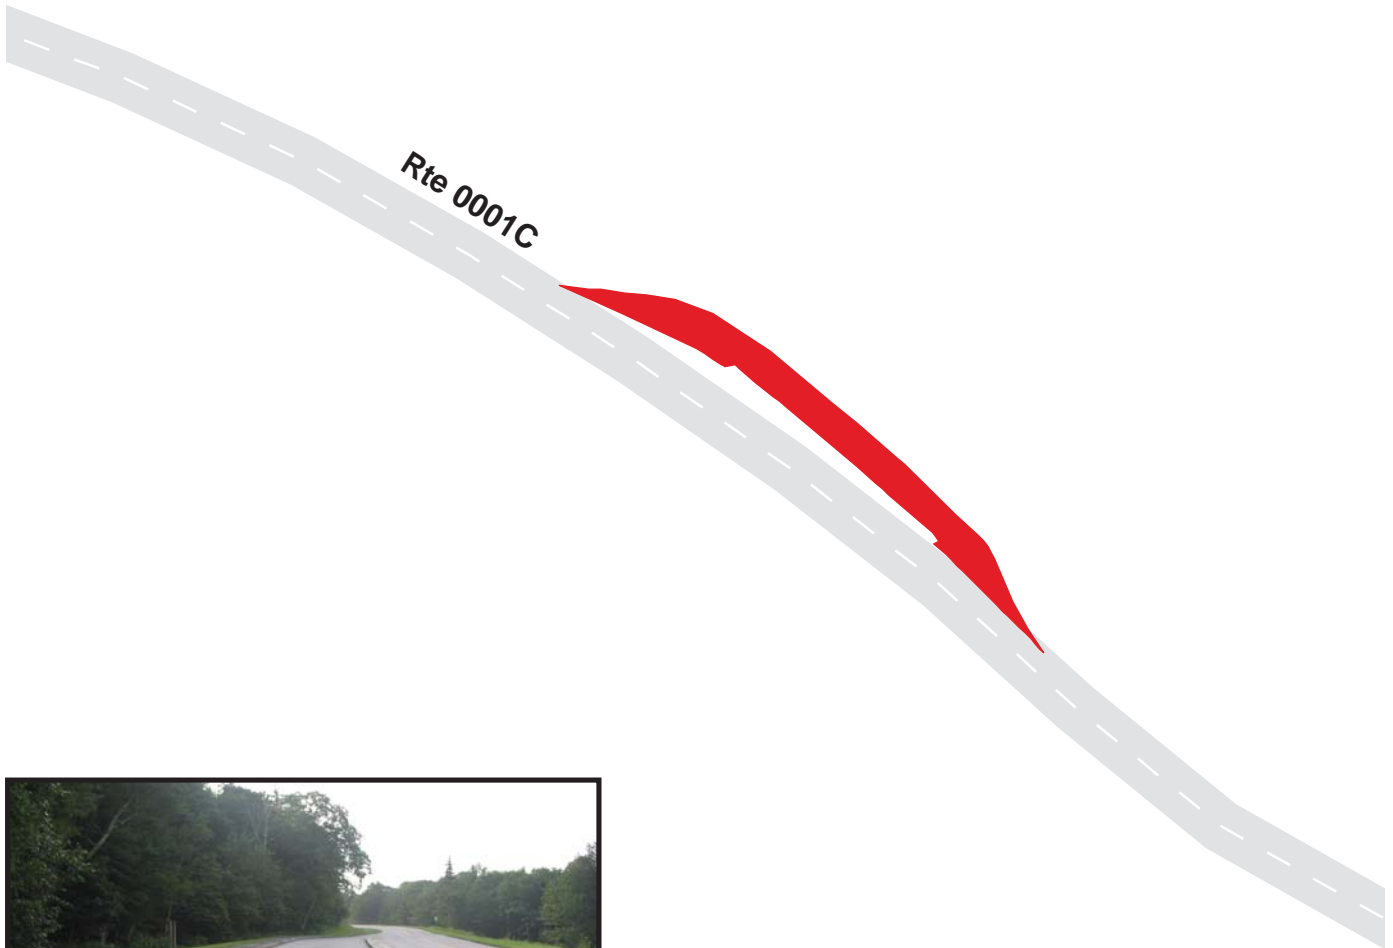
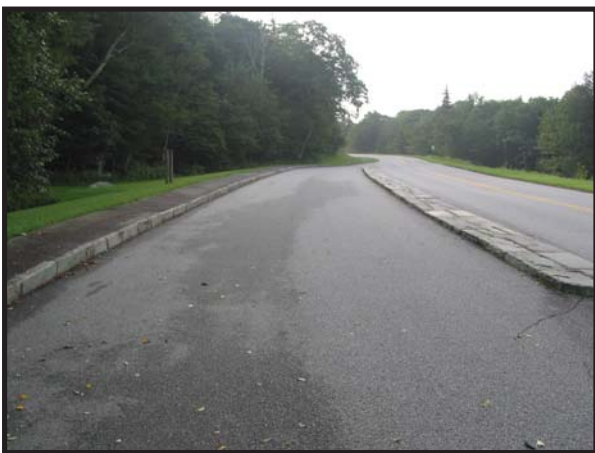
Blue Ridge Parkway Route 1047

Ravens Rock Overlook
From Route 0001C at MP 301.50 on Right

Route	Public / NonPublic	Date Visited	Area (sq ft)	Lane Miles *	Surface Type	Condition / PCR
1047	Public	9/3/2003	5546	0.10	AS	GOOD / 90

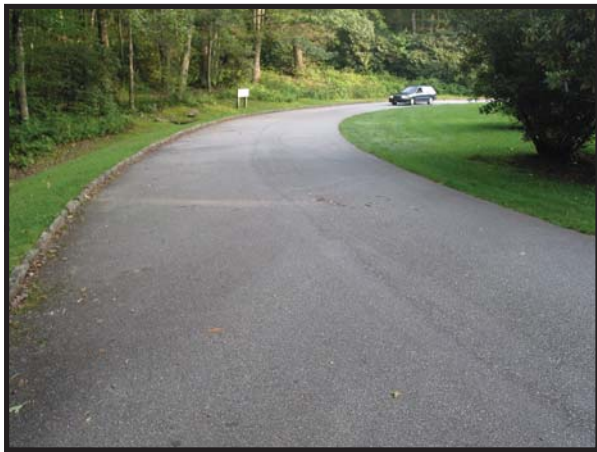
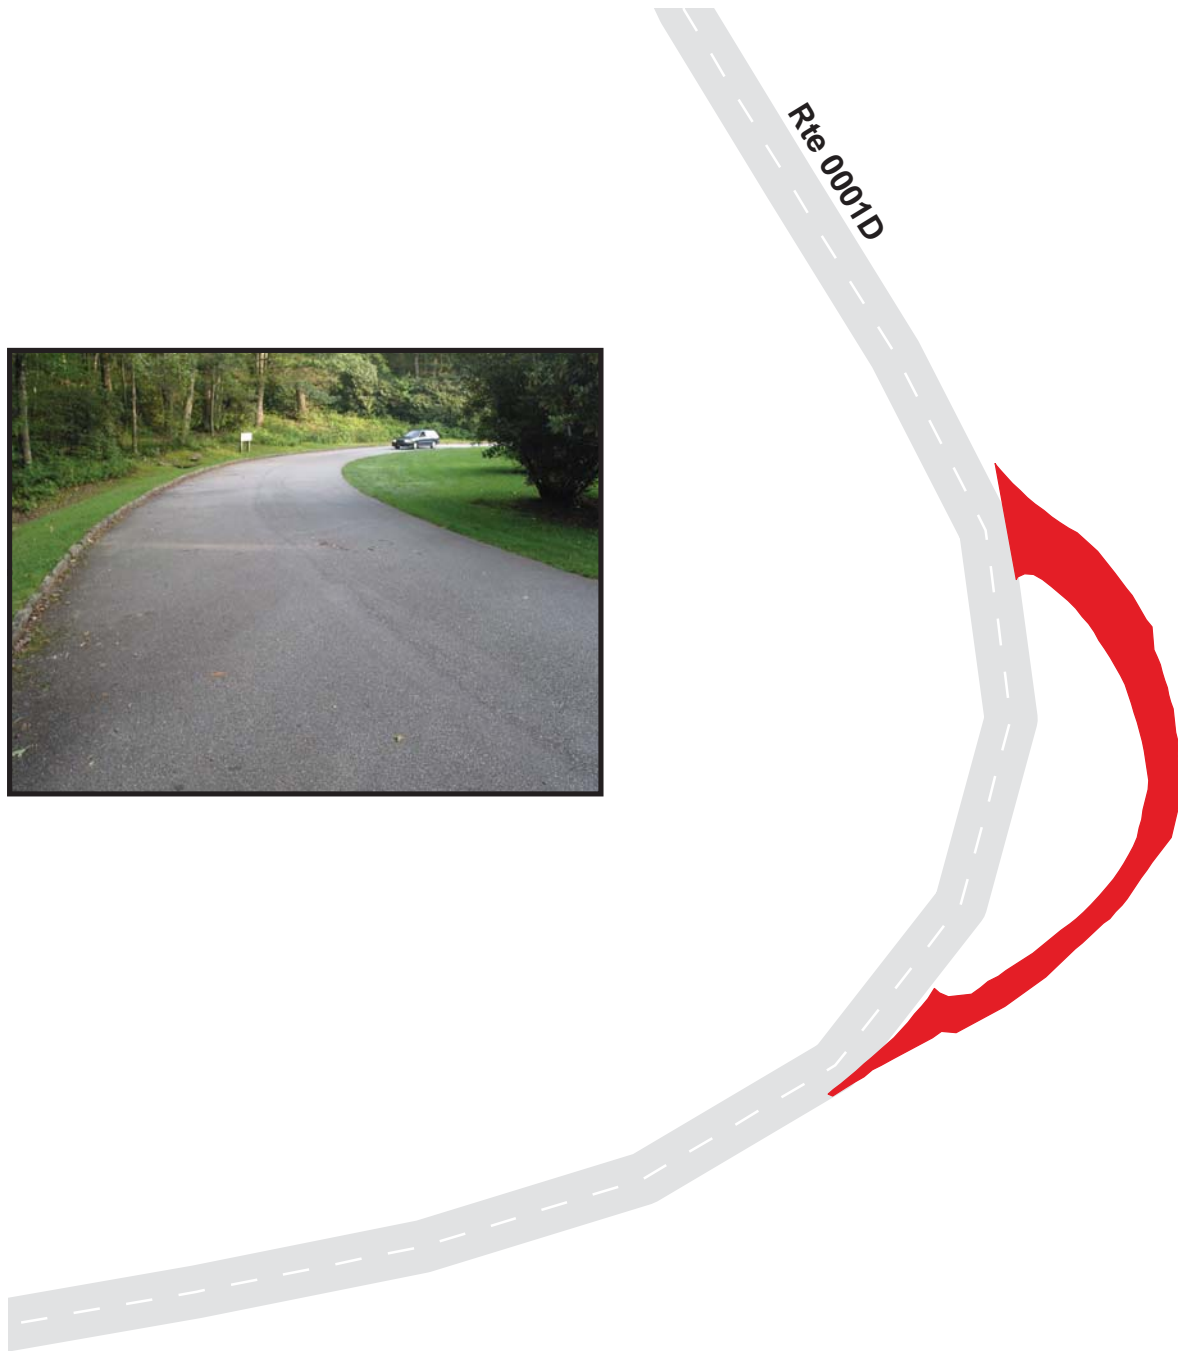
Blue Ridge Parkway Route 1055

Grandmother Mountain Parking Overlook
From Route 0001D at MP 307.16 on Left

Route	Public / NonPublic	Date Visited	Area (sq ft)	Lane Miles *	Surface Type	Condition / PCR
1055	Public	9/1/2003	6710	0.12	AS	GOOD / 90

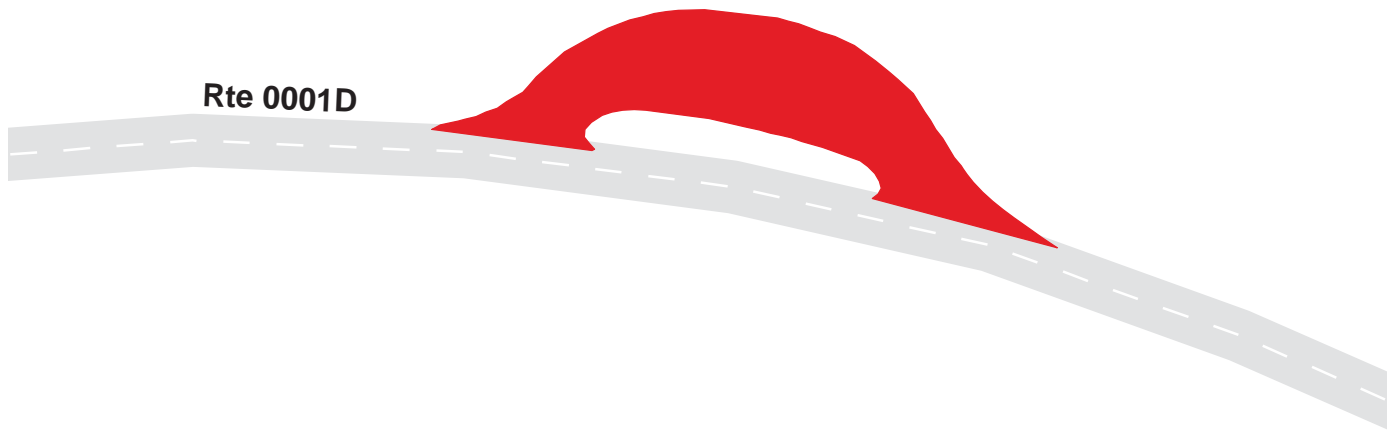
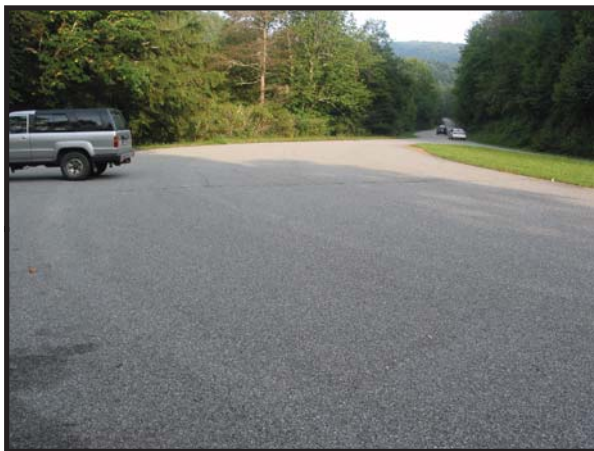
Blue Ridge Parkway Route 1058

Camp Creek Overlook
From Route 0001D at MP 315.24 on Right

Route	Public / NonPublic	Date Visited	Area (sq ft)	Lane Miles *	Surface Type	Condition / PCR
1058	Public	9/1/2003	9074	0.16	AS	FAIR / 73

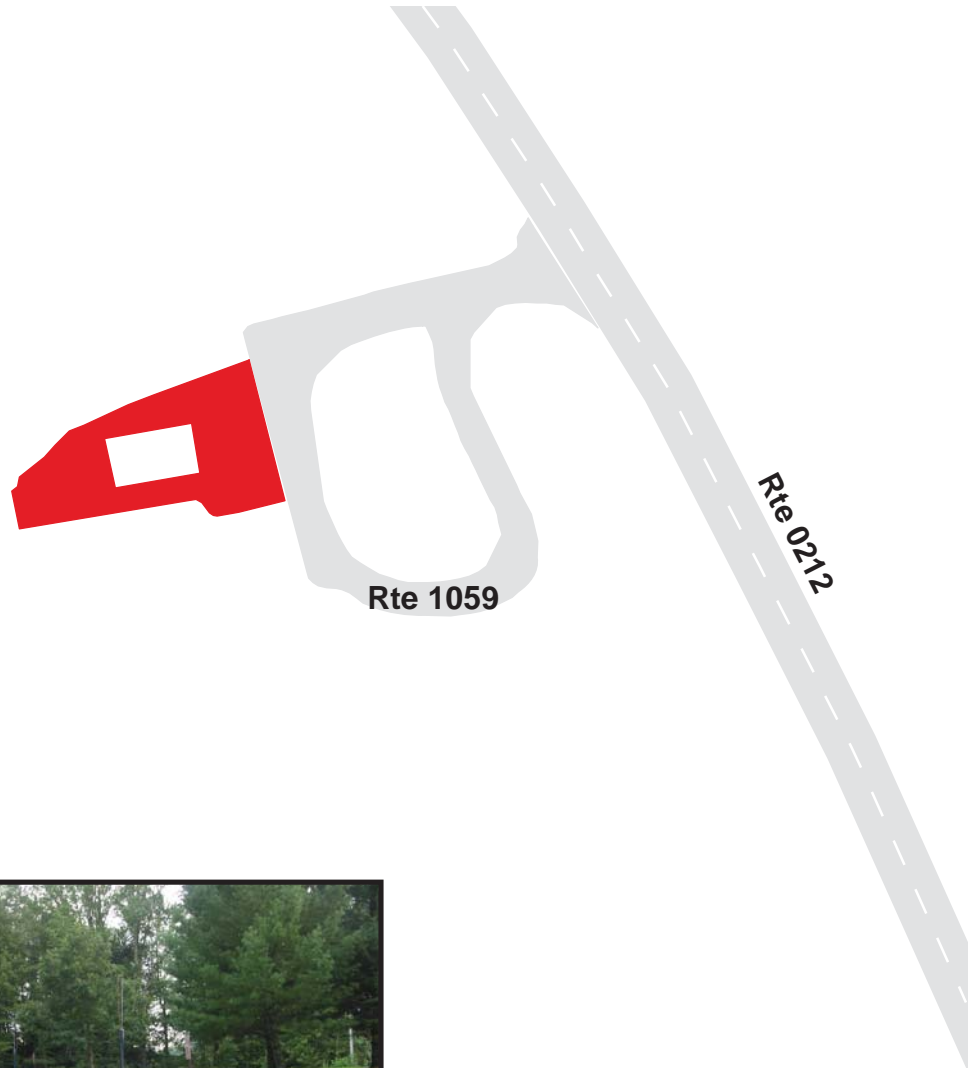
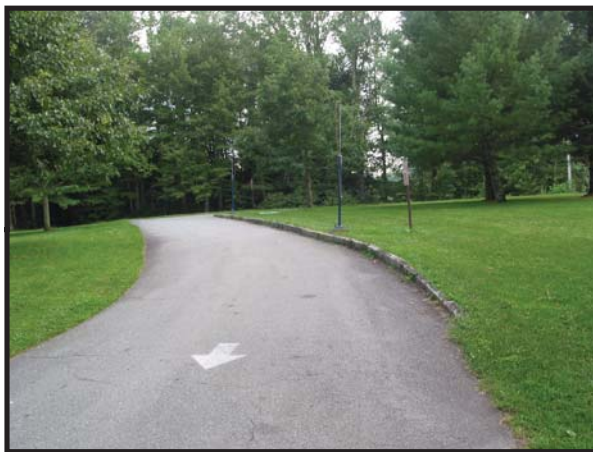
Blue Ridge Parkway Route 1060

Linville Maintenance Yard
From Route 1059

Route	Public / NonPublic	Date Visited	Area (sq ft)	Lane Miles *	Surface Type	Condition / PCR
1060	Public	9/1/2003	5538	0.10	AS	POOR / 45

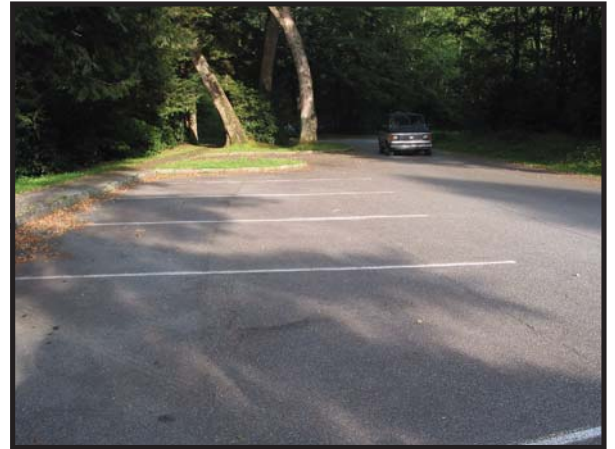
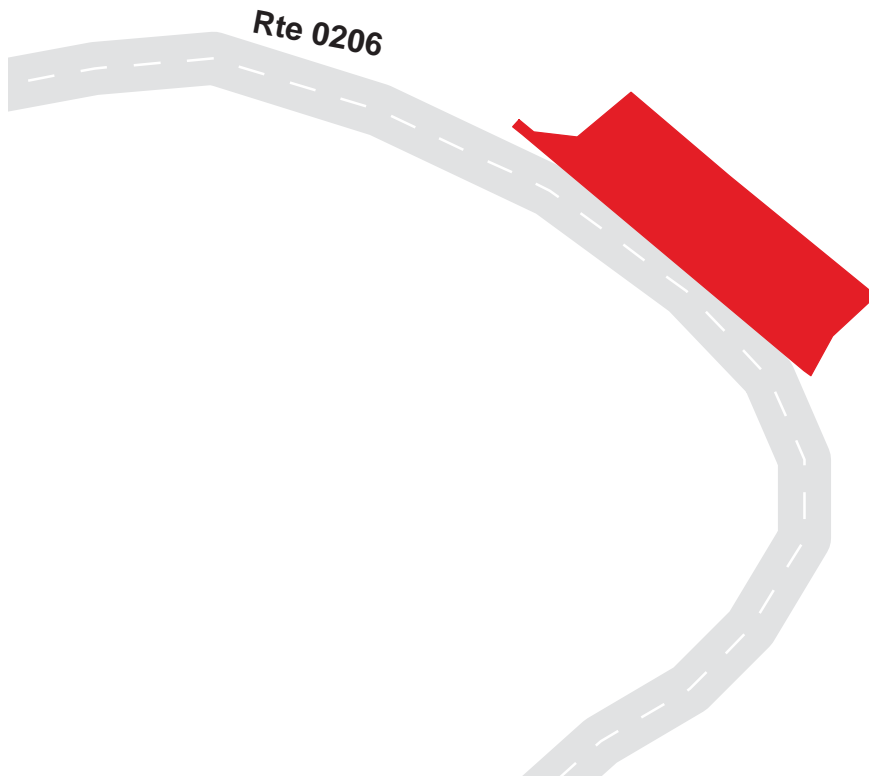
Route 1061C

Route	Public / NonPublic	Date Visited	Area (sq ft)	Lane Miles *	Surface Type	Condition / PCR
1061C	Public	9/1/2003	2007	0.03	AS	FAIR / 73

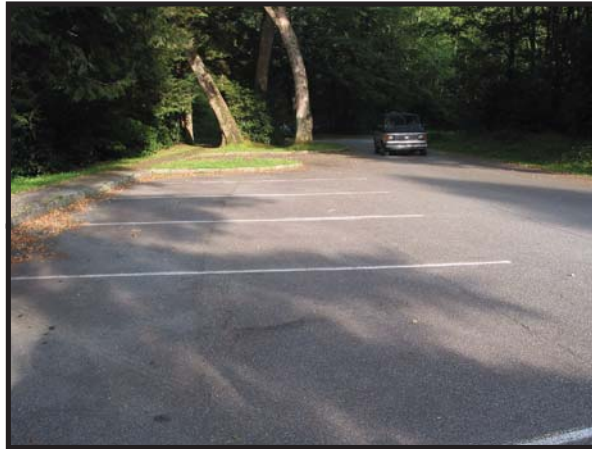
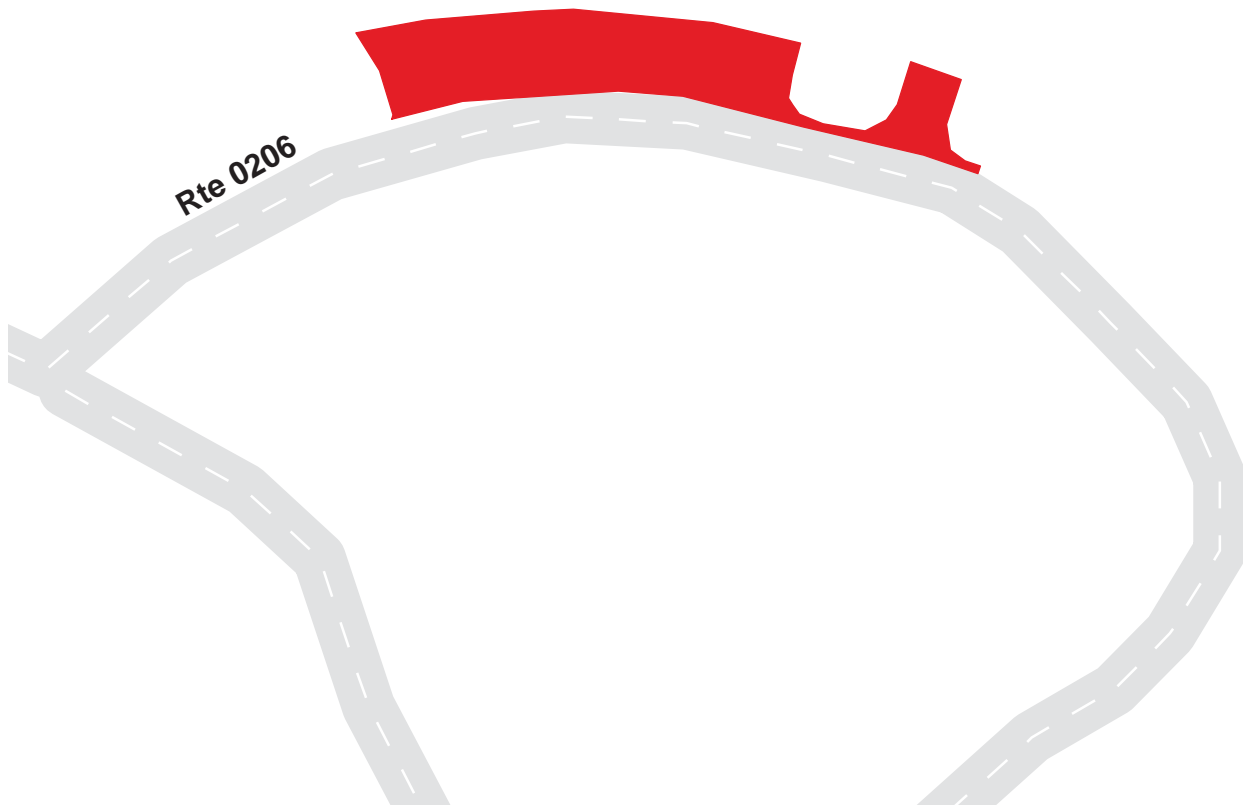
Route 1062

Route	Public / NonPublic	Date Visited	Area (sq ft)	Lane Miles *	Surface Type	Condition / PCR
1062	Public	9/1/2003	55563	0.96	AS	FAIR / 73
