The Road Inventory of Blue Ridge Parkway BLRI – 5140 Volume 1

Road Inventory Program

Prepared By:
Federal Highway Administration
Eastern Federal Lands Highway Division
Cycle 3

Blue Ridge Parkway in North Carolina

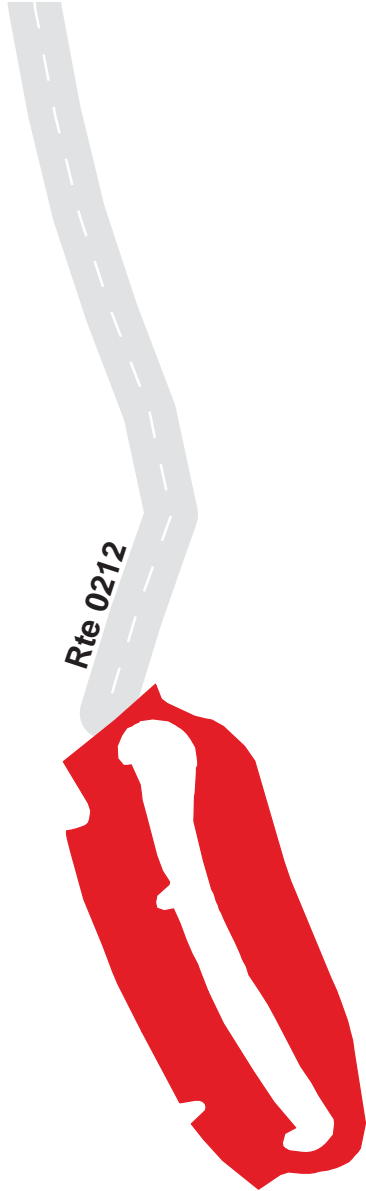
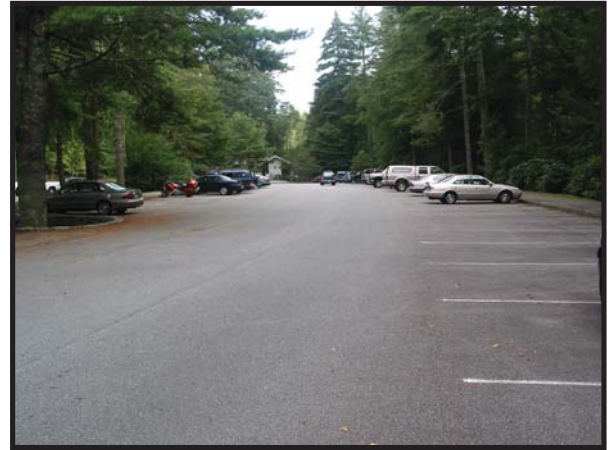
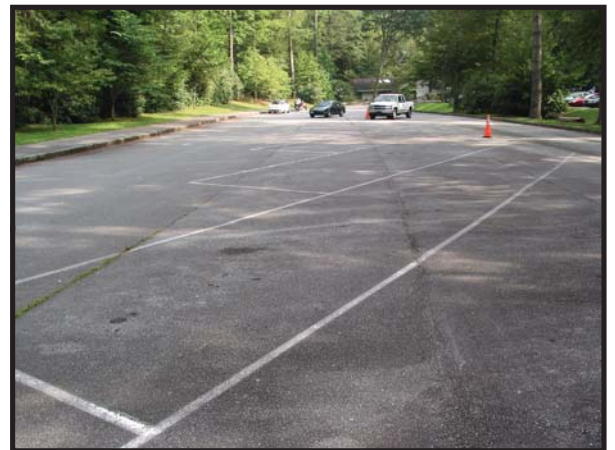
Route 1064

Route	Public / NonPublic	Date Visited	Area (sq ft)	Lane Miles *	Surface Type	Condition / PCR
1064	Public	9/1/2003	4063	0.07	AS	GOOD / 90

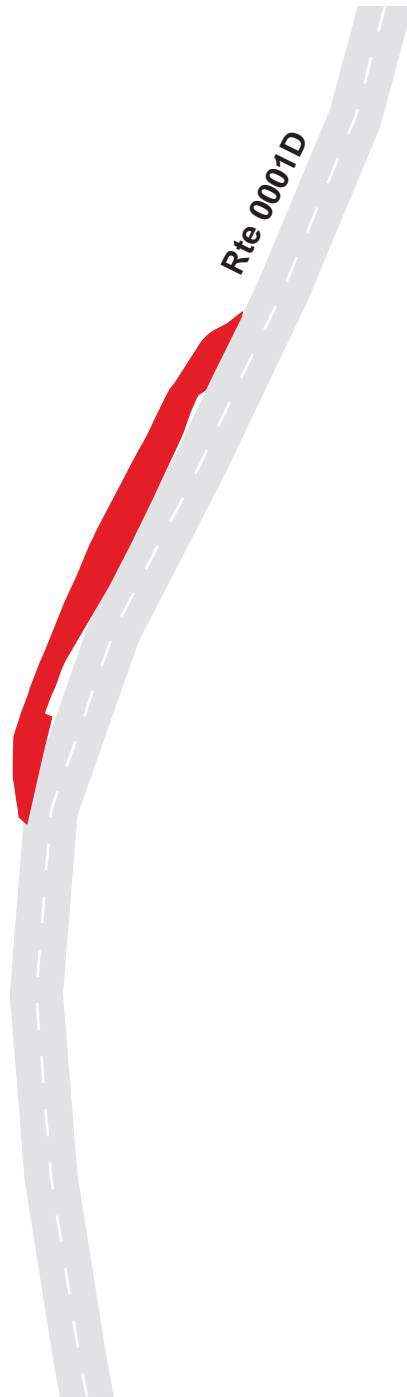
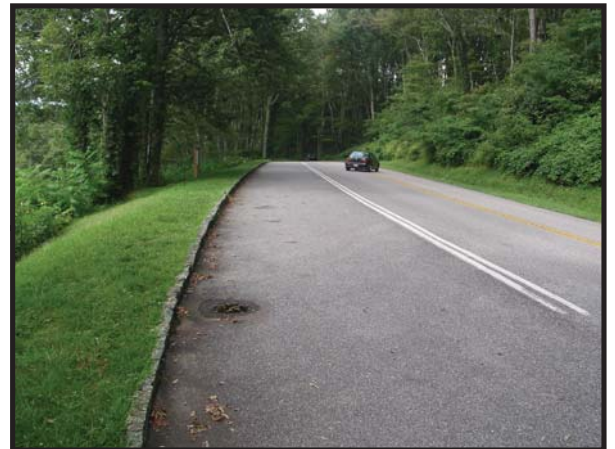
Route 1065

Route	Public / NonPublic	Date Visited	Area (sq ft)	Lane Miles *	Surface Type	Condition / PCR
1065	Public	9/1/2003	14996	0.26	AS	GOOD / 90

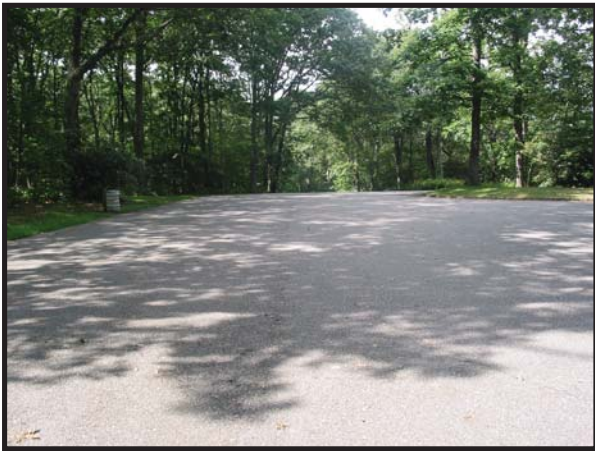
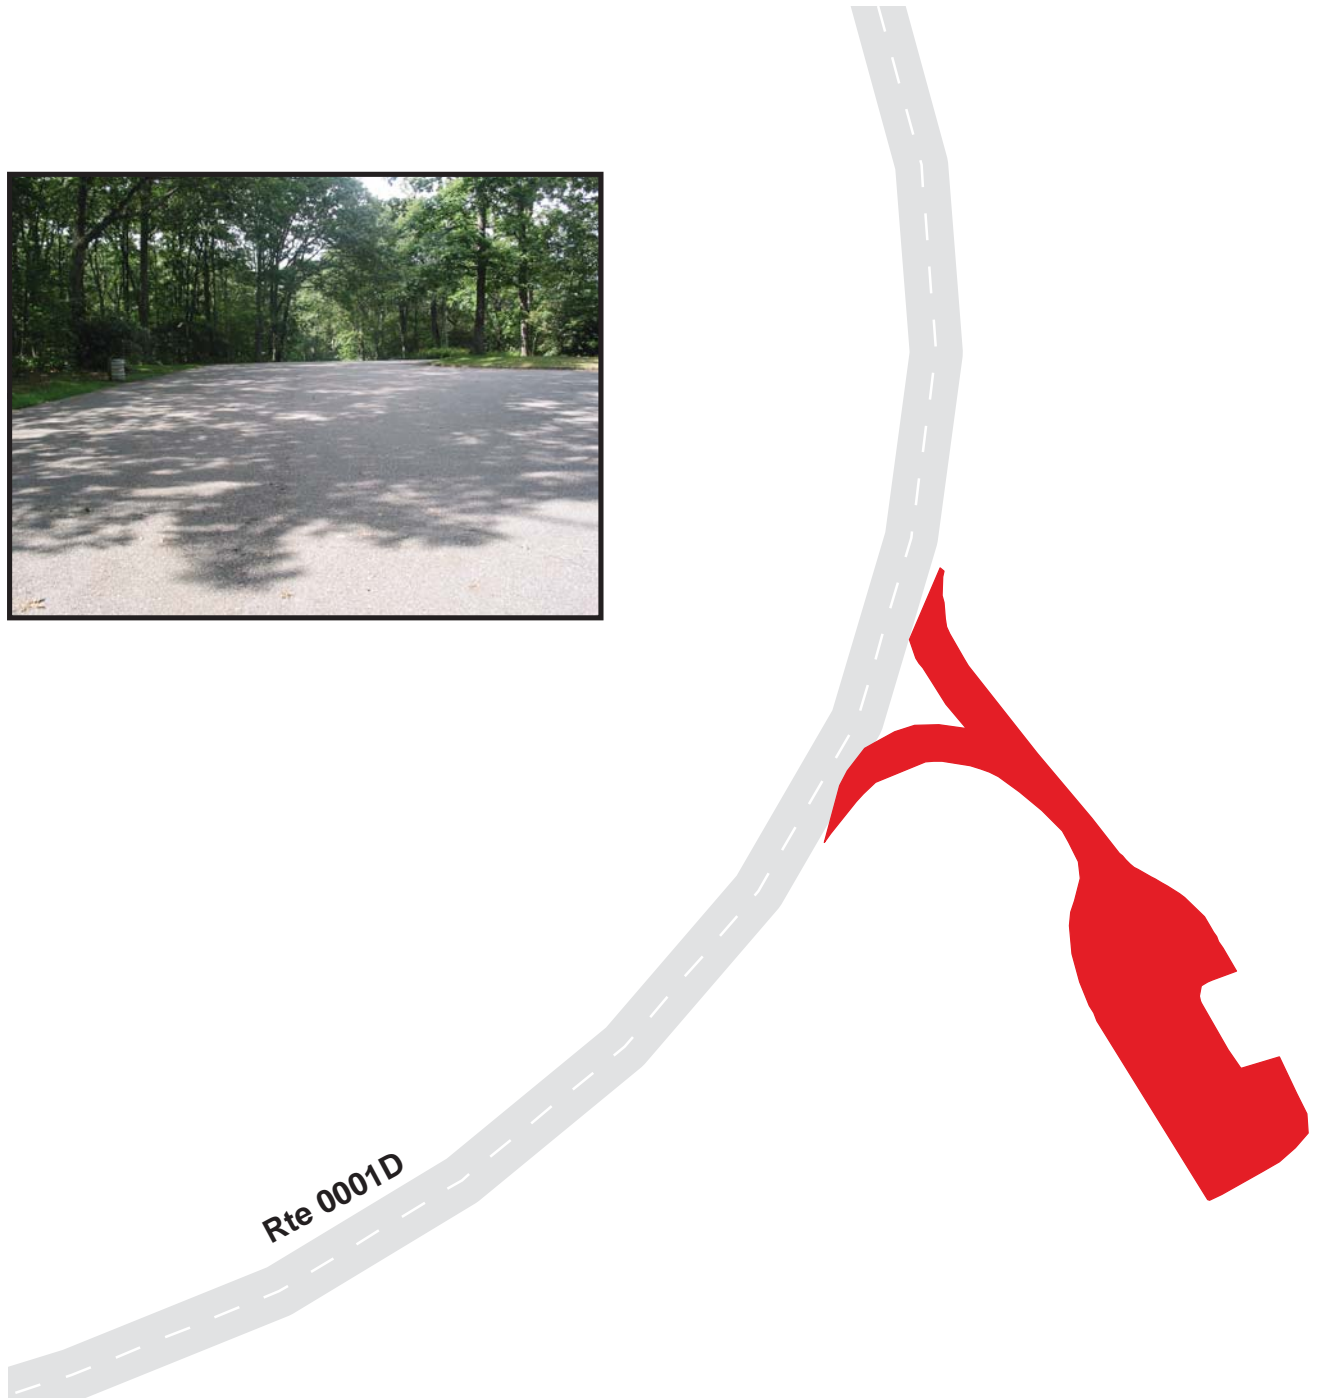
Route 1066

Route	Public / NonPublic	Date Visited	Area (sq ft)	Lane Miles *	Surface Type	Condition / PCR
1066	Public	9/1/2003	5084	0.09	AS	FAIR / 73

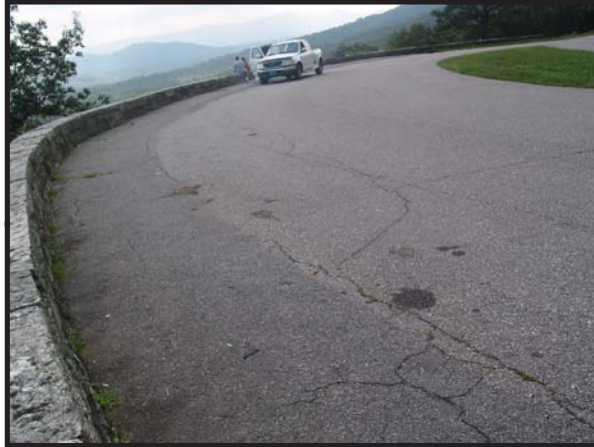
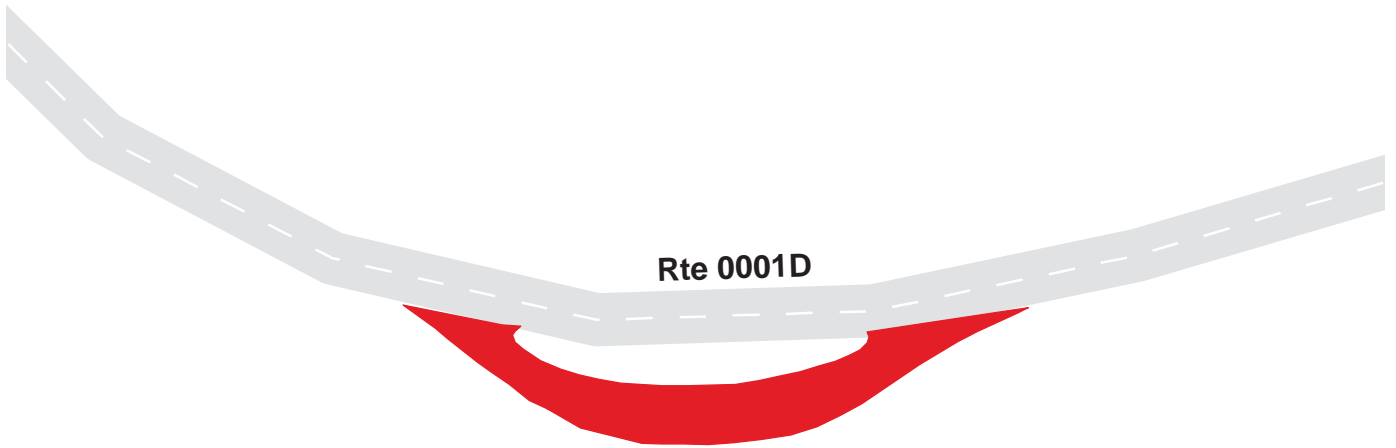
Route 1067

Route	Public / NonPublic	Date Visited	Area (sq ft)	Lane Miles *	Surface Type	Condition / PCR
1067	Public	9/1/2003	7178	0.12	AS	FAIR / 73

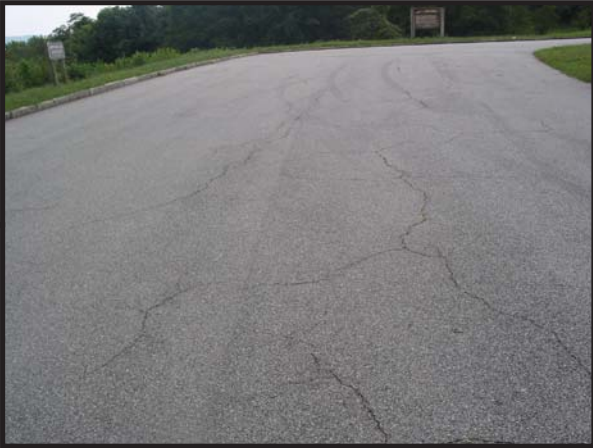
Route 1068

Route	Public / NonPublic	Date Visited	Area (sq ft)	Lane Miles *	Surface Type	Condition / PCR
1068	Public	9/1/2003	18105	0.31	AS	GOOD / 90

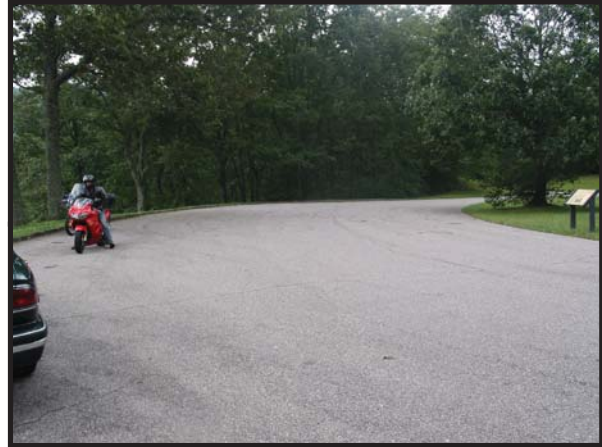
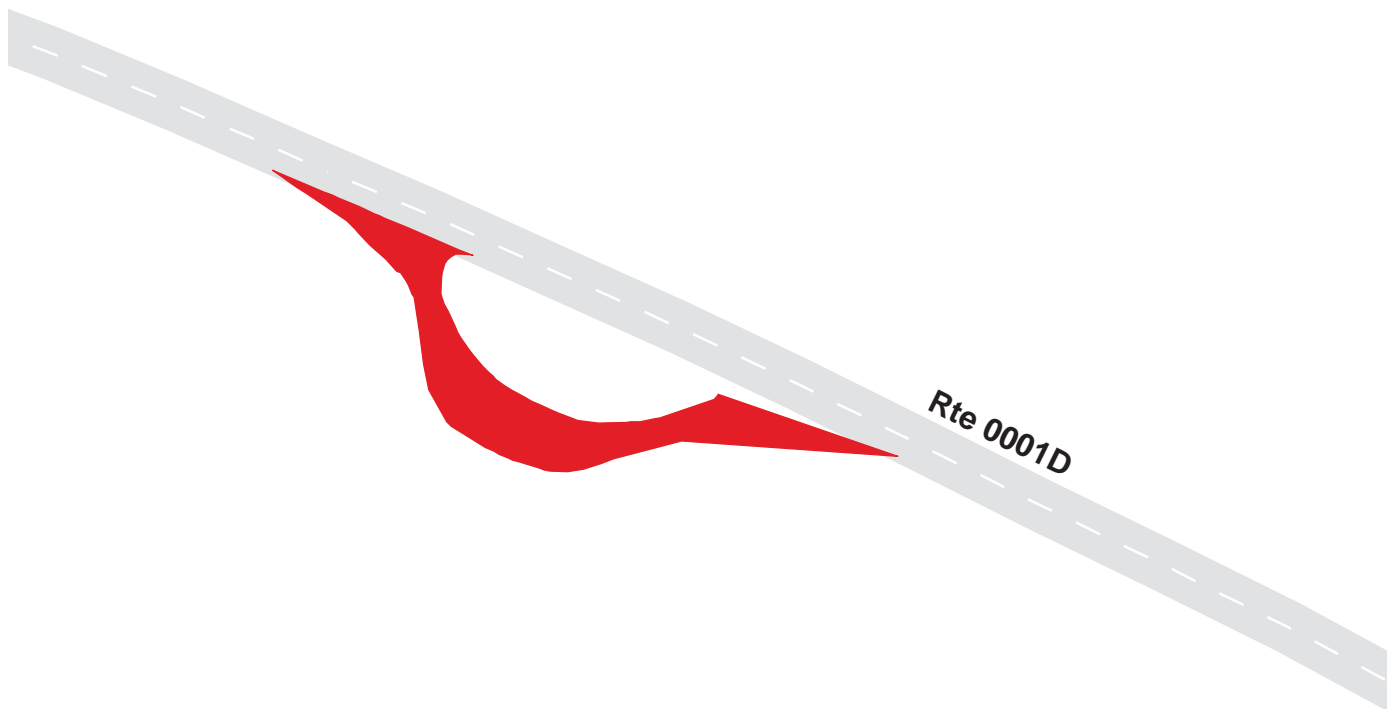
Route 1069

Route	Public / NonPublic	Date Visited	Area (sq ft)	Lane Miles *	Surface Type	Condition / PCR
1069	Public	9/1/2003	5309	0.09	AS	EXCELLENT / 97

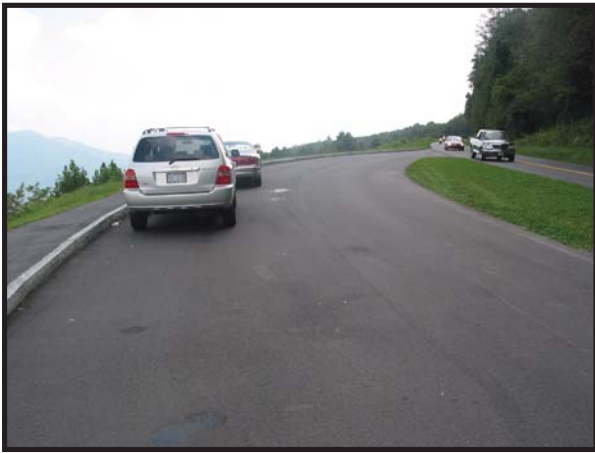
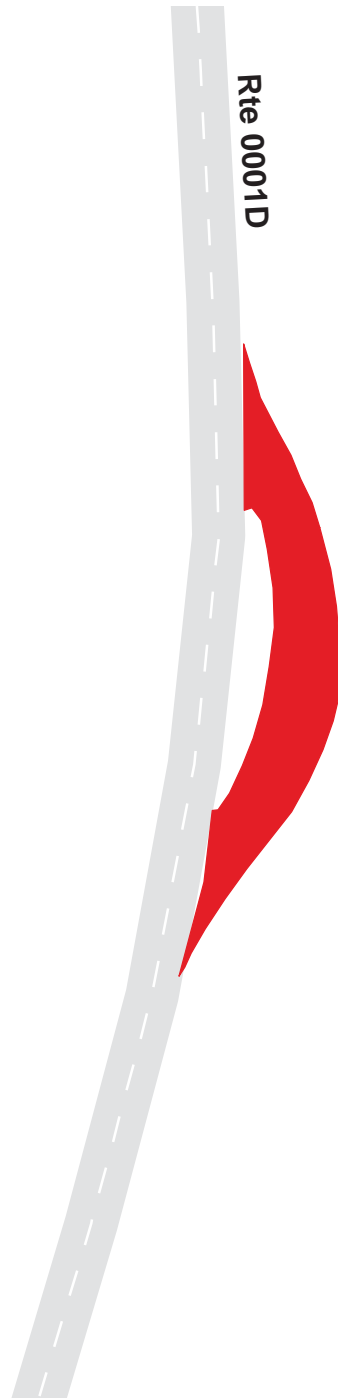
Route 1070

Route	Public / NonPublic	Date Visited	Area (sq ft)	Lane Miles *	Surface Type	Condition / PCR
1070	Public	4/8/2004	8692	0.15	AS	EXCELLENT / 97

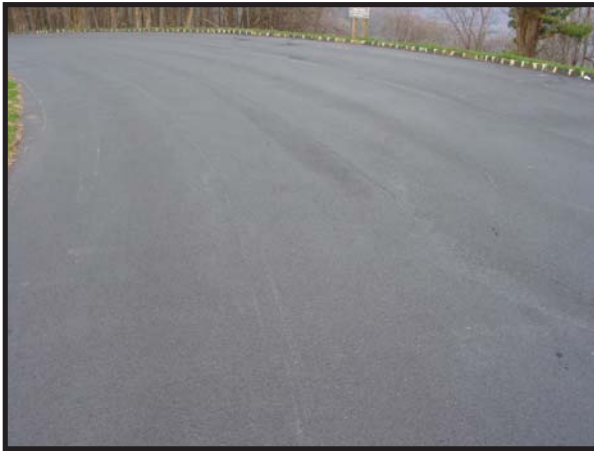
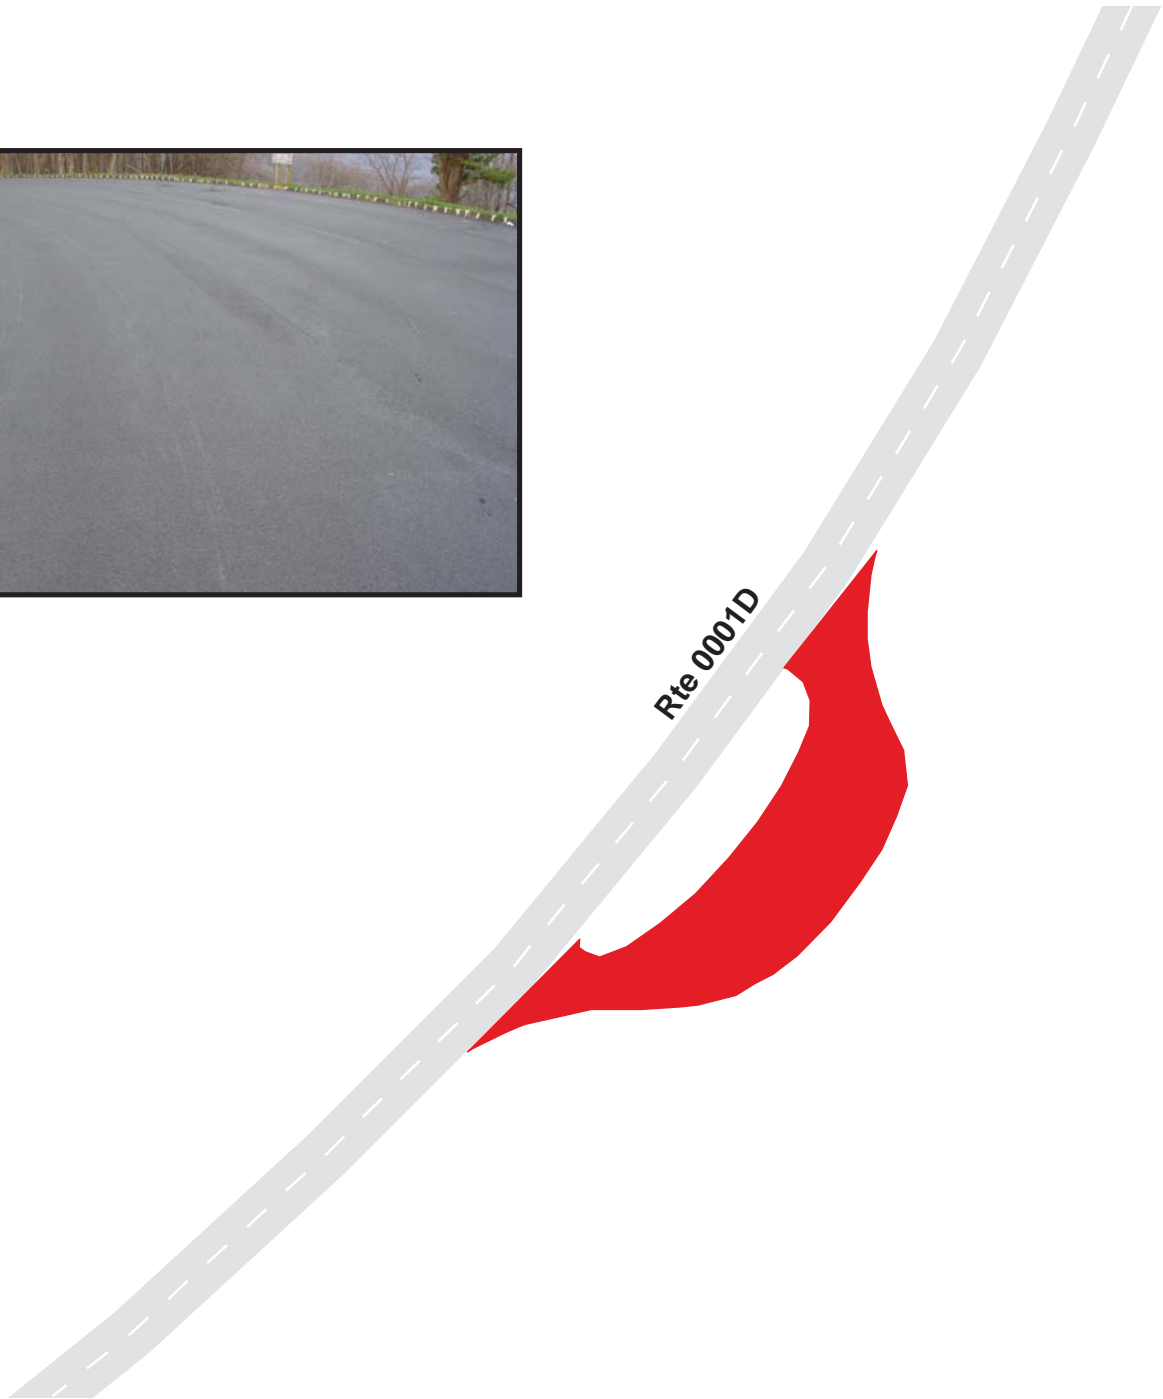
Blue Ridge Parkway Route 1071

Museum of NC Minerals
From Route 0210 at MP 0.02 on Left

Route	Public / NonPublic	Date Visited	Area (sq ft)	Lane Miles *	Surface Type	Condition / PCR
1071	Public	9/1/2003	15290	0.26	AS	EXCELLENT / 97

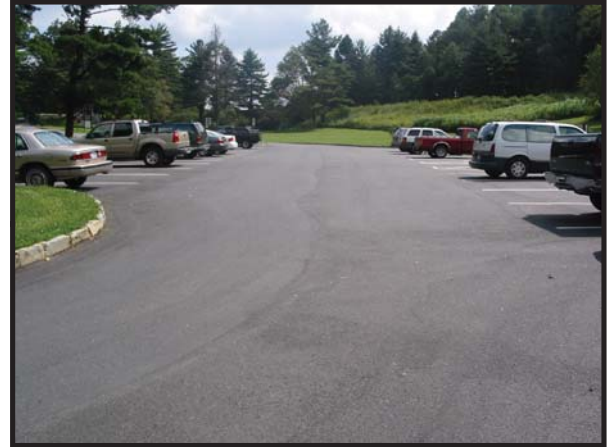
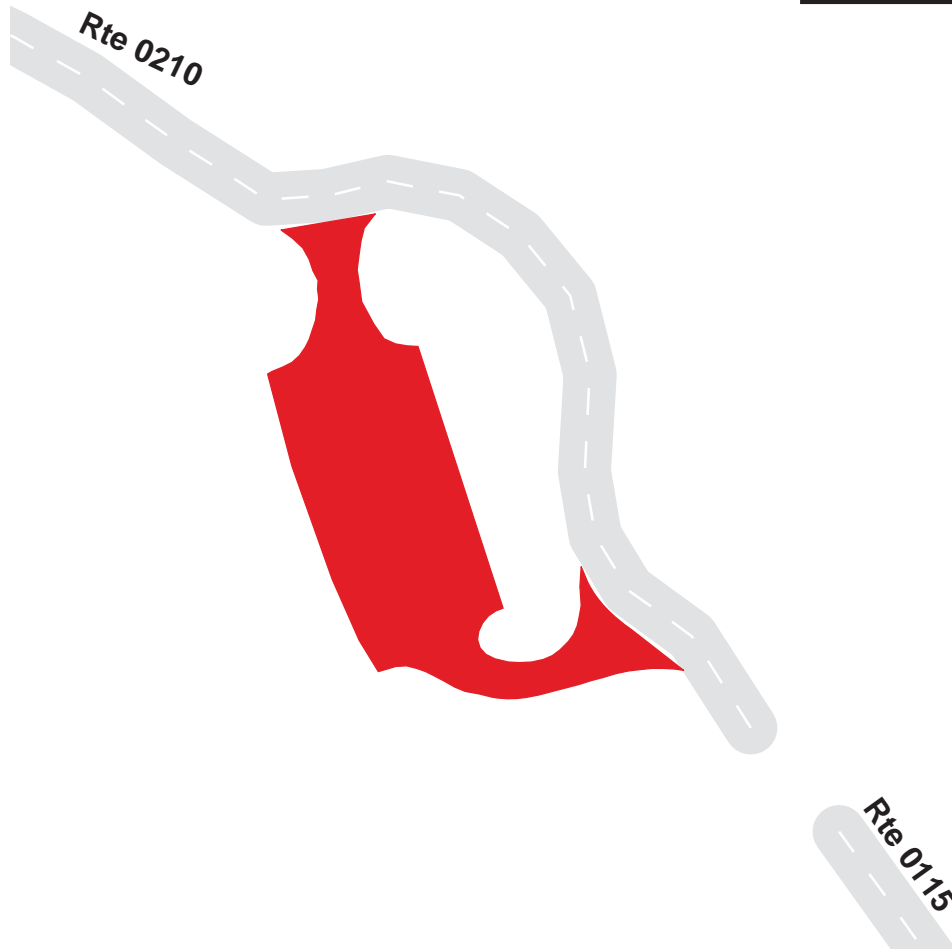
Route 1072A

Route	Public / NonPublic	Date Visited	Area (sq ft)	Lane Miles *	Surface Type	Condition / PCR
1072A	Public	9/1/2003	3981	0.07	AS	FAIR / 73

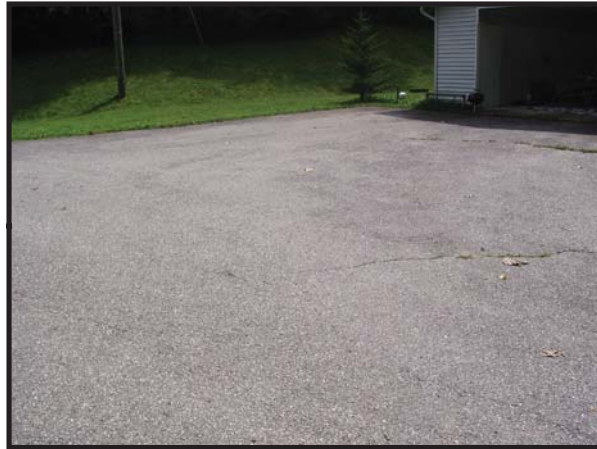
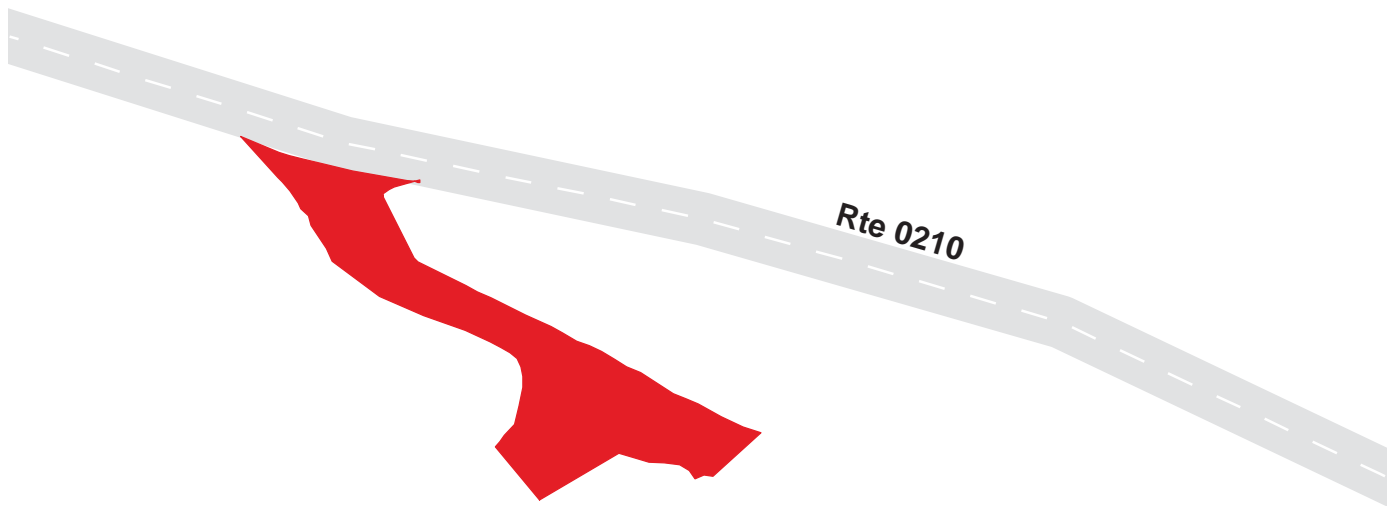
Blue Ridge Parkway Route 1072B

Gillespie Maintenance Yard
At End of Route 0210

Route	Public / NonPublic	Date Visited	Area (sq ft)	Lane Miles *	Surface Type	Condition / PCR
1072B	Public	9/1/2003	26317	0.45	AS	GOOD / 90

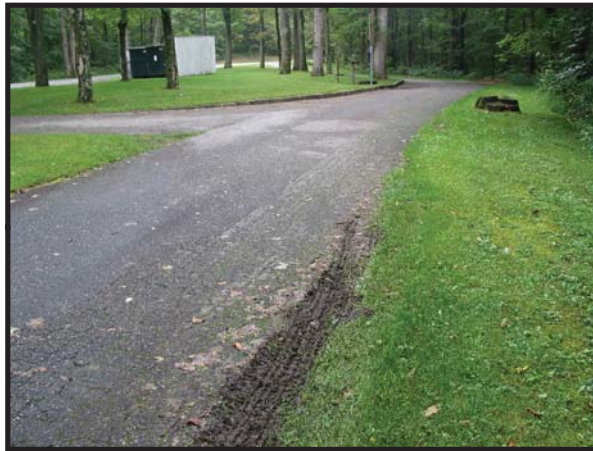
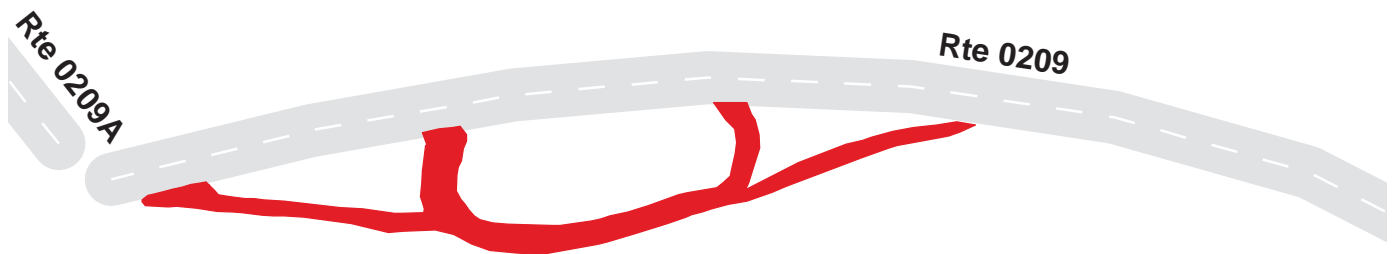
Route 1073B

Route	Public / NonPublic	Date Visited	Area (sq ft)	Lane Miles *	Surface Type	Condition / PCR
1073B	Public	9/1/2003	885	0.02	AS	POOR / 45

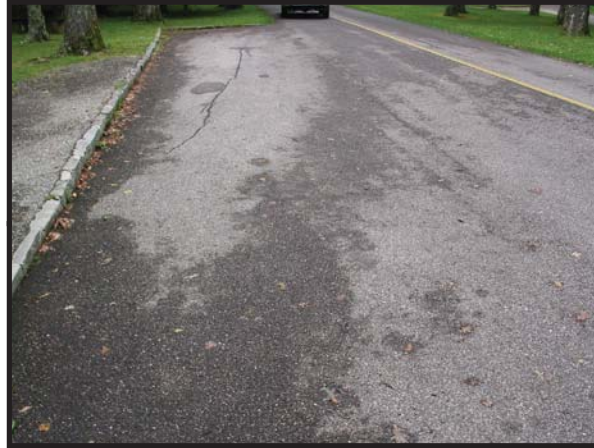
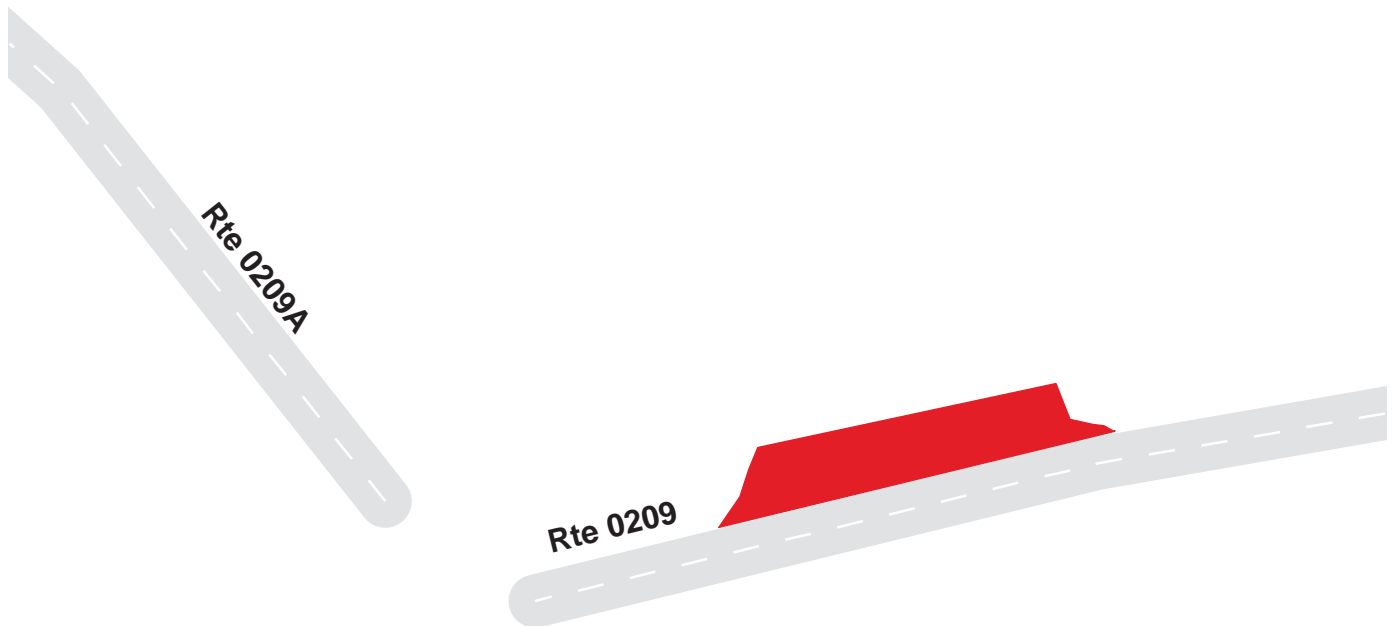
Route 1074A

Route	Public / NonPublic	Date Visited	Area (sq ft)	Lane Miles *	Surface Type	Condition / PCR
1074A	Public	9/1/2003	19165	0.33	AS	FAIR / 73

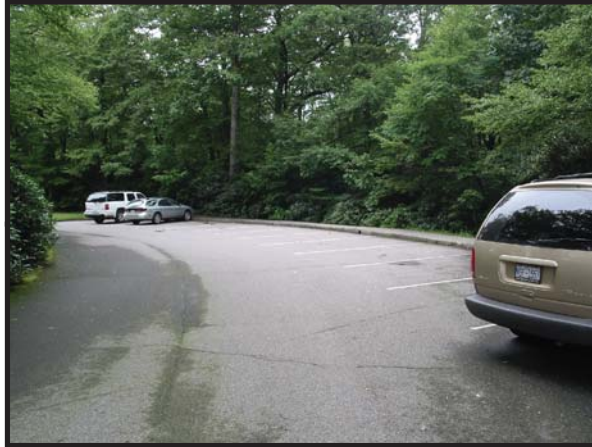
Route 1074B

Route	Public / NonPublic	Date Visited	Area (sq ft)	Lane Miles *	Surface Type	Condition / PCR
1074B	NonPublic	9/1/2003	2141	0.04	AS	FAIR / 73

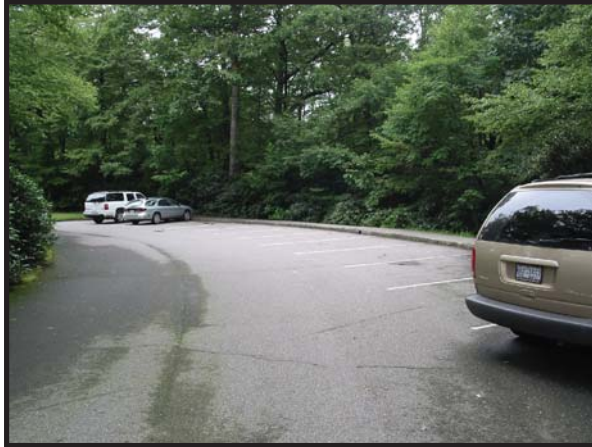
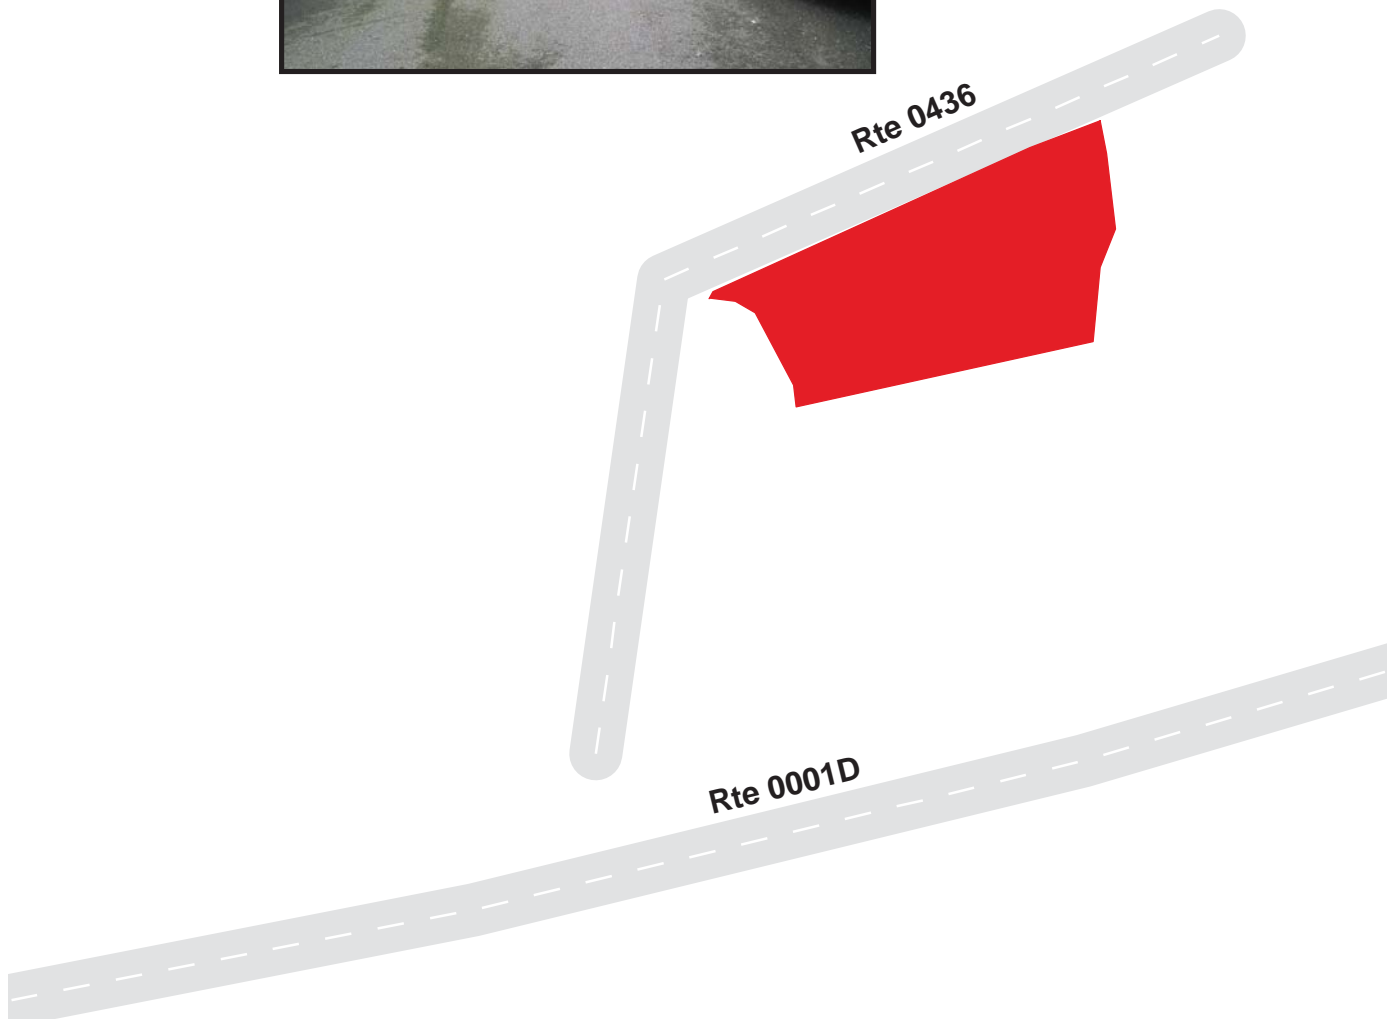
Route 1074C

Route	Public / NonPublic	Date Visited	Area (sq ft)	Lane Miles *	Surface Type	Condition / PCR
1074C	Public	9/1/2003	1277	0.02	AS	FAIR / 73

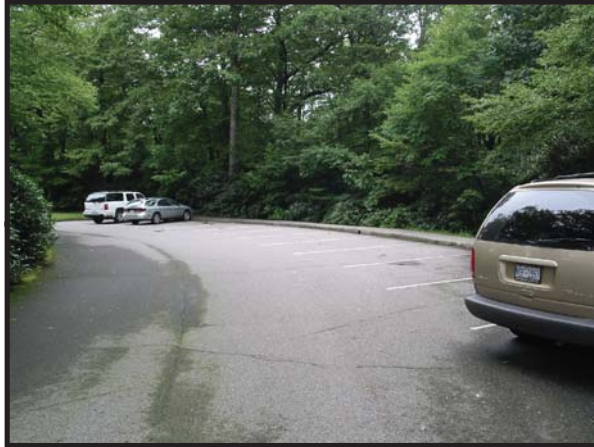
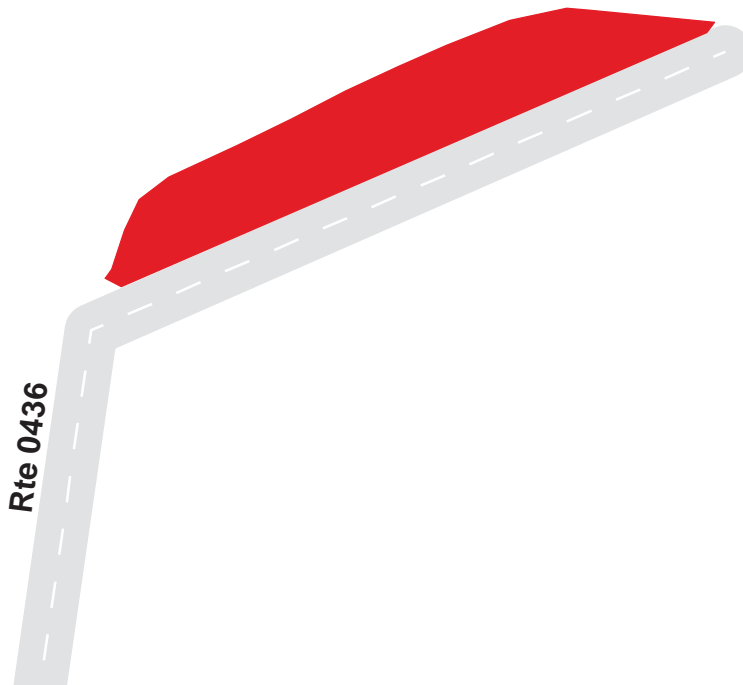
Blue Ridge Parkway Route 1075

Black Mountain Overlook
From Route 0001D at MP 341.80 on Right

Route	Public / NonPublic	Date Visited	Area (sq ft)	Lane Miles *	Surface Type	Condition / PCR
1075	Public	9/1/2003	10608	0.18	AS	FAIR / 73

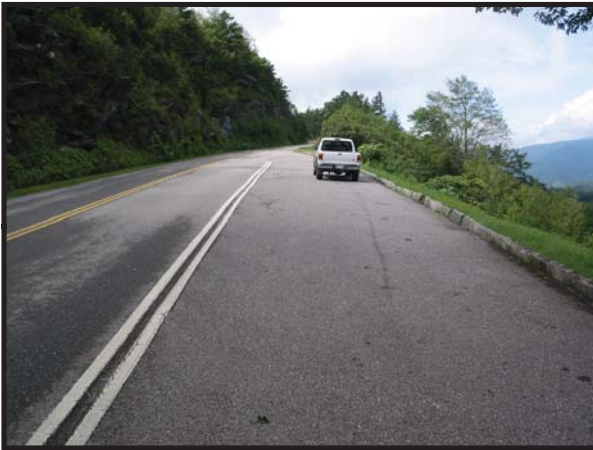
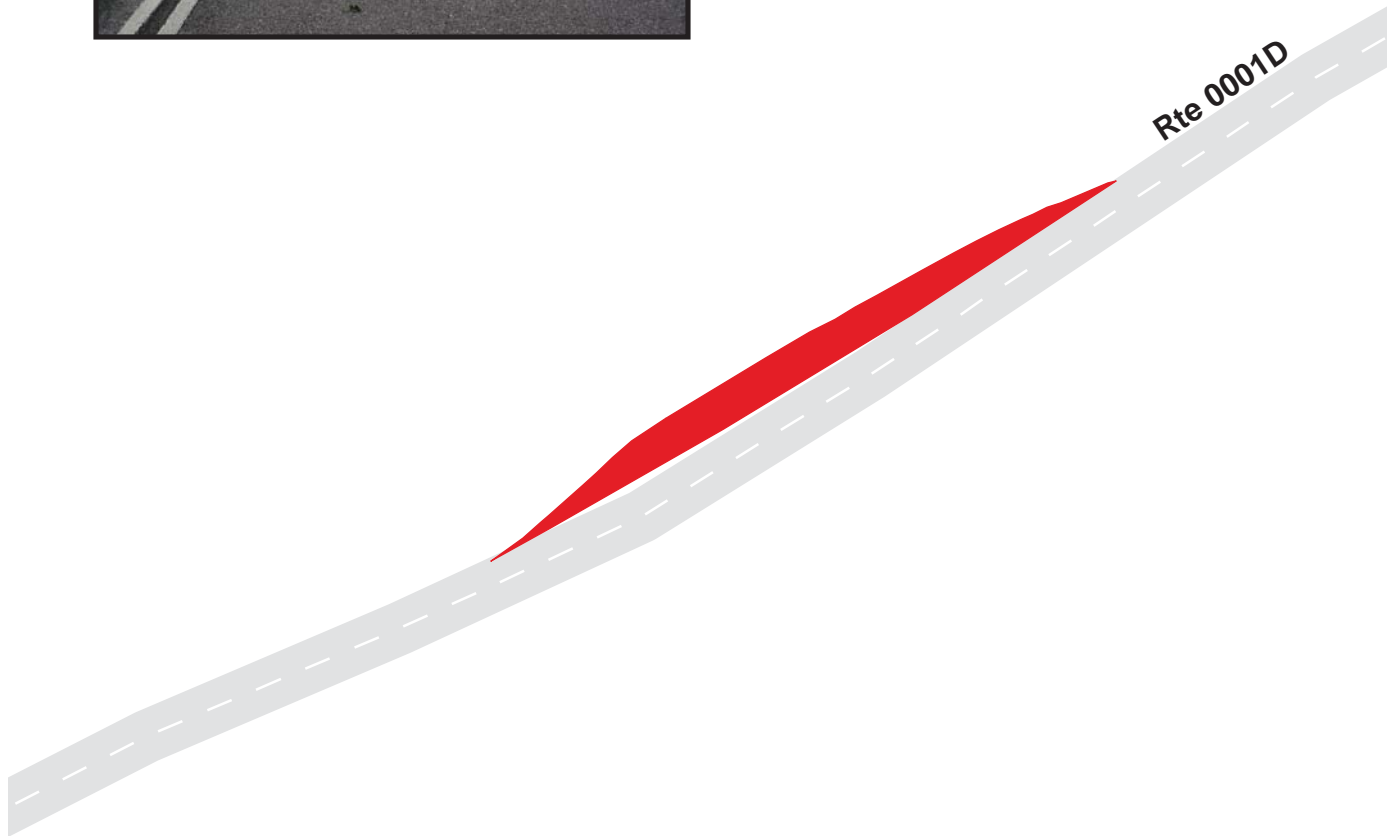
Route 1077B

Route	Public / NonPublic	Date Visited	Area (sq ft)	Lane Miles *	Surface Type	Condition / PCR
1077B	Public	9/1/2003	5341	0.09	AS	GOOD / 90

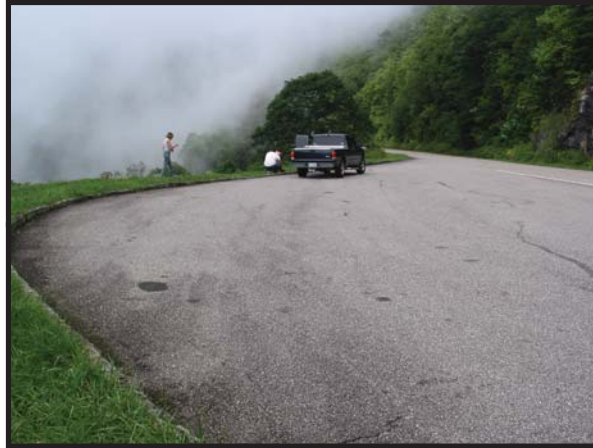
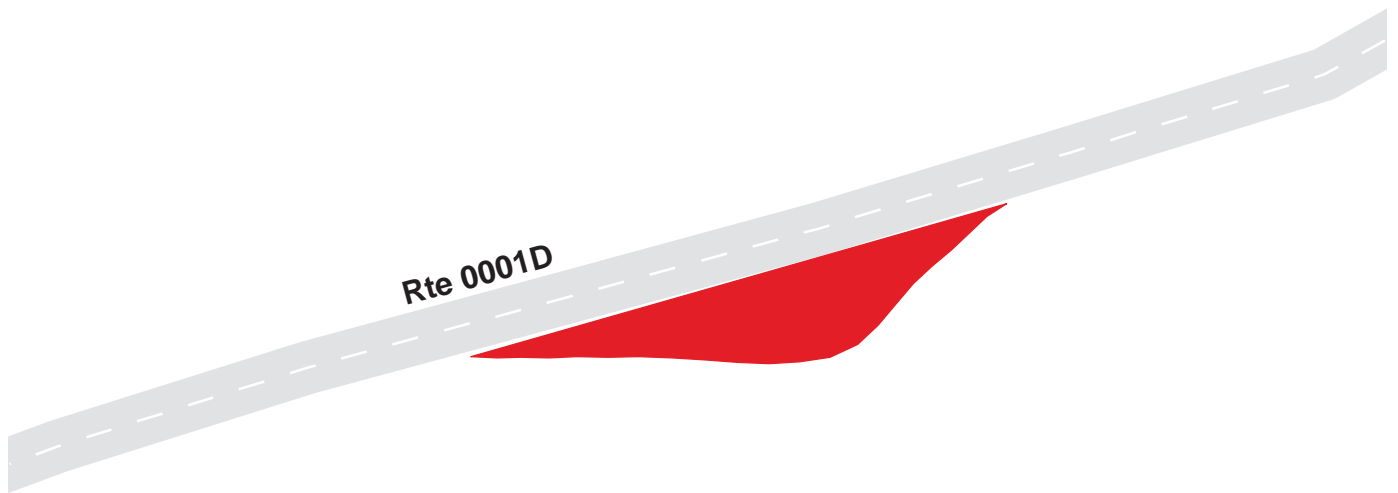
Route 1078

Route	Public / NonPublic	Date Visited	Area (sq ft)	Lane Miles *	Surface Type	Condition / PCR
1078	Public	9/1/2003	7912	0.14	AS	GOOD / 90

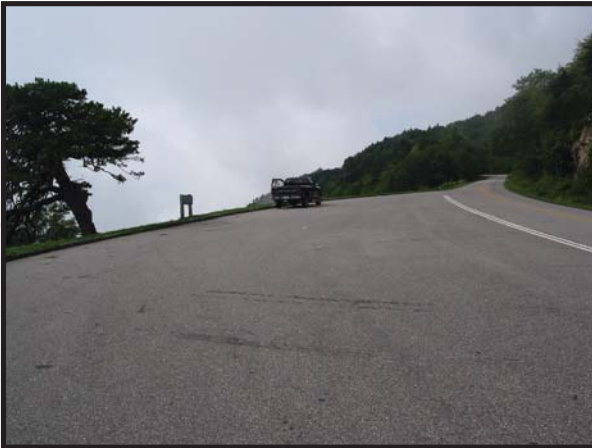
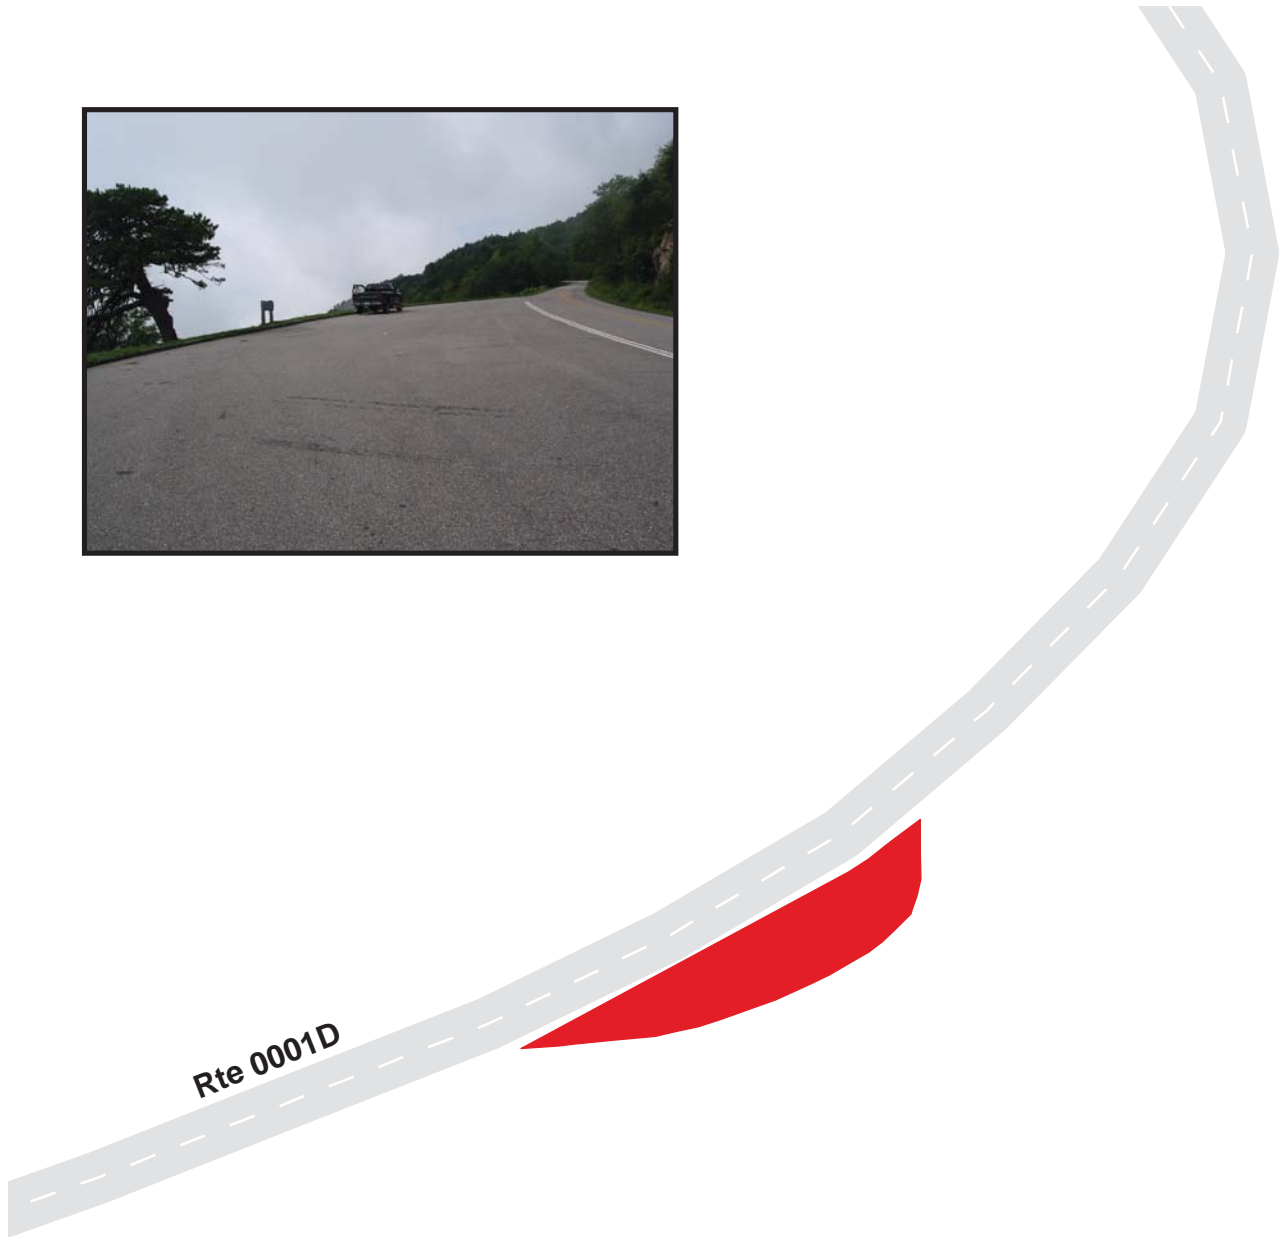
Route 1079

Route	Public / NonPublic	Date Visited	Area (sq ft)	Lane Miles *	Surface Type	Condition / PCR
1079	Public	9/1/2003	15841	0.27	AS	GOOD / 90

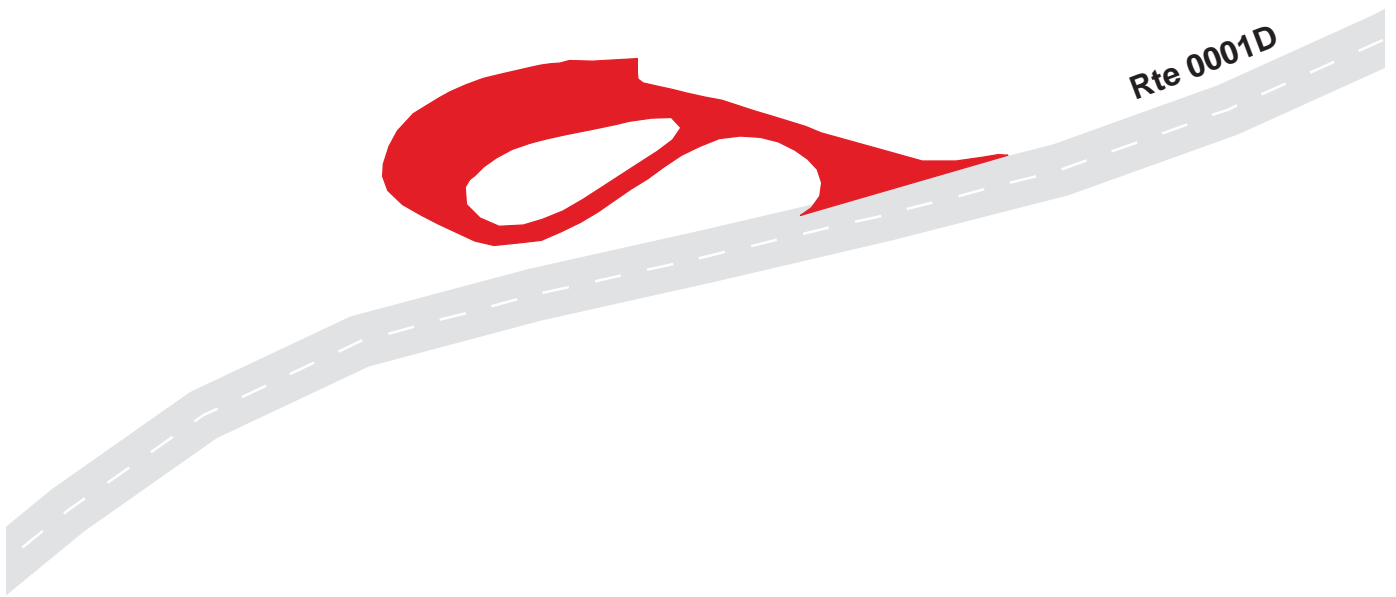
Route 1080

Route	Public / NonPublic	Date Visited	Area (sq ft)	Lane Miles *	Surface Type	Condition / PCR
1080	Public	9/1/2003	9600	0.17	AS	GOOD / 90

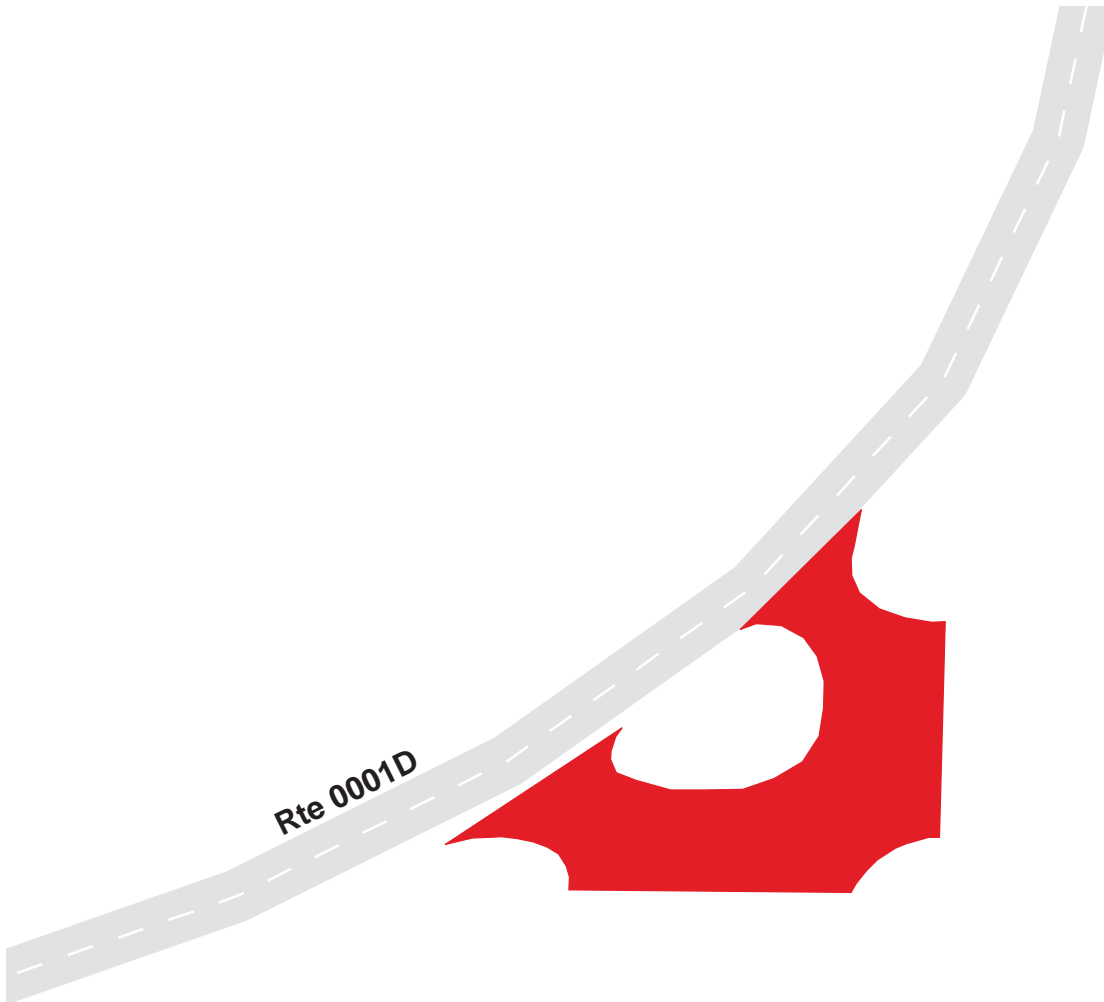
Route 1081

Route	Public / NonPublic	Date Visited	Area (sq ft)	Lane Miles *	Surface Type	Condition / PCR
1081	Public	9/1/2003	8830	0.15	AS	GOOD / 90
