The Road Inventory of Blue Ridge Parkway BLRI – 5140 Volume 1

Road Inventory Program

Prepared By:
Federal Highway Administration
Eastern Federal Lands Highway Division
Cycle 3

Blue Ridge Parkway in North Carolina

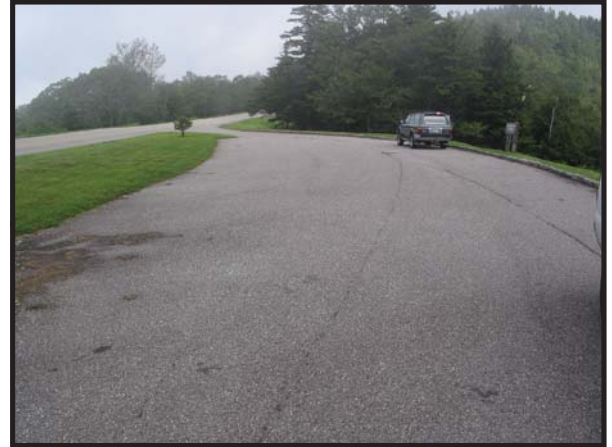
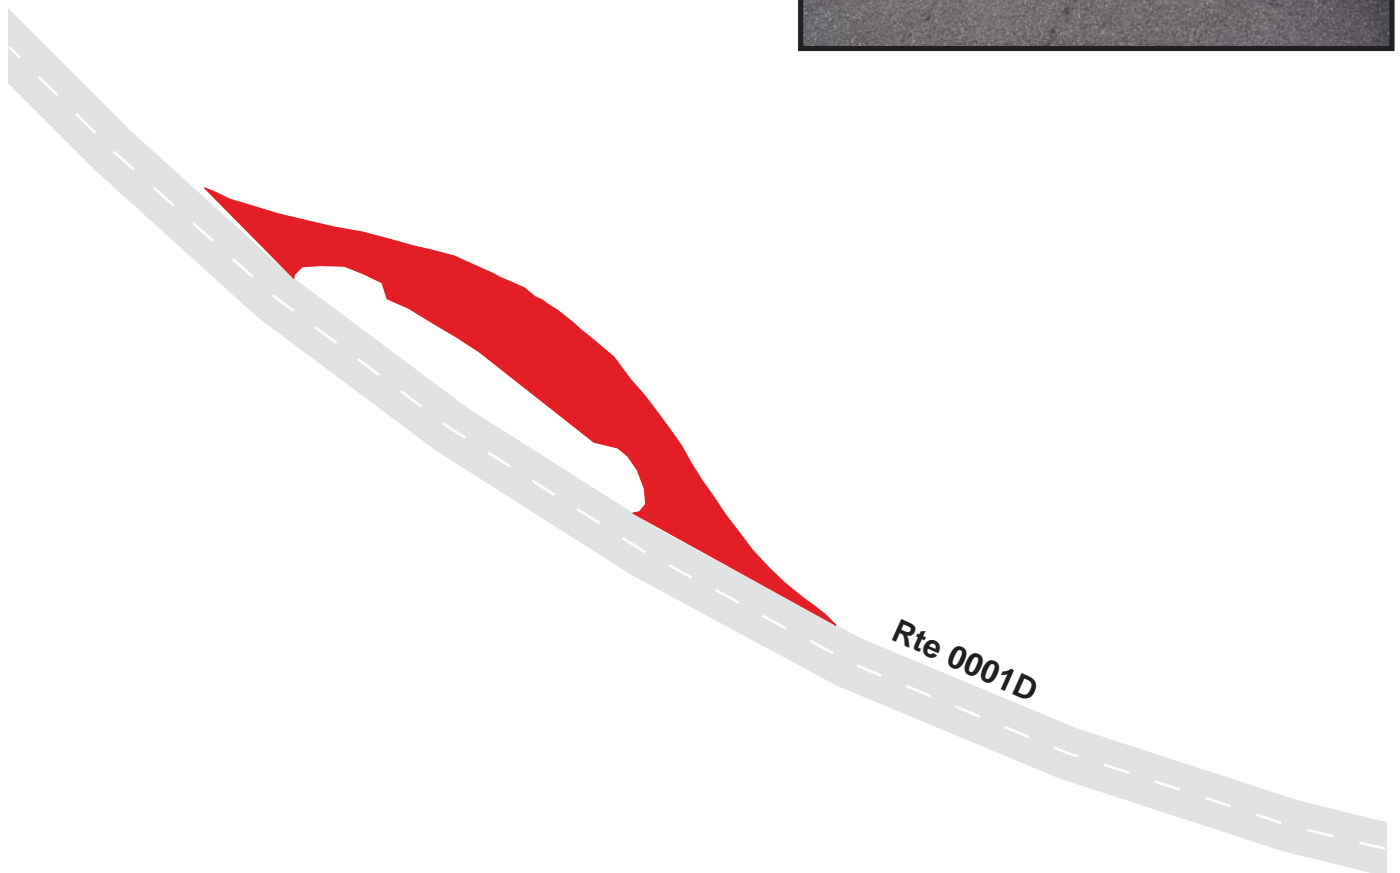
Route 1082

Route	Public / NonPublic	Date Visited	Area (sq ft)	Lane Miles *	Surface Type	Condition / PCR
1082	Public	9/1/2003	4192	0.07	AS	FAIR / 73

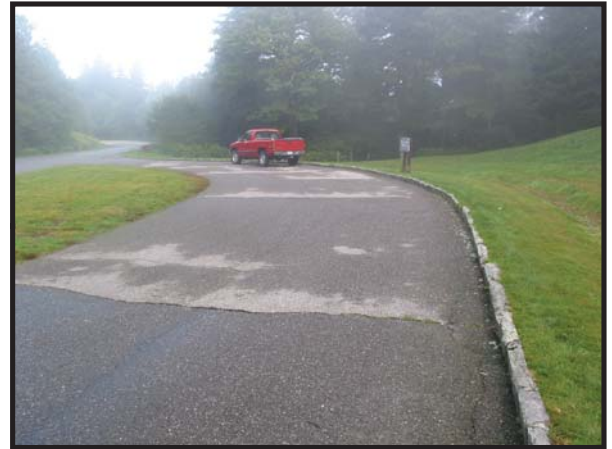
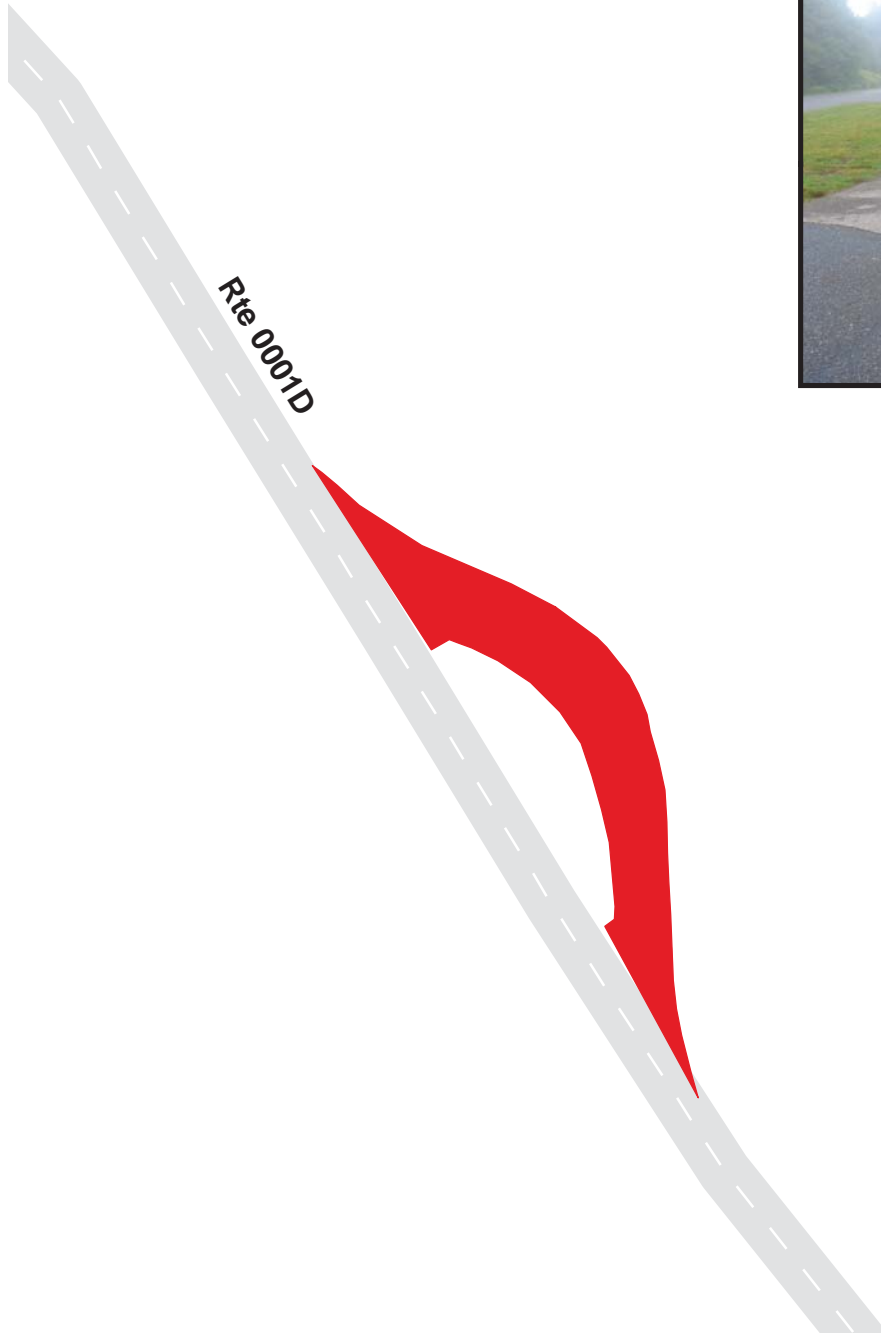
Route 1083

Route	Public / NonPublic	Date Visited	Area (sq ft)	Lane Miles *	Surface Type	Condition / PCR
1083	Public	9/1/2003	9066	0.16	AS	FAIR / 73

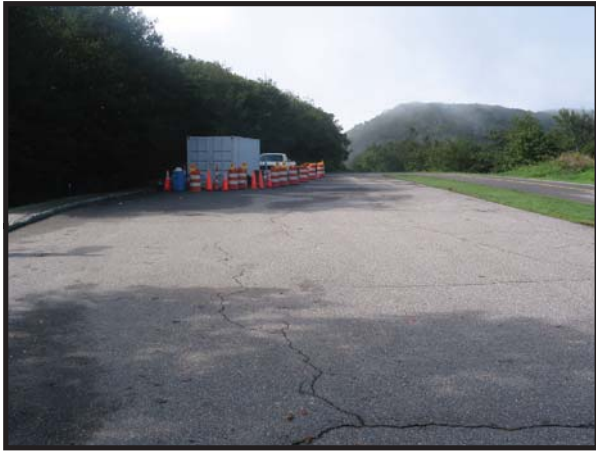
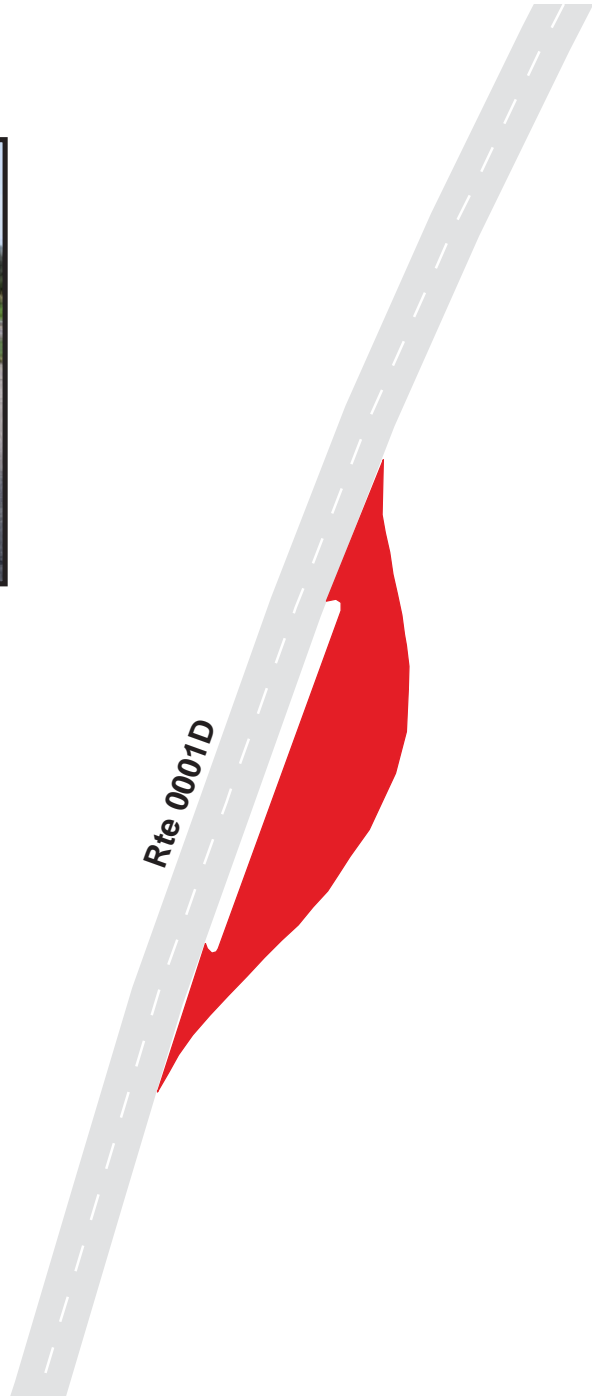
Route 1084

Route	Public / NonPublic	Date Visited	Area (sq ft)	Lane Miles *	Surface Type	Condition / PCR
1084	Public	9/1/2003	7300	0.13	AS	FAIR / 73

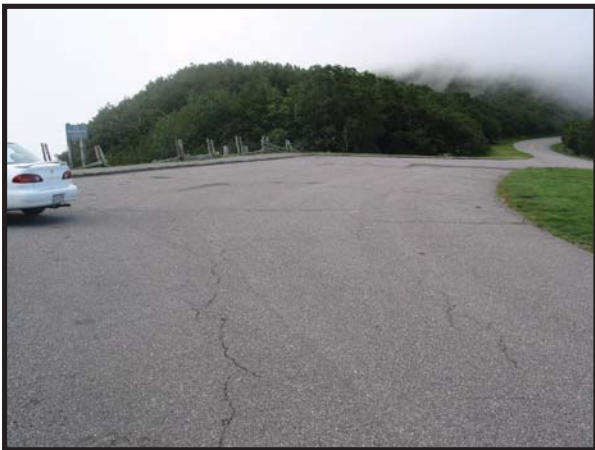
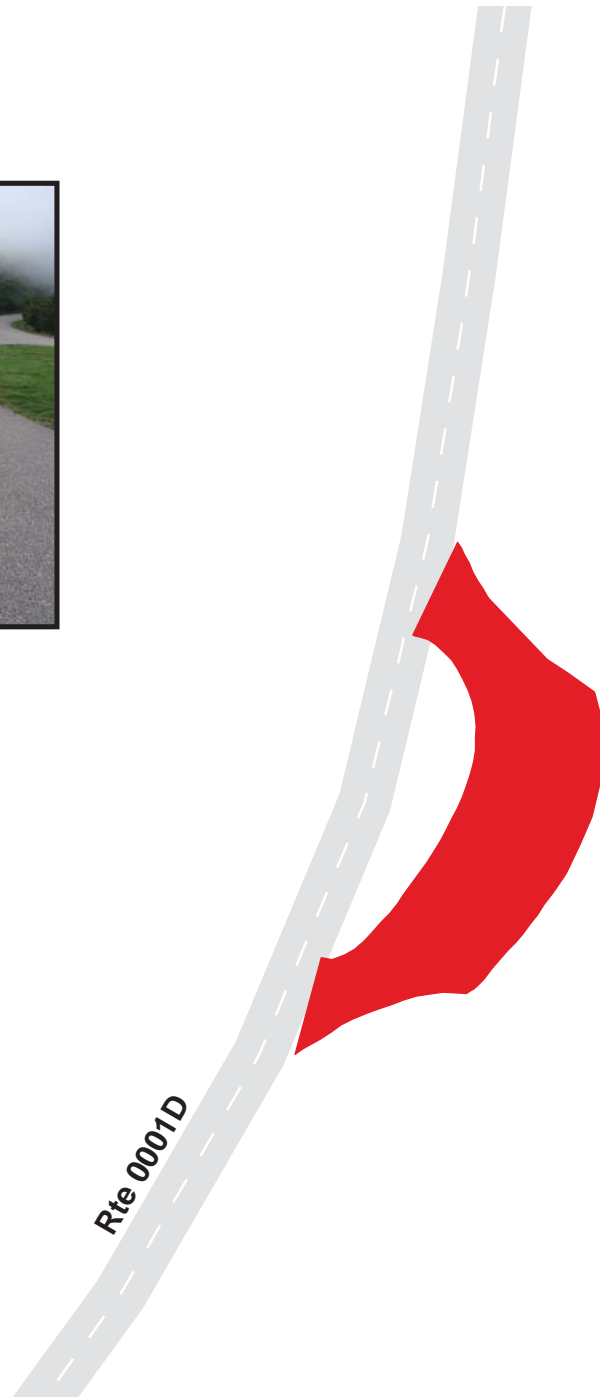
Route 1085

Route	Public / NonPublic	Date Visited	Area (sq ft)	Lane Miles *	Surface Type	Condition / PCR
1085	Public	9/1/2003	28925	0.50	AS	POOR / 45

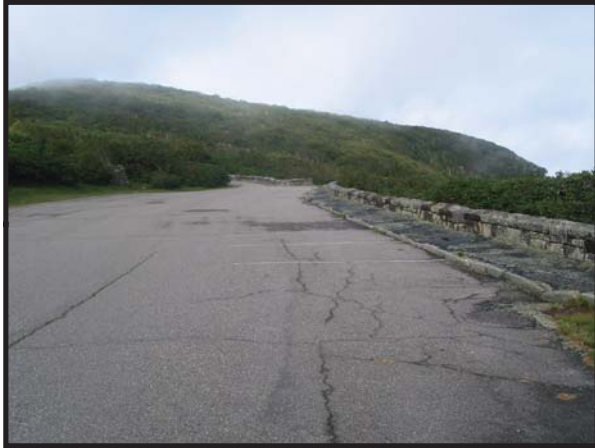
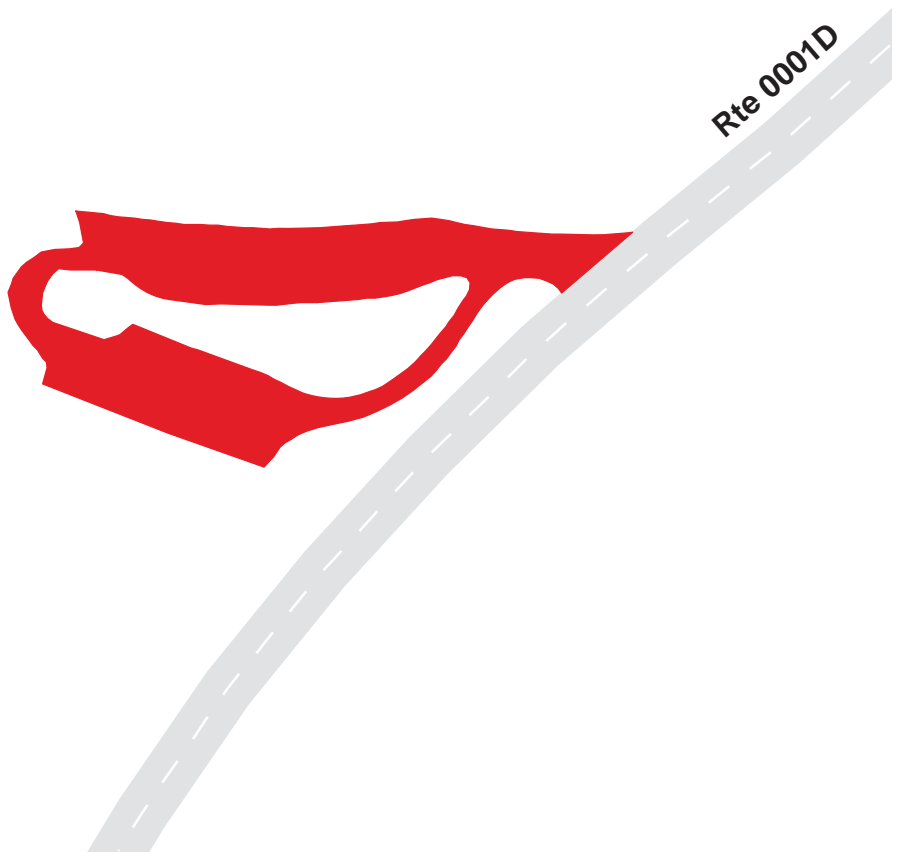
Route 1086A

Route	Public / NonPublic	Date Visited	Area (sq ft)	Lane Miles *	Surface Type	Condition / PCR
1086A	Public	9/1/2003	9967	0.17	AS	FAIR / 73

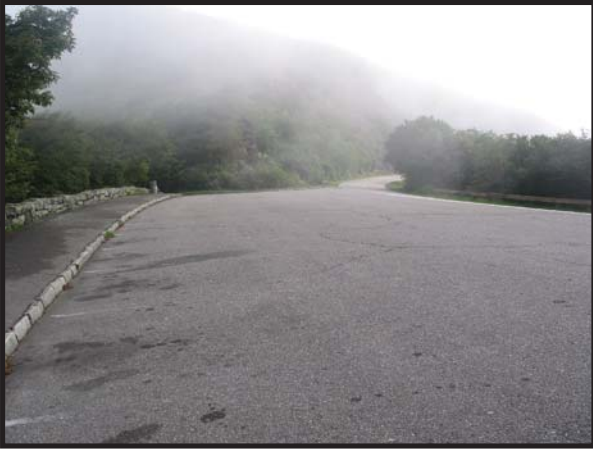
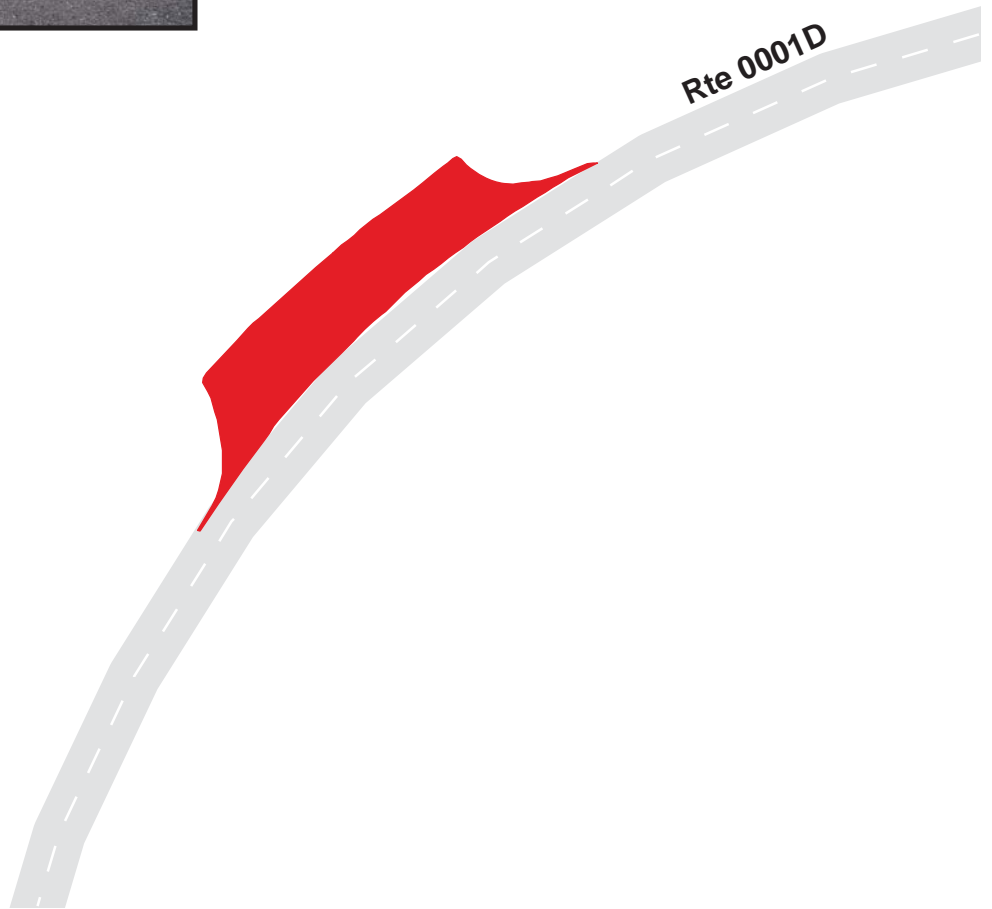
Route 1086B

Route	Public / NonPublic	Date Visited	Area (sq ft)	Lane Miles *	Surface Type	Condition / PCR
1086B	Public	9/1/2003	14413	0.25	AS	FAIR / 73

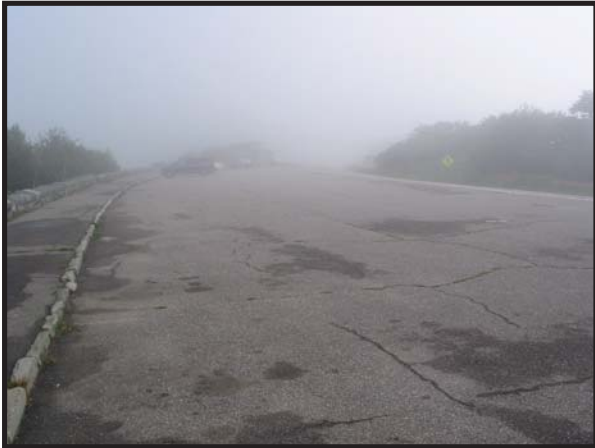
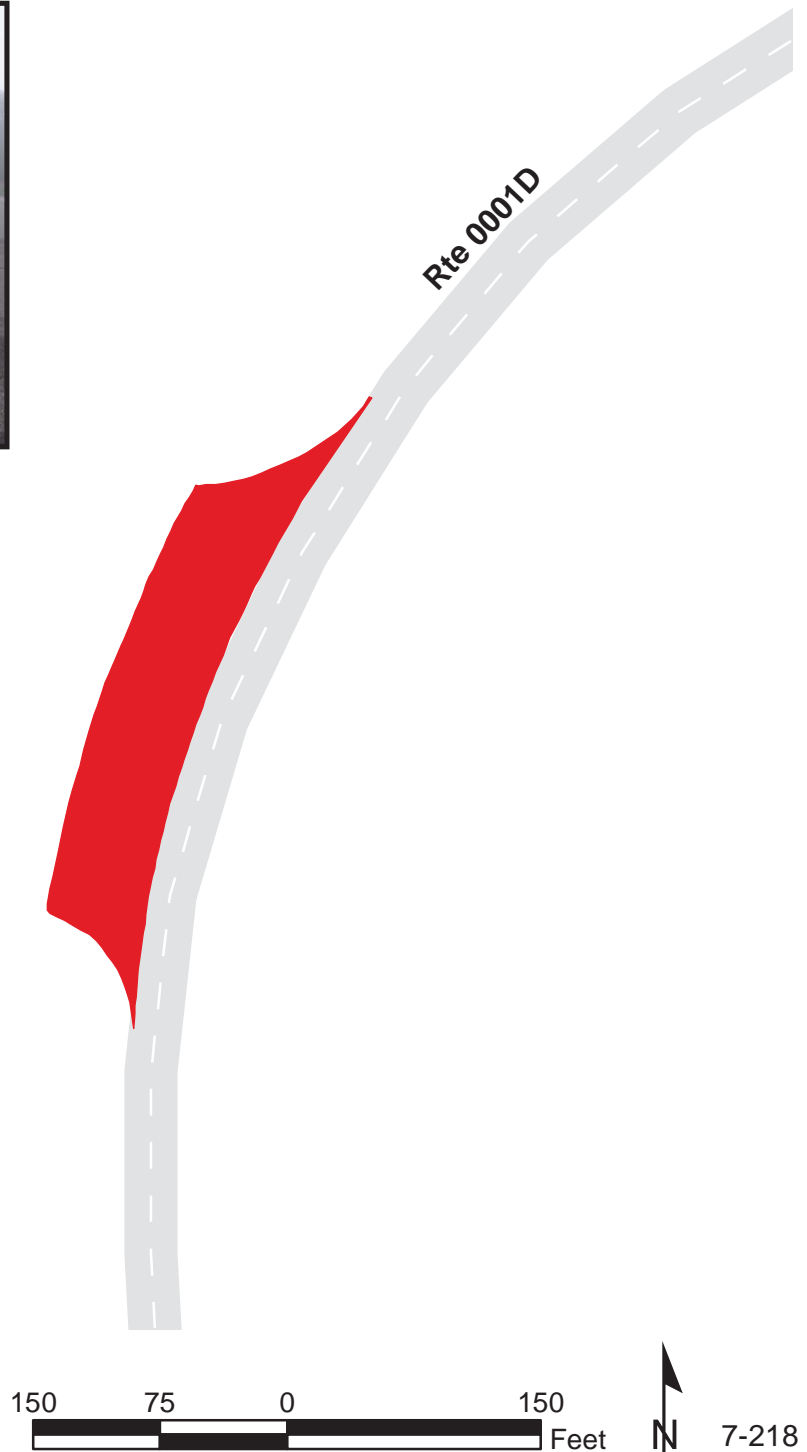
Route 1087A

Route	Public / NonPublic	Date Visited	Area (sq ft)	Lane Miles *	Surface Type	Condition / PCR
1087A	Public	9/1/2003	9372	0.16	AS	FAIR / 73

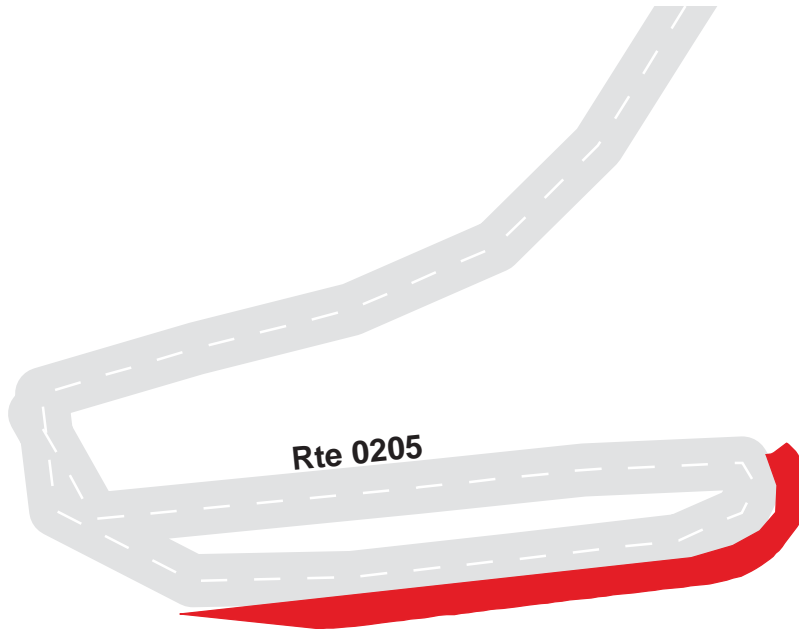
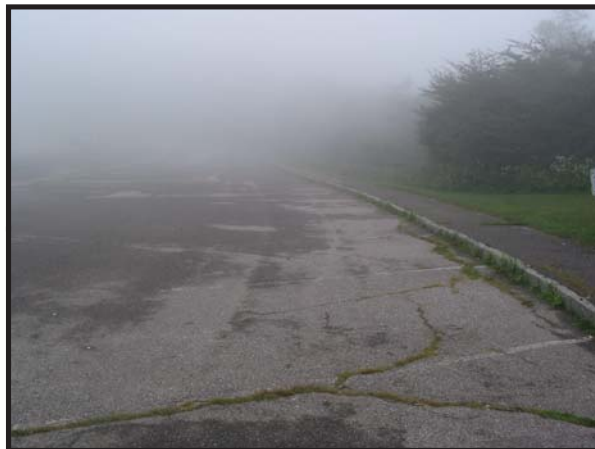
Route 1087B

Route	Public / NonPublic	Date Visited	Area (sq ft)	Lane Miles *	Surface Type	Condition / PCR
1087B	Public	9/1/2003	5367	0.09	AS	FAIR / 73

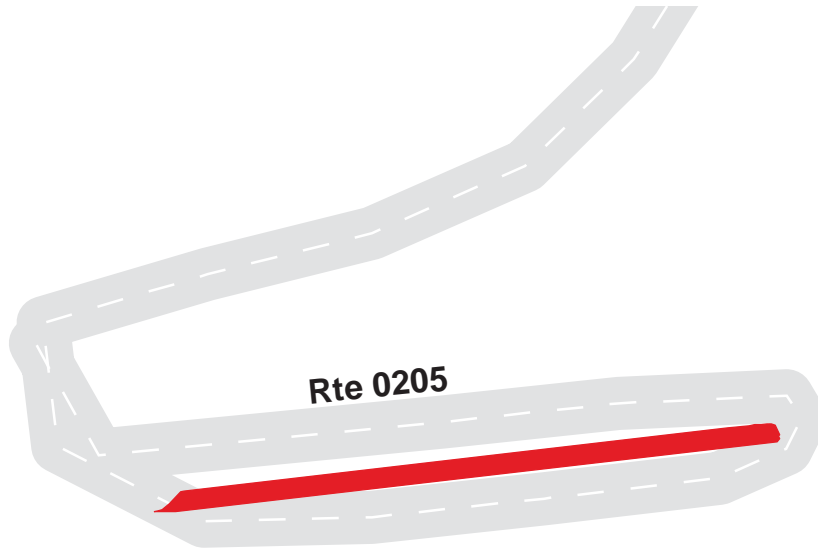
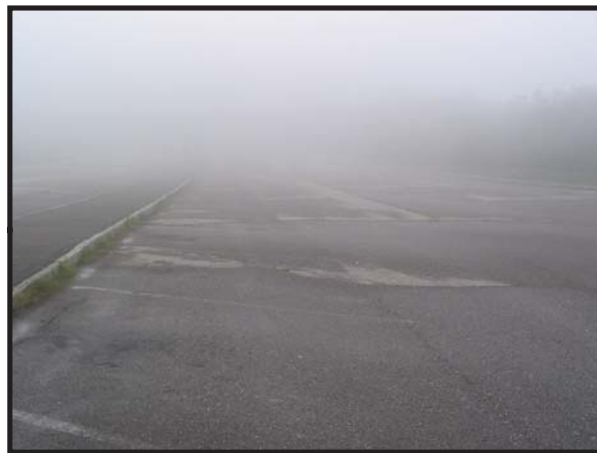
Blue Ridge Parkway Route 1087C

Bear Pen Gap Picnic Area C
Adjacent to Route 0205 at MP 1.24 on Left

Route	Public / NonPublic	Date Visited	Area (sq ft)	Lane Miles *	Surface Type	Condition / PCR
1087C	Public	9/1/2003	5497	0.09	AS	FAIR / 73

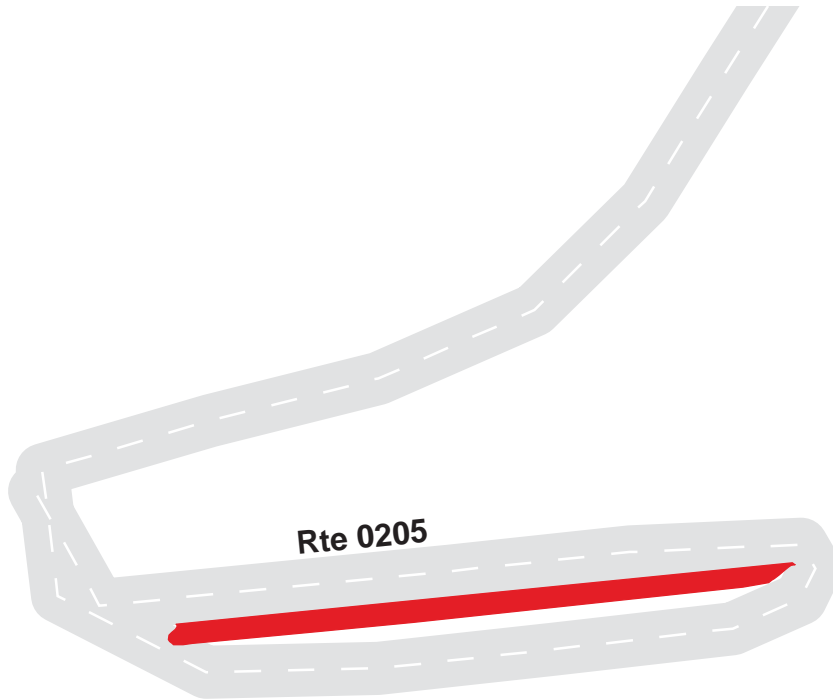
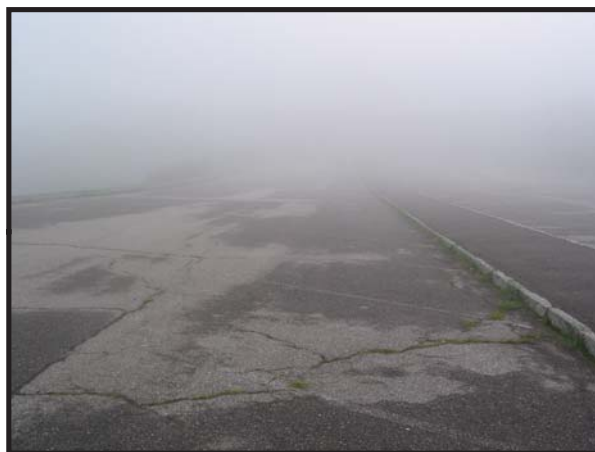
Route 1087D

Route	Public / NonPublic	Date Visited	Area (sq ft)	Lane Miles *	Surface Type	Condition / PCR
1087D	Public	9/1/2003	6447	0.11	AS	FAIR / 73

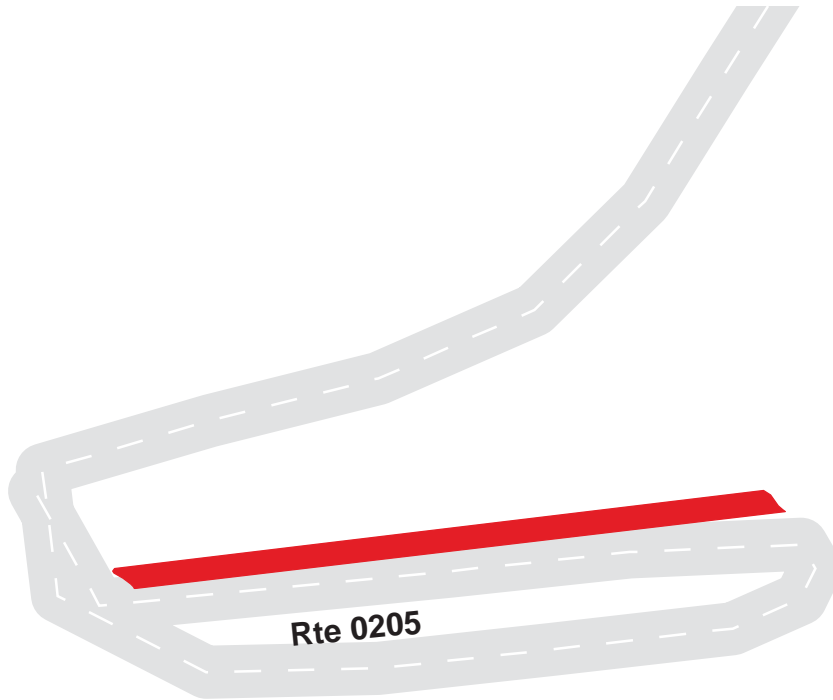
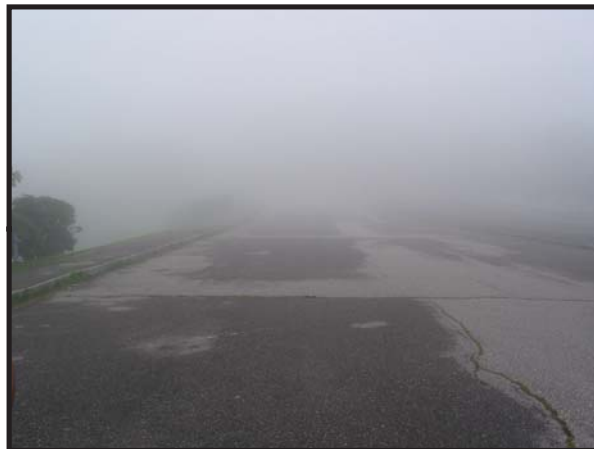
Route 1088

Route	Public / NonPublic	Date Visited	Area (sq ft)	Lane Miles *	Surface Type	Condition / PCR
1088	Public	9/1/2003	6082	0.10	AS	FAIR / 73

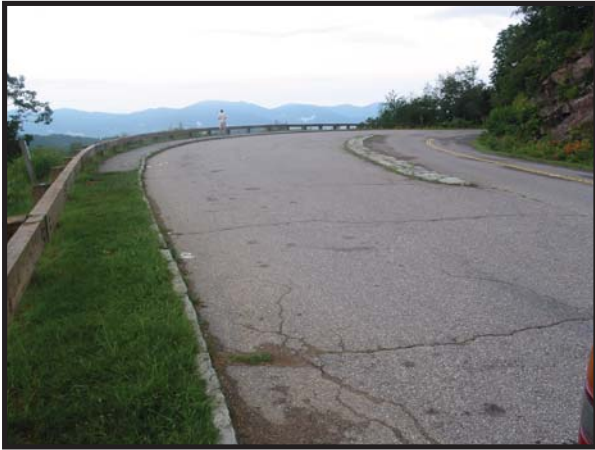
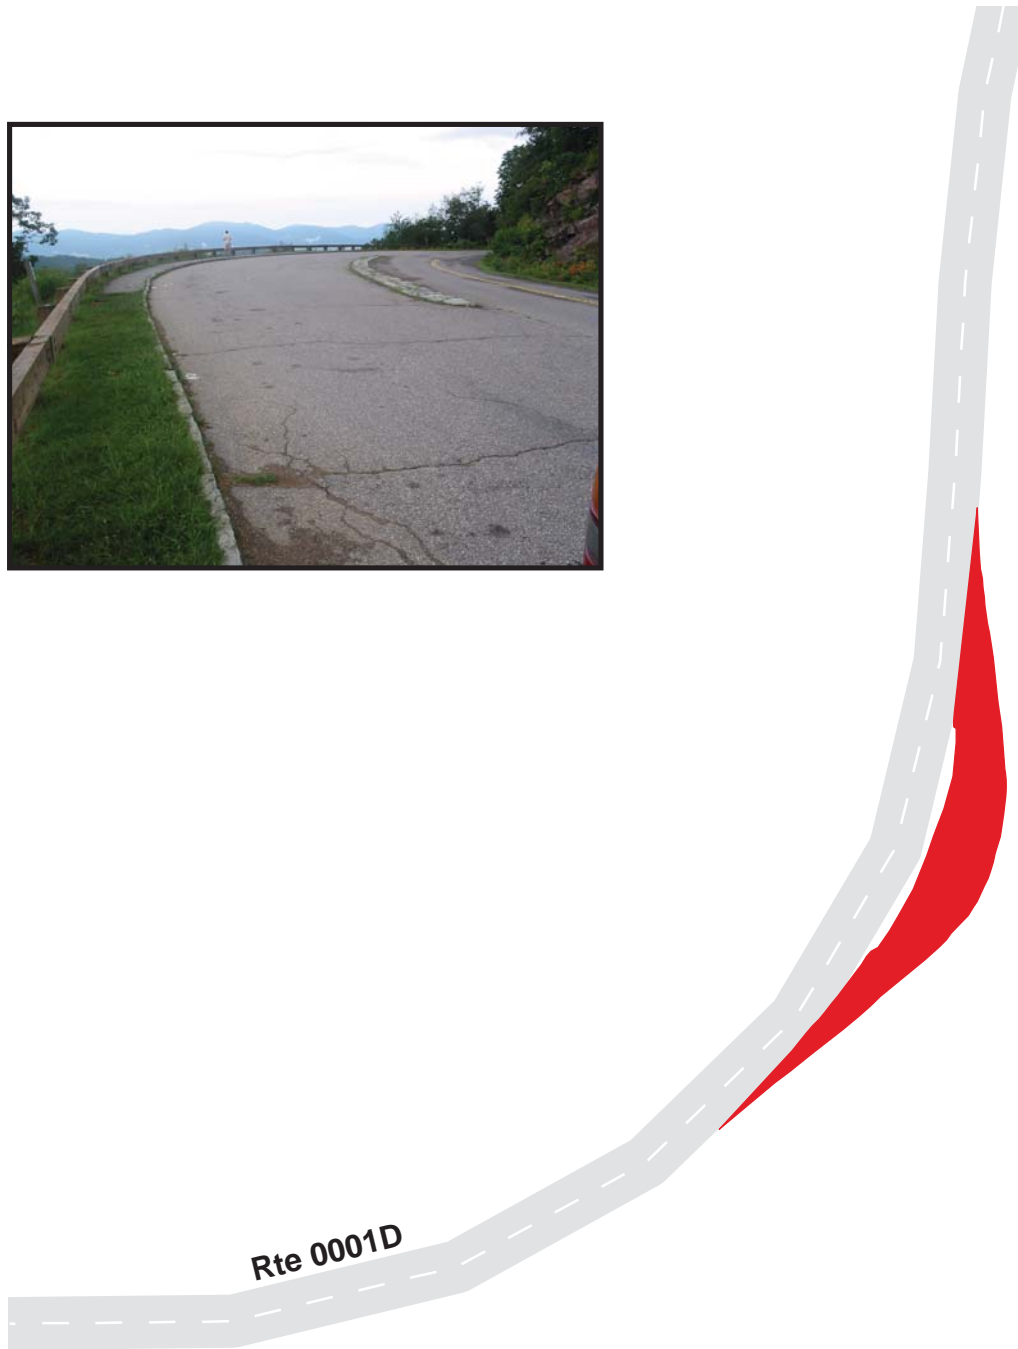
Route 1089

Route	Public / NonPublic	Date Visited	Area (sq ft)	Lane Miles *	Surface Type	Condition / PCR
1089	Public	9/1/2003	8792	0.15	AS	FAIR / 73

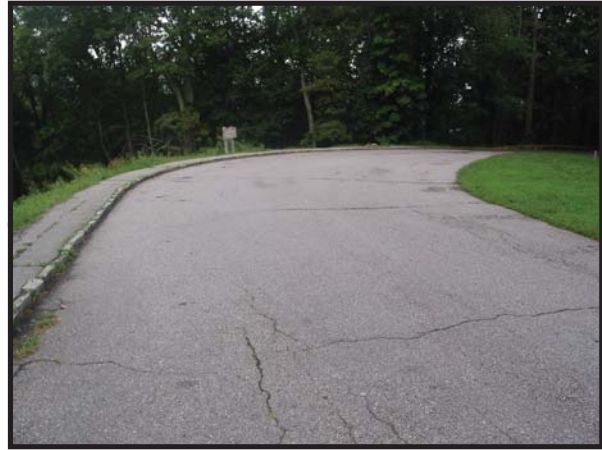
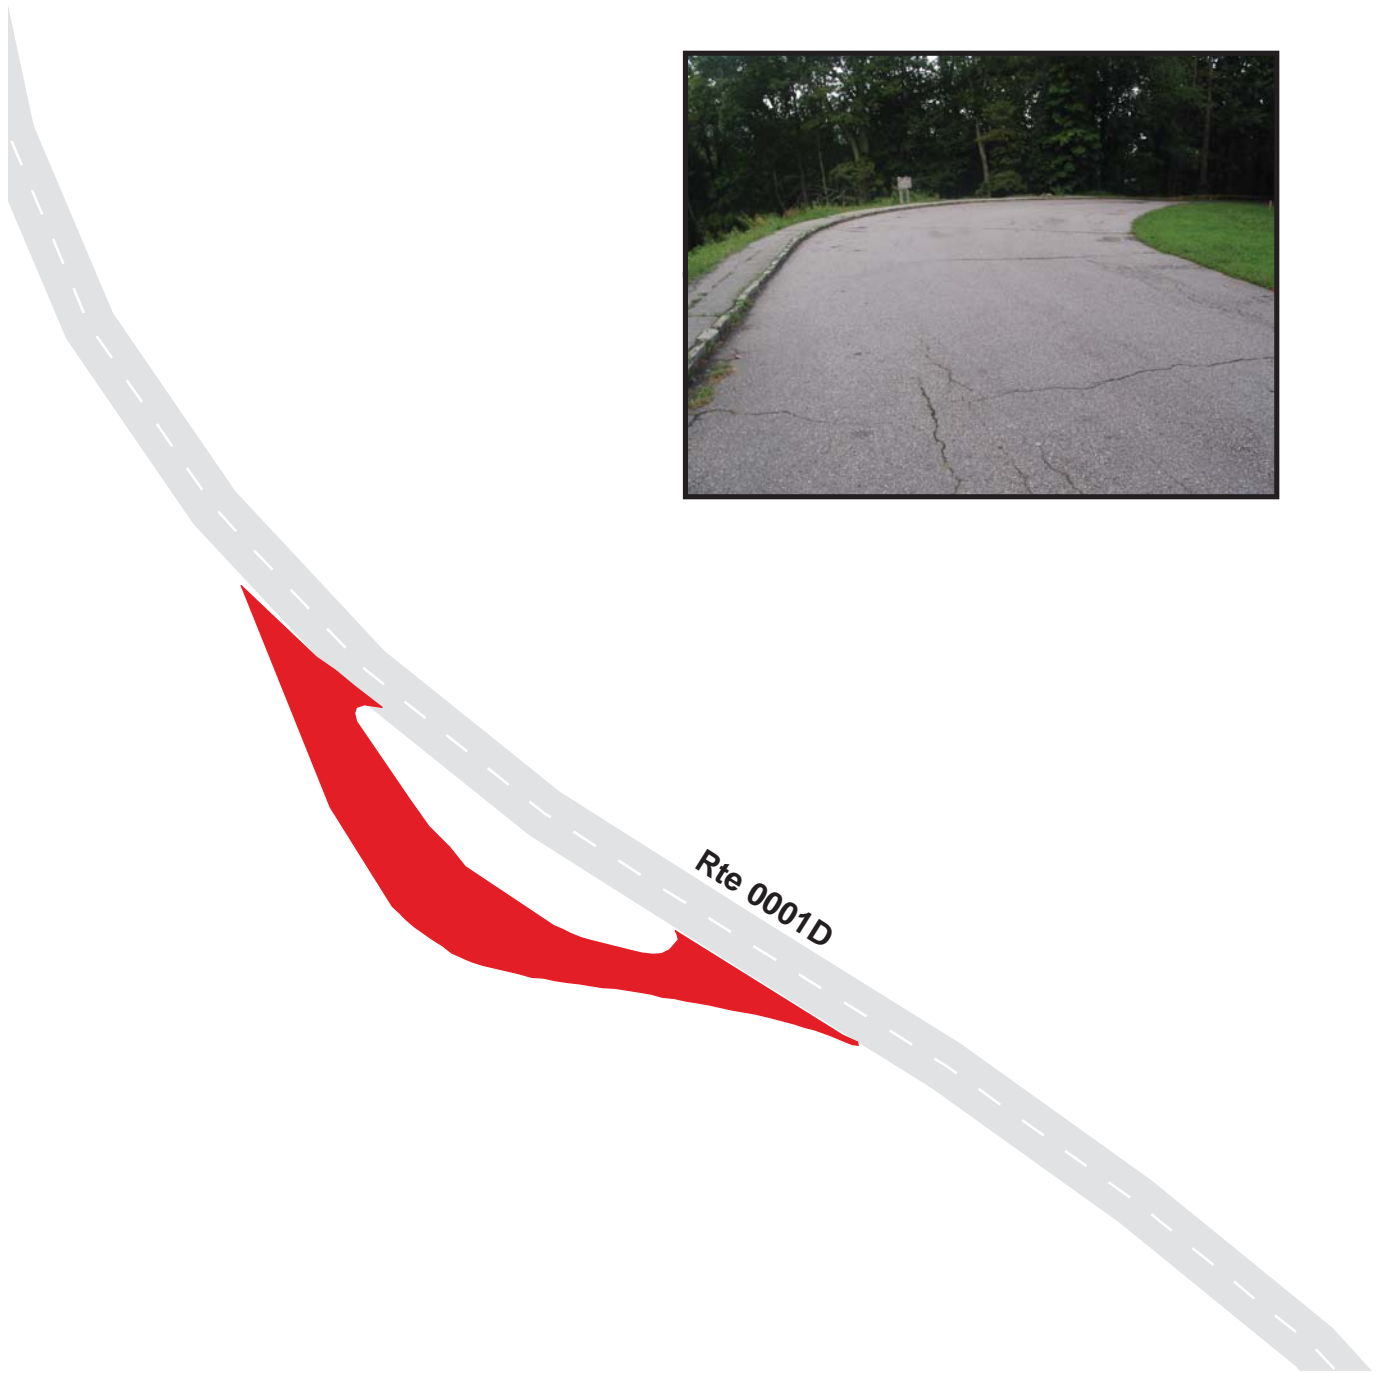
Blue Ridge Parkway Route 1090

Tanbark Ridge Overlook
From Route 0001D at MP 376.28 on Left

Route	Public / NonPublic	Date Visited	Area (sq ft)	Lane Miles *	Surface Type	Condition / PCR
1090	Public	9/1/2003	11559	0.20	AS	EXCELLENT / 97

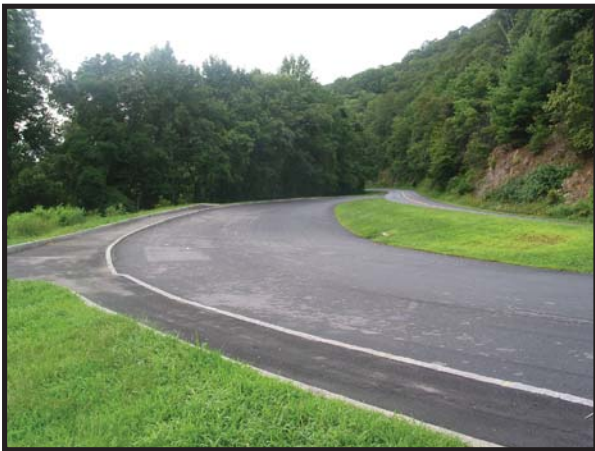
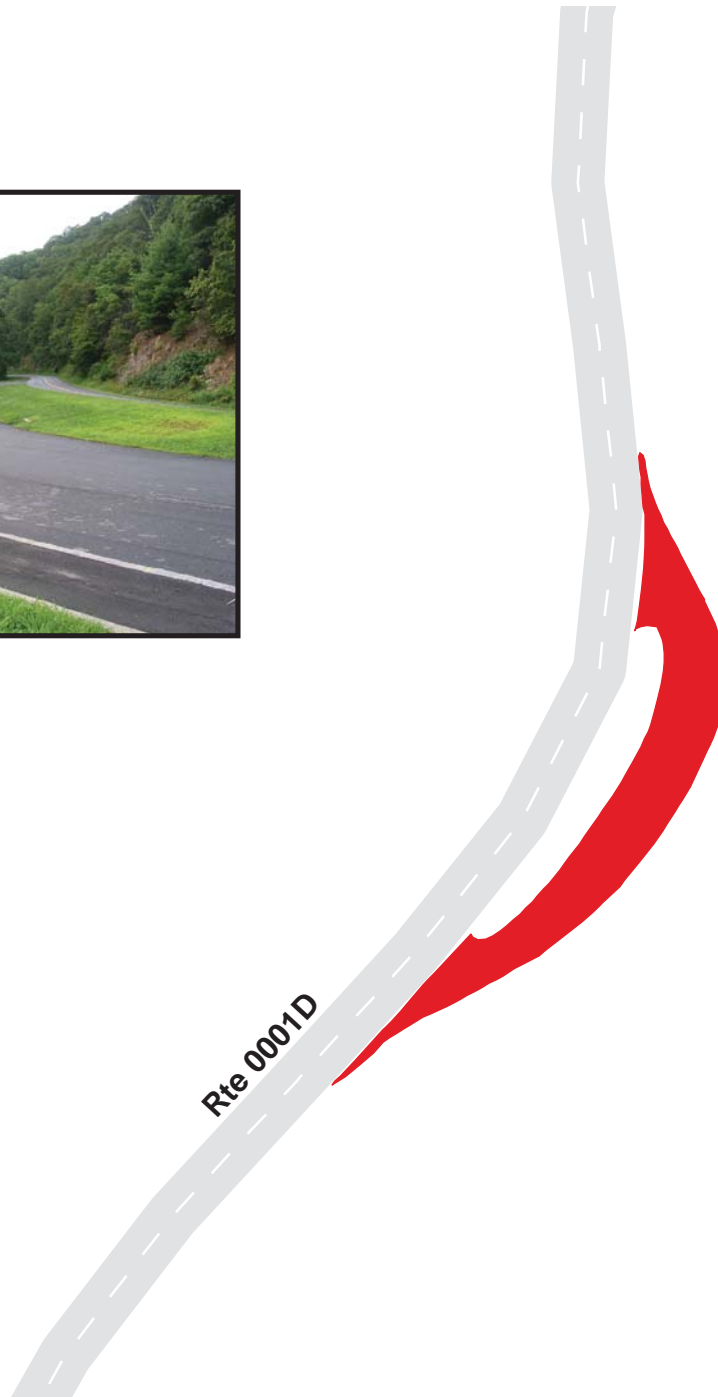
Route 1091

Route	Public / NonPublic	Date Visited	Area (sq ft)	Lane Miles *	Surface Type	Condition / PCR
1091	Public	8/30/2003	3644	0.06	AS	GOOD / 90

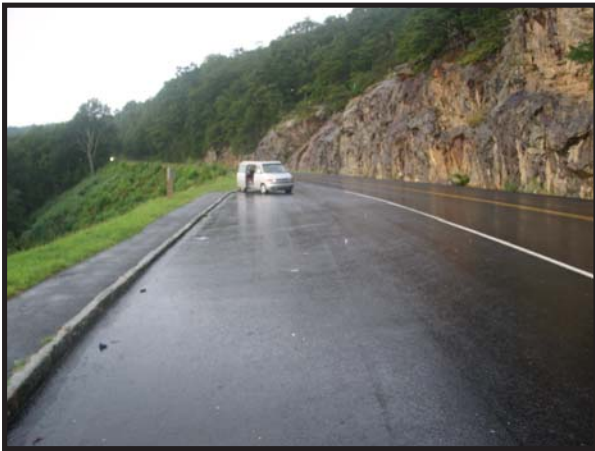
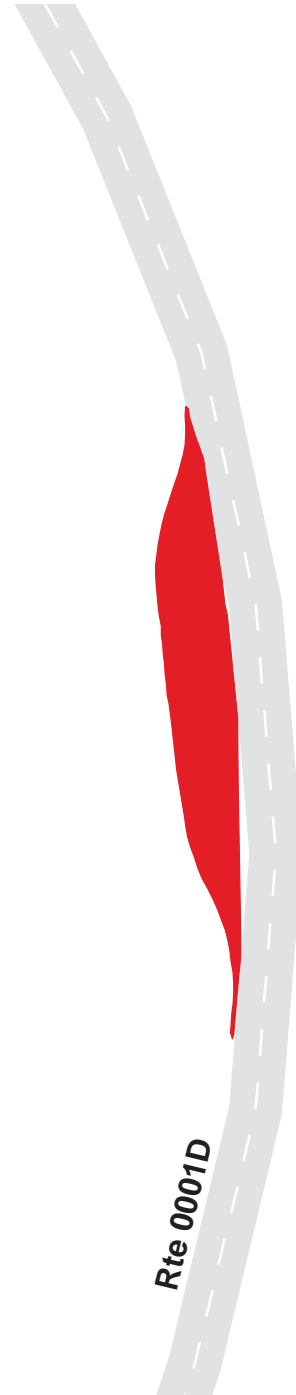
Route 1092A

Route	Public / NonPublic	Date Visited	Area (sq ft)	Lane Miles *	Surface Type	Condition / PCR
1092A	Public	4/8/2004	43547	0.75	AS	POOR / 45

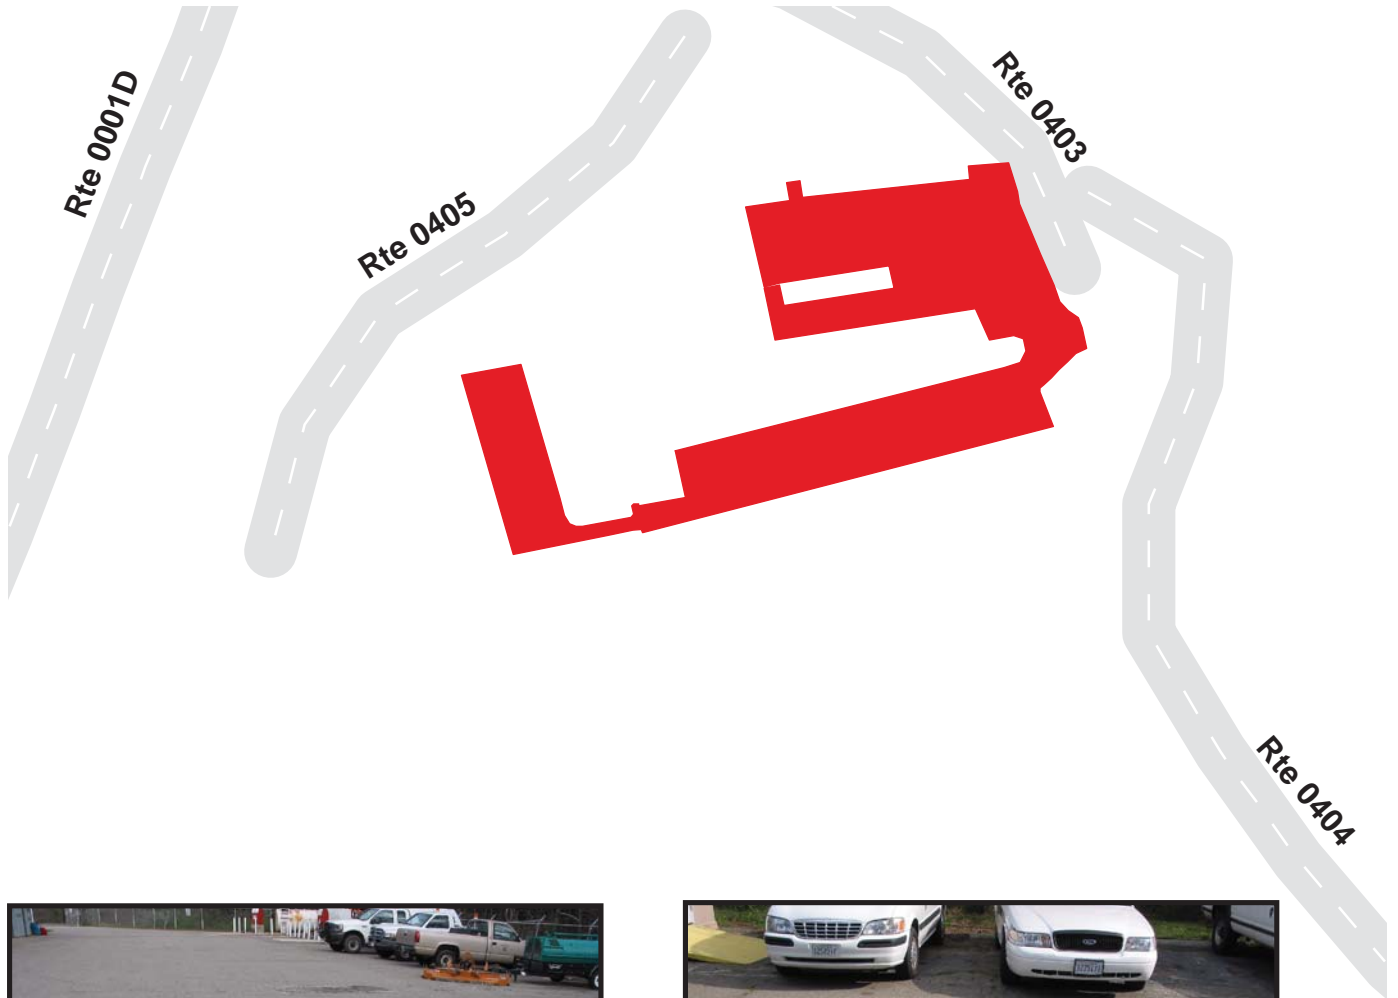
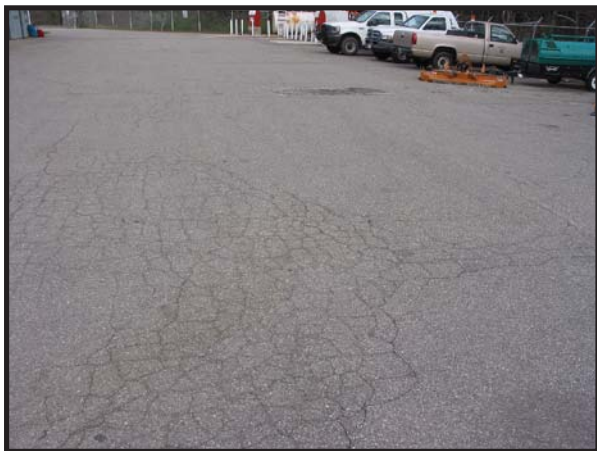
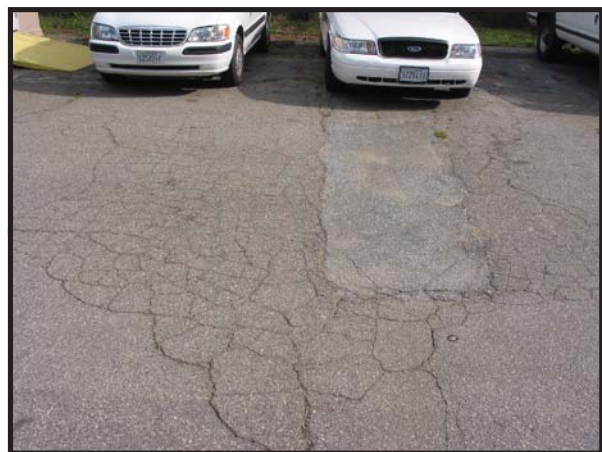
Route 1092B

Route	Public / NonPublic	Date Visited	Area (sq ft)	Lane Miles *	Surface Type	Condition / PCR
1092B	NonPublic	4/8/2004	3212	0.06	AS	POOR / 45

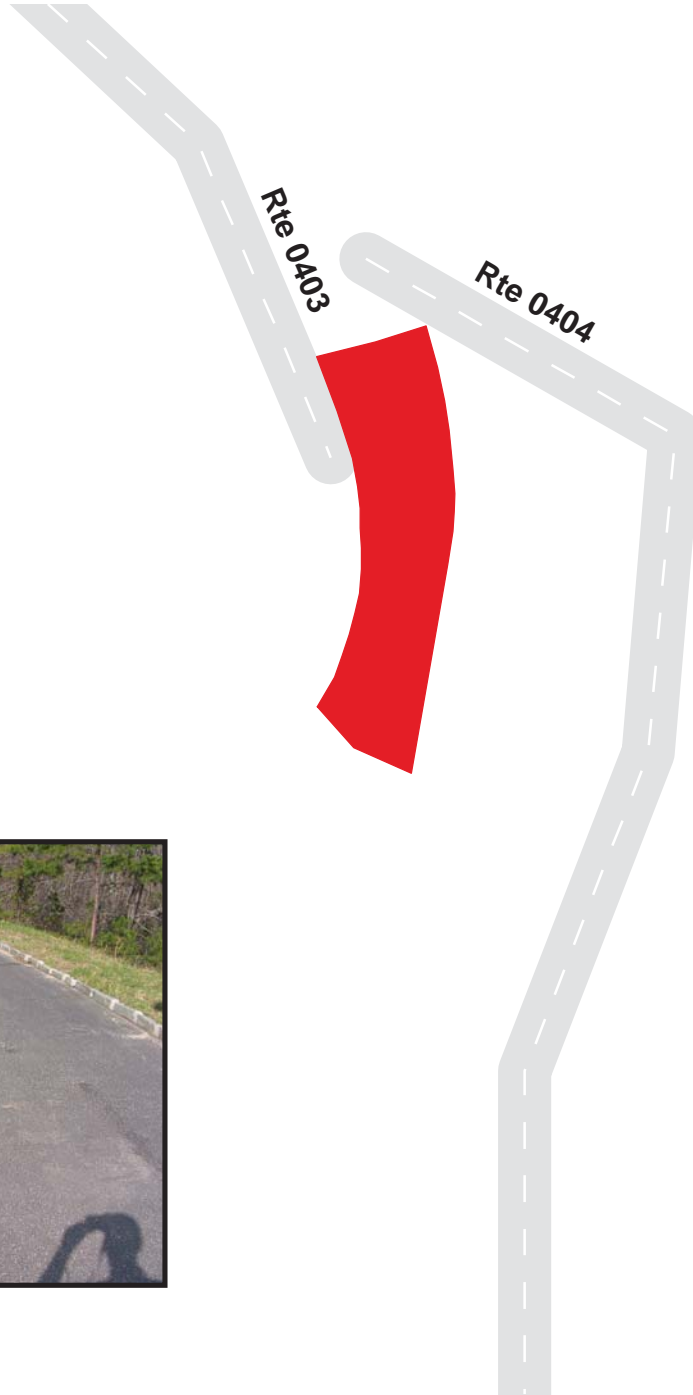
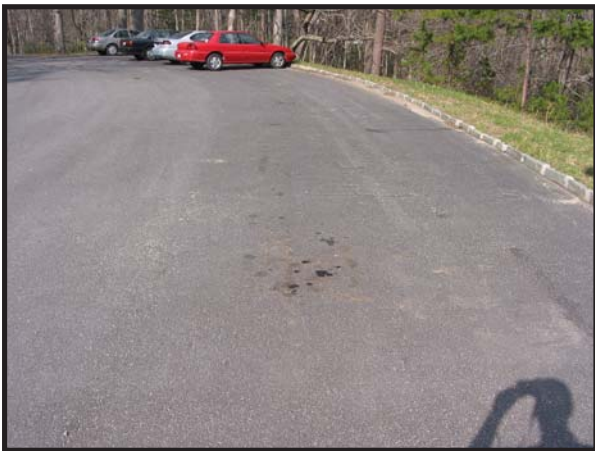
Route 1093

Route	Public / NonPublic	Date Visited	Area (sq ft)	Lane Miles *	Surface Type	Condition / PCR
1093	Public	8/30/2003	7399	0.13	AS	GOOD / 90

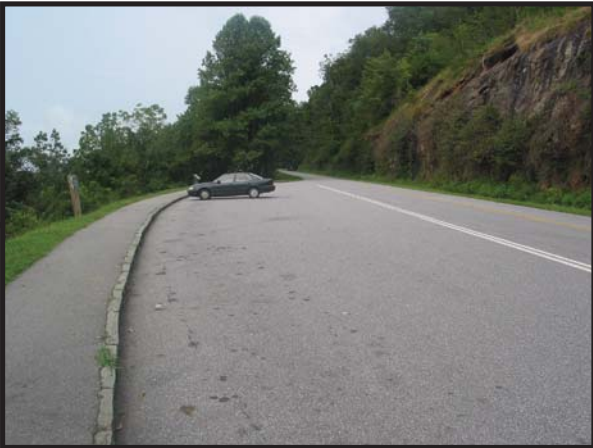
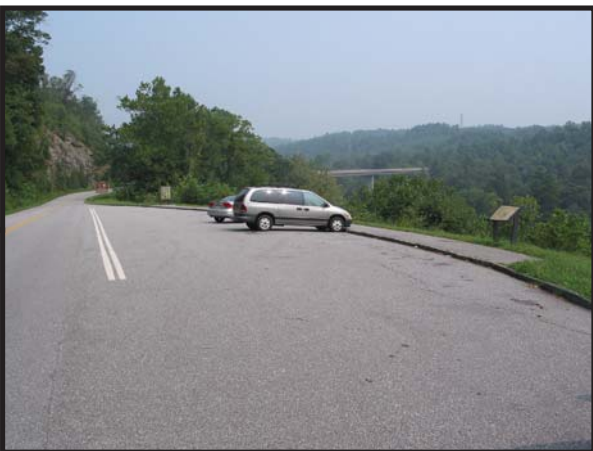
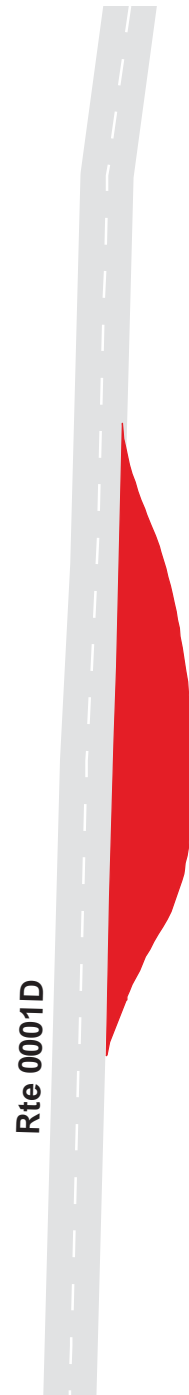
Route 1094

Route	Public / NonPublic	Date Visited	Area (sq ft)	Lane Miles *	Surface Type	Condition / PCR
1094	Public	8/28/2003	11282	0.19	AS	GOOD / 90

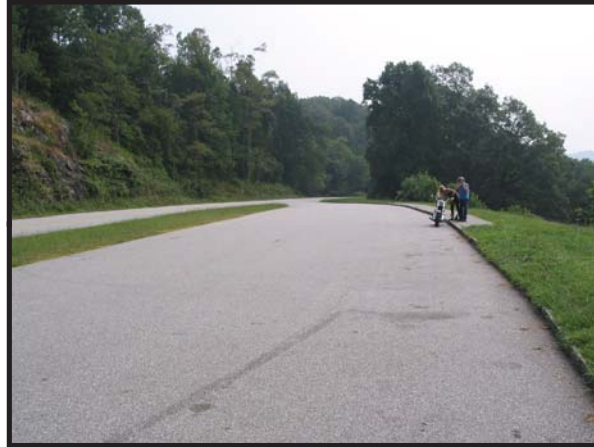
Route 1095

Route	Public / NonPublic	Date Visited	Area (sq ft)	Lane Miles *	Surface Type	Condition / PCR
1095	Public	8/28/2003	11063	0.19	AS	GOOD / 90
