The Road Inventory of Blue Ridge Parkway BLRI – 5140 Volume 1

Road Inventory Program

Prepared By:
Federal Highway Administration
Eastern Federal Lands Highway Division
Cycle 3

Blue Ridge Parkway in North Carolina

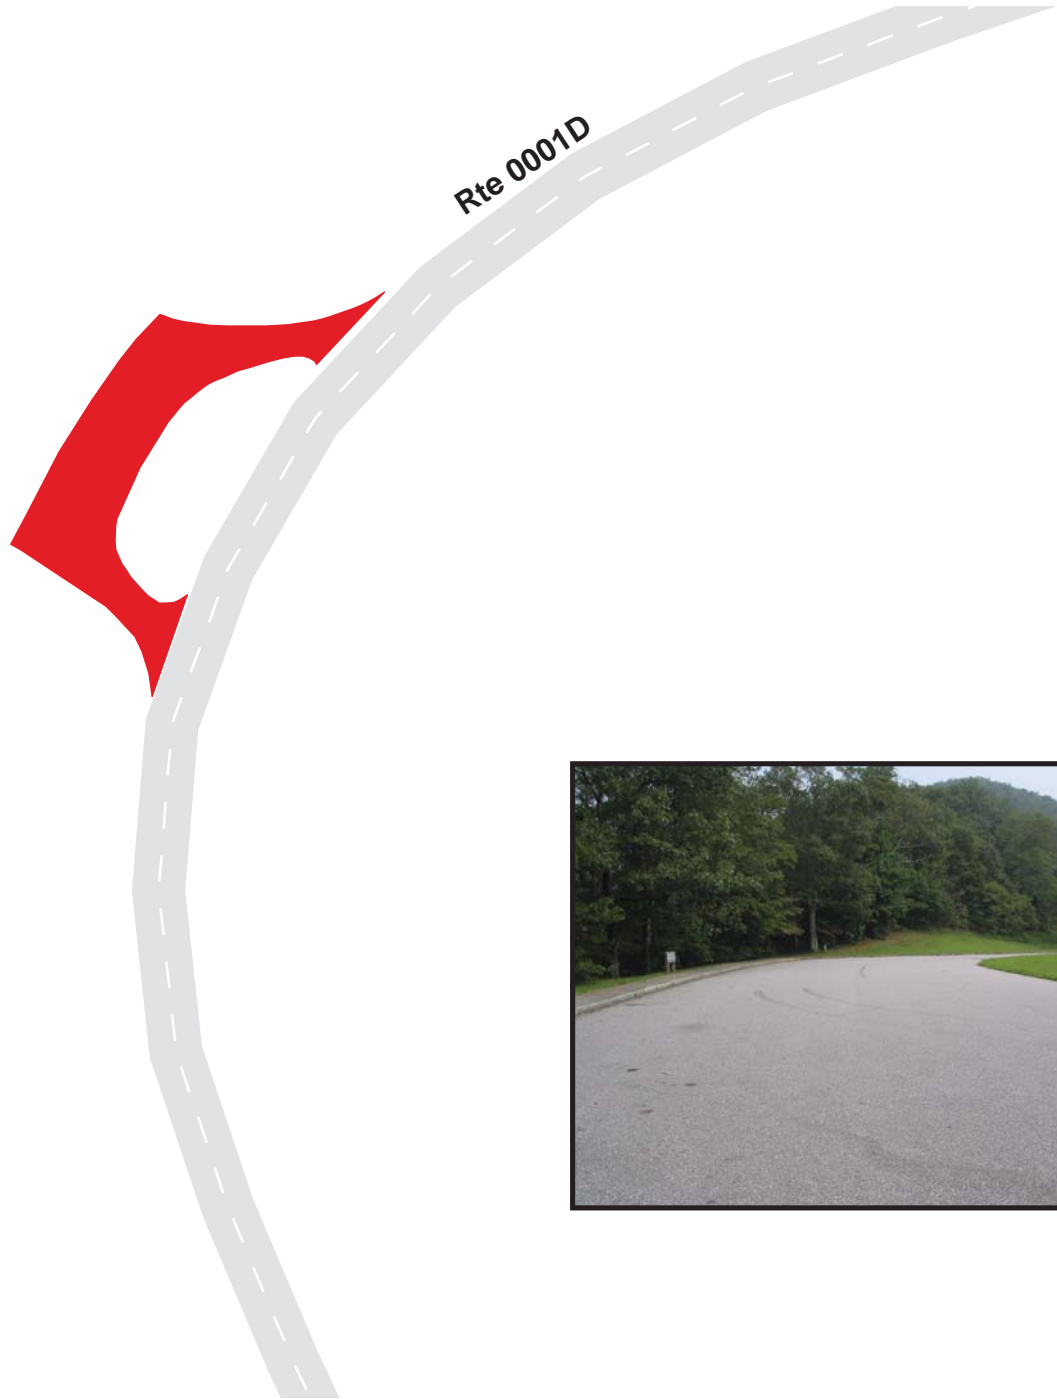
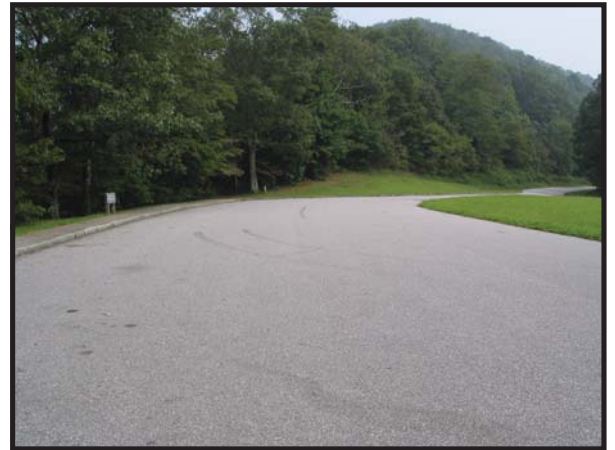
Route 1096

Route	Public / NonPublic	Date Visited	Area (sq ft)	Lane Miles *	Surface Type	Condition / PCR
1096	Public	8/28/2003	5614	0.10	AS	GOOD / 90

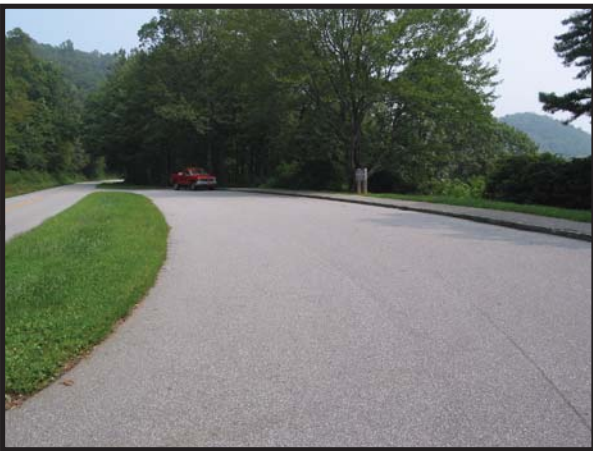
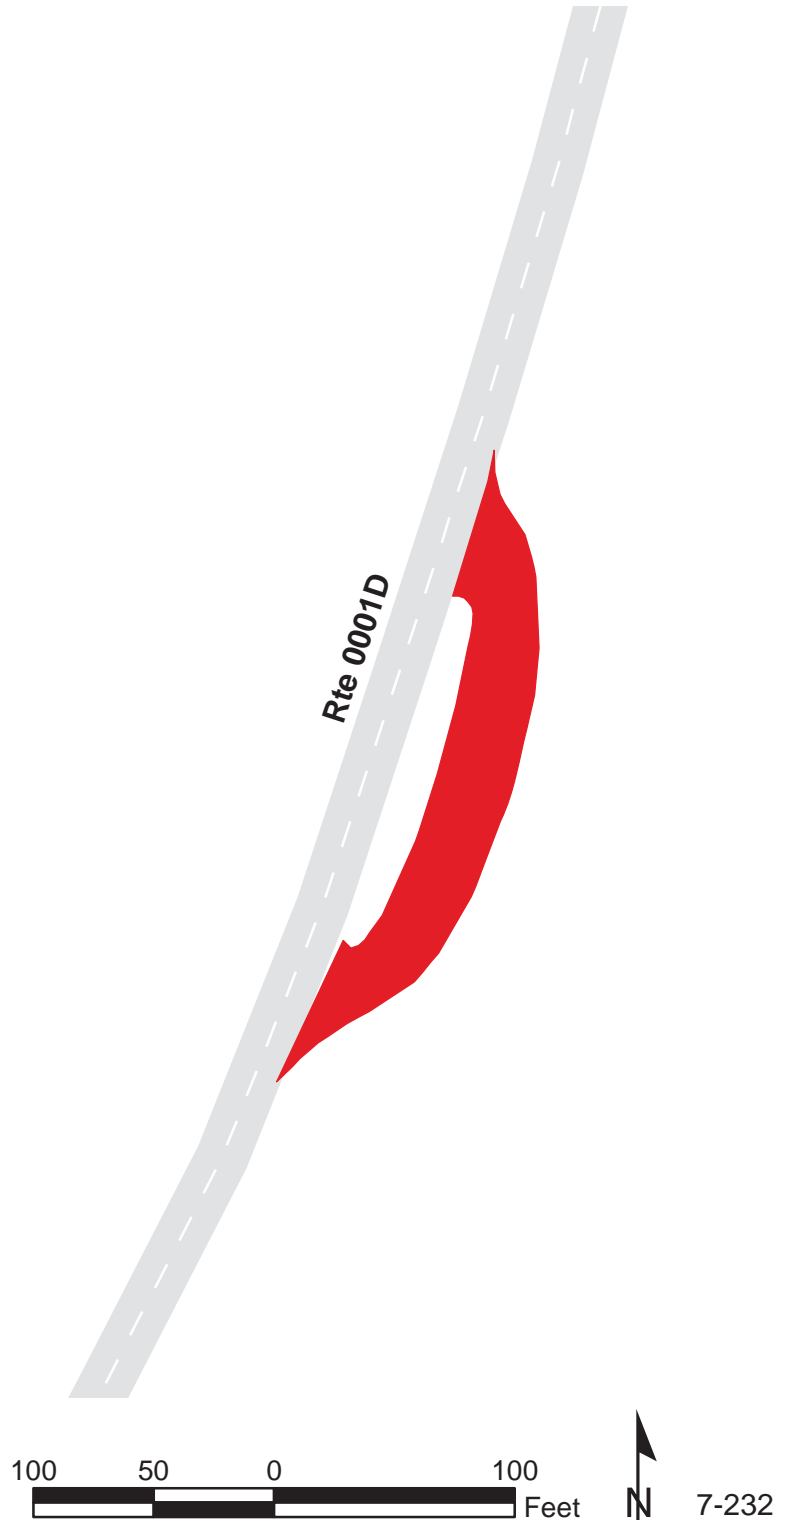
Route 1097

Route	Public / NonPublic	Date Visited	Area (sq ft)	Lane Miles *	Surface Type	Condition / PCR
1097	Public	8/28/2003	11588	0.20	AS	GOOD / 90

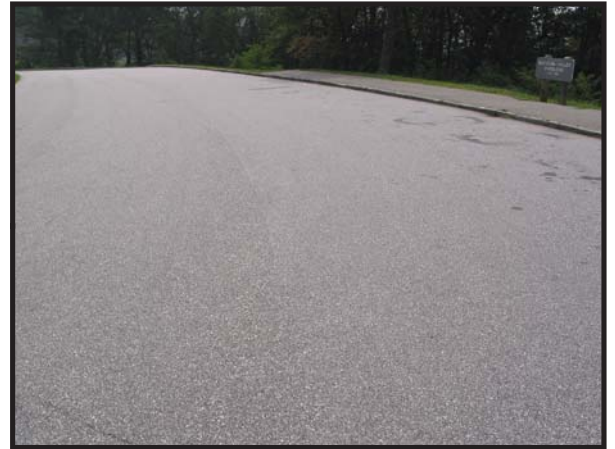
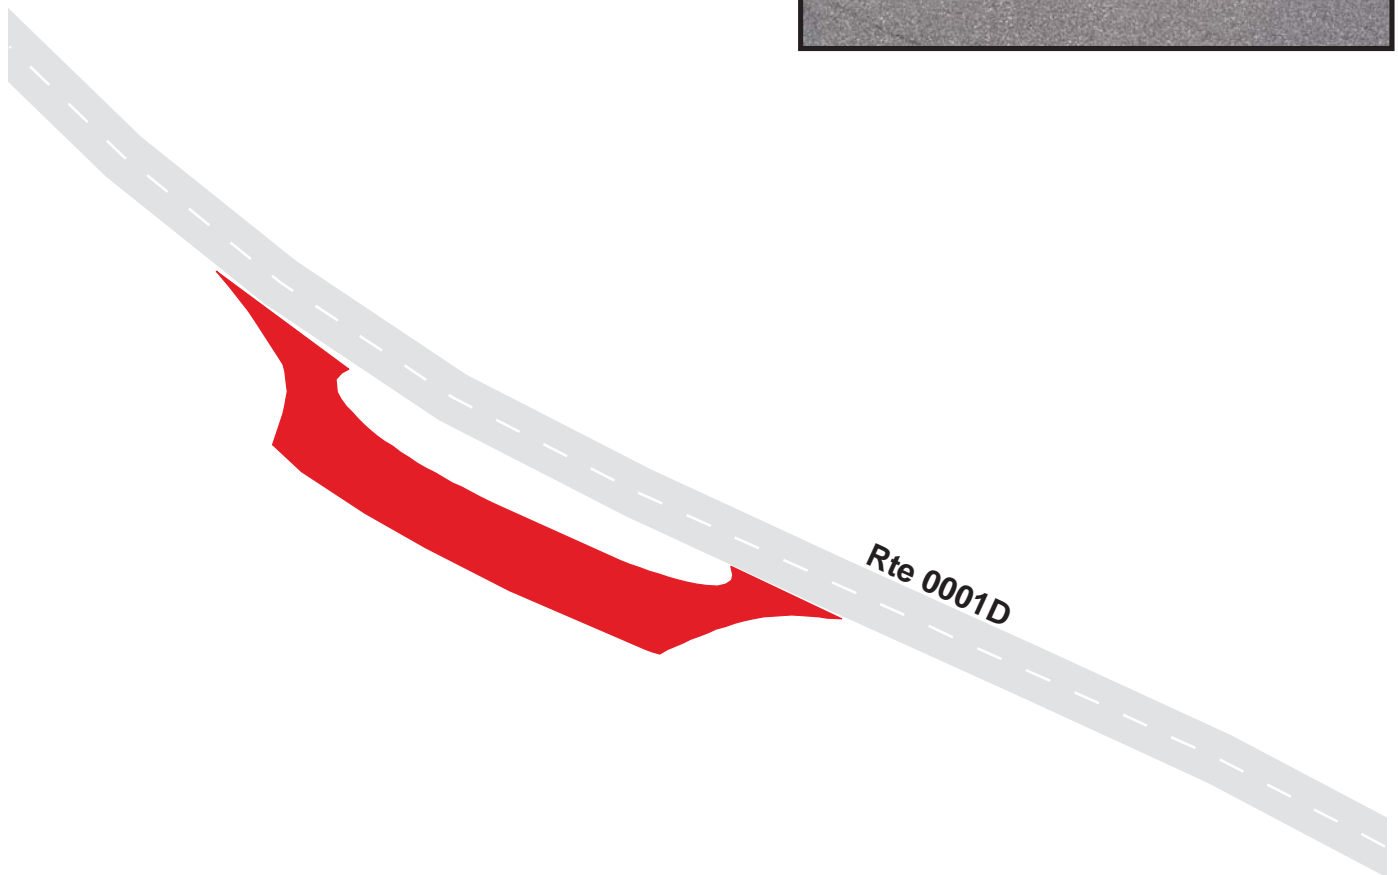
Route 1098

Route	Public / NonPublic	Date Visited	Area (sq ft)	Lane Miles *	Surface Type	Condition / PCR
1098	Public	8/28/2003	10334	0.18	AS	GOOD / 90

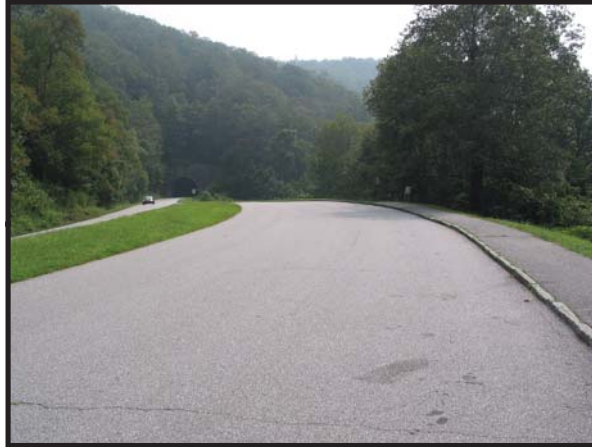
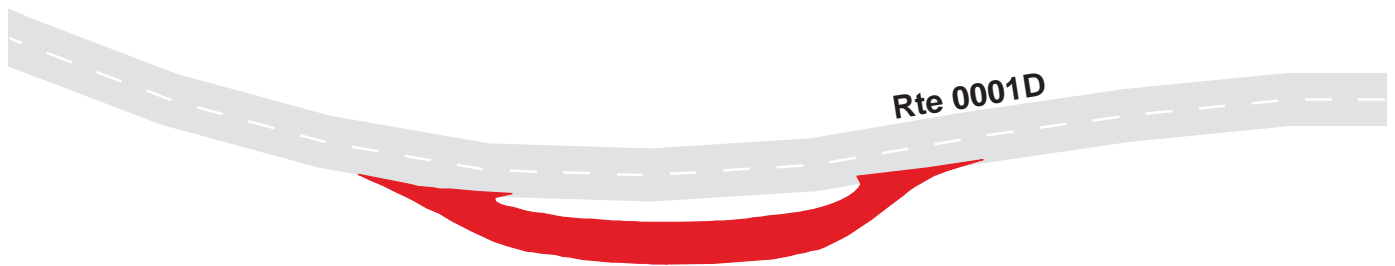
Blue Ridge Parkway Route 1099

Beaver Dam Gap Overlook
From Route 0001D at MP 401.18 on Right

Route	Public / NonPublic	Date Visited	Area (sq ft)	Lane Miles *	Surface Type	Condition / PCR
1099	Public	8/28/2003	9263	0.16	AS	GOOD / 90

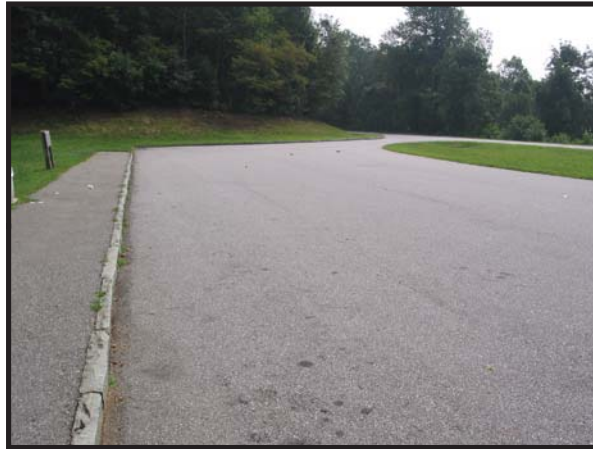
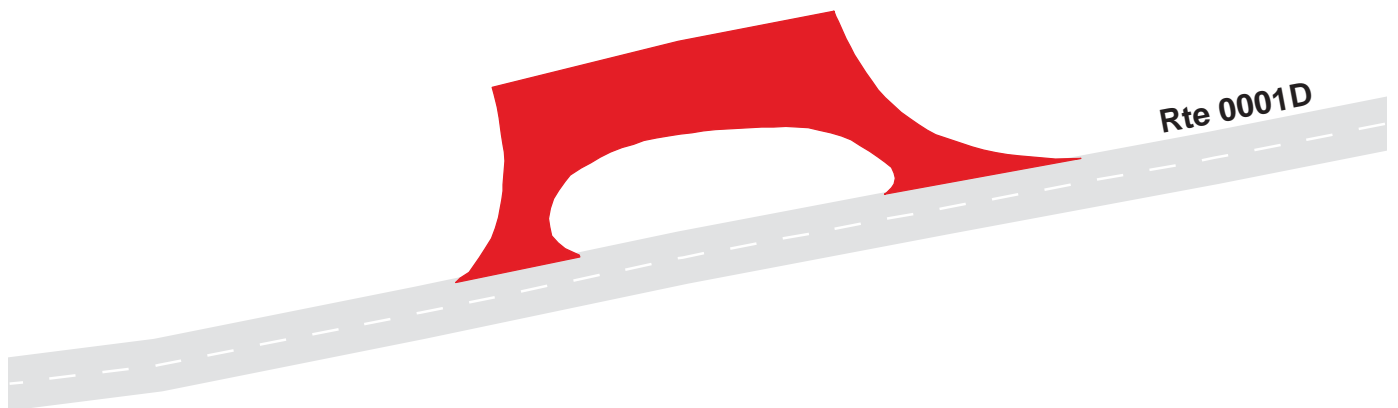
Route 1100

Route	Public / NonPublic	Date Visited	Area (sq ft)	Lane Miles *	Surface Type	Condition / PCR
1100	Public	8/28/2003	10796	0.19	AS	GOOD / 90

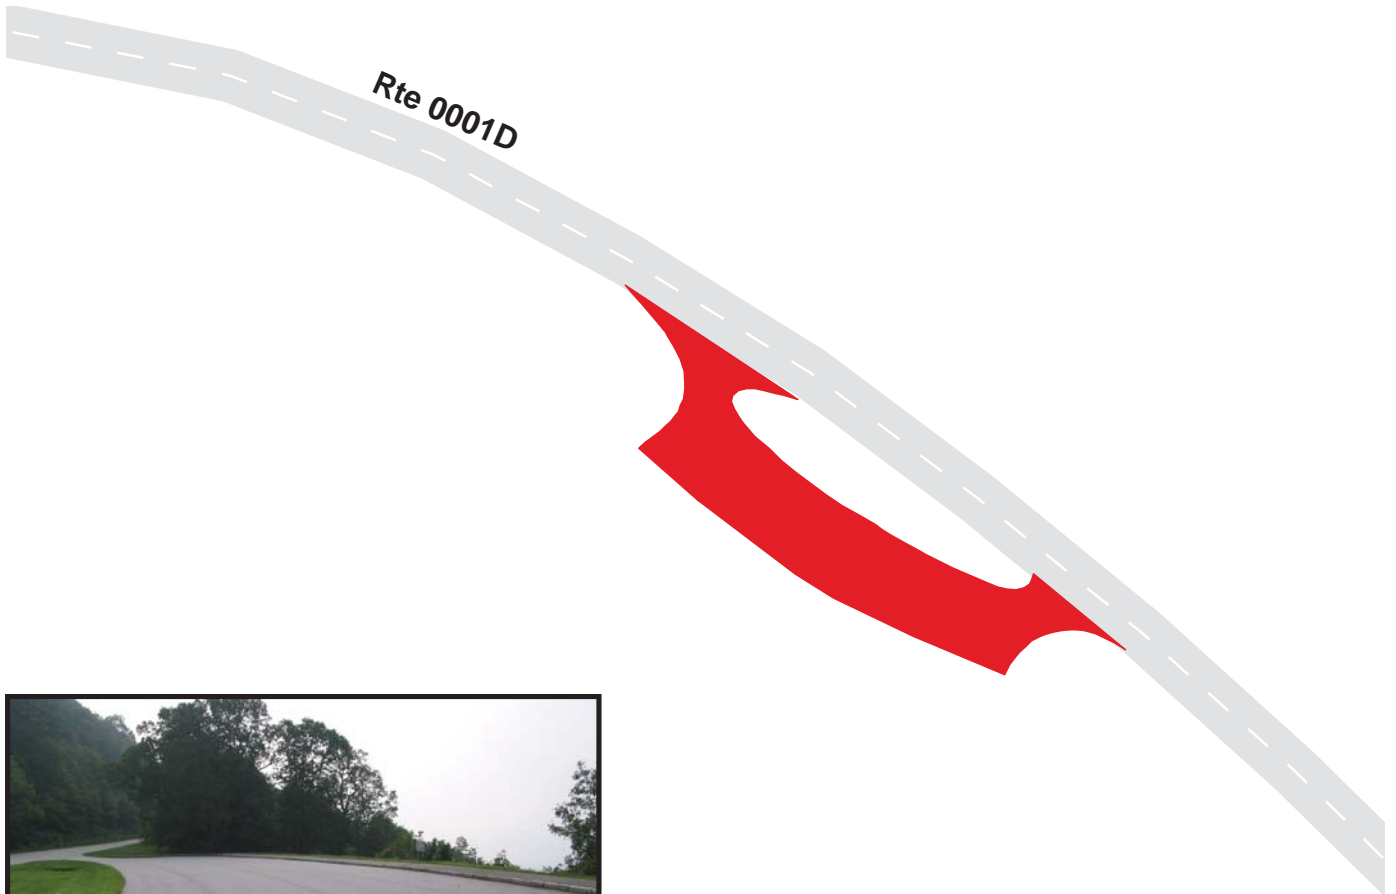
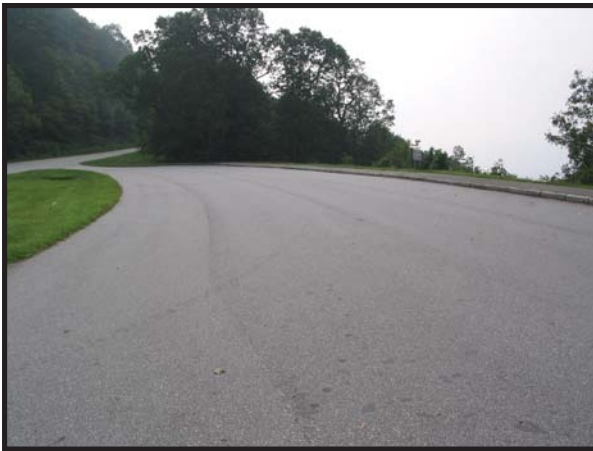
Route 1101

Route	Public / NonPublic	Date Visited	Area (sq ft)	Lane Miles *	Surface Type	Condition / PCR
1101	Public	8/28/2003	8991	0.15	AS	GOOD / 90

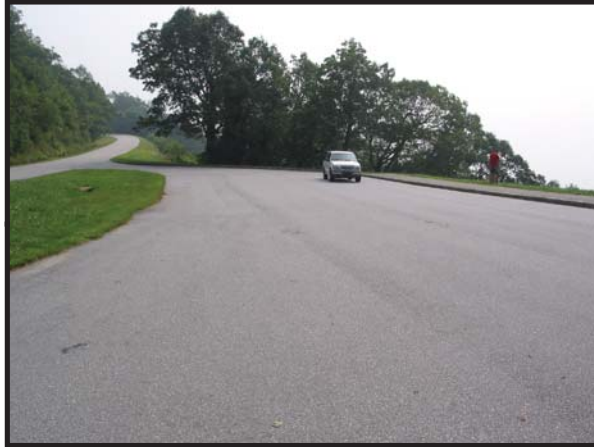
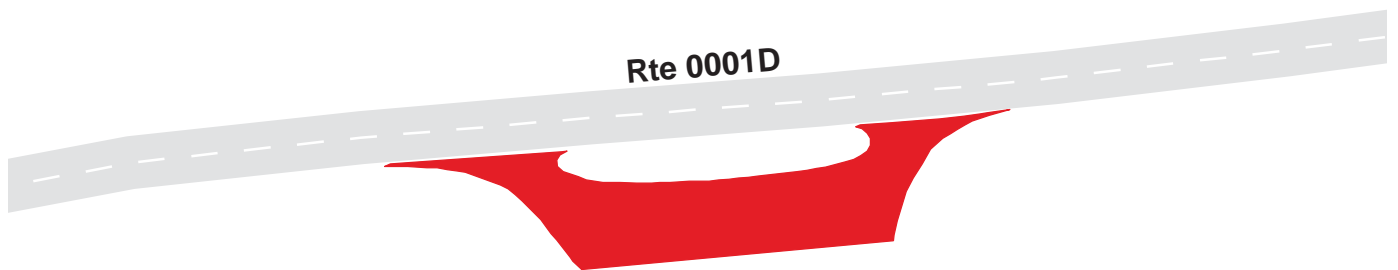
Route 1102

Route	Public / NonPublic	Date Visited	Area (sq ft)	Lane Miles *	Surface Type	Condition / PCR
1102	Public	8/28/2003	9379	0.16	AS	GOOD / 90

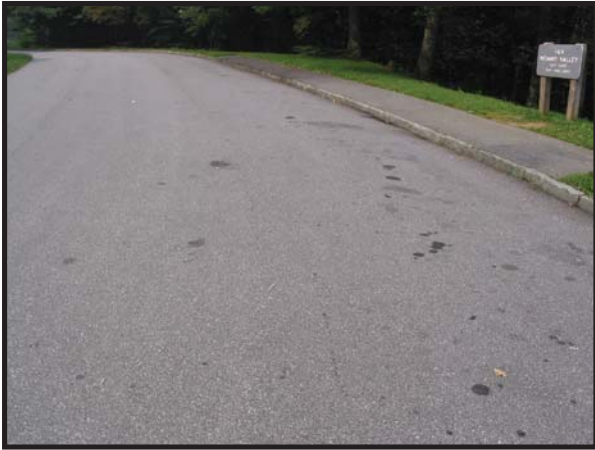
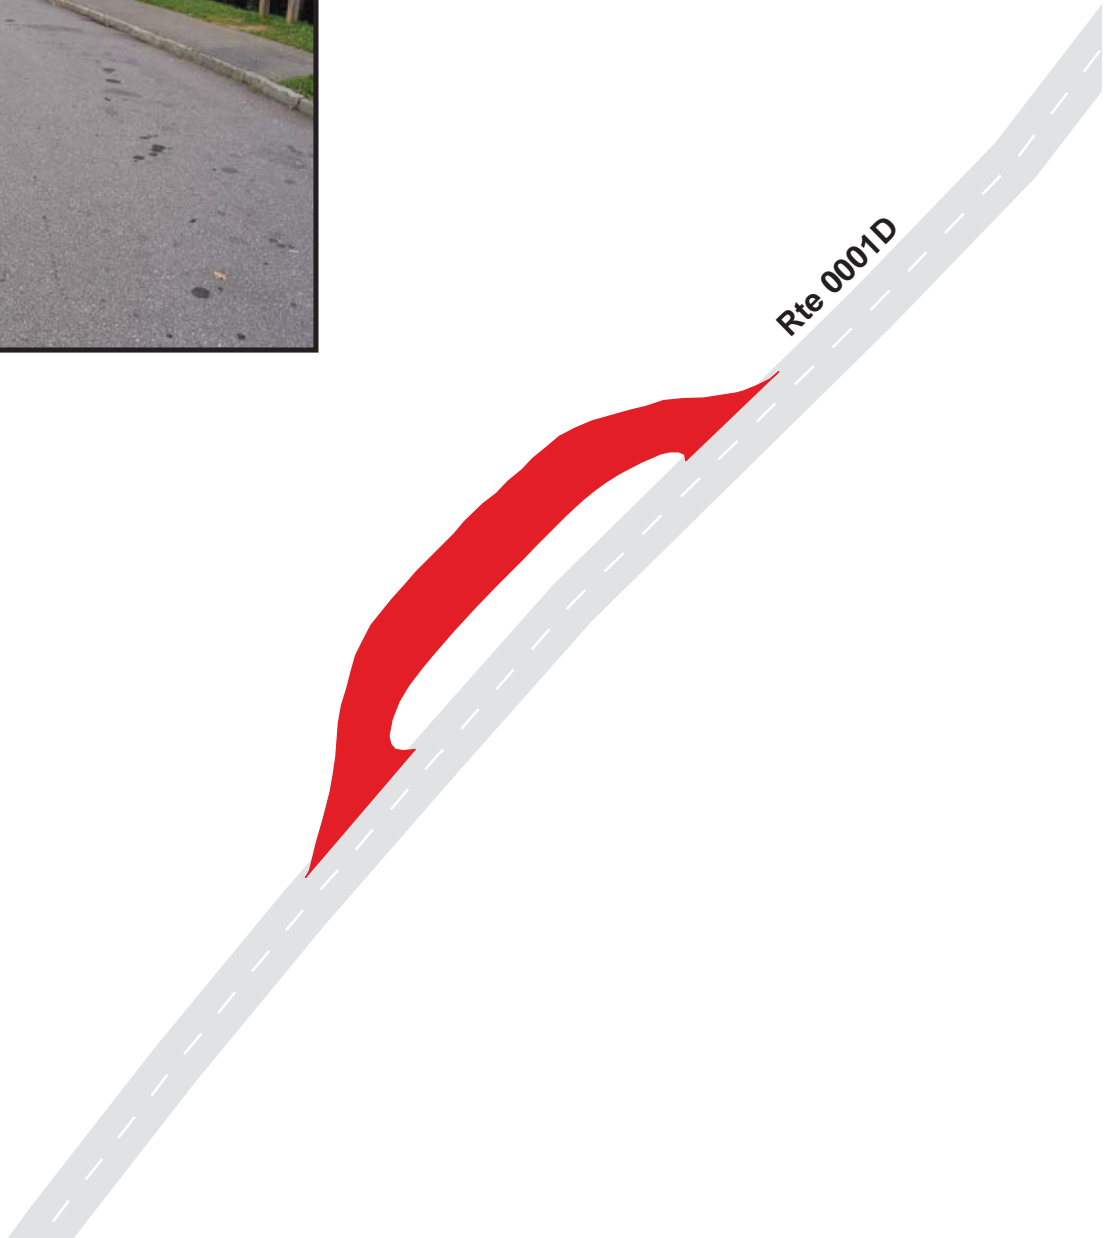
Route 1103

Route	Public / NonPublic	Date Visited	Area (sq ft)	Lane Miles *	Surface Type	Condition / PCR
1103	Public	8/28/2003	8556	0.15	AS	GOOD / 90

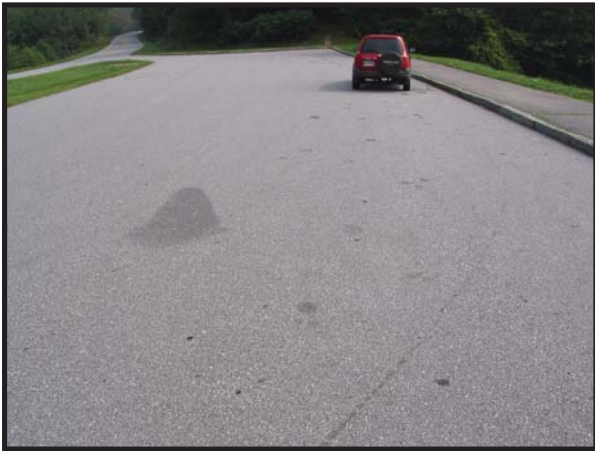
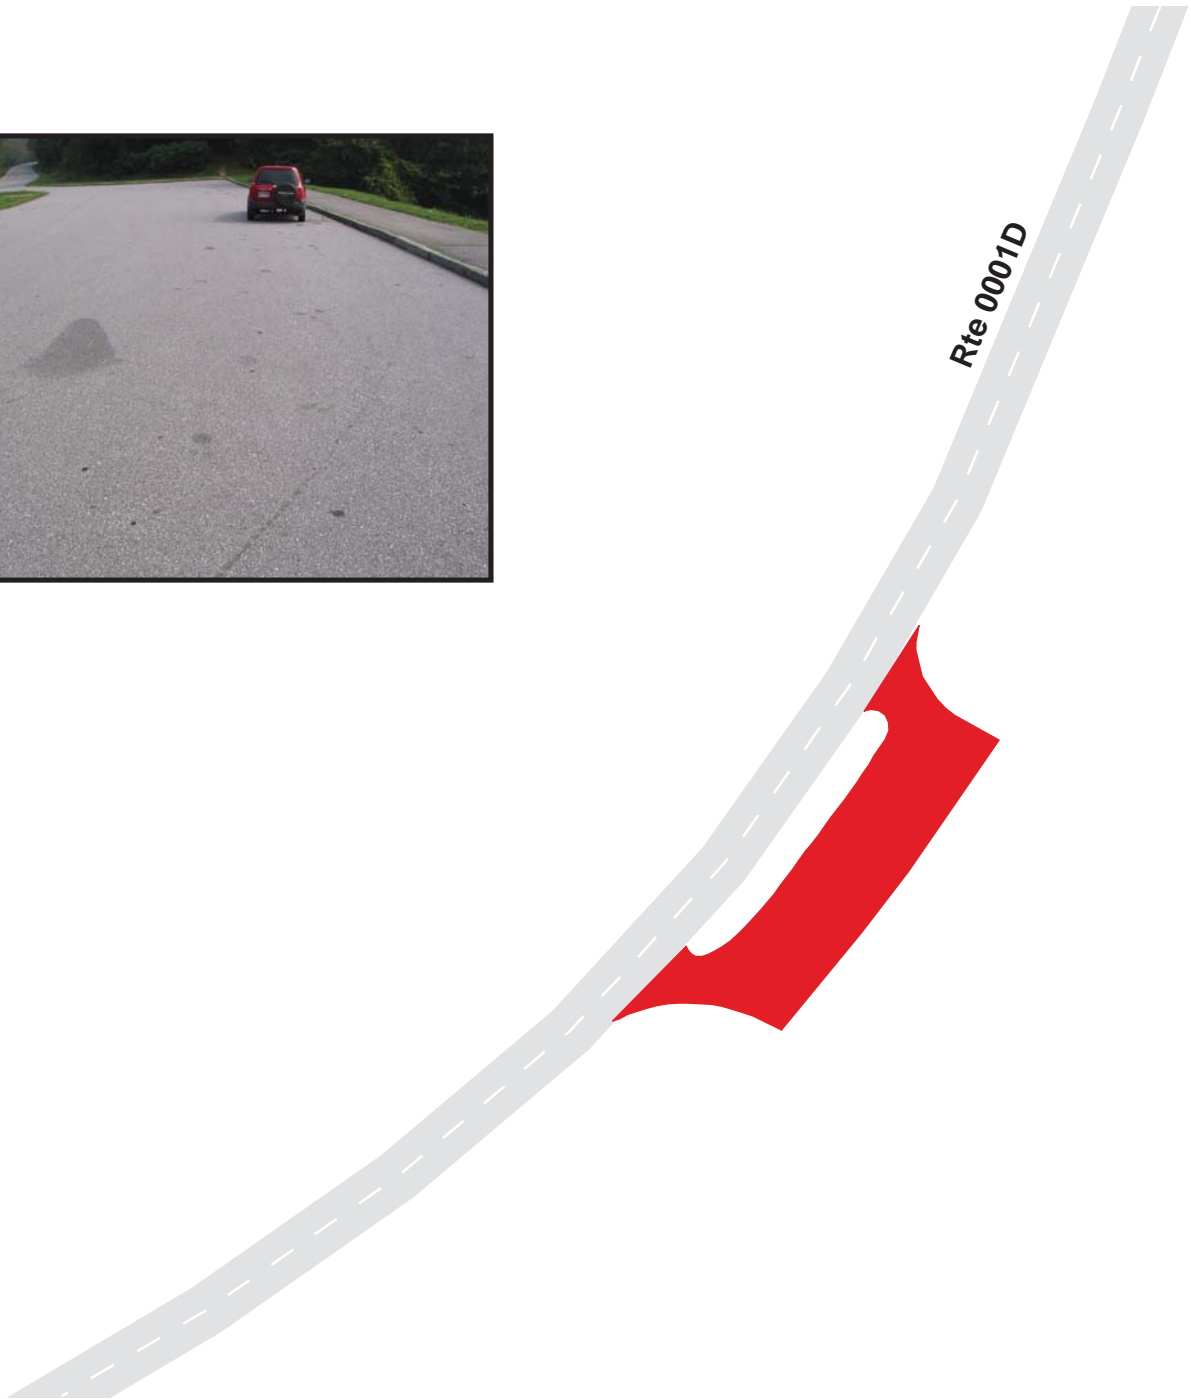
Route 1104

Route	Public / NonPublic	Date Visited	Area (sq ft)	Lane Miles *	Surface Type	Condition / PCR
1104	Public	8/28/2003	29130	0.50	AS	GOOD / 90

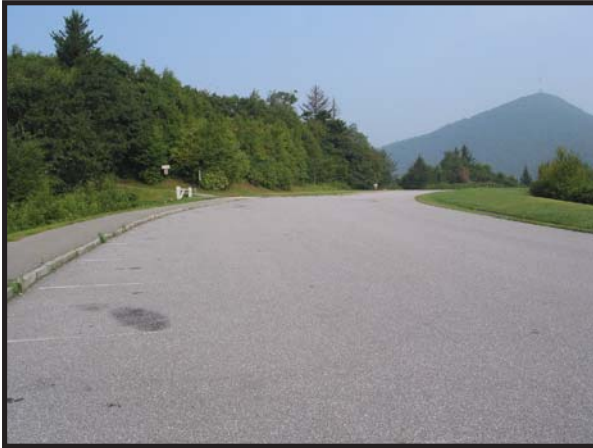
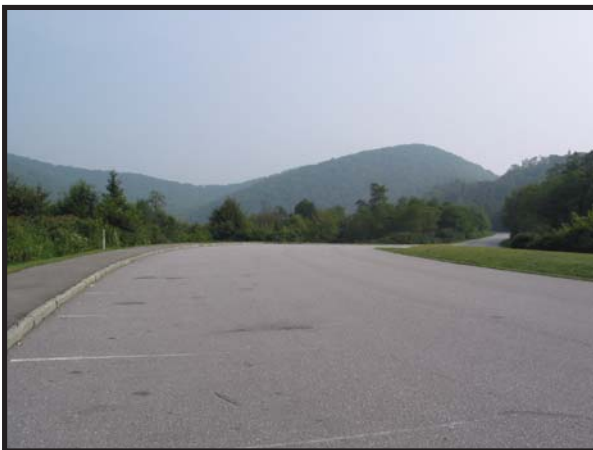
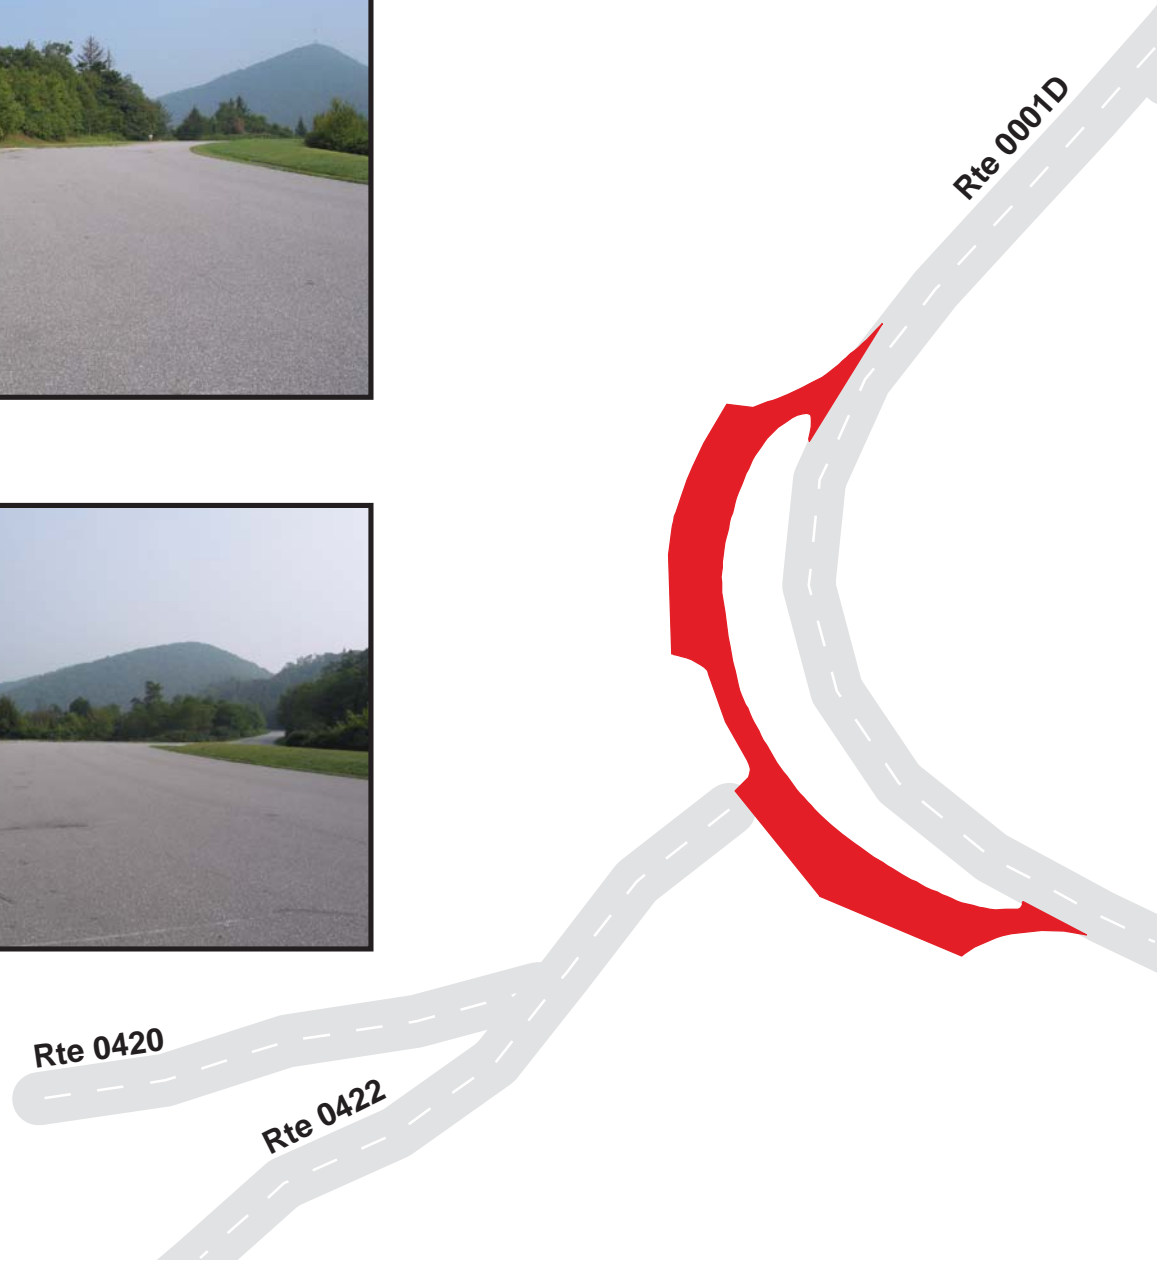
Route 1105

Route	Public / NonPublic	Date Visited	Area (sq ft)	Lane Miles *	Surface Type	Condition / PCR
1105	Public	8/28/2003	30834	0.53	AS	GOOD / 90

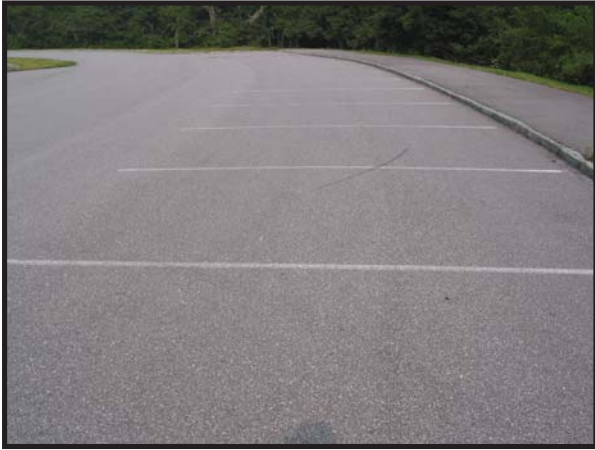
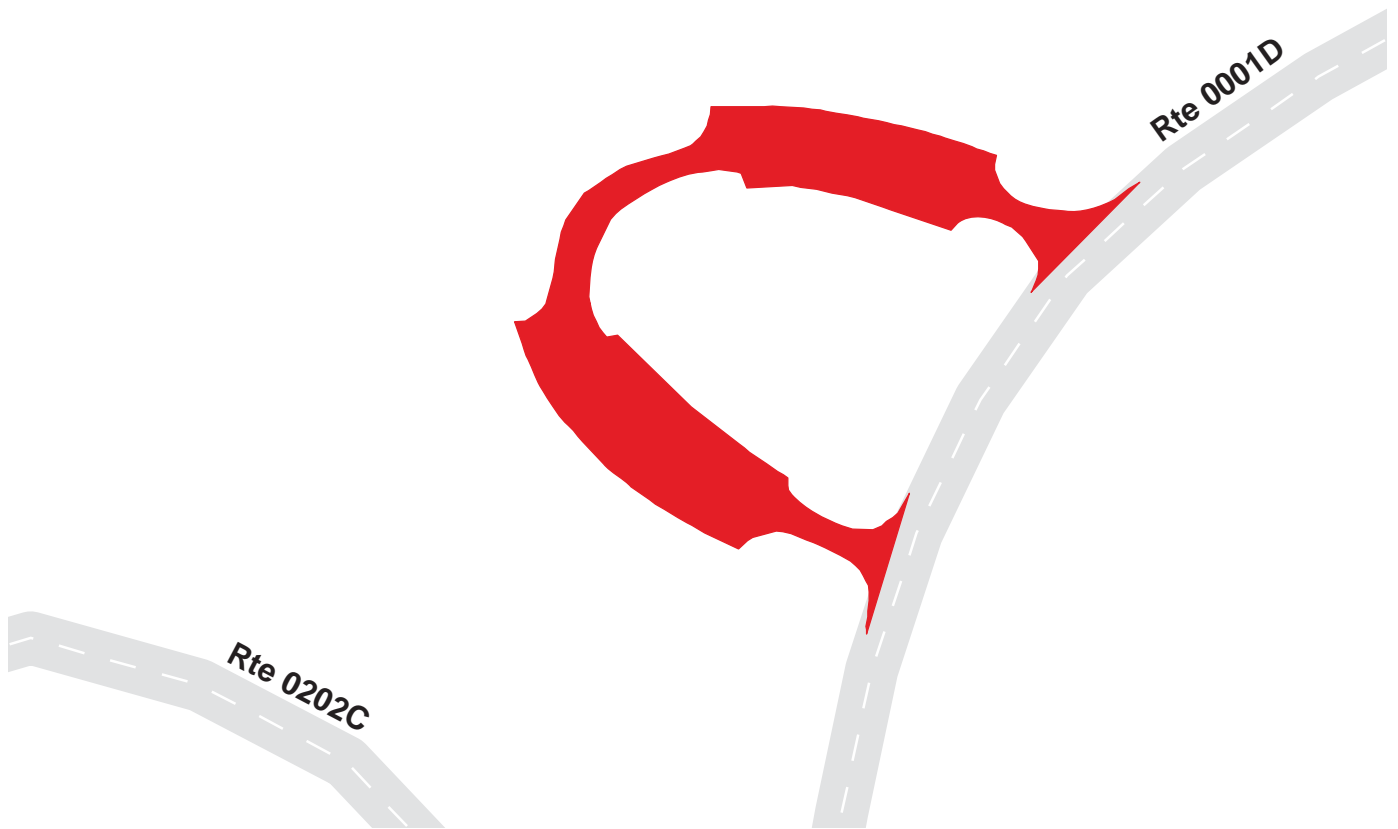
Route 1106A

Route	Public / NonPublic	Date Visited	Area (sq ft)	Lane Miles *	Surface Type	Condition / PCR
1106A	Public	8/28/2003	12198	0.21	AS	GOOD / 90

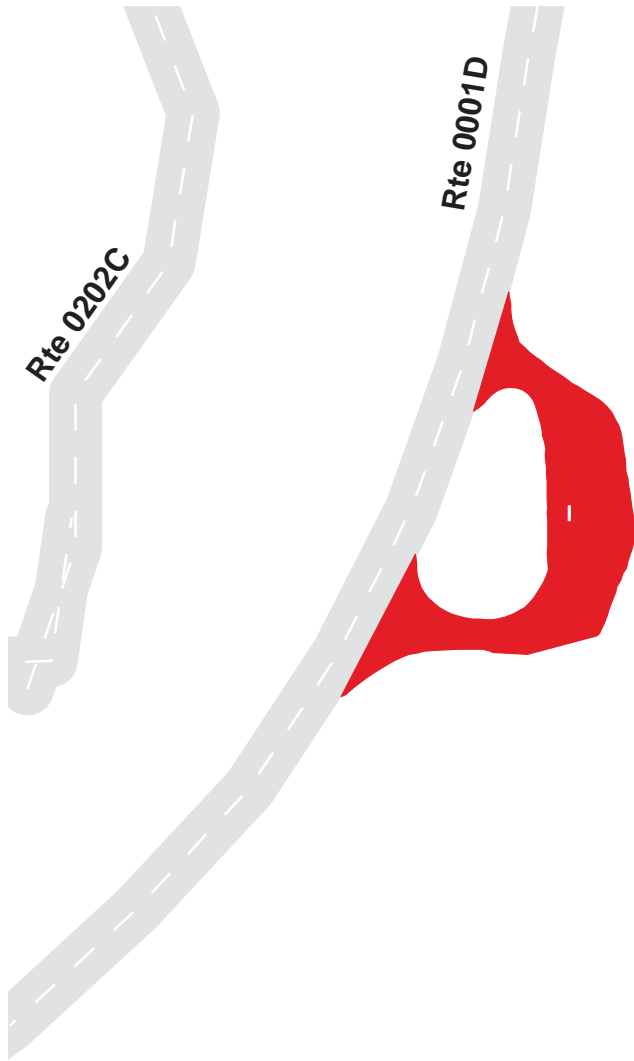
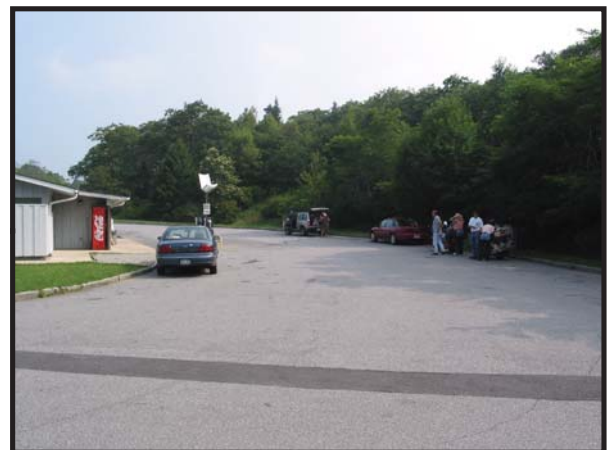
Route 1106B

Route	Public / NonPublic	Date Visited	Area (sq ft)	Lane Miles *	Surface Type	Condition / PCR
1106B	Public	8/28/2003	64695	1.11	AS	GOOD / 90

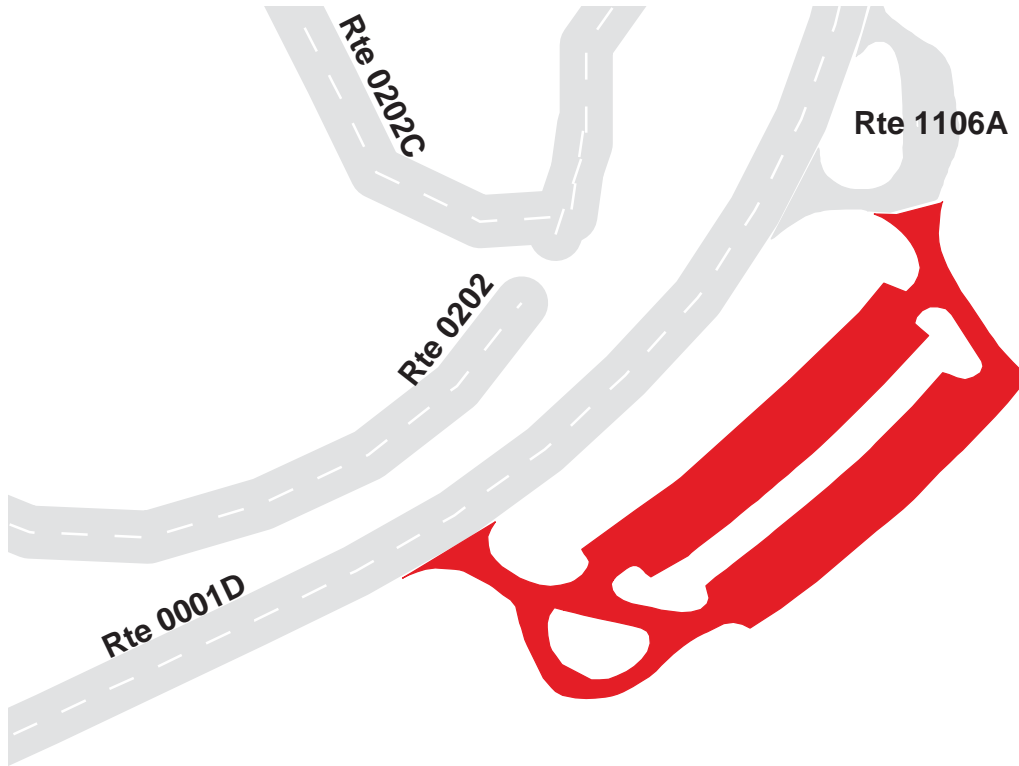
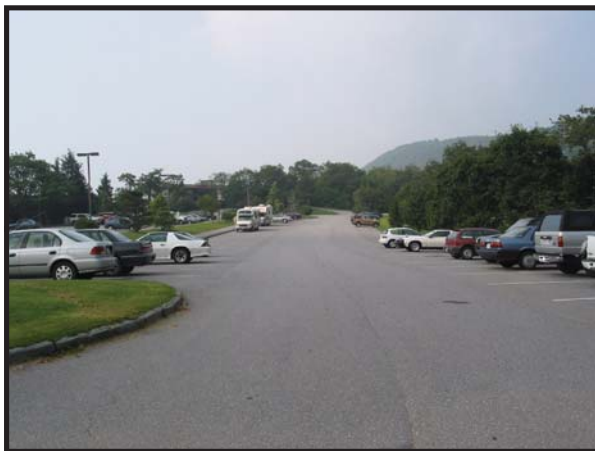
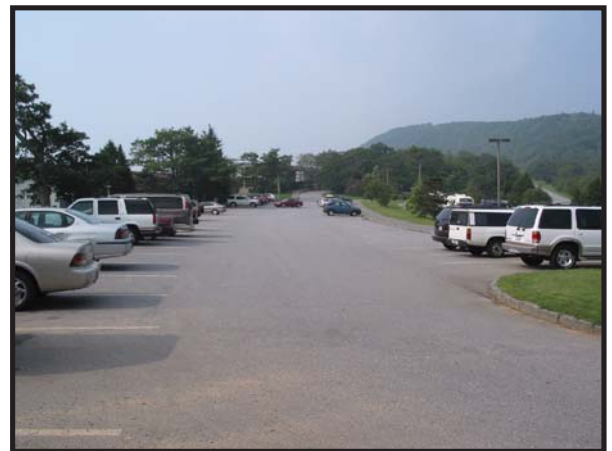
Route 1106C

Route	Public / NonPublic	Date Visited	Area (sq ft)	Lane Miles *	Surface Type	Condition / PCR
1106C	NonPublic	8/28/2003	9756	0.17	AS	POOR / 45

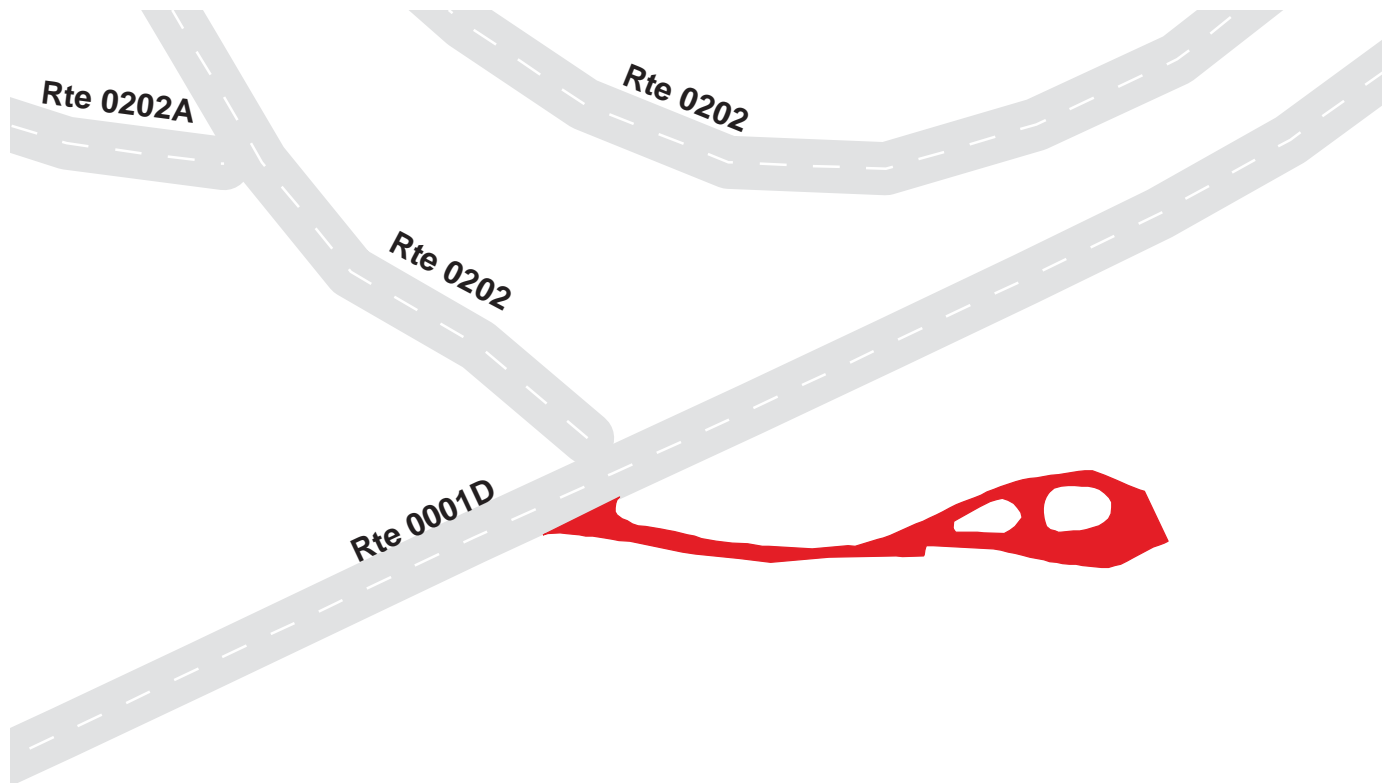
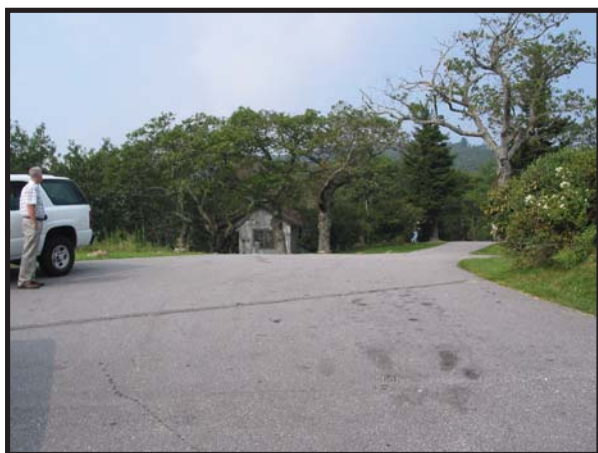
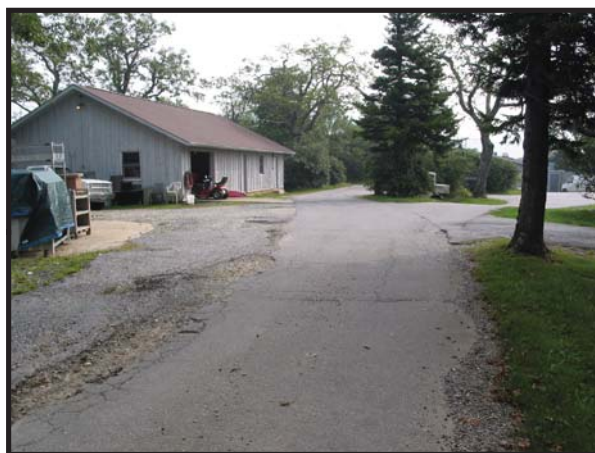
Route 1107

Route	Public / NonPublic	Date Visited	Area (sq ft)	Lane Miles *	Surface Type	Condition / PCR
1107	Public	8/28/2003	5139	0.09	AS	GOOD / 90

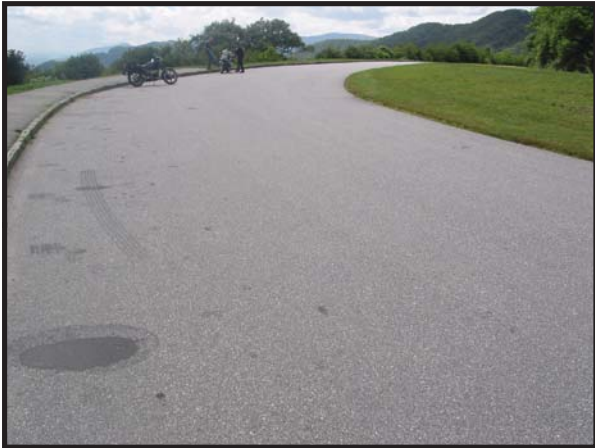
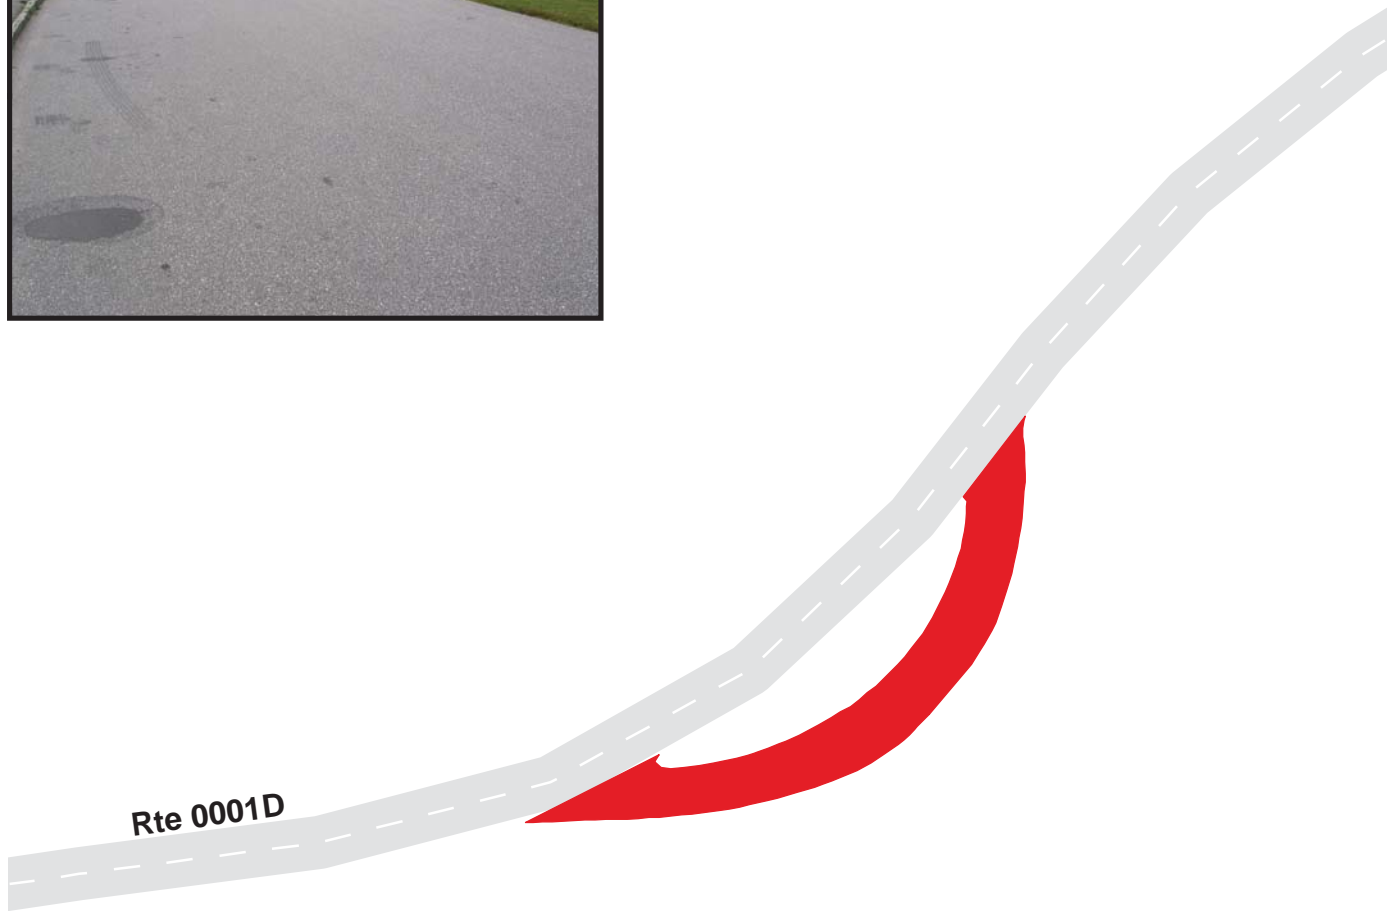
Route 1108

Route	Public / NonPublic	Date Visited	Area (sq ft)	Lane Miles *	Surface Type	Condition / PCR
1108	Public	8/30/2003	7745	0.13	AS	GOOD / 90
