The Road Inventory of Blue Ridge Parkway BLRI – 5140 Volume 1

Road Inventory Program

Prepared By:
Federal Highway Administration
Eastern Federal Lands Highway Division
Cycle 3

Blue Ridge Parkway in North Carolina

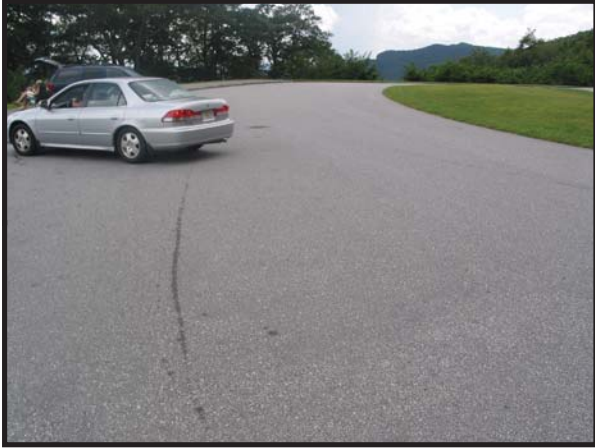
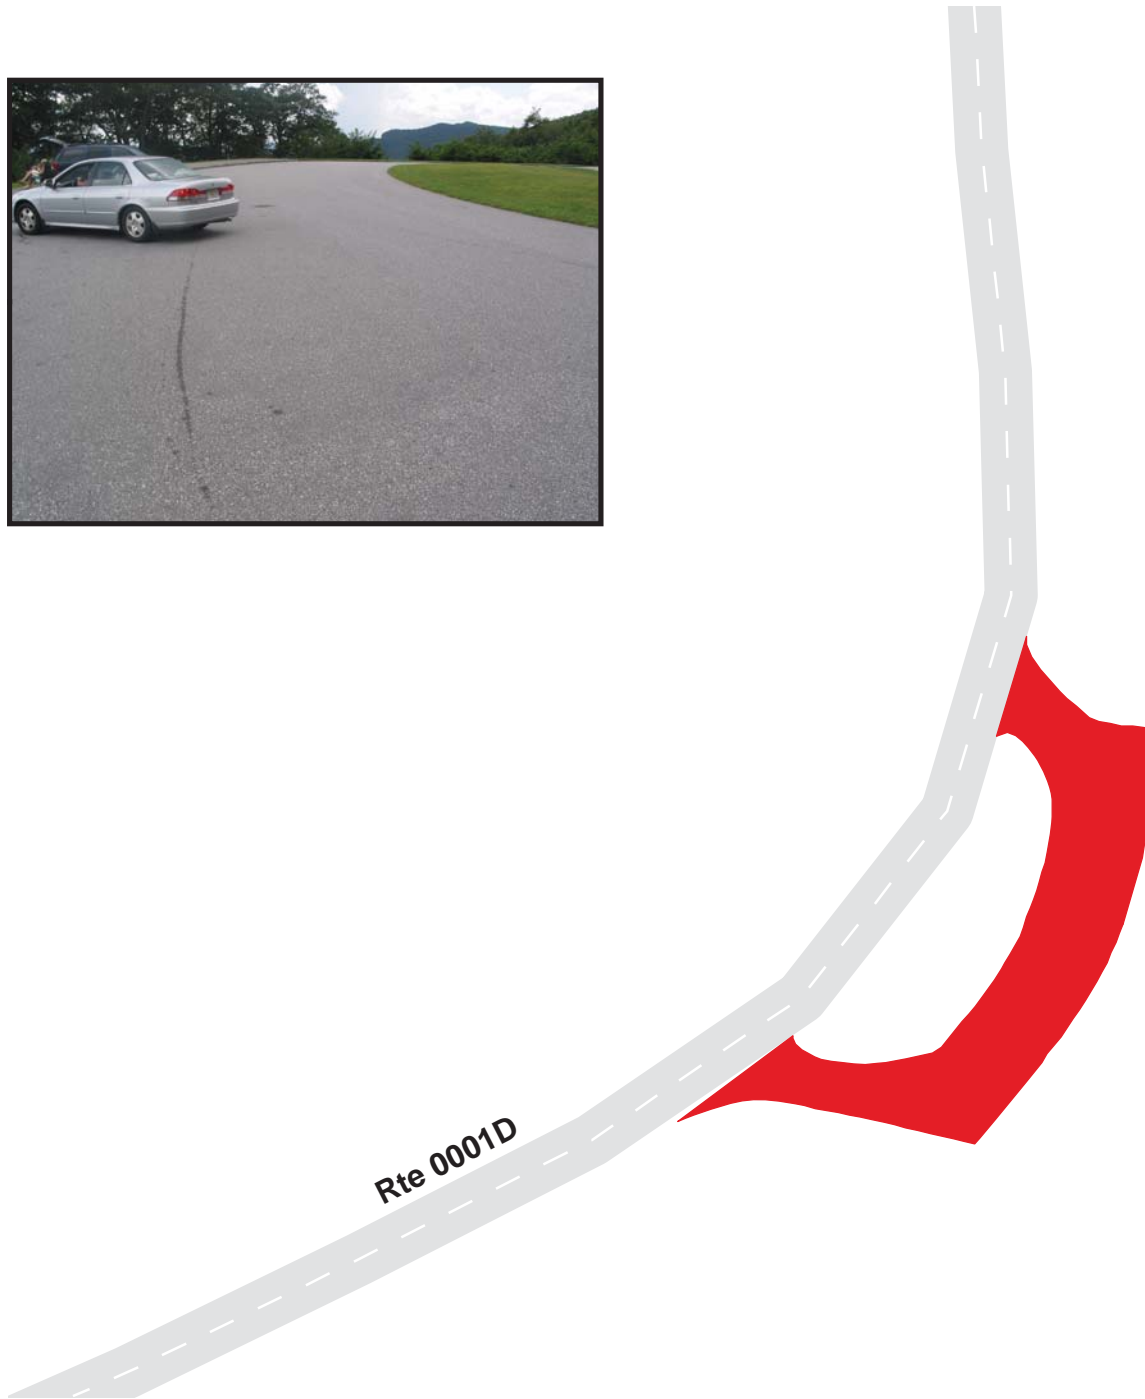
Route 1109

Route	Public / NonPublic	Date Visited	Area (sq ft)	Lane Miles *	Surface Type	Condition / PCR
1109	Public	8/30/2003	10489	0.18	AS	GOOD / 90

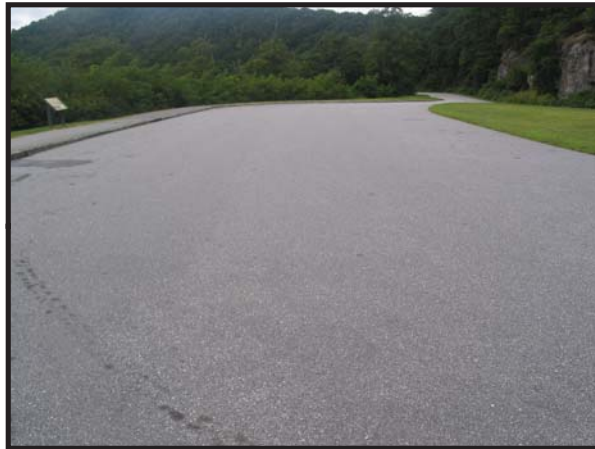
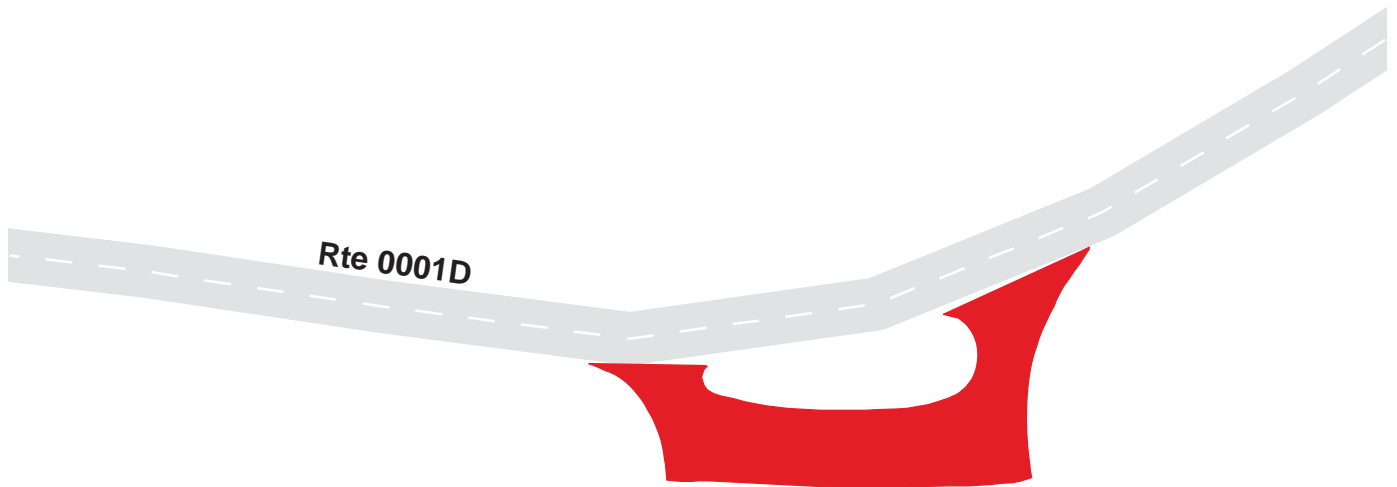
Route 1110

Route	Public / NonPublic	Date Visited	Area (sq ft)	Lane Miles *	Surface Type	Condition / PCR
1110	Public	8/30/2003	9182	0.16	AS	GOOD / 90

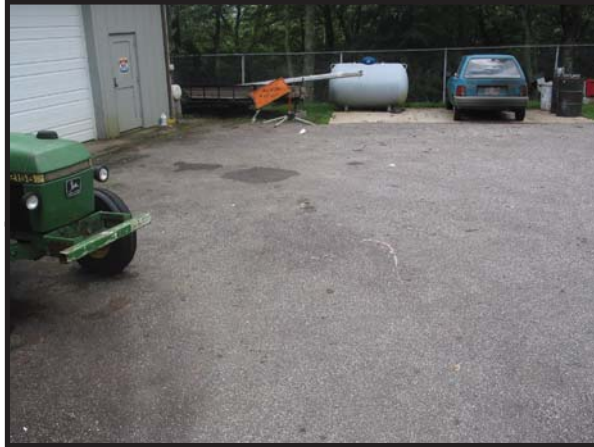
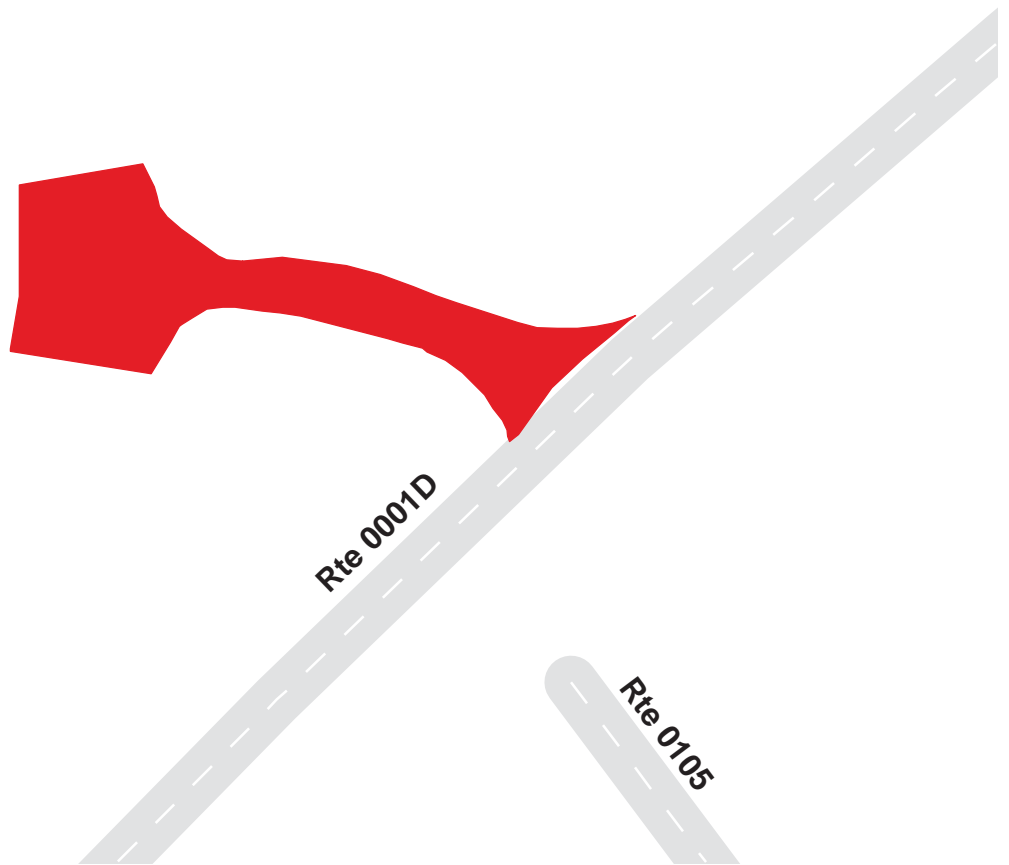
Route 1111

Route	Public / NonPublic	Date Visited	Area (sq ft)	Lane Miles *	Surface Type	Condition / PCR
1111	NonPublic	8/30/2003	2565	0.04	AS	FAIR / 73

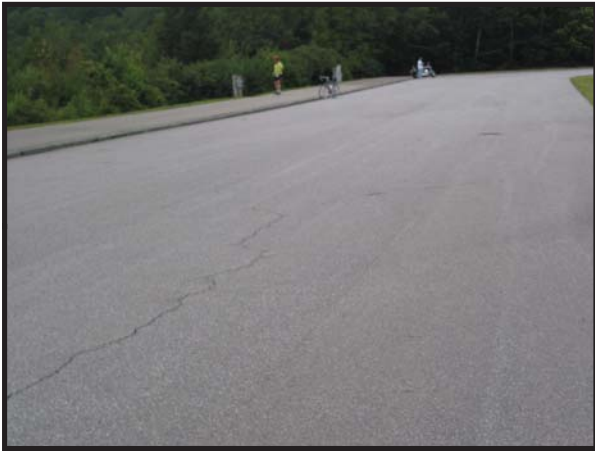
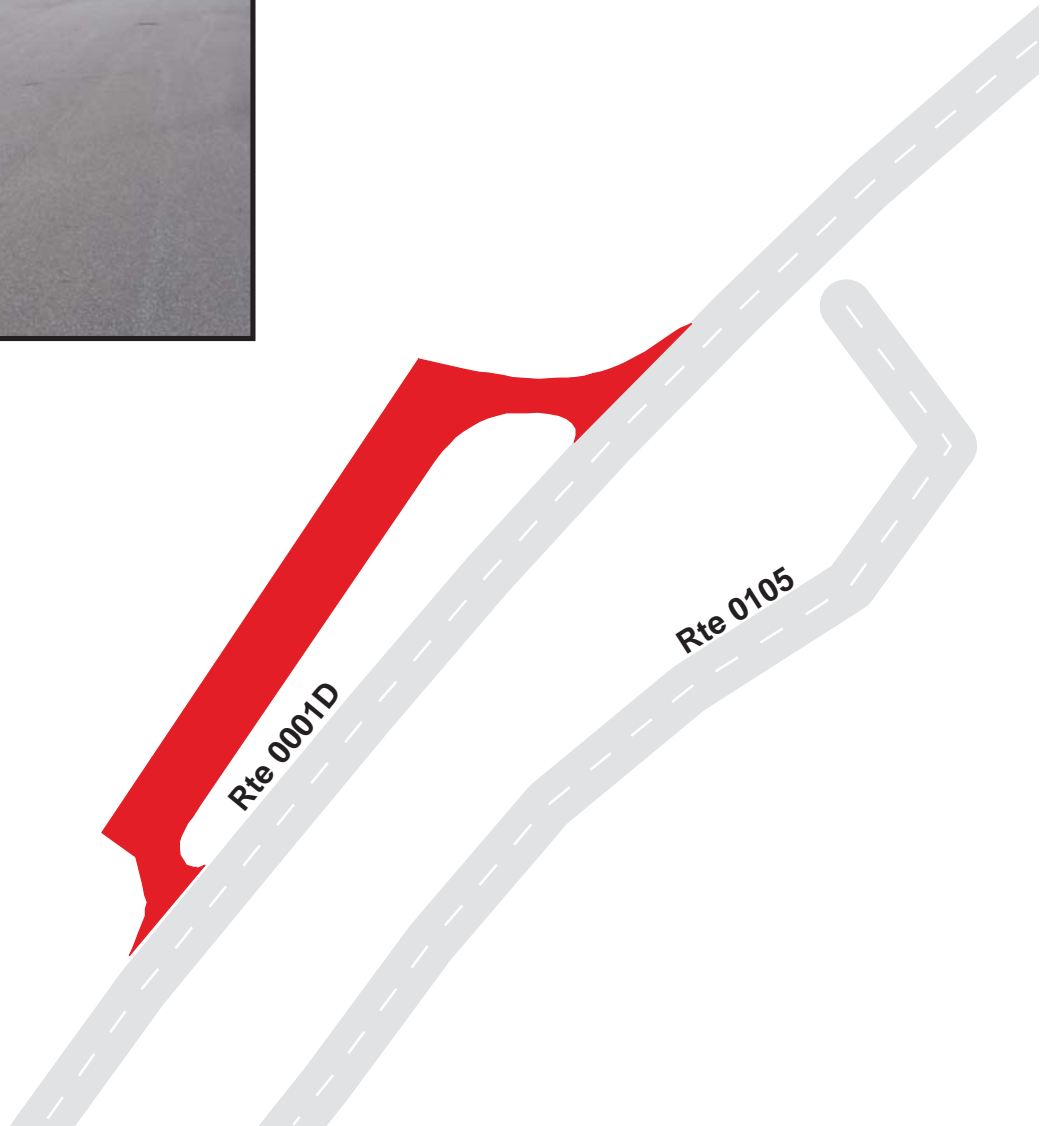
Route 1112

Route	Public / NonPublic	Date Visited	Area (sq ft)	Lane Miles *	Surface Type	Condition / PCR
1112	Public	8/30/2003	16438	0.28	AS	GOOD / 90

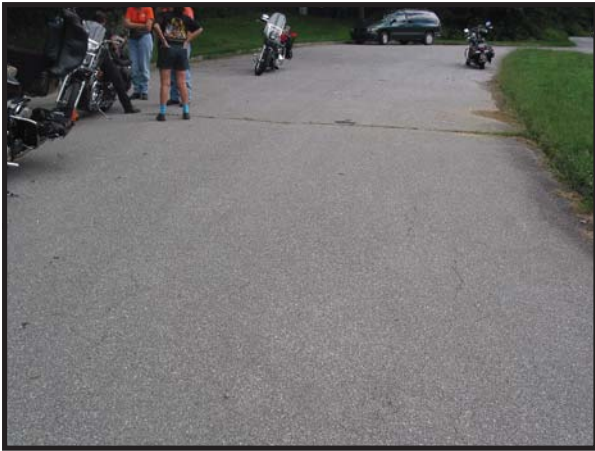
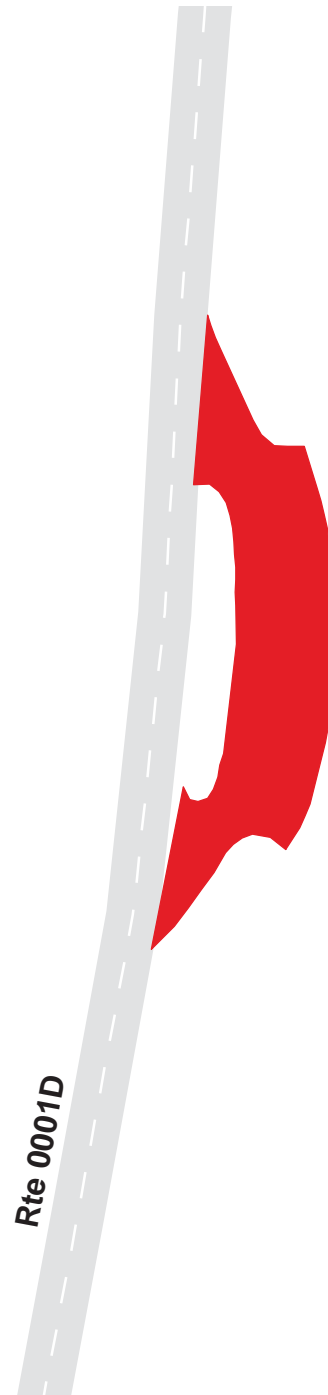
Route 1113

Route	Public / NonPublic	Date Visited	Area (sq ft)	Lane Miles *	Surface Type	Condition / PCR
1113	Public	8/30/2003	4936	0.08	AS	FAIR / 73

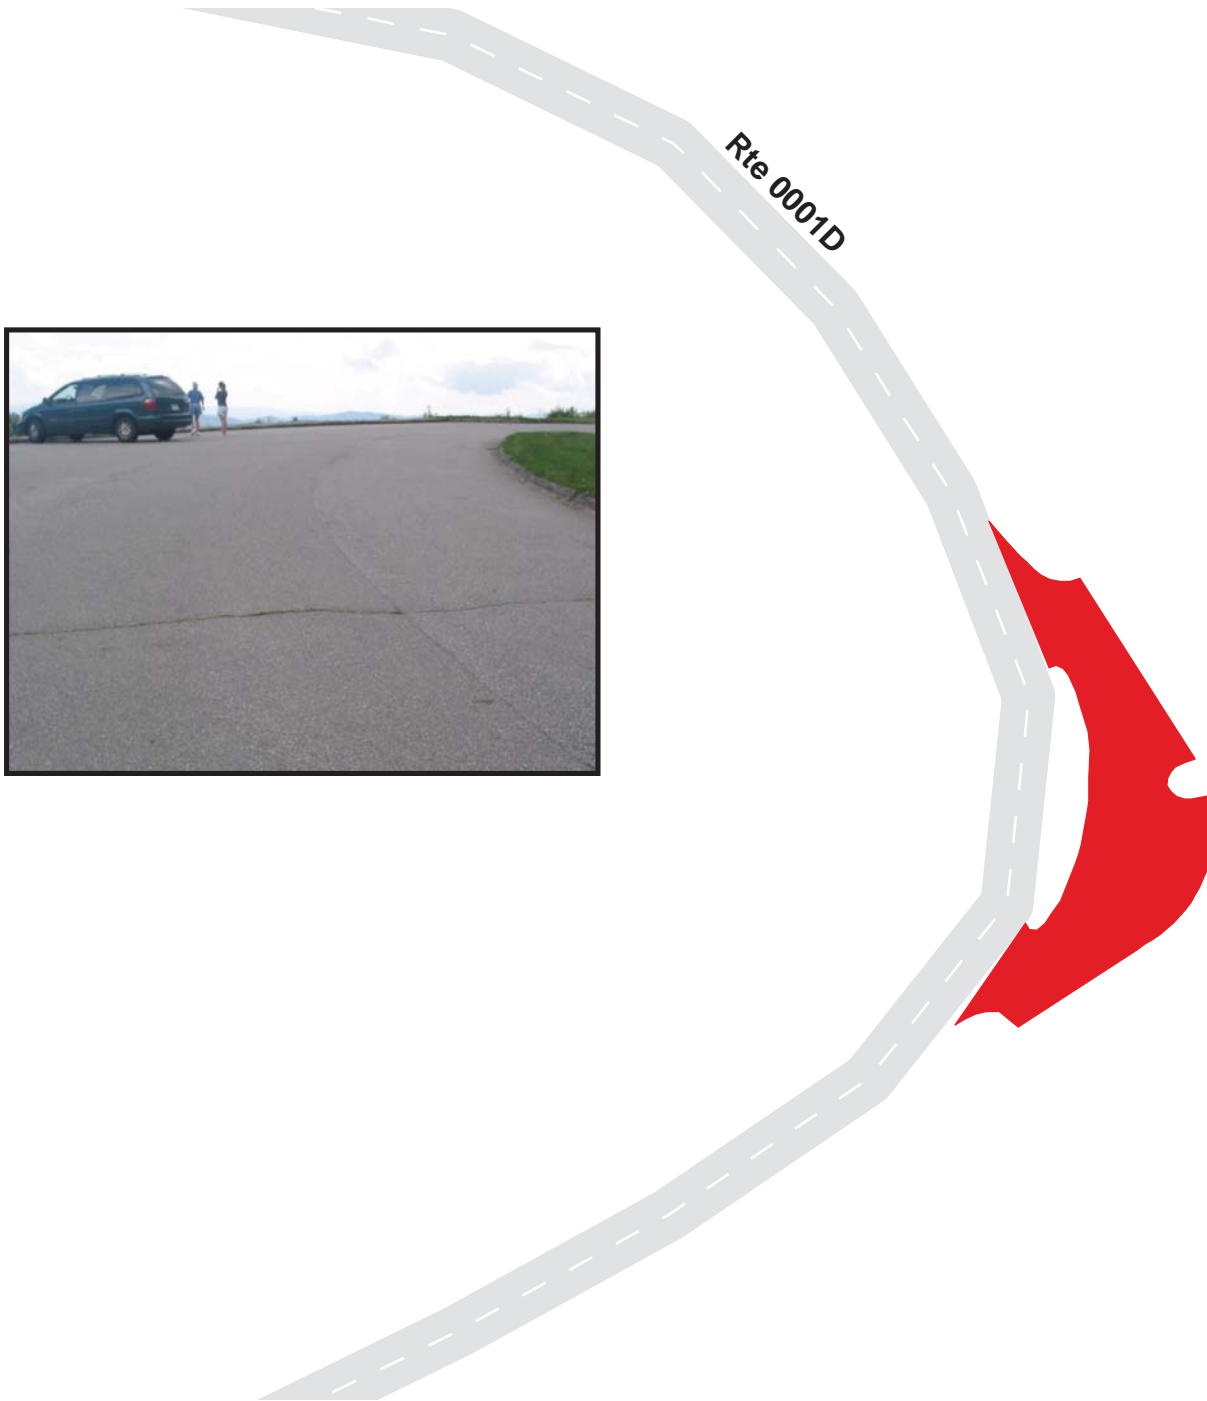
Route 1114

Route	Public / NonPublic	Date Visited	Area (sq ft)	Lane Miles *	Surface Type	Condition / PCR
1114	Public	8/30/2003	9312	0.16	AS	GOOD / 90

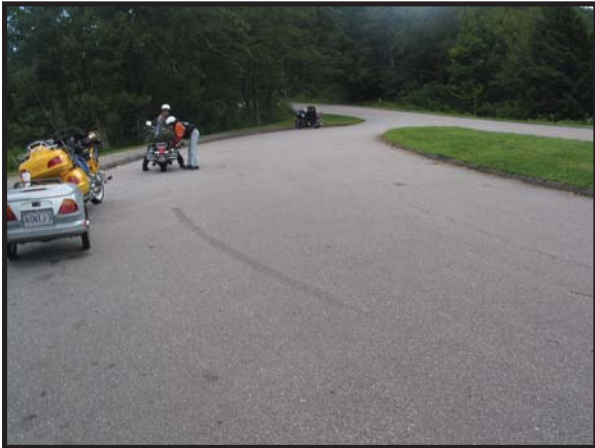
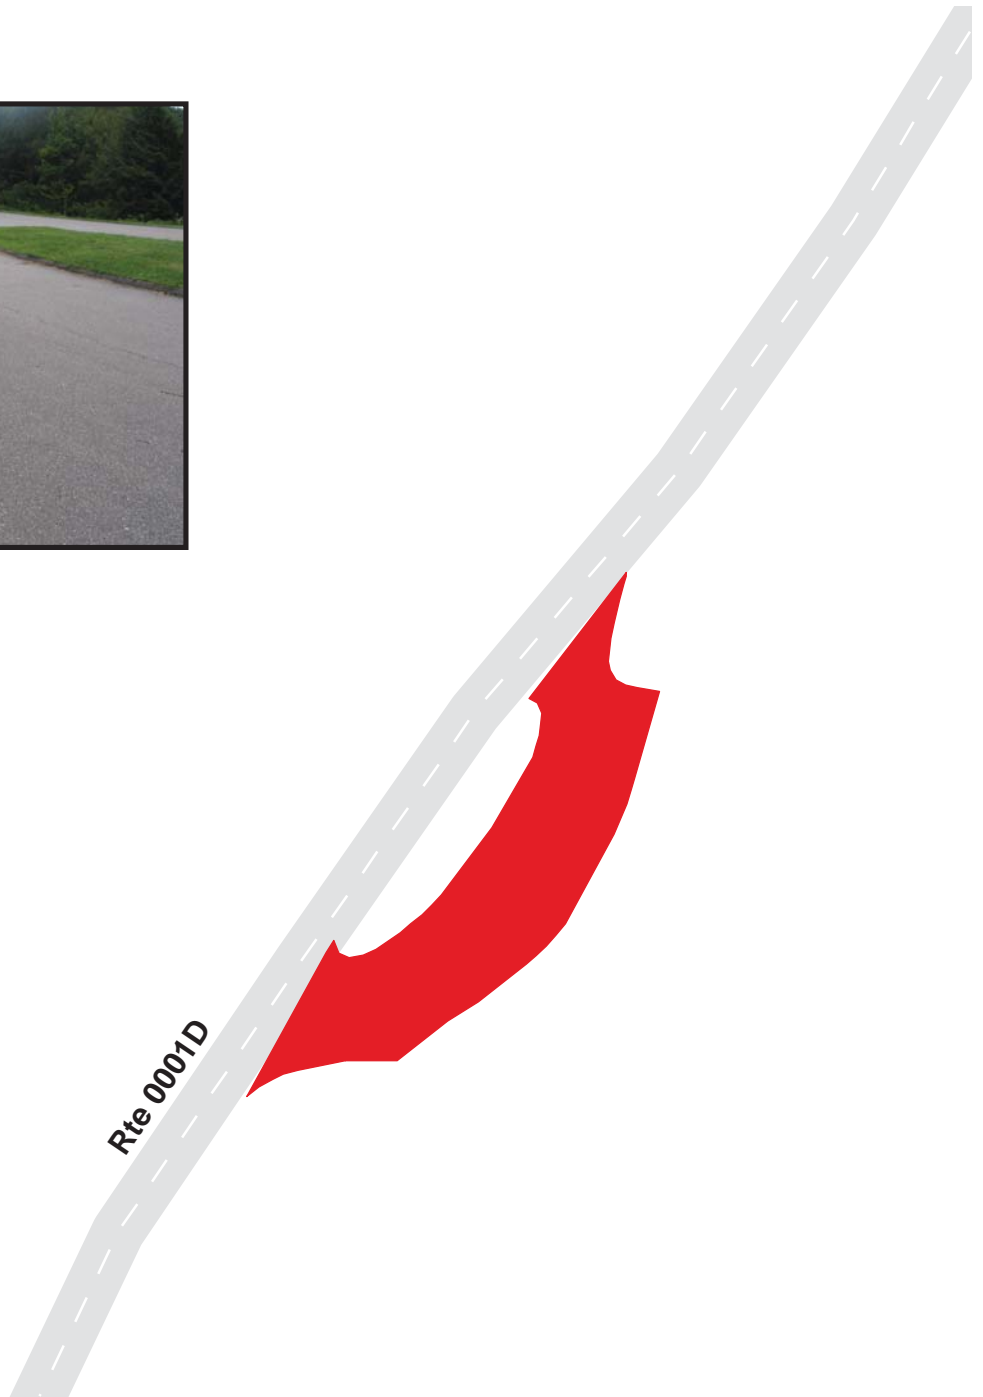
Route 1115

Route	Public / NonPublic	Date Visited	Area (sq ft)	Lane Miles *	Surface Type	Condition / PCR
1115	Public	8/30/2003	6321	0.11	AS	GOOD / 90

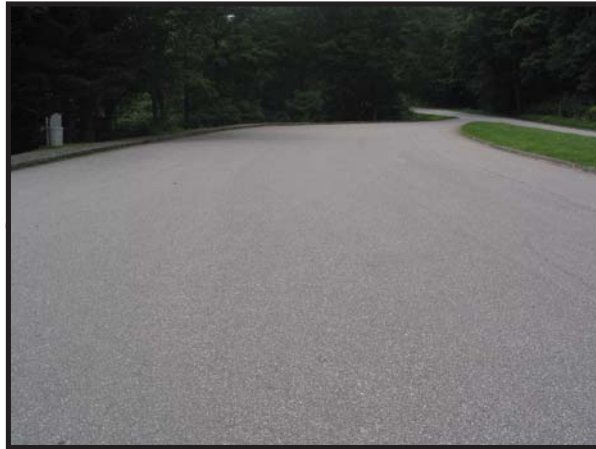
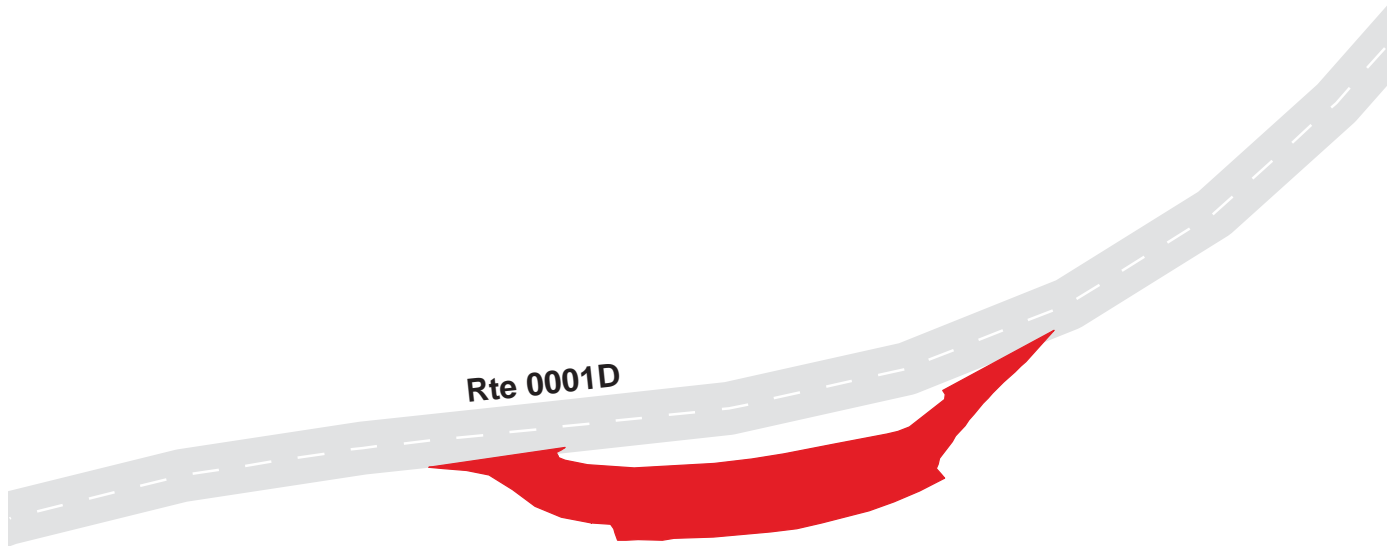
Route 1116

Route	Public / NonPublic	Date Visited	Area (sq ft)	Lane Miles *	Surface Type	Condition / PCR
1116	Public	8/30/2003	13882	0.24	AS	GOOD / 90

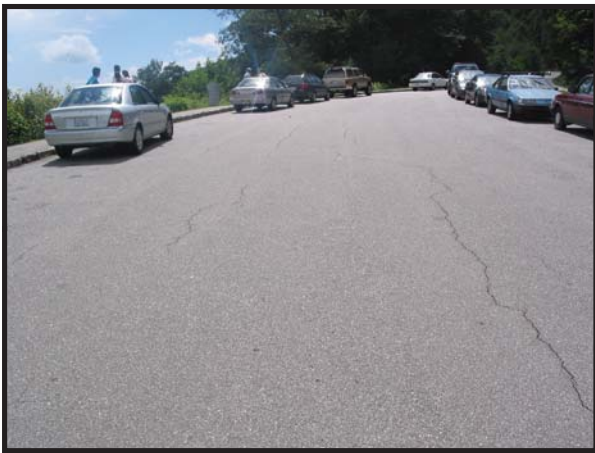
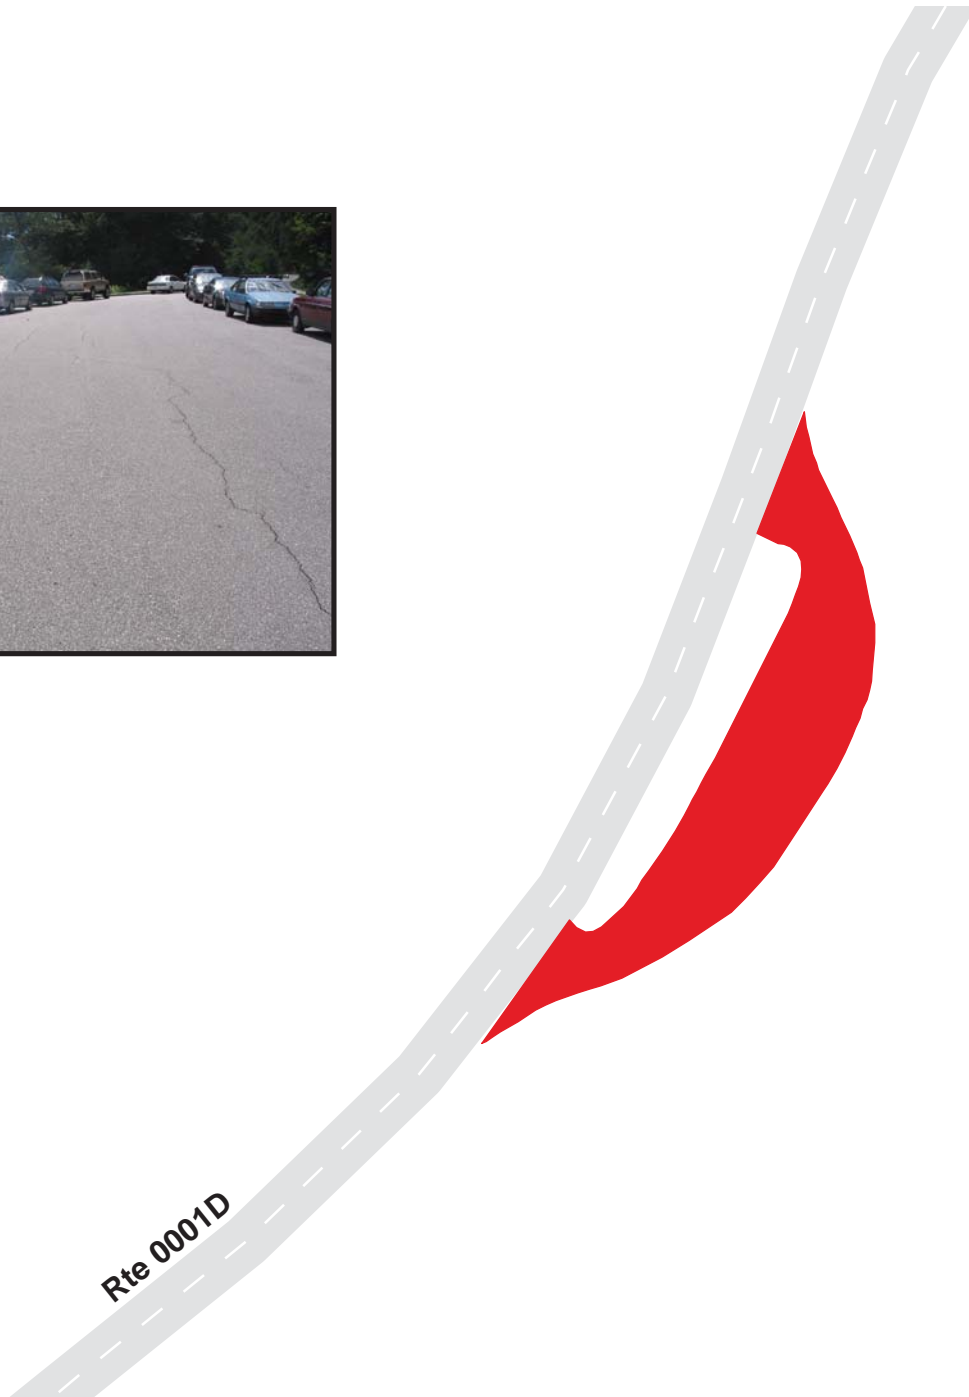
Route 1117

Route	Public / NonPublic	Date Visited	Area (sq ft)	Lane Miles *	Surface Type	Condition / PCR
1117	Public	8/30/2003	10709	0.18	AS	FAIR / 73

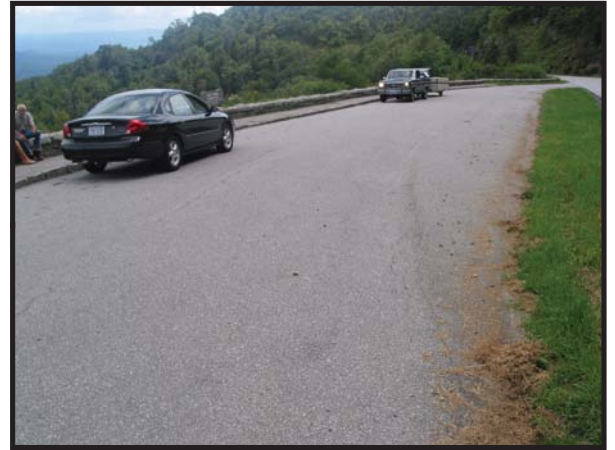
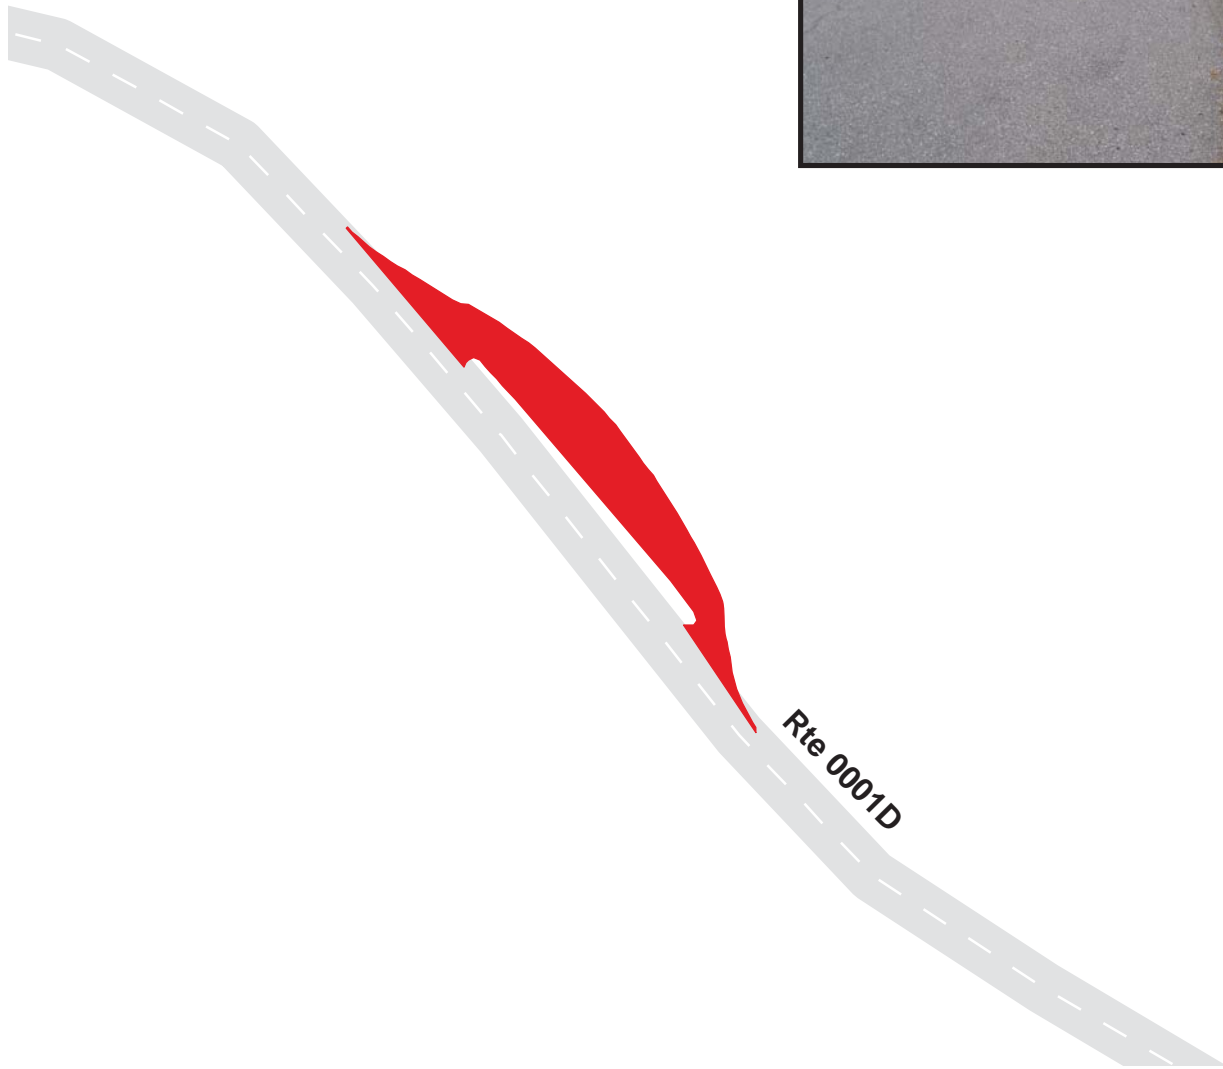
Route 1118

Route	Public / NonPublic	Date Visited	Area (sq ft)	Lane Miles *	Surface Type	Condition / PCR
1118	Public	8/30/2003	6763	0.12	AS	FAIR / 73

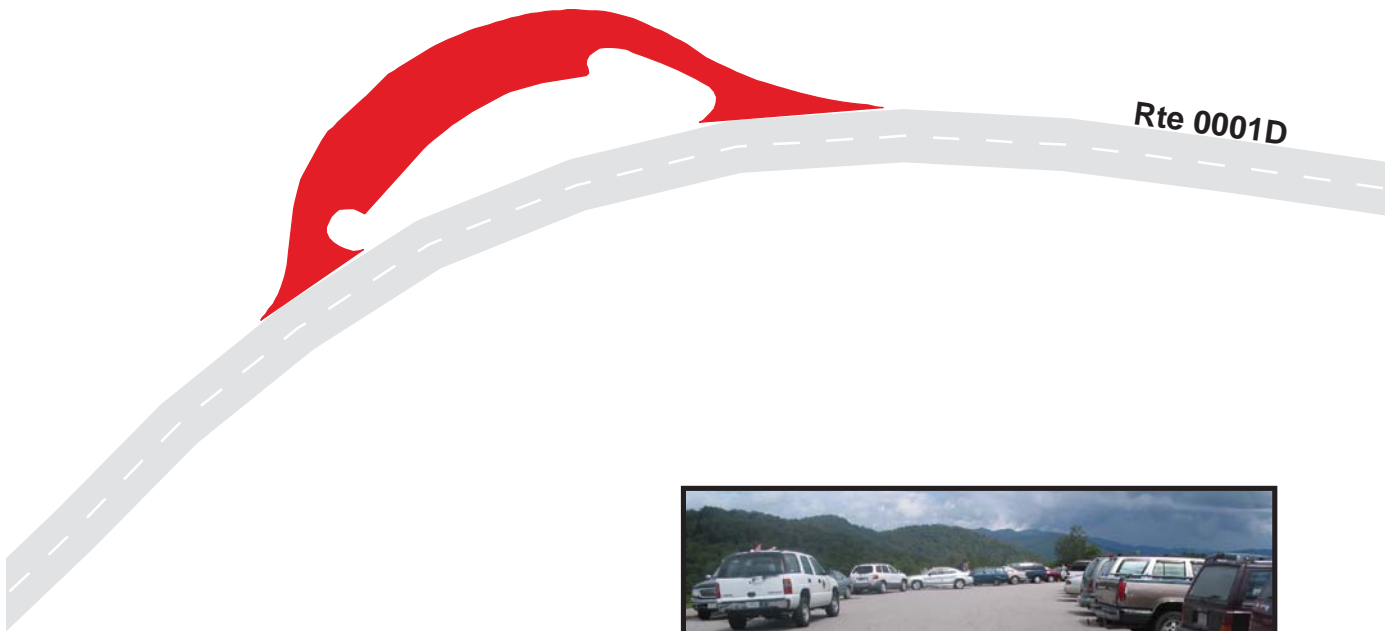
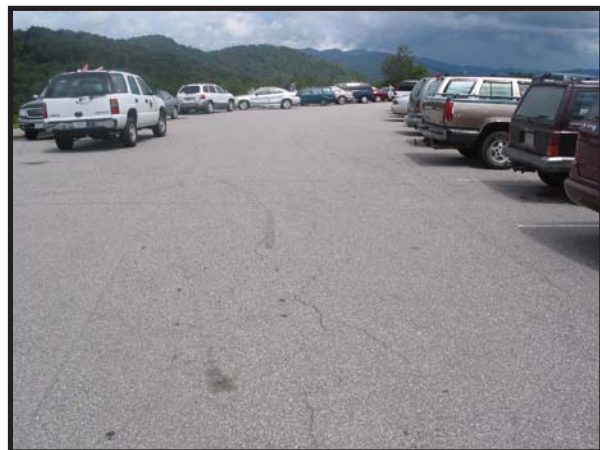
Route 1119

Route	Public / NonPublic	Date Visited	Area (sq ft)	Lane Miles *	Surface Type	Condition / PCR
1119	Public	8/30/2003	17492	0.30	AS	FAIR / 73

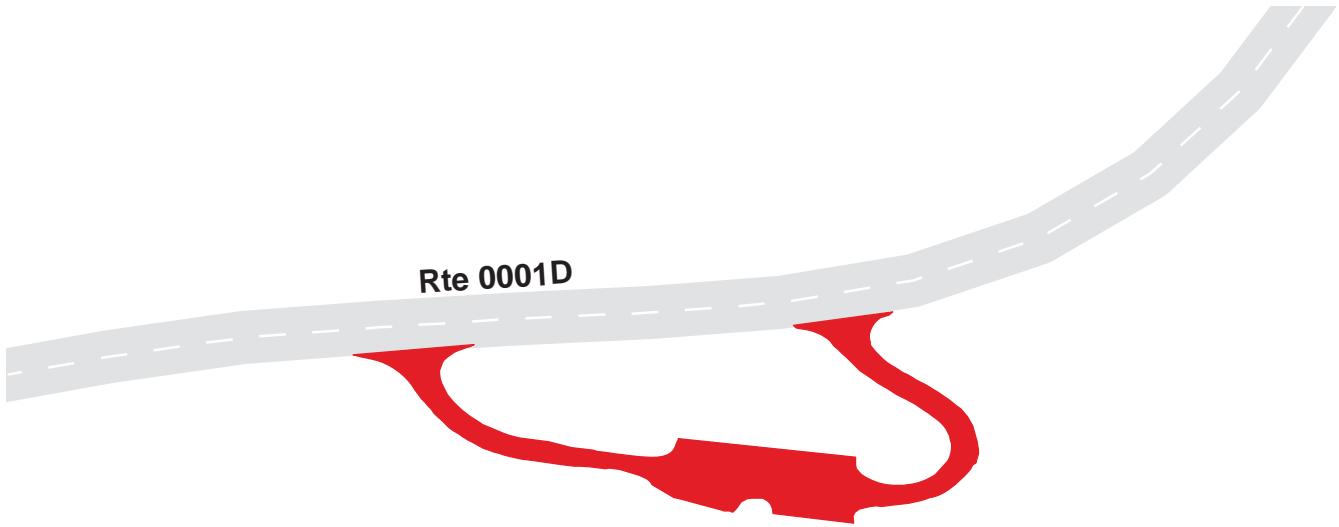
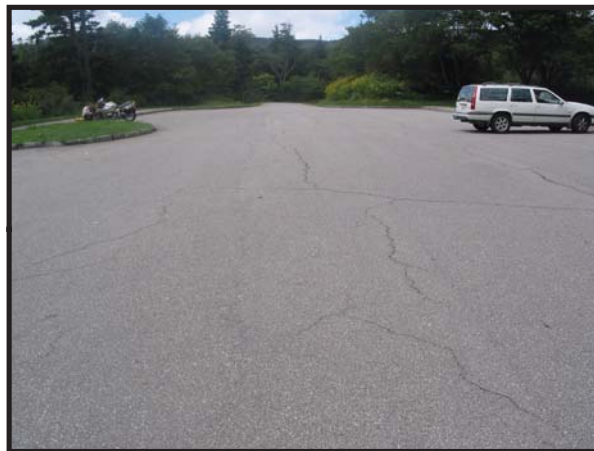
Route 1120

Route	Public / NonPublic	Date Visited	Area (sq ft)	Lane Miles *	Surface Type	Condition / PCR
1120	Public	8/30/2003	20179	0.35	AS	FAIR / 73

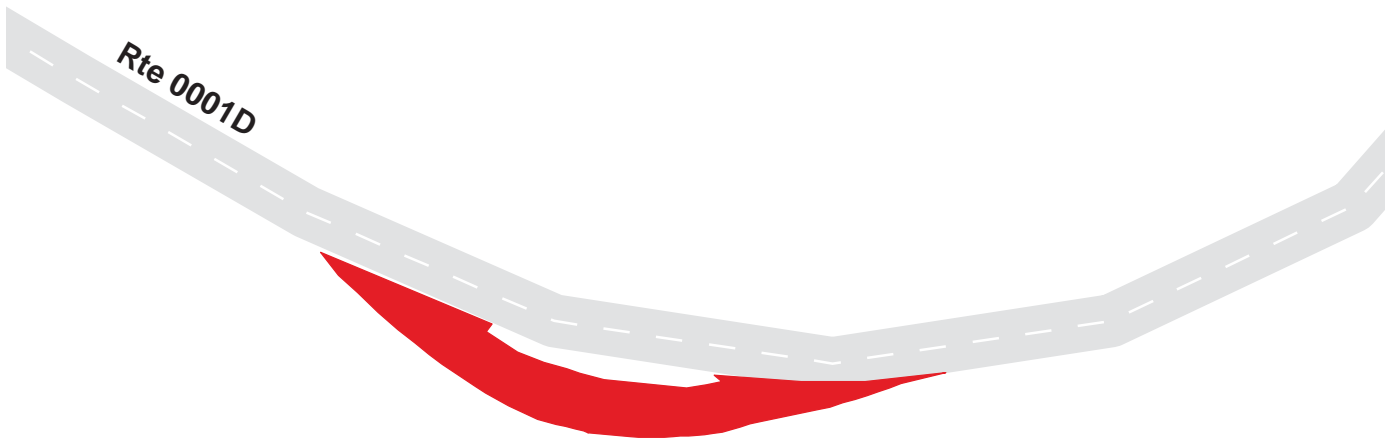
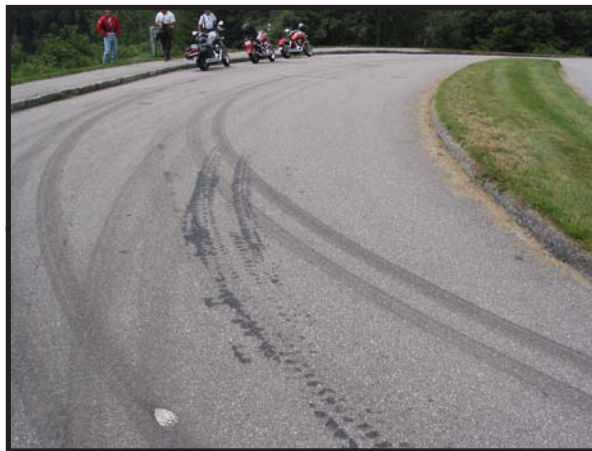
Route 1121

Route	Public / NonPublic	Date Visited	Area (sq ft)	Lane Miles *	Surface Type	Condition / PCR
1121	Public	8/30/2003	4432	0.08	AS	GOOD / 90

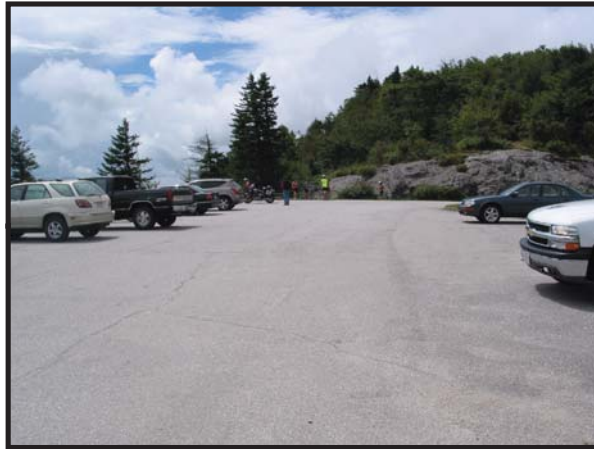
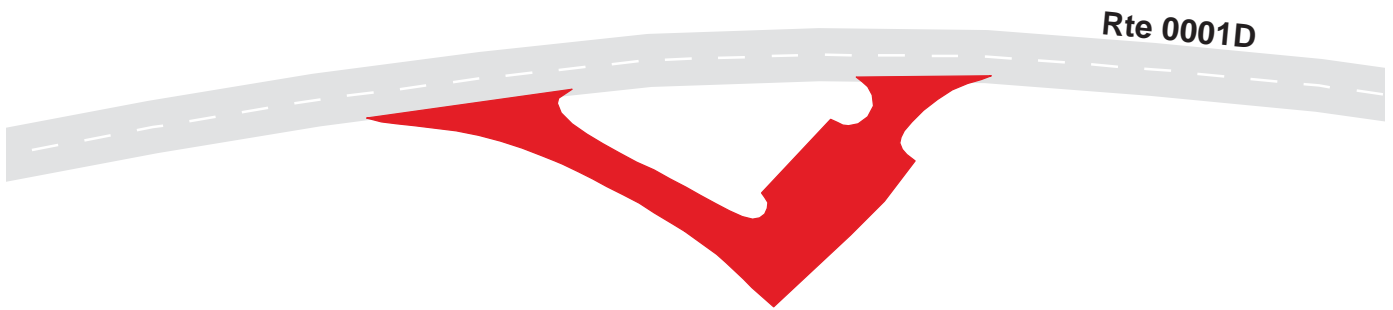
Route 1122

Route	Public / NonPublic	Date Visited	Area (sq ft)	Lane Miles *	Surface Type	Condition / PCR
1122	Public	8/30/2003	16771	0.29	AS	FAIR / 73

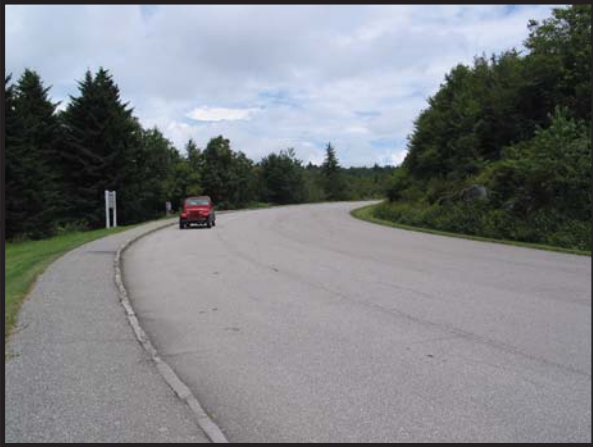
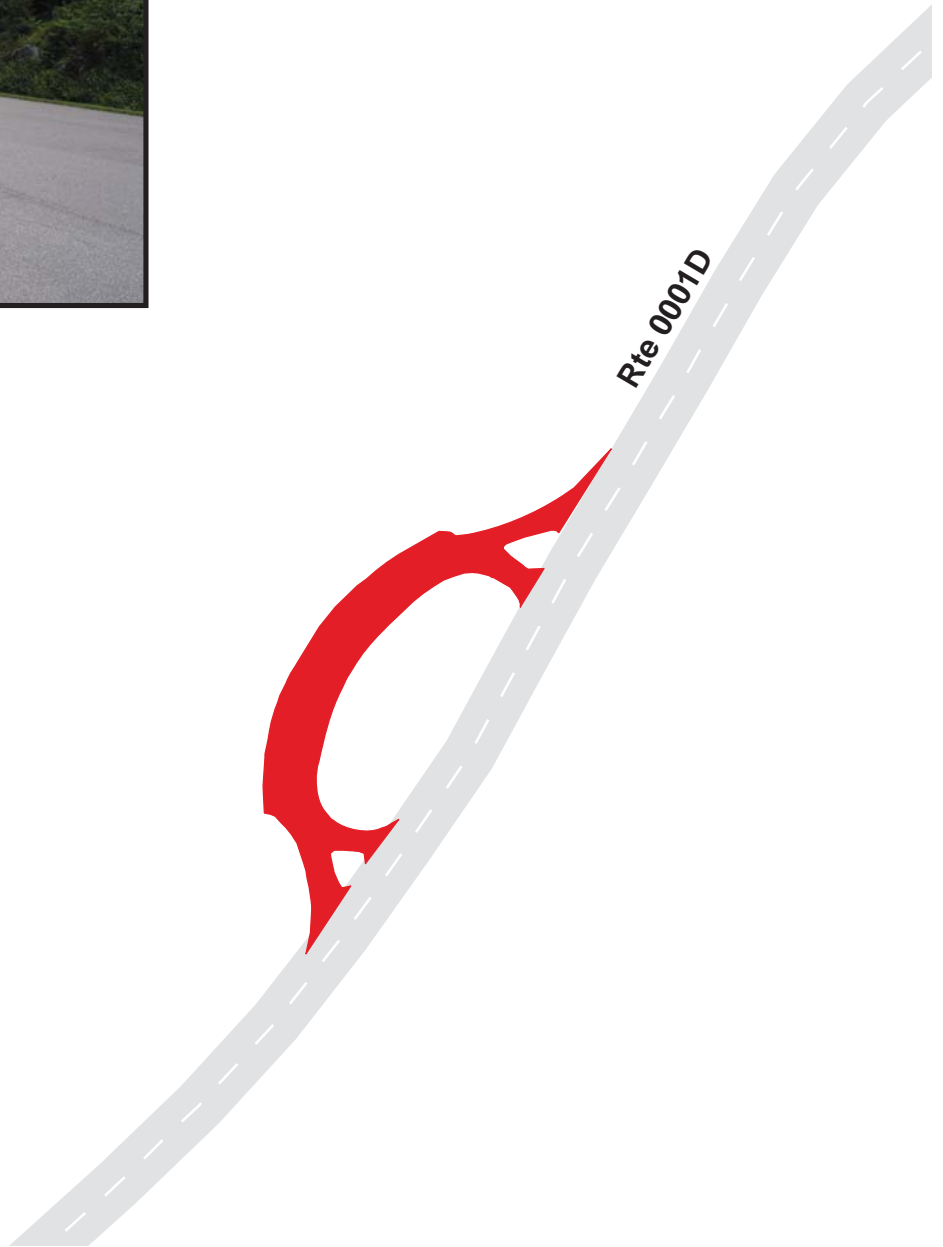
Blue Ridge Parkway
Route 1123
 Mount Hardy
 From Route 0001D at MP 422.20 on Right

Route	Public / NonPublic	Date Visited	Area (sq ft)	Lane Miles *	Surface Type	Condition / PCR
1123	Public	8/30/2003	23257	0.40	AS	FAIR / 73

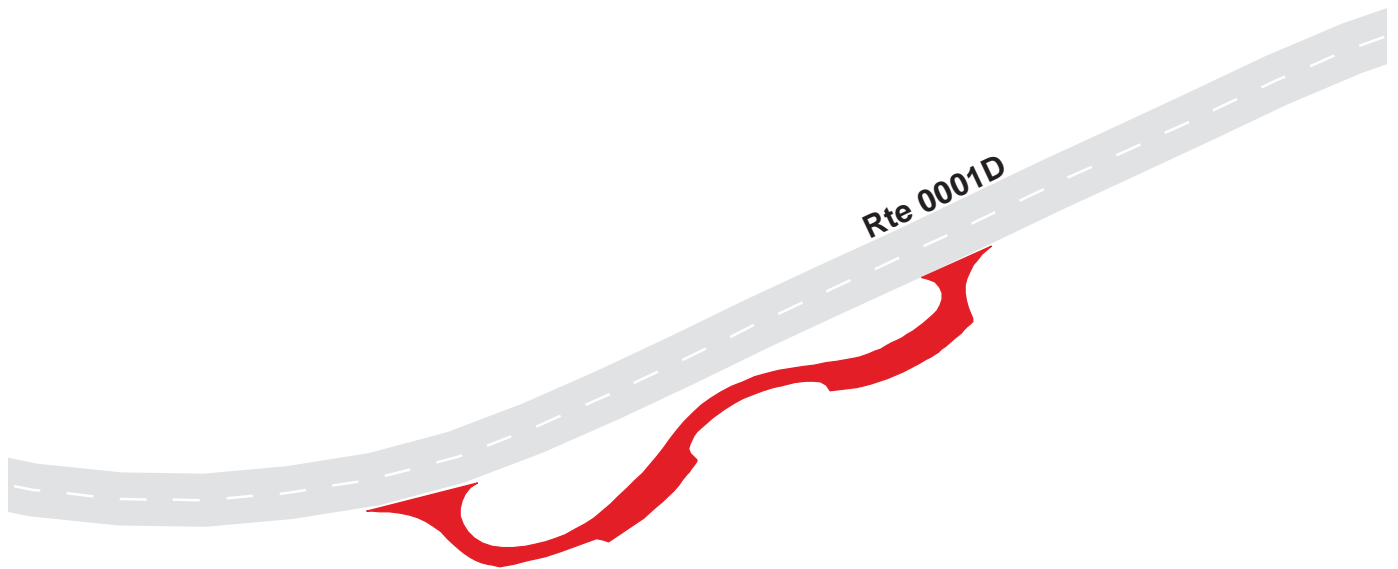
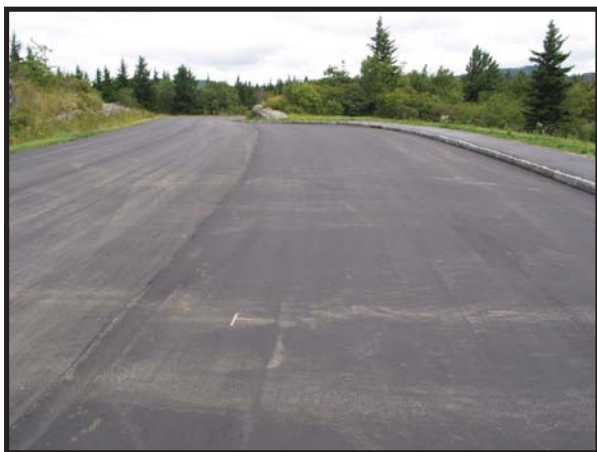
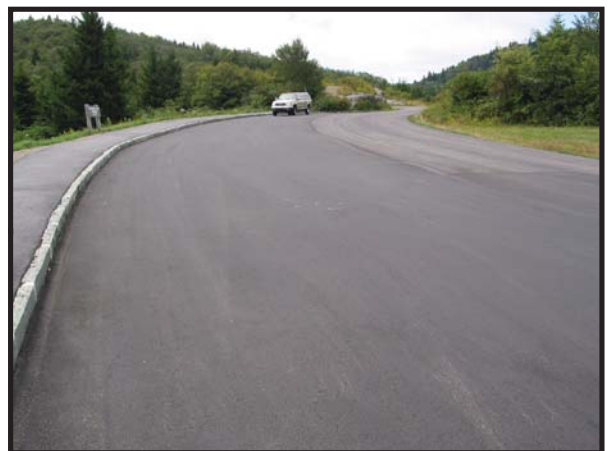
Route 1124

Route	Public / NonPublic	Date Visited	Area (sq ft)	Lane Miles *	Surface Type	Condition / PCR
1124	Public	8/30/2003	32753	0.56	AS	EXCELLENT / 97

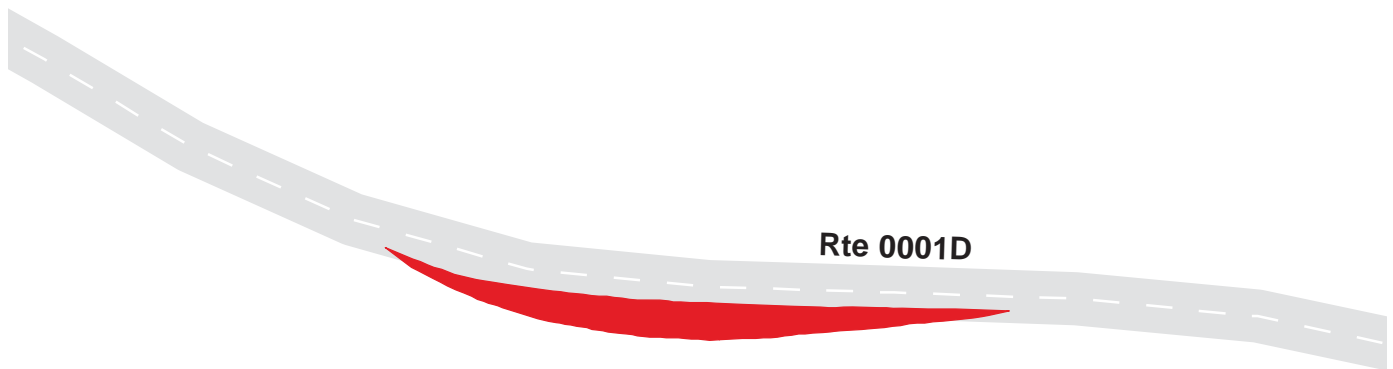
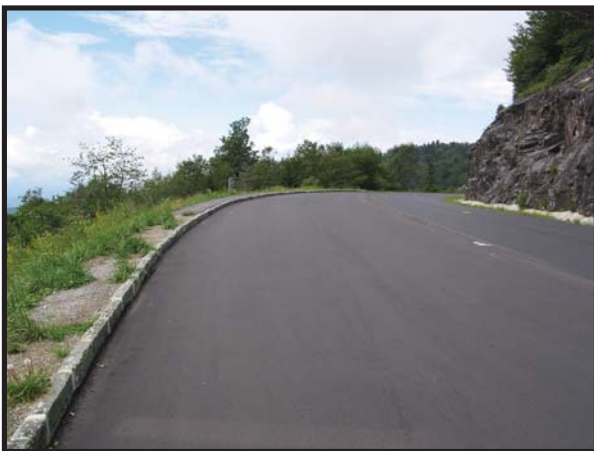
Route 1125

Route	Public / NonPublic	Date Visited	Area (sq ft)	Lane Miles *	Surface Type	Condition / PCR
1125	Public	8/30/2003	5991	0.10	AS	EXCELLENT / 97
