The Road Inventory of Blue Ridge Parkway BLRI – 5140 Volume 1

Road Inventory Program

Prepared By:
Federal Highway Administration
Eastern Federal Lands Highway Division
Cycle 3

Blue Ridge Parkway in North Carolina

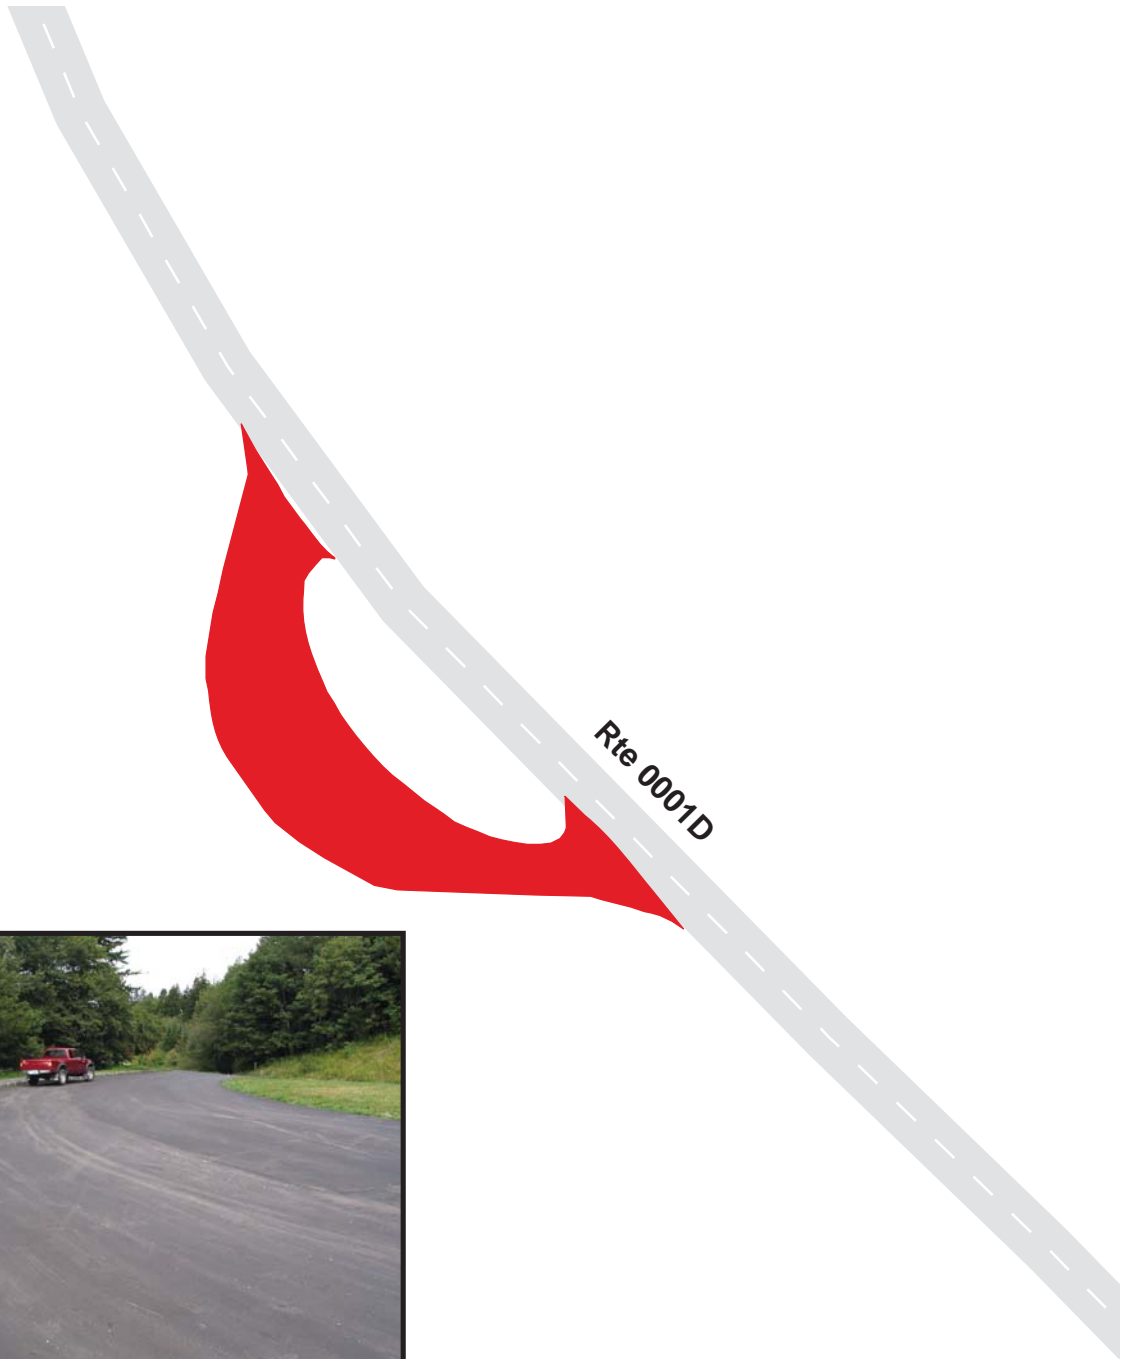
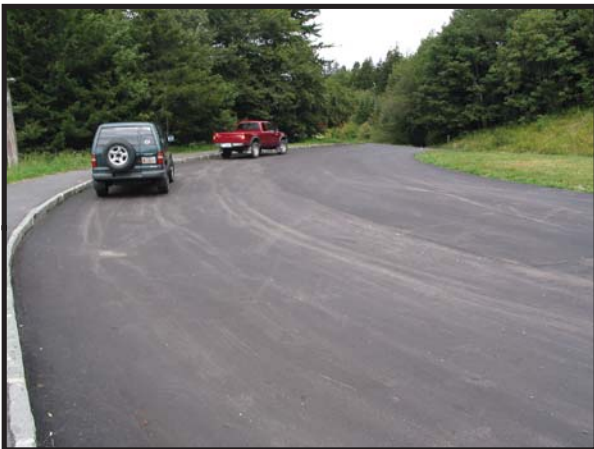
Blue Ridge Parkway Route 1128

Bear Pen Gap Parking Area
From Route 0001D at MP 427.04 on Left

Route	Public / NonPublic	Date Visited	Area (sq ft)	Lane Miles *	Surface Type	Condition / PCR
1128	Public	8/30/2003	6646	0.11	AS	EXCELLENT / 97

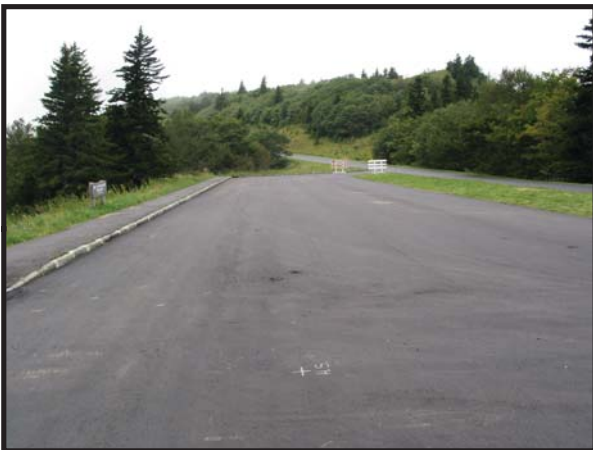
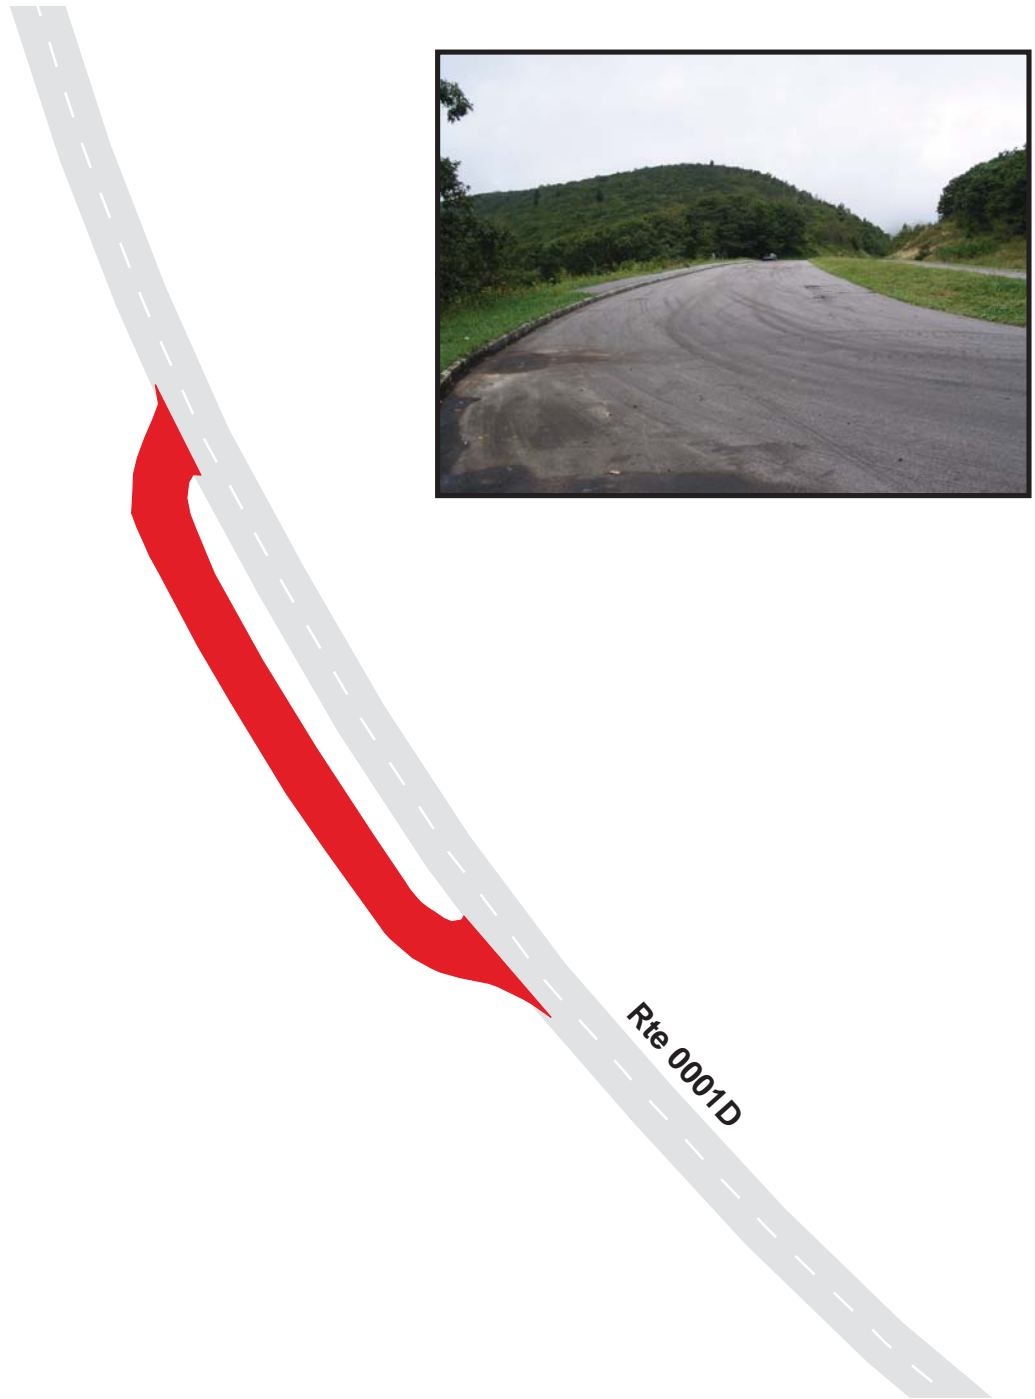
Blue Ridge Parkway Route 1138

Doubletop Mountain
From Route 0001D at MP 434.58 on Left

Route	Public / NonPublic	Date Visited	Area (sq ft)	Lane Miles *	Surface Type	Condition / PCR
1138	Public	8/30/2003	13364	0.23	AS	GOOD / 90

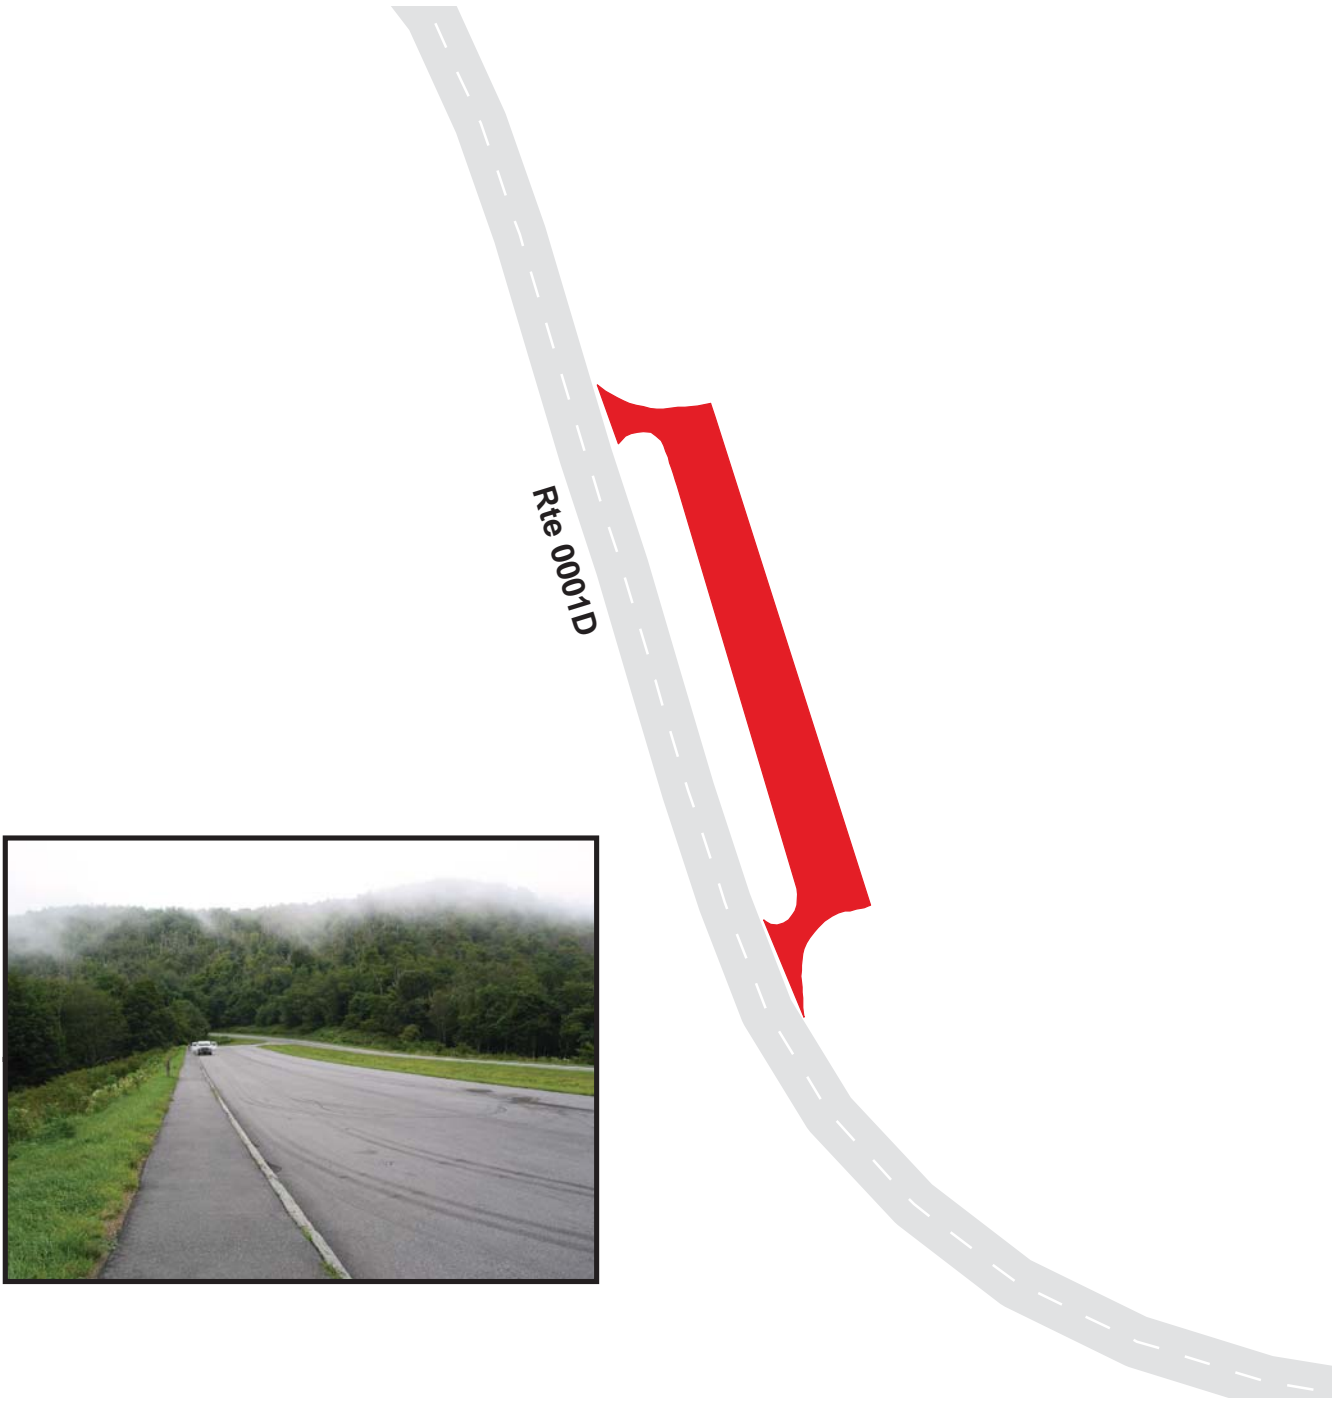
Blue Ridge Parkway Route 1139

Licklog Gap Overlook
From Route 0001D at MP 435.22 on Right

Route	Public / NonPublic	Date Visited	Area (sq ft)	Lane Miles *	Surface Type	Condition / PCR
1139	Public	8/30/2003	25032	0.43	AS	GOOD / 90

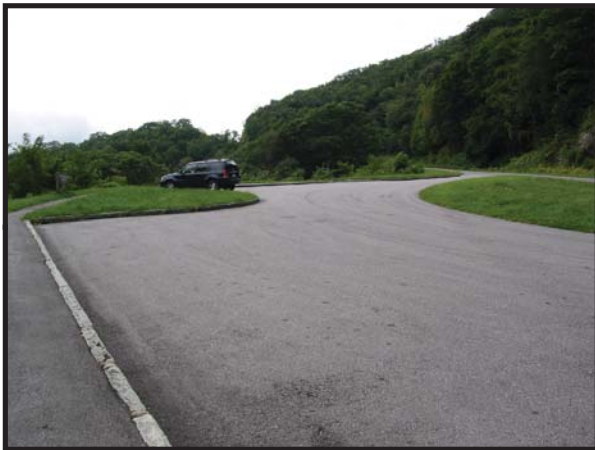
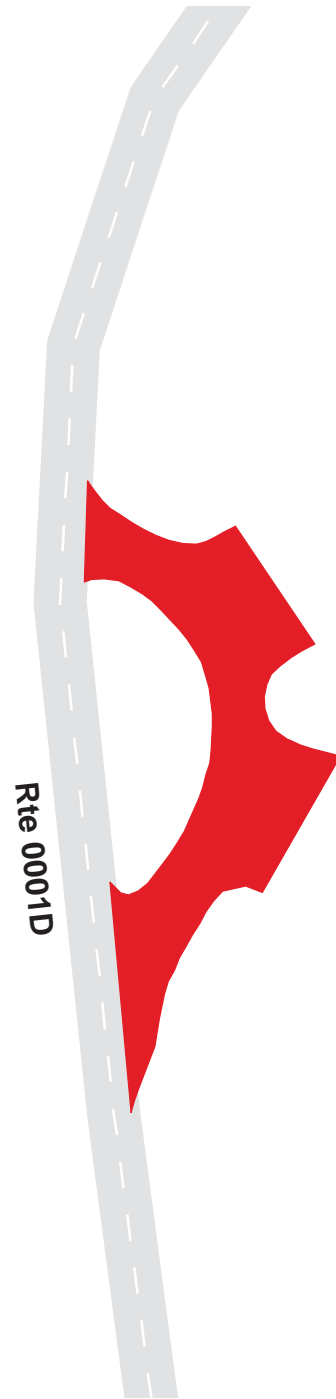
Blue Ridge Parkway Route 1142

Cove Field Ridge Overlook
From Route 0001D at MP 438.78 on Right

Route	Public / NonPublic	Date Visited	Area (sq ft)	Lane Miles *	Surface Type	Condition / PCR
1142	Public	8/30/2003	7187	0.12	AS	GOOD / 90

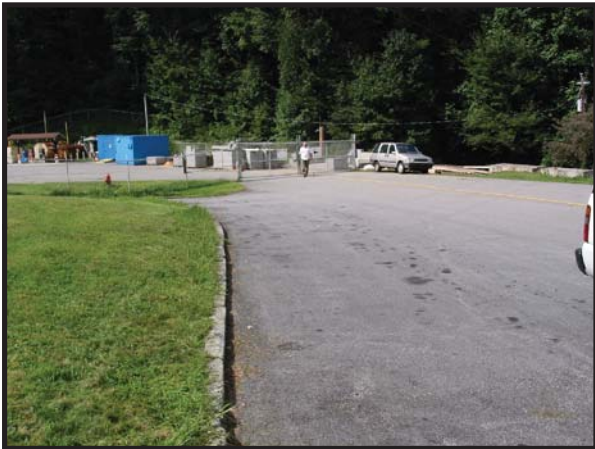
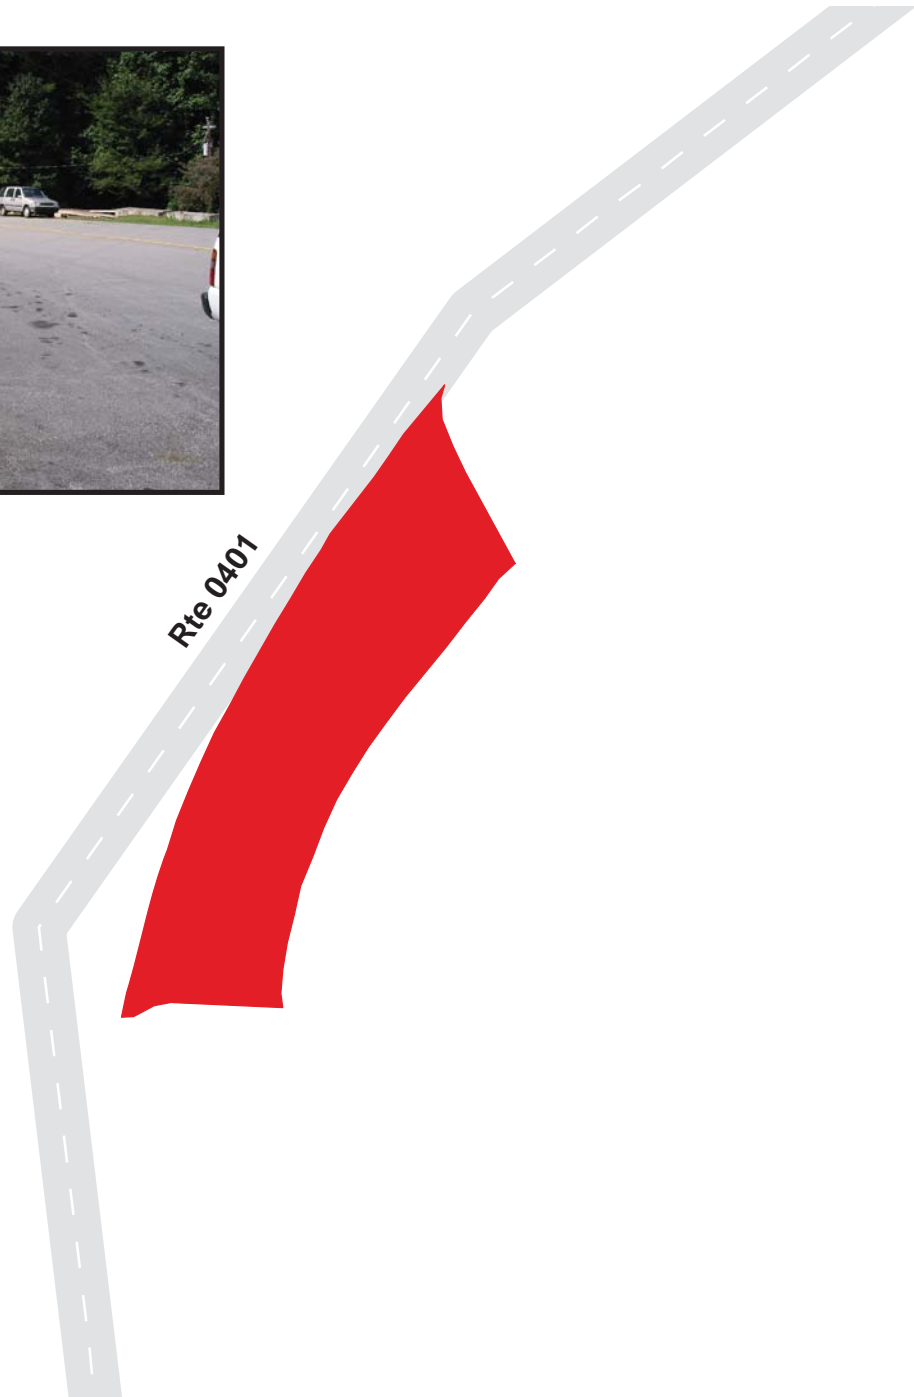
Route 1148A

Route	Public / NonPublic	Date Visited	Area (sq ft)	Lane Miles *	Surface Type	Condition / PCR
1148A	Public	8/30/2003	1724	0.03	AS	GOOD / 90

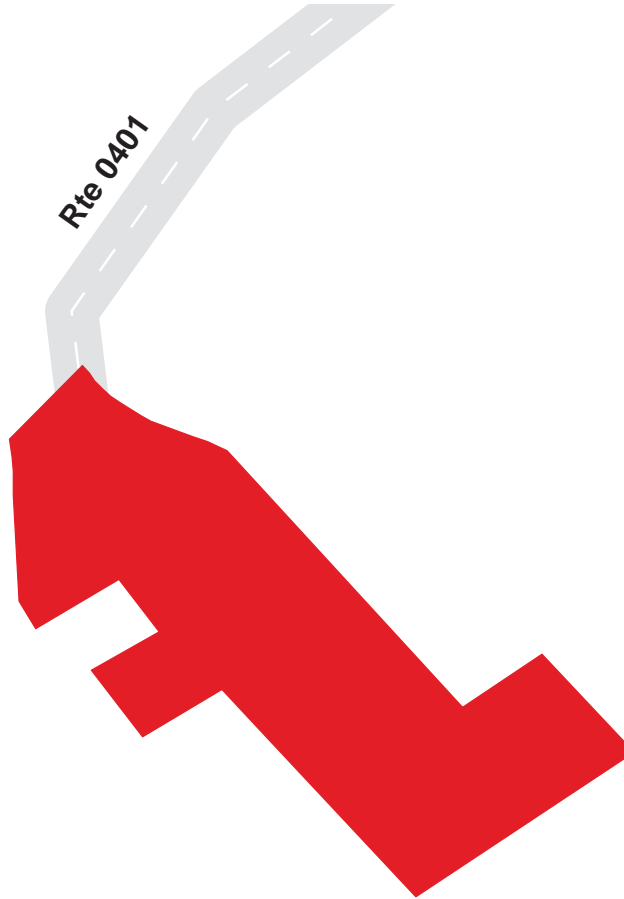
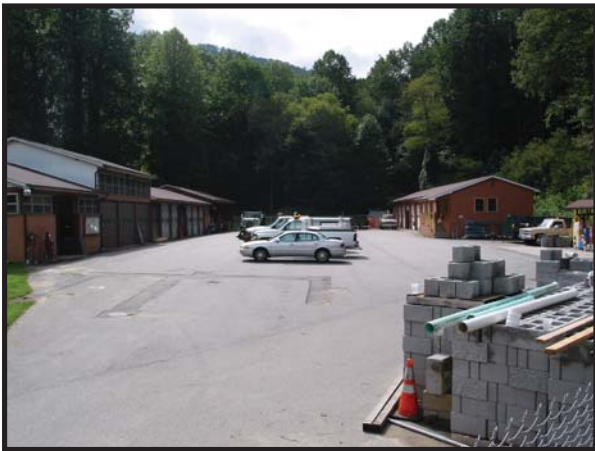
Route 1148B

Route	Public / NonPublic	Date Visited	Area (sq ft)	Lane Miles *	Surface Type	Condition / PCR
1148B	Nonpublic	8/30/2003	22614	0.39	AS	GOOD / 90

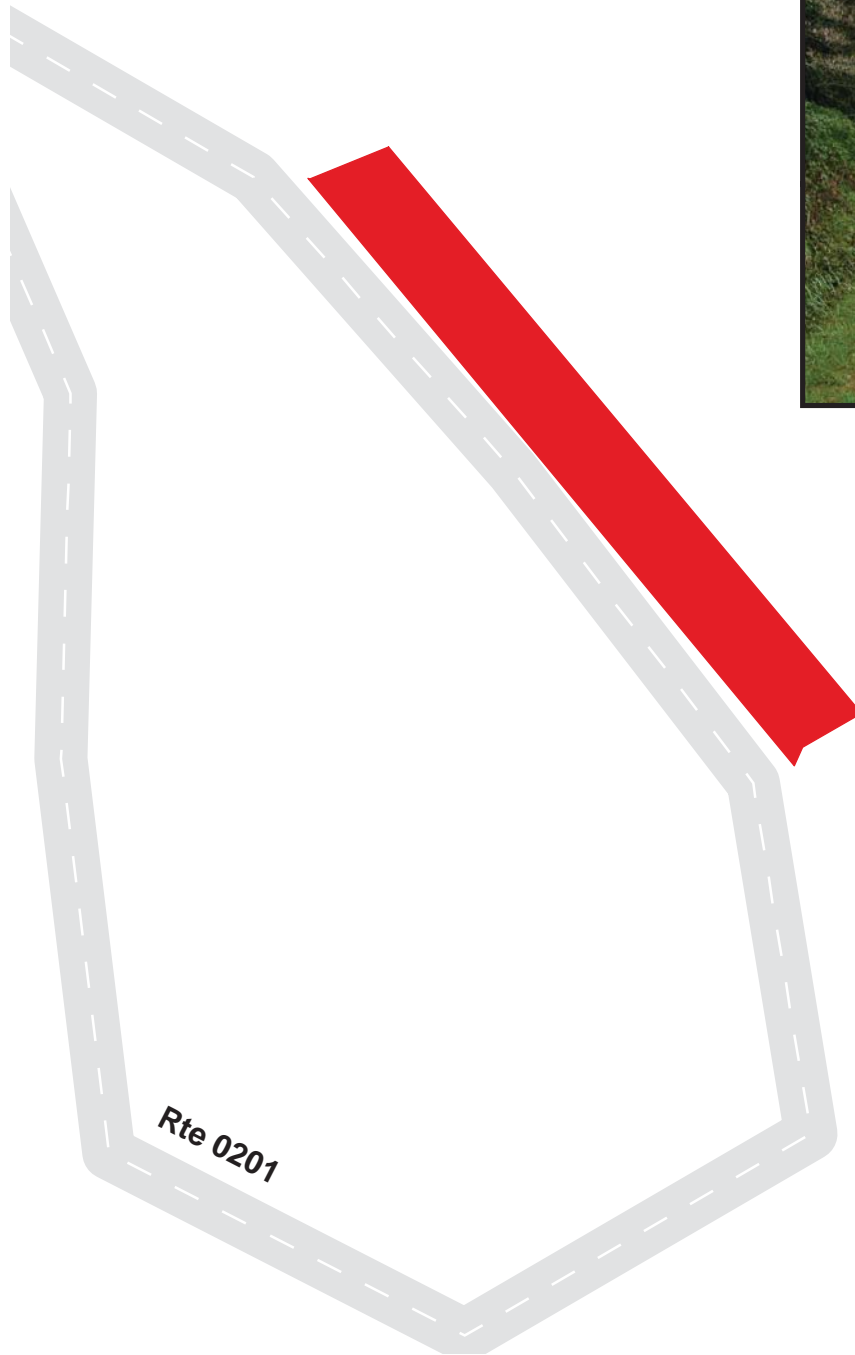
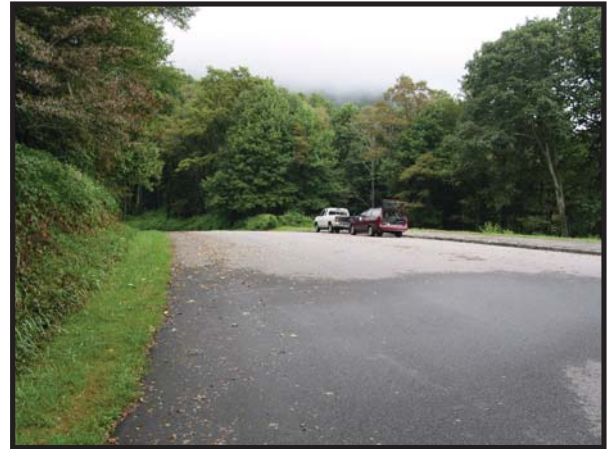
Route 1149

Route	Public / NonPublic	Date Visited	Area (sq ft)	Lane Miles *	Surface Type	Condition / PCR
1149	Public	8/30/2003	4244	0.07	AS	GOOD / 90

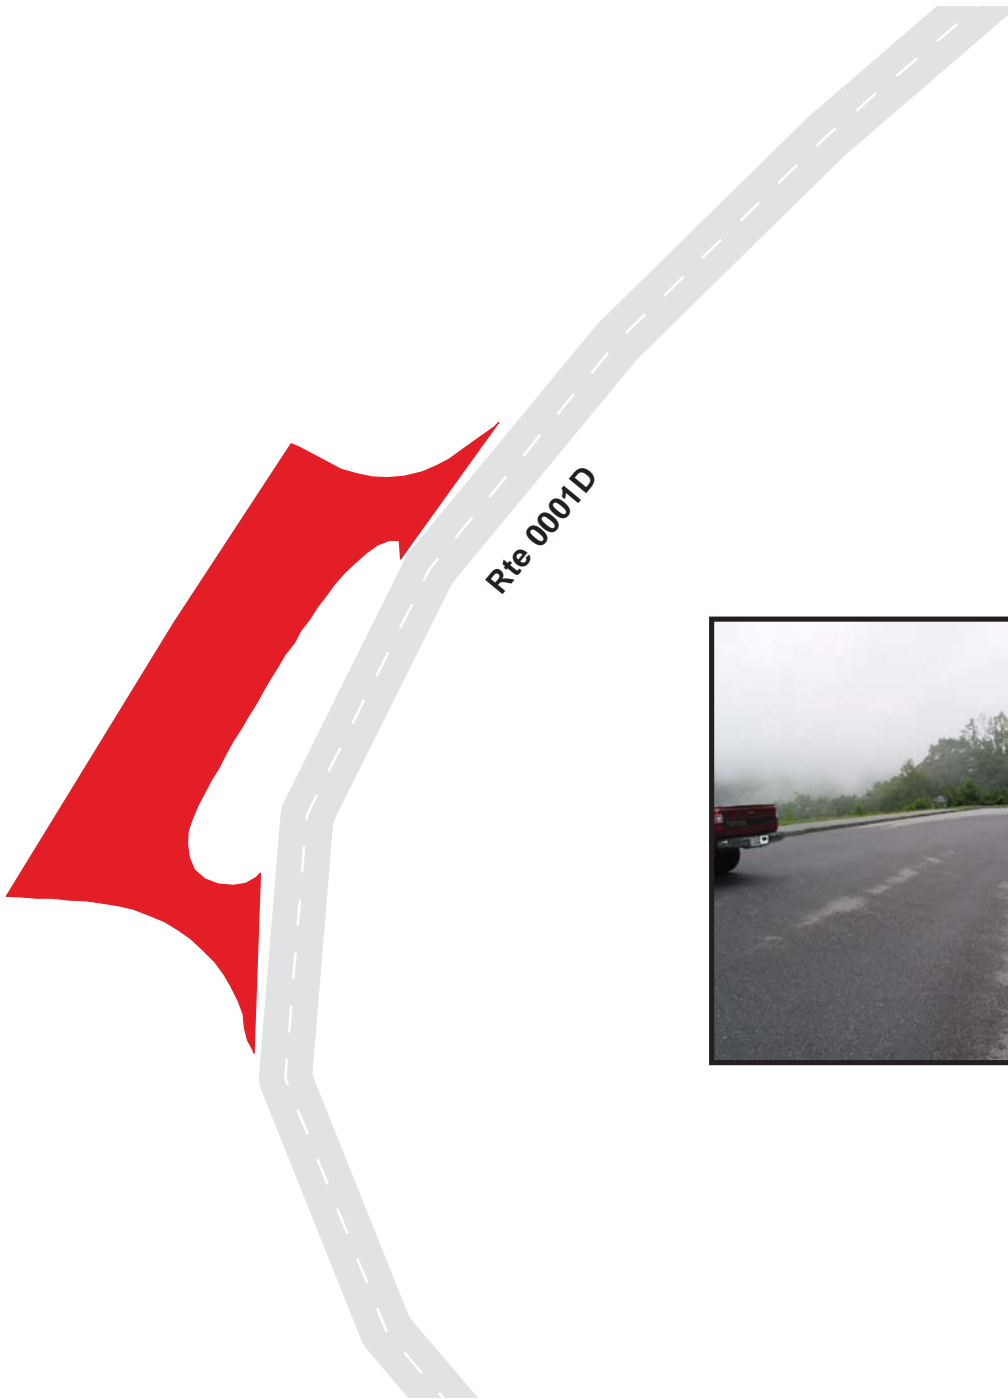
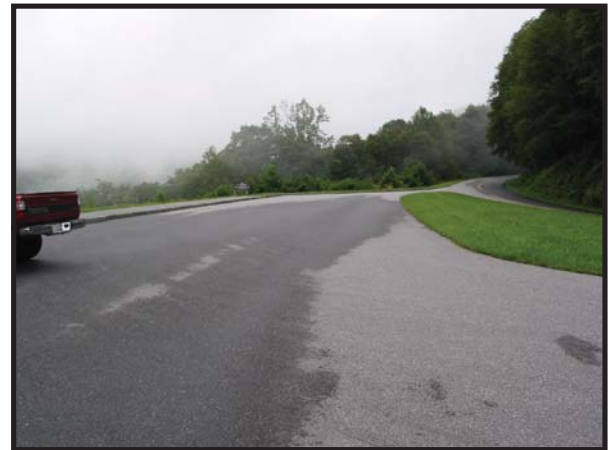
Route 1150

Route	Public / NonPublic	Date Visited	Area (sq ft)	Lane Miles *	Surface Type	Condition / PCR
1150	Public	8/30/2003	8869	0.15	AS	GOOD / 90

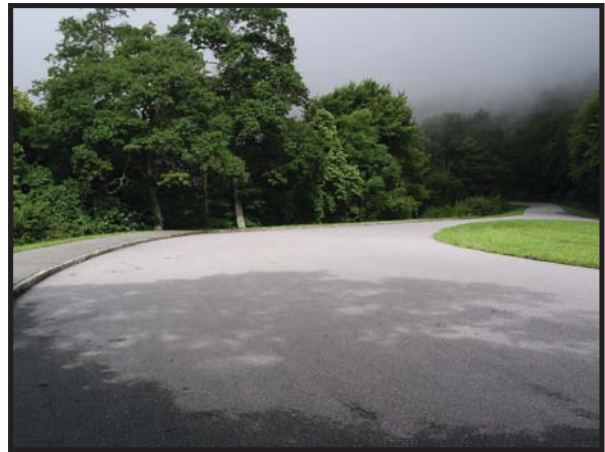
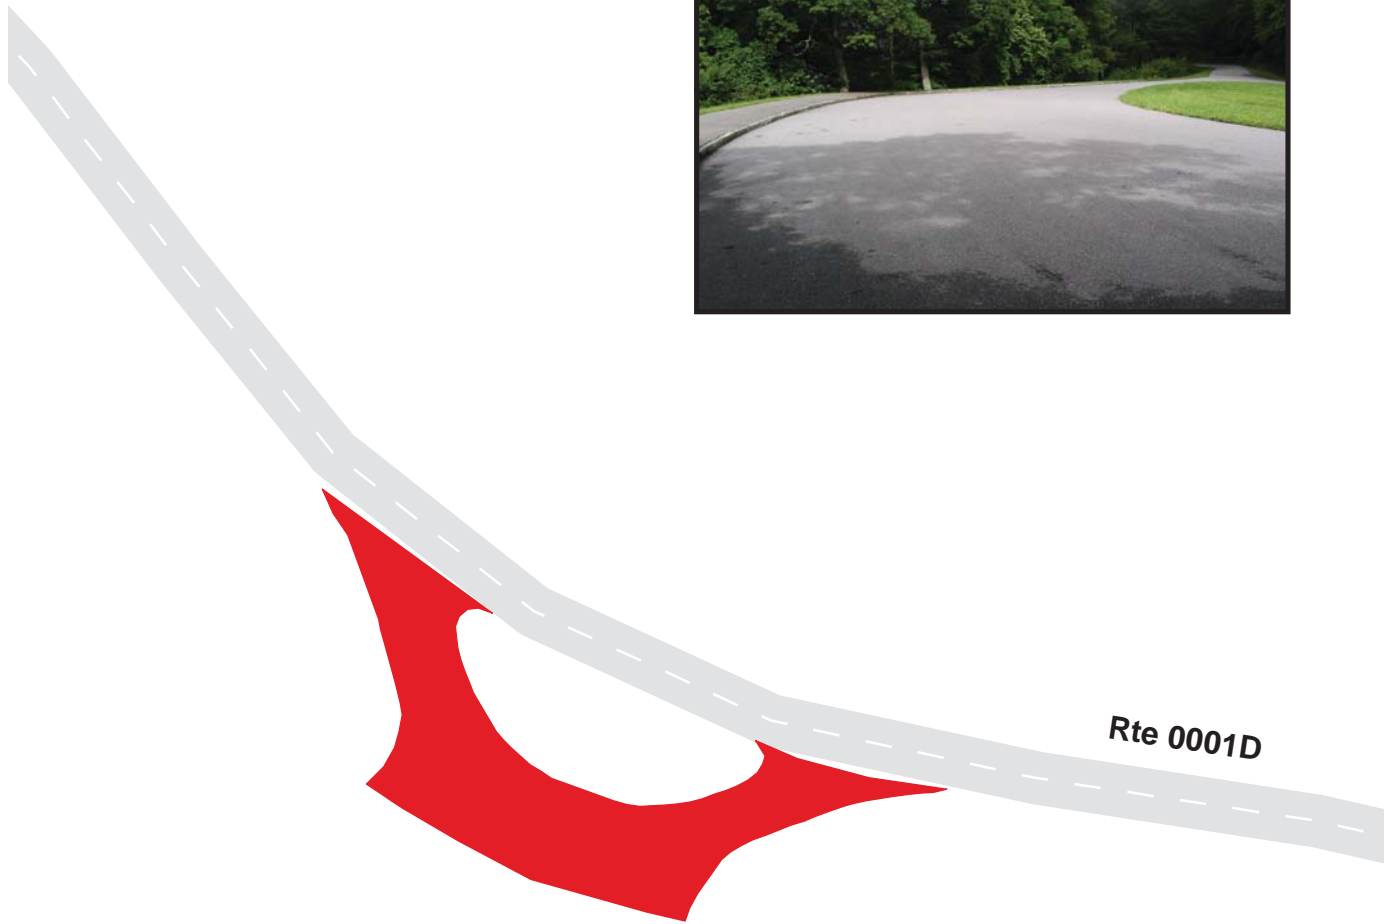
Route 1151

Route	Public / NonPublic	Date Visited	Area (sq ft)	Lane Miles *	Surface Type	Condition / PCR
1151	Public	8/30/2003	10288	0.18	AS	GOOD / 90

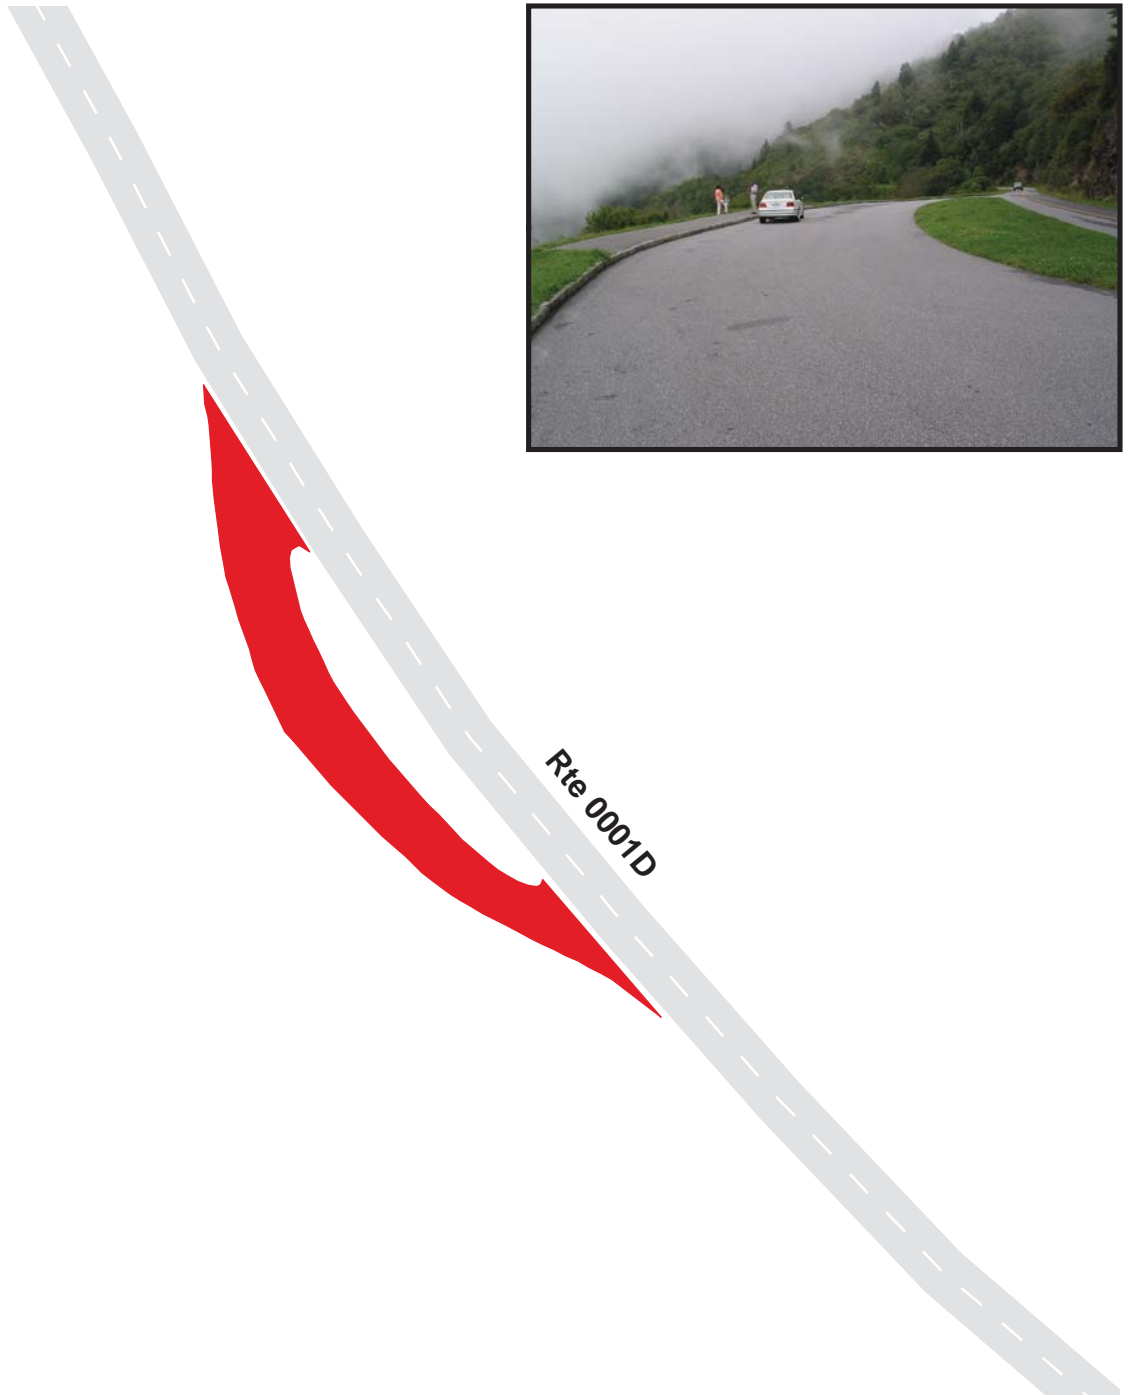
Blue Ridge Parkway
Route 1156
 Yellow Face
 From Route 0001D at MP 449.64 on Left

Route	Public / NonPublic	Date Visited	Area (sq ft)	Lane Miles *	Surface Type	Condition / PCR
1156	Public	8/30/2003	7132	0.12	AS	GOOD / 90

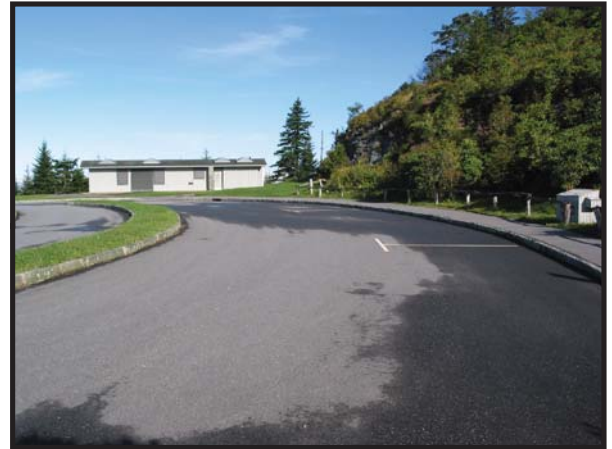
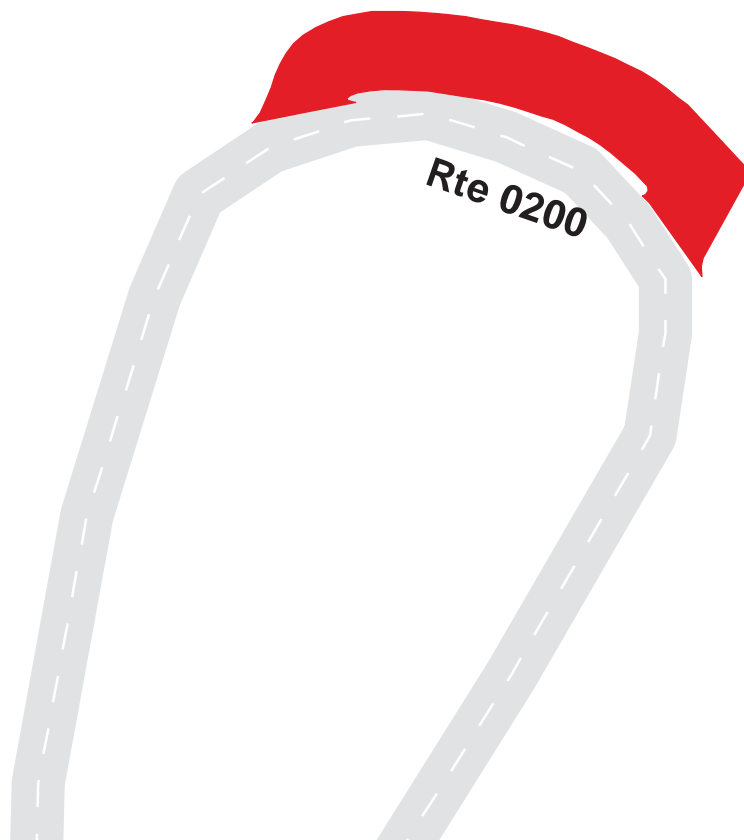
Blue Ridge Parkway Route 1158C

Water Rock Knob Overlook Parking C
Adjacent to Route 0200 at MP 0.34 on Right

Route	Public / NonPublic	Date Visited	Area (sq ft)	Lane Miles *	Surface Type	Condition / PCR
1158C	Public	8/30/2003	5552	0.10	AS	GOOD / 90

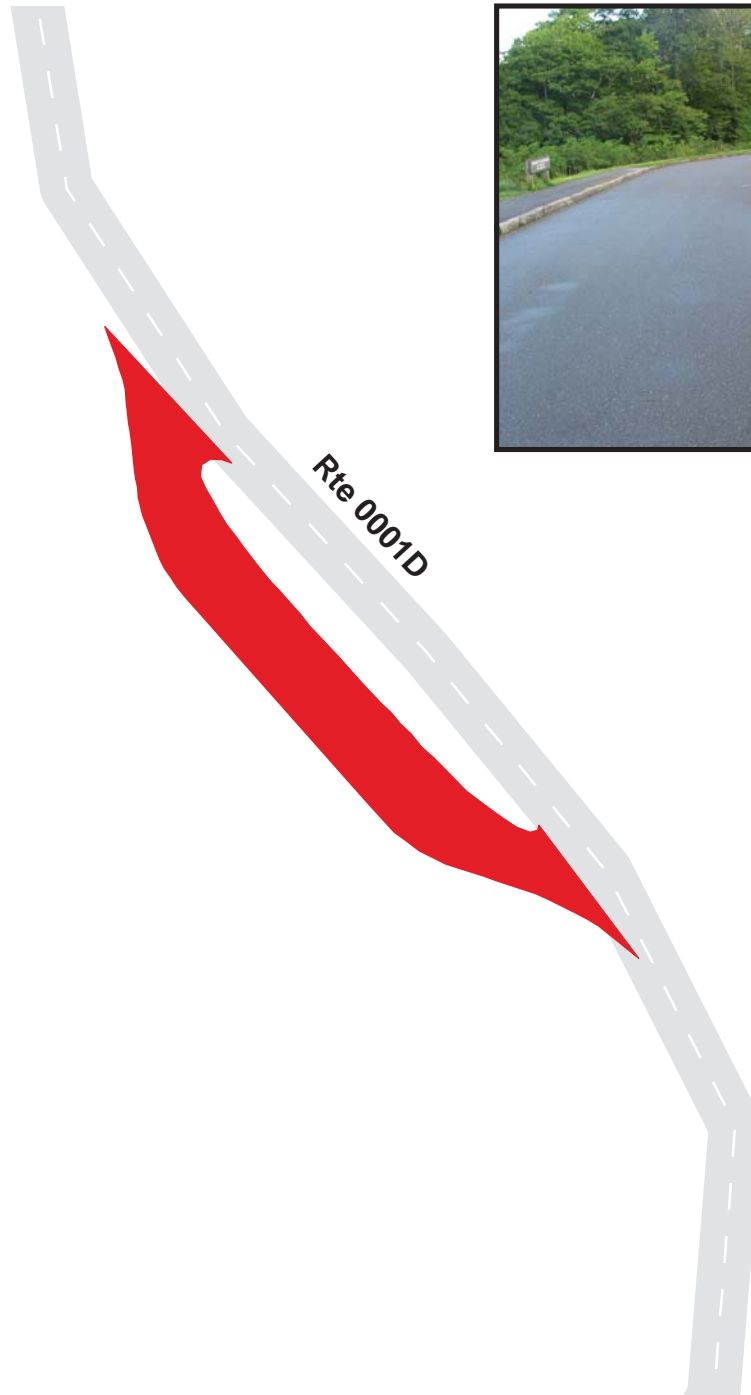
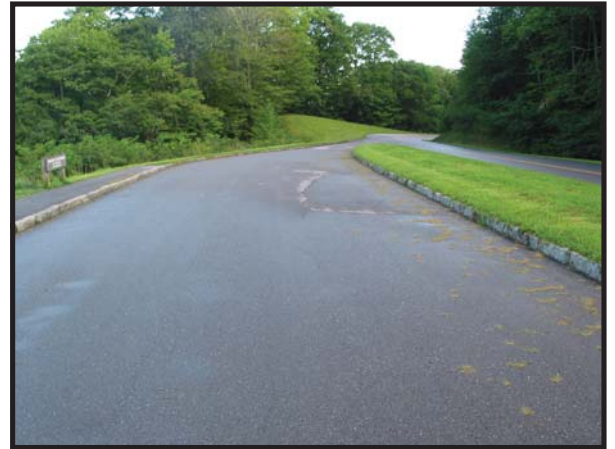
Route	Public / NonPublic	Date Visited	Area (sq ft)	Lane Miles *	Surface Type	Condition / PCR
1162	Public	8/30/2003	6145	0.11	AS	GOOD / 90

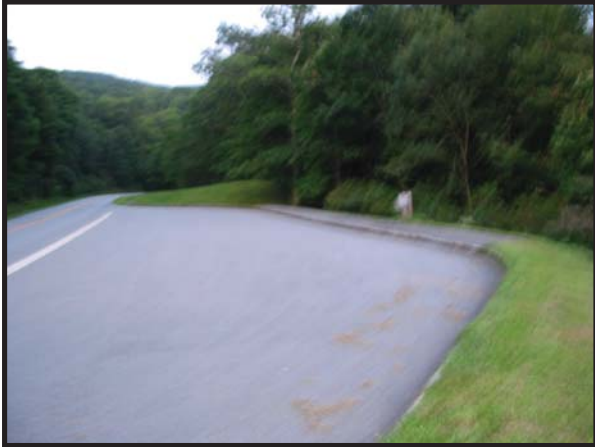
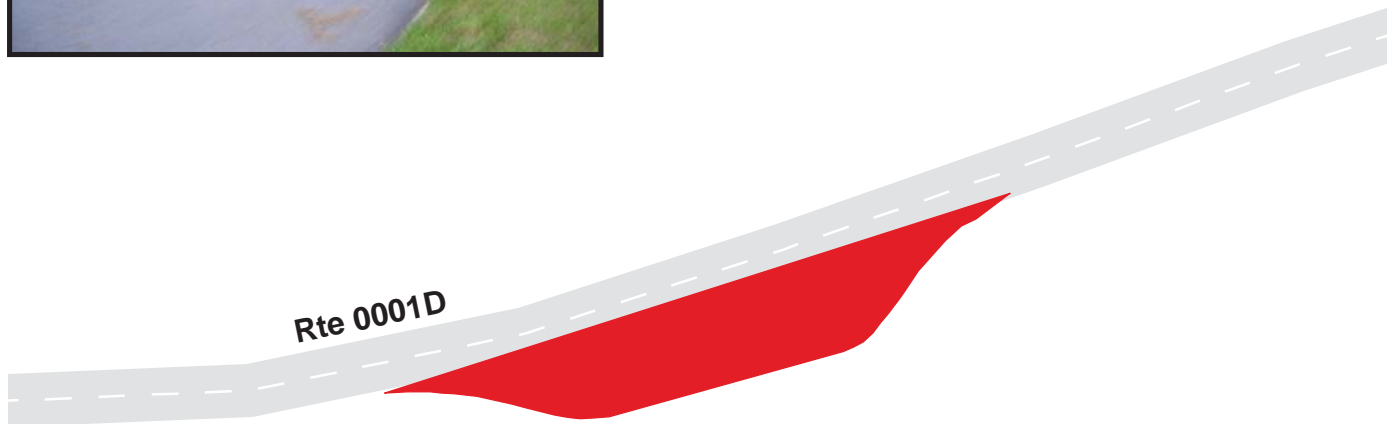
Route 1163

Route	Public / NonPublic	Date Visited	Area (sq ft)	Lane Miles *	Surface Type	Condition / PCR
1163	Public	8/29/2003	7344	0.13	AS	GOOD / 90

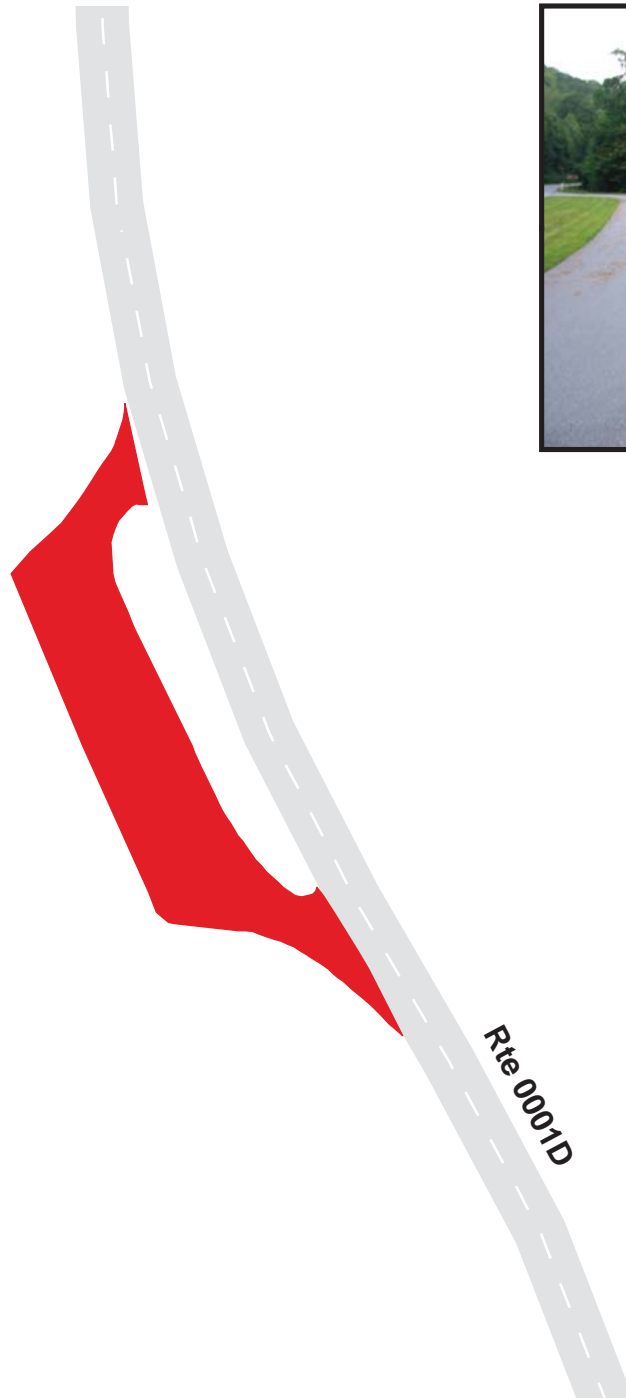
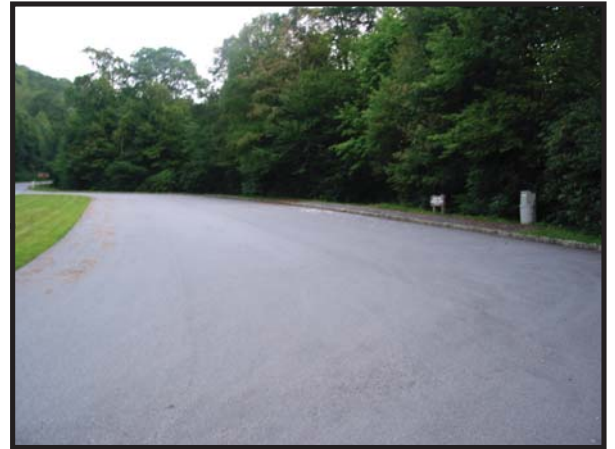
Route 1164

Route	Public / NonPublic	Date Visited	Area (sq ft)	Lane Miles *	Surface Type	Condition / PCR
1164	Public	8/29/2003	14747	0.25	AS	GOOD / 90

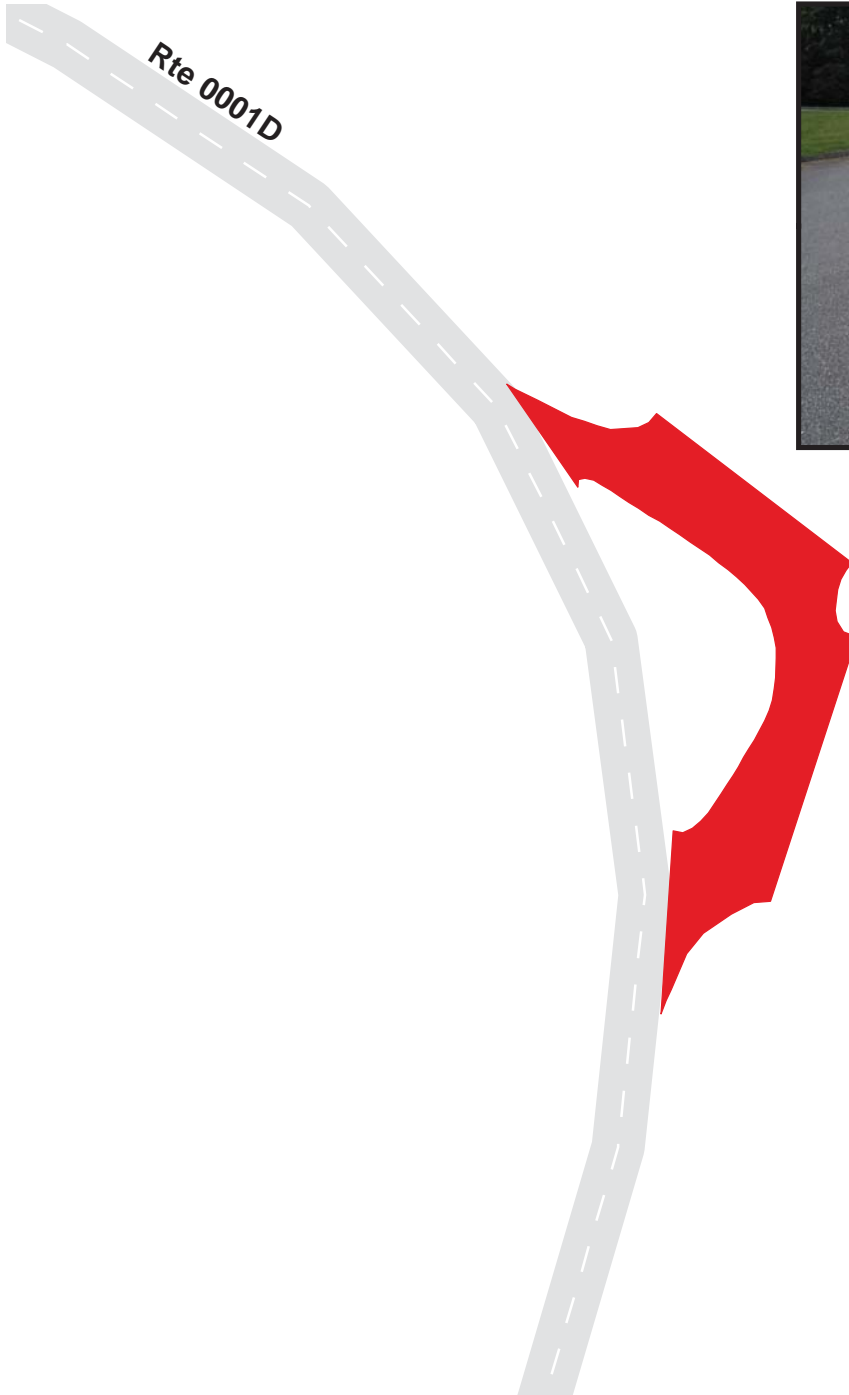
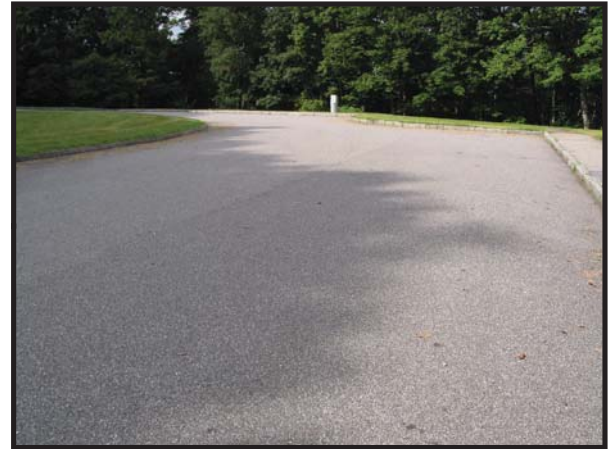
Route 1166

Route	Public / NonPublic	Date Visited	Area (sq ft)	Lane Miles *	Surface Type	Condition / PCR
1166	Public	8/29/2003	7415	0.13	AS	FAIR / 73

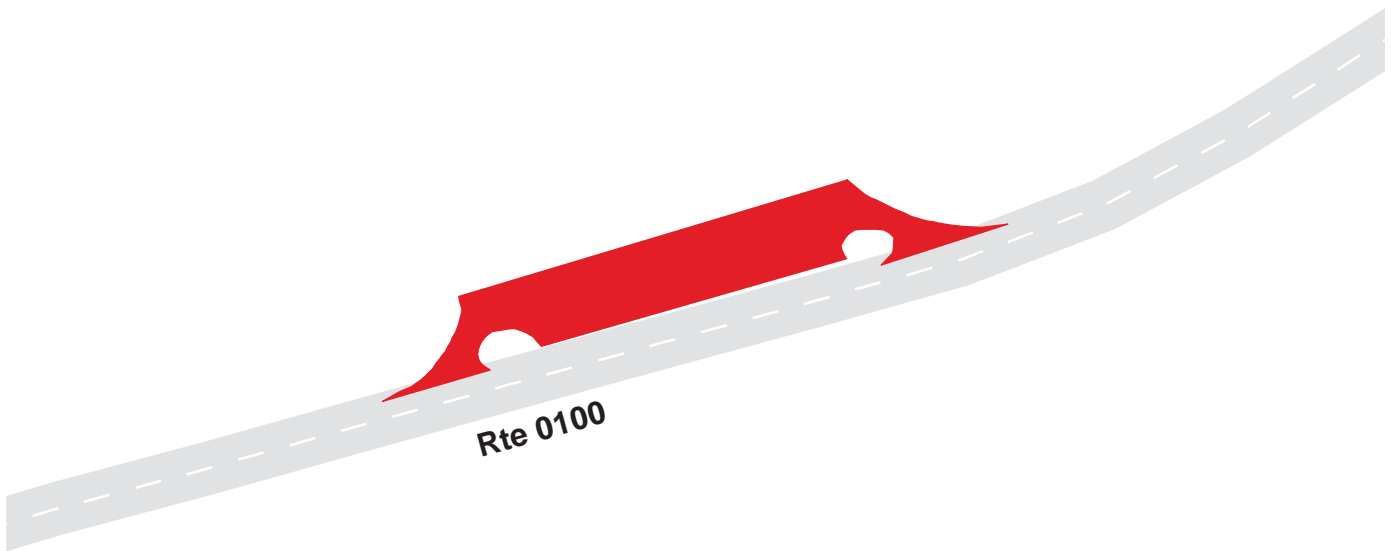
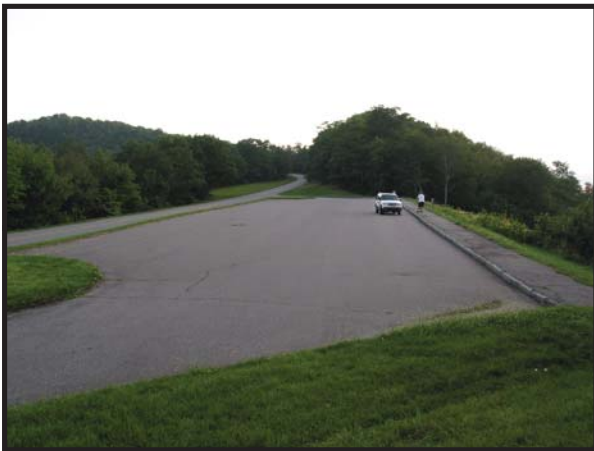
Blue Ridge Parkway
Route 1168
Mile High Overlook
From Route 0100 at MP 1.3 on Left

Route	Public / NonPublic	Date Visited	Area (sq ft)	Lane Miles *	Surface Type	Condition / PCR
1168	Public	8/29/2003	18138	0.31	AS	GOOD / 90
