The Road Inventory of Blue Ridge Parkway BLRI – 5140 Volume 1

Road Inventory Program

Prepared By:
Federal Highway Administration
Eastern Federal Lands Highway Division
Cycle 3

Blue Ridge Parkway in North Carolina

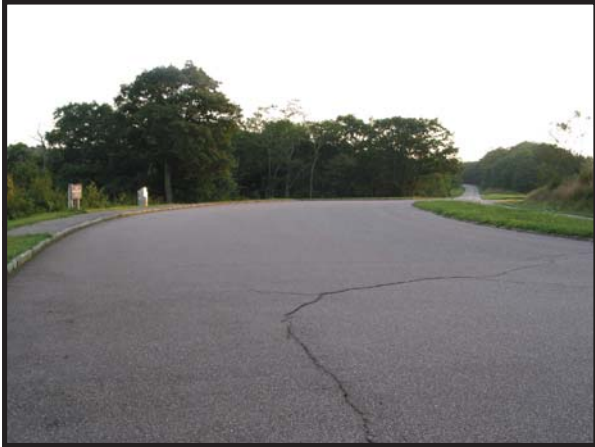
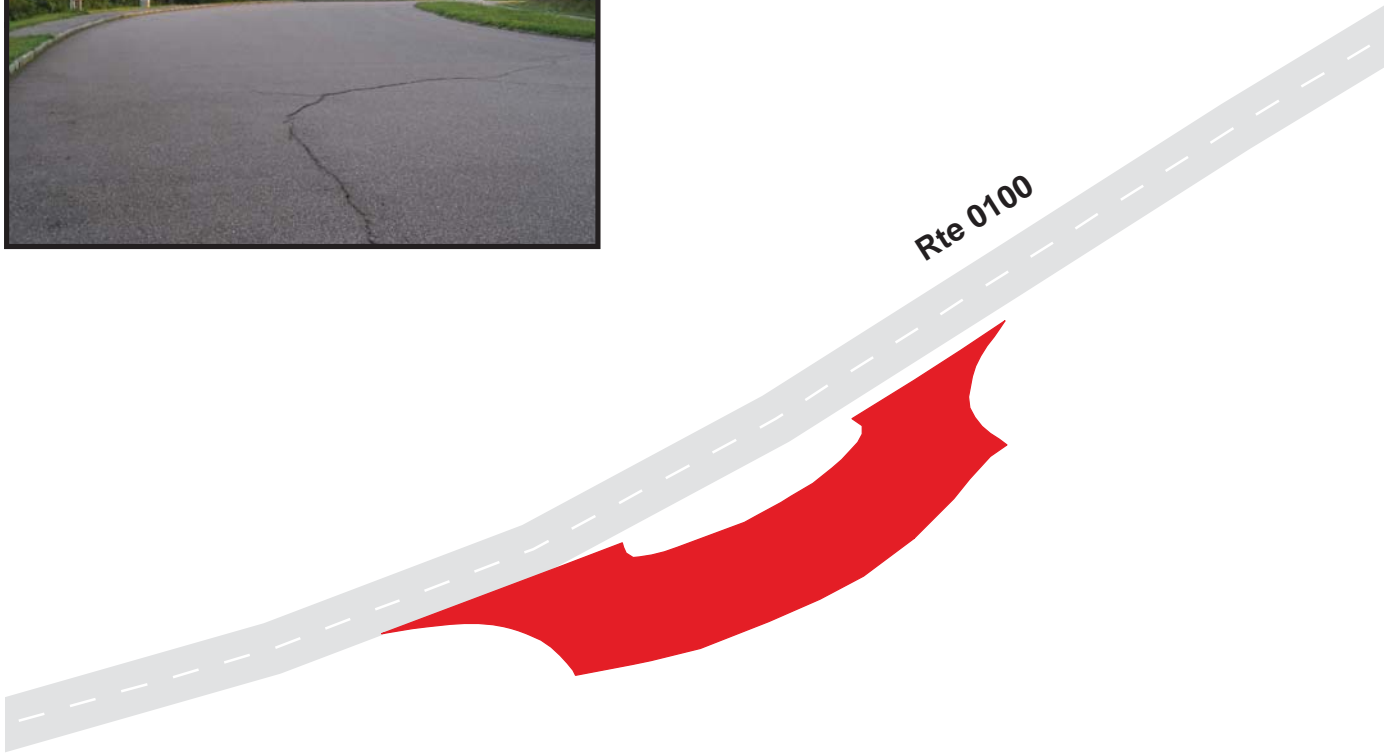
Blue Ridge Parkway
Route 1169
Maggie Valley
From Route 0100 at MP 1.40 on Right

Route	Public / NonPublic	Date Visited	Area (sq ft)	Lane Miles *	Surface Type	Condition / PCR
1169	Public	8/29/2003	9464	0.16	AS	GOOD / 90

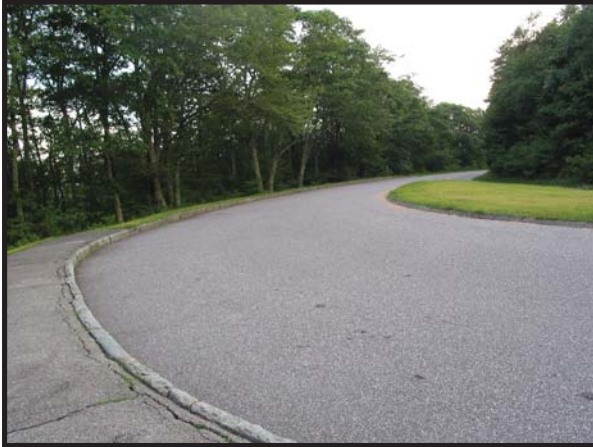
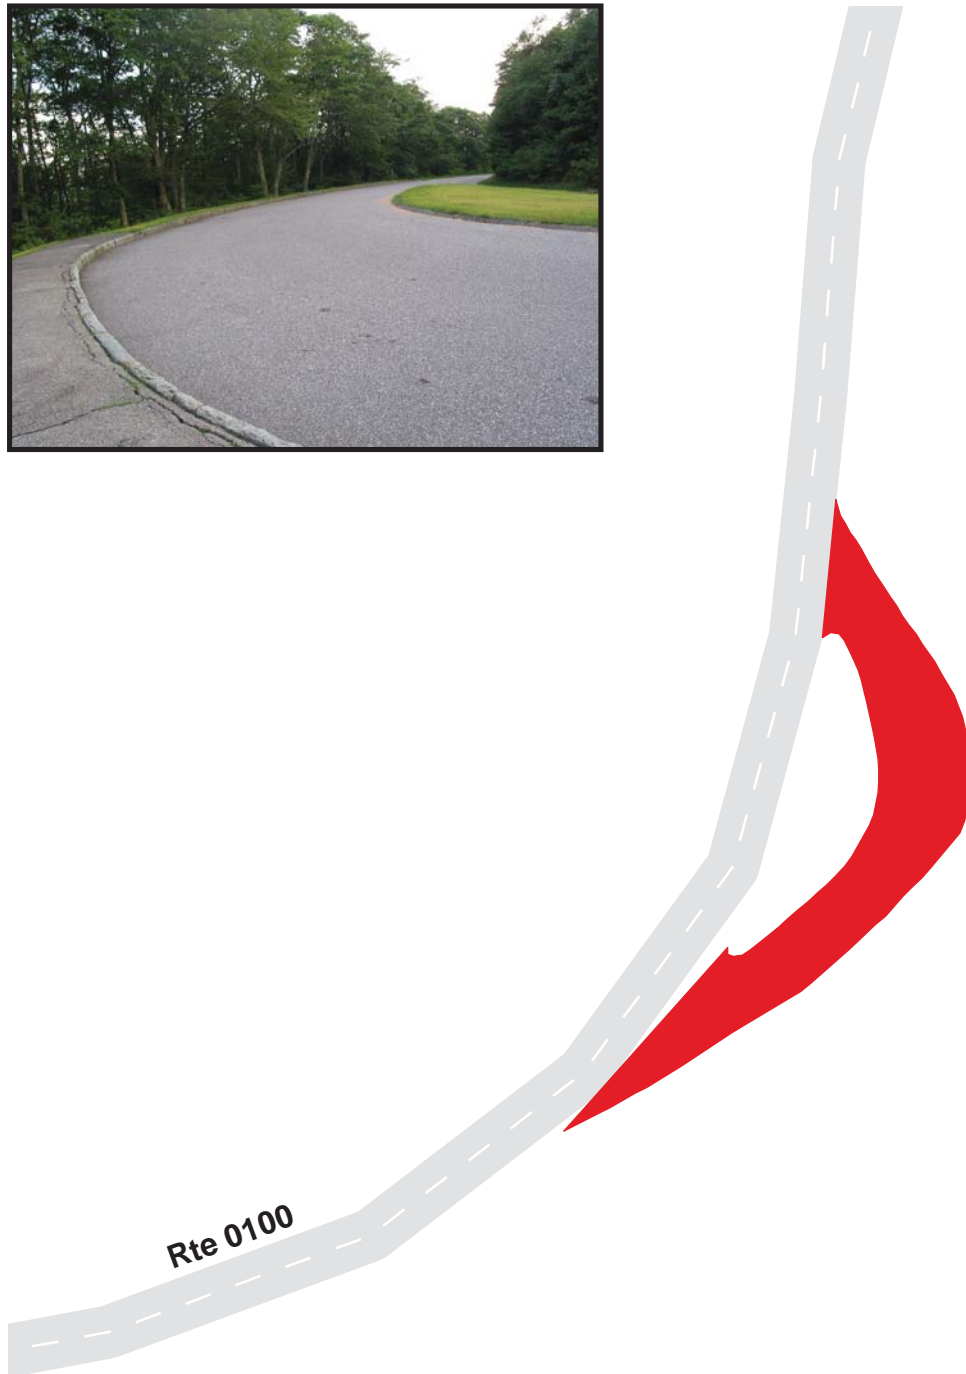
Route 1170

Route	Public / NonPublic	Date Visited	Area (sq ft)	Lane Miles *	Surface Type	Condition / PCR
1170	Public	8/29/2003	7666	0.13	AS	GOOD / 90

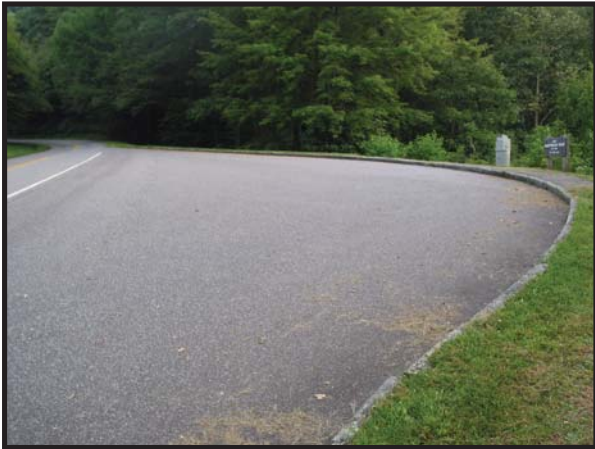
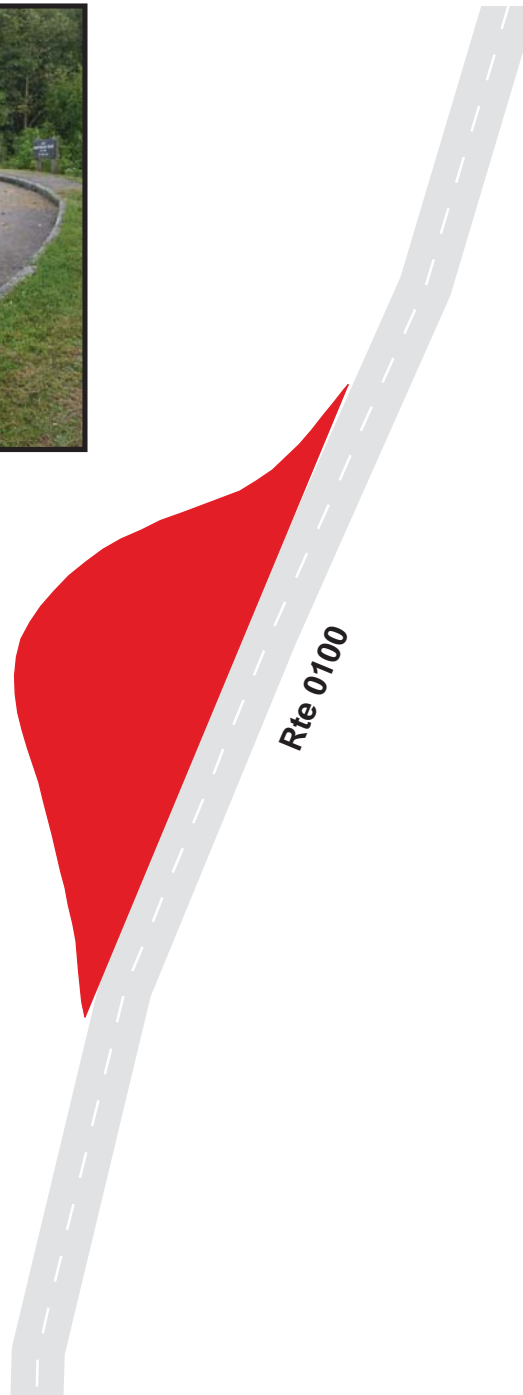
Route 1171

Route	Public / NonPublic	Date Visited	Area (sq ft)	Lane Miles *	Surface Type	Condition / PCR
1171	Public	8/29/2003	4825	0.08	AS	GOOD / 90

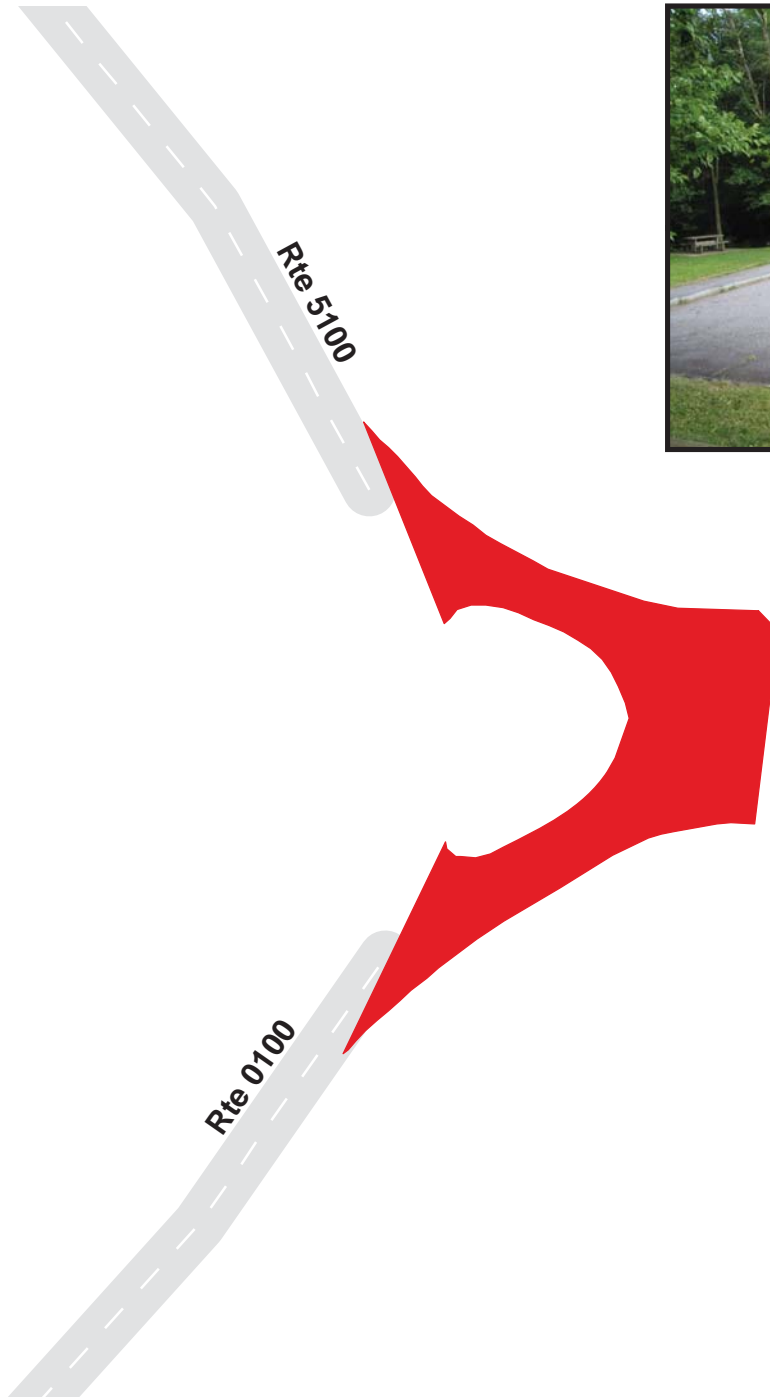
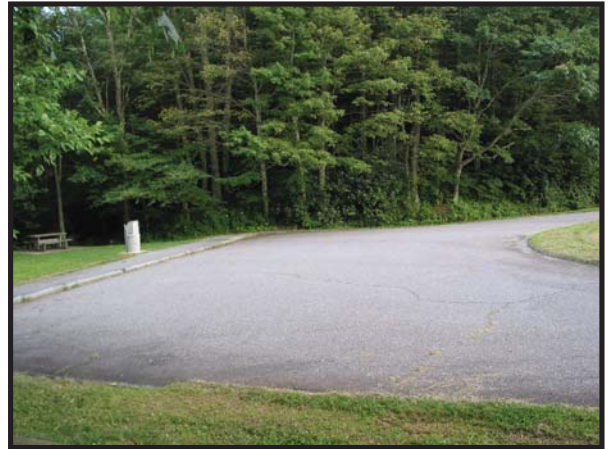
Route 1172

Route	Public / NonPublic	Date Visited	Area (sq ft)	Lane Miles *	Surface Type	Condition / PCR
1172	Public	8/29/2003	6660	0.11	AS	FAIR / 73

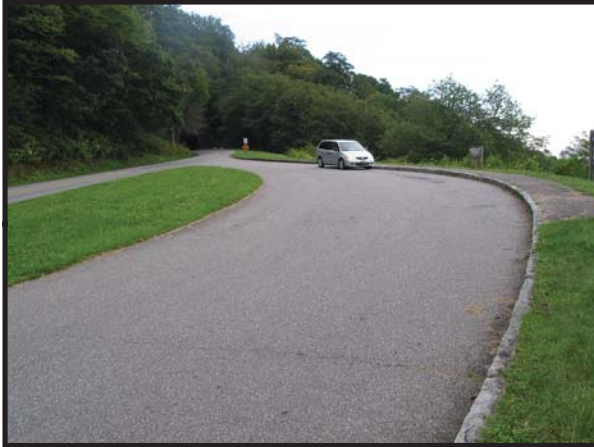
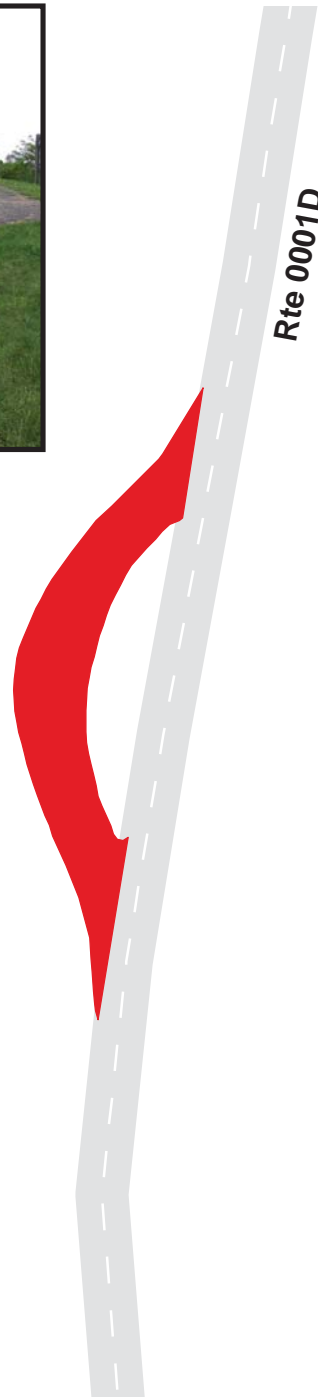
Route 1173

Route	Public / NonPublic	Date Visited	Area (sq ft)	Lane Miles *	Surface Type	Condition / PCR
1173	Public	8/29/2003	5443	0.09	AS	GOOD / 90

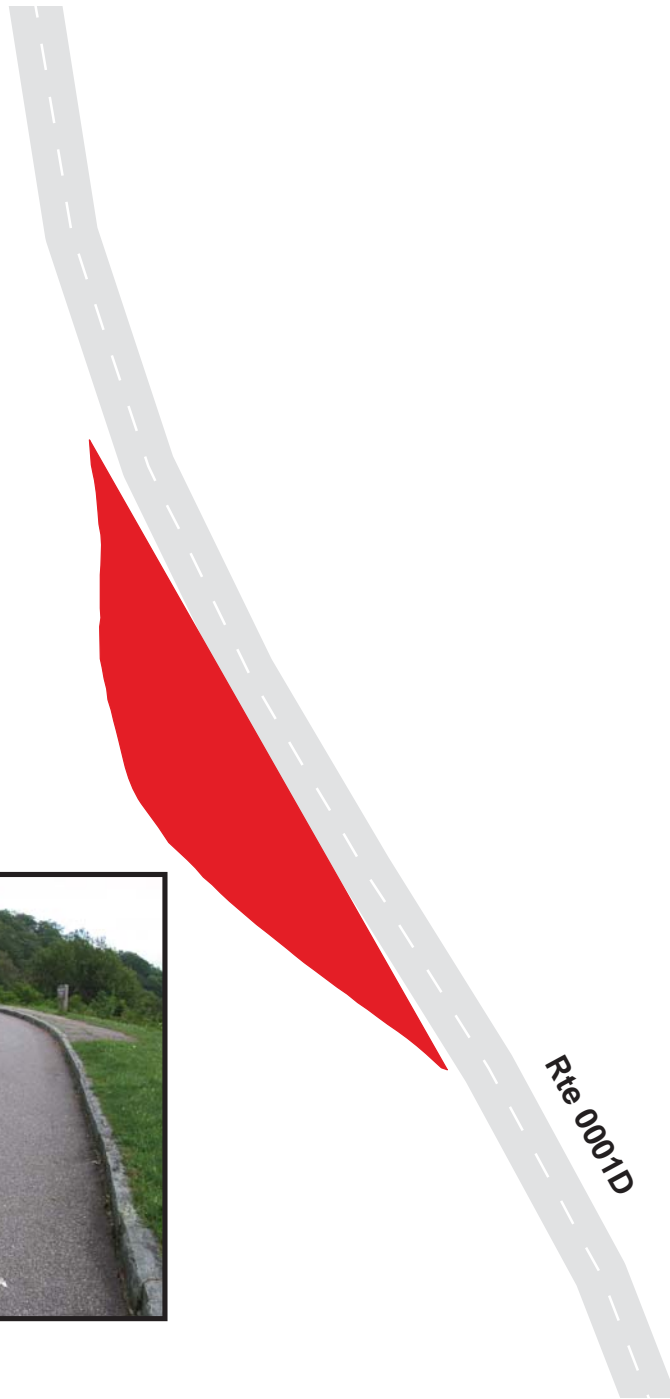
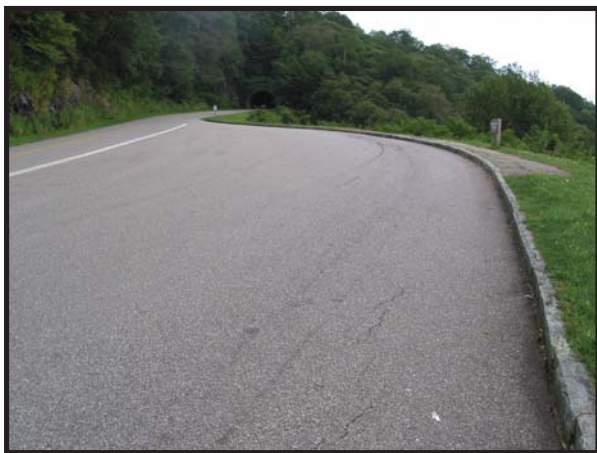
Blue Ridge Parkway Route 1174

Route	Public / NonPublic	Date Visited	Area (sq ft)	Lane Miles *	Surface Type	Condition / PCR
1174	Public	8/29/2003	10195	0.18	AS	GOOD / 90

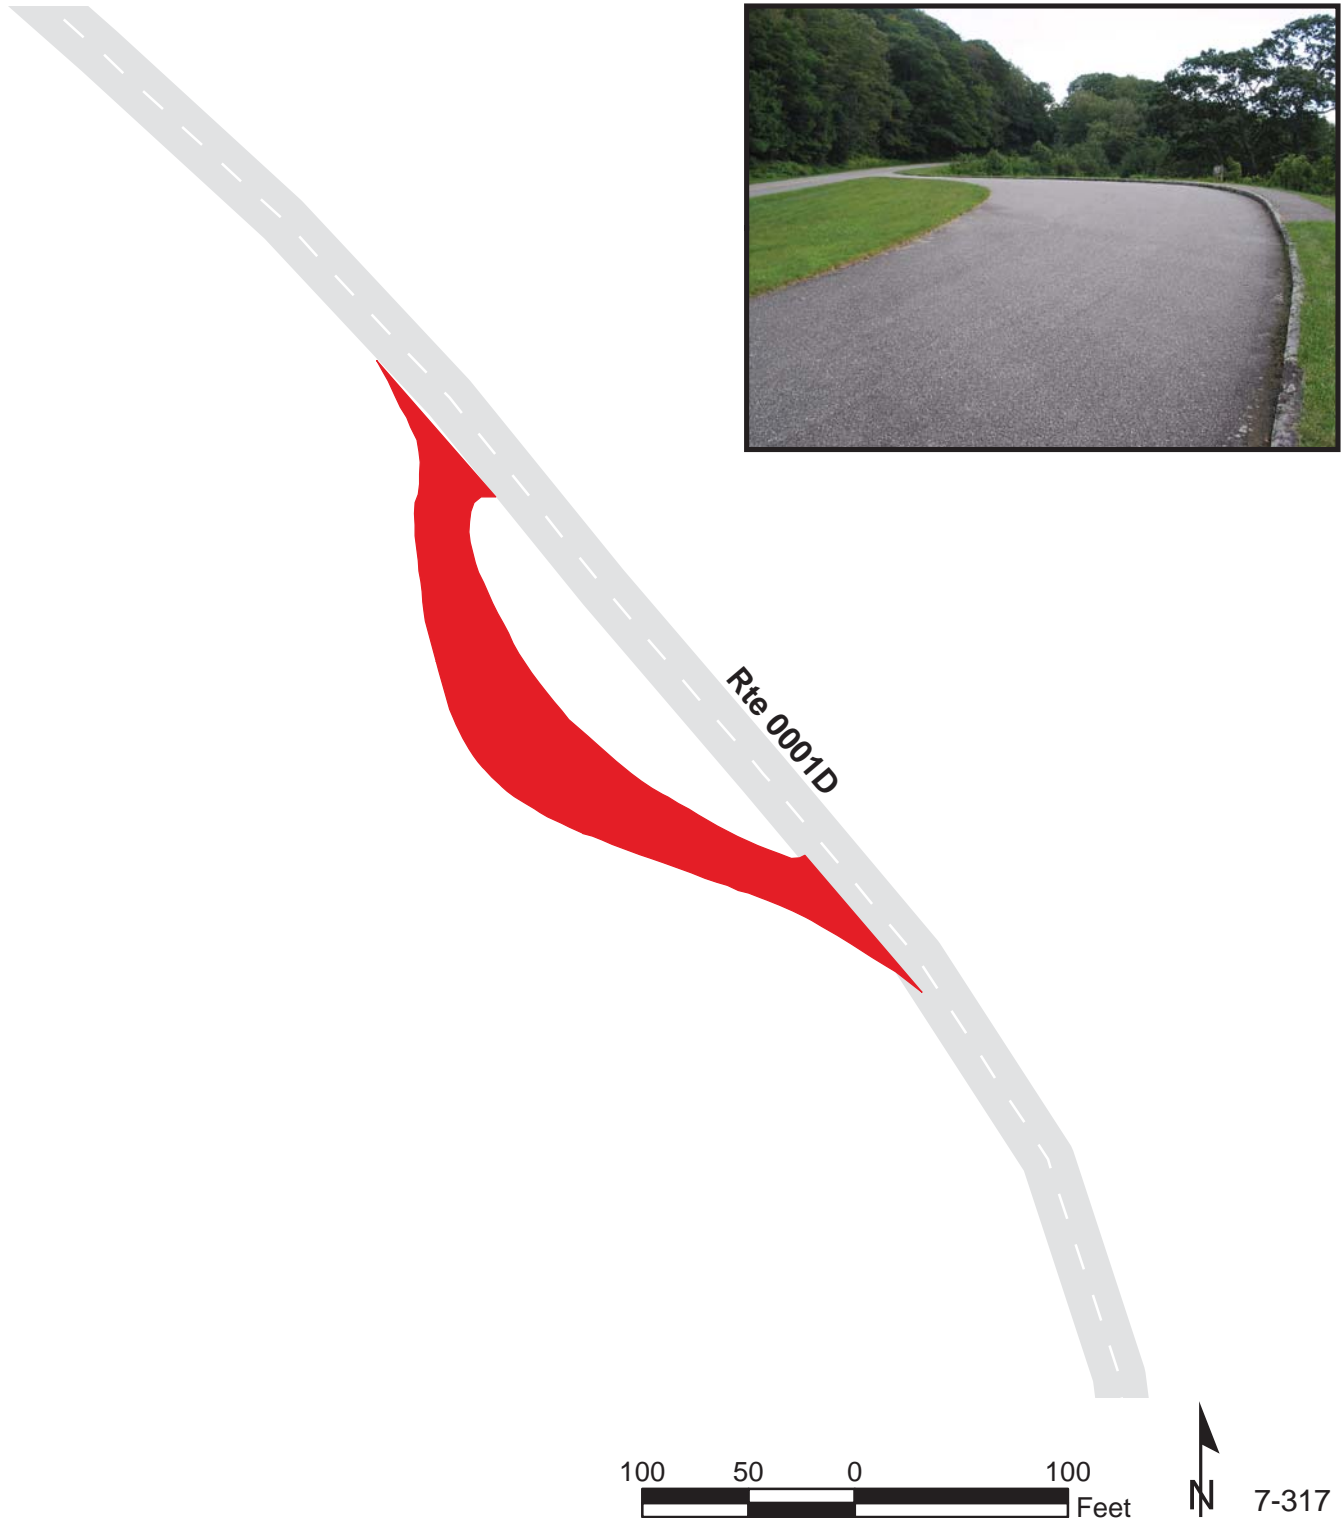
Blue Ridge Parkway Route 1175

Route	Public / NonPublic	Date Visited	Area (sq ft)	Lane Miles *	Surface Type	Condition / PCR
1175	Public	8/29/2003	8635	0.15	AS	GOOD / 90

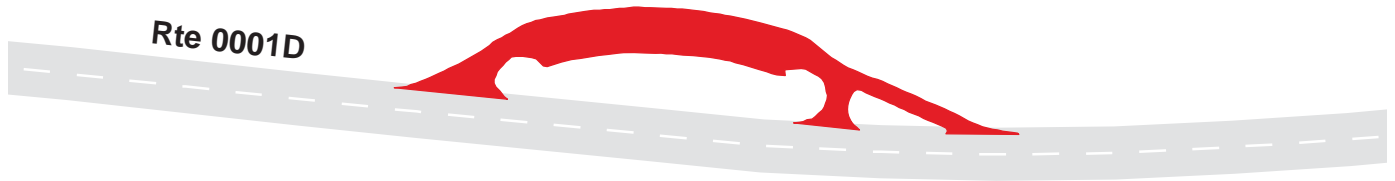
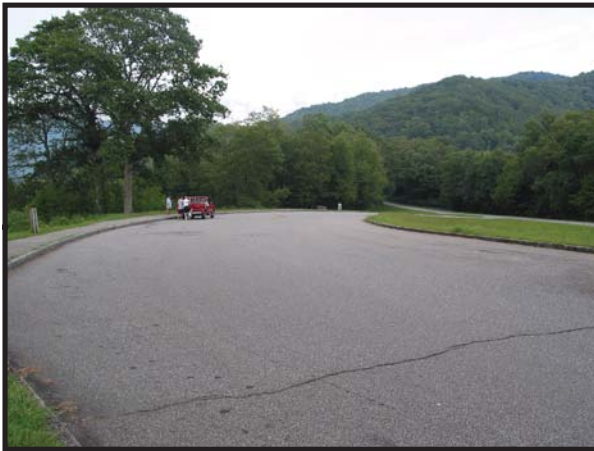
Route 1176

Route	Public / NonPublic	Date Visited	Area (sq ft)	Lane Miles *	Surface Type	Condition / PCR
1176	Public	8/29/2003	20576	0.35	AS	GOOD / 90

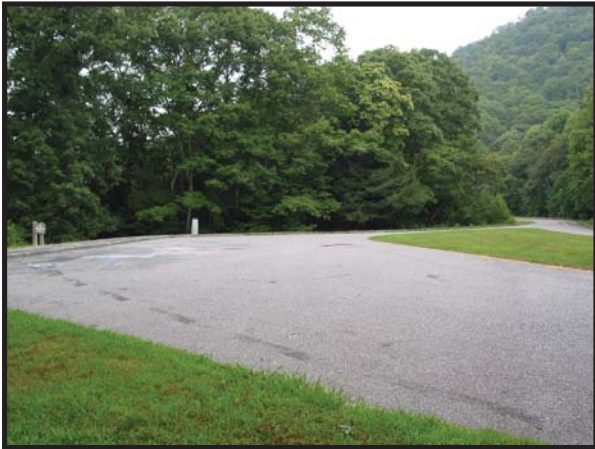
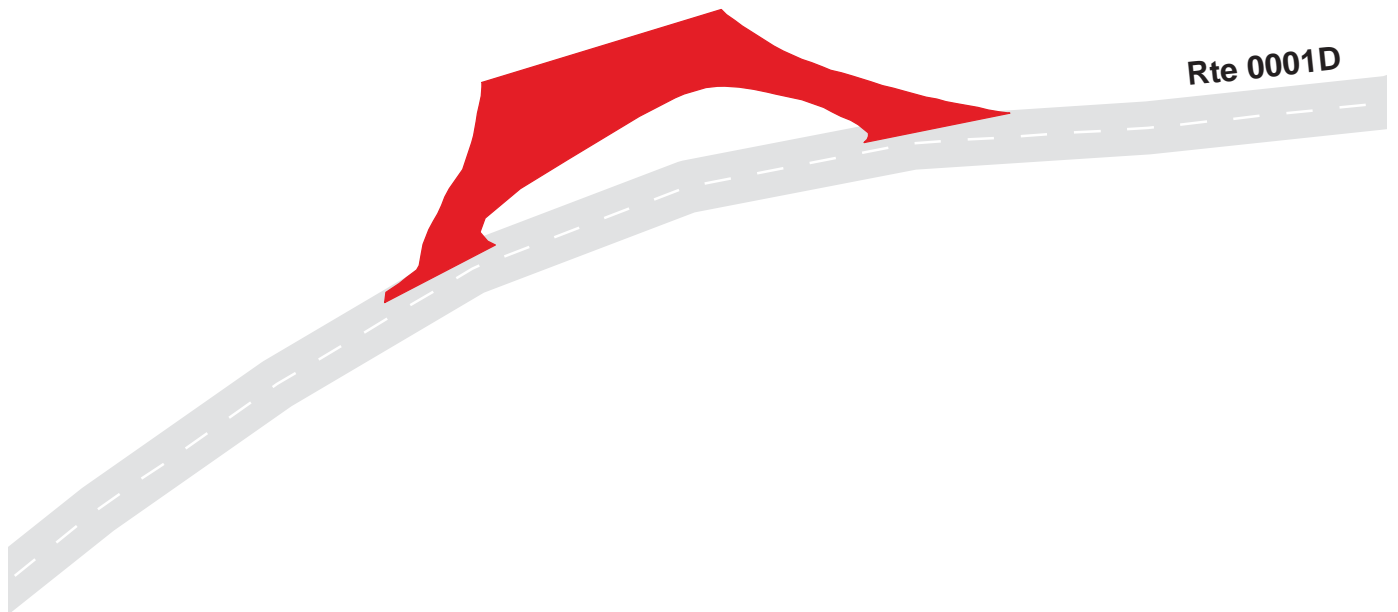
Route 1177

Route	Public / NonPublic	Date Visited	Area (sq ft)	Lane Miles *	Surface Type	Condition / PCR
1177	Public	8/29/2003	9620	0.17	AS	GOOD / 90

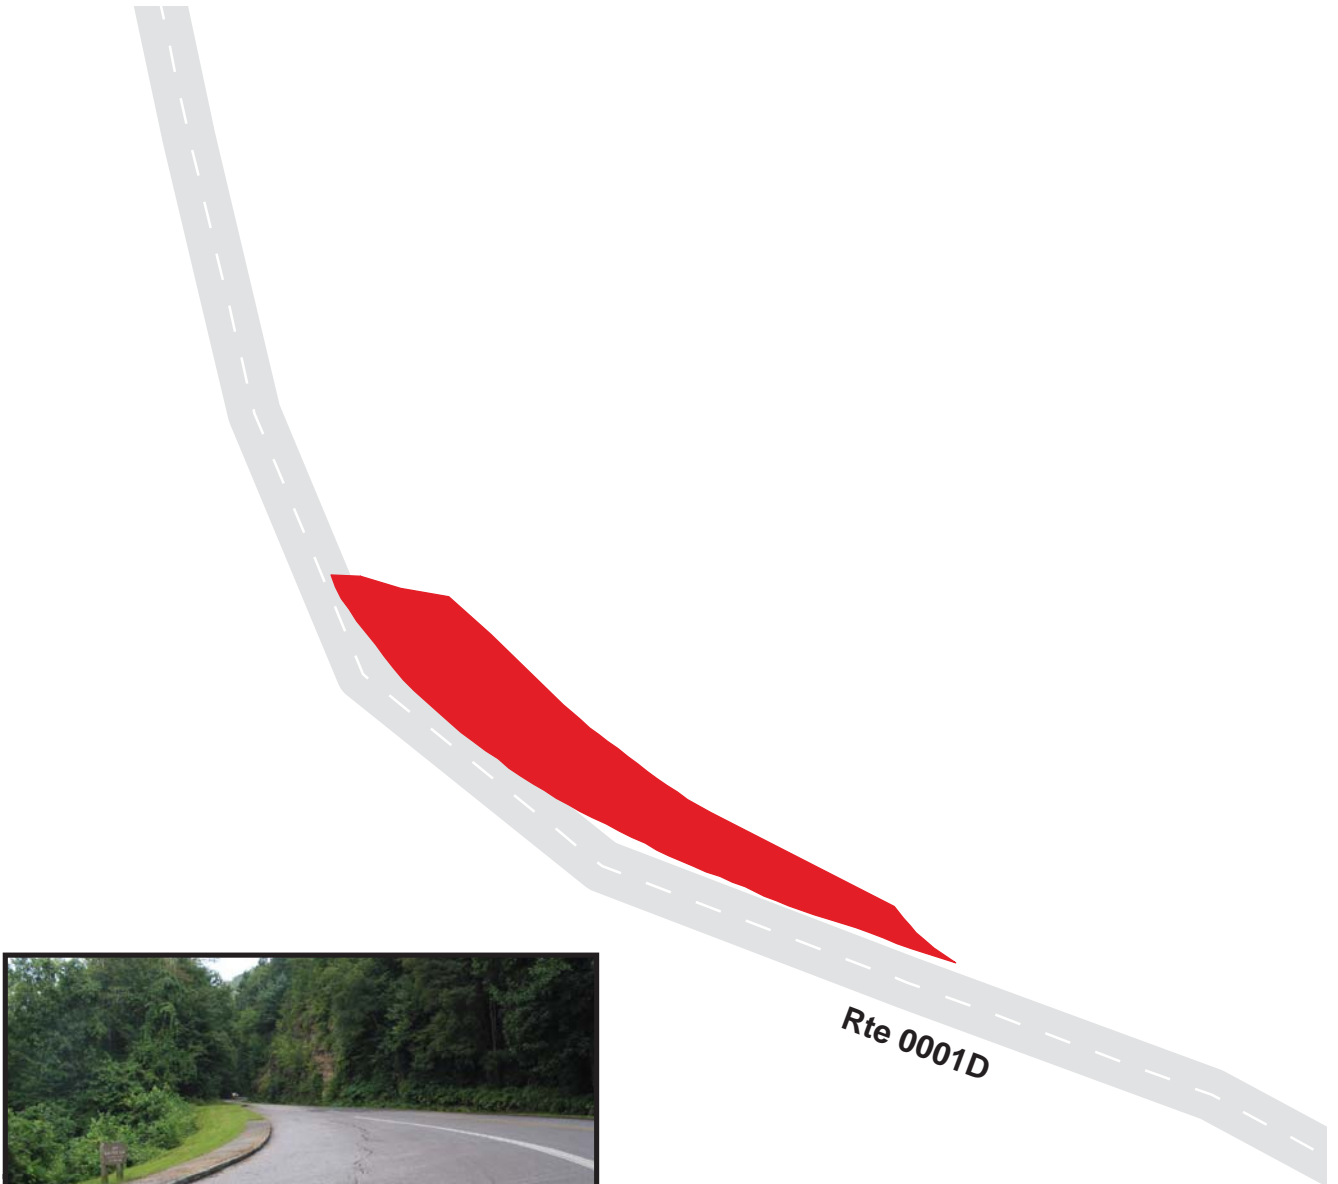
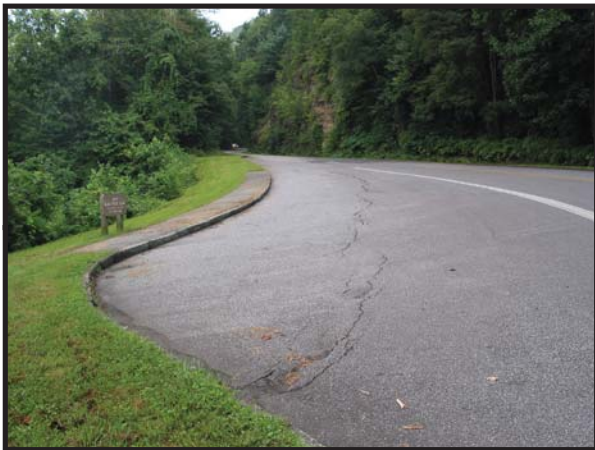
Route 1178A

Route	Public / NonPublic	Date Visited	Area (sq ft)	Lane Miles *	Surface Type	Condition / PCR
1178A	Public	8/29/2003	5187	0.09	AS	FAIR / 73

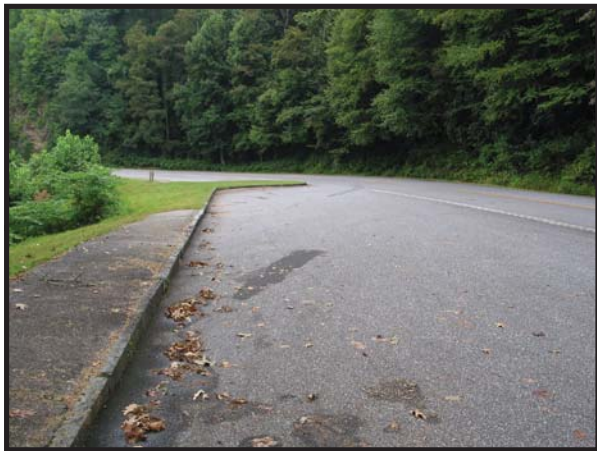
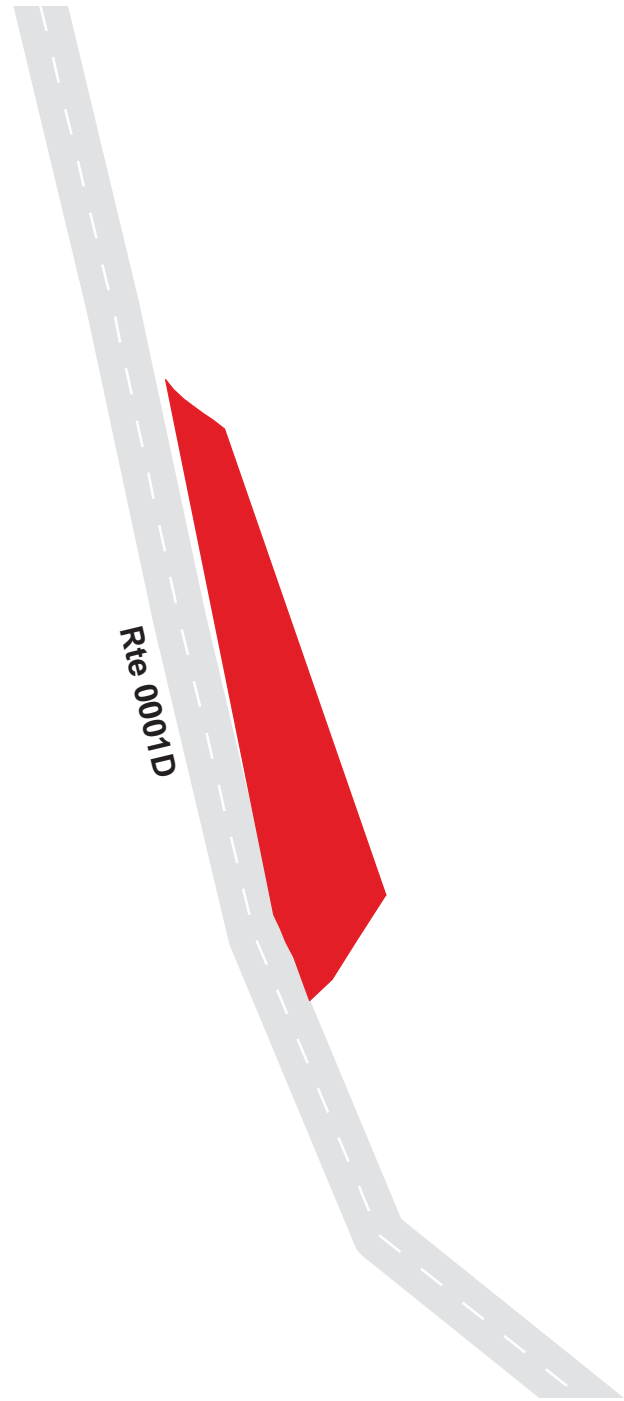
Route 1178B

Route	Public / NonPublic	Date Visited	Area (sq ft)	Lane Miles *	Surface Type	Condition / PCR
1178B	Public	8/29/2003	4189	0.07	AS	FAIR / 73

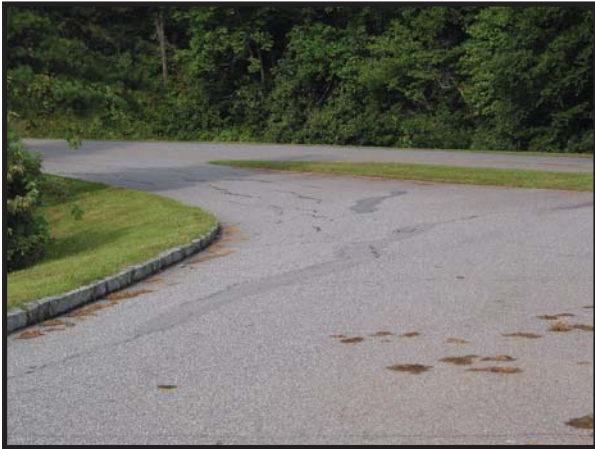
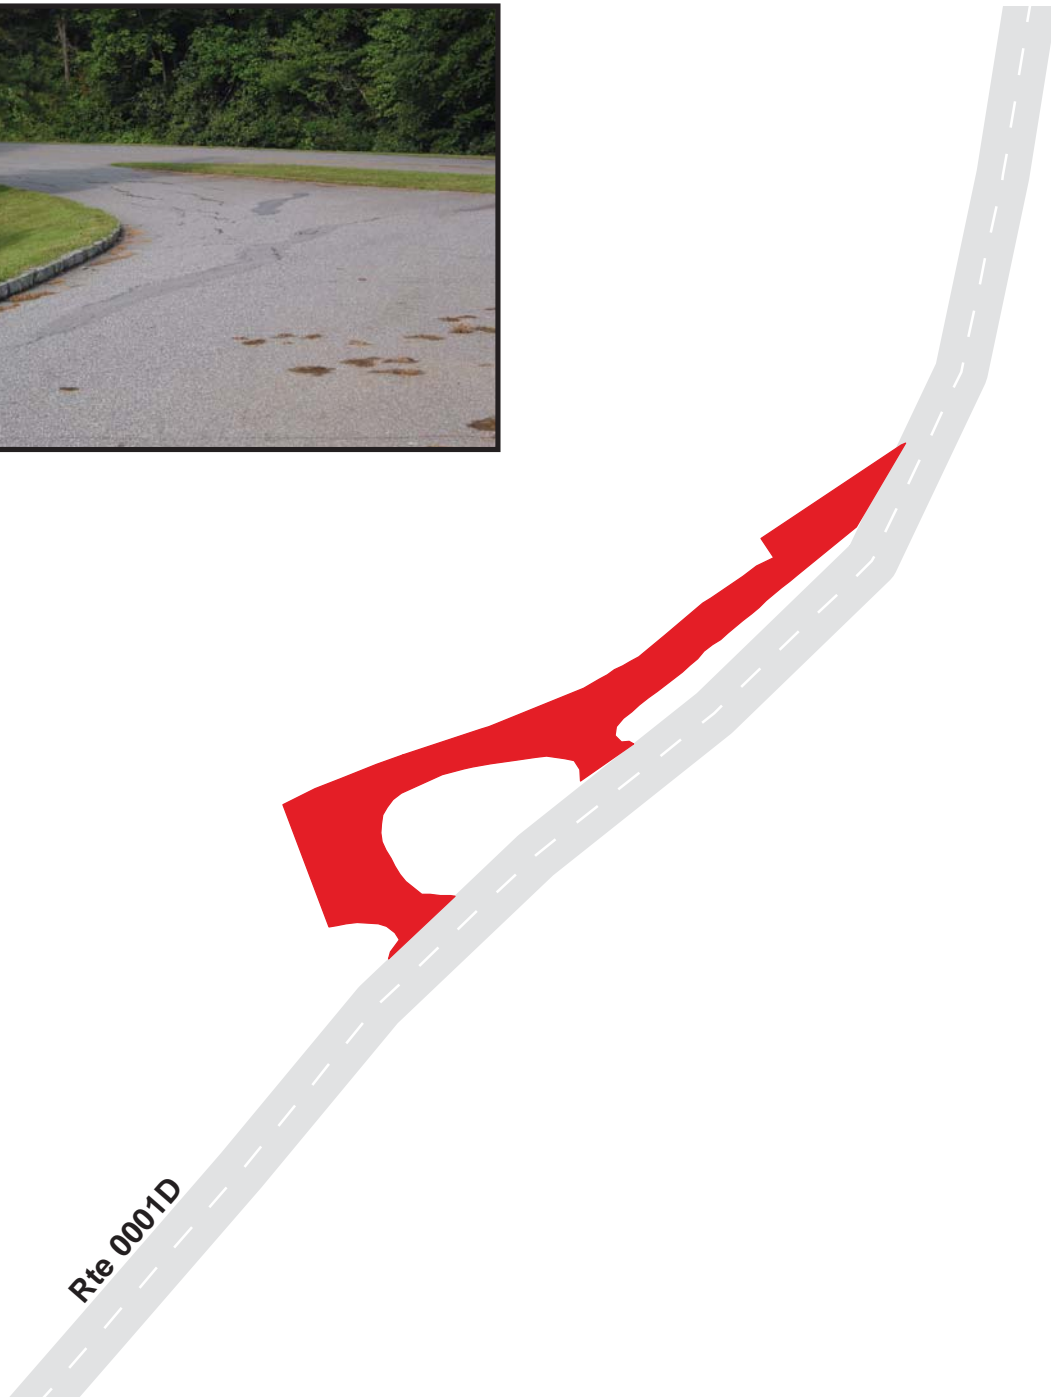
Route 1179

Route	Public / NonPublic	Date Visited	Area (sq ft)	Lane Miles *	Surface Type	Condition / PCR
1179	Public	8/29/2003	9202	0.16	AS	POOR / 45

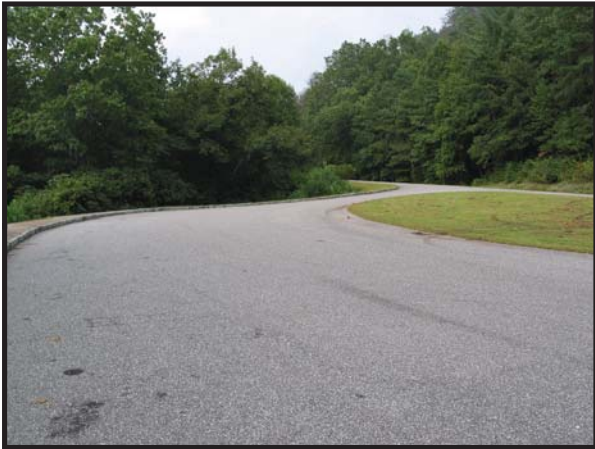
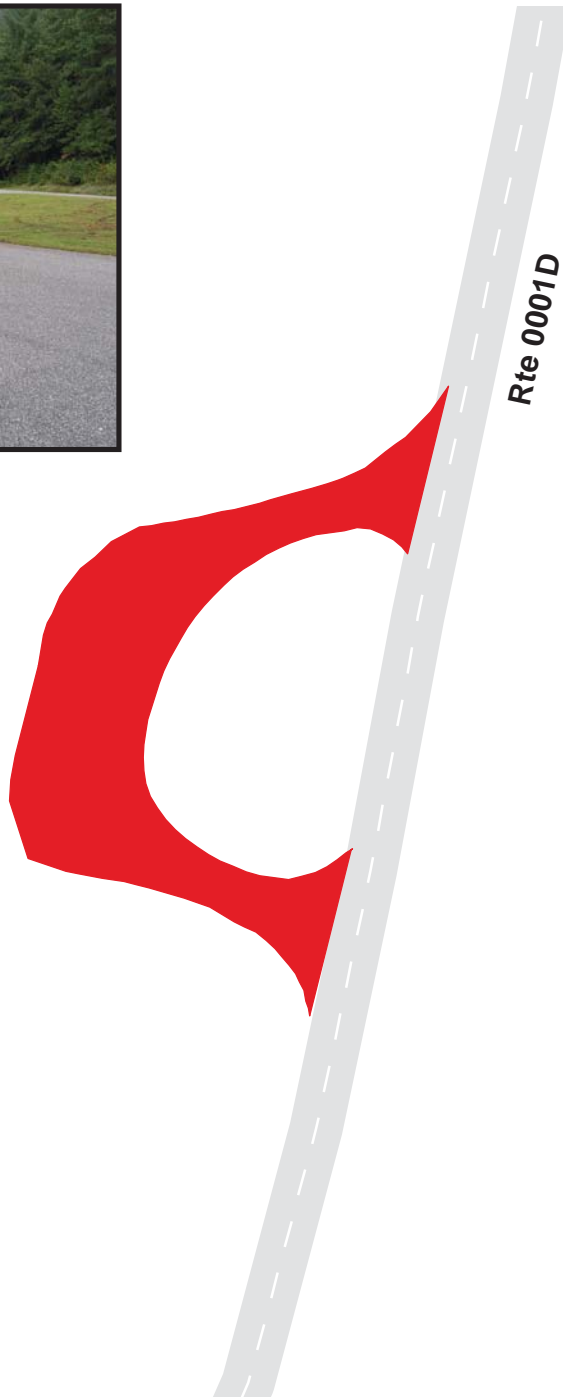
Route 1180

Route	Public / NonPublic	Date Visited	Area (sq ft)	Lane Miles *	Surface Type	Condition / PCR
1180	Public	8/29/2003	10113	0.17	AS	GOOD / 90

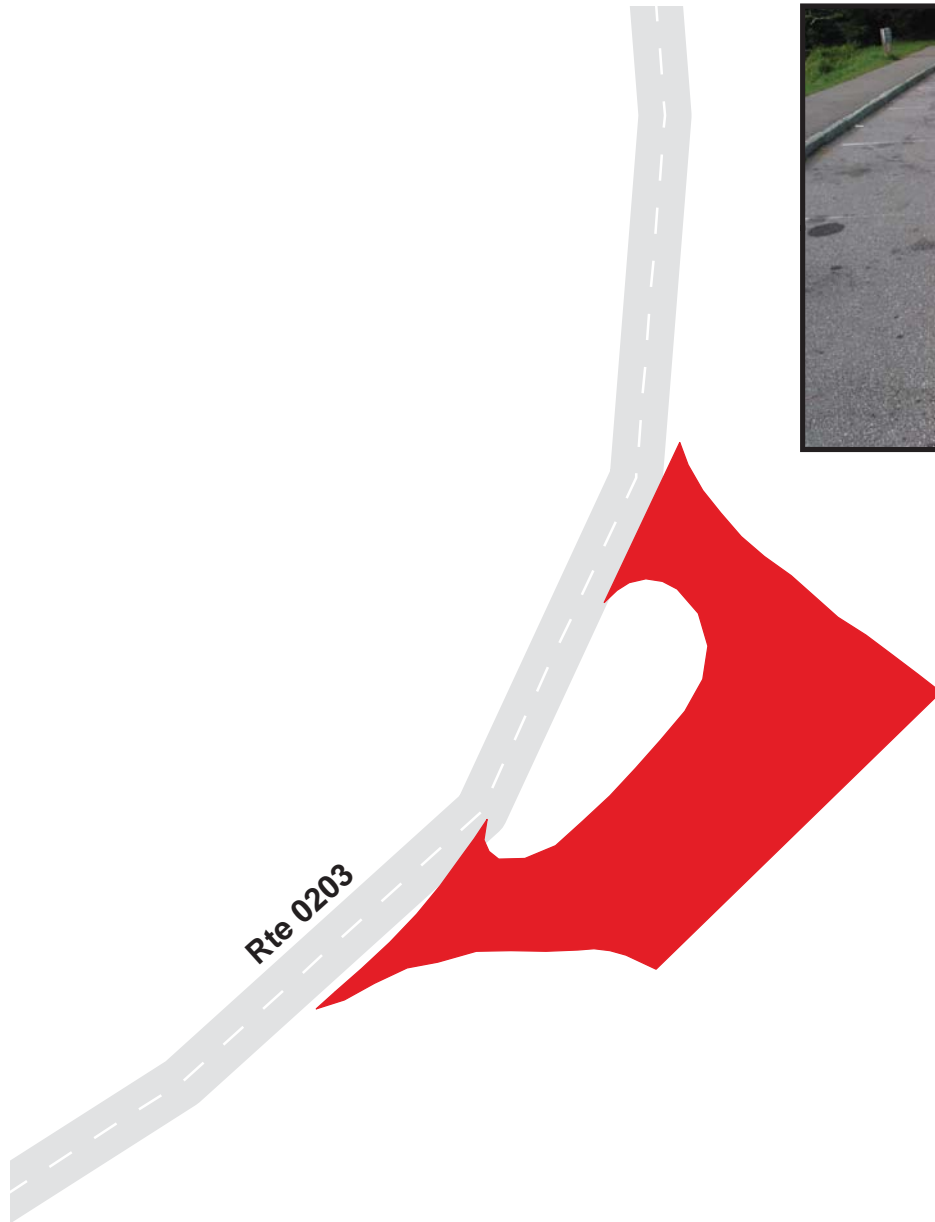
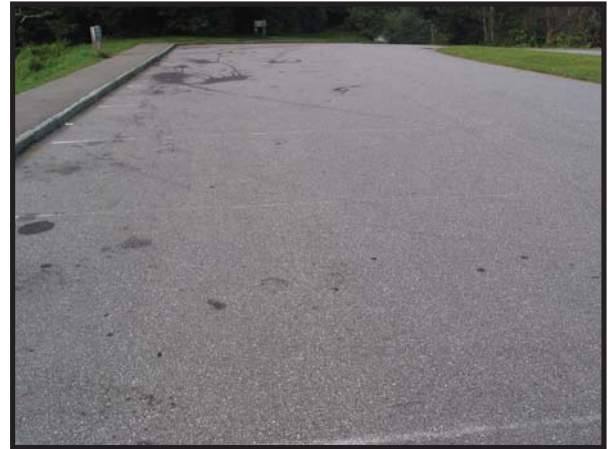
Route 1181A

Route	Public / NonPublic	Date Visited	Area (sq ft)	Lane Miles *	Surface Type	Condition / PCR
1181A	Public	8/28/2003	6696	0.12	AS	GOOD / 90

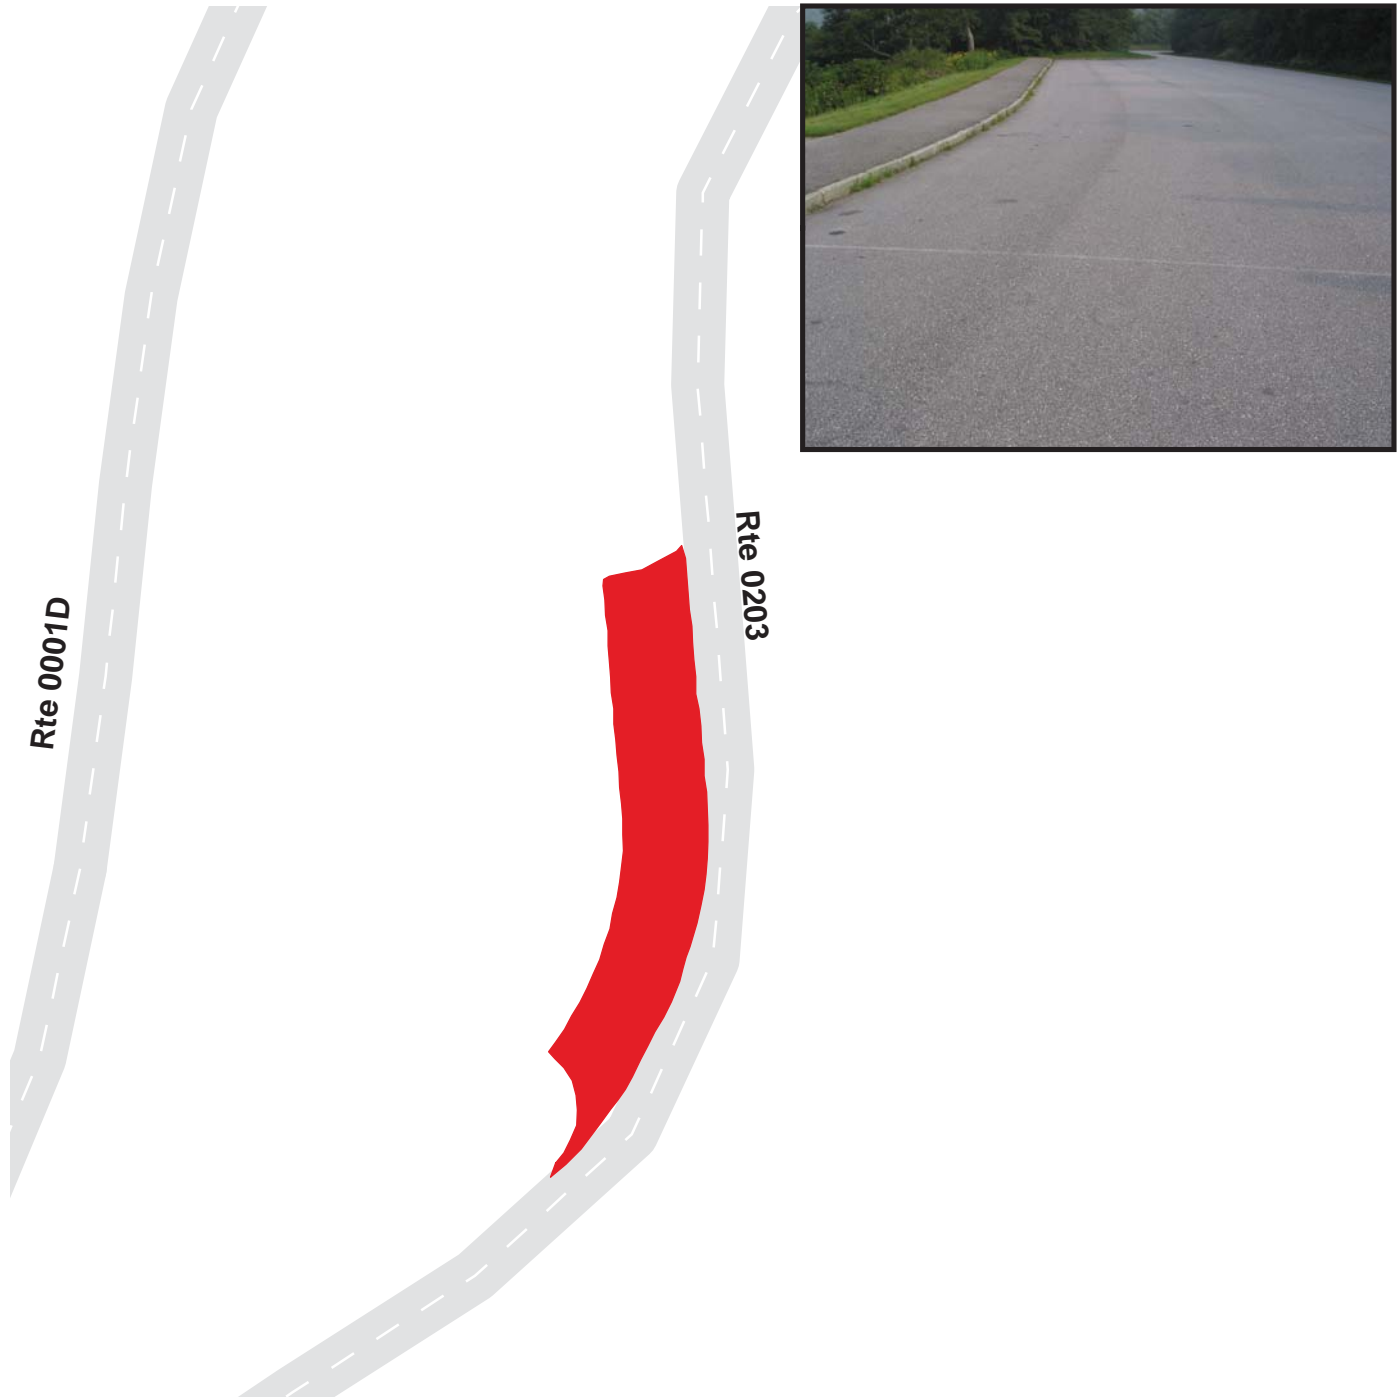
Blue Ridge Parkway Route 1181B

Route	Public / NonPublic	Date Visited	Area (sq ft)	Lane Miles *	Surface Type	Condition / PCR
1181B	Public	8/28/2003	11474	0.20	AS	GOOD / 90

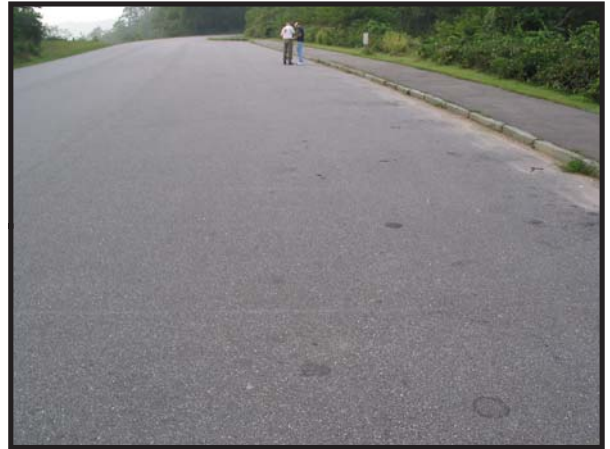
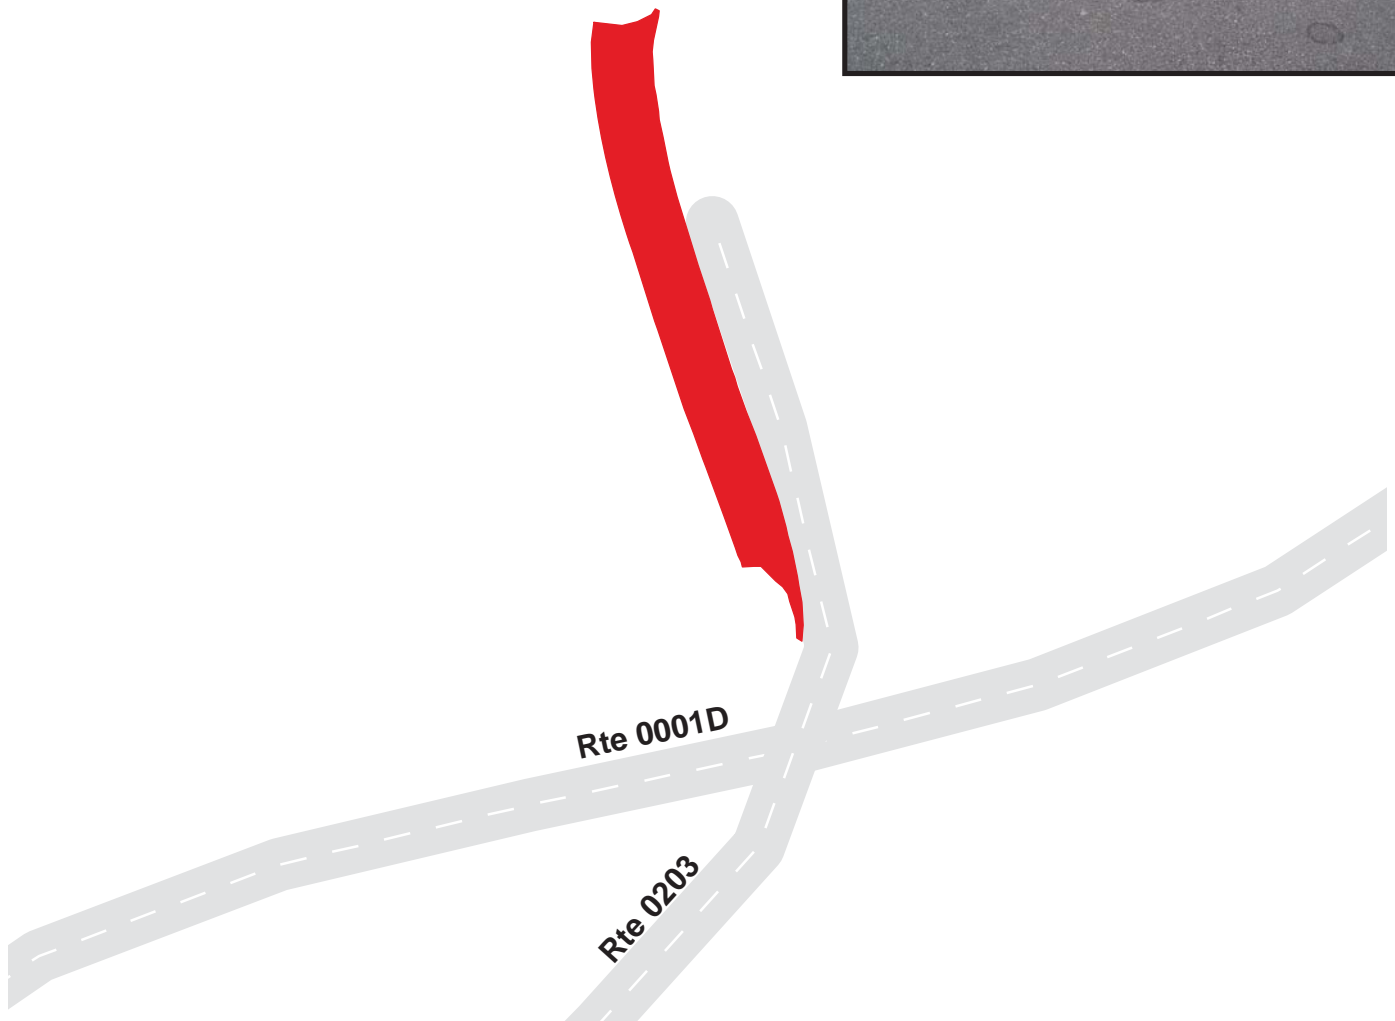
Route 1186

Route	Public / NonPublic	Date Visited	Area (sq ft)	Lane Miles *	Surface Type	Condition / PCR
1186	Public	9/1/2003	22435	0.39	AS	GOOD / 90
