The Road Inventory of Blue Ridge Parkway BLRI – 5140 Volume 1

Road Inventory Program

Prepared By:
Federal Highway Administration
Eastern Federal Lands Highway Division
Cycle 3

Blue Ridge Parkway in North Carolina

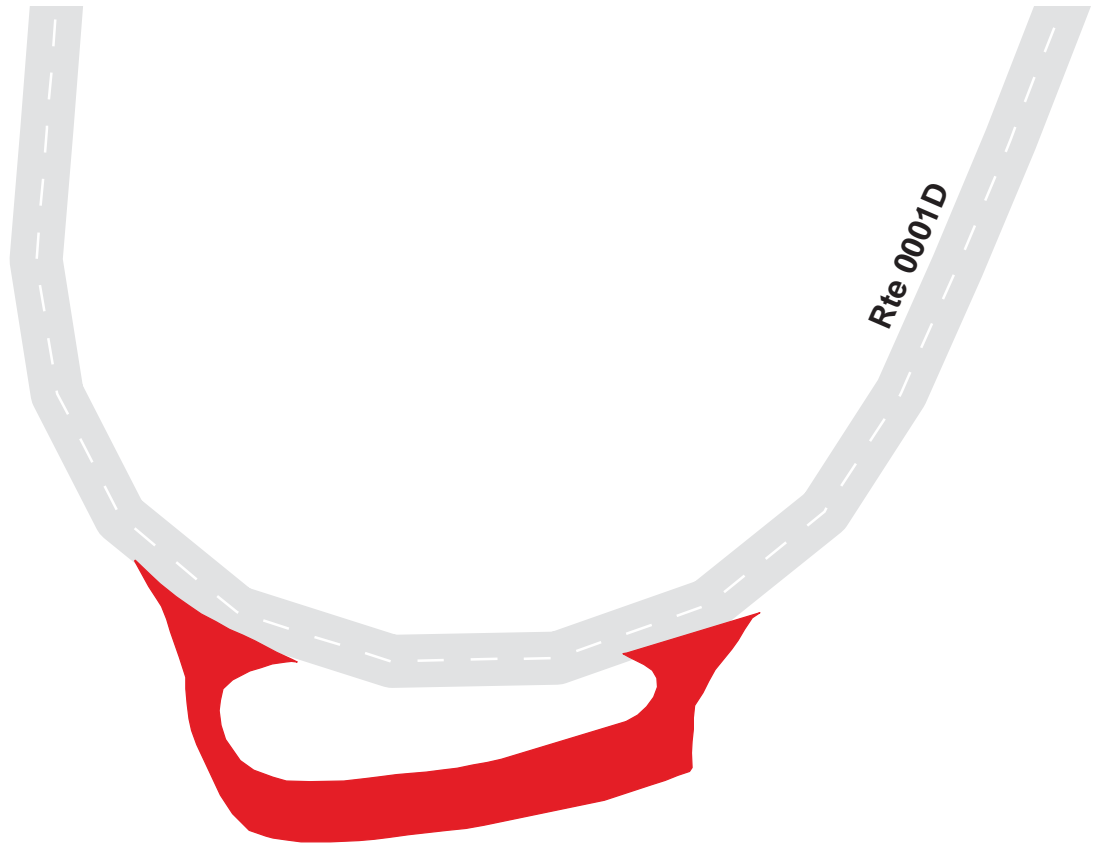
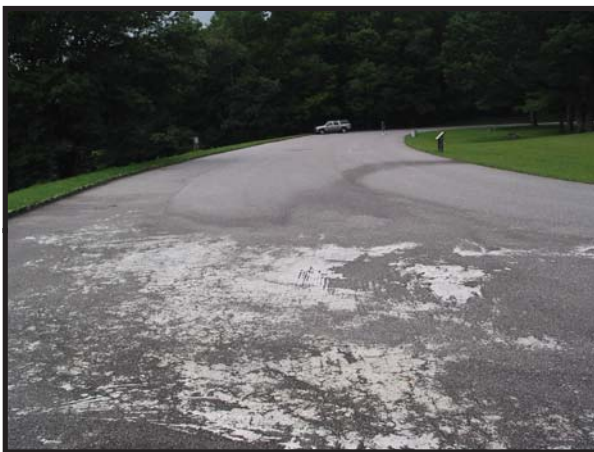
Blue Ridge Parkway Route 1187

Three Knobs Overlook
From Route 0001D at MP 338.48 on Left

Route	Public / NonPublic	Date Visited	Area (sq ft)	Lane Miles *	Surface Type	Condition / PCR
1187	Public	9/1/2003	8157	0.14	AS	GOOD / 90

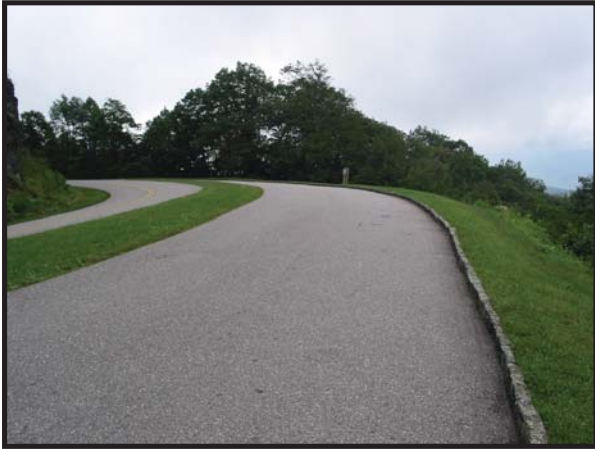
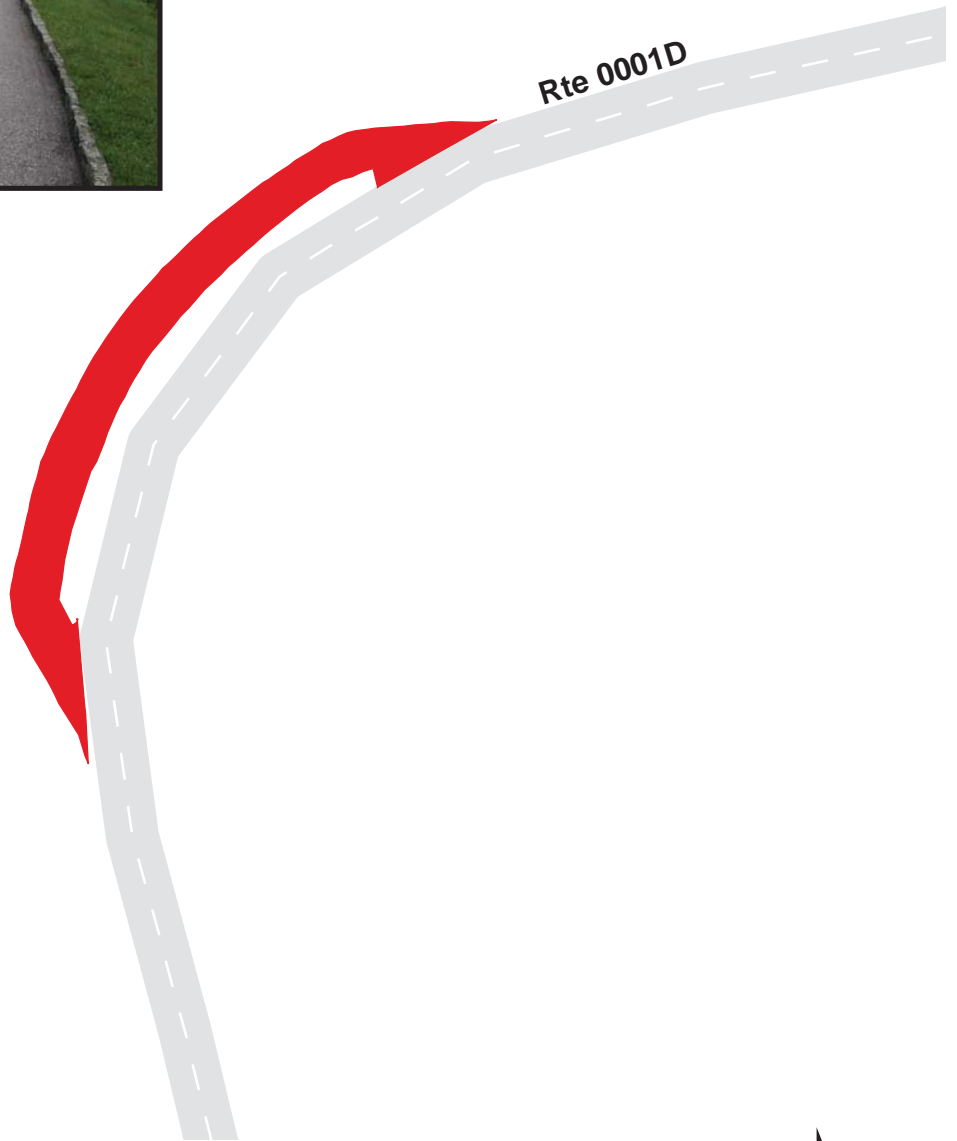
Route 1188

Route	Public / NonPublic	Date Visited	Area (sq ft)	Lane Miles *	Surface Type	Condition / PCR
1188	Public	4/8/2004	5047	0.09	AS	POOR / 45

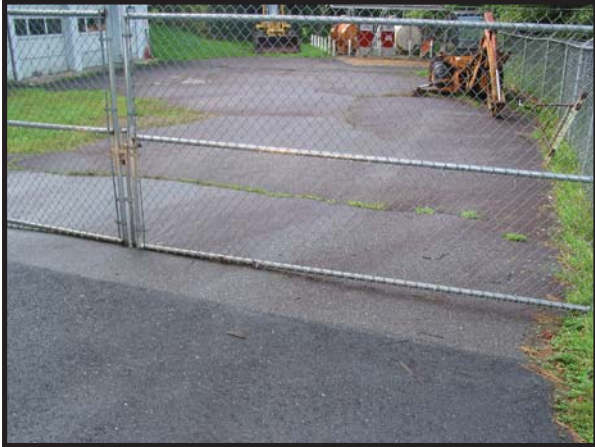
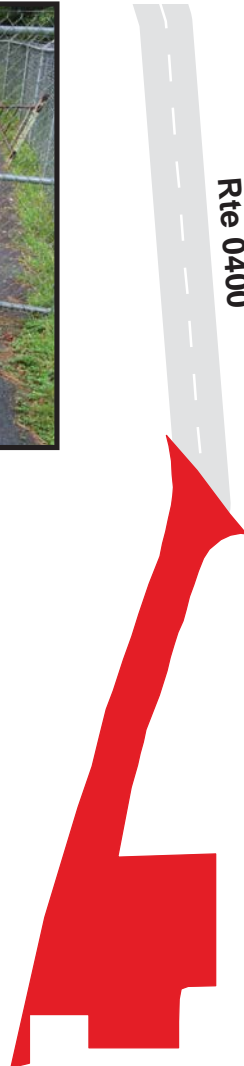
Route 1191A

Route	Public / NonPublic	Date Visited	Area (sq ft)	Lane Miles *	Surface Type	Condition / PCR
1191A	Public	8/31/2003	5838	0.10	AS	EXCELLENT / 97

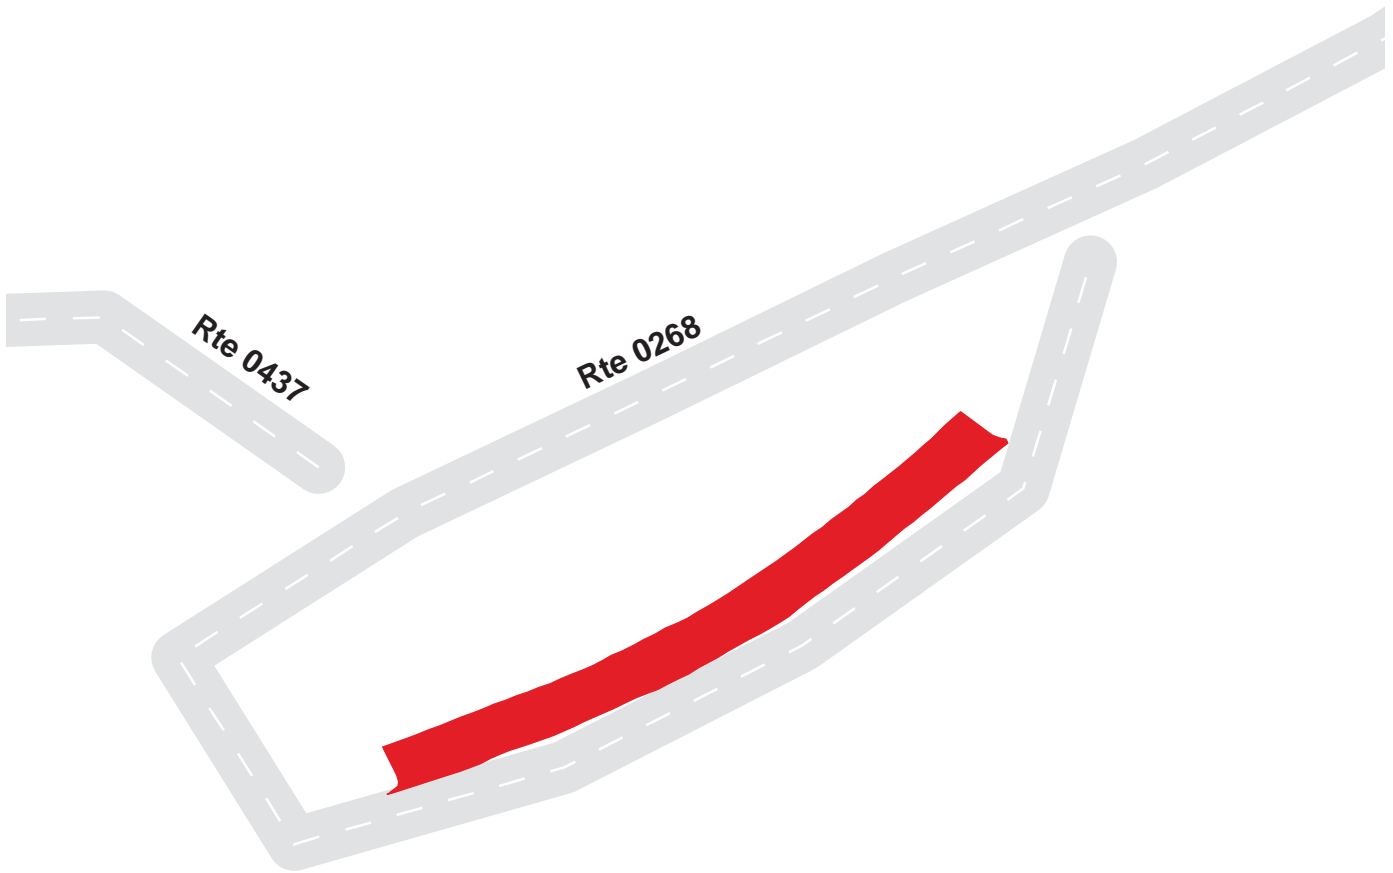
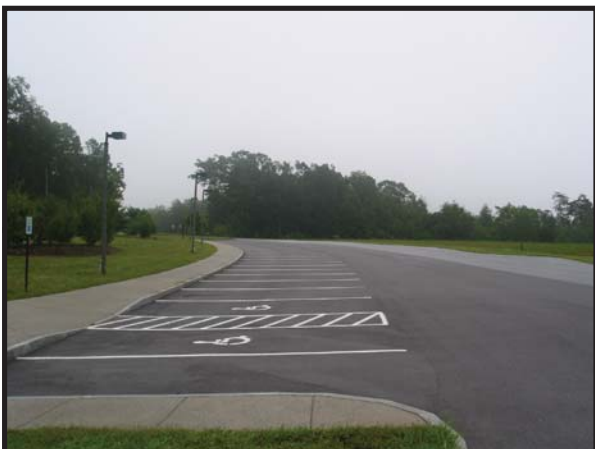
Route 1191B

Route	Public / NonPublic	Date Visited	Area (sq ft)	Lane Miles *	Surface Type	Condition / PCR
1191B	Public	8/31/2003	6730	0.12	AS	EXCELLENT / 97

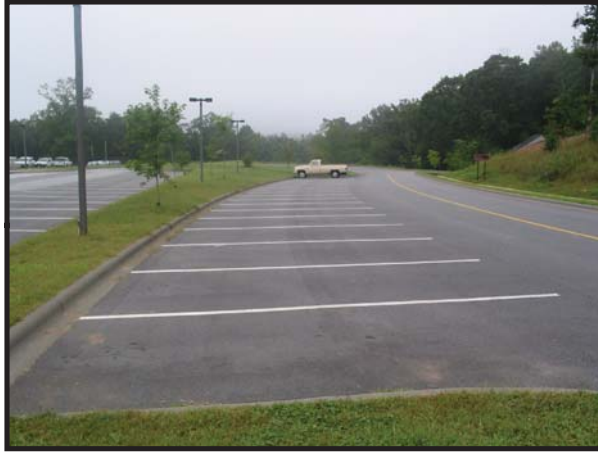
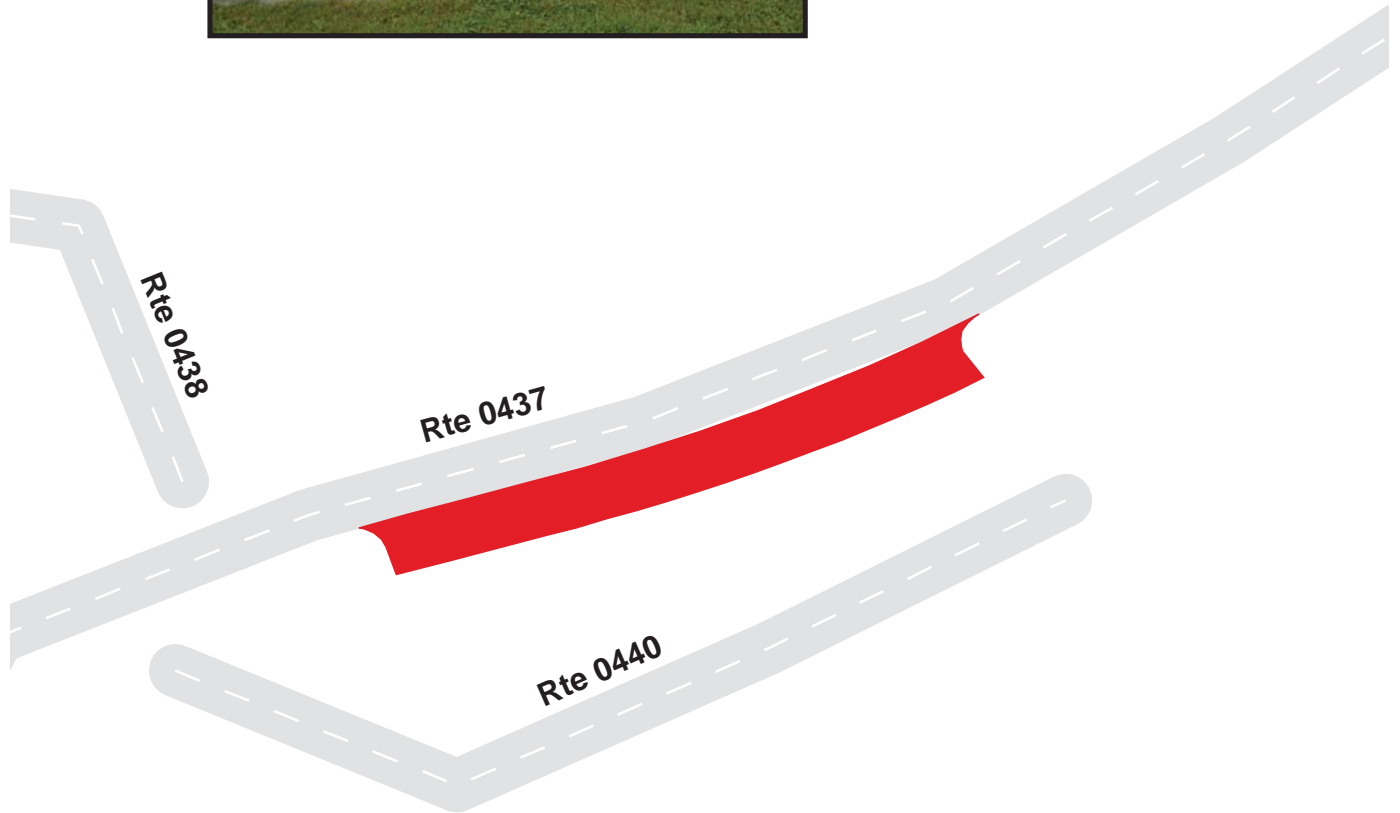
Blue Ridge Parkway Route 1192B

Headquarters Parking Area B
From Route 0440 at MP 0.02 on Left

Route	Public / NonPublic	Date Visited	Area (sq ft)	Lane Miles *	Surface Type	Condition / PCR
1192B	Public	8/31/2003	4461	0.08	AS	EXCELLENT / 97

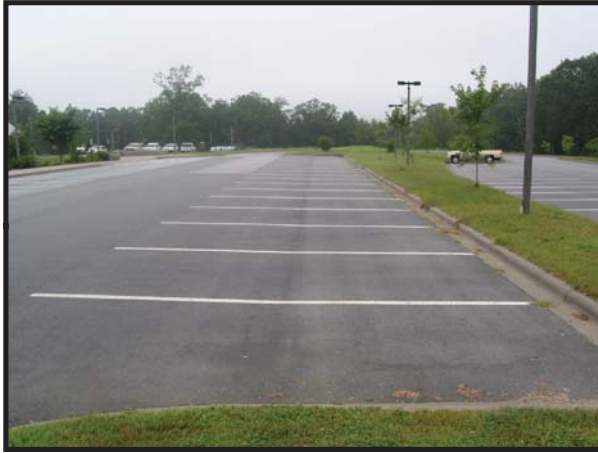
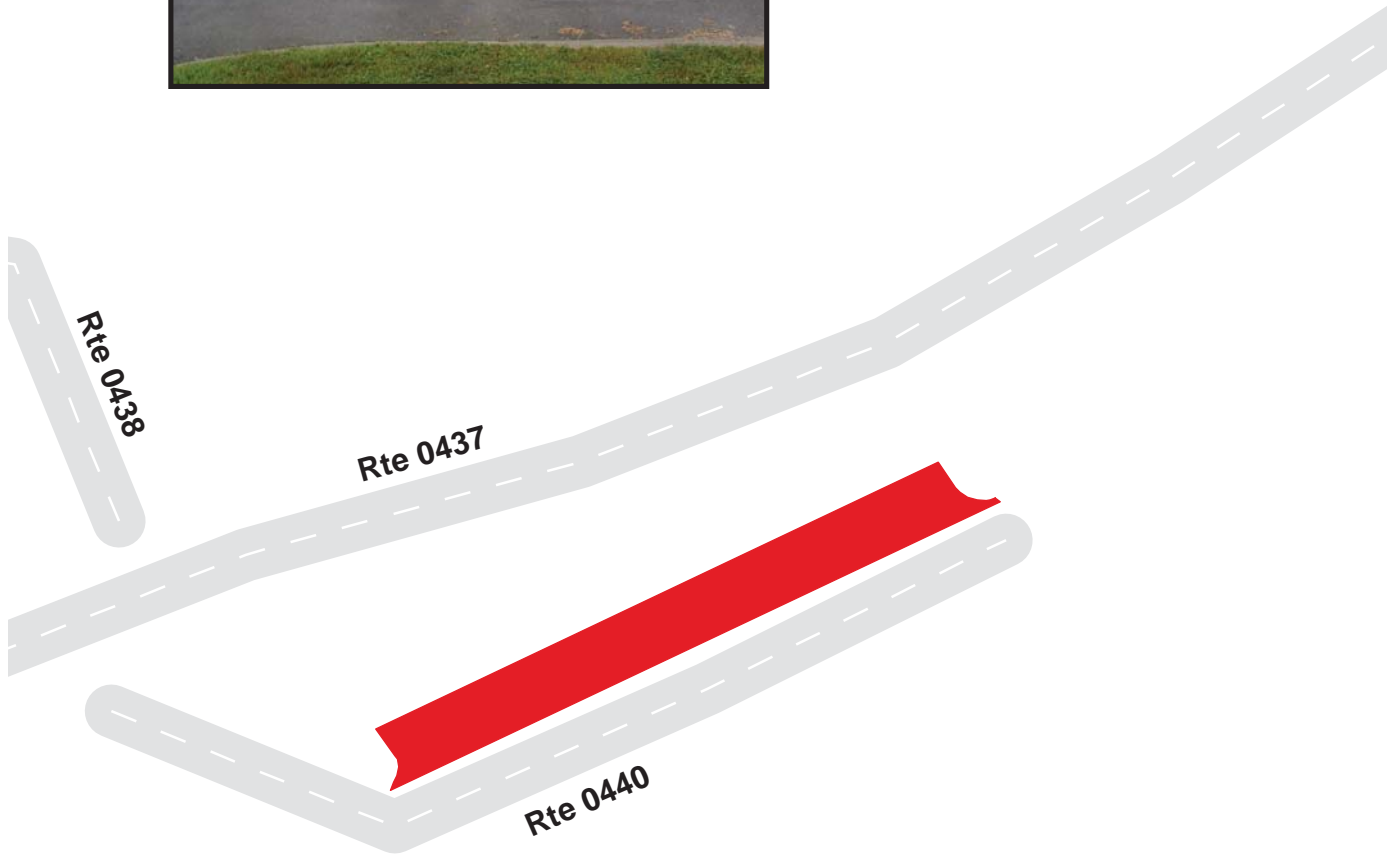
Route 1192C

Route	Public / NonPublic	Date Visited	Area (sq ft)	Lane Miles *	Surface Type	Condition / PCR
1192C	Public	8/31/2003	4468	0.08	AS	EXCELLENT / 97

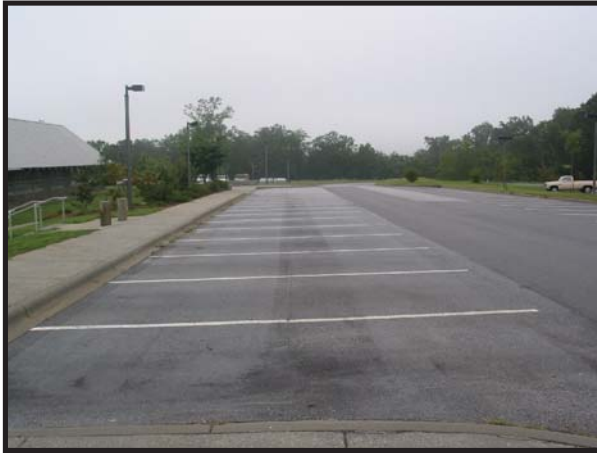
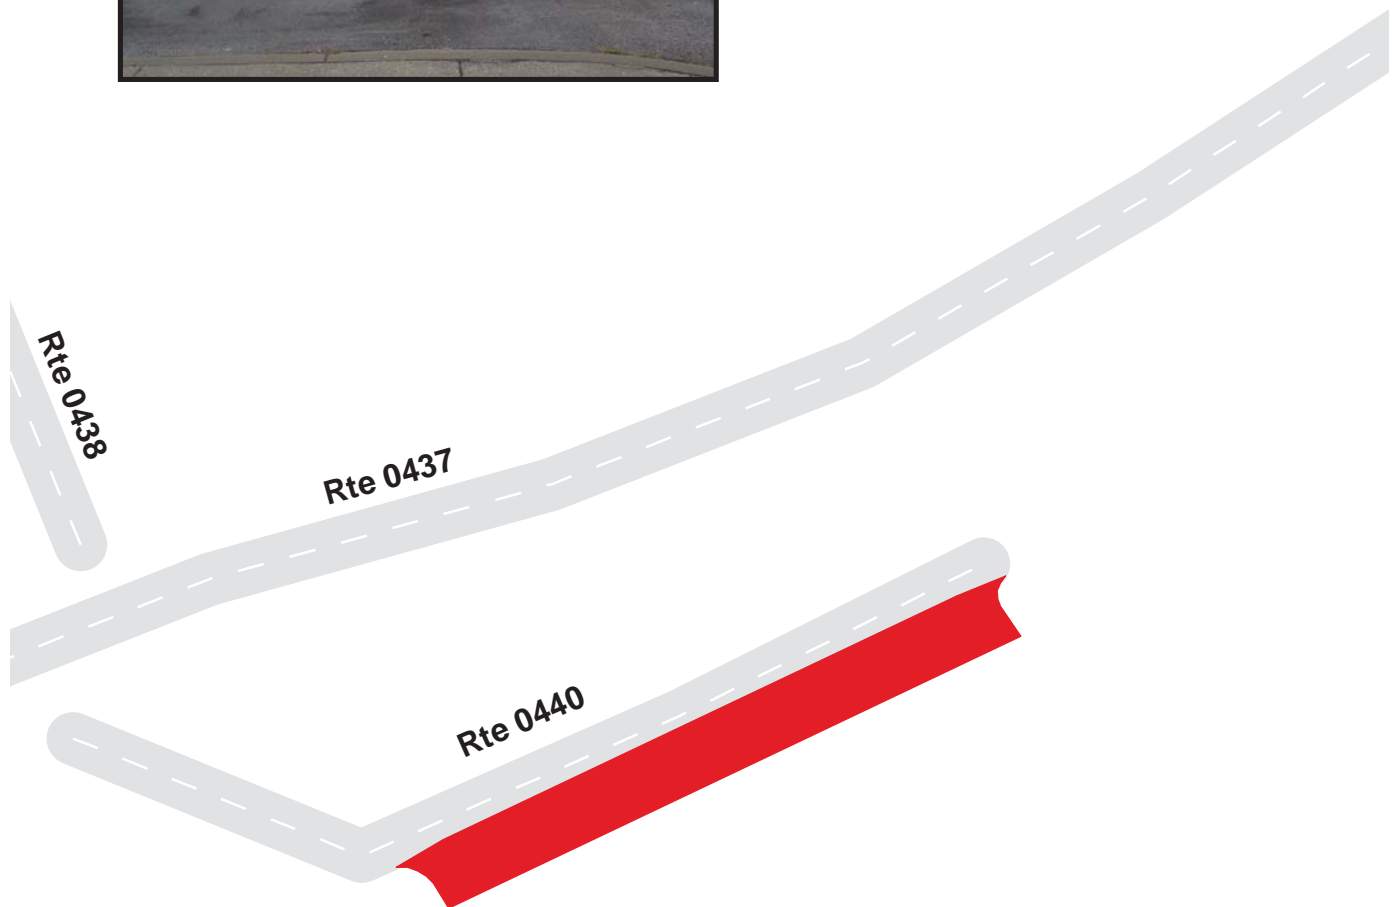
Route 1193

Route	Public / NonPublic	Date Visited	Area (sq ft)	Lane Miles *	Surface Type	Condition / PCR
1193	NonPublic	8/31/2003	8299	0.14	AS	EXCELLENT / 97

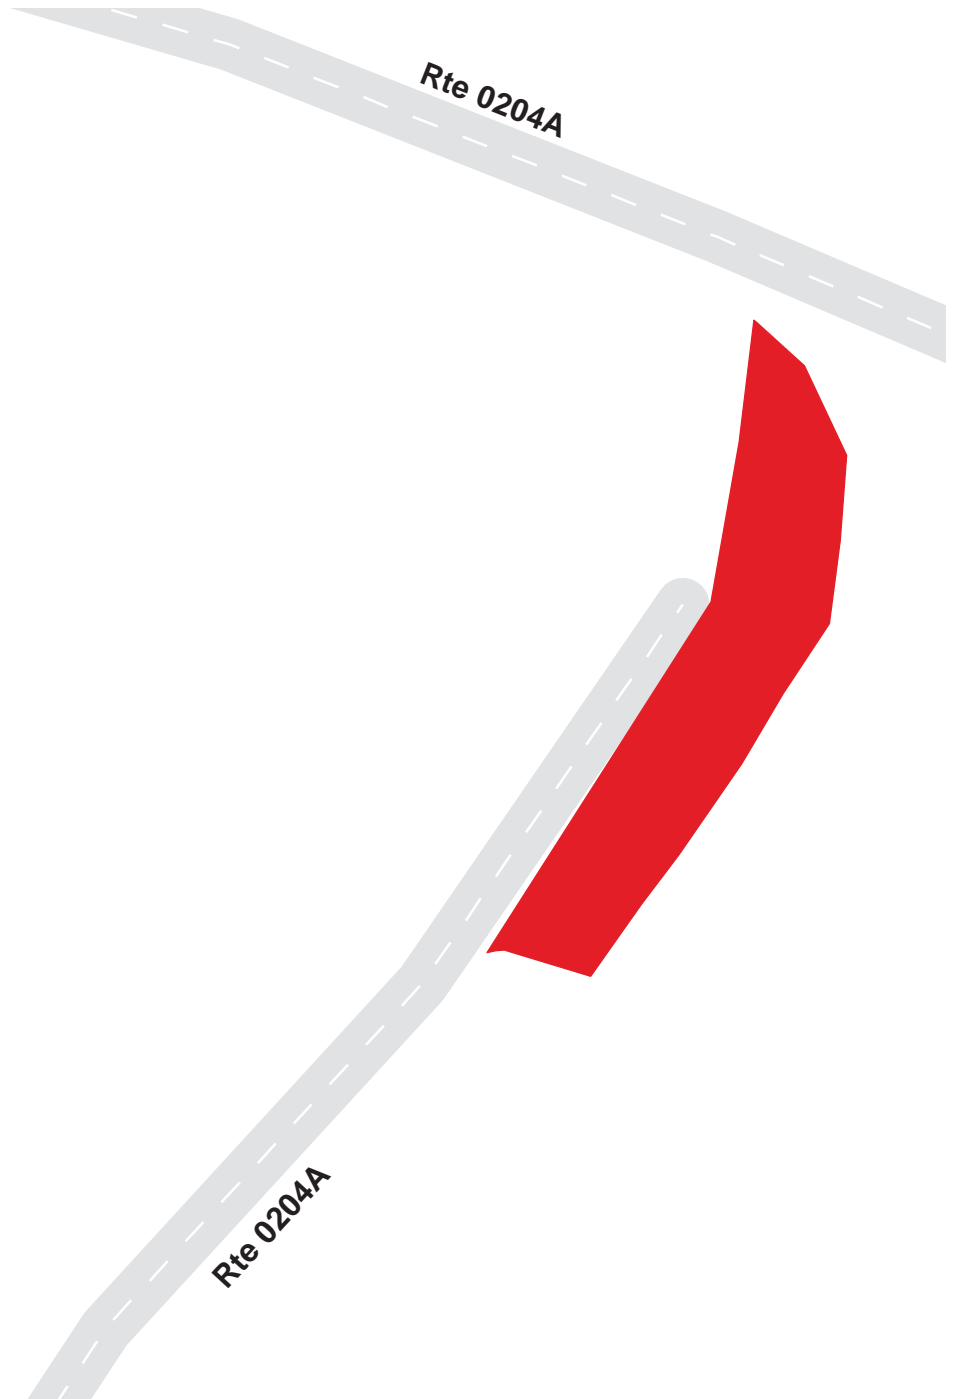
Route 1196N

Route	Public / NonPublic	Date Visited	Area (sq ft)	Lane Miles *	Surface Type	Condition / PCR
1196N	Public	8/31/2003	2429	0.04	AS	FAIR / 73

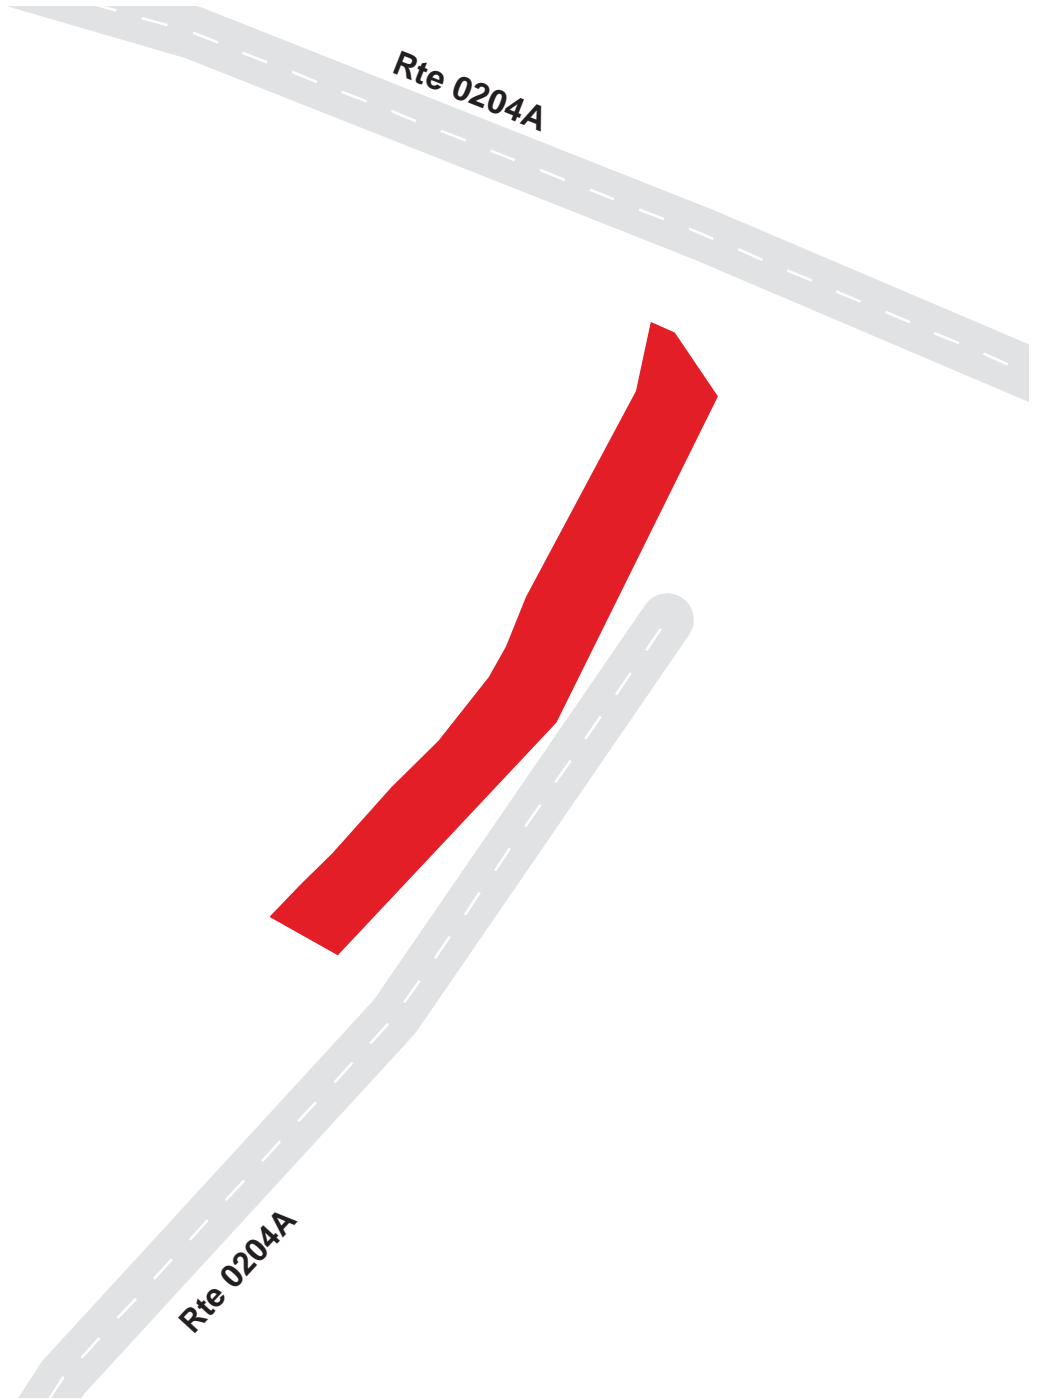
Route 1197A

Route	Public / NonPublic	Date Visited	Area (sq ft)	Lane Miles *	Surface Type	Condition / PCR
1197A	Public	9/1/2003	4082	0.07	AS	GOOD / 90

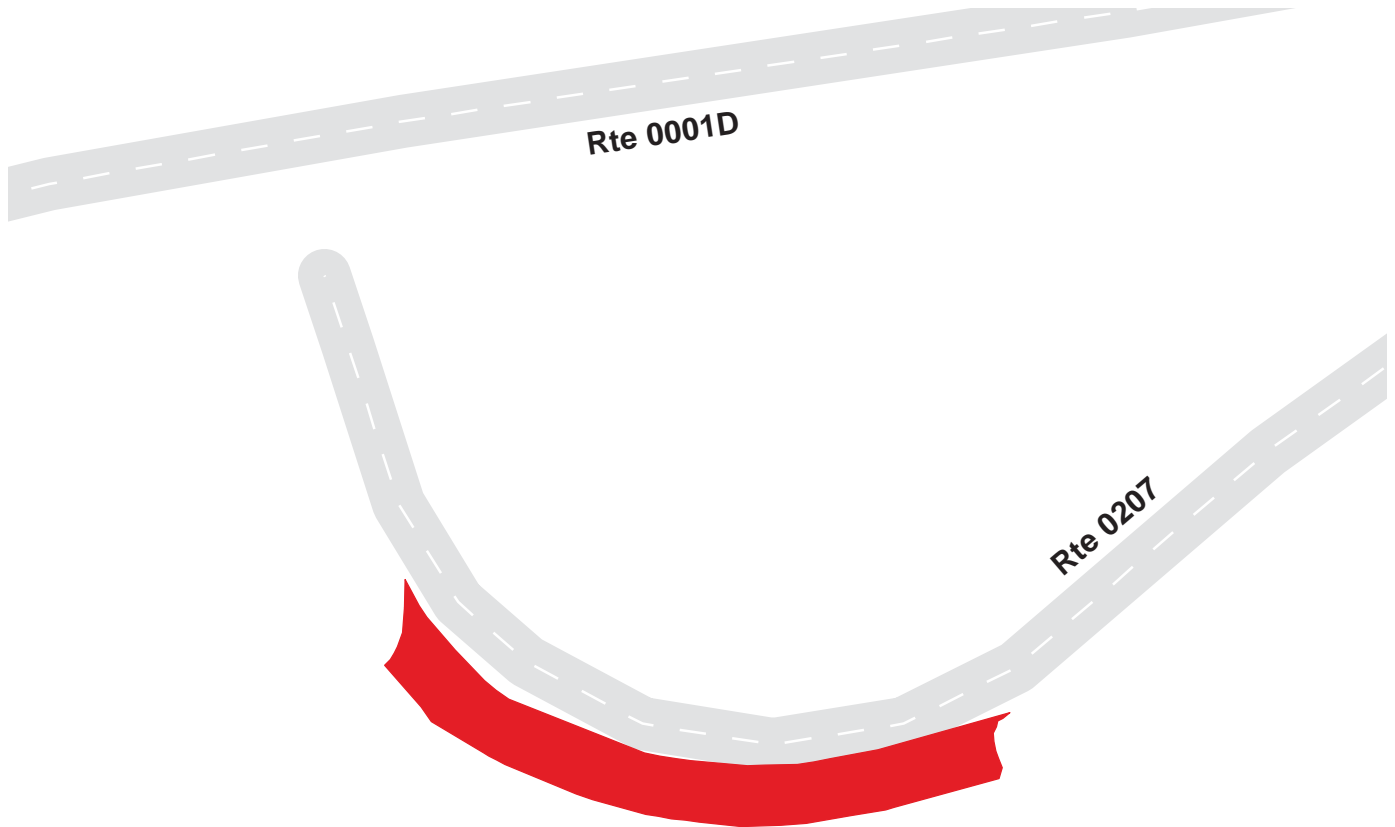
Route 1197B

Route	Public / NonPublic	Date Visited	Area (sq ft)	Lane Miles *	Surface Type	Condition / PCR
1197B	Public	9/1/2003	1062	0.02	AS	GOOD / 90

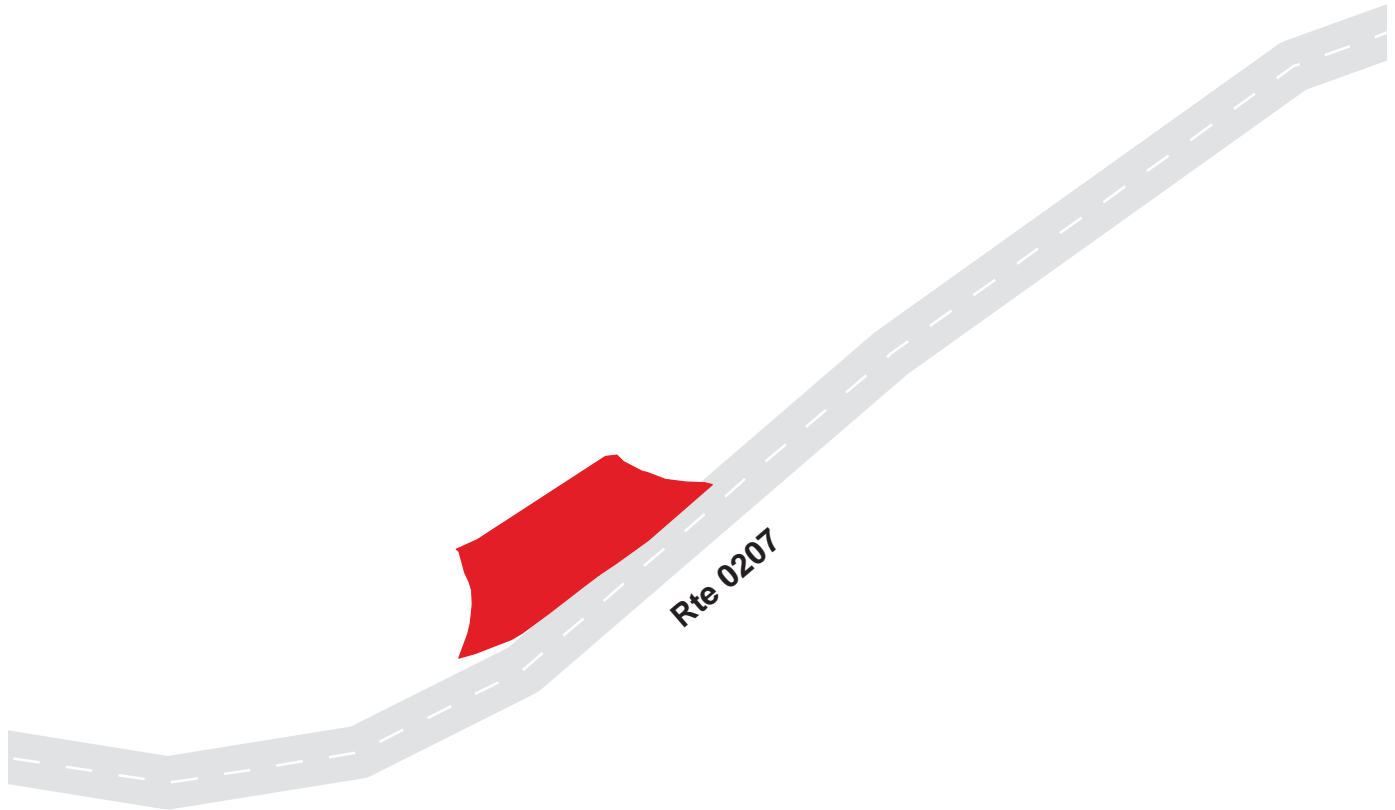
Route 1197C

Route	Public / NonPublic	Date Visited	Area (sq ft)	Lane Miles *	Surface Type	Condition / PCR
1197C	Public	9/1/2003	2095	0.04	AS	GOOD / 90

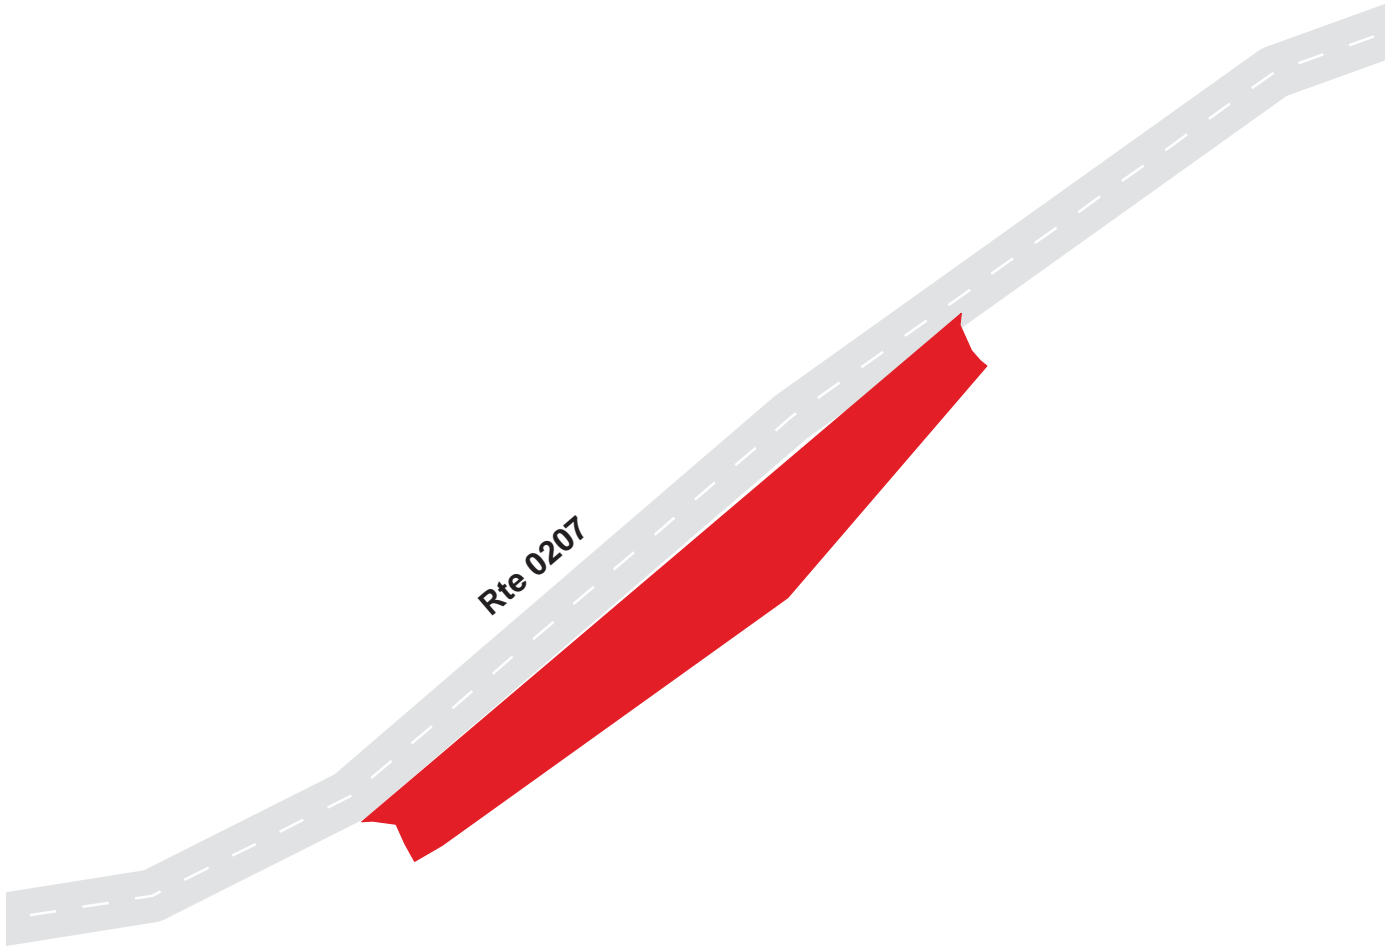
Route 1197D

Route	Public / NonPublic	Date Visited	Area (sq ft)	Lane Miles *	Surface Type	Condition / PCR
1197D	Public	9/1/2003	1308	0.02	AS	GOOD / 90

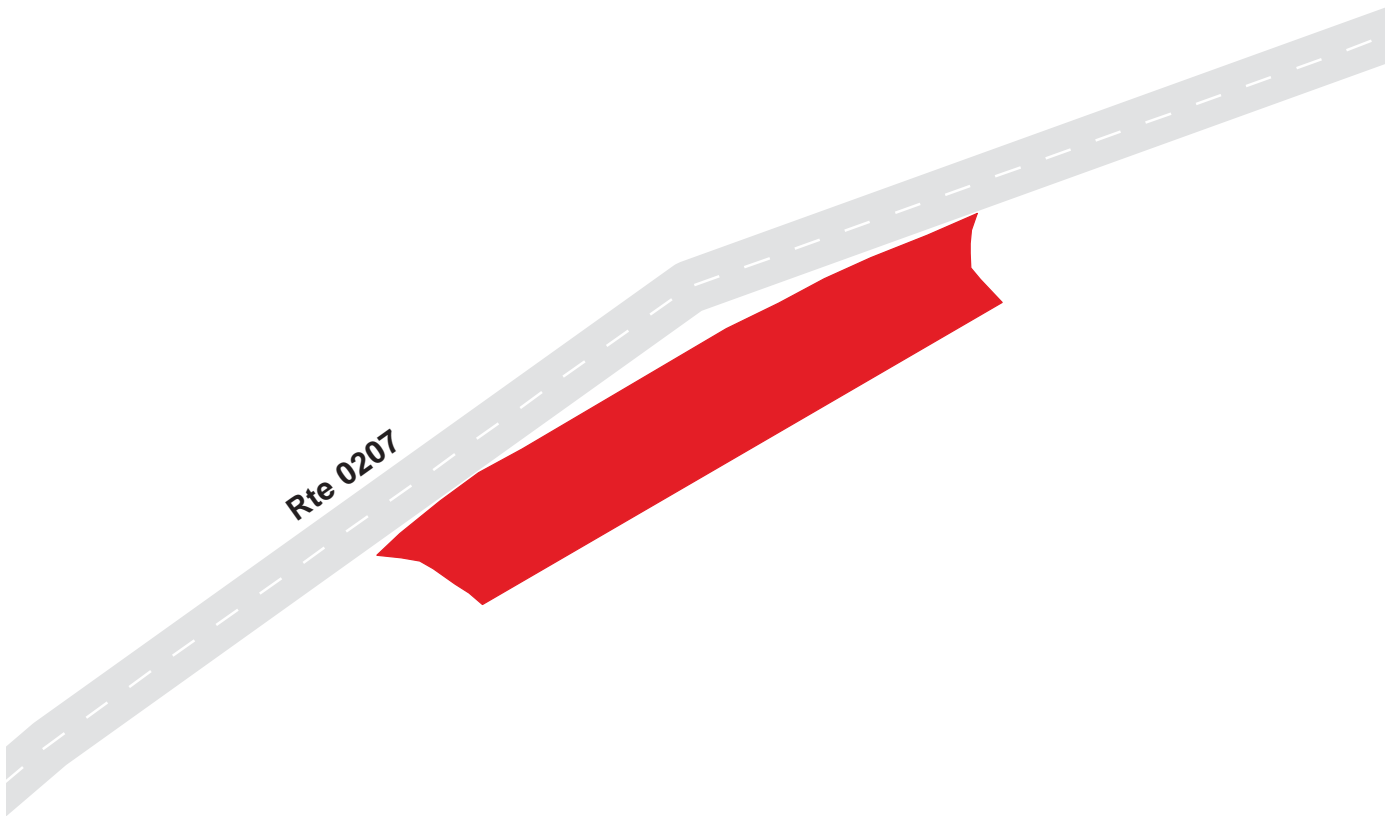
Route 1197E

Route	Public / NonPublic	Date Visited	Area (sq ft)	Lane Miles *	Surface Type	Condition / PCR
1197E	Public	9/1/2003	1272	0.02	AS	GOOD / 90

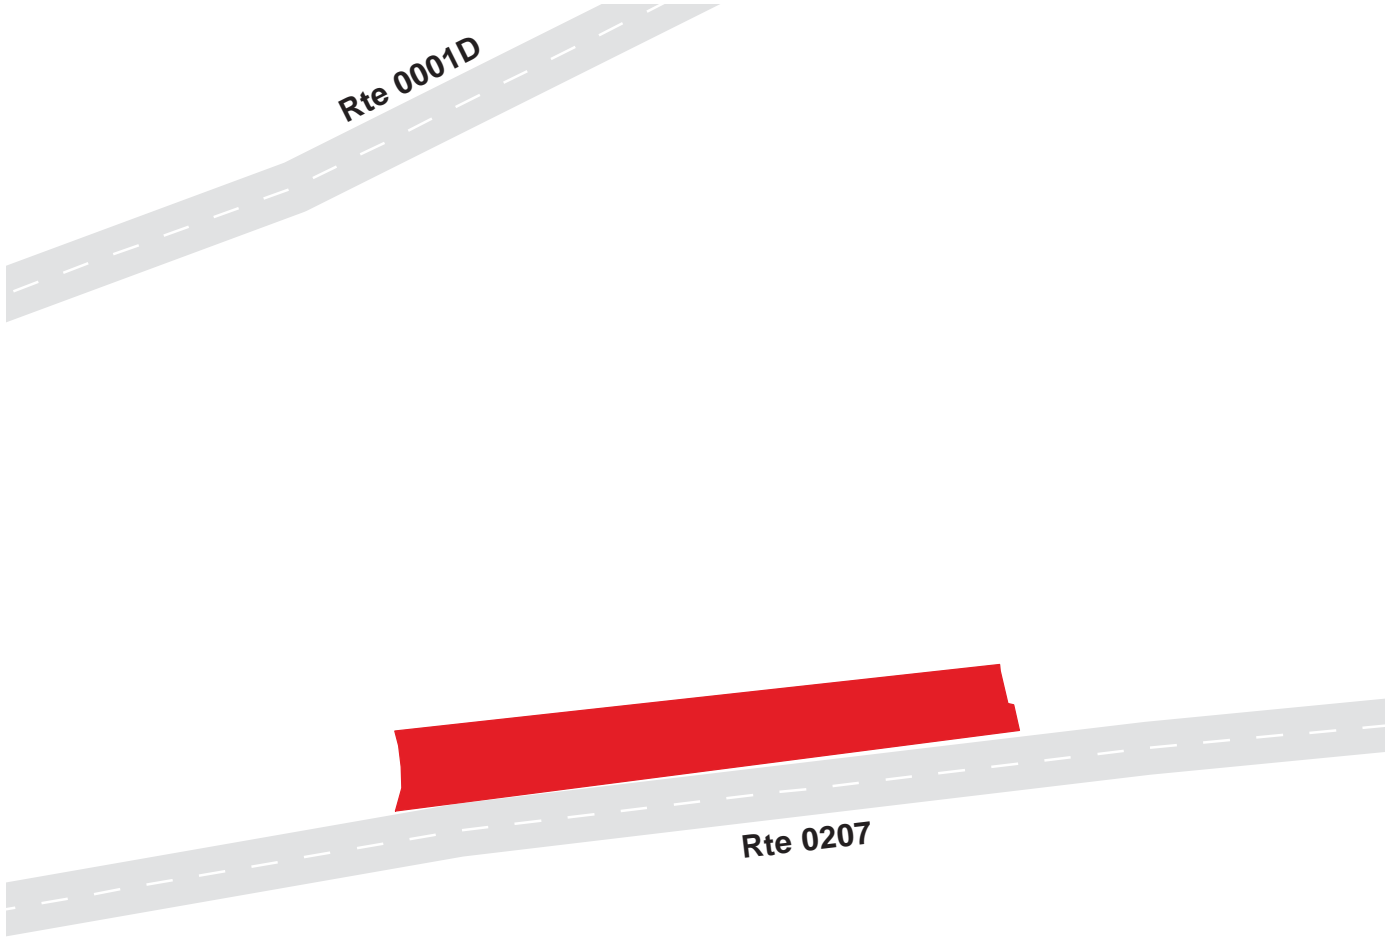
Route 1197F

Route	Public / NonPublic	Date Visited	Area (sq ft)	Lane Miles *	Surface Type	Condition / PCR
1197F	Public	9/1/2003	1704	0.03	AS	GOOD / 90

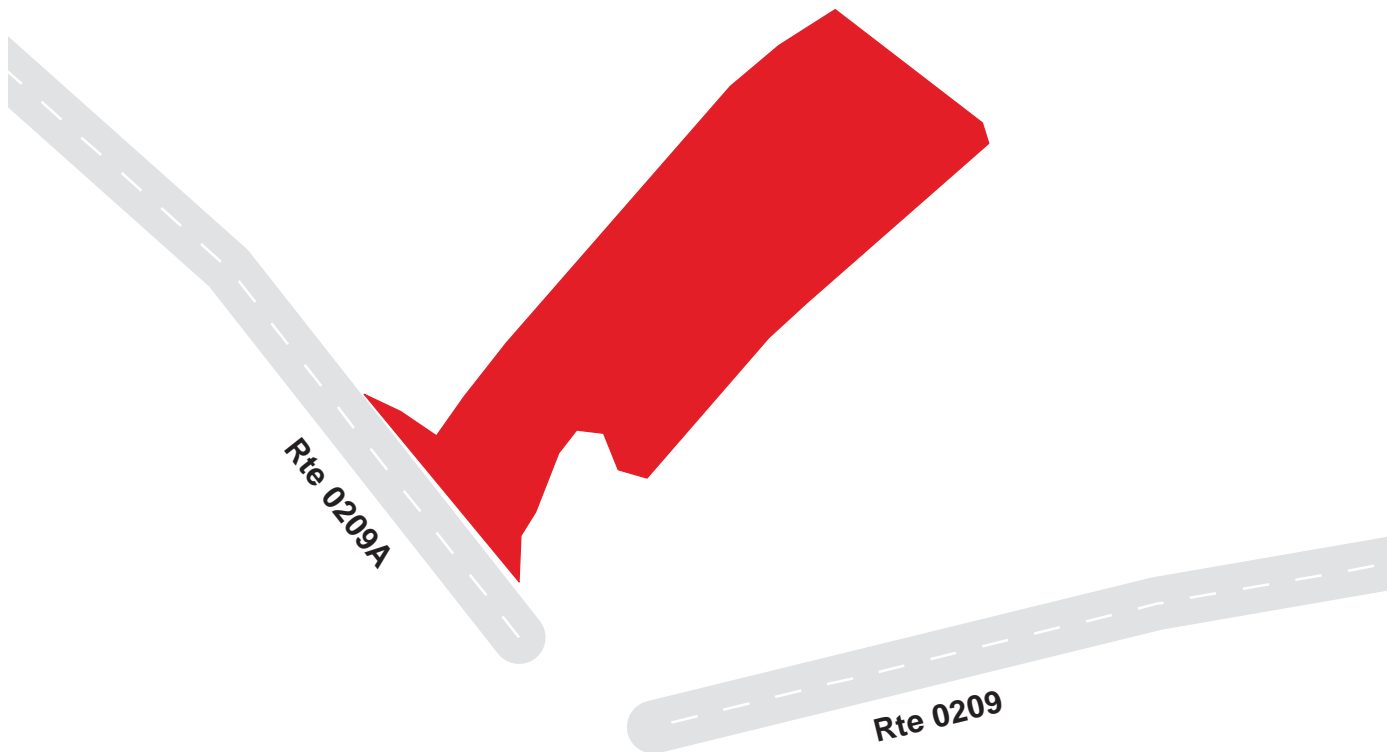
Route 1199A

Route	Public / NonPublic	Date Visited	Area (sq ft)	Lane Miles *	Surface Type	Condition / PCR
1199A	Public	9/1/2003	11625	0.20	AS	GOOD / 90

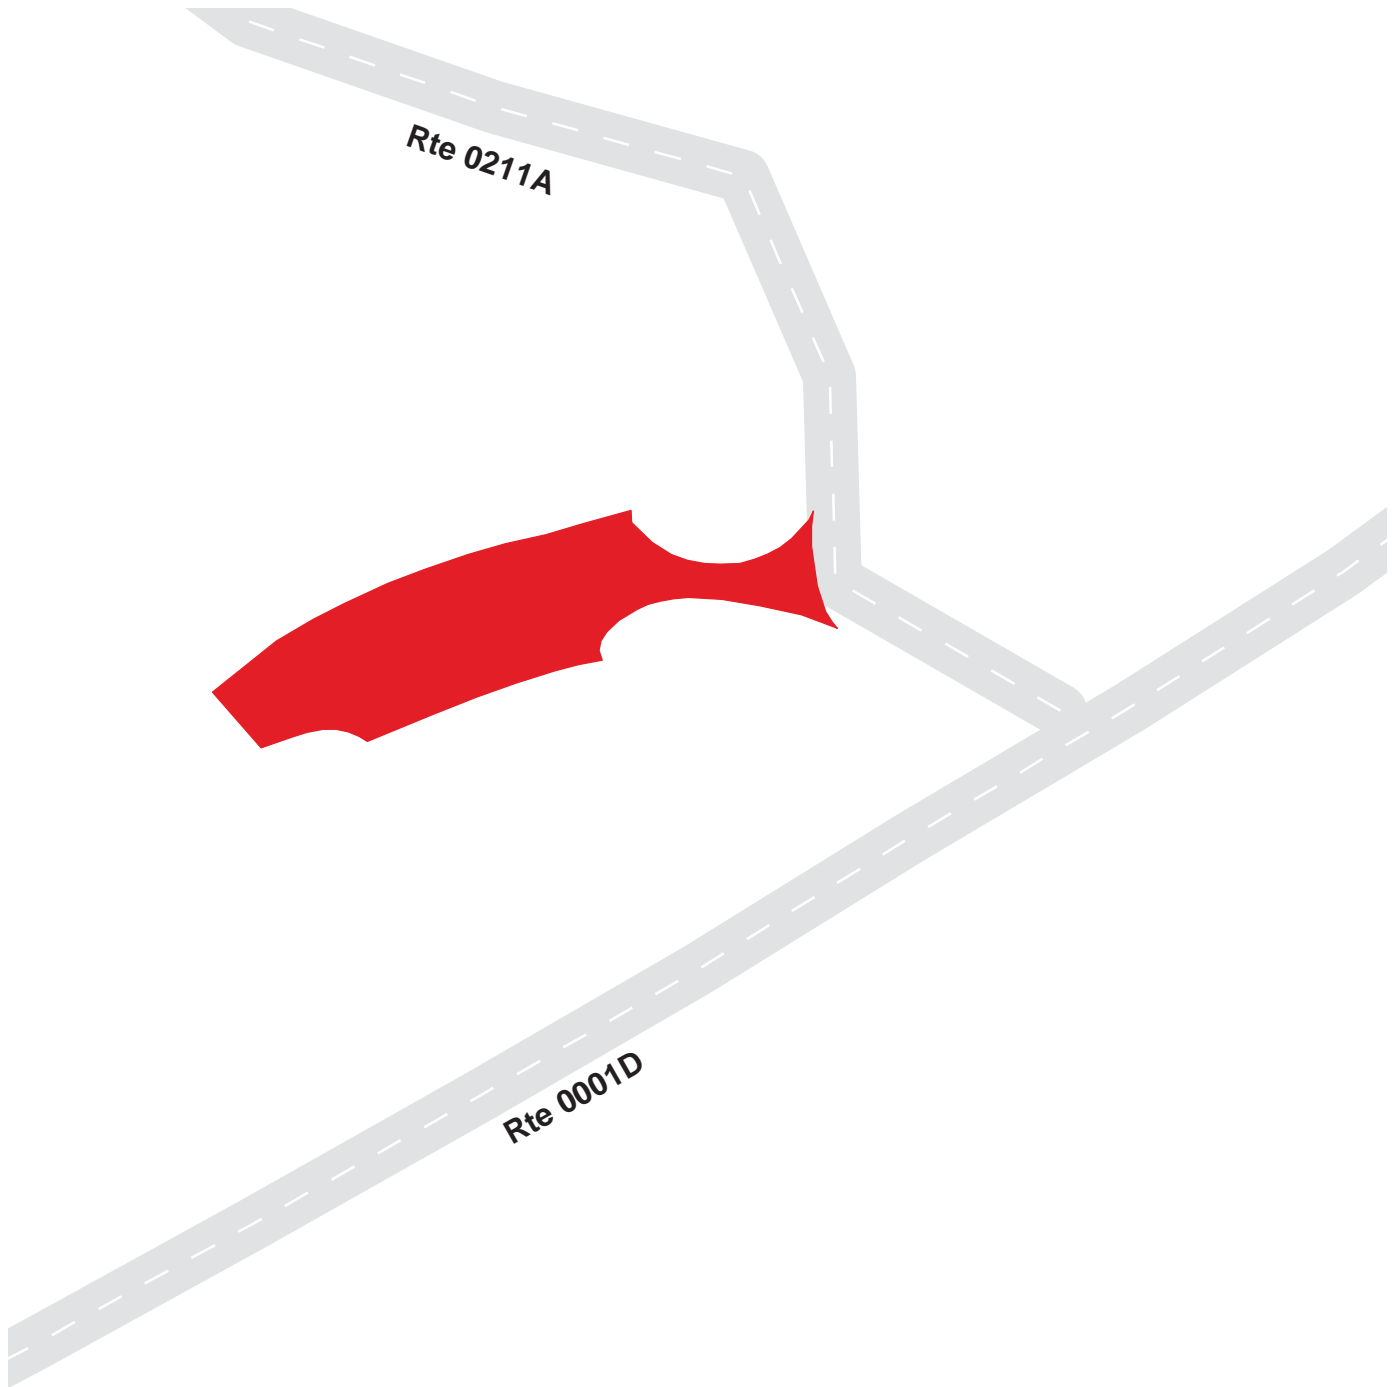
Route 1199B

Route	Public / NonPublic	Date Visited	Area (sq ft)	Lane Miles *	Surface Type	Condition / PCR
1199B	Public	9/1/2003	1649	0.03	AS	FAIR / 73

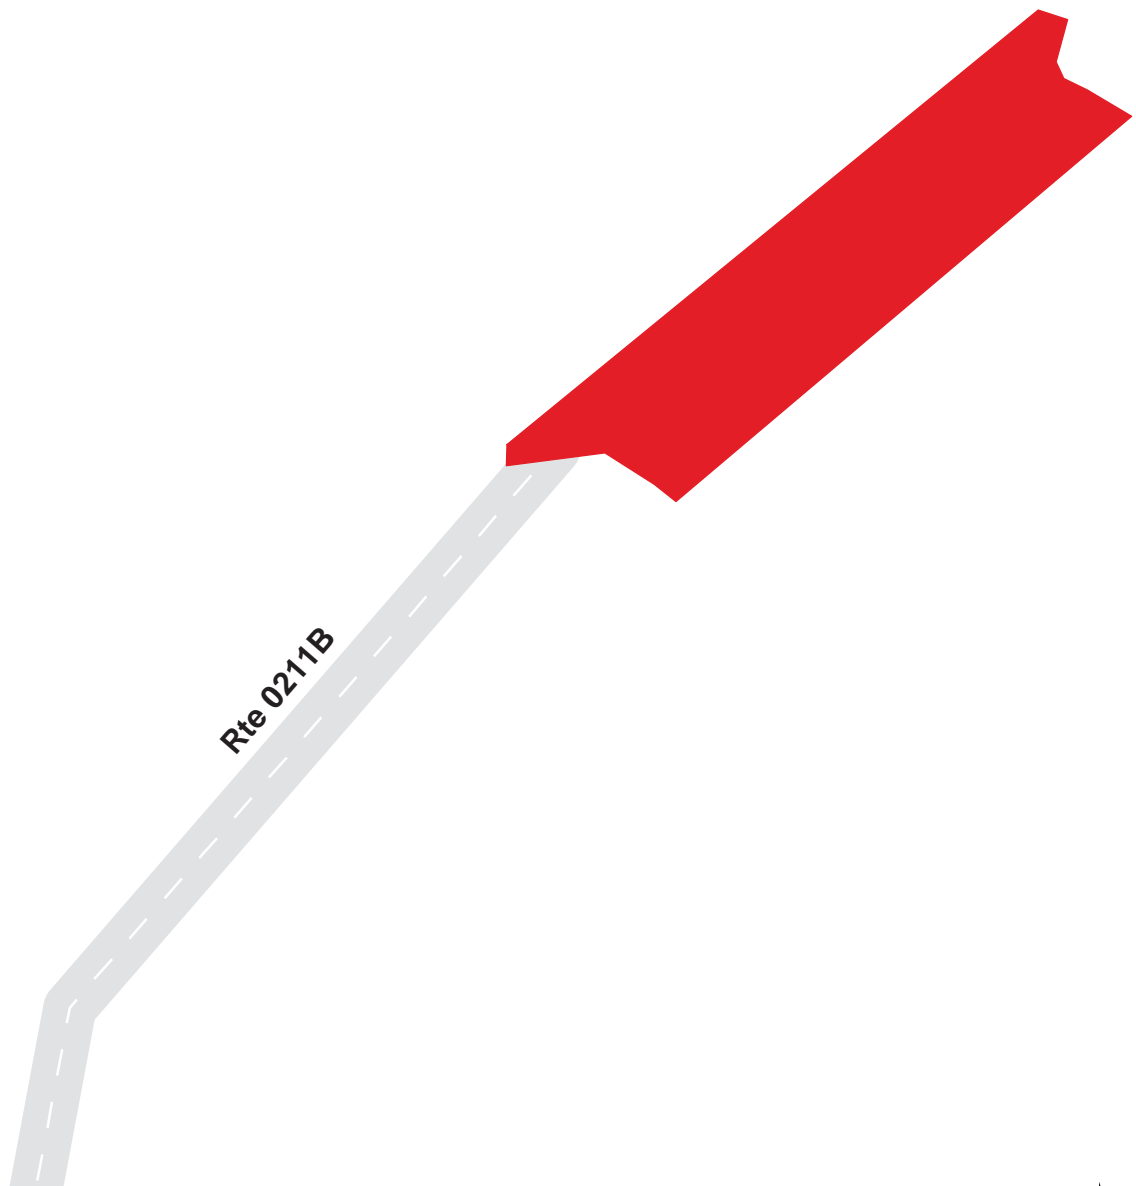
Route 1199C

Route	Public / NonPublic	Date Visited	Area (sq ft)	Lane Miles *	Surface Type	Condition / PCR
1199C	Public	9/1/2003	1340	0.02	AS	FAIR / 73
