The Road Inventory of Blue Ridge Parkway BLRI – 5140 Volume 1

Road Inventory Program

Prepared By:
Federal Highway Administration
Eastern Federal Lands Highway Division
Cycle 3

Blue Ridge Parkway in North Carolina

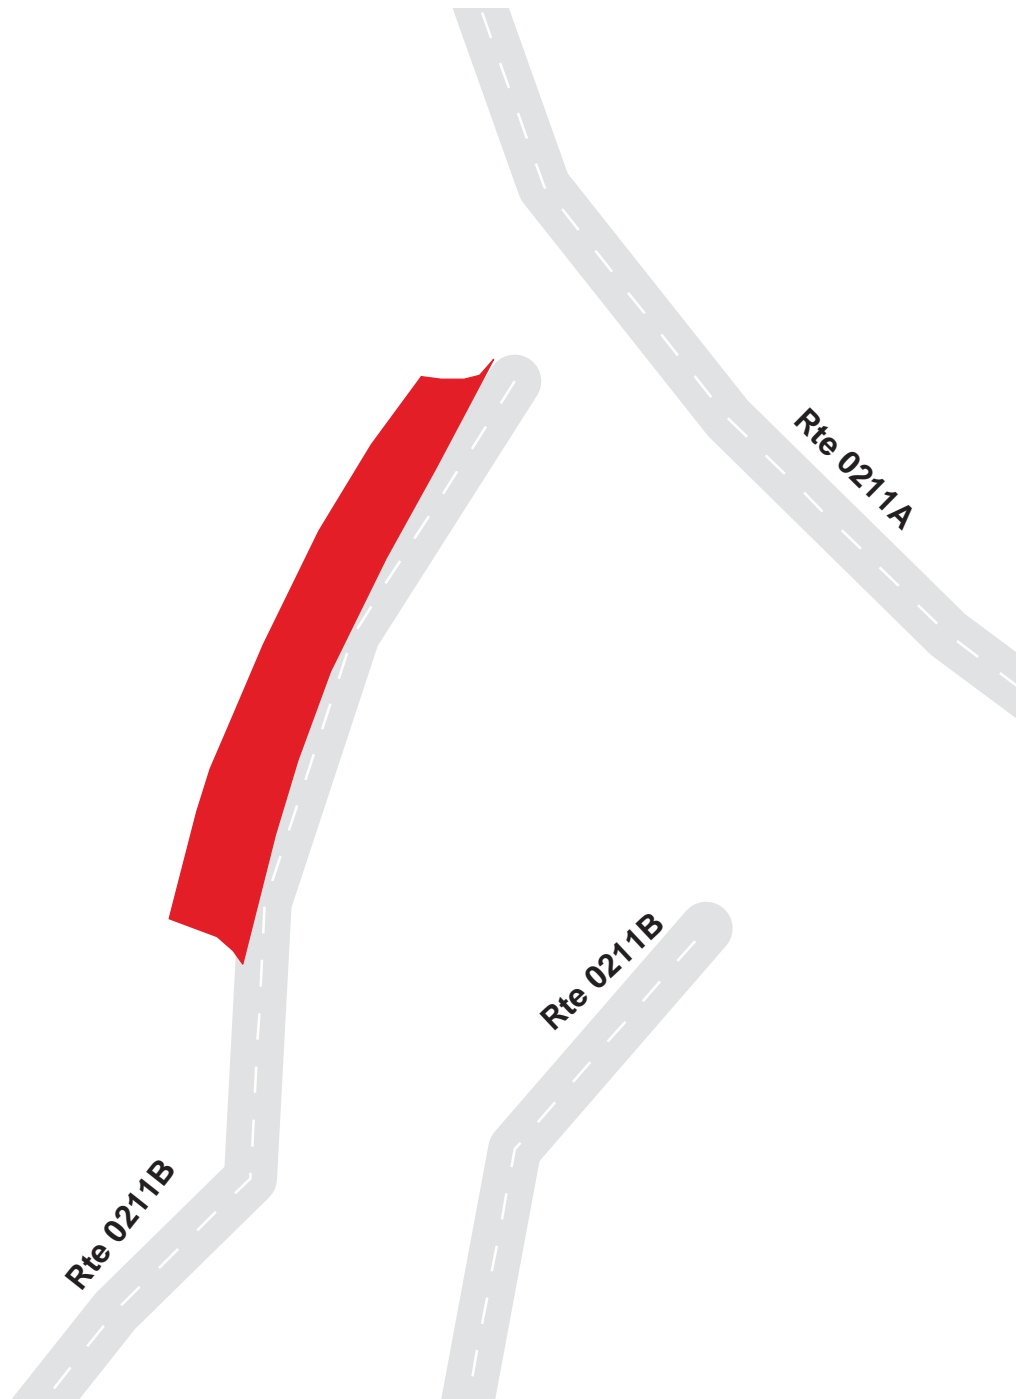
Route 1199G

Route	Public / NonPublic	Date Visited	Area (sq ft)	Lane Miles *	Surface Type	Condition / PCR
1199G	Public	9/1/2003	1402	0.02	AS	FAIR / 73

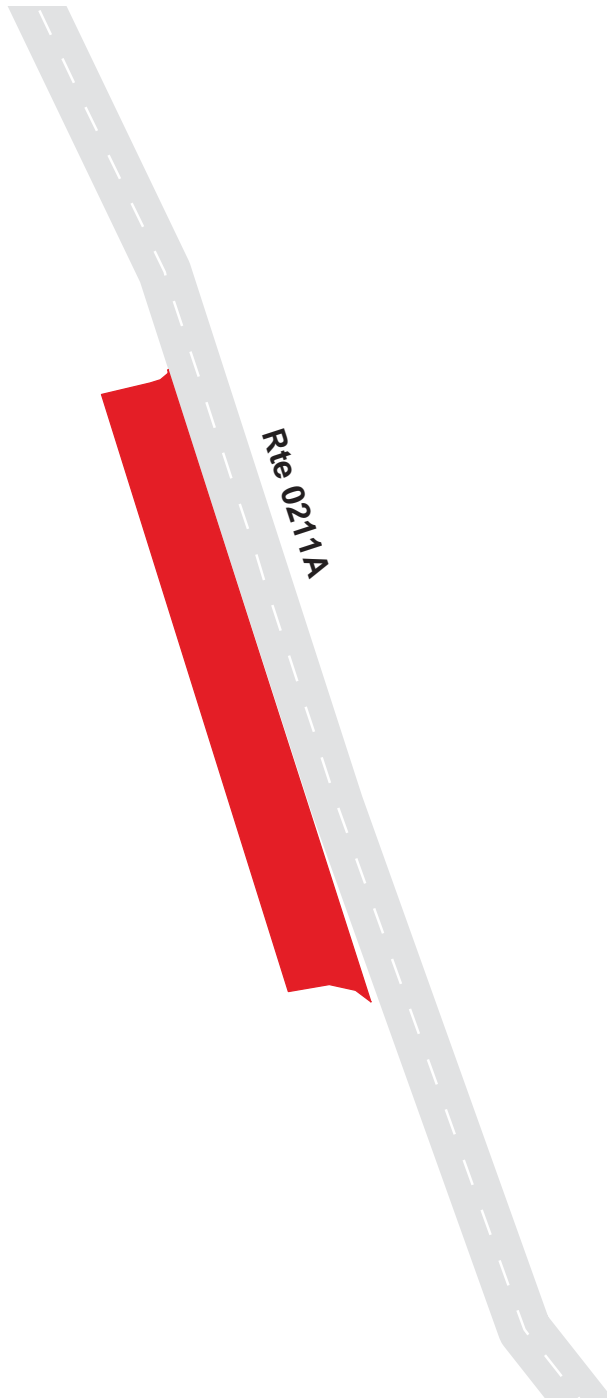
Route 1199H

Route	Public / NonPublic	Date Visited	Area (sq ft)	Lane Miles *	Surface Type	Condition / PCR
1199H	Public	9/1/2003	4050	0.07	AS	POOR / 45

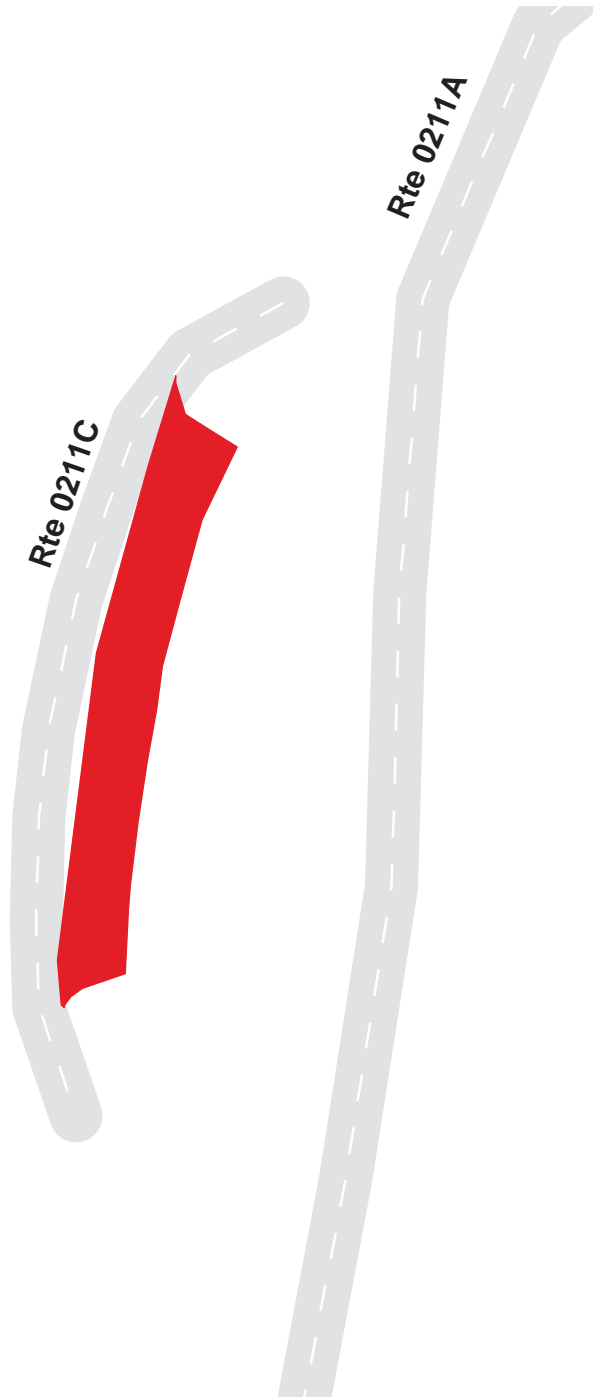
Route 1199I

Route	Public / NonPublic	Date Visited	Area (sq ft)	Lane Miles *	Surface Type	Condition / PCR
1199I	Public	9/1/2003	4555	0.08	AS	FAIR / 73

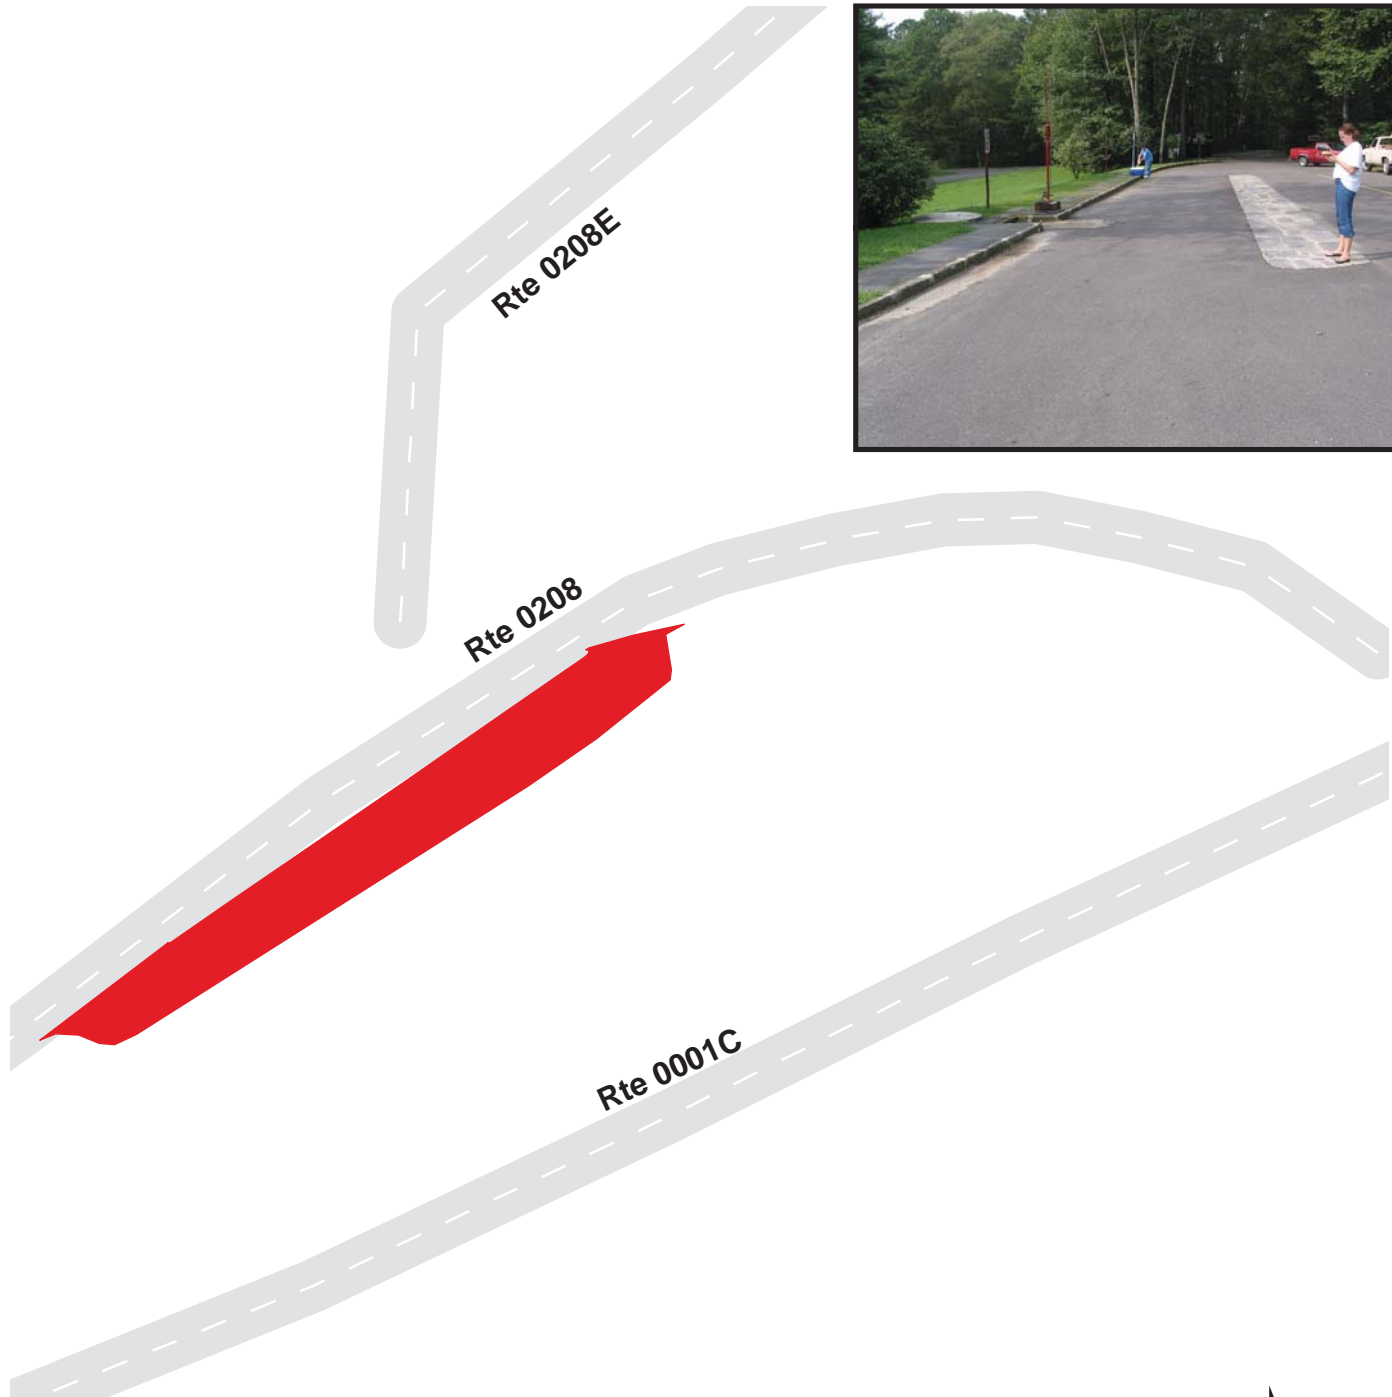
Blue Ridge Parkway Route 1201C

Price Campground Trailhead Parking
At End of Route 0208B on Left

Route	Public / NonPublic	Date Visited	Area (sq ft)	Lane Miles *	Surface Type	Condition / PCR
1201C	Public	9/3/2003	641	0.01	AS	POOR / 45

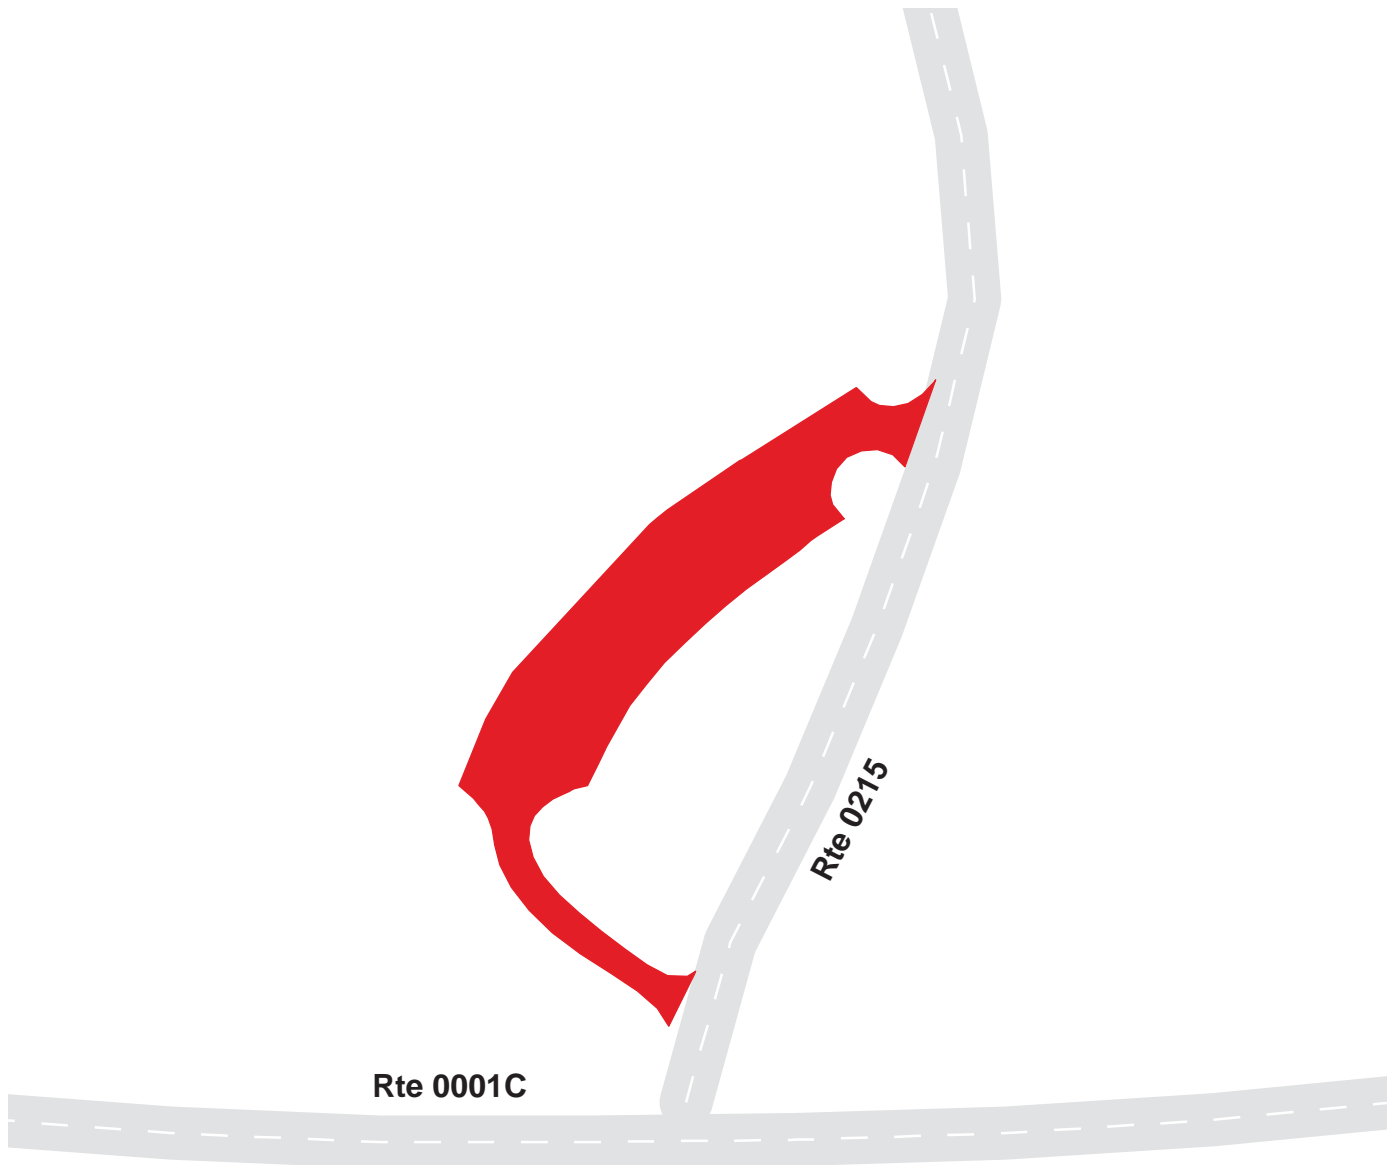
Route 1202B

Route	Public / NonPublic	Date Visited	Area (sq ft)	Lane Miles *	Surface Type	Condition / PCR
1202B	Public	9/3/2003	11326	0.20	AS	FAIR / 73

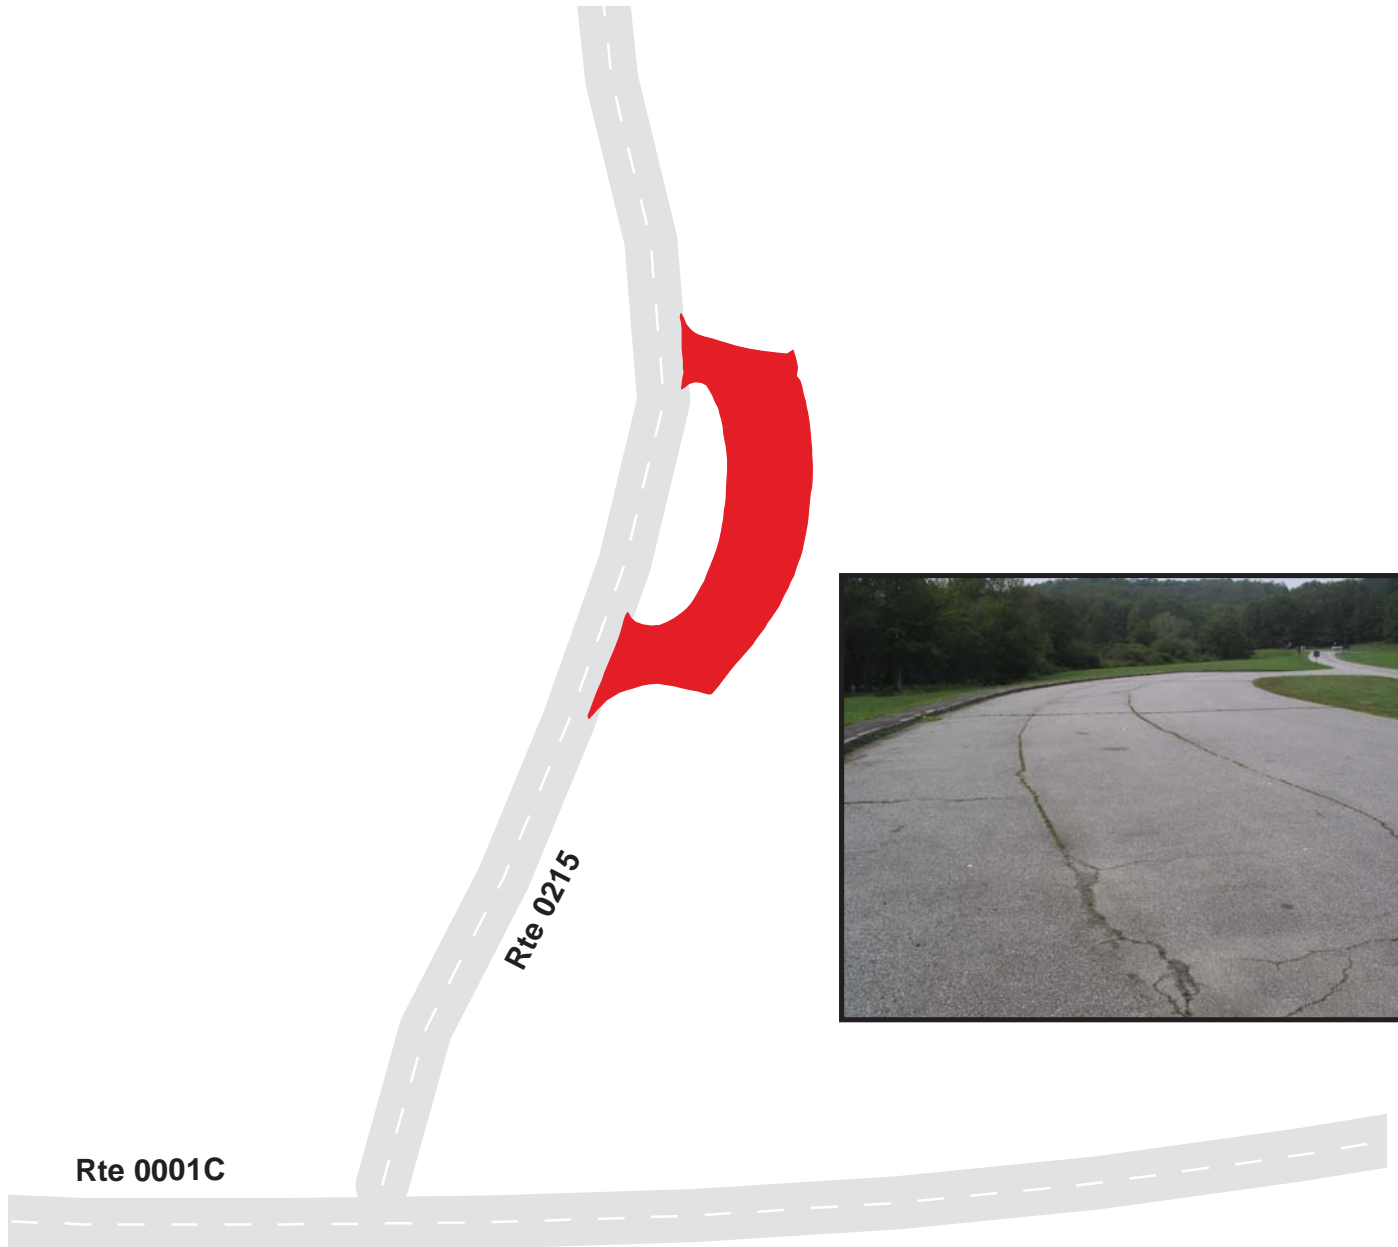
Route 1202C

Route	Public / NonPublic	Date Visited	Area (sq ft)	Lane Miles *	Surface Type	Condition / PCR
1202C	Public	9/3/2003	9031	0.16	AS	FAIR / 73

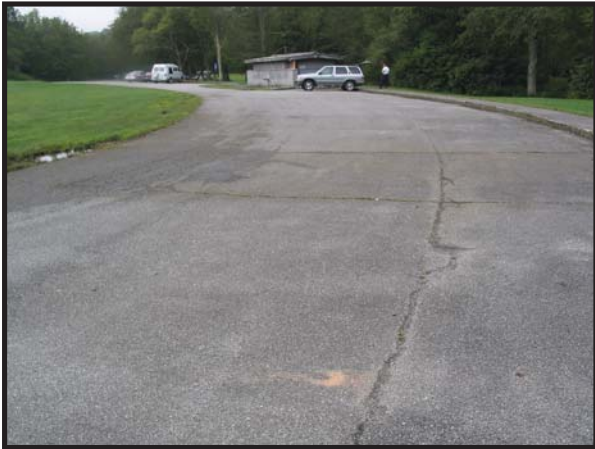
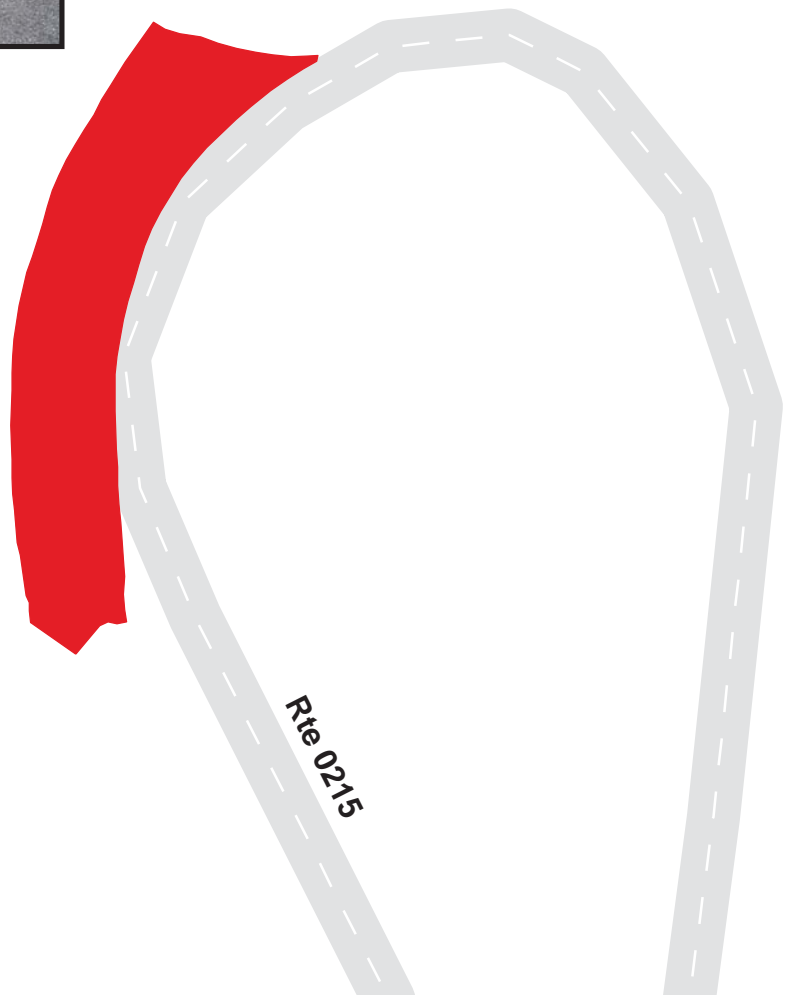
Route 1202F

Route	Public / NonPublic	Date Visited	Area (sq ft)	Lane Miles *	Surface Type	Condition / PCR
1202F	Public	9/3/2003	2559	0.04	AS	FAIR / 73

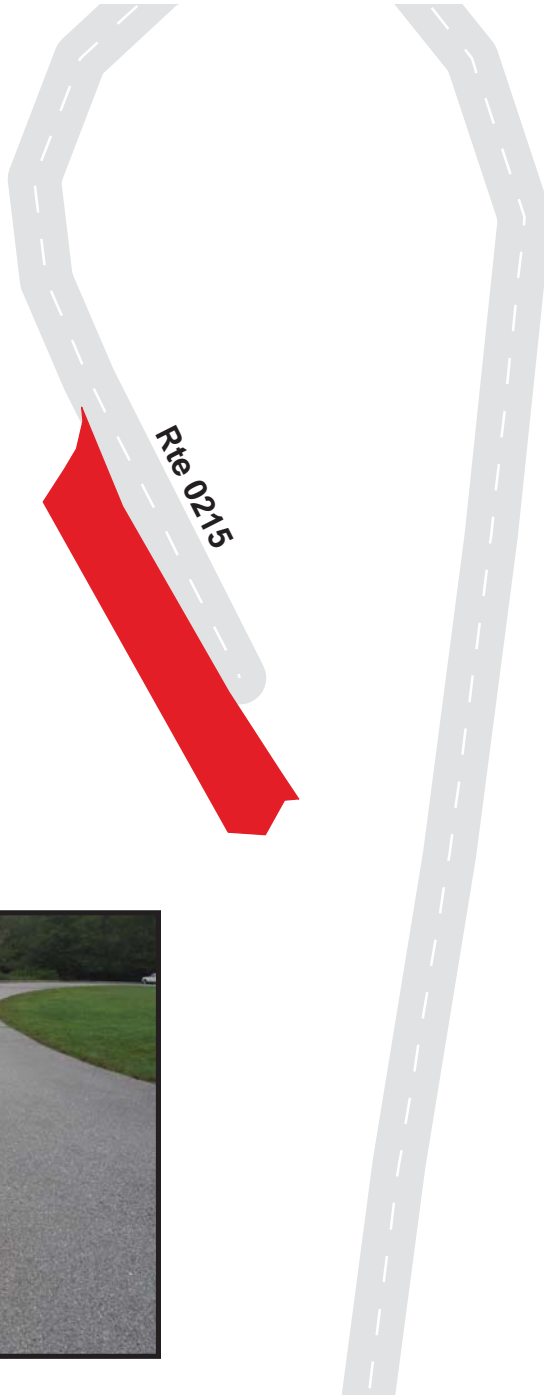
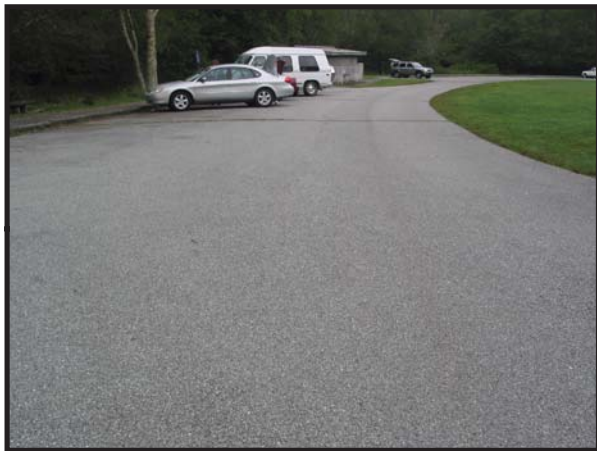
Route 1203A

Route	Public / NonPublic	Date Visited	Area (sq ft)	Lane Miles *	Surface Type	Condition / PCR
1203A	NonPublic	9/3/2003	14159	0.24	AS	POOR / 45

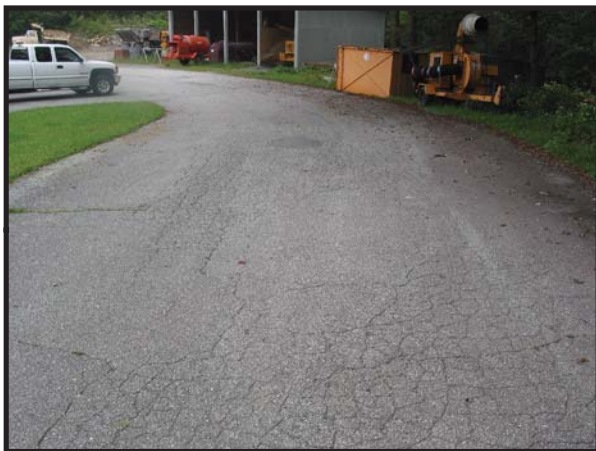
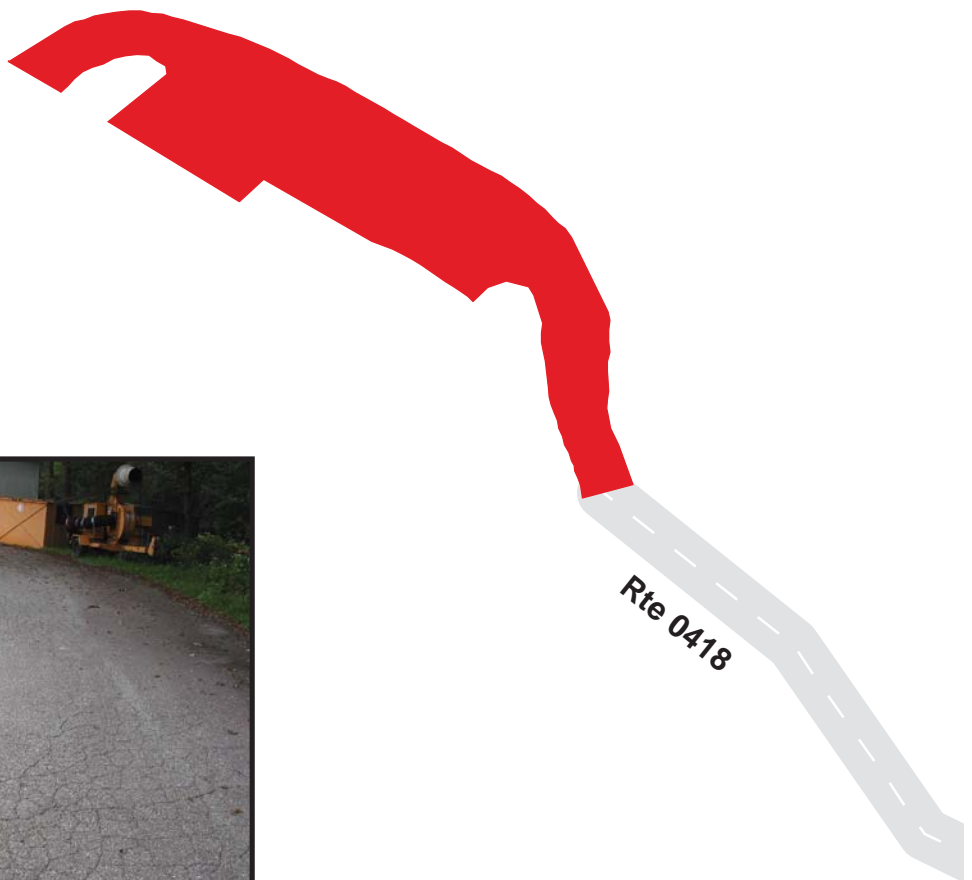
Route 1203B

Route	Public / NonPublic	Date Visited	Area (sq ft)	Lane Miles *	Surface Type	Condition / PCR
1203B	NonPublic	9/3/2003	36486	0.63	AS	POOR / 45

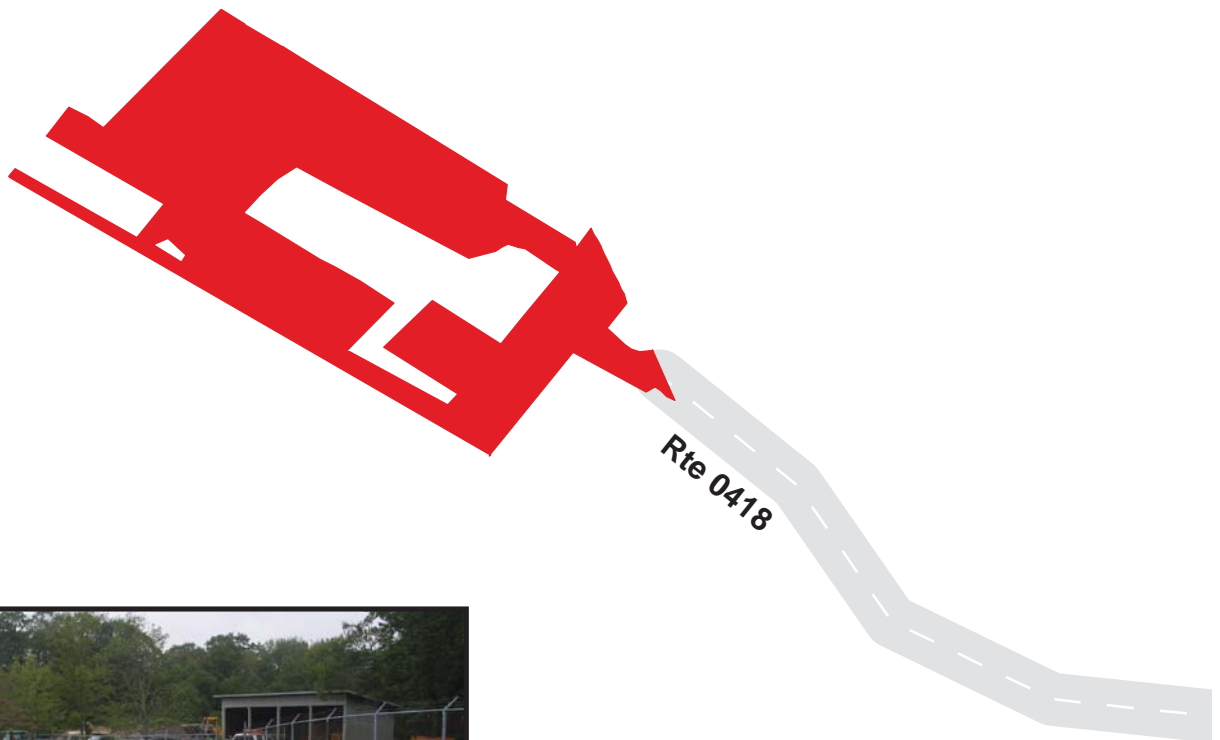
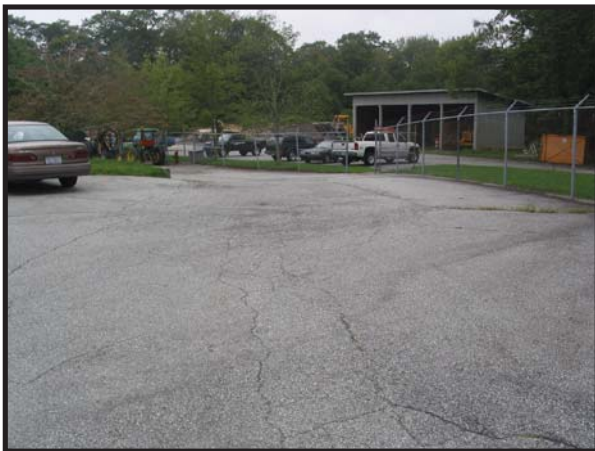
Route 1204A

Route	Public / NonPublic	Date Visited	Area (sq ft)	Lane Miles *	Surface Type	Condition / PCR
1204A	Public	9/3/2003	1577	0.03	AS	GOOD / 90

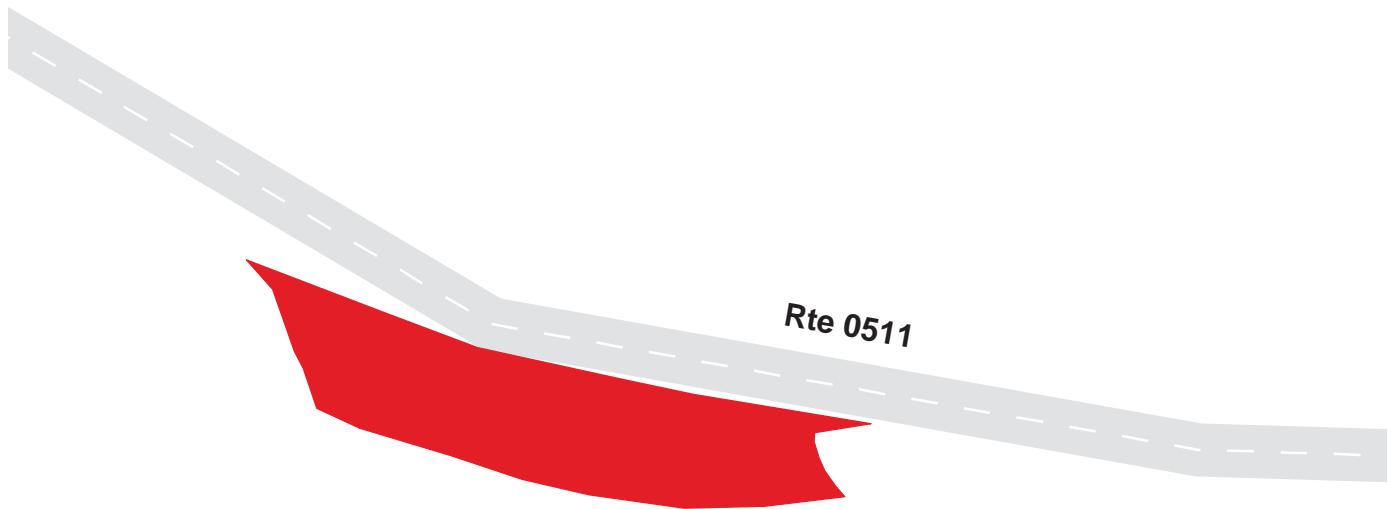
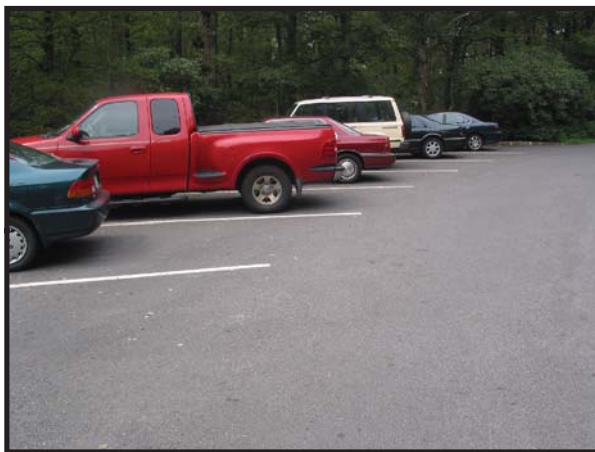
Route 1204B

Route	Public / NonPublic	Date Visited	Area (sq ft)	Lane Miles *	Surface Type	Condition / PCR
1204B	Public	9/3/2003	1098	0.02	AS	GOOD / 90

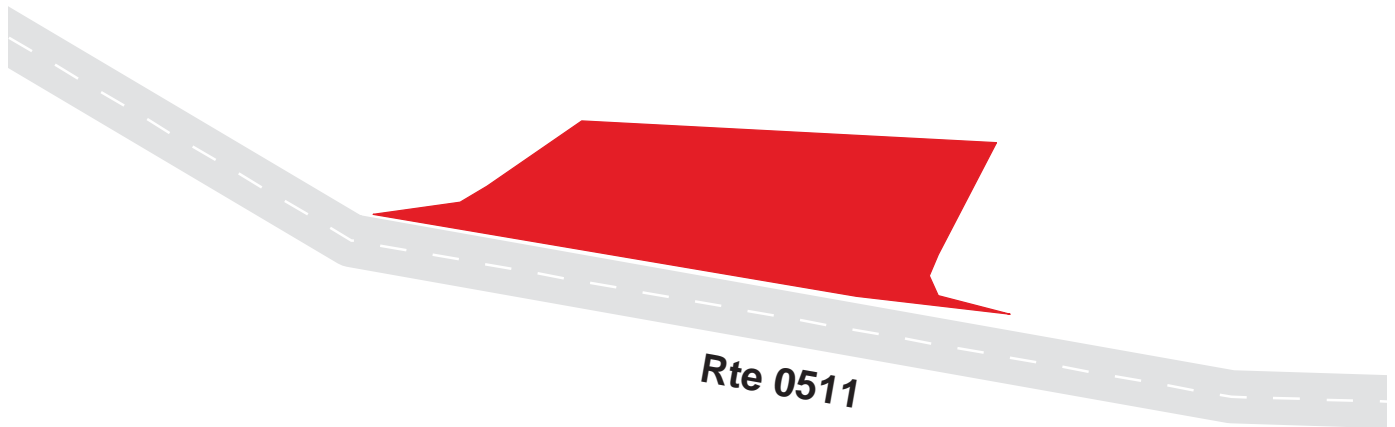
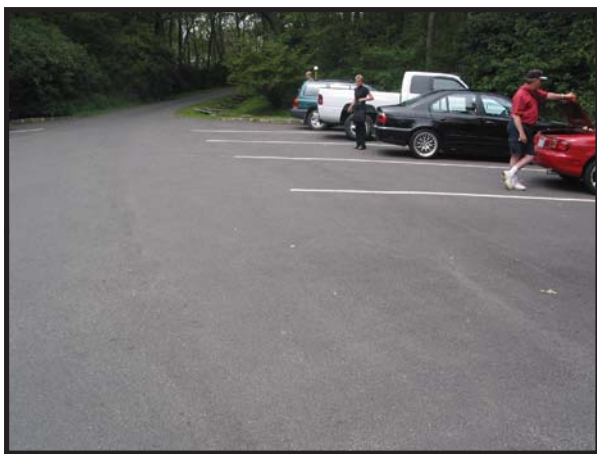
Route 1204C

Route	Public / NonPublic	Date Visited	Area (sq ft)	Lane Miles *	Surface Type	Condition / PCR
1204C	Public	9/3/2003	9289	0.16	AS	GOOD / 90

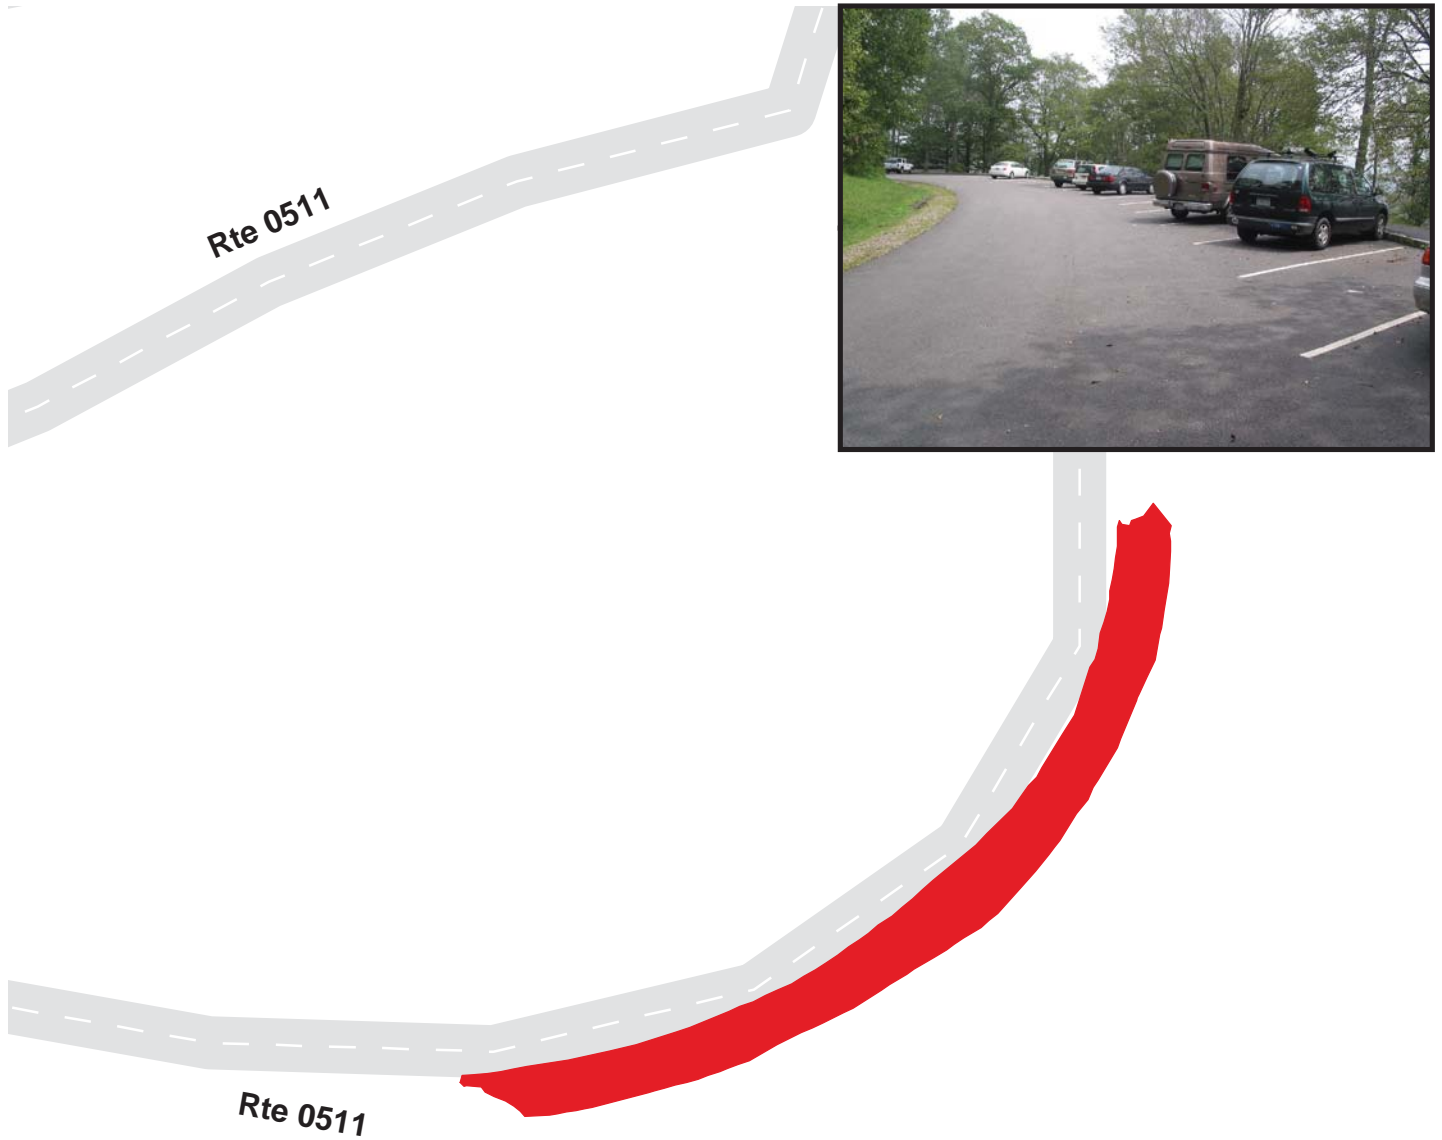
Route 1205A

Route	Public / NonPublic	Date Visited	Area (sq ft)	Lane Miles *	Surface Type	Condition / PCR
1205A	Public	9/4/2003	2871	0.05	AS	FAIR / 73

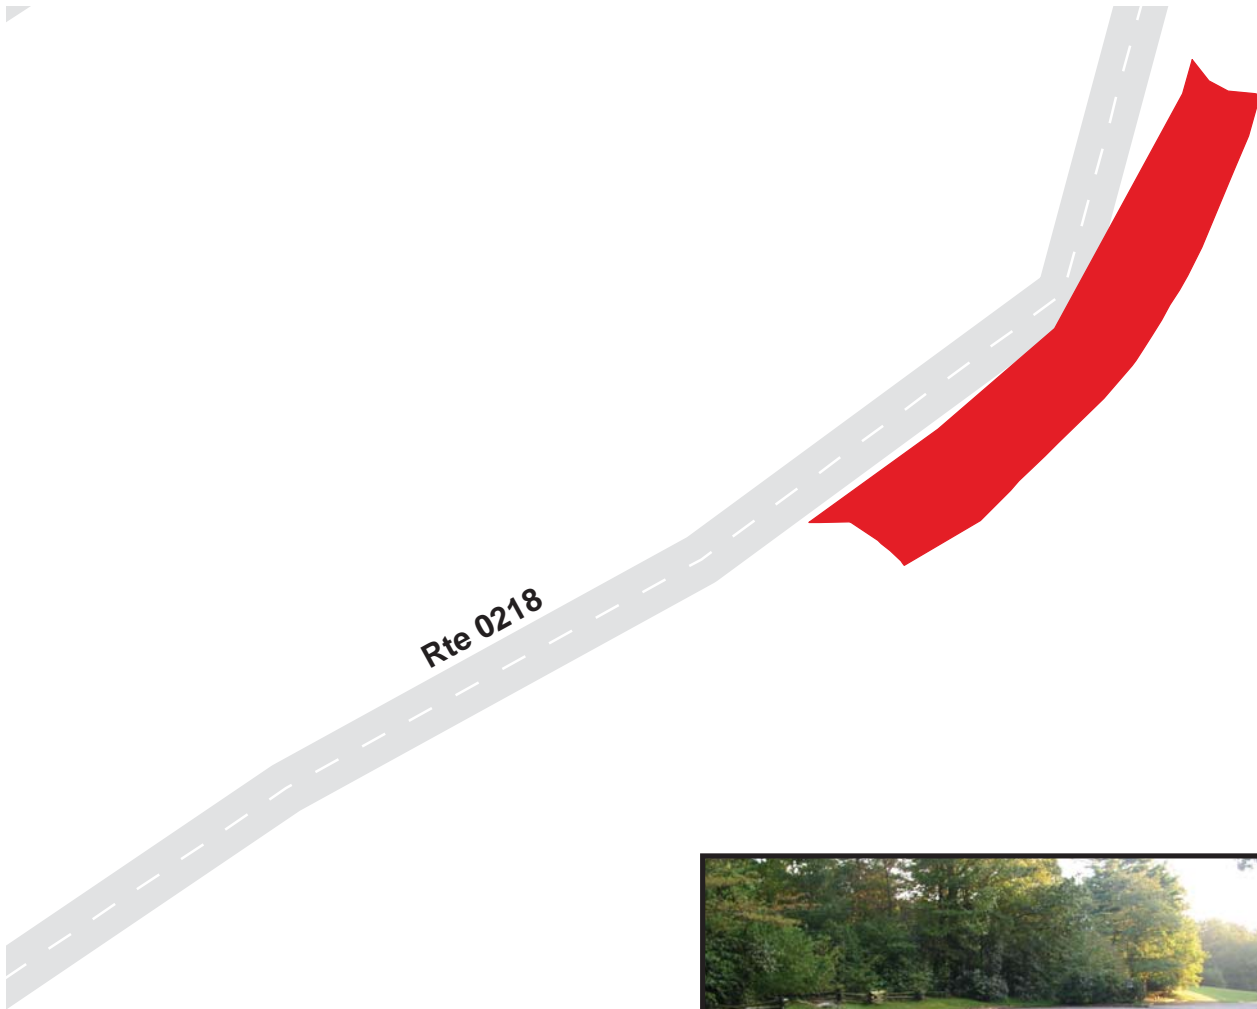
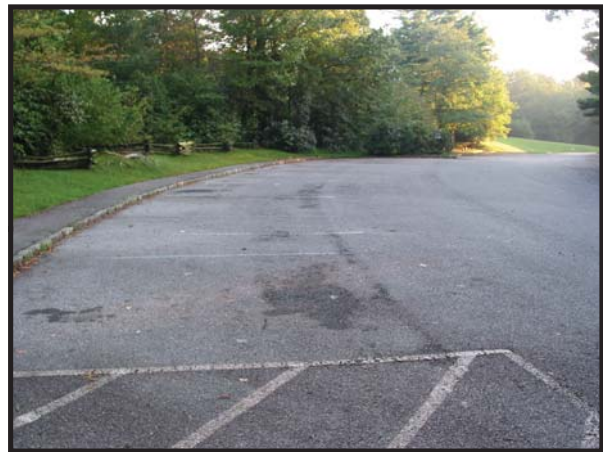
Route 1205B

Route	Public / NonPublic	Date Visited	Area (sq ft)	Lane Miles *	Surface Type	Condition / PCR
1205B	Public	9/4/2003	6199	0.11	AS	FAIR / 73

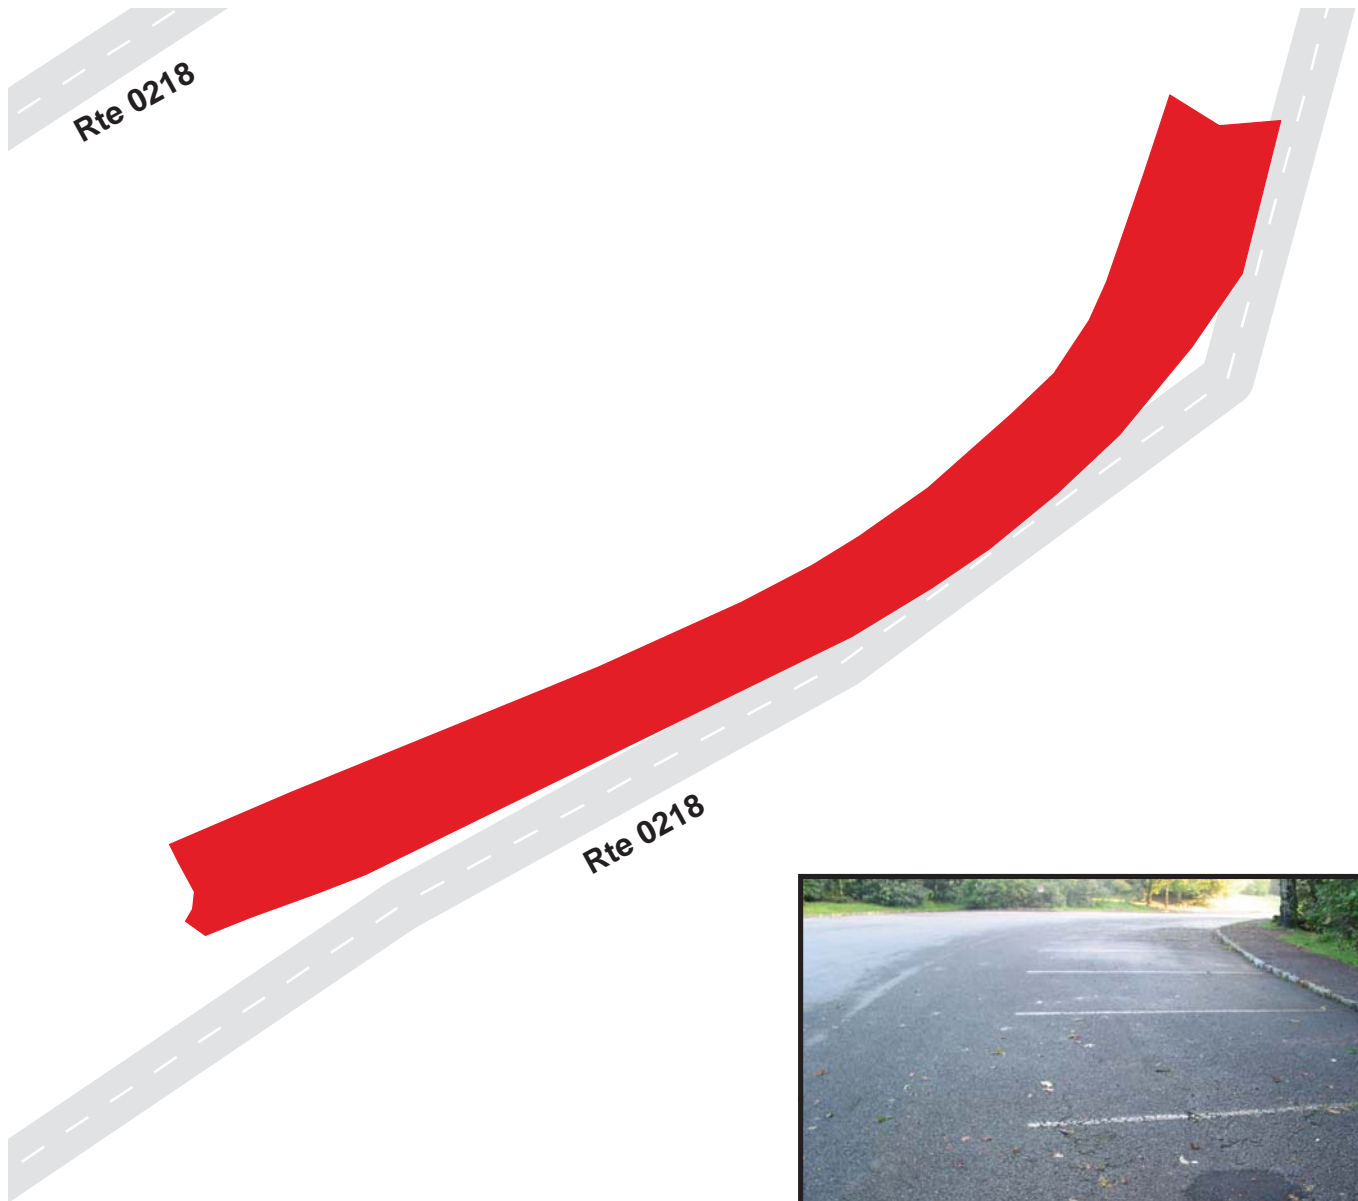
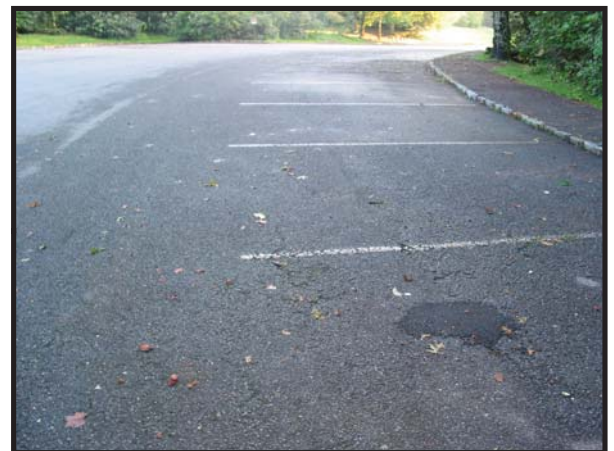
Route 1205C

Route	Public / NonPublic	Date Visited	Area (sq ft)	Lane Miles *	Surface Type	Condition / PCR
1205C	Public	9/4/2003	3637	0.06	AS	FAIR / 73

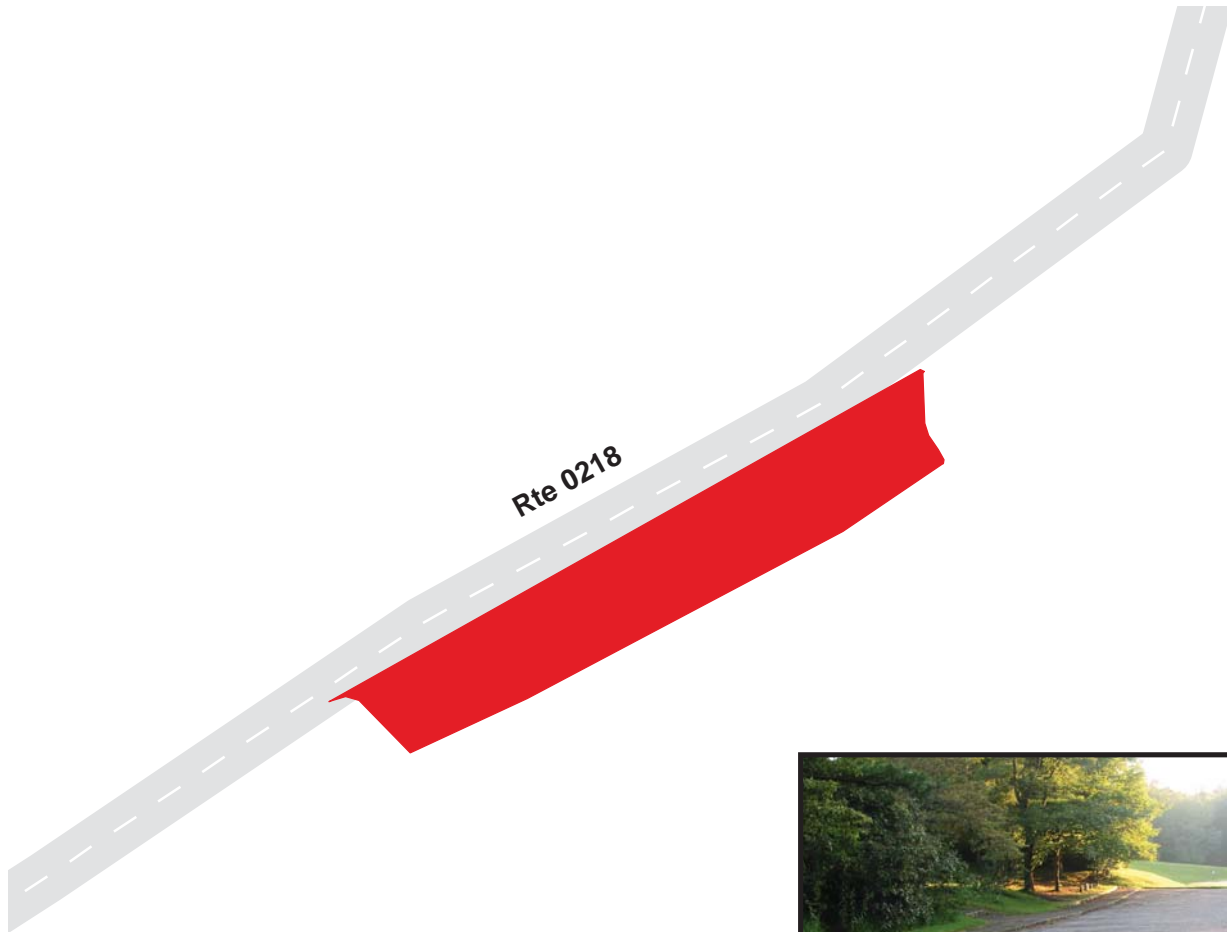
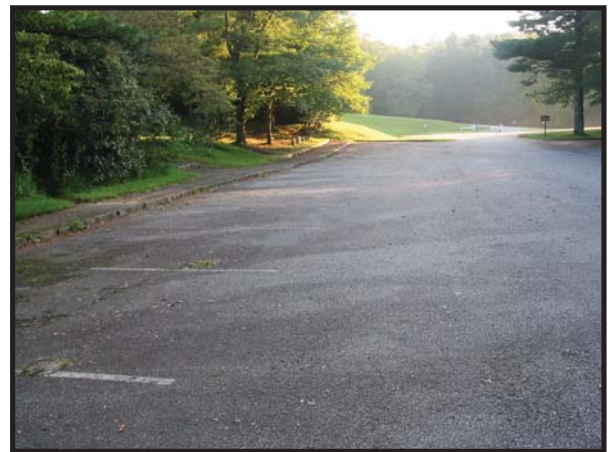
Route 1205D

Route	Public / NonPublic	Date Visited	Area (sq ft)	Lane Miles *	Surface Type	Condition / PCR
1205D	Public	9/4/2003	6772	0.12	AS	POOR / 45
