The Road Inventory of Blue Ridge Parkway BLRI – 5140 Volume 1

Road Inventory Program

Prepared By:
Federal Highway Administration
Eastern Federal Lands Highway Division
Cycle 3

Blue Ridge Parkway in North Carolina

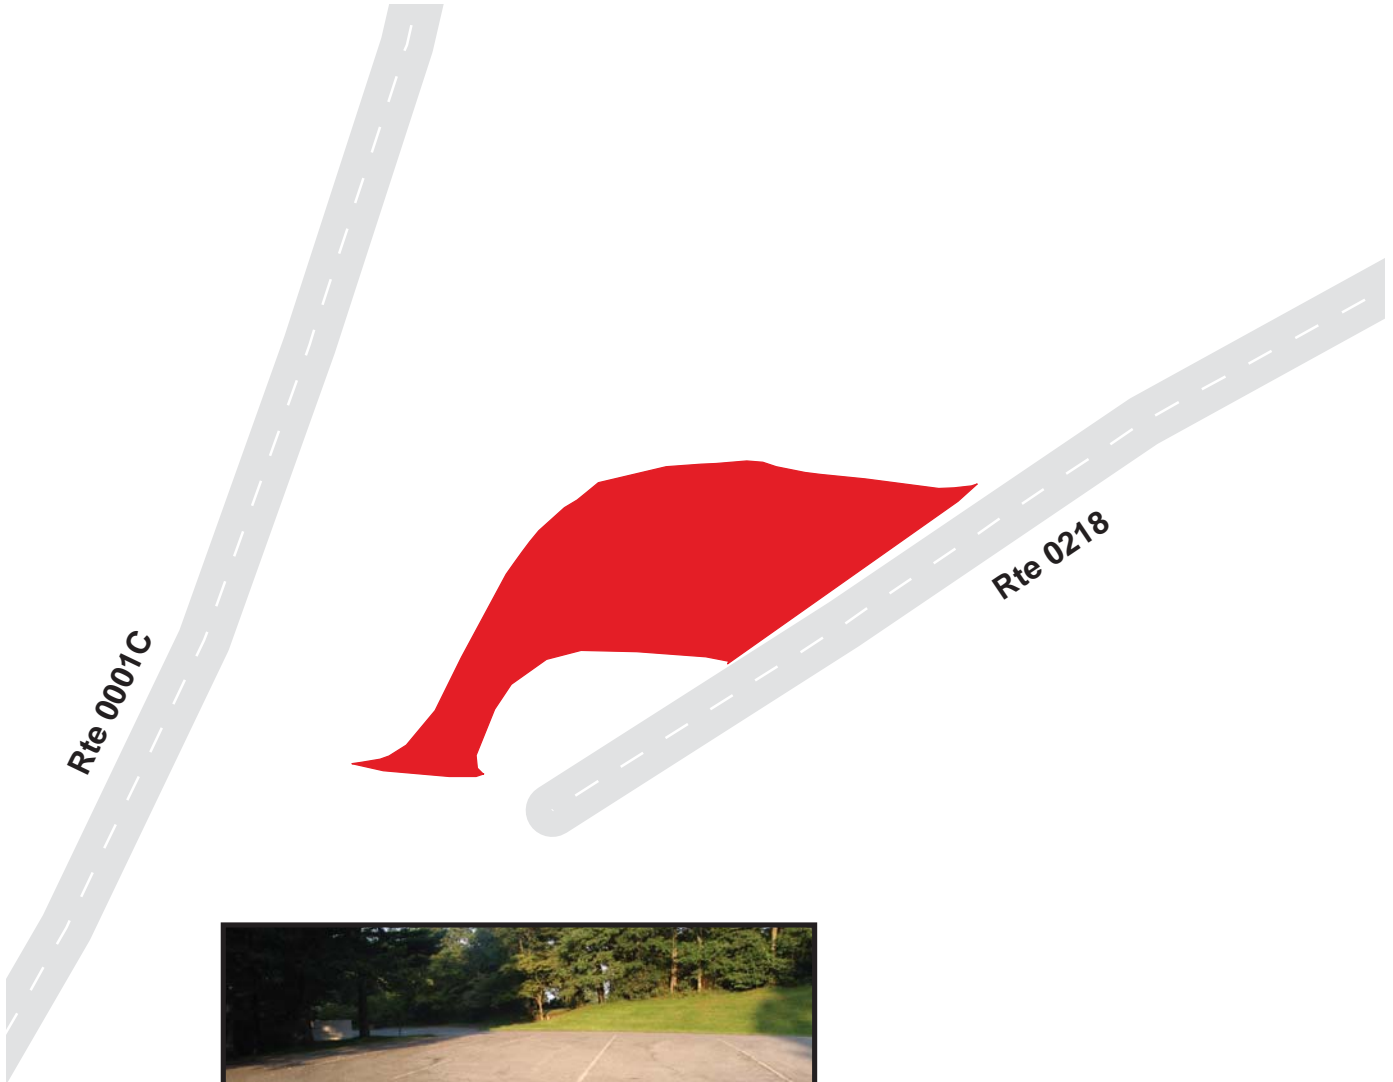
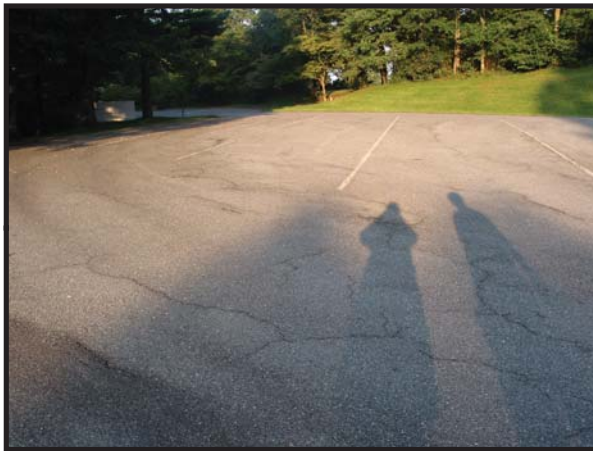
Route 1206A

Route	Public / NonPublic	Date Visited	Area (sq ft)	Lane Miles *	Surface Type	Condition / PCR
1206A	Public	9/5/2003	5468	0.09	AS	GOOD / 90

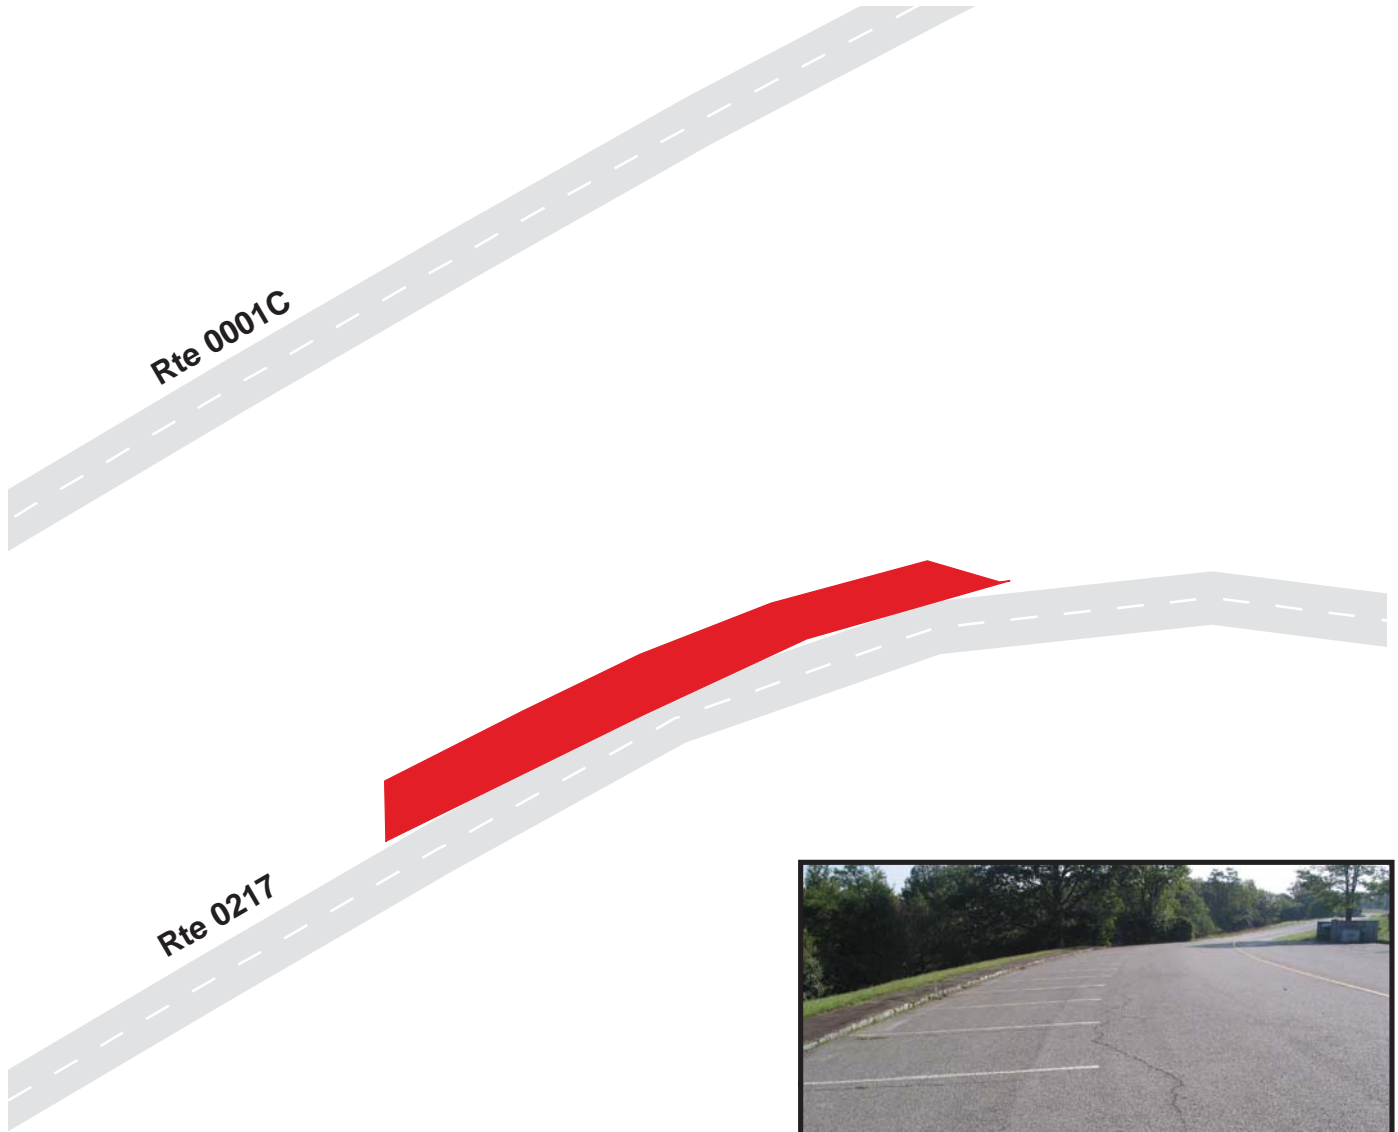
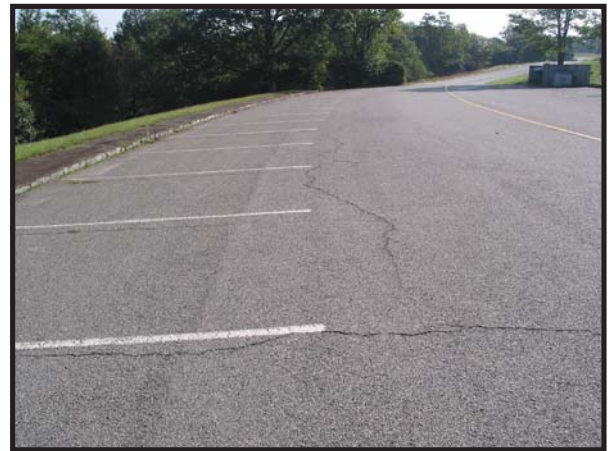
Route 1206B

Route	Public / NonPublic	Date Visited	Area (sq ft)	Lane Miles *	Surface Type	Condition / PCR
1206B	Public	9/5/2003	4390	0.08	AS	GOOD / 90

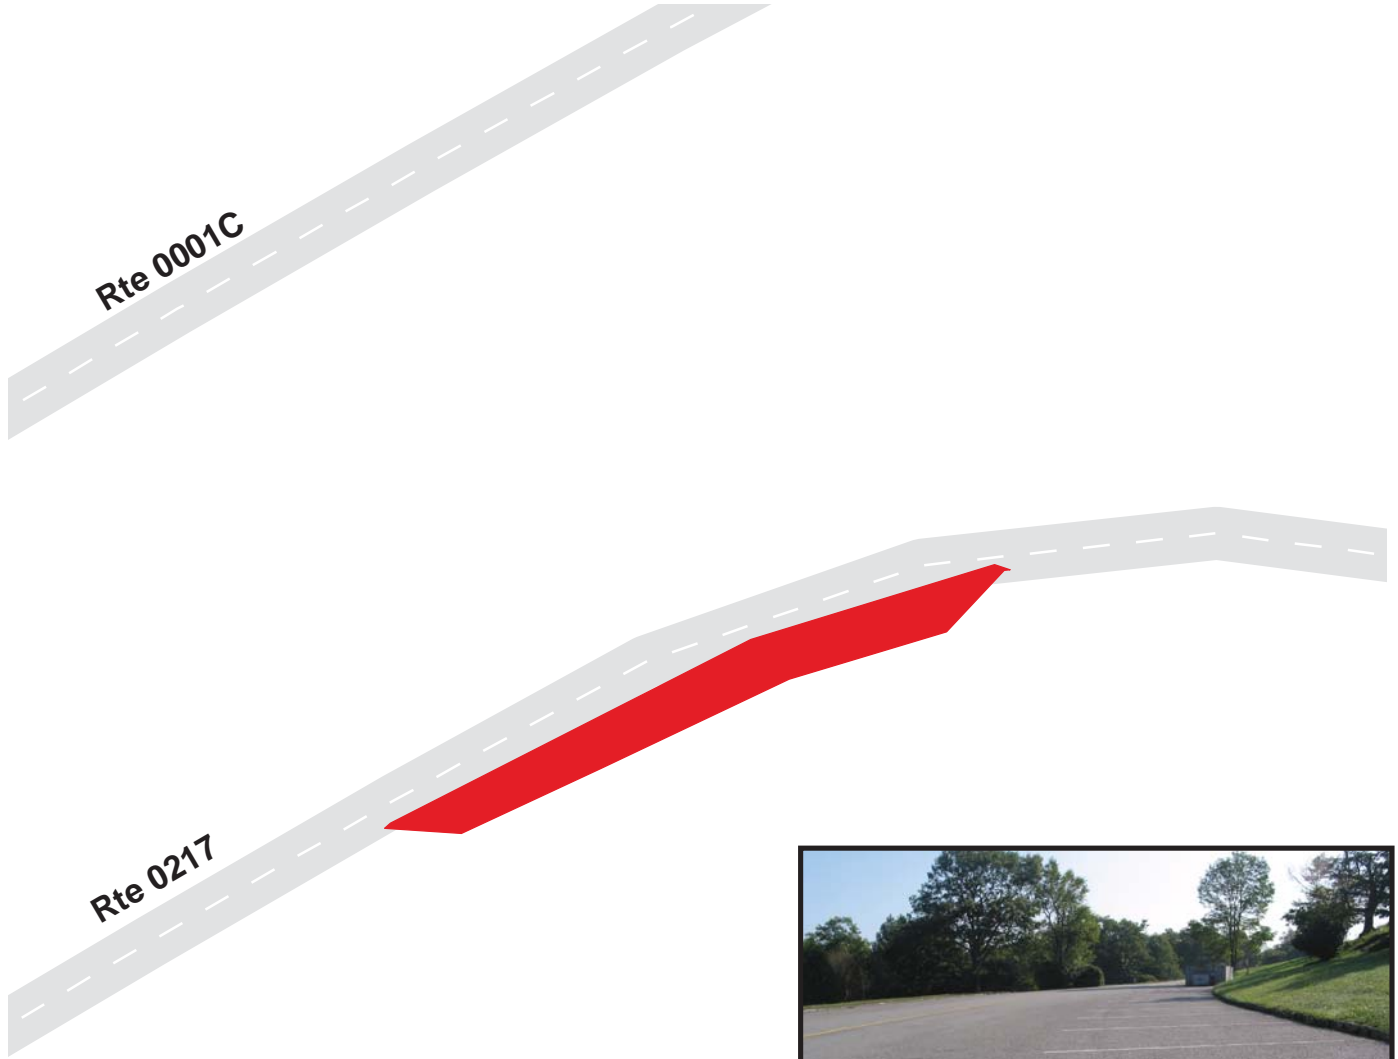
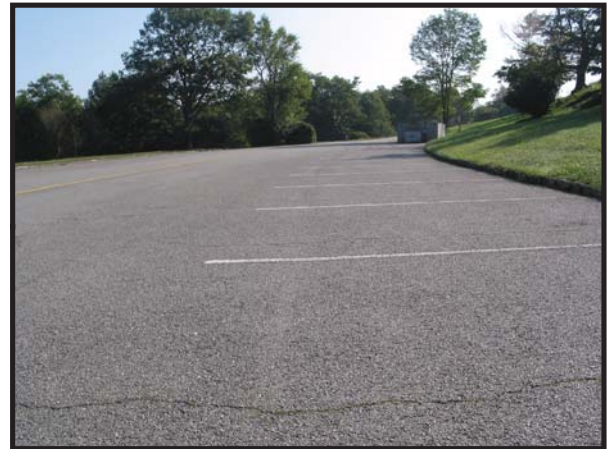
Blue Ridge Parkway Route 1206C

Doughton Picnic Parking Area C
Adjacent to Route 0217 at MP 0.18 on Right

Route	Public / NonPublic	Date Visited	Area (sq ft)	Lane Miles *	Surface Type	Condition / PCR
1206C	Public	9/5/2003	6403	0.11	AS	GOOD / 90

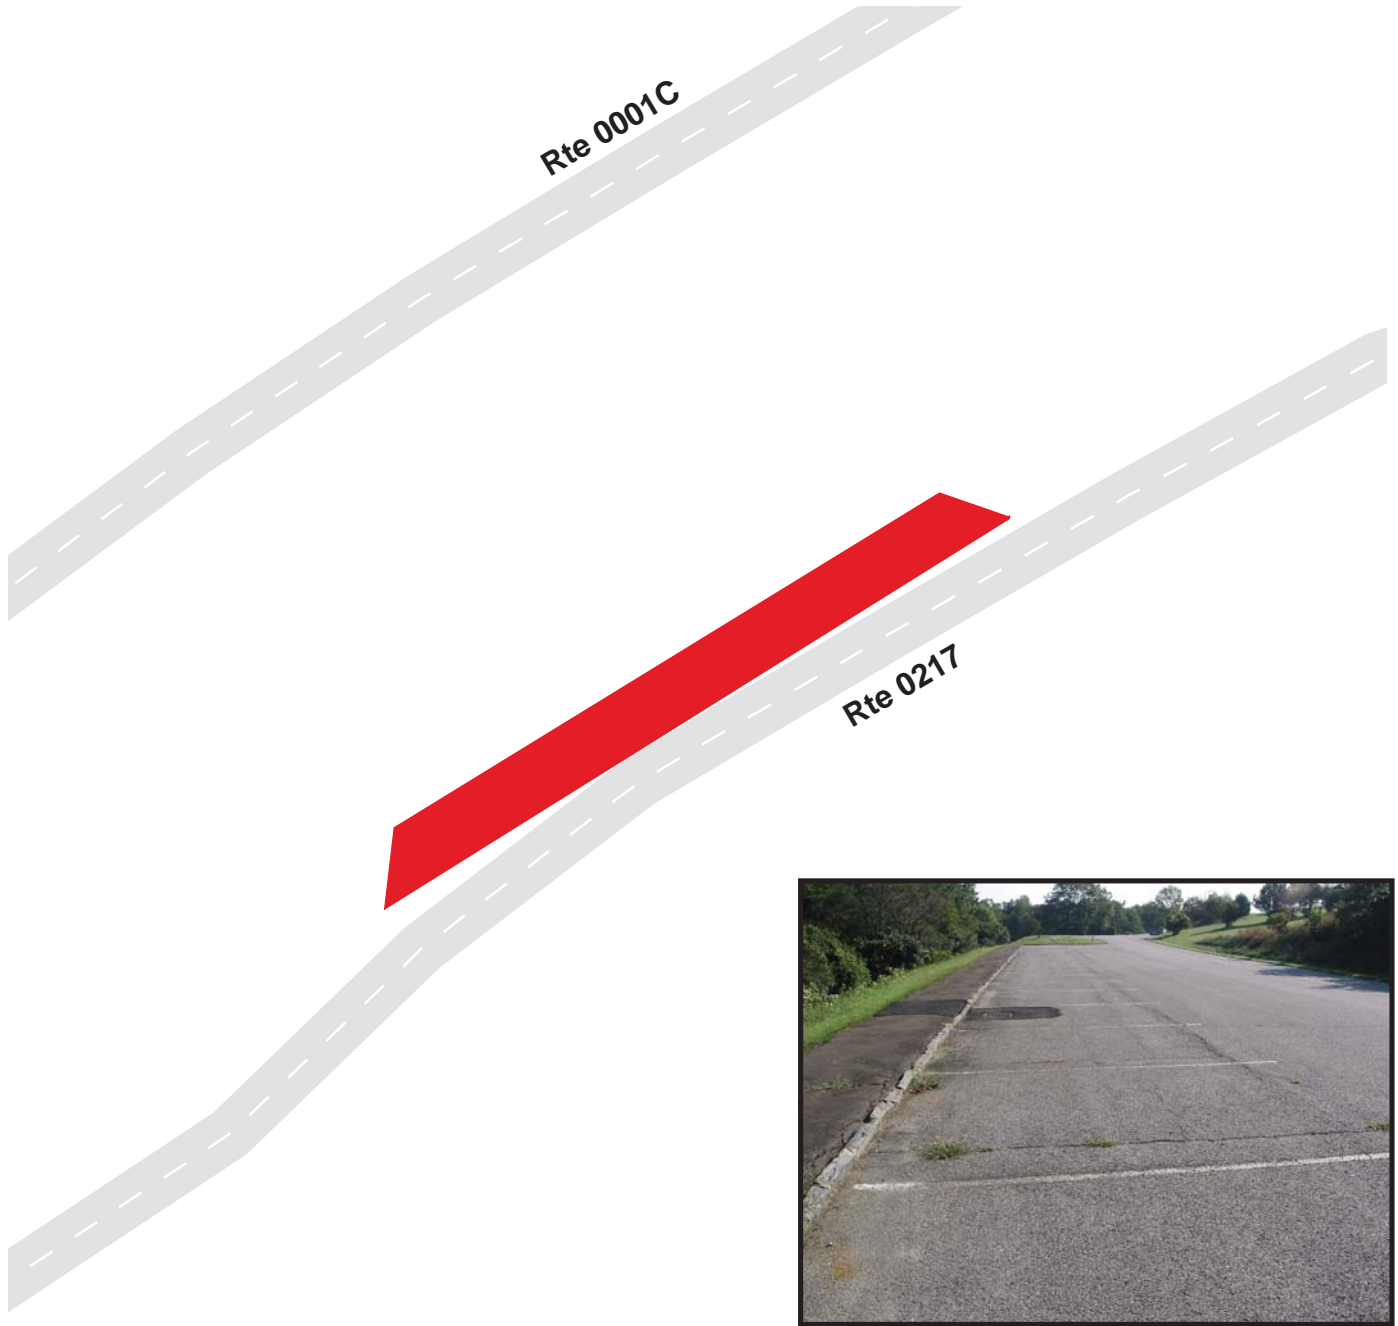
Route 1206D

Route	Public / NonPublic	Date Visited	Area (sq ft)	Lane Miles *	Surface Type	Condition / PCR
1206D	Public	9/5/2003	6377	0.11	AS	FAIR / 73

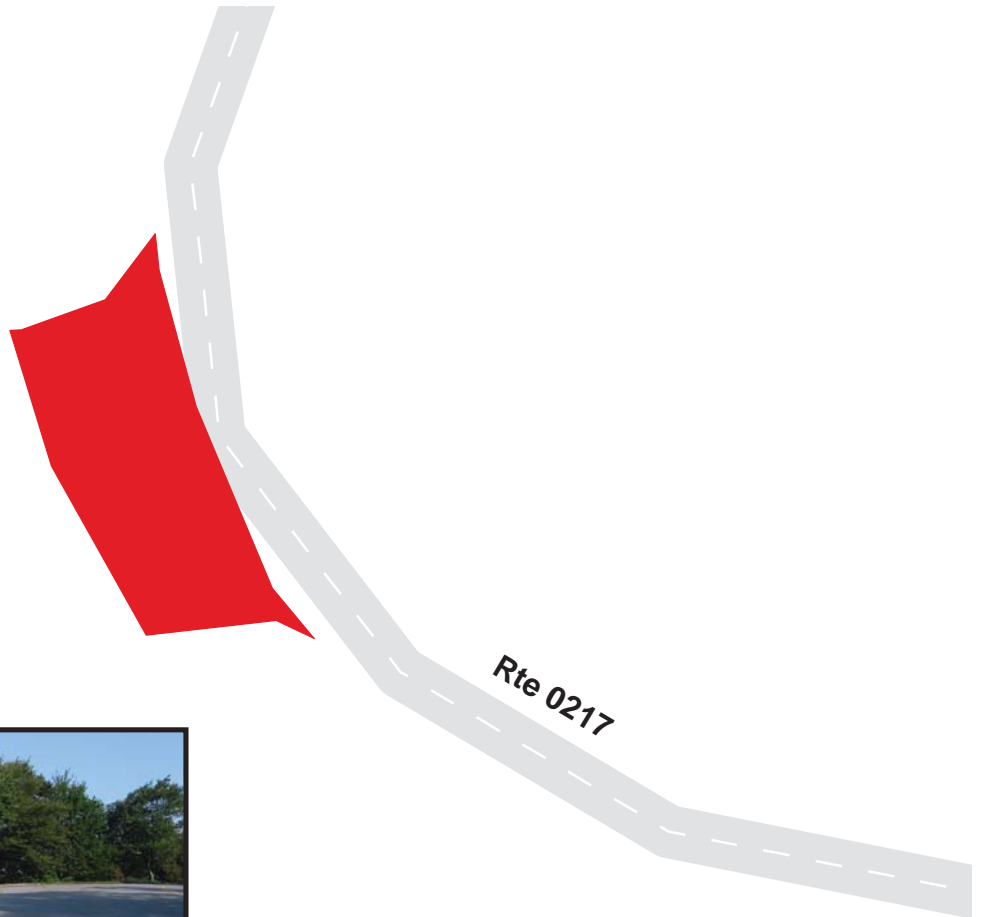
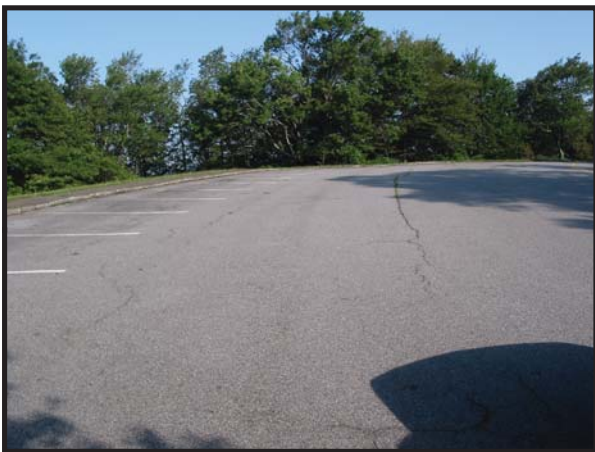
Route 1206E

Route	Public / NonPublic	Date Visited	Area (sq ft)	Lane Miles *	Surface Type	Condition / PCR
1206E	Public	9/5/2003	3496	0.06	AS	GOOD / 90

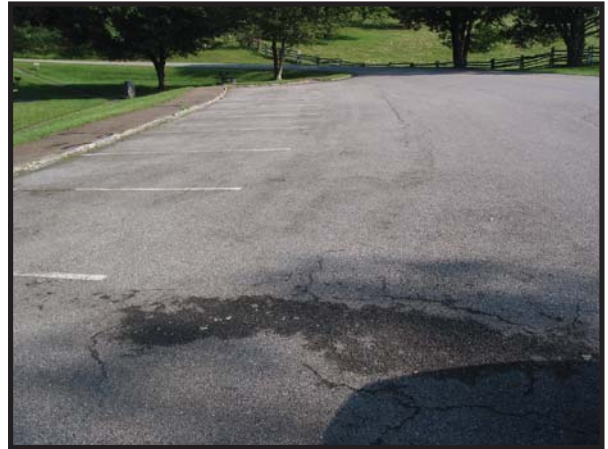
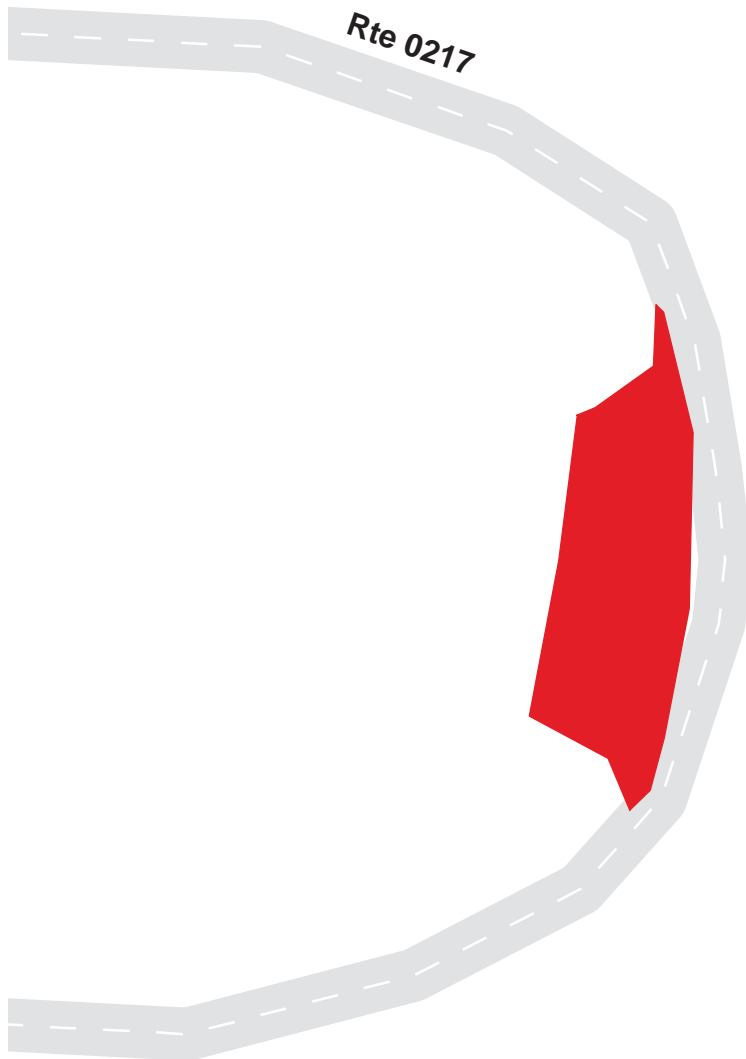
Route 1206F

Route	Public / NonPublic	Date Visited	Area (sq ft)	Lane Miles *	Surface Type	Condition / PCR
1206F	Public	9/5/2003	2828	0.05	AS	FAIR / 73

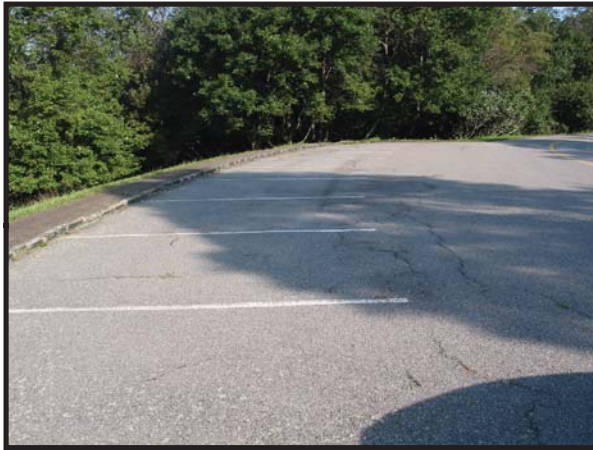
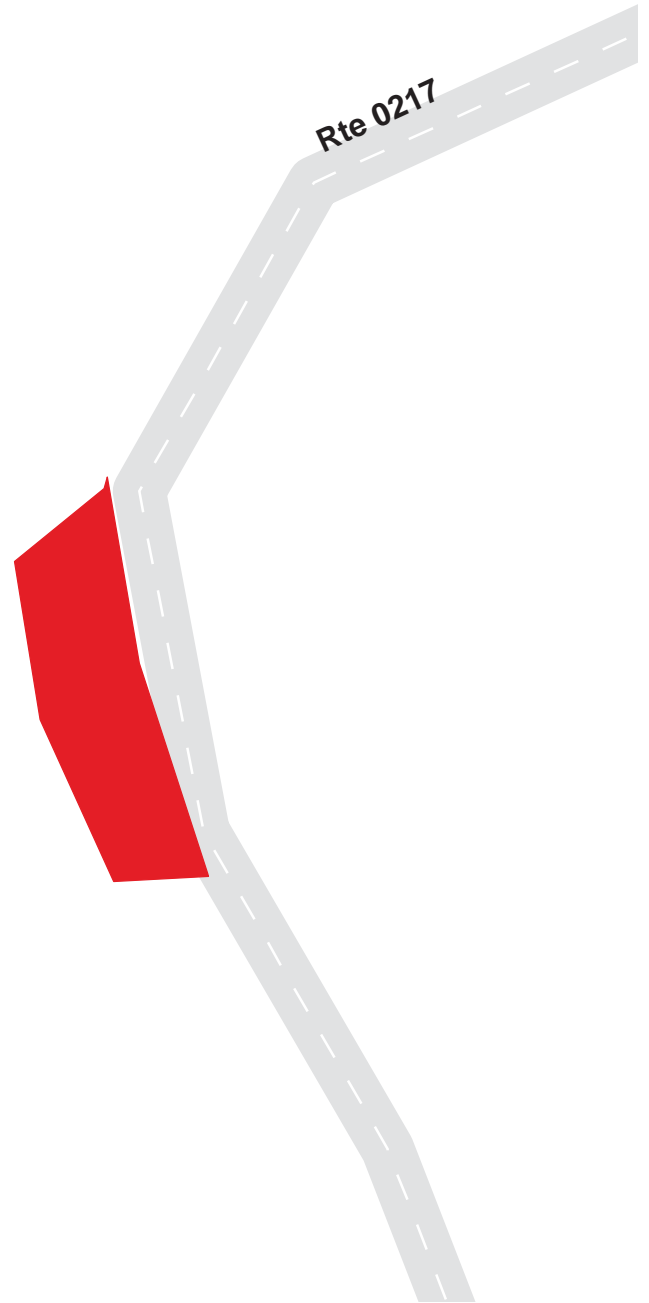
Route 1206G

Route	Public / NonPublic	Date Visited	Area (sq ft)	Lane Miles *	Surface Type	Condition / PCR
1206G	Public	9/5/2003	3453	0.06	AS	FAIR / 73

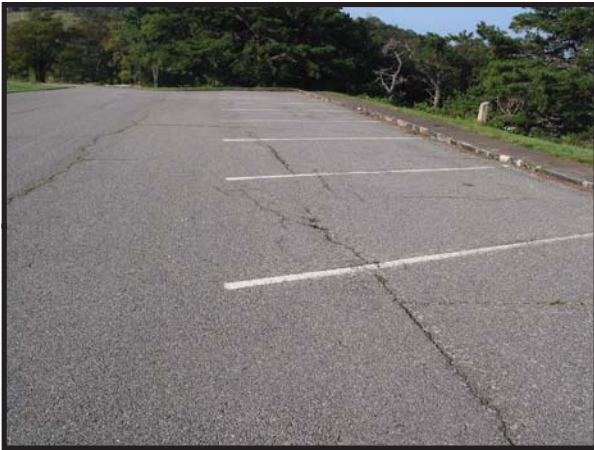
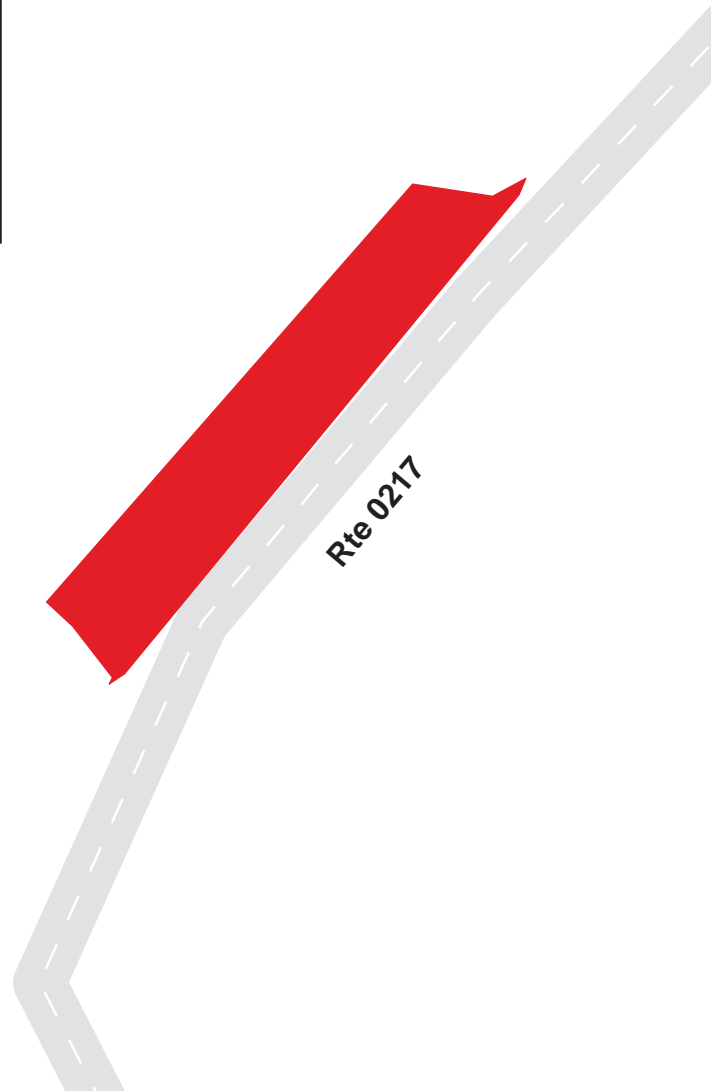
Route 1206H

Route	Public / NonPublic	Date Visited	Area (sq ft)	Lane Miles *	Surface Type	Condition / PCR
1206H	Public	9/5/2003	1109	0.02	AS	FAIR / 73

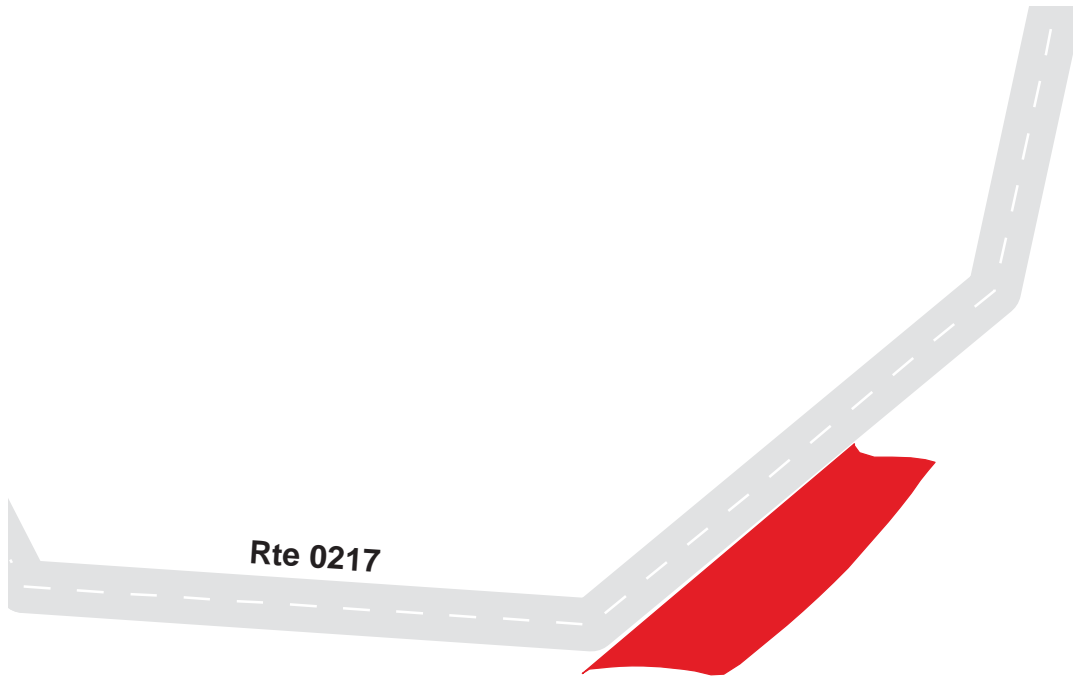
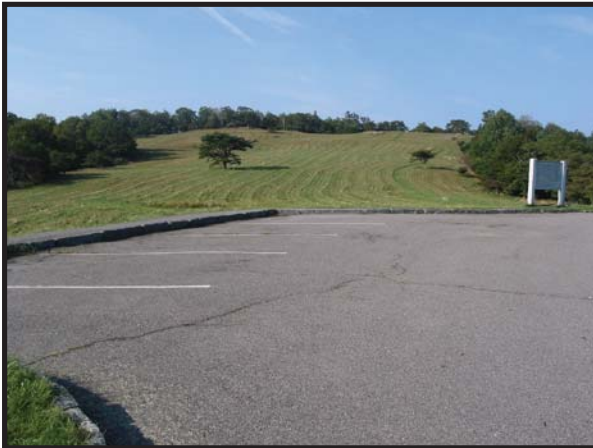
Blue Ridge Parkway Route 1206I

Doughton Picnic Parking Area I
Adjacent to Route 0217 at MP 1.04 on Right

Route	Public / NonPublic	Date Visited	Area (sq ft)	Lane Miles *	Surface Type	Condition / PCR
1206I	Public	9/5/2003	2107	0.04	AS	FAIR / 73

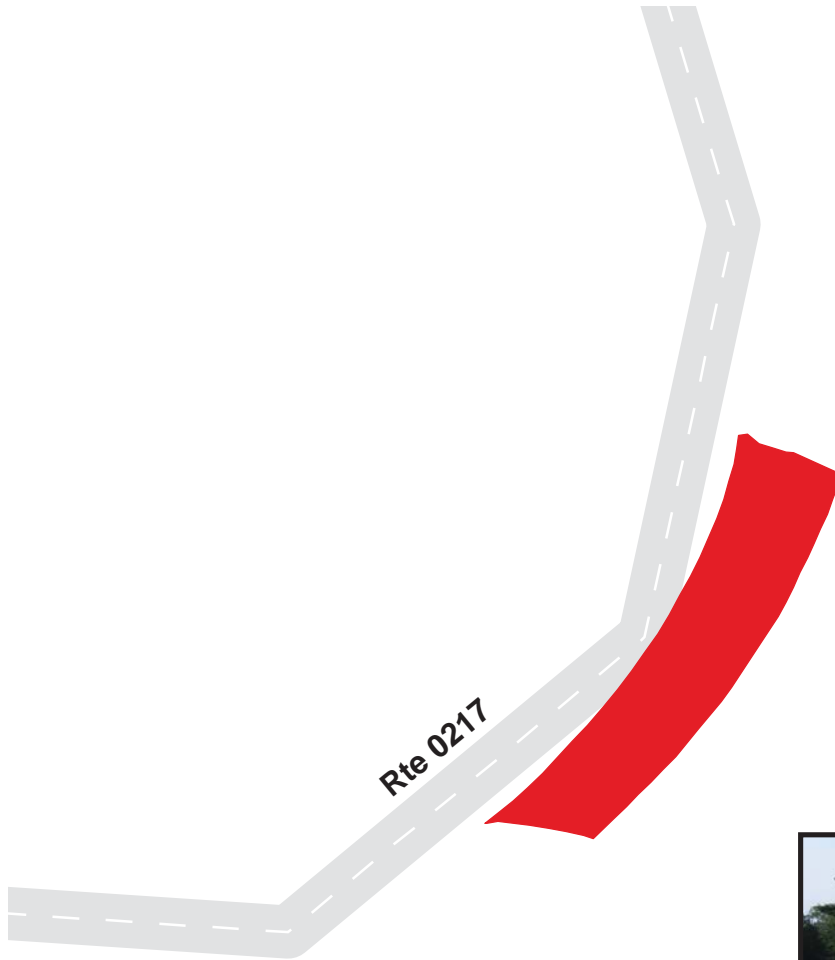
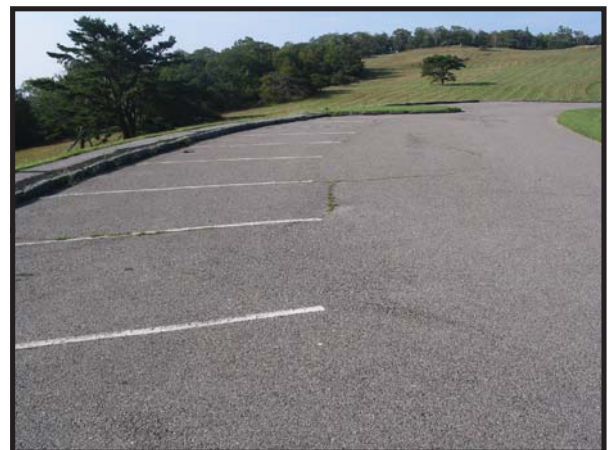
Blue Ridge Parkway Route 1207

Doughton Campground Dump Station
From Route 0513C at MP 0.02 on Right

Route	Public / NonPublic	Date Visited	Area (sq ft)	Lane Miles *	Surface Type	Condition / PCR
1207	Public	9/5/2003	2890	0.05	AS	POOR / 45

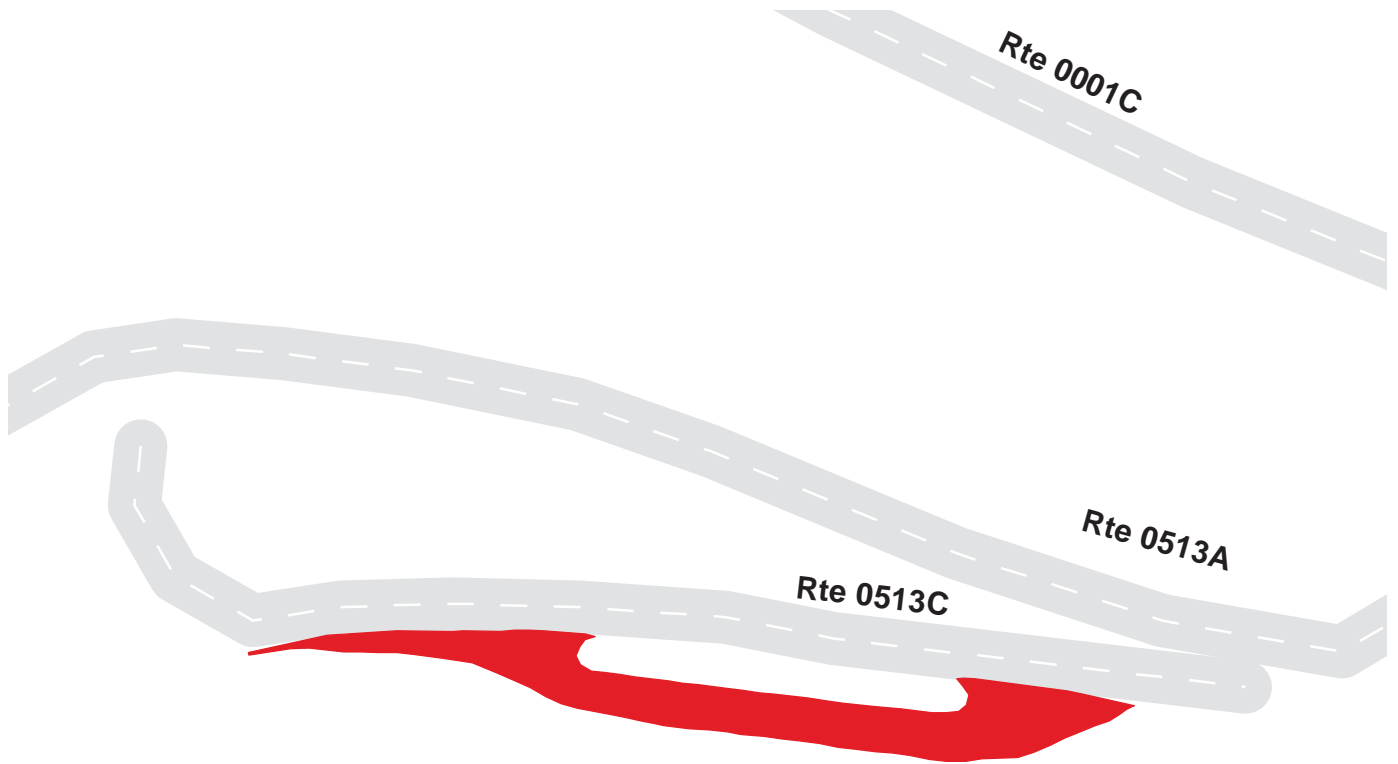
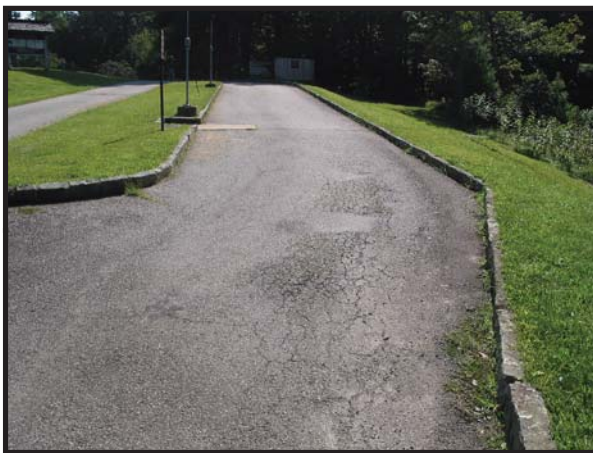
Route 1208A

Route	Public / NonPublic	Date Visited	Area (sq ft)	Lane Miles *	Surface Type	Condition / PCR
1208A	Public	9/5/2003	952	0.02	AS	GOOD / 90

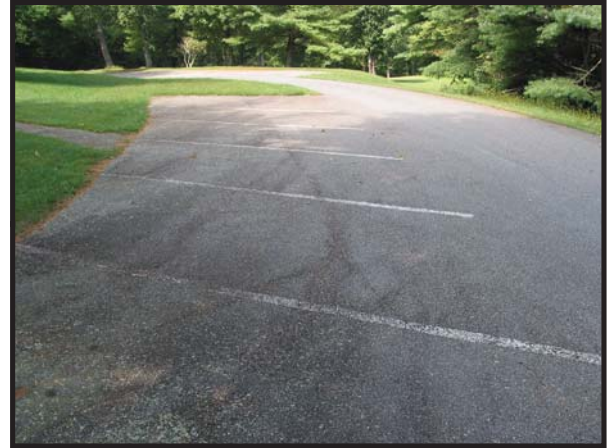
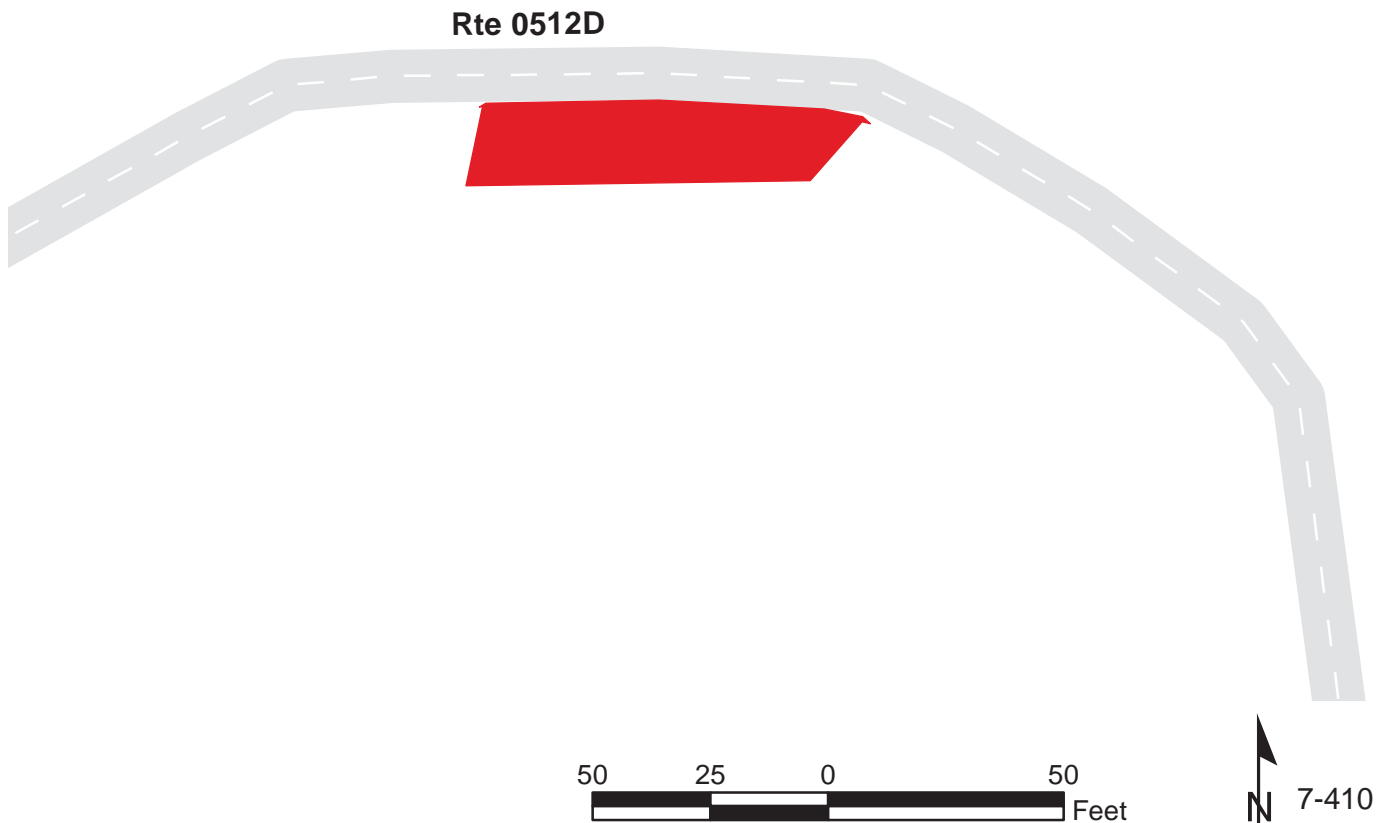
Route 1209

Route	Public / NonPublic	Date Visited	Area (sq ft)	Lane Miles *	Surface Type	Condition / PCR
1209	NonPublic	9/5/2003	13018	0.22	AS	GOOD / 90

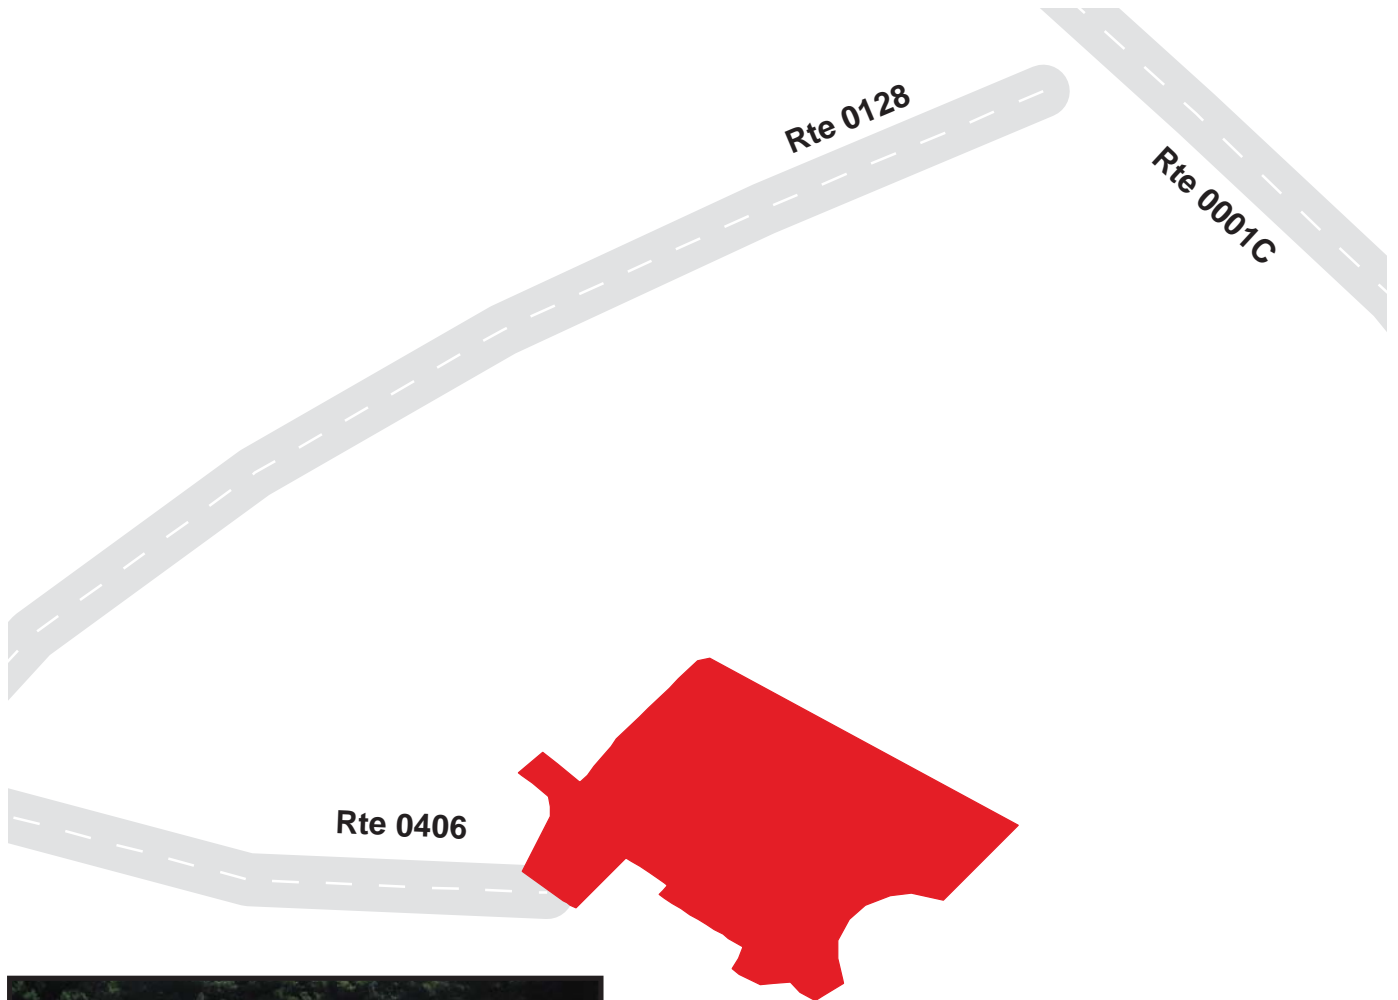
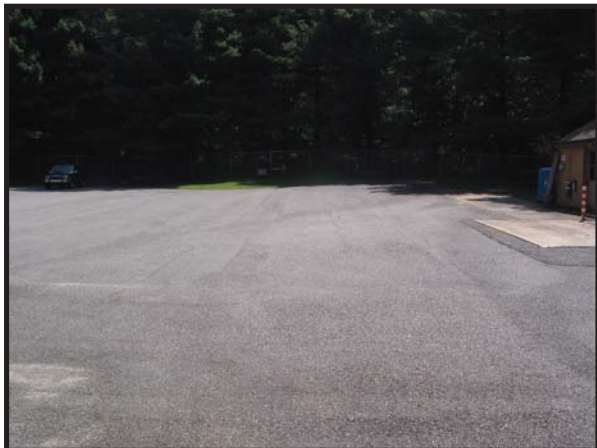
Blue Ridge Parkway Route 1210

Music Center Ampitheatre Parking
At End of Route 0160

Route	Public / NonPublic	Date Visited	Area (sq ft)	Lane Miles *	Surface Type	Condition / PCR
1210	Public	9/8/2003	37728	0.65	AS	EXCELLENT / 97

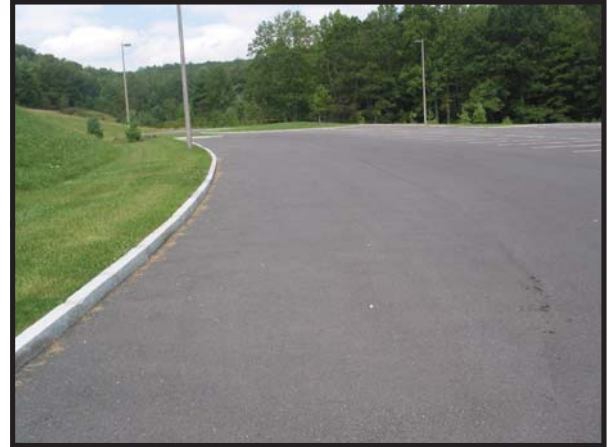
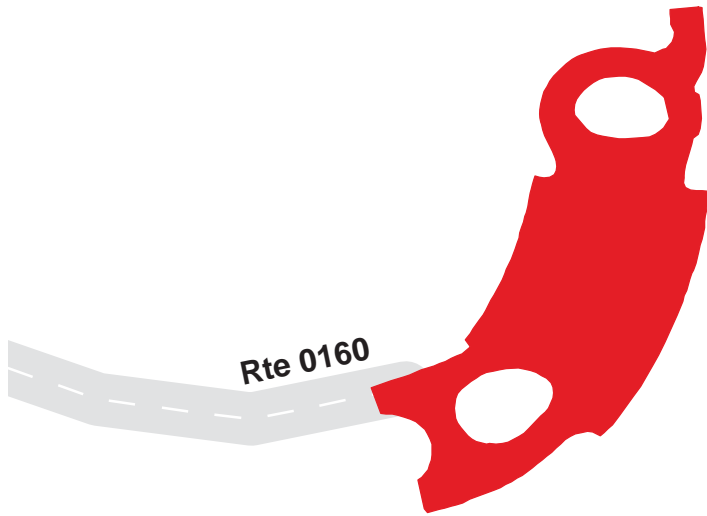
Route 1211A

Route	Public / NonPublic	Date Visited	Area (sq ft)	Lane Miles *	Surface Type	Condition / PCR
1211A	Public	9/5/2003	1403	0.02	AS	GOOD / 90

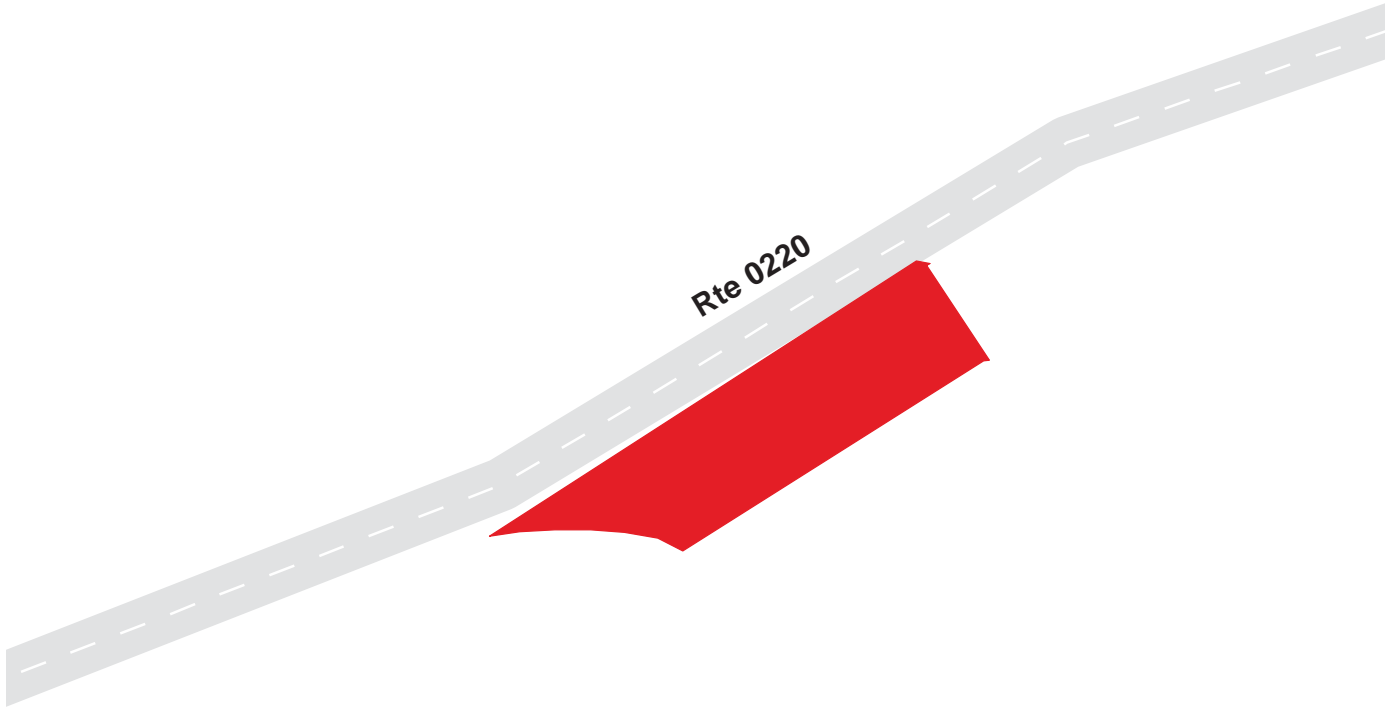
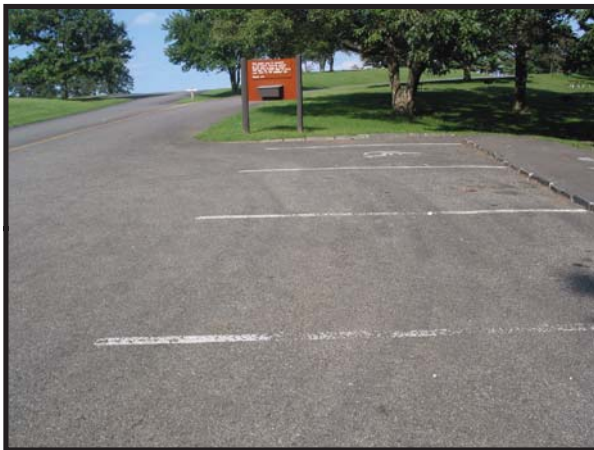
Route 1211B

Route	Public / NonPublic	Date Visited	Area (sq ft)	Lane Miles *	Surface Type	Condition / PCR
1211B	Public	9/5/2003	4715	0.08	AS	GOOD / 90

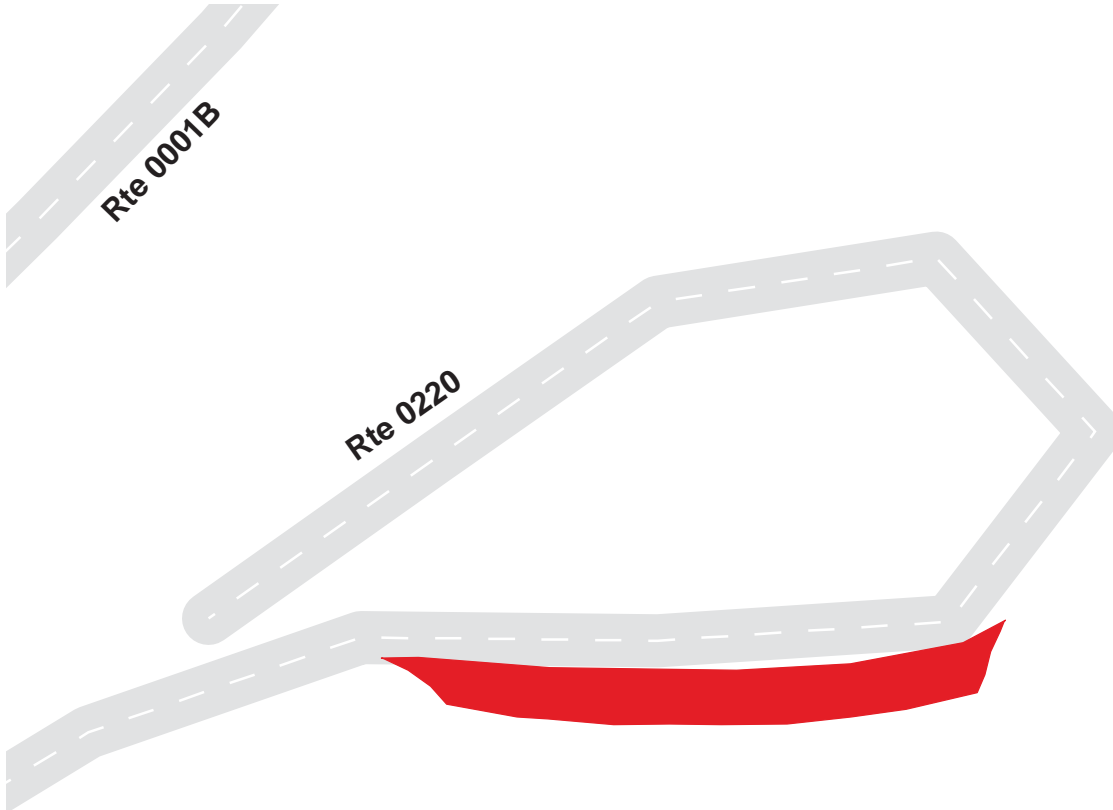
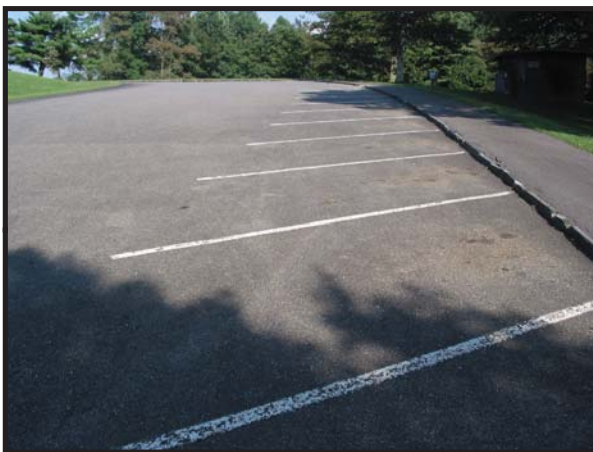
Route 1211C

Route	Public / NonPublic	Date Visited	Area (sq ft)	Lane Miles *	Surface Type	Condition / PCR
1211C	Public	9/5/2003	3021	0.05	AS	GOOD / 90
