The Road Inventory of Blue Ridge Parkway BLRI – 5140 Volume 1

Road Inventory Program

Prepared By:
Federal Highway Administration
Eastern Federal Lands Highway Division
Cycle 3

Blue Ridge Parkway in North Carolina

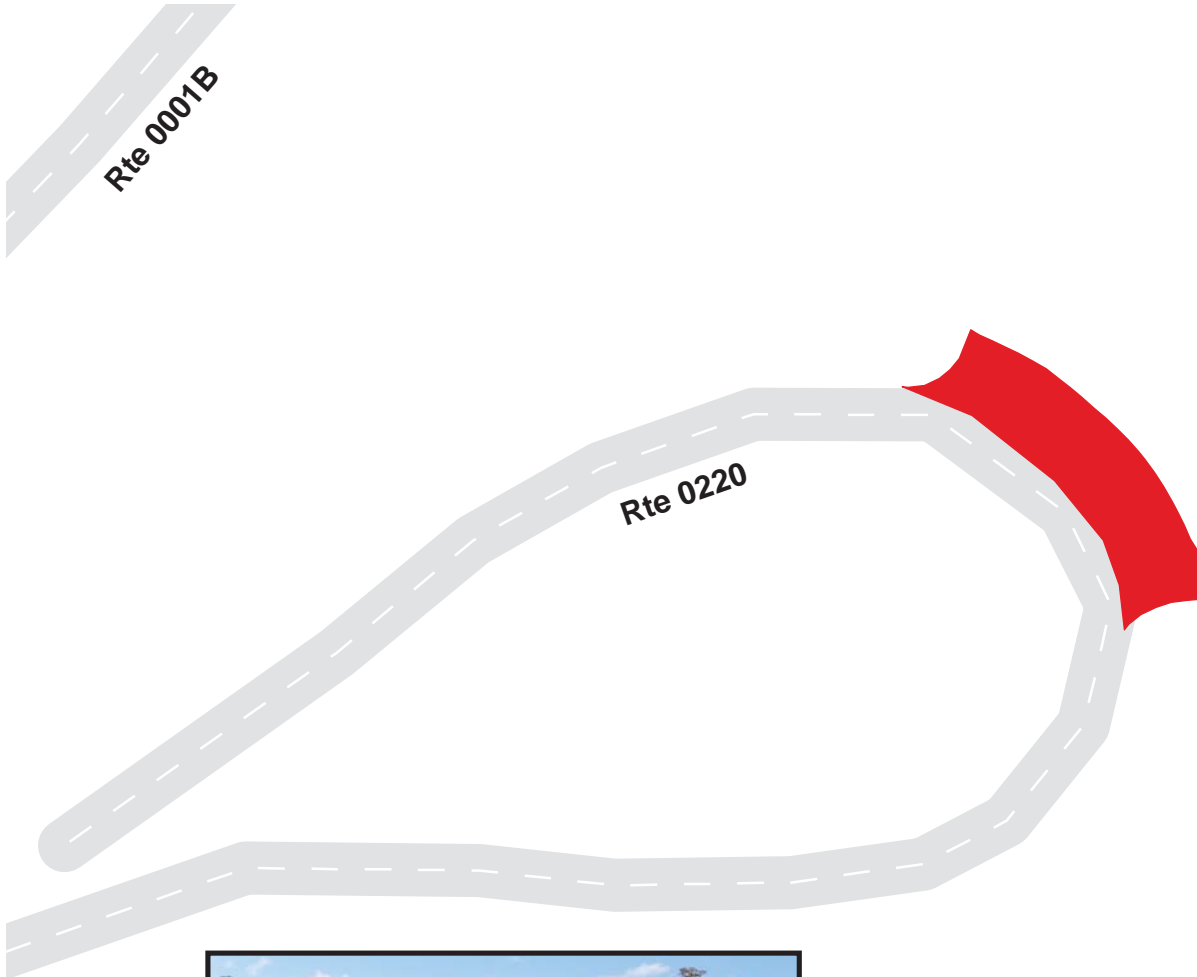
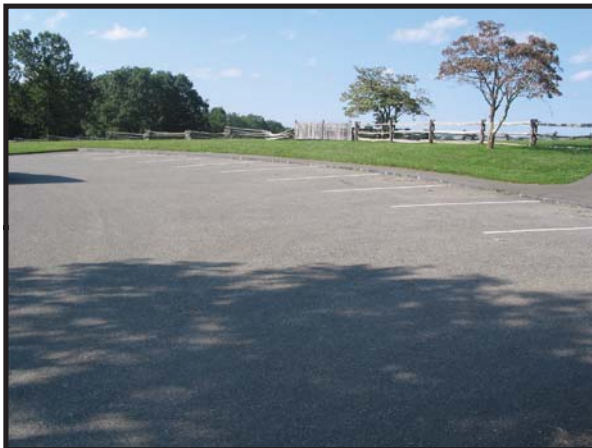
Route 1211D

Route	Public / NonPublic	Date Visited	Area (sq ft)	Lane Miles *	Surface Type	Condition / PCR
1211D	Public	9/5/2003	6010	0.10	AS	GOOD / 90

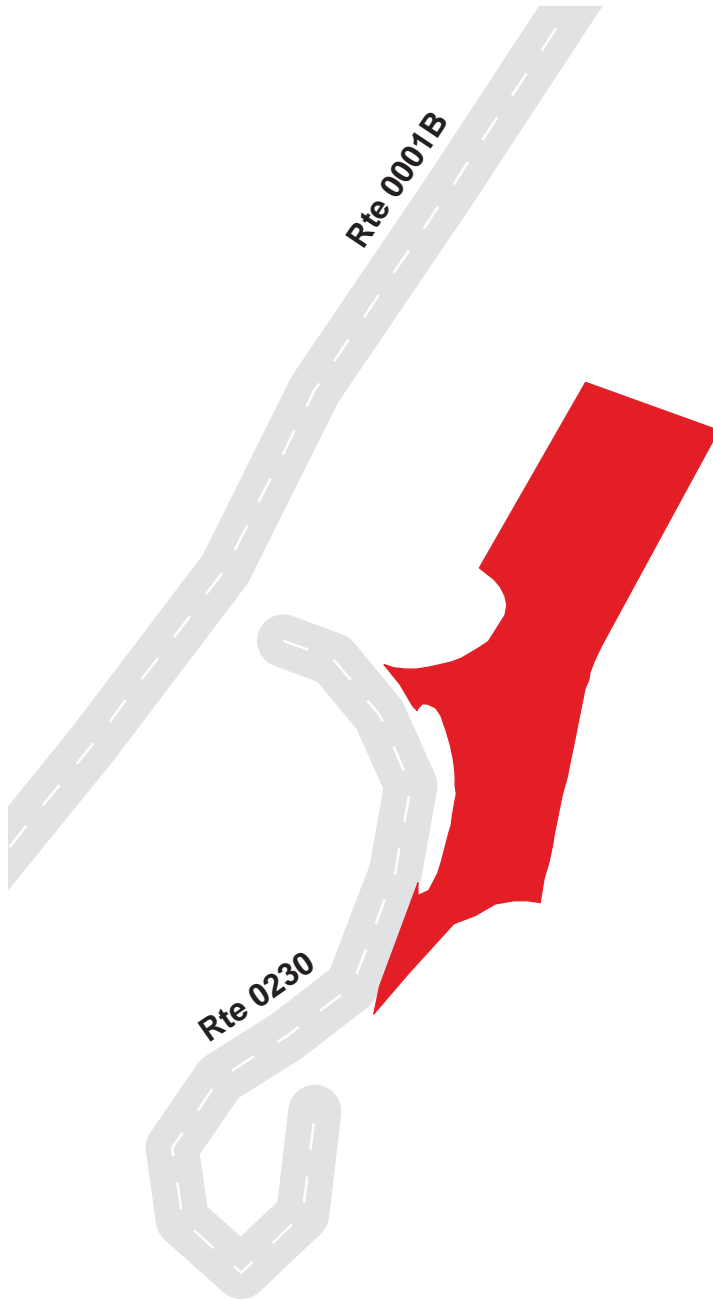
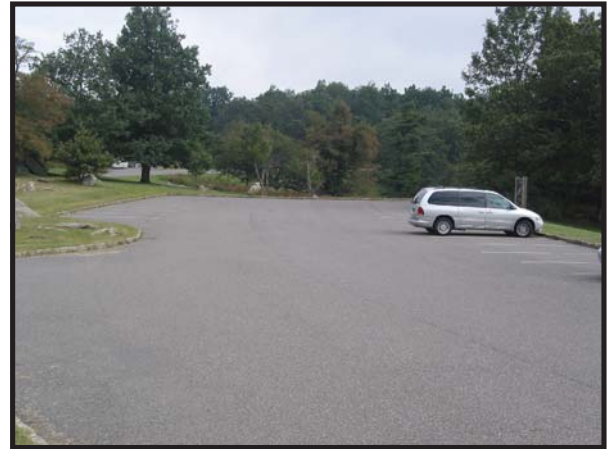
Route 1218A

Route	Public / NonPublic	Date Visited	Area (sq ft)	Lane Miles *	Surface Type	Condition / PCR
1218A	Public	9/7/2003	1373	0.02	AS	GOOD / 90

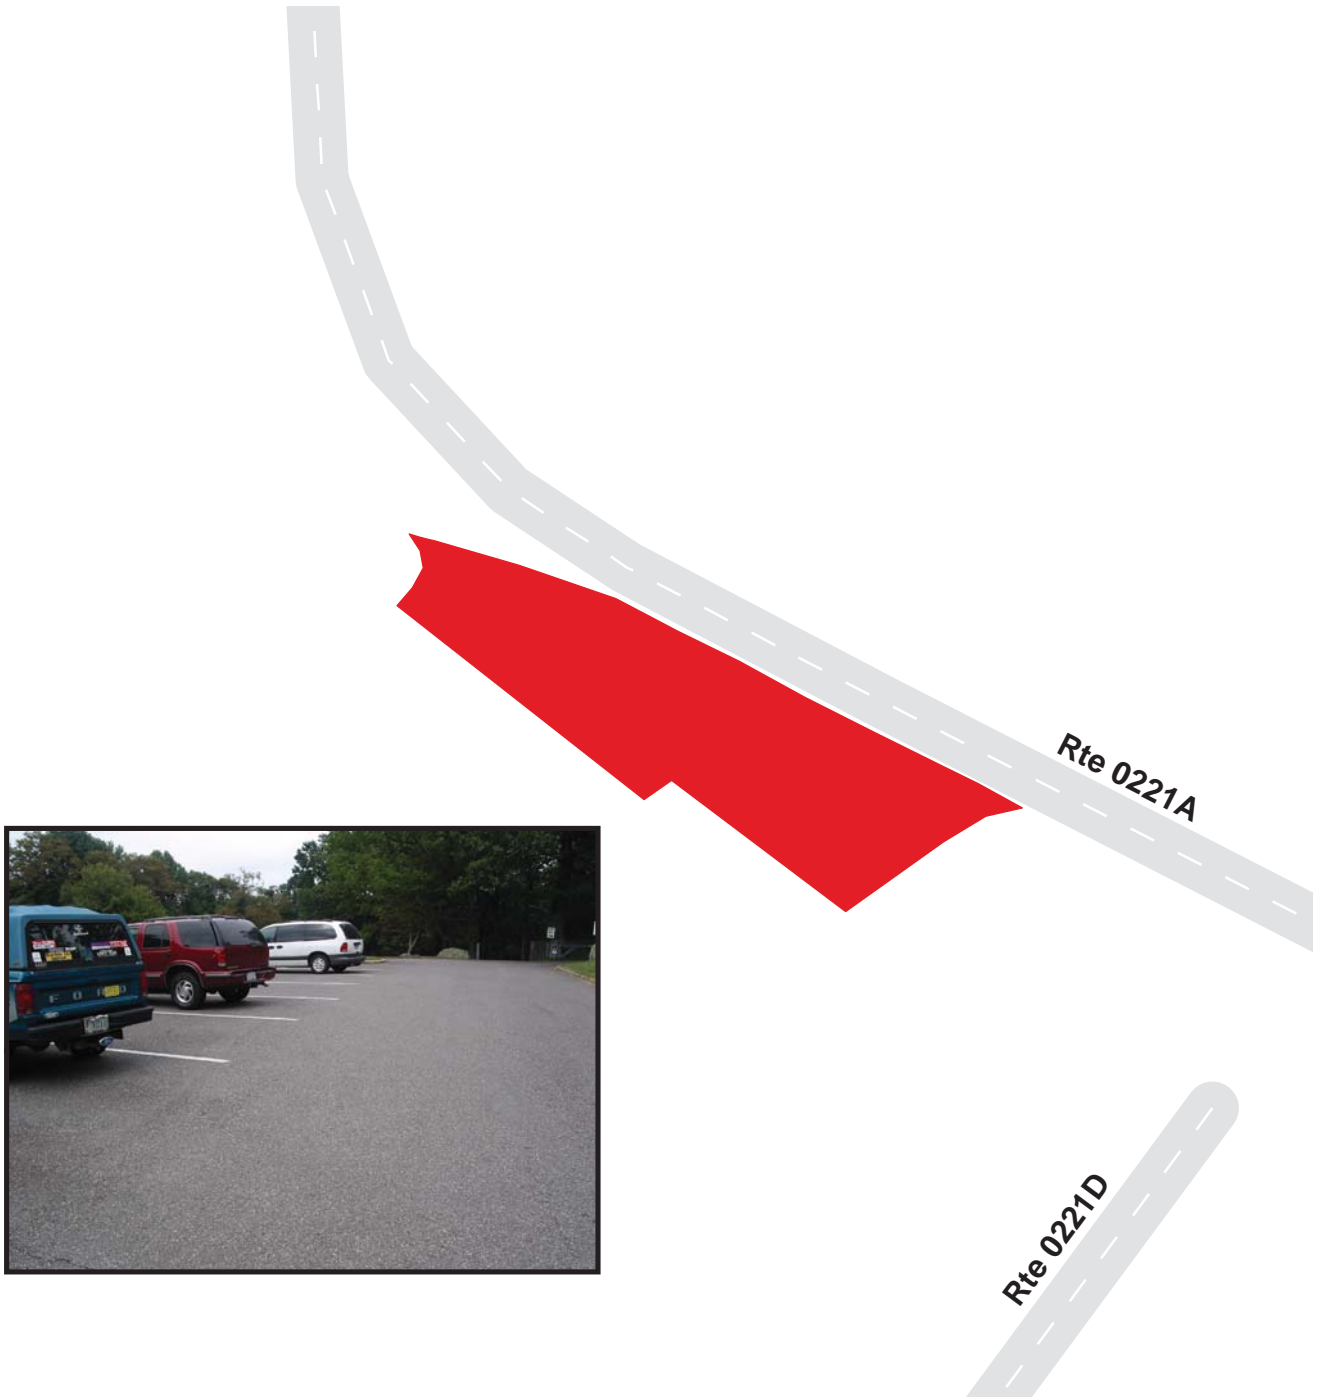
Blue Ridge Parkway Route 1218B

Rocky Knob Picnic Parking Area B
Adjacent to Route 0221A at MP 0.04 on Left

Route	Public / NonPublic	Date Visited	Area (sq ft)	Lane Miles *	Surface Type	Condition / PCR
1218B	Public	9/7/2003	12316	0.21	AS	GOOD / 90

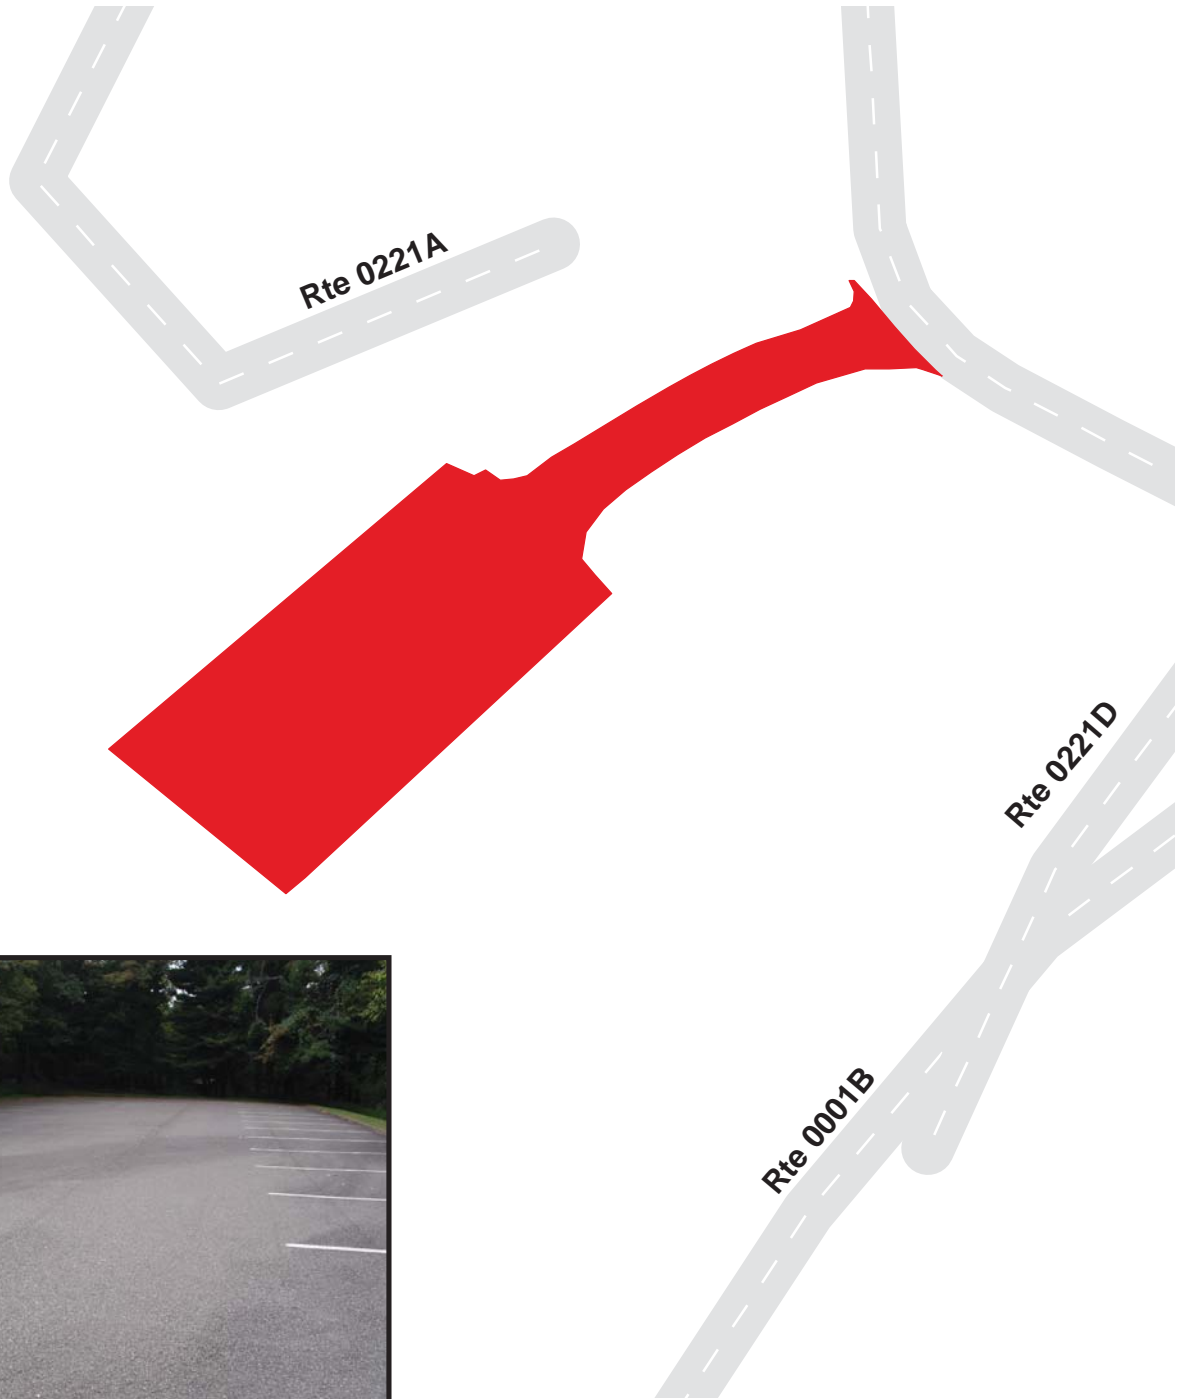
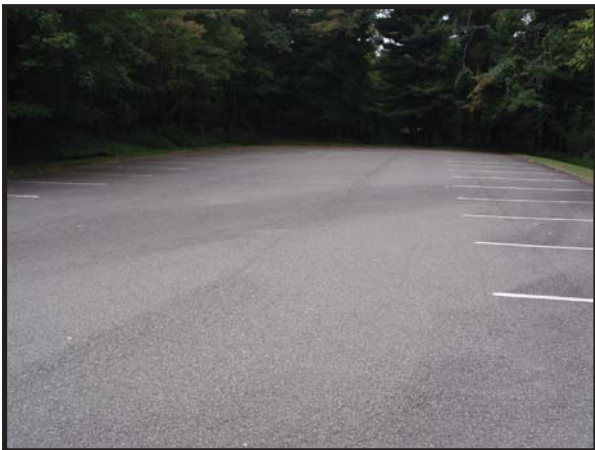
Route 1218C

Route	Public / NonPublic	Date Visited	Area (sq ft)	Lane Miles *	Surface Type	Condition / PCR
1218C	Public	9/7/2003	2448	0.04	AS	FAIR / 73

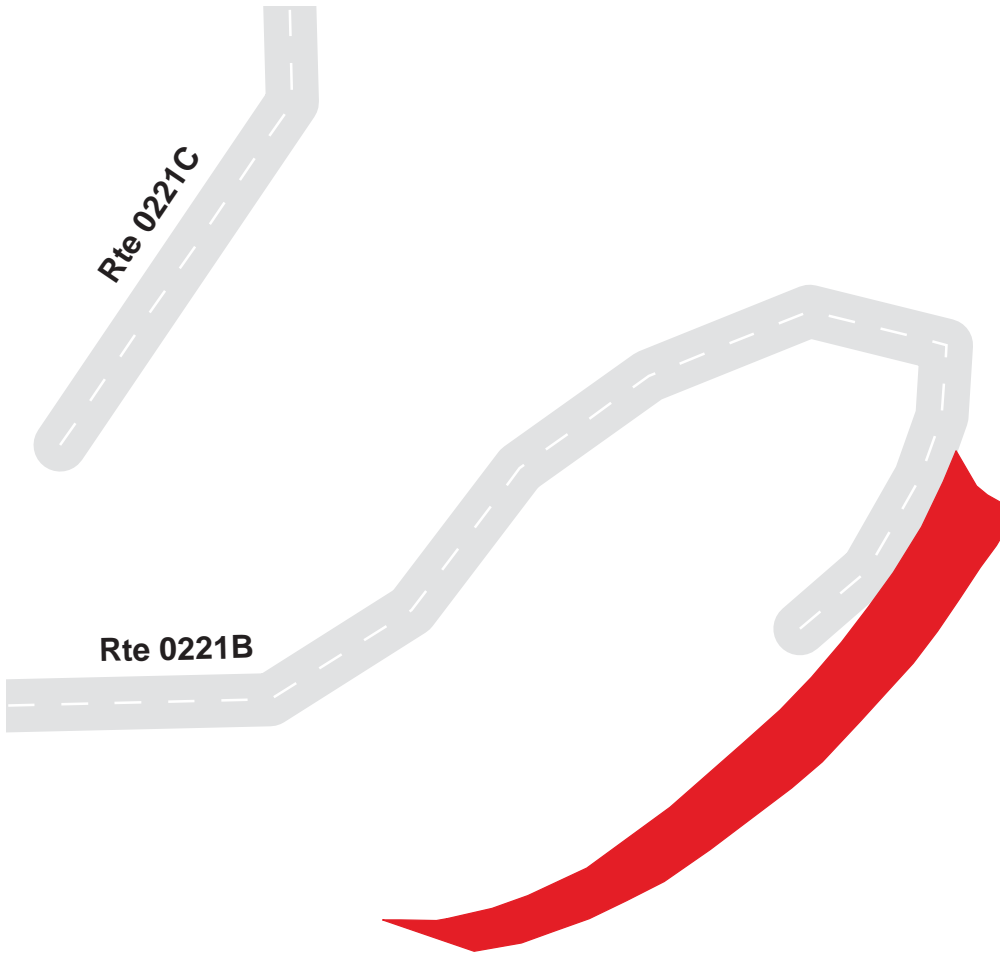
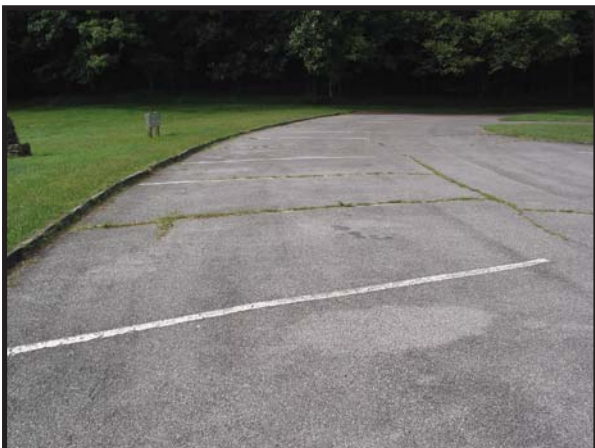
Route 1218D

Route	Public / NonPublic	Date Visited	Area (sq ft)	Lane Miles *	Surface Type	Condition / PCR
1218D	Public	9/7/2003	2668	0.05	AS	FAIR / 73

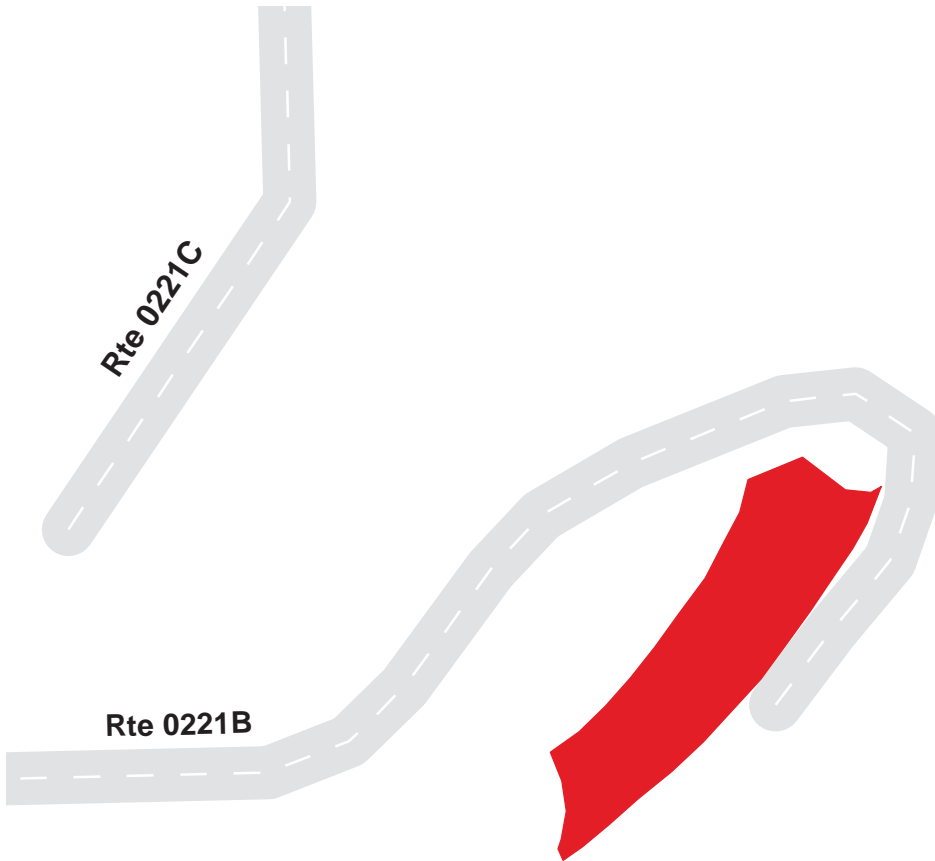
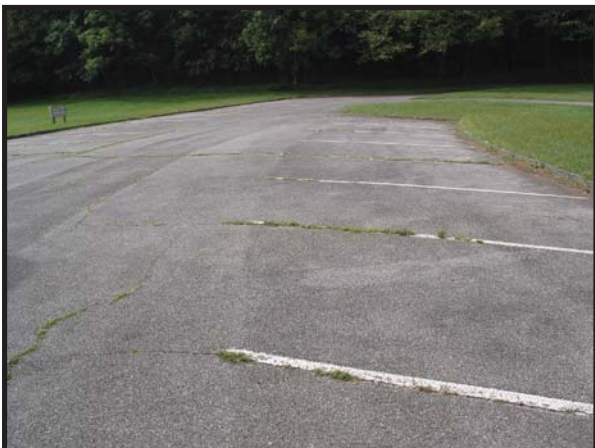
Route 1218E

Route	Public / NonPublic	Date Visited	Area (sq ft)	Lane Miles *	Surface Type	Condition / PCR
1218E	Public	9/7/2003	1999	0.03	AS	FAIR / 73

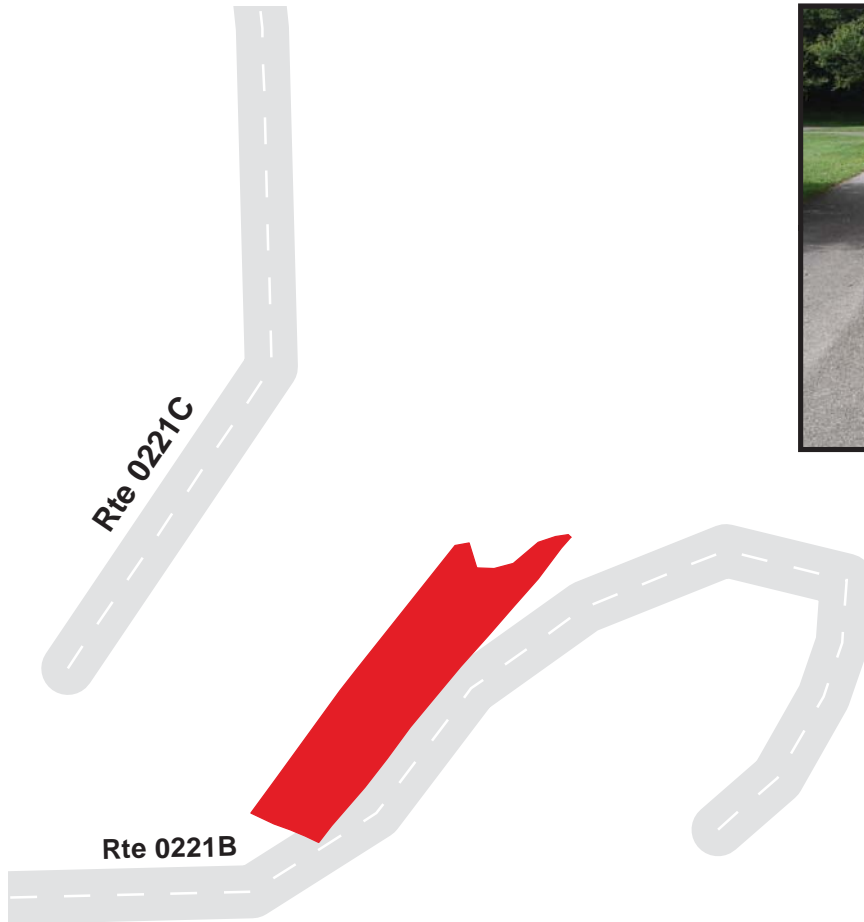
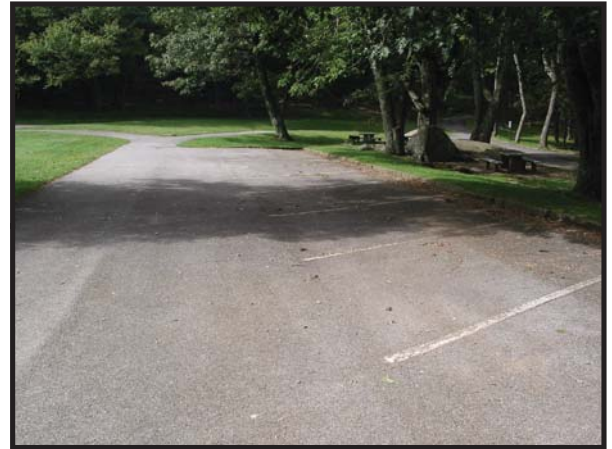
Route 1218F

Route	Public / NonPublic	Date Visited	Area (sq ft)	Lane Miles *	Surface Type	Condition / PCR
1218F	Public	9/7/2003	1772	0.03	AS	FAIR / 73

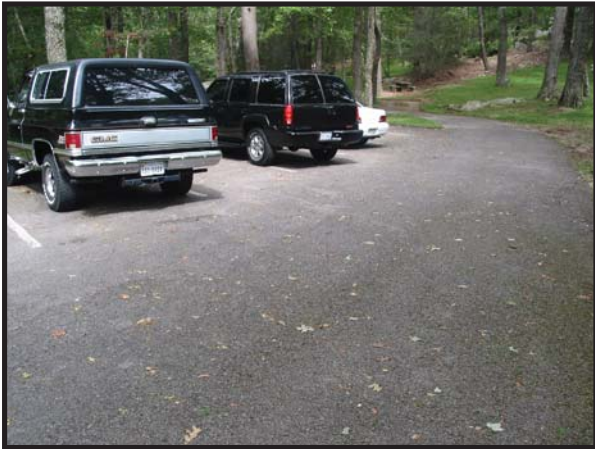
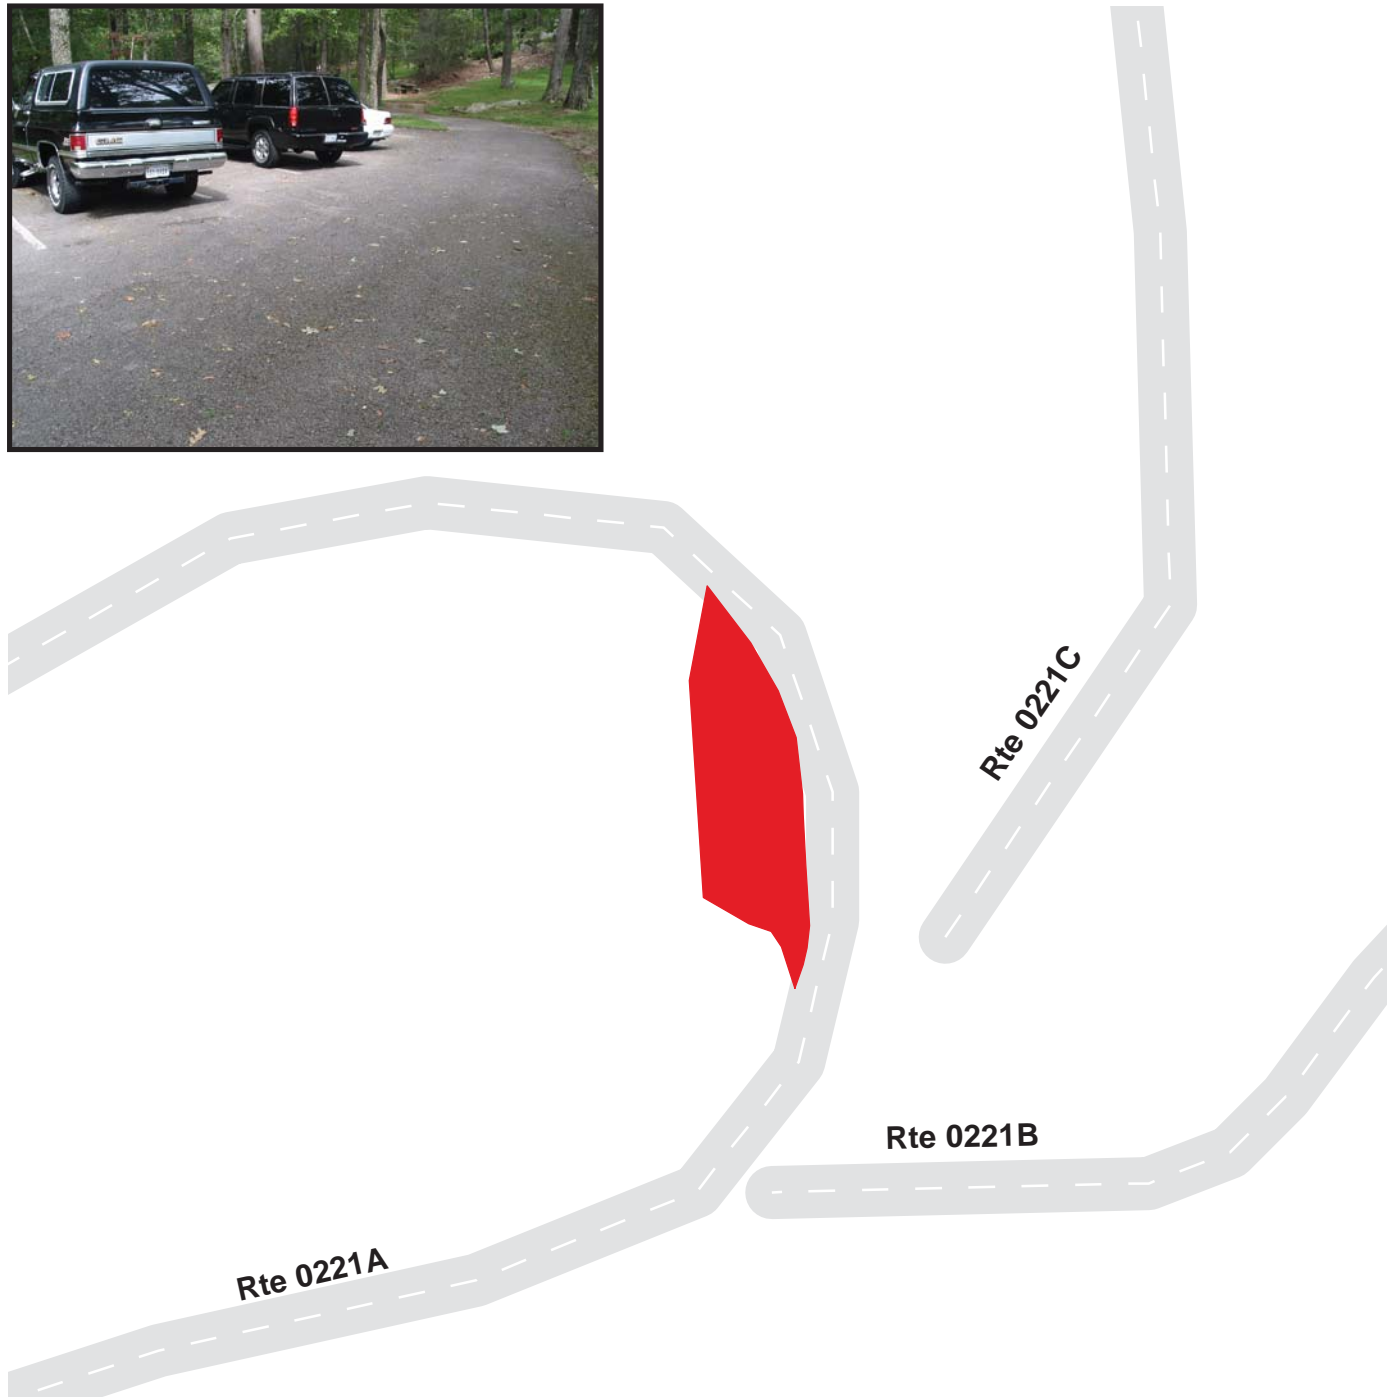
Route 1218G

Route	Public / NonPublic	Date Visited	Area (sq ft)	Lane Miles *	Surface Type	Condition / PCR
1218G	Public	9/7/2003	3135	0.05	AS	FAIR / 73

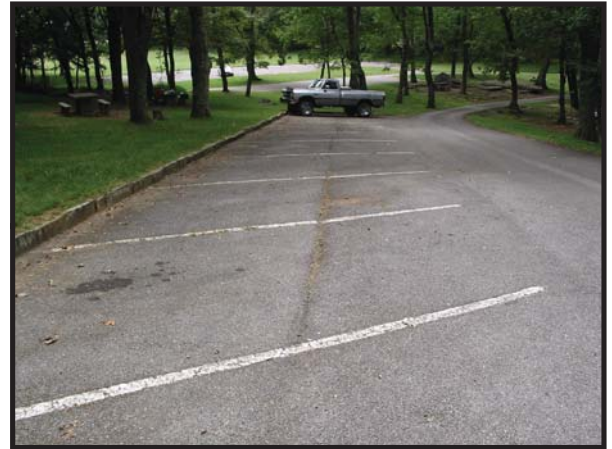
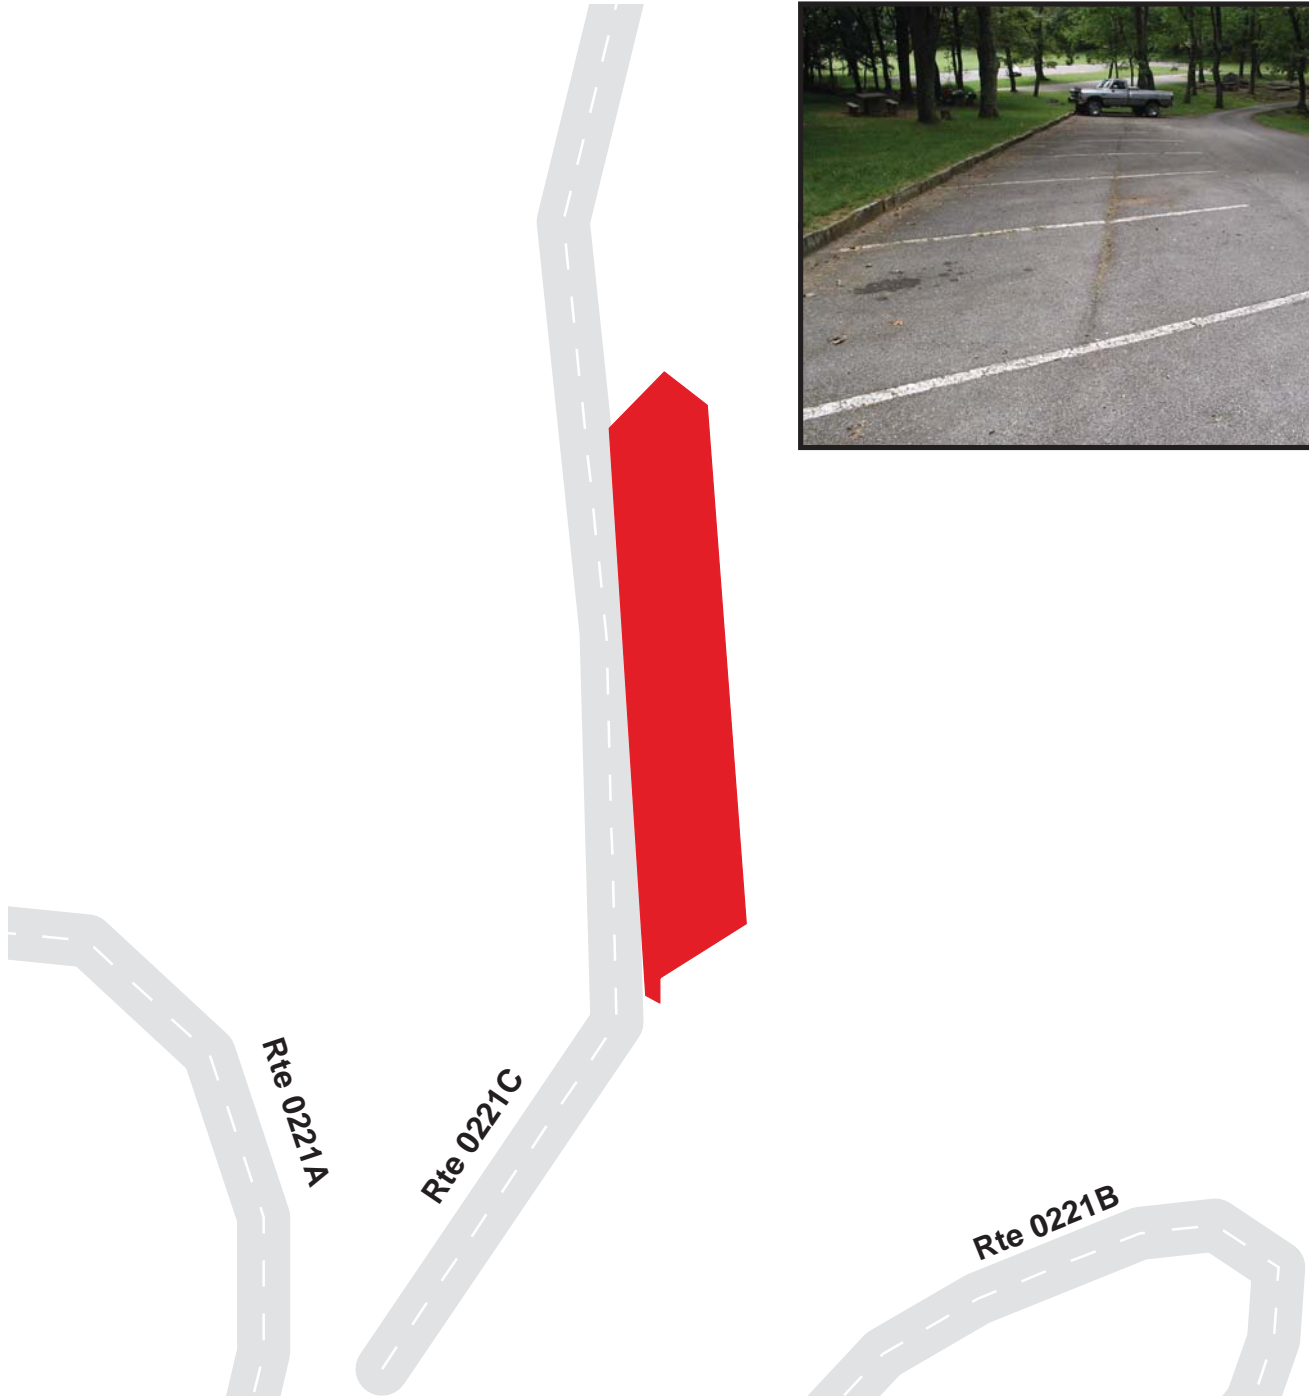
Route 1218H

Route	Public / NonPublic	Date Visited	Area (sq ft)	Lane Miles *	Surface Type	Condition / PCR
1218H	Public	9/7/2003	990	0.02	AS	FAIR / 73

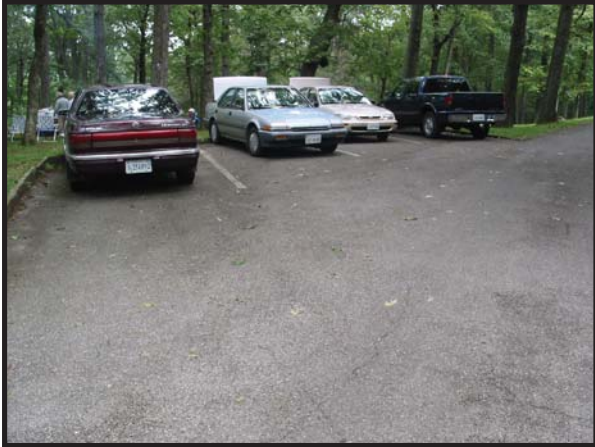
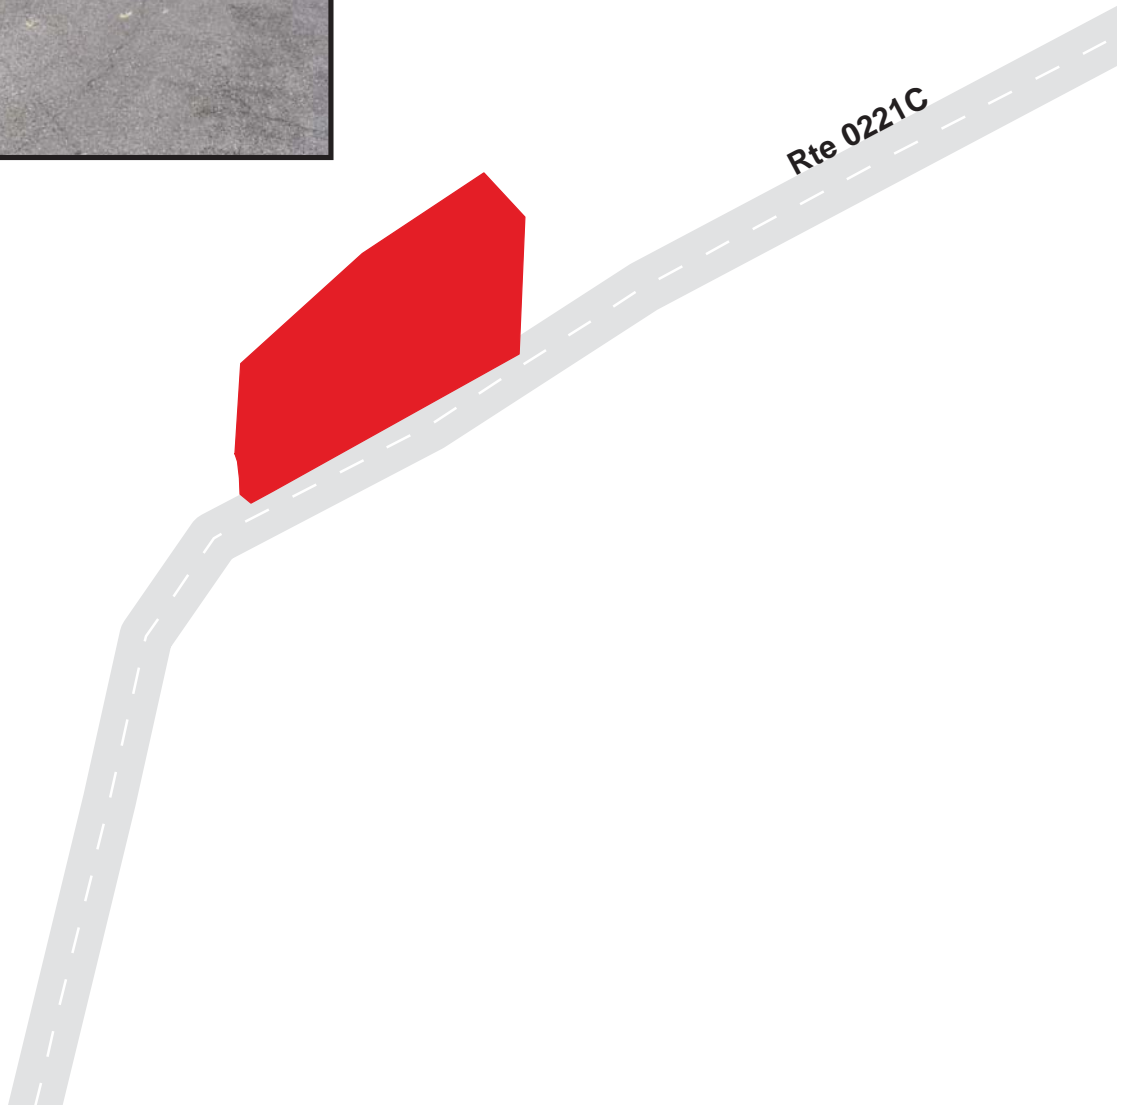
Route 1218I

Route	Public / NonPublic	Date Visited	Area (sq ft)	Lane Miles *	Surface Type	Condition / PCR
1218I	Public	9/7/2003	1063	0.02	AS	FAIR / 73

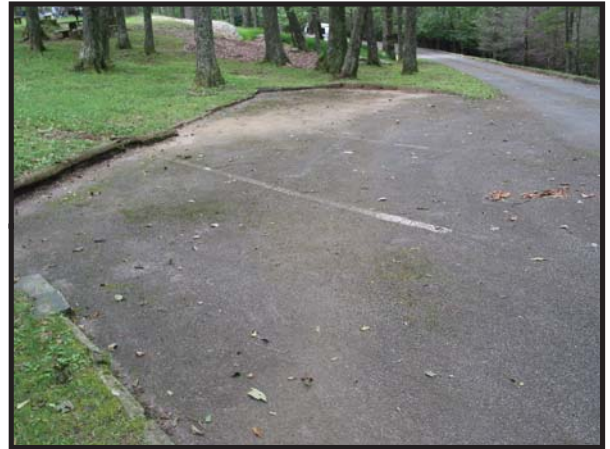
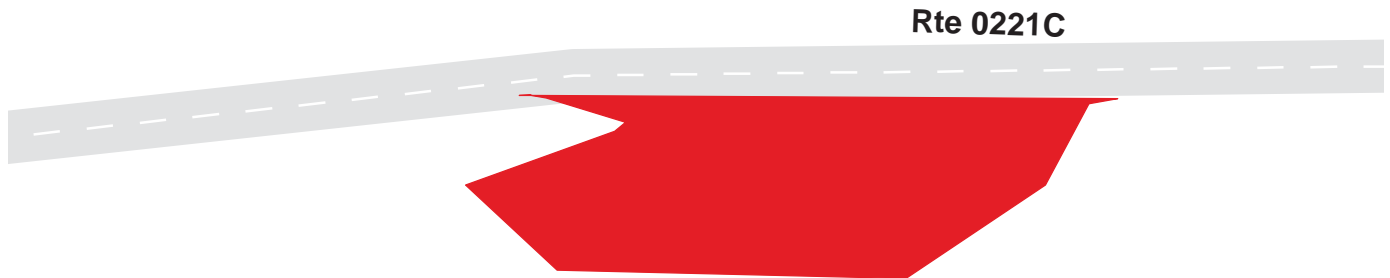
Route 1218J

Route	Public / NonPublic	Date Visited	Area (sq ft)	Lane Miles *	Surface Type	Condition / PCR
1218J	Public	9/7/2003	1132	0.02	AS	FAIR / 73

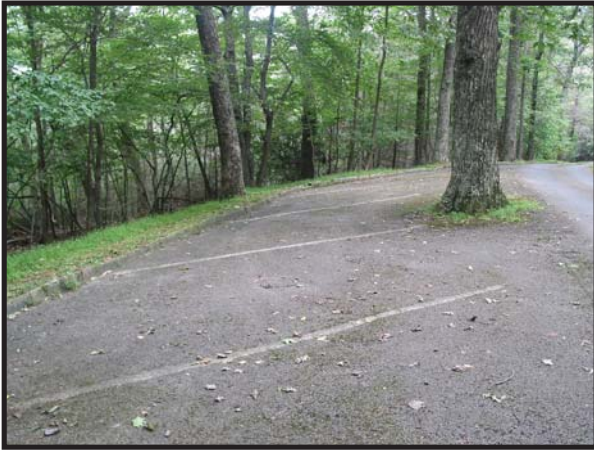
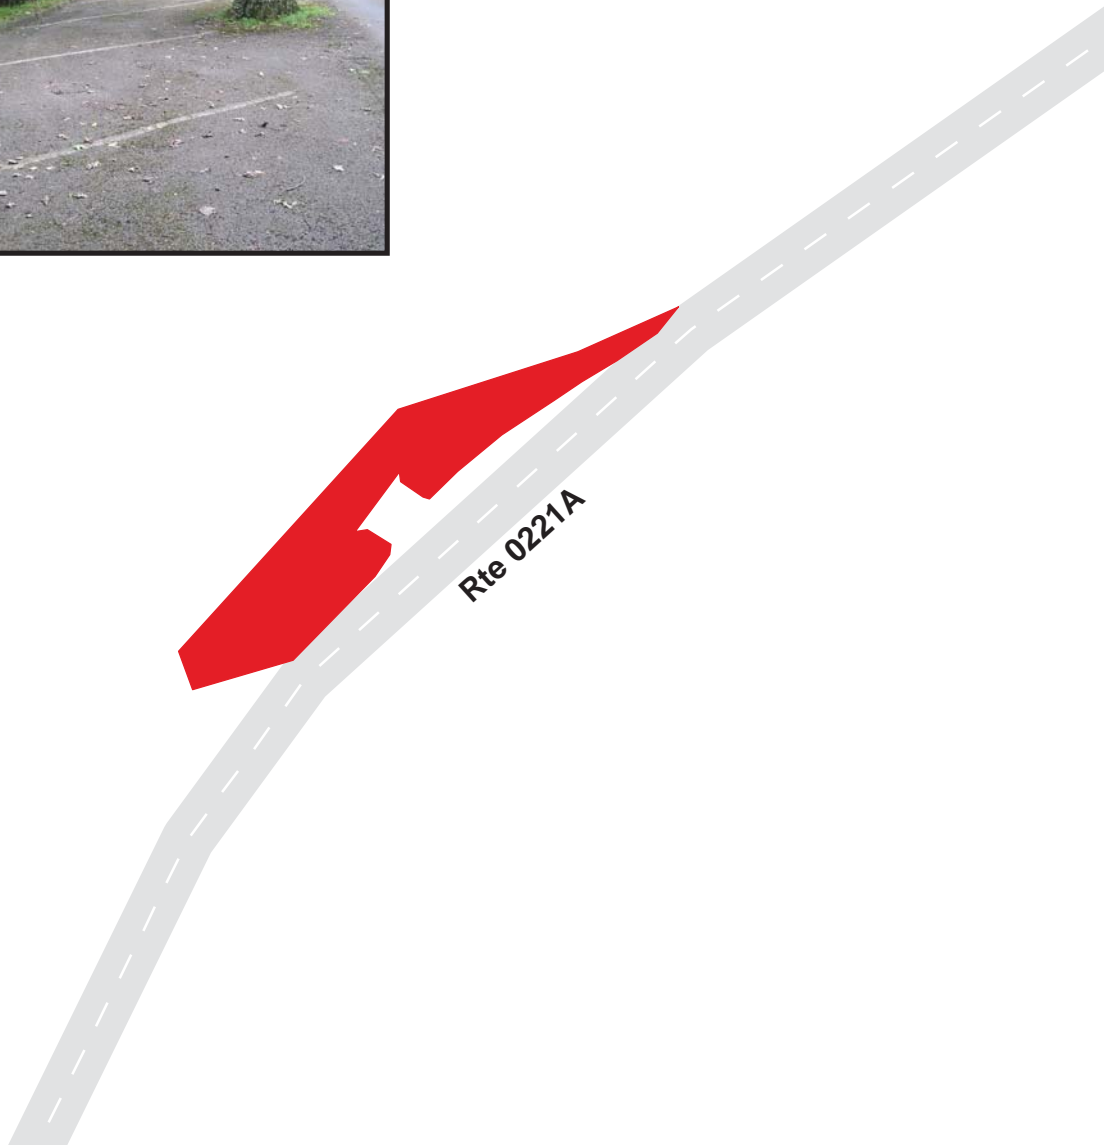
Route 1219

Route	Public / NonPublic	Date Visited	Area (sq ft)	Lane Miles *	Surface Type	Condition / PCR
1219	Public	9/7/2003	3301	0.06	AS	GOOD / 90

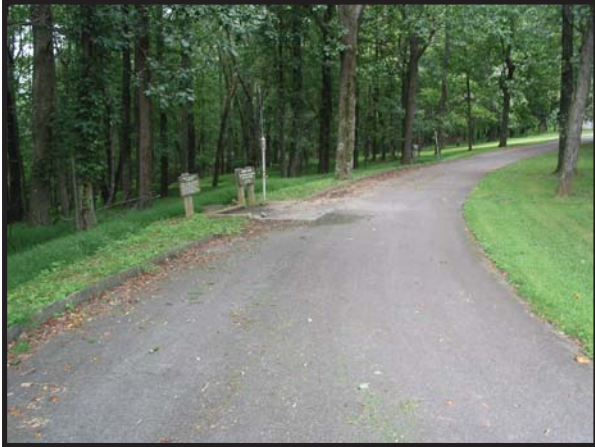
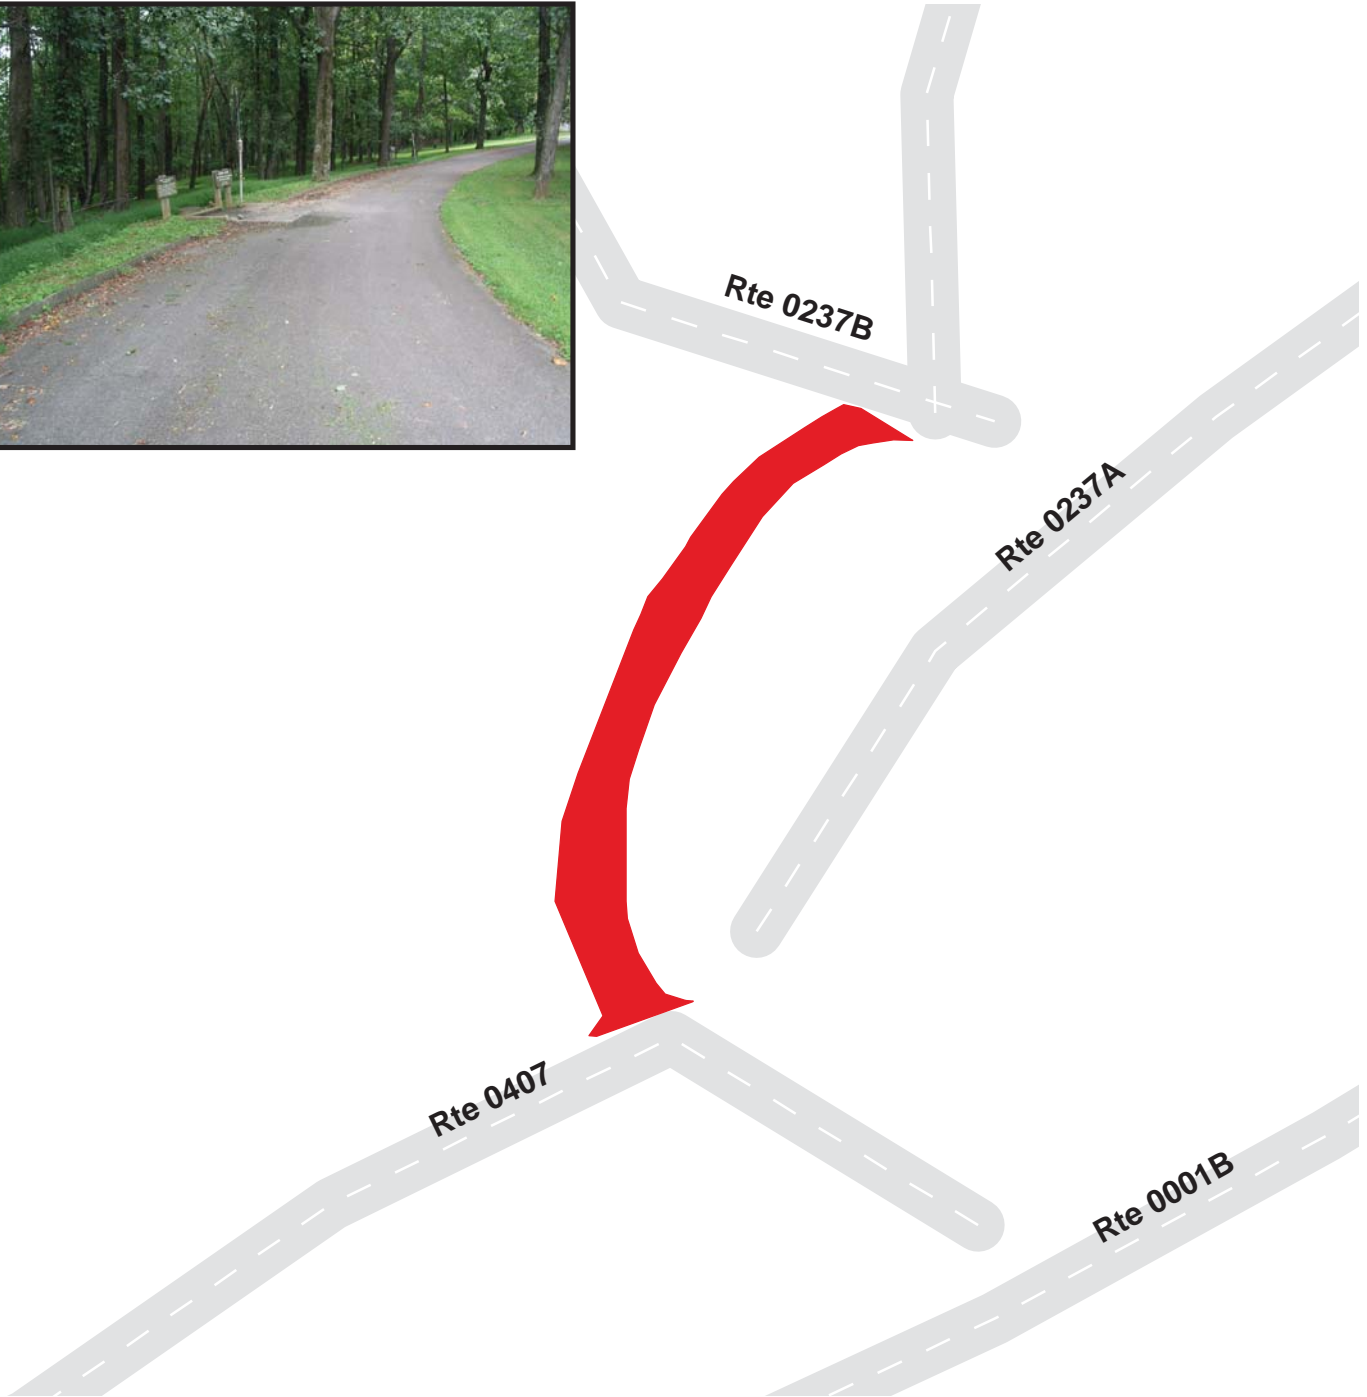
Route 1220

Route	Public / NonPublic	Date Visited	Area (sq ft)	Lane Miles *	Surface Type	Condition / PCR
1220	Public	9/7/2003	491	0.01	AS	GOOD / 90

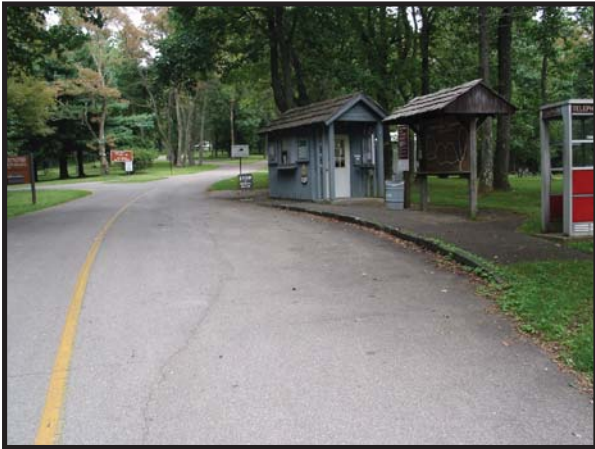
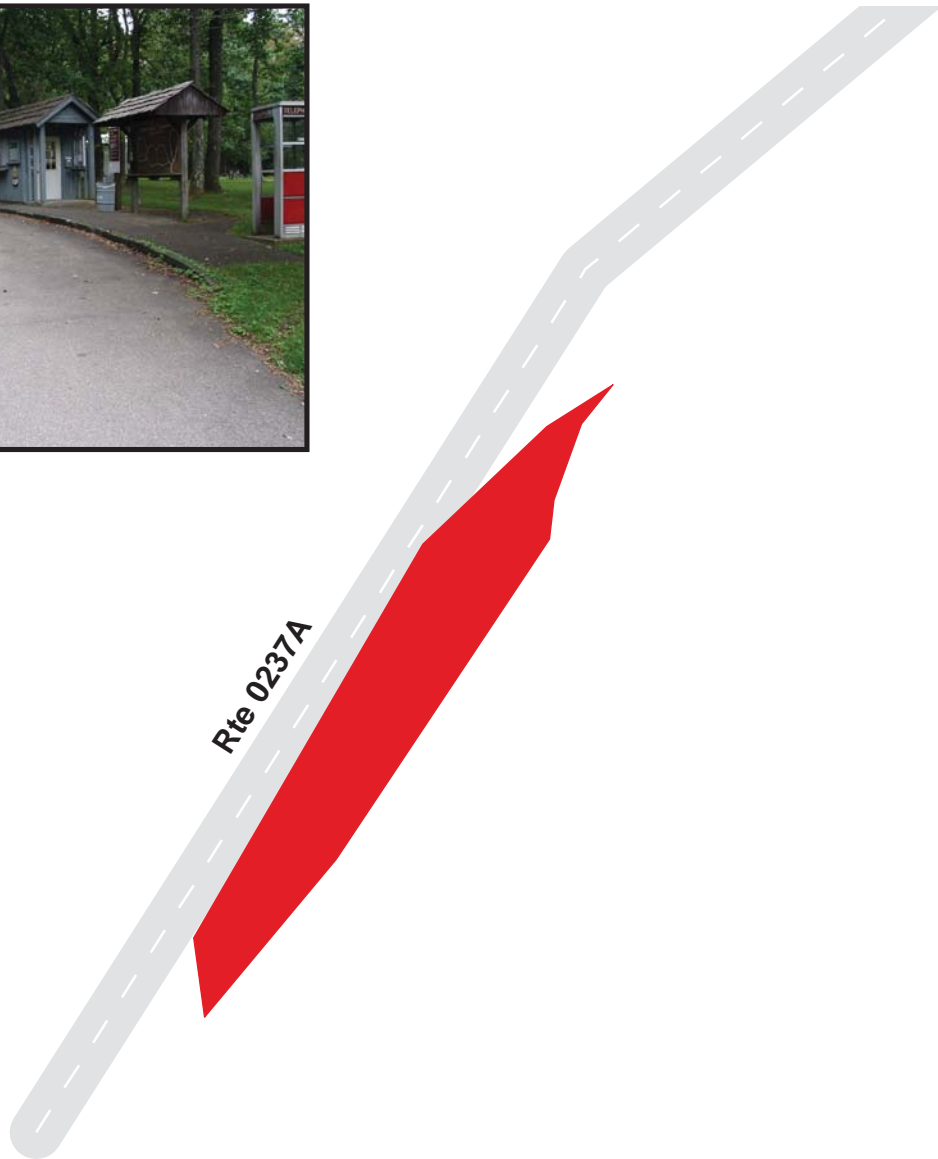
Blue Ridge Parkway Route 1221A

Smart View Picnic Parking Area A
Adjacent to Route 0223 at MP 0.02 on Left

Route	Public / NonPublic	Date Visited	Area (sq ft)	Lane Miles *	Surface Type	Condition / PCR
1221A	Public	9/7/2003	4904	0.08	AS	GOOD / 90
