The Road Inventory of Blue Ridge Parkway BLRI – 5140 Volume 1

Road Inventory Program

Prepared By:
Federal Highway Administration
Eastern Federal Lands Highway Division
Cycle 3

Blue Ridge Parkway in North Carolina

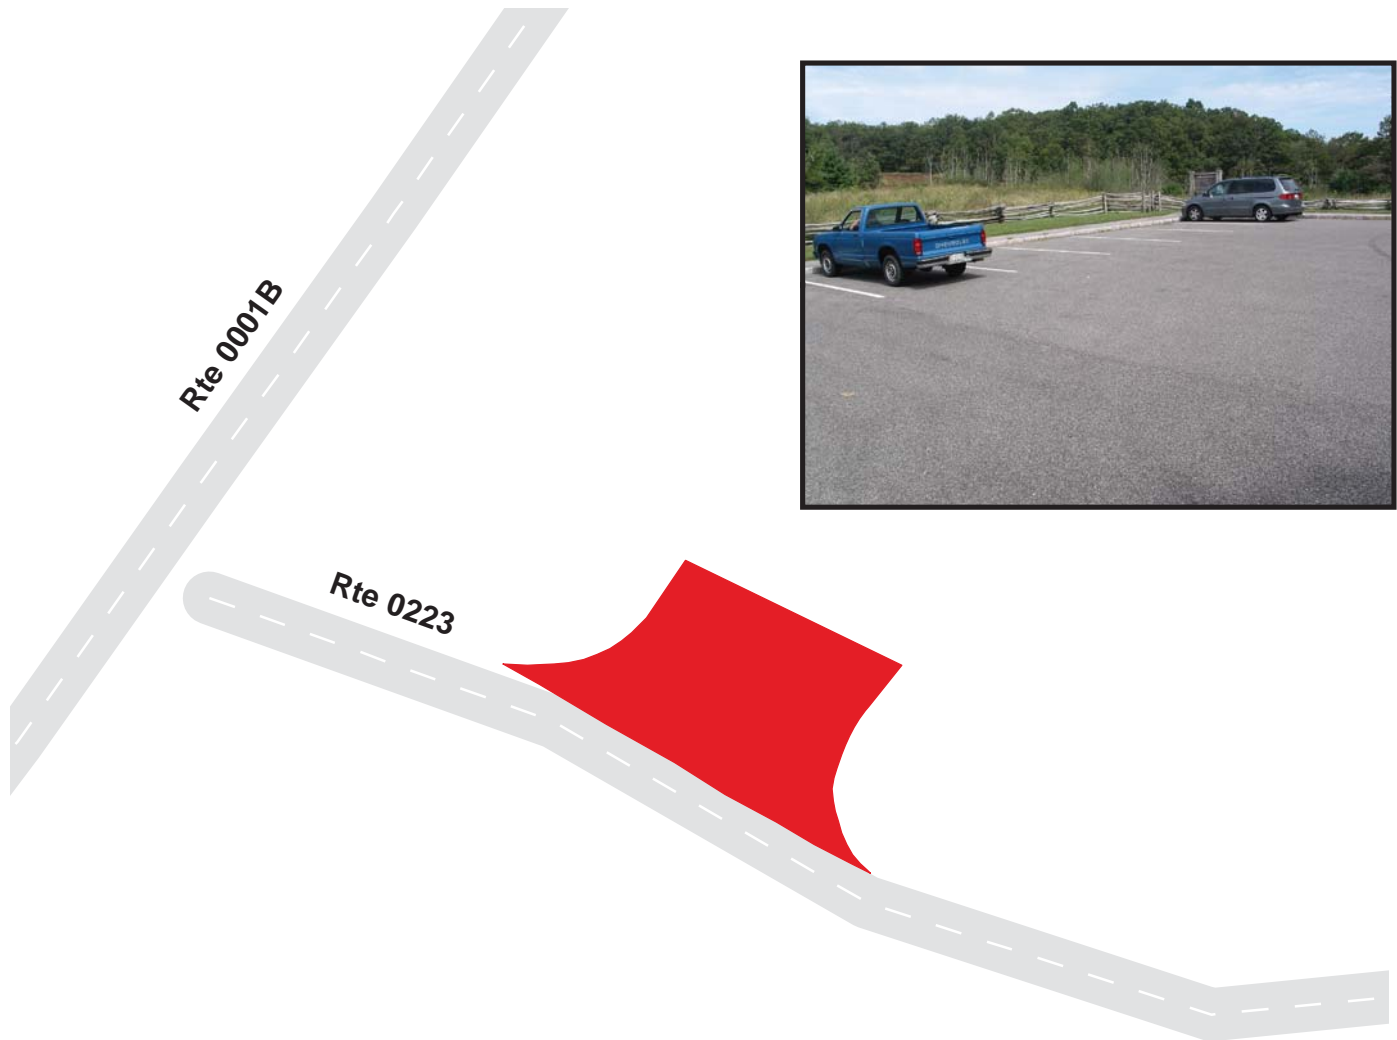
Route 1221B

Route	Public / NonPublic	Date Visited	Area (sq ft)	Lane Miles *	Surface Type	Condition / PCR
1221B	Public	9/7/2003	2431	0.04	AS	GOOD / 90

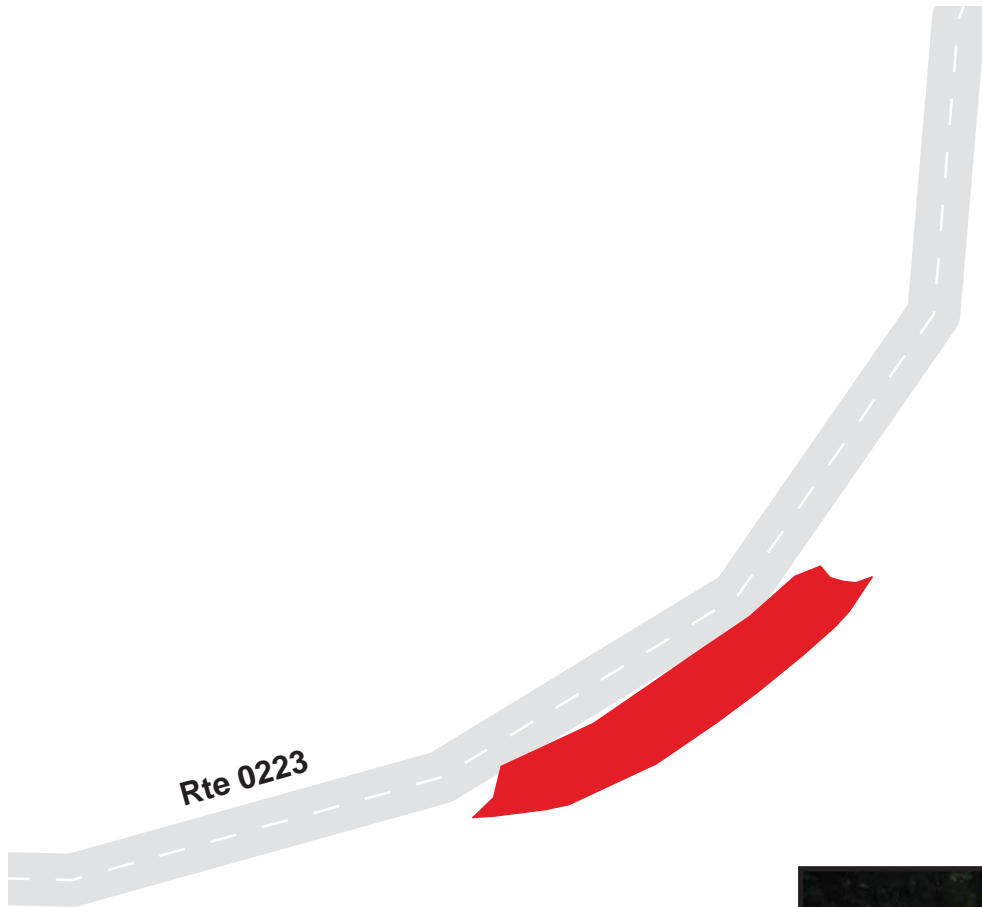
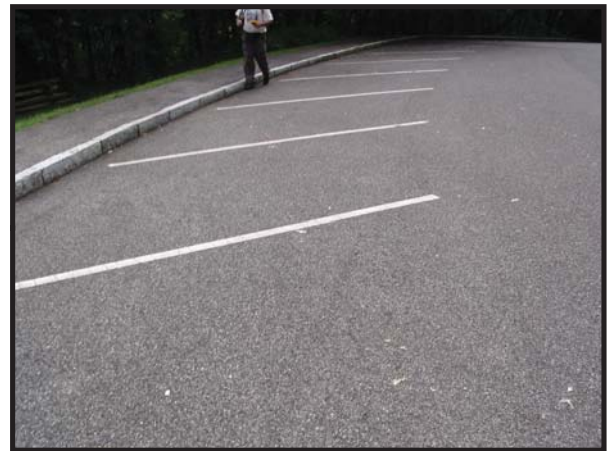
Blue Ridge Parkway Route 1221C

Smart View Picnic Parking Area C
Adjacent to Route 0223 at MP 0.34 on Left

Route	Public / NonPublic	Date Visited	Area (sq ft)	Lane Miles *	Surface Type	Condition / PCR
1221C	Public	9/7/2003	1370	0.02	AS	GOOD / 90

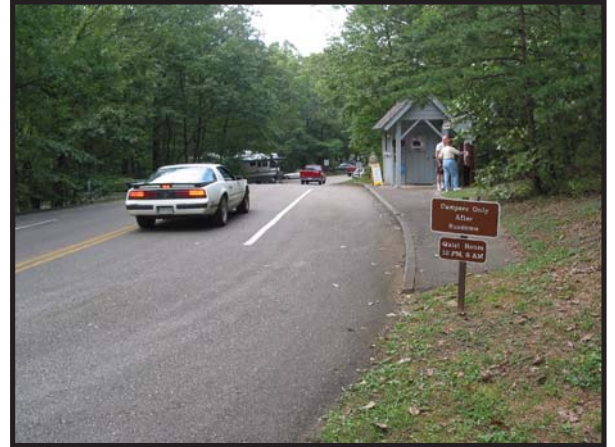
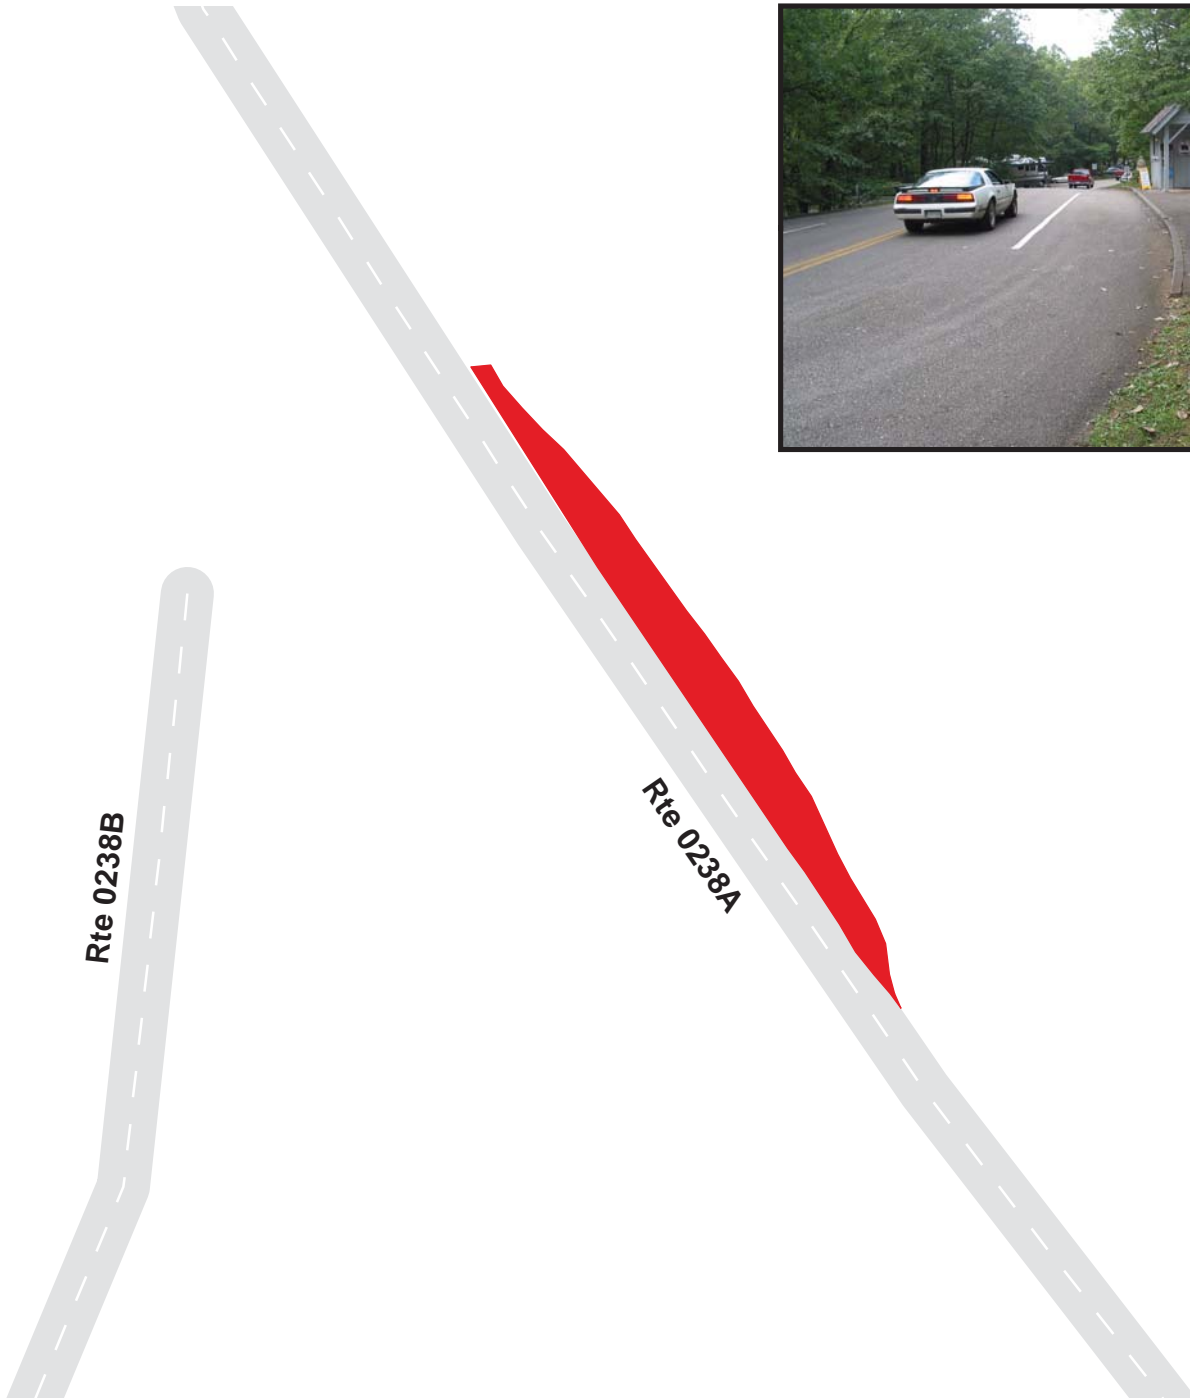
Blue Ridge Parkway Route 1224A

Stewart Knob Overlook A
From Route 0224 at MP 0.12 on Left

Route	Public / NonPublic	Date Visited	Area (sq ft)	Lane Miles *	Surface Type	Condition / PCR
1224A	Public	9/8/2003	4216	0.07	AS	GOOD / 90

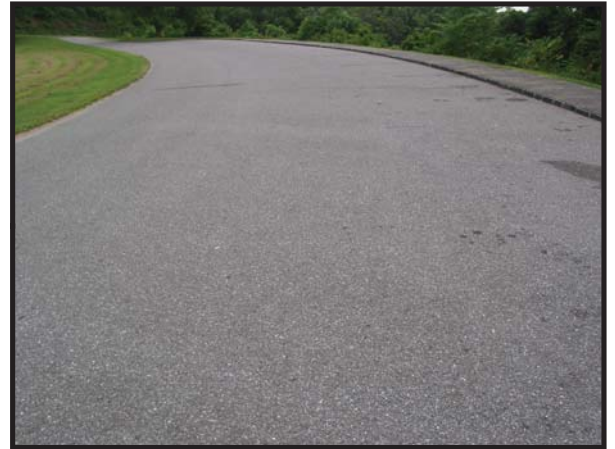
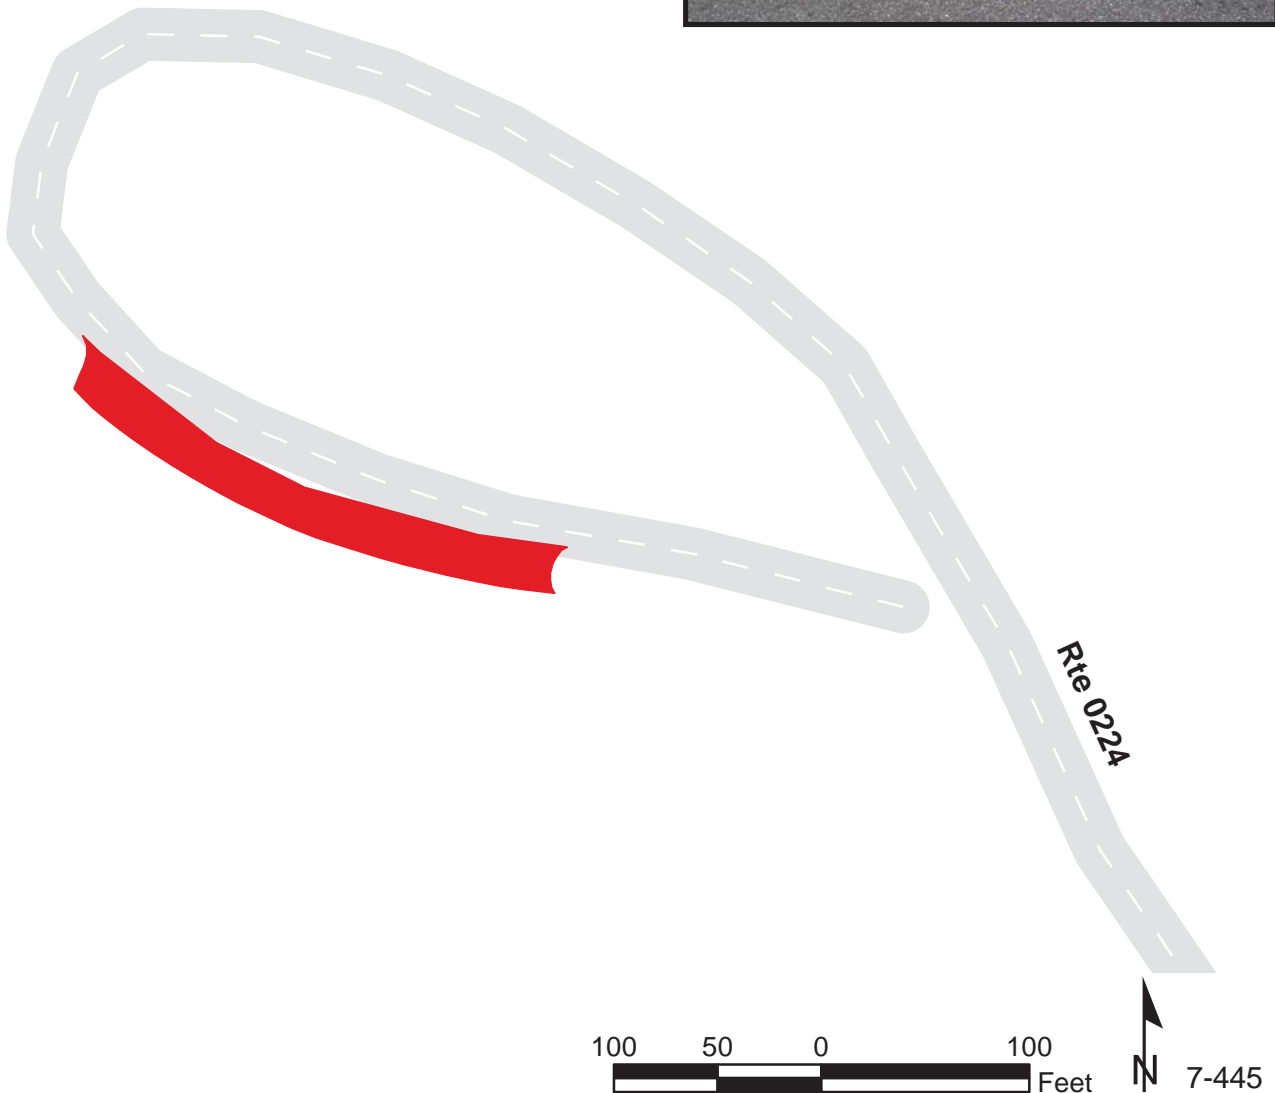
Blue Ridge Parkway
Route 1225
Back Creek Valley
From Route 0161 at MP 0.36 on Right

Route	Public / NonPublic	Date Visited	Area (sq ft)	Lane Miles *	Surface Type	Condition / PCR
1225	Public	9/8/2003	22132	0.38	AS	GOOD / 90

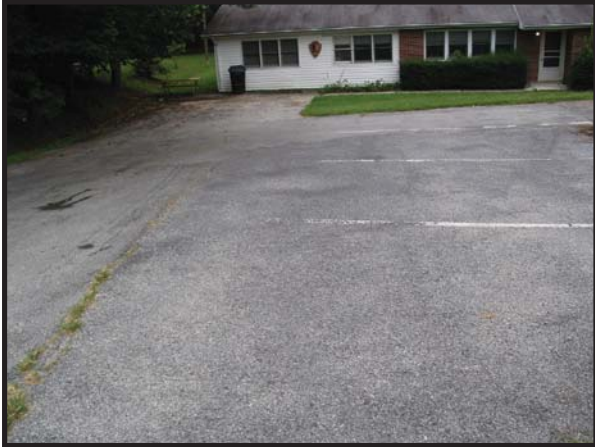
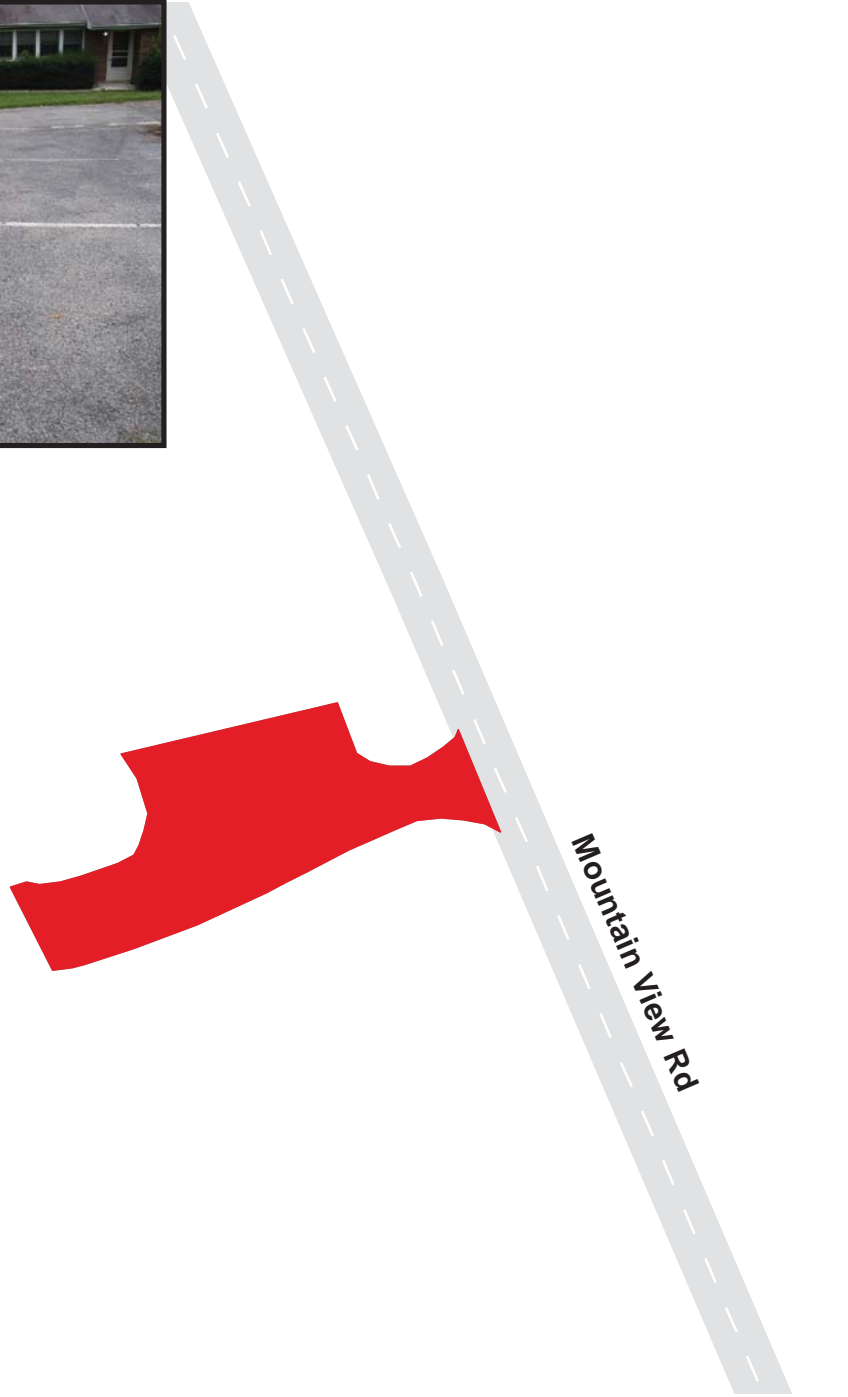
**Blue Ridge Parkway
Route 1229
Ranger Offices
From Mountain View Road**

Route	Public / NonPublic	Date Visited	Area (sq ft)	Lane Miles *	Surface Type	Condition / PCR
1229	Public	9/8/2003	3011	0.05	AS	FAIR / 73

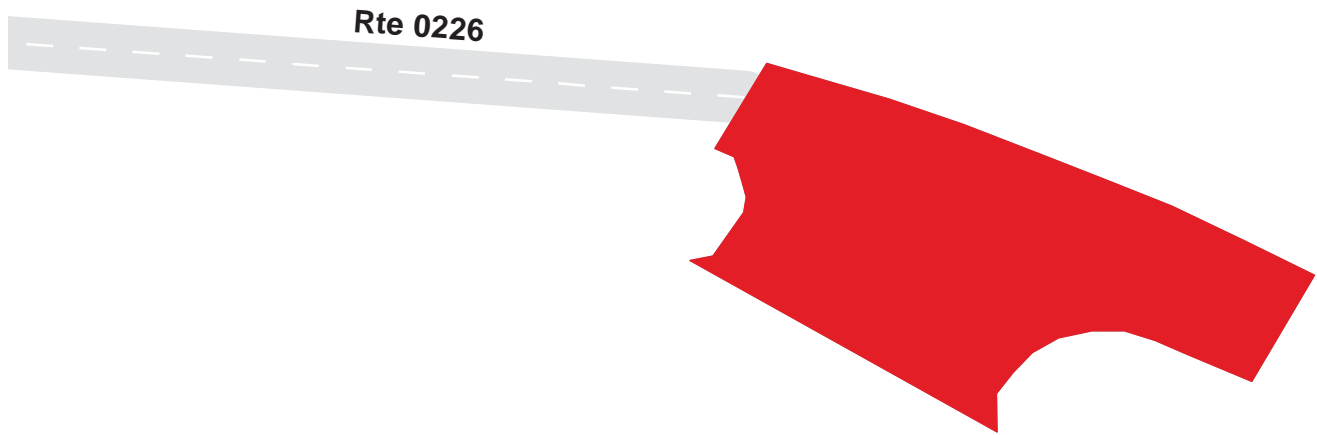
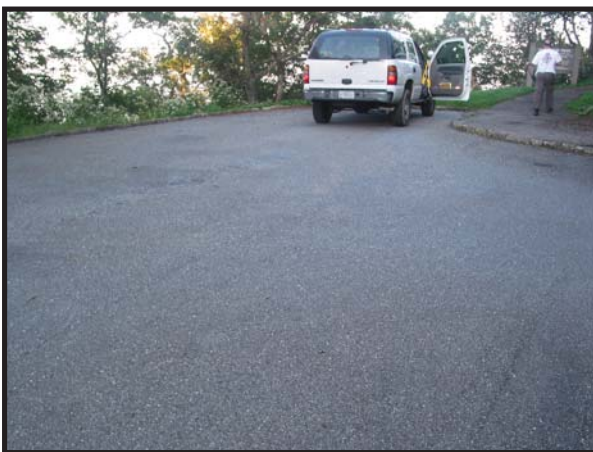
Route 1230

Route	Public / NonPublic	Date Visited	Area (sq ft)	Lane Miles *	Surface Type	Condition / PCR
1230	NonPublic	9/8/2003	2192	0.04	AS	GOOD / 90

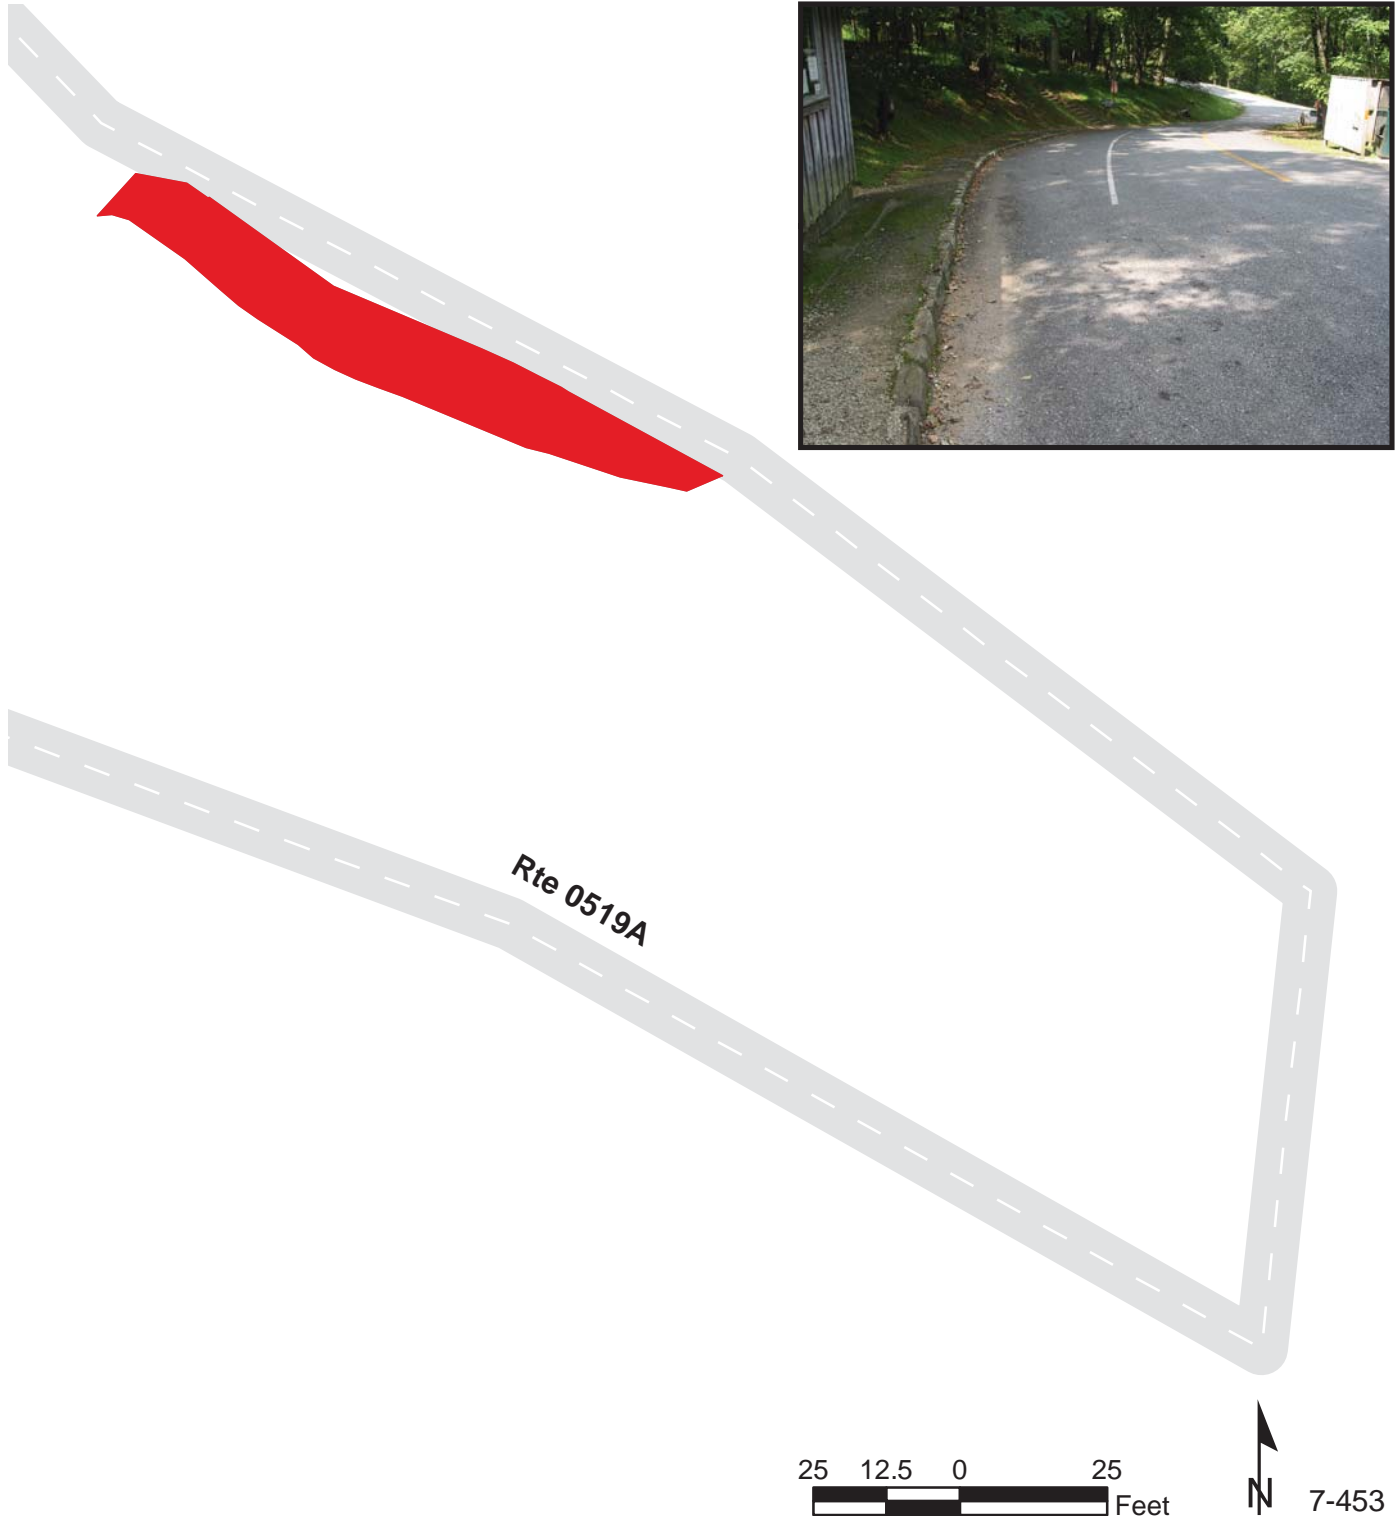
Route 1231

Route	Public / NonPublic	Date Visited	Area (sq ft)	Lane Miles *	Surface Type	Condition / PCR
1231	Public	9/9/2003	969	0.02	AS	GOOD / 90

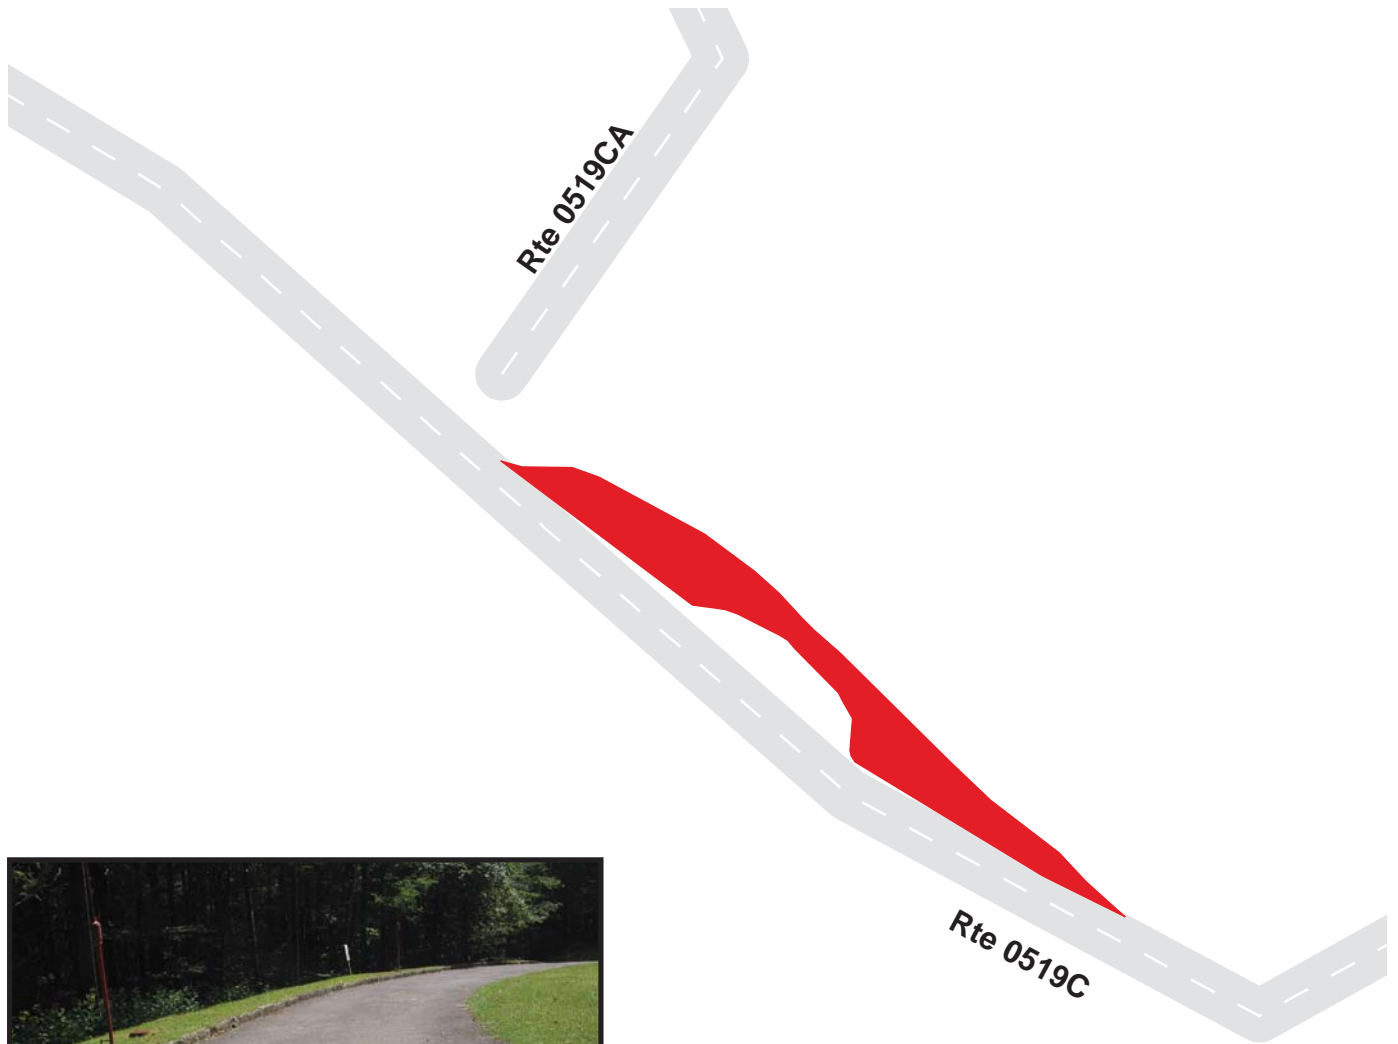
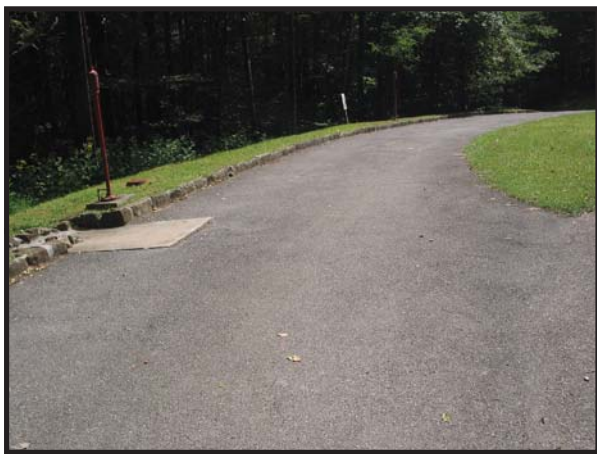
Route 1232

Route	Public / NonPublic	Date Visited	Area (sq ft)	Lane Miles *	Surface Type	Condition / PCR
1232	Public	9/9/2003	1690	0.03	AS	GOOD / 90

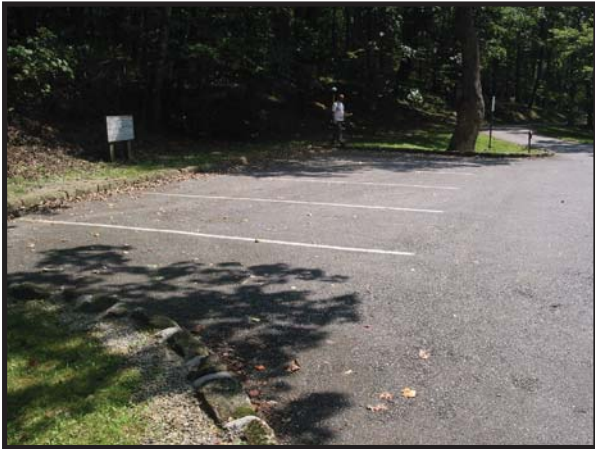
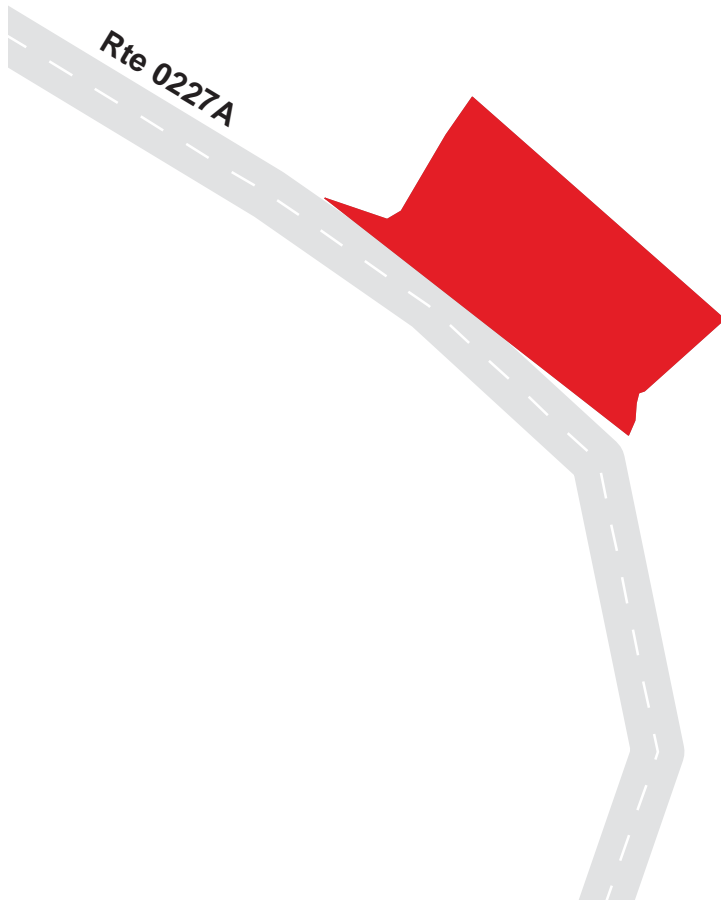
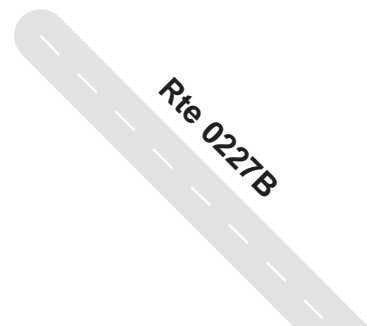
Route 1233A

Route	Public / NonPublic	Date Visited	Area (sq ft)	Lane Miles *	Surface Type	Condition / PCR
1233A	Public	9/9/2003	1201	0.02	AS	GOOD / 90

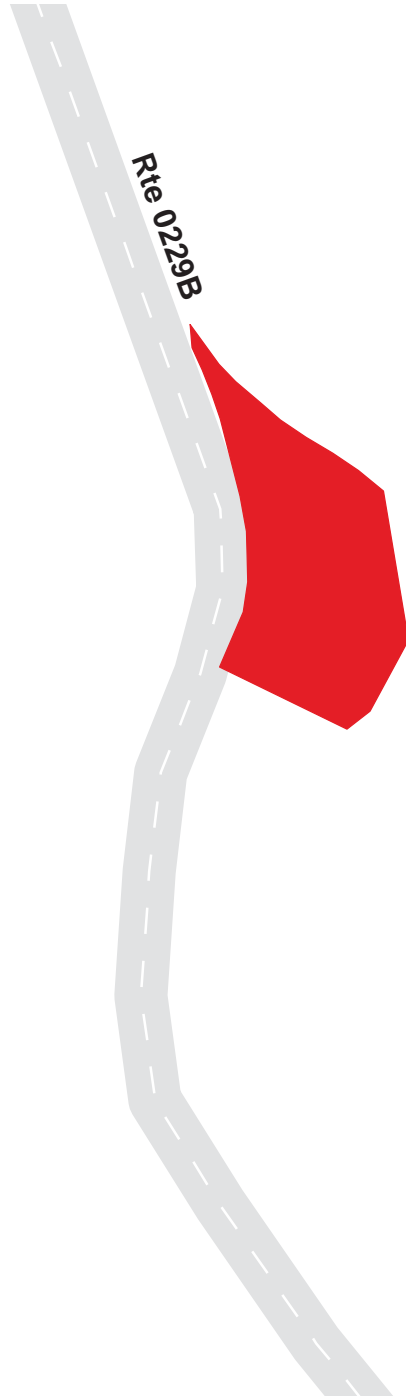
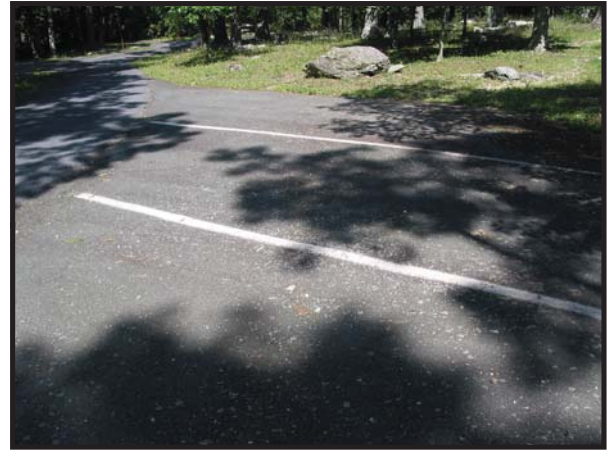
Route	Public / NonPublic	Date Visited	Area (sq ft)	Lane Miles *	Surface Type	Condition / PCR
1244C	Public	9/10/2003	1061	0.02	AS	FAIR / 73

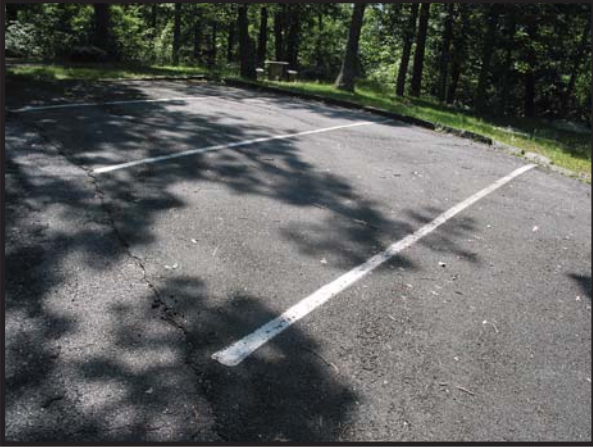
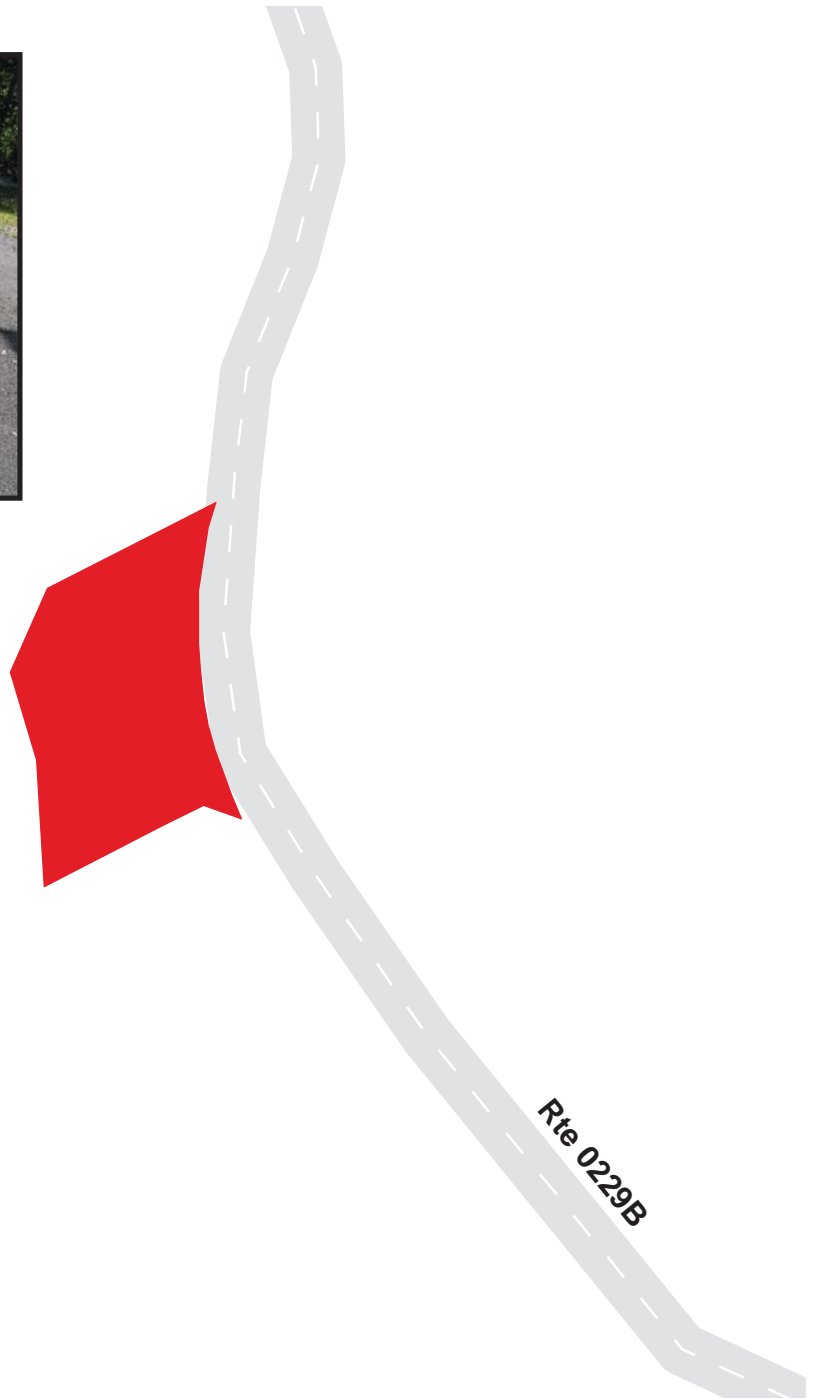
Route	Public / NonPublic	Date Visited	Area (sq ft)	Lane Miles *	Surface Type	Condition / PCR
1244D	Public	9/10/2003	949	0.02	AS	FAIR / 73

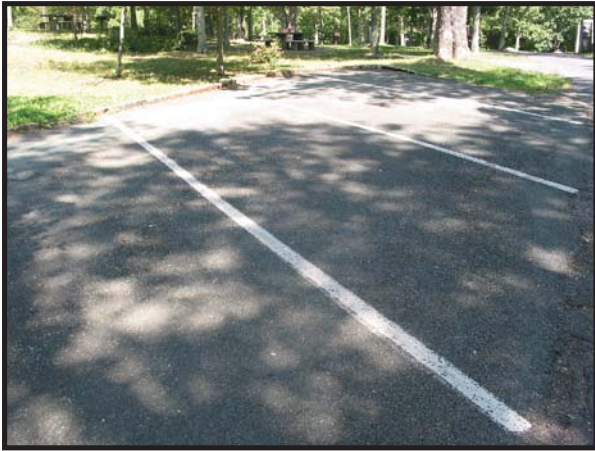
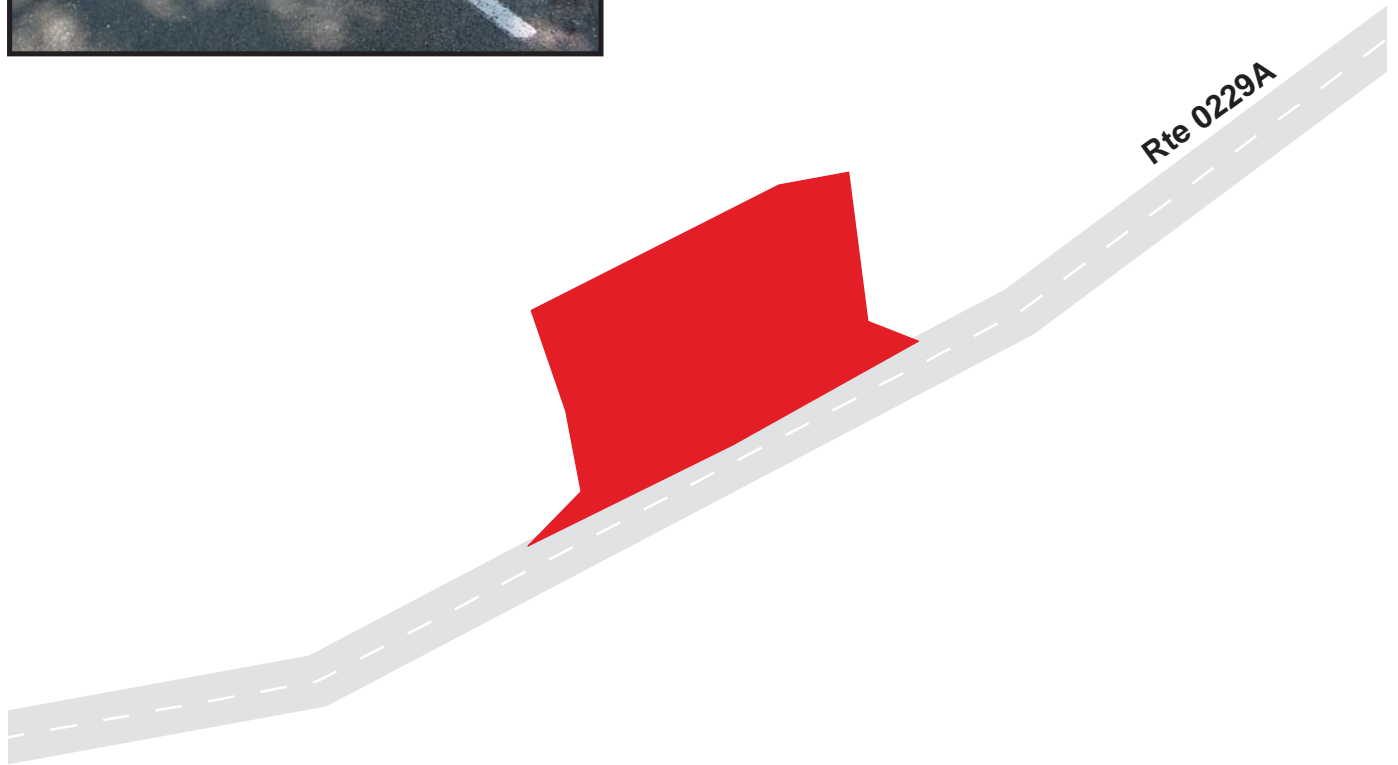
Route	Public / NonPublic	Date Visited	Area (sq ft)	Lane Miles *	Surface Type	Condition / PCR
1244E	Public	9/10/2003	1270	0.02	AS	FAIR / 73

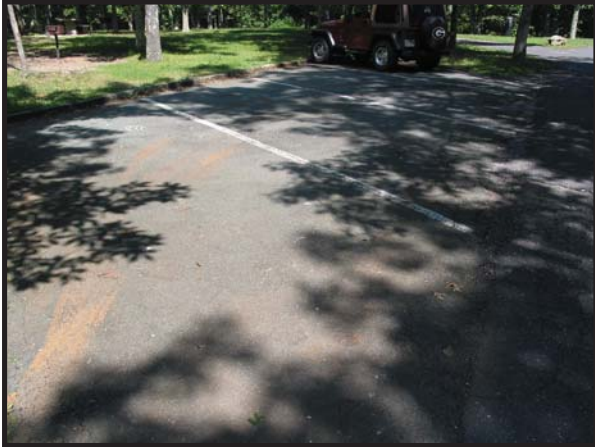
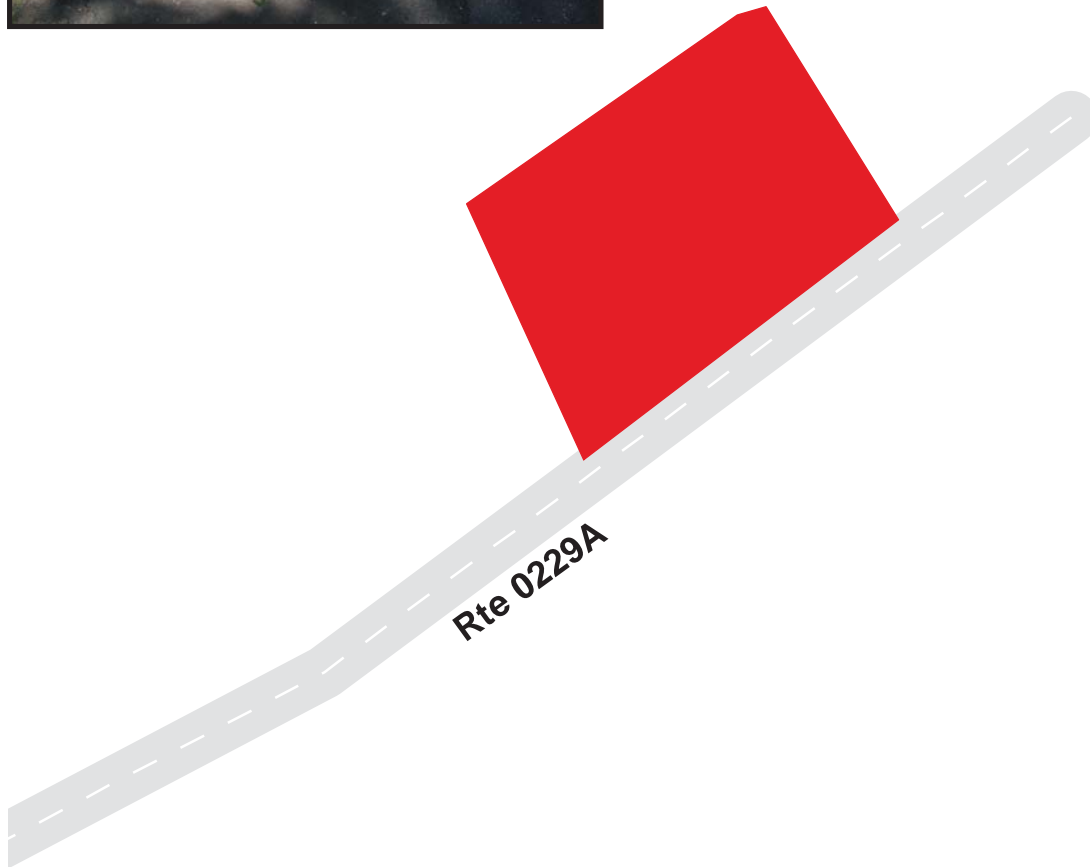
Route 1244F

Route	Public / NonPublic	Date Visited	Area (sq ft)	Lane Miles *	Surface Type	Condition / PCR
1244F	Public	9/10/2003	1356	0.02	AS	FAIR / 73

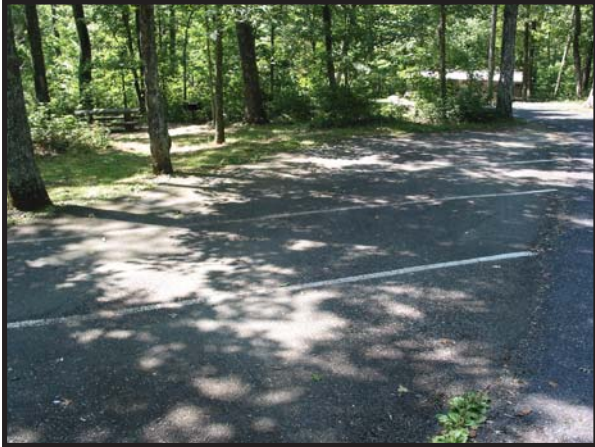
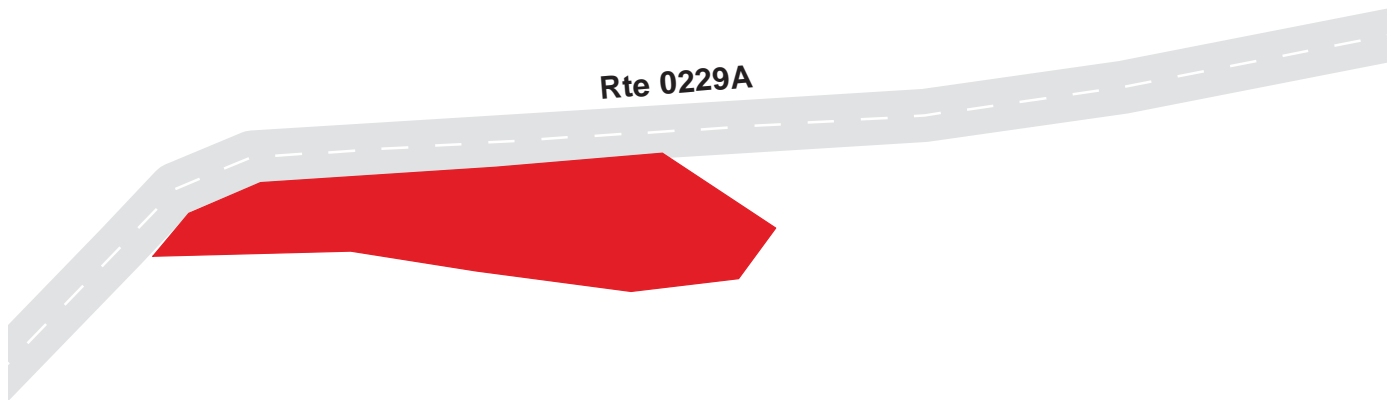
Route 1244G

Route	Public / NonPublic	Date Visited	Area (sq ft)	Lane Miles *	Surface Type	Condition / PCR
1244G	Public	9/10/2003	959	0.02	AS	FAIR / 73
