# The Road Inventory of Gateway National Recreation Area GATE - 1770

## Road Inventory Program

Prepared By:  
Federal Highway Administration  
Eastern Federal Lands Highway Division  
Cycle 3

# Gateway National Recreation Area in New York

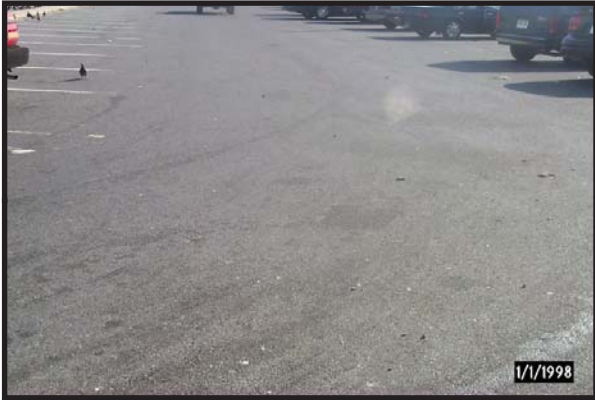
Route	Length (mi)	Width (ft)	Area (sq ft)	Lane Miles *	Condition / PCR	Surface Type
0204	0.27	0.00	47527	0.82	GOOD / 90	AS

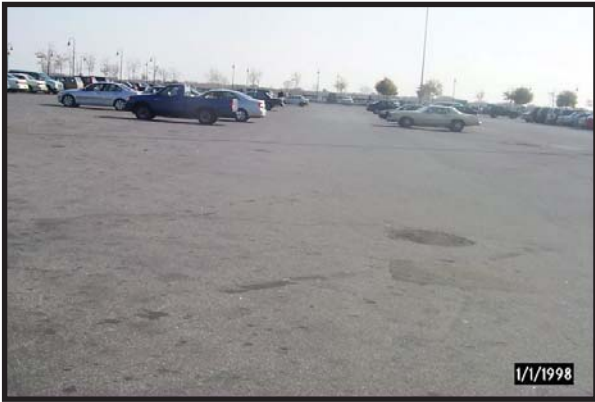
Route	Length (mi)	Width (ft)	Area (sq ft)	Lane Miles *	Condition / PCR	Surface Type
0205	0.41	0.00	49887	0.86	FAIR / 73	AS

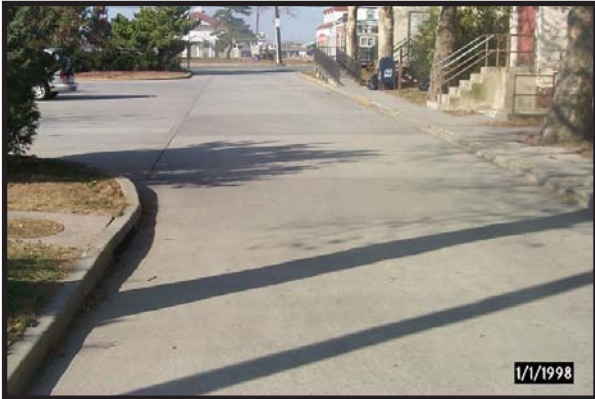
Route	Length (mi)	Width (ft)	Area (sq ft)	Lane Miles *	Condition / PCR	Surface Type
0225	0.04	15.00	3326	0.06	GOOD / 90	CO

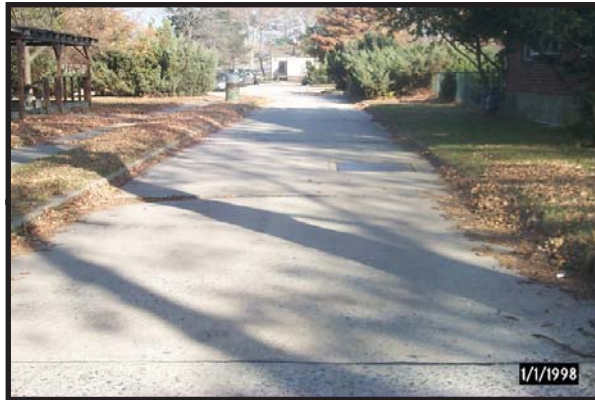
Route	Length (mi)	Width (ft)	Area (sq ft)	Lane Miles *	Condition / PCR	Surface Type
0226	0.08	20.00	8237	0.14	FAIR / 73	CO

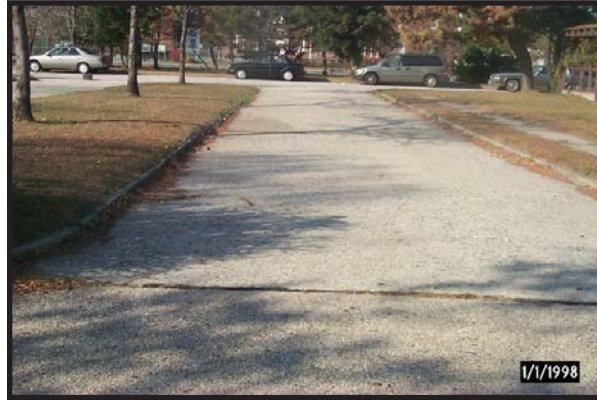
Route	Length (mi)	Width (ft)	Area (sq ft)	Lane Miles *	Condition / PCR	Surface Type
0227	0.03	20.00	2746	0.05	FAIR / 73	CO

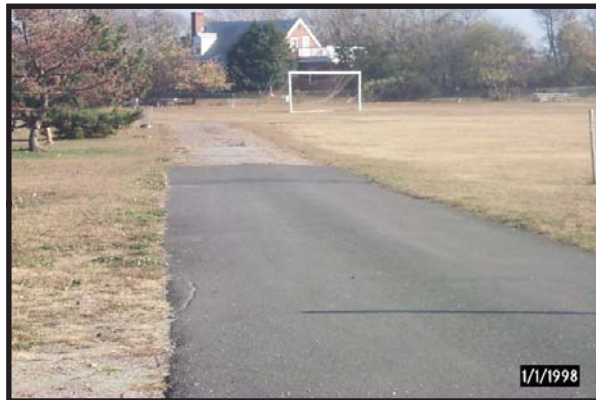
Route	Length (mi)	Width (ft)	Area (sq ft)	Lane Miles *	Condition / PCR	Surface Type
0229	0.06	10.00	3115	0.05	POOR / 45	AS

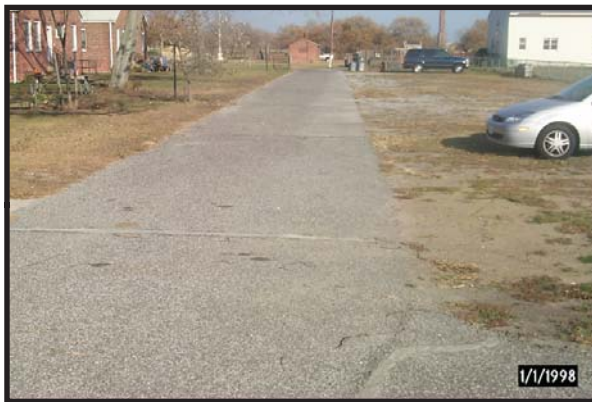
Route	Length (mi)	Width (ft)	Area (sq ft)	Lane Miles *	Condition / PCR	Surface Type
0230	0.05	20.00	5174	0.09	GOOD / 90	NC

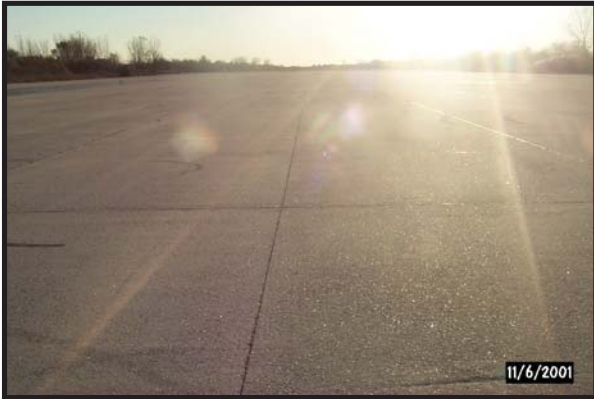
Route	Length (mi)	Width (ft)	Area (sq ft)	Lane Miles *	Condition / PCR	Surface Type
0403	1.13	0.00	1797671	30.95	FAIR / 73	CO

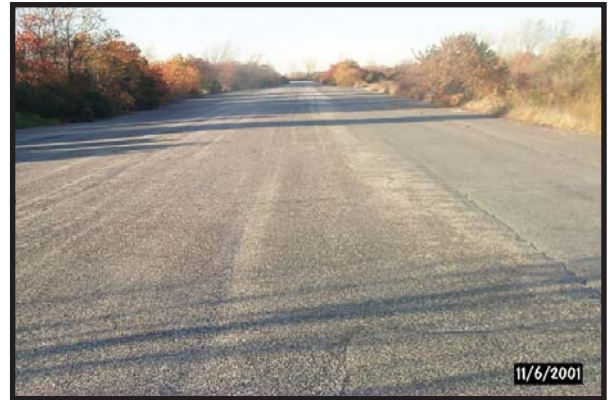
Route	Length (mi)	Width (ft)	Area (sq ft)	Lane Miles *	Condition / PCR	Surface Type
0405	0.50	0.00	234051	4.03	FAIR / 73	AS

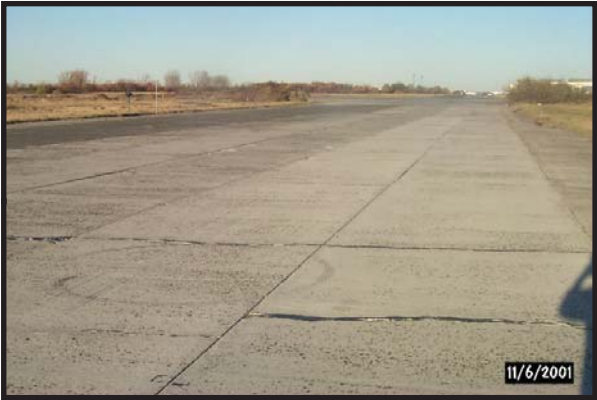
Route	Length (mi)	Width (ft)	Area (sq ft)	Lane Miles *	Condition / PCR	Surface Type
0406	0.68	0.00	367674	6.33	POOR / 45	CO

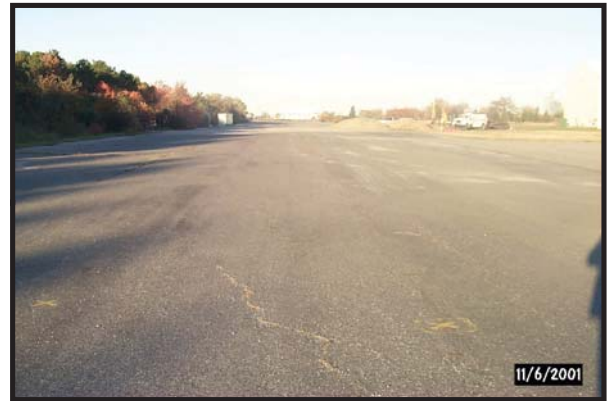
Route	Length (mi)	Width (ft)	Area (sq ft)	Lane Miles *	Condition / PCR	Surface Type
0410	0.36	85.00	159773	2.75	FAIR / 73	NC

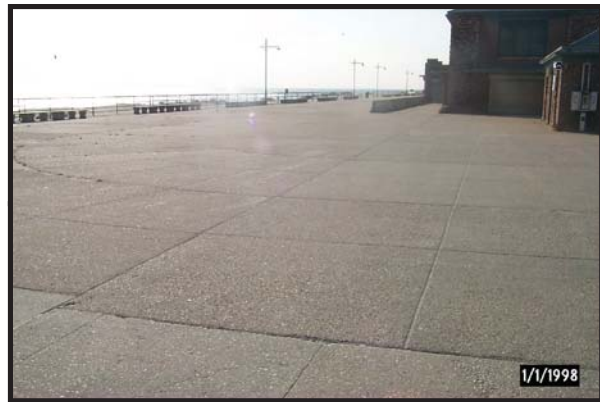
Route	Length (mi)	Width (ft)	Area (sq ft)	Lane Miles *	Condition / PCR	Surface Type
0412	0.93	25.00	123024	2.12	FAIR / 73	CO

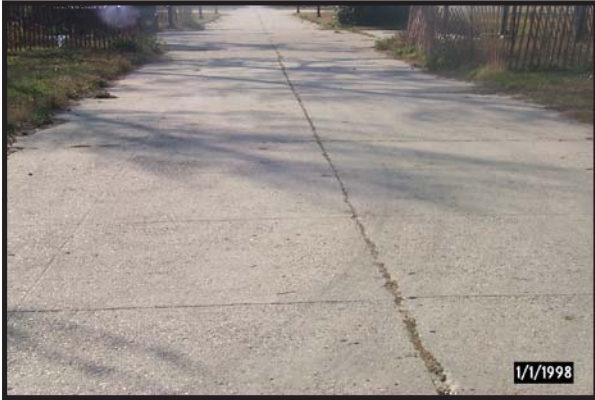
Route	Length (mi)	Width (ft)	Area (sq ft)	Lane Miles *	Condition / PCR	Surface Type
0413	0.08	20.00	8448	0.15	FAIR / 73	AS

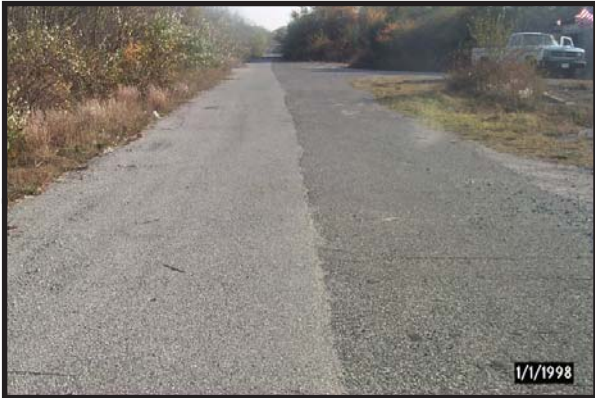
Route	Length (mi)	Width (ft)	Area (sq ft)	Lane Miles *	Condition / PCR	Surface Type
0415	0.18	20.00	19008	0.33	POOR / 45	NC

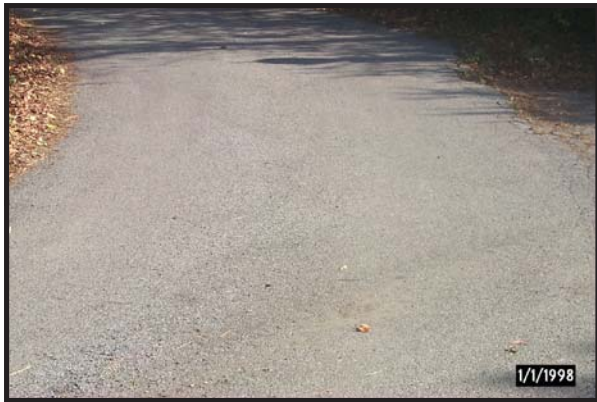
Route	Length (mi)	Width (ft)	Area (sq ft)	Lane Miles *	Condition / PCR	Surface Type
0419	0.03	20.00	2851	0.05	FAIR / 73	NC

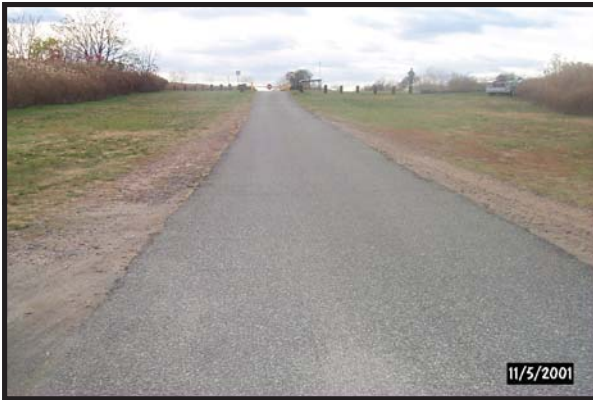
Route	Length (mi)	Width (ft)	Area (sq ft)	Lane Miles *	Condition / PCR	Surface Type
0437	0.75	15.00	59242	1.02	FAIR / 73	NC

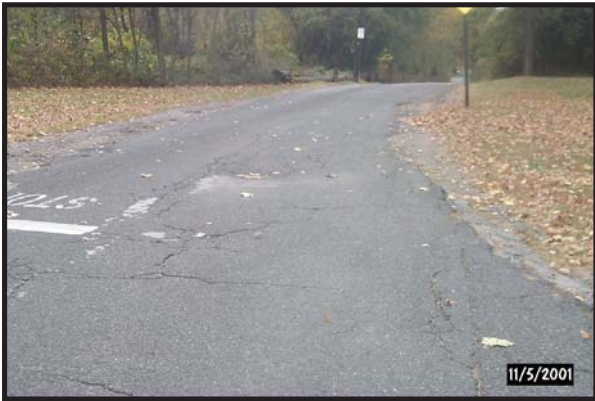
Route	Length (mi)	Width (ft)	Area (sq ft)	Lane Miles *	Condition / PCR	Surface Type
0438	0.31	20.00	32525	0.56	POOR / 45	AS

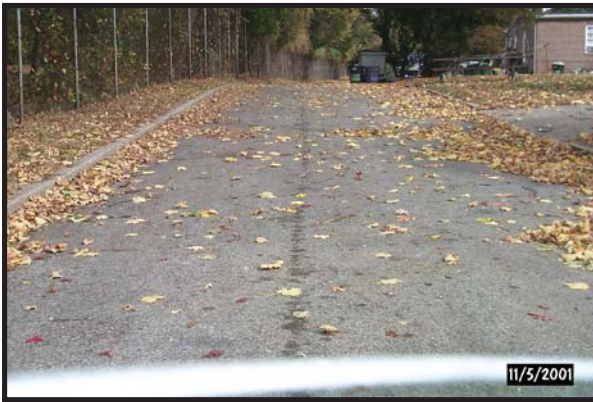
Route	Length (mi)	Width (ft)	Area (sq ft)	Lane Miles *	Condition / PCR	Surface Type
0442	0.15	20.00	15418	0.27	POOR / 45	AS

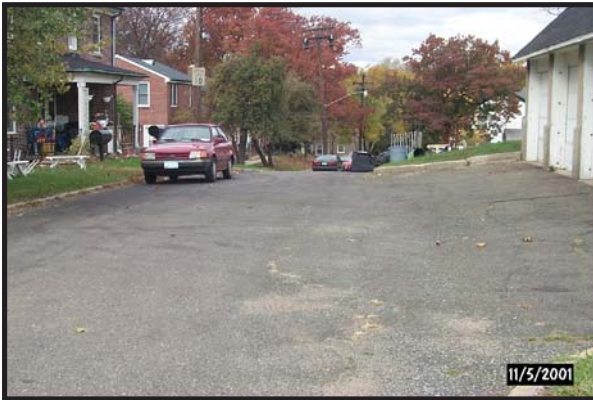
Route	Length (mi)	Width (ft)	Area (sq ft)	Lane Miles *	Condition / PCR	Surface Type
0444	0.07	20.00	7498	0.13	POOR / 45	AS

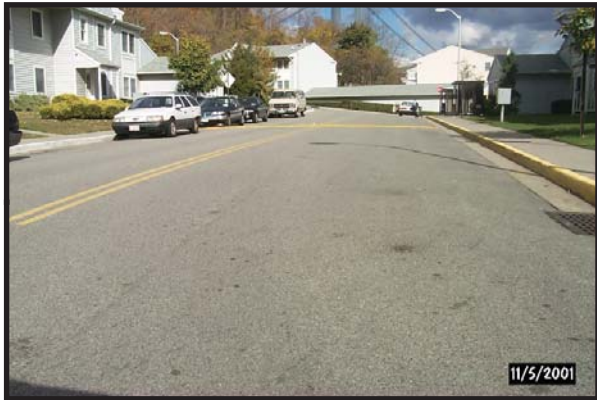
Route	Length (mi)	Width (ft)	Area (sq ft)	Lane Miles *	Condition / PCR	Surface Type
0457	0.05	20.00	5174	0.09	GOOD / 90	AS

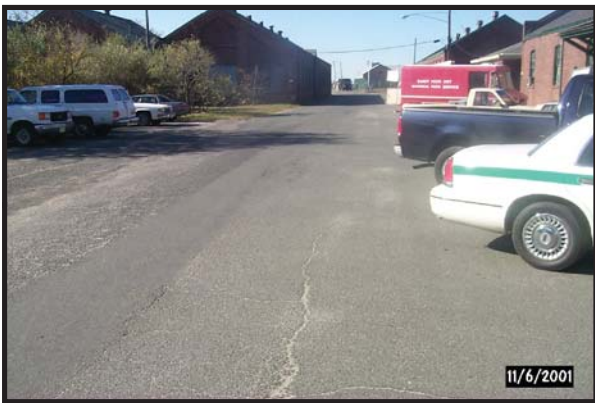
Route	Length (mi)	Width (ft)	Area (sq ft)	Lane Miles *	Condition / PCR	Surface Type
0460	0.20	25.00	26400	0.45	FAIR / 73	AS

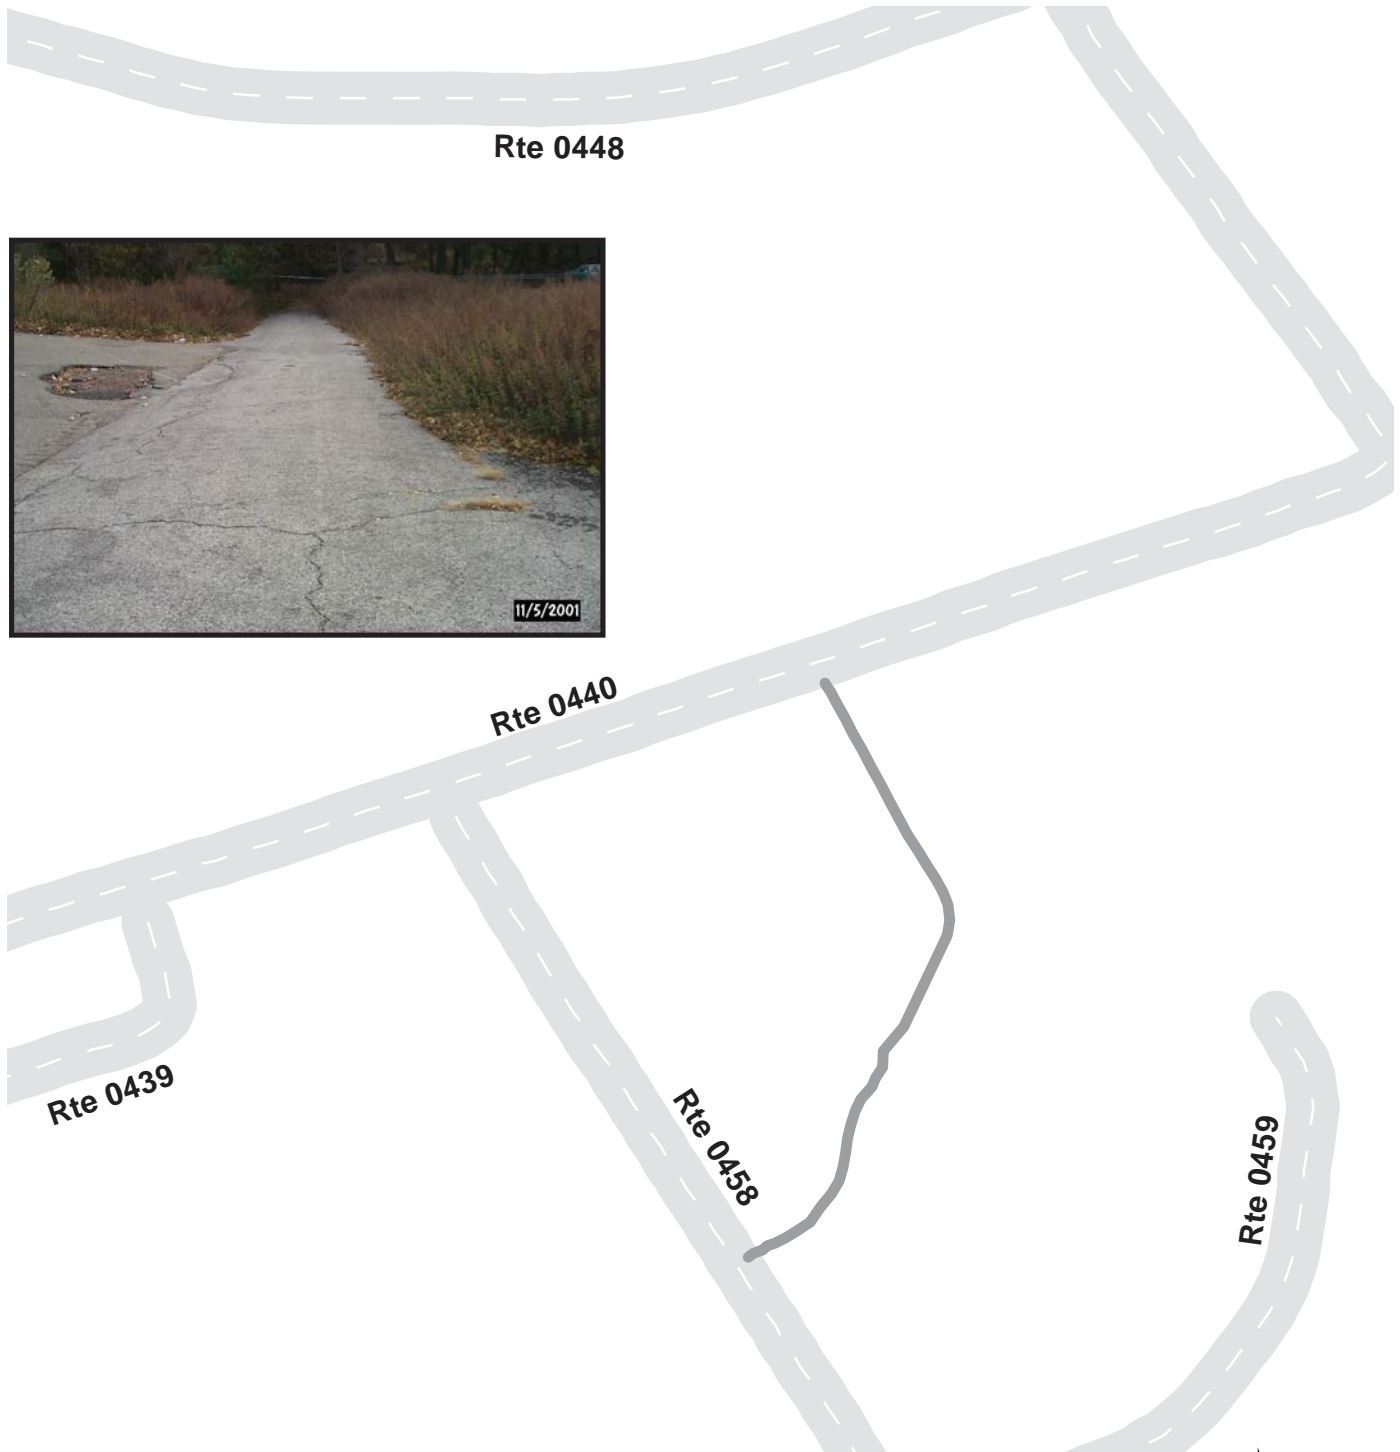
Route	Length (mi)	Width (ft)	Area (sq ft)	Lane Miles *	Condition / PCR	Surface Type
0471	0.14	20.00	14362	0.25	POOR / 45	AS

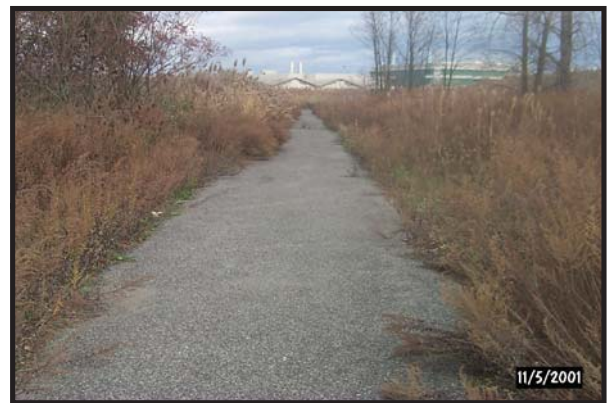
Route	Length (mi)	Width (ft)	Area (sq ft)	Lane Miles *	Condition / PCR	Surface Type
0473	0.22	15.00	17424	0.30	POOR / 45	NC

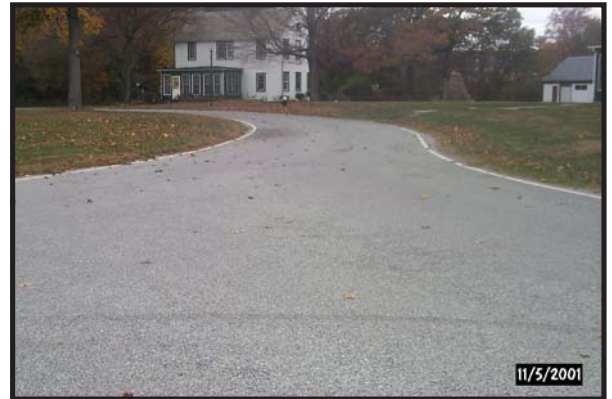
## Route 0476

Route	Length (mi)	Width (ft)	Area (sq ft)	Lane Miles *	Condition / PCR	Surface Type
0476	0.14	0.00	16636	0.29	GOOD / 90	AS

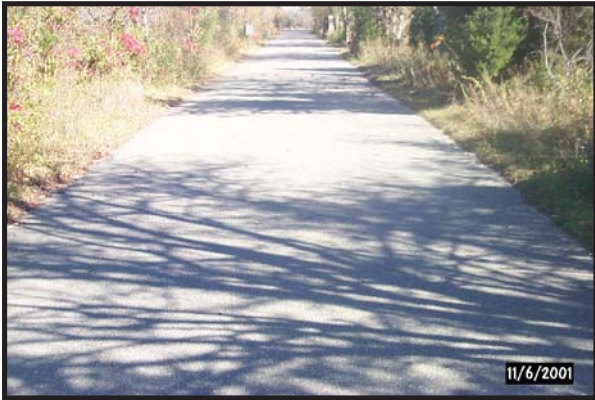
## Route 0477

Route	Length (mi)	Width (ft)	Area (sq ft)	Lane Miles *	Condition / PCR	Surface Type
0477	0.24	16.00	20106	0.35	POOR / 45	AS

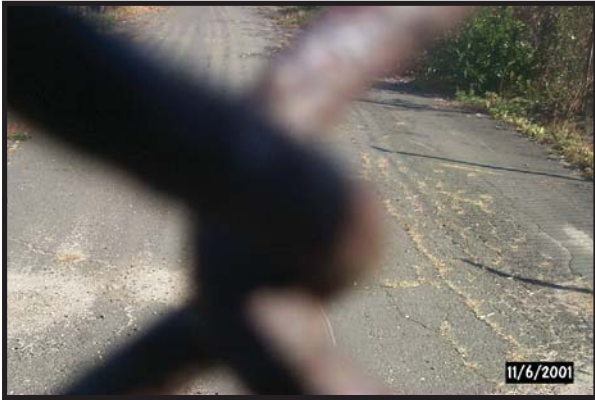
## Route 0478

Route	Length (mi)	Width (ft)	Area (sq ft)	Lane Miles *	Condition / PCR	Surface Type
0478	0.08	0.00	9777	0.17	POOR / 45	AS

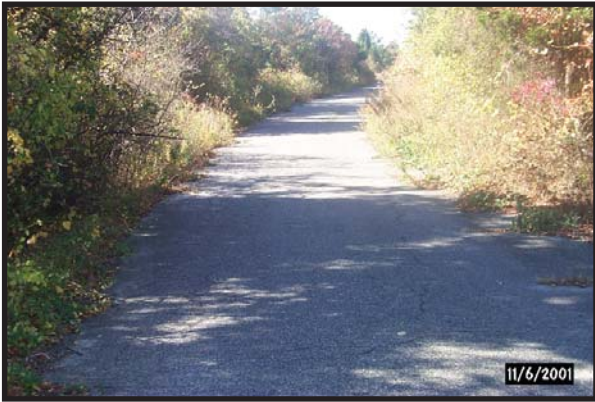
## Route 0481

Route	Length (mi)	Width (ft)	Area (sq ft)	Lane Miles *	Condition / PCR	Surface Type
0481	0.19	0.00	21085	0.36	POOR / 45	AS

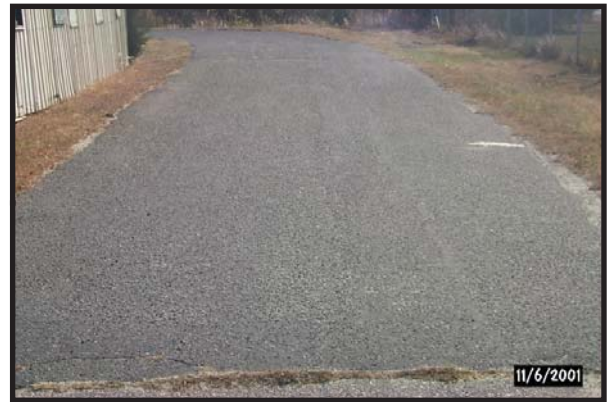
## Route 0483

Route	Length (mi)	Width (ft)	Area (sq ft)	Lane Miles *	Condition / PCR	Surface Type
0483	0.08	0.00	10136	0.17	FAIR / 73	AS

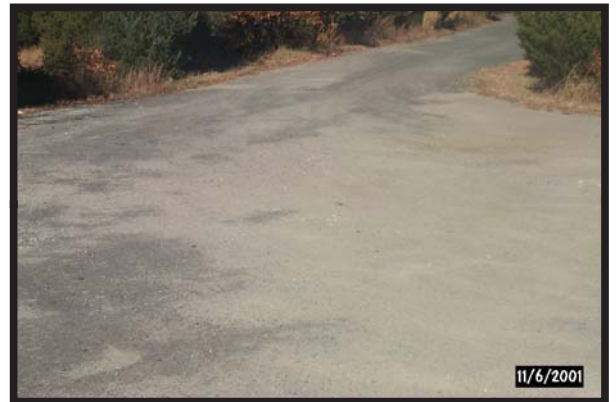
## Route 0484

Route	Length (mi)	Width (ft)	Area (sq ft)	Lane Miles *	Condition / PCR	Surface Type
0484	0.27	0.00	31976	0.55	GOOD / 90	AS

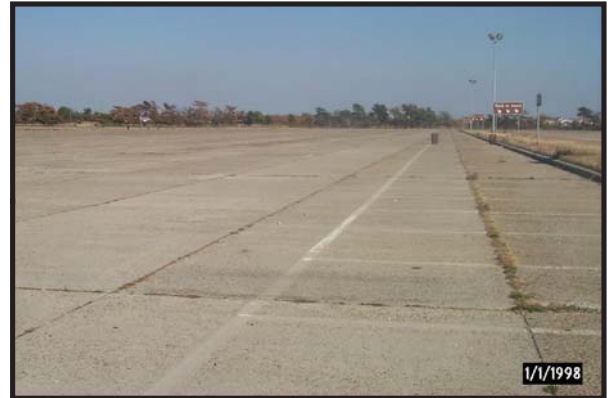
## Route 0907

Route	Public / NonPublic	Date Visited	Area (sq ft)	Lane Miles *	Surface Type	Condition / PCR
0907	Public	11/7/2001	5713	0.10	AS	EXCELLENT / 97

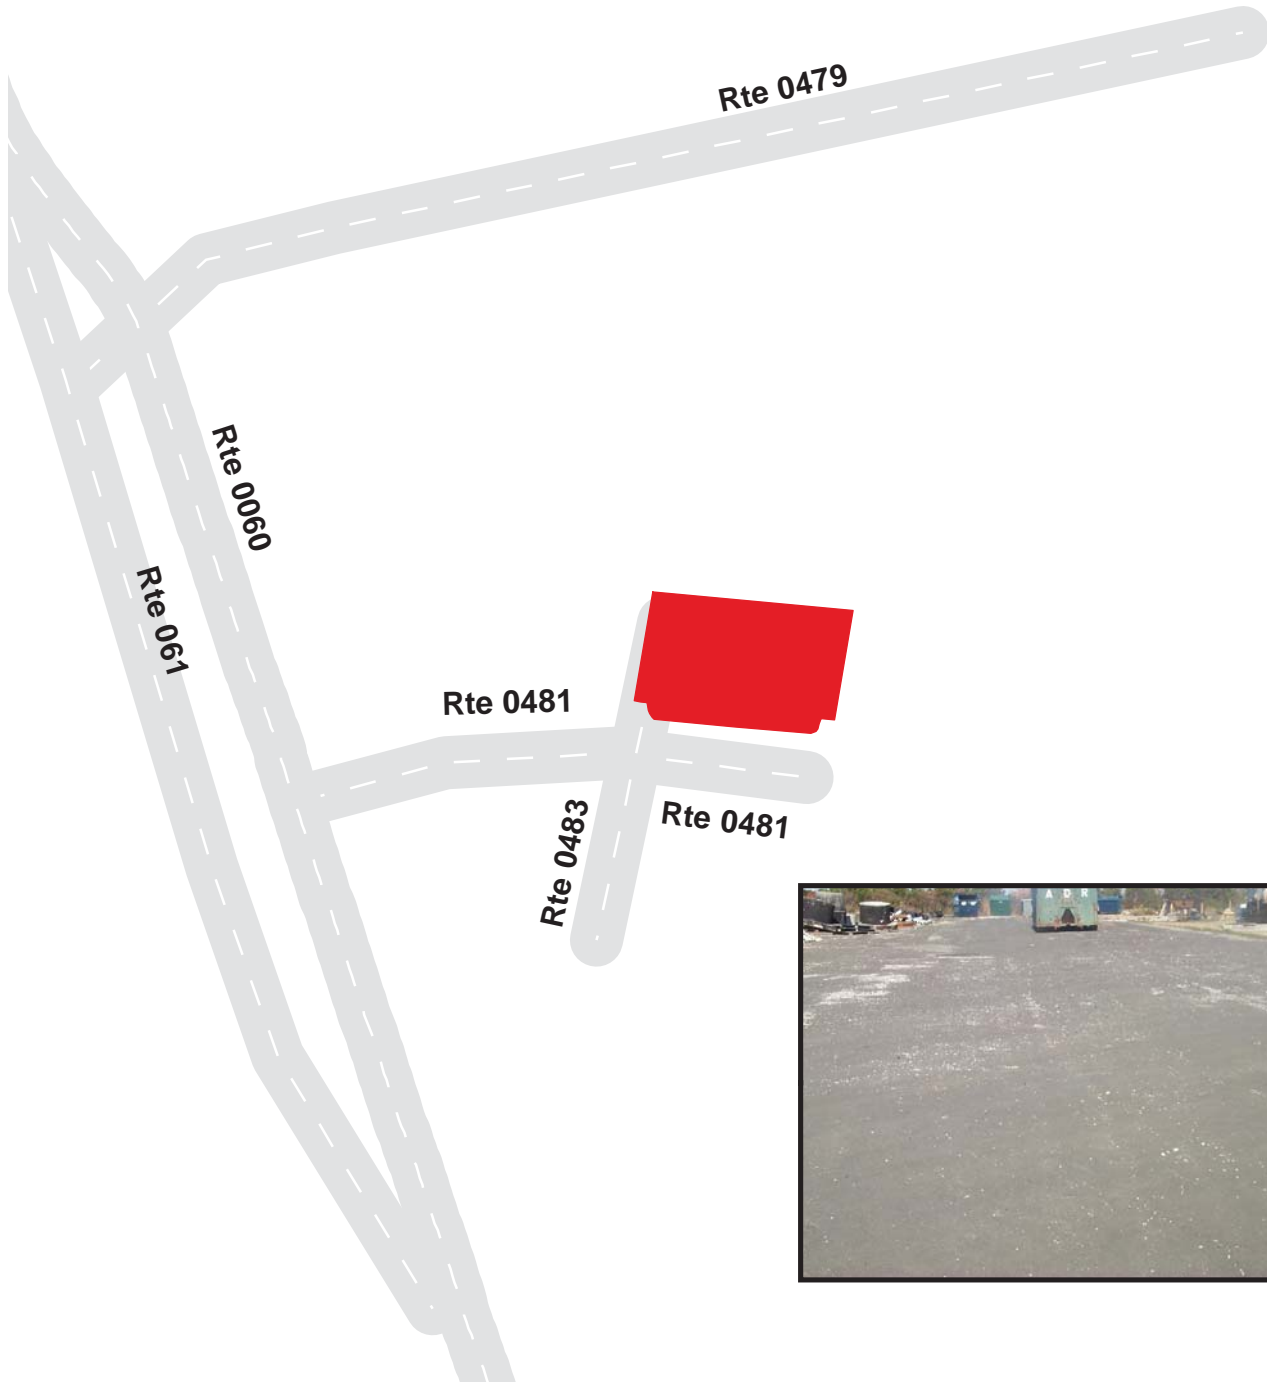
Route	Public / NonPublic	Date Visited	Area (sq ft)	Lane Miles *	Surface Type	Condition / PCR
0909A	NonPublic	11/7/2001	133408	2.30	AS	POOR / 45

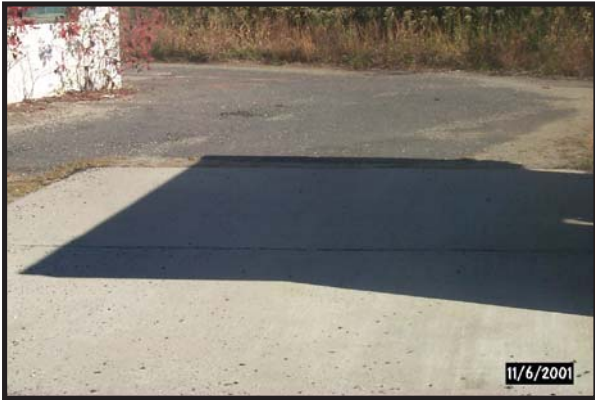
Route	Public / NonPublic	Date Visited	Area (sq ft)	Lane Miles *	Surface Type	Condition / PCR
0910A	NonPublic	11/7/2001	6593	0.11	AS	POOR / 45

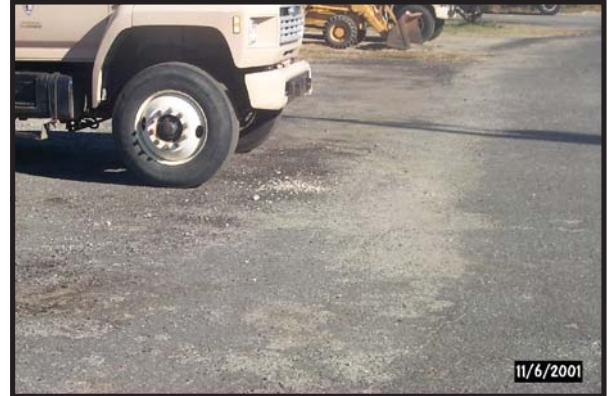
## Route 0911

Route	Public / NonPublic	Date Visited	Area (sq ft)	Lane Miles *	Surface Type	Condition / PCR
0911	NonPublic	11/7/2001	9450	0.16	AS	POOR / 45

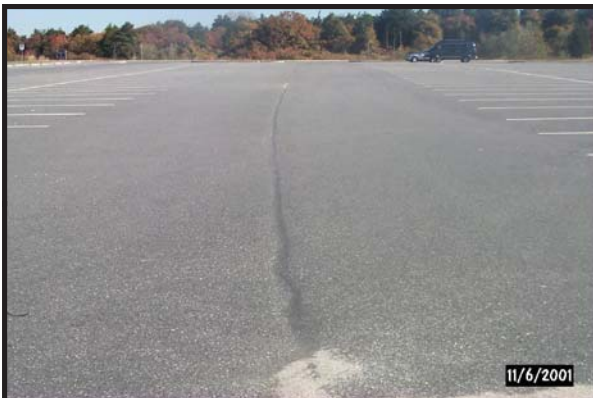
## Route 0930

Route	Public / NonPublic	Date Visited	Area (sq ft)	Lane Miles *	Surface Type	Condition / PCR
0930	Public	11/7/2001	145935	2.51	AS	GOOD / 90

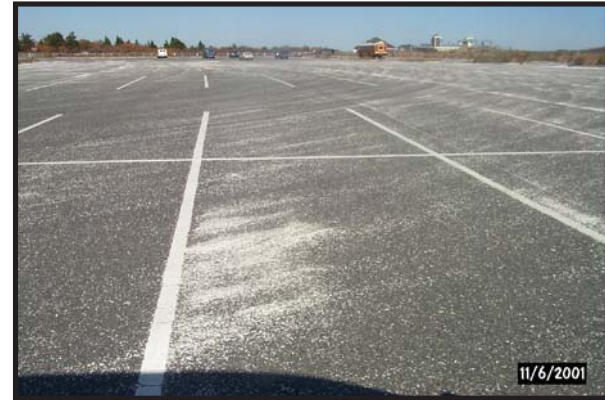
## Route 0931

Route	Public / NonPublic	Date Visited	Area (sq ft)	Lane Miles *	Surface Type	Condition / PCR
0931	NonPublic	11/7/2001	6458	0.11	NC	EXCELLENT / 97

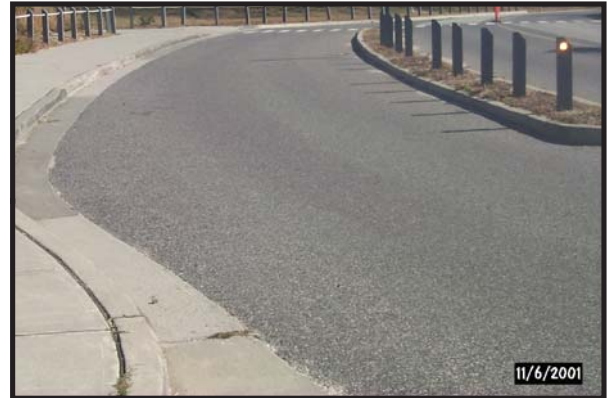
## Route 0933

Route	Public / NonPublic	Date Visited	Area (sq ft)	Lane Miles *	Surface Type	Condition / PCR
0933	Public	11/7/2001	12230	0.21	OC	GOOD / 90

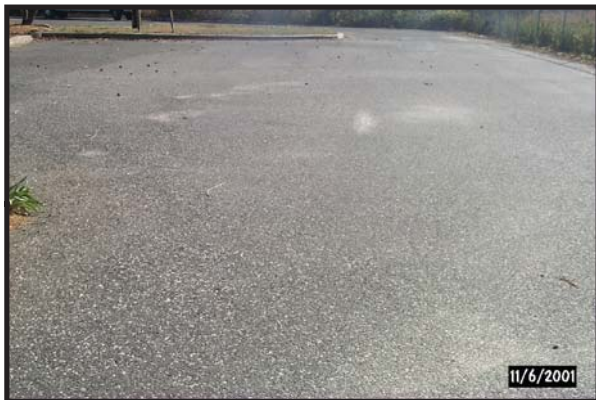
## Route 0934

Route	Public / NonPublic	Date Visited	Area (sq ft)	Lane Miles *	Surface Type	Condition / PCR
0934	NonPublic	11/7/2001	10307	0.18	AS	GOOD / 90

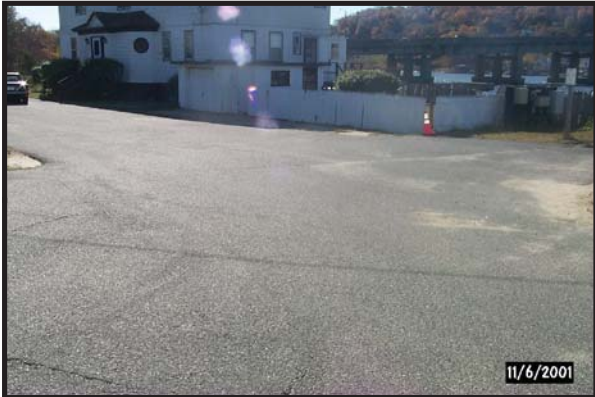
## Route 0935

Route	Public / NonPublic	Date Visited	Area (sq ft)	Lane Miles *	Surface Type	Condition / PCR
0935	NonPublic	11/7/2001	8909	0.15	AS	EXCELLENT / 97

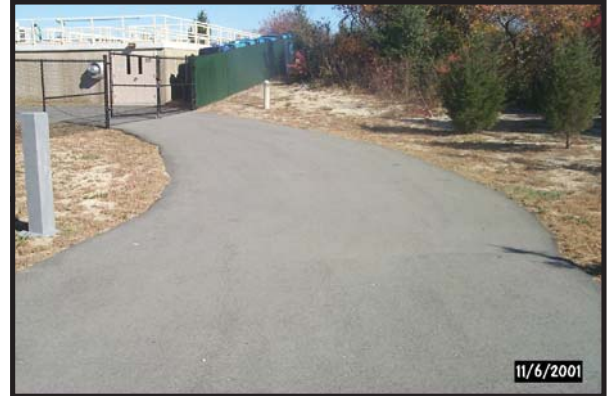
## Route 0936

Route	Public / NonPublic	Date Visited	Area (sq ft)	Lane Miles *	Surface Type	Condition / PCR
0936	Public	11/7/2001	10085	0.17	AS	GOOD / 90

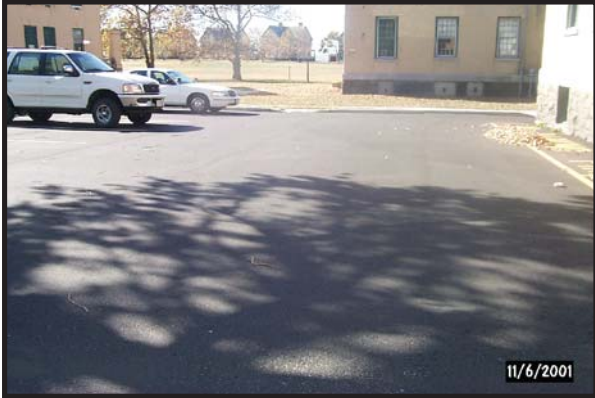
## Route 0938

Route	Public / NonPublic	Date Visited	Area (sq ft)	Lane Miles *	Surface Type	Condition / PCR
0938	Public	11/7/2001	107911	1.86	AS	GOOD / 90

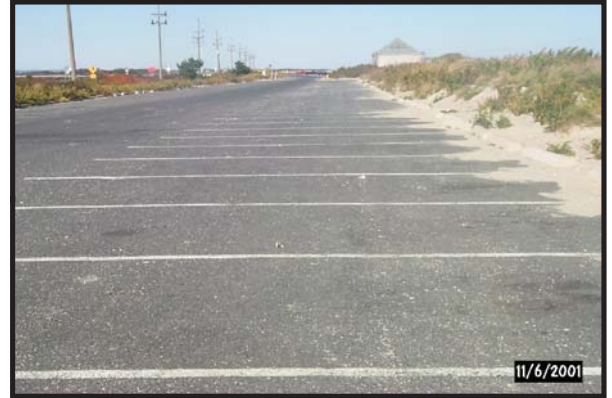
## Route 0939

Route	Public / NonPublic	Date Visited	Area (sq ft)	Lane Miles *	Surface Type	Condition / PCR
0939	Public	11/7/2001	99474	1.71	AS	FAIR / 73

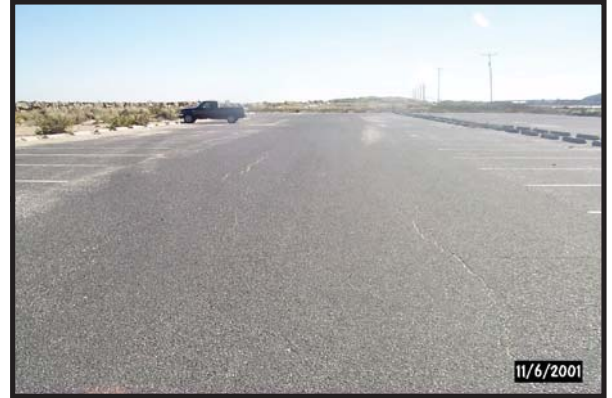
## Route 0940

Route	Public / NonPublic	Date Visited	Area (sq ft)	Lane Miles *	Surface Type	Condition / PCR
0940	Public	11/7/2001	17696	0.30	AS	EXCELLENT / 97

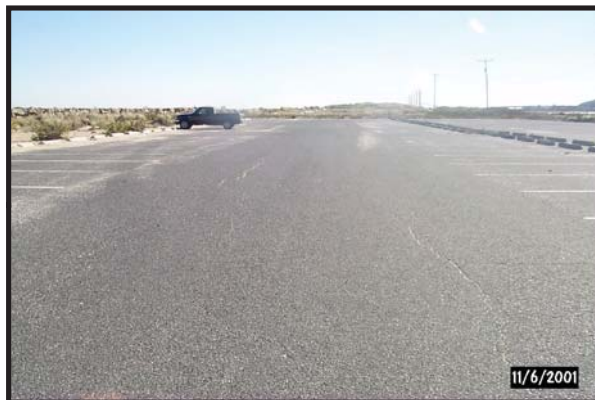
## Route 0941

Route	Public / NonPublic	Date Visited	Area (sq ft)	Lane Miles *	Surface Type	Condition / PCR
0941	Public	11/7/2001	21987	0.38	AS	GOOD / 90

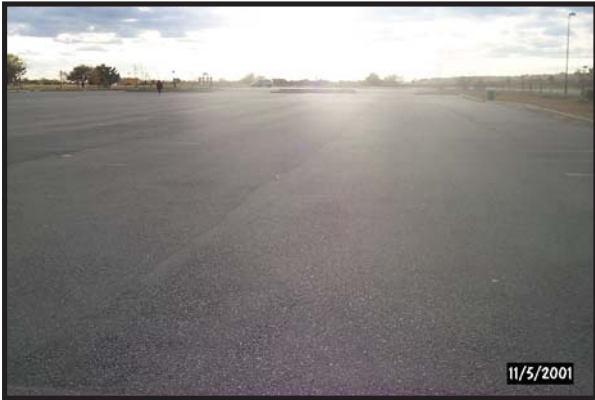
## Route 0943

Route	Public / NonPublic	Date Visited	Area (sq ft)	Lane Miles *	Surface Type	Condition / PCR
0943	Public	11/7/2001	82052	1.41	OC	GOOD / 90

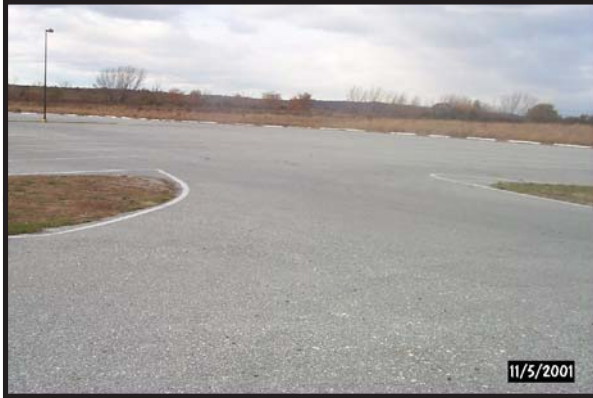
## Route 0944

Route	Public / NonPublic	Date Visited	Area (sq ft)	Lane Miles *	Surface Type	Condition / PCR
0944	Public	11/7/2001	34435	0.59	AS	GOOD / 90

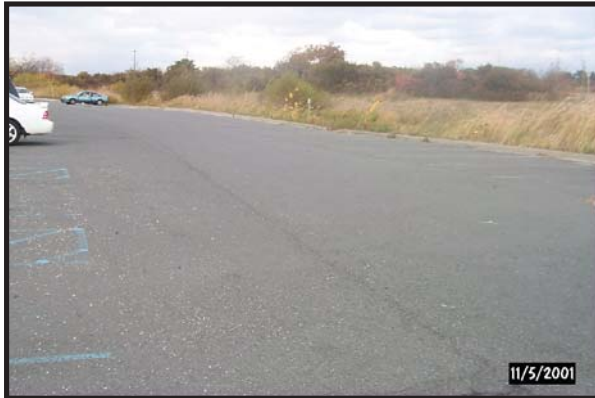
## Route 0945

Route	Public / NonPublic	Date Visited	Area (sq ft)	Lane Miles *	Surface Type	Condition / PCR
0945	Public	11/7/2001	24585	0.42	AS	EXCELLENT / 97

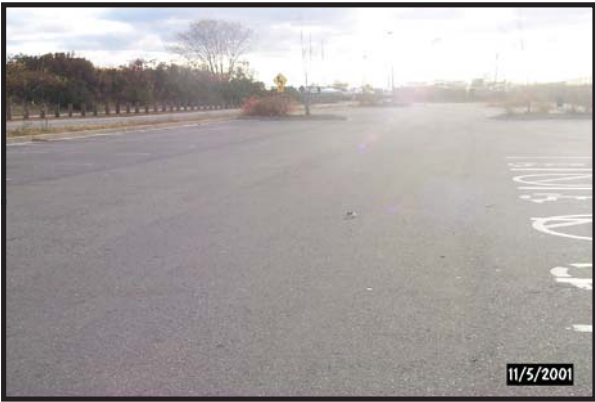
## Route 0946

Route	Public / NonPublic	Date Visited	Area (sq ft)	Lane Miles *	Surface Type	Condition / PCR
0946	Public	11/7/2001	48955	0.84	AS	EXCELLENT / 97

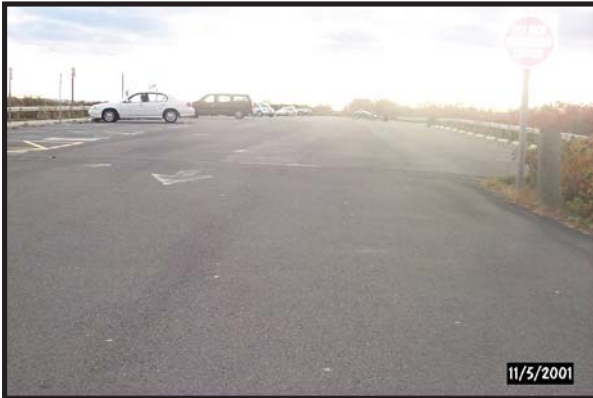
## Route 0947

Route	Public / NonPublic	Date Visited	Area (sq ft)	Lane Miles *	Surface Type	Condition / PCR
0947	Public	11/7/2001	9856	0.17	AS	EXCELLENT / 97

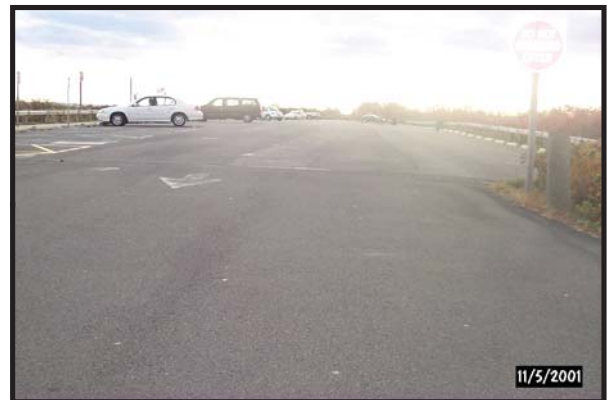
## Route 0948

Route	Public / NonPublic	Date Visited	Area (sq ft)	Lane Miles *	Surface Type	Condition / PCR
0948	Public	11/7/2001	102418	1.76	AS	POOR / 45

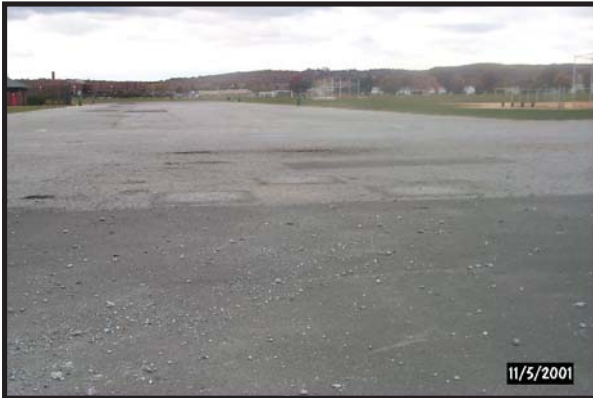
## Route 0949

Route	Public / NonPublic	Date Visited	Area (sq ft)	Lane Miles *	Surface Type	Condition / PCR
0949	Public	11/7/2001	7986	0.14	AS	GOOD / 90

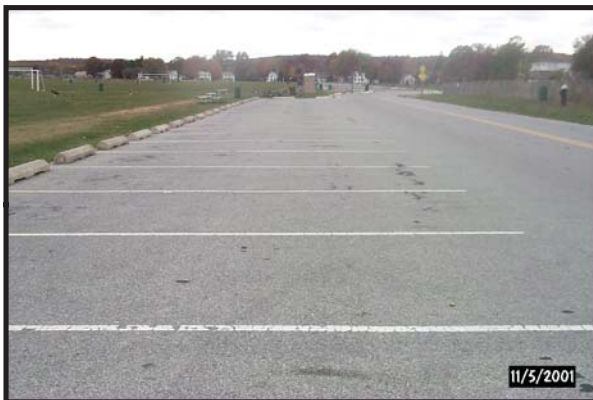
## Route 0950

Route	Public / NonPublic	Date Visited	Area (sq ft)	Lane Miles *	Surface Type	Condition / PCR
0950	Public	11/7/2001	6981	0.12	AS	POOR / 45

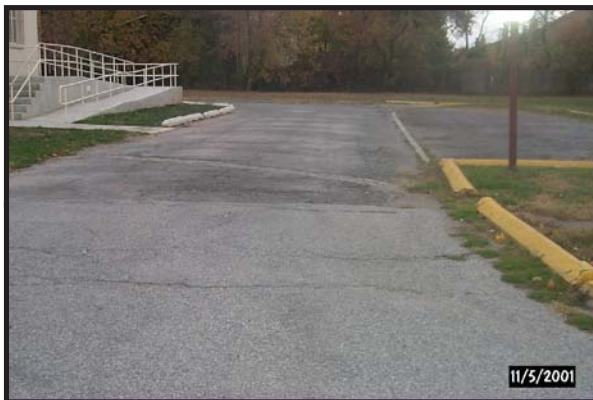
## Route 0951

Route	Public / NonPublic	Date Visited	Area (sq ft)	Lane Miles *	Surface Type	Condition / PCR
0951	Public	11/7/2001	58698	1.01	AS	GOOD / 90

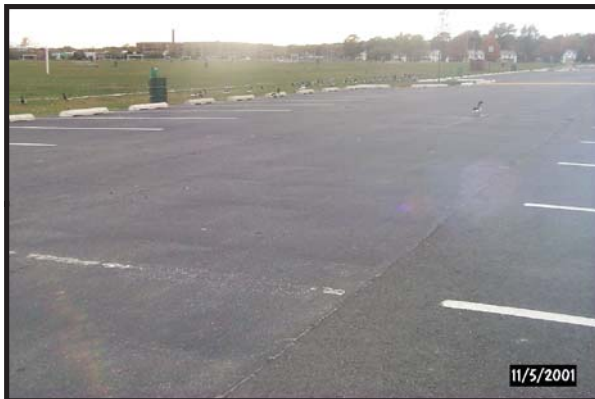
## Route 0952

Route	Public / NonPublic	Date Visited	Area (sq ft)	Lane Miles *	Surface Type	Condition / PCR
0952	Public	11/7/2001	6981	0.12	OC	GOOD / 90

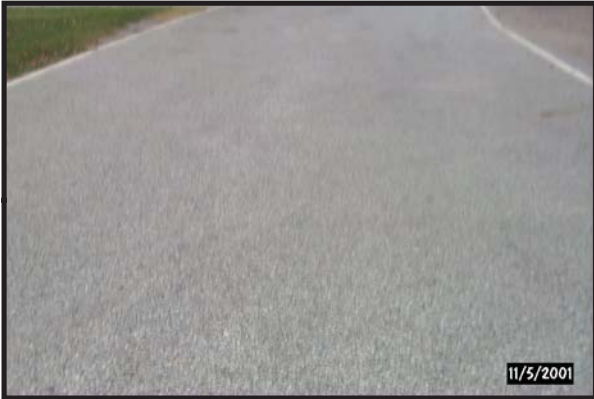
## Route 0953A

Route	Public / NonPublic	Date Visited	Area (sq ft)	Lane Miles *	Surface Type	Condition / PCR
0953A	Public	11/7/2001	18836	0.32	OC	FAIR / 73

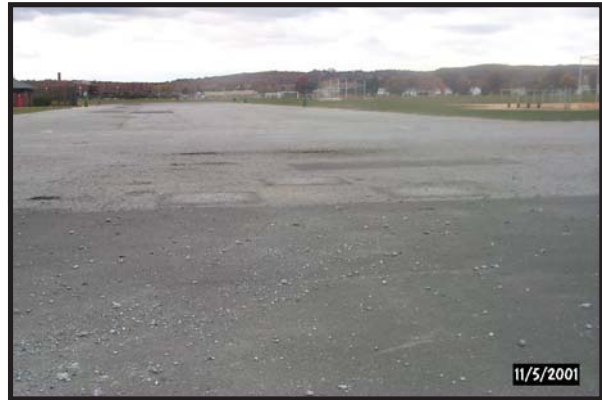
## Route 0954

Route	Public / NonPublic	Date Visited	Area (sq ft)	Lane Miles *	Surface Type	Condition / PCR
0954	Public	11/7/2001	6210	0.11	OC	FAIR / 73

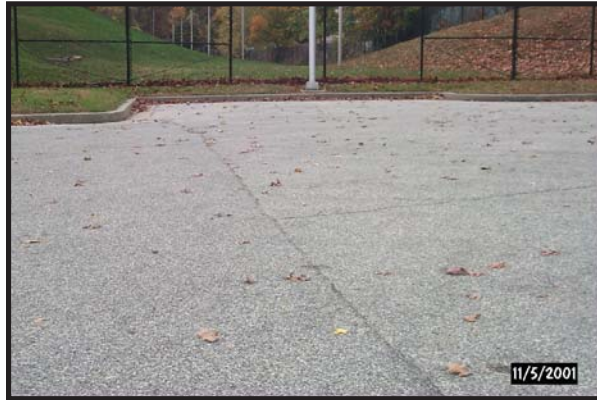
## Route 0955A

Route	Public / NonPublic	Date Visited	Area (sq ft)	Lane Miles *	Surface Type	Condition / PCR
0955A	Public	11/7/2001	27200	0.47	AS	EXCELLENT / 97

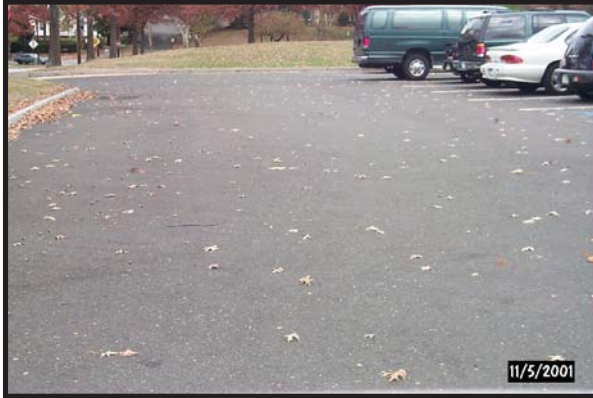
**Gateway National Recreation Area**  
**Route 0955D**  
 USCG GALLEY REAR PARKING & FIRE LANE  
 Adjacent to Route 0449

Route	Public / NonPublic	Date Visited	Area (sq ft)	Lane Miles *	Surface Type	Condition / PCR
0955D	Public	11/7/2001	4038	0.07	AS	FAIR / 73

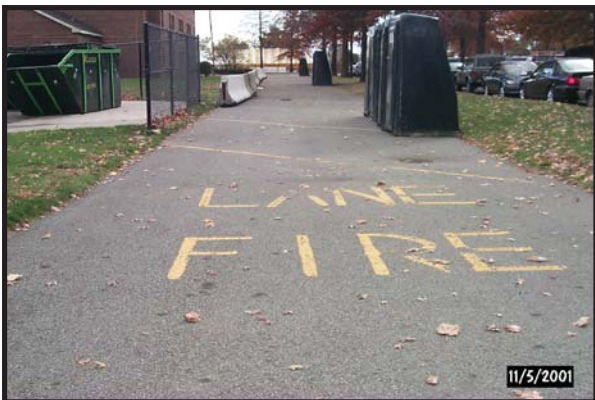
## Route 0955F

Route	Public / NonPublic	Date Visited	Area (sq ft)	Lane Miles *	Surface Type	Condition / PCR
0955F	Public	11/7/2001	16912	0.29	AS	GOOD / 90

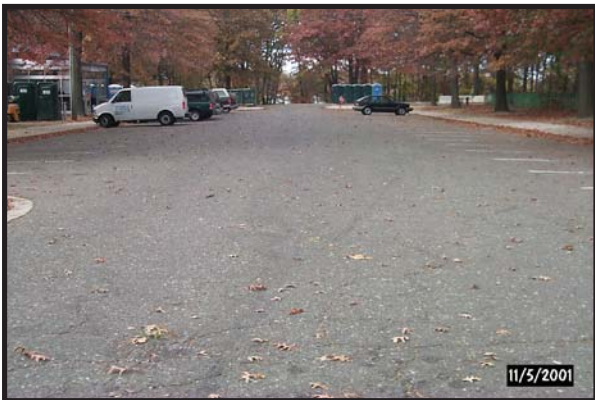
**Gateway National Recreation Area**  
**Route 0956A**  
 DRUM AVE USCG BARRACKS PARKING A  
 Adjacent to Route 0450

Route	Public / NonPublic	Date Visited	Area (sq ft)	Lane Miles *	Surface Type	Condition / PCR
0956A	NonPublic	11/7/2001	4325	0.07	OC	FAIR / 73

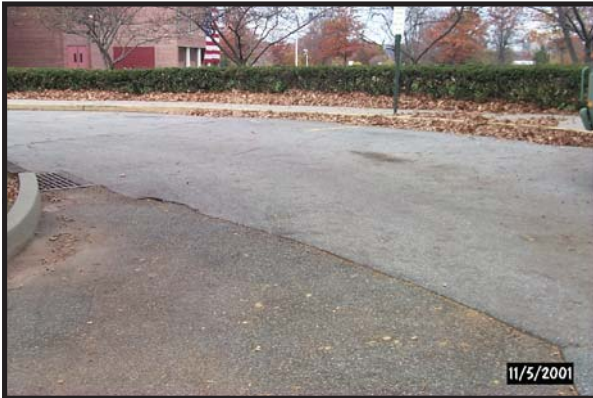
## Route 0956B

Route	Public / NonPublic	Date Visited	Area (sq ft)	Lane Miles *	Surface Type	Condition / PCR
0956B	Public	11/7/2001	2881	0.05	AS	GOOD / 90

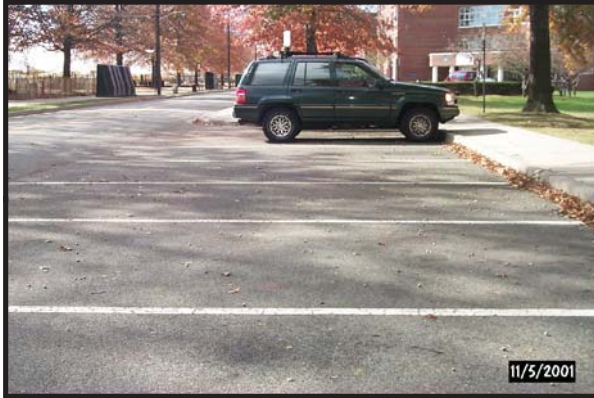
## Route 0956C

Route	Public / NonPublic	Date Visited	Area (sq ft)	Lane Miles *	Surface Type	Condition / PCR
0956C	Public	11/7/2001	1873	0.03	AS	GOOD / 90

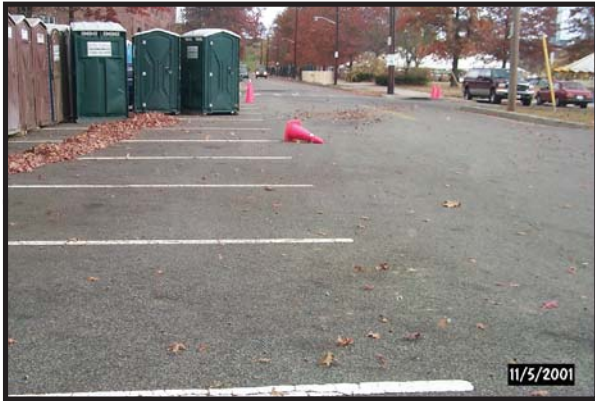
## Route 0957A

Route	Public / NonPublic	Date Visited	Area (sq ft)	Lane Miles *	Surface Type	Condition / PCR
0957A	Public	11/7/2001	31682	0.55	AS	FAIR / 73

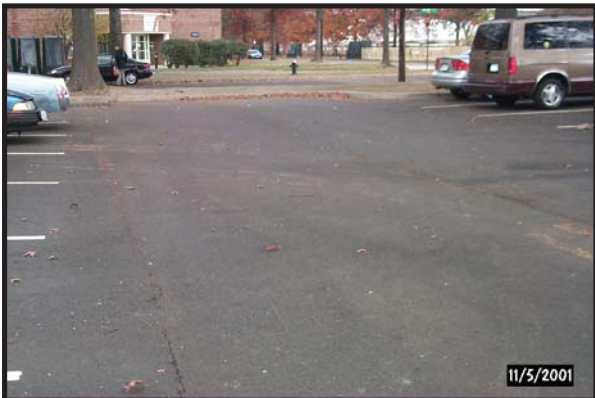
## Route 0957B

Route	Public / NonPublic	Date Visited	Area (sq ft)	Lane Miles *	Surface Type	Condition / PCR
0957B	Public	11/7/2001	12206	0.21	OC	POOR / 45

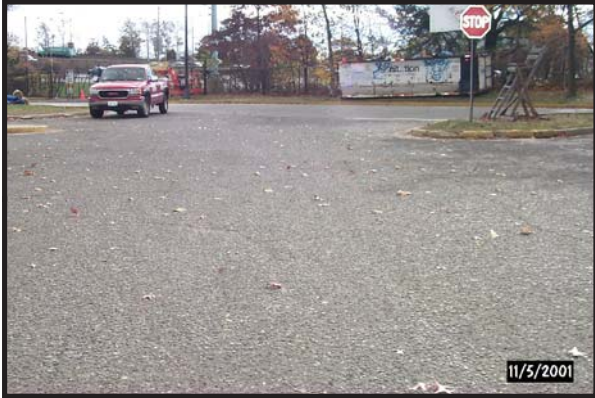
## Route 0957C

Route	Public / NonPublic	Date Visited	Area (sq ft)	Lane Miles *	Surface Type	Condition / PCR
0957C	Public	11/7/2001	92091	1.59	AS	FAIR / 73

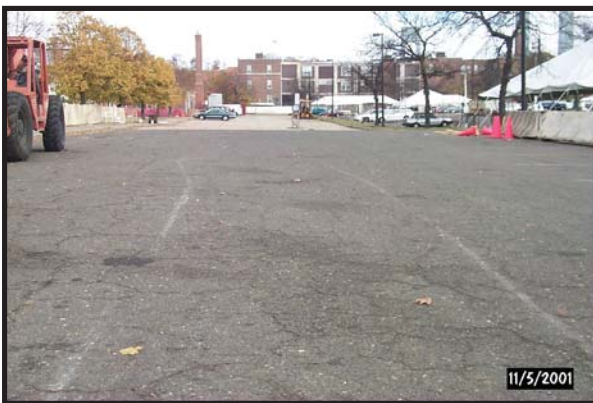
## Route 0957D

Route	Public / NonPublic	Date Visited	Area (sq ft)	Lane Miles *	Surface Type	Condition / PCR
0957D	Public	11/7/2001	10970	0.19	AS	GOOD / 90

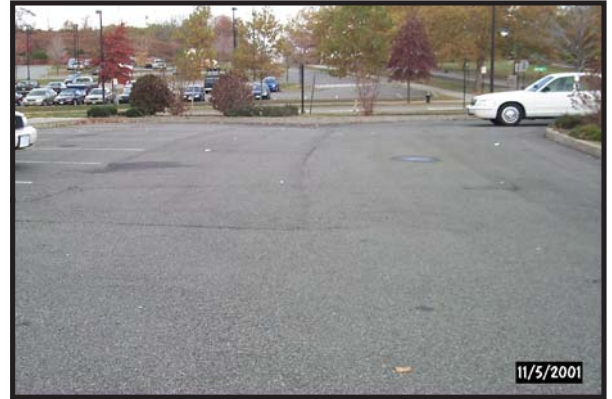
## Route 0958A

Route	Public / NonPublic	Date Visited	Area (sq ft)	Lane Miles *	Surface Type	Condition / PCR
0958A	Public	11/7/2001	97859	1.68	AS	GOOD / 90

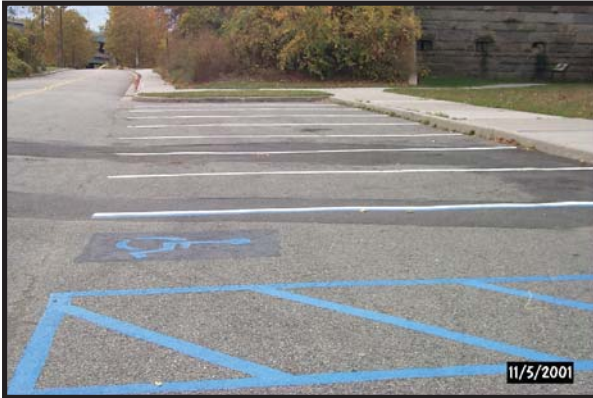
## Route 0959A

Route	Public / NonPublic	Date Visited	Area (sq ft)	Lane Miles *	Surface Type	Condition / PCR
0959A	Public	11/7/2001	2873	0.05	AS	POOR / 45

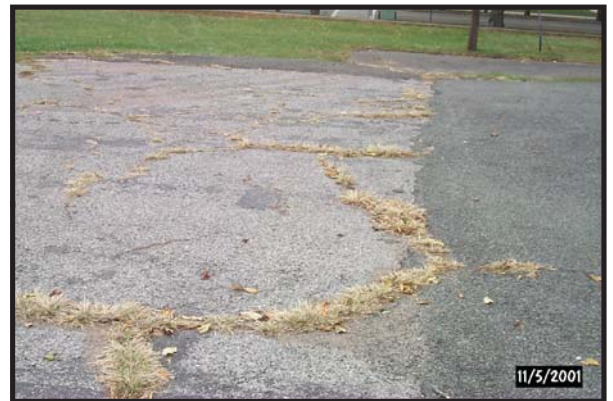
## Route 0959B

Route	Public / NonPublic	Date Visited	Area (sq ft)	Lane Miles *	Surface Type	Condition / PCR
0959B	Public	11/7/2001	7776	0.13	AS	POOR / 45

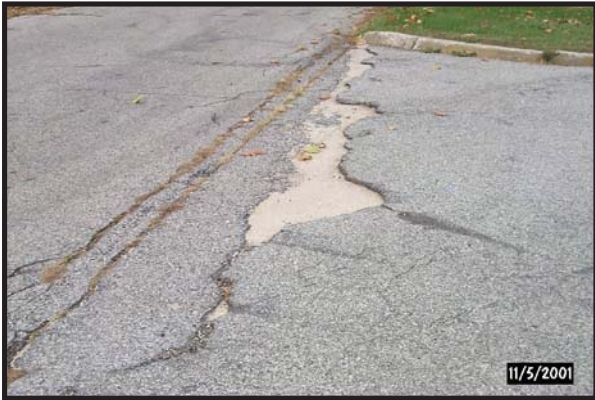
## Route 0960B

Route	Public / NonPublic	Date Visited	Area (sq ft)	Lane Miles *	Surface Type	Condition / PCR
0960B	Public	11/7/2001	13059	0.22	OC	GOOD / 90

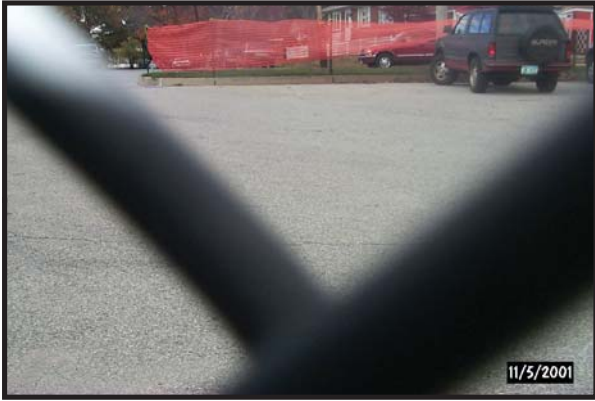
## Route 0960C

Route	Public / NonPublic	Date Visited	Area (sq ft)	Lane Miles *	Surface Type	Condition / PCR
0960C	Public	11/7/2001	2782	0.05	AS	GOOD / 90
