# The Road Inventory of Gateway National Recreation Area GATE - 1770

## Road Inventory Program

Prepared By:  
Federal Highway Administration  
Eastern Federal Lands Highway Division  
Cycle 3

# Gateway National Recreation Area in New York

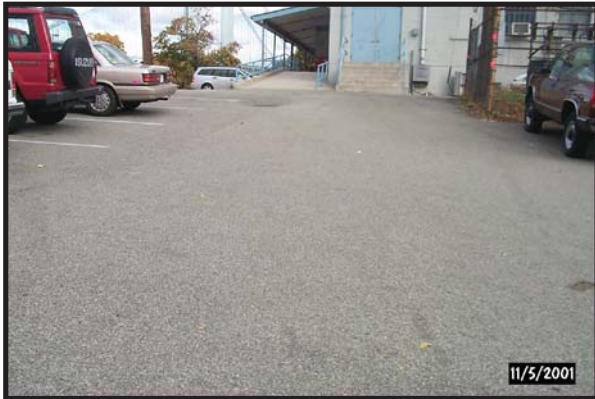
## Route 0961C

Route	Public / NonPublic	Date Visited	Area (sq ft)	Lane Miles *	Surface Type	Condition / PCR
0961C	Public	11/7/2001	6275	0.11	OC	POOR / 45

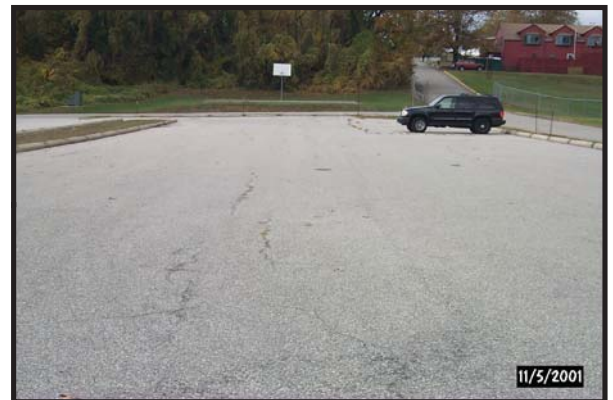
**Gateway National Recreation Area**  
**Route 0962B**  
 USS NORTH CAROLINA AREA PARKING B  
 Adjacent to Route 0453

Route	Public / NonPublic	Date Visited	Area (sq ft)	Lane Miles *	Surface Type	Condition / PCR
0962B	Public	11/7/2001	3455	0.06	AS	EXCELLENT / 97

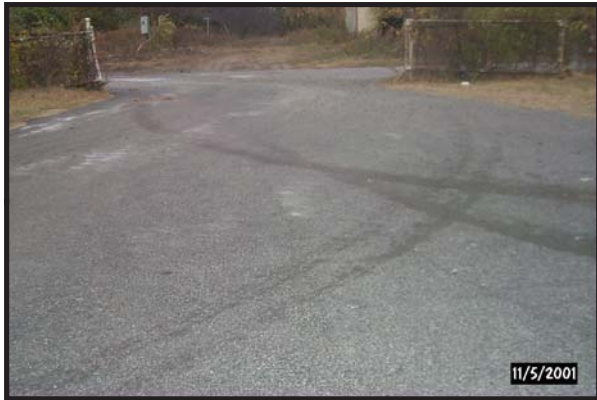
## Route 0965A

Route	Public / NonPublic	Date Visited	Area (sq ft)	Lane Miles *	Surface Type	Condition / PCR
0965A	Public	11/7/2001	187007	3.22	CO	POOR / 45

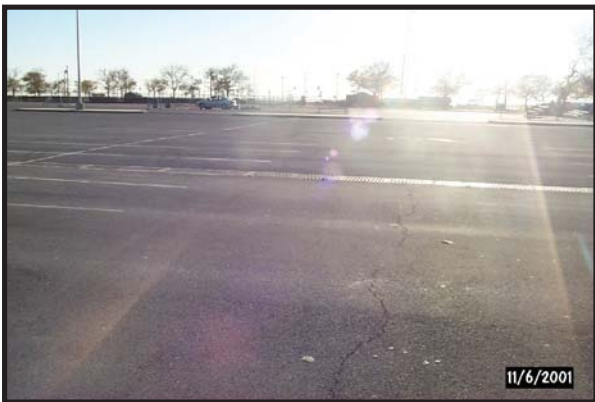
## Route 0965D

Route	Public / NonPublic	Date Visited	Area (sq ft)	Lane Miles *	Surface Type	Condition / PCR
0965D	Public	11/7/2001	36545	0.63	AS	POOR / 45

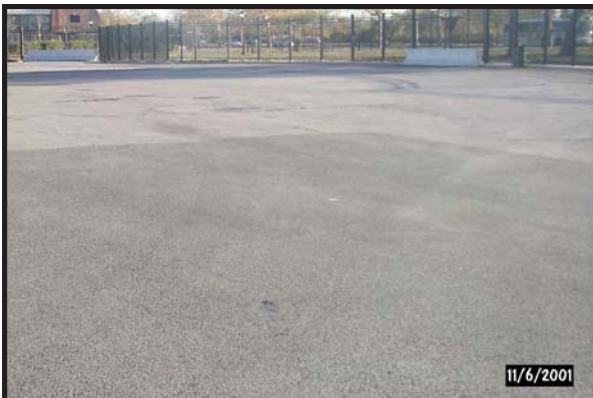
## Route 0965E

Route	Public / NonPublic	Date Visited	Area (sq ft)	Lane Miles *	Surface Type	Condition / PCR
0965E	NonPublic	11/7/2001	20775	0.36	AS	POOR / 45

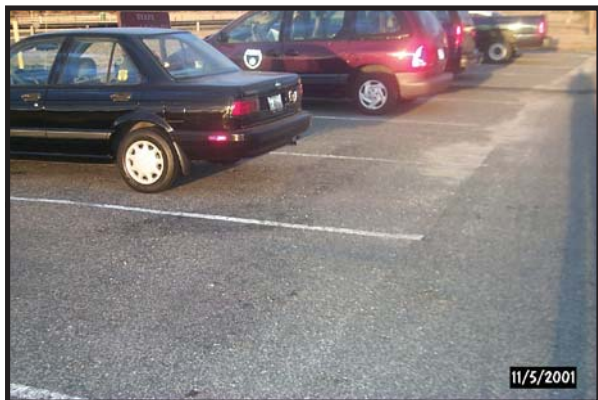
**Gateway National Recreation Area**  
**Route 0968C**  
NPS HEADQUARTERS AREA PARKING C  
At End of Route 0231

Route	Public / NonPublic	Date Visited	Area (sq ft)	Lane Miles *	Surface Type	Condition / PCR
0968C	Public	11/7/2001	12618	0.22	OC	FAIR / 73

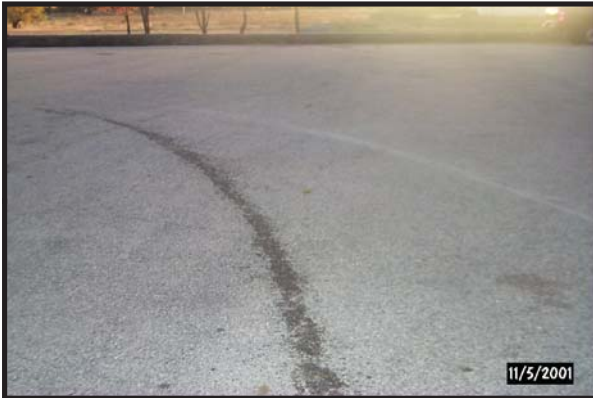
## Route 0968D

Route	Public / NonPublic	Date Visited	Area (sq ft)	Lane Miles *	Surface Type	Condition / PCR
0968D	Public	11/7/2001	35619	0.61	OC	POOR / 45

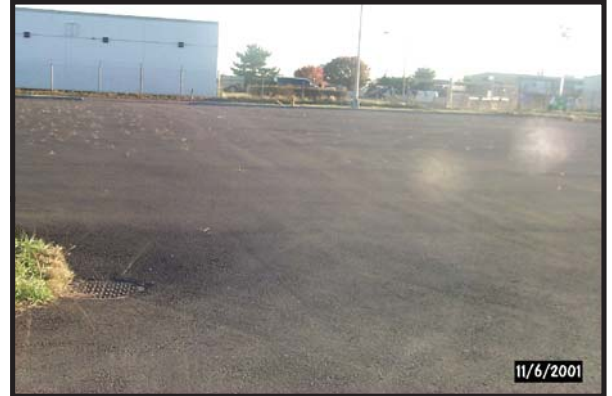
## Route 0972A

Route	Public / NonPublic	Date Visited	Area (sq ft)	Lane Miles *	Surface Type	Condition / PCR
0972A	Public	11/7/2001	27122	0.47	AS	POOR / 45

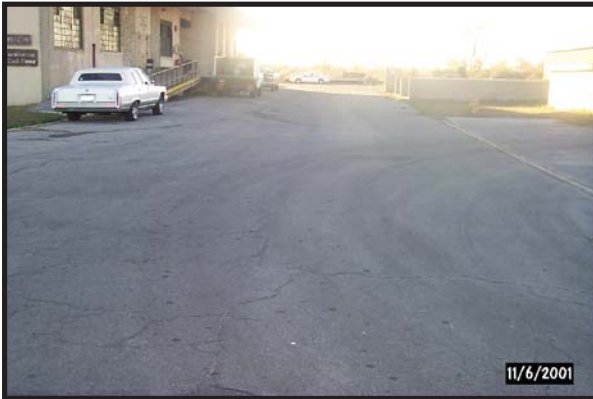
## Route 0972B

Route	Public / NonPublic	Date Visited	Area (sq ft)	Lane Miles *	Surface Type	Condition / PCR
0972B	Public	11/7/2001	15039	0.26	AS	POOR / 45

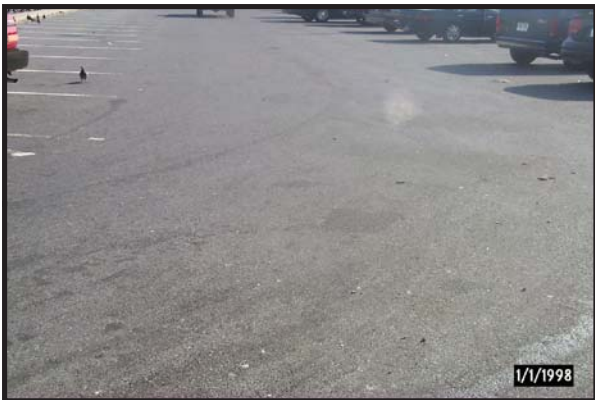
## Route 0993

Route	Public / NonPublic	Date Visited	Area (sq ft)	Lane Miles *	Surface Type	Condition / PCR
0993	Public	11/7/2001	289542	4.99	AS	FAIR / 73
