The Road Inventory of Glen Canyon National Recreation Area GLCA - 1440

Road Inventory Program

Prepared By:
Federal Highway Administration
Eastern Federal Lands Highway Division
Cycle 3

Glen Canyon National Recreation Area in Arizona and Utah

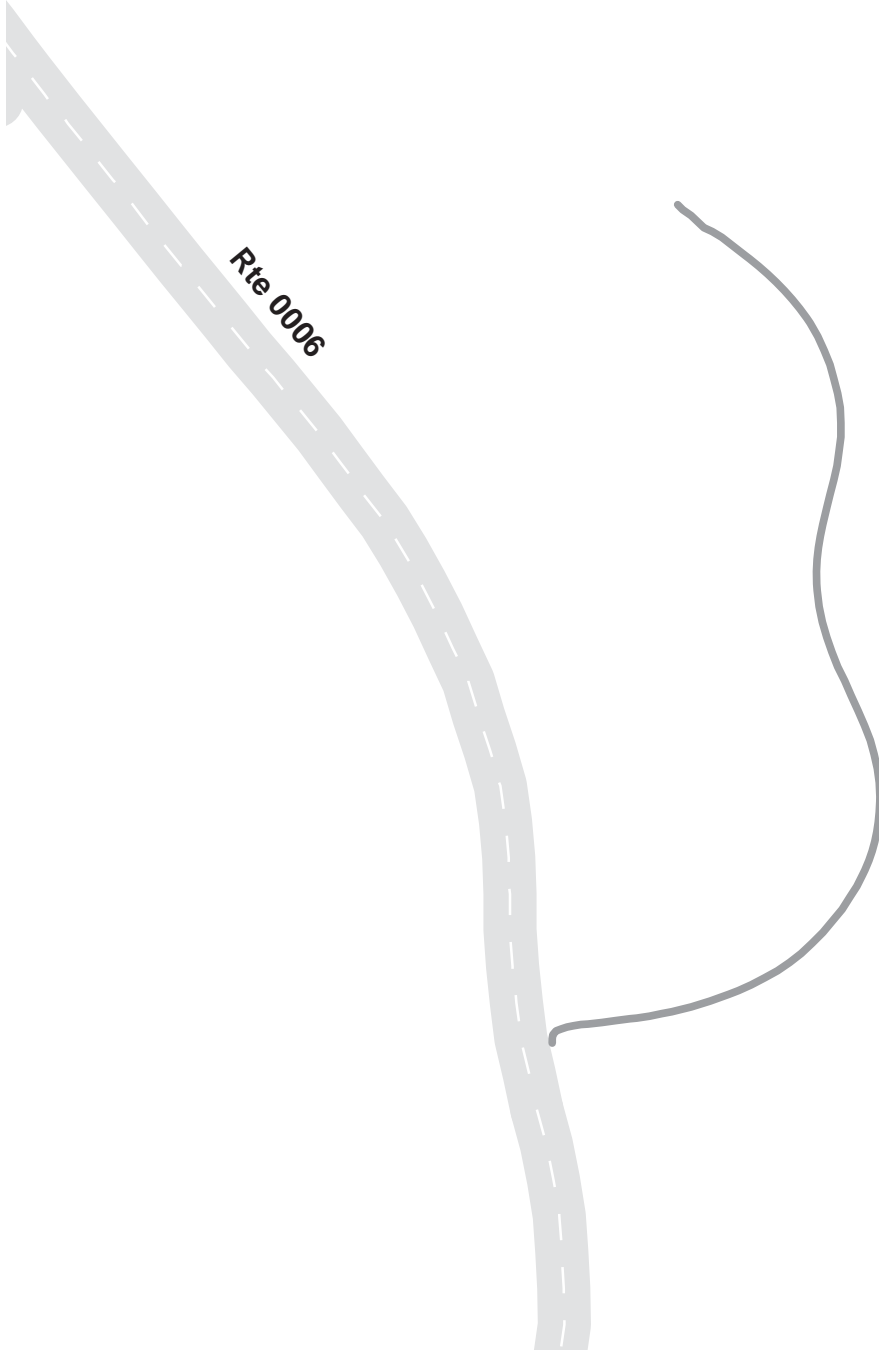
Route 0412

Route	Length (mi)	Width (ft)	Area (sq ft)	Lane Miles *	Condition / PCR	Surface Type
0412	0.64	21.00	71074	1.22	NC / -1	AS

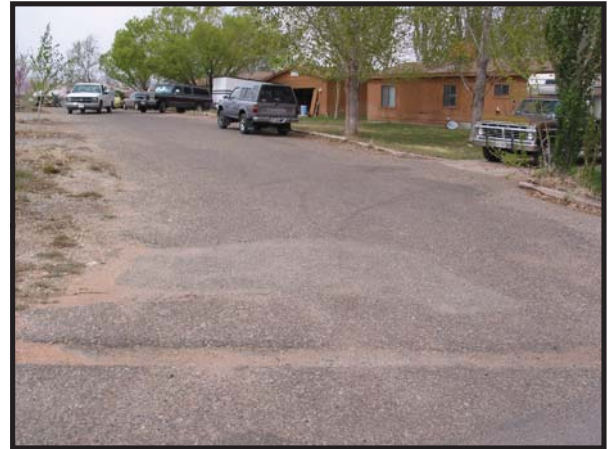
Route 0800

Route	Public / NonPublic	Date Visited	Area (sq ft)	Lane Miles *	Surface Type	Condition / PCR
0800	Public	4/2/2003	189328	3.26	CO	GOOD / 90

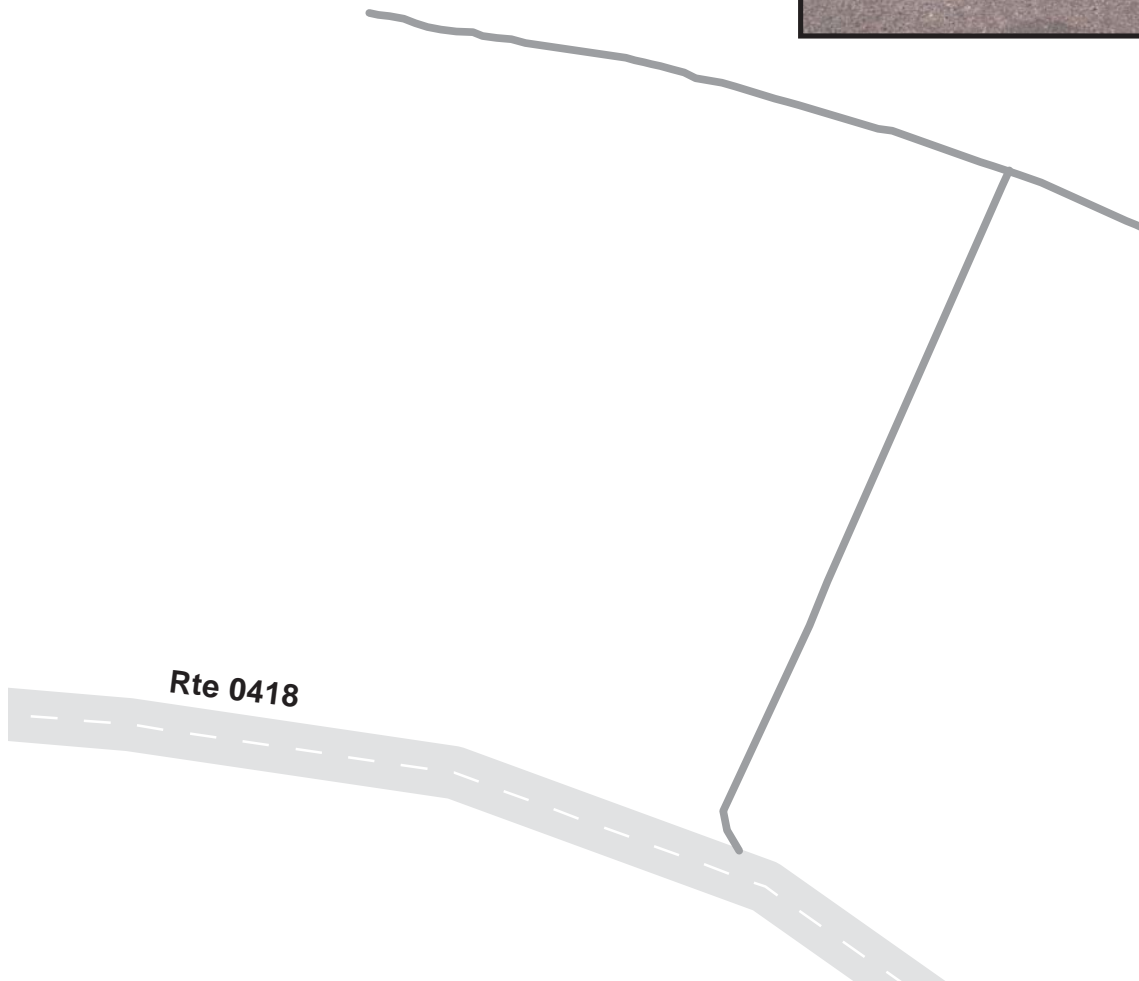
Route 0420

Route	Length (mi)	Width (ft)	Area (sq ft)	Lane Miles *	Condition / PCR	Surface Type
0420	0.11	21.00	11642	0.20	FAIR / 73	AS

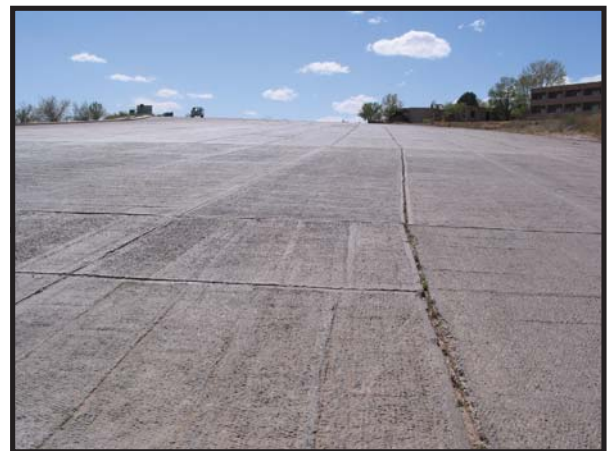
Route 0801

Route	Public / NonPublic	Date Visited	Area (sq ft)	Lane Miles *	Surface Type	Condition / PCR
0801	Public	4/4/2003	181639	3.13	CO	GOOD / 90

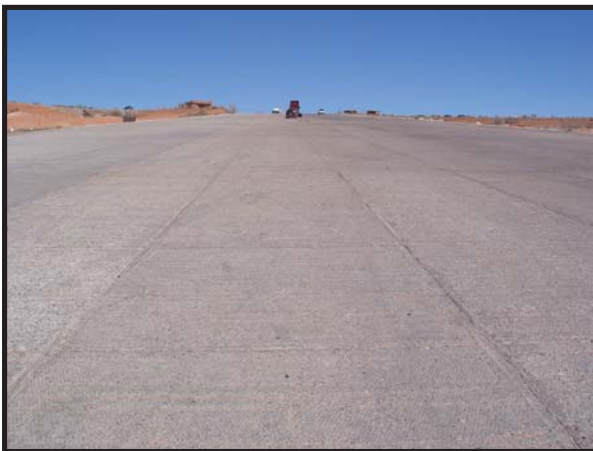
Route 0802

Route	Public / NonPublic	Date Visited	Area (sq ft)	Lane Miles *	Surface Type	Condition / PCR
0802	Public	4/5/2003	63818	1.10	CO	GOOD / 90

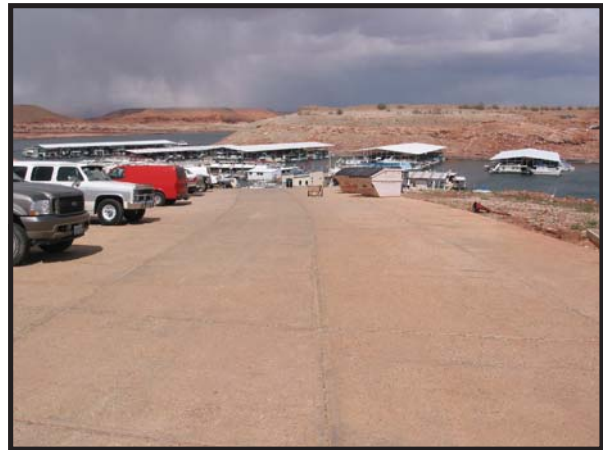
Route 0803

Route	Public / NonPublic	Date Visited	Area (sq ft)	Lane Miles *	Surface Type	Condition / PCR
0803	Public	4/5/2003	127359	2.19	CO	GOOD / 90

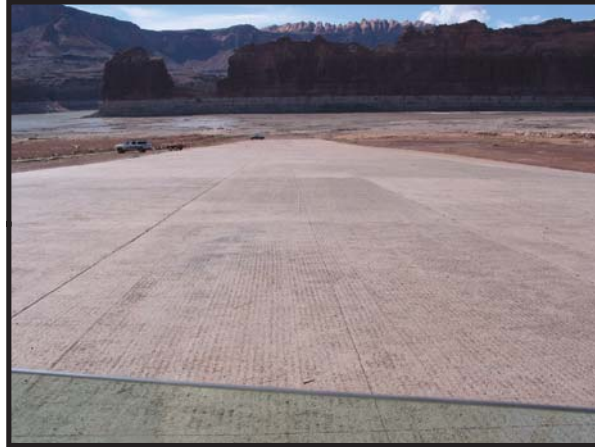
Route 0804

Route	Public / NonPublic	Date Visited	Area (sq ft)	Lane Miles *	Surface Type	Condition / PCR
0804	Public	4/1/2003	144383	2.49	CO	GOOD / 90

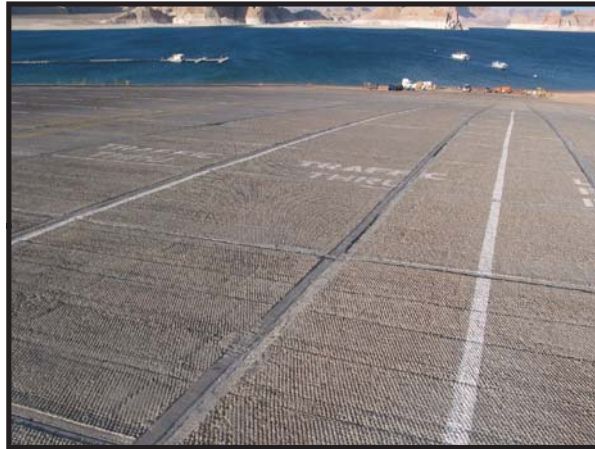
Route 0805

Route	Public / NonPublic	Date Visited	Area (sq ft)	Lane Miles *	Surface Type	Condition / PCR
0805	Public	4/1/2003	126412	2.18	CO	EXCELLENT / 97

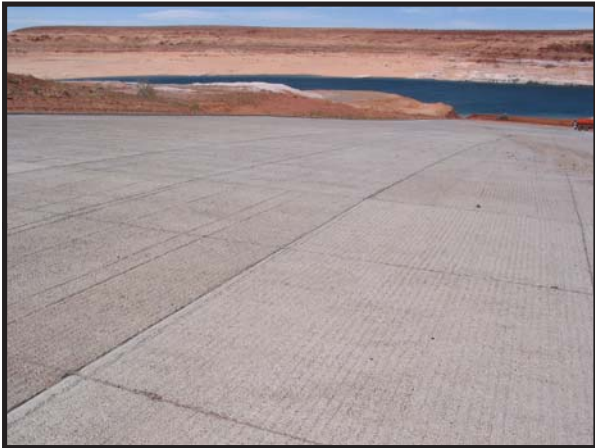
Route 0806

Route	Public / NonPublic	Date Visited	Area (sq ft)	Lane Miles *	Surface Type	Condition / PCR
0806	Public	4/5/2003	62882	1.08	CO	GOOD / 90

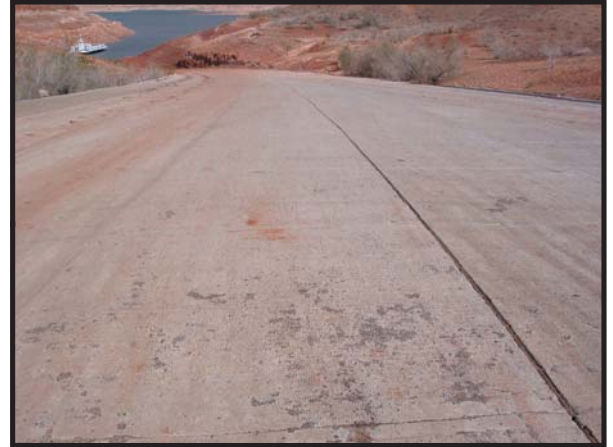
Route 0807

Route	Public / NonPublic	Date Visited	Area (sq ft)	Lane Miles *	Surface Type	Condition / PCR
0807	Public	4/5/2003	91777	1.58	CO	GOOD / 90

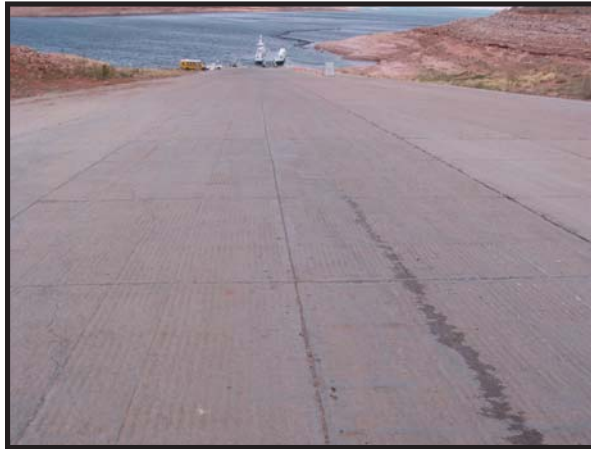
Route 0808

Route	Public / NonPublic	Date Visited	Area (sq ft)	Lane Miles *	Surface Type	Condition / PCR
0808	Public	4/4/2003	79756	1.37	CO	GOOD / 90

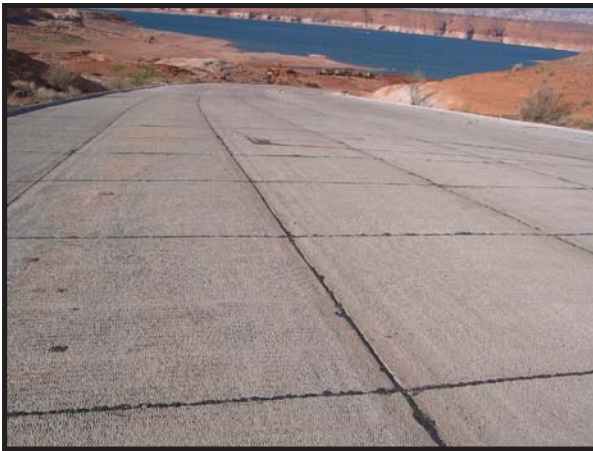
Route 0809

Route	Public / NonPublic	Date Visited	Area (sq ft)	Lane Miles *	Surface Type	Condition / PCR
0809	NonPublic	4/1/2003	33476	0.58	CO	FAIR / 73

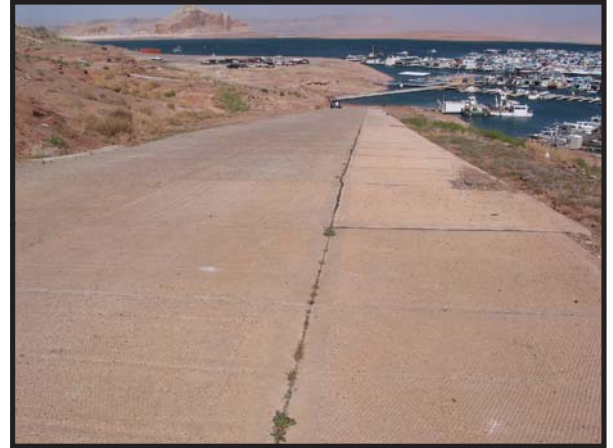
Route 0901A

Route	Public / NonPublic	Date Visited	Area (sq ft)	Lane Miles *	Surface Type	Condition / PCR
0901A	Public	4/1/2003	40480	0.70	AS	FAIR / 73

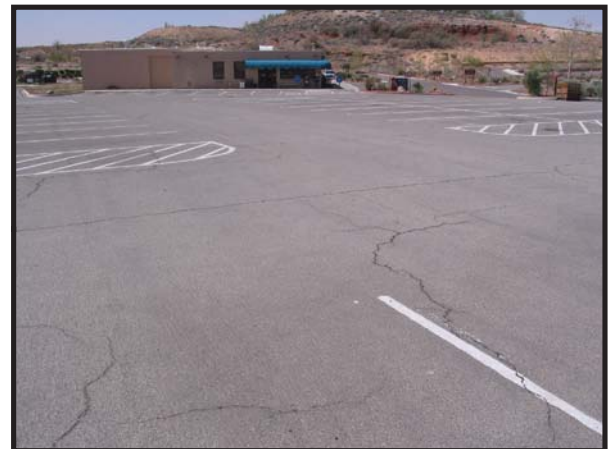
Route 0901B

Route	Public / NonPublic	Date Visited	Area (sq ft)	Lane Miles *	Surface Type	Condition / PCR
0901B	Public	4/1/2003	1815	0.03	AS	FAIR / 73

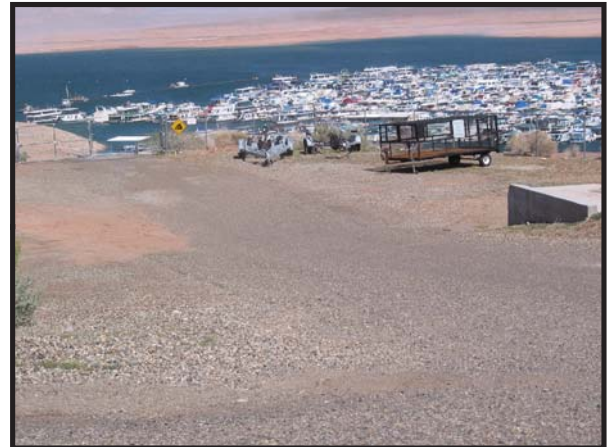
Route 0904

Route	Public / NonPublic	Date Visited	Area (sq ft)	Lane Miles *	Surface Type	Condition / PCR
0904	Public	4/1/2003	97813	1.68	AS	GOOD / 90

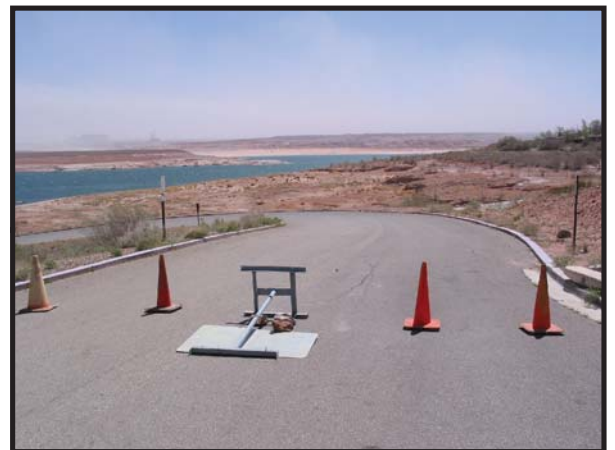
Route 0905

Route	Public / NonPublic	Date Visited	Area (sq ft)	Lane Miles *	Surface Type	Condition / PCR
0905	Public	4/1/2003	236384	4.07	AS	FAIR / 73

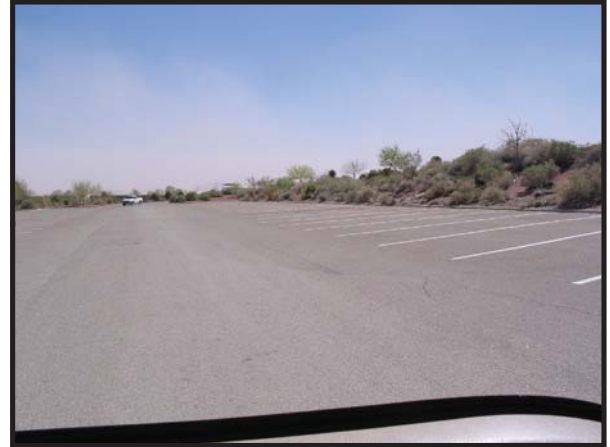
Route 0906

Route	Public / NonPublic	Date Visited	Area (sq ft)	Lane Miles *	Surface Type	Condition / PCR
0906	NonPublic	4/1/2003	42202	0.73	AS	FAIR / 73

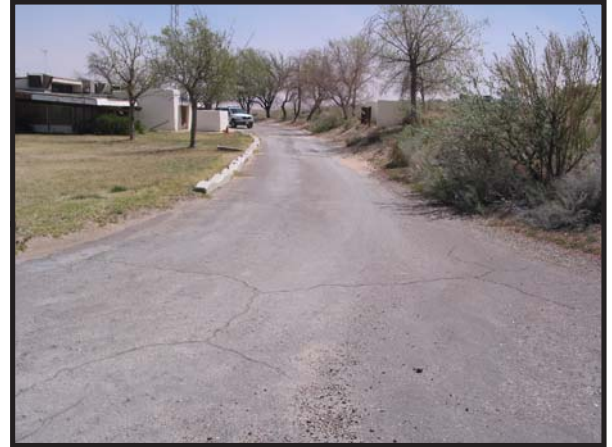
Route 0907

Route	Public / NonPublic	Date Visited	Area (sq ft)	Lane Miles *	Surface Type	Condition / PCR
0907	NonPublic	4/4/2003	34913	0.60	AS	POOR / 45

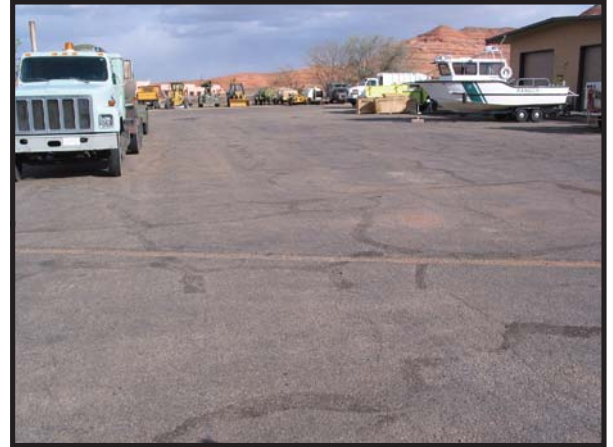
Route 0908

Route	Public / NonPublic	Date Visited	Area (sq ft)	Lane Miles *	Surface Type	Condition / PCR
0908	NonPublic	4/4/2003	11270	0.19	AS	FAIR / 73

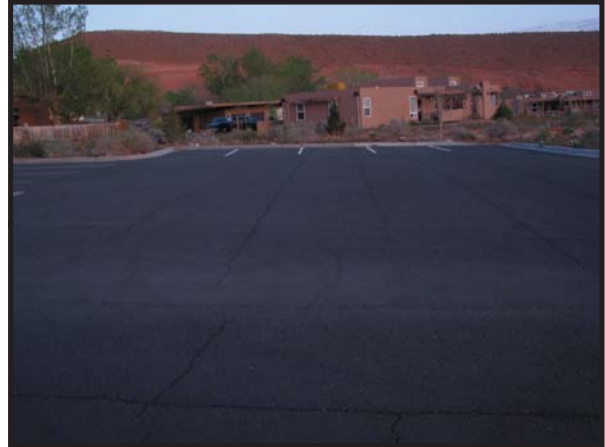
Route 0909

Route	Public / NonPublic	Date Visited	Area (sq ft)	Lane Miles *	Surface Type	Condition / PCR
0909	Public	4/1/2003	62174	1.07	AS	GOOD / 90

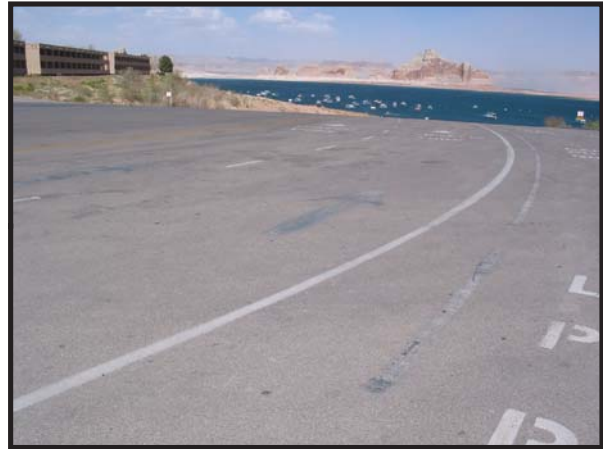
Route 0910

Route	Public / NonPublic	Date Visited	Area (sq ft)	Lane Miles *	Surface Type	Condition / PCR
0910	Public	4/1/2003	10802	0.19	AS	FAIR / 73

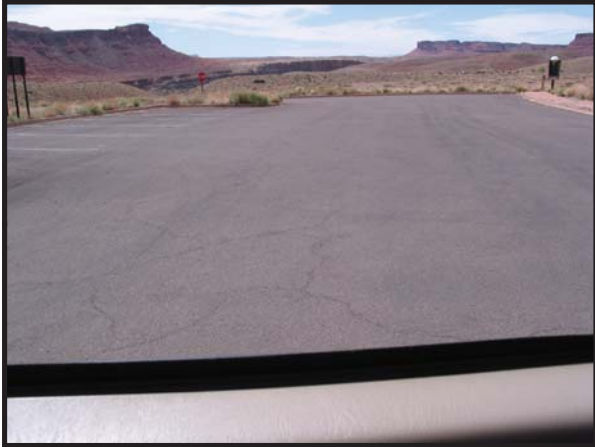
Route 0911

Route	Public / NonPublic	Date Visited	Area (sq ft)	Lane Miles *	Surface Type	Condition / PCR
0911	Public	4/1/2003	78228	1.35	AS	FAIR / 73

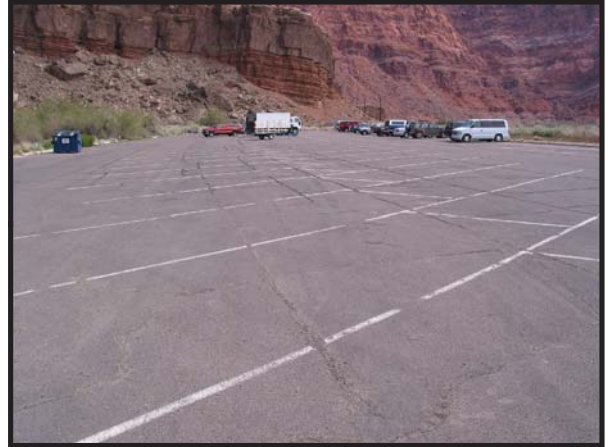
Route 0913

Route	Public / NonPublic	Date Visited	Area (sq ft)	Lane Miles *	Surface Type	Condition / PCR
0913	Public	4/1/2003	40964	0.71	AS	FAIR / 73

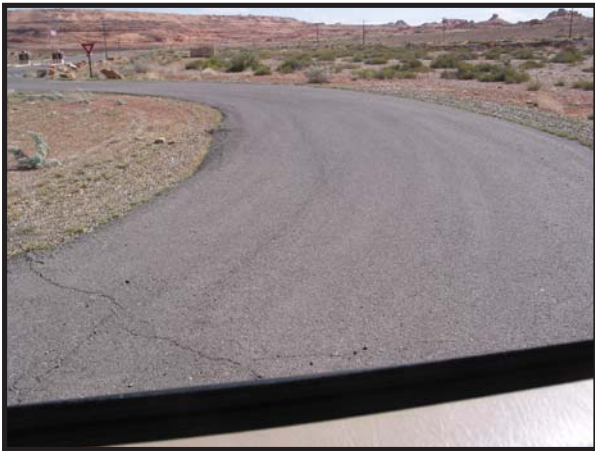
Glen Canyon National Recreation Area Route 0957B

WAHWEAP ENTRANCE STATION PARKING
Adjacent To Route 0001 on Right

Route	Public / NonPublic	Date Visited	Area (sq ft)	Lane Miles *	Surface Type	Condition / PCR
0957B	Public	4/1/2003	6434	0.11	AS	FAIR / 73

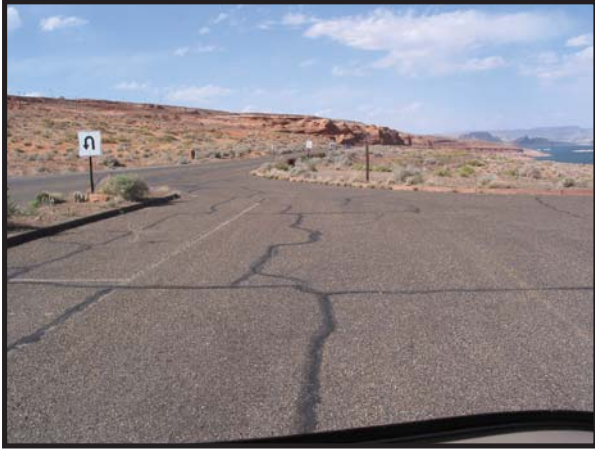
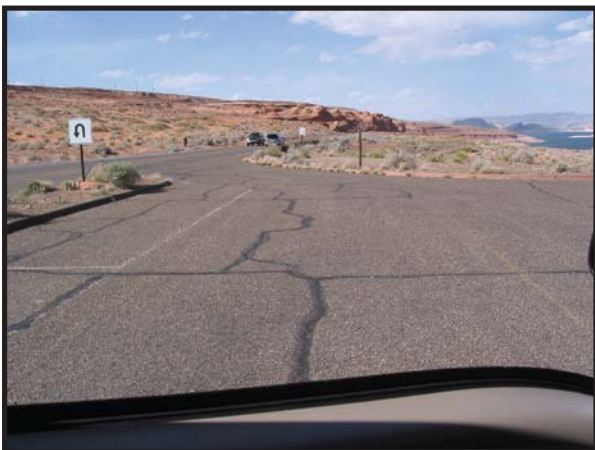
Route 0958

Route	Public / NonPublic	Date Visited	Area (sq ft)	Lane Miles *	Surface Type	Condition / PCR
0958	Public	4/1/2003	17505	0.30	AS	FAIR / 73

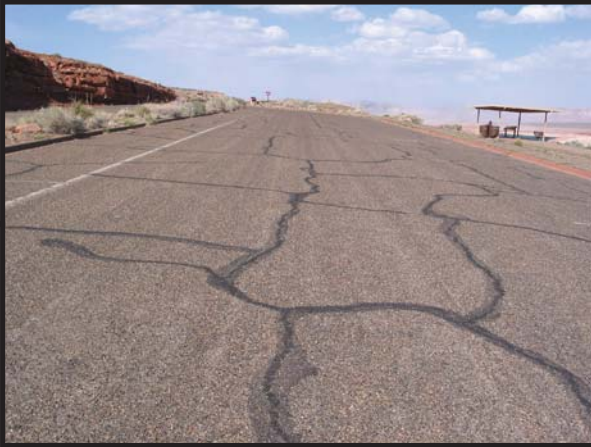
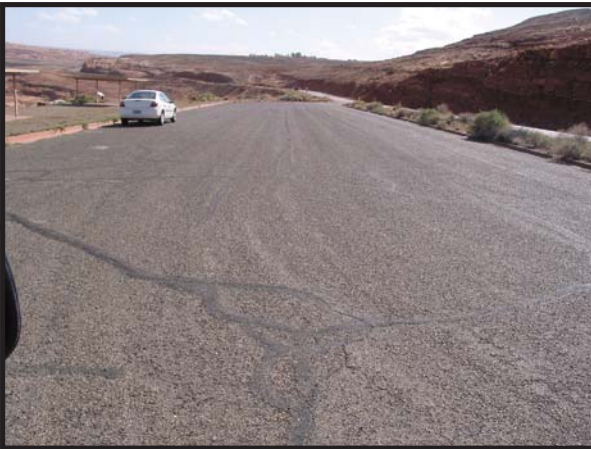
Route 0959

Route	Public / NonPublic	Date Visited	Area (sq ft)	Lane Miles *	Surface Type	Condition / PCR
0959	Public	4/1/2003	33662	0.58	AS	FAIR / 73

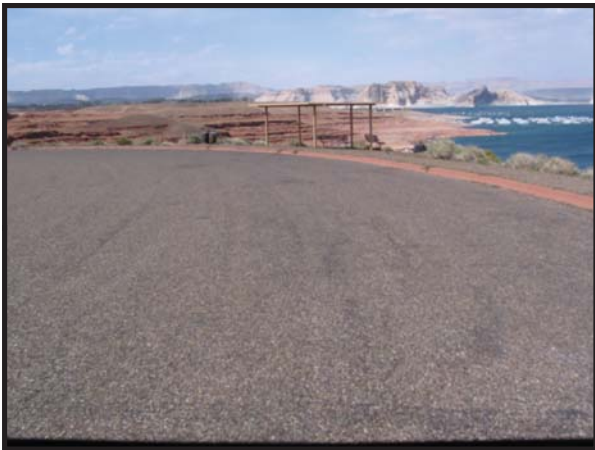
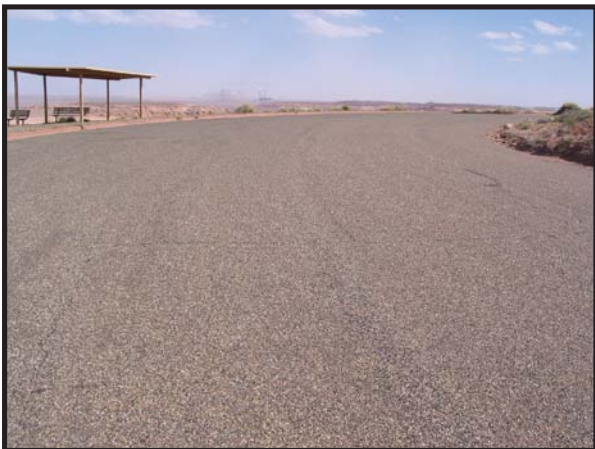
Route 0960

Route	Public / NonPublic	Date Visited	Area (sq ft)	Lane Miles *	Surface Type	Condition / PCR
0960	Public	4/1/2003	477860	8.23	AS	FAIR / 73

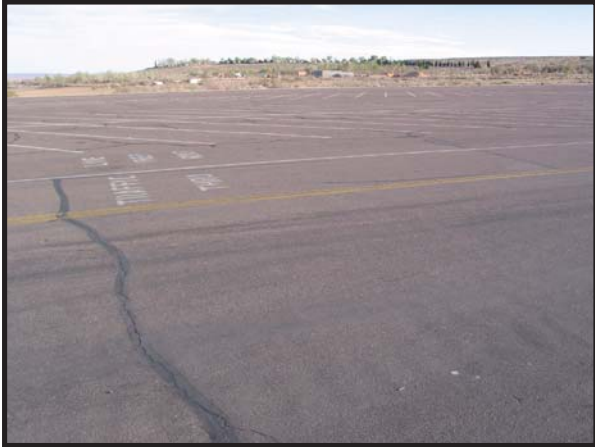
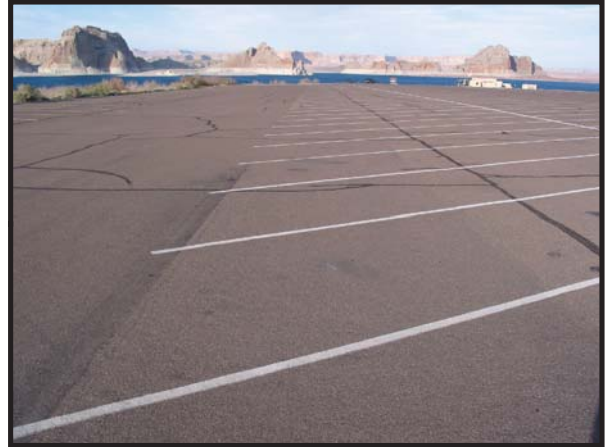
Route 0961

WAHWEAP BOAT REPAIR PARKING

Route	Public / NonPublic	Date Visited	Area (sq ft)	Lane Miles *	Surface Type	Condition / PCR
0961	NonPublic	4/1/2003	16535	0.28	AS	GOOD / 90

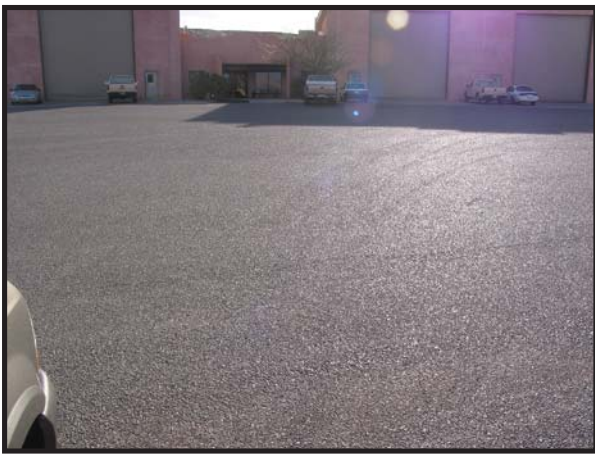
Route 0962

Route	Public / NonPublic	Date Visited	Area (sq ft)	Lane Miles *	Surface Type	Condition / PCR
0962	Public	4/1/2003	281064	4.84	AS	FAIR / 73

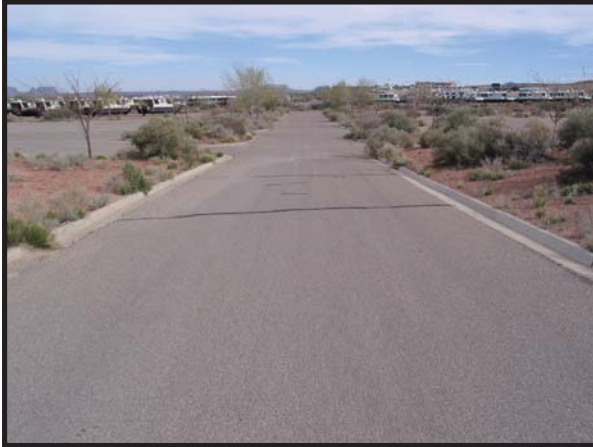
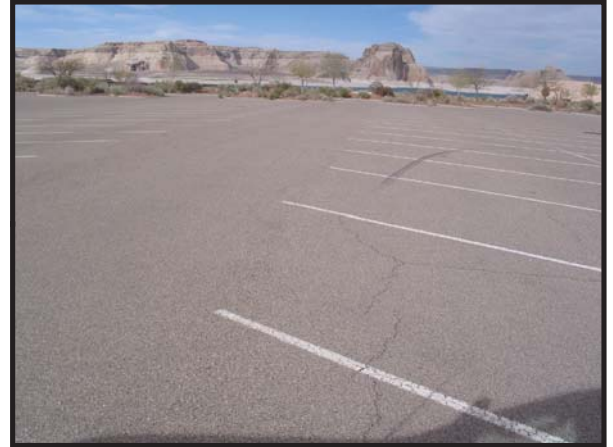
Route 0963

Route	Public / NonPublic	Date Visited	Area (sq ft)	Lane Miles *	Surface Type	Condition / PCR
0963	Public	4/1/2003	78807	1.36	AS	FAIR / 73

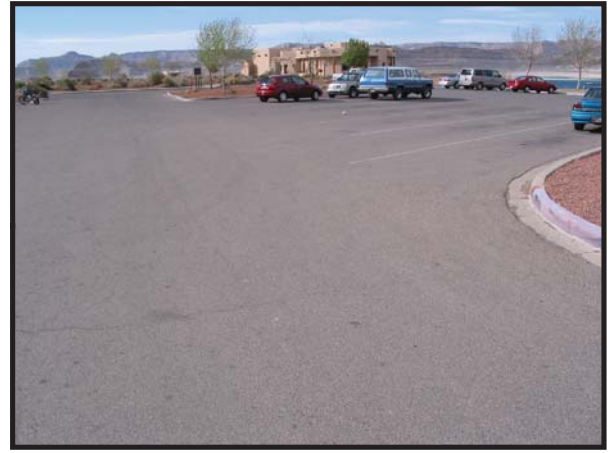
Route 0964

Route	Public / NonPublic	Date Visited	Area (sq ft)	Lane Miles *	Surface Type	Condition / PCR
0964	Public	4/1/2003	441258	7.60	AS	FAIR / 73

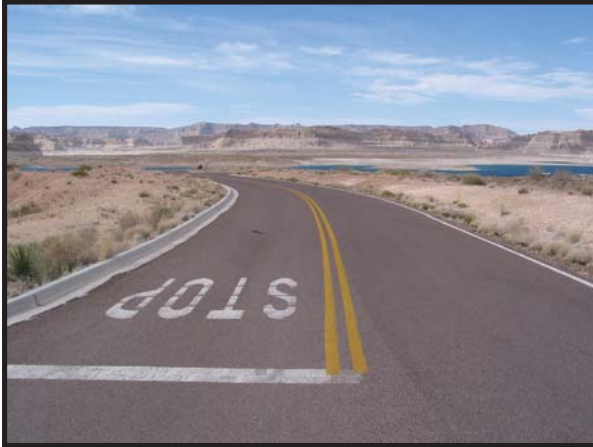
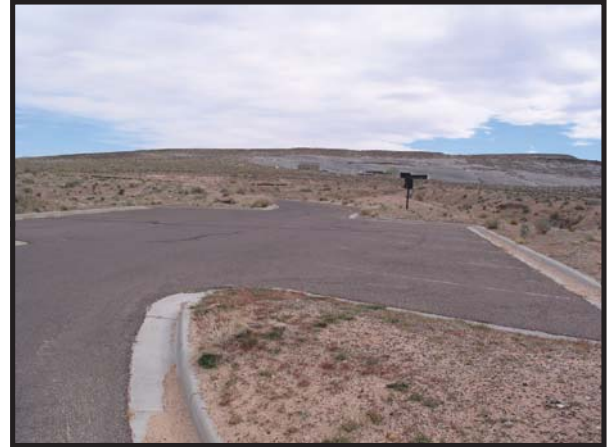
Route 0967

Route	Public / NonPublic	Date Visited	Area (sq ft)	Lane Miles *	Surface Type	Condition / PCR
0967	Public	4/1/2003	28096	0.48	AS	GOOD / 90

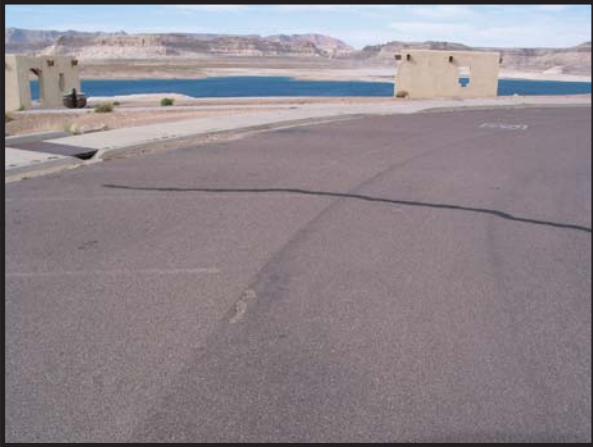
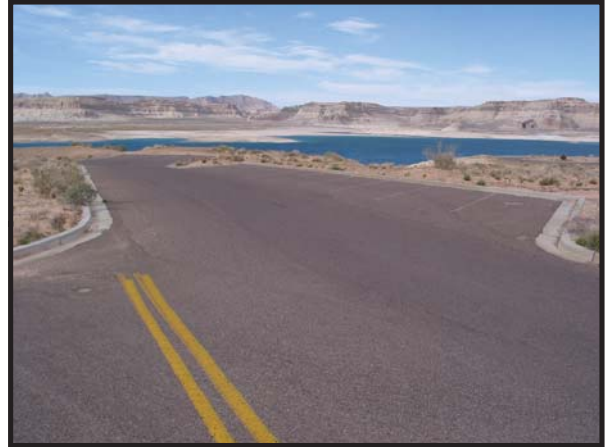
Route 0968

Route	Public / NonPublic	Date Visited	Area (sq ft)	Lane Miles *	Surface Type	Condition / PCR
0968	Public	4/1/2003	18970	0.33	AS	GOOD / 90

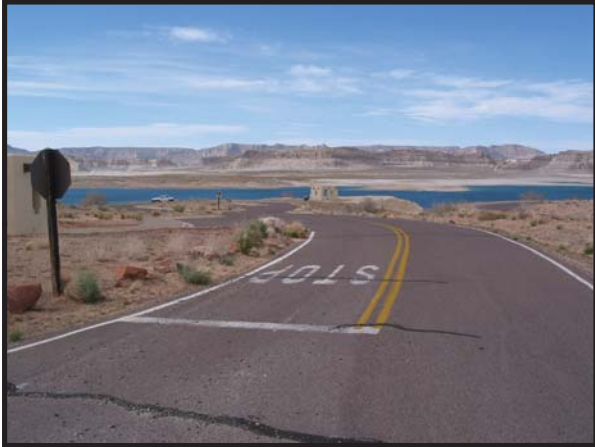
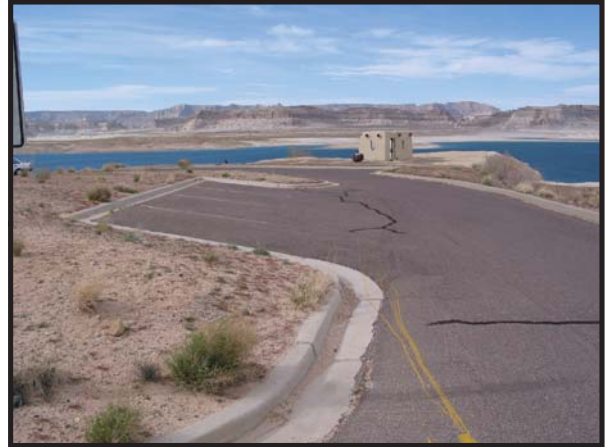
Route 0969A

Route	Public / NonPublic	Date Visited	Area (sq ft)	Lane Miles *	Surface Type	Condition / PCR
0969A	Public	4/2/2003	88253	1.52	AS	POOR / 45

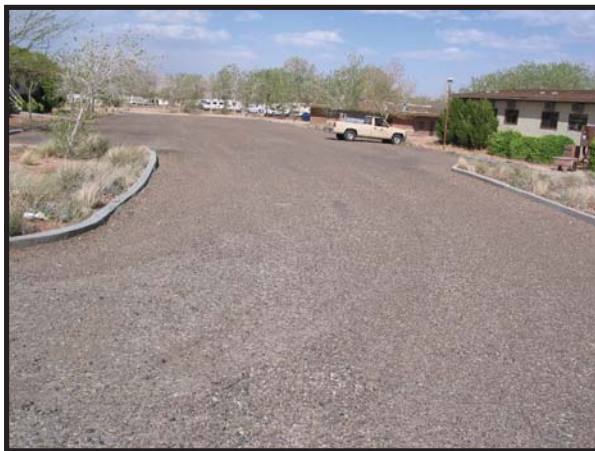
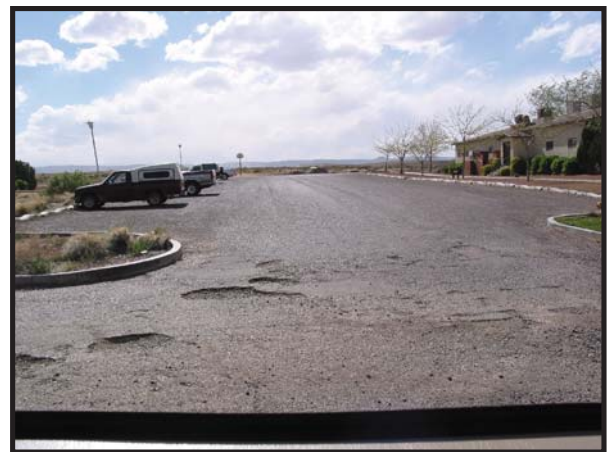
Route 0969B

Route	Public / NonPublic	Date Visited	Area (sq ft)	Lane Miles *	Surface Type	Condition / PCR
0969B	Public	4/2/2003	7336	0.13	AS	FAIR / 73

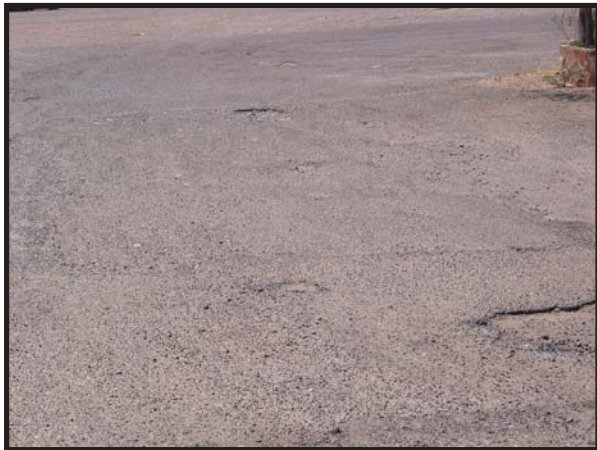
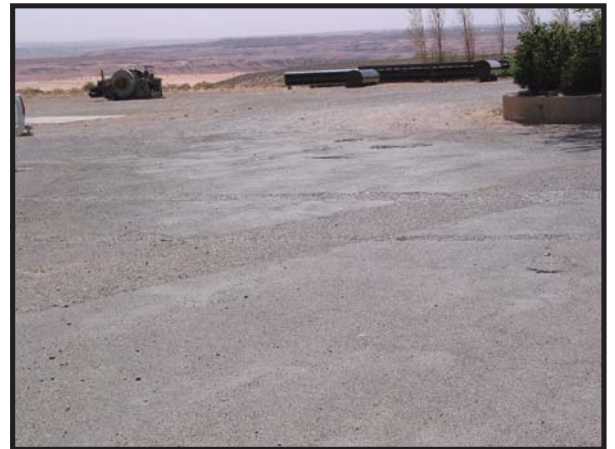
Route 0969D

Route	Public / NonPublic	Date Visited	Area (sq ft)	Lane Miles *	Surface Type	Condition / PCR
0969D	Public	4/2/2003	2073	0.04	AS	POOR / 45

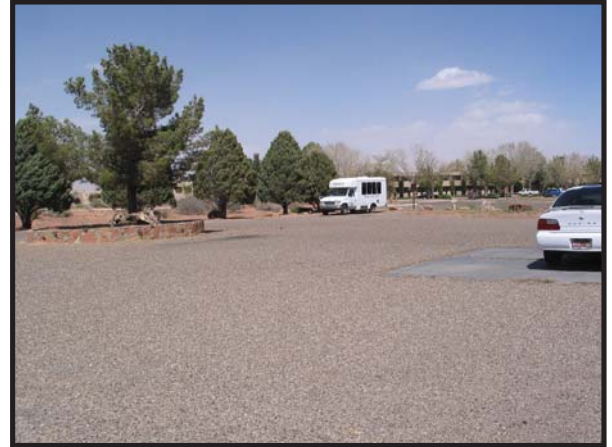
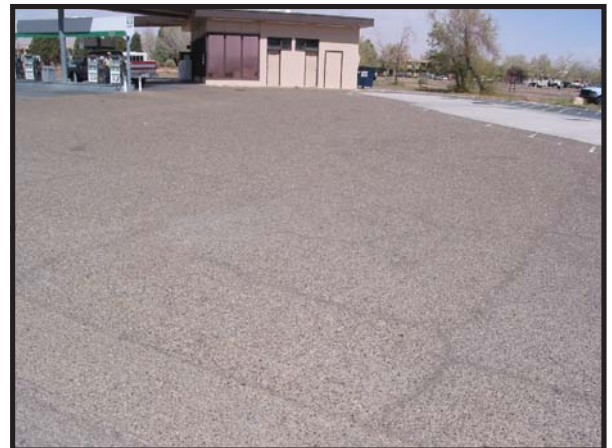
Route 0971

Route	Public / NonPublic	Date Visited	Area (sq ft)	Lane Miles *	Surface Type	Condition / PCR
0971	Public	4/1/2003	17956	0.31	AS	EXCELLENT / 97

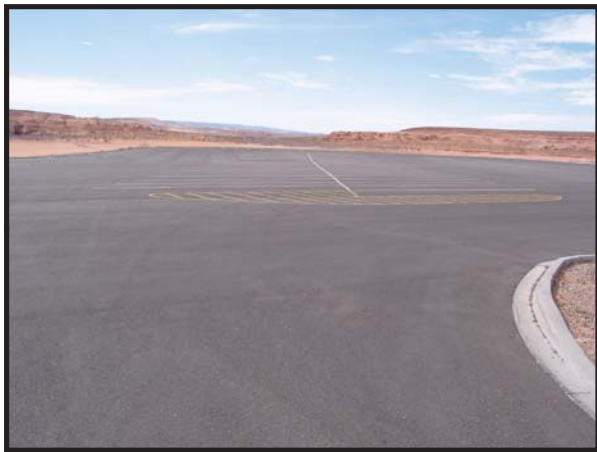
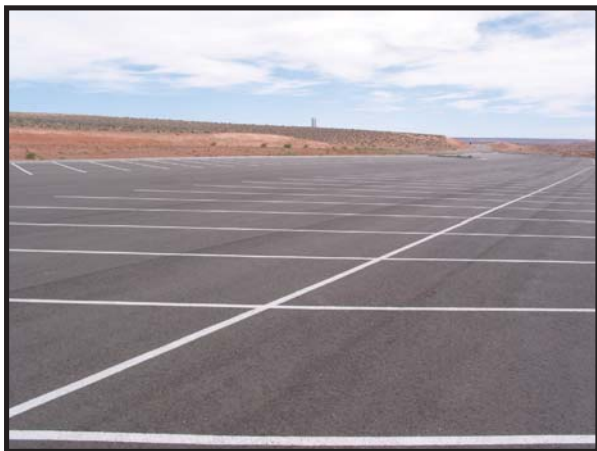
Route 0973

Route	Public / NonPublic	Date Visited	Area (sq ft)	Lane Miles *	Surface Type	Condition / PCR
0973	Public	4/1/2003	6863	0.12	AS	FAIR / 73

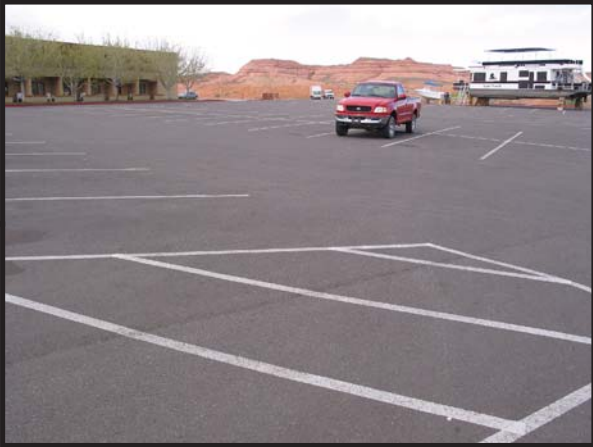
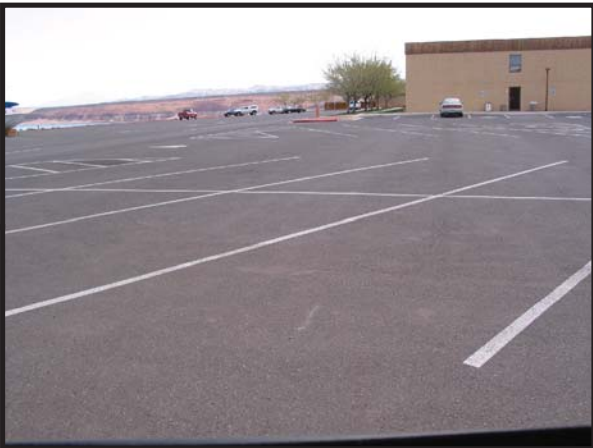
Route 0976A

Route	Public / NonPublic	Date Visited	Area (sq ft)	Lane Miles *	Surface Type	Condition / PCR
0976A	Public	4/4/2003	2836	0.05	AS	POOR / 45

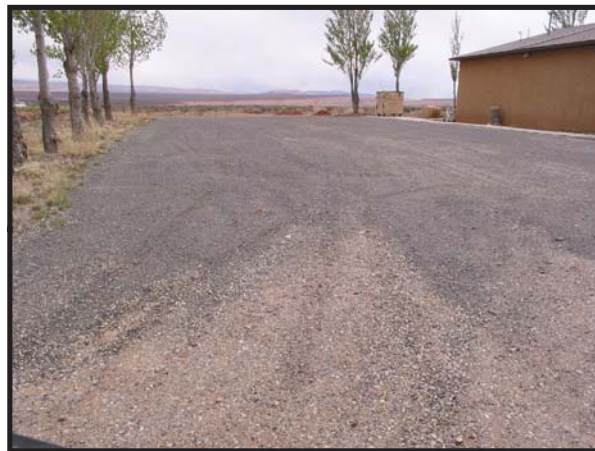
Route 0980

Route	Public / NonPublic	Date Visited	Area (sq ft)	Lane Miles *	Surface Type	Condition / PCR
0980	Public	4/5/2003	9769	0.17	OC	POOR / 45

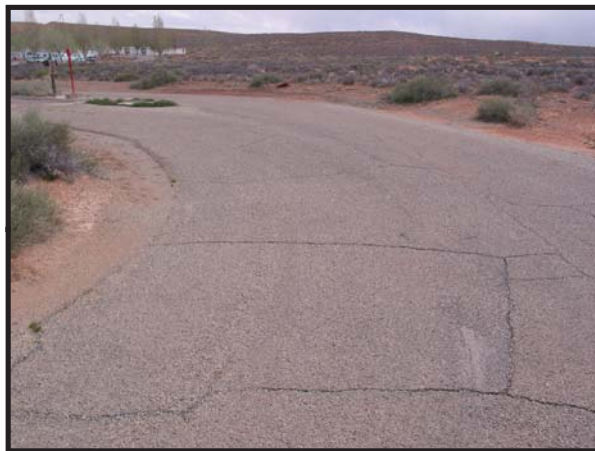
Route 0981

Route	Public / NonPublic	Date Visited	Area (sq ft)	Lane Miles *	Surface Type	Condition / PCR
0981	Public	4/4/2003	77321	1.33	AS	FAIR / 73

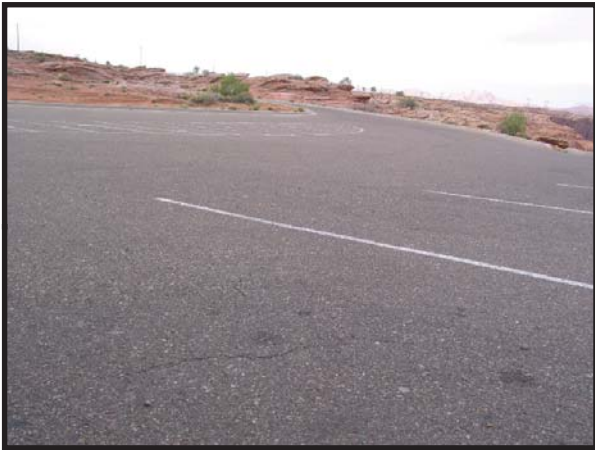
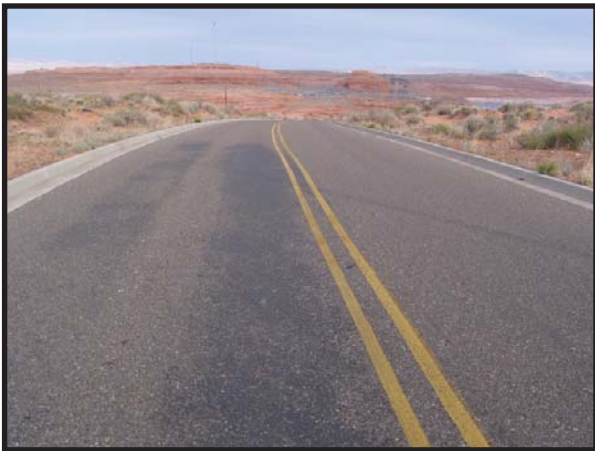
Route 0985

Route	Public / NonPublic	Date Visited	Area (sq ft)	Lane Miles *	Surface Type	Condition / PCR
0985	Public	4/5/2003	343114	5.91	AS	FAIR / 73

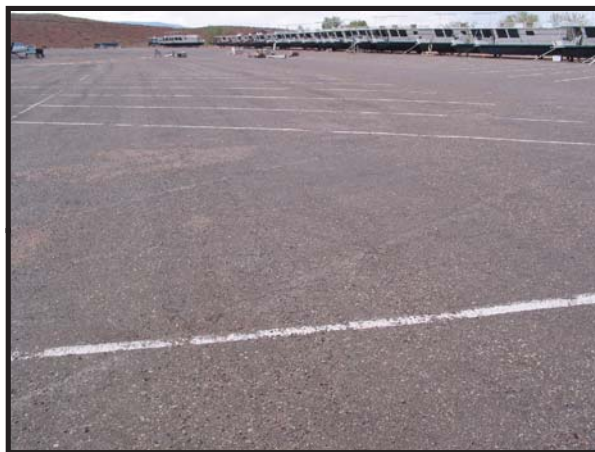
Route 0987

Route	Public / NonPublic	Date Visited	Area (sq ft)	Lane Miles *	Surface Type	Condition / PCR
0987	Public	4/5/2003	63205	1.09	AS	GOOD / 90
