**The Road Inventory
of
Shenandoah National Park
SHEN – 4840
Volume 1**

Prepared By:
Federal Highway Administration
Eastern Federal Lands Highway Division
Cycle 3

Shenandoah National Park in Virginia

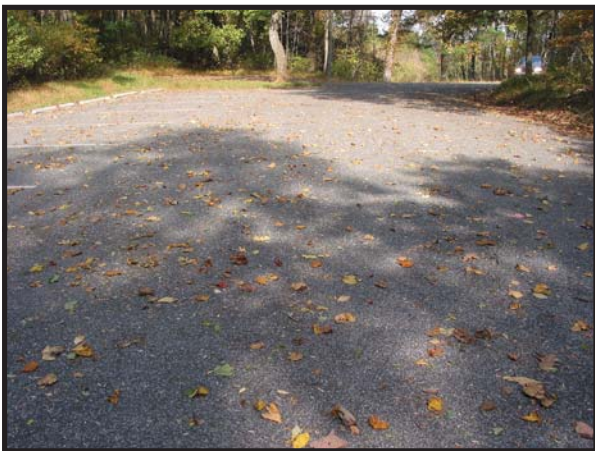
Route	Public / NonPublic	Date Visited	Area (sq ft)	Lane Miles *	Surface Type	Condition / PCR
0901	Public	10/21/2003	8887	0.15	AS	GOOD / 90

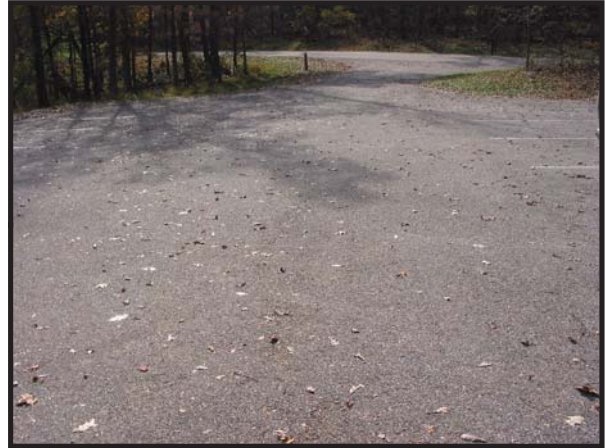
Route 0902

Route	Public / NonPublic	Date Visited	Area (sq ft)	Lane Miles *	Surface Type	Condition / PCR
0902	Public	10/21/2003	6925	0.12	AS	GOOD / 90

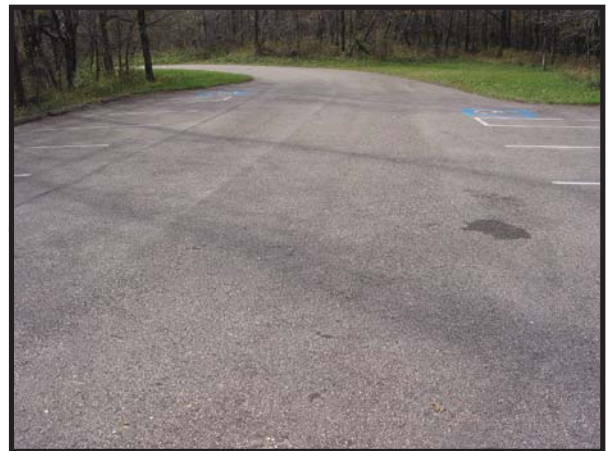
Route 0903

Route	Public / NonPublic	Date Visited	Area (sq ft)	Lane Miles *	Surface Type	Condition / PCR
0903	Public	10/21/2003	11088	0.19	AS	GOOD / 90

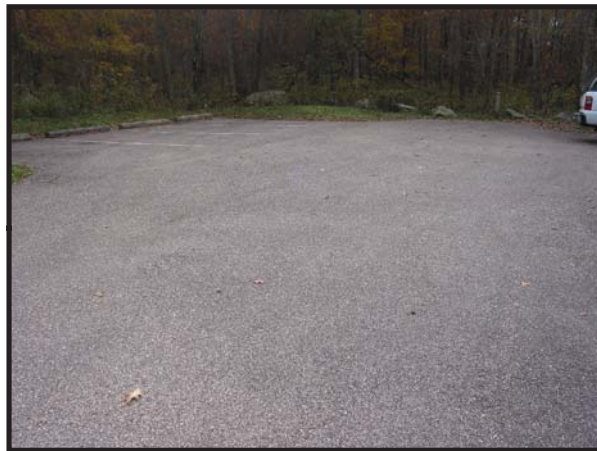
Route 0904

Route	Public / NonPublic	Date Visited	Area (sq ft)	Lane Miles *	Surface Type	Condition / PCR
0904	Public	10/21/2003	3744	0.06	AS	GOOD / 90

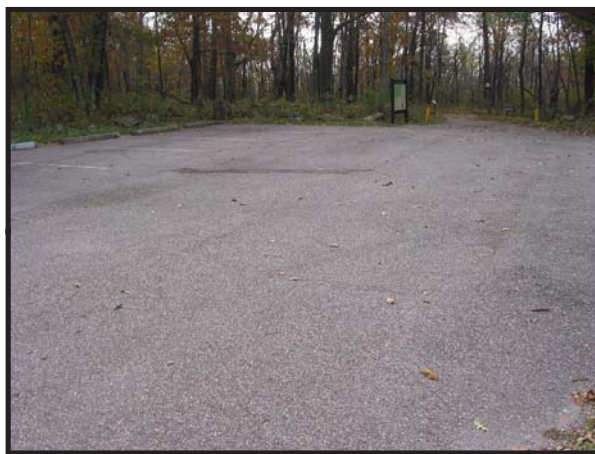
Route 0905

Route	Public / NonPublic	Date Visited	Area (sq ft)	Lane Miles *	Surface Type	Condition / PCR
0905	Public	10/21/2003	4754	0.08	AS	GOOD / 90

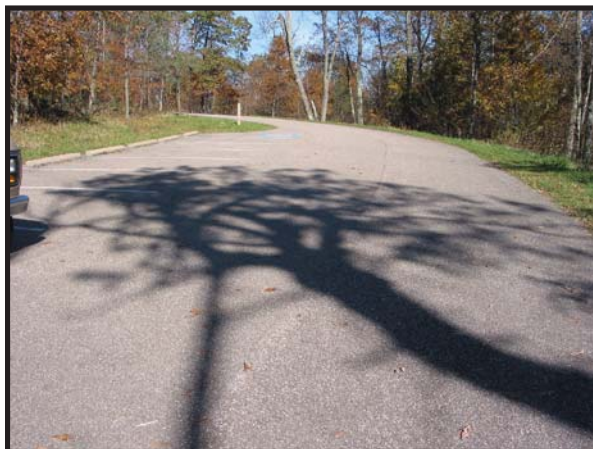
Route 0906

Route	Public / NonPublic	Date Visited	Area (sq ft)	Lane Miles *	Surface Type	Condition / PCR
0906	Public	10/20/2003	8442	0.15	CO	GOOD / 90

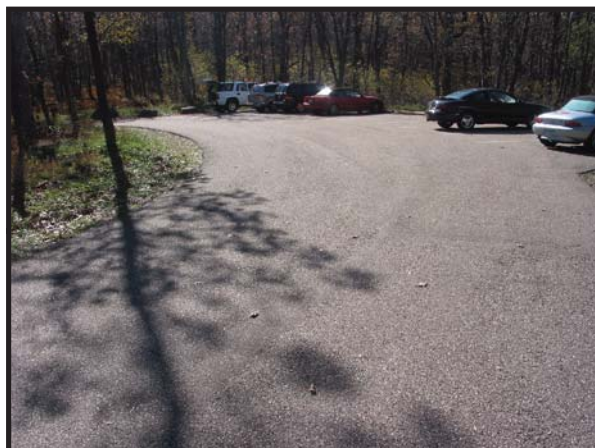
Route 0907

Route	Public / NonPublic	Date Visited	Area (sq ft)	Lane Miles *	Surface Type	Condition / PCR
0907	Public	10/20/2003	6146	0.11	AS	GOOD / 90

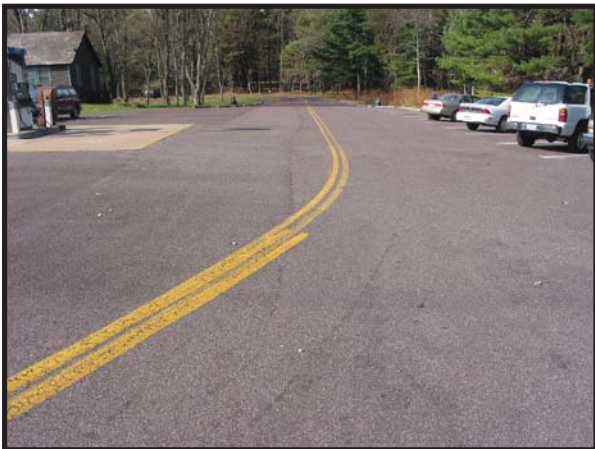
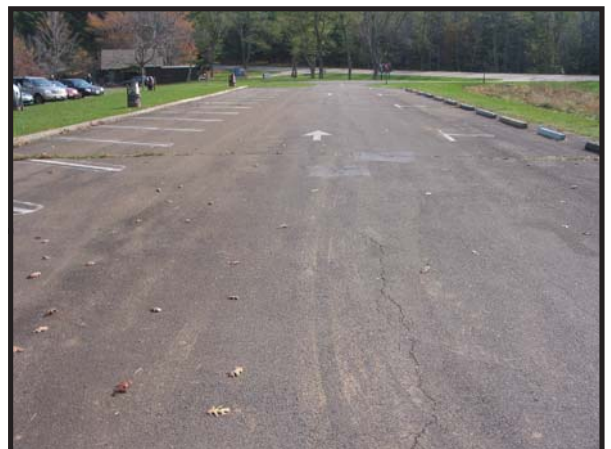
Route 0908

Route	Public / NonPublic	Date Visited	Area (sq ft)	Lane Miles *	Surface Type	Condition / PCR
0908	Public	10/21/2003	69127	1.19	AS	FAIR / 73

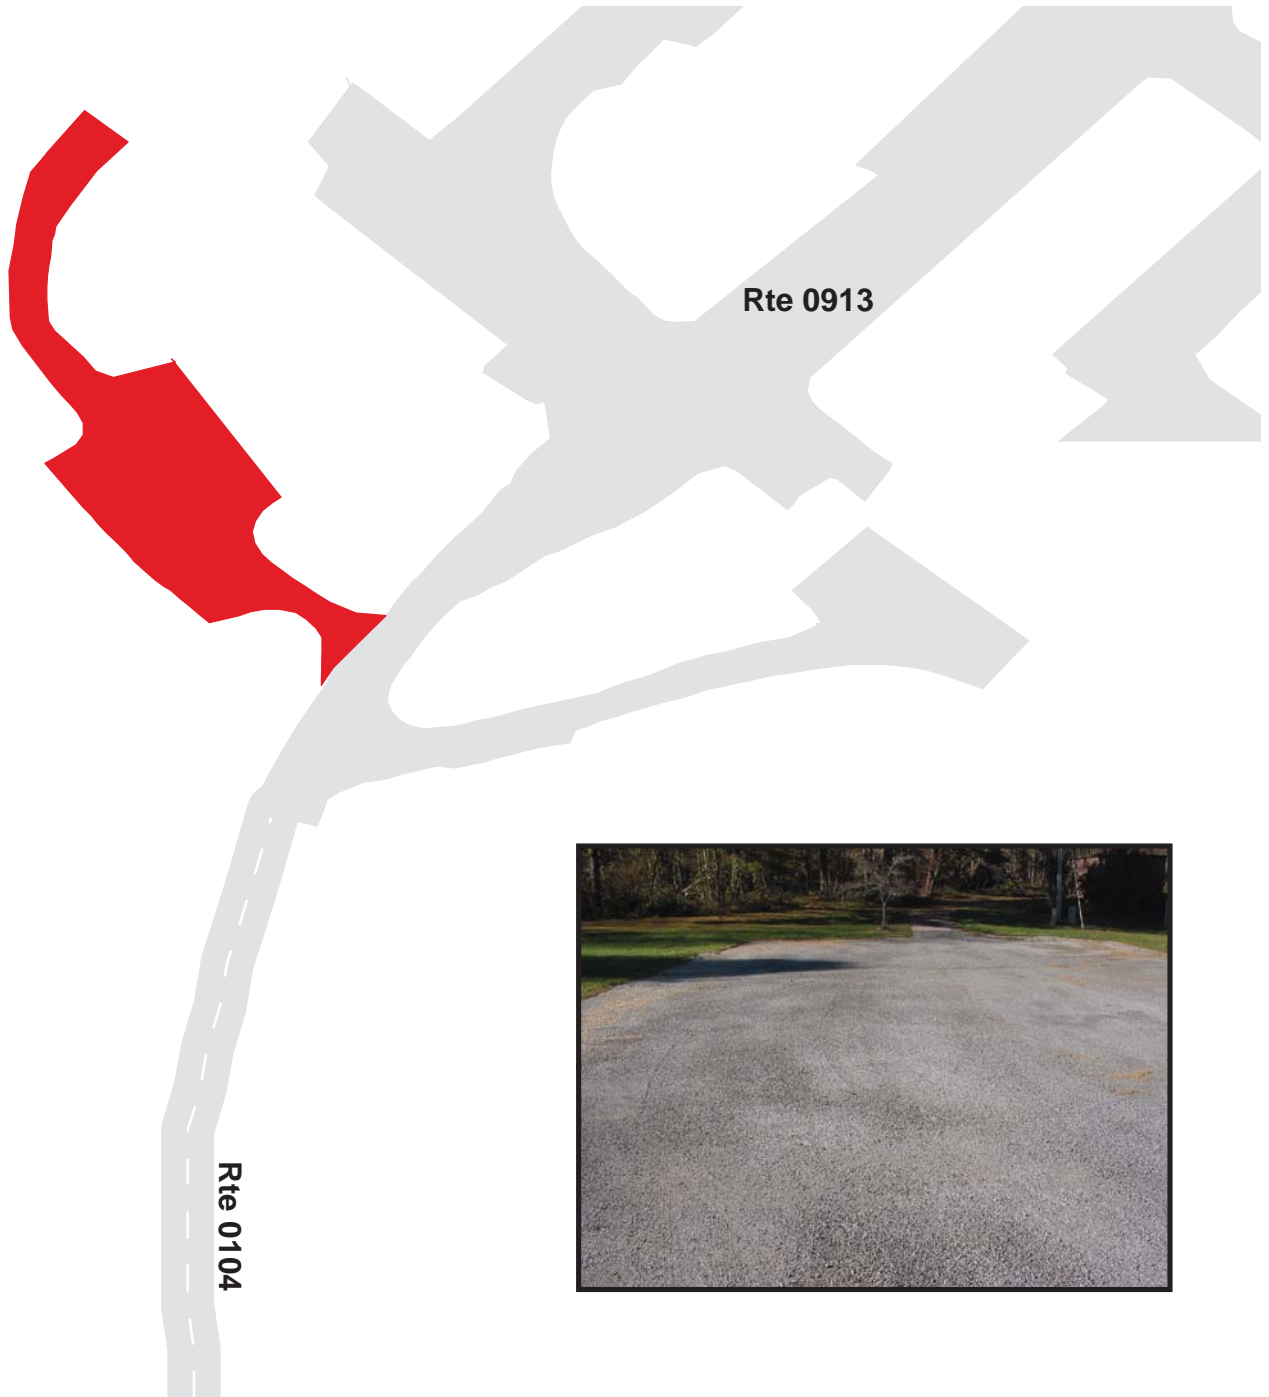
Route 0916

Route	Public / NonPublic	Date Visited	Area (sq ft)	Lane Miles *	Surface Type	Condition / PCR
0916	Public	10/24/2003	7361	0.13	NC	FAIR / 73

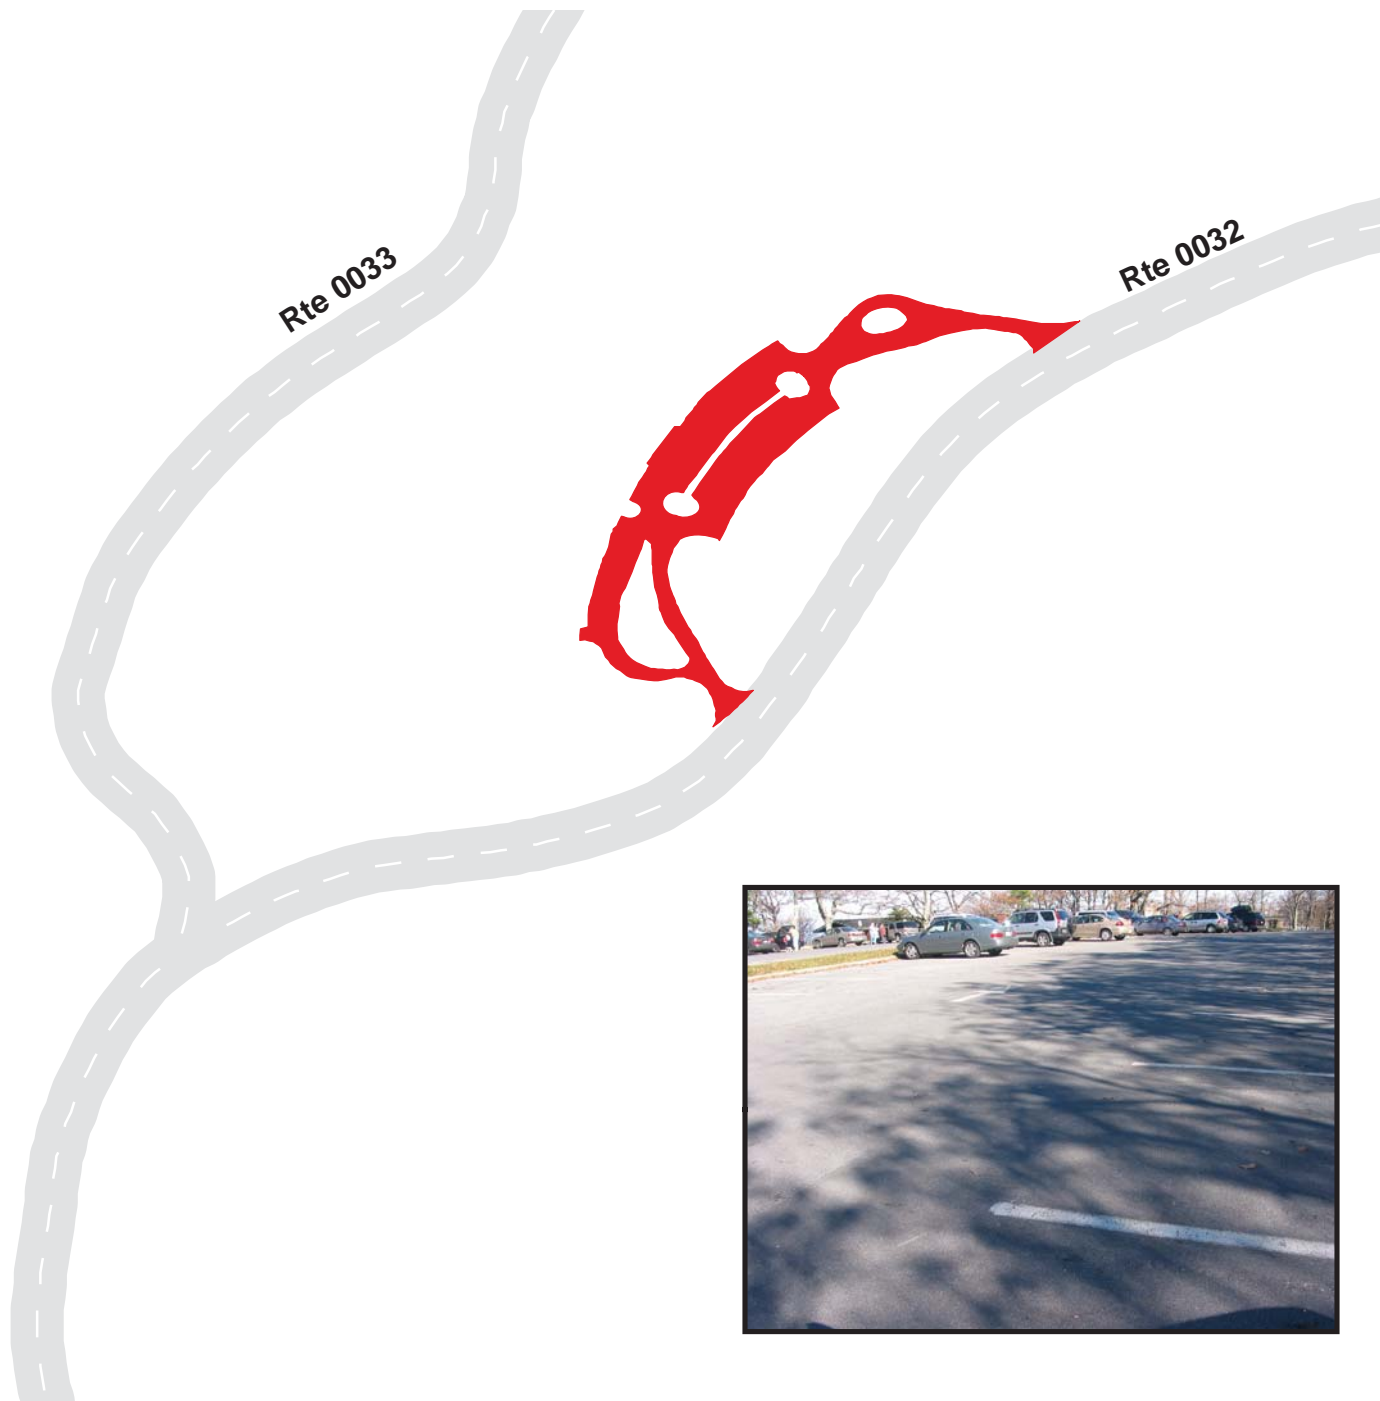
Route	Public / NonPublic	Date Visited	Area (sq ft)	Lane Miles *	Surface Type	Condition / PCR
0919	Public	10/24/2003	65235	1.12	AS	GOOD / 90

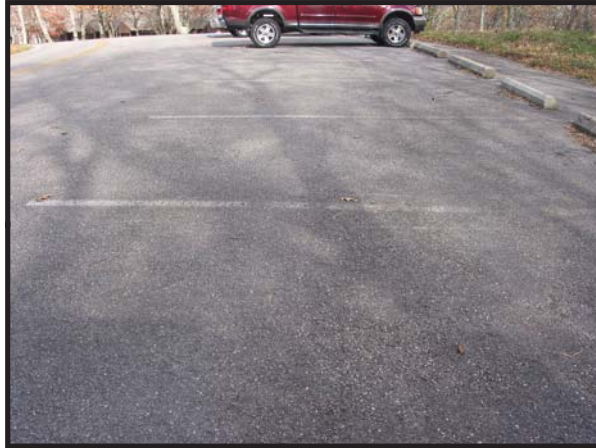
Route 0926D

Route	Public / NonPublic	Date Visited	Area (sq ft)	Lane Miles *	Surface Type	Condition / PCR
0926D	Public	10/23/2003	1612	0.03	AS	GOOD / 90

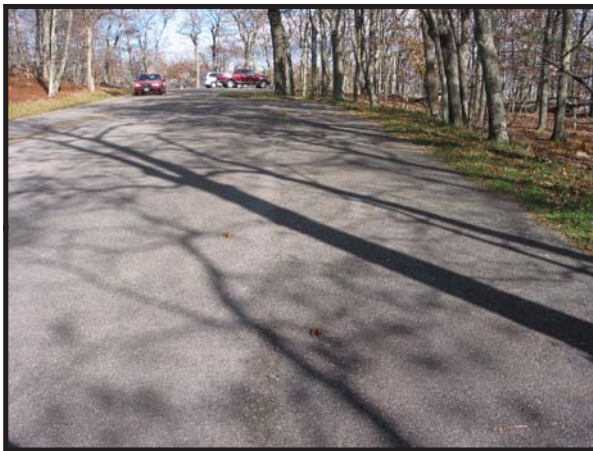
Route 0926E

Route	Public / NonPublic	Date Visited	Area (sq ft)	Lane Miles *	Surface Type	Condition / PCR
0926E	Public	10/23/2003	1482	0.03	AS	GOOD / 90

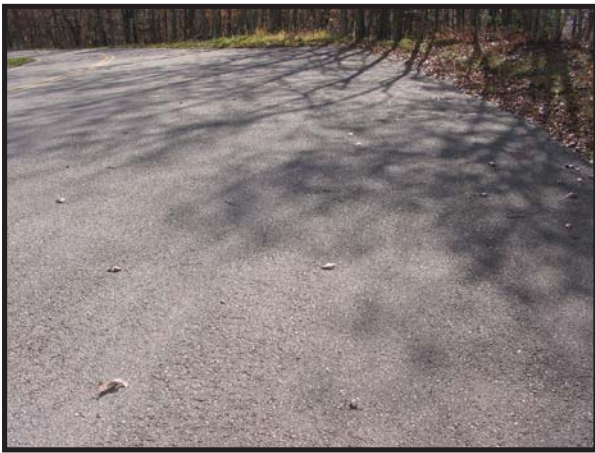
Route 0926F

Route	Public / NonPublic	Date Visited	Area (sq ft)	Lane Miles *	Surface Type	Condition / PCR
0926F	Public	10/23/2003	1277	0.02	AS	GOOD / 90

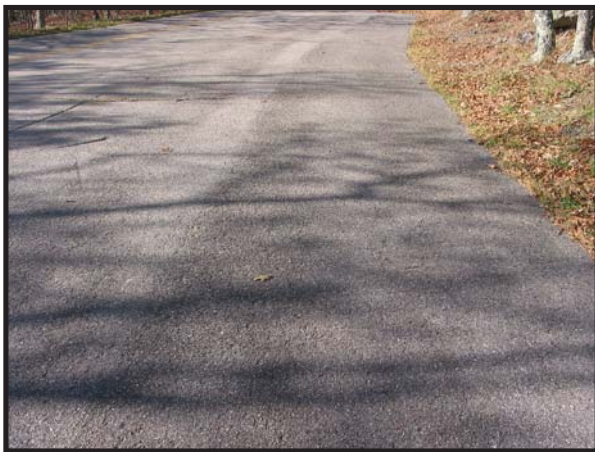
Route 0926G

Route	Public / NonPublic	Date Visited	Area (sq ft)	Lane Miles *	Surface Type	Condition / PCR
0926G	Public	10/23/2003	2064	0.04	AS	GOOD / 90

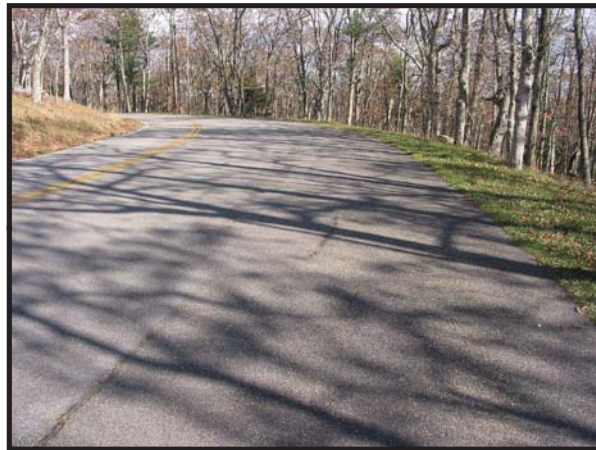
Route 0926H

Route	Public / NonPublic	Date Visited	Area (sq ft)	Lane Miles *	Surface Type	Condition / PCR
0926H	Public	10/23/2003	3755	0.06	AS	GOOD / 90

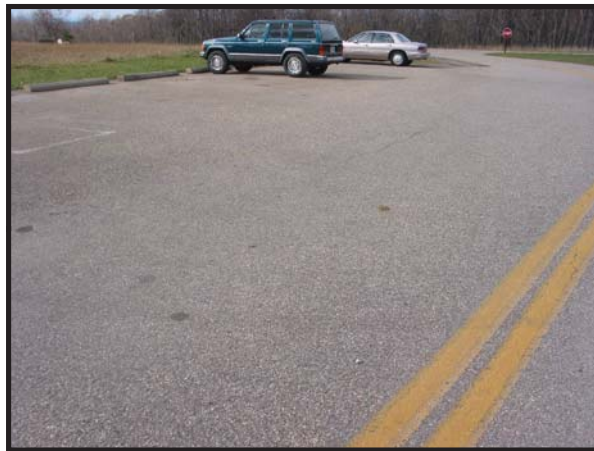
Route 0928

Route	Public / NonPublic	Date Visited	Area (sq ft)	Lane Miles *	Surface Type	Condition / PCR
0928	Public	10/23/2003	2311	0.04	AS	GOOD / 90

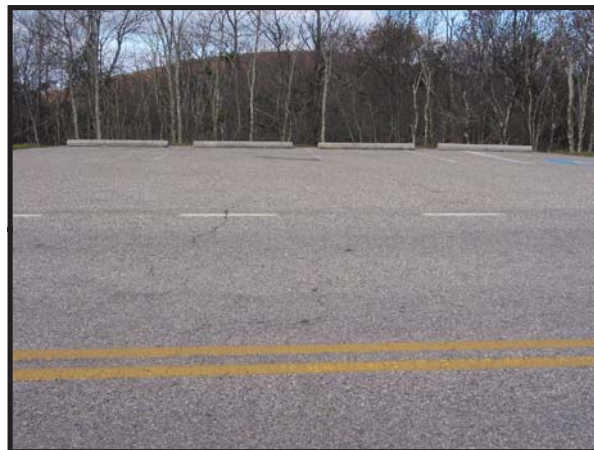
Route 0929

Route	Public / NonPublic	Date Visited	Area (sq ft)	Lane Miles *	Surface Type	Condition / PCR
0929	Public	10/23/2003	16650	0.29	AS	GOOD / 90

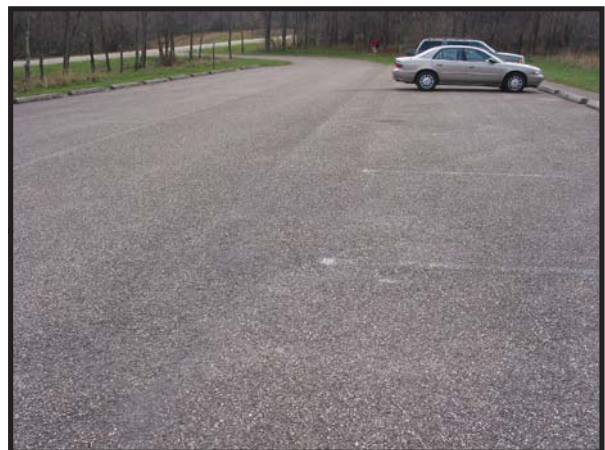
Route 0930

Route	Public / NonPublic	Date Visited	Area (sq ft)	Lane Miles *	Surface Type	Condition / PCR
0930	Public	10/23/2003	2963	0.05	AS	GOOD / 90

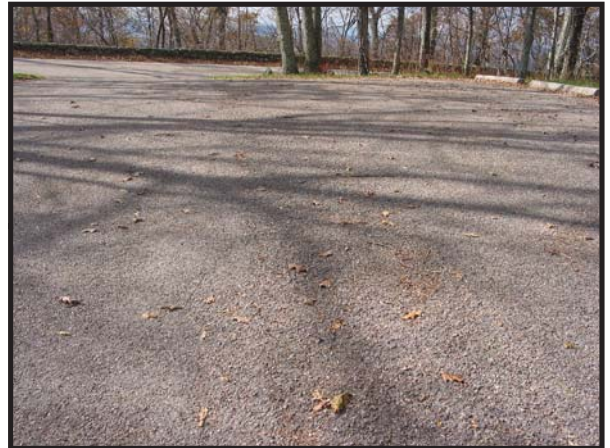
Route 0931

Route	Public / NonPublic	Date Visited	Area (sq ft)	Lane Miles *	Surface Type	Condition / PCR
0931	Public	10/23/2003	5752	0.10	AS	GOOD / 90

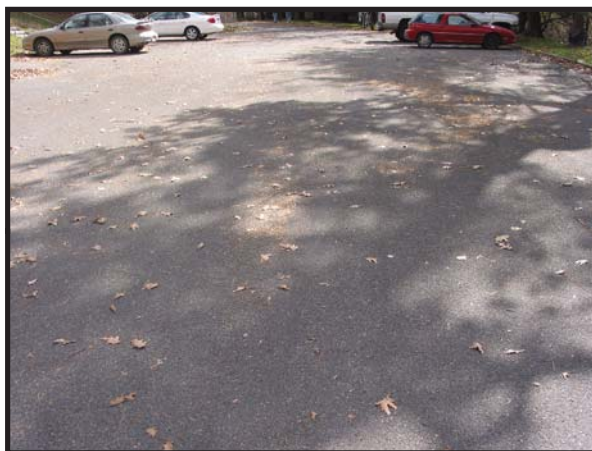
Route 0934

Route	Public / NonPublic	Date Visited	Area (sq ft)	Lane Miles *	Surface Type	Condition / PCR
0934	Public	10/21/2003	10487	0.18	AS	GOOD / 90

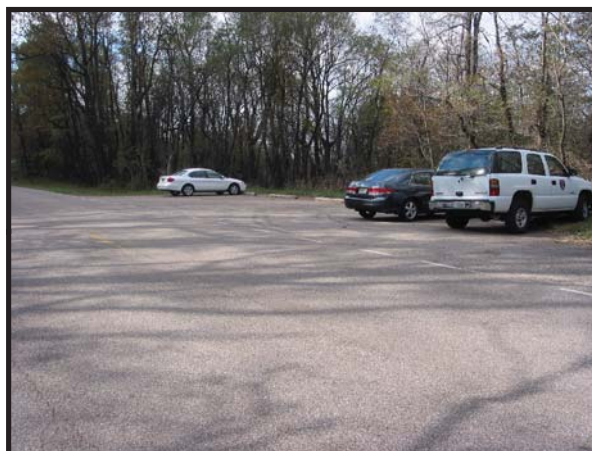
Route 0936

Route	Public / NonPublic	Date Visited	Area (sq ft)	Lane Miles *	Surface Type	Condition / PCR
0936	Public	10/23/2003	12213	0.21	AS	POOR / 45

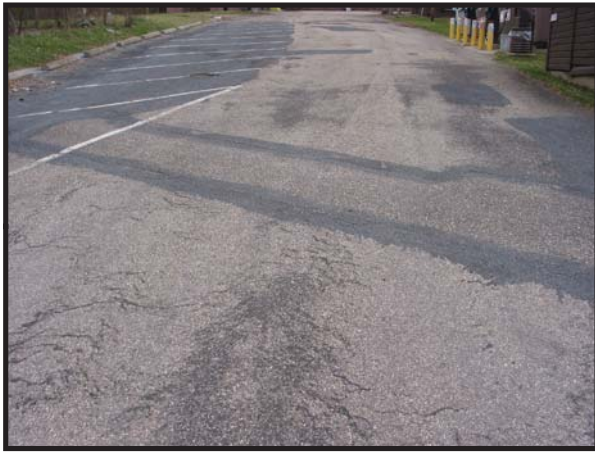
Route 0937

Route	Public / NonPublic	Date Visited	Area (sq ft)	Lane Miles *	Surface Type	Condition / PCR
0937	Public	10/22/2003	5439	0.09	AS	FAIR / 73

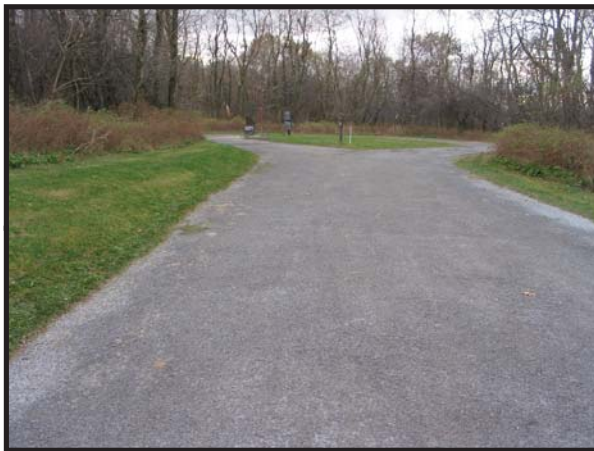
Route 0938

Route	Public / NonPublic	Date Visited	Area (sq ft)	Lane Miles *	Surface Type	Condition / PCR
0938	Public	10/22/2003	14351	0.25	AS	FAIR / 73

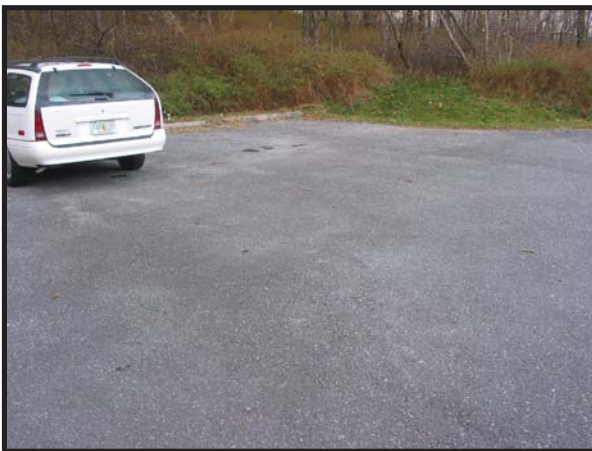
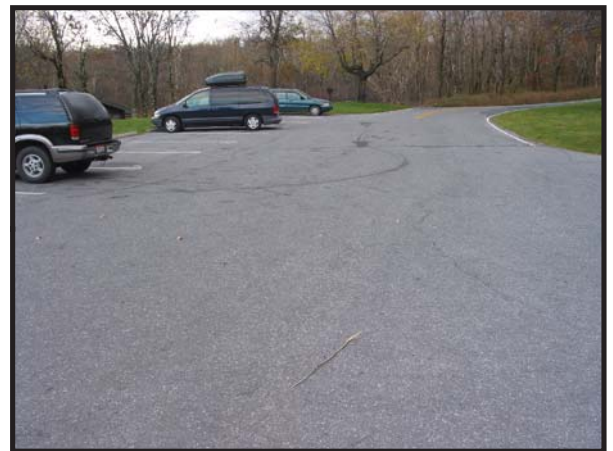
Route 0939

Route	Public / NonPublic	Date Visited	Area (sq ft)	Lane Miles *	Surface Type	Condition / PCR
0939	Public	10/22/2003	9215	0.16	AS	FAIR / 73

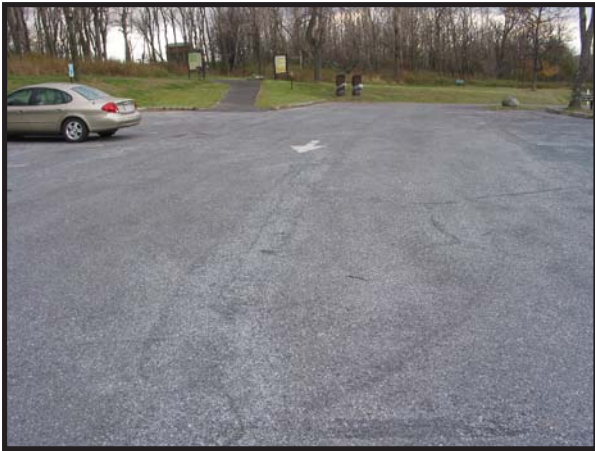
Route 0940

Route	Public / NonPublic	Date Visited	Area (sq ft)	Lane Miles *	Surface Type	Condition / PCR
0940	Public	10/22/2003	36318	0.63	AS	FAIR / 73

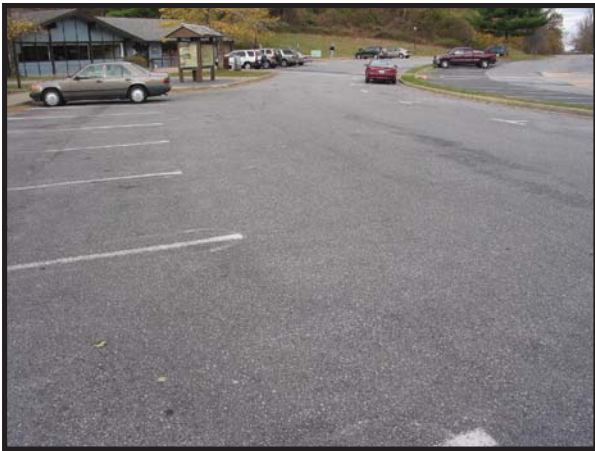
Route 0941

Route	Public / NonPublic	Date Visited	Area (sq ft)	Lane Miles *	Surface Type	Condition / PCR
0941	Public	10/22/2003	8718	0.15	AS	FAIR / 73

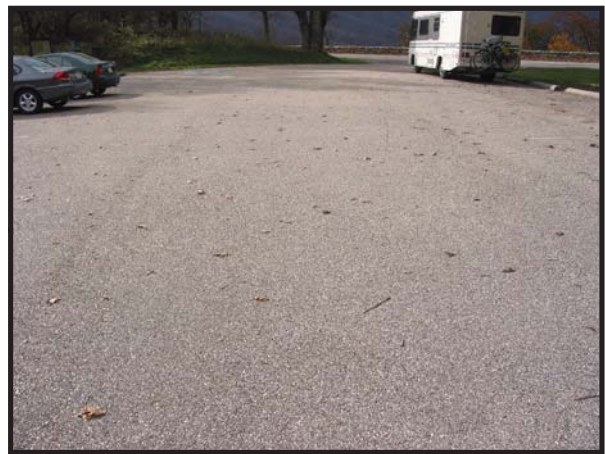
Route 0942

Route	Public / NonPublic	Date Visited	Area (sq ft)	Lane Miles *	Surface Type	Condition / PCR
0942	Public	10/22/2003	9569	0.16	AS	GOOD / 90

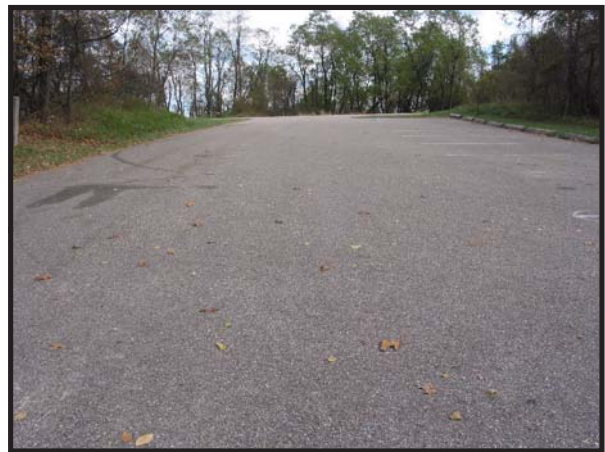
Route 0943

Route	Public / NonPublic	Date Visited	Area (sq ft)	Lane Miles *	Surface Type	Condition / PCR
0943	Public	10/22/2003	6683	0.12	AS	GOOD / 90

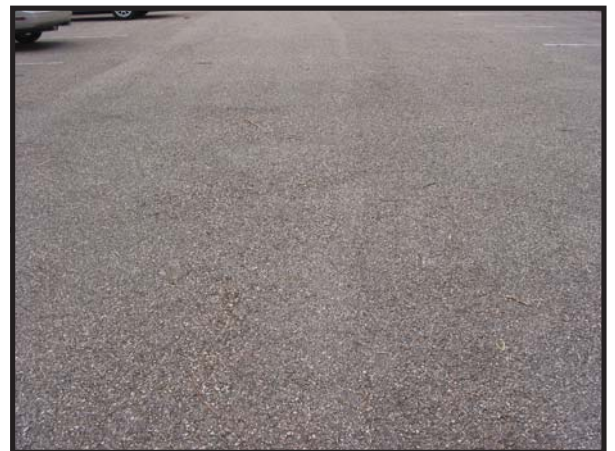
Route 0944

Route	Public / NonPublic	Date Visited	Area (sq ft)	Lane Miles *	Surface Type	Condition / PCR
0944	Public	10/22/2003	8069	0.14	AS	GOOD / 90

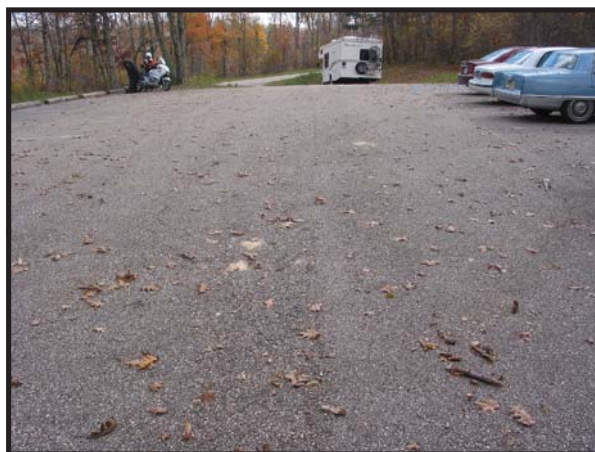
Route 0945

Route	Public / NonPublic	Date Visited	Area (sq ft)	Lane Miles *	Surface Type	Condition / PCR
0945	Public	10/22/2003	4215	0.07	AS	GOOD / 90

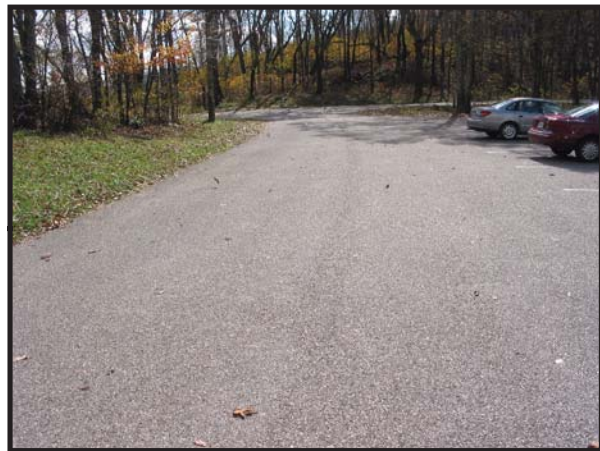
Route 0947

Route	Public / NonPublic	Date Visited	Area (sq ft)	Lane Miles *	Surface Type	Condition / PCR
0947	Public	10/22/2003	5203	0.09	AS	GOOD / 90

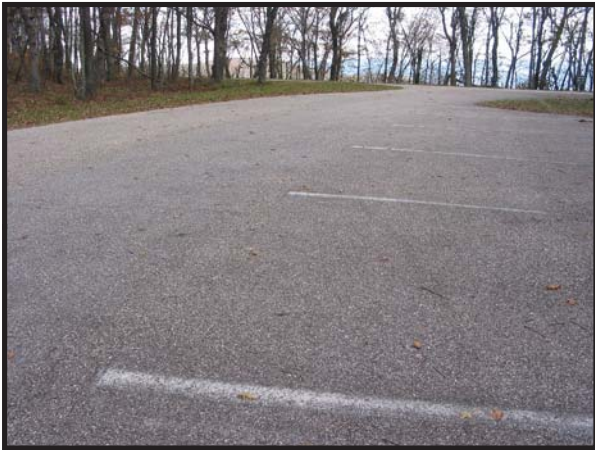
Route 0948

Route	Public / NonPublic	Date Visited	Area (sq ft)	Lane Miles *	Surface Type	Condition / PCR
0948	Public	10/22/2003	7522	0.13	AS	GOOD / 90

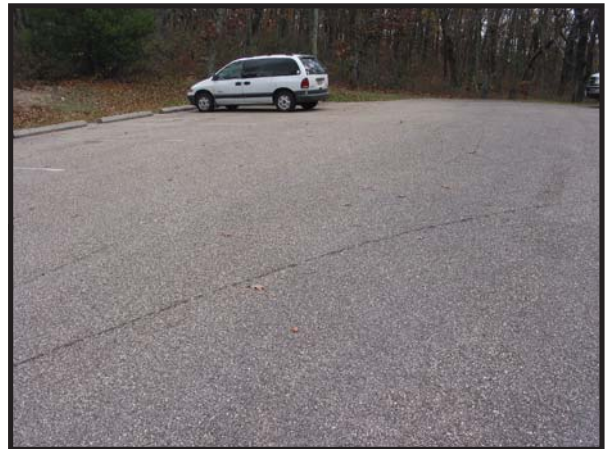
Route 0949

Route	Public / NonPublic	Date Visited	Area (sq ft)	Lane Miles *	Surface Type	Condition / PCR
0949	Public	10/22/2003	6378	0.11	AS	EXCELLENT / 97

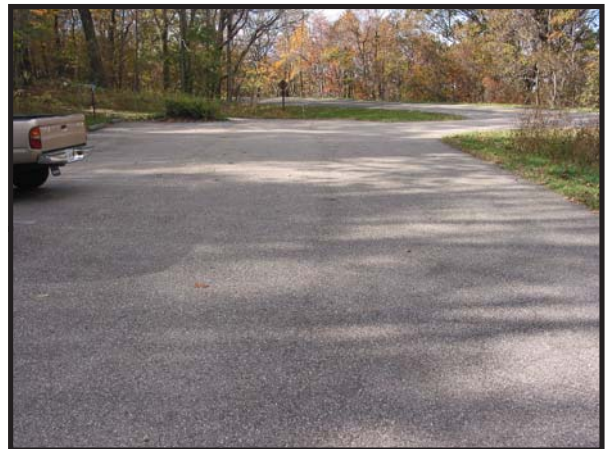
Route 0950

Route	Public / NonPublic	Date Visited	Area (sq ft)	Lane Miles *	Surface Type	Condition / PCR
0950	Public	10/24/2003	18610	0.32	AS	FAIR / 73

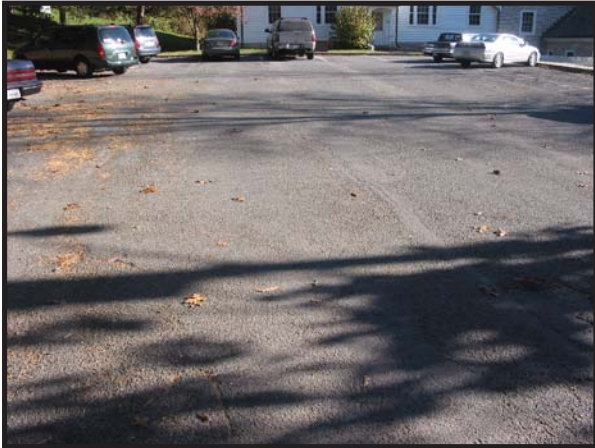
Route 0951

Route	Public / NonPublic	Date Visited	Area (sq ft)	Lane Miles *	Surface Type	Condition / PCR
0951	Public	10/21/2003	2774	0.05	AS	FAIR / 73

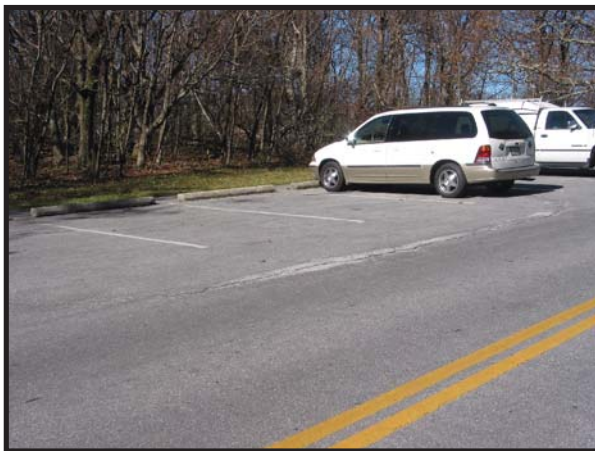
Route 0954A

Route	Public / NonPublic	Date Visited	Area (sq ft)	Lane Miles *	Surface Type	Condition / PCR
0954A	Public	10/22/2003	460	0.01	AS	EXCELLENT / 97

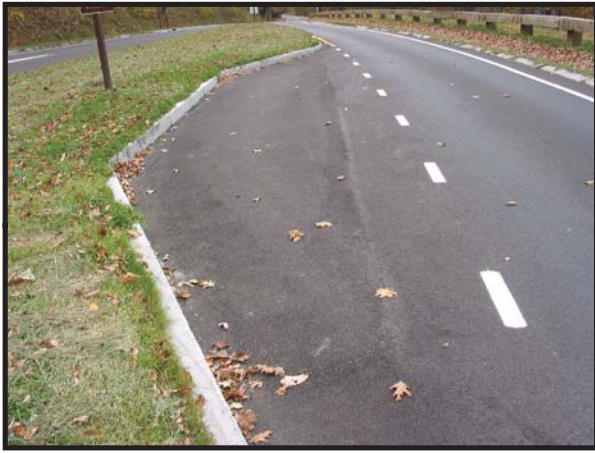
Route 0954B

Route	Public / NonPublic	Date Visited	Area (sq ft)	Lane Miles *	Surface Type	Condition / PCR
0954B	Public	10/22/2003	754	0.01	AS	GOOD / 90

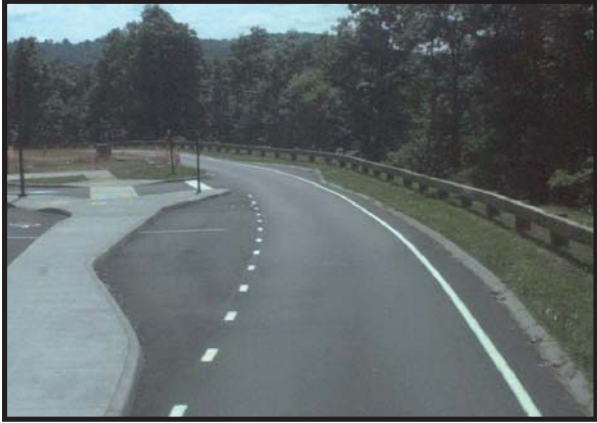
Route 0954C

Route	Public / NonPublic	Date Visited	Area (sq ft)	Lane Miles *	Surface Type	Condition / PCR
0954C	Public	10/22/2003	1373	0.02	AS	EXCELLENT / 97

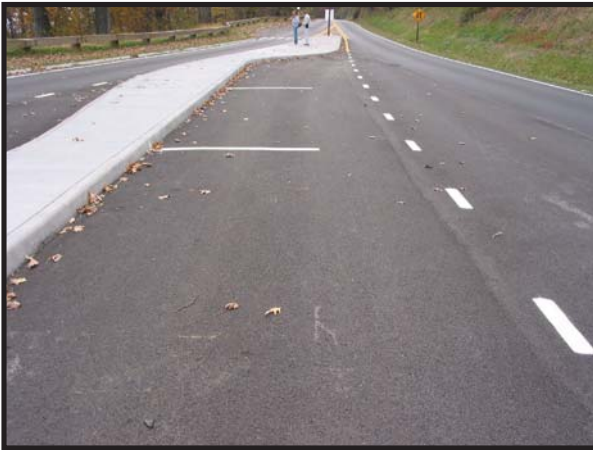
Route 0954D

Route	Public / NonPublic	Date Visited	Area (sq ft)	Lane Miles *	Surface Type	Condition / PCR
0954D	Public	10/22/2003	1023	0.02	AS	GOOD / 90

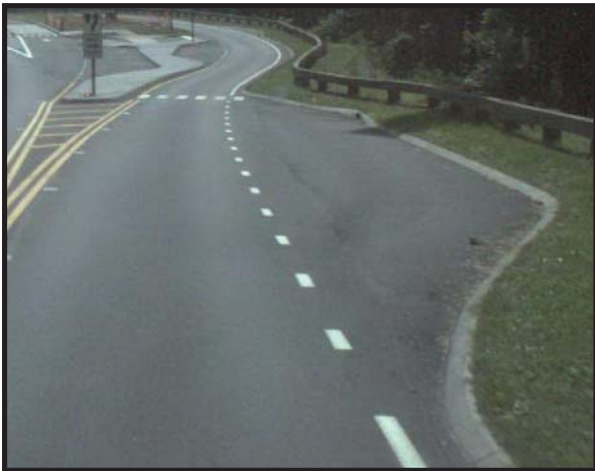
Route 0955

Route	Public / NonPublic	Date Visited	Area (sq ft)	Lane Miles *	Surface Type	Condition / PCR
0955	Public	10/22/2003	661	0.01	AS	EXCELLENT / 97

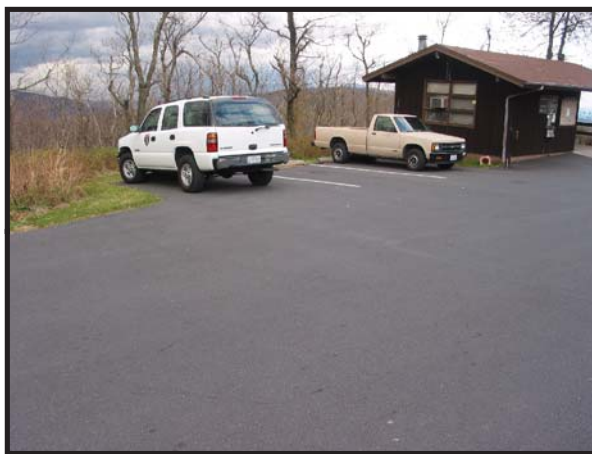
Route 0956

Route	Public / NonPublic	Date Visited	Area (sq ft)	Lane Miles *	Surface Type	Condition / PCR
0956	Public	10/22/2003	8599	0.15	AS	FAIR / 73

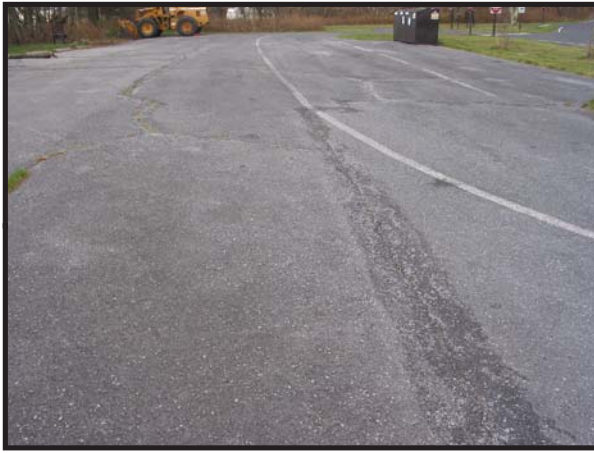
Route 0957A

Route	Public / NonPublic	Date Visited	Area (sq ft)	Lane Miles *	Surface Type	Condition / PCR
0957A	Public	10/22/2003	2918	0.05	AS	GOOD / 90

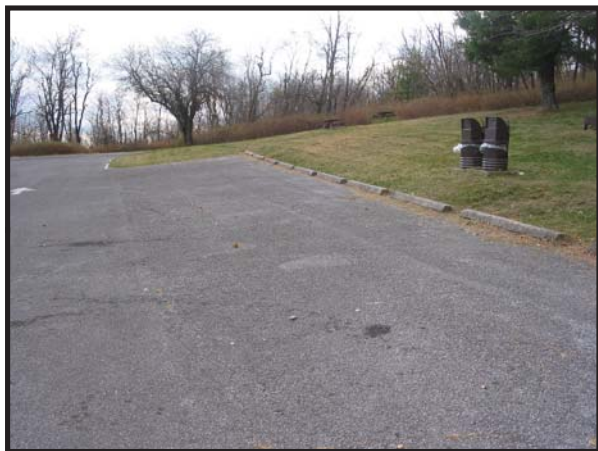
Route 0957B

Route	Public / NonPublic	Date Visited	Area (sq ft)	Lane Miles *	Surface Type	Condition / PCR
0957B	Public	10/22/2003	1962	0.03	AS	FAIR / 73

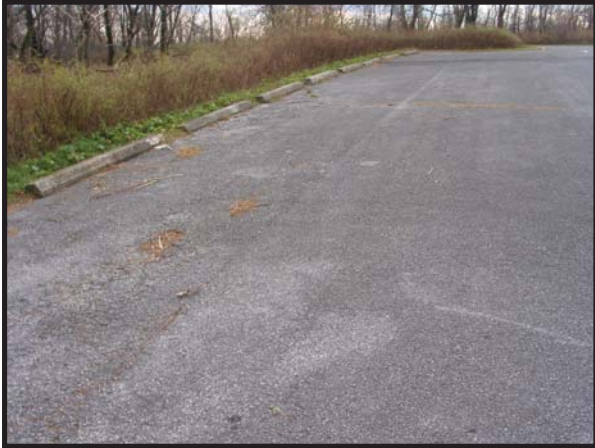
Route 0957C

Route	Public / NonPublic	Date Visited	Area (sq ft)	Lane Miles *	Surface Type	Condition / PCR
0957C	Public	10/22/2003	1914	0.03	AS	FAIR / 73

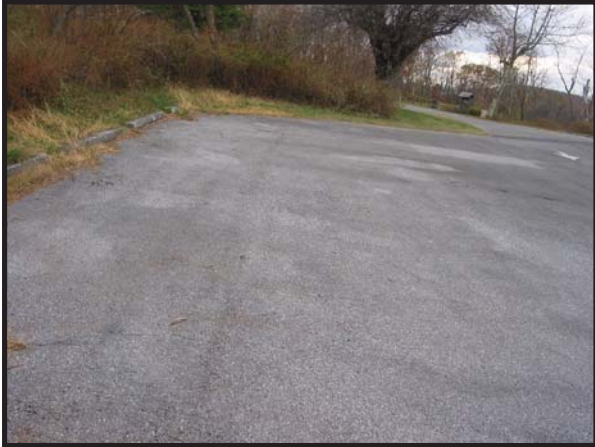
Route 0957D

Route	Public / NonPublic	Date Visited	Area (sq ft)	Lane Miles *	Surface Type	Condition / PCR
0957D	Public	10/22/2003	1567	0.03	AS	FAIR / 73

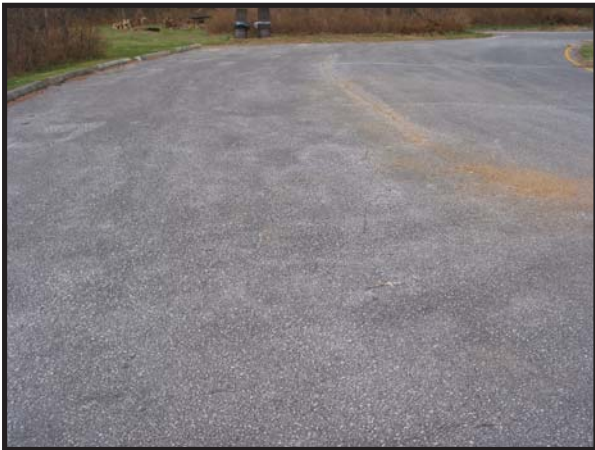
Route 0957E

Route	Public / NonPublic	Date Visited	Area (sq ft)	Lane Miles *	Surface Type	Condition / PCR
0957E	Public	10/22/2003	4207	0.07	AS	GOOD / 90

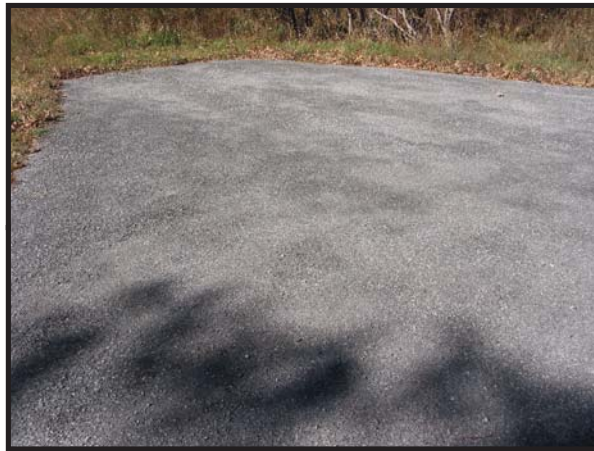
Route 0973A

Route	Public / NonPublic	Date Visited	Area (sq ft)	Lane Miles *	Surface Type	Condition / PCR
0973A	Public	10/24/2003	11902	0.20	AS	GOOD / 90

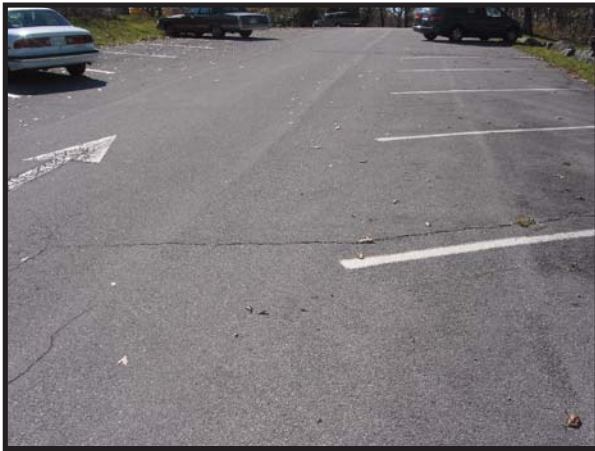
Route 0973B

Route	Public / NonPublic	Date Visited	Area (sq ft)	Lane Miles *	Surface Type	Condition / PCR
0973B	Public	10/24/2003	20211	0.35	AS	GOOD / 90

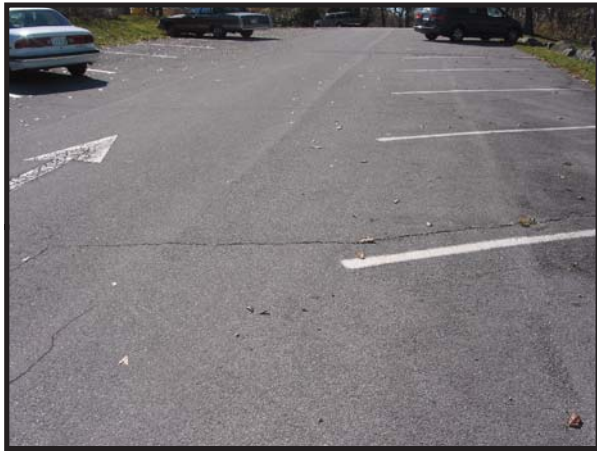
Route 0973C

Route	Public / NonPublic	Date Visited	Area (sq ft)	Lane Miles *	Surface Type	Condition / PCR
0973C	Public	10/24/2003	10257	0.18	AS	GOOD / 90

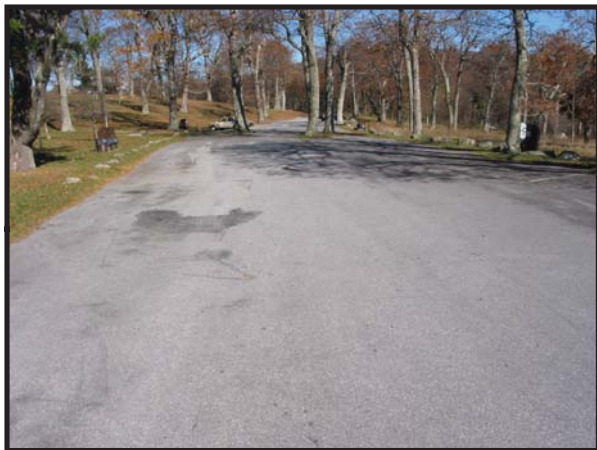
Route 0973D

Route	Public / NonPublic	Date Visited	Area (sq ft)	Lane Miles *	Surface Type	Condition / PCR
0973D	Public	10/24/2003	10257	0.18	AS	GOOD / 90

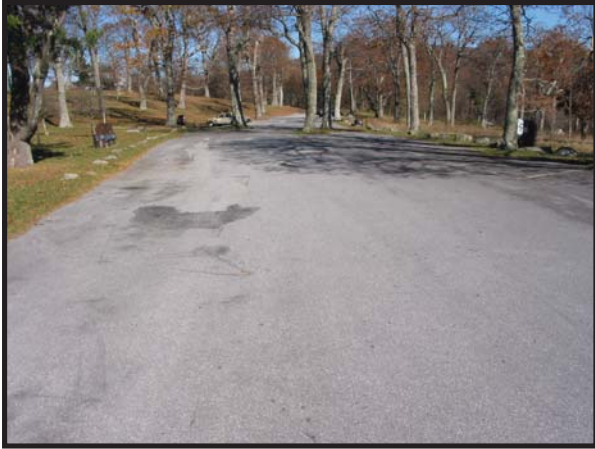
Route 0974

Route	Public / NonPublic	Date Visited	Area (sq ft)	Lane Miles *	Surface Type	Condition / PCR
0974	Public	10/24/2003	47140	0.81	AS	GOOD / 90

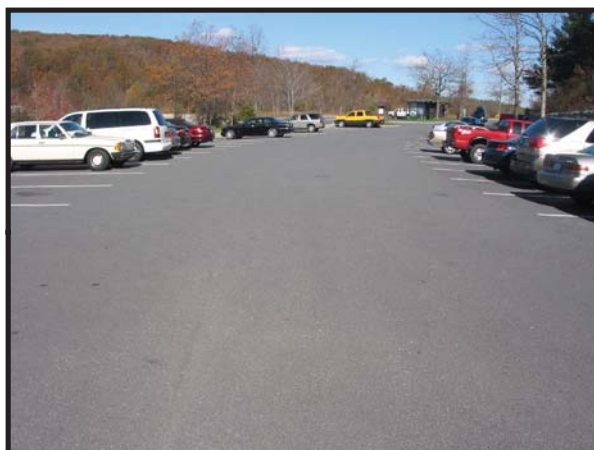
Route 0975

Route	Public / NonPublic	Date Visited	Area (sq ft)	Lane Miles *	Surface Type	Condition / PCR
0975	Public	10/24/2003	42181	0.73	AS	GOOD / 90

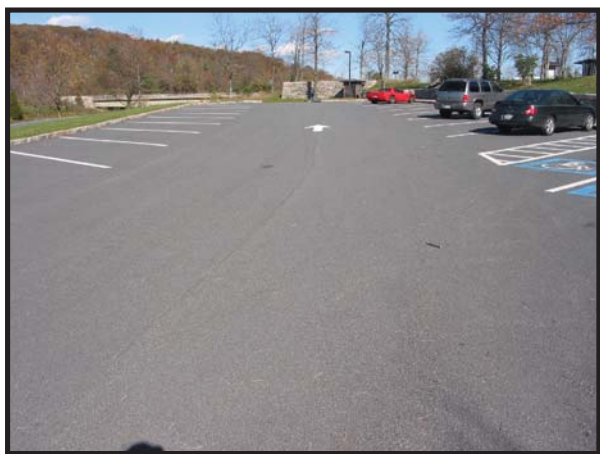
Route 0976

Route	Public / NonPublic	Date Visited	Area (sq ft)	Lane Miles *	Surface Type	Condition / PCR
0976	Public	10/24/2003	1544	0.03	AS	FAIR / 73

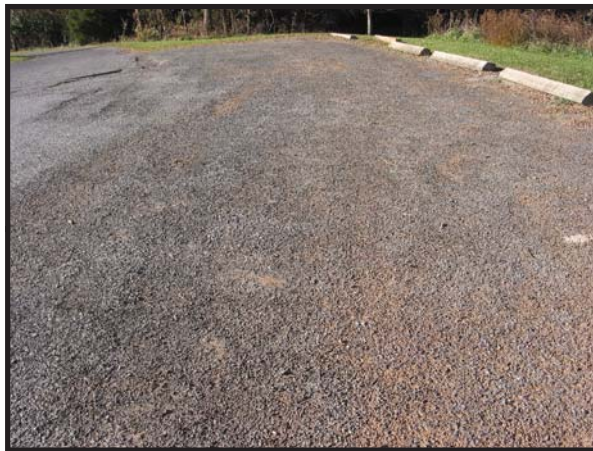
Route 0978A

Route	Public / NonPublic	Date Visited	Area (sq ft)	Lane Miles *	Surface Type	Condition / PCR
0978A	Public	10/24/2003	3892	0.07	AS	GOOD / 90

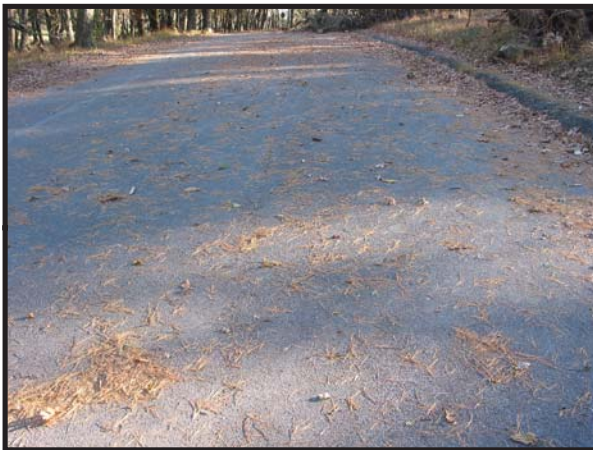
Route 0978B

Route	Public / NonPublic	Date Visited	Area (sq ft)	Lane Miles *	Surface Type	Condition / PCR
0978B	Public	10/24/2003	10555	0.18	AS	GOOD / 90

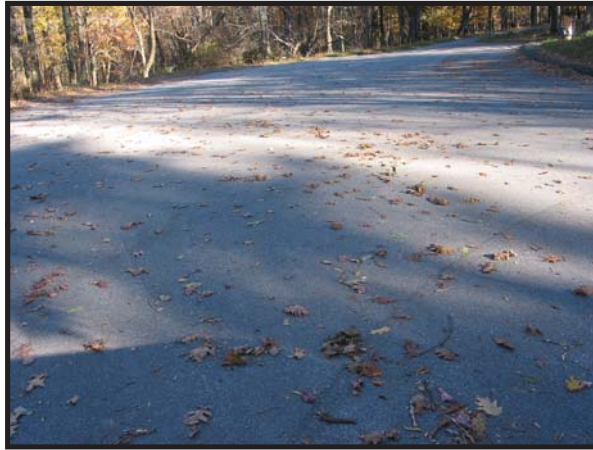
Route 0978C

Route	Public / NonPublic	Date Visited	Area (sq ft)	Lane Miles *	Surface Type	Condition / PCR
0978C	Public	10/24/2003	13418	0.23	AS	FAIR / 73

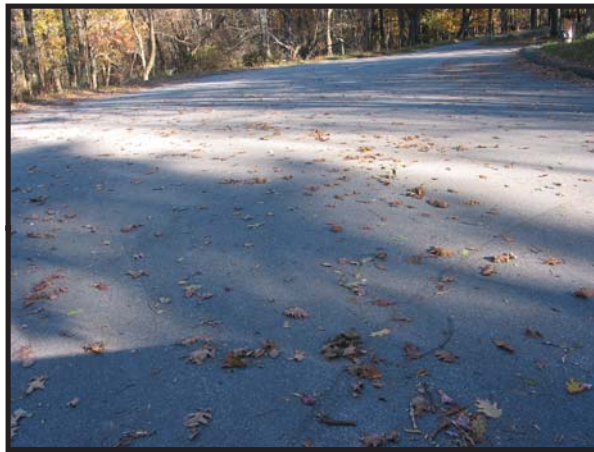
Route 0978D

Route	Public / NonPublic	Date Visited	Area (sq ft)	Lane Miles *	Surface Type	Condition / PCR
0978D	Public	10/24/2003	13418	0.23	AS	FAIR / 73

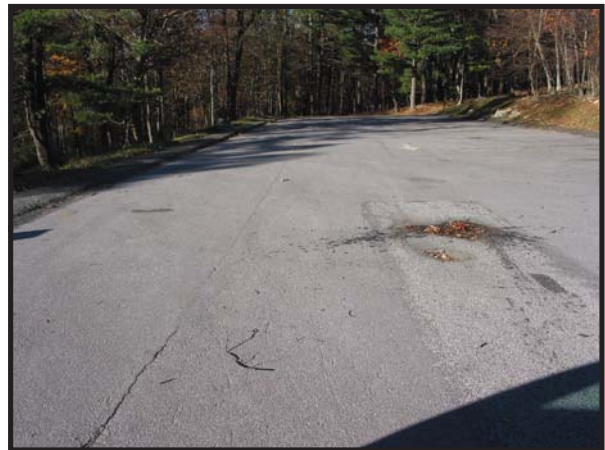
Route 0978E

Route	Public / NonPublic	Date Visited	Area (sq ft)	Lane Miles *	Surface Type	Condition / PCR
0978E	Public	10/24/2003	13418	0.23	AS	FAIR / 73

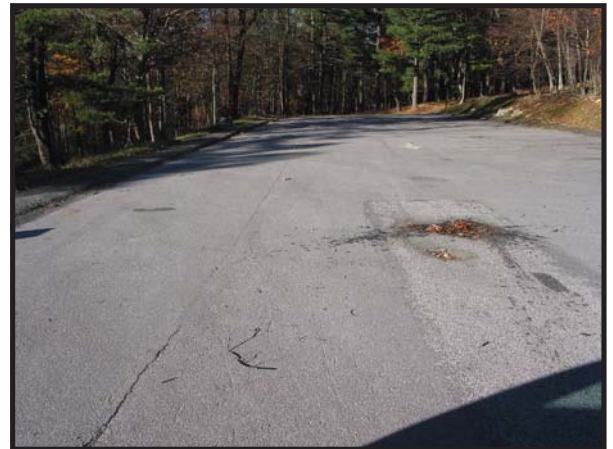
Route 0979A

Route	Public / NonPublic	Date Visited	Area (sq ft)	Lane Miles *	Surface Type	Condition / PCR
0979A	Public	10/24/2003	529	0.01	AS	GOOD / 90

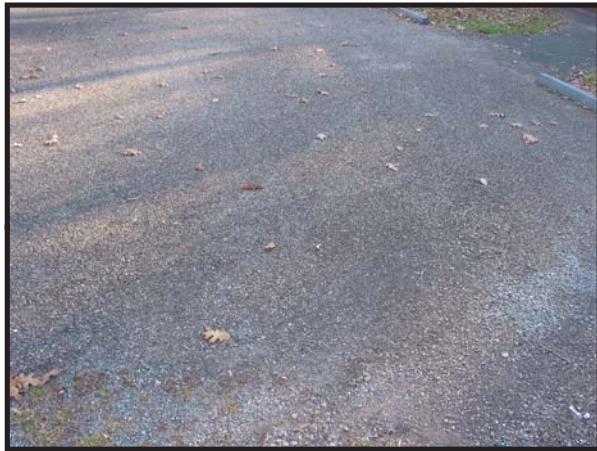
Route 0979B

Route	Public / NonPublic	Date Visited	Area (sq ft)	Lane Miles *	Surface Type	Condition / PCR
0979B	Public	10/24/2003	622	0.01	AS	GOOD / 90

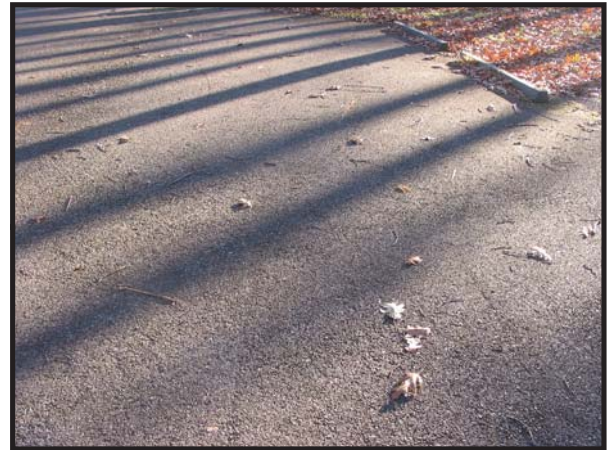
Route 0979C

Route	Public / NonPublic	Date Visited	Area (sq ft)	Lane Miles *	Surface Type	Condition / PCR
0979C	Public	10/24/2003	1247	0.02	AS	GOOD / 90

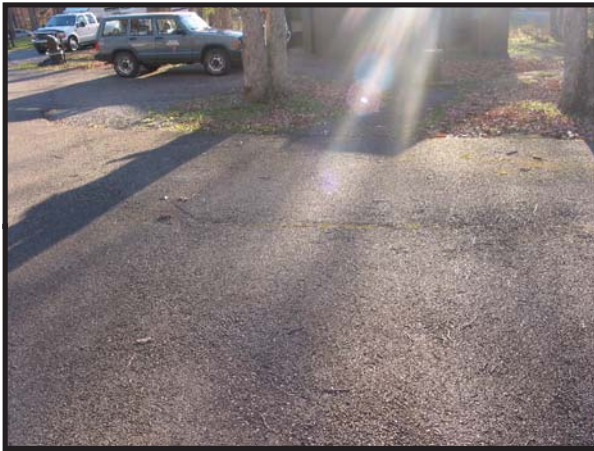
Route 0980A

Route	Public / NonPublic	Date Visited	Area (sq ft)	Lane Miles *	Surface Type	Condition / PCR
0980A	Public	10/30/2003	1261	0.02	AS	POOR / 45
