**The Road Inventory
of
Shenandoah National Park
SHEN – 4840
Volume 1**

Prepared By:
Federal Highway Administration
Eastern Federal Lands Highway Division
Cycle 3

Shenandoah National Park in Virginia

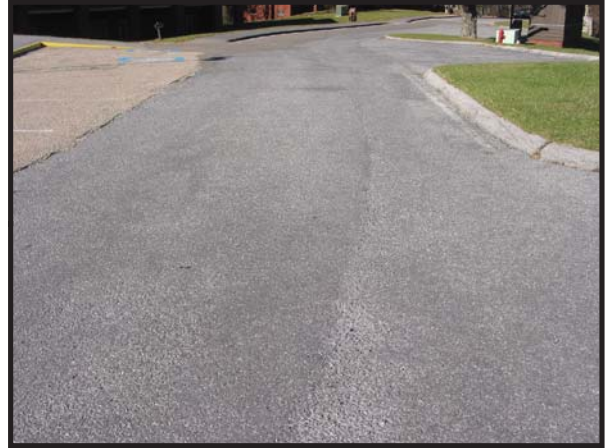
Route 0980E

Route	Public / NonPublic	Date Visited	Area (sq ft)	Lane Miles *	Surface Type	Condition / PCR
0980E	Public	10/30/2003	13797	0.24	AS	GOOD / 90

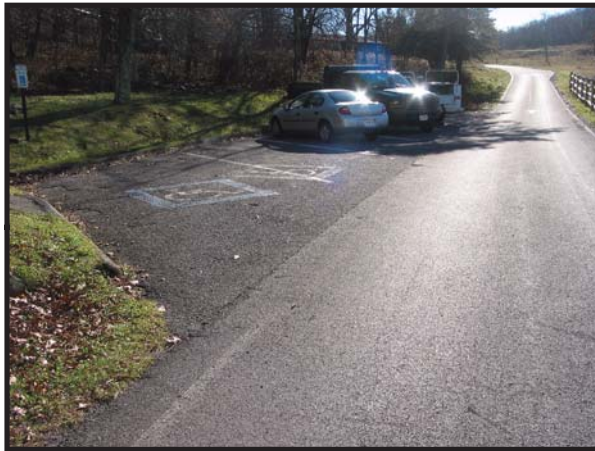
Route 0980H

Route	Public / NonPublic	Date Visited	Area (sq ft)	Lane Miles *	Surface Type	Condition / PCR
0980H	Public	10/30/2003	6825	0.12	AS	GOOD / 90

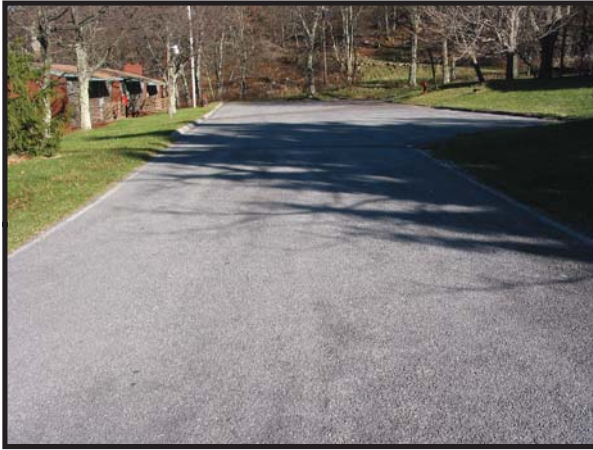
Route 0980I

Route	Public / NonPublic	Date Visited	Area (sq ft)	Lane Miles *	Surface Type	Condition / PCR
0980I	Public	10/30/2003	11170	0.19	AS	FAIR / 73

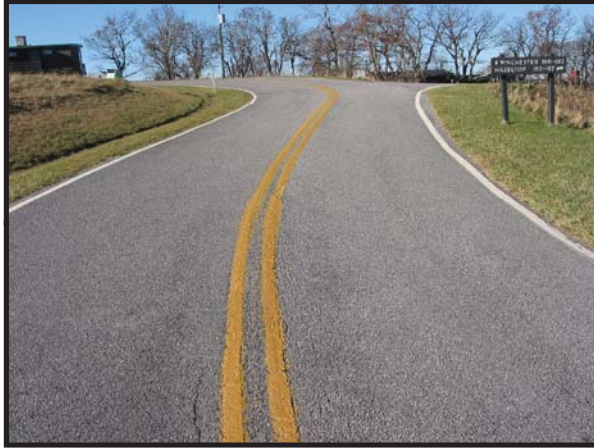
Route 0980J

Route	Public / NonPublic	Date Visited	Area (sq ft)	Lane Miles *	Surface Type	Condition / PCR
0980J	Public	10/30/2003	6725	0.12	AS	GOOD / 90

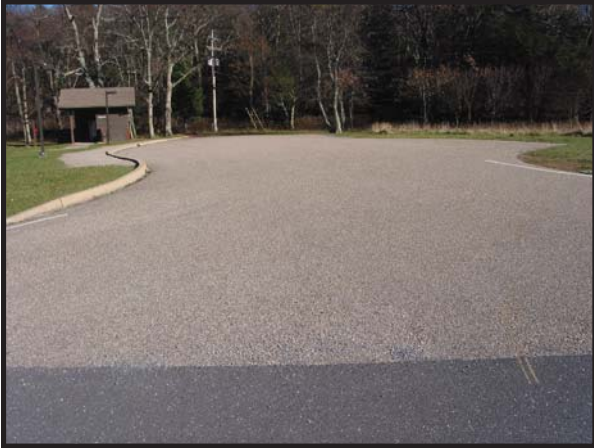
Route 0981A

Route	Public / NonPublic	Date Visited	Area (sq ft)	Lane Miles *	Surface Type	Condition / PCR
0981A	Public	10/30/2003	1144	0.02	AS	FAIR / 73

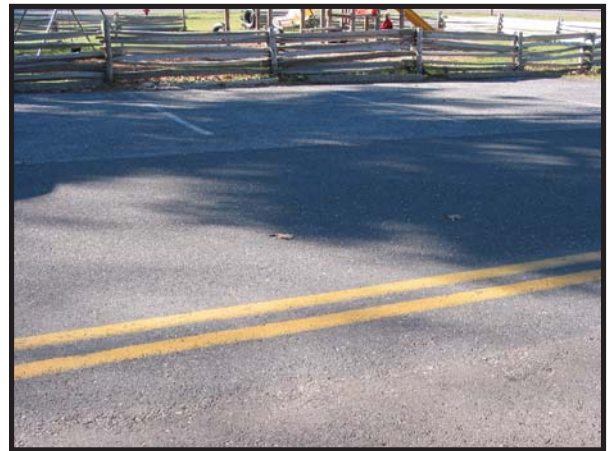
Route 0981B

Route	Public / NonPublic	Date Visited	Area (sq ft)	Lane Miles *	Surface Type	Condition / PCR
0981B	Public	10/30/2003	1991	0.03	AS	GOOD / 90

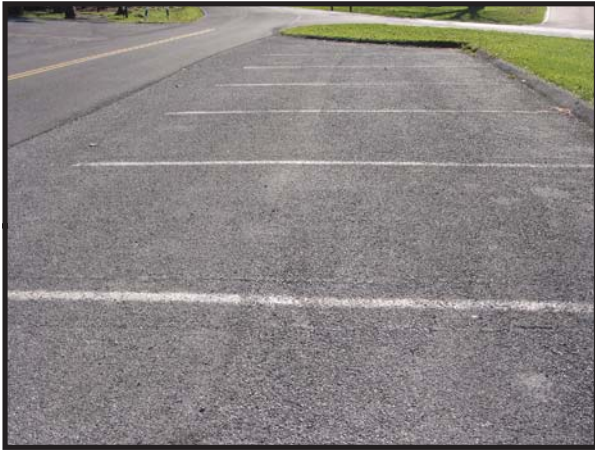
Route 0981D

Route	Public / NonPublic	Date Visited	Area (sq ft)	Lane Miles *	Surface Type	Condition / PCR
0981D	Public	10/30/2003	2970	0.05	AS	GOOD / 90

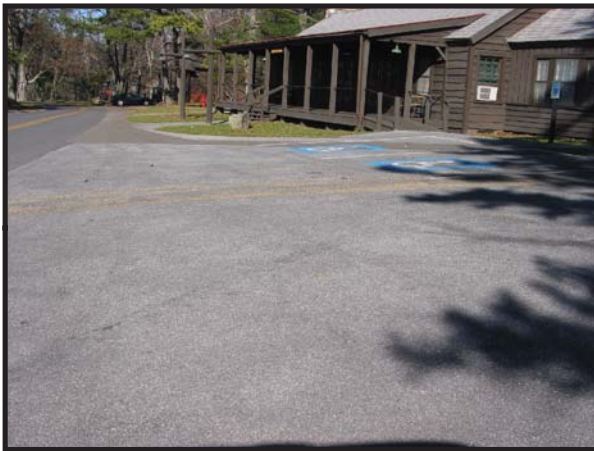
Route 0982A

Route	Public / NonPublic	Date Visited	Area (sq ft)	Lane Miles *	Surface Type	Condition / PCR
0982A	Public	10/30/2003	341	0.01	AS	FAIR / 73

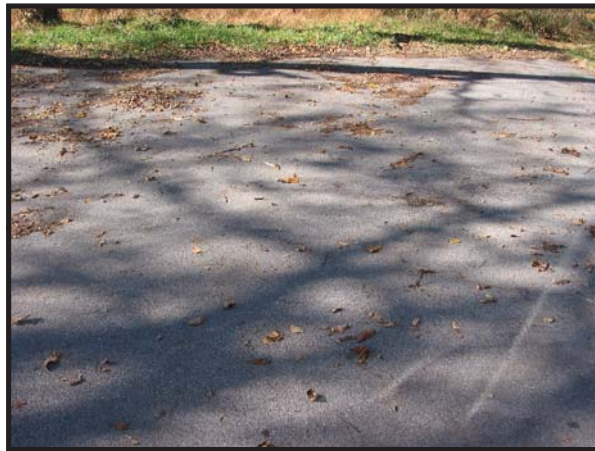
Route 0982C

Route	Public / NonPublic	Date Visited	Area (sq ft)	Lane Miles *	Surface Type	Condition / PCR
0982C	Public	10/30/2003	834	0.01	AS	FAIR / 73

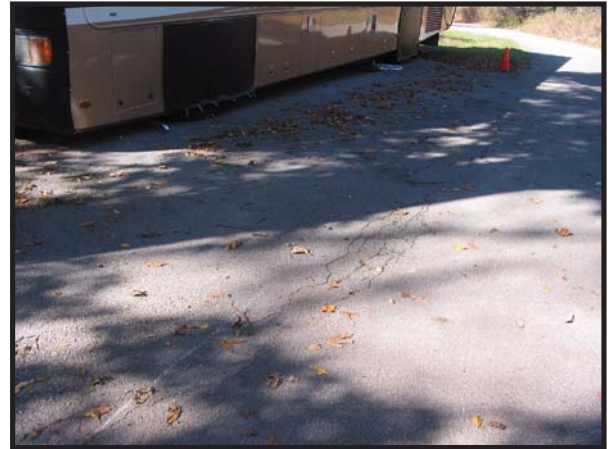
Route 0982D

Route	Public / NonPublic	Date Visited	Area (sq ft)	Lane Miles *	Surface Type	Condition / PCR
0982D	Public	10/30/2003	455	0.01	AS	FAIR / 73

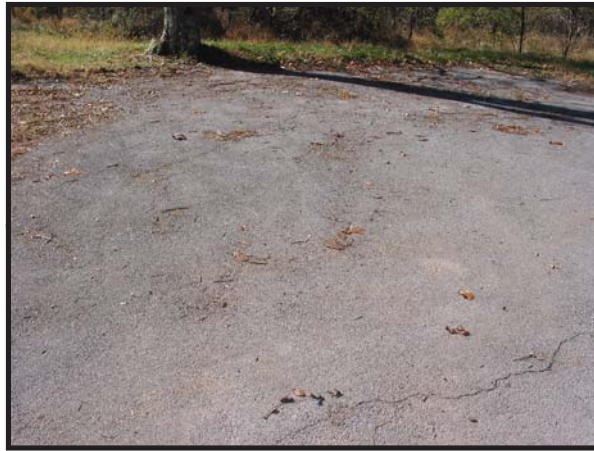
Route 0982E

Route	Public / NonPublic	Date Visited	Area (sq ft)	Lane Miles *	Surface Type	Condition / PCR
0982E	Public	10/30/2003	2575	0.04	AS	FAIR / 73

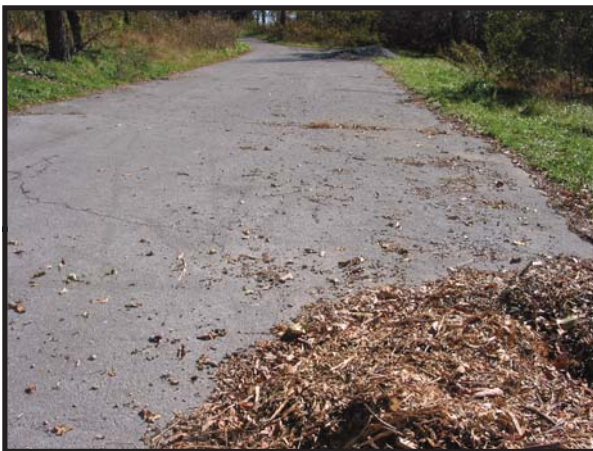
Route 0983A

Route	Public / NonPublic	Date Visited	Area (sq ft)	Lane Miles *	Surface Type	Condition / PCR
0983A	Public	10/30/2003	2505	0.04	AS	GOOD / 90

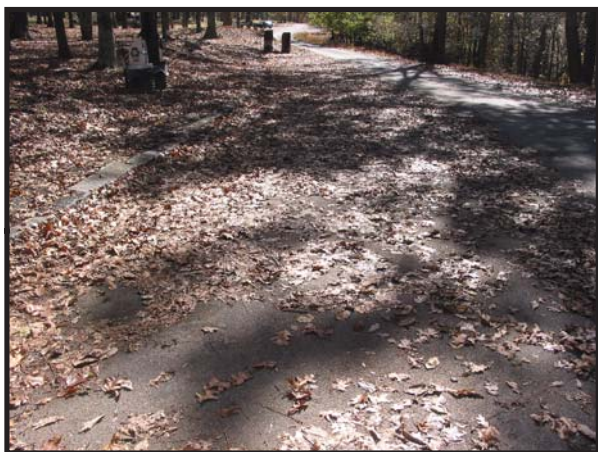
Route 0983B

Route	Public / NonPublic	Date Visited	Area (sq ft)	Lane Miles *	Surface Type	Condition / PCR
0983B	Public	10/30/2003	13798	0.24	AS	GOOD / 90

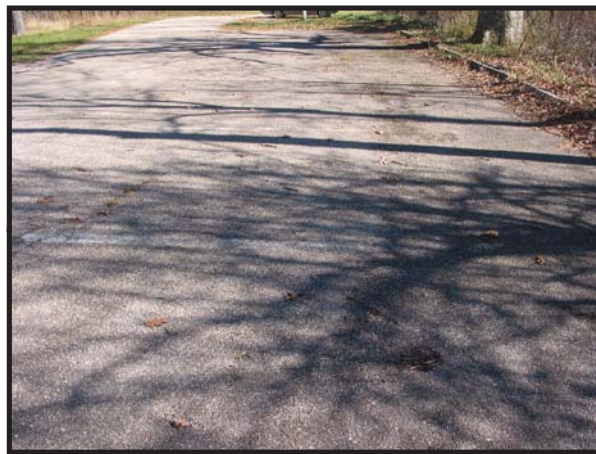
Route 0984B

Route	Public / NonPublic	Date Visited	Area (sq ft)	Lane Miles *	Surface Type	Condition / PCR
0984B	NonPublic	10/30/2003	10848	0.19	AS	FAIR / 73

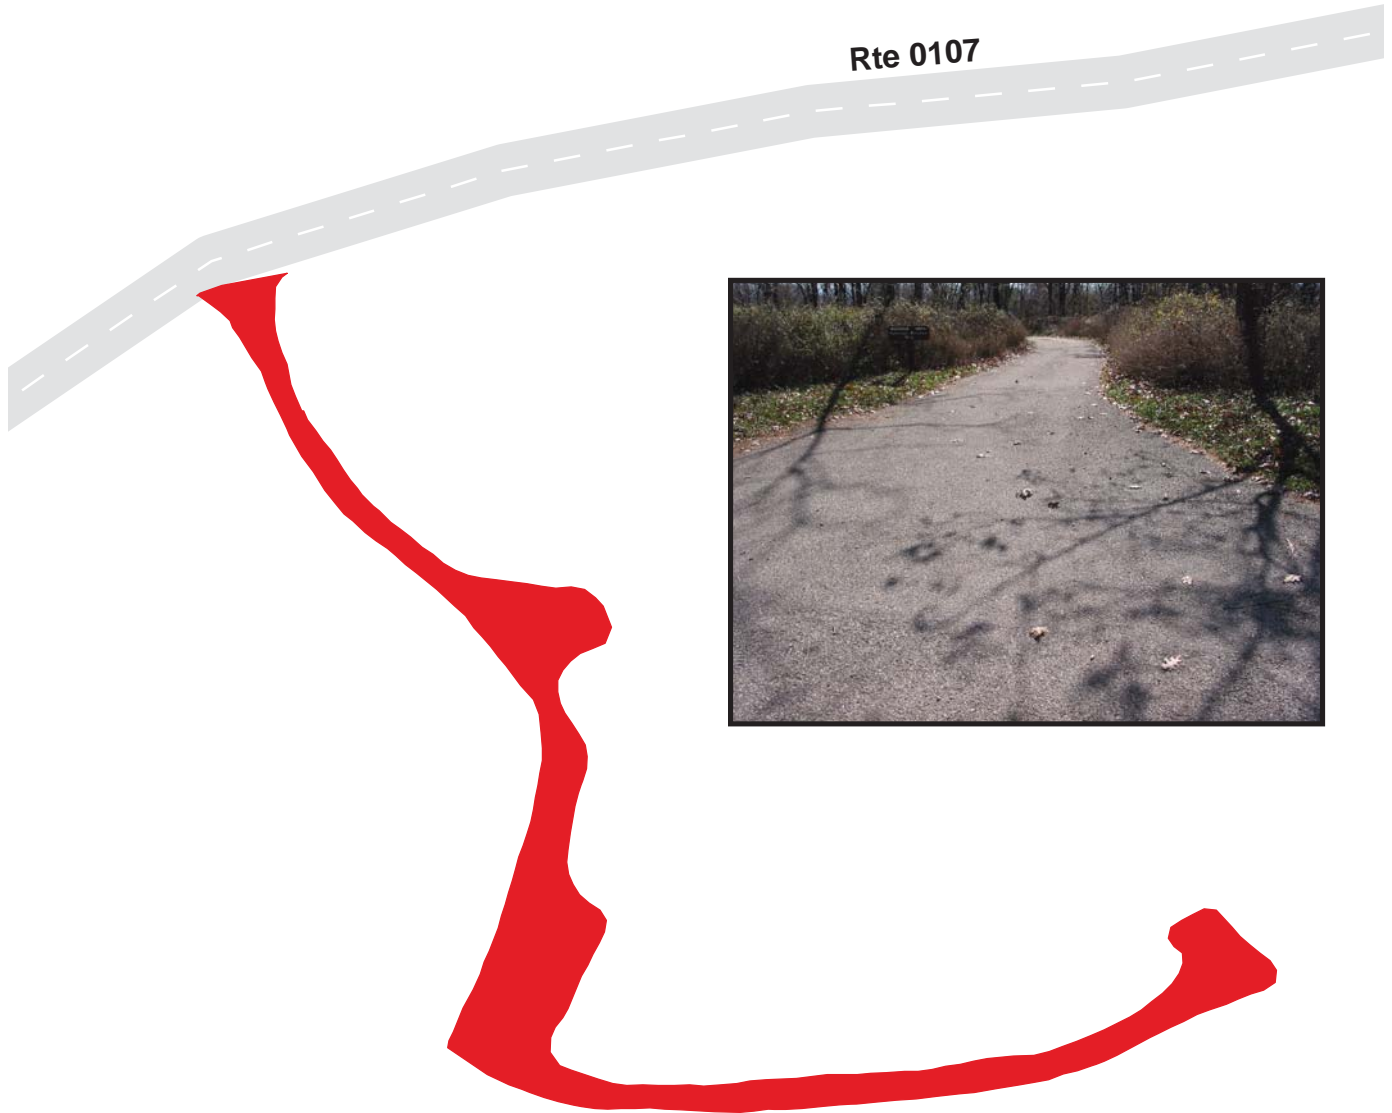
Route 0984C

Route	Public / NonPublic	Date Visited	Area (sq ft)	Lane Miles *	Surface Type	Condition / PCR
0984C	NonPublic	10/30/2003	11383	0.20	AS	FAIR / 73

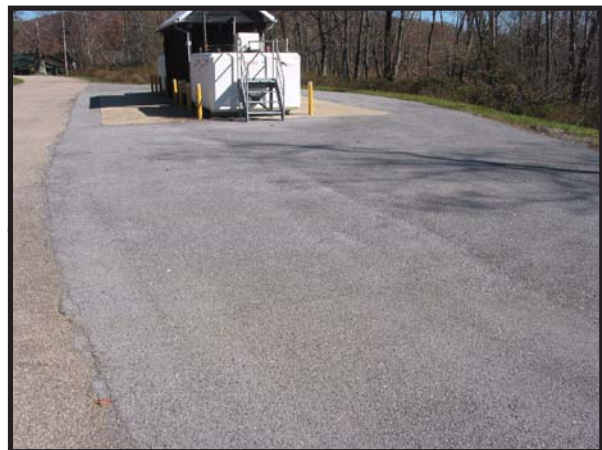
Route 0984E

Route	Public / NonPublic	Date Visited	Area (sq ft)	Lane Miles *	Surface Type	Condition / PCR
0984E	NonPublic	10/30/2003	13134	0.23	AS	FAIR / 73

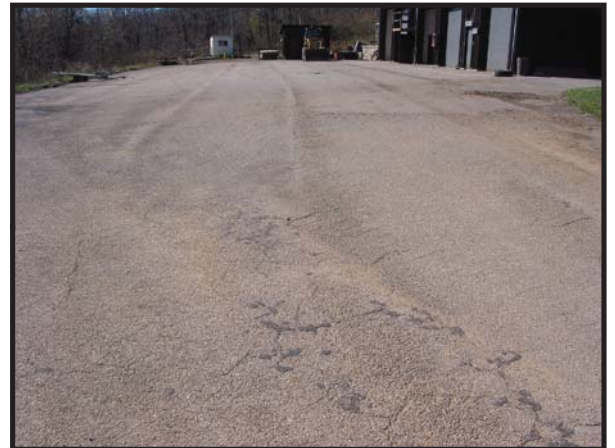
Route 1001

Route	Public / NonPublic	Date Visited	Area (sq ft)	Lane Miles *	Surface Type	Condition / PCR
1001	Public	10/21/2003	11930	0.21	AS	FAIR / 73

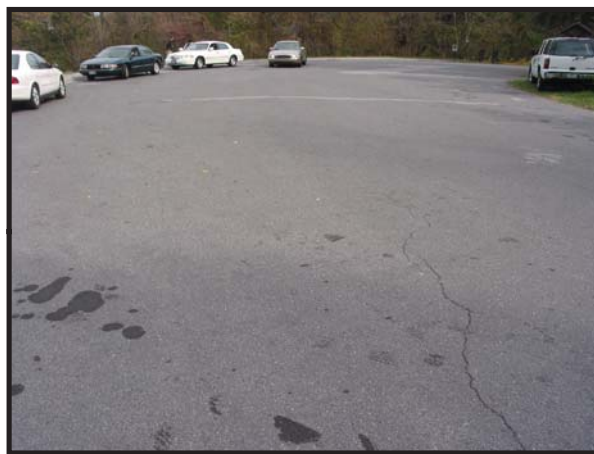
Route 1002

Route	Public / NonPublic	Date Visited	Area (sq ft)	Lane Miles *	Surface Type	Condition / PCR
1002	Public	10/21/2003	52642	0.91	AS	GOOD / 90

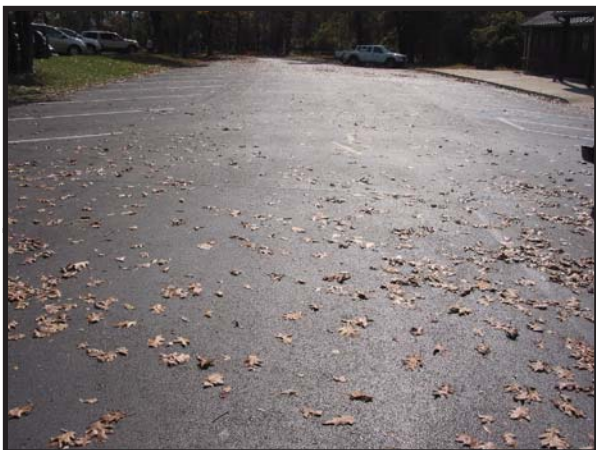
Route 1003

Route	Public / NonPublic	Date Visited	Area (sq ft)	Lane Miles *	Surface Type	Condition / PCR
1003	Public	10/21/2003	8812	0.15	AS	GOOD / 90

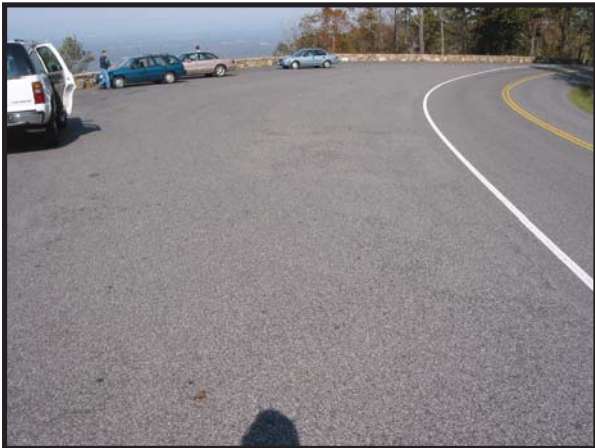
Route 1004

Route	Public / NonPublic	Date Visited	Area (sq ft)	Lane Miles *	Surface Type	Condition / PCR
1004	Public	10/21/2003	10804	0.19	AS	FAIR / 73

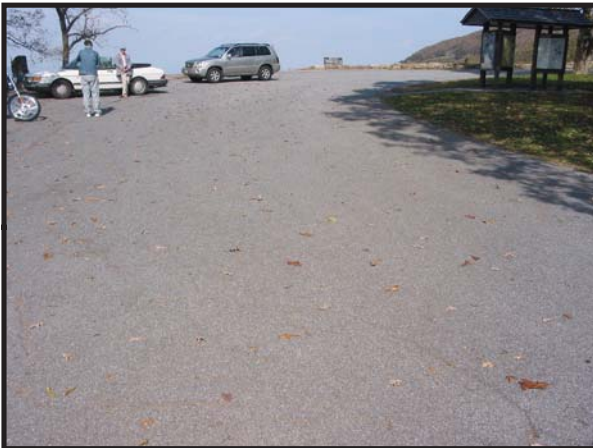
Route 1005

Route	Public / NonPublic	Date Visited	Area (sq ft)	Lane Miles *	Surface Type	Condition / PCR
1005	Public	10/21/2003	14945	0.26	AS	FAIR / 73

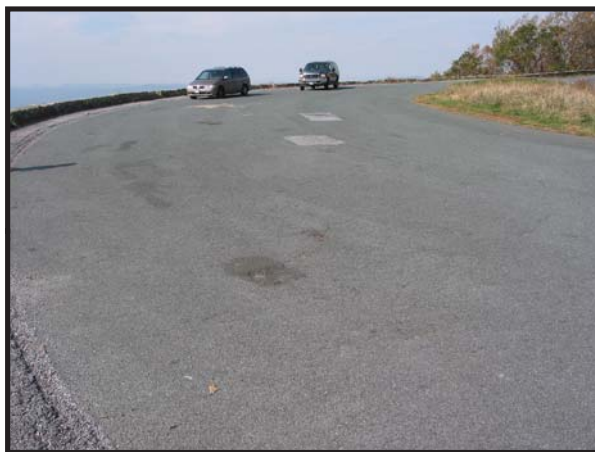
Route 1006

Route	Public / NonPublic	Date Visited	Area (sq ft)	Lane Miles *	Surface Type	Condition / PCR
1006	Public	10/21/2003	4313	0.07	AS	GOOD / 90

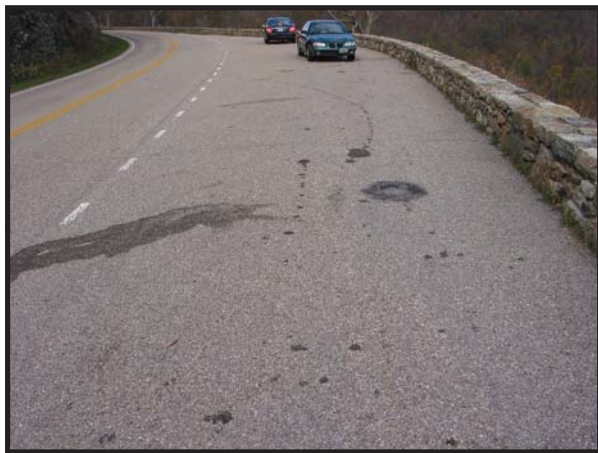
Route 1007

Route	Public / NonPublic	Date Visited	Area (sq ft)	Lane Miles *	Surface Type	Condition / PCR
1007	Public	10/21/2003	5810	0.10	AS	FAIR / 73

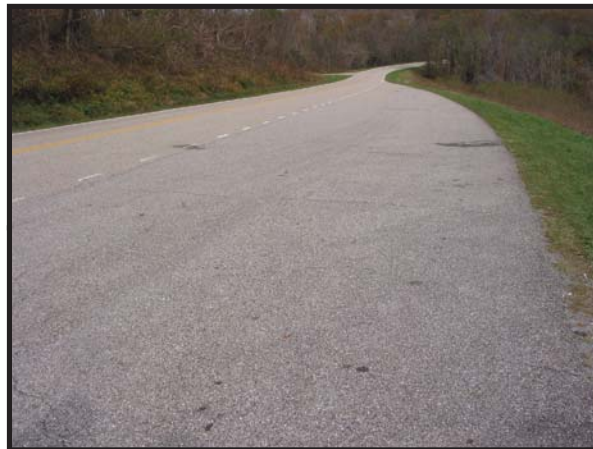
Route 1008

Route	Public / NonPublic	Date Visited	Area (sq ft)	Lane Miles *	Surface Type	Condition / PCR
1008	Public	10/21/2003	12213	0.21	AS	GOOD / 90

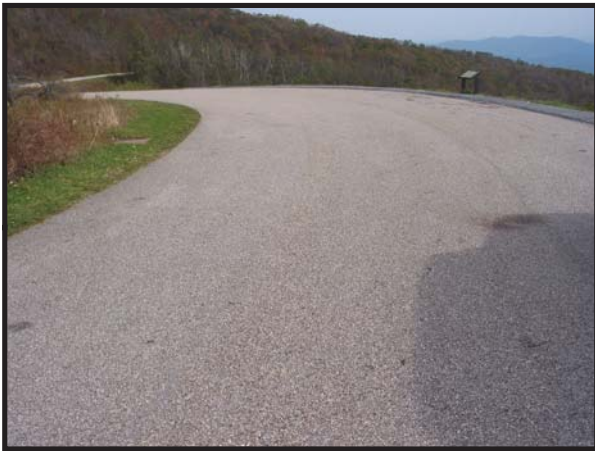
Route 1009

Route	Public / NonPublic	Date Visited	Area (sq ft)	Lane Miles *	Surface Type	Condition / PCR
1009	Public	10/21/2003	8929	0.15	AS	FAIR / 73

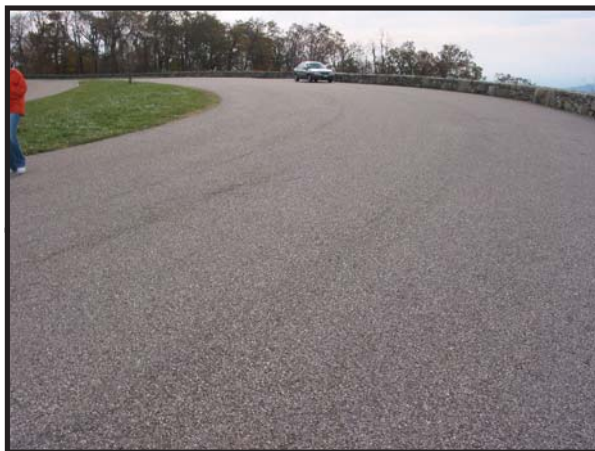
Route 1011

Route	Public / NonPublic	Date Visited	Area (sq ft)	Lane Miles *	Surface Type	Condition / PCR
1011	Public	10/20/2003	11733	0.20	OC	FAIR / 73

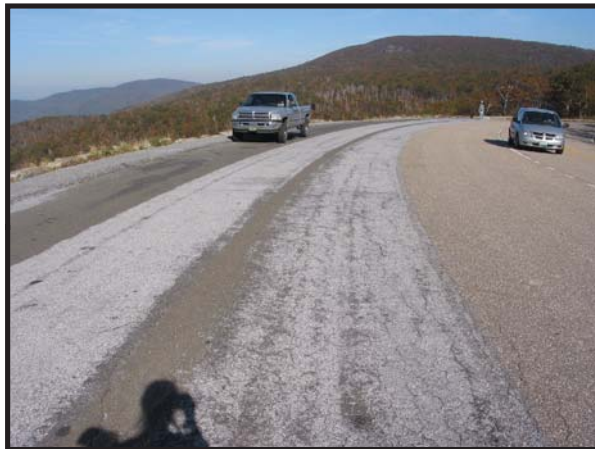
Route 1012

Route	Public / NonPublic	Date Visited	Area (sq ft)	Lane Miles *	Surface Type	Condition / PCR
1012	Public	10/20/2003	4419	0.08	AS	GOOD / 90

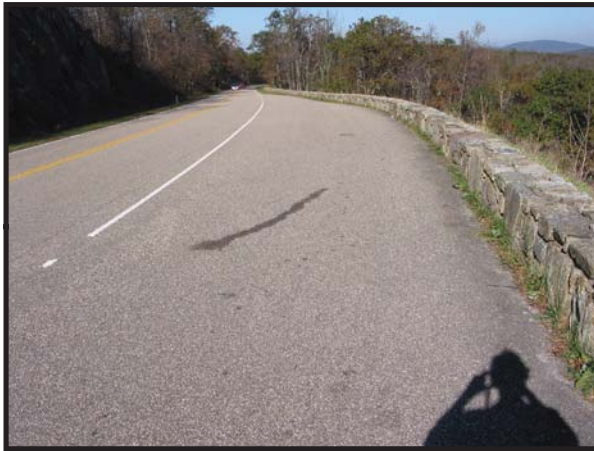
Route 1013

Route	Public / NonPublic	Date Visited	Area (sq ft)	Lane Miles *	Surface Type	Condition / PCR
1013	Public	10/20/2003	12761	0.22	OC	FAIR / 73

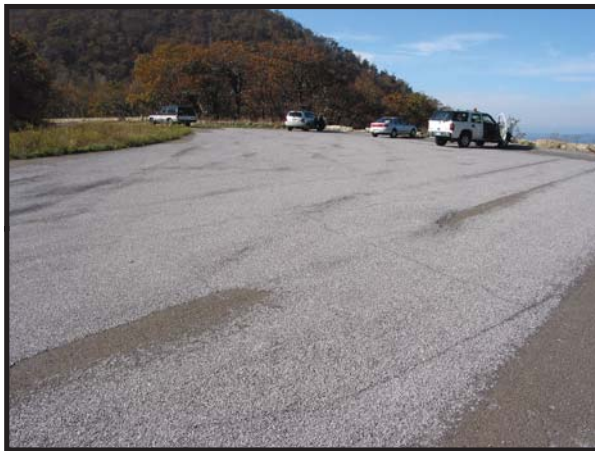
Route 1014

Route	Public / NonPublic	Date Visited	Area (sq ft)	Lane Miles *	Surface Type	Condition / PCR
1014	Public	10/20/2003	8782	0.15	AS	GOOD / 90

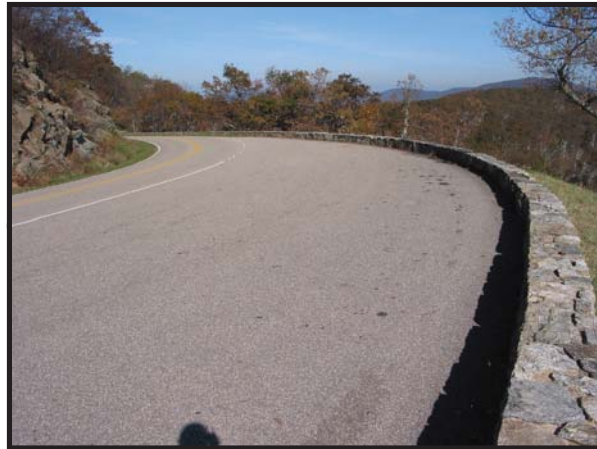
Route 1015

Route	Public / NonPublic	Date Visited	Area (sq ft)	Lane Miles *	Surface Type	Condition / PCR
1015	Public	10/20/2003	18785	0.32	AS	GOOD / 90

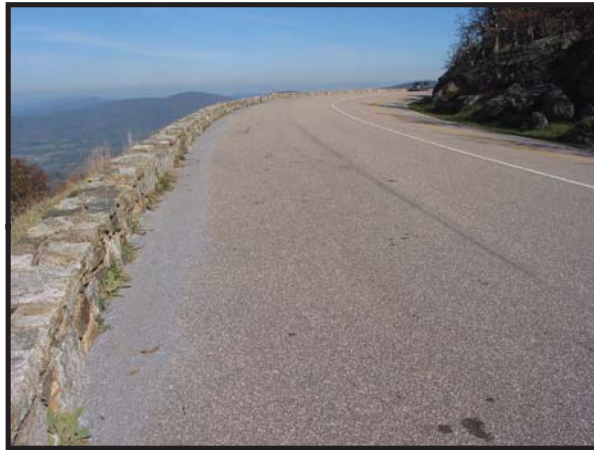
Route 1016

Route	Public / NonPublic	Date Visited	Area (sq ft)	Lane Miles *	Surface Type	Condition / PCR
1016	Public	10/20/2003	5399	0.09	AS	GOOD / 90

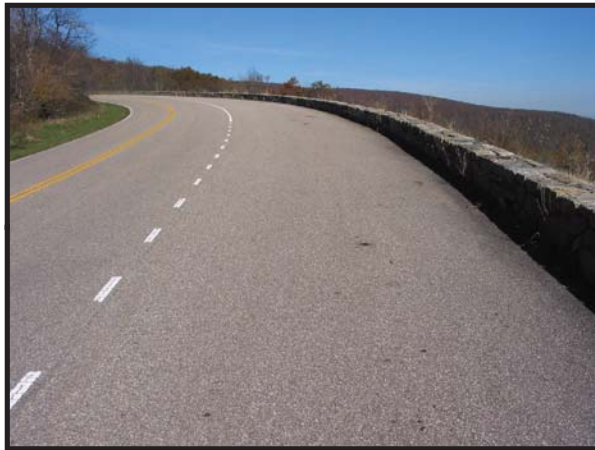
Route 1017

Route	Public / NonPublic	Date Visited	Area (sq ft)	Lane Miles *	Surface Type	Condition / PCR
1017	Public	10/20/2003	9808	0.17	AS	POOR / 45

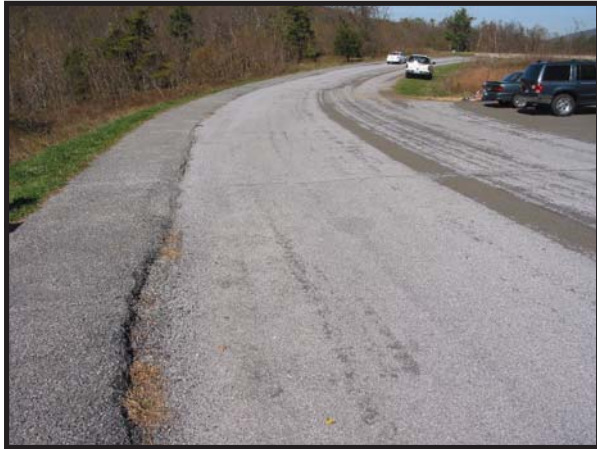
Route 1020

Route	Public / NonPublic	Date Visited	Area (sq ft)	Lane Miles *	Surface Type	Condition / PCR
1020	Public	10/20/2003	12810	0.22	AS	POOR / 45

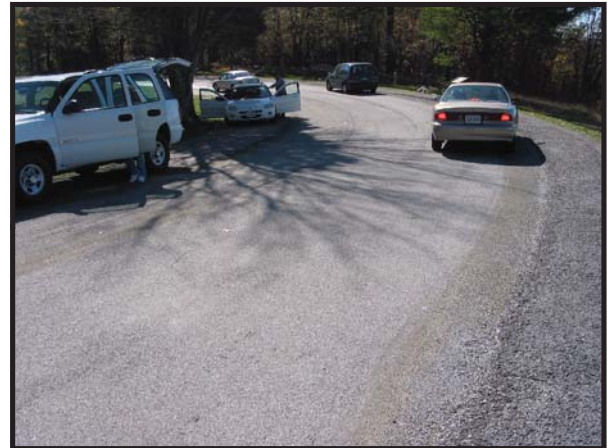
Route 1021

Route	Public / NonPublic	Date Visited	Area (sq ft)	Lane Miles *	Surface Type	Condition / PCR
1021	Public	10/24/2003	17136	0.30	AS	FAIR / 73

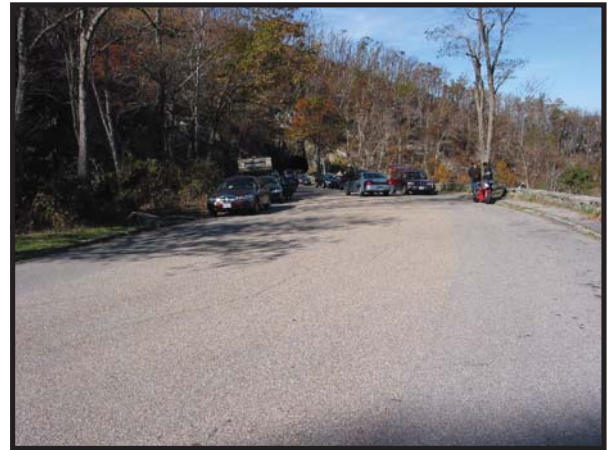
Route 1022

Route	Public / NonPublic	Date Visited	Area (sq ft)	Lane Miles *	Surface Type	Condition / PCR
1022	Public	10/24/2003	6499	0.11	AS	GOOD / 90

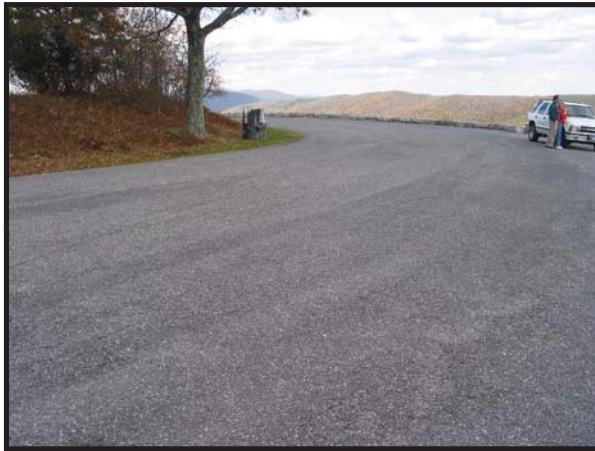
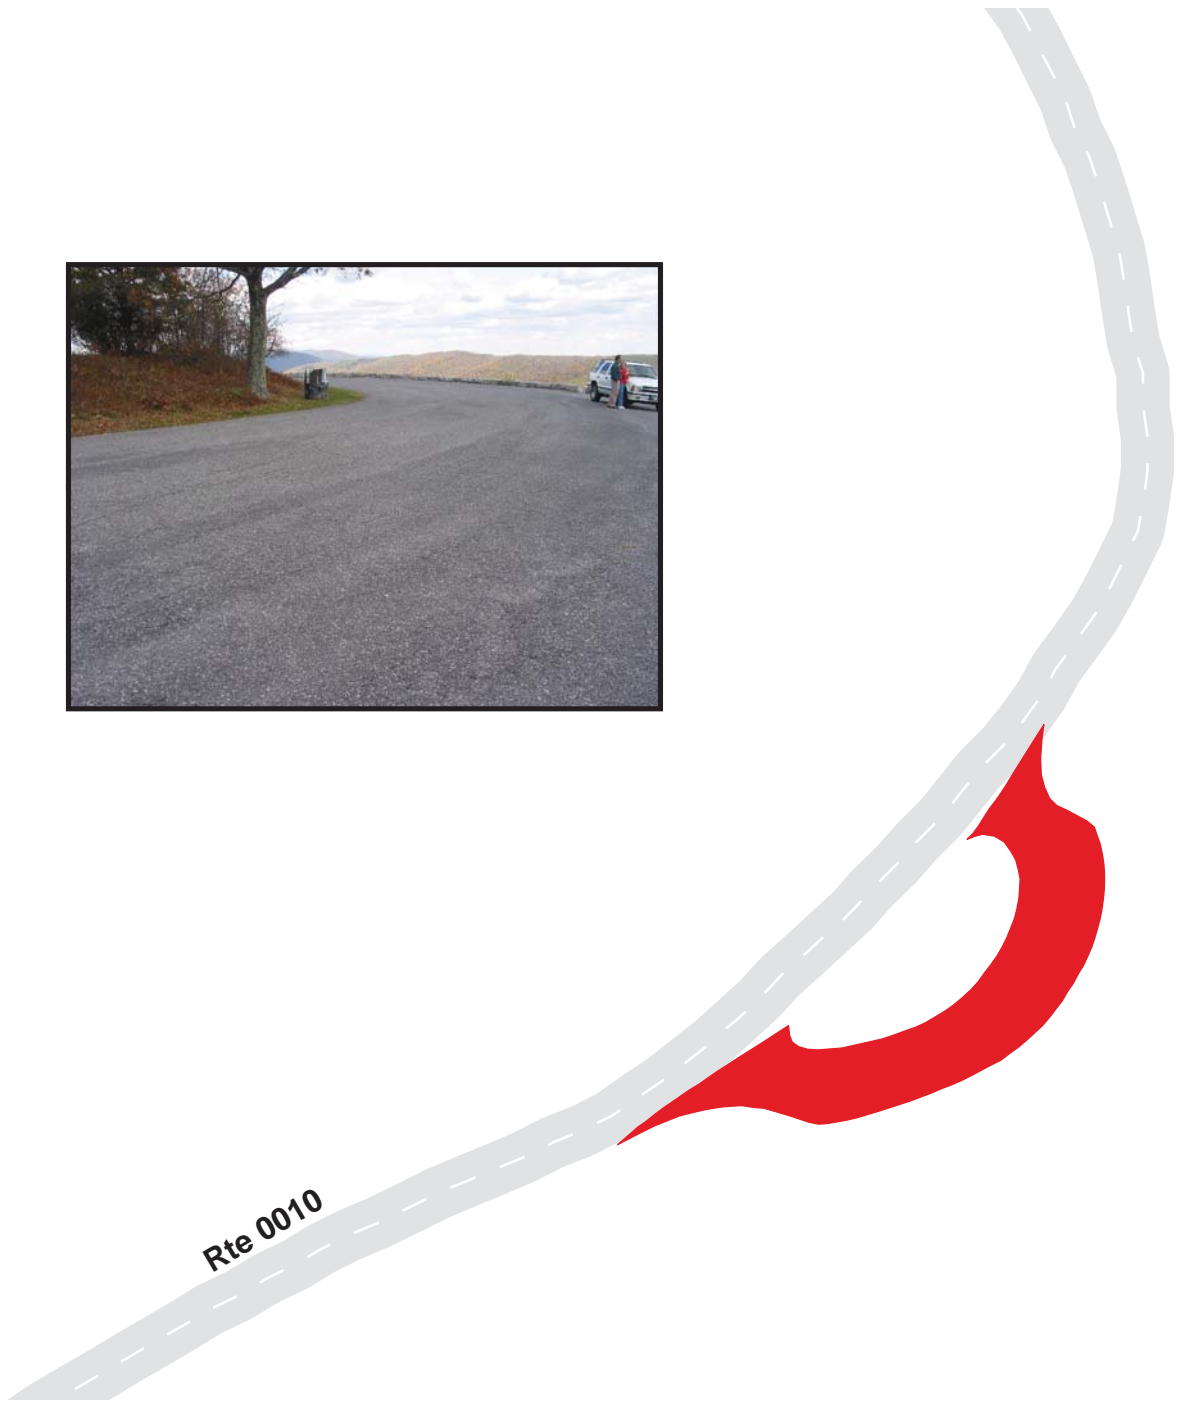
Route 1063

Route	Public / NonPublic	Date Visited	Area (sq ft)	Lane Miles *	Surface Type	Condition / PCR
1063	Public	10/22/2003	4883	0.08	AS	GOOD / 90

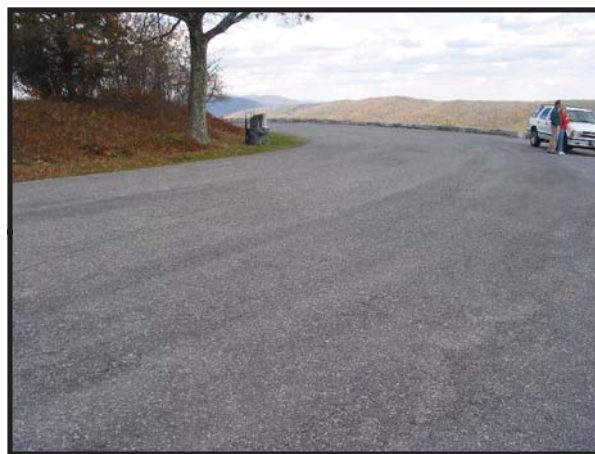
Route 1064

Route	Public / NonPublic	Date Visited	Area (sq ft)	Lane Miles *	Surface Type	Condition / PCR
1064	Public	10/22/2003	15585	0.27	OC	FAIR / 73

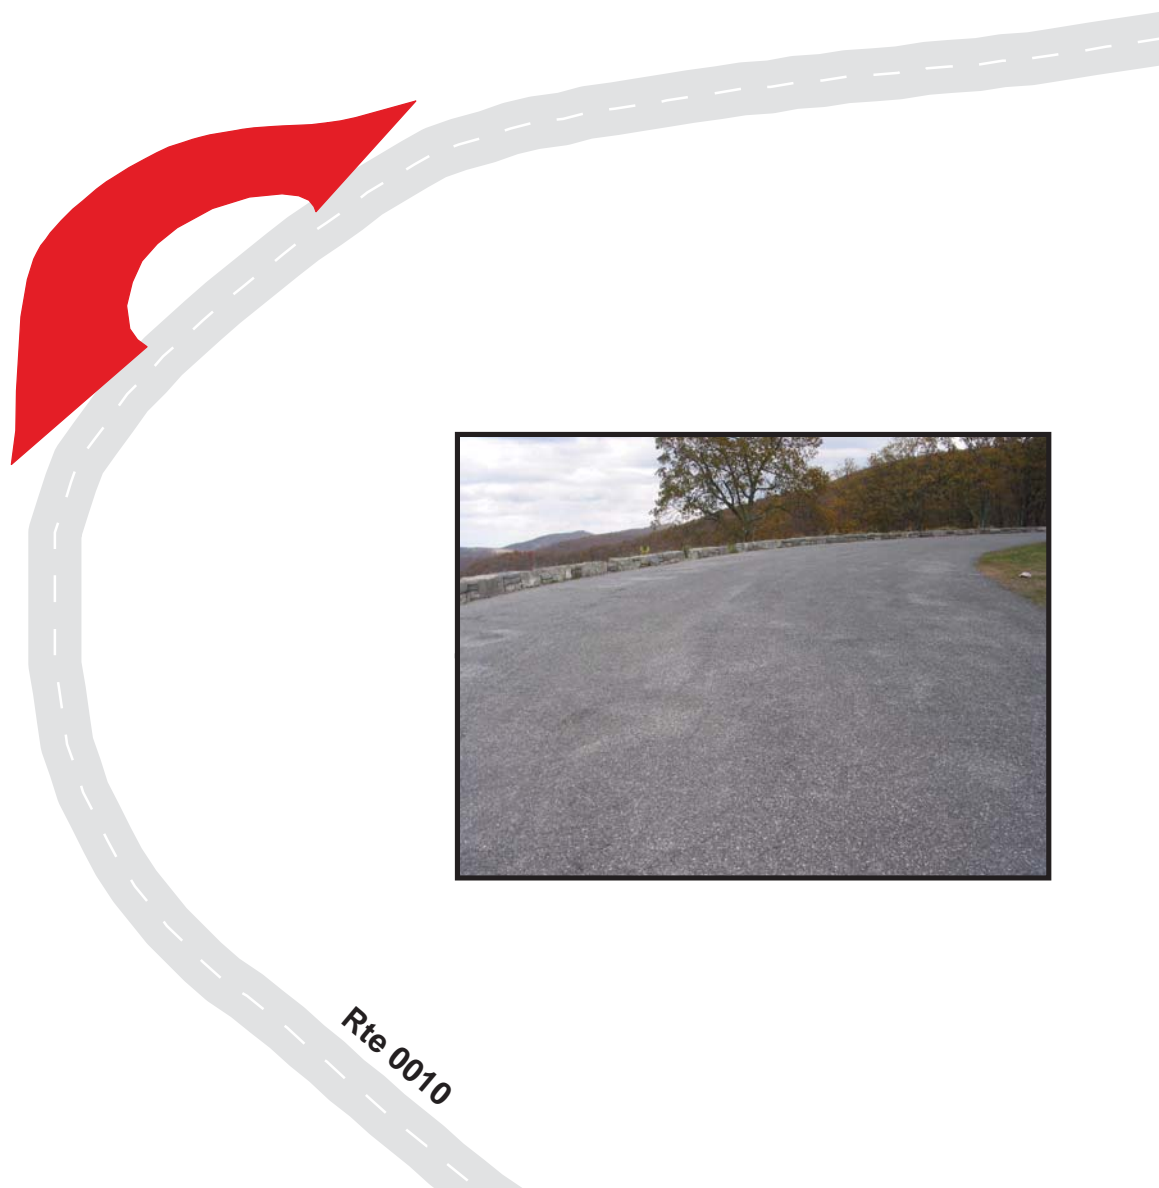
Route 1065

Route	Public / NonPublic	Date Visited	Area (sq ft)	Lane Miles *	Surface Type	Condition / PCR
1065	Public	10/22/2003	12343	0.21	OC	GOOD / 90

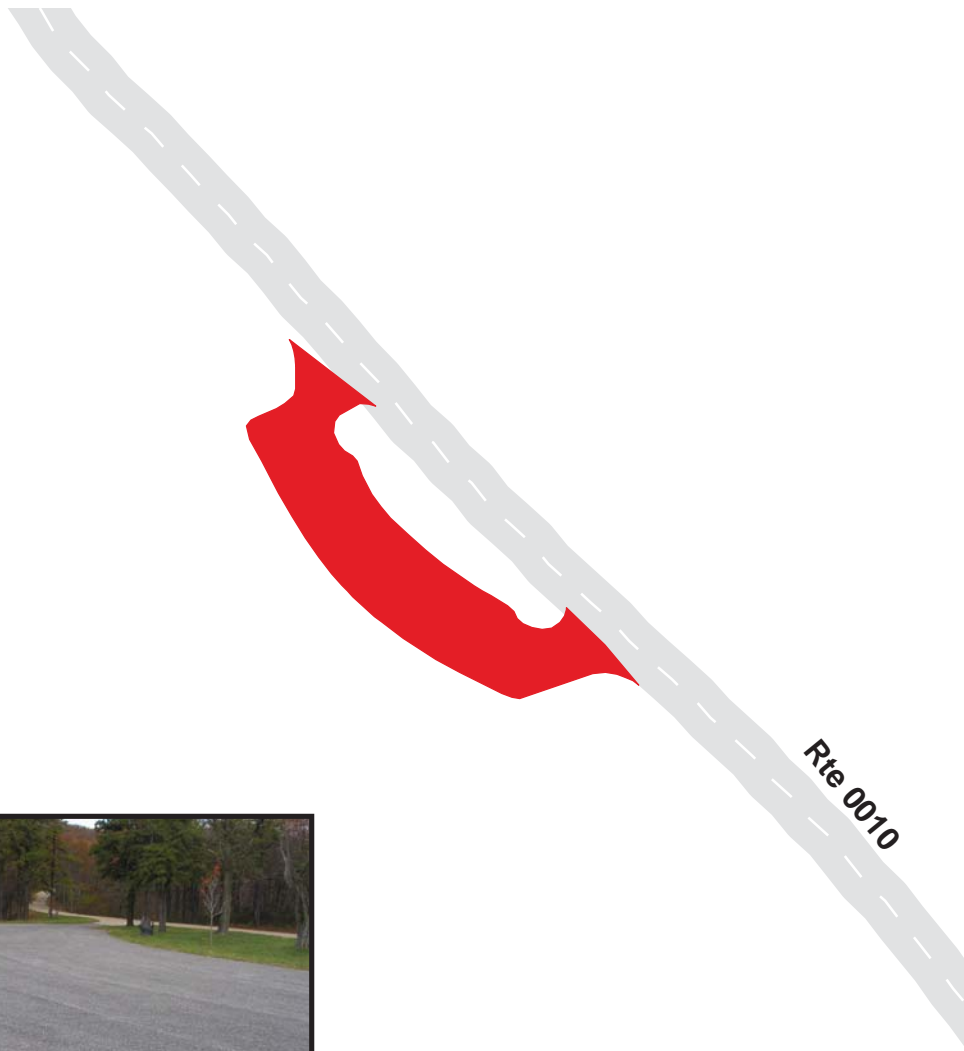
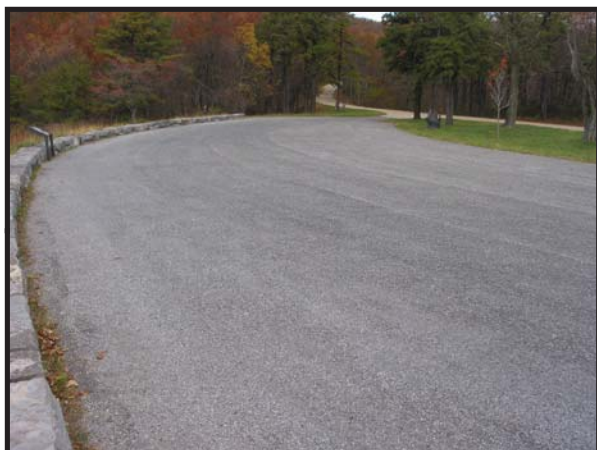
Route 1066

Route	Public / NonPublic	Date Visited	Area (sq ft)	Lane Miles *	Surface Type	Condition / PCR
1066	Public	10/22/2003	7777	0.13	AS	FAIR / 73
