# The Road Inventory of Shiloh National Military Park SHIL - 5580

## Road Inventory Program

Prepared By:  
Federal Highway Administration  
Eastern Federal Lands Highway Division  
Cycle 3

# Shiloh National Military Park in Tennessee

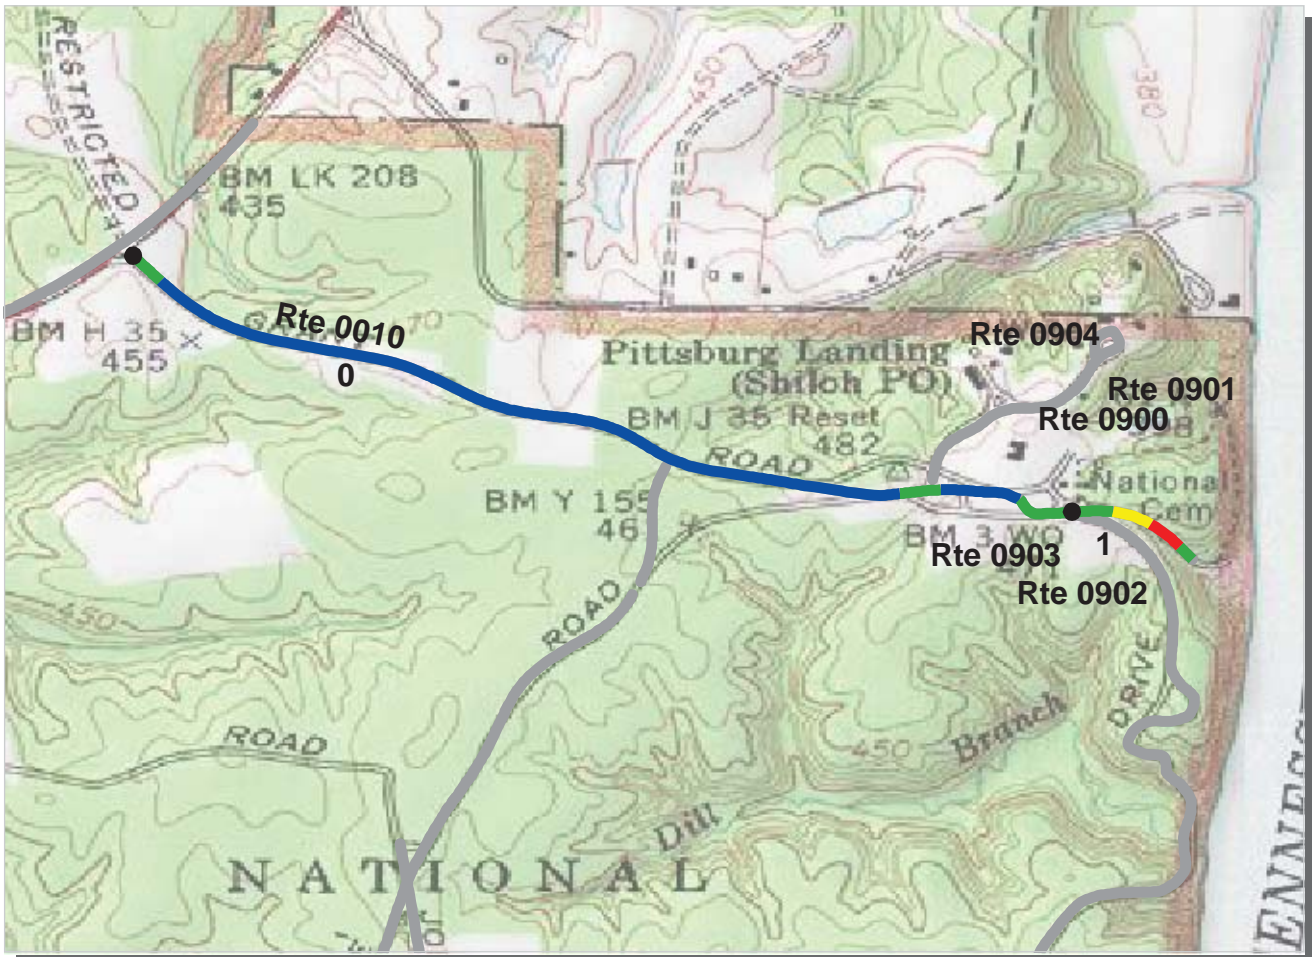
**ROUTE: 0010 PITTSBURG LANDING ROAD** **TOTAL LENGTH: 1.16 Miles**

| Section Number | 0 | 1 | | | |
|---|---|---|--|--|--|
| PCR (Pavement Condition Rating) | 97 | 72 | | | |
| RCI (Roughness Condition Index) | 98 | 60 | | | |
| SCR (Surface Condition Rating) | 97 | 80 | | | |

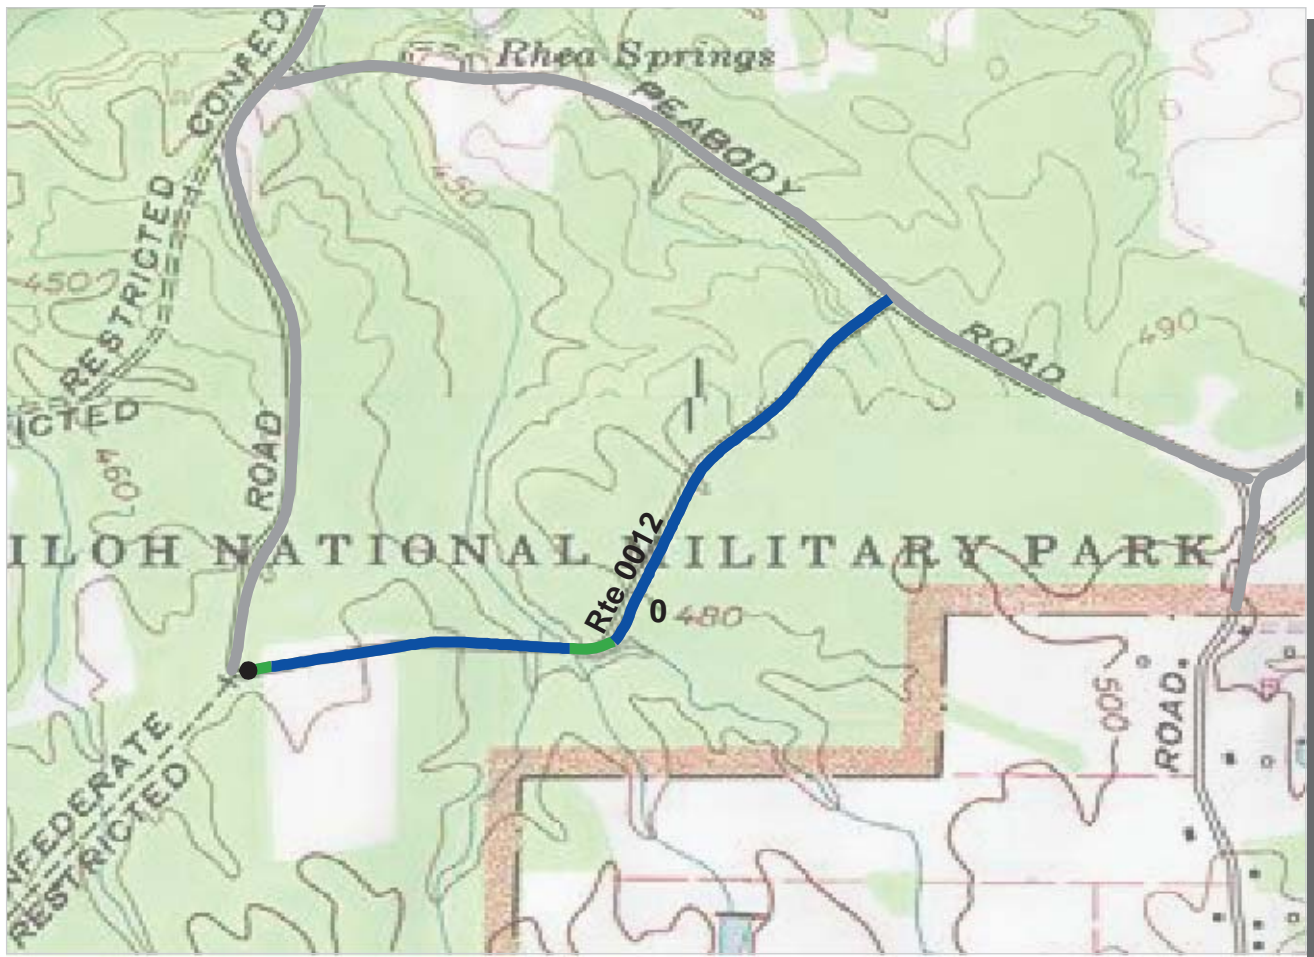
ROUTE: 0012 RECONNOITERING ROAD

| PCR (Pavement Condition Rating) | 96 | | | | |

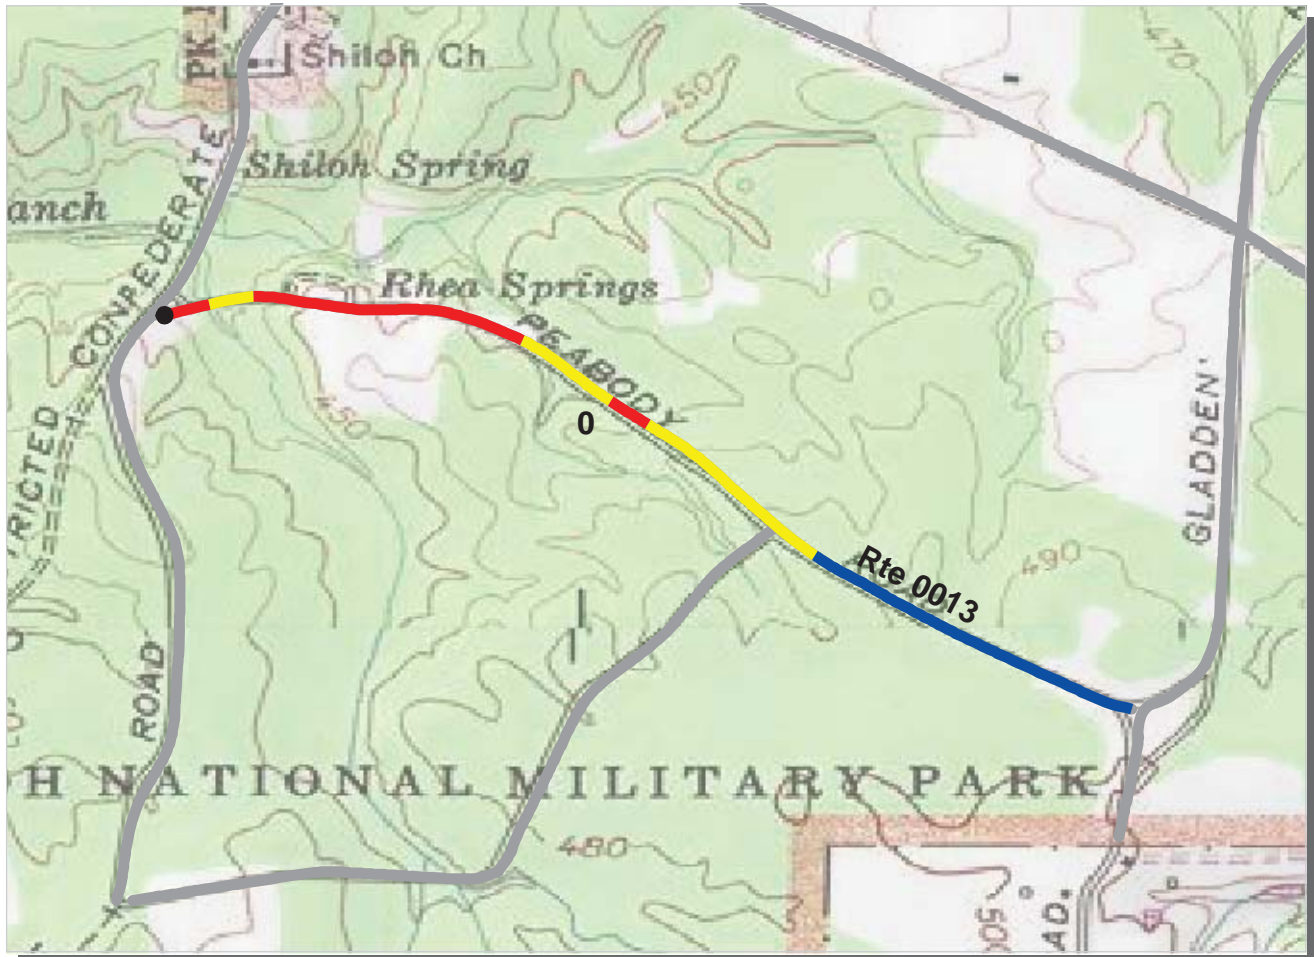
ROUTE: 0013 PEABODY ROAD

| PCR (Pavement Condition Rating) | 70 | | | | |
| SCR (Surface Condition Rating) | 66 | | | | |
| Drainage Condition Rating | POOR | | | | |

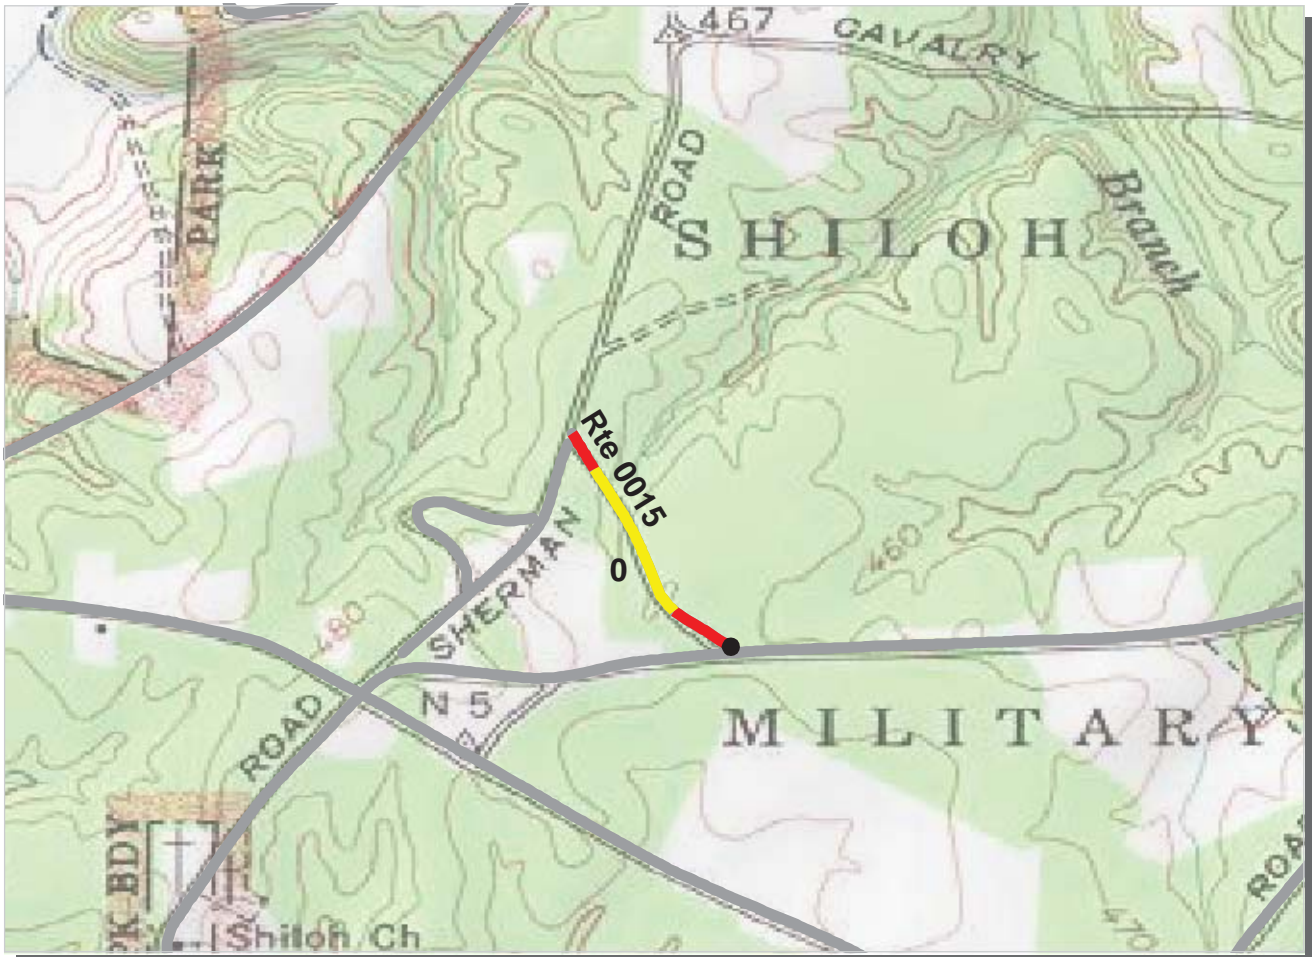
**ROUTE: 0015 MCCLERNAND ROAD** **TOTAL LENGTH: 0.27 Miles**

| PCR (Pavement Condition Rating) | 58 | | | | |
| SCR (Surface Condition Rating) | 51 | | | | |
| Drainage Condition Rating | POOR | | | | |

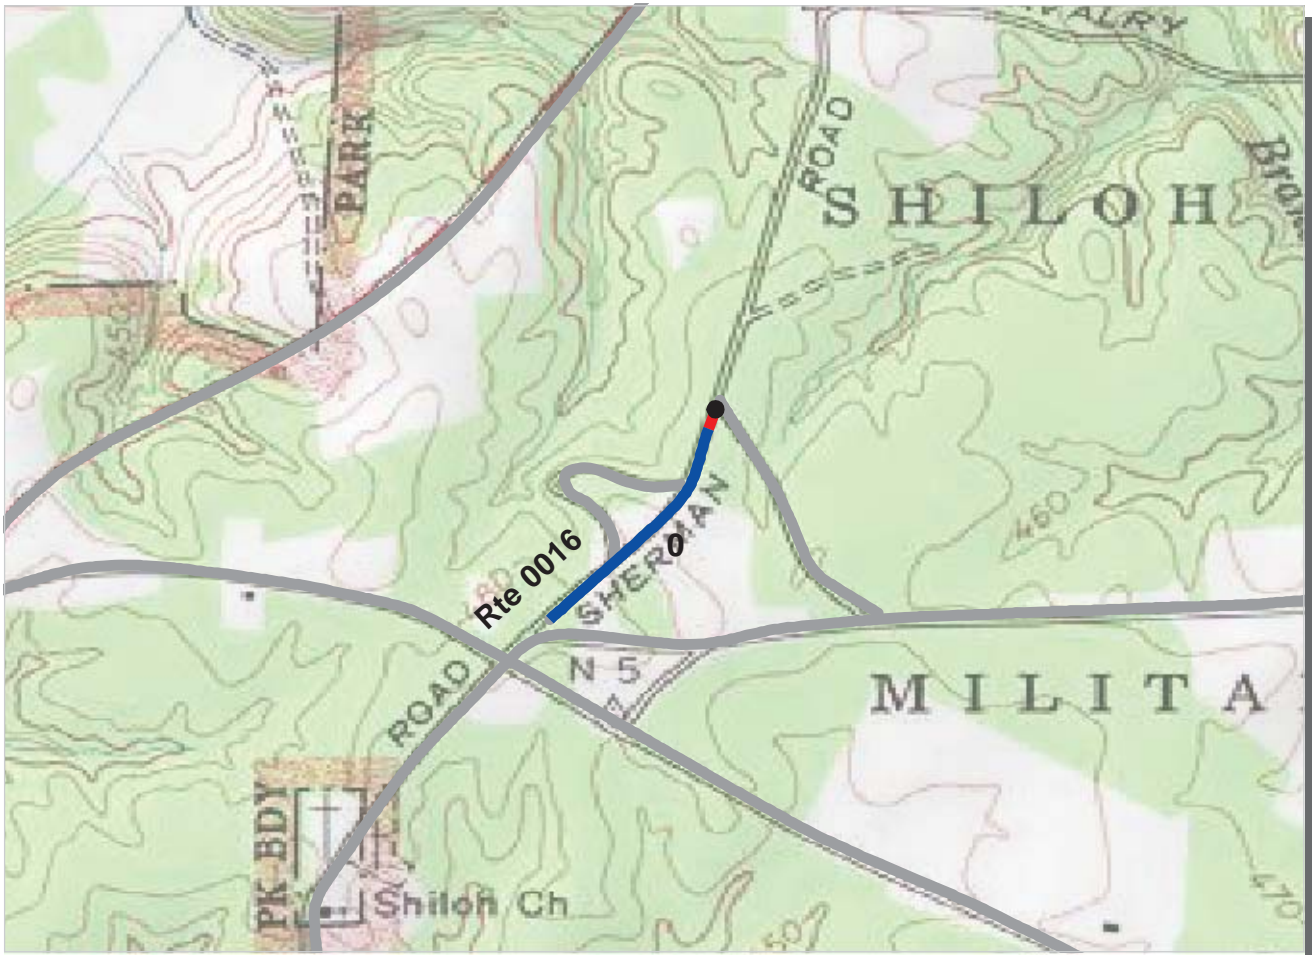
**ROUTE: 0016 SHERMAN ROAD** **TOTAL LENGTH: 0.28 Miles**

| PCR (Pavement Condition Rating) | 91 | | | | |

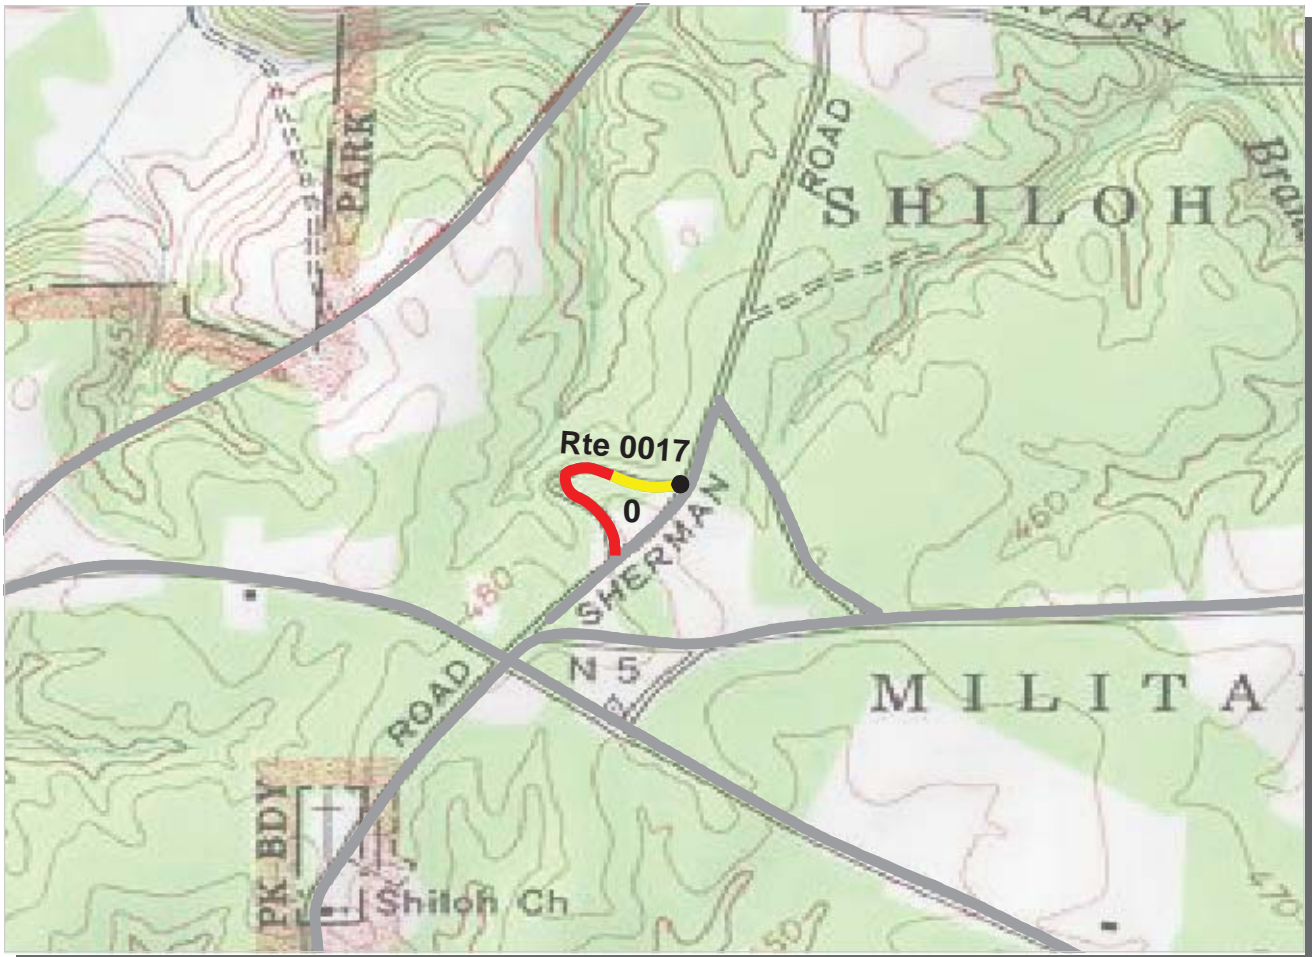
**ROUTE: 0017 CONFEDERATE TRENCH ROAD** **TOTAL LENGTH: 0.22 Miles**

| PCR (Pavement Condition Rating) | 52 | | | | |
| SCR (Surface Condition Rating) | 49 | | | | |
| Drainage Condition Rating | POOR | | | | |

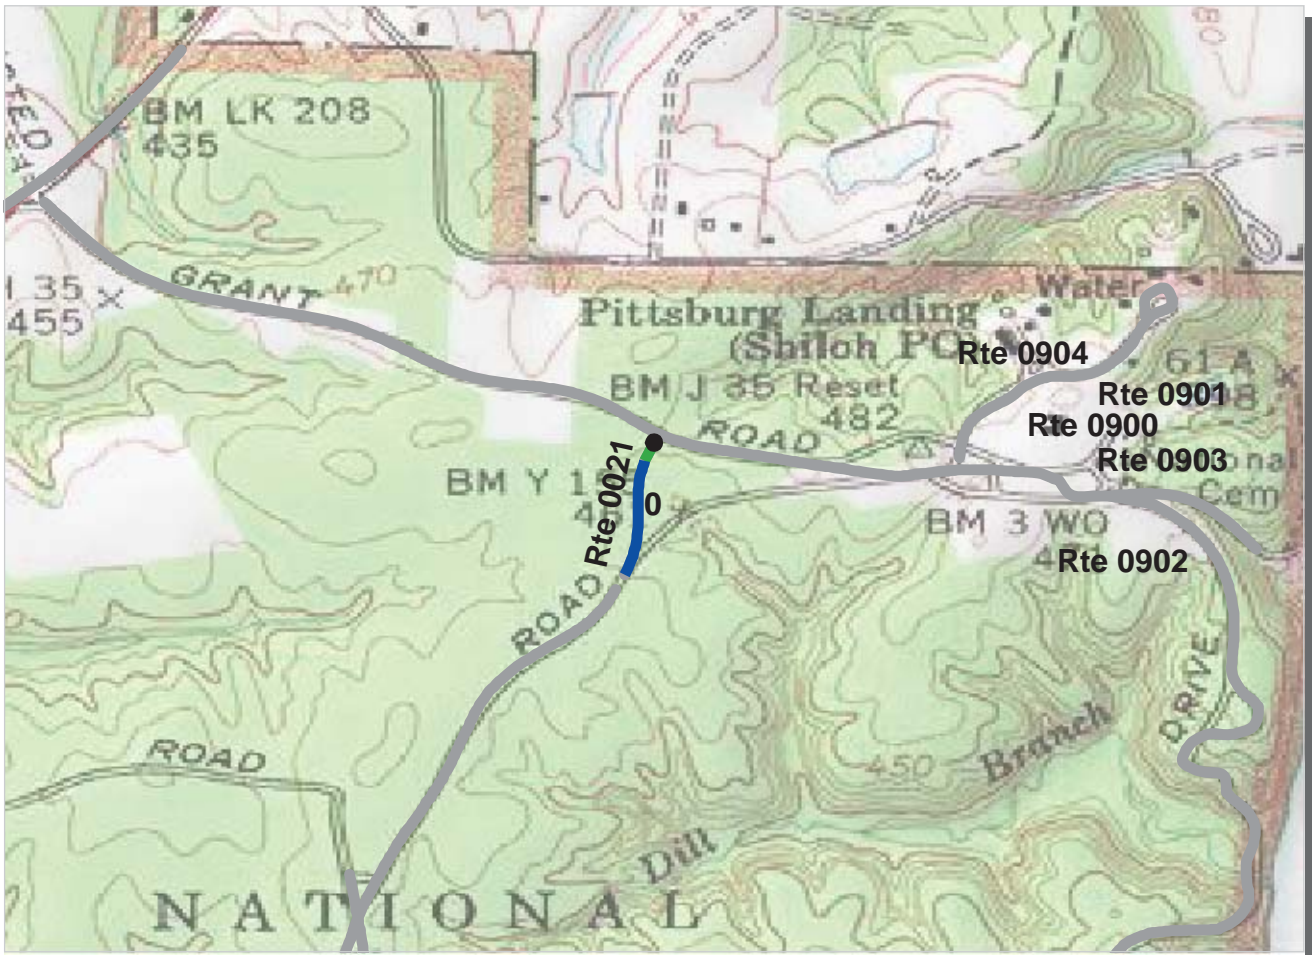
**ROUTE: 0021 HAGY ROAD** **TOTAL LENGTH: 0.16 Miles**

| PCR (Pavement Condition Rating) | 98 | | | | |

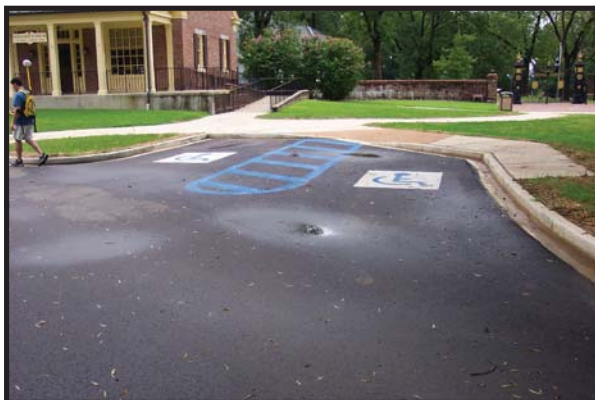
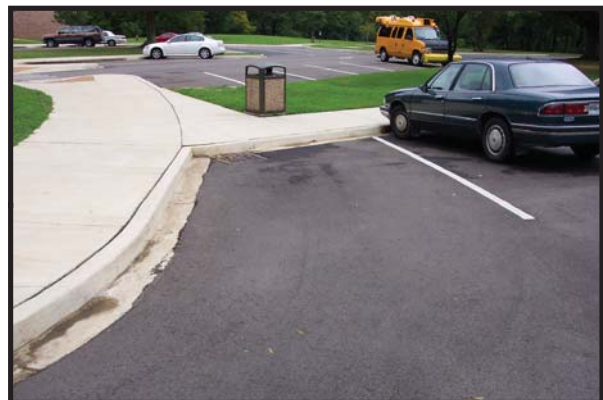
| Route | Public / NonPublic | Date Visited | Area (sq ft) | Lane Miles * | Surface Type | Condition / PCR |
|---|---|---|---|---|---|---|
| 0900 | Public | 9/3/2003 | 51087 | 0.88 | AS | GOOD / 90 |

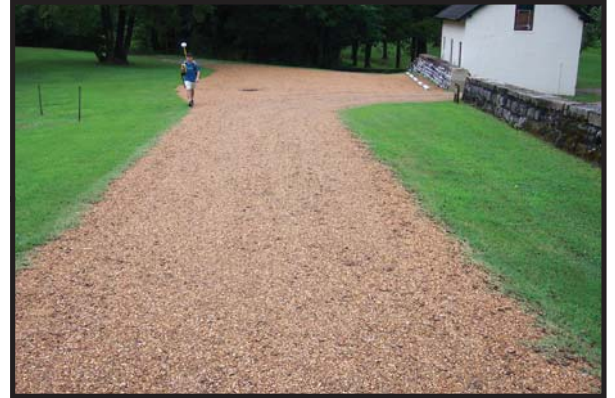
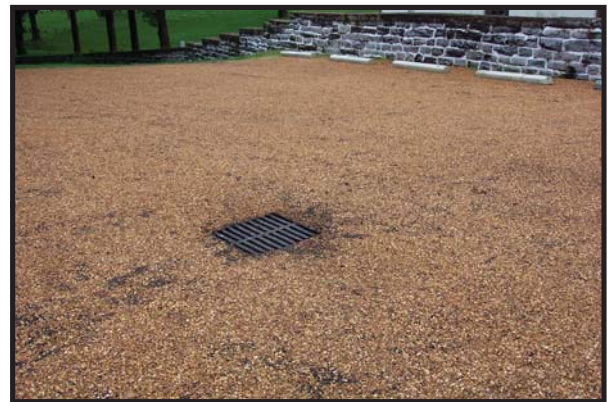
## Route 0901

| Route | Public / NonPublic | Date Visited | Area (sq ft) | Lane Miles * | Surface Type | Condition / PCR |
|---|---|---|---|---|---|---|
| 0901 | NonPublic | 9/3/2003 | 3989 | 0.07 | NC | GOOD / 90 |

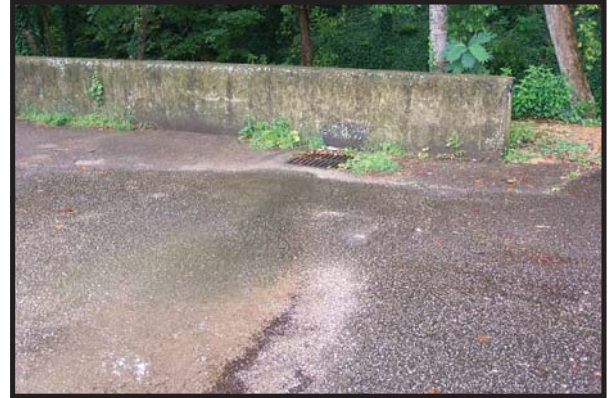
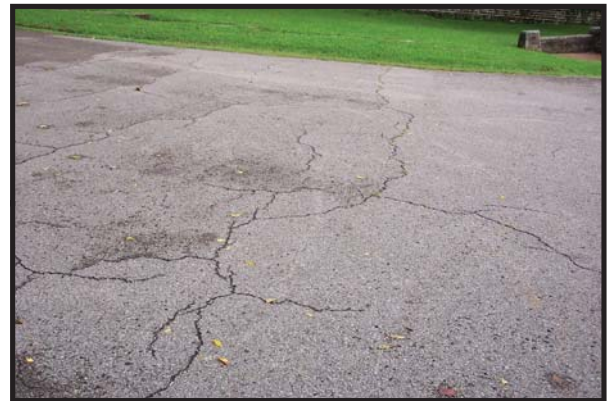
## Route 0902

| Route | Public / NonPublic | Date Visited | Area (sq ft) | Lane Miles * | Surface Type | Condition / PCR |
|---|---|---|---|---|---|---|
| 0902 | Public | 9/3/2003 | 5952 | 0.10 | AS | POOR / 45 |

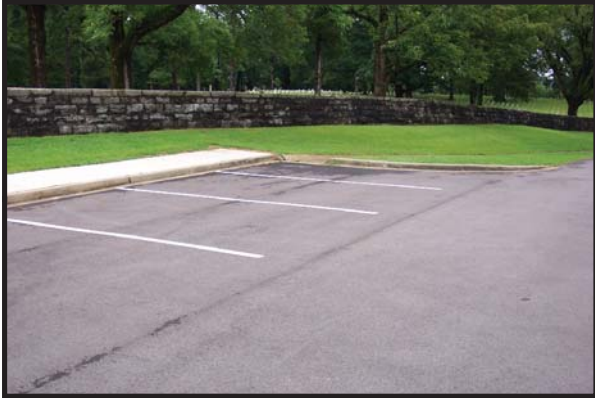
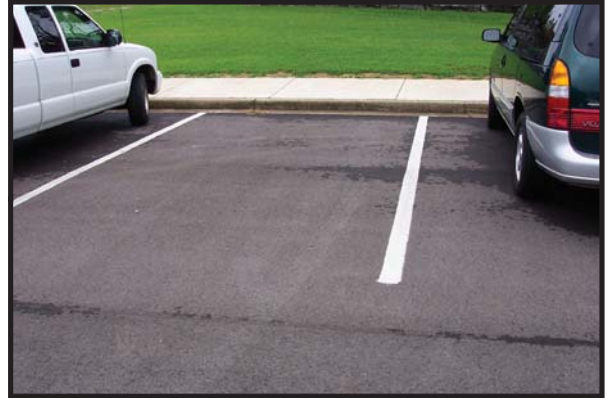
| Route | Public / NonPublic | Date Visited | Area (sq ft) | Lane Miles * | Surface Type | Condition / PCR |
|---|---|---|---|---|---|---|
| 0903 | Public | 9/3/2003 | 2394 | 0.04 | GR | GOOD / 90 |

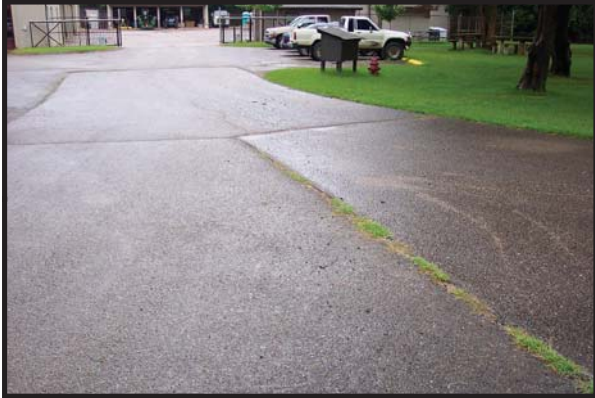
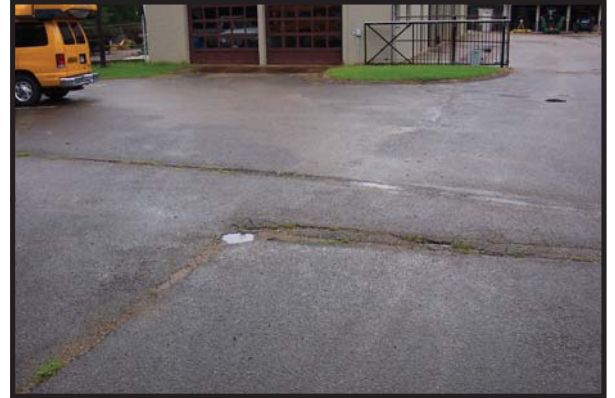
## Route 0904

| Route | Public / NonPublic | Date Visited | Area (sq ft) | Lane Miles * | Surface Type | Condition / PCR |
|---|---|---|---|---|---|---|
| 0904 | NonPublic | 9/3/2003 | 36892 | 0.64 | AS | FAIR / 73 |

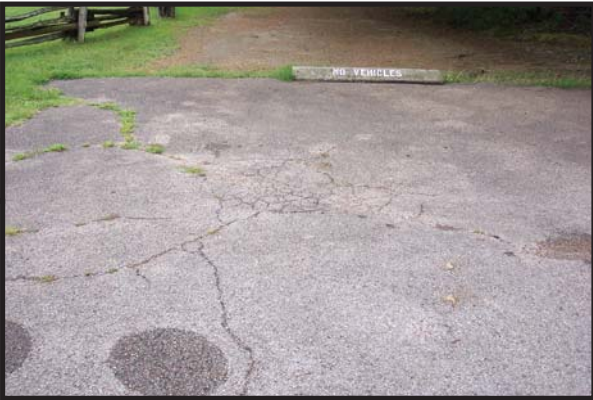
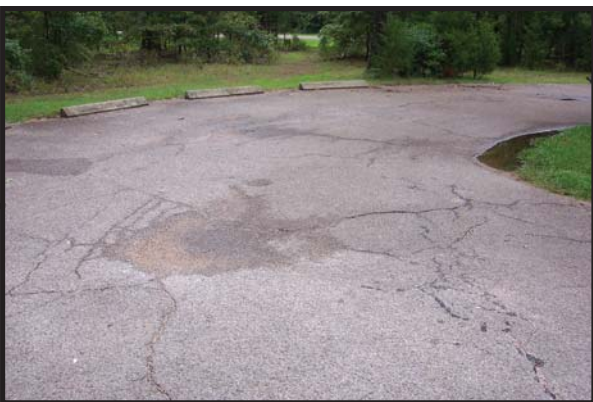
## Route 0905

| Route | Public / NonPublic | Date Visited | Area (sq ft) | Lane Miles * | Surface Type | Condition / PCR |
|---|---|---|---|---|---|---|
| 0905 | Public | 9/3/2003 | 9349 | 0.16 | AS | FAIR / 73 |

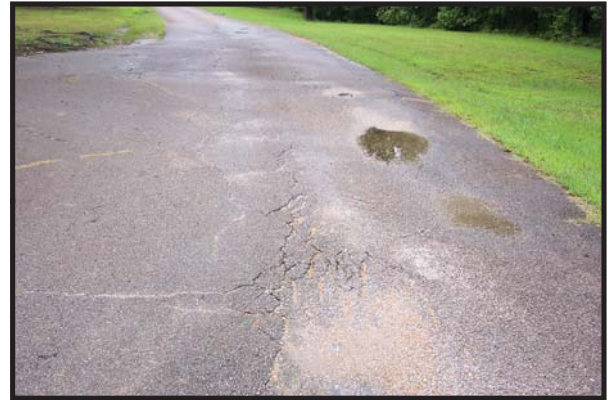
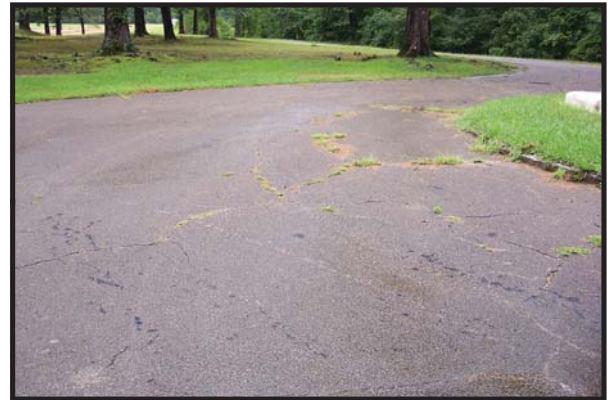
## Route 0906

| Route | Public / NonPublic | Date Visited | Area (sq ft) | Lane Miles * | Surface Type | Condition / PCR |
|---|---|---|---|---|---|---|
| 0906 | Public | 9/3/2003 | 10589 | 0.18 | AS | FAIR / 73 |

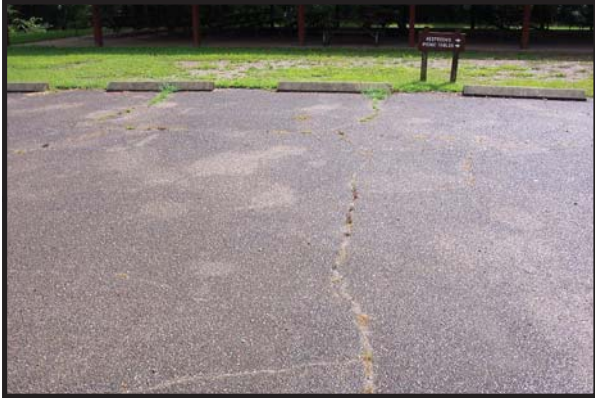
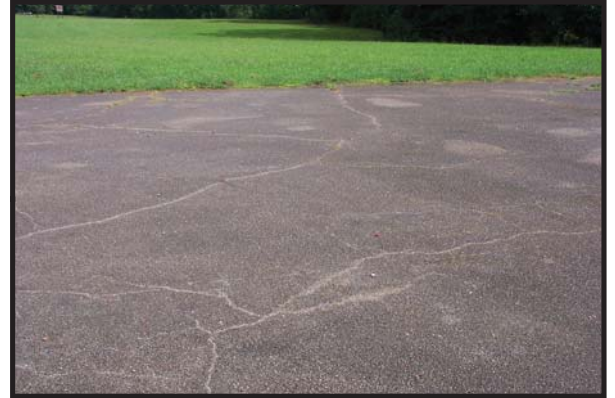
**Shiloh National Military Park**  
**Route 0907**  
 PICNIC AREA PAVILLION PARKING  
 FROM ROUTE 0200

| Route | Public / NonPublic | Date Visited | Area (sq ft) | Lane Miles * | Surface Type | Condition / PCR |
|---|---|---|---|---|---|---|
| 0907 | Public | 9/3/2003 | 6854 | 0.12 | AS | POOR / 45 |

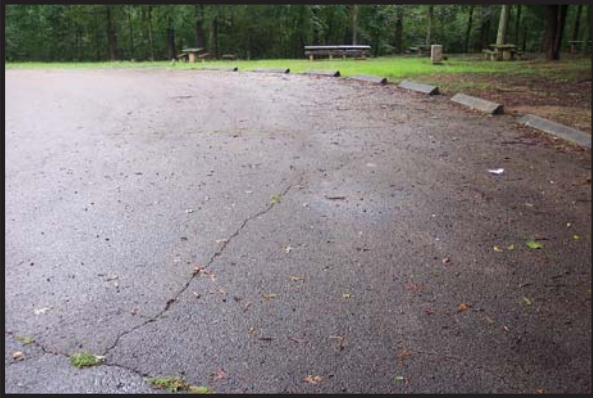
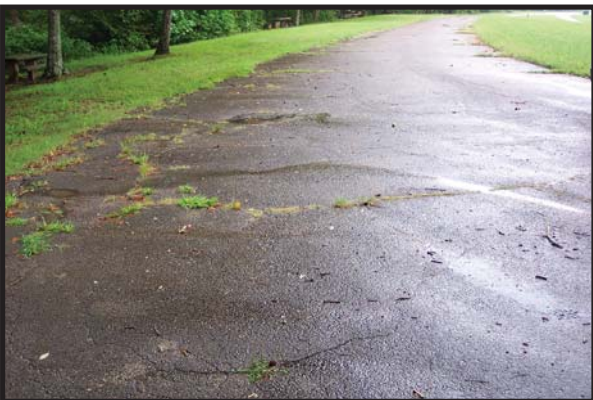
## Route 0908A

| Route | Public / NonPublic | Date Visited | Area (sq ft) | Lane Miles * | Surface Type | Condition / PCR |
|---|---|---|---|---|---|---|
| 0908A | Public | 9/3/2003 | 2544 | 0.04 | AS | POOR / 45 |

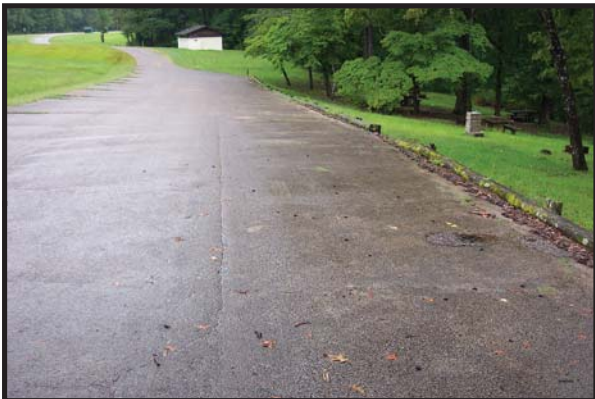
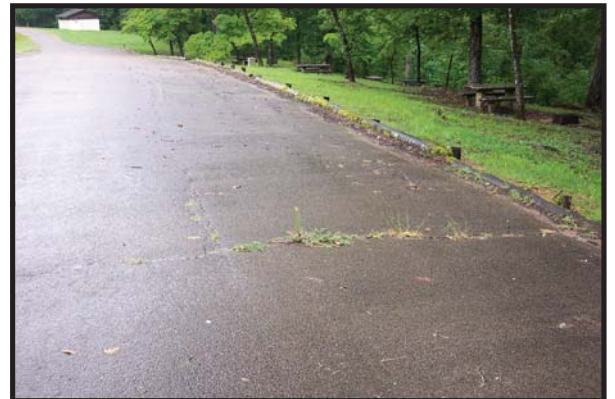
## Route 0908B

| Route | Public / NonPublic | Date Visited | Area (sq ft) | Lane Miles * | Surface Type | Condition / PCR |
|---|---|---|---|---|---|---|
| 0908B | Public | 9/3/2003 | 3405 | 0.06 | AS | POOR / 45 |
