The Road Inventory of Yosemite National Park YOSE – 8800

Road Inventory Program

Prepared By:
Federal Highway Administration
Eastern Federal Lands Highway Division
Cycle 3

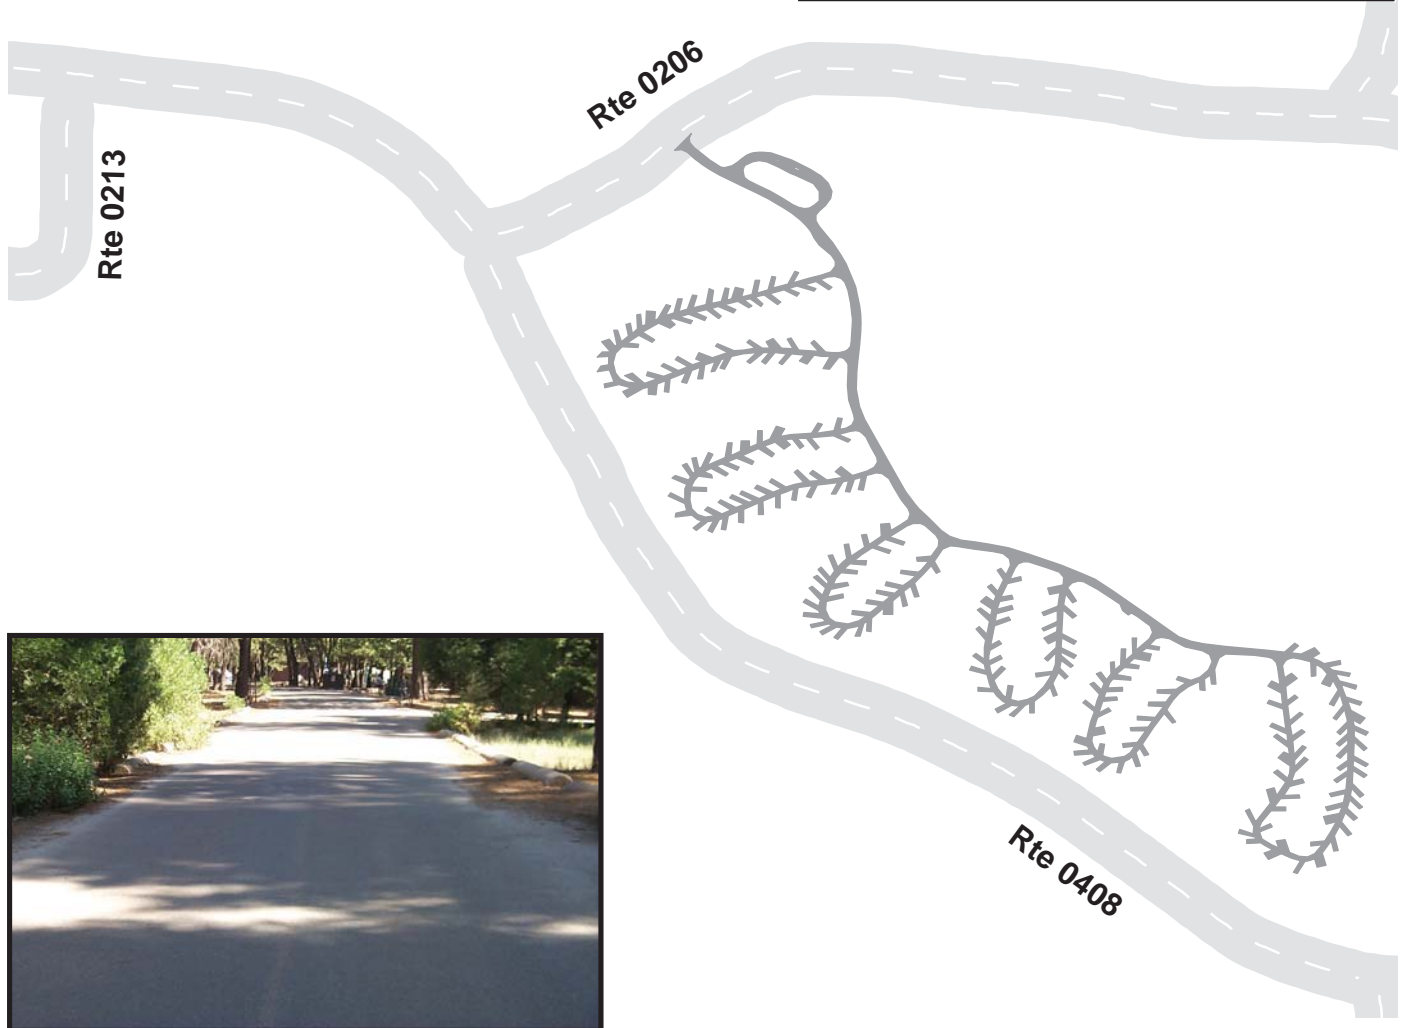
YOSEMITE NATIONAL PARK
Route 0211
 LOWER PINES CAMPGROUND
 FROM ROUTE 0206 AT MP 0.46 ON LEFT

Route	Length (mi)	Width (ft)	Area (sq ft)	Lane Miles *	Condition / PCR	Surface Type
0211	2.21	0.00	128698	2.22	FAIR / 73	AS

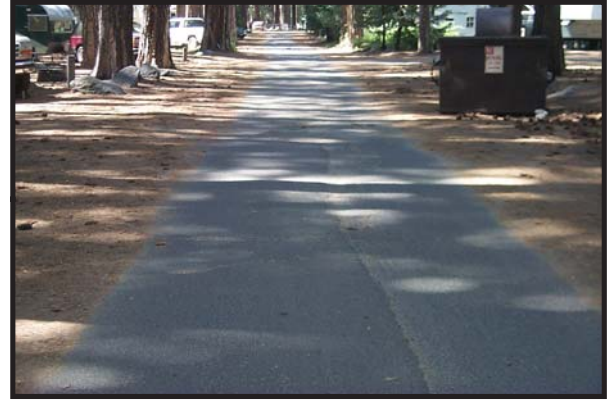
YOSEMITE NATIONAL PARK
Route 0212
 NORTH PINES CAMPGROUND
 FROM ROUTE 0206 AT MP 0.54 ON LEFT

Route	Length (mi)	Width (ft)	Area (sq ft)	Lane Miles *	Condition / PCR	Surface Type
0212	1.98	0.00	115277	1.98	FAIR / 73	AS

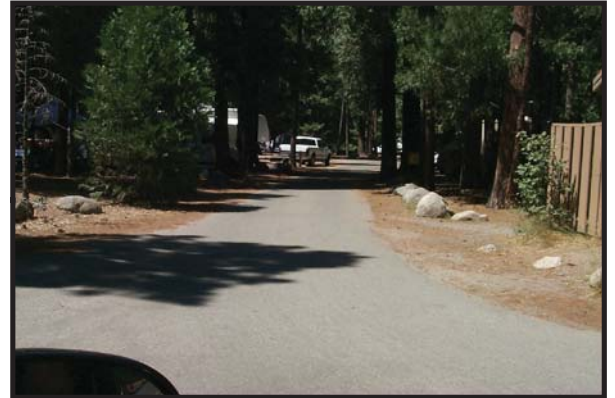
YOSEMITE NATIONAL PARK
Route 0214
 CURRY VILLAGE PARKING AND REGISTRATION LOOP
 FROM ROUTE 0500

Route	Length (mi)	Width (ft)	Area (sq ft)	Lane Miles *	Condition / PCR	Surface Type
0214	0.72	0.00	83692	1.44	GOOD / 90	AS

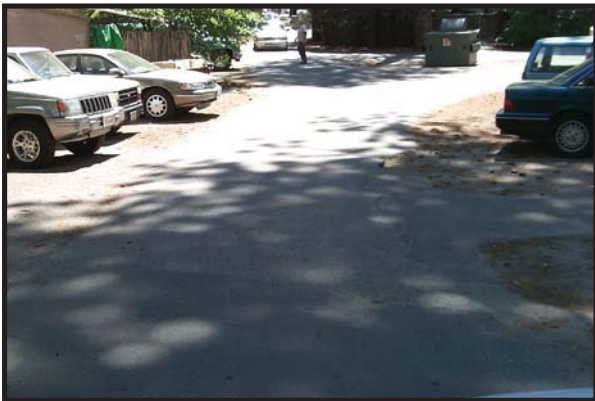
Route 0215

Route	Length (mi)	Width (ft)	Area (sq ft)	Lane Miles *	Condition / PCR	Surface Type
0215	0.24	0.00	14365	0.25	FAIR / 73	AS

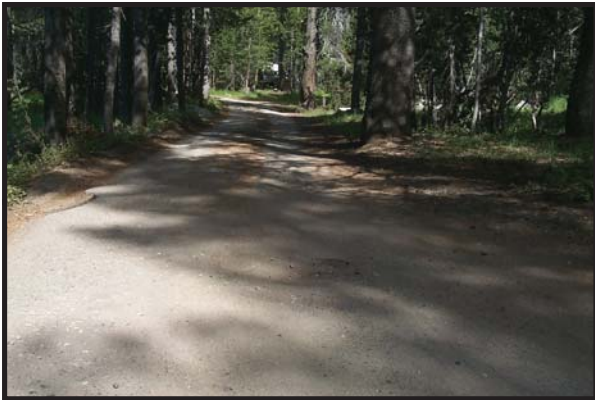
YOSEMITE NATIONAL PARK
Route 0231
 WHITE WOLF CAMPGROUND
 FROM END OF ROUTE 0101 AT MP 1.13

Route	Length (mi)	Width (ft)	Area (sq ft)	Lane Miles *	Condition / PCR	Surface Type
0231	1.13	0.00	66208	1.14	POOR / 45	AS

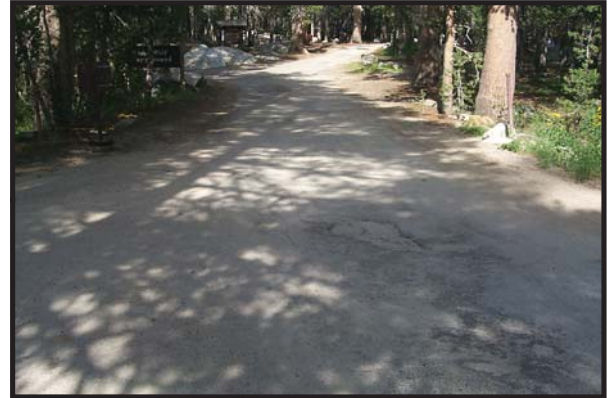
Route 0235

Route	Length (mi)	Width (ft)	Area (sq ft)	Lane Miles *	Condition / PCR	Surface Type
0235	0.21	0.00	24564	0.42	POOR / 45	AS

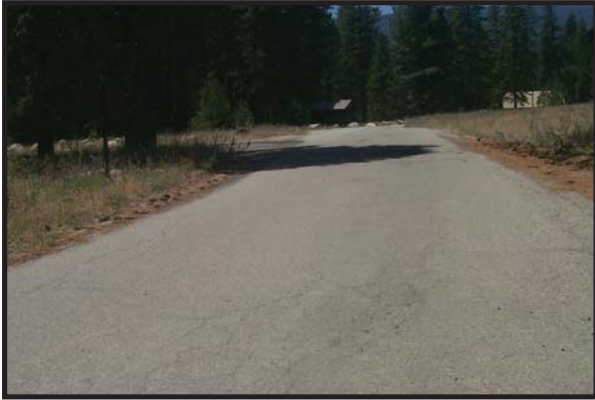
YOSEMITE NATIONAL PARK
Route 0239
 CATHEDRAL PICNIC AREA
 FROM ROUTE 0500 AT MP 2.55 ON LEFT

Route	Length (mi)	Width (ft)	Area (sq ft)	Lane Miles *	Condition / PCR	Surface Type
0239	0.08	9.50	5020	0.09	POOR / 45	AS

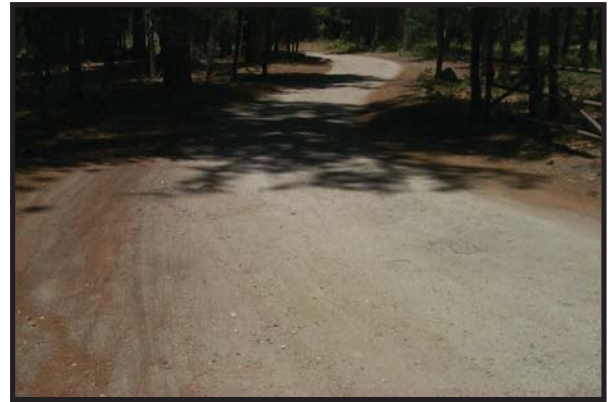
YOSEMITE NATIONAL PARK
Route 0240
 PORCUPINE FLAT CAMPGROUND
 FROM ROUTE 0017 AT MP 23.8 ON LEFT

Route	Length (mi)	Width (ft)	Area (sq ft)	Lane Miles *	Condition / PCR	Surface Type
0240	0.14	14.00	8672	0.15	POOR / 45	AS

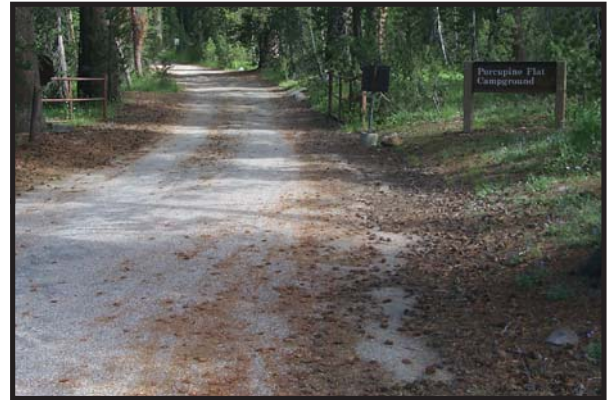
Route 0241

Route	Length (mi)	Width (ft)	Area (sq ft)	Lane Miles *	Condition / PCR	Surface Type
0241	0.10	0.00	11842	0.20	FAIR / 73	AS

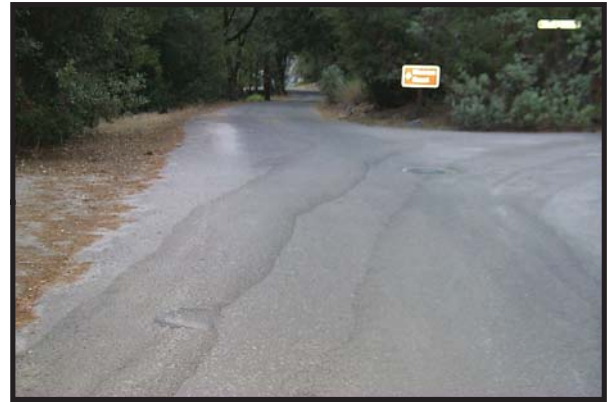
Route 0242

Route	Length (mi)	Width (ft)	Area (sq ft)	Lane Miles *	Condition / PCR	Surface Type
0242	0.22	0.00	18257	0.31	POOR / 45	AS

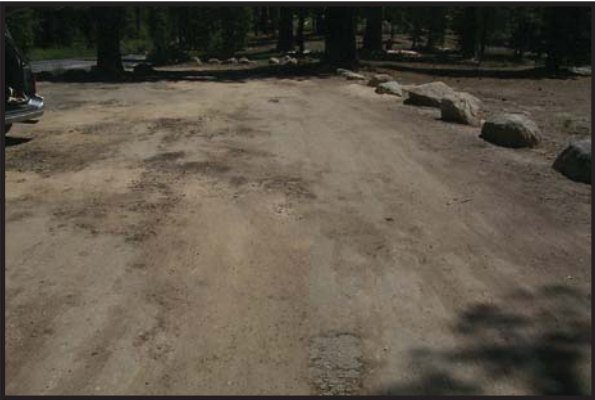
YOSEMITE NATIONAL PARK
Route 0410
 EL PORTEL RESIDENCE AREA
 FROM ROUTE 0406 AT MP 1.05 ON LEFT

Route	Length (mi)	Width (ft)	Area (sq ft)	Lane Miles *	Condition / PCR	Surface Type
0410	1.20	0.00	139662	2.40	FAIR / 73	AS

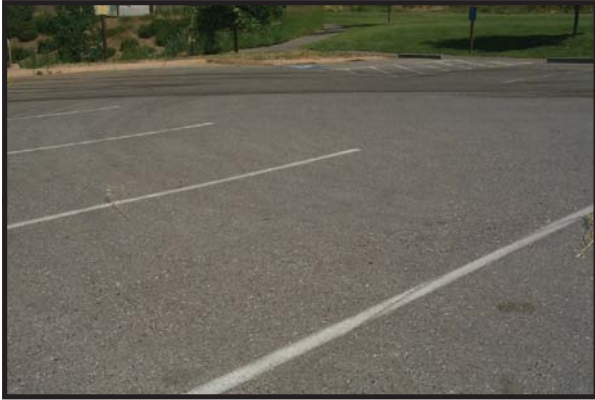
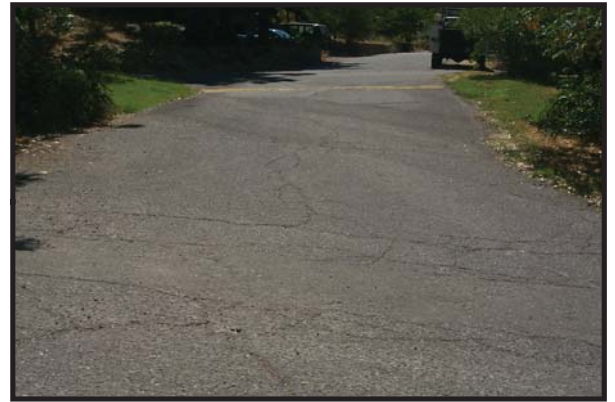
YOSEMITE NATIONAL PARK
Route 0411
 EL PORTEL WATER TANK ACCESS
 FROM ROUTE 0410

Route	Length (mi)	Width (ft)	Area (sq ft)	Lane Miles *	Condition / PCR	Surface Type
0411	0.10	0.00	6344	0.11	POOR / 45	AS

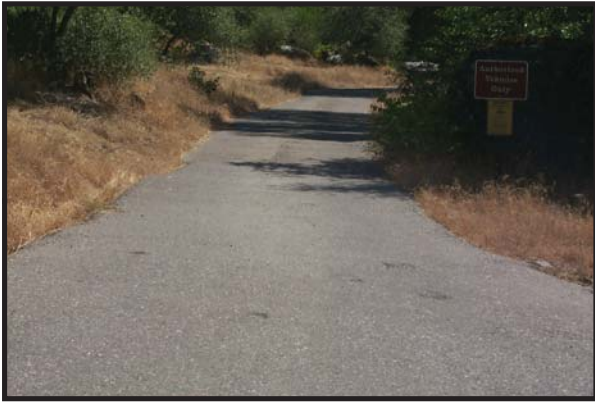
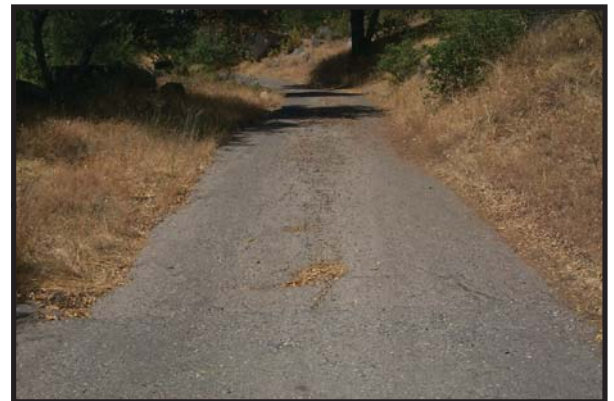
Route 0412

Route	Length (mi)	Width (ft)	Area (sq ft)	Lane Miles *	Condition / PCR	Surface Type
0412	0.82	0.00	47714	0.82	FAIR / 73	AS

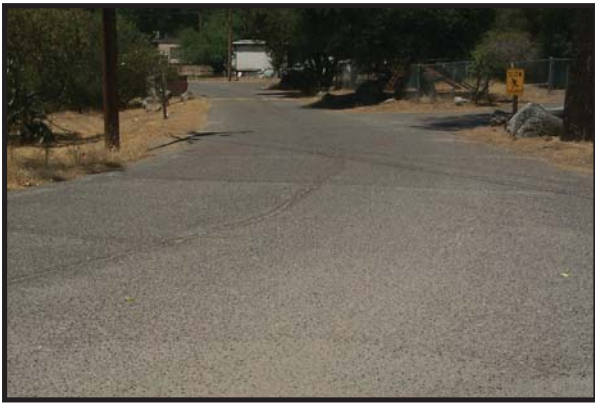
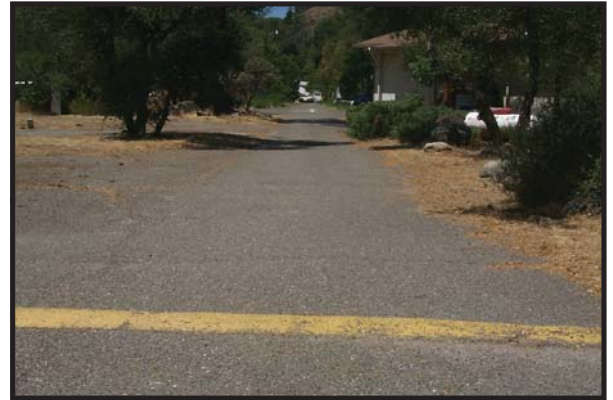
Route 0413

Route	Length (mi)	Width (ft)	Area (sq ft)	Lane Miles *	Condition / PCR	Surface Type
0413	0.12	0.00	14335	0.25	GOOD / 90	AS

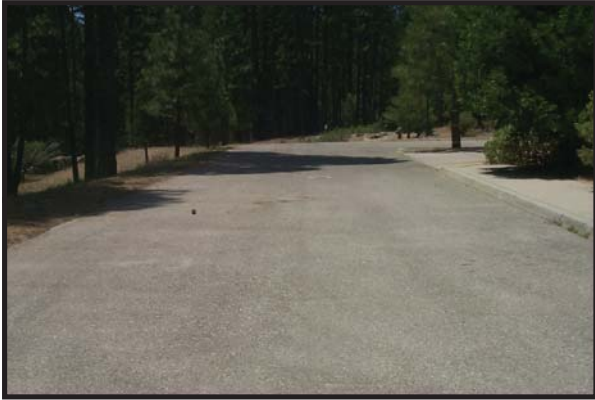
YOSEMITE NATIONAL PARK
Route 0414
WAWONA WASTEWATER TREATMENT FACILITY
FROM ROUTE 0221 AT MP 0.6 ON LEFT

Route	Length (mi)	Width (ft)	Area (sq ft)	Lane Miles *	Condition / PCR	Surface Type
0414	0.28	0.00	32992	0.57	FAIR / 73	AS

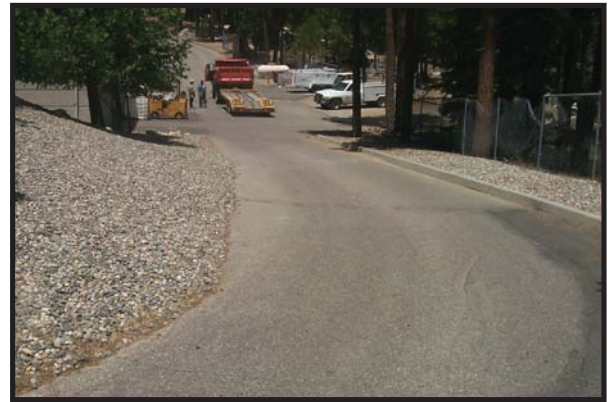
YOSEMITE NATIONAL PARK
Route 0416
 TUOLUMNE RESIDENCES AND RANGER STATION
 FROM ROUTE 0230

Route	Length (mi)	Width (ft)	Area (sq ft)	Lane Miles *	Condition / PCR	Surface Type
0416	0.14	13.60	10269	0.18	POOR / 45	AS

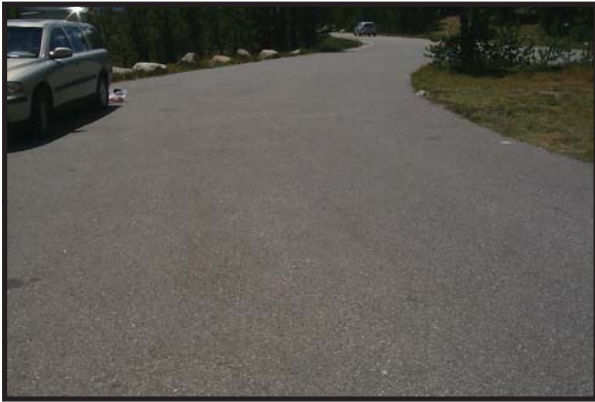
YOSEMITE NATIONAL PARK
Route 0419
 GLACIER POINT RESIDENCE AREA
 FROM ROUTE 0015 AT MP 15.28

Route	Length (mi)	Width (ft)	Area (sq ft)	Lane Miles *	Condition / PCR	Surface Type
0419	0.05	0.00	3089	0.05	FAIR / 73	AS

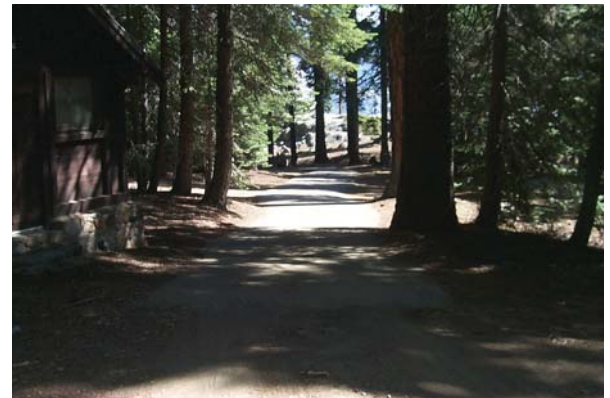
Route 0420

Route	Length (mi)	Width (ft)	Area (sq ft)	Lane Miles *	Condition / PCR	Surface Type
0420	0.08	11.50	5100	0.09	POOR / 45	AS

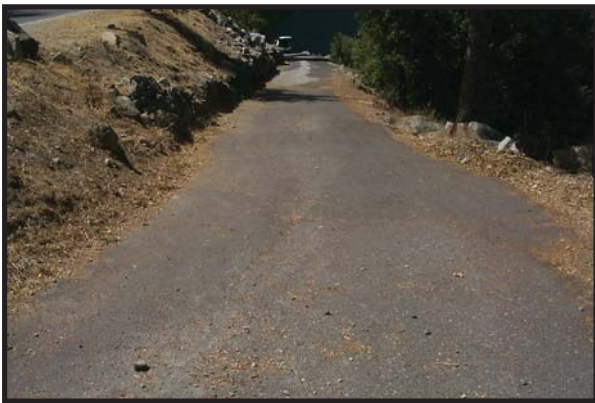
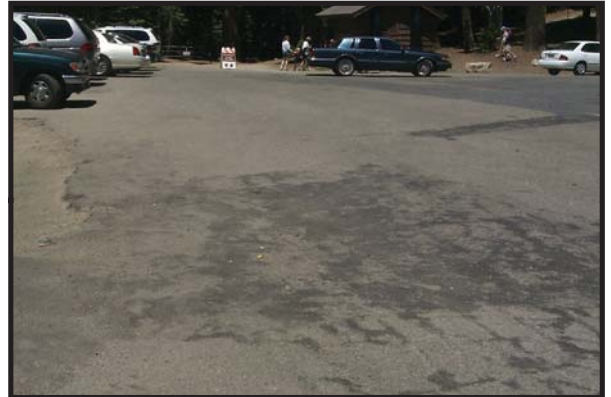
YOSEMITE NATIONAL PARK
Route 0600
 VALLEY RESIDENCE AREA
 FROM ROUTE 0409, THROUGH RESIDENCE AREA

Route	Length (mi)	Width (ft)	Area (sq ft)	Lane Miles *	Condition / PCR	Surface Type
0600	0.87	0.00	101209	1.74	FAIR / 73	AS

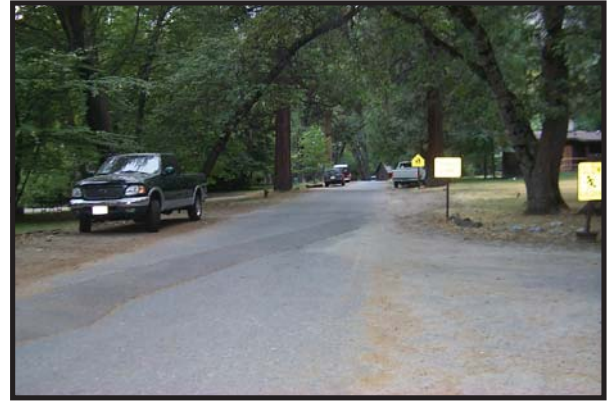
Route 0900

Route	Public / NonPublic	Date Visited	Area (sq ft)	Lane Miles *	Surface Type	Condition / PCR
0900	PUBLIC	7/16/2002	15014	0.26	AS	GOOD / 90

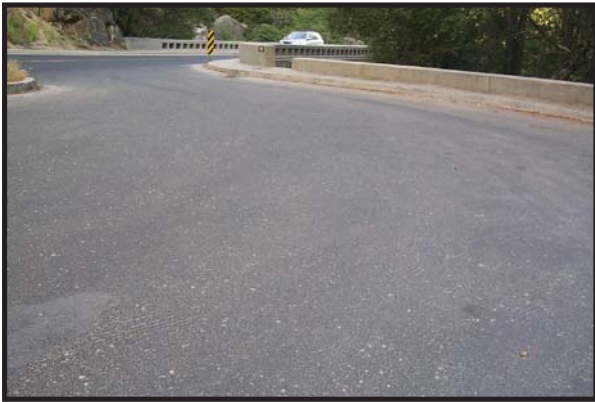
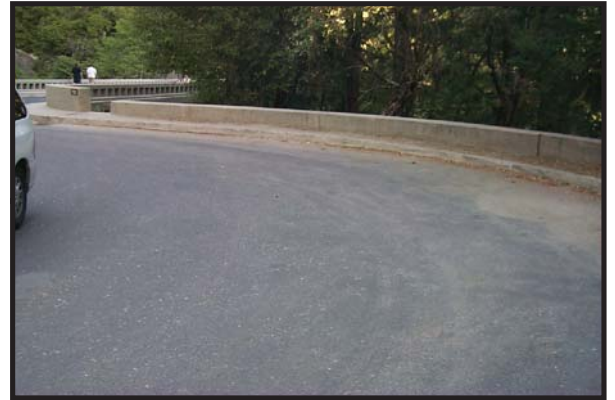
YOSEMITE NATIONAL PARK
Route 0902
 FIRE OVERLOOK
 ADJACENT TO ROUTE 0013 AT MP 4.1 ON LEFT

Route	Public / NonPublic	Date Visited	Area (sq ft)	Lane Miles *	Surface Type	Condition / PCR
0902	PUBLIC	7/16/2002	6494	0.11	AS	GOOD / 90

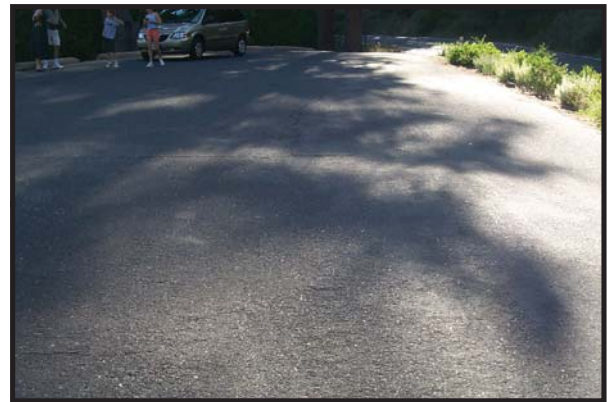
YOSEMITE NATIONAL PARK
Route 0904
 SAN JOAQUIN OVERLOOK
 ADJACENT TO ROUTE 0013 AT MP 11.92 ON LEFT

Route	Public / NonPublic	Date Visited	Area (sq ft)	Lane Miles *	Surface Type	Condition / PCR
0904	PUBLIC	7/16/2002	15221	0.26	AS	GOOD / 90

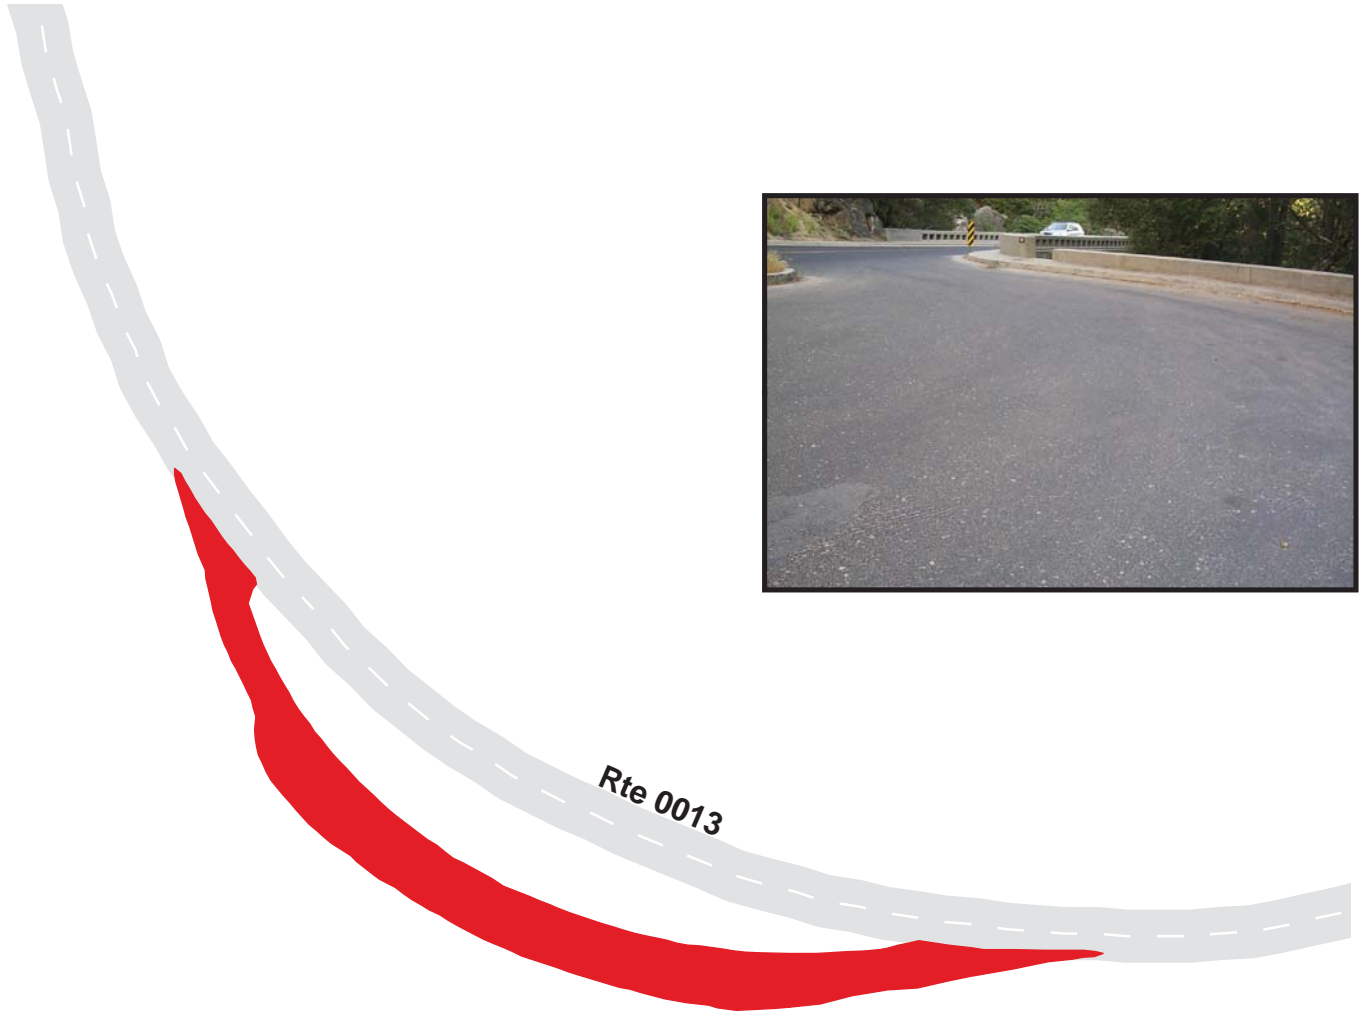
YOSEMITE NATIONAL PARK
Route 0905
 MERCED GROVE
 ADJACENT TO ROUTE 0013 AT MP 14.15 ON LEFT

Route	Public / NonPublic	Date Visited	Area (sq ft)	Lane Miles *	Surface Type	Condition / PCR
0905	PUBLIC	7/16/2002	5933	0.10	AS	FAIR / 73

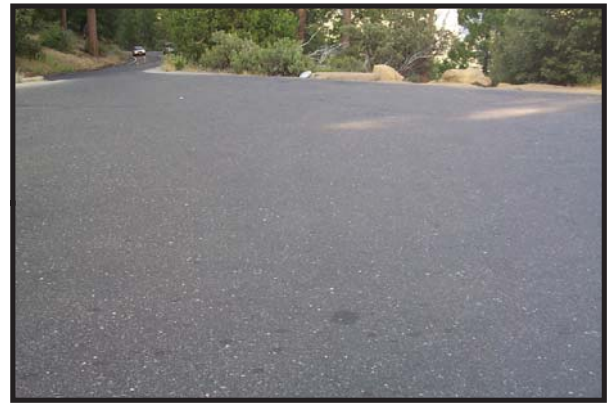
YOSEMITE NATIONAL PARK
Route 0906
HODGDON MEADOW MAINTENANCE AREA
ADJACENT TO ROUTE 0415A ON RIGHT

Route	Public / NonPublic	Date Visited	Area (sq ft)	Lane Miles *	Surface Type	Condition / PCR
0906	NONPUBLIC	7/16/2002	19868	0.34	AS	POOR / 45

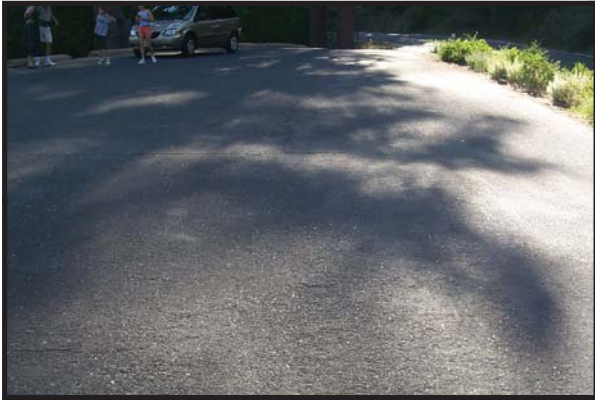
YOSEMITE NATIONAL PARK
Route 0907
 BIG OAK FLAT ENTRANCE PARKING
 ADJACENT TO ROUTE 0013 AT MP 18.18 ON LEFT

Route	Public / NonPublic	Date Visited	Area (sq ft)	Lane Miles *	Surface Type	Condition / PCR
0907	PUBLIC	7/16/2002	20020	0.34	AS	POOR / 45

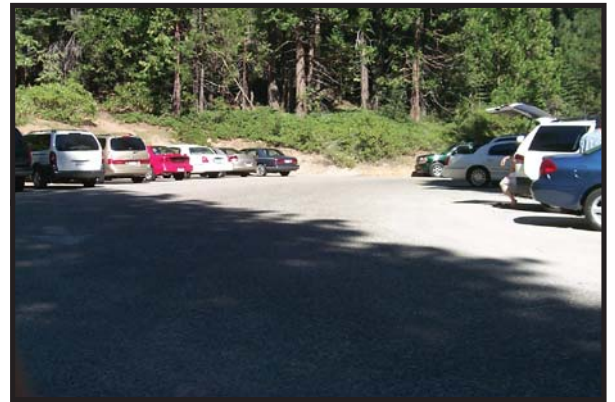
YOSEMITE NATIONAL PARK
Route 0910
MARIPOSA GROVE BUS PARKING
ADJACENT TO ROUTE 0219 AT MP 2.00 ON RIGHT

Route	Public / NonPublic	Date Visited	Area (sq ft)	Lane Miles *	Surface Type	Condition / PCR
0910	PUBLIC	7/16/2002	0	0.00	AS	FAIR / 73

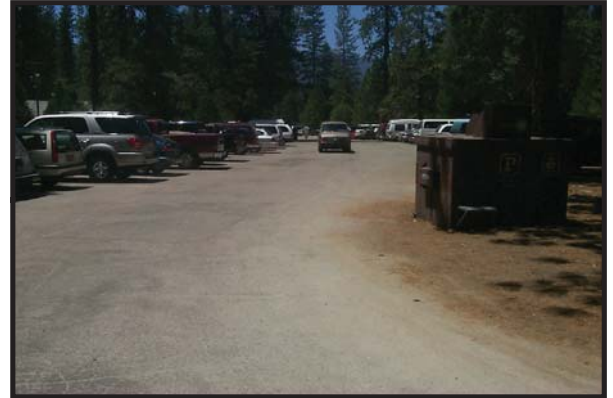
YOSEMITE NATIONAL PARK
Route 0913
 WAWONA DUMP STATION
 ADJACENT TO ROUTE 0220 ON LEFT

Route	Public / NonPublic	Date Visited	Area (sq ft)	Lane Miles *	Surface Type	Condition / PCR
0913	PUBLIC	7/16/2002	6686	0.12	AS	GOOD / 90

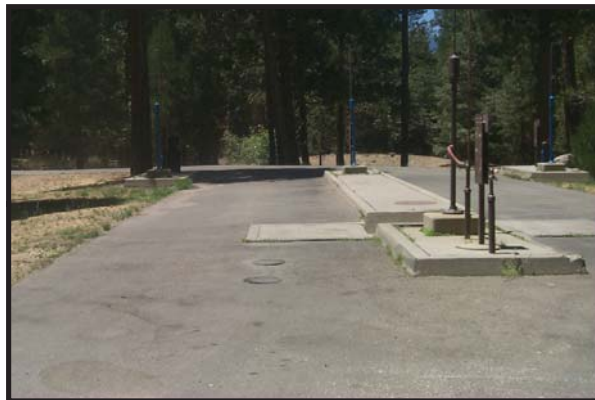
YOSEMITE NATIONAL PARK
Route 0914
 WAWONA UTILITY AREA
 ADJACENT TO ROUTE 0235 ON RIGHT

Route	Public / NonPublic	Date Visited	Area (sq ft)	Lane Miles *	Surface Type	Condition / PCR
0914	NONPUBLIC	7/16/2002	35343	0.61	AS	POOR / 45

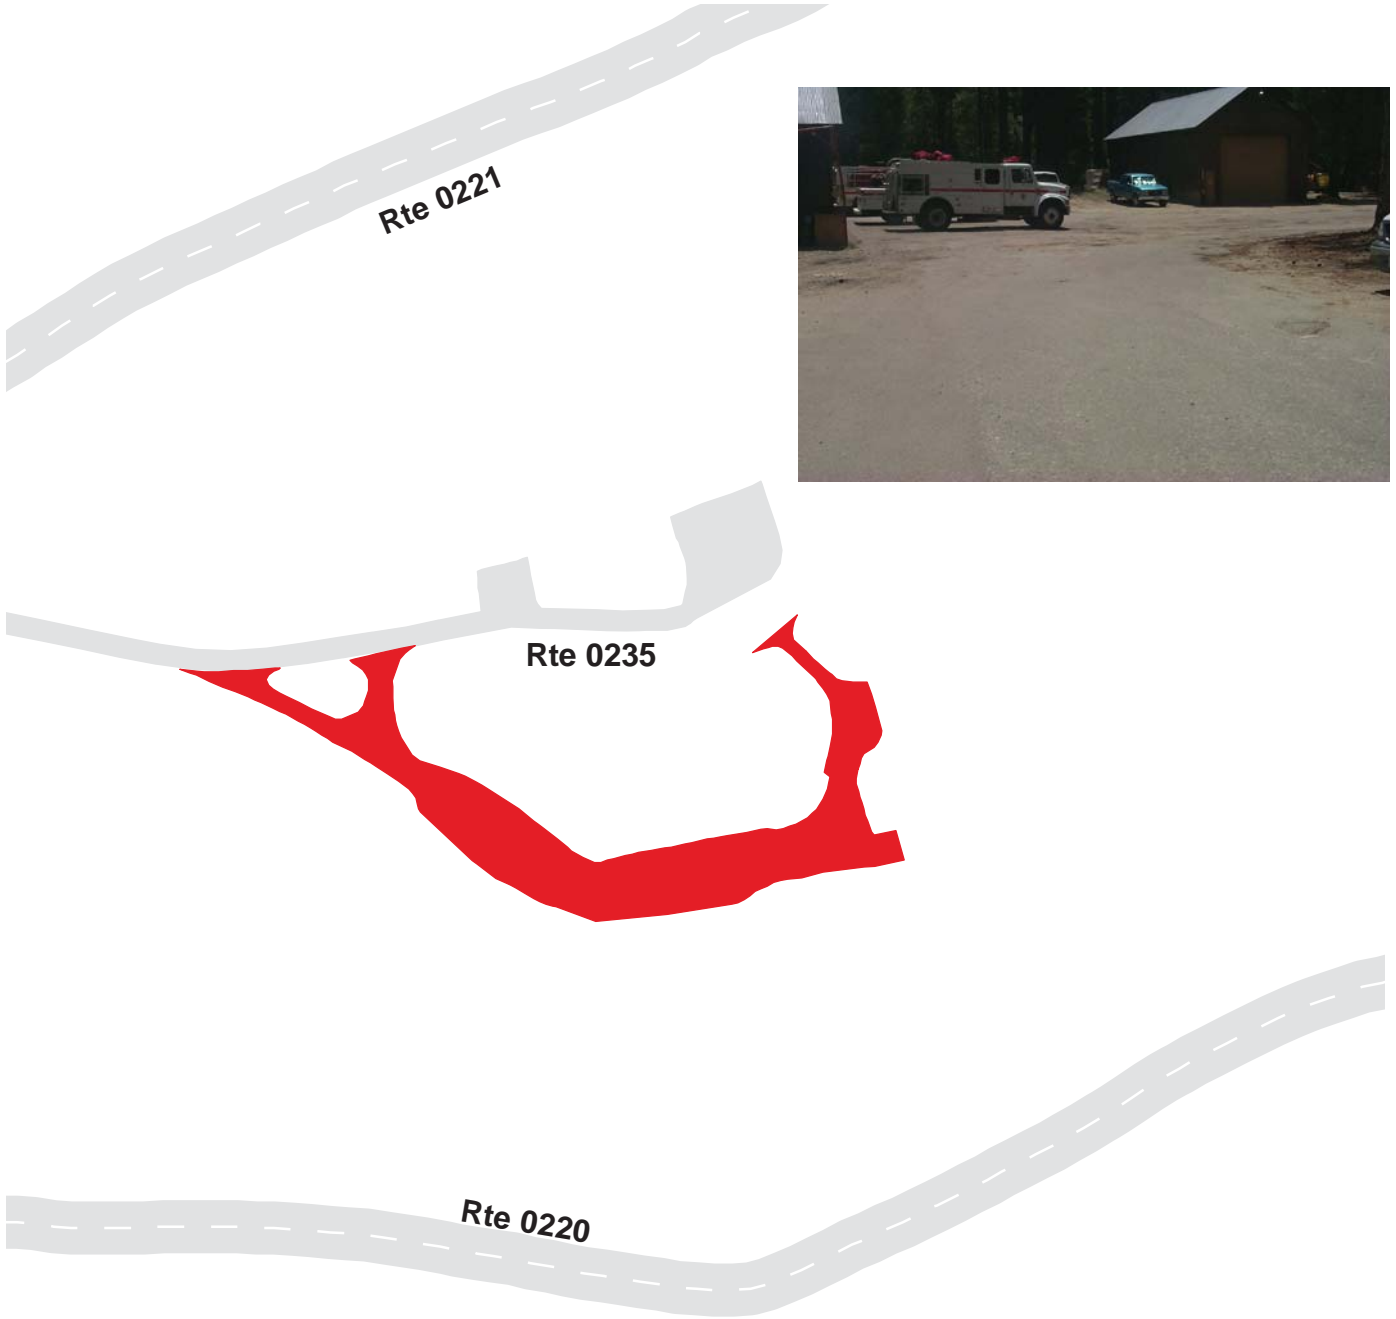
YOSEMITE NATIONAL PARK
Route 0915
 WAWONA DISTRICT OFFICE
 ADJACENT TO ROUTE 0413 ON LEFT

Route	Public / NonPublic	Date Visited	Area (sq ft)	Lane Miles *	Surface Type	Condition / PCR
0915	NONPUBLIC	7/16/2002	9281	0.16	AS	FAIR / 73

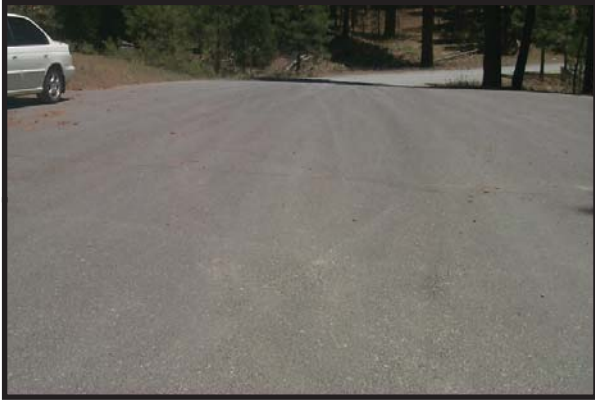
YOSEMITE NATIONAL PARK
Route 0916
 RESTROOM PARKING
 ADJACENT TO ROUTE 0014 AND ROUTE 0015

Route	Public / NonPublic	Date Visited	Area (sq ft)	Lane Miles *	Surface Type	Condition / PCR
0916	PUBLIC	7/16/2002	10138	0.17	AS	FAIR / 73

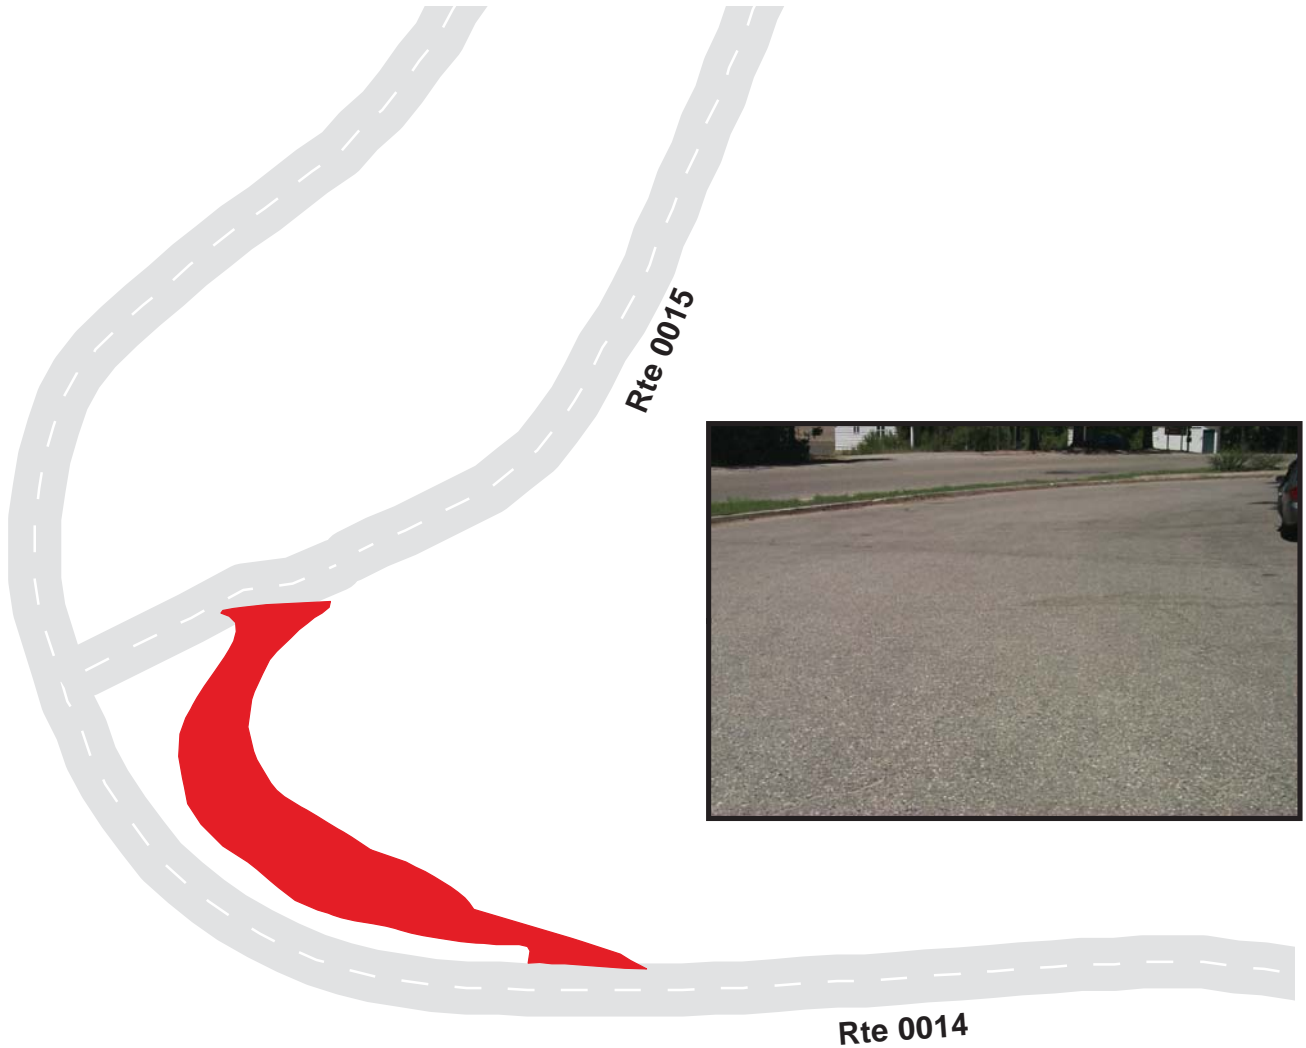
YOSEMITE NATIONAL PARK
Route 0917A
 TUNNEL VIEW PARKING AREA A
 ADJACENT TO ROUTE 0014 AT MP 25.4 ON LEFT

Route	Public / NonPublic	Date Visited	Area (sq ft)	Lane Miles *	Surface Type	Condition / PCR
0917A	PUBLIC	7/16/2002	22029	0.38	AS	POOR / 45

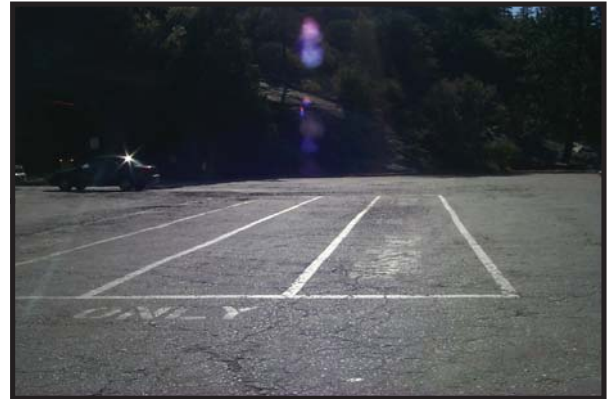
YOSEMITE NATIONAL PARK
Route 0917B
TUNNEL VIEW PARKING AREA B
ADJACENT TO ROUTE 0014 AT MP 25.4 ON RIGHT

Route	Public / NonPublic	Date Visited	Area (sq ft)	Lane Miles *	Surface Type	Condition / PCR
0917B	PUBLIC	7/16/2002	12342	0.21	AS	POOR / 45

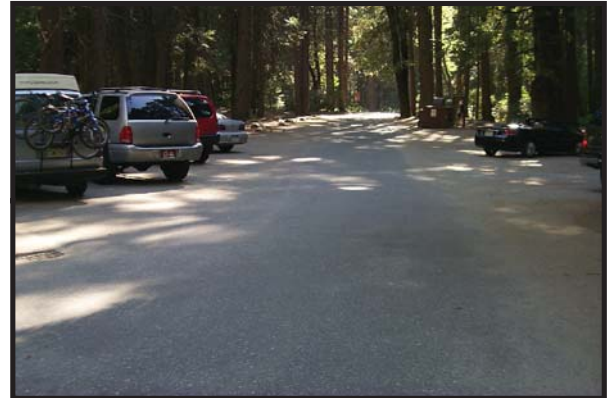
YOSEMITE NATIONAL PARK
Route 0919
 BADGER PASS SKI AREA
 ADJACENT TO ROUTE 0015 AT MP 5.0 ON RIGHT

Route	Public / NonPublic	Date Visited	Area (sq ft)	Lane Miles *	Surface Type	Condition / PCR
0919	PUBLIC	7/16/2002	313178	5.39	AS	POOR / 45

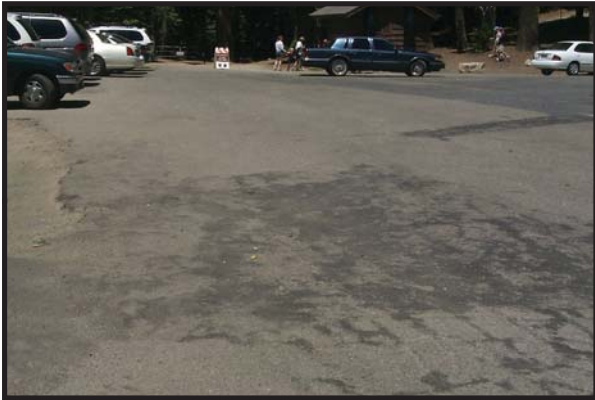
YOSEMITE NATIONAL PARK
Route 0924
 HISTORIC TIOGA ROAD TURNOUT
 ADJACENT TO ROUTE 0017 AT MP 3.85 ON RIGHT

Route	Public / NonPublic	Date Visited	Area (sq ft)	Lane Miles *	Surface Type	Condition / PCR
0924	PUBLIC	7/16/2002	6963	0.12	AS	FAIR / 73

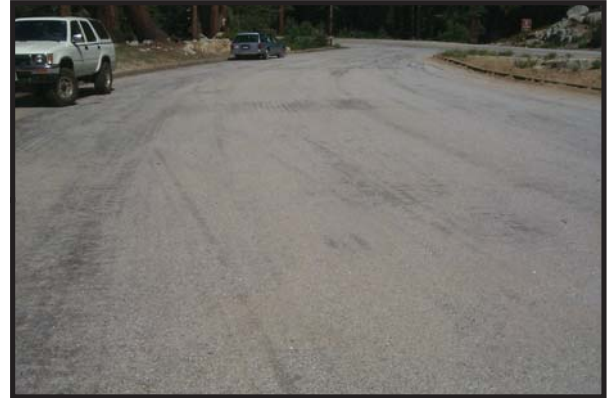
YOSEMITE NATIONAL PARK
Route 0927
 YOSEMITE CREEK TURNOUT
 ADJACENT TO ROUTE 0017 AT MP 16.7 ON RIGHT

Route	Public / NonPublic	Date Visited	Area (sq ft)	Lane Miles *	Surface Type	Condition / PCR
0927	PUBLIC	7/16/2002	9921	0.17	AS	FAIR / 73

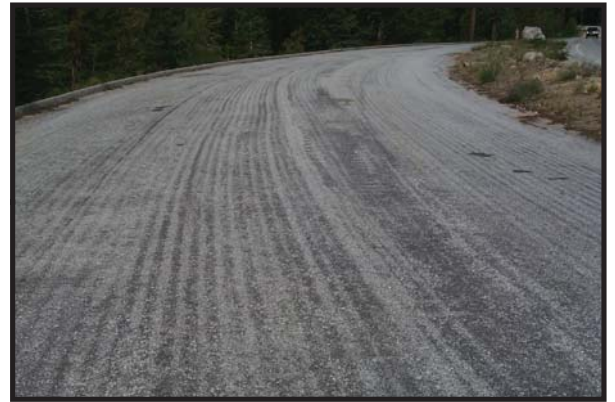
YOSEMITE NATIONAL PARK
Route 0928
 YOSEMITE CREEK CANYON TURNOUT
 ADJACENT TO ROUTE 0017 AT MP 18.3 ON RIGHT

Route	Public / NonPublic	Date Visited	Area (sq ft)	Lane Miles *	Surface Type	Condition / PCR
0928	PUBLIC	7/16/2002	10182	0.18	AS	FAIR / 73

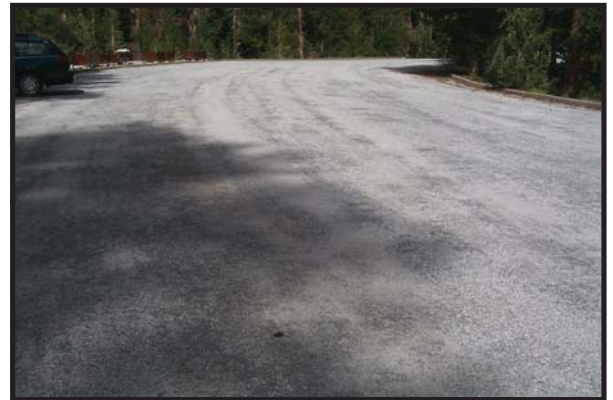
YOSEMITE NATIONAL PARK
Route 0930
 YOSEMITE CREEK PICNIC LOOP
 FROM ROUTE 0017 AT MP 19.9 ON RIGHT

Route	Public / NonPublic	Date Visited	Area (sq ft)	Lane Miles *	Surface Type	Condition / PCR
0930	PUBLIC	7/16/2002	9658	0.17	AS	FAIR / 73

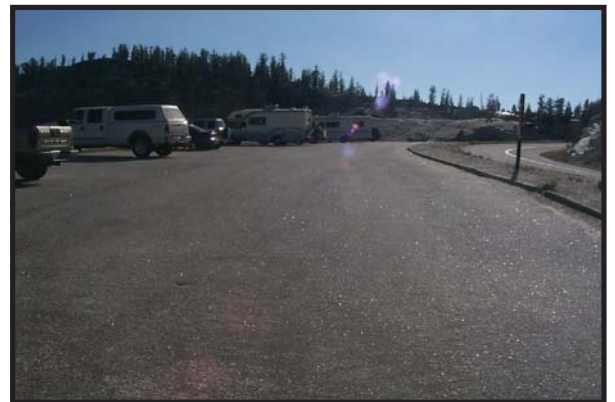
YOSEMITE NATIONAL PARK
Route 0938
 SUNRISE TRAILHEAD
 ADJACENT TO ROUTE 0017 AT MP 30.8 ON RIGHT

Route	Public / NonPublic	Date Visited	Area (sq ft)	Lane Miles *	Surface Type	Condition / PCR
0938	PUBLIC	7/16/2002	9915	0.17	AS	FAIR / 73

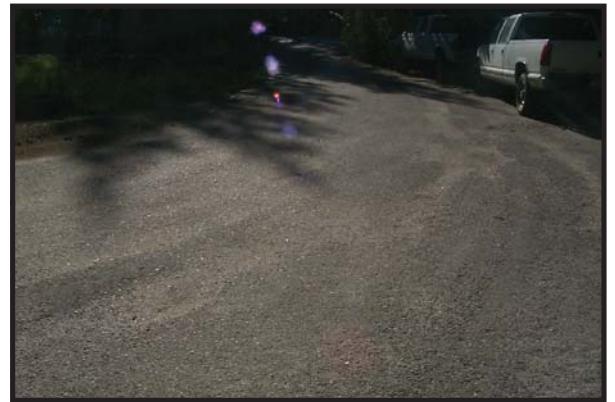
YOSEMITE NATIONAL PARK
Route 0940
 TENAYA LAKE PICNIC PARKING
 ADJACENT TO ROUTE 0017 AT MP 32.2 ON RIGHT

Route	Public / NonPublic	Date Visited	Area (sq ft)	Lane Miles *	Surface Type	Condition / PCR
0940	PUBLIC	7/16/2002	23982	0.41	AS	FAIR / 73

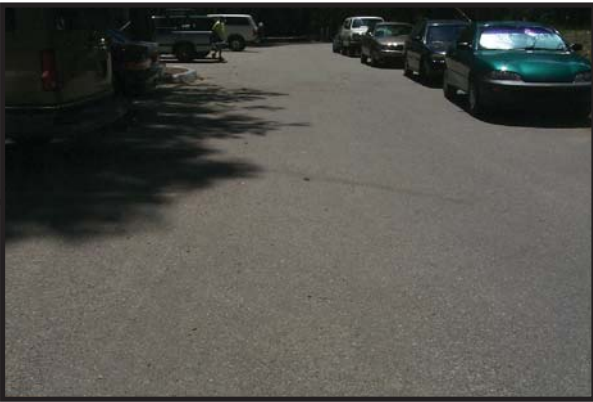
YOSEMITE NATIONAL PARK
Route 0948
 DANA MEADOWS
 ADJACENT TO ROUTE 0017 AT MP 46.4 ON RIGHT

Route	Public / NonPublic	Date Visited	Area (sq ft)	Lane Miles *	Surface Type	Condition / PCR
0948	PUBLIC	7/16/2002	10573	0.18	AS	GOOD / 90

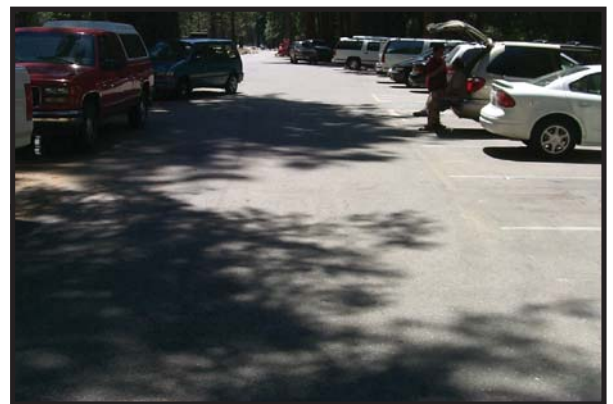
YOSEMITE NATIONAL PARK
Route 0951
 CHAPEL PARKING AREA
 ADJACENT TO ROUTE 0500 AT MP 4.9 ON RIGHT

Route	Public / NonPublic	Date Visited	Area (sq ft)	Lane Miles *	Surface Type	Condition / PCR
0951	PUBLIC	7/16/2002	11143	0.19	AS	FAIR / 73

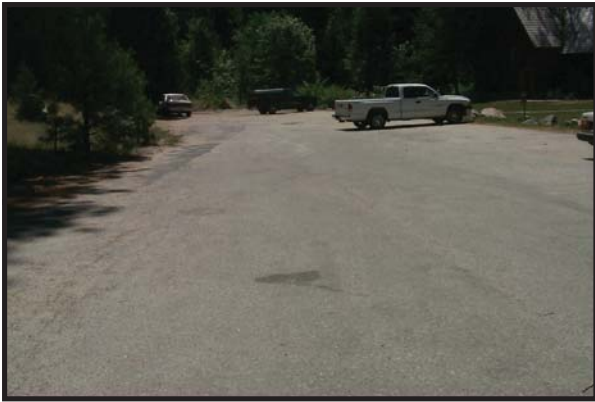
YOSEMITE NATIONAL PARK
Route 0952
LECONTE MEMORIAL PARKING
ADJACENT TO ROUTE 0500 ON RIGHT

Route	Public / NonPublic	Date Visited	Area (sq ft)	Lane Miles *	Surface Type	Condition / PCR
0952	PUBLIC	7/16/2002	5059	0.09	AS	FAIR / 73

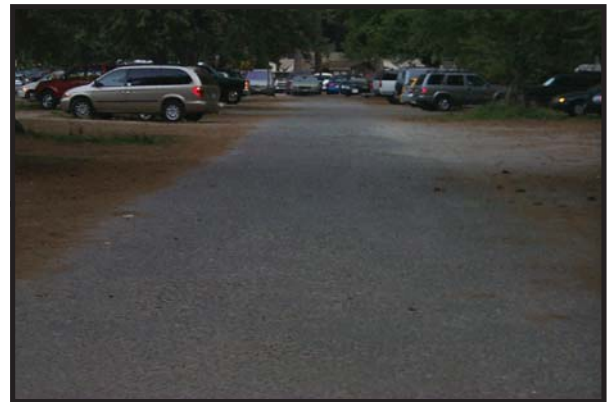
YOSEMITE NATIONAL PARK
Route 0955
 NORTH DOME PARKING
 ADJACENT TO ROUTE 0500 AT MP 6.5 ON RIGHT

Route	Public / NonPublic	Date Visited	Area (sq ft)	Lane Miles *	Surface Type	Condition / PCR
0955	PUBLIC	7/16/2002	2224	0.04	AS	FAIR / 73

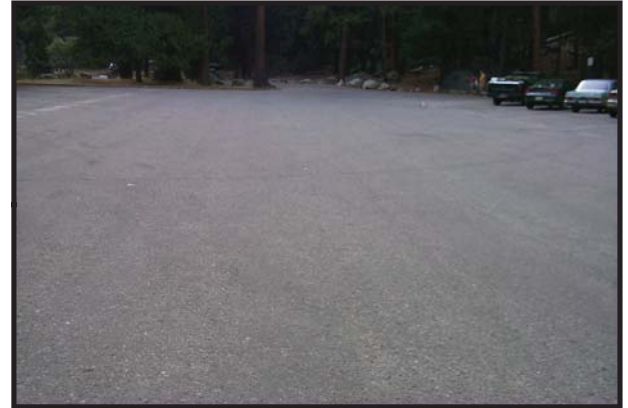
YOSEMITE NATIONAL PARK
Route 0962
 EL CAPITAN PICNIC AREA
 ADJACENT TO ROUTE 0500 AT MP 9.60 ON RIGHT

Route	Public / NonPublic	Date Visited	Area (sq ft)	Lane Miles *	Surface Type	Condition / PCR
0962	PUBLIC	7/16/2002	20272	0.35	AS	GOOD / 90

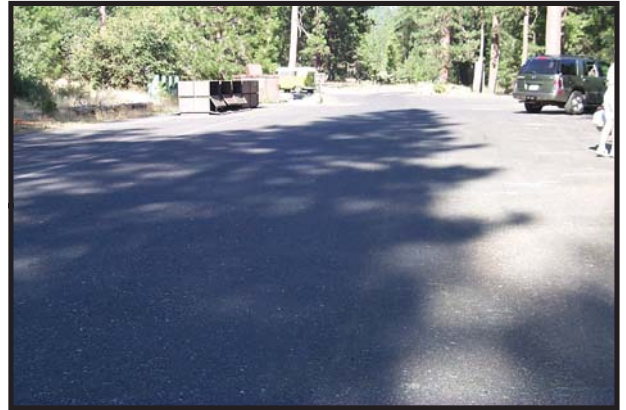
YOSEMITE NATIONAL PARK
Route 0963
 YOSEMITE VALLEY PARKING
 ADJACENT TO ROUTE 0500 AT MP 12.20 ON LEFT

Route	Public / NonPublic	Date Visited	Area (sq ft)	Lane Miles *	Surface Type	Condition / PCR
0963	PUBLIC	7/16/2002	4350	0.07	AS	FAIR / 73

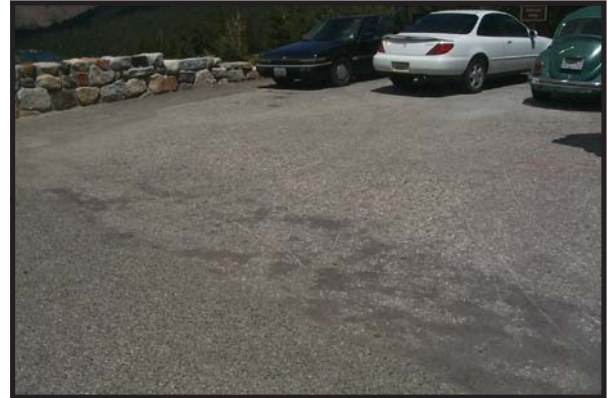
YOSEMITE NATIONAL PARK

Route	Public / NonPublic	Date Visited	Area (sq ft)	Lane Miles *	Surface Type	Condition / PCR
0973	PUBLIC	7/16/2002	5287	0.09	AS	POOR / 45

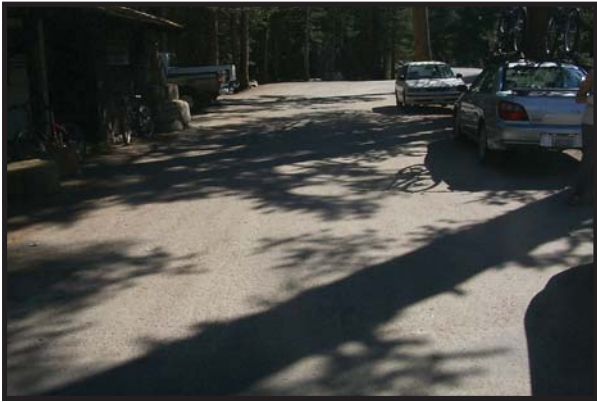
YOSEMITE NATIONAL PARK
Route 0974
TIOGA ROAD MP 4.8 TURNOUT
ADJACENT TO ROUTE 0017 AT MP 4.8 ON RIGHT

Route	Public / NonPublic	Date Visited	Area (sq ft)	Lane Miles *	Surface Type	Condition / PCR
0974	PUBLIC	7/16/2002	5978	0.10	AS	POOR / 45

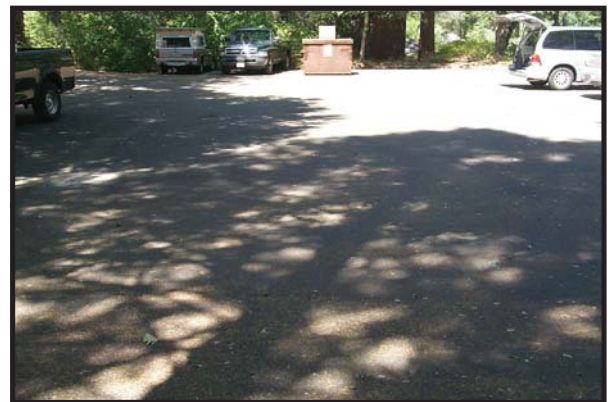
YOSEMITE NATIONAL PARK
Route 0976A
CASCADE FALLS PARKING AREA A
ADJACENT TO ROUTE 0016 AT MP 5 ON RIGHT

Route	Public / NonPublic	Date Visited	Area (sq ft)	Lane Miles *	Surface Type	Condition / PCR
0976A	PUBLIC	7/16/2002	9712	0.17	AS	GOOD / 90

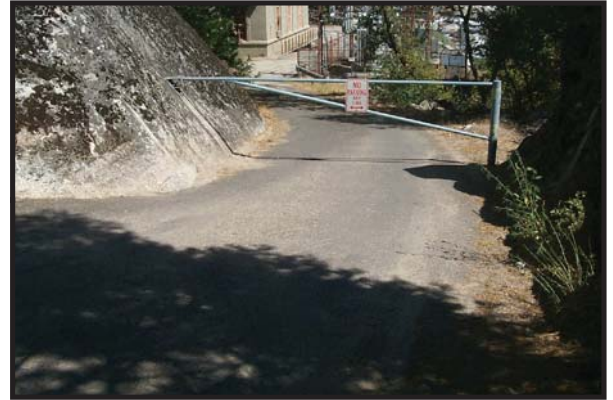
YOSEMITE NATIONAL PARK
Route 0978
 O'SHAUGHNESSY DAM PARKING
 ADJACENT TO ROUTE 0100 JUST BEFORE DAM

Route	Public / NonPublic	Date Visited	Area (sq ft)	Lane Miles *	Surface Type	Condition / PCR
0978	PUBLIC	7/16/2002	7069	0.12	AS	POOR / 45

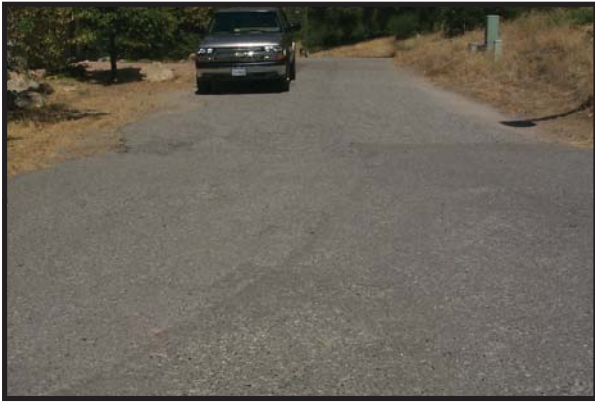
YOSEMITE NATIONAL PARK
Route 0980
 HAPPY ISLES WATER TANK PARKING
 AT END OF ROUTE 0417

Route	Public / NonPublic	Date Visited	Area (sq ft)	Lane Miles *	Surface Type	Condition / PCR
0980	NONPUBLIC	7/16/2002	8592	0.15	AS	GOOD / 90
