**The Road Inventory
of
Sleeping Bear Dunes National Lakeshore
SLBE – 6620
Cycle 4**

**Prepared By:
Federal Highway Administration
Road Inventory Program
Cycle 4**

Sleeping Bear Dunes National Lakeshore in Michigan

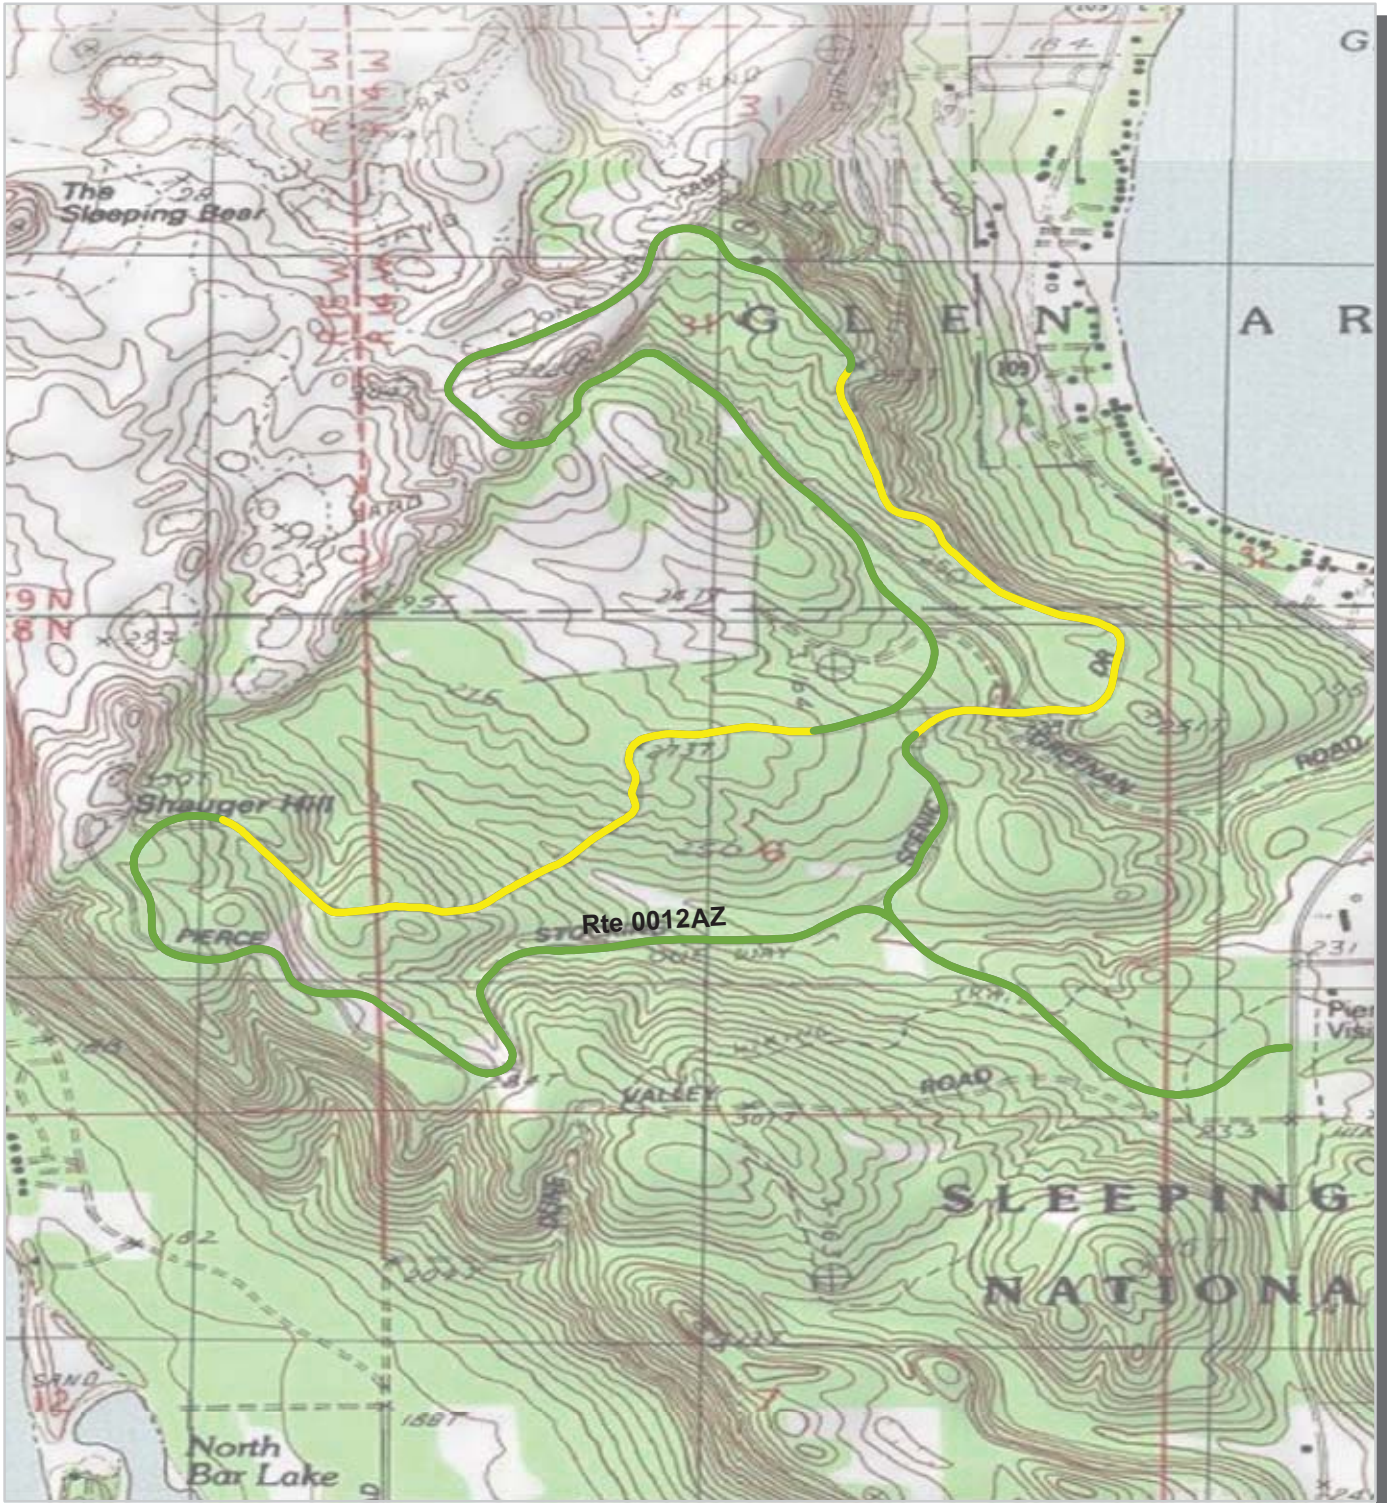
Sleeping Bear Dunes National Lakeshore Route Condition Map PCR - Mile by Mile Area 2

PCR	Poor		Fair		Good		Excellent		No Data	
	(<=60)		(61 - 84)	(85 - 94)	(95 - 100)

* If the PCR rating is not available for a section, the SCR rating will be displayed. See appendix for definitions and formulas.

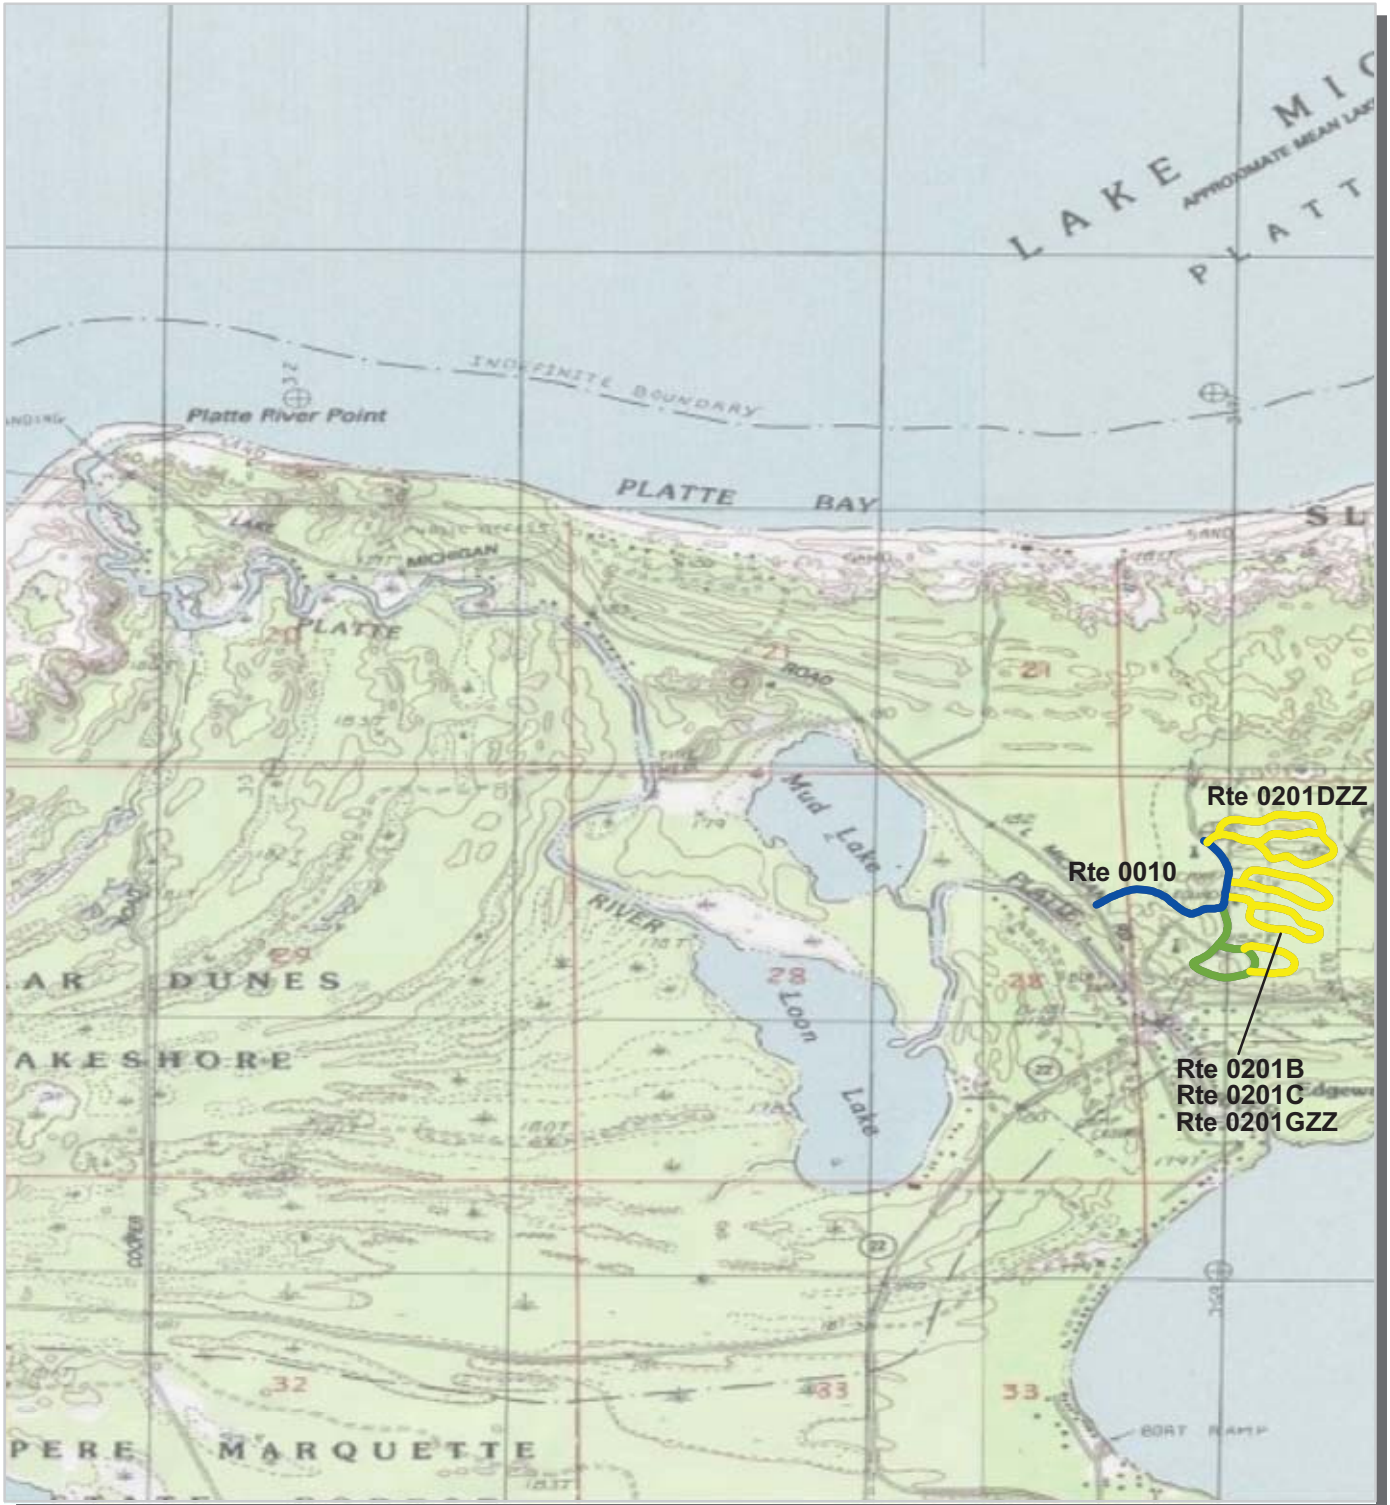
**Sleeping Bear Dunes National Lakeshore
Route Condition Map
PCR - Mile by Mile
Area 4**

PCR	Poor (≤60)	Fair (61 - 84)	Good (85 - 94)	Excellent (95 - 100)	No Data
-----	--	---	--	---	--

* If the PCR rating is not available for a section, the SCR rating will be displayed. See appendix for definitions and formulas.

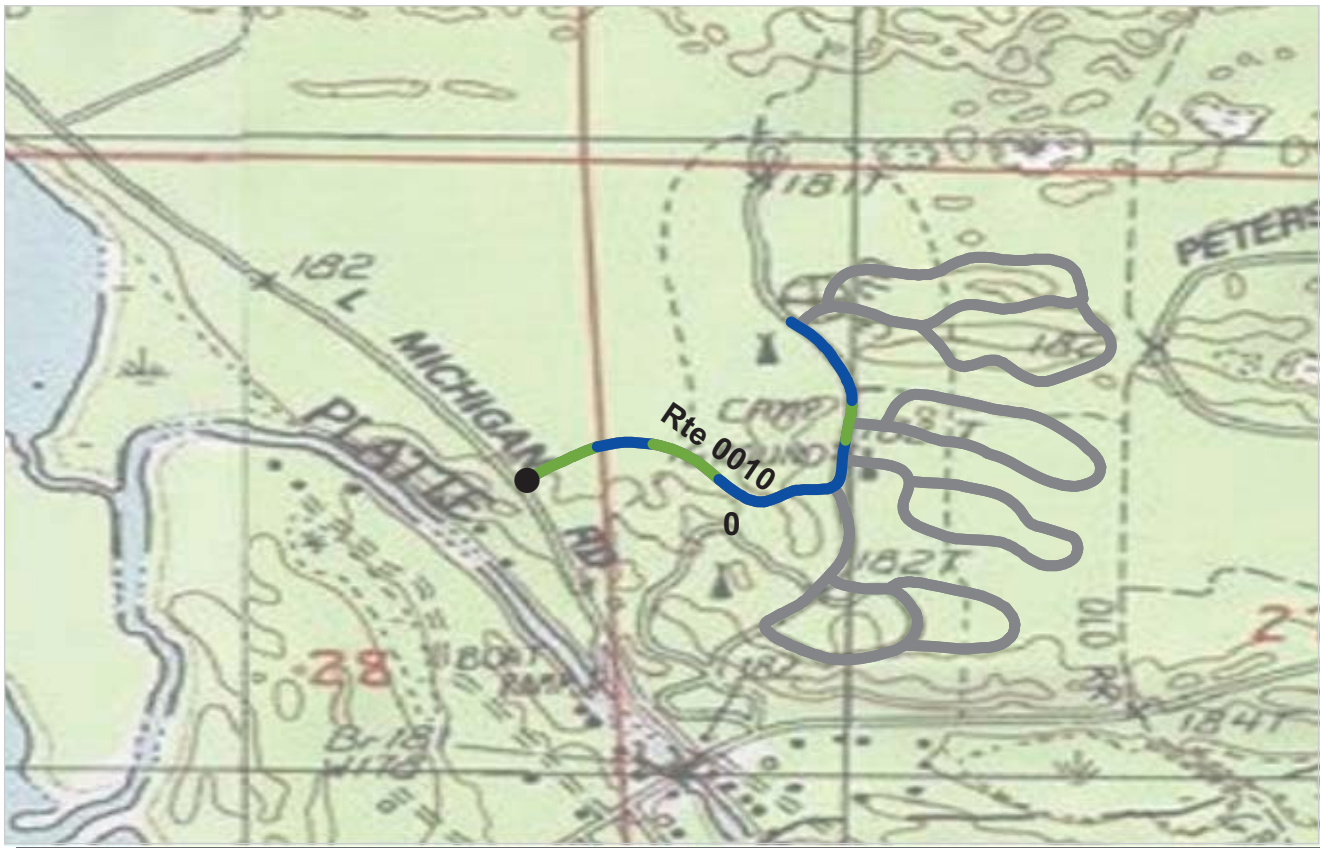
Section Number	0				
Section Length (mi)	0.43				
Traffic	Traffic data may be found at www.efl.fhwa.dot.gov Click on PROGRAMS / NPS Traffic Data (Note: Not all parks have traffic data)				
Cross Section Information					
Number of Lanes	2				
Paved Width (ft)	25				
Lane Width (ft)	10				
Shoulder Width Right (ft)	NC				
Shoulder Width Left (ft)	NC				
Roadway Condition Information					
SCR (Surface Condition Rating)	97				
PCR (Pavement Condition Rating)	95				
Distress Index Values					
Alligator Cracking Index	100				
Longitudinal Cracking Index	100				
Transverse Cracking Index	100				
Patching Index	100				
Rutting Index	97				
Roughness Condition Index (RCI)	90

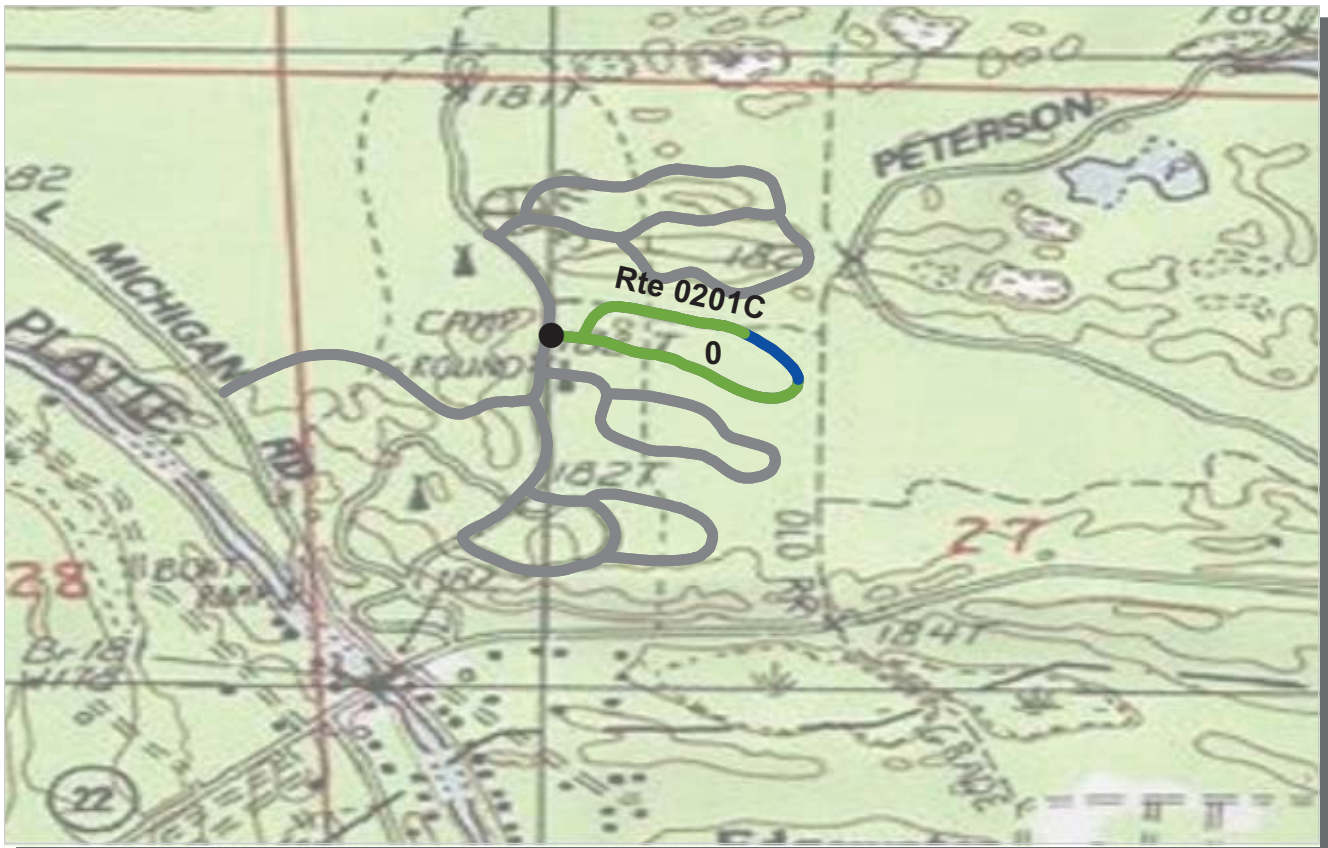
ROUTE: 0201B PRCG LOOP 2 ROAD

Section Number	0				
Section Length (mi)	0.38				
Traffic	Traffic data may be found at www.efl.fhwa.dot.gov Click on PROGRAMS / NPS Traffic Data (Note: Not all parks have traffic data)				
Cross Section Information					
Number of Lanes	1				
Paved Width (ft)	16				
Lane Width (ft)	13				
Shoulder Width Right (ft)	NC				
Shoulder Width Left (ft)	NC				
Roadway Condition Information					
SCR (Surface Condition Rating)	85				
PCR (Pavement Condition Rating)	81				
Distress Index Values					
Alligator Cracking Index	100				
Longitudinal Cracking Index	100				
Transverse Cracking Index	100				
Patching Index	100				
Rutting Index	86				
Roughness Condition Index (RCI)	69

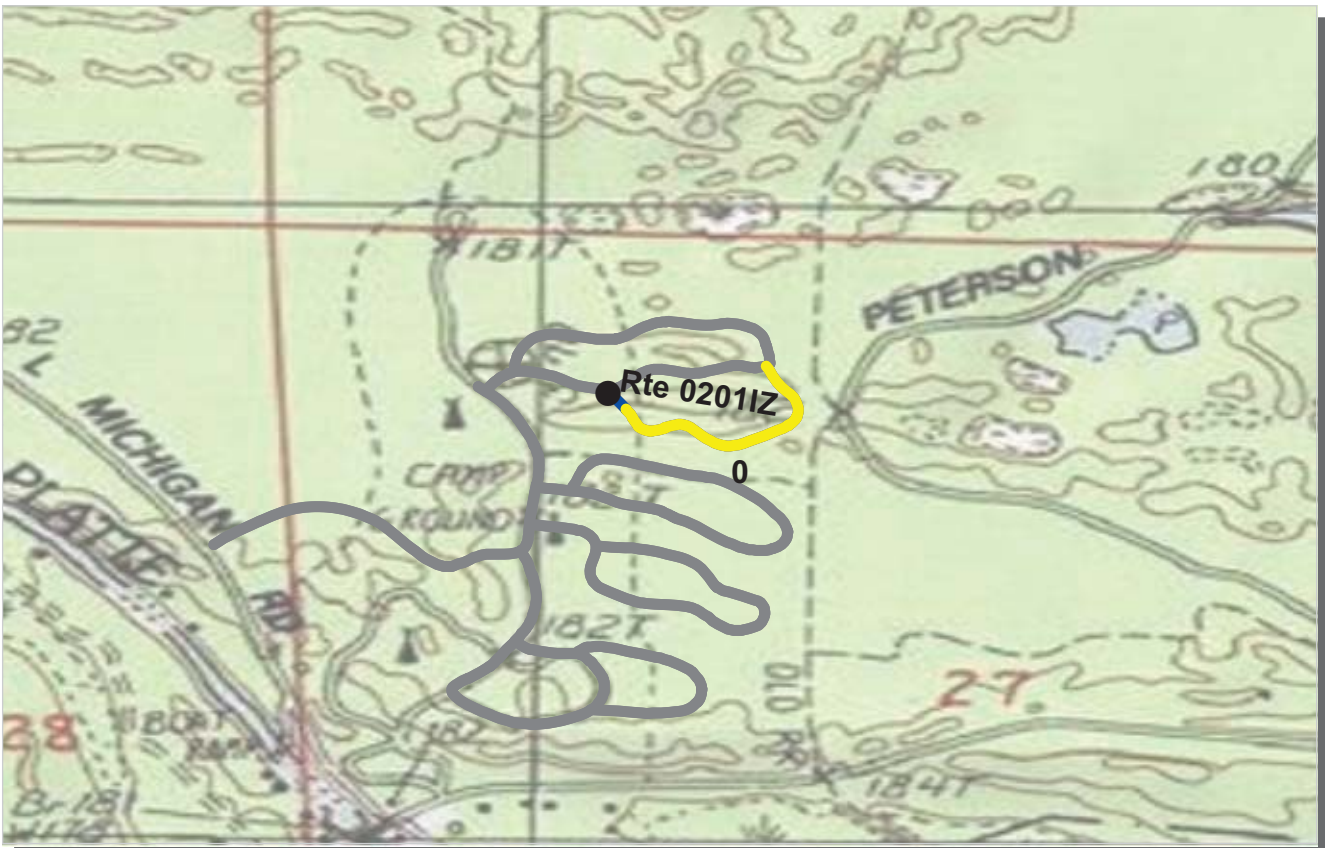
ROUTE: 0201DZ PRCG LOOP 4DZ ROAD

Section Number	0				
Section Length (mi)	0.45				
Traffic	Traffic data may be found at www.efl.fhwa.dot.gov Click on PROGRAMS / NPS Traffic Data (Note: Not all parks have traffic data)				
Cross Section Information					
Number of Lanes	1				
Paved Width (ft)	15				
Lane Width (ft)	14				
Shoulder Width Right (ft)	NC				
Shoulder Width Left (ft)	NC				
Roadway Condition Information					
SCR (Surface Condition Rating)	86				
PCR (Pavement Condition Rating)	81				
Distress Index Values					
Alligator Cracking Index	100				
Longitudinal Cracking Index	100				
Transverse Cracking Index	100				
Patching Index	100				
Rutting Index	86				
Roughness Condition Index (RCI)	56

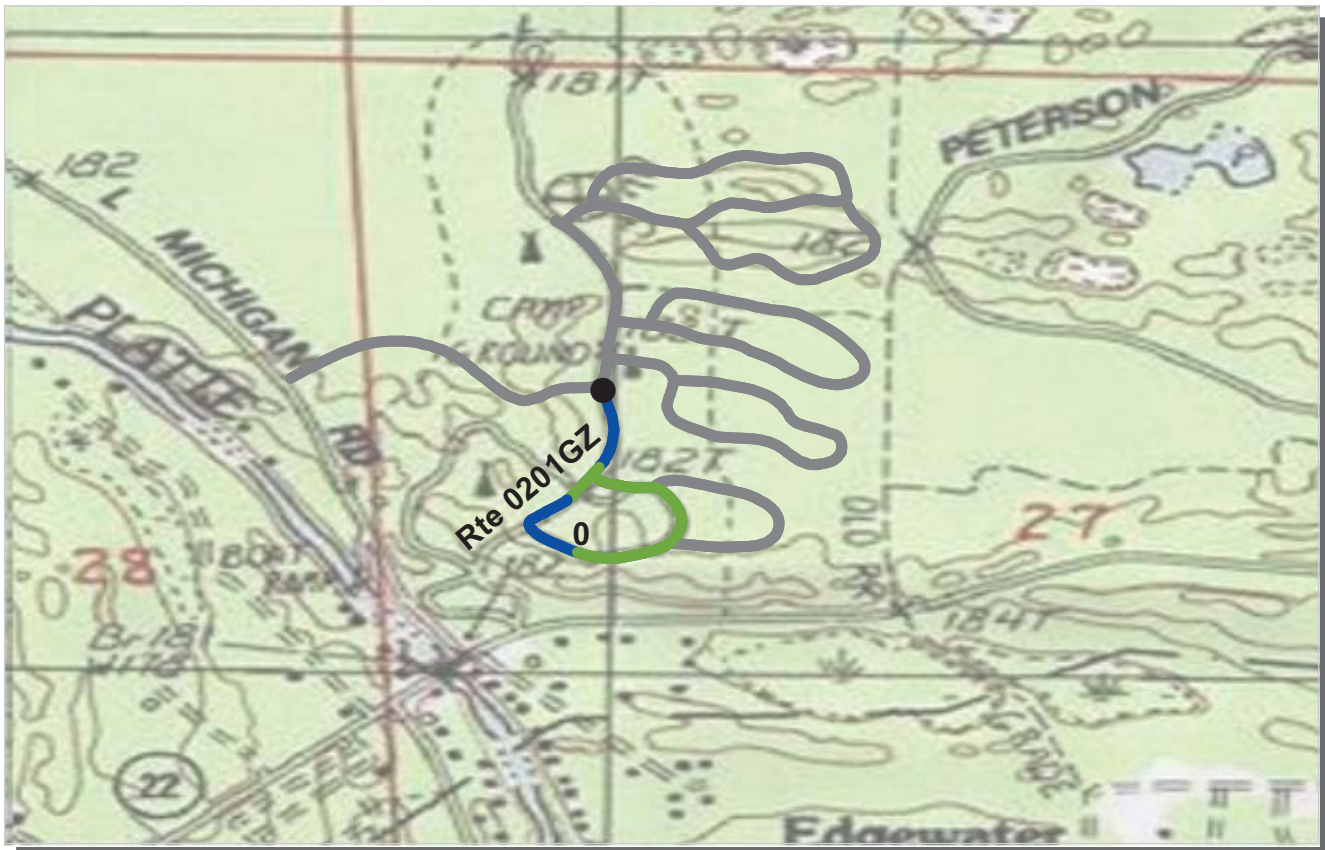
ROUTE: 0201GZZ PRCG LOOP 1 ROAD

Section Number					
Section Length (mi)					
Traffic	Traffic data may be found at www.efl.fhwa.dot.gov Click on PROGRAMS / NPS Traffic Data (Note: Not all parks have traffic data)				
Cross Section Information					
Number of Lanes	N/A				
Paved Width (ft)	N/A				
Lane Width (ft)	N/A				
Shoulder Width Right (ft)	NC				
Shoulder Width Left (ft)	NC				
Roadway Condition Information					
SCR (Surface Condition Rating)	91				
PCR (Pavement Condition Rating)	87				
Distress Index Values					
Alligator Cracking Index	N/A				
Longitudinal Cracking Index	N/A				
Transverse Cracking Index	N/A				
Patching Index	N/A				
Rutting Index	N/A				
Roughness Condition Index (RCI)	N/A

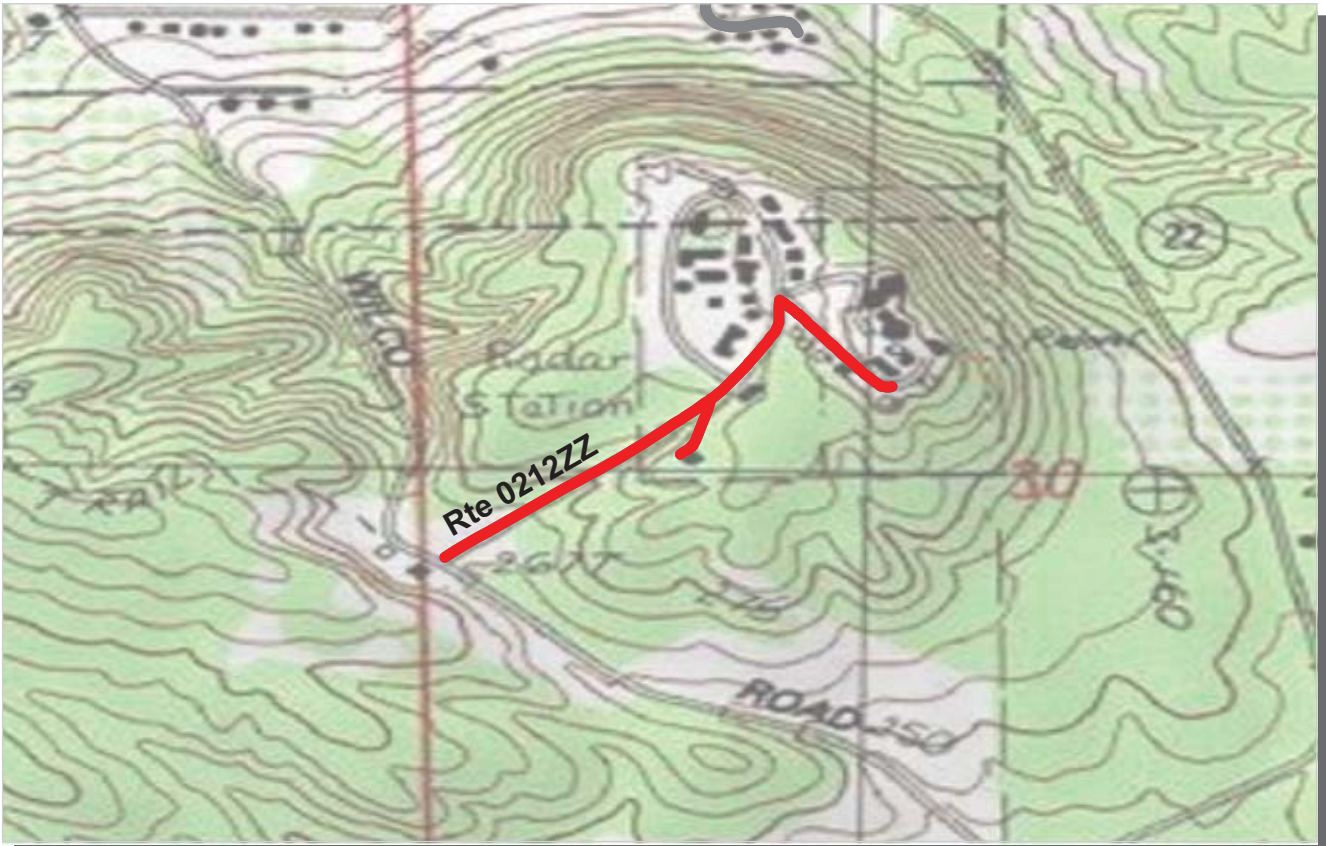
ROUTE: 0201HZ PRCG LOOP 1HZ ROAD

Section Number	0				
Section Length (mi)	0.20				
Traffic	Traffic data may be found at www.efl.fhwa.dot.gov Click on PROGRAMS / NPS Traffic Data (Note: Not all parks have traffic data)				
Cross Section Information					
Number of Lanes	1				
Paved Width (ft)	14				
Lane Width (ft)	14				
Shoulder Width Right (ft)	NC				
Shoulder Width Left (ft)	NC				
Roadway Condition Information					
SCR (Surface Condition Rating)	91				
PCR (Pavement Condition Rating)	84				
Distress Index Values					
Alligator Cracking Index	100				
Longitudinal Cracking Index	100				
Transverse Cracking Index	100				
Patching Index	100				
Rutting Index	91				
Roughness Condition Index (RCI)	66

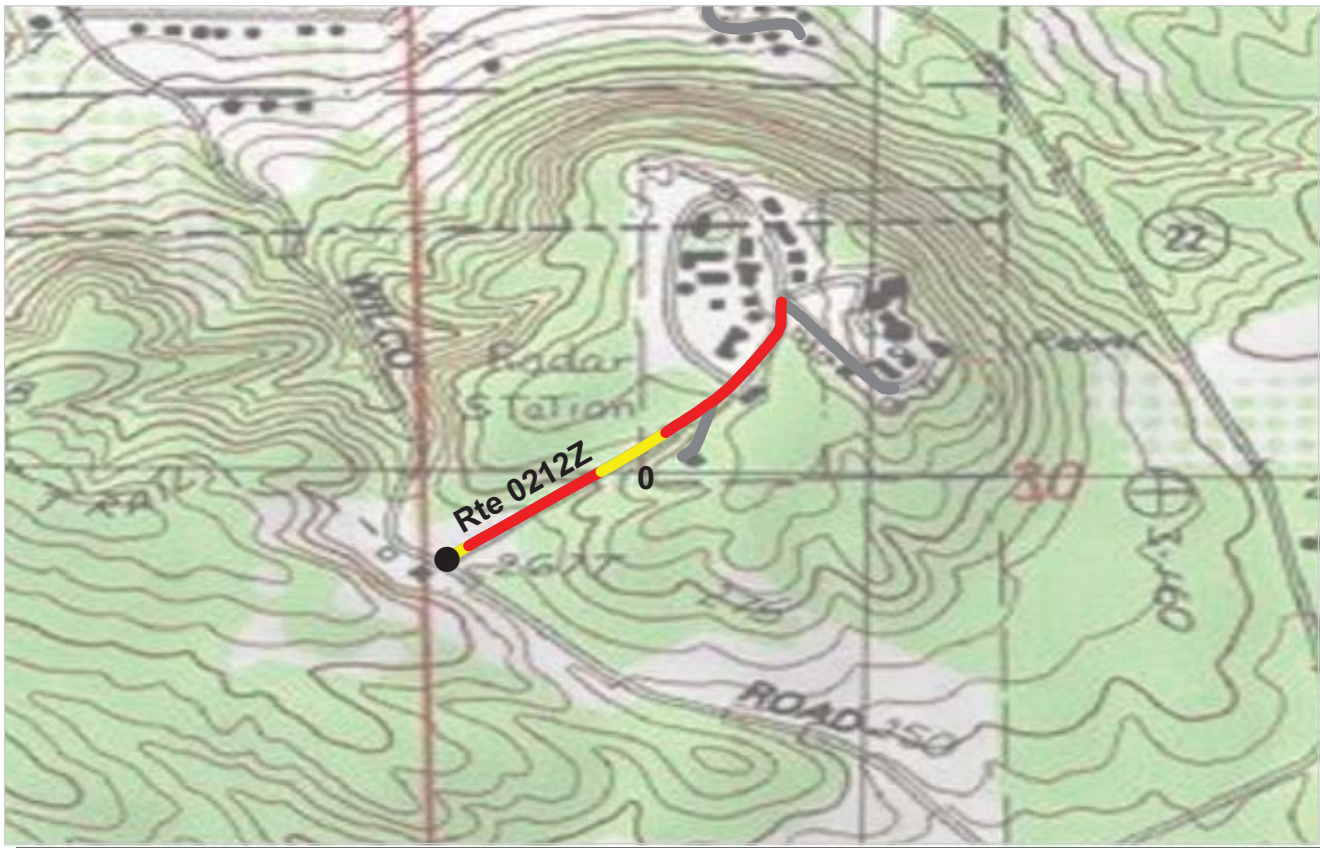
ROUTE: 0212ZZ EMPIRE MAINTENANCE AREA ROADS

Section Number					
Section Length (mi)					
Traffic	Traffic data may be found at www.efl.fhwa.dot.gov Click on PROGRAMS / NPS Traffic Data (Note: Not all parks have traffic data)				
Cross Section Information					
Number of Lanes	N/A				
Paved Width (ft)	N/A				
Lane Width (ft)	N/A				
Shoulder Width Right (ft)	NC				
Shoulder Width Left (ft)	NC				
Roadway Condition Information					
SCR (Surface Condition Rating)	58				
PCR (Pavement Condition Rating)	59				
Distress Index Values					
Alligator Cracking Index	N/A				
Longitudinal Cracking Index	N/A				
Transverse Cracking Index	N/A				
Patching Index	N/A				
Rutting Index	N/A				
Roughness Condition Index (RCI)	N/A

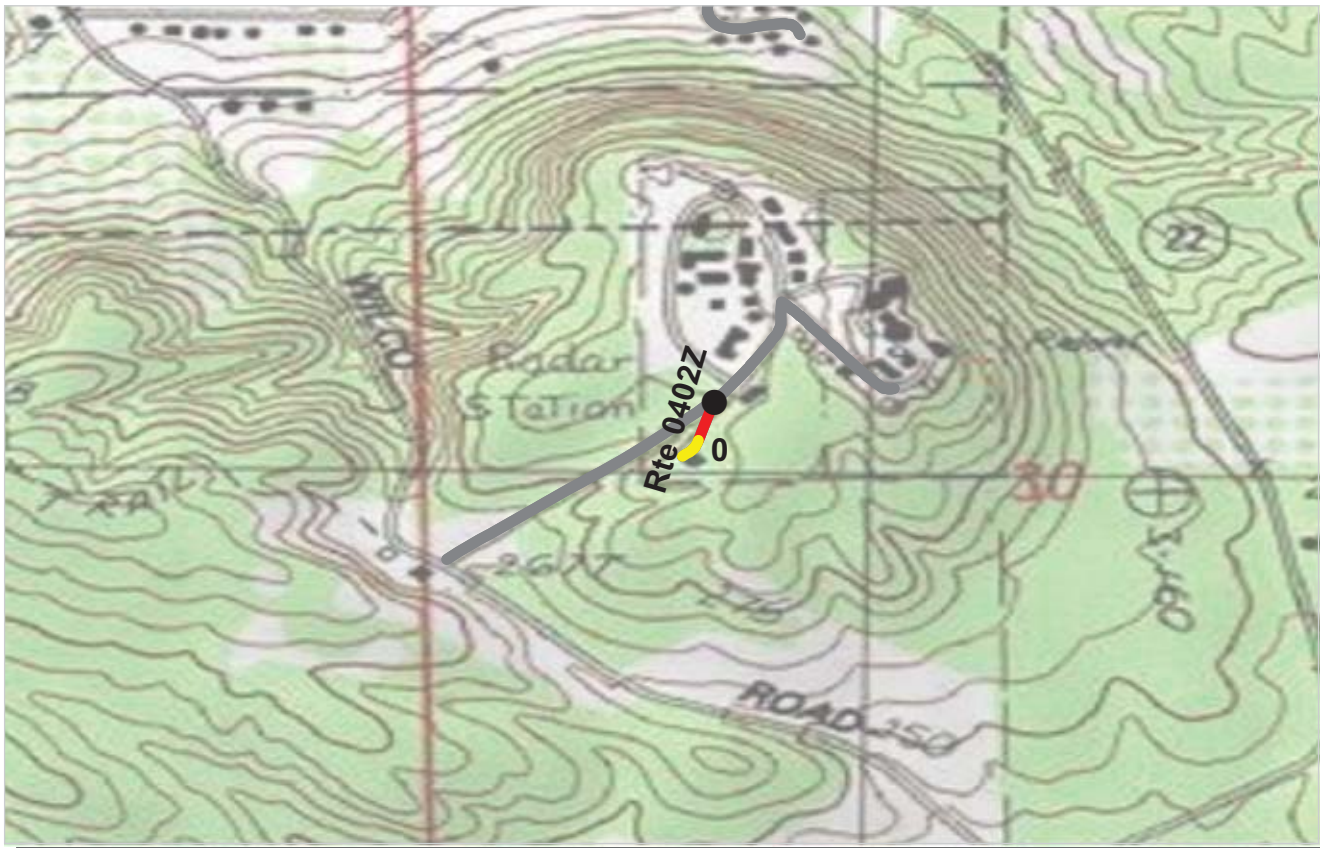
ROUTE: 0212Z EMPIRE MAINTENANCE ACCESS ROAD (WISNEWSKI RD)

Section Number	0				
Section Length (mi)	0.36				
Traffic	Traffic data may be found at www.efl.fhwa.dot.gov Click on PROGRAMS / NPS Traffic Data (Note: Not all parks have traffic data)				
Cross Section Information					
Number of Lanes	2				
Paved Width (ft)	24				
Lane Width (ft)	12				
Shoulder Width Right (ft)	NC				
Shoulder Width Left (ft)	NC				
Roadway Condition Information					
SCR (Surface Condition Rating)	51				
PCR (Pavement Condition Rating)	53				
Distress Index Values					
Alligator Cracking Index	65				
Longitudinal Cracking Index	95				
Transverse Cracking Index	98				
Patching Index	99				
Rutting Index	93				
Roughness Condition Index (RCI)	60

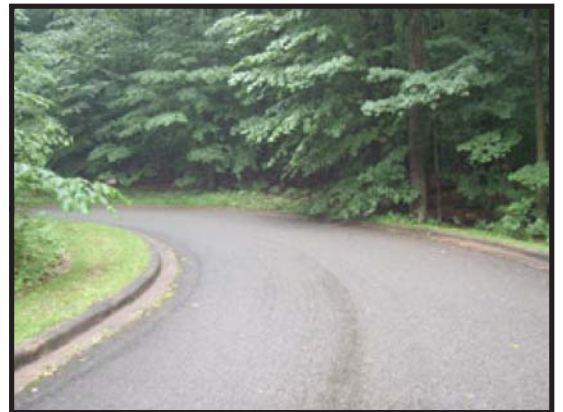
Route Number	Public / NonPublic	Date Visited		Area (sq ft)	Lane Miles *	Surface Type
0012BZ	PUBLIC	7/18/2008		5,297	0.09	AS
Culverts	Drop Inlets	Gates	Fire Hydrants	Curb & Gutter	Curb	PCR
0	0	0	0	CONCRETE CURB AND GUTTER	NO CURB	FAIR/73

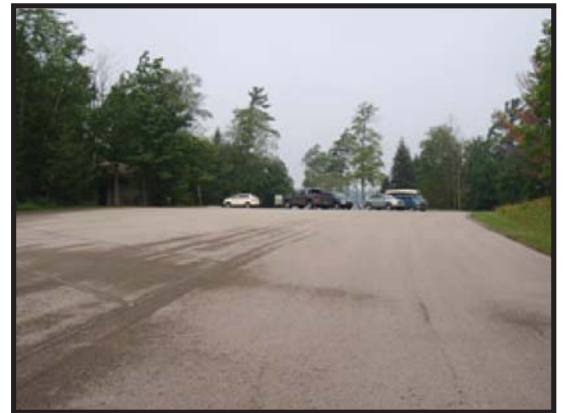
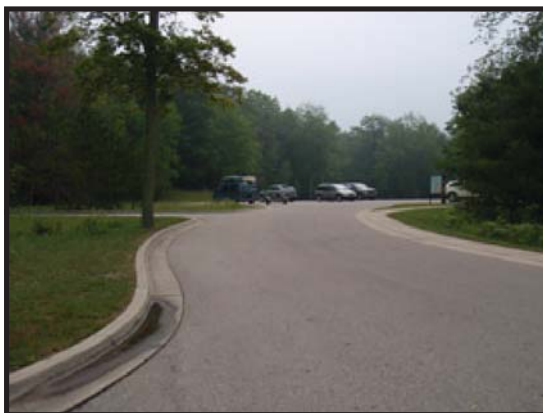
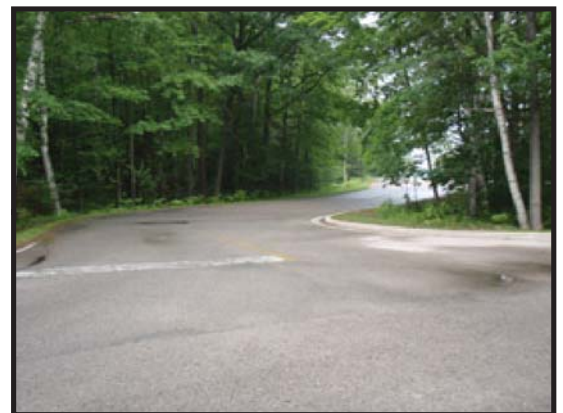
Route Number	Public / NonPublic	Date Visited		Area (sq ft)	Lane Miles *	Surface Type
0900	PUBLIC	7/18/2008		50,871	0.88	AS
Culverts	Drop Inlets	Gates	Fire Hydrants	Curb & Gutter	Curb	PCR
0	0	0	0	CONCRETE CURB AND GUTTER	CONCRETE CURB	GOOD/90

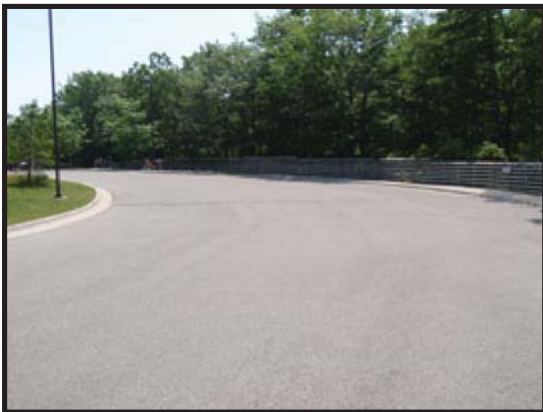
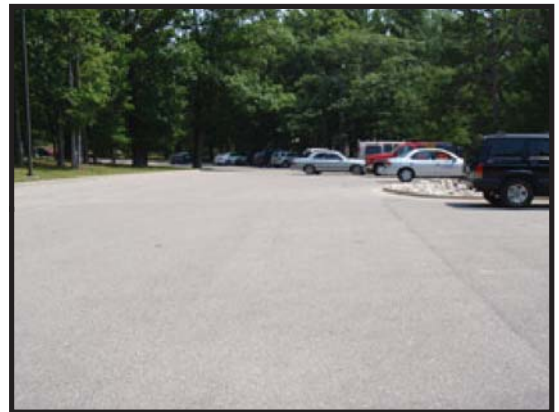
Route Number	Public / NonPublic	Date Visited		Area (sq ft)	Lane Miles *	Surface Type
0901	PUBLIC	7/17/2008		27,385	0.47	AS
Culverts	Drop Inlets	Gates	Fire Hydrants	Curb & Gutter	Curb	PCR
0	0	0	0	CONCRETE CURB AND GUTTER	NO CURB	GOOD/90

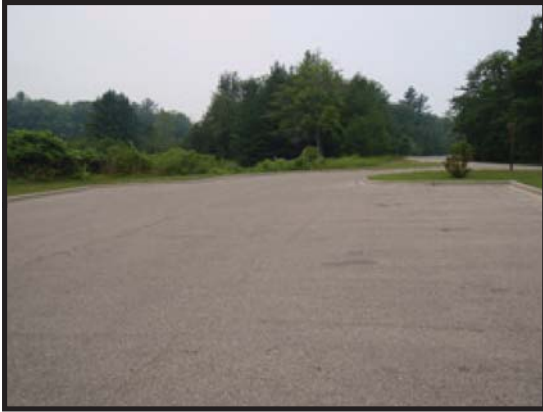
Route Number	Public / NonPublic	Date Visited		Area (sq ft)	Lane Miles *	Surface Type
0902	PUBLIC	7/18/2008		10,337	0.18	AS
Culverts	Drop Inlets	Gates	Fire Hydrants	Curb & Gutter	Curb	PCR
0	0	0	0	CONCRETE CURB AND GUTTER	NO CURB	FAIR/73

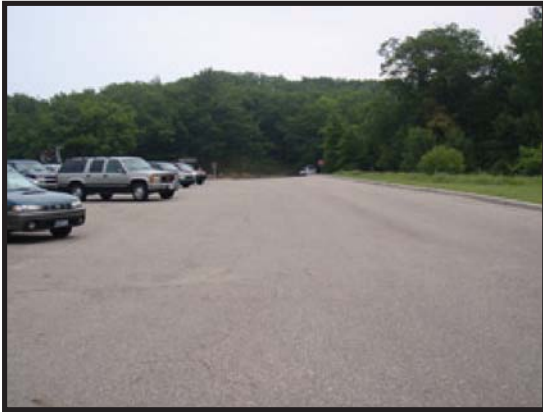
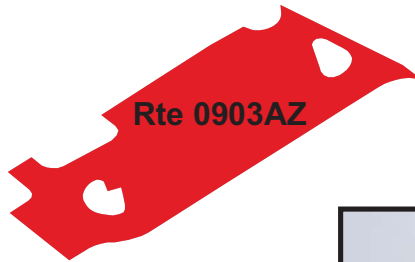
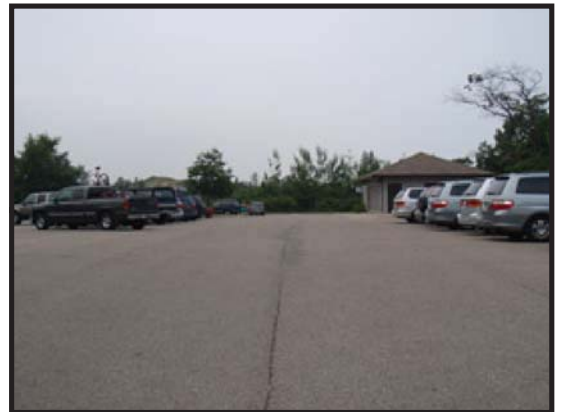
Route Number	Public / NonPublic	Date Visited		Area (sq ft)	Lane Miles *	Surface Type
0903AZ	PUBLIC	7/18/2008		32,412	0.56	AS
Culverts	Drop Inlets	Gates	Fire Hydrants	Curb & Gutter	Curb	PCR
0	1	0	0	CONCRETE CURB AND GUTTER	NO CURB	FAIR/73

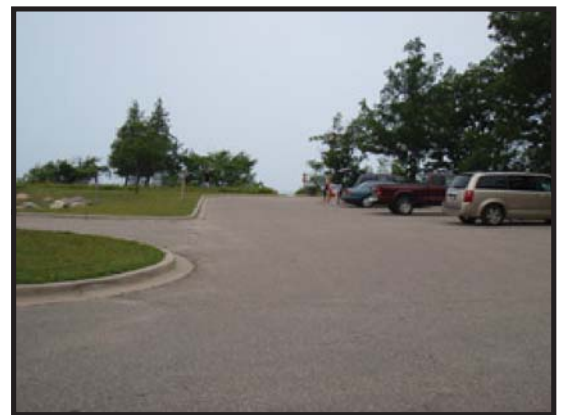
Route Number	Public / NonPublic	Date Visited		Area (sq ft)	Lane Miles *	Surface Type
0903BZ	PUBLIC	7/18/2008		8,364	0.14	AS
Culverts	Drop Inlets	Gates	Fire Hydrants	Curb & Gutter	Curb	PCR
0	1	0	0	CONCRETE CURB AND GUTTER	NO CURB	GOOD/90

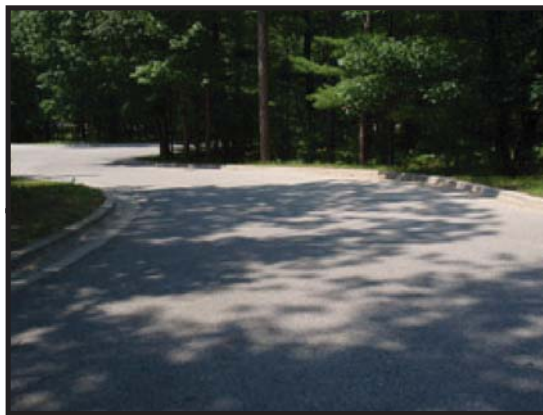
Route Number	Public / NonPublic	Date Visited		Area (sq ft)	Lane Miles *	Surface Type
0904Z	PUBLIC	7/17/2008		8,728	0.15	AS
Culverts	Drop Inlets	Gates	Fire Hydrants	Curb & Gutter	Curb	PCR
0	0	0	1	CONCRETE CURB AND GUTTER	NO CURB	GOOD/90

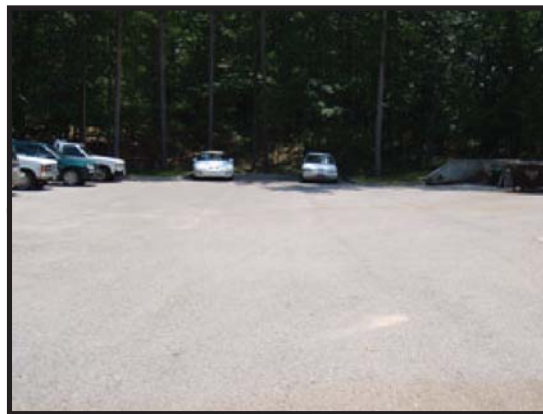
Route Number	Public / NonPublic	Date Visited		Area (sq ft)	Lane Miles *	Surface Type
0905Z	PUBLIC	7/17/2008		4,390	0.08	AS
Culverts	Drop Inlets	Gates	Fire Hydrants	Curb & Gutter	Curb	PCR
0	0	0	0	CONCRETE CURB AND GUTTER	NO CURB	GOOD/90

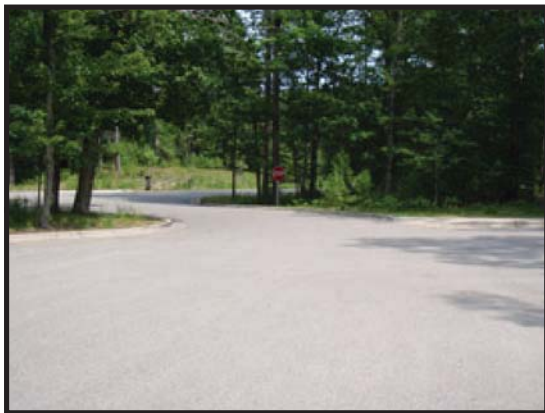
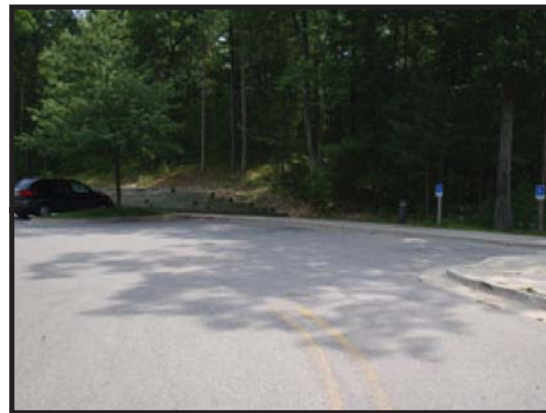
Route Number	Public / NonPublic	Date Visited		Area (sq ft)	Lane Miles *	Surface Type
0906Z	PUBLIC	7/17/2008		10,757	0.19	AS
Culverts	Drop Inlets	Gates	Fire Hydrants	Curb & Gutter	Curb	PCR
0	0	0	0	CONCRETE CURB AND GUTTER	NO CURB	GOOD/90

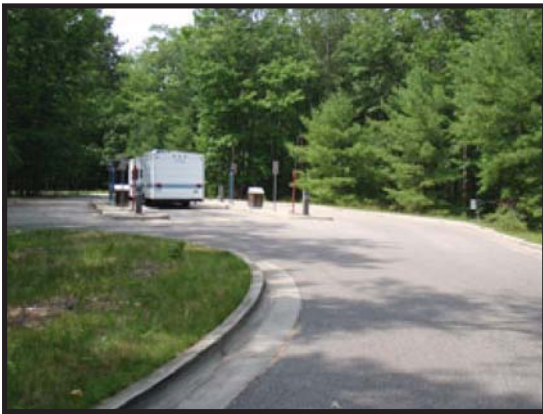
Route Number	Public / NonPublic	Date Visited		Area (sq ft)	Lane Miles *	Surface Type
0907Z	PUBLIC	7/17/2008		8,698	0.15	AS
Culverts	Drop Inlets	Gates	Fire Hydrants	Curb & Gutter	Curb	PCR
0	0	0	0	CONCRETE CURB AND GUTTER	NO CURB	GOOD/90

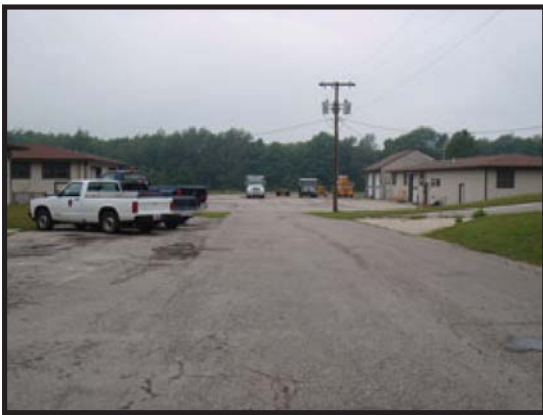
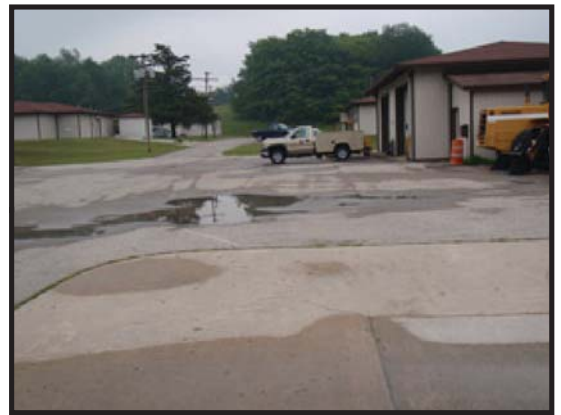
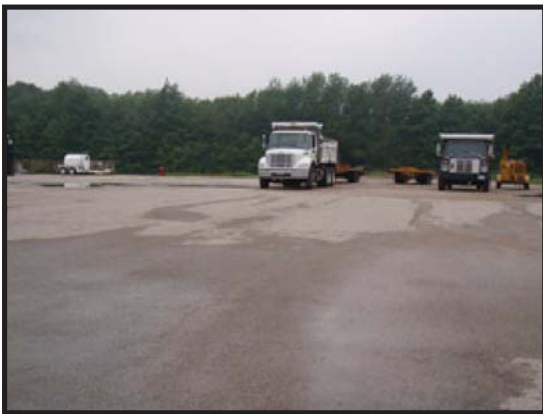
Route Number	Public / NonPublic	Date Visited		Area (sq ft)	Lane Miles *	Surface Type
0910AZ	PUBLIC	7/18/2008		72,163	1.24	AS
Culverts	Drop Inlets	Gates	Fire Hydrants	Curb & Gutter	Curb	PCR
0	1	0	3	NO CURB AND GUTTER	ASPHALT CURB	POOR/45

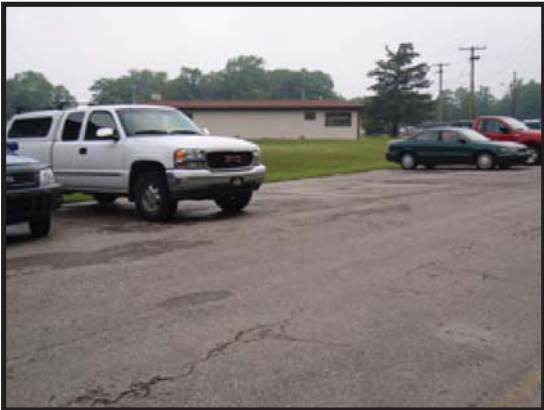
Route 0910DZ

Route Number	Public / NonPublic	Date Visited		Area (sq ft)	Lane Miles *	Surface Type
0910DZ	PUBLIC	7/18/2008		1,069	0.02	AS
Culverts	Drop Inlets	Gates	Fire Hydrants	Curb & Gutter	Curb	PCR
0	0	0	0	NO CURB AND GUTTER	NO CURB	FAIR/73

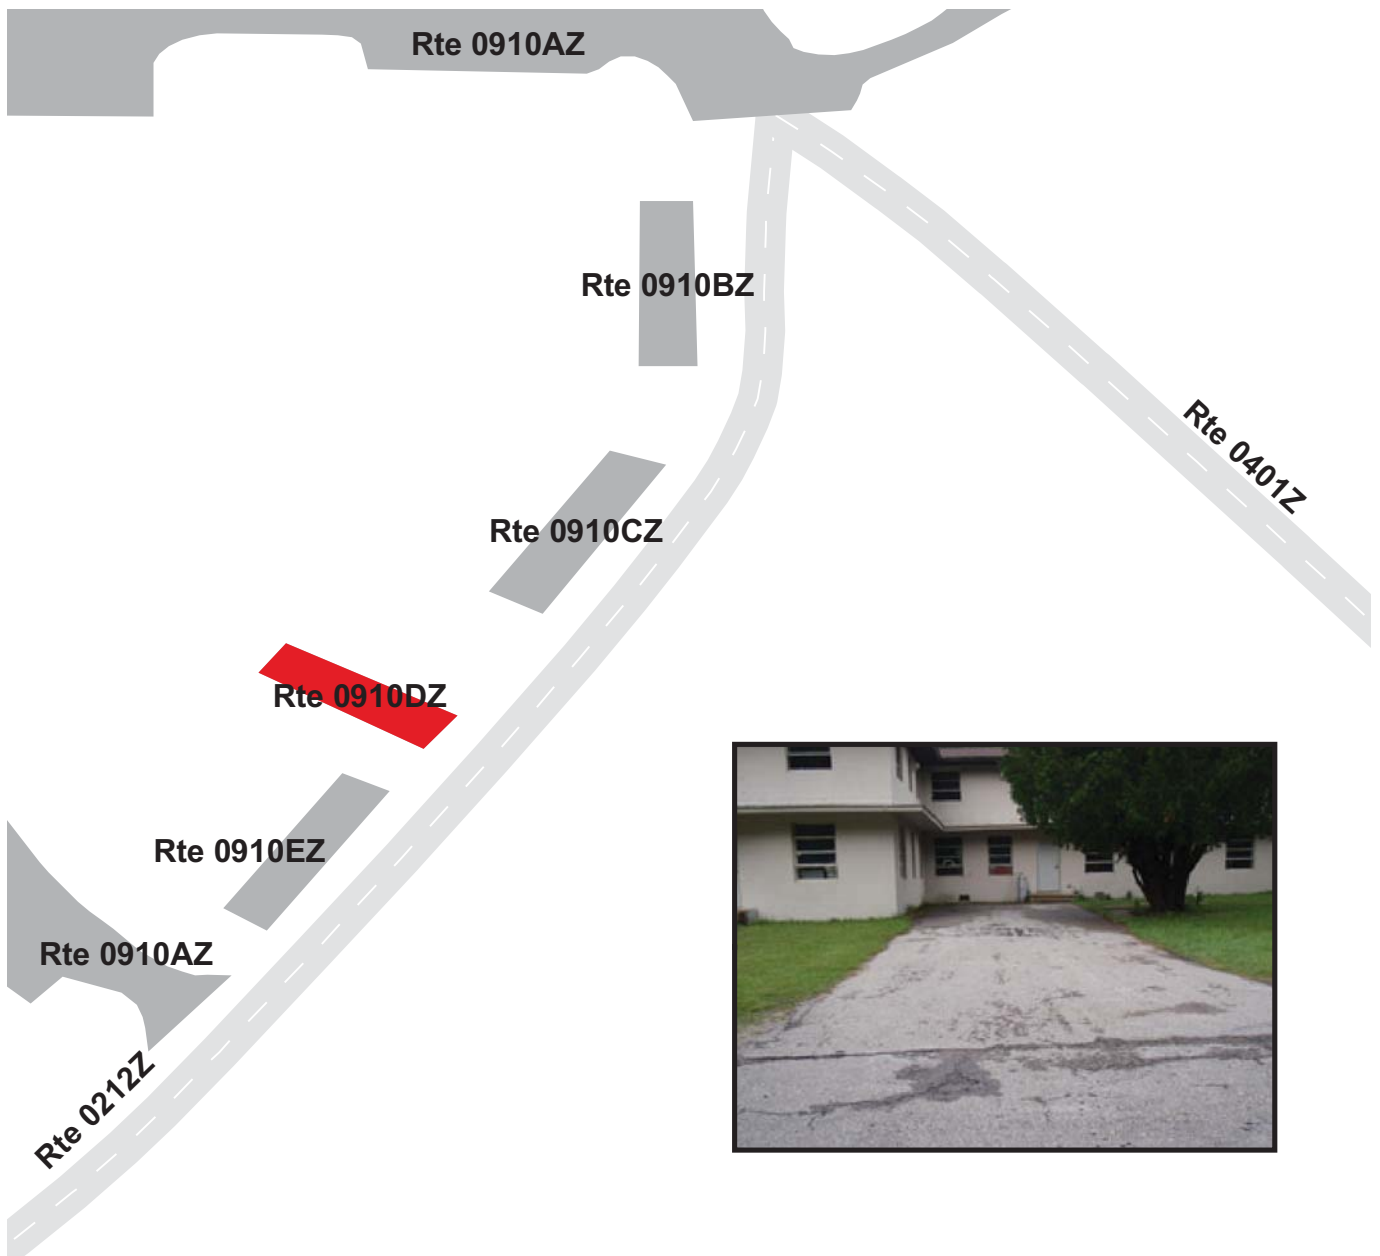
Route 0910EZ

Route Number	Public / NonPublic	Date Visited		Area (sq ft)	Lane Miles *	Surface Type
0910EZ	PUBLIC	7/18/2008		1,234	0.02	AS
Culverts	Drop Inlets	Gates	Fire Hydrants	Curb & Gutter	Curb	PCR
0	0	0	0	NO CURB AND GUTTER	NO CURB	FAIR/73

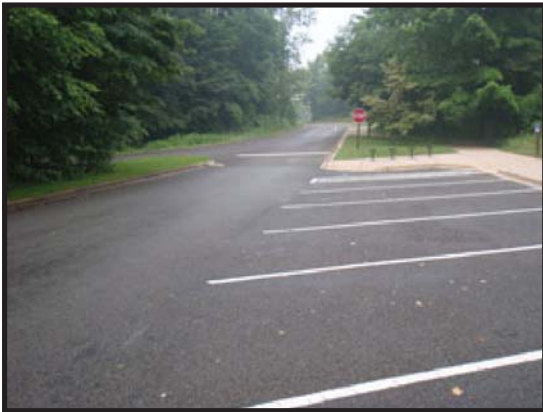
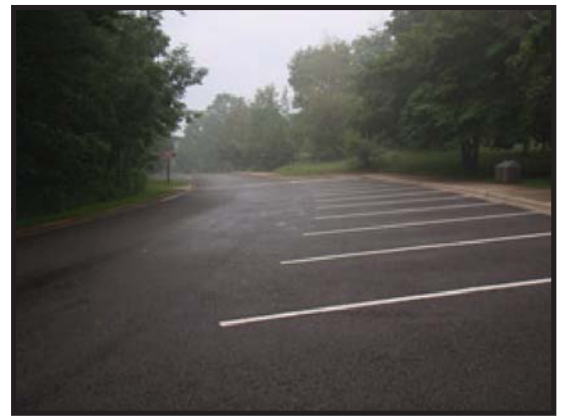
Route 0915Z

Route Number	Public / NonPublic	Date Visited		Area (sq ft)	Lane Miles *	Surface Type
0915Z	PUBLIC	7/18/2008		18,413	0.32	AS
Culverts	Drop Inlets	Gates	Fire Hydrants	Curb & Gutter	Curb	PCR
0	0	0	0	CONCRETE CURB AND GUTTER	NO CURB	GOOD/90

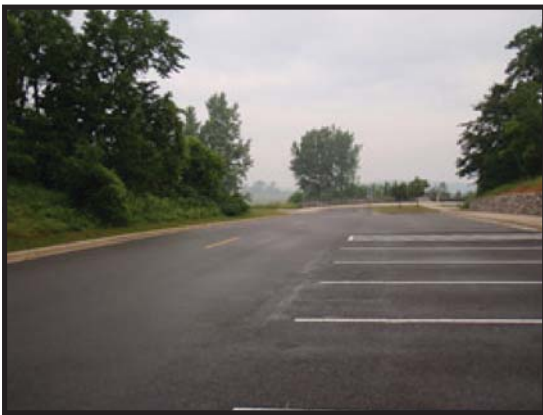
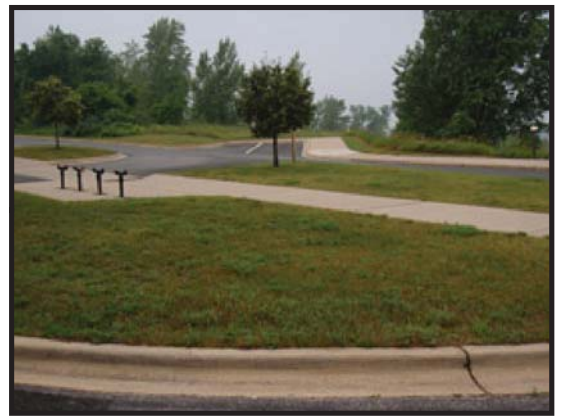
Route 0916Z

Route Number	Public / NonPublic	Date Visited		Area (sq ft)	Lane Miles *	Surface Type
0916Z	PUBLIC	7/18/2008		12,147	0.21	AS
Culverts	Drop Inlets	Gates	Fire Hydrants	Curb & Gutter	Curb	PCR
0	1	0	0	CONCRETE CURB AND GUTTER	NO CURB	GOOD/90

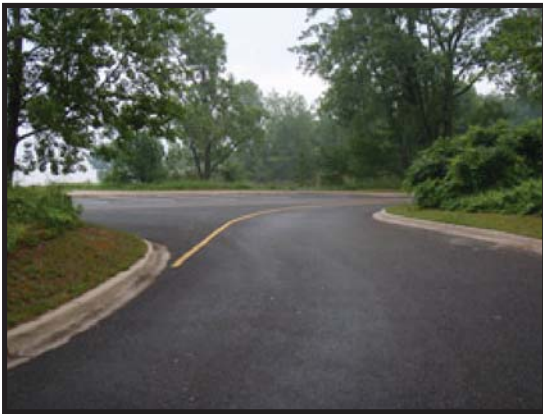
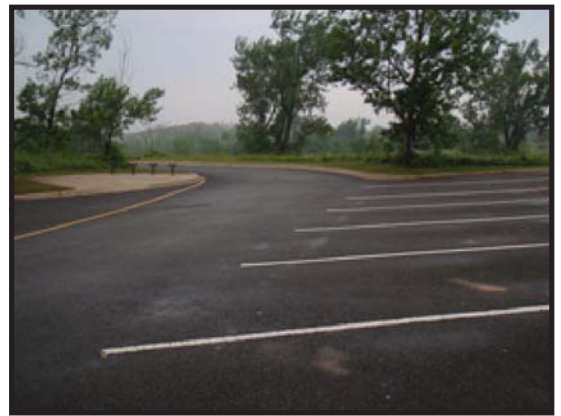
Route 0918Z

Route Number	Public / NonPublic	Date Visited		Area (sq ft)	Lane Miles *	Surface Type
0918Z	PUBLIC	7/18/2008		29,294	0.50	AS
Culverts	Drop Inlets	Gates	Fire Hydrants	Curb & Gutter	Curb	PCR
0	1	1	0	CONCRETE CURB AND GUTTER	NO CURB	GOOD/90

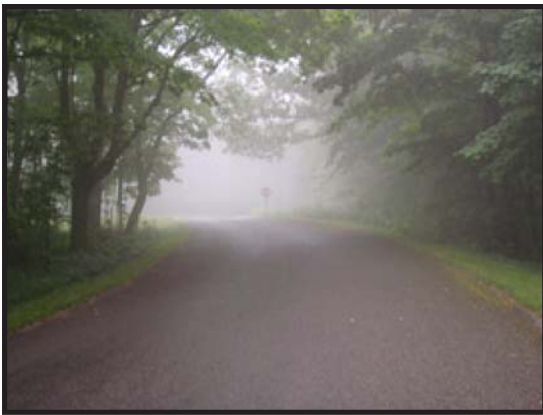
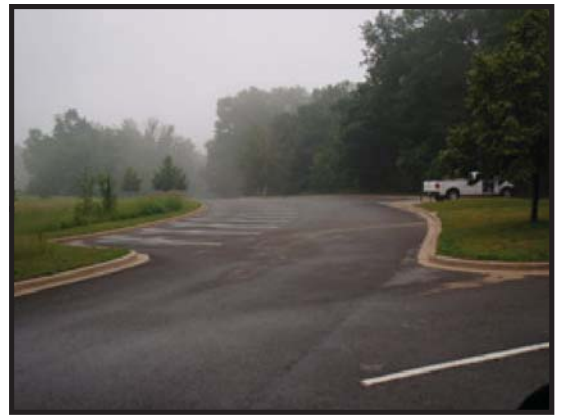
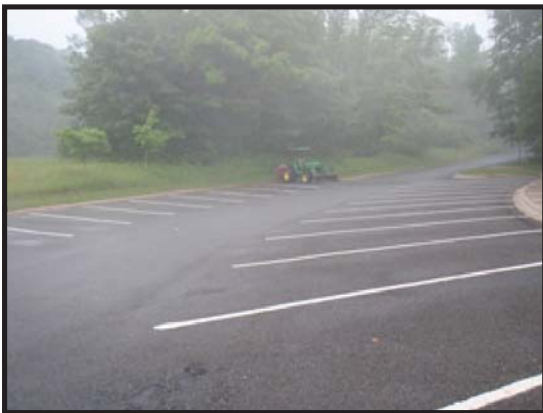
Route 0919Z

Route Number	Public / NonPublic	Date Visited		Area (sq ft)	Lane Miles *	Surface Type
0919Z	PUBLIC	7/18/2008		28,418	0.49	AS
Culverts	Drop Inlets	Gates	Fire Hydrants	Curb & Gutter	Curb	PCR
0	0	0	0	CONCRETE CURB AND GUTTER	NO CURB	GOOD/90
