**The Road Inventory
of
Sleeping Bear Dunes National Lakeshore
SLBE – 6620
Cycle 4**

**Prepared By:
Federal Highway Administration
Road Inventory Program
Cycle 4**

Sleeping Bear Dunes National Lakeshore in Michigan

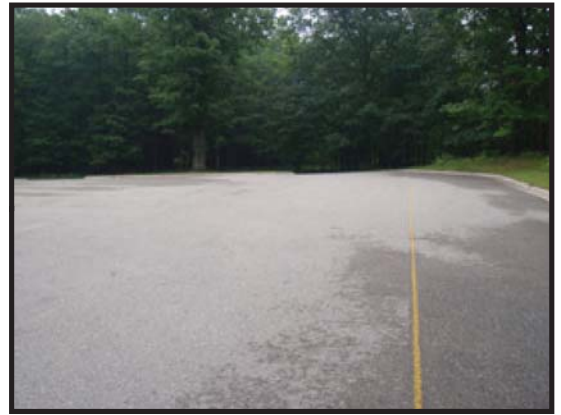
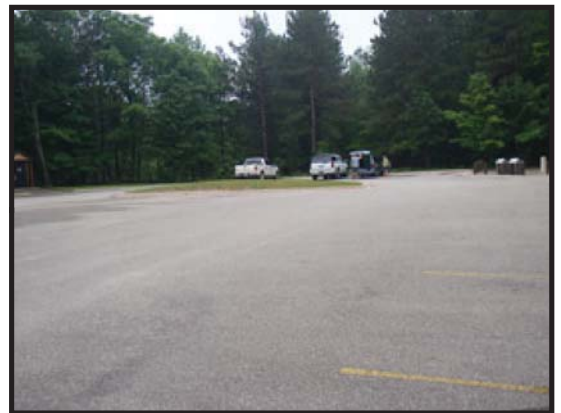
Route 0940

Route Number	Public / NonPublic	Date Visited		Area (sq ft)	Lane Miles *	Surface Type
0940	PUBLIC	7/18/2008		23,866	0.41	AS
Culverts	Drop Inlets	Gates	Fire Hydrants	Curb & Gutter	Curb	PCR
0	0	0	0	CONCRETE CURB AND GUTTER	NO CURB	GOOD/90
