**The Road Inventory  
of  
Yosemite National Park  
YOSE – 8800  
Cycle 4**

**Prepared By:  
Federal Highway Administration  
Road Inventory Program  
Cycle 4**

# Yosemite National Park in California

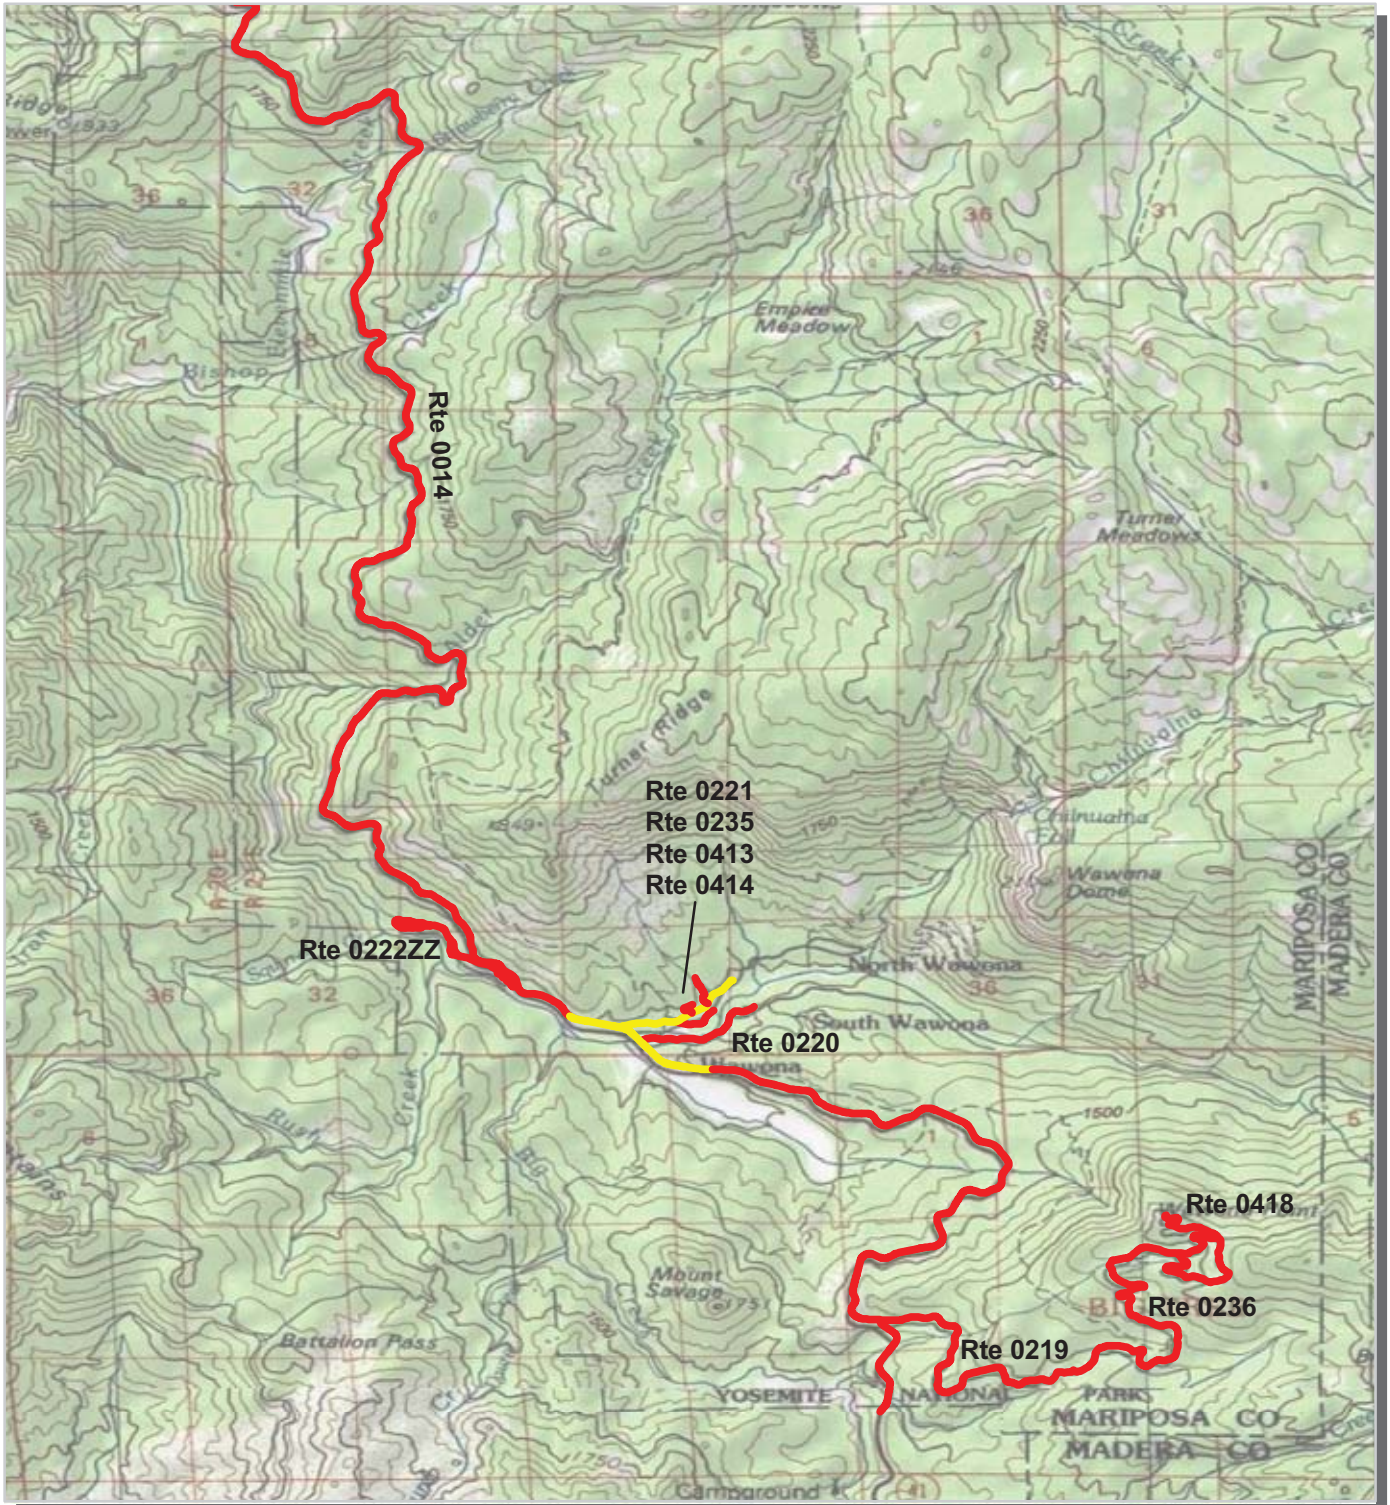
# Yosemite National Park Route Condition Map PCR - Mile by Mile Area 5

PCR	Poor (≤60)	<span style="color: red;">■</span>	Fair (61 - 84)	<span style="color: yellow;">■</span>	Good (85 - 94)	<span style="color: green;">■</span>	Excellent (95 - 100)	<span style="color: blue;">■</span>	No Data ■
-----	---------------	------------------------------------	-------------------	---------------------------------------	-------------------	--------------------------------------	-------------------------	-------------------------------------	--------------

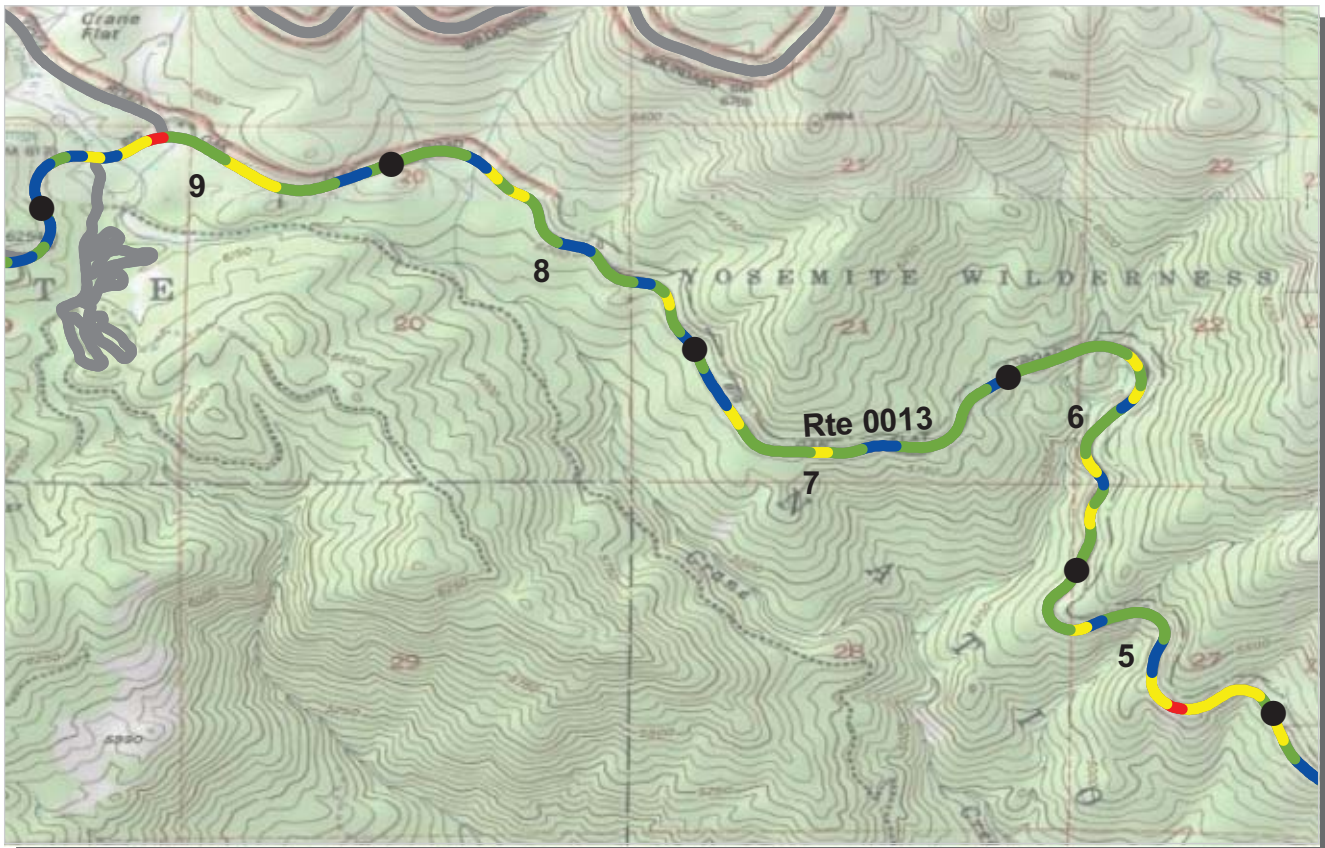
**ROUTE: 0013 BIG OAK FLAT ROAD**

Section Number	5	6	7	8	9
Section Length (mi)	1.00	1.00	1.00	1.00	1.00
Traffic	Traffic data may be found at <a href="http://www.efl.fhwa.dot.gov">www.efl.fhwa.dot.gov</a> Click on PROGRAMS / NPS Traffic Data (Note: Not all parks have traffic data)				
Cross Section Information					
Number of Lanes	2	2	2	2	2
Paved Width (ft)	24	24	25	24	27
Lane Width (ft)	10	10	10	10	12
Shoulder Width Right (ft)	NC	NC	NC	NC	NC
Shoulder Width Left (ft)	NC	NC	NC	NC	NC
Roadway Condition Information					
SCR (Surface Condition Rating)	88	89	92	92	87
PCR (Pavement Condition Rating)	84	88	90	90	87
Distress Index Values					
Alligator Cracking Index	100	100	100	100	100
Longitudinal Cracking Index	100	100	100	100	100
Transverse Cracking Index	100	100	100	100	100
Patching Index	100	100	100	100	100
Rutting Index	88	89	92	92	87
Roughness Condition Index (RCI)	79	87	87	86	86

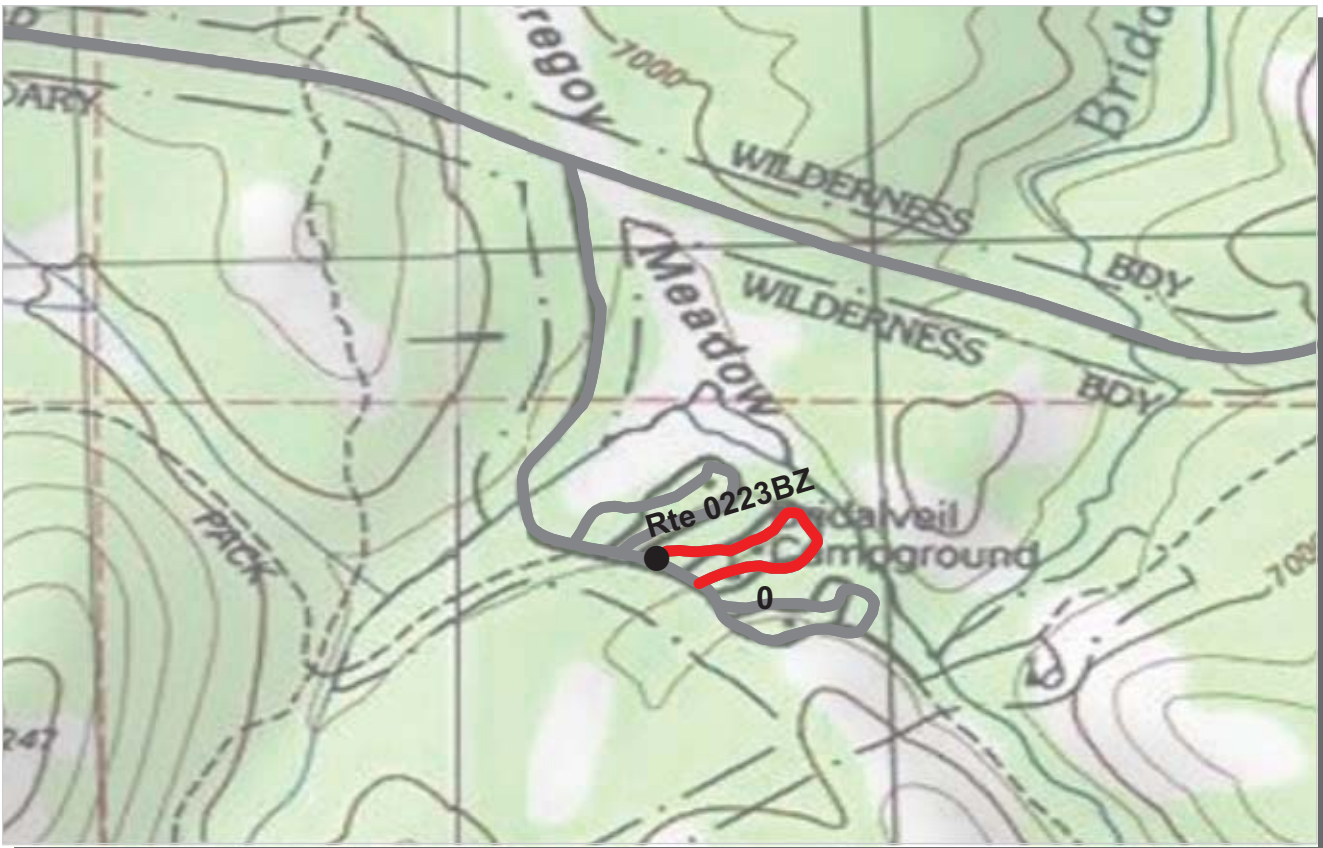
**ROUTE: 0223AZ BRIDALVEIL CREEK CAMPGROUND LOOP A**

<b>Section Number</b>	0				
<b>Section Length (mi)</b>	0.28				
<b>Traffic</b>	Traffic data may be found at <a href="http://www.efl.fhwa.dot.gov">www.efl.fhwa.dot.gov</a> Click on PROGRAMS / NPS Traffic Data (Note: Not all parks have traffic data)				
<b>Cross Section Information</b>					
Number of Lanes	1				
Paved Width (ft)	14				
Lane Width (ft)	14				
Shoulder Width Right (ft)	NC				
Shoulder Width Left (ft)	NC				
<b>Roadway Condition Information</b>					
SCR (Surface Condition Rating)	43				
PCR (Pavement Condition Rating)	43				
<b>Distress Index Values</b>					
Alligator Cracking Index	100				
Longitudinal Cracking Index	100				
Transverse Cracking Index	100				
Patching Index	100				
Rutting Index	43				
Roughness Condition Index (RCI)	NC

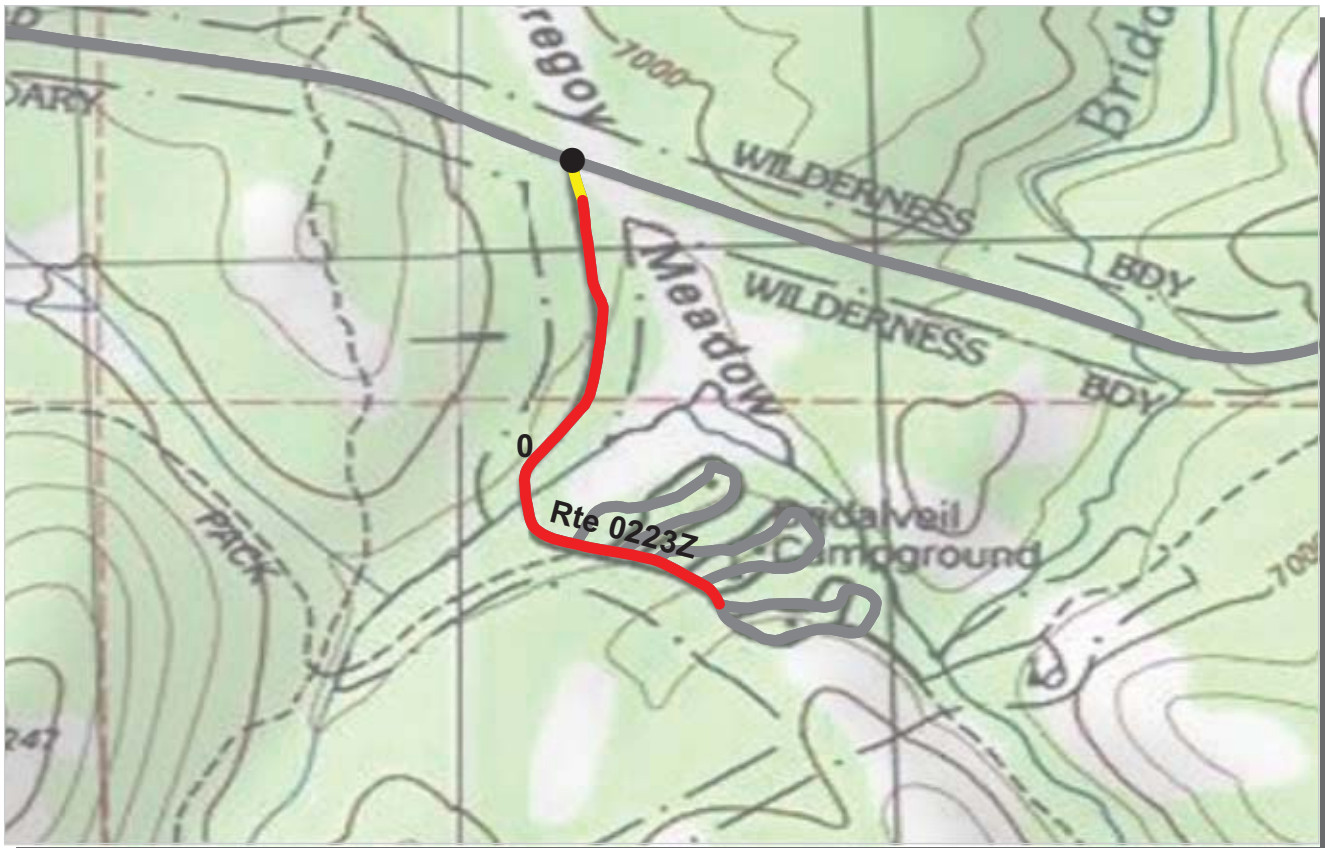
**ROUTE: 0223BZ BRIDALVEIL CREEK CAMPGROUND LOOP B**

<b>Section Number</b>	0				
<b>Section Length (mi)</b>	0.27				
<b>Traffic</b>	Traffic data may be found at <a href="http://www.efl.fhwa.dot.gov">www.efl.fhwa.dot.gov</a> Click on PROGRAMS / NPS Traffic Data (Note: Not all parks have traffic data)				
<b>Cross Section Information</b>					
Number of Lanes	1				
Paved Width (ft)	12				
Lane Width (ft)	12				
Shoulder Width Right (ft)	NC				
Shoulder Width Left (ft)	NC				
<b>Roadway Condition Information</b>					
SCR (Surface Condition Rating)	44				
PCR (Pavement Condition Rating)	44				
<b>Distress Index Values</b>					
Alligator Cracking Index	100				
Longitudinal Cracking Index	100				
Transverse Cracking Index	100				
Patching Index	100				
Rutting Index	45				
Roughness Condition Index (RCI)	NC

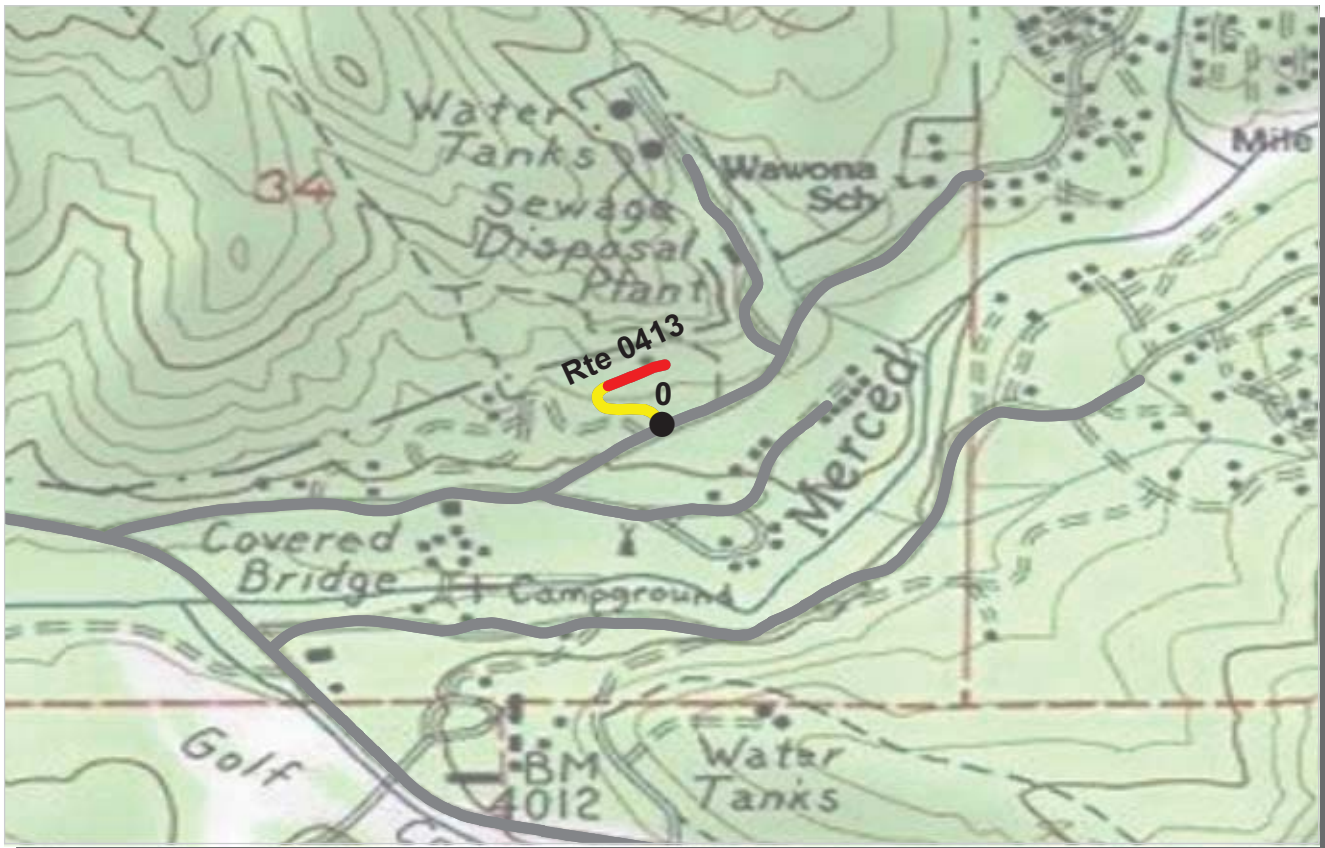
**ROUTE: 0409 VILLAGE SHUTTLE ROAD**

PCR    Poor ■    Fair ■    Good ■    Excellent ■    No Data ■  
           (<=60)            (61 - 84)            (85 - 94)            (95 - 100)

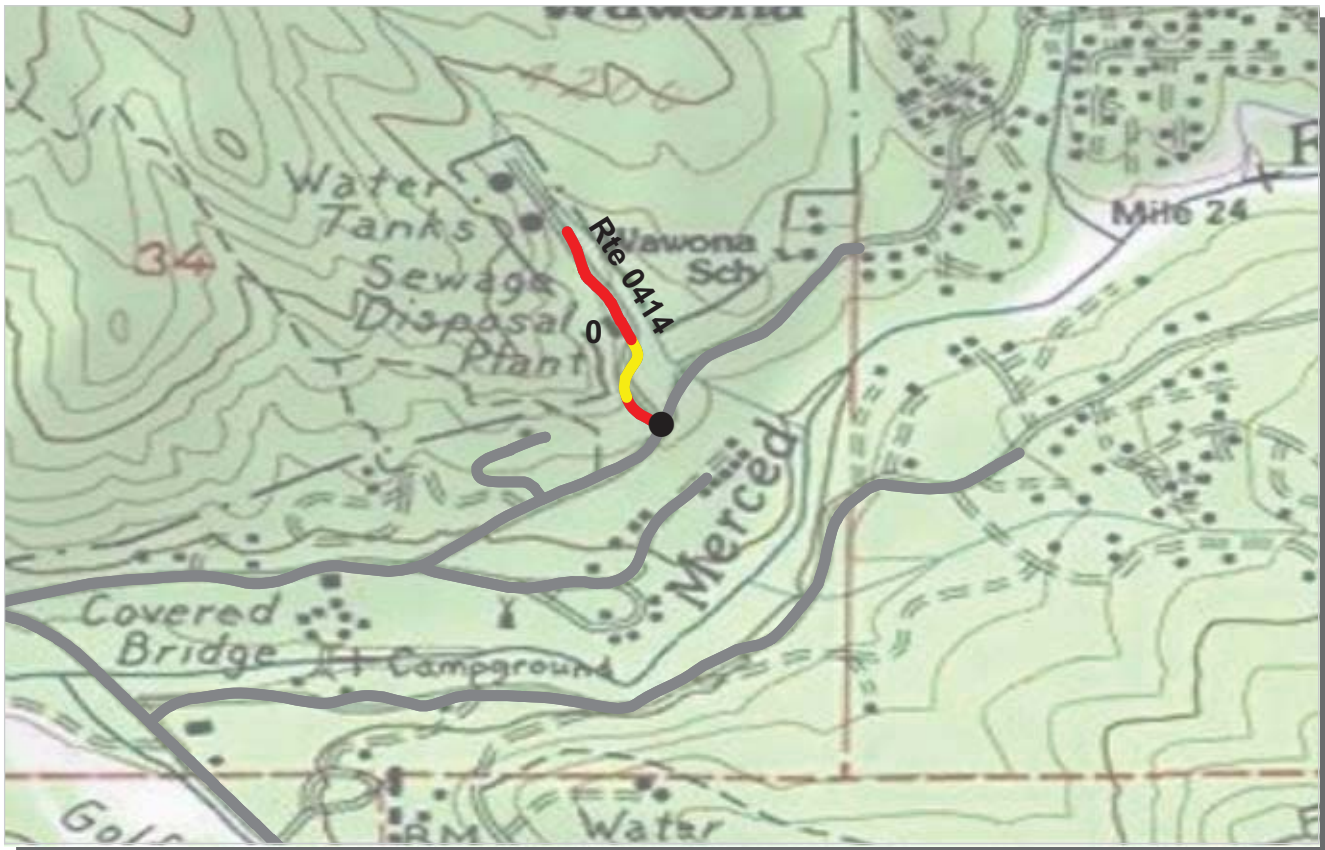
ROUTE: 0413 WAWONA WATER TREATMENT FACILITY ACCESS ROAD / GORDON WAY

PCR	Poor	Fair	Good	Excellent	No Data
	(≤60)	(61 - 84)	(85 - 94)	(95 - 100)

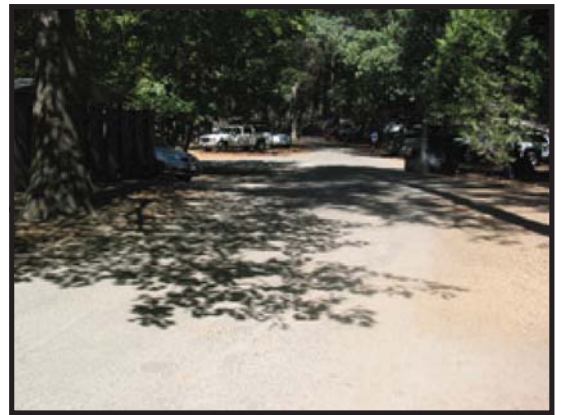
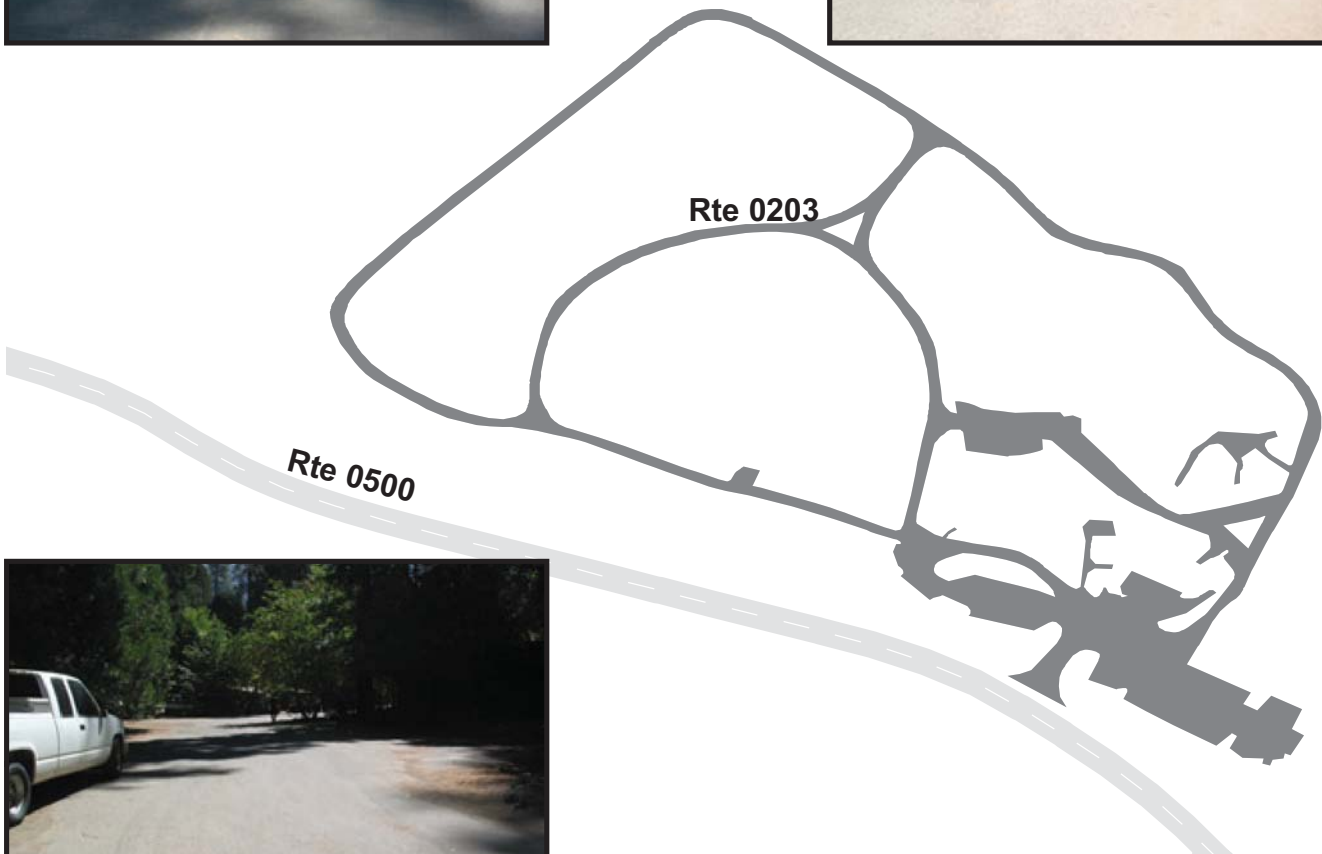
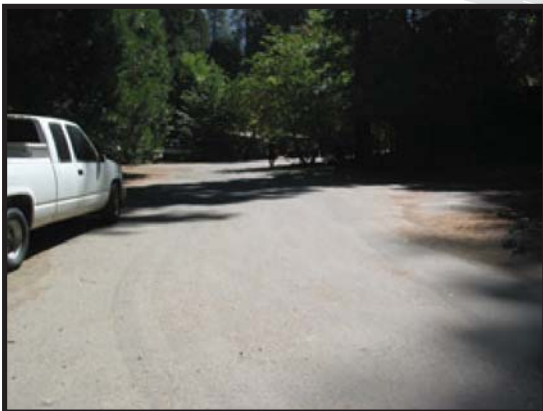
Route Number	Public / NonPublic	Date Visited		Area (sq ft)	Lane Miles *	Surface Type
0203	PUBLIC	8/20/2007		84,311	1.45	AS
Culverts	Drop Inlets	Gates	Fire Hydrants	Curb & Gutter	Curb	PCR
0	0	0	4	NO CURB AND GUTTER	NO CURB	FAIR/73

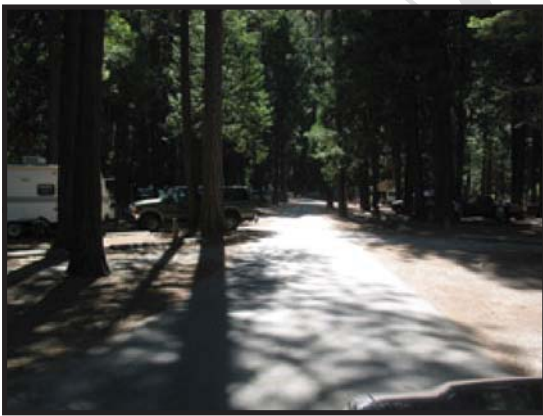
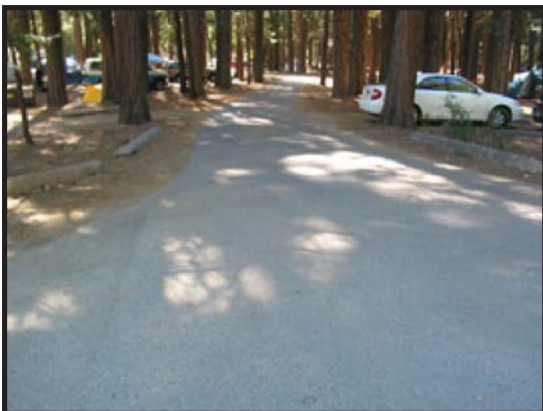
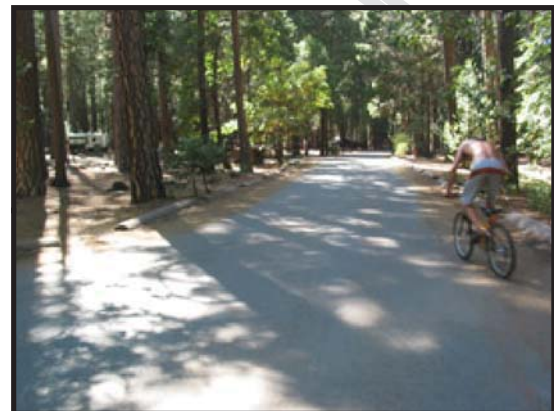
Route Number	Public / NonPublic	Date Visited		Area (sq ft)	Lane Miles *	Surface Type
0210	PUBLIC	8/20/2007		240,734	4.15	AS
Culverts	Drop Inlets	Gates	Fire Hydrants	Curb & Gutter	Curb	PCR
4	0	1	0	NO CURB AND GUTTER	NO CURB	FAIR/73

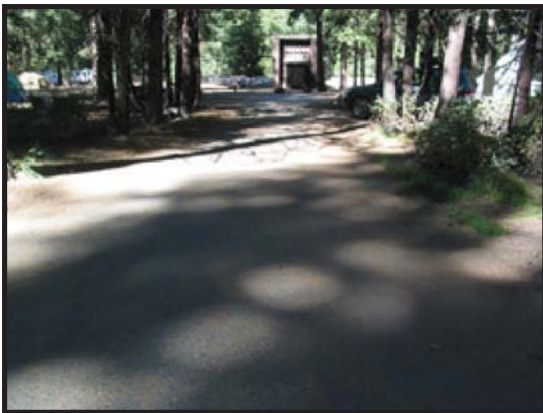
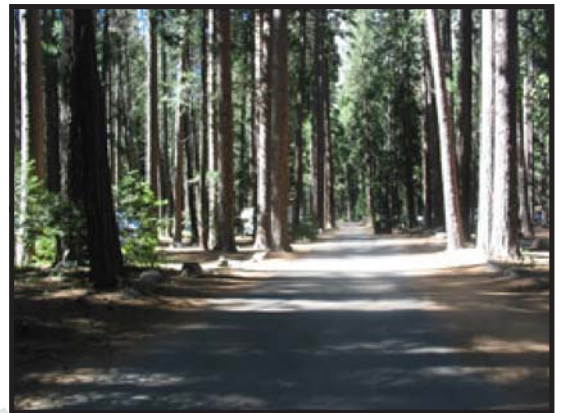
Route Number	Public / NonPublic	Date Visited		Area (sq ft)	Lane Miles *	Surface Type
0211	PUBLIC	8/20/2007		128,633	2.22	AS
Culverts	Drop Inlets	Gates	Fire Hydrants	Curb & Gutter	Curb	PCR
0	0	0	0	NO CURB AND GUTTER	NO CURB	POOR/45

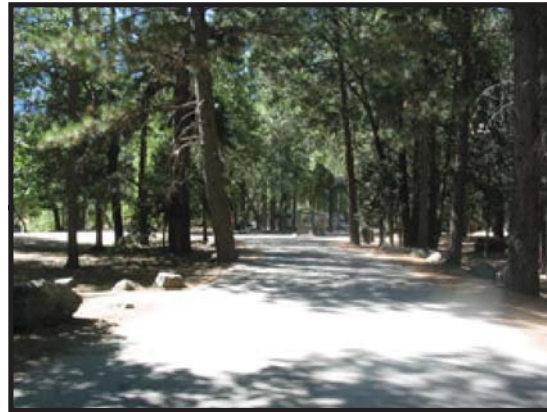
Route Number	Public / NonPublic	Date Visited		Area (sq ft)	Lane Miles *	Surface Type
0212	PUBLIC	8/20/2007		115,219	1.98	AS
Culverts	Drop Inlets	Gates	Fire Hydrants	Curb & Gutter	Curb	PCR
0	0	0	0	NO CURB AND GUTTER	NO CURB	FAIR/73

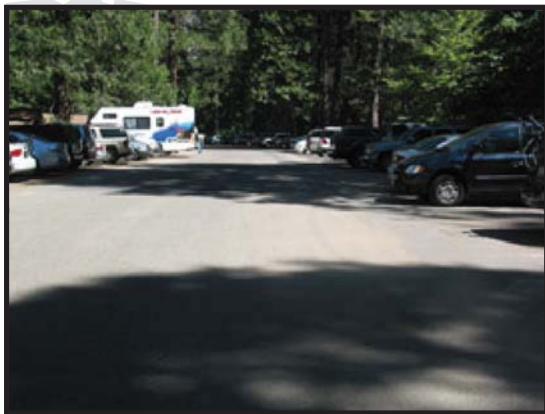
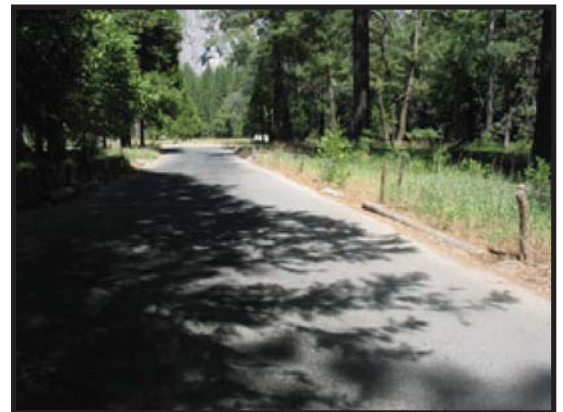
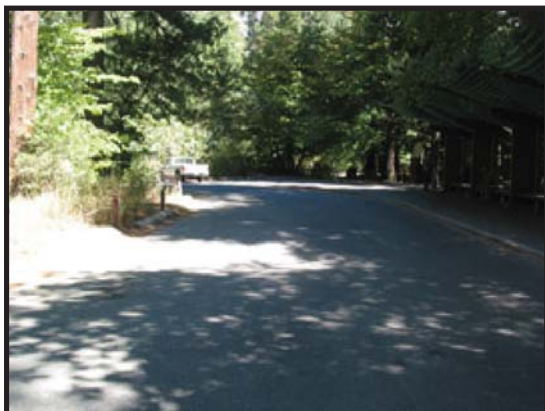
Route Number	Public / NonPublic	Date Visited		Area (sq ft)	Lane Miles *	Surface Type
0214	PUBLIC	8/20/2007		62,571	1.08	AS
Culverts	Drop Inlets	Gates	Fire Hydrants	Curb & Gutter	Curb	PCR
1	0	1	2	NO CURB AND GUTTER	CONCRETE CURB	FAIR/73

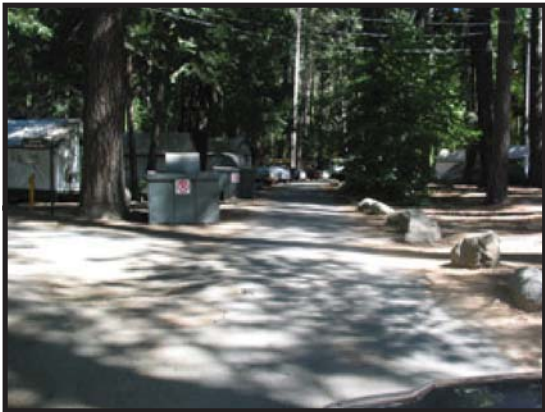
Route Number	Public / NonPublic	Date Visited		Area (sq ft)	Lane Miles *	Surface Type
0215	PUBLIC	8/20/2007		14,358	0.25	AS
Culverts	Drop Inlets	Gates	Fire Hydrants	Curb & Gutter	Curb	PCR
0	0	0	0	NO CURB AND GUTTER	NO CURB	FAIR/73

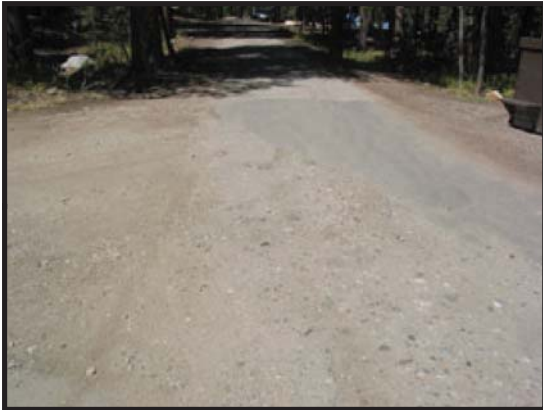
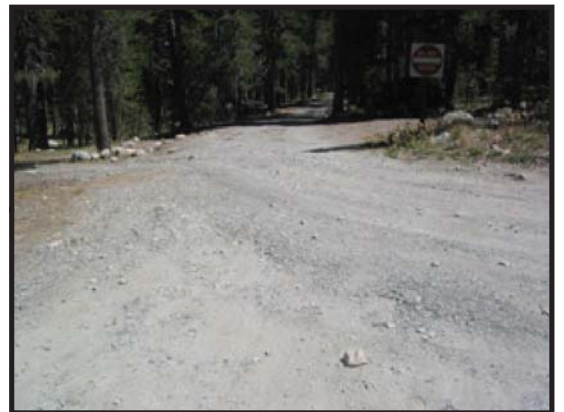
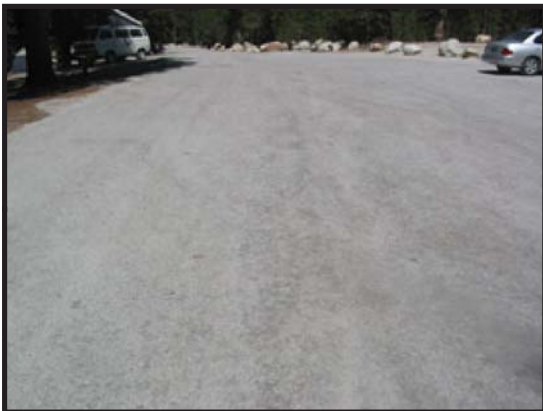
Route Number	Public / NonPublic	Date Visited		Area (sq ft)	Lane Miles *	Surface Type
0229	PUBLIC	8/20/2007		146,828	2.53	AS
Culverts	Drop Inlets	Gates	Fire Hydrants	Curb & Gutter	Curb	PCR
9	0	5	0	NO CURB AND GUTTER	NO CURB	POOR/45

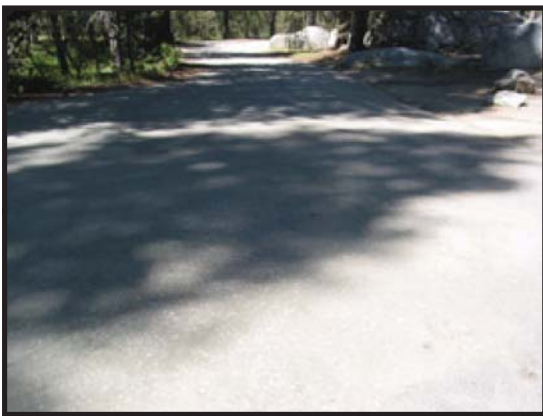
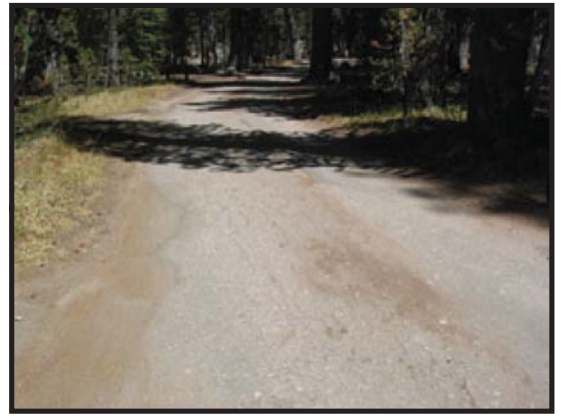
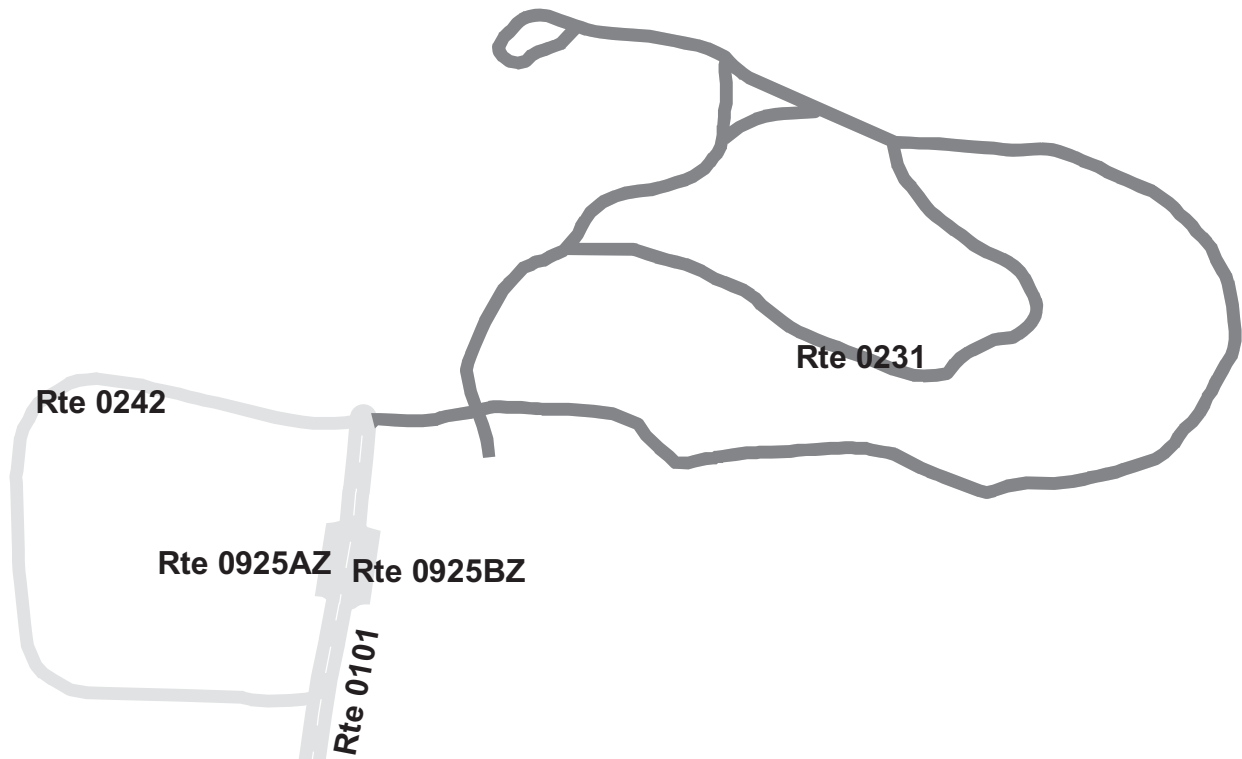
Route Number	Public / NonPublic	Date Visited		Area (sq ft)	Lane Miles *	Surface Type
0231	PUBLIC	8/20/2007		66,175	1.14	AS
Culverts	Drop Inlets	Gates	Fire Hydrants	Curb & Gutter	Curb	PCR
1	0	0	0	NO CURB AND GUTTER	NO CURB	POOR/45

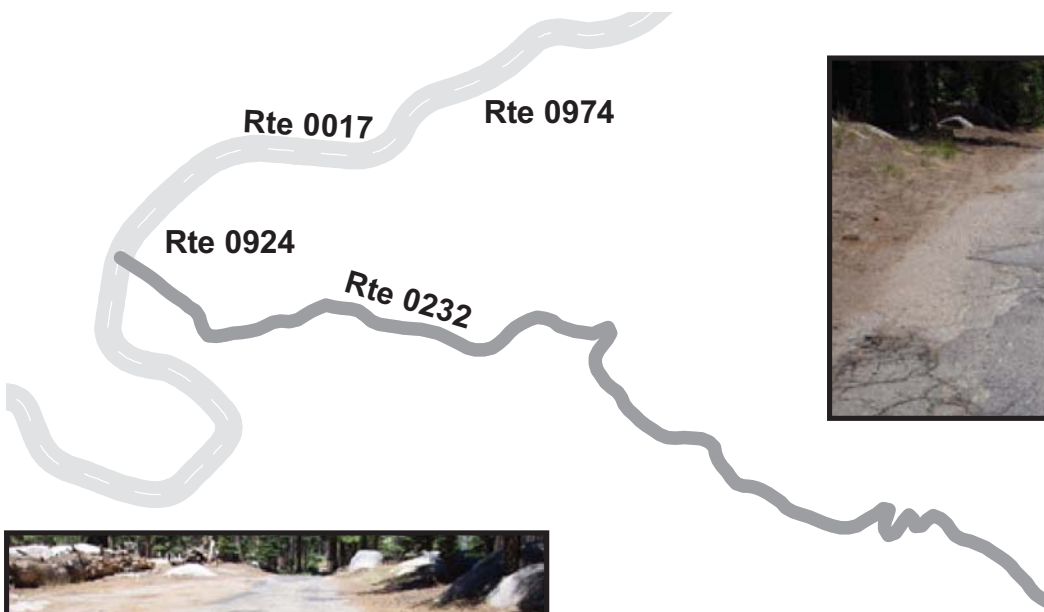
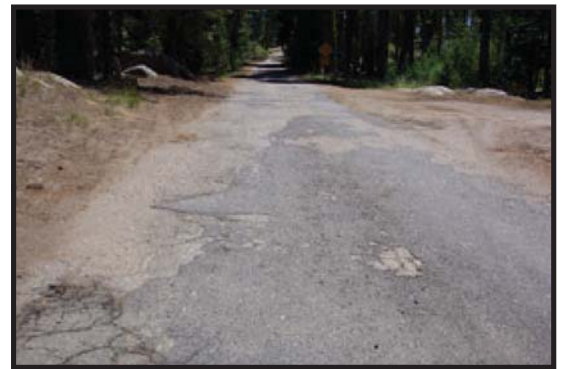
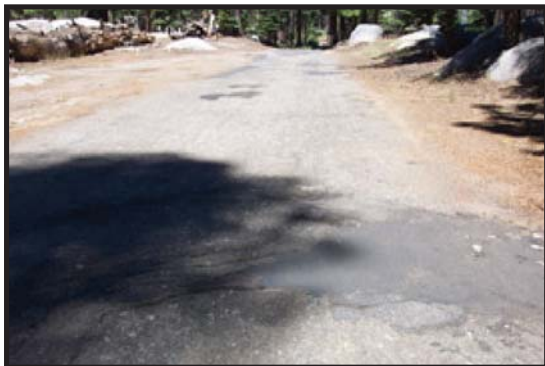
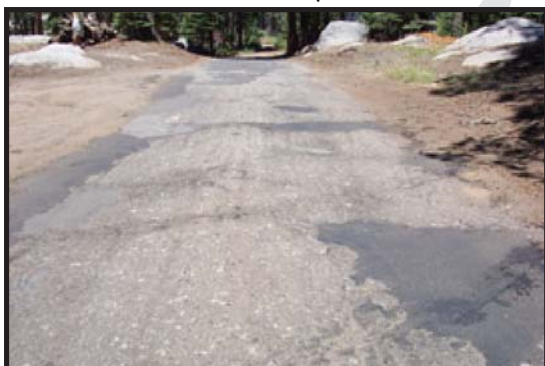
Route Number	Public / NonPublic	Date Visited		Area (sq ft)	Lane Miles *	Surface Type
0232	PUBLIC	7/31/2008		158,779	2.73	AS
Culverts	Drop Inlets	Gates	Fire Hydrants	Curb & Gutter	Curb	PCR
5	0	0	0	NO CURB AND GUTTER	NO CURB	POOR/45

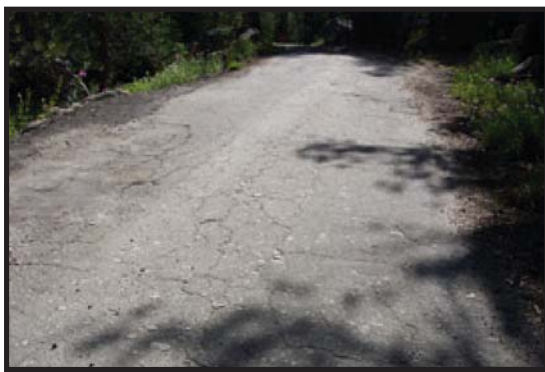
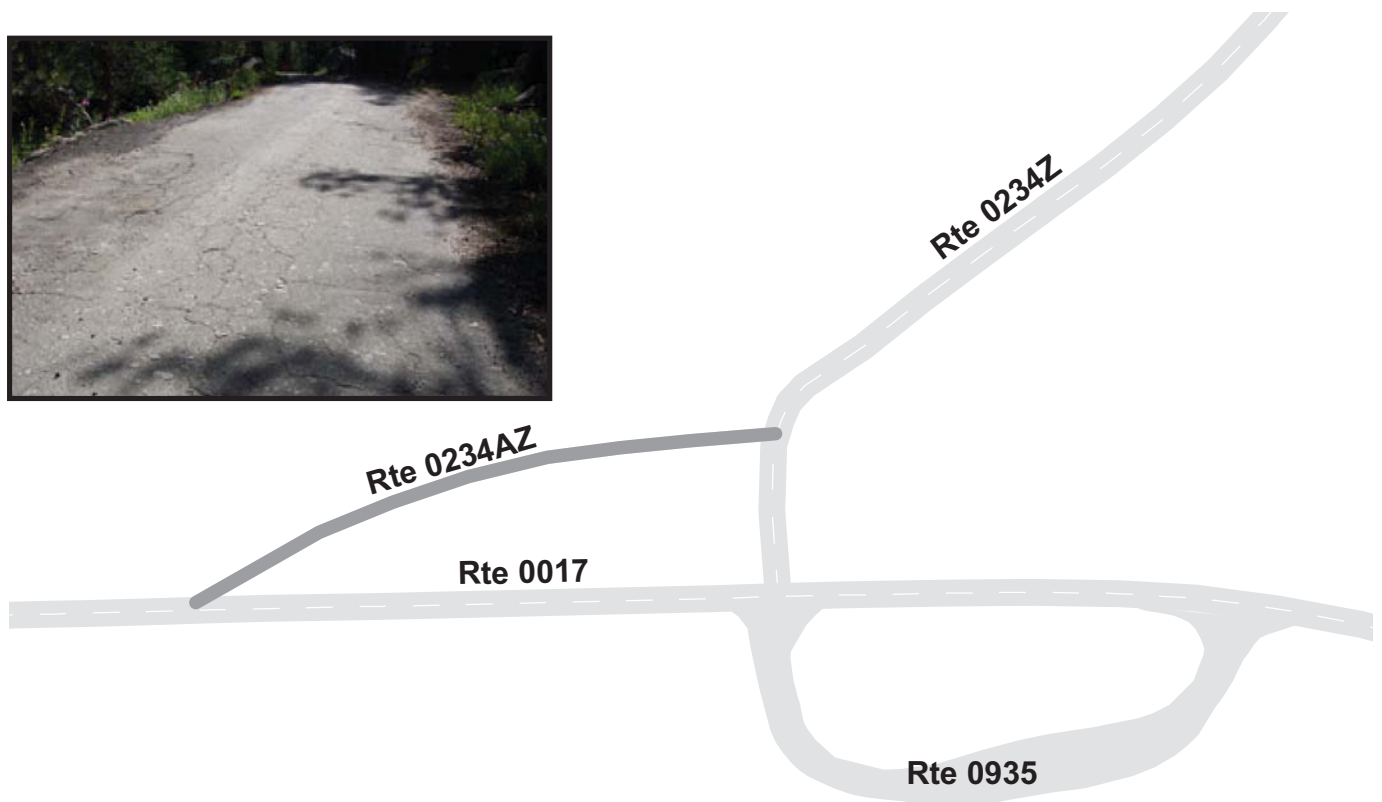
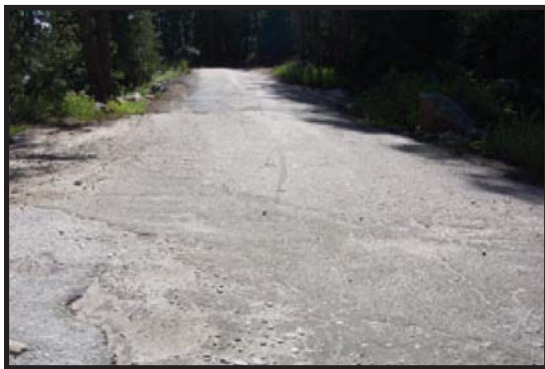
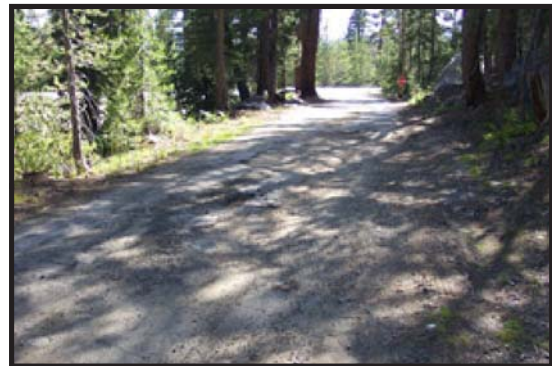
Route Number	Public / NonPublic	Date Visited		Area (sq ft)	Lane Miles *	Surface Type
0234AZ	PUBLIC	7/31/2008		3,300	0.06	AS
Culverts	Drop Inlets	Gates	Fire Hydrants	Curb & Gutter	Curb	PCR
1	0	0	0	NO CURB AND GUTTER	NO CURB	POOR/45

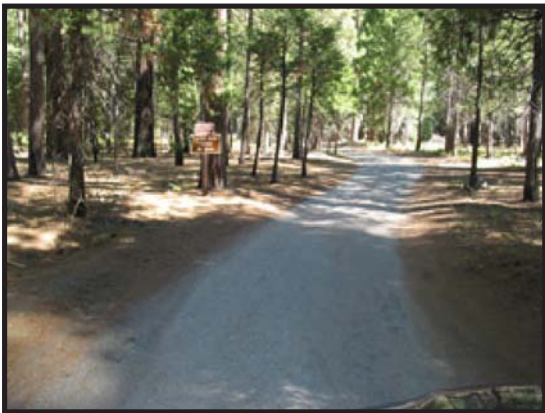
Route Number	Public / NonPublic	Date Visited		Area (sq ft)	Lane Miles *	Surface Type
0239	PUBLIC	8/20/2007		5,018	0.09	AS
Culverts	Drop Inlets	Gates	Fire Hydrants	Curb & Gutter	Curb	PCR
0	0	1	0	NO CURB AND GUTTER	NO CURB	POOR/45

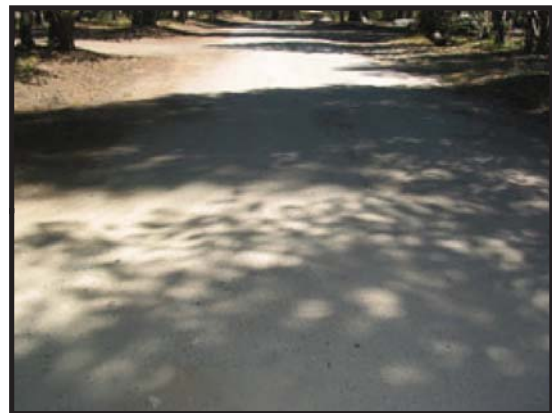
Route Number	Public / NonPublic	Date Visited		Area (sq ft)	Lane Miles *	Surface Type
0240	PUBLIC	8/20/2007		8,667	0.15	AS
Culverts	Drop Inlets	Gates	Fire Hydrants	Curb & Gutter	Curb	PCR
0	0	1	0	NO CURB AND GUTTER	NO CURB	POOR/45

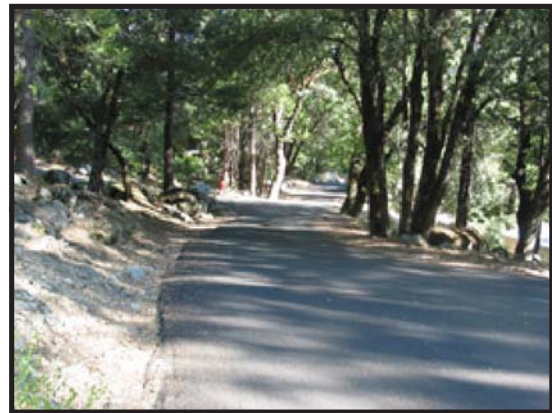
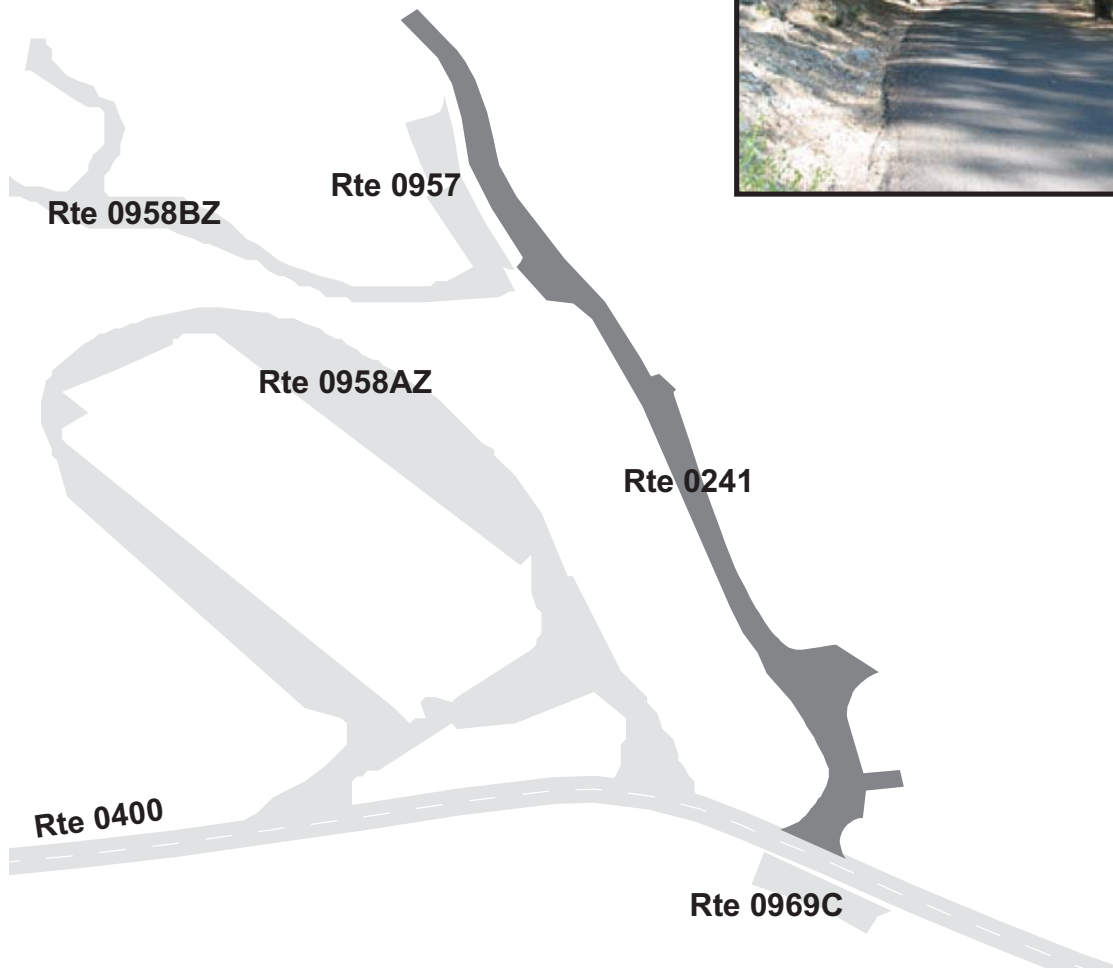
Route Number	Public / NonPublic	Date Visited		Area (sq ft)	Lane Miles *	Surface Type
0241	PUBLIC	8/20/2007		11,835	0.20	AS
Culverts	Drop Inlets	Gates	Fire Hydrants	Curb & Gutter	Curb	PCR
0	0	0	1	NO CURB AND GUTTER	CONCRETE CURB	GOOD/90

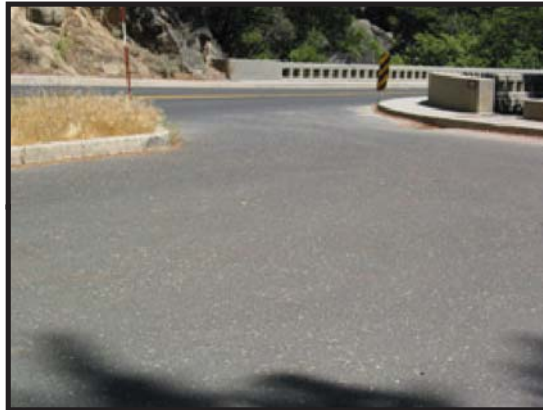
Route Number	Public / NonPublic	Date Visited		Area (sq ft)	Lane Miles *	Surface Type
0901	PUBLIC	8/20/2007		3,568	0.06	AS
Culverts	Drop Inlets	Gates	Fire Hydrants	Curb & Gutter	Curb	PCR
0	1	0	0	NO CURB AND GUTTER	CONCRETE CURB	GOOD/90

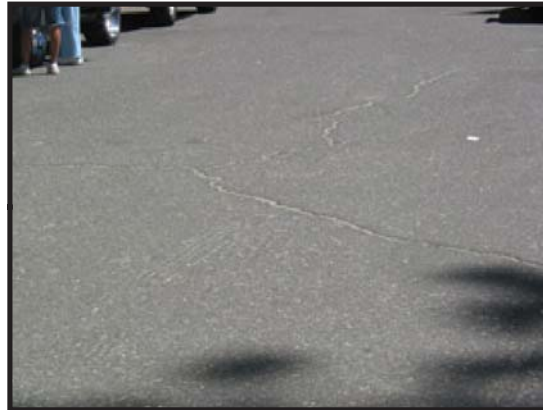
Route Number	Public / NonPublic	Date Visited		Area (sq ft)	Lane Miles *	Surface Type
0903	PUBLIC	8/20/2007		5,736	0.10	AS
Culverts	Drop Inlets	Gates	Fire Hydrants	Curb & Gutter	Curb	PCR
0	0	0	0	NO CURB AND GUTTER	NO CURB	FAIR/73

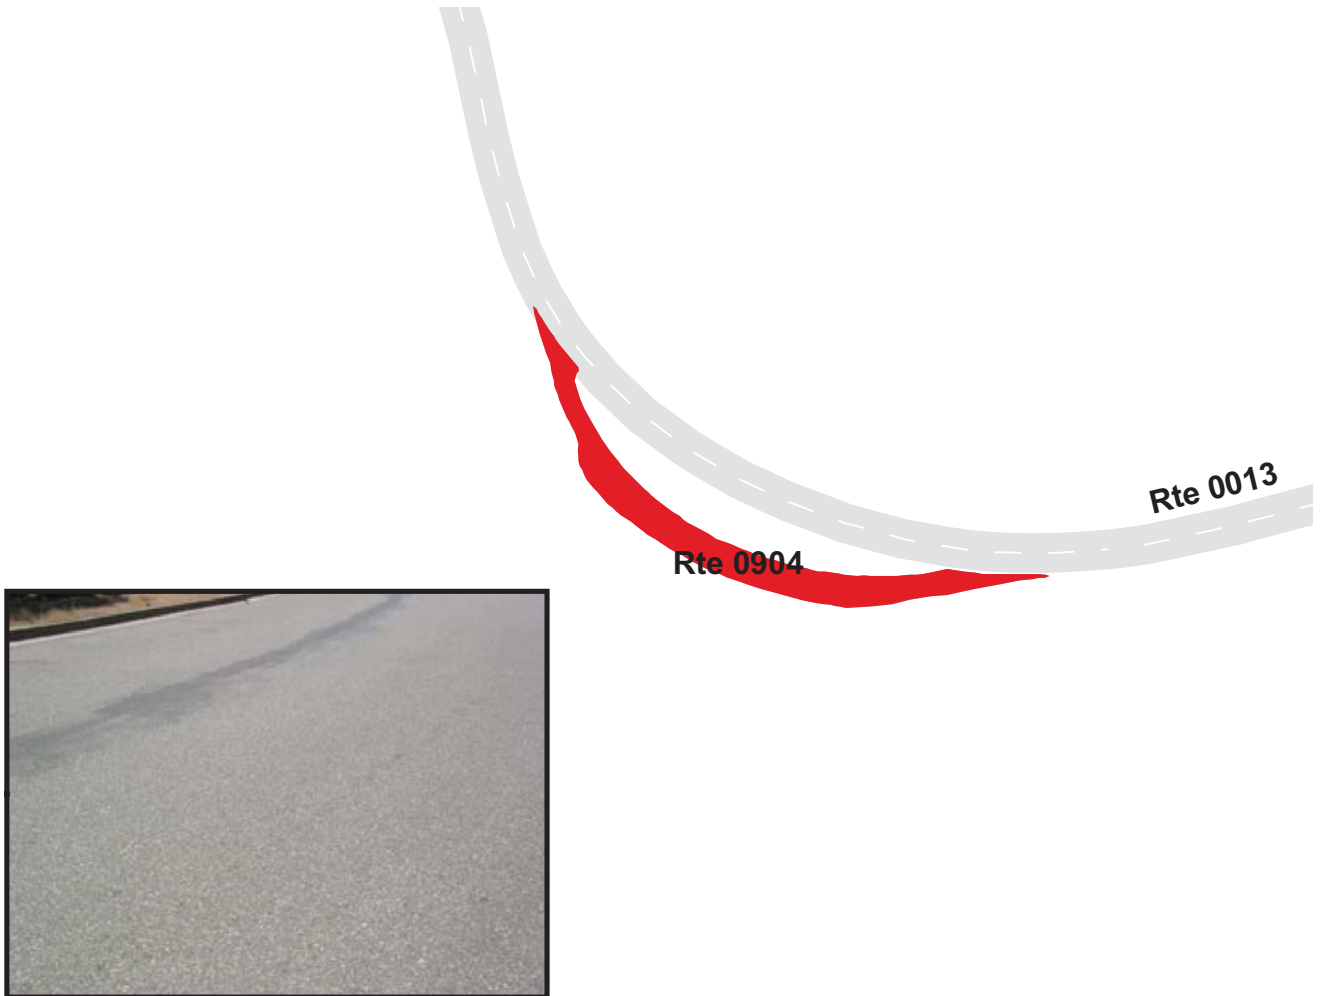
Route Number	Public / NonPublic	Date Visited		Area (sq ft)	Lane Miles *	Surface Type
0904	PUBLIC	8/20/2007		15,213	0.26	AS
Culverts	Drop Inlets	Gates	Fire Hydrants	Curb & Gutter	Curb	PCR
0	0	0	0	CONCRETE CURB AND GUTTER	NO CURB	GOOD/90

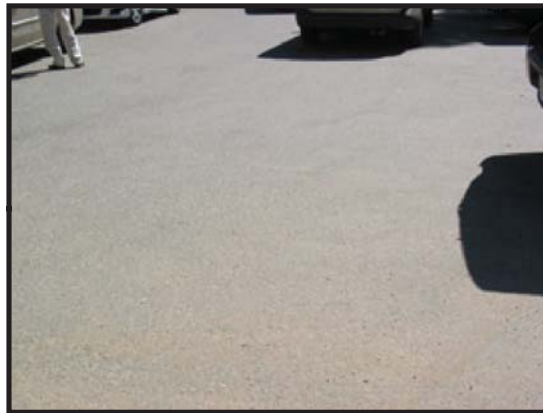
Route Number	Public / NonPublic	Date Visited		Area (sq ft)	Lane Miles *	Surface Type
0905	PUBLIC	8/20/2007		5,930	0.10	AS
Culverts	Drop Inlets	Gates	Fire Hydrants	Curb & Gutter	Curb	PCR
0	0	0	0	CONCRETE CURB AND GUTTER	NO CURB	FAIR/73

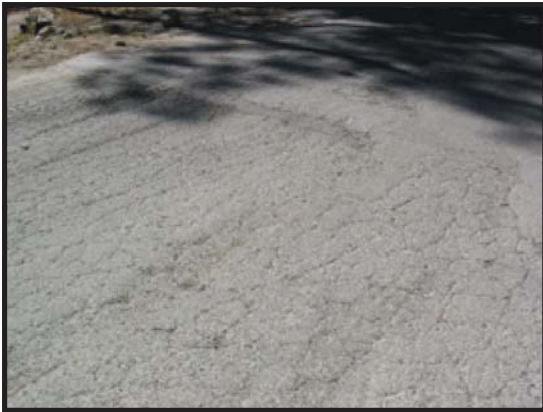
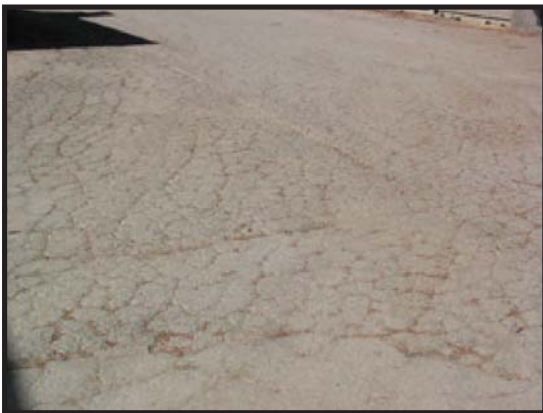
Route Number	Public / NonPublic	Date Visited		Area (sq ft)	Lane Miles *	Surface Type
0906	NONPUBLIC	8/20/2007		19,858	0.34	AS
Culverts	Drop Inlets	Gates	Fire Hydrants	Curb & Gutter	Curb	PCR
1	1	0	1	NO CURB AND GUTTER	NO CURB	POOR/45
