**The Road Inventory  
of  
Yosemite National Park  
YOSE – 8800  
Cycle 4**

**Prepared By:  
Federal Highway Administration  
Road Inventory Program  
Cycle 4**

# Yosemite National Park in California

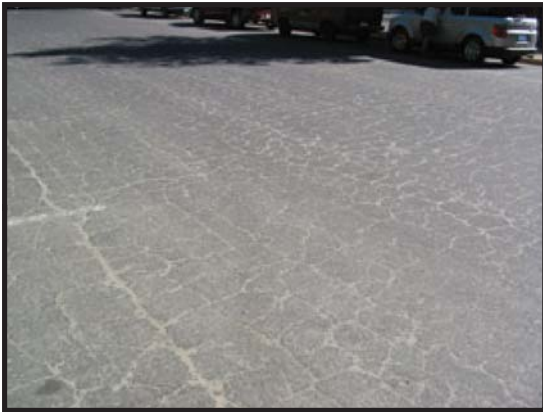
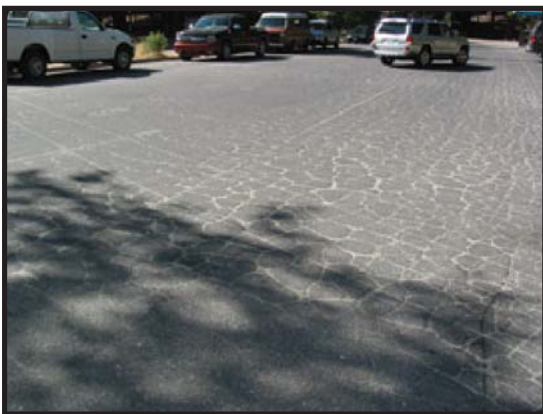
Route Number	Public / NonPublic	Date Visited		Area (sq ft)	Lane Miles *	Surface Type
0907	PUBLIC	8/20/2007		20,010	0.35	AS
Culverts	Drop Inlets	Gates	Fire Hydrants	Curb & Gutter	Curb	PCR
0	0	0	0	CONCRETE CURB AND GUTTER	NO CURB	POOR/45

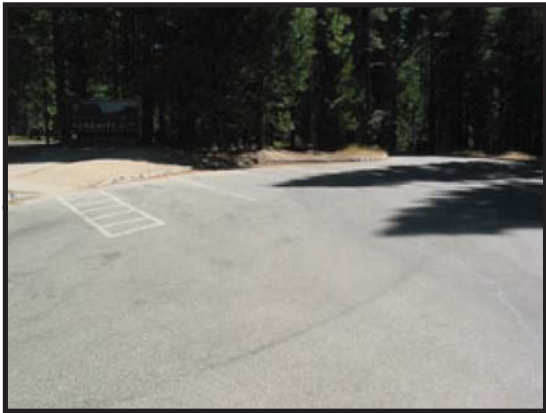
Route Number	Public / NonPublic	Date Visited		Area (sq ft)	Lane Miles *	Surface Type
0908	PUBLIC	8/20/2007		7,547	0.13	AS
Culverts	Drop Inlets	Gates	Fire Hydrants	Curb & Gutter	Curb	PCR
0	0	0	0	NO CURB AND GUTTER	STONE CURB	FAIR/73

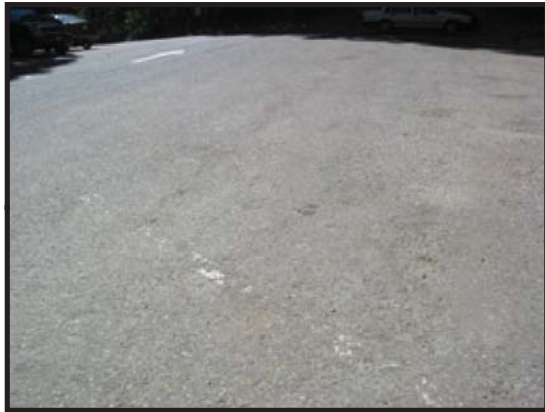
Route Number	Public / NonPublic	Date Visited		Area (sq ft)	Lane Miles *	Surface Type
0909	PUBLIC	8/20/2007		11,646	0.20	AS
Culverts	Drop Inlets	Gates	Fire Hydrants	Curb & Gutter	Curb	PCR
0	0	0	0	NO CURB AND GUTTER	NO CURB	FAIR/73

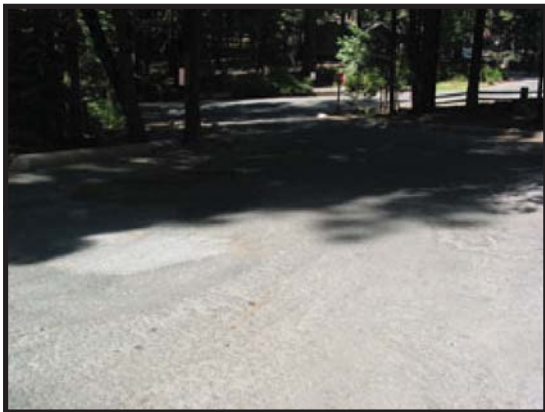
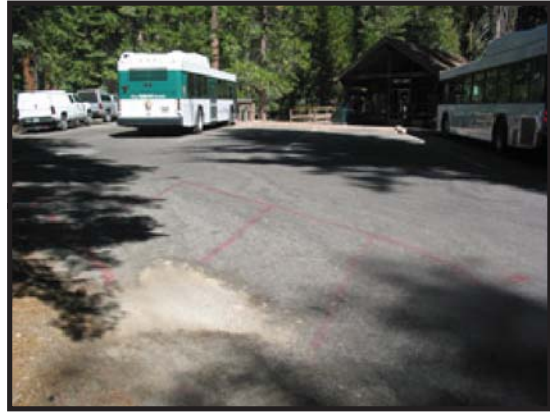
Route Number	Public / NonPublic	Date Visited		Area (sq ft)	Lane Miles *	Surface Type
0910	PUBLIC	8/20/2007		20,236	0.35	AS
Culverts	Drop Inlets	Gates	Fire Hydrants	Curb & Gutter	Curb	PCR
0	0	0	0	NO CURB AND GUTTER	NO CURB	FAIR/73

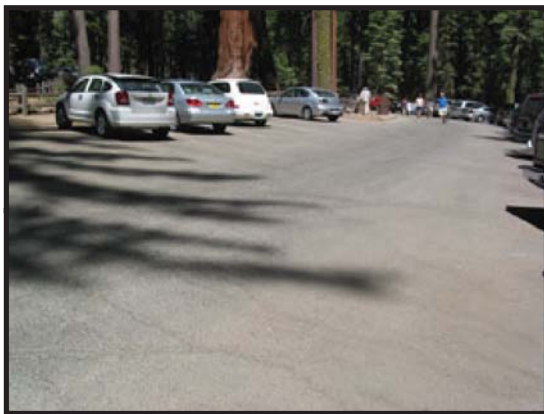
Route Number	Public / NonPublic	Date Visited		Area (sq ft)	Lane Miles *	Surface Type
0911	PUBLIC	8/20/2007		57,130	0.98	AS
Culverts	Drop Inlets	Gates	Fire Hydrants	Curb & Gutter	Curb	PCR
0	0	0	0	NO CURB AND GUTTER	NO CURB	POOR/45

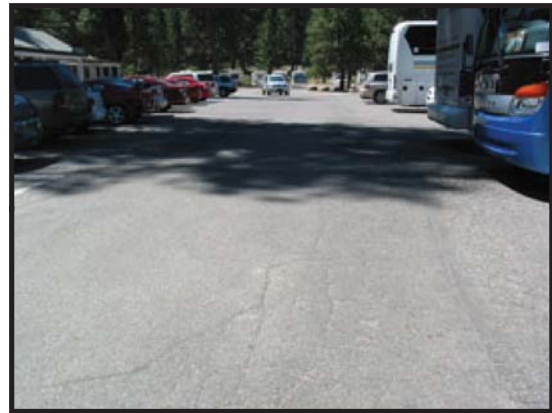
Route Number	Public / NonPublic	Date Visited		Area (sq ft)	Lane Miles *	Surface Type
0912	PUBLIC	8/20/2007		18,617	0.32	AS
Culverts	Drop Inlets	Gates	Fire Hydrants	Curb & Gutter	Curb	PCR
0	0	0	1	NO CURB AND GUTTER	WOOD CURB	POOR/45

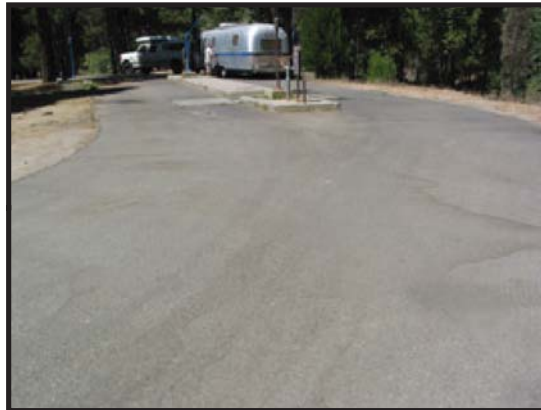
Route Number	Public / NonPublic	Date Visited		Area (sq ft)	Lane Miles *	Surface Type
0913	PUBLIC	8/20/2007		6,683	0.12	AS
Culverts	Drop Inlets	Gates	Fire Hydrants	Curb & Gutter	Curb	PCR
0	0	0	0	NO CURB AND GUTTER	NO CURB	FAIR/73

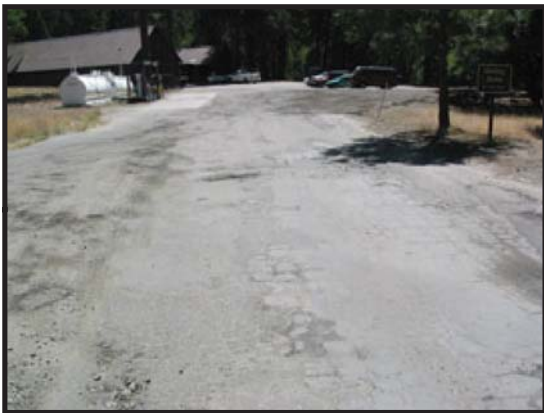
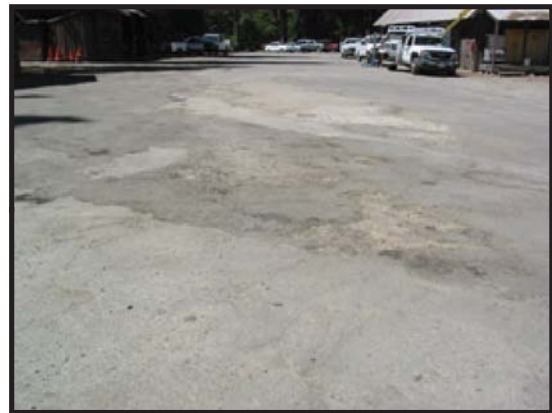
Route Number	Public / NonPublic	Date Visited		Area (sq ft)	Lane Miles *	Surface Type
0914	NONPUBLIC	8/20/2007		35,325	0.61	AS
Culverts	Drop Inlets	Gates	Fire Hydrants	Curb & Gutter	Curb	PCR
1	0	0	1	NO CURB AND GUTTER	NO CURB	POOR/45

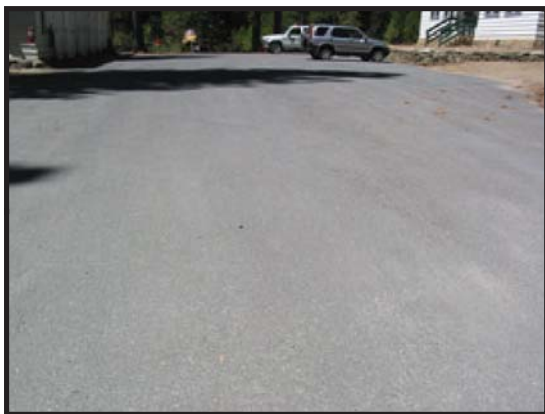
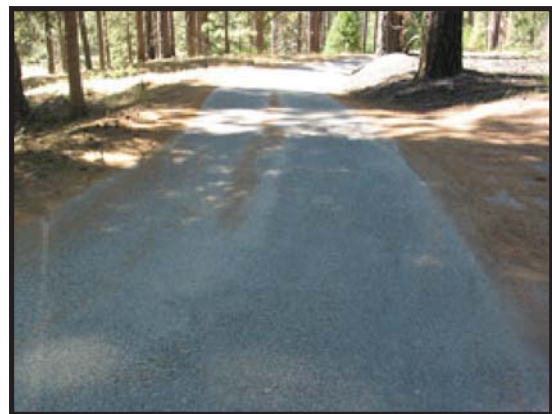
Route Number	Public / NonPublic	Date Visited		Area (sq ft)	Lane Miles *	Surface Type
0915	NONPUBLIC	8/20/2007		9,276	0.16	AS
Culverts	Drop Inlets	Gates	Fire Hydrants	Curb & Gutter	Curb	PCR
0	0	0	1	NO CURB AND GUTTER	NO CURB	GOOD/90

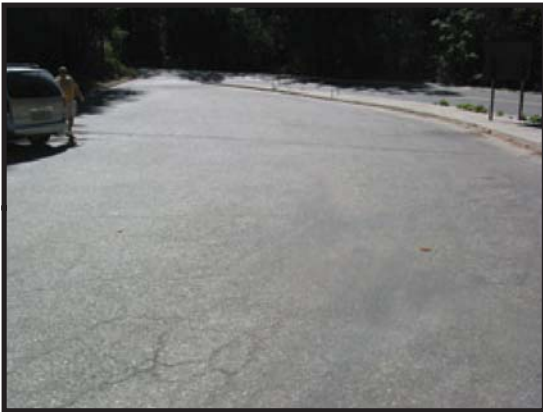
Route Number	Public / NonPublic	Date Visited		Area (sq ft)	Lane Miles *	Surface Type
0916	PUBLIC	8/20/2007		10,133	0.17	AS
Culverts	Drop Inlets	Gates	Fire Hydrants	Curb & Gutter	Curb	PCR
1	0	0	0	CONCRETE CURB AND GUTTER	CONCRETE CURB	POOR/45

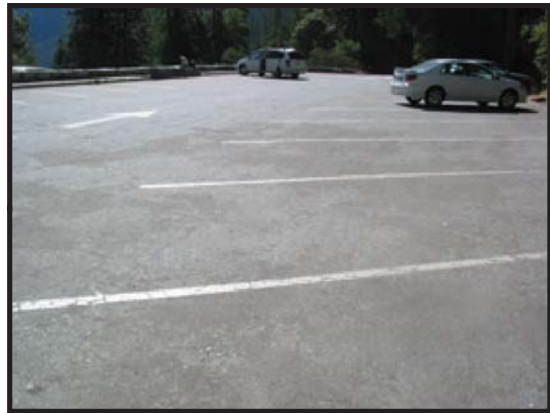
Route Number	Public / NonPublic	Date Visited		Area (sq ft)	Lane Miles *	Surface Type
0917AZ	PUBLIC	8/20/2007		22,017	0.38	AS
Culverts	Drop Inlets	Gates	Fire Hydrants	Curb & Gutter	Curb	PCR
0	0	0	0	NO CURB AND GUTTER	STONE CURB	POOR/45

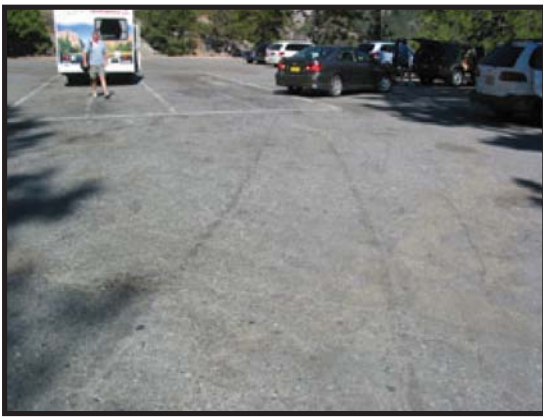
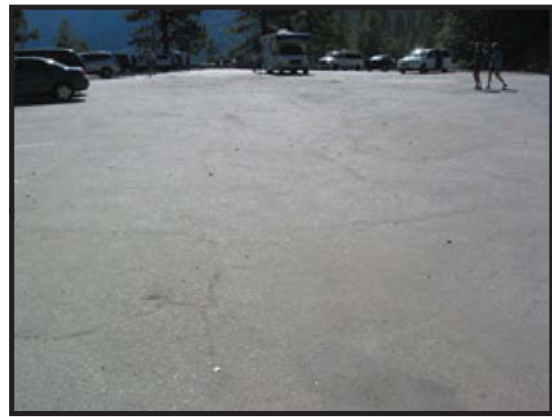
Route Number	Public / NonPublic	Date Visited		Area (sq ft)	Lane Miles *	Surface Type
0917BZ	PUBLIC	8/20/2007		12,336	0.21	AS
Culverts	Drop Inlets	Gates	Fire Hydrants	Curb & Gutter	Curb	PCR
0	0	0	0	NO CURB AND GUTTER	STONE CURB	POOR/45

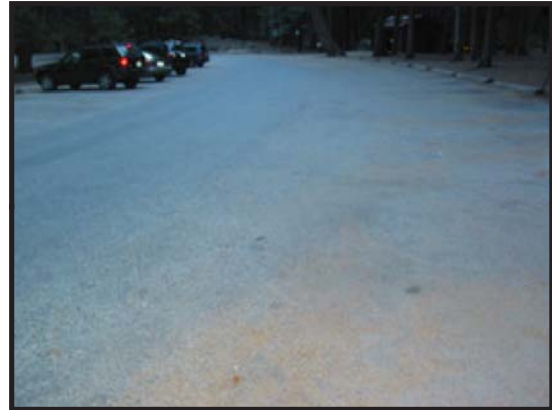
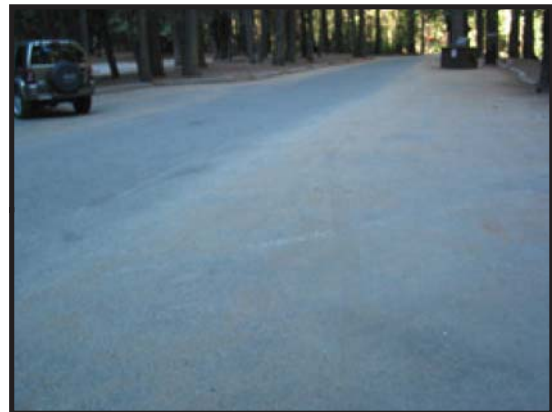
Route Number	Public / NonPublic	Date Visited		Area (sq ft)	Lane Miles *	Surface Type
0918	PUBLIC	8/20/2007		29,490	0.51	AS
Culverts	Drop Inlets	Gates	Fire Hydrants	Curb & Gutter	Curb	PCR
0	0	0	0	NO CURB AND GUTTER	NO CURB	FAIR/73

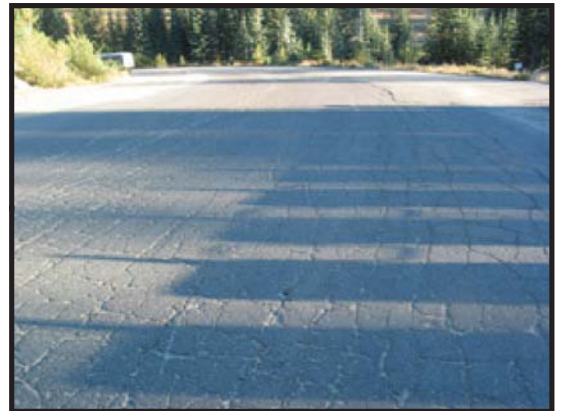
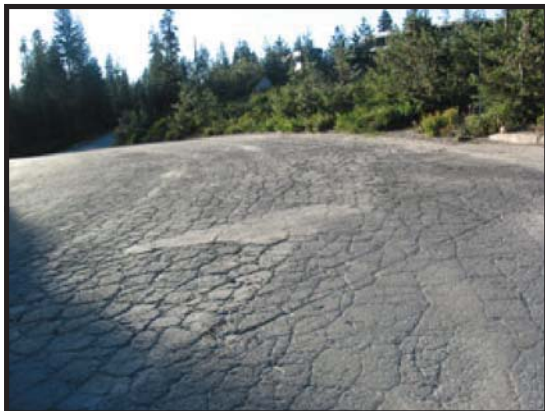
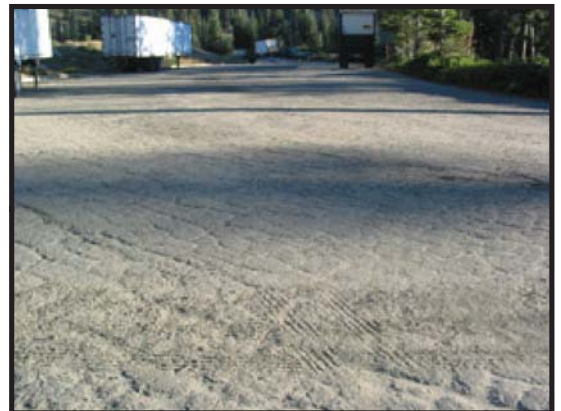
Route Number	Public / NonPublic	Date Visited		Area (sq ft)	Lane Miles *	Surface Type
0919	PUBLIC	8/20/2007		313,019	5.39	AS
Culverts	Drop Inlets	Gates	Fire Hydrants	Curb & Gutter	Curb	PCR
0	1	0	0	NO CURB AND GUTTER	CONCRETE CURB	POOR/45

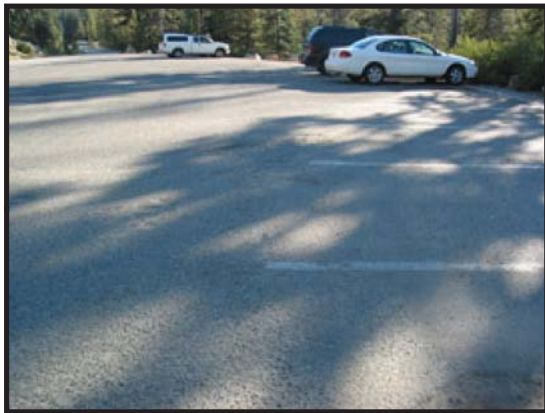
Route Number	Public / NonPublic	Date Visited		Area (sq ft)	Lane Miles *	Surface Type
0920	PUBLIC	8/20/2007		11,052	0.19	AS
Culverts	Drop Inlets	Gates	Fire Hydrants	Curb & Gutter	Curb	PCR
0	0	0	0	NO CURB AND GUTTER	NO CURB	FAIR/73

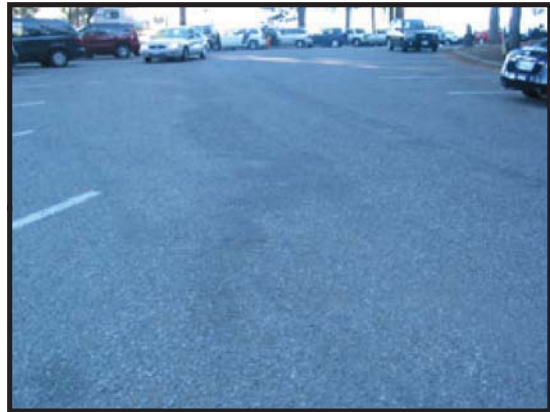
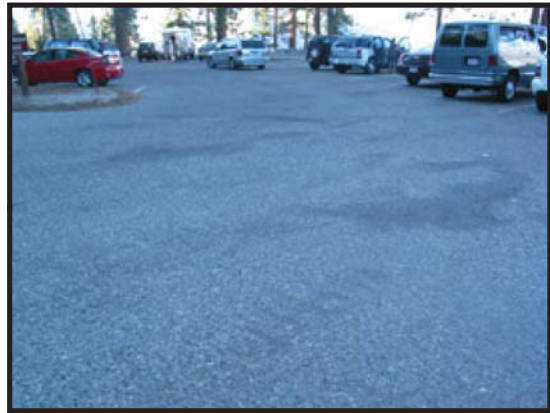
Route Number	Public / NonPublic	Date Visited		Area (sq ft)	Lane Miles *	Surface Type
0921	PUBLIC	8/20/2007		18,313	0.32	AS
Culverts	Drop Inlets	Gates	Fire Hydrants	Curb & Gutter	Curb	PCR
0	0	0	0	CONCRETE CURB AND GUTTER	CONCRETE CURB	FAIR/73

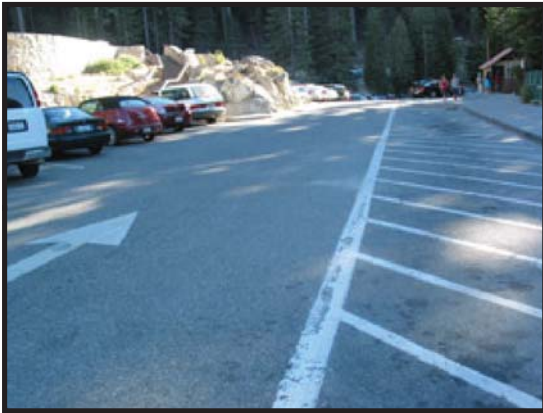
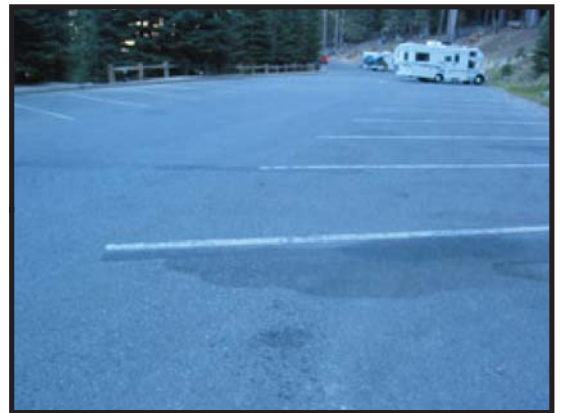
Route Number	Public / NonPublic	Date Visited		Area (sq ft)	Lane Miles *	Surface Type
0922	PUBLIC	8/20/2007		72,061	1.24	AS
Culverts	Drop Inlets	Gates	Fire Hydrants	Curb & Gutter	Curb	PCR
0	4	0	0	CONCRETE CURB AND GUTTER	CONCRETE CURB	GOOD/90

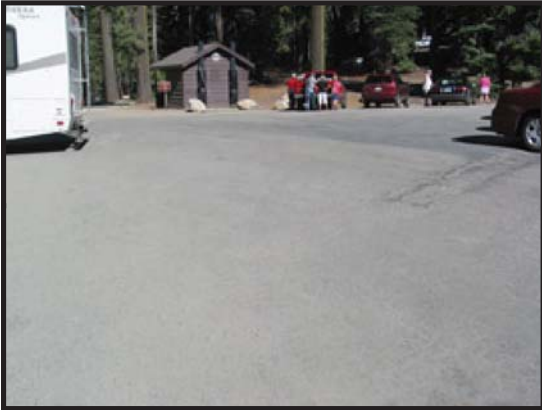
Route Number	Public / NonPublic	Date Visited		Area (sq ft)	Lane Miles *	Surface Type
0923	PUBLIC	8/20/2007		17,008	0.29	AS
Culverts	Drop Inlets	Gates	Fire Hydrants	Curb & Gutter	Curb	PCR
0	0	0	0	NO CURB AND GUTTER	NO CURB	POOR/45

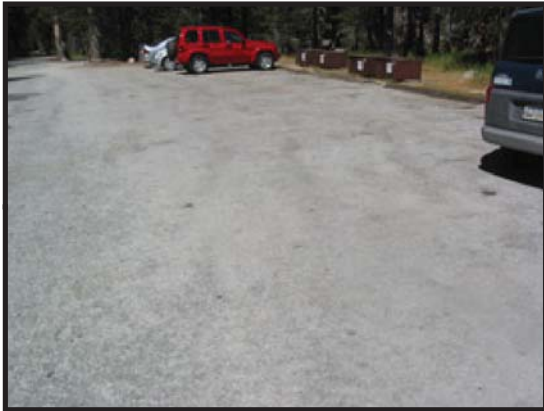
Route Number	Public / NonPublic	Date Visited		Area (sq ft)	Lane Miles *	Surface Type
0925AZ	PUBLIC	8/20/2007		2,783	0.05	AS
Culverts	Drop Inlets	Gates	Fire Hydrants	Curb & Gutter	Curb	PCR
0	0	0	0	NO CURB AND GUTTER	NO CURB	POOR/45

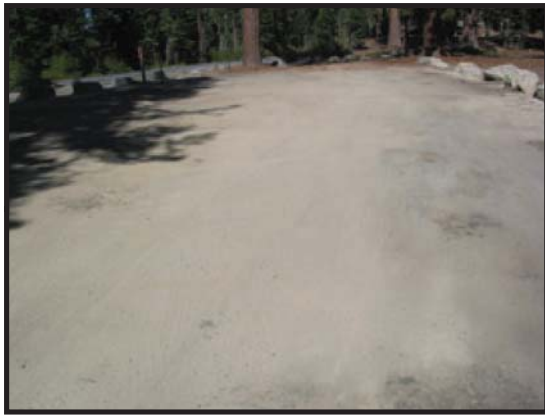
Route Number	Public / NonPublic	Date Visited		Area (sq ft)	Lane Miles *	Surface Type
0925BZ	PUBLIC	8/20/2007		2,336	0.04	AS
Culverts	Drop Inlets	Gates	Fire Hydrants	Curb & Gutter	Curb	PCR
0	0	0	0	NO CURB AND GUTTER	NO CURB	POOR/45

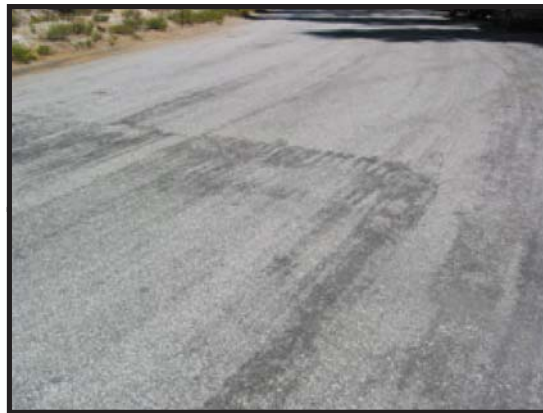
Route Number	Public / NonPublic	Date Visited		Area (sq ft)	Lane Miles *	Surface Type
0926	PUBLIC	8/20/2007		12,045	0.21	AS
Culverts	Drop Inlets	Gates	Fire Hydrants	Curb & Gutter	Curb	PCR
0	0	0	0	CONCRETE CURB AND GUTTER	CONCRETE CURB	FAIR/73

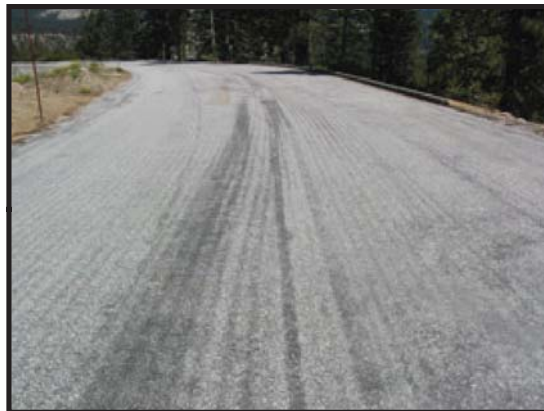
Route Number	Public / NonPublic	Date Visited		Area (sq ft)	Lane Miles *	Surface Type
0927	PUBLIC	8/20/2007		9,916	0.17	AS
Culverts	Drop Inlets	Gates	Fire Hydrants	Curb & Gutter	Curb	PCR
0	0	0	0	NO CURB AND GUTTER	ASPHALT CURB	FAIR/73

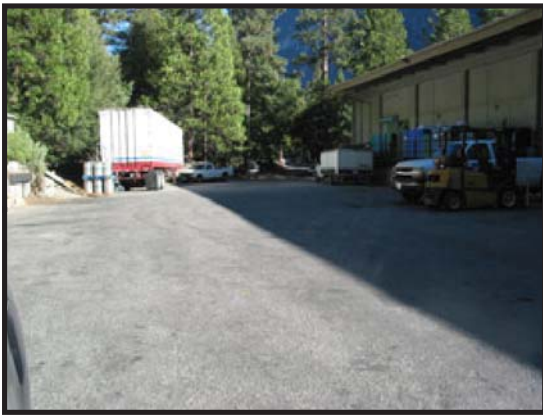
Route Number	Public / NonPublic	Date Visited		Area (sq ft)	Lane Miles *	Surface Type
0958AZ	NONPUBLIC	8/20/2007		30,549	0.53	AS
Culverts	Drop Inlets	Gates	Fire Hydrants	Curb & Gutter	Curb	PCR
0	1	0	1	CONCRETE CURB AND GUTTER	NO CURB	POOR/45

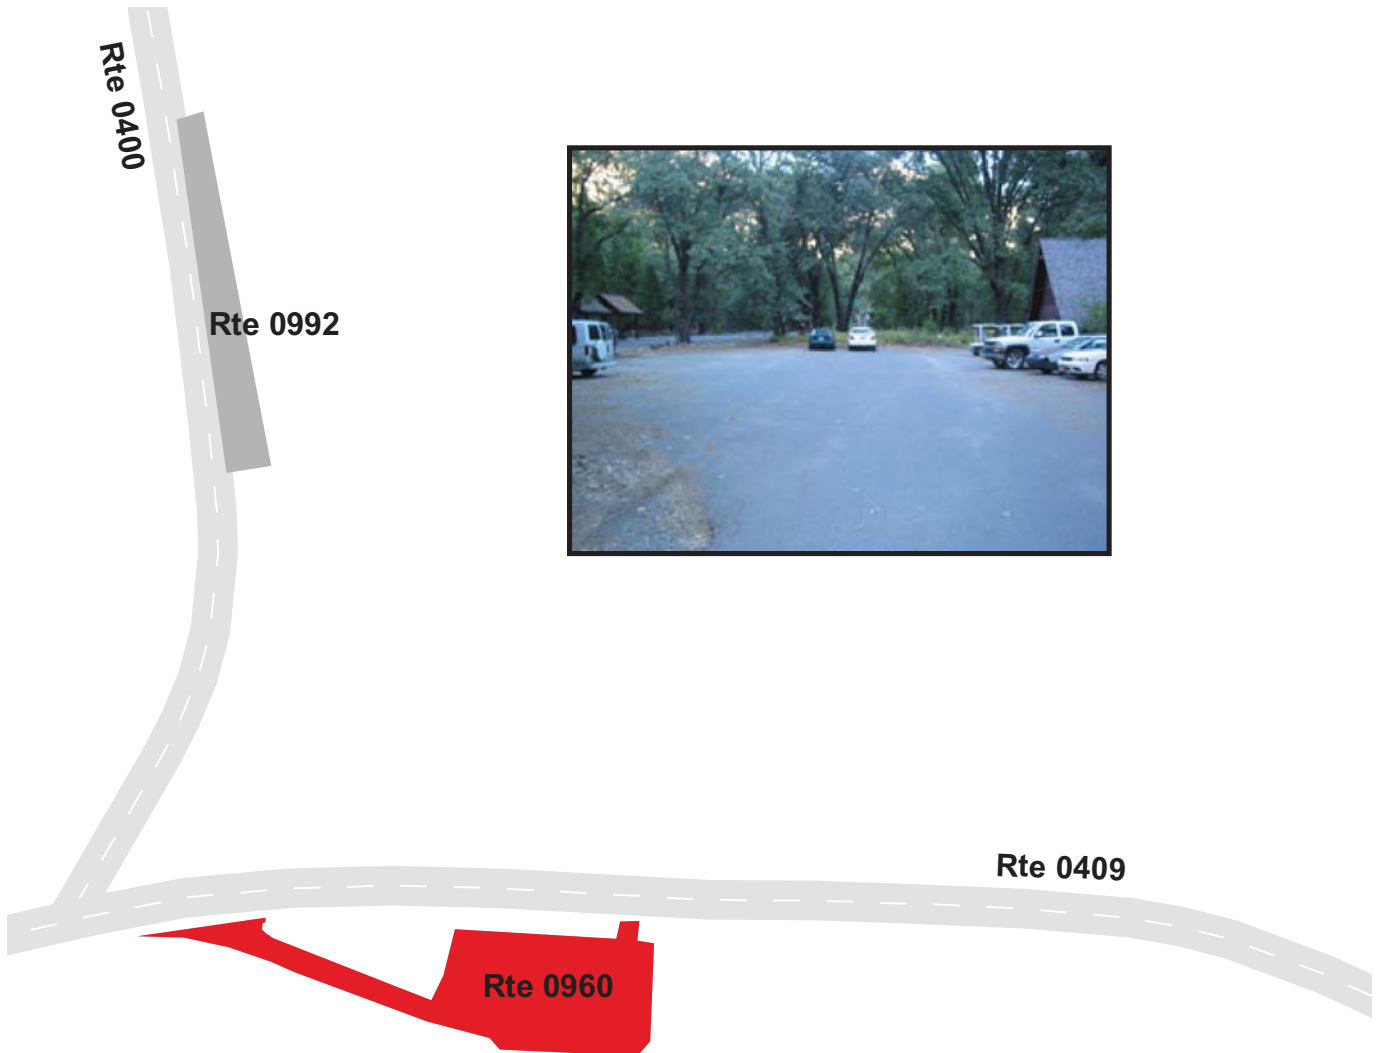
Route Number	Public / NonPublic	Date Visited		Area (sq ft)	Lane Miles *	Surface Type
0960	PUBLIC	8/20/2007		9,431	0.16	AS
Culverts	Drop Inlets	Gates	Fire Hydrants	Curb & Gutter	Curb	PCR
0	0	0	0	NO CURB AND GUTTER	NO CURB	FAIR/73

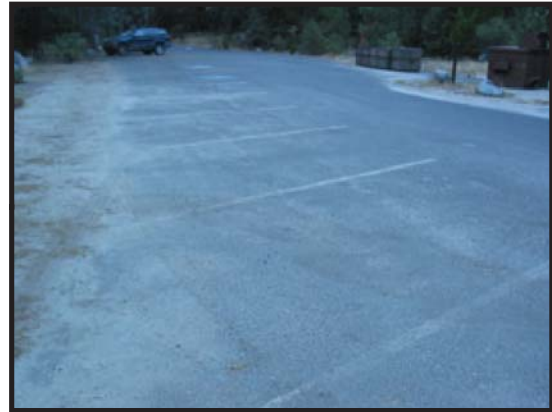
## Route 0963

Route Number	Public / NonPublic	Date Visited		Area (sq ft)	Lane Miles *	Surface Type
0963	PUBLIC	8/20/2007		5,978	0.10	AS
Culverts	Drop Inlets	Gates	Fire Hydrants	Curb & Gutter	Curb	PCR
1	0	0	0	CONCRETE CURB AND GUTTER	NO CURB	FAIR/73

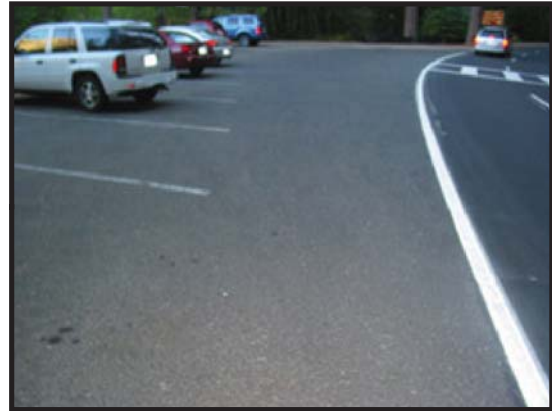
## Route 0964

Route Number	Public / NonPublic	Date Visited		Area (sq ft)	Lane Miles *	Surface Type
0964	NONPUBLIC	8/20/2007		307,431	5.29	AS
Culverts	Drop Inlets	Gates	Fire Hydrants	Curb & Gutter	Curb	PCR
0	16	6	8	CONCRETE CURB AND GUTTER	CONCRETE CURB	FAIR/73

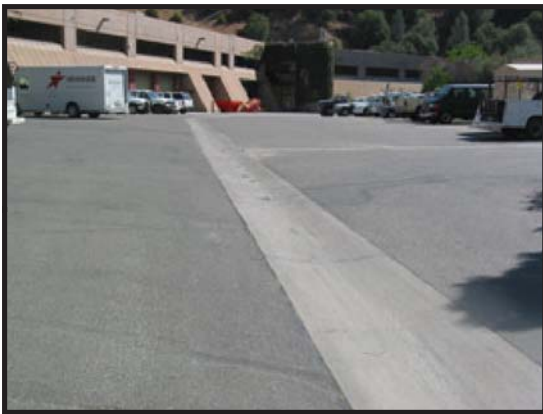
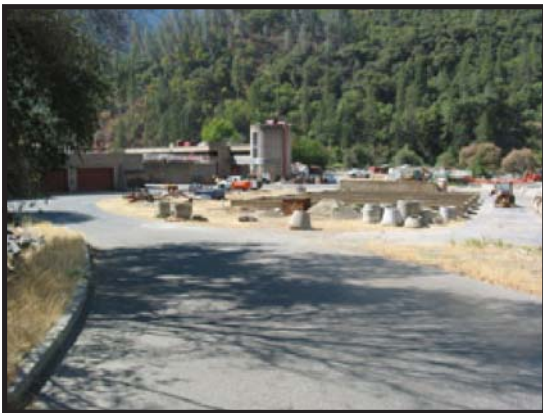
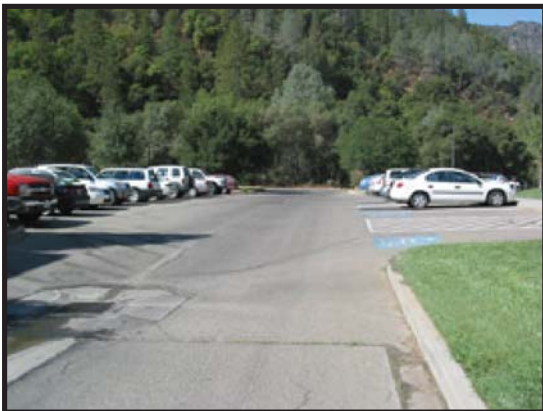
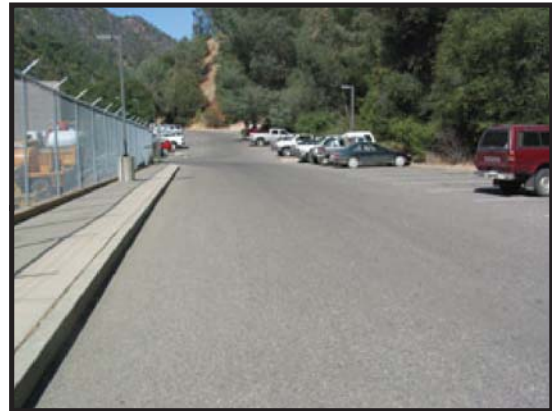
## Route 0965

Route Number	Public / NonPublic	Date Visited		Area (sq ft)	Lane Miles *	Surface Type
0965	NONPUBLIC	8/20/2007		3,580	0.06	AS
Culverts	Drop Inlets	Gates	Fire Hydrants	Curb & Gutter	Curb	PCR
0	0	0	0	NO CURB AND GUTTER	NO CURB	FAIR/73

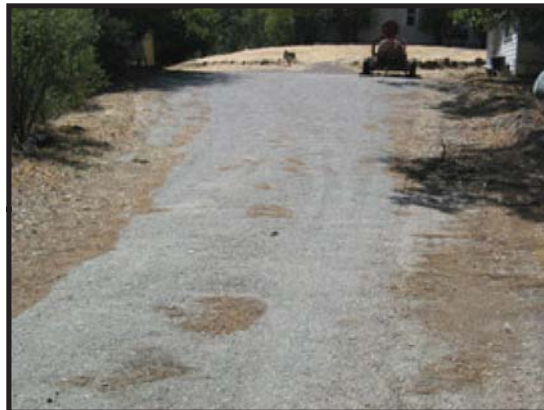
## Route 0966

Route Number	Public / NonPublic	Date Visited		Area (sq ft)	Lane Miles *	Surface Type
0966	PUBLIC	8/20/2007		16,953	0.29	AS
Culverts	Drop Inlets	Gates	Fire Hydrants	Curb & Gutter	Curb	PCR
0	0	0	1	NO CURB AND GUTTER	NO CURB	POOR/45

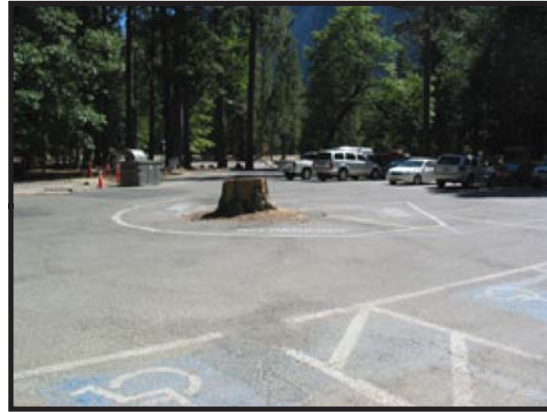
## Route 0967

Route Number	Public / NonPublic	Date Visited		Area (sq ft)	Lane Miles *	Surface Type
0967	PUBLIC	8/20/2007		1,829	0.03	AS
Culverts	Drop Inlets	Gates	Fire Hydrants	Curb & Gutter	Curb	PCR
0	0	0	0	NO CURB AND GUTTER	NO CURB	FAIR/73

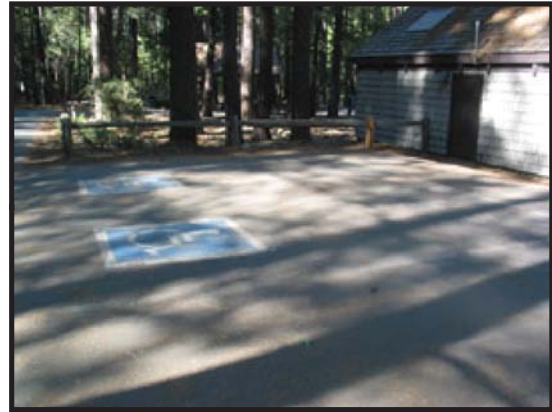
## Route 0968

Route Number	Public / NonPublic	Date Visited		Area (sq ft)	Lane Miles *	Surface Type
0968	PUBLIC	8/20/2007		1,085	0.02	AS
Culverts	Drop Inlets	Gates	Fire Hydrants	Curb & Gutter	Curb	PCR
0	0	0	0	NO CURB AND GUTTER	NO CURB	FAIR/73

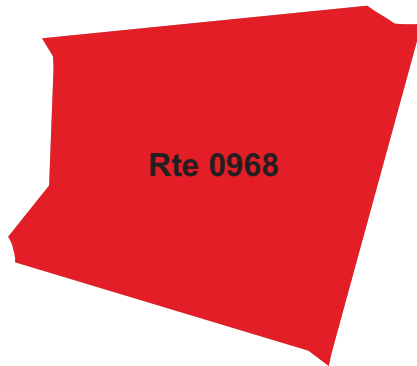
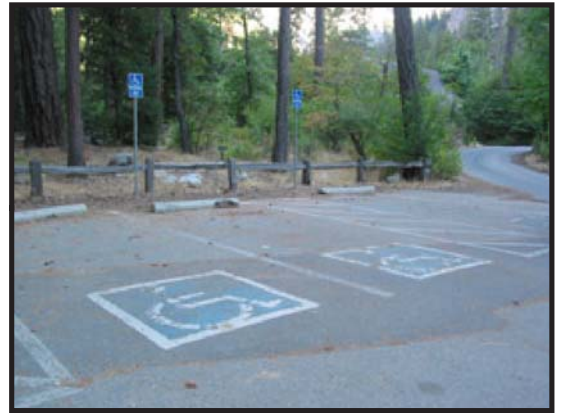
## Route 0969A

Route Number	Public / NonPublic	Date Visited		Area (sq ft)	Lane Miles *	Surface Type
0969A	NONPUBLIC	8/20/2007		3,438	0.06	AS
Culverts	Drop Inlets	Gates	Fire Hydrants	Curb & Gutter	Curb	PCR
0	0	0	0	CONCRETE CURB AND GUTTER	NO CURB	FAIR/73

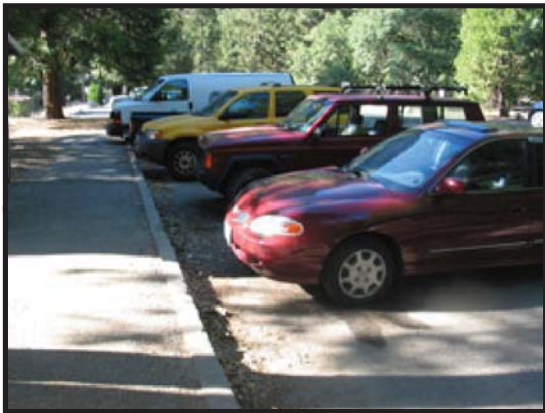
## Route 0969B

Route Number	Public / NonPublic	Date Visited		Area (sq ft)	Lane Miles *	Surface Type
0969B	NONPUBLIC	8/20/2007		1,633	0.03	AS
Culverts	Drop Inlets	Gates	Fire Hydrants	Curb & Gutter	Curb	PCR
0	0	0	0	NO CURB AND GUTTER	NO CURB	FAIR/73

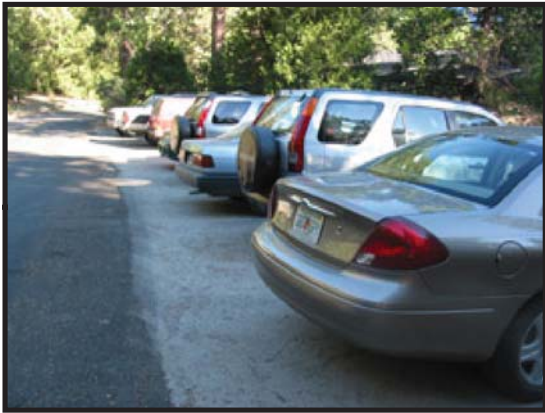
## Route 0969C

Route Number	Public / NonPublic	Date Visited		Area (sq ft)	Lane Miles *	Surface Type
0969C	NONPUBLIC	8/20/2007		1,506	0.03	AS
Culverts	Drop Inlets	Gates	Fire Hydrants	Curb & Gutter	Curb	PCR
0	0	0	0	NO CURB AND GUTTER	NO CURB	FAIR/73

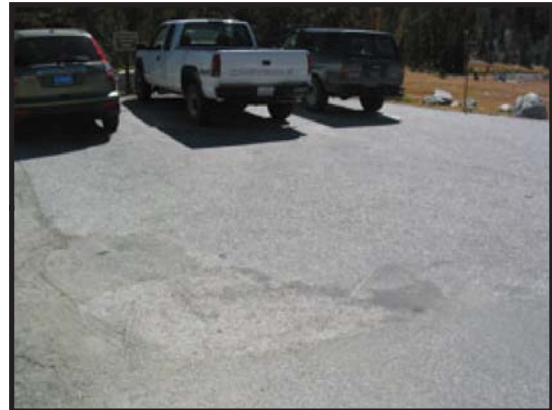
## Route 0973

Route Number	Public / NonPublic	Date Visited		Area (sq ft)	Lane Miles *	Surface Type
0973	PUBLIC	8/20/2007		5,284	0.09	AS
Culverts	Drop Inlets	Gates	Fire Hydrants	Curb & Gutter	Curb	PCR
0	0	0	0	NO CURB AND GUTTER	NO CURB	POOR/45

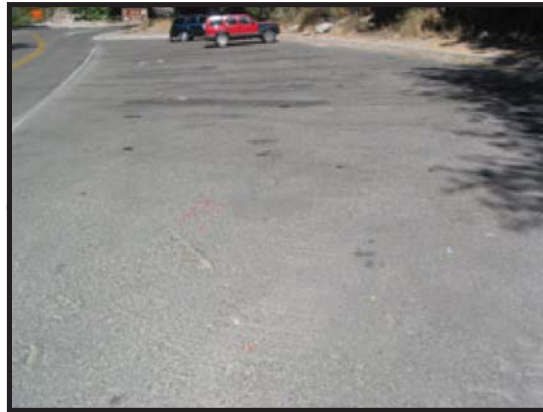
## Route 0976A

Route Number	Public / NonPublic	Date Visited		Area (sq ft)	Lane Miles *	Surface Type
0976A	PUBLIC	8/20/2007		9,707	0.17	AS
Culverts	Drop Inlets	Gates	Fire Hydrants	Curb & Gutter	Curb	PCR
0	0	0	0	CONCRETE CURB AND GUTTER	CONCRETE CURB	GOOD/90

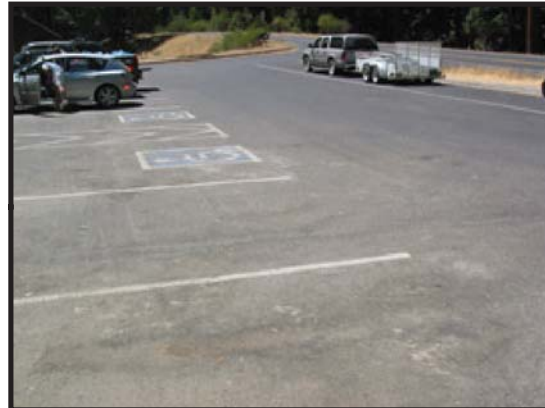
## Route 0976B

Route Number	Public / NonPublic	Date Visited		Area (sq ft)	Lane Miles *	Surface Type
0976B	PUBLIC	8/20/2007		6,921	0.12	AS
Culverts	Drop Inlets	Gates	Fire Hydrants	Curb & Gutter	Curb	PCR
0	0	0	0	CONCRETE CURB AND GUTTER	NO CURB	FAIR/73

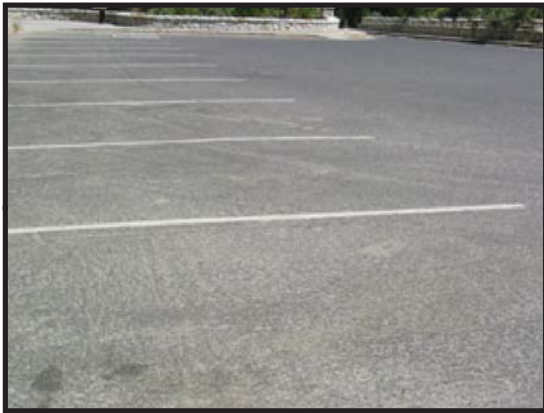
## Route 0977

Route Number	Public / NonPublic	Date Visited		Area (sq ft)	Lane Miles *	Surface Type
0977	PUBLIC	8/20/2007		9,770	0.17	AS
Culverts	Drop Inlets	Gates	Fire Hydrants	Curb & Gutter	Curb	PCR
0	2	1	0	NO CURB AND GUTTER	NO CURB	FAIR/73

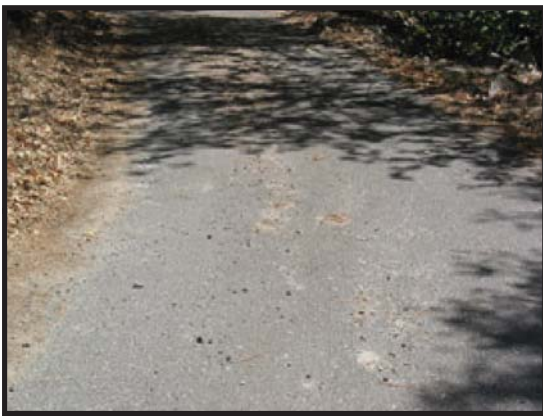
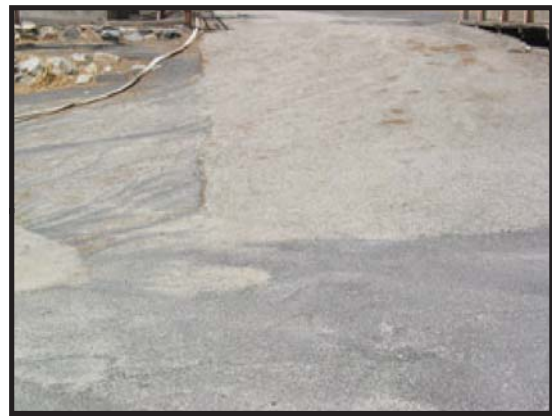
## Route 0978

Route Number	Public / NonPublic	Date Visited		Area (sq ft)	Lane Miles *	Surface Type
0978	PUBLIC	8/20/2007		7,066	0.12	AS
Culverts	Drop Inlets	Gates	Fire Hydrants	Curb & Gutter	Curb	PCR
0	0	0	0	NO CURB AND GUTTER	ASPHALT CURB	GOOD/90

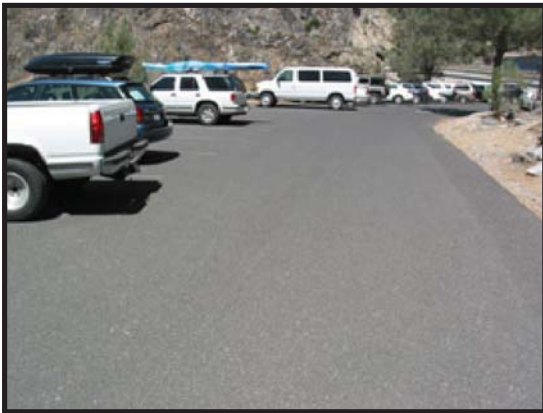
## Route 0980

Route Number	Public / NonPublic	Date Visited		Area (sq ft)	Lane Miles *	Surface Type
0980	NONPUBLIC	8/20/2007		4,065	0.07	AS
Culverts	Drop Inlets	Gates	Fire Hydrants	Curb & Gutter	Curb	PCR
0	0	0	0	NO CURB AND GUTTER	NO CURB	GOOD/90

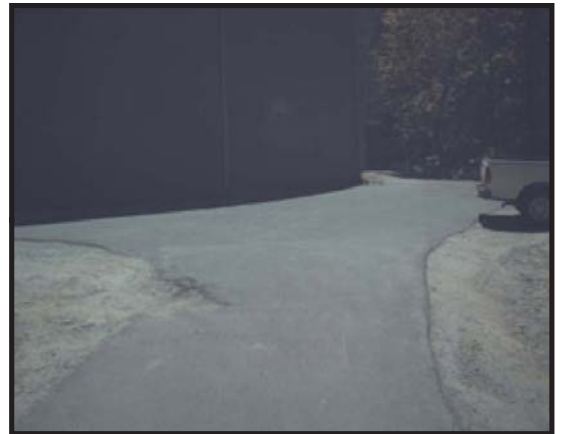
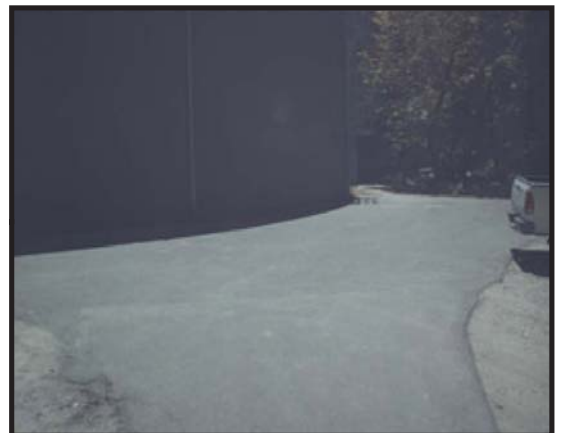
## Route 0981

Route Number	Public / NonPublic	Date Visited		Area (sq ft)	Lane Miles *	Surface Type
0981	NONPUBLIC	8/20/2007		518	0.01	AS
Culverts	Drop Inlets	Gates	Fire Hydrants	Curb & Gutter	Curb	PCR
0	0	0	0	NO CURB AND GUTTER	NO CURB	FAIR/73

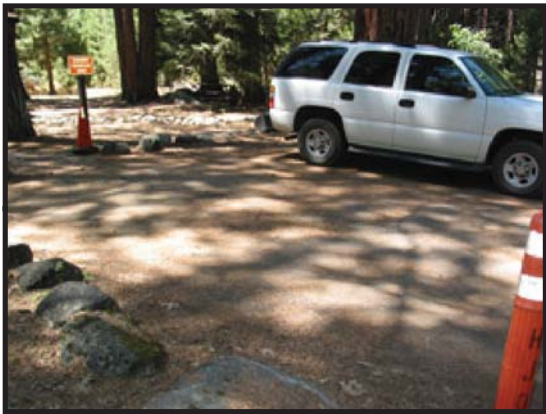
## Route 0982

Route Number	Public / NonPublic	Date Visited		Area (sq ft)	Lane Miles *	Surface Type
0982	PUBLIC	8/20/2007		8,816	0.15	AS
Culverts	Drop Inlets	Gates	Fire Hydrants	Curb & Gutter	Curb	PCR
0	0	0	1	CONCRETE CURB AND GUTTER	CONCRETE CURB	GOOD/90

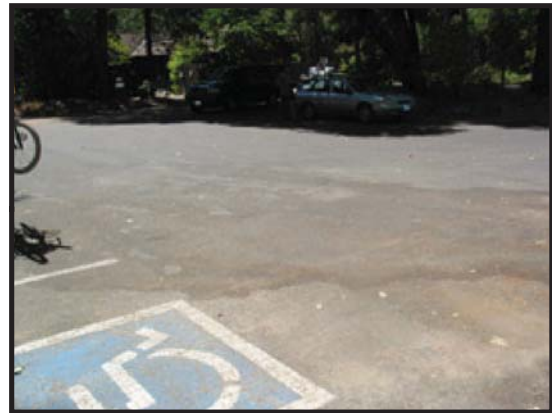
## Route 0983

Route Number	Public / NonPublic	Date Visited		Area (sq ft)	Lane Miles *	Surface Type
0983	NONPUBLIC	8/20/2007		8,322	0.14	AS
Culverts	Drop Inlets	Gates	Fire Hydrants	Curb & Gutter	Curb	PCR
0	0	0	1	NO CURB AND GUTTER	NO CURB	GOOD/90

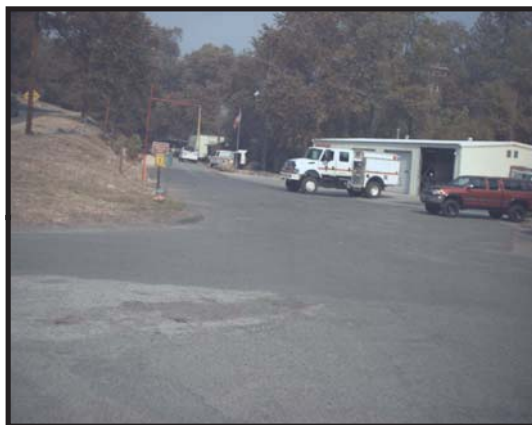
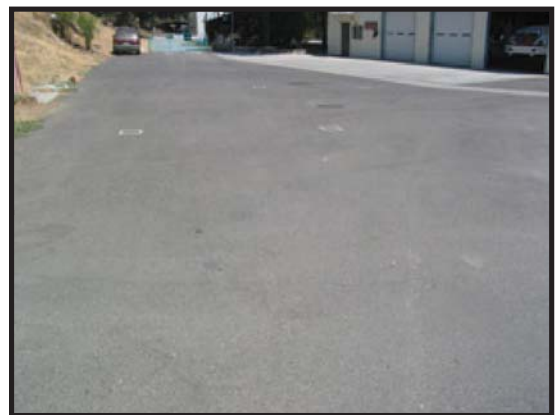
## Route 0984

Route Number	Public / NonPublic	Date Visited		Area (sq ft)	Lane Miles *	Surface Type
0984	PUBLIC	8/20/2007		50,300	0.87	AS
Culverts	Drop Inlets	Gates	Fire Hydrants	Curb & Gutter	Curb	PCR
1	0	0	1	NO CURB AND GUTTER	NO CURB	GOOD/90

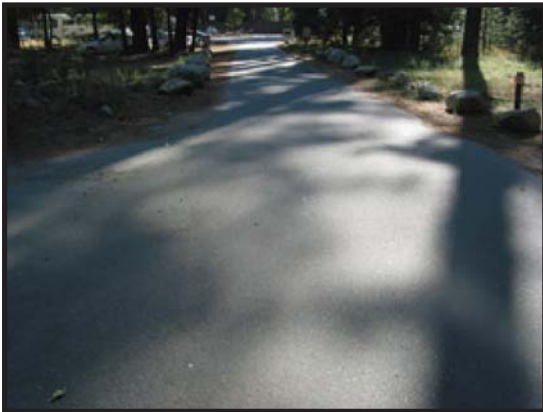
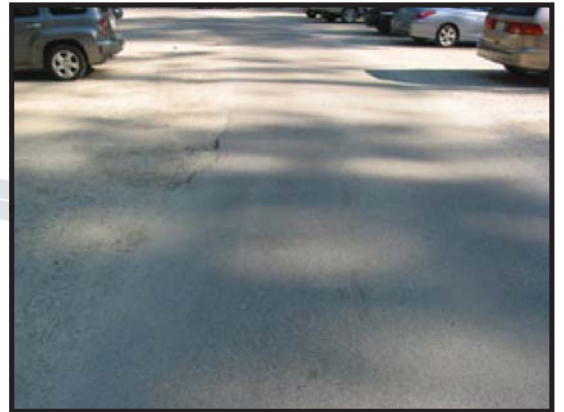
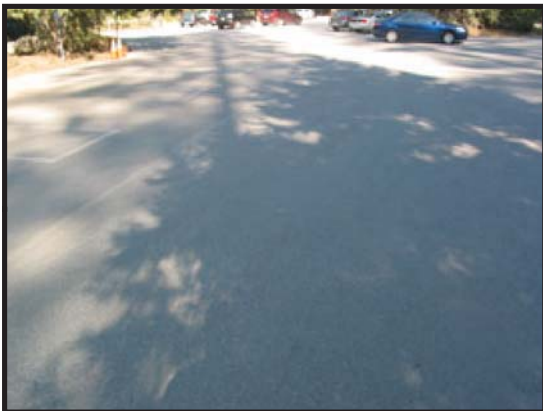
## Route 0985

Route Number	Public / NonPublic	Date Visited		Area (sq ft)	Lane Miles *	Surface Type
0985	NONPUBLIC	8/20/2007		17,538	0.30	AS
Culverts	Drop Inlets	Gates	Fire Hydrants	Curb & Gutter	Curb	PCR
0	0	0	1	NO CURB AND GUTTER	NO CURB	POOR/45

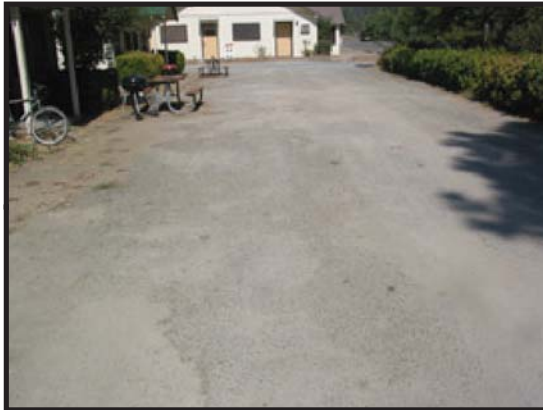
**YOSEMITE NATIONAL PARK**  
**Route 0986**  
**CURRY VILLAGE REGISTRATION PARKING**  
**ADJACENT TO ROUTE 0500**

Route Number	Public / NonPublic	Date Visited		Area (sq ft)	Lane Miles *	Surface Type
0986	PUBLIC	8/20/2007		12,024	0.21	AS
Culverts	Drop Inlets	Gates	Fire Hydrants	Curb & Gutter	Curb	PCR
0	0	0	0	NO CURB AND GUTTER	ASPHALT CURB	FAIR/73

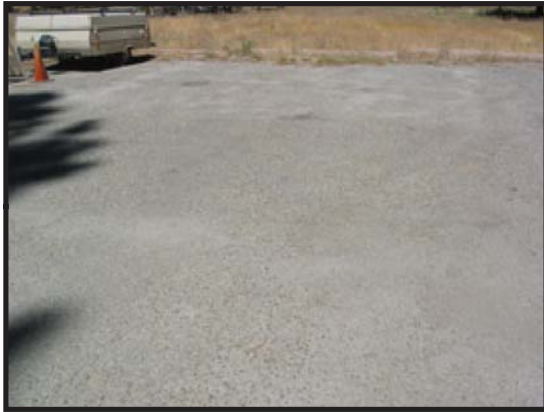
Route Number	Public / NonPublic	Date Visited		Area (sq ft)	Lane Miles *	Surface Type
0987AZ	PUBLIC	8/20/2007		1,931	0.03	AS
Culverts	Drop Inlets	Gates	Fire Hydrants	Curb & Gutter	Curb	PCR
0	0	0	0	NO CURB AND GUTTER	NO CURB	POOR/45

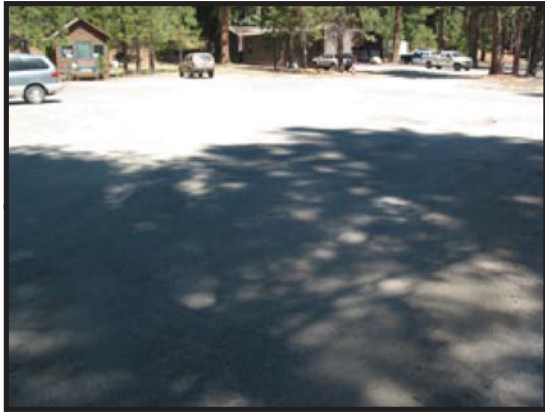
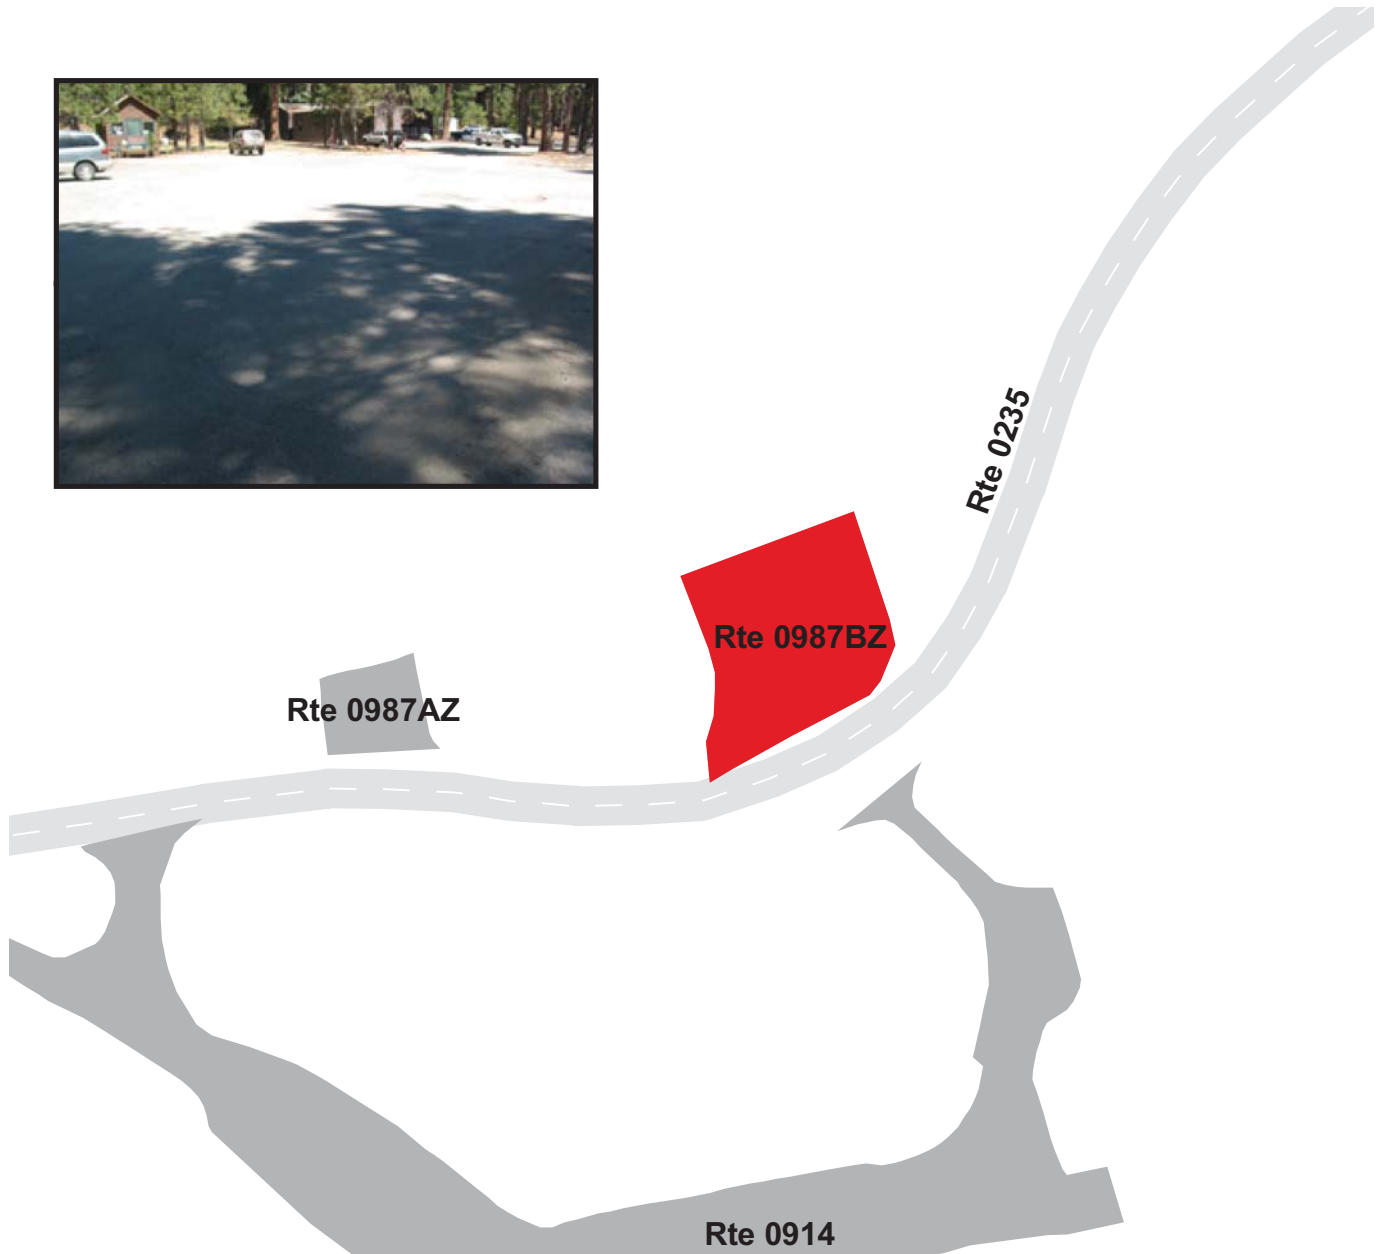
Route Number	Public / NonPublic	Date Visited		Area (sq ft)	Lane Miles *	Surface Type
0987BZ	PUBLIC	8/20/2007		7,646	0.13	AS
Culverts	Drop Inlets	Gates	Fire Hydrants	Curb & Gutter	Curb	PCR
0	0	0	1	NO CURB AND GUTTER	NO CURB	POOR/45

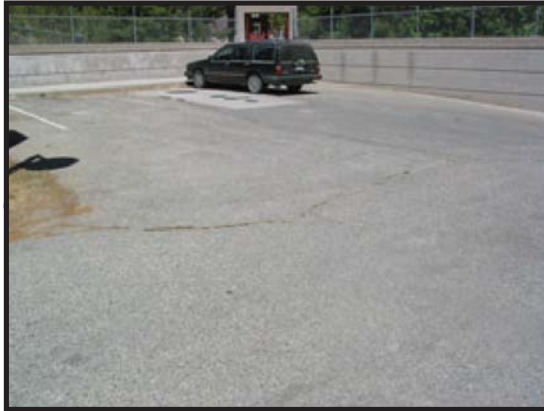
Route Number	Public / NonPublic	Date Visited		Area (sq ft)	Lane Miles *	Surface Type
0989AZ	NONPUBLIC	8/20/2007		1,342	0.02	AS
Culverts	Drop Inlets	Gates	Fire Hydrants	Curb & Gutter	Curb	PCR
0	0	0	0	NO CURB AND GUTTER	CONCRETE CURB	FAIR/73
