**The Road Inventory  
of  
Yosemite National Park  
YOSE – 8800  
Cycle 4**

**Prepared By:  
Federal Highway Administration  
Road Inventory Program  
Cycle 4**

# Yosemite National Park in California

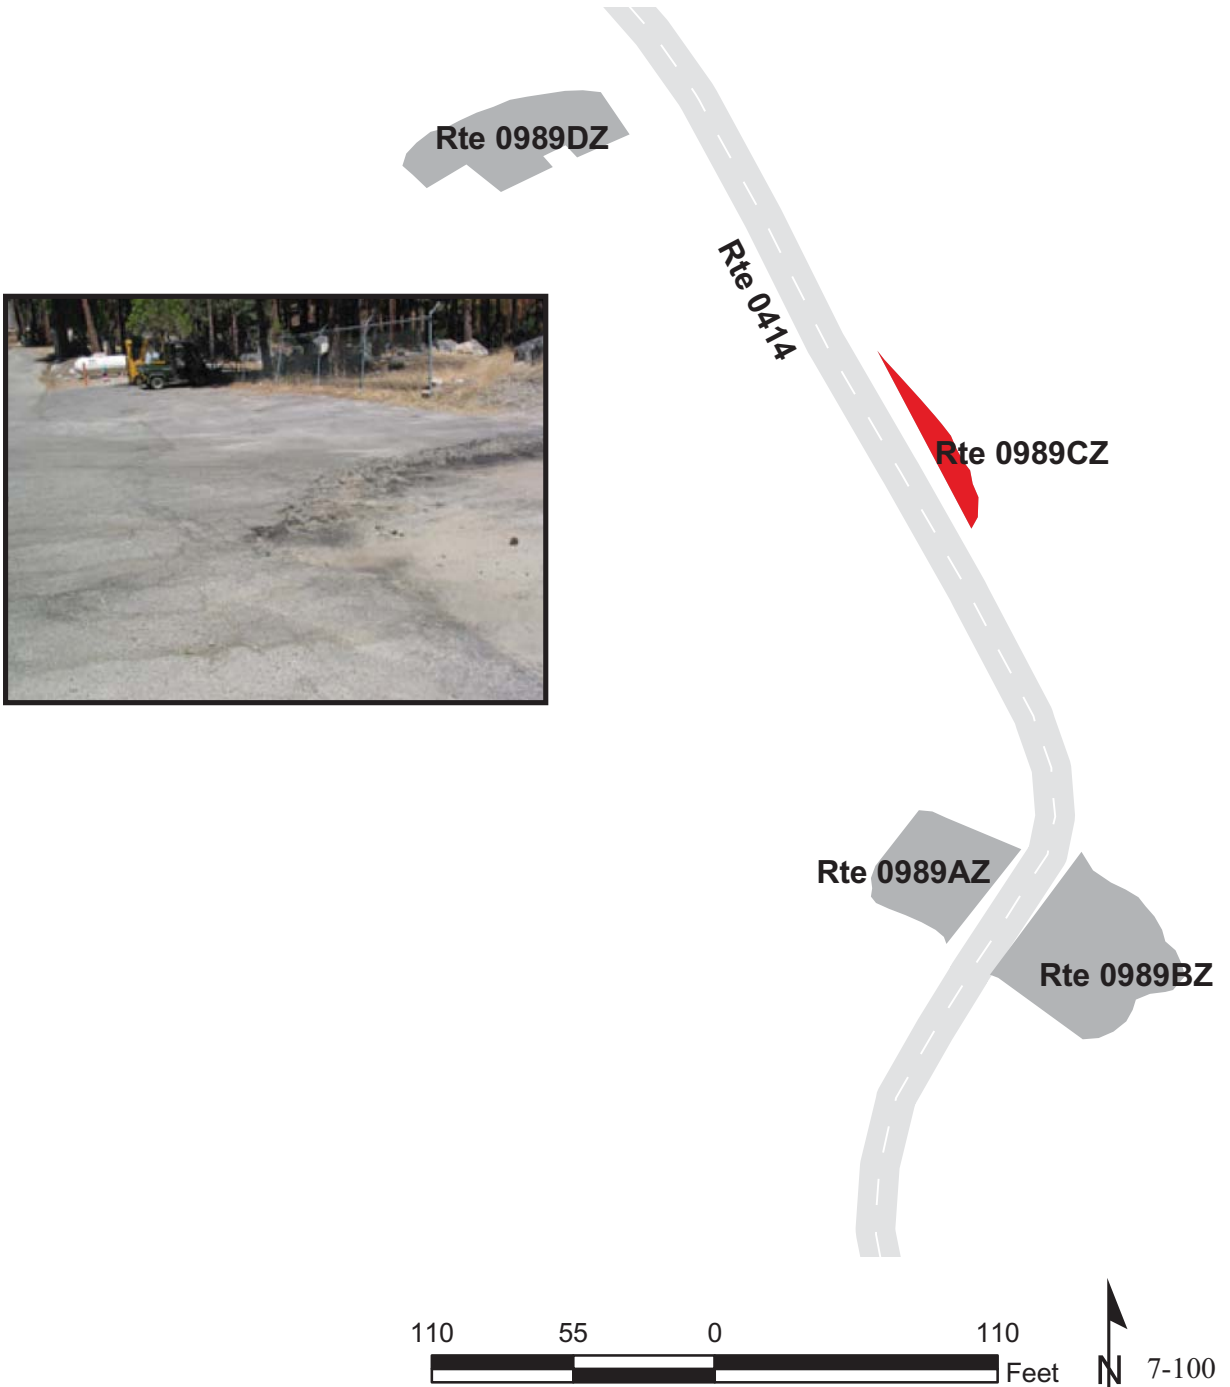
Route Number	Public / NonPublic	Date Visited		Area (sq ft)	Lane Miles *	Surface Type
0989CZ	NONPUBLIC	8/20/2007		399	0.01	AS
Culverts	Drop Inlets	Gates	Fire Hydrants	Curb & Gutter	Curb	PCR
0	0	0	0	NO CURB AND GUTTER	NO CURB	POOR/45

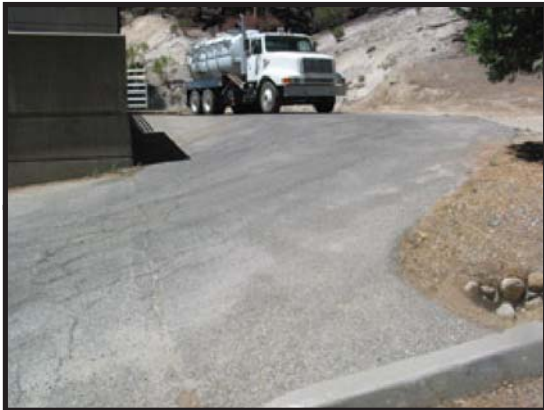
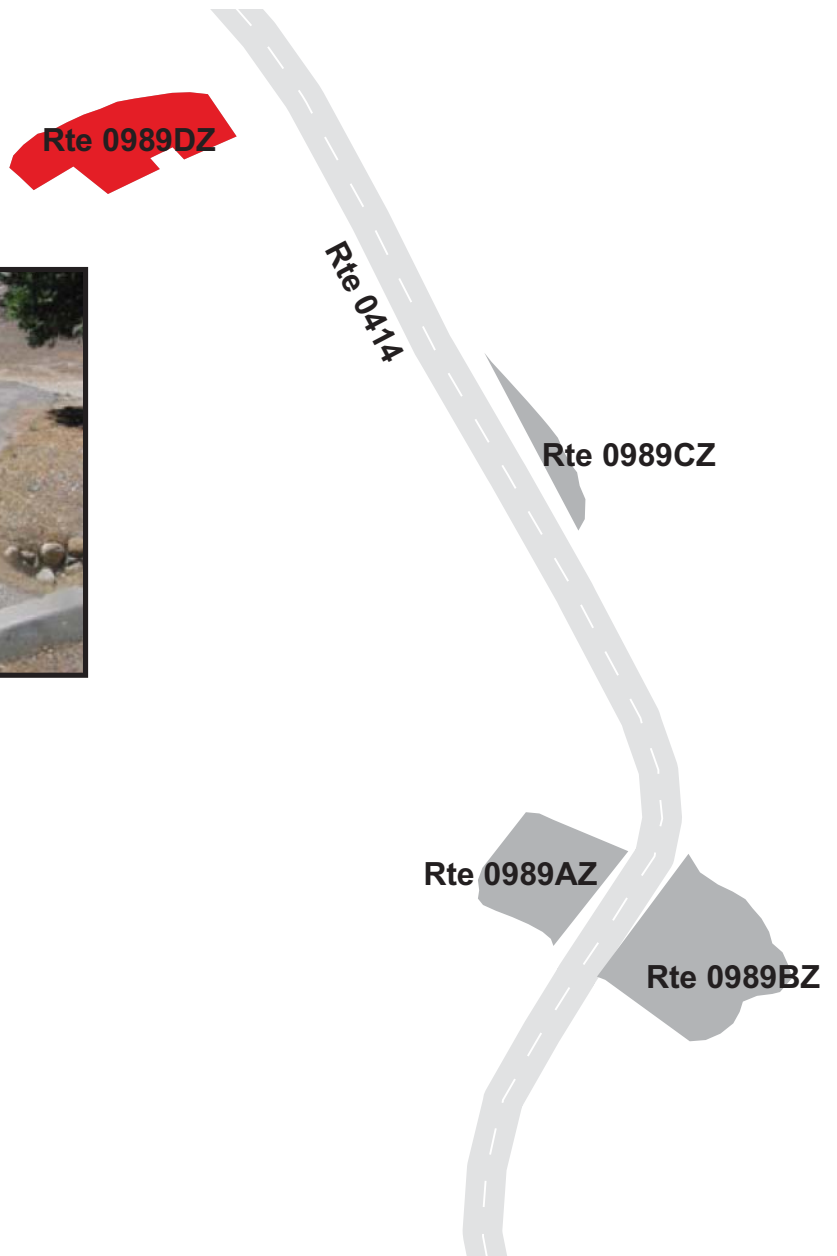
Route Number	Public / NonPublic	Date Visited		Area (sq ft)	Lane Miles *	Surface Type
0989DZ	NONPUBLIC	8/20/2007		1,544	0.03	AS
Culverts	Drop Inlets	Gates	Fire Hydrants	Curb & Gutter	Curb	PCR
0	0	0	0	NO CURB AND GUTTER	NO CURB	FAIR/73

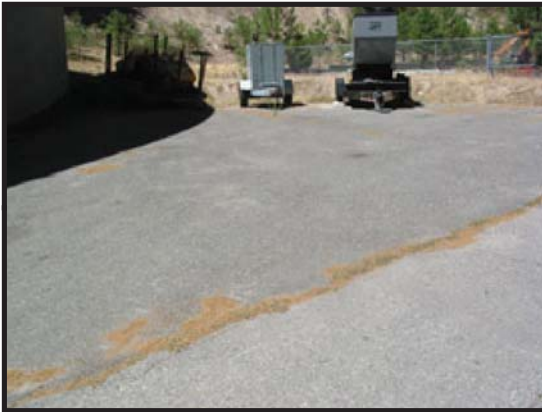
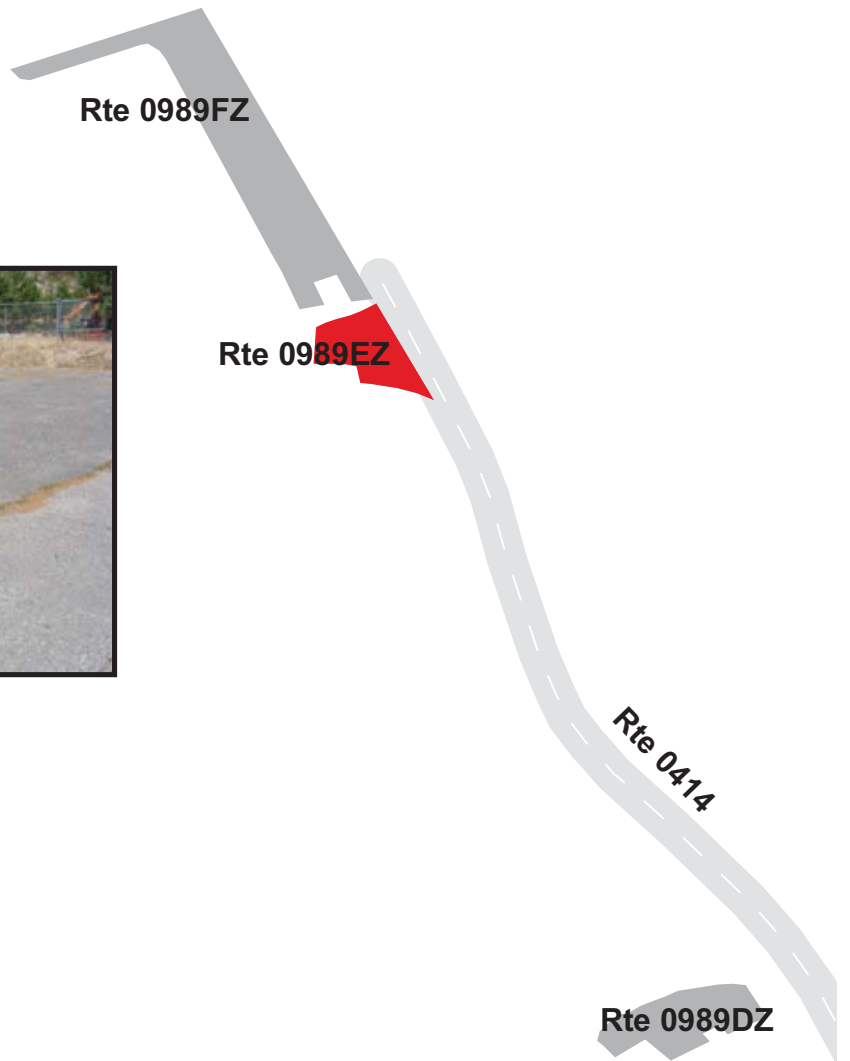
Route Number	Public / NonPublic	Date Visited		Area (sq ft)	Lane Miles *	Surface Type
0989EZ	NONPUBLIC	8/20/2007		1,179	0.02	AS
Culverts	Drop Inlets	Gates	Fire Hydrants	Curb & Gutter	Curb	PCR
0	0	0	0	NO CURB AND GUTTER	NO CURB	FAIR/73

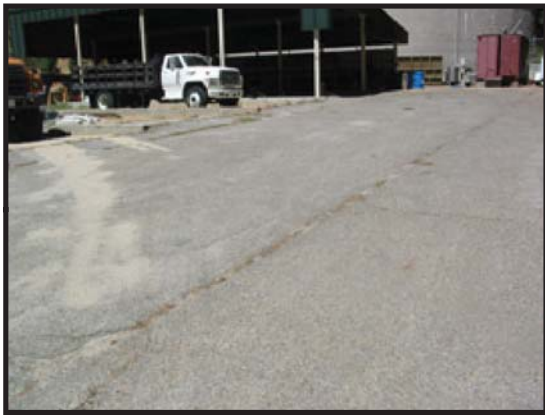
Route Number	Public / NonPublic	Date Visited		Area (sq ft)	Lane Miles *	Surface Type
0989FZ	NONPUBLIC	8/20/2007		4,697	0.08	AS
Culverts	Drop Inlets	Gates	Fire Hydrants	Curb & Gutter	Curb	PCR
0	0	0	0	NO CURB AND GUTTER	NO CURB	POOR/45

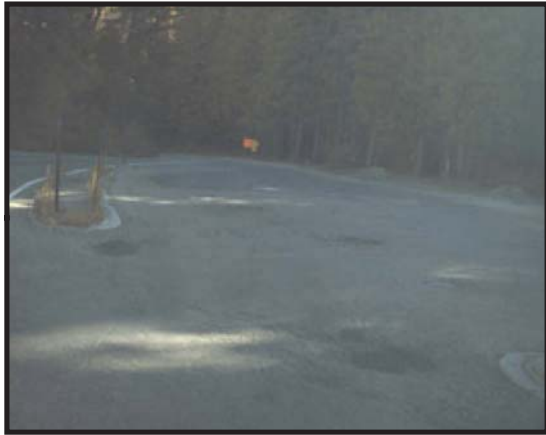
Route Number	Public / NonPublic	Date Visited		Area (sq ft)	Lane Miles *	Surface Type
0994	PUBLIC	8/3/2008		32,809	0.57	AS
Culverts	Drop Inlets	Gates	Fire Hydrants	Curb & Gutter	Curb	PCR
0	0	0	0	CONCRETE CURB AND GUTTER	CONCRETE CURB	GOOD/90
