# Federal Lands Highway Road Inventory Program

Road Inventory and Condition Assessment

## Abraham Lincoln Birthplace National Historical Park ABLI

### Cycle 5 Report

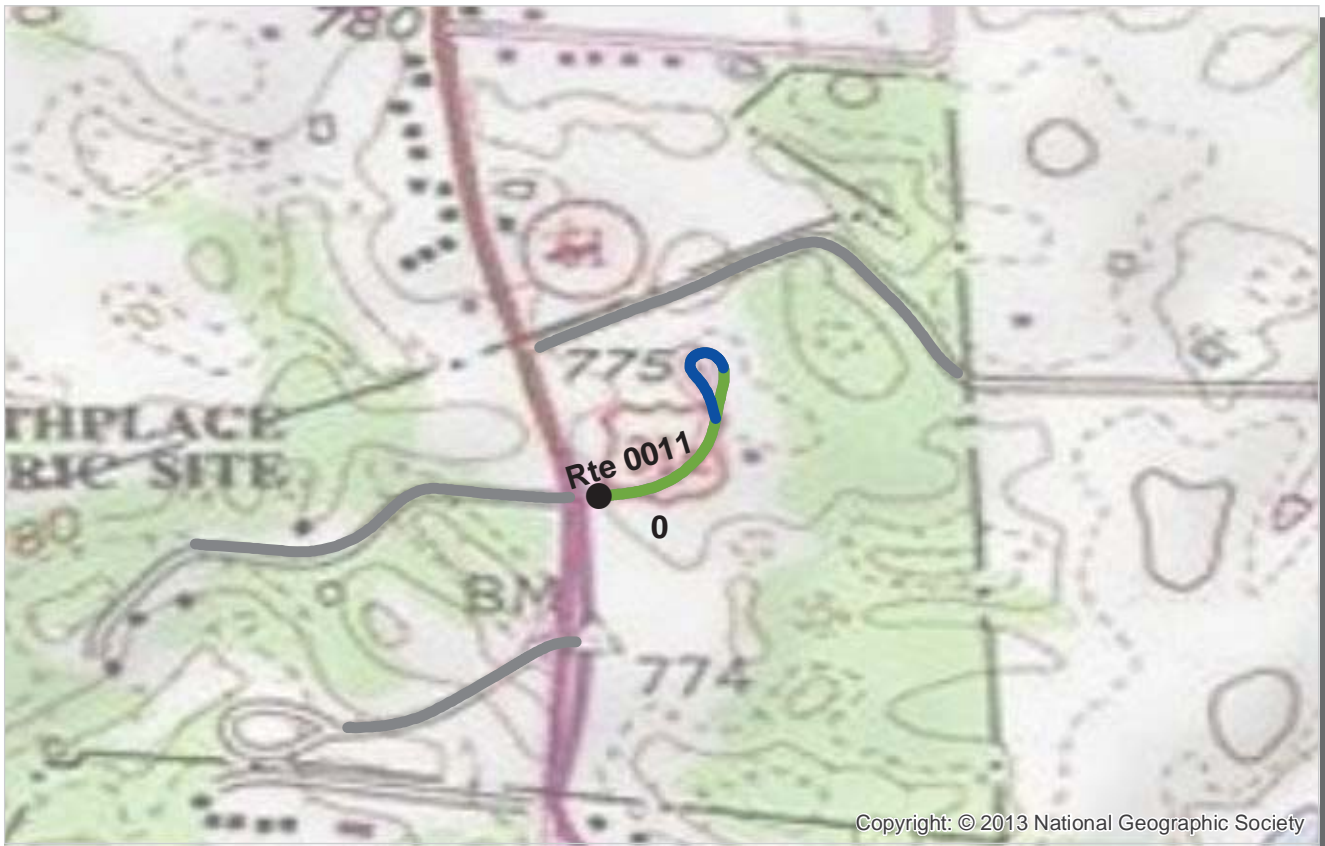
**ROUTE: 0011 BIRTHPLACE PICNIC AREA LOOP ROAD**

<b>Section Number</b>	0				
<b>Section Length (mi)</b>	0.18				
<b>Cross Section Information</b>					
Number of Lanes	2				
Paved Width (ft)	21				
Lane Width (ft)	14				
<b>Roadway Condition Information</b>					
SCR (Surface Condition Rating)	93				
PCR (Pavement Condition Rating)	93				
<b>Distress Index Values</b>					
Structural Crack Index	97				
Transverse Cracking Index	100				
Patching Index	100				
Rutting Index	93				
Roughness Condition Index (RCI)	NC

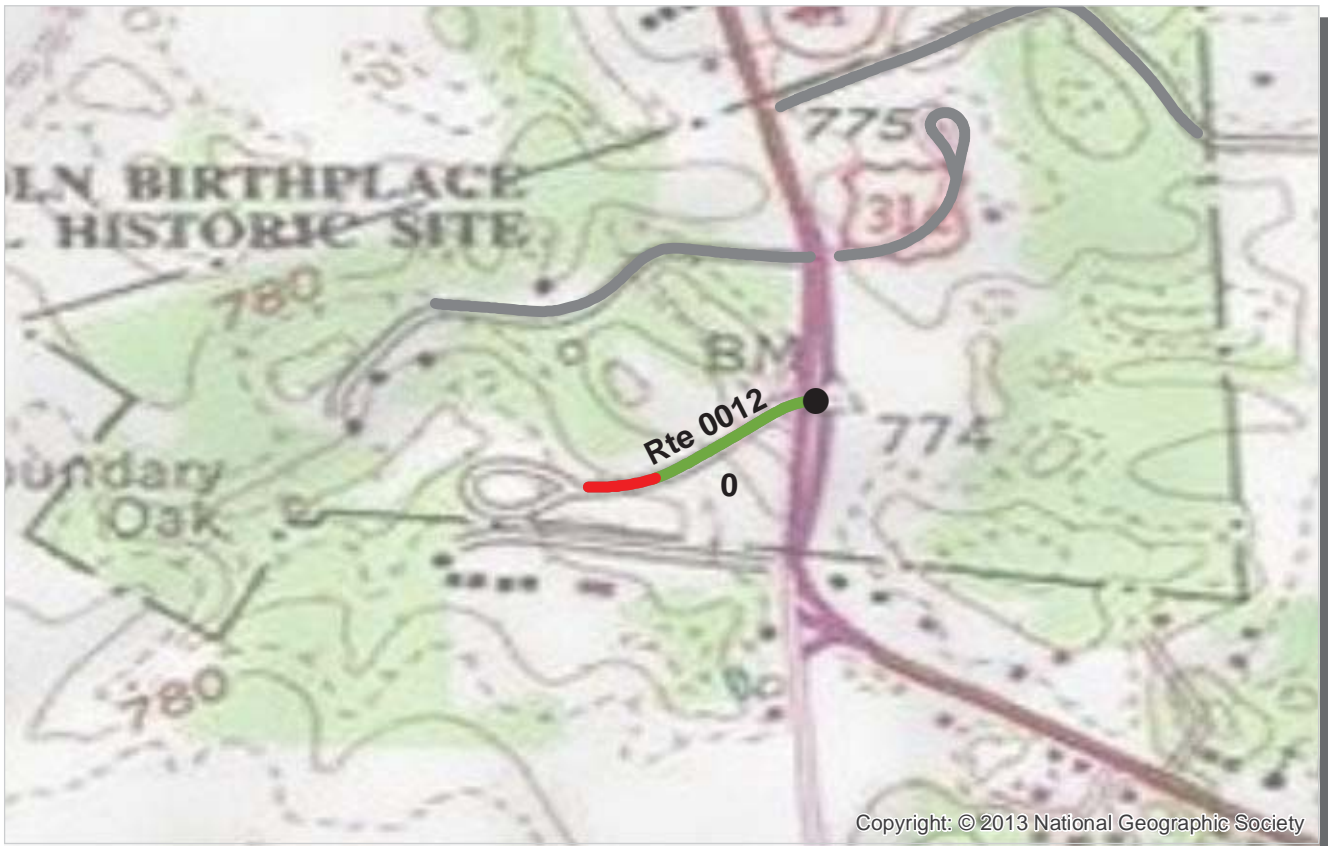
**ROUTE: 0012 VISITOR CENTER ENTRANCE ROAD**

<b>Section Number</b>	0				
<b>Section Length (mi)</b>	0.14				
<b>Cross Section Information</b>					
Number of Lanes	2				
Paved Width (ft)	20				
Lane Width (ft)	10				
<b>Roadway Condition Information</b>					
SCR (Surface Condition Rating)	86				
PCR (Pavement Condition Rating)	86				
<b>Distress Index Values</b>					
Structural Crack Index	86				
Transverse Cracking Index	98				
Patching Index	99				
Rutting Index	99				
Roughness Condition Index (RCI)	NC

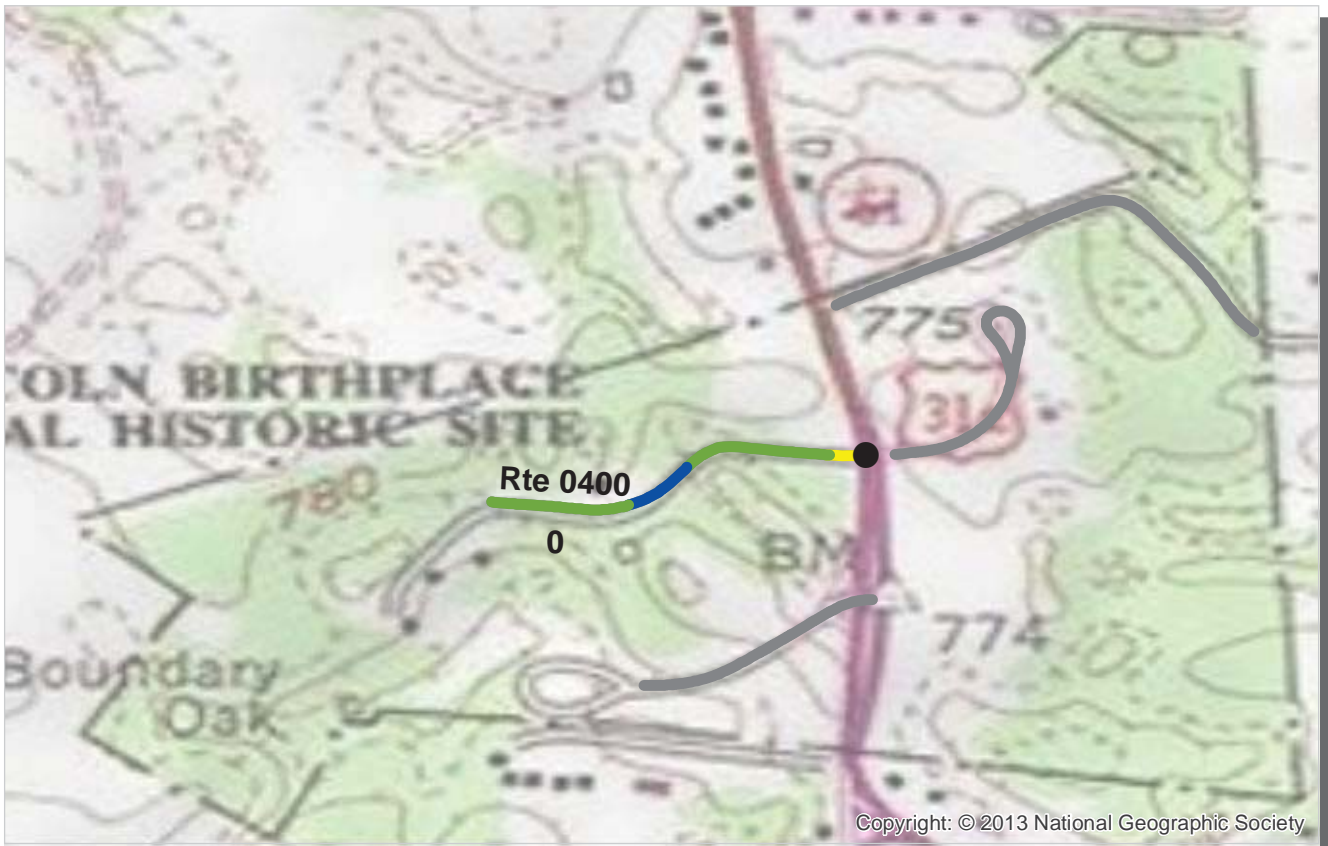
**ROUTE: 0400 MAINTENANCE SERVICE ROAD**

<b>Section Number</b>	0				
<b>Section Length (mi)</b>	0.21				
<b>Cross Section Information</b>					
Number of Lanes	1				
Paved Width (ft)	15				
Lane Width (ft)	15				
<b>Roadway Condition Information</b>					
SCR (Surface Condition Rating)	89				
PCR (Pavement Condition Rating)	89				
<b>Distress Index Values</b>					
Structural Crack Index	89				
Transverse Cracking Index	97				
Patching Index	100				
Rutting Index	94				
Roughness Condition Index (RCI)	NC

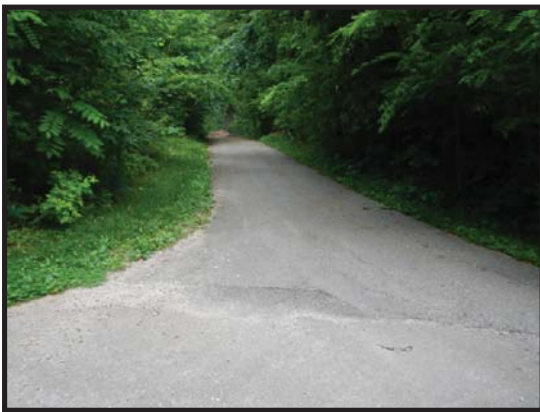
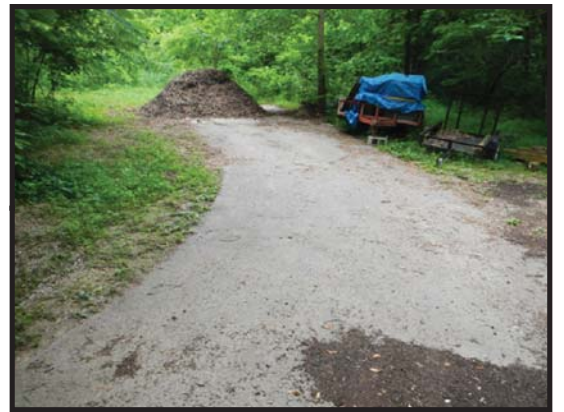
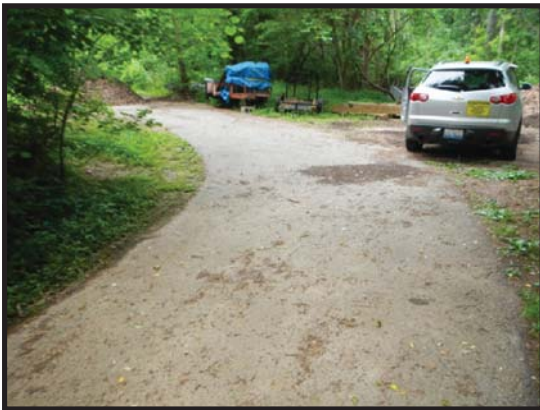
Route Number	Public / NonPublic	Date Visited	Area (sq ft)	Lane Miles *	Paved Length (mi)	Paved Width (ft)
0403	NONPUBLIC	5/22/2012	1,901	0.03	0.04	10
Culverts	Drop Inlets	Gates	Curb & Gutter	Curb	PCR	Surface Type
0	0	0	NO CURB AND GUTTER	NO CURB	FAIR/73	AS

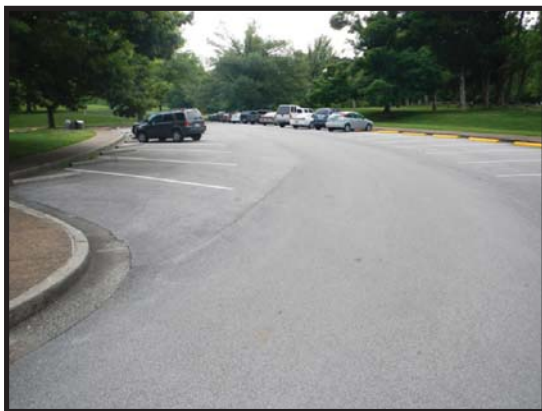
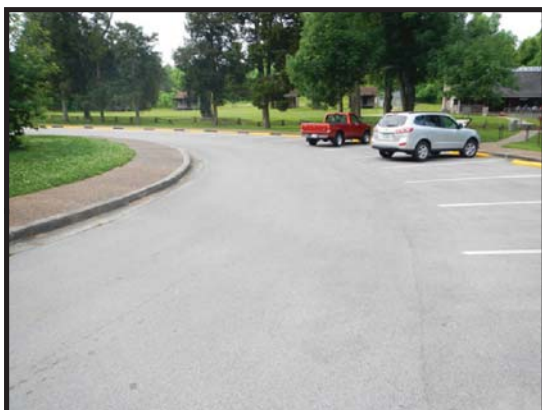
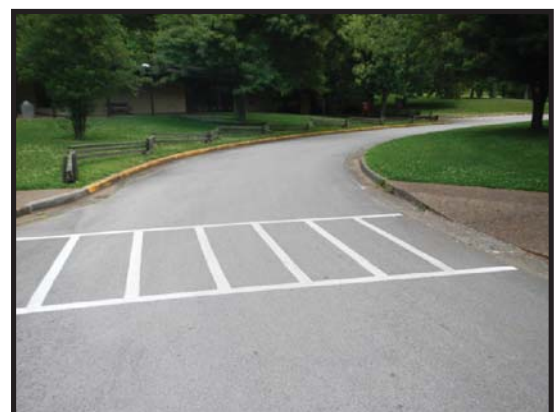
Route Number	Public / NonPublic	Date Visited	Area (sq ft)	Lane Miles *	Surface Type
0900	PUBLIC	5/22/2012	29,143	0.50	AS
Culverts	Drop Inlets	Gates	Curb & Gutter	Curb	PCR
0	3	0	CONCRETE CURB AND GUTTER	NO CURB	GOOD/90

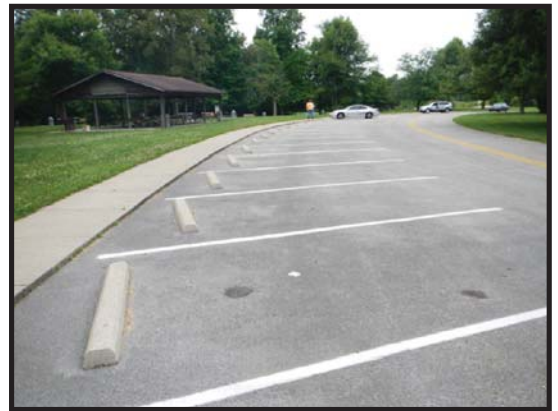
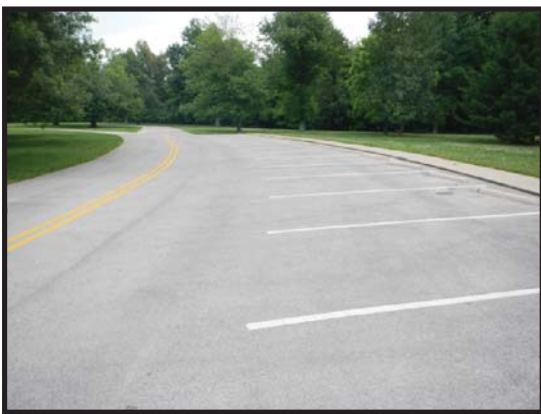
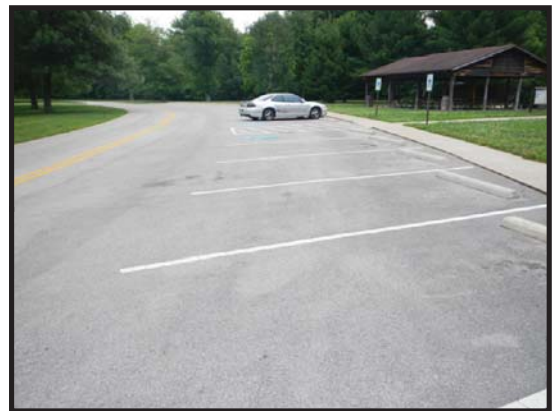
## Route 0901

Route Number	Public / NonPublic	Date Visited	Area (sq ft)	Lane Miles *	Surface Type
0901	PUBLIC	5/22/2012	6,918	0.12	AS
Culverts	Drop Inlets	Gates	Curb & Gutter	Curb	PCR
0	0	0	NO CURB AND GUTTER	NO CURB	GOOD/90

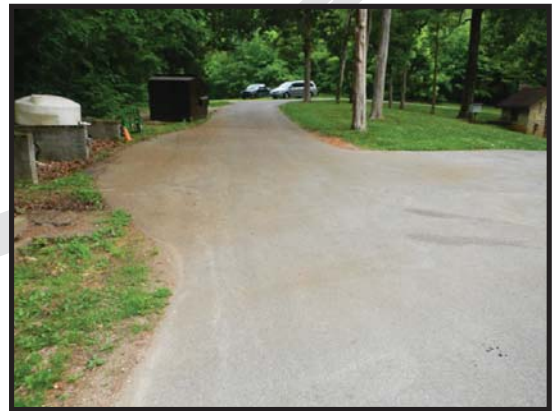
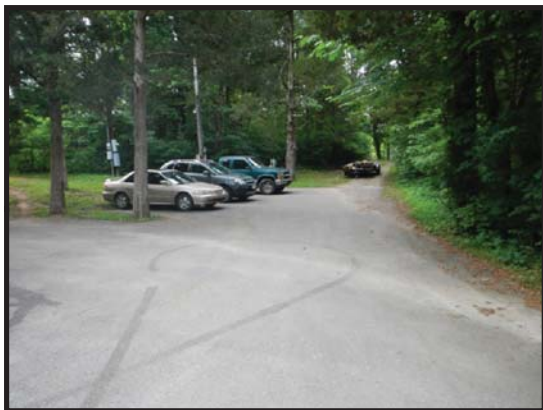
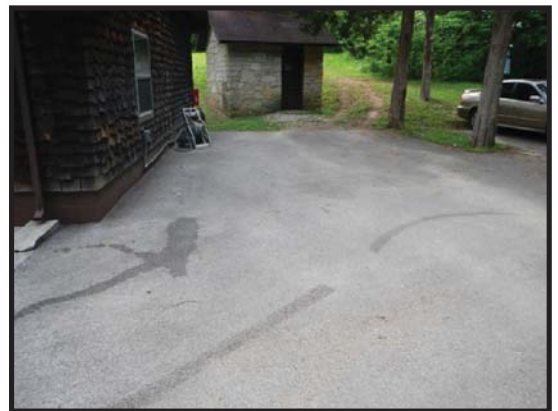
## Route 0903

Route Number	Public / NonPublic	Date Visited	Area (sq ft)	Lane Miles *	Surface Type
0903	NONPUBLIC	5/22/2012	8,116	0.14	AS
Culverts	Drop Inlets	Gates	Curb & Gutter	Curb	PCR
0	1	0	NO CURB AND GUTTER	NO CURB	GOOD/90

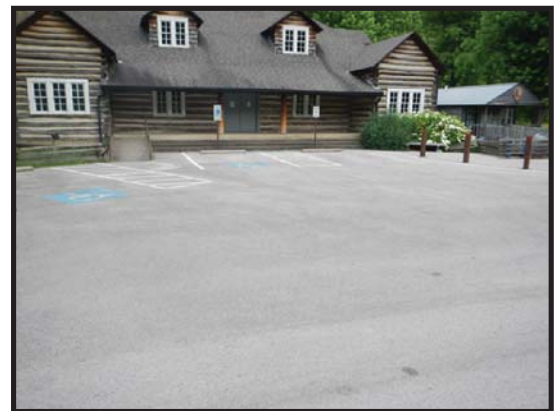
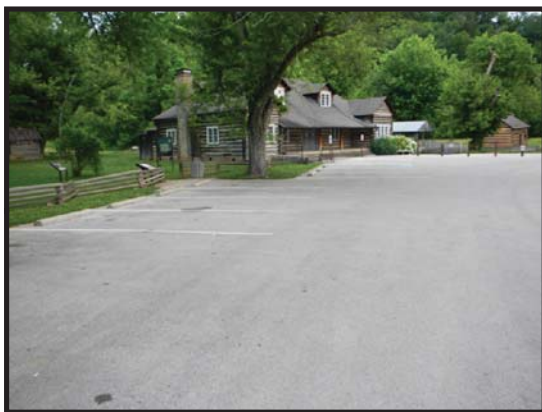
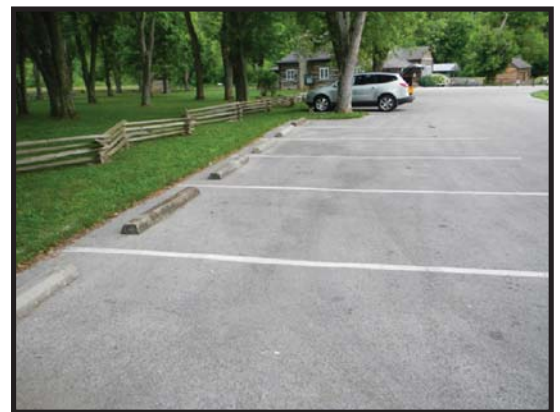
## Route 0904

Route Number	Public / NonPublic	Date Visited	Area (sq ft)	Lane Miles *	Surface Type
0904	PUBLIC	5/22/2012	15,316	0.26	AS
Culverts	Drop Inlets	Gates	Curb & Gutter	Curb	PCR
0	0	0	NO CURB AND GUTTER	NO CURB	GOOD/90

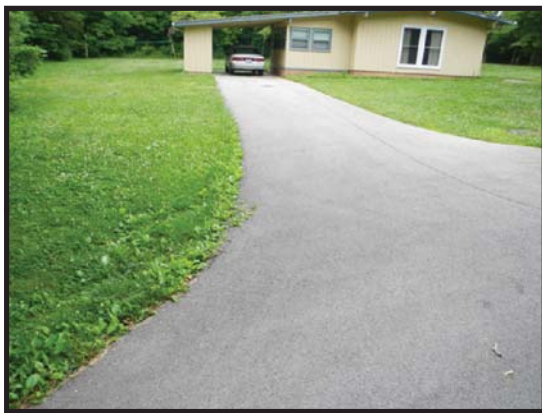
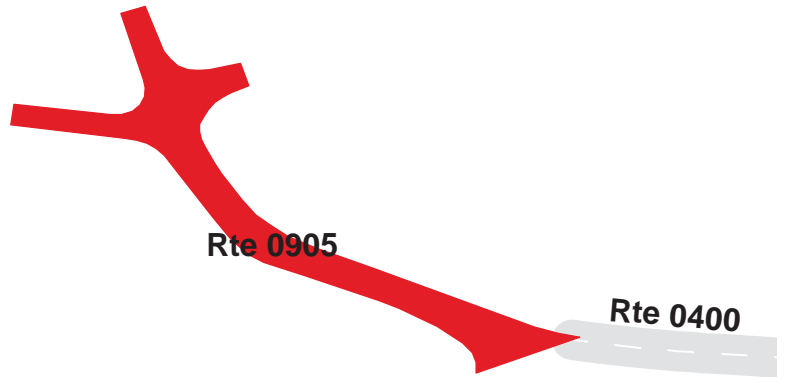
## Route 0905

Route Number	Public / NonPublic	Date Visited	Area (sq ft)	Lane Miles *	Surface Type
0905	NONPUBLIC	5/22/2012	5,986	0.10	AS
Culverts	Drop Inlets	Gates	Curb & Gutter	Curb	PCR
0	0	0	NO CURB AND GUTTER	NO CURB	GOOD/90
