Federal Lands Highway Road Inventory Program

Road Inventory and Condition Assessment

Apostle Islands National Lakeshore APIS

Cycle 5 Report

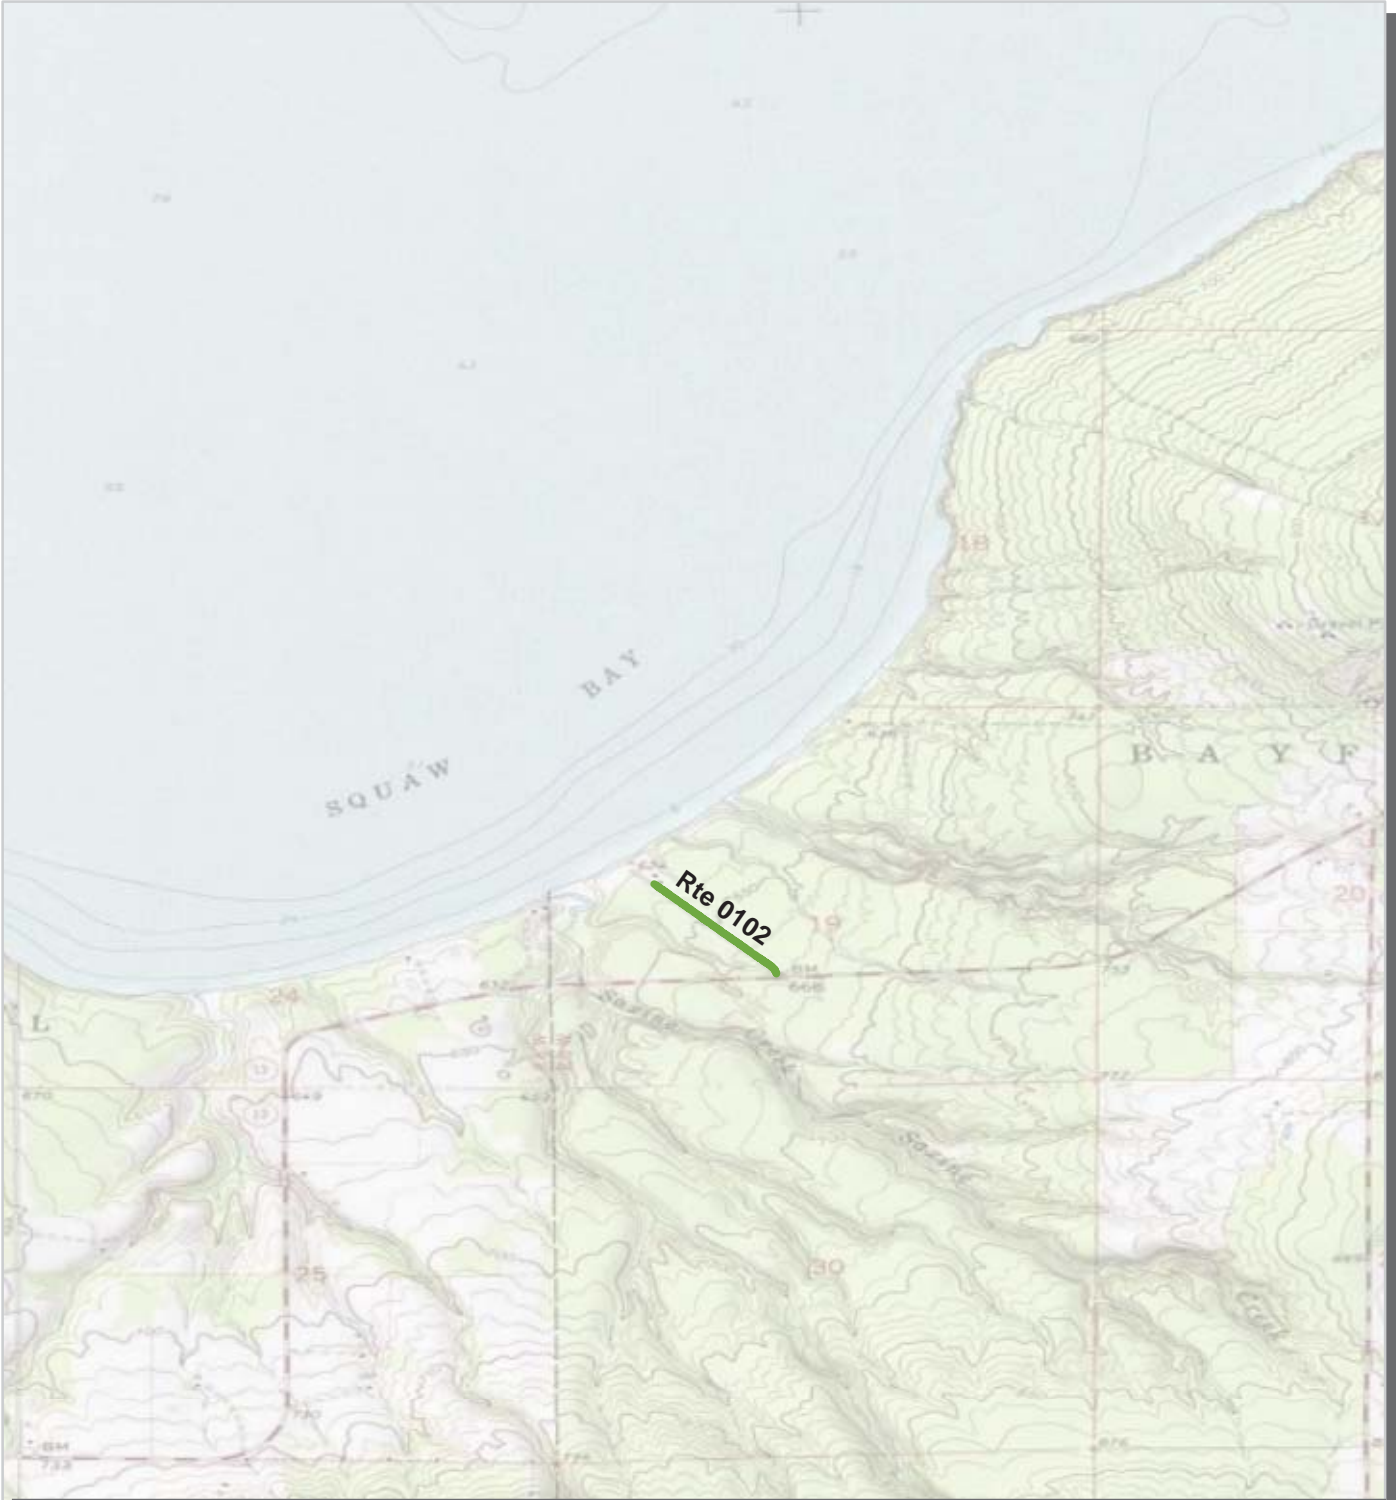
**Apostle Islands National Lakeshore
Route Condition Map
PCR - Mile by Mile
Area 2**

PCR	Poor		Fair		Good		Excellent		No Data	
	(0 - 60)		(61 - 84)	(85 - 94)		(95 - 100)

* If the PCR rating is not available for a section, the SCR rating will be displayed. See appendix for definitions and formulas.

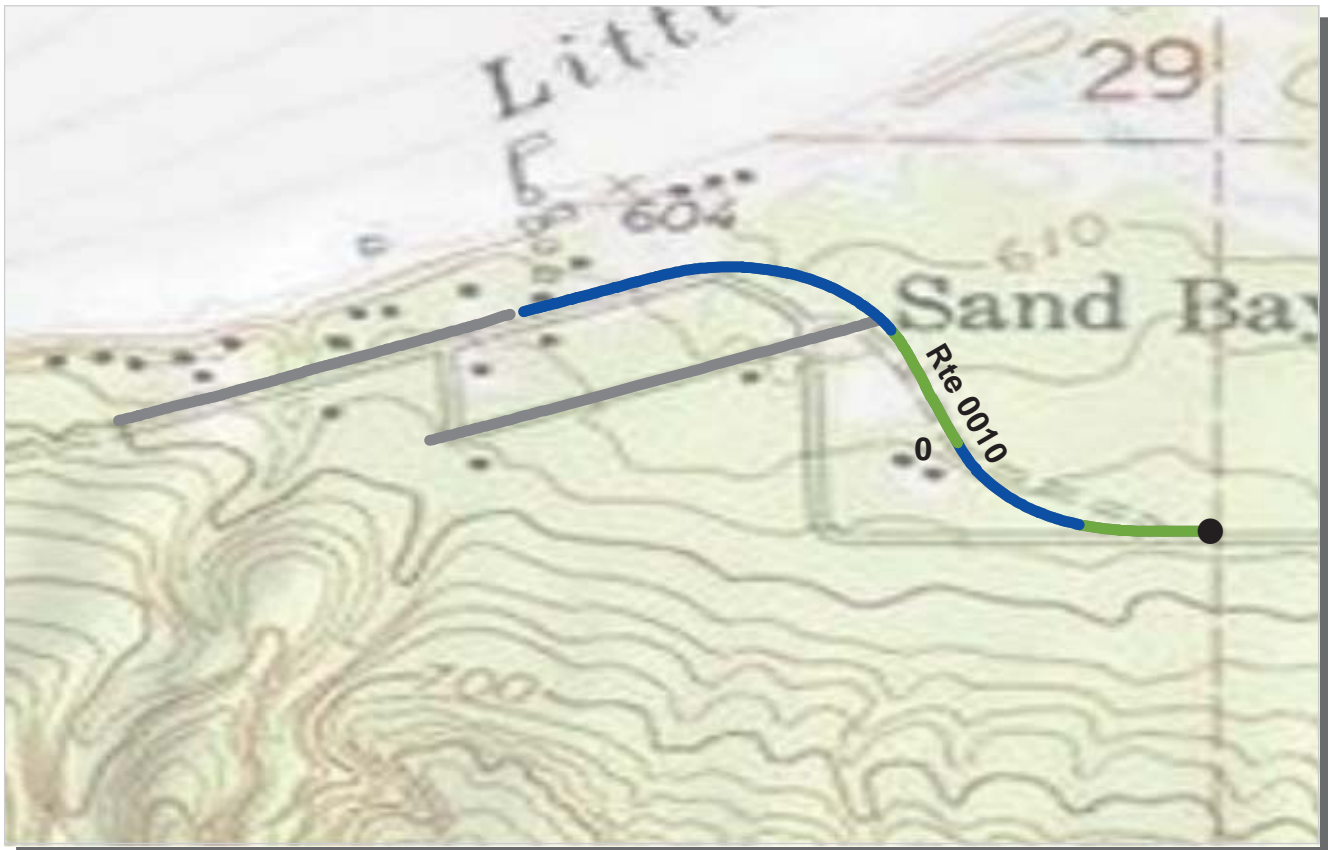
PCR Poor ■ Fair ■ Good ■ Excellent ■ No Data ■
 (0 - 60) (61 - 84) (85 - 94) (95 - 100)

<i>Section Number</i>	0				
<i>Section Length (mi)</i>	0.40				
<i>Cross Section Information</i>					
Number of Lanes	2				
Paved Width (ft)	24				
Lane Width (ft)	12				
<i>Roadway Condition Information</i>					
SCR (Surface Condition Rating)	96				
PCR (Pavement Condition Rating)	96				
<i>Distress Index Values</i>					
Structural Crack Index	98				
Transverse Cracking Index	99				
Patching Index	100				
Rutting Index	96				
Roughness Condition Index (RCI)	NC

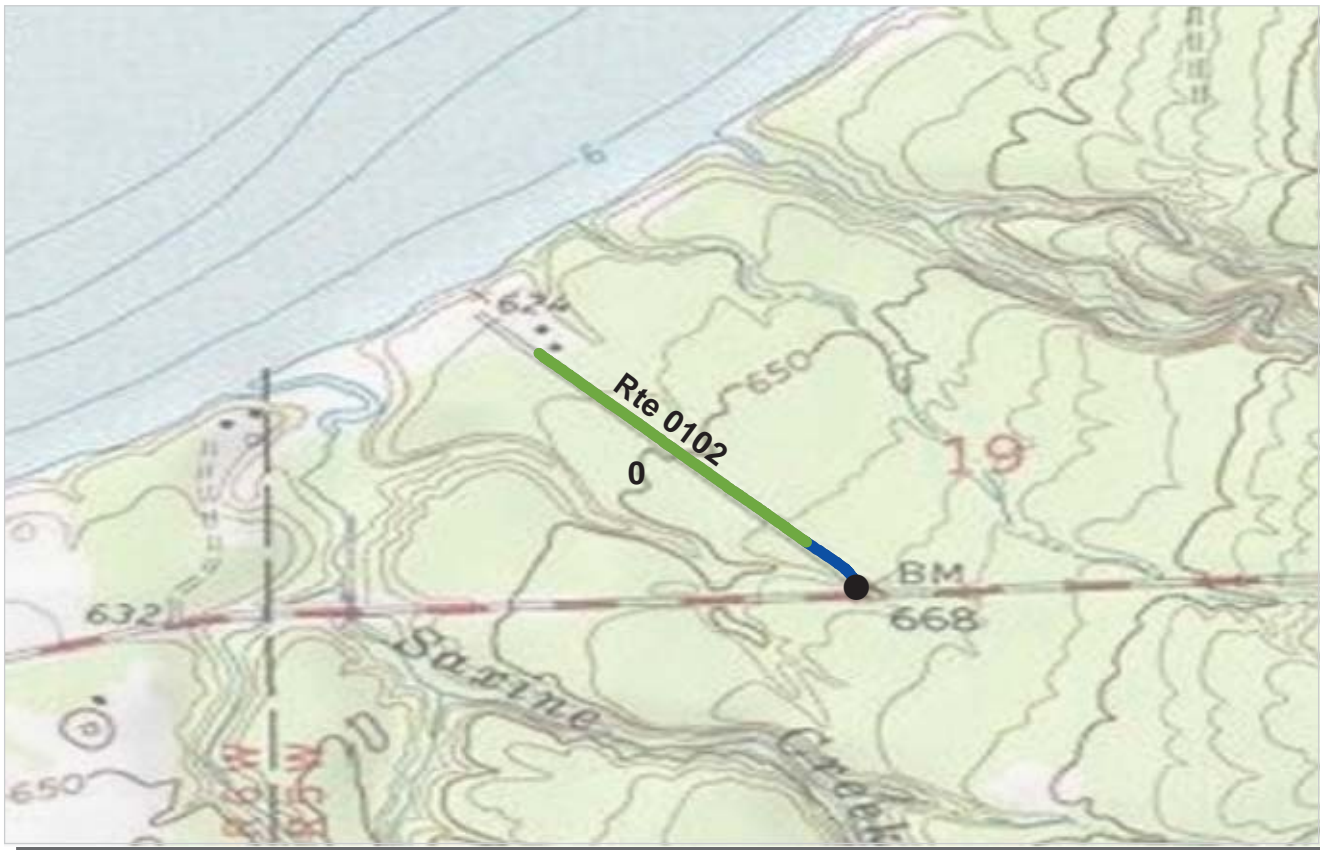
ROUTE: 0010 LITTLE SAND BAY ROAD

PCR Poor ■ Fair ■ Good ■ Excellent ■ No Data ■
 (0 - 60) (61 - 84) (85 - 94) (95 - 100)

Section Number	0				
Section Length (mi)	0.33				
Cross Section Information					
Number of Lanes	2				
Paved Width (ft)	20				
Lane Width (ft)	10				
Roadway Condition Information					
SCR (Surface Condition Rating)	94				
PCR (Pavement Condition Rating)	94				
Distress Index Values					
Structural Crack Index	99				
Transverse Cracking Index	100				
Patching Index	100				
Rutting Index	94				
Roughness Condition Index (RCI)	NC

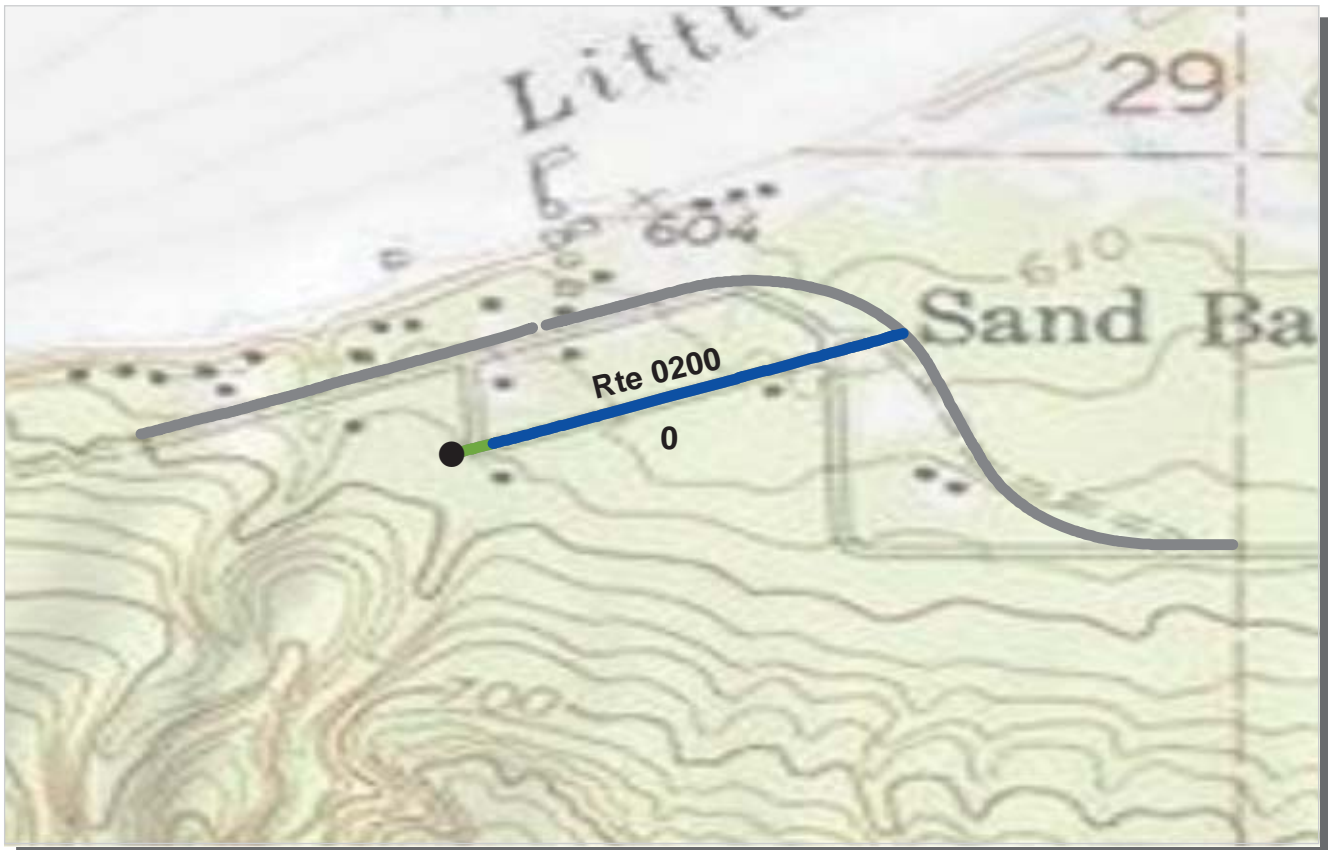
ROUTE: 0102 MEYERS BEACH ROAD

PCR Poor ■ Fair ■ Good ■ Excellent ■ No Data ■
 (0 - 60) (61 - 84) (85 - 94) (95 - 100)

<i>Section Number</i>	0				
<i>Section Length (mi)</i>	0.22				
<i>Cross Section Information</i>					
Number of Lanes	1				
Paved Width (ft)	16				
Lane Width (ft)	16				
<i>Roadway Condition Information</i>					
SCR (Surface Condition Rating)	98				
PCR (Pavement Condition Rating)	98				
<i>Distress Index Values</i>					
Structural Crack Index	100				
Transverse Cracking Index	100				
Patching Index	98				
Rutting Index	98				
Roughness Condition Index (RCI)	NC

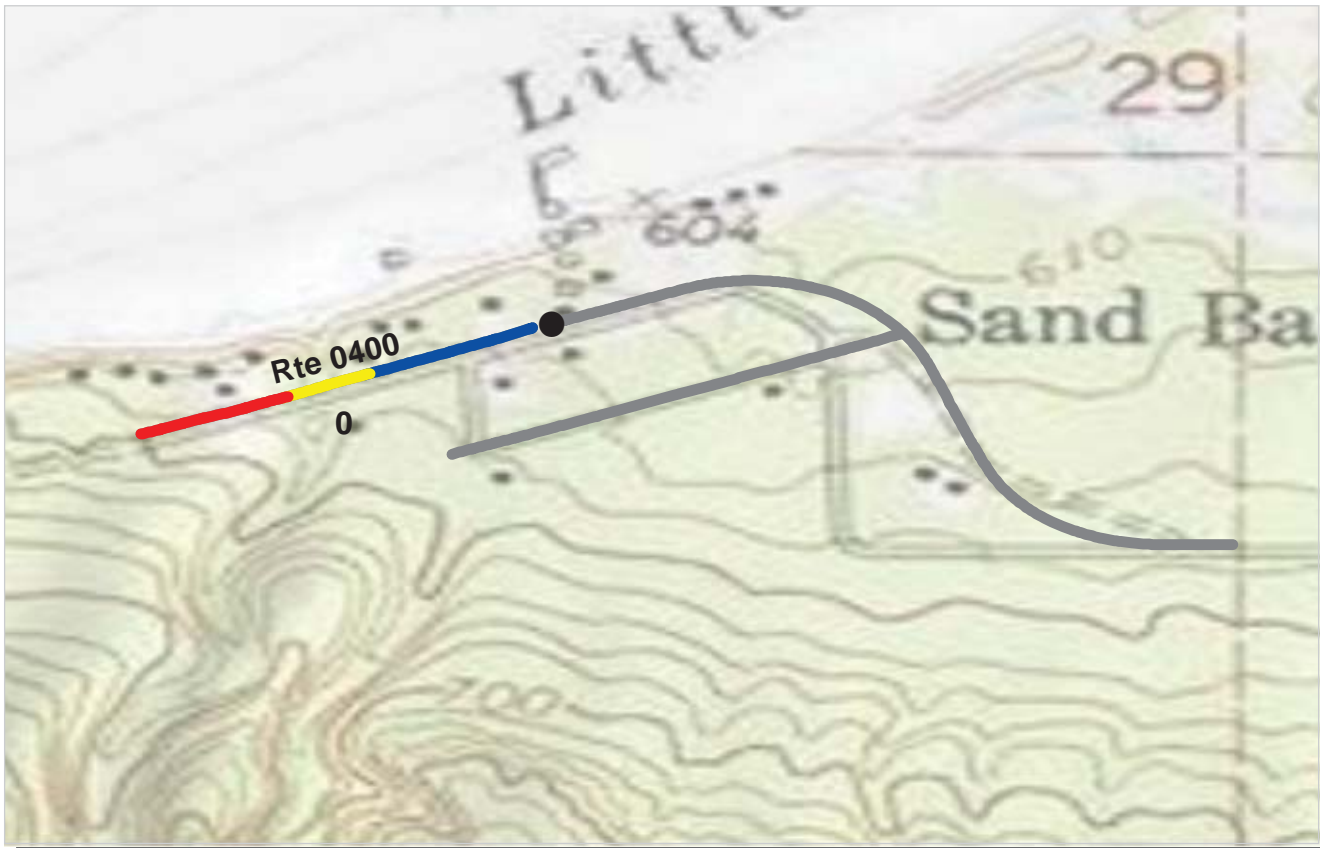
ROUTE: 0200 SHAFT STREET

PCR Poor ■ Fair ■ Good ■ Excellent ■ No Data ■
 (0 - 60) (61 - 84) (85 - 94) (95 - 100)

Section Number	0				
Section Length (mi)	0.19				
Cross Section Information					
Number of Lanes	2				
Paved Width (ft)	22				
Lane Width (ft)	12				
Roadway Condition Information					
SCR (Surface Condition Rating)	0				
PCR (Pavement Condition Rating)	0				
Distress Index Values					
Structural Crack Index	0				
Transverse Cracking Index	92				
Patching Index	100				
Rutting Index	88				
Roughness Condition Index (RCI)	NC

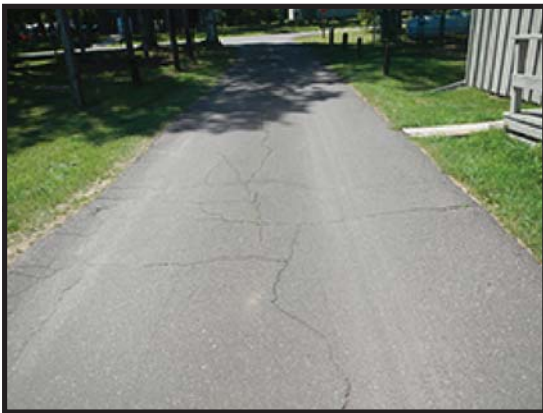
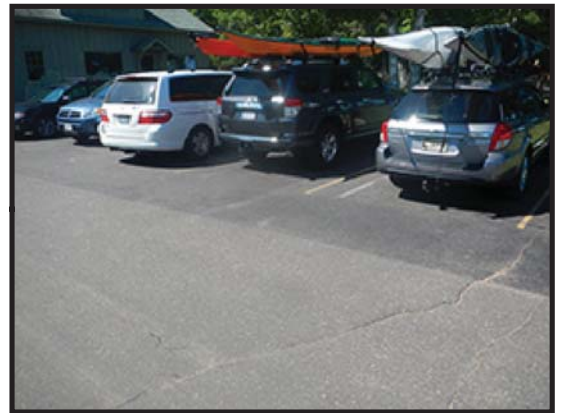
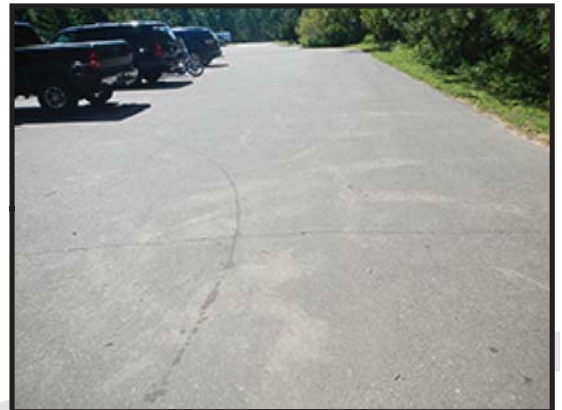
Route Number	Public / NonPublic	Date Visited	Area (sq ft)	Lane Miles *	Surface Type
0900	PUBLIC	8/10/2012	17,071	0.29	AS
Culverts	Drop Inlets	Gates	Curb & Gutter	Curb	PCR
0	0	0	NO CURB AND GUTTER	NO CURB	FAIR/73

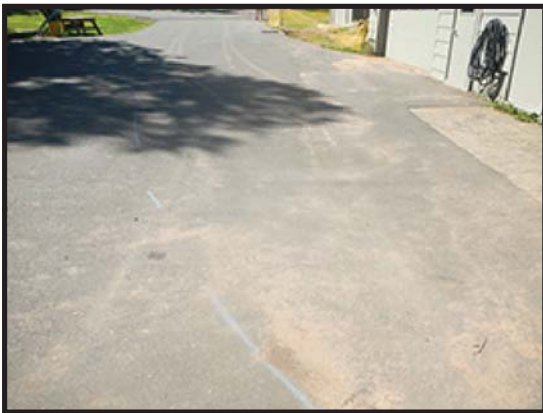
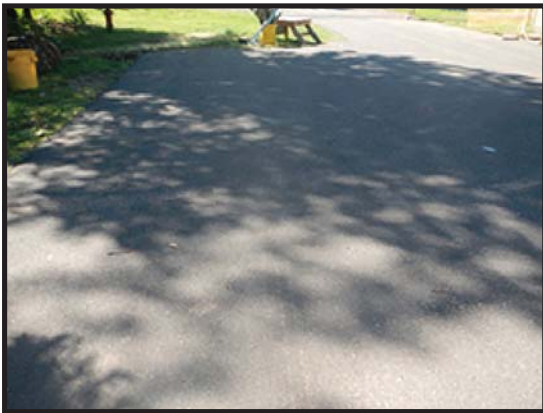
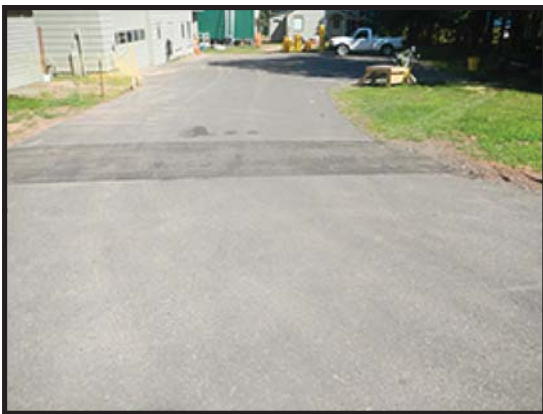
Route 0901

Route Number	Public / NonPublic	Date Visited	Area (sq ft)	Lane Miles *	Surface Type
0901	NONPUBLIC	8/10/2012	3,564	0.06	AS
Culverts	Drop Inlets	Gates	Curb & Gutter	Curb	PCR
0	0	0	NO CURB AND GUTTER	NO CURB	GOOD/90

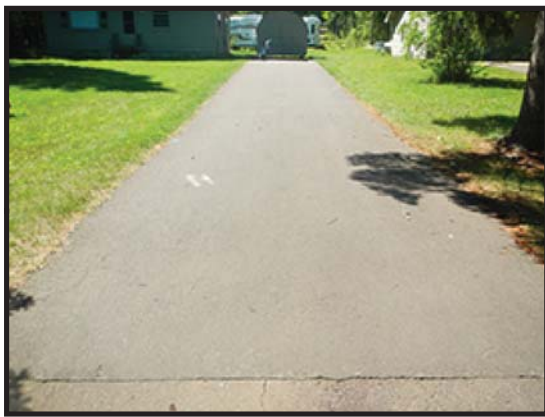
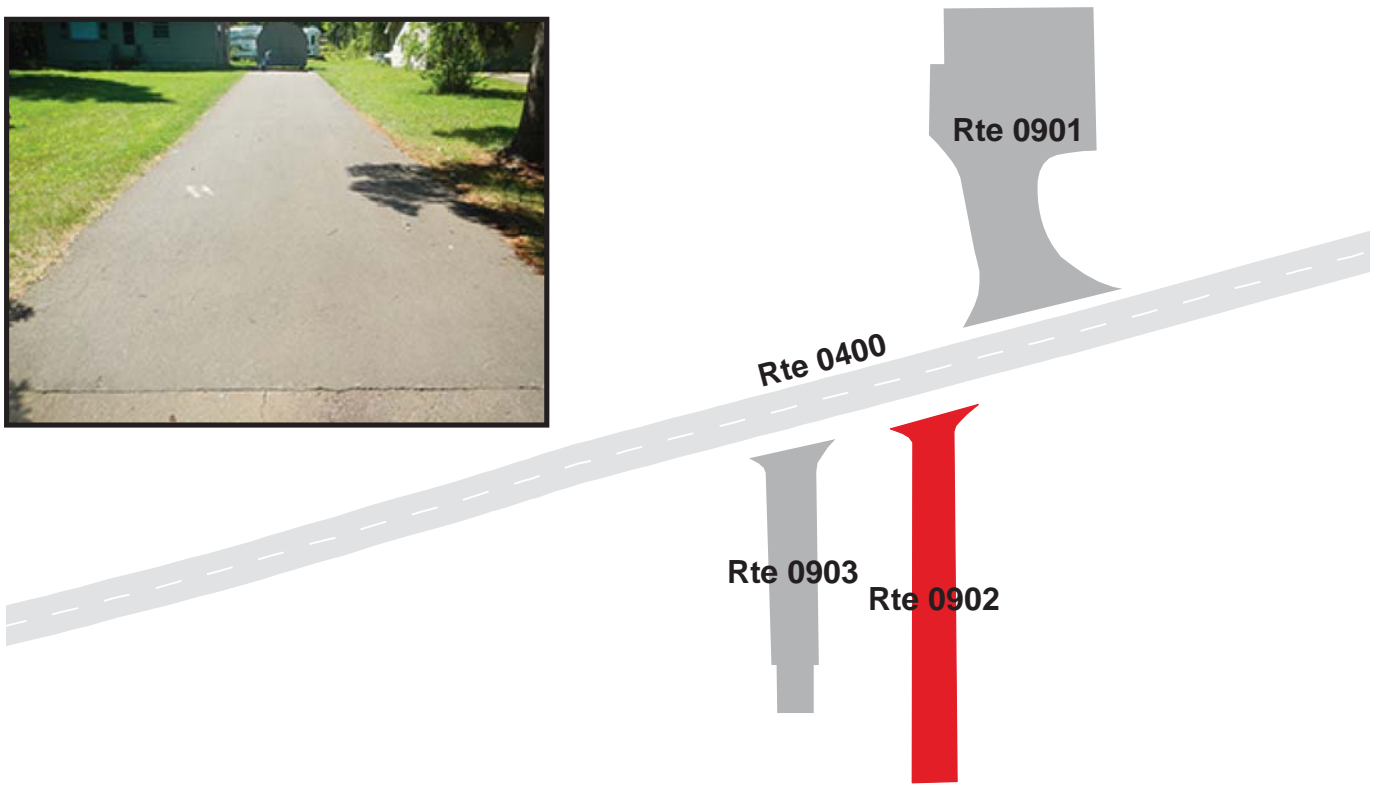
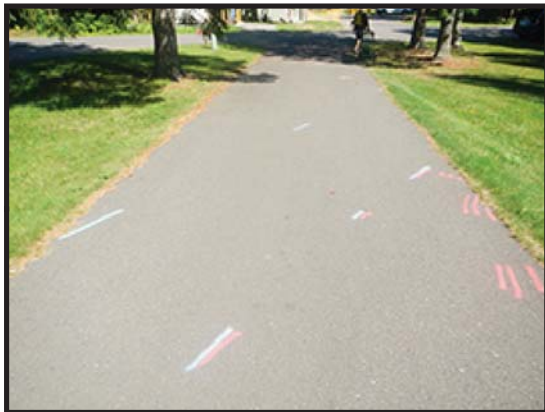
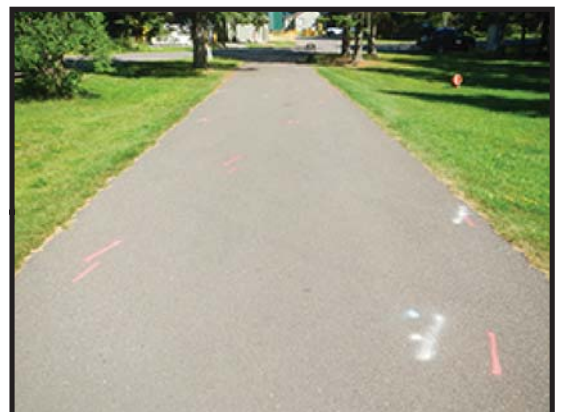
Route 0902

Route Number	Public / NonPublic	Date Visited	Area (sq ft)	Lane Miles *	Surface Type
0902	NONPUBLIC	8/10/2012	1,531	0.03	AS
Culverts	Drop Inlets	Gates	Curb & Gutter	Curb	PCR
0	0	0	NO CURB AND GUTTER	NO CURB	GOOD/90

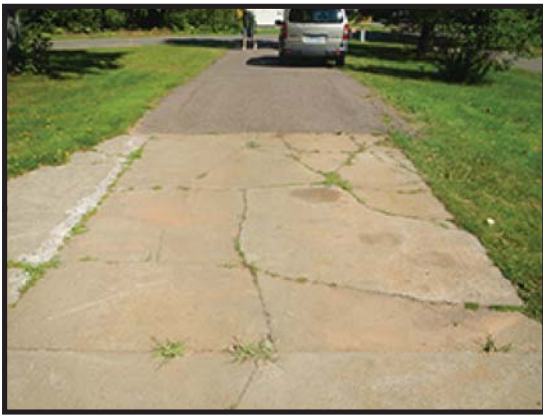
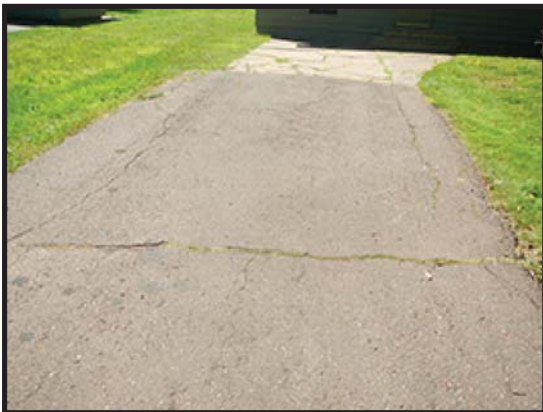
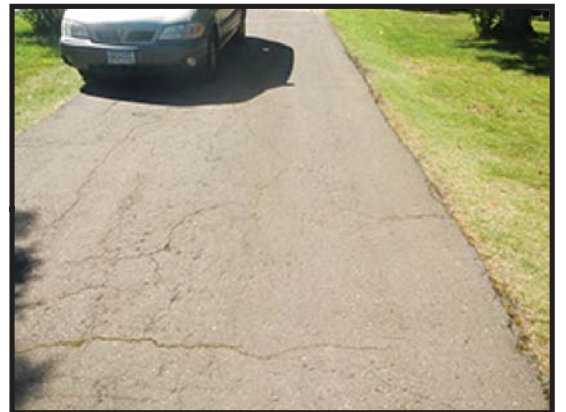
Route 0903

Route Number	Public / NonPublic	Date Visited	Area (sq ft)	Lane Miles *	Surface Type
0903	NONPUBLIC	8/10/2012	1,206	0.02	AS
Culverts	Drop Inlets	Gates	Curb & Gutter	Curb	PCR
0	0	0	NO CURB AND GUTTER	NO CURB	POOR/45

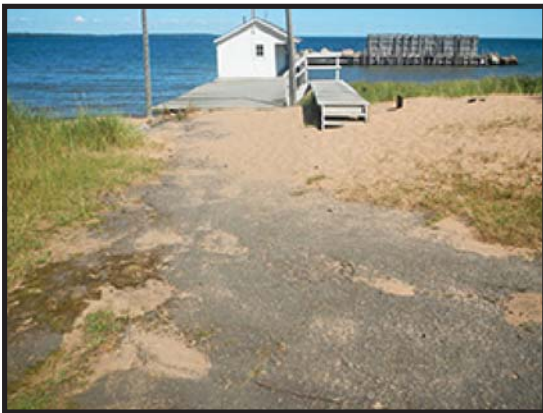
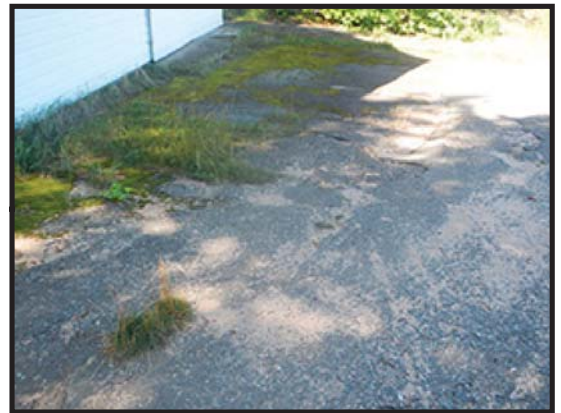
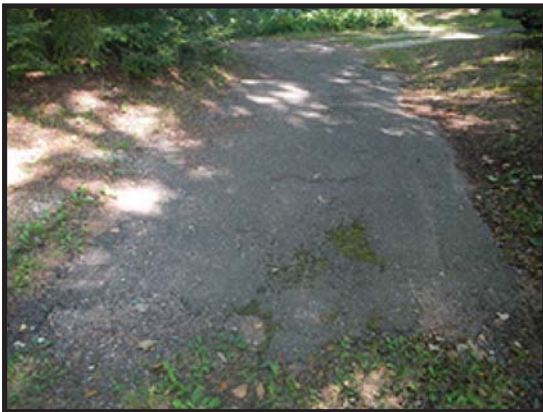
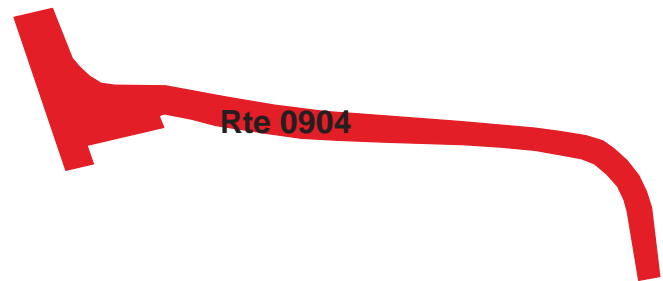
Route 0904

Route Number	Public / NonPublic	Date Visited	Area (sq ft)	Lane Miles *	Surface Type
0904	NONPUBLIC	8/10/2012	2,468	0.04	AS
Culverts	Drop Inlets	Gates	Curb & Gutter	Curb	PCR
0	0	0	NO CURB AND GUTTER	NO CURB	POOR/45

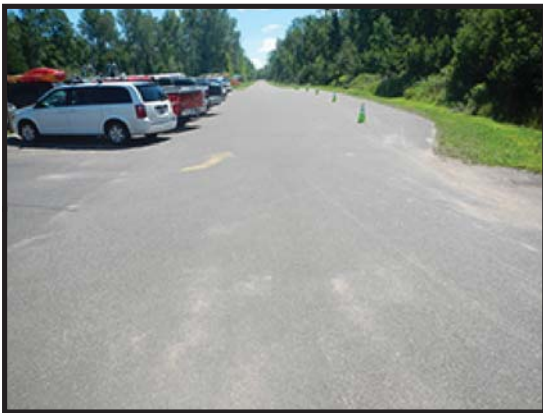
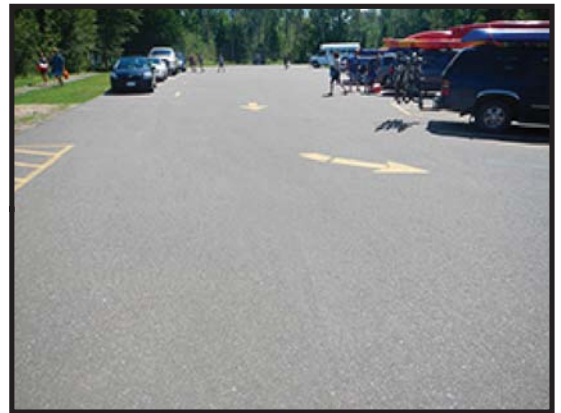
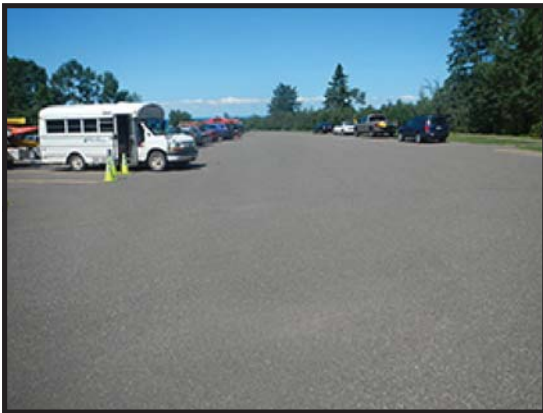
Route 0907

Route Number	Public / NonPublic	Date Visited	Area (sq ft)	Lane Miles *	Surface Type
0907	PUBLIC	8/10/2012	35,617	0.61	AS
Culverts	Drop Inlets	Gates	Curb & Gutter	Curb	PCR
1	0	0	NO CURB AND GUTTER	NO CURB	GOOD/90

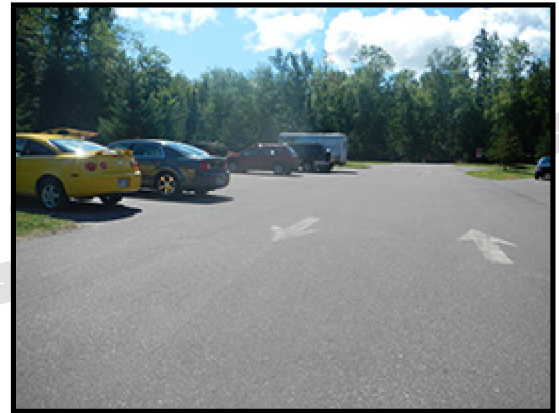
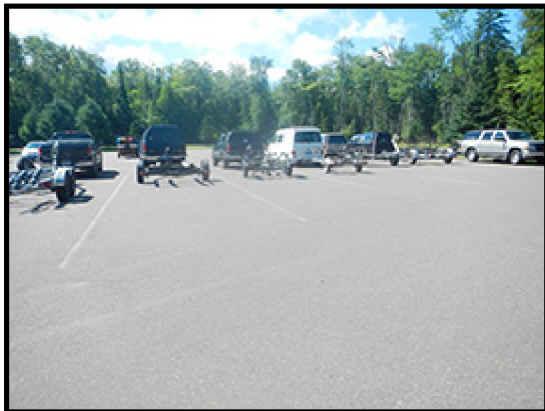
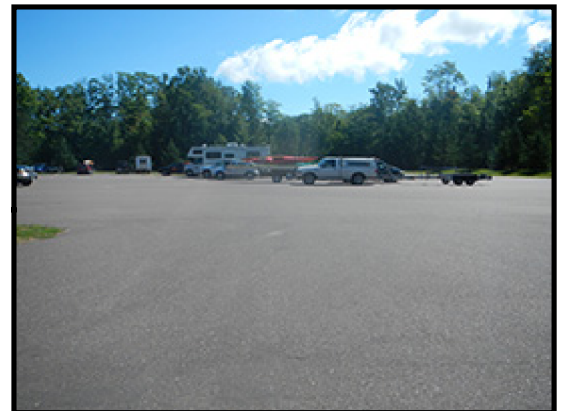
Route 0908

Route Number	Public / NonPublic	Date Visited	Area (sq ft)	Lane Miles *	Surface Type
0908	PUBLIC	8/10/2012	72,730	1.25	AS
Culverts	Drop Inlets	Gates	Curb & Gutter	Curb	PCR
2	0	0	NO CURB AND GUTTER	NO CURB	GOOD/90
