# Federal Lands Highway Road Inventory Program

Road Inventory and Condition Assessment

## Arkansas Post National Memorial ARPO - 7110

### Cycle 5 Report

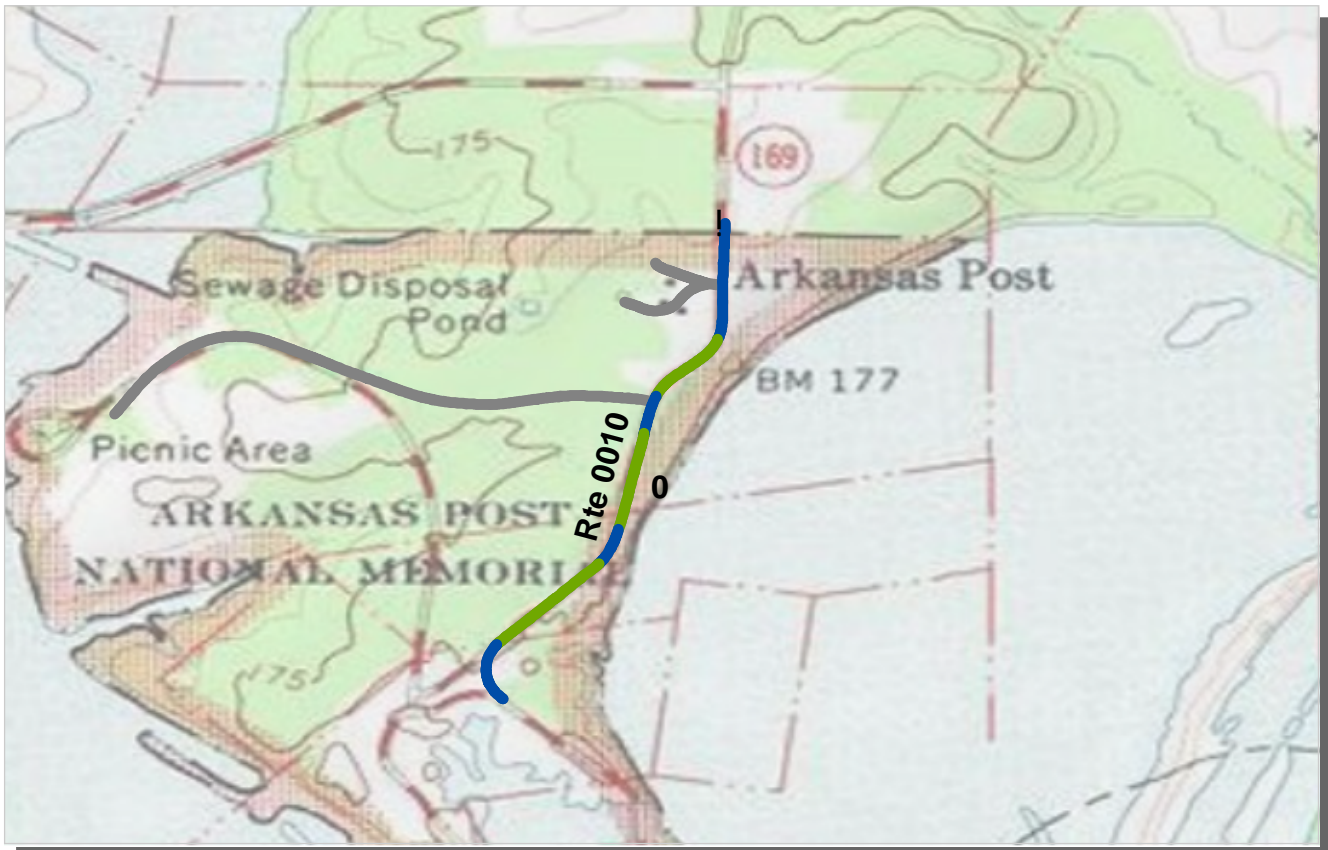
**ROUTE: 0010 MAIN ENTRANCE ROAD**

<b>Section Number</b>	0				
<b>Section Length (mi)</b>	0.56				
<b>Cross Section Information</b>					
Number of Lanes	2				
Paved Width (ft)	20				
Lane Width (ft)	10				
<b>Roadway Condition Information</b>					
SCR (Surface Condition Rating)	90				
PCR (Pavement Condition Rating)	90				
<b>Distress Index Values</b>					
Structural Crack Index	100				
Transverse Cracking Index	100				
Patching Index	100				
Rutting Index	90				
Roughness Condition Index (RCI)	NC

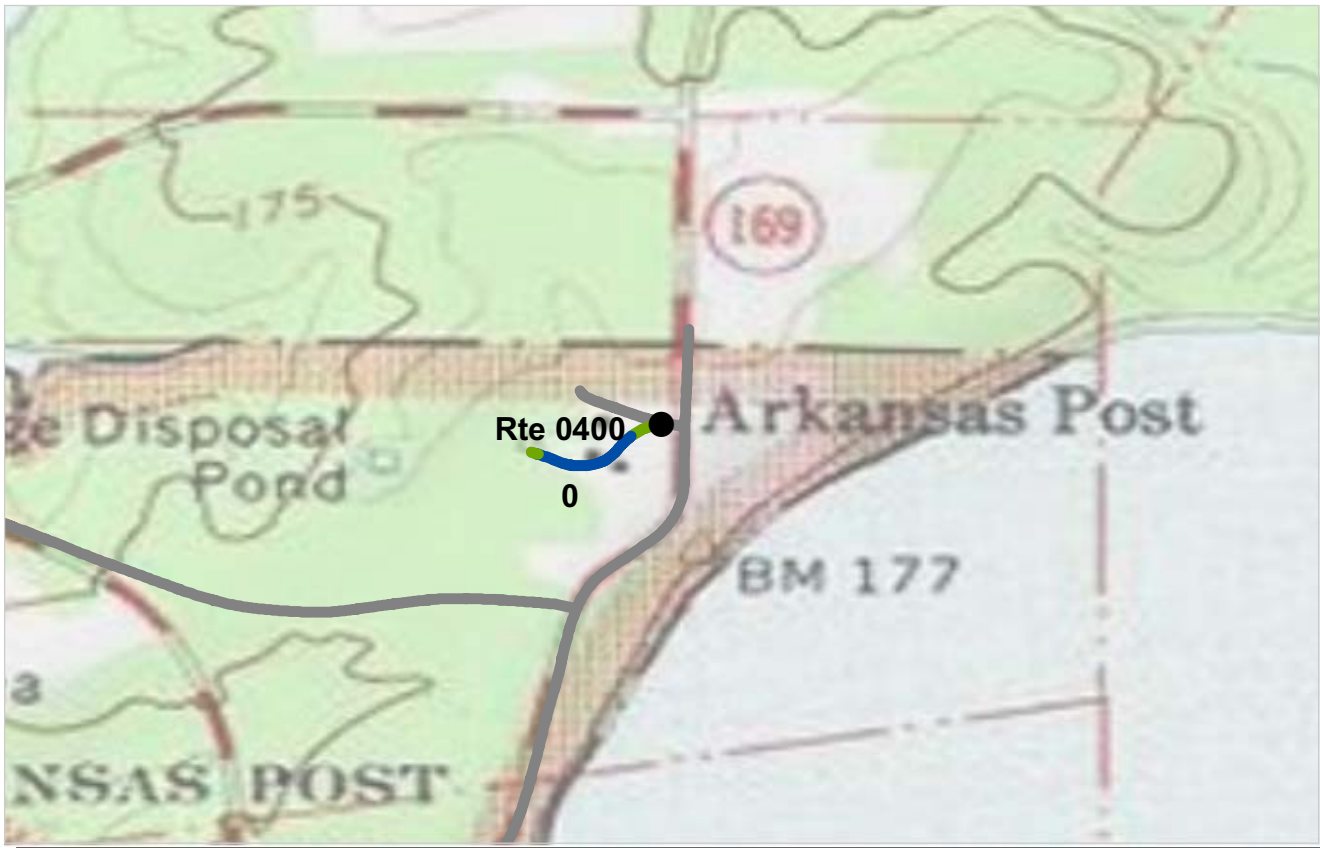
**ROUTE: 0400 MAINTENANCE ROAD**

<b>Section Number</b>	0				
<b>Section Length (mi)</b>	0.08				
<b>Cross Section Information</b>					
Number of Lanes	1				
Paved Width (ft)	13				
Lane Width (ft)	13				
<b>Roadway Condition Information</b>					
SCR (Surface Condition Rating)	97				
PCR (Pavement Condition Rating)	97				
<b>Distress Index Values</b>					
Structural Crack Index	98				
Transverse Cracking Index	97				
Patching Index	100				
Rutting Index	98				
Roughness Condition Index (RCI)	NC

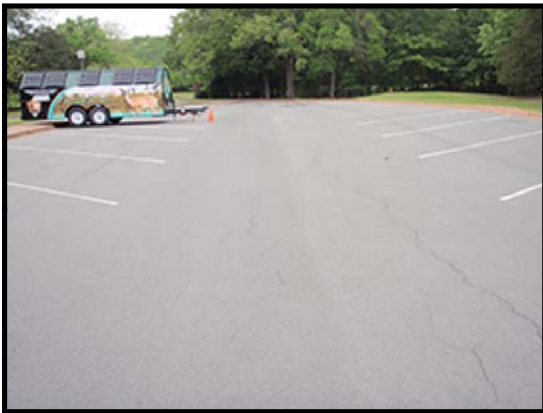
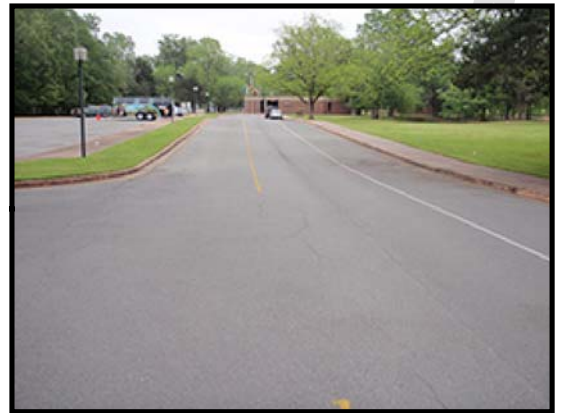
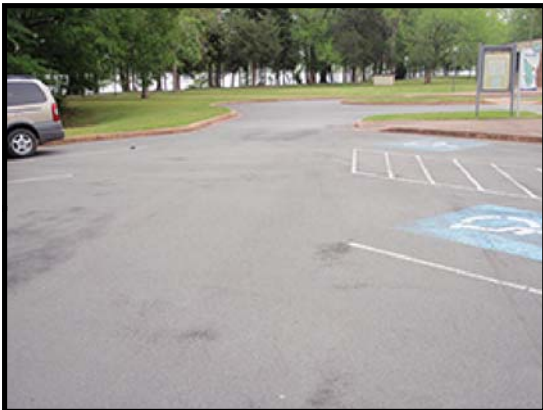
## Route 0900

Route Number	Public / NonPublic	Date Visited	Area (sq ft)	Lane Miles *	Surface Type
0900	PUBLIC	4/18/2011	35,038	0.60	AS
Culverts	Drop Inlets	Gates	Curb & Gutter	Curb	PCR
0	5	0	CONCRETE CURB AND GUTTER	NO CURB	FAIR/73

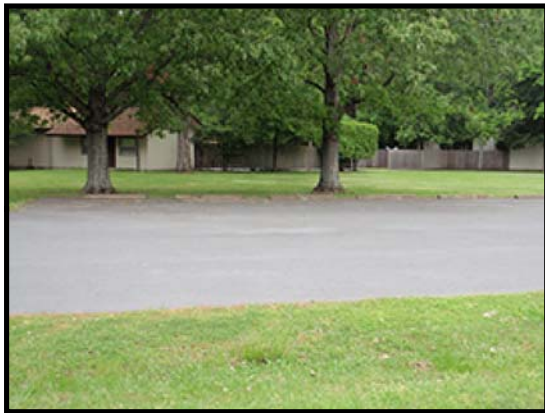
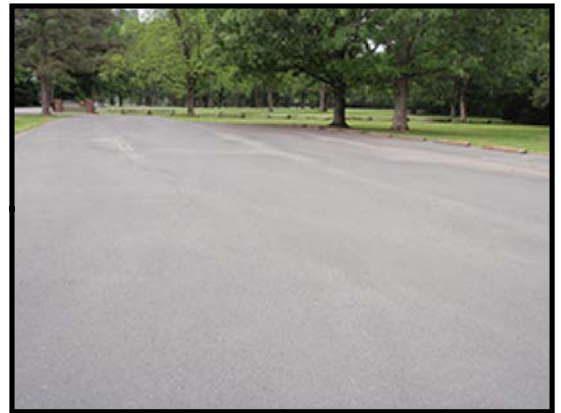
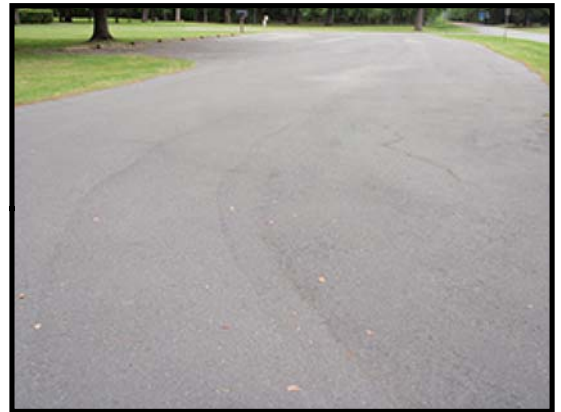
## Route 0901

Route Number	Public / NonPublic	Date Visited	Area (sq ft)	Lane Miles *	Surface Type
0901	PUBLIC	4/18/2011	8,630	0.15	AS
Culverts	Drop Inlets	Gates	Curb & Gutter	Curb	PCR
0	0	0	NO CURB AND GUTTER	NO CURB	FAIR/73

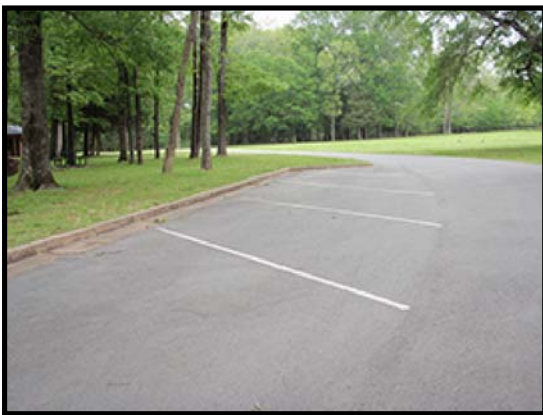
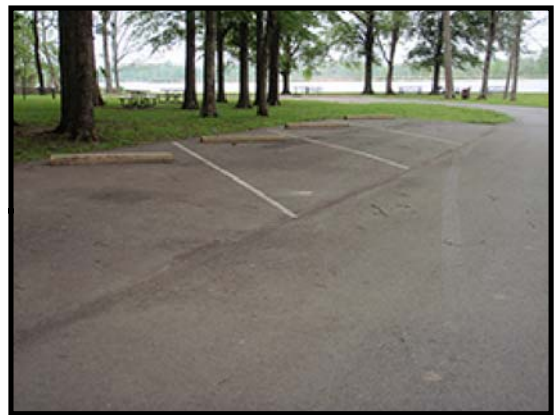
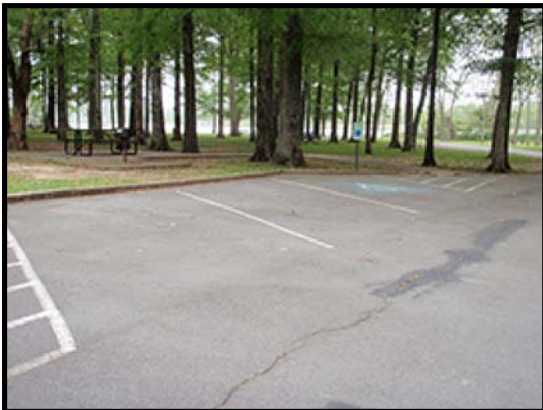
## Route 0904

Route Number	Public / NonPublic	Date Visited	Area (sq ft)	Lane Miles *	Surface Type
0904	PUBLIC	4/18/2011	22,618	0.39	AS
Culverts	Drop Inlets	Gates	Curb & Gutter	Curb	PCR
1	1	0	CONCRETE CURB AND GUTTER	CONCRETE CURB	FAIR/73

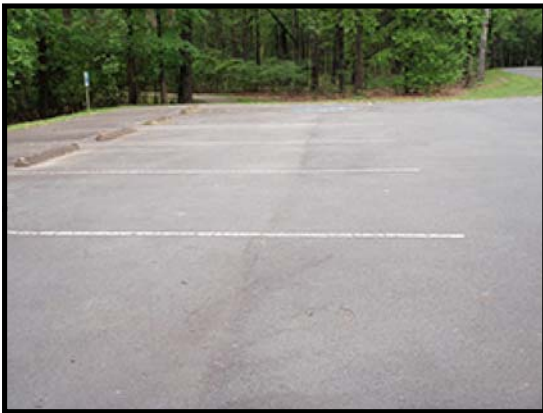
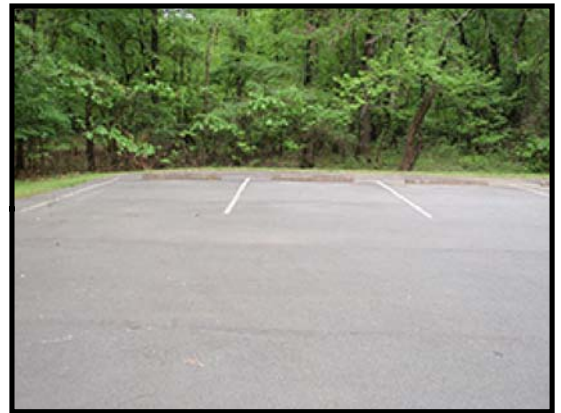
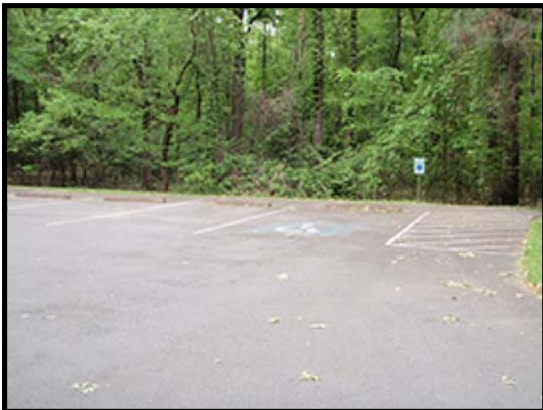
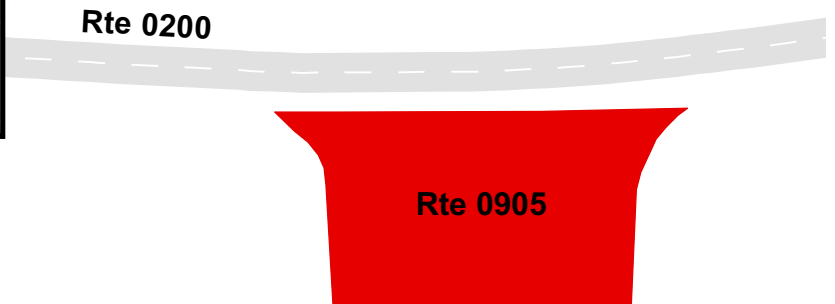
## Route 0905

Route Number	Public / NonPublic	Date Visited	Area (sq ft)	Lane Miles *	Surface Type
0905	PUBLIC	4/18/2011	5,186	0.09	AS
Culverts	Drop Inlets	Gates	Curb & Gutter	Curb	PCR
0	0	0	NO CURB AND GUTTER	NO CURB	FAIR/73

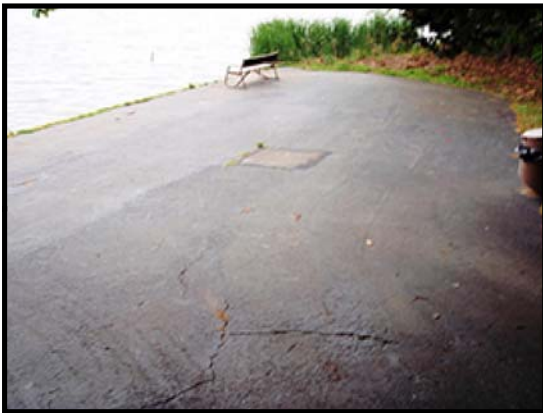
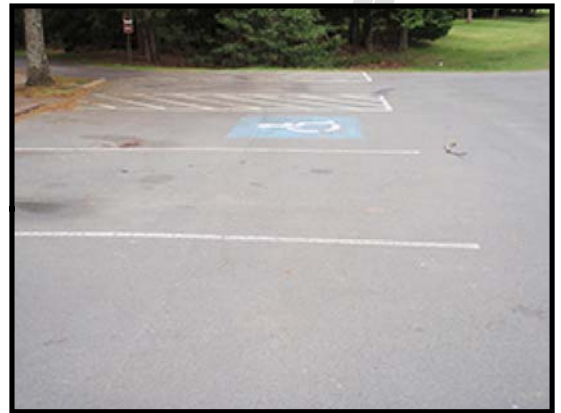
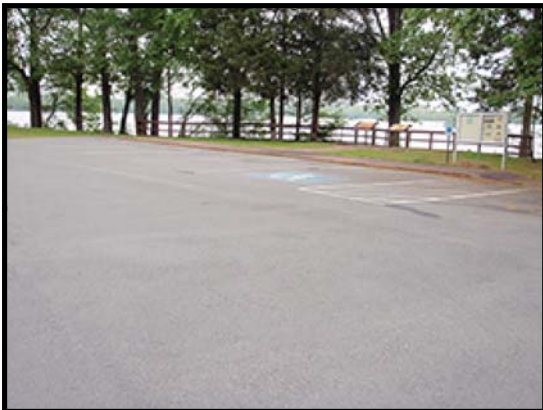
## Route 0906

Route Number	Public / NonPublic	Date Visited	Area (sq ft)	Lane Miles *	Surface Type
0906	PUBLIC	4/18/2011	6,660	0.12	AS
Culverts	Drop Inlets	Gates	Curb & Gutter	Curb	PCR
1	0	0	NO CURB AND GUTTER	NO CURB	FAIR/73
