Federal Lands Highway Road Inventory Program

Road Inventory and Condition Assessment

Big Hole National Battlefield BIHO - 9374

Cycle 5 Report

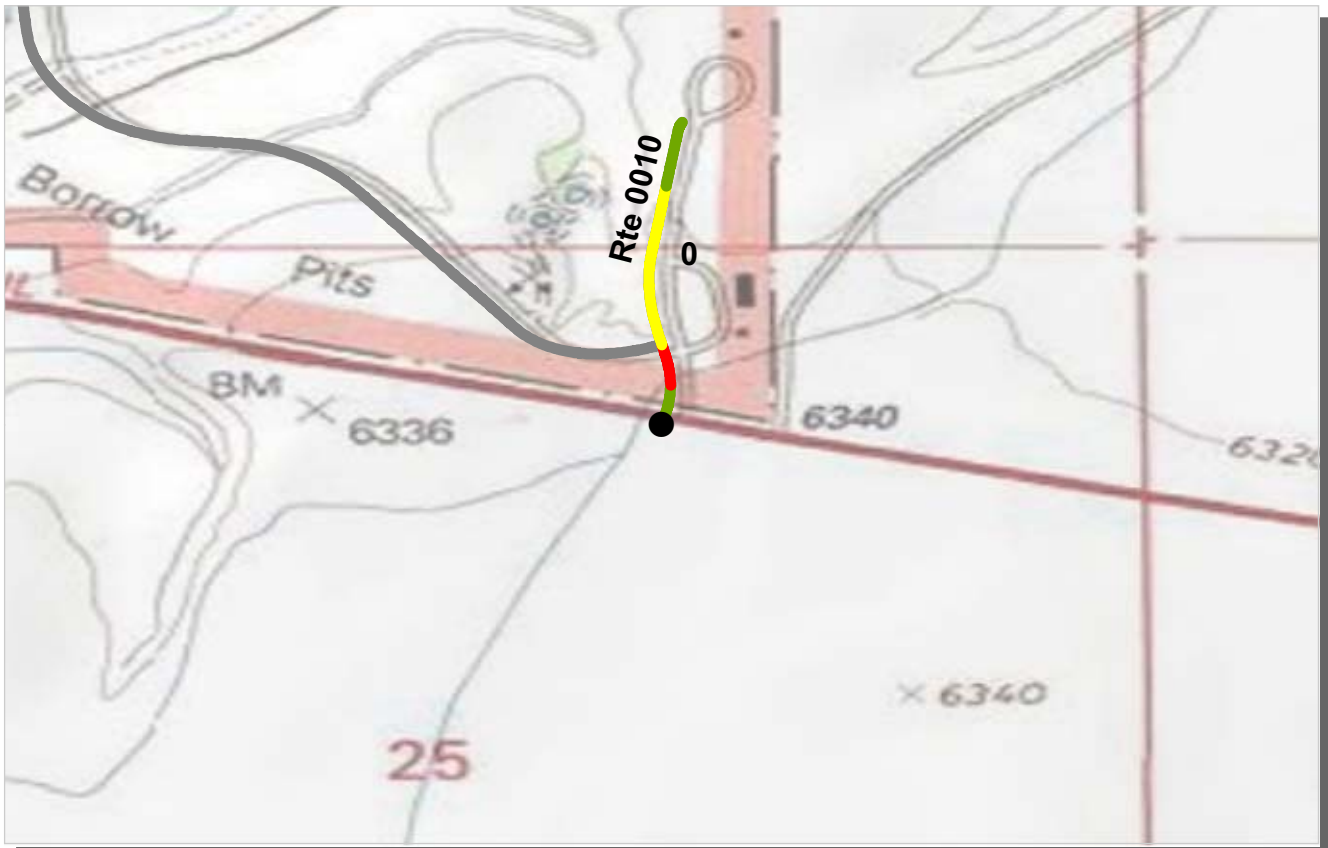
ROUTE: 0010 ENTRANCE ROAD

Section Number	0				
Section Length (mi)	0.30				
Cross Section Information					
Number of Lanes	2				
Paved Width (ft)	23				
Lane Width (ft)	10				
Roadway Condition Information					
SCR (Surface Condition Rating)	77				
PCR (Pavement Condition Rating)	77				
Distress Index Values					
Structural Crack Index	86				
Transverse Cracking Index	77				
Patching Index	100				
Rutting Index	97				
Roughness Condition Index (RCI)	NC

Structural Crack Index is a combination of the Longitudinal Cracking Index and Alligator Cracking Index.
 See Section 10 for explanation of SCR, PCR, & all Distress Index Values.

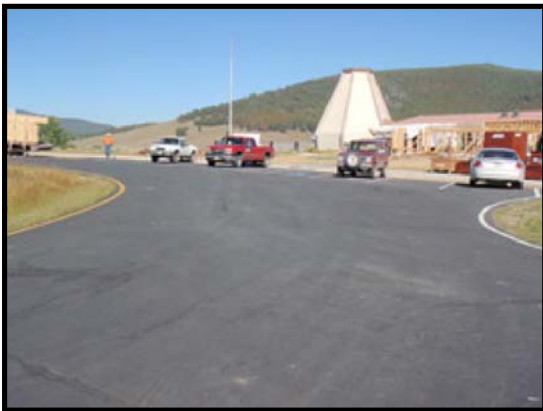
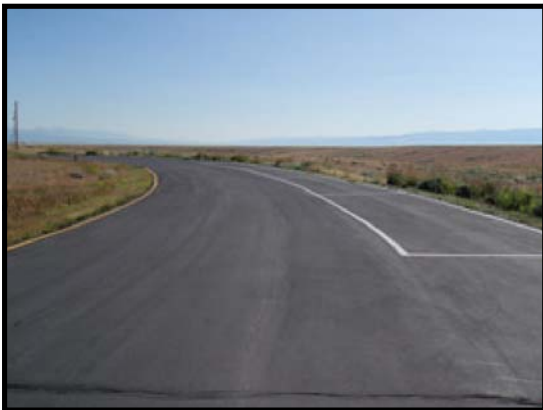
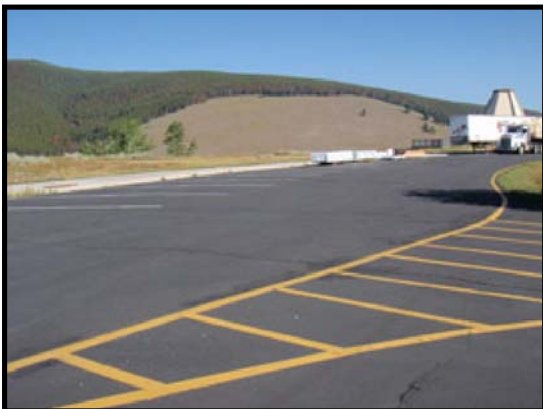
Route 0900

Route Number	Public / NonPublic	Date Visited	Area (sq ft)	Lane Miles *	Surface Type
0900	PUBLIC	8/20/2010	30,517	0.53	AS
Culverts	Drop Inlets	Gates	Curb & Gutter	Curb	PCR
0	0	0	CONCRETE CURB AND GUTTER	NO CURB	FAIR/73

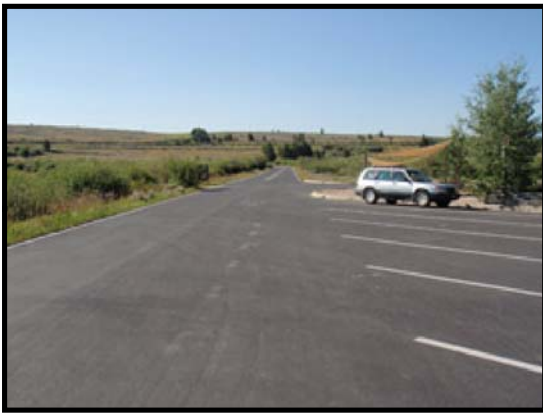
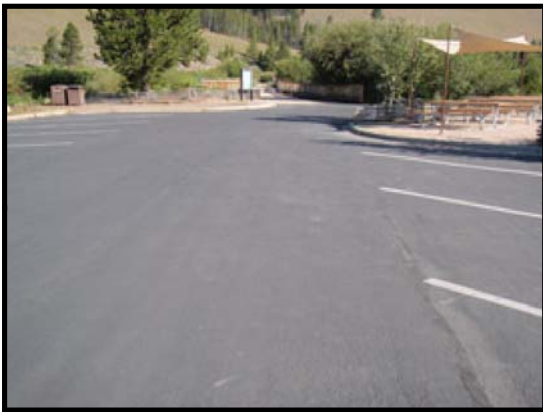
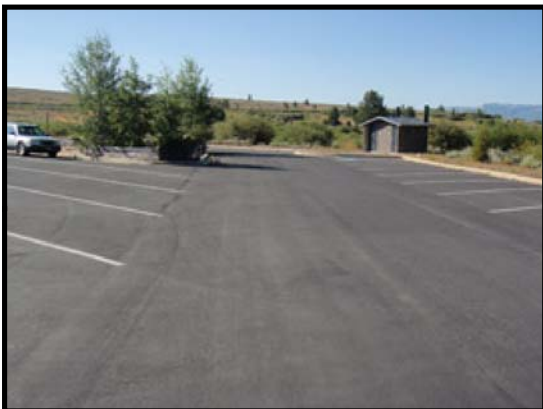
Route 0901

Route Number	Public / NonPublic	Date Visited	Area (sq ft)	Lane Miles *	Surface Type
0901	PUBLIC	8/20/2010	27,756	0.48	AS
Culverts	Drop Inlets	Gates	Curb & Gutter	Curb	PCR
0	0	0	CONCRETE CURB AND GUTTER	NO CURB	GOOD/90

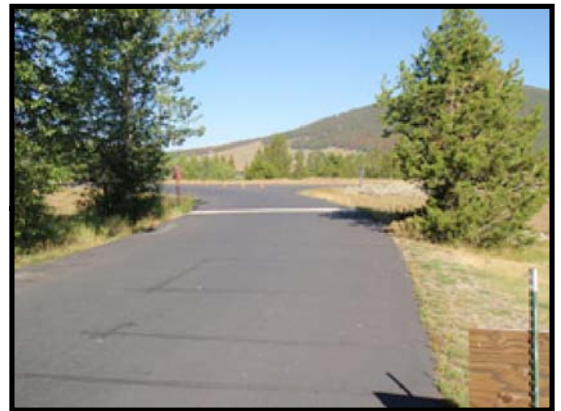
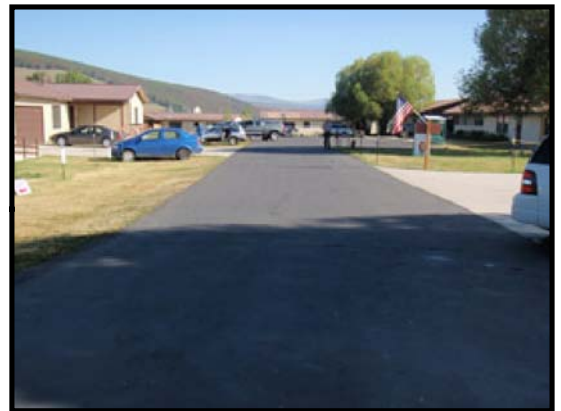
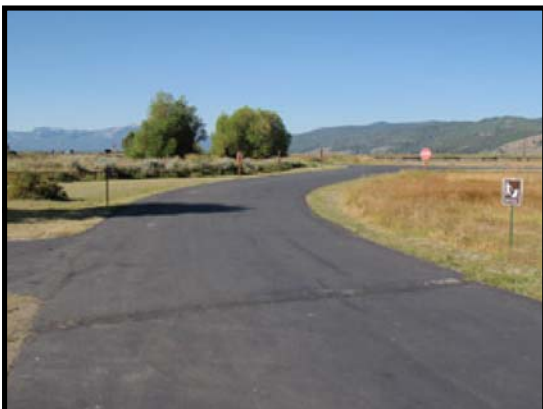
Route 0902

Route Number	Public / NonPublic	Date Visited	Area (sq ft)	Lane Miles *	Surface Type
0902	NONPUBLIC	8/20/2010	20,143	0.35	AS
Culverts	Drop Inlets	Gates	Curb & Gutter	Curb	PCR
0	0	0	CONCRETE CURB AND GUTTER	NO CURB	GOOD/90

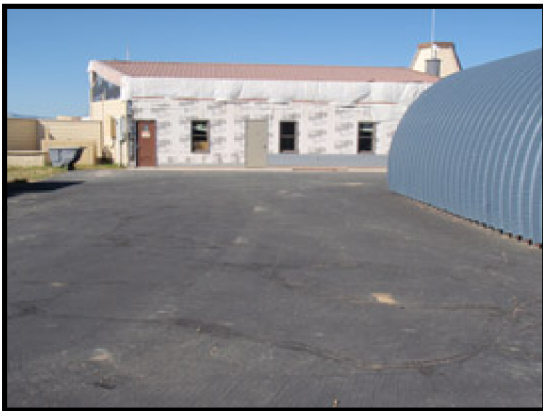
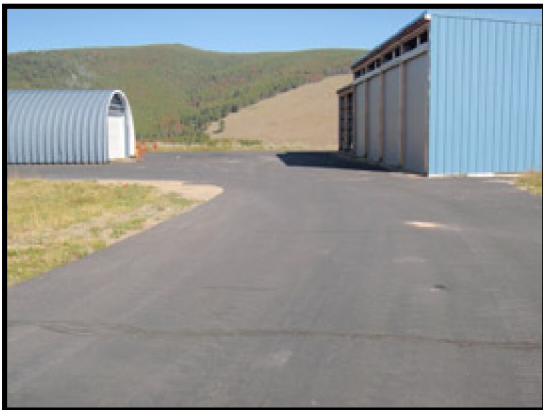
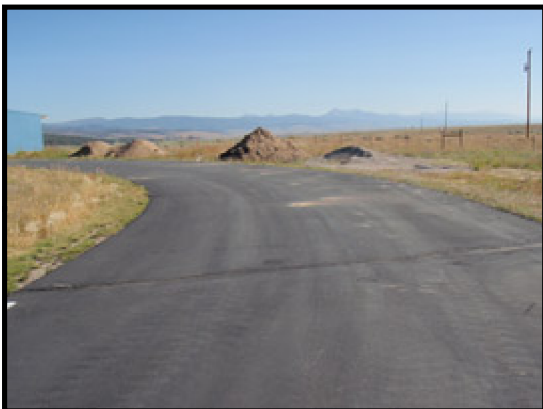
Route 0903

Route Number	Public / NonPublic	Date Visited	Area (sq ft)	Lane Miles *	Surface Type
0903	NONPUBLIC	8/20/2010	17,947	0.31	AS
Culverts	Drop Inlets	Gates	Curb & Gutter	Curb	PCR
1	0	0	NO CURB AND GUTTER	NO CURB	POOR/45
