Federal Lands Highway Road Inventory Program

Road Inventory and Condition Assessment

Carlsbad Caverns National Park
CAVE - 7170

Cycle 5 Report

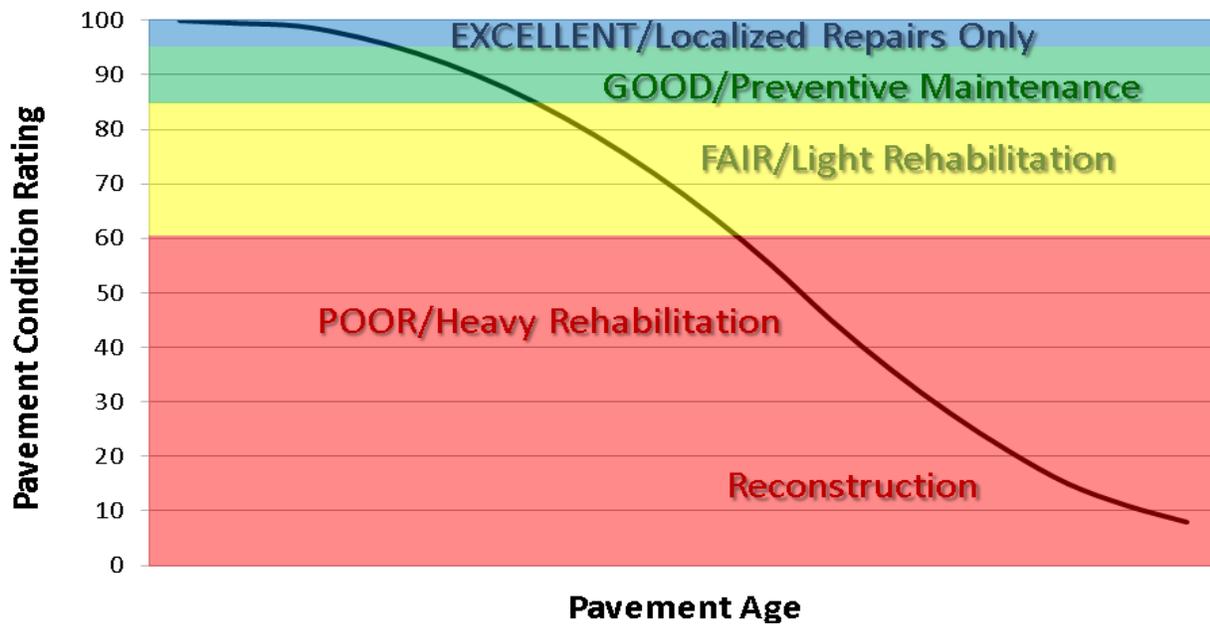
Condition Categories and Treatments

- Excellent/New: PCR of 95-100. Pavements in this range will require only spot repairs
- Good: PCR of 85-94. Pavements in this range will likely be candidates for Preventive Maintenance. Examples include Chip and Slurry Seals, Micro Surfacing and Thin Overlays.
- Fair: PCR of 61-84. Pavements in this range will likely be candidates of Light Rehabilitation (L3R). Examples include single-lift overlays up to 2.5 inches in total thickness, milling and overlays.
- Poor: PCR of 0-60. Pavements in this range will likely be candidates of Heavy Rehabilitation or Reconstruction (H3R or 4R). Examples include Pulverization, Multiple Lift Overlays, and Reconstruction.

At this time, specific Maintenance and Rehabilitation activities should be evaluated and recommended at the project level. Site-specific conditions that influence treatment type should be determined based on performing a subsurface investigation and/or pavement condition survey, and not be based solely on RIP data. Additionally, RIP produces a snapshot of conditions the year in which the data was collected. For further information or to obtain additional Pavement Management System's data from our Highway Pavement Management Application (HPMA) please contact the Eastern Federal Lands pavement team.

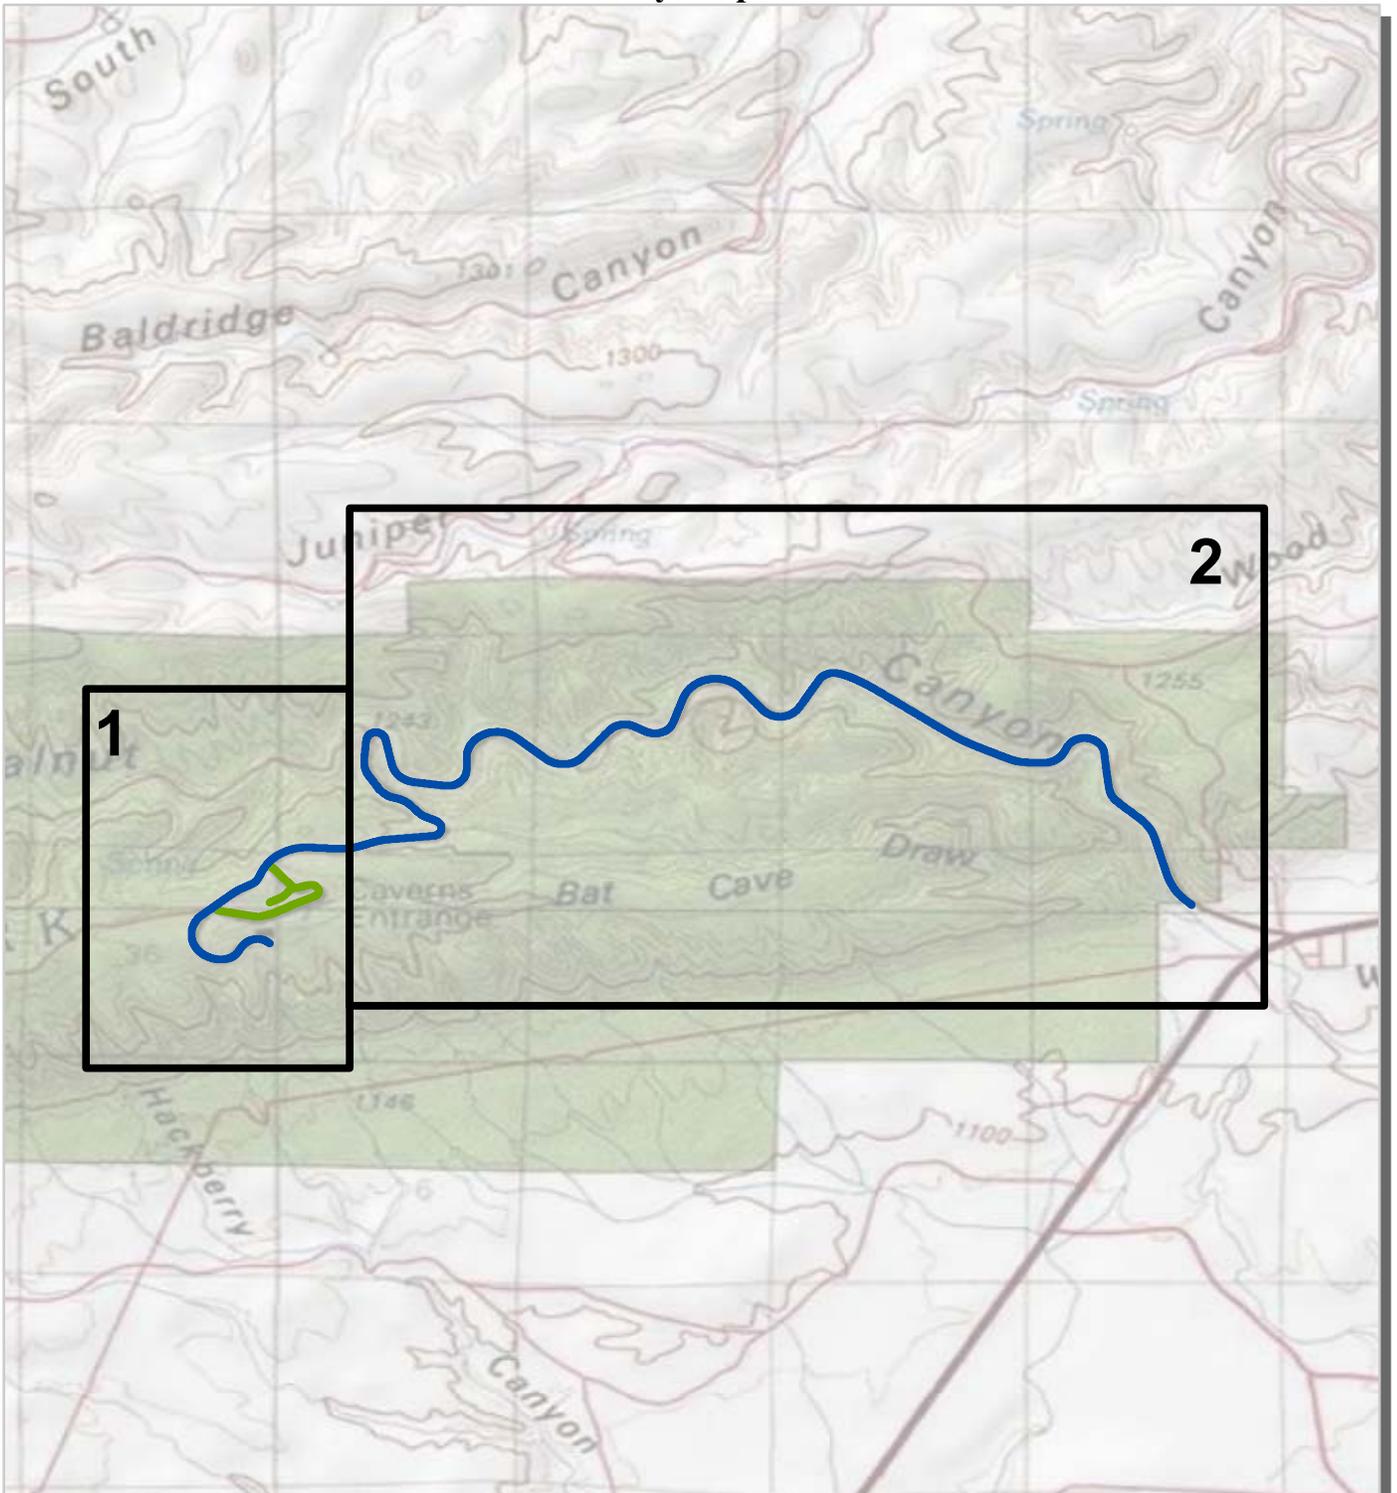
**Carlsbad Caverns National Park
Route Condition Map
PCR - Mile by Mile
Key Map**

PCR	Poor	Fair	Good	Excellent	No Data
	(0 - 60)	(61 - 84)	(85 - 94)	(95 - 100)

* If the PCR rating is not available for a section, the SCR rating will be displayed. See appendix for definitions and formulas.

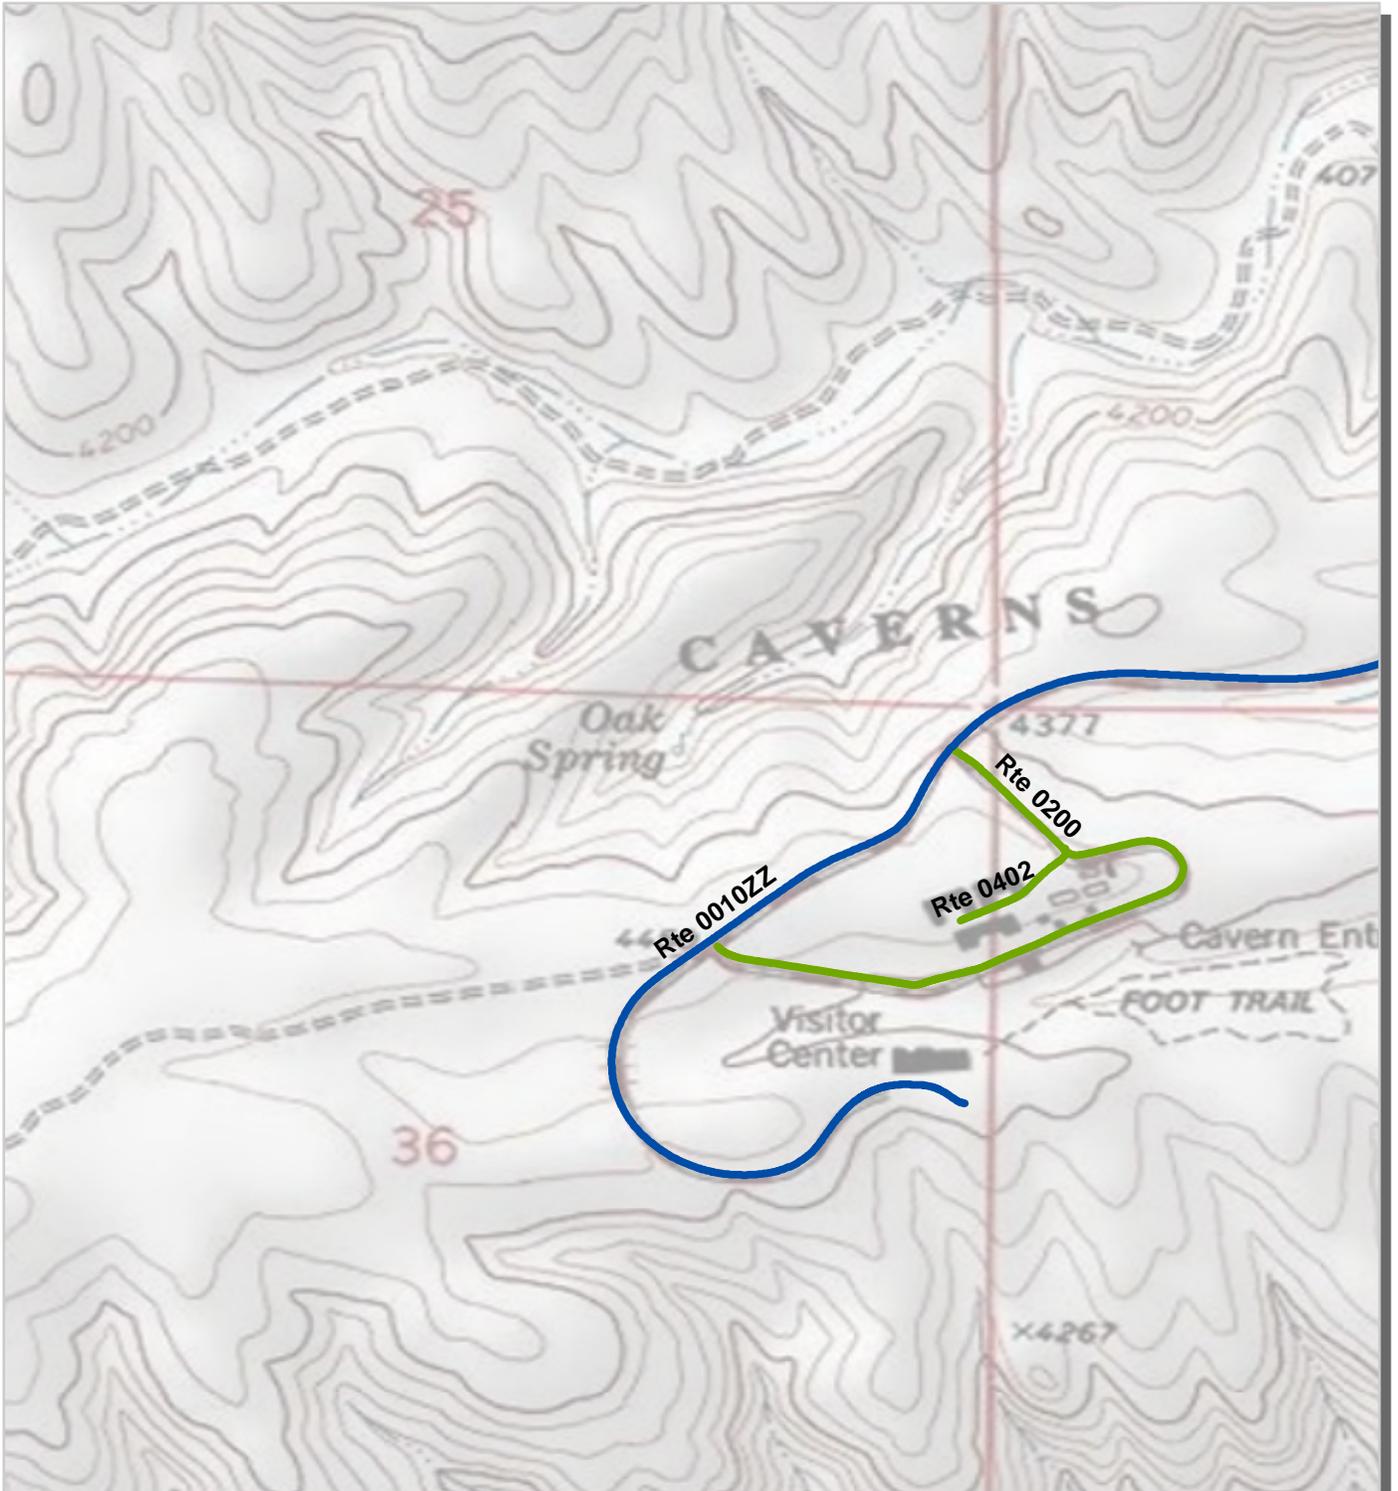
**Carlsbad Caverns National Park
Route Condition Map
PCR - Mile by Mile
Area 1**

PCR	Poor	Fair	Good	Excellent	No Data
	(0 - 60)	(61 - 84)	(85 - 94)	(95 - 100)

* If the PCR rating is not available for a section, the SCR rating will be displayed. See appendix for definitions and formulas.

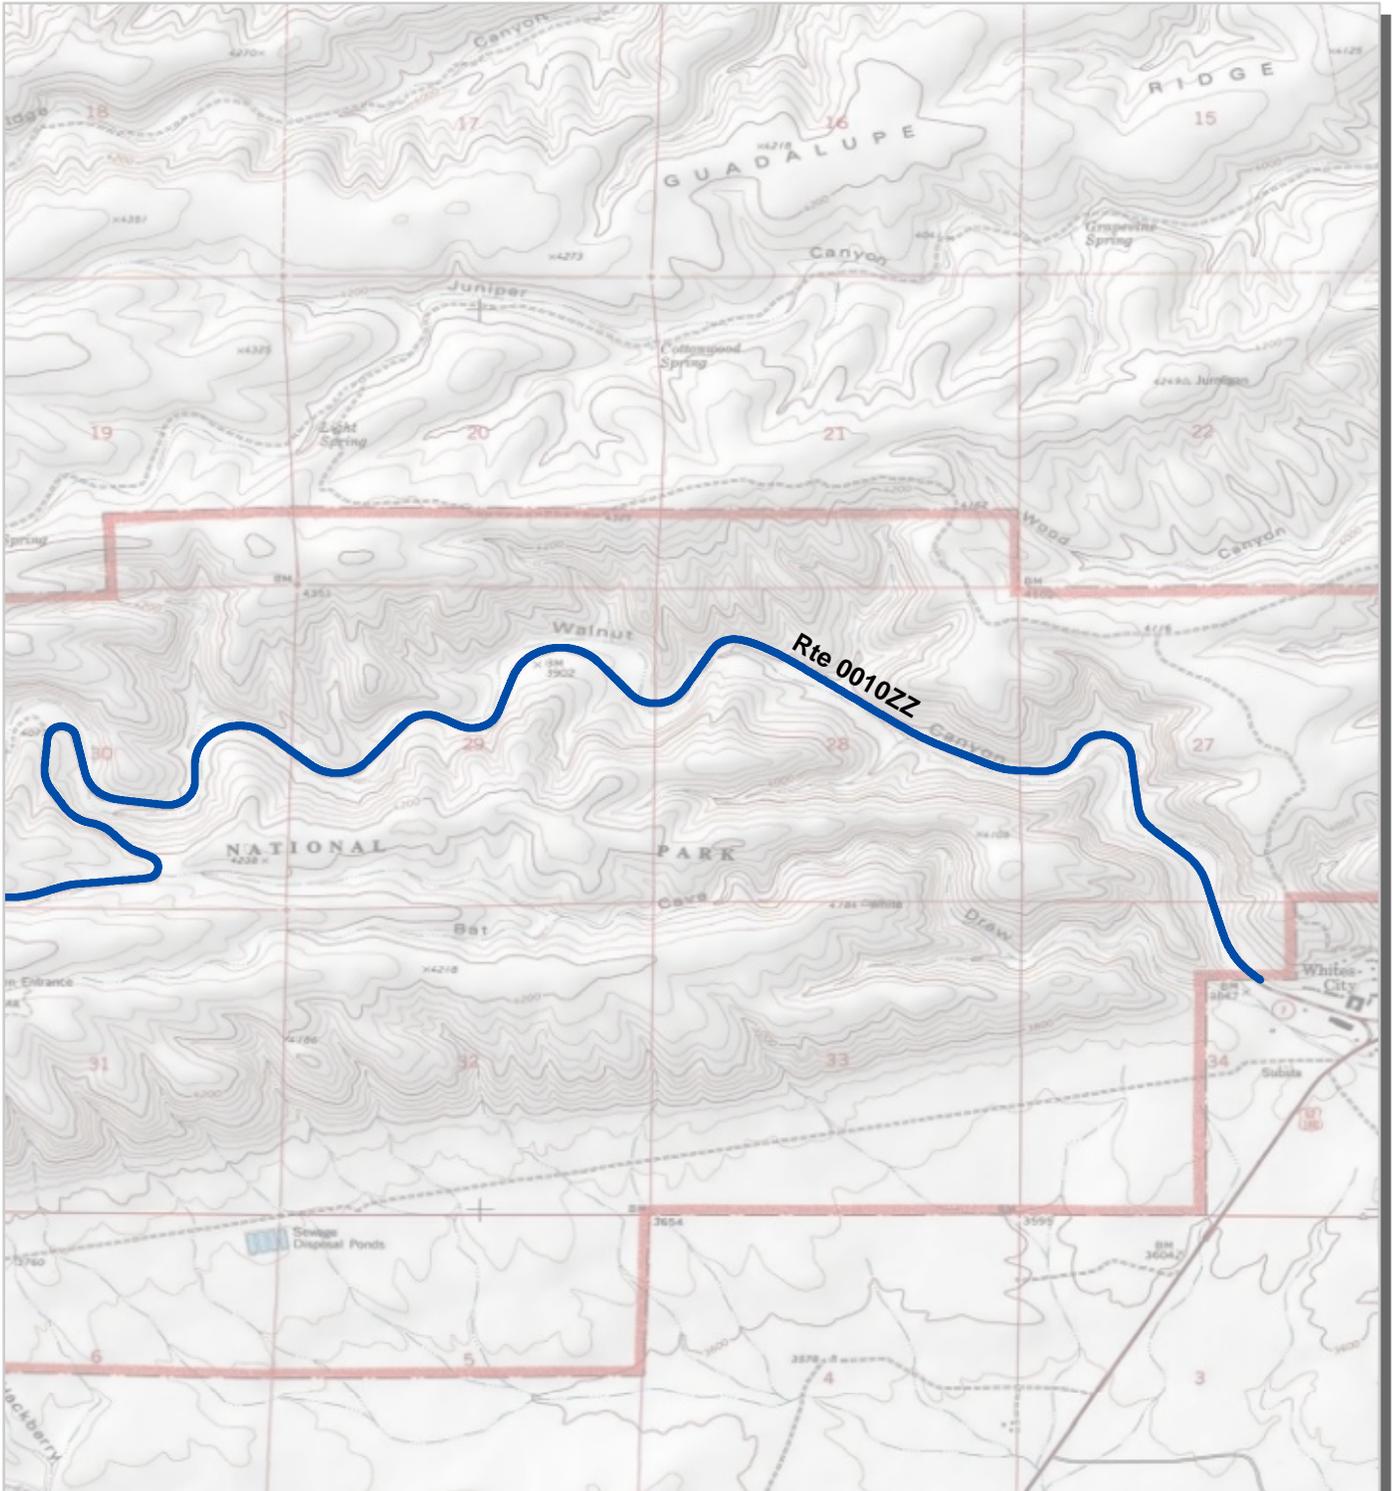
Carlsbad Caverns National Park Route Condition Map PCR - Mile by Mile Area 2

PCR	Poor		Fair		Good		Excellent		No Data	
	(0 - 60)		(61 - 84)	(85 - 94)	(95 - 100)

* If the PCR rating is not available for a section, the SCR rating will be displayed. See appendix for definitions and formulas.

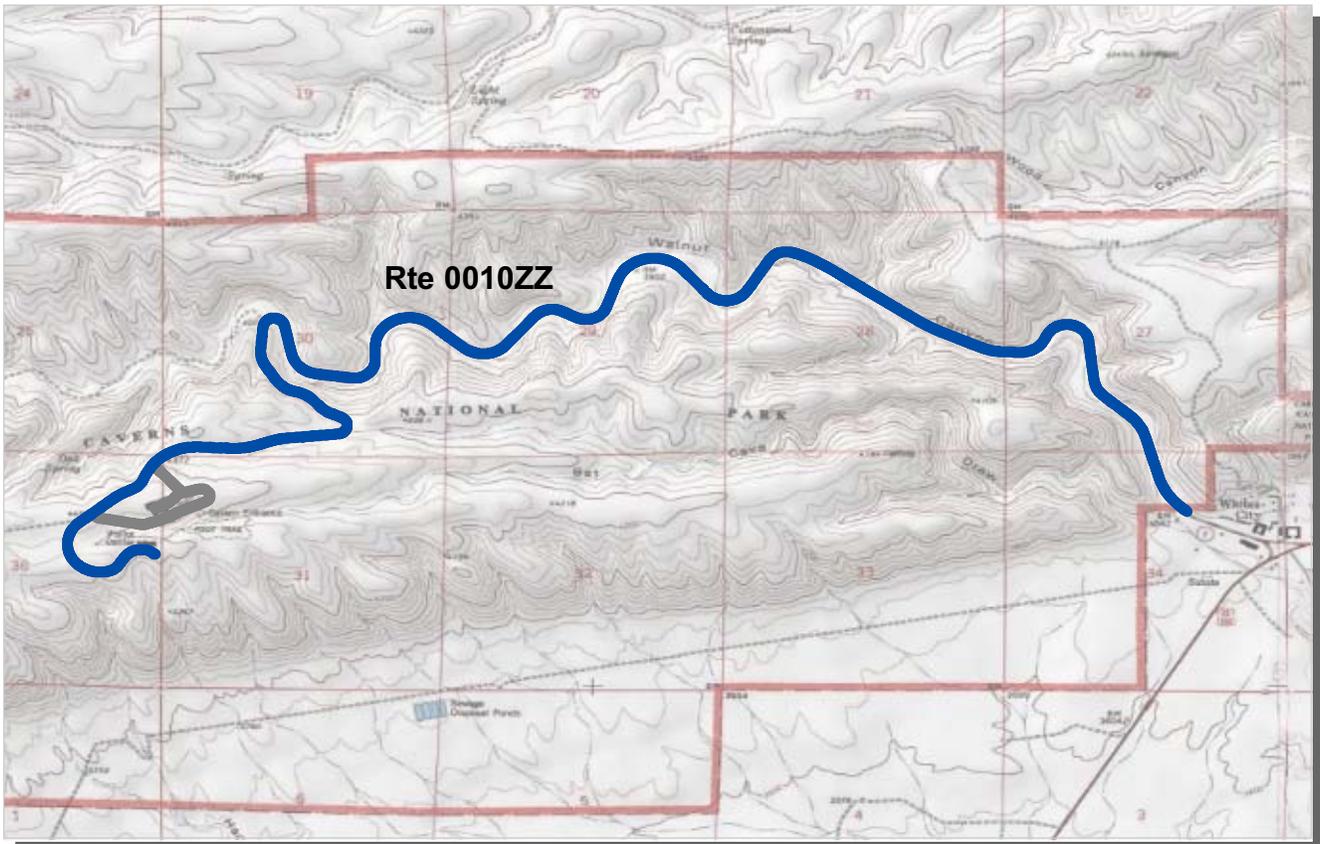
Section Number					
Section Length (mi)					
Cross Section Information					
Number of Lanes	N/A				
Paved Width (ft)	N/A				
Lane Width (ft)	N/A				
Roadway Condition Information					
SCR (Surface Condition Rating)	100				
PCR (Pavement Condition Rating)	100				
Distress Index Values					
Structural Crack Index	N/A				
Transverse Cracking Index	N/A				
Patching Index	N/A				
Rutting Index	N/A				
Roughness Condition Index (RCI)	N/A

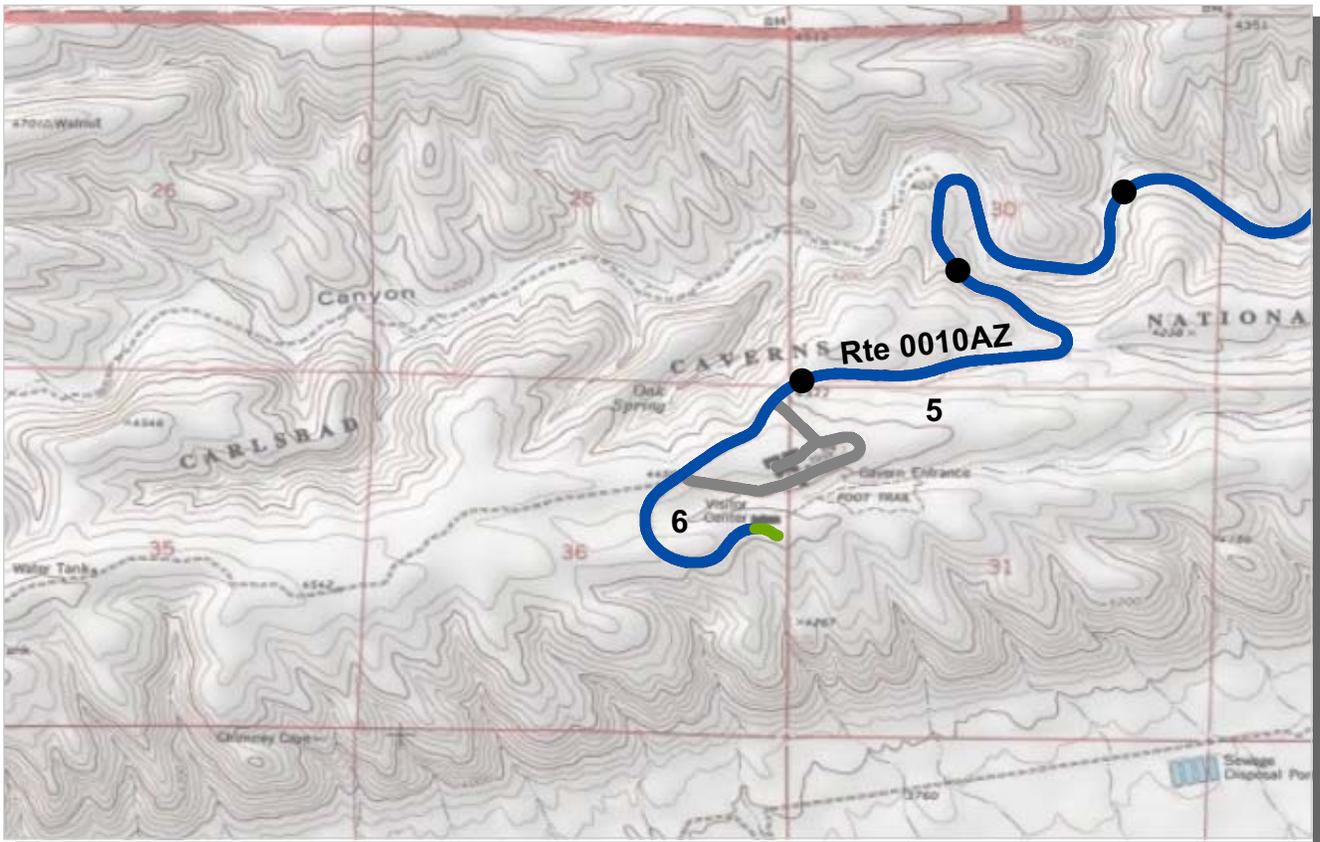
ROUTE: 0010ZZ WALNUT CANYON ENTRANCE ROADS

Section Number	5	6			
Section Length (mi)	1.00	0.98			
Cross Section Information					
Number of Lanes	2	2			
Paved Width (ft)	26	27			
Lane Width (ft)	10	11			
Roadway Condition Information					
SCR (Surface Condition Rating)	100	100			
PCR (Pavement Condition Rating)	100	100			
Distress Index Values					
Structural Crack Index	100	100			
Transverse Cracking Index	100	100			
Patching Index	100	100			
Rutting Index	100	100			
Roughness Condition Index (RCI)	100	100

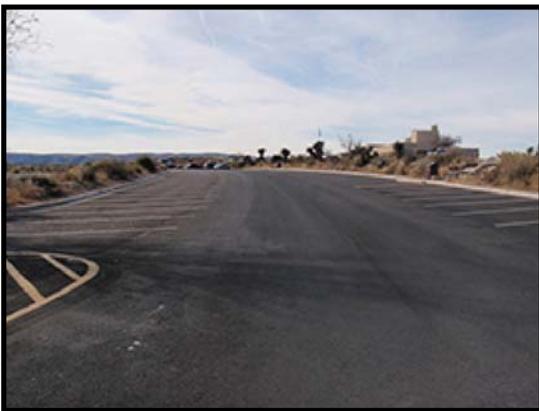
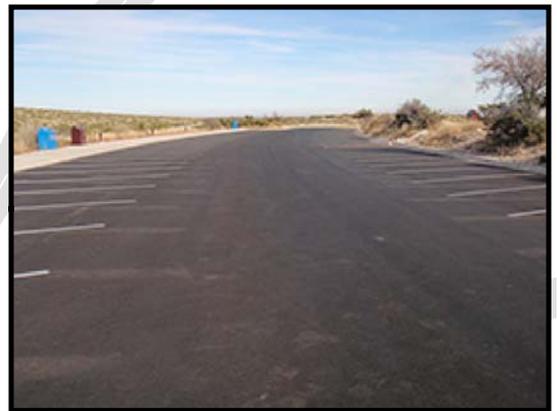
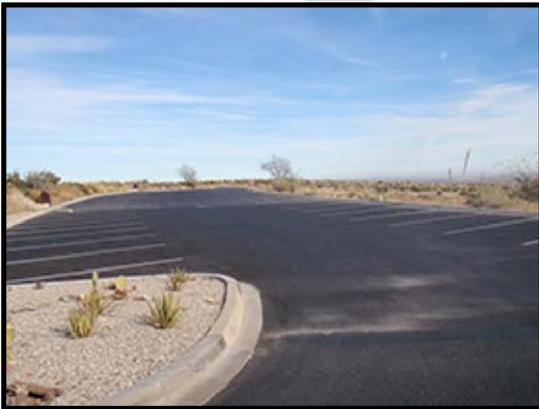
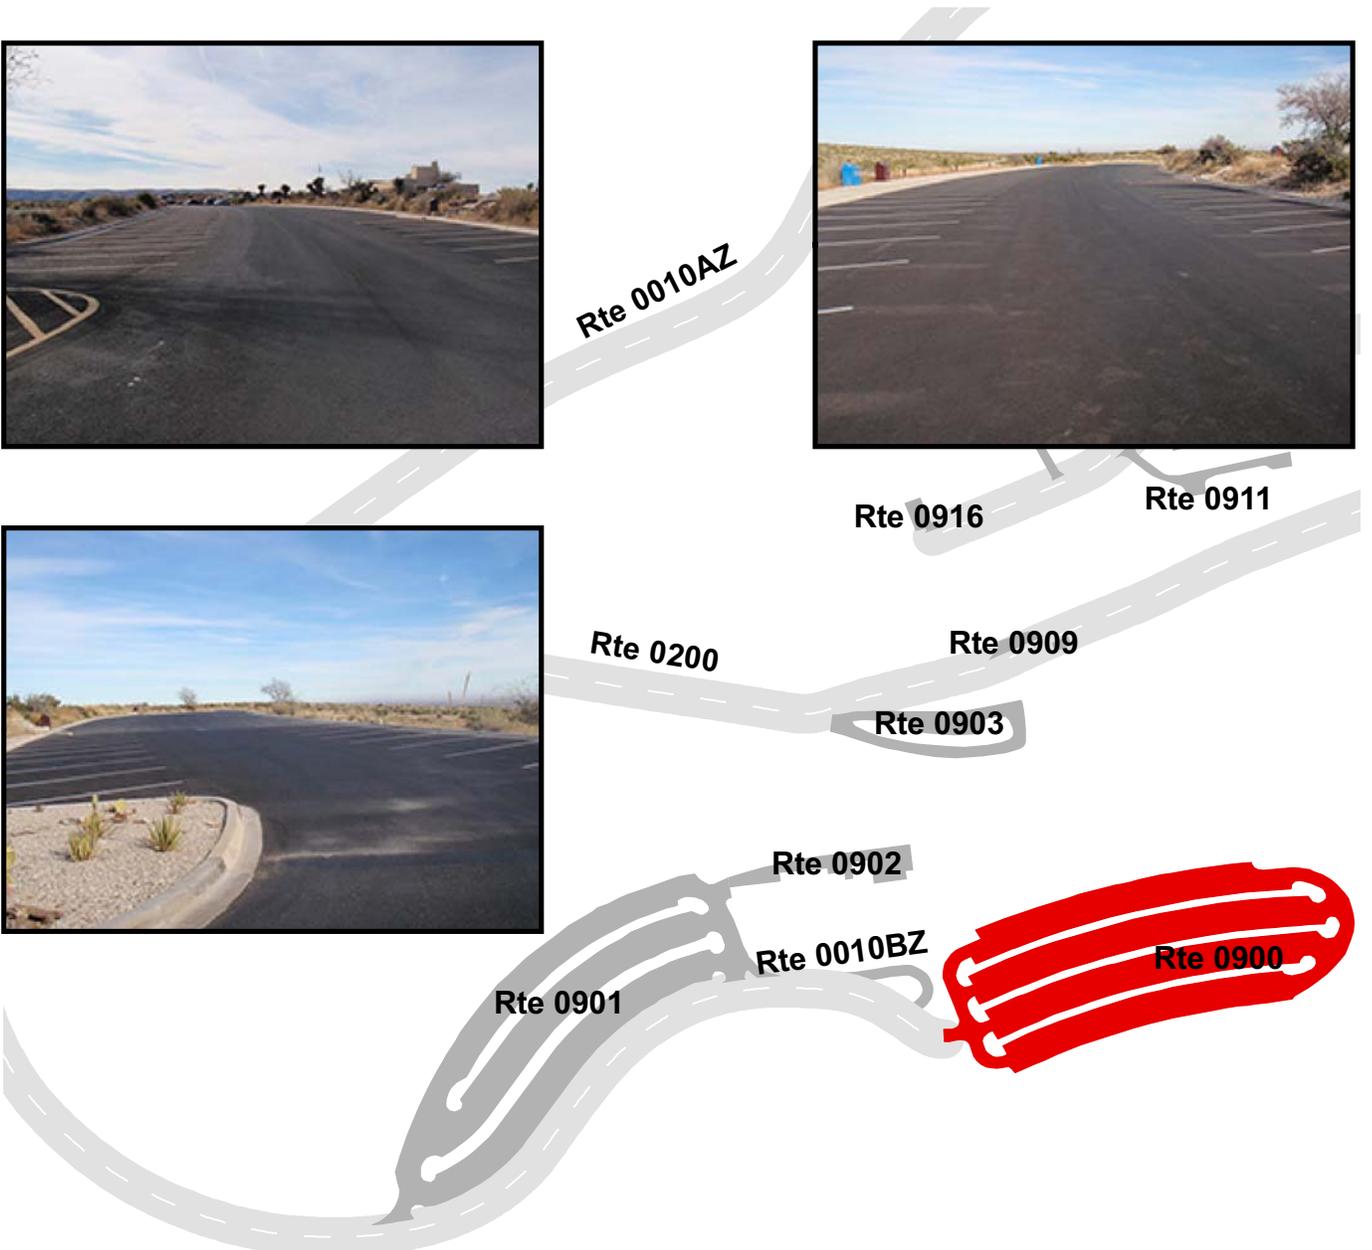
Route Number	Public / NonPublic	Date Visited	Area (sq ft)	Lane Miles *	Surface Type
0900	PUBLIC	12/3/2010	151,934	2.62	AS
Culverts	Drop Inlets	Gates	Curb & Gutter	Curb	PCR
0	5	0	CONCRETE CURB AND GUTTER	NO CURB	EXCELLENT/97

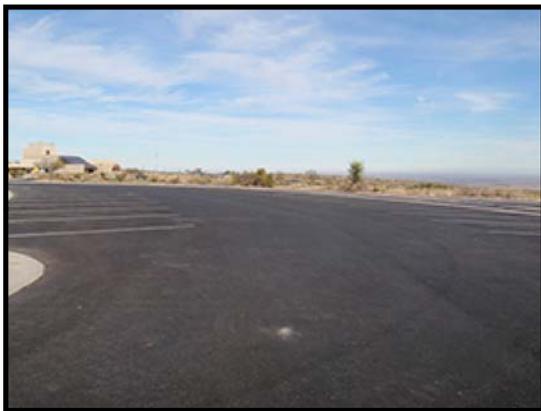
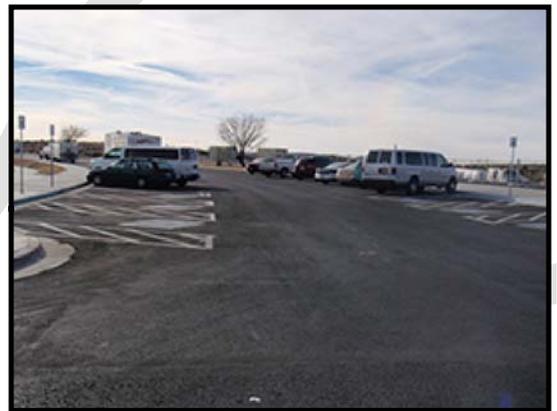
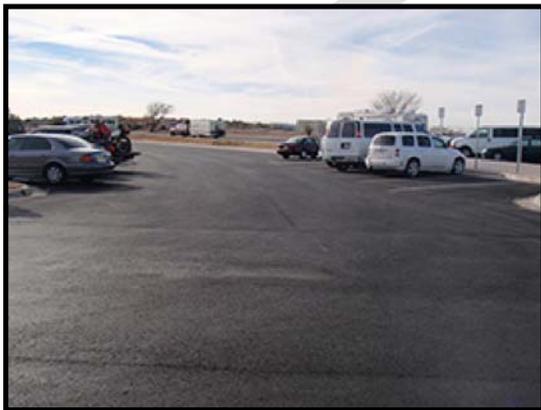
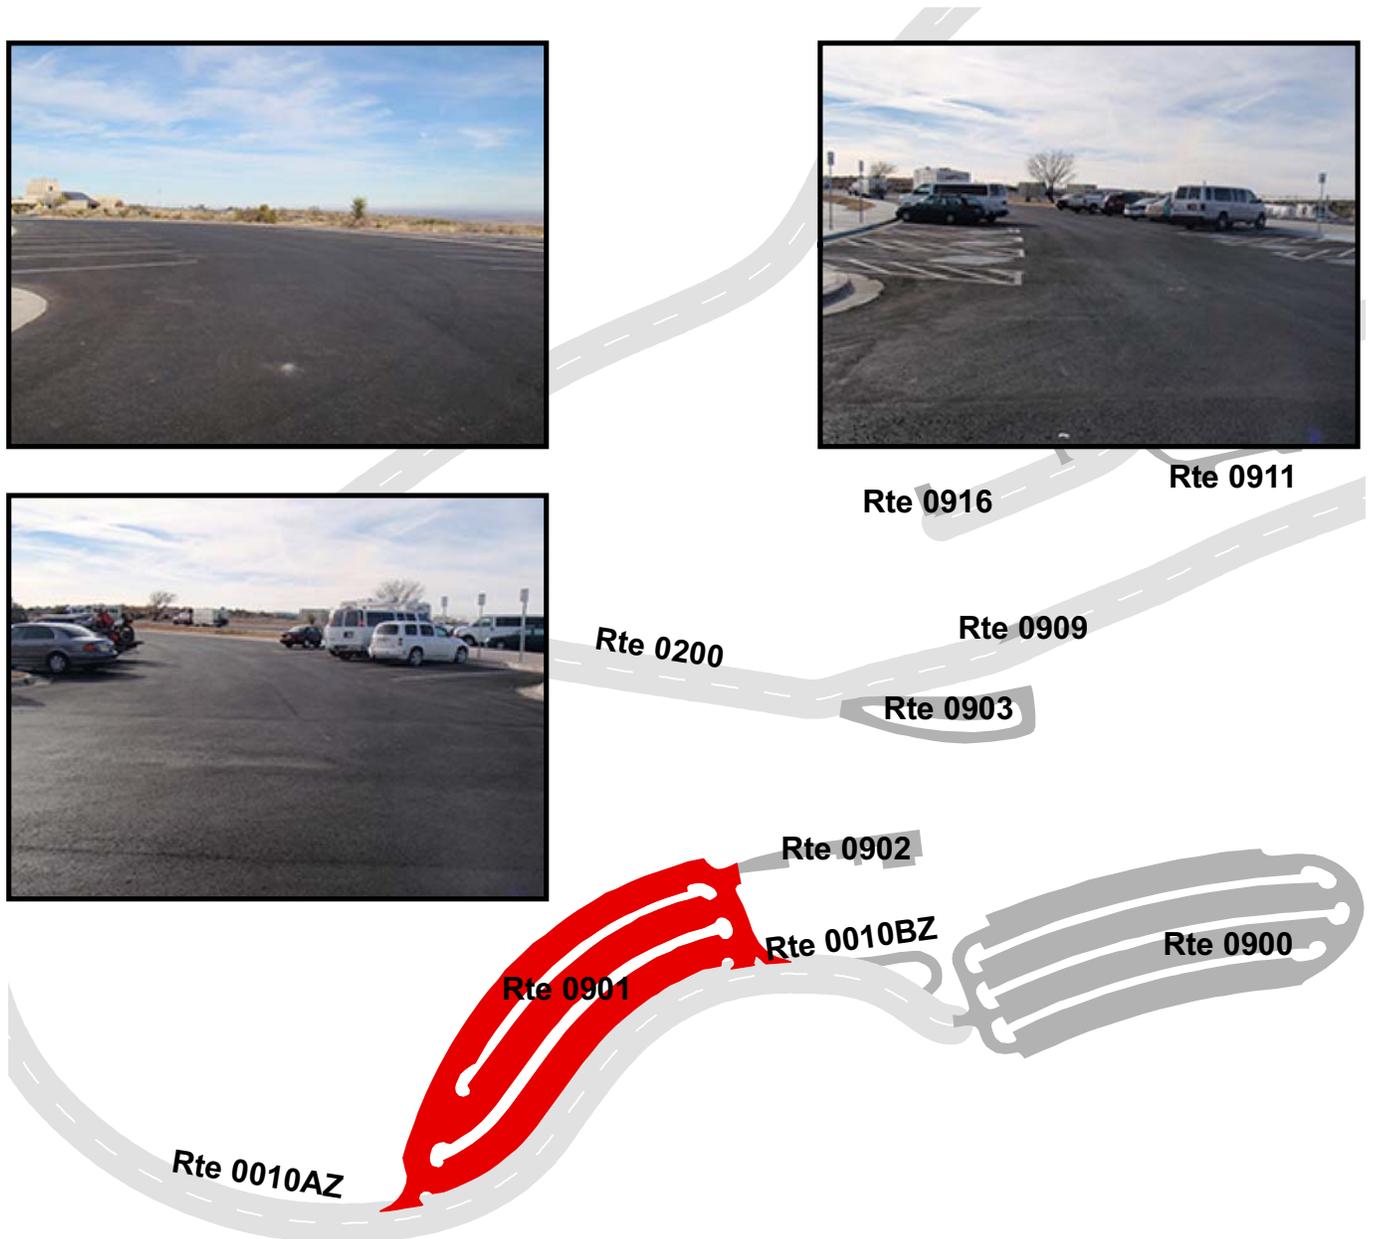
Route 0901

Route Number	Public / NonPublic	Date Visited	Area (sq ft)	Lane Miles *	Surface Type
0901	PUBLIC	12/3/2010	132,636	2.28	AS
Culverts	Drop Inlets	Gates	Curb & Gutter	Curb	PCR
0	2	0	CONCRETE CURB AND GUTTER	NO CURB	EXCELLENT/97

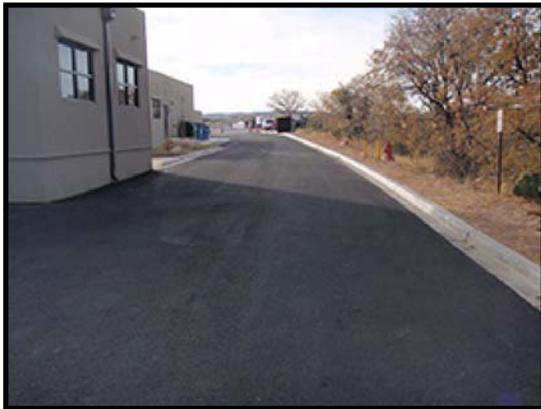
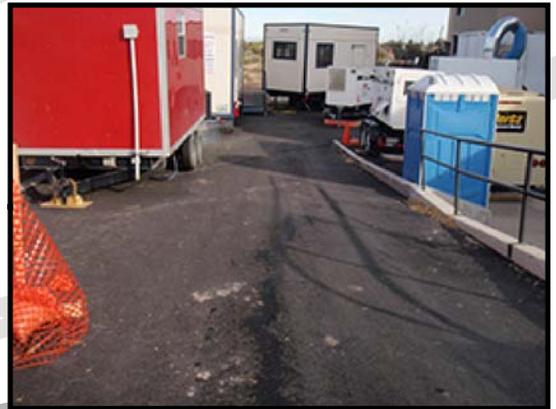
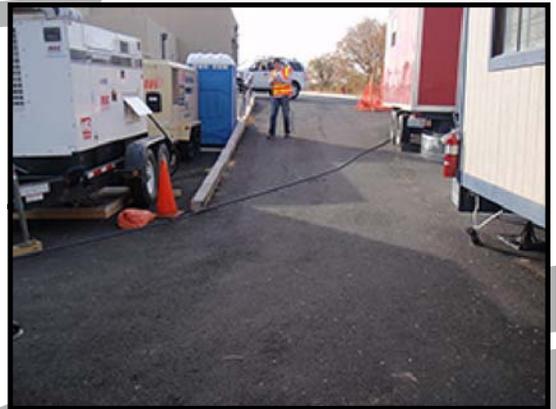
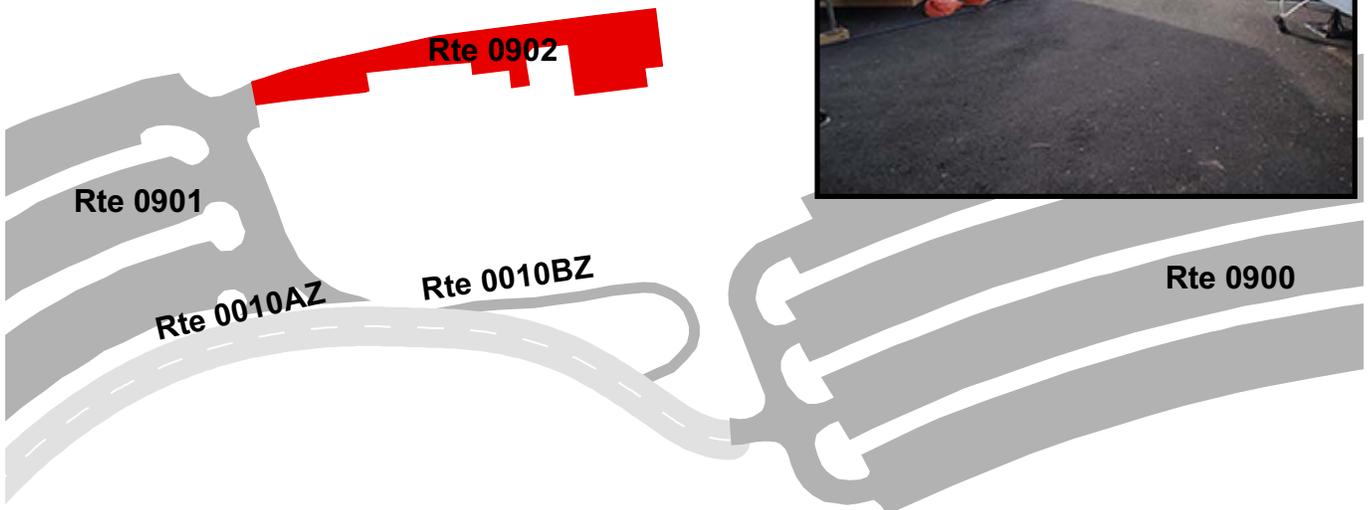
Route 0902

Route Number	Public / NonPublic	Date Visited	Area (sq ft)	Lane Miles *	Surface Type
0902	NONPUBLIC	12/3/2010	11,723	0.20	AS
Culverts	Drop Inlets	Gates	Curb & Gutter	Curb	PCR
0	1	0	CONCRETE CURB AND GUTTER	CONCRETE CURB	EXCELLENT/97

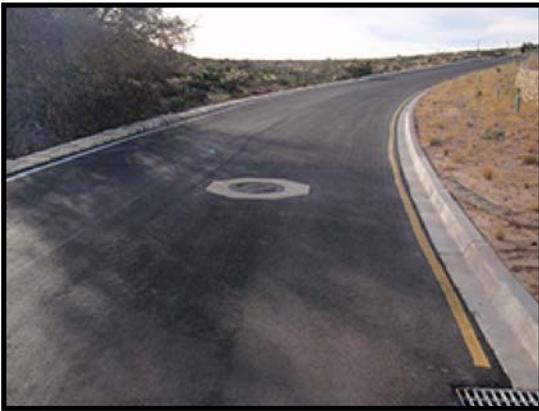
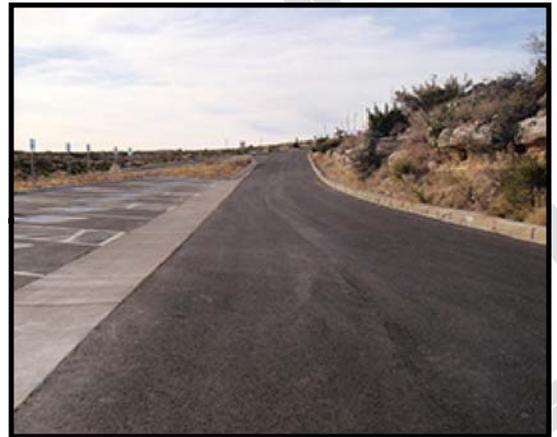
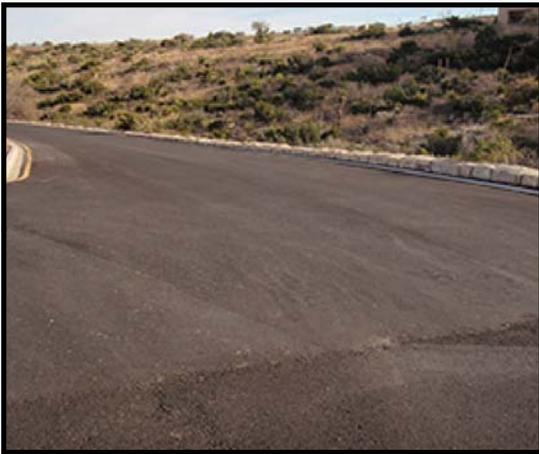
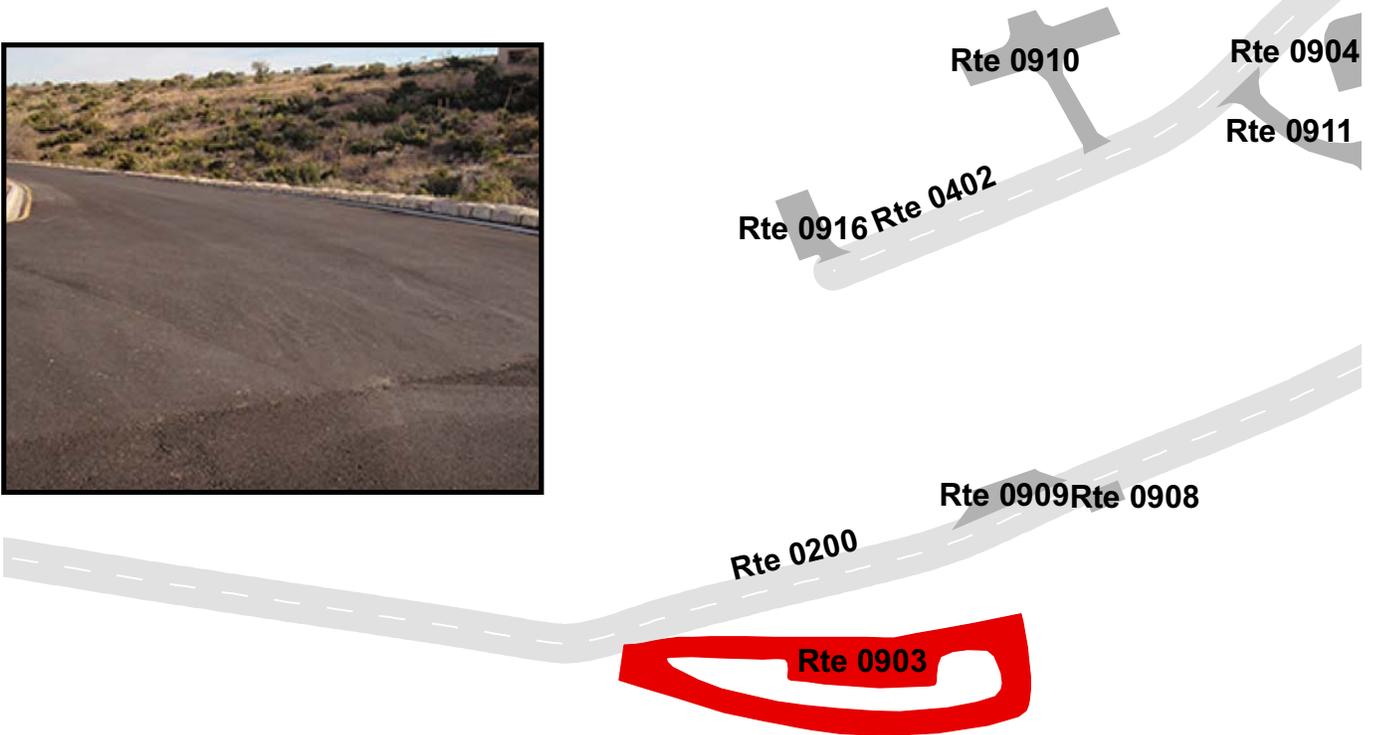
Route 0903

Route Number	Public / NonPublic	Date Visited	Area (sq ft)	Lane Miles *	Surface Type
0903	PUBLIC	12/3/2010	18,973	0.33	AS
Culverts	Drop Inlets	Gates	Curb & Gutter	Curb	PCR
0	1	0	CONCRETE CURB AND GUTTER	STONE CURB	EXCELLENT/97

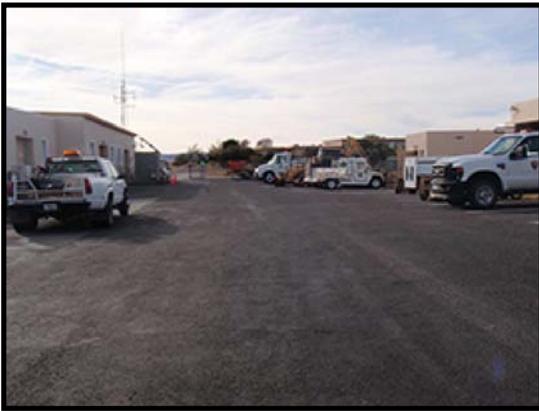
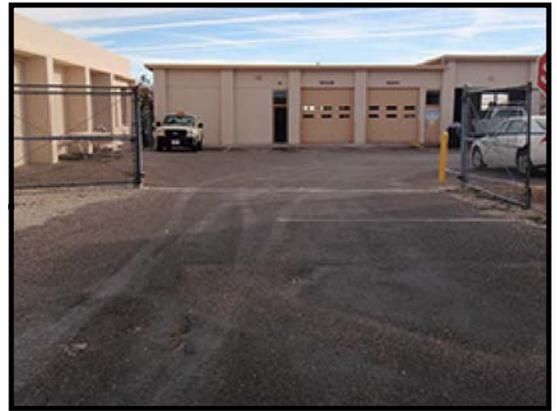
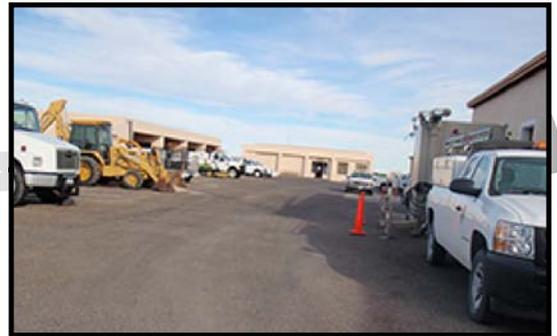
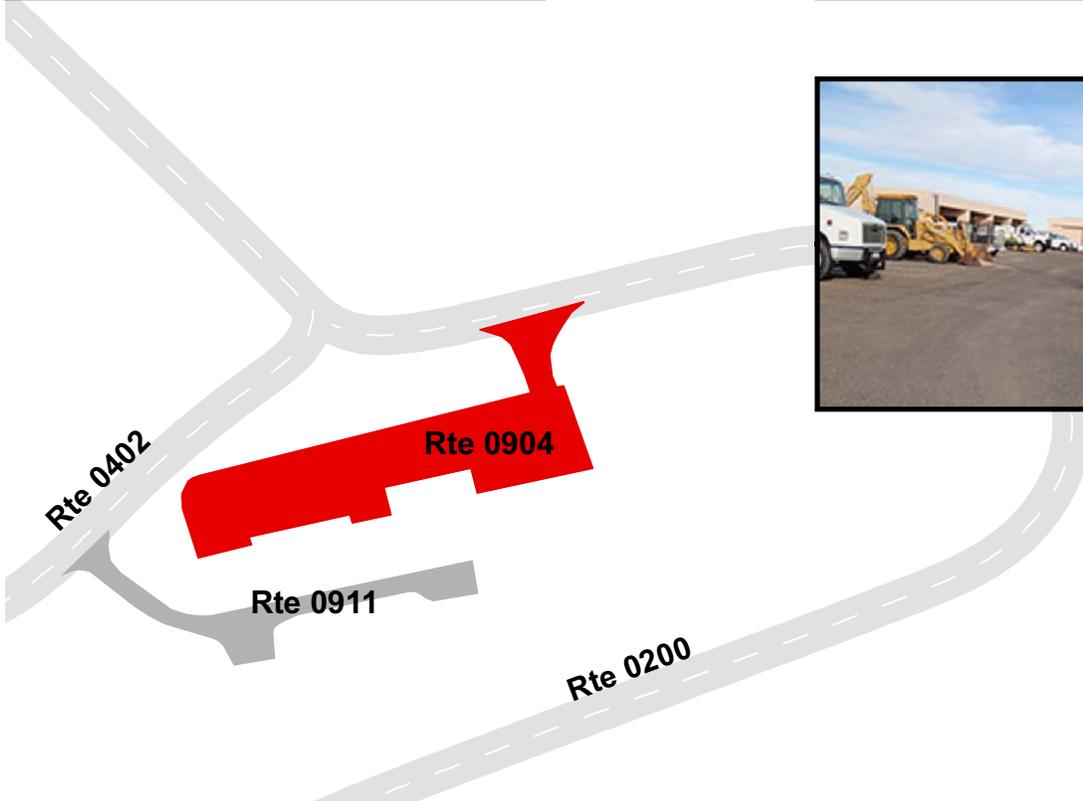
Route 0904

Route Number	Public / NonPublic	Date Visited	Area (sq ft)	Lane Miles *	Surface Type
0904	NONPUBLIC	12/3/2010	19,926	0.34	AS
Culverts	Drop Inlets	Gates	Curb & Gutter	Curb	PCR
0	1	2	NO CURB AND GUTTER	NO CURB	FAIR/73

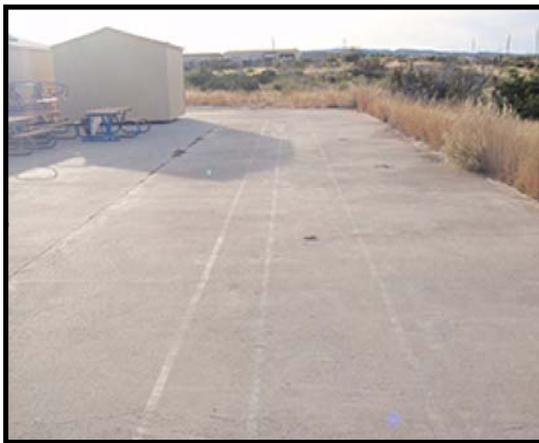
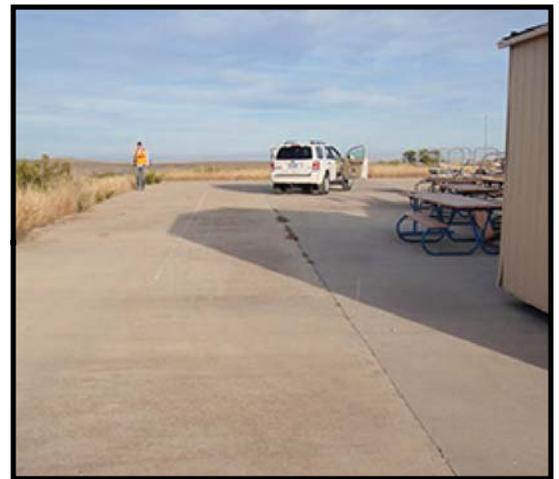
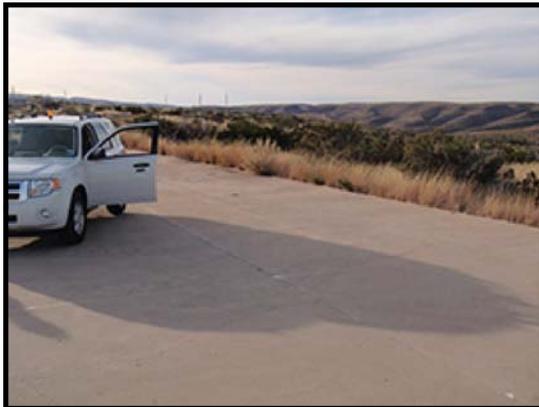
Route 0905

Route Number	Public / NonPublic	Date Visited	Area (sq ft)	Lane Miles *	Surface Type
0905	NONPUBLIC	12/3/2010	5,883	0.10	CO
Culverts	Drop Inlets	Gates	Curb & Gutter	Curb	PCR
0	0	0	NO CURB AND GUTTER	NO CURB	FAIR/73

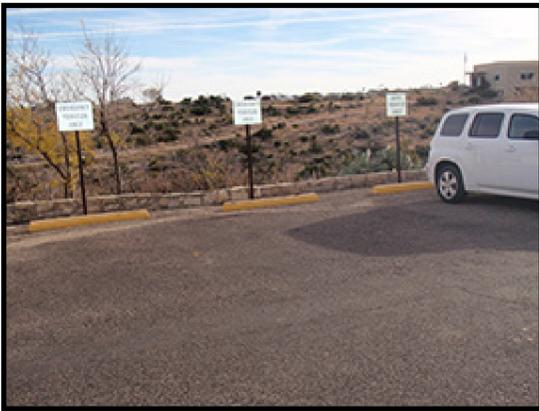
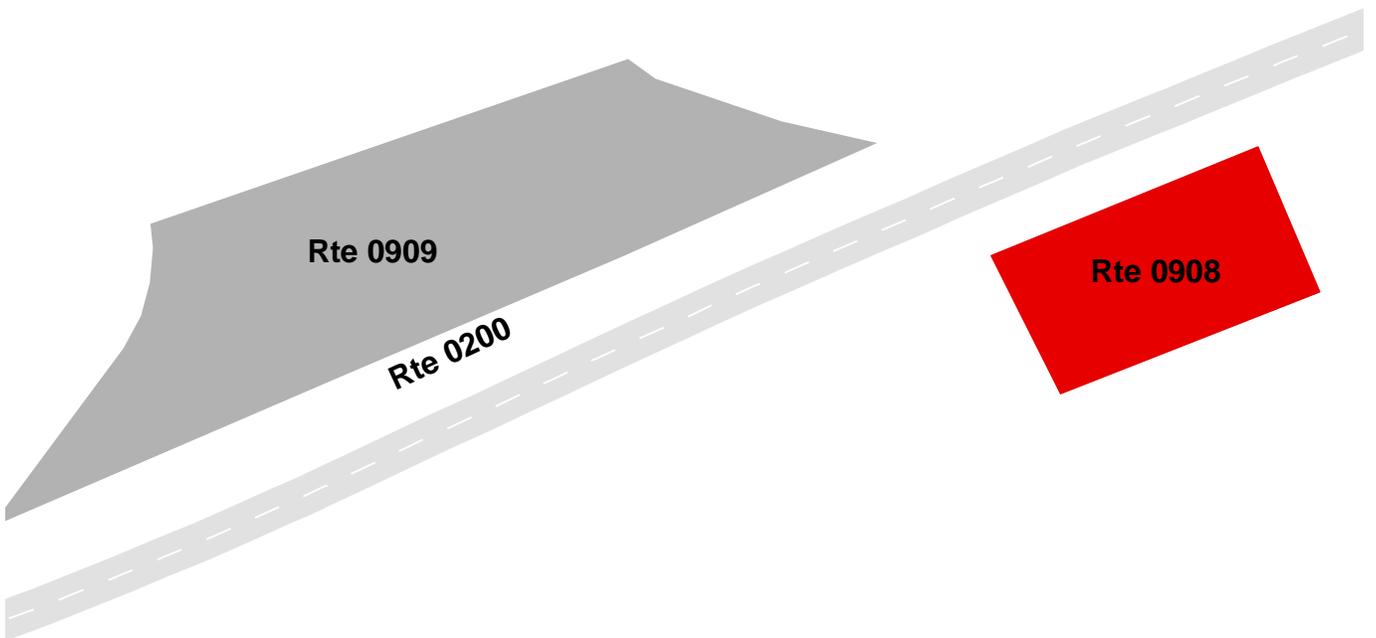
Route 0908

Route Number	Public / NonPublic	Date Visited	Area (sq ft)	Lane Miles *	Surface Type
0908	NONPUBLIC	12/3/2010	590	0.01	AS
Culverts	Drop Inlets	Gates	Curb & Gutter	Curb	PCR
0	0	0	NO CURB AND GUTTER	STONE CURB	FAIR/73

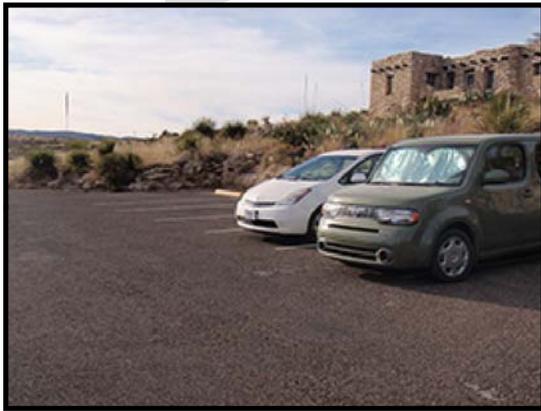
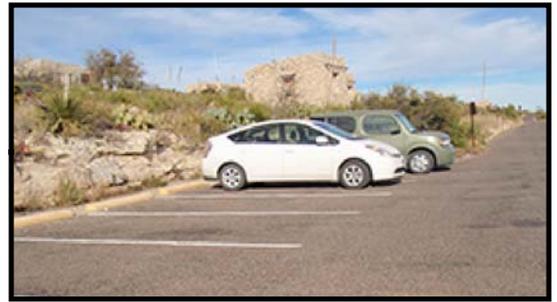
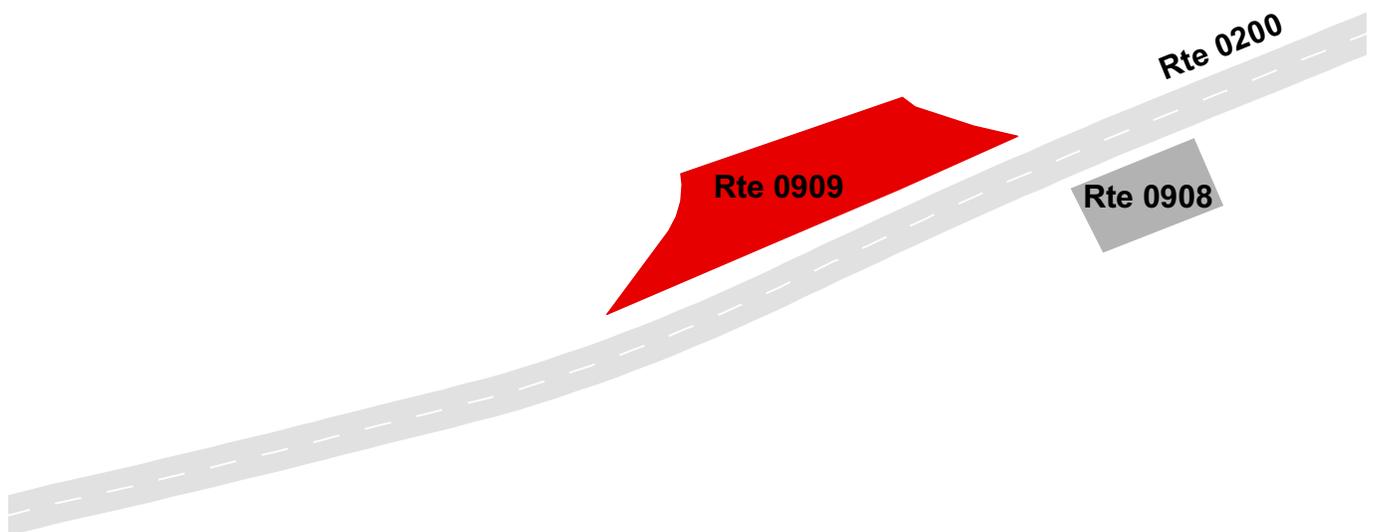
Route Number	Public / NonPublic	Date Visited	Area (sq ft)	Lane Miles *	Surface Type
0909	NONPUBLIC	12/3/2010	1,827	0.03	AS
Culverts	Drop Inlets	Gates	Curb & Gutter	Curb	PCR
0	0	0	NO CURB AND GUTTER	NO CURB	FAIR/73
