Federal Lands Highway Road Inventory Program

Road Inventory and Condition Assessment

Carlsbad Caverns National Park
CAVE - 7170

Cycle 5 Report

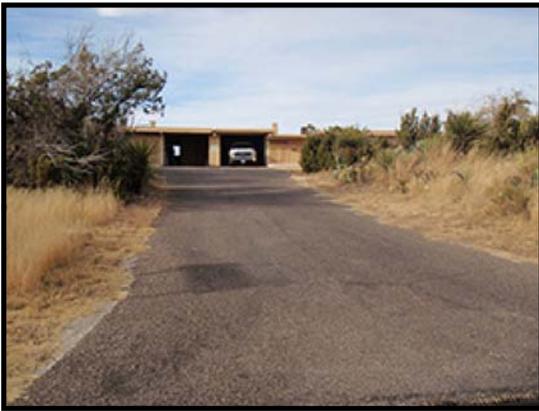
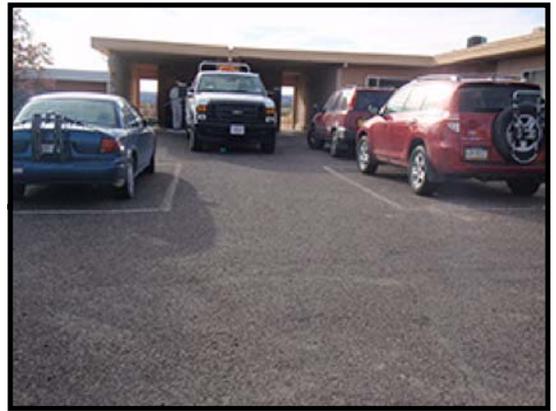
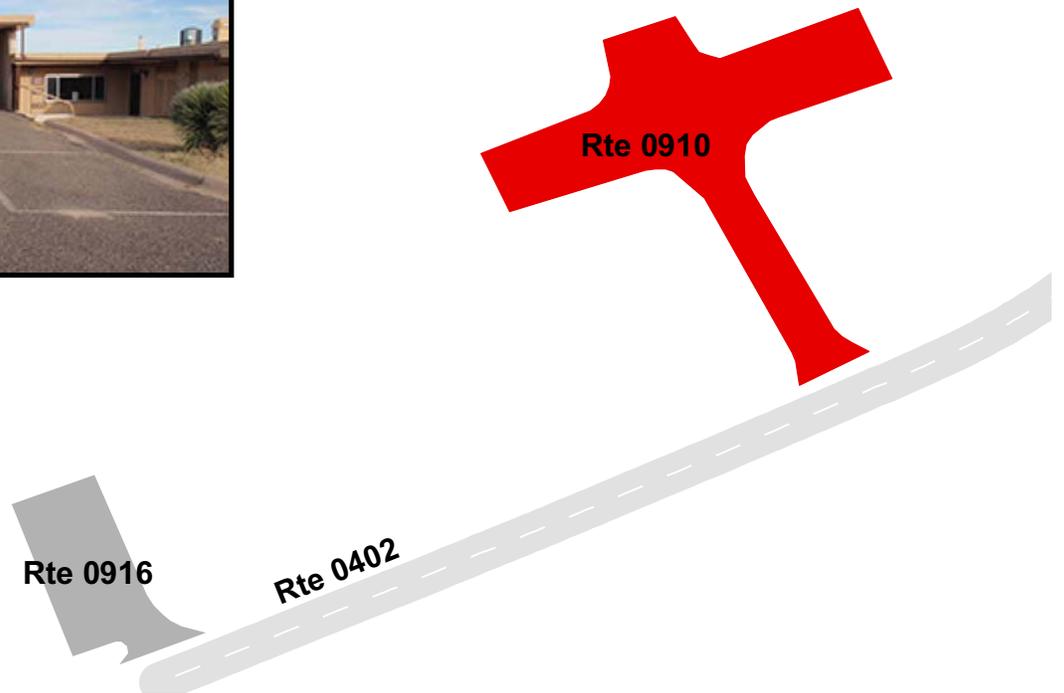
Route 0910

Route Number	Public / NonPublic	Date Visited	Area (sq ft)	Lane Miles *	Surface Type
0910	NONPUBLIC	12/3/2010	5,512	0.10	AS
Culverts	Drop Inlets	Gates	Curb & Gutter	Curb	PCR
0	1	0	CONCRETE CURB AND GUTTER	NO CURB	FAIR/73

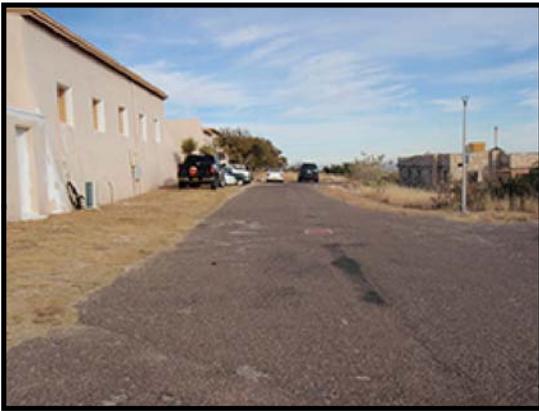
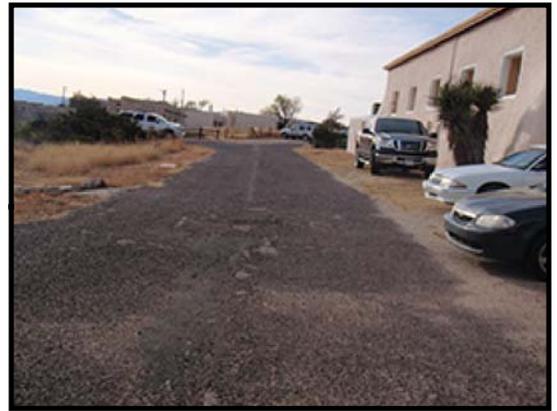
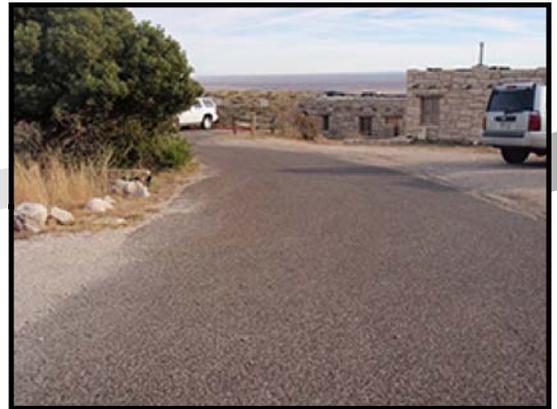
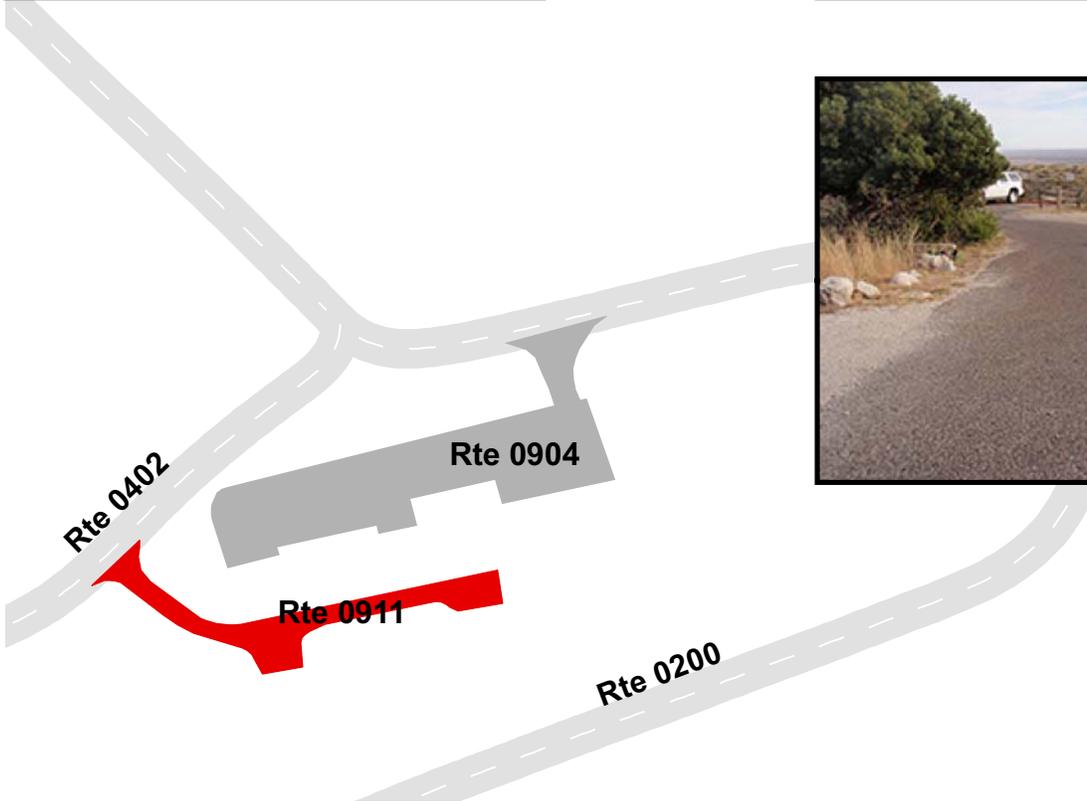
Route 0911

Route Number	Public / NonPublic	Date Visited	Area (sq ft)	Lane Miles *	Surface Type
0911	NONPUBLIC	12/3/2010	6,751	0.12	AS
Culverts	Drop Inlets	Gates	Curb & Gutter	Curb	PCR
0	1	0	NO CURB AND GUTTER	NO CURB	FAIR/73

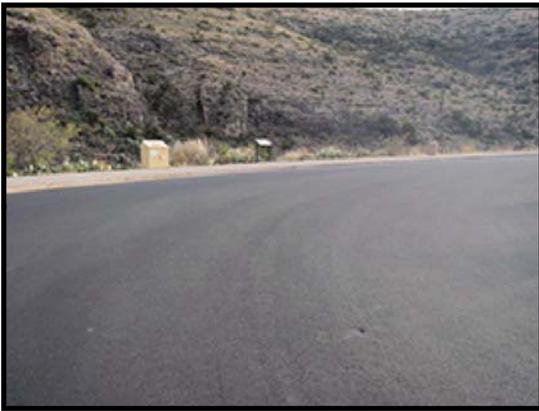
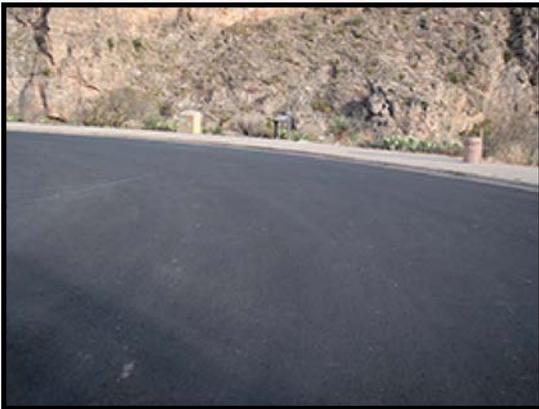
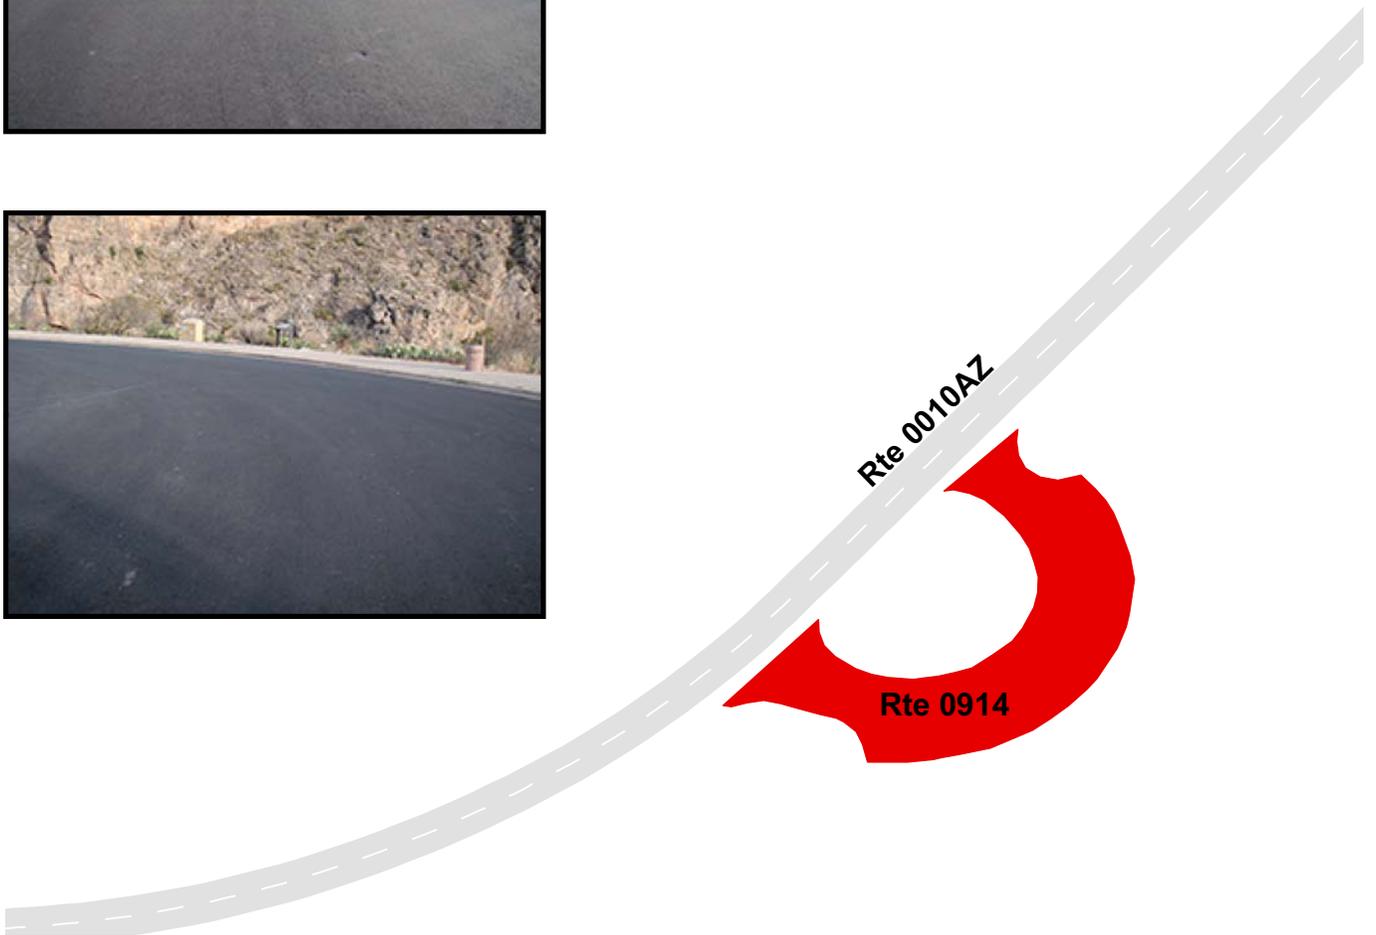
Route 0914

Route Number	Public / NonPublic	Date Visited	Area (sq ft)	Lane Miles *	Surface Type
0914	PUBLIC	12/3/2010	12,469	0.22	AS
Culverts	Drop Inlets	Gates	Curb & Gutter	Curb	PCR
0	1	0	CONCRETE CURB AND GUTTER	NO CURB	EXCELLENT/97

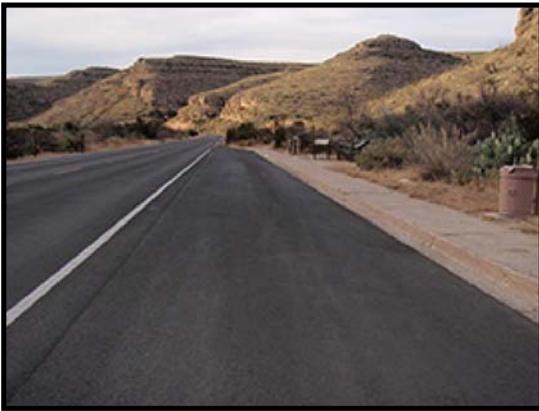
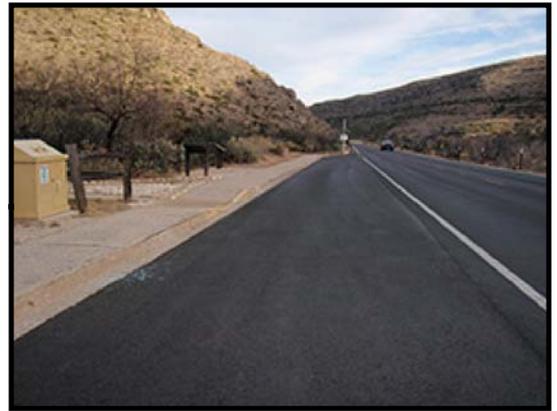
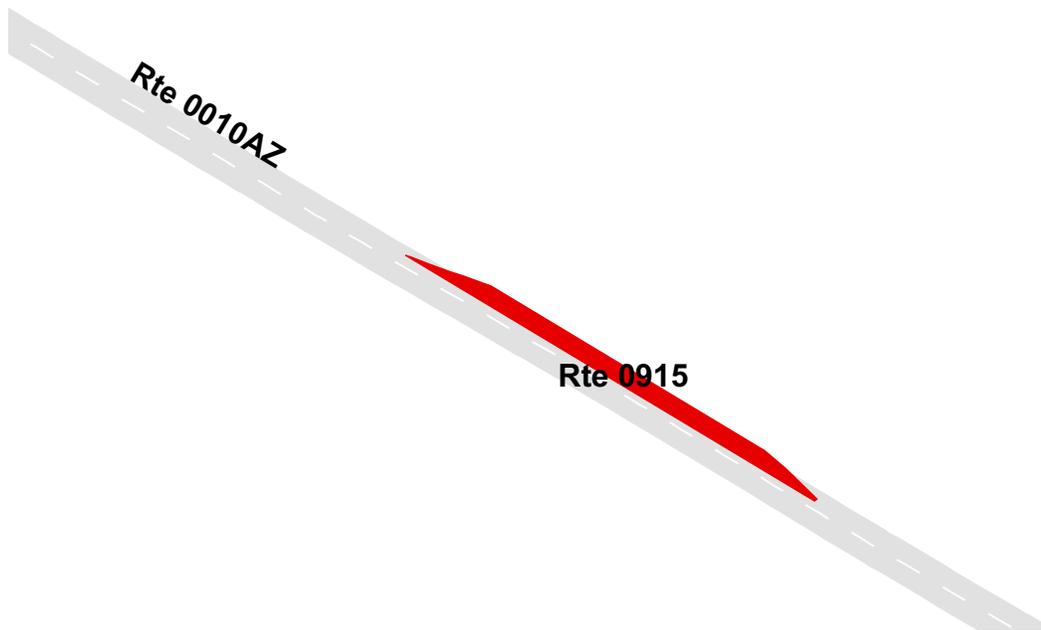
Route 0915

Route Number	Public / NonPublic	Date Visited	Area (sq ft)	Lane Miles *	Surface Type
0915	PUBLIC	12/3/2010	3,094	0.05	AS
Culverts	Drop Inlets	Gates	Curb & Gutter	Curb	PCR
0	0	0	CONCRETE CURB AND GUTTER	NO CURB	GOOD/90

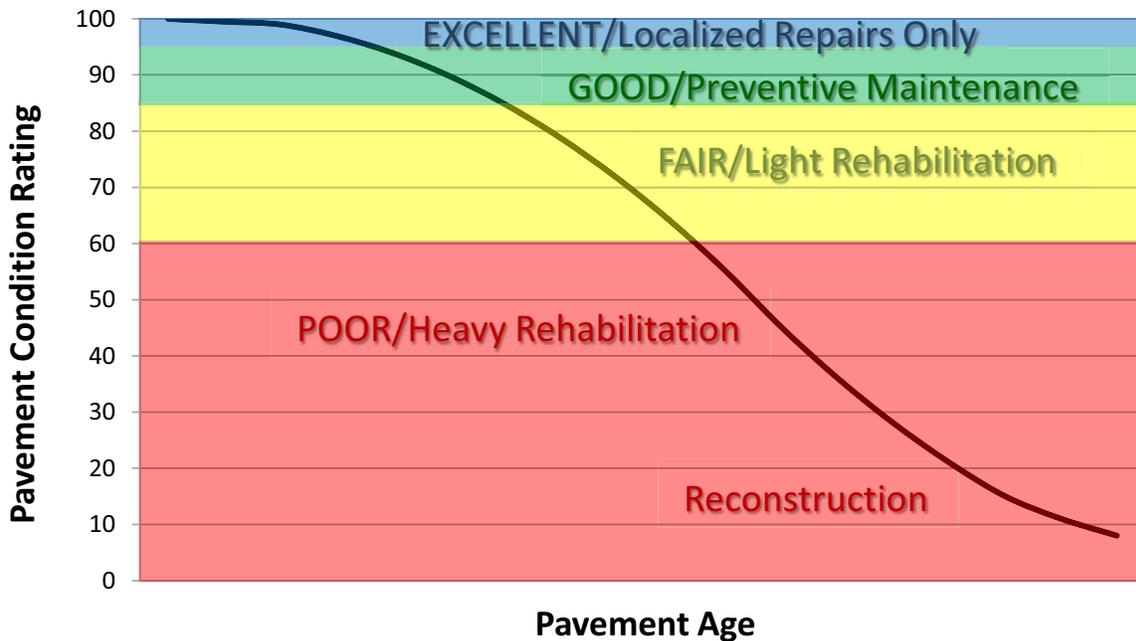
Condition Categories and Treatments

- Excellent/New: PCR of 95-100. Pavements in this range will require only spot repairs
- Good: PCR of 85-94. Pavements in this range will likely be candidates for Preventive Maintenance. Examples include Chip and Slurry Seals, Micro Surfacing and Thin Overlays.
- Fair: PCR of 61-84. Pavements in this range will likely be candidates of Light Rehabilitation (L3R). Examples include single-lift overlays up to 2.5 inches in total thickness, milling and overlays.
- Poor: PCR of 60 or below. Pavements in this range will likely be candidates of Heavy Rehabilitation or Reconstruction (H3R or 4R). Examples include Pulverization, Multiple Lift Overlays, and Reconstruction.

At this time, specific Maintenance and Rehabilitation activities should be evaluated and recommended at the project level. Site-specific conditions that influence treatment type should be determined based on performing a subsurface investigation and/or pavement condition survey, and not be based solely on RIP data. Additionally, RIP produces a snapshot of conditions the year in which the data was collected. For further information or to obtain additional Pavement Management System's data from our Highway Pavement Management Application (HPMA) please contact the Eastern Federal Lands pavement team.
