# Federal Lands Highway Road Inventory Program

Road Inventory and Condition Assessment

## Colorado National Monument COLM - 1378

### Cycle 5 Report

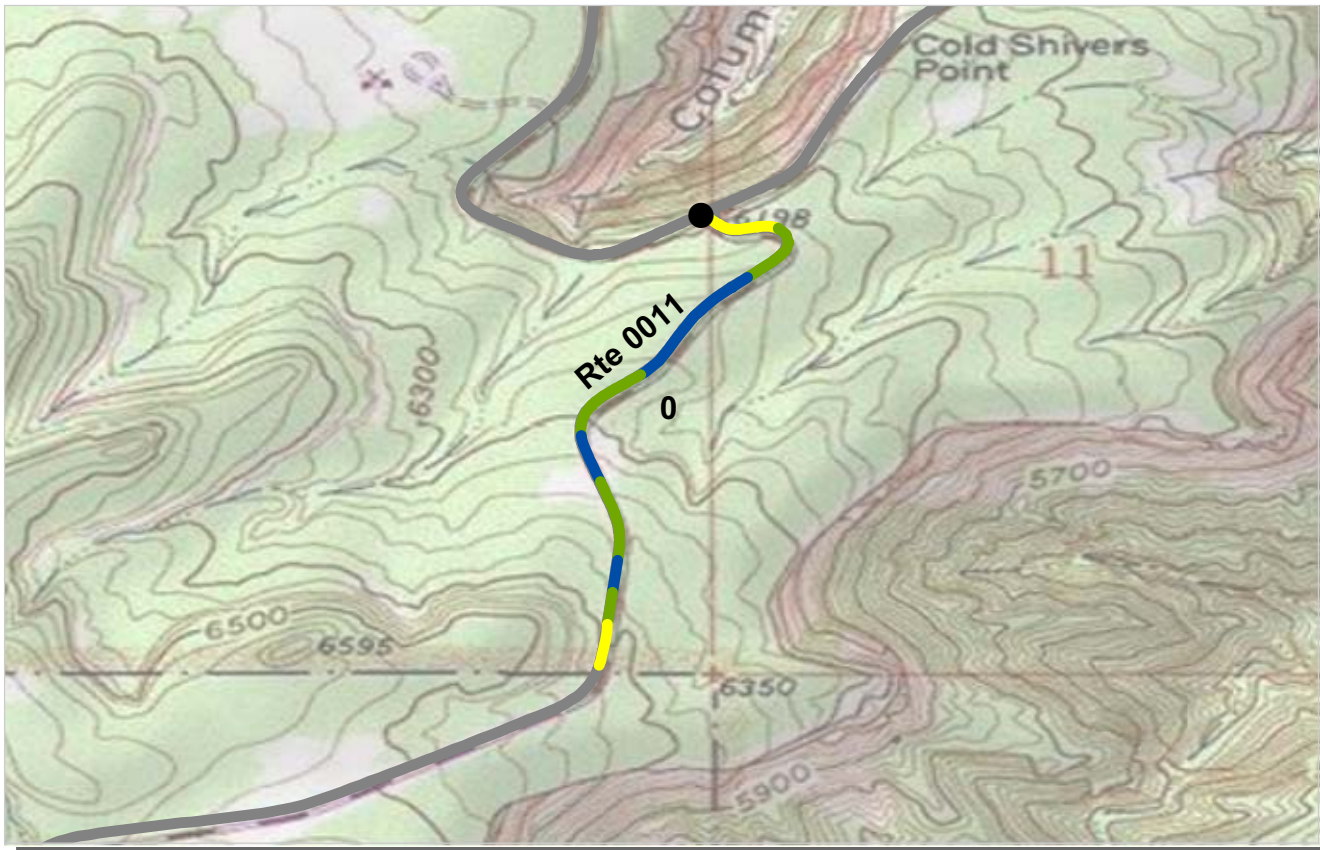
**ROUTE: 0011 EAST GLADE PARK ROAD**

<b>Section Number</b>	0				
<b>Section Length (mi)</b>	0.71				
<b>Cross Section Information</b>					
Number of Lanes	2				
Paved Width (ft)	23				
Lane Width (ft)	10				
<b>Roadway Condition Information</b>					
SCR (Surface Condition Rating)	96				
PCR (Pavement Condition Rating)	91				
<b>Distress Index Values</b>					
Structural Crack Index	98				
Transverse Cracking Index	96				
Patching Index	100				
Rutting Index	96				
Roughness Condition Index (RCI)	84

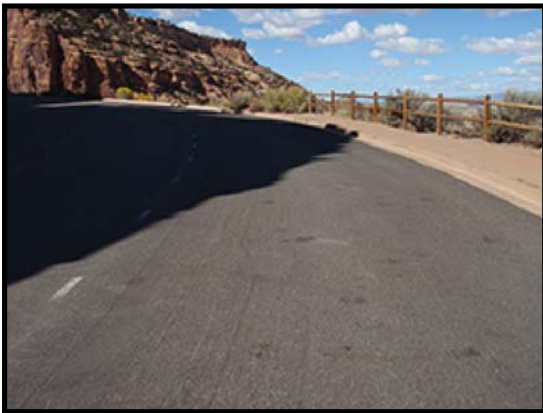
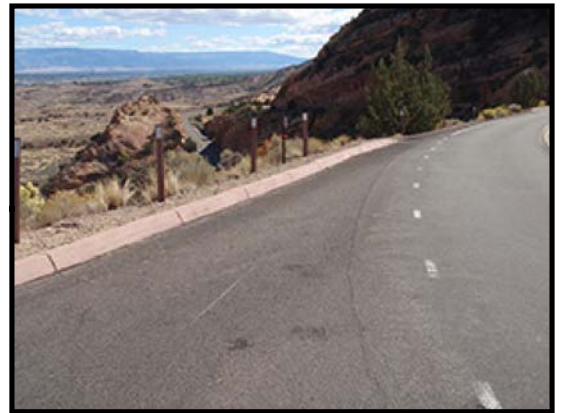
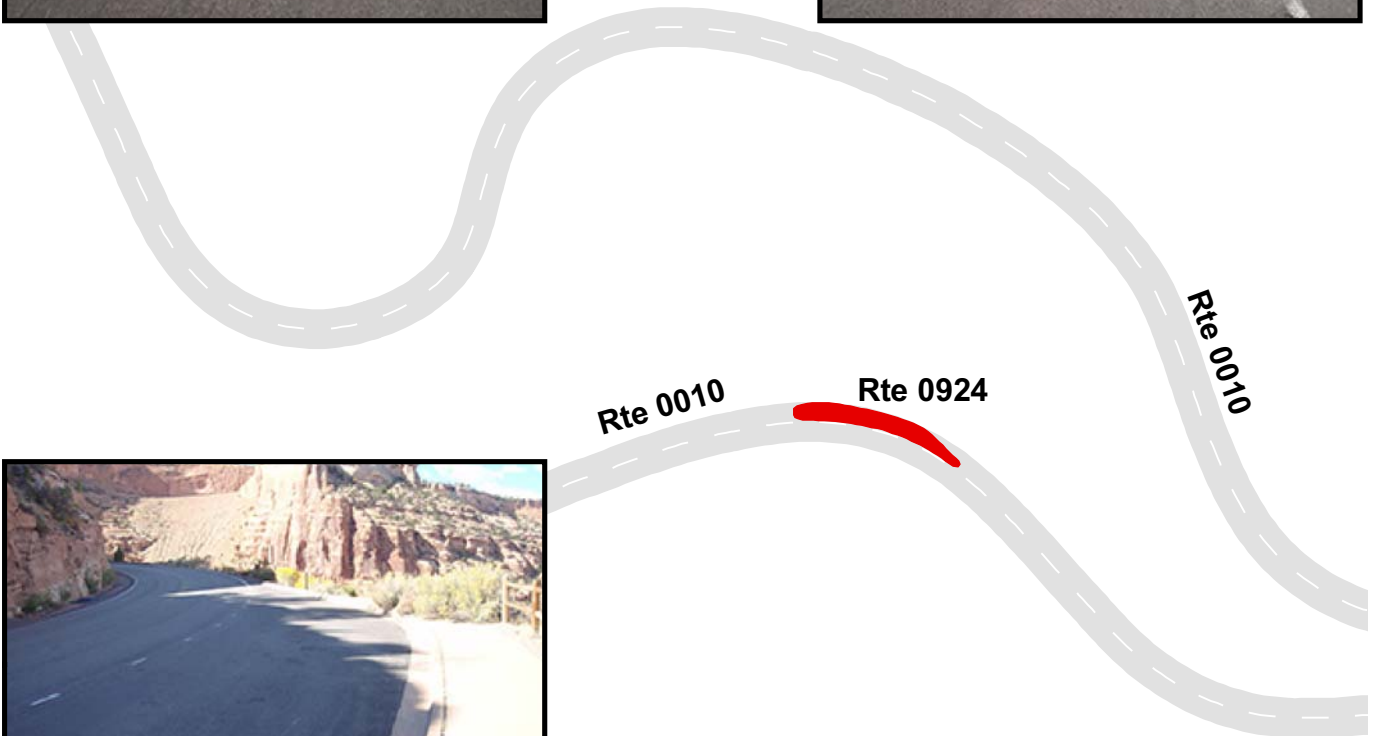
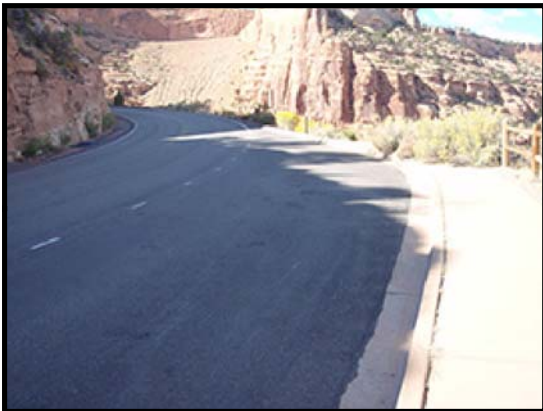
## Route 0924

Route Number	Public / NonPublic	Date Visited	Area (sq ft)	Lane Miles *	Surface Type
0924	PUBLIC	10/17/2011	3,138	0.05	AS
Culverts	Drop Inlets	Gates	Curb & Gutter	Curb	PCR
0	0	0	CONCRETE CURB AND GUTTER	CONCRETE CURB	GOOD/90
