Federal Lands Highway Road Inventory Program

Road Inventory and Condition Assessment

Cowpens National Battlefield COWP

Cycle 5 Report

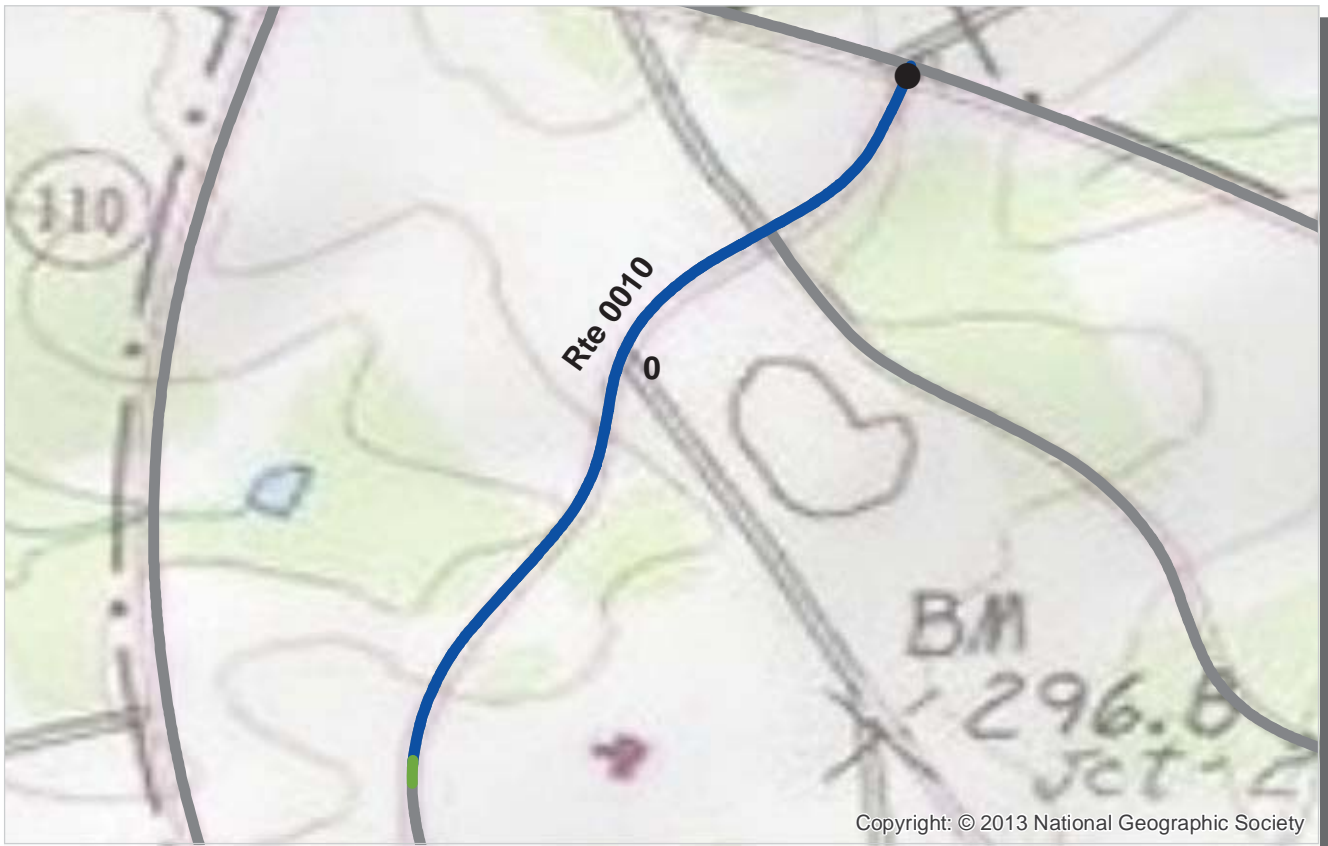
ROUTE: 0010 MAIN ENTRANCE ROAD

Section Number	0				
Section Length (mi)	0.45				
Cross Section Information					
Number of Lanes	2				
Paved Width (ft)	20				
Lane Width (ft)	9				
Roadway Condition Information					
SCR (Surface Condition Rating)	98				
PCR (Pavement Condition Rating)	98				
Distress Index Values					
Structural Crack Index	99				
Transverse Cracking Index	100				
Patching Index	100				
Rutting Index	98				
Roughness Condition Index (RCI)	NC

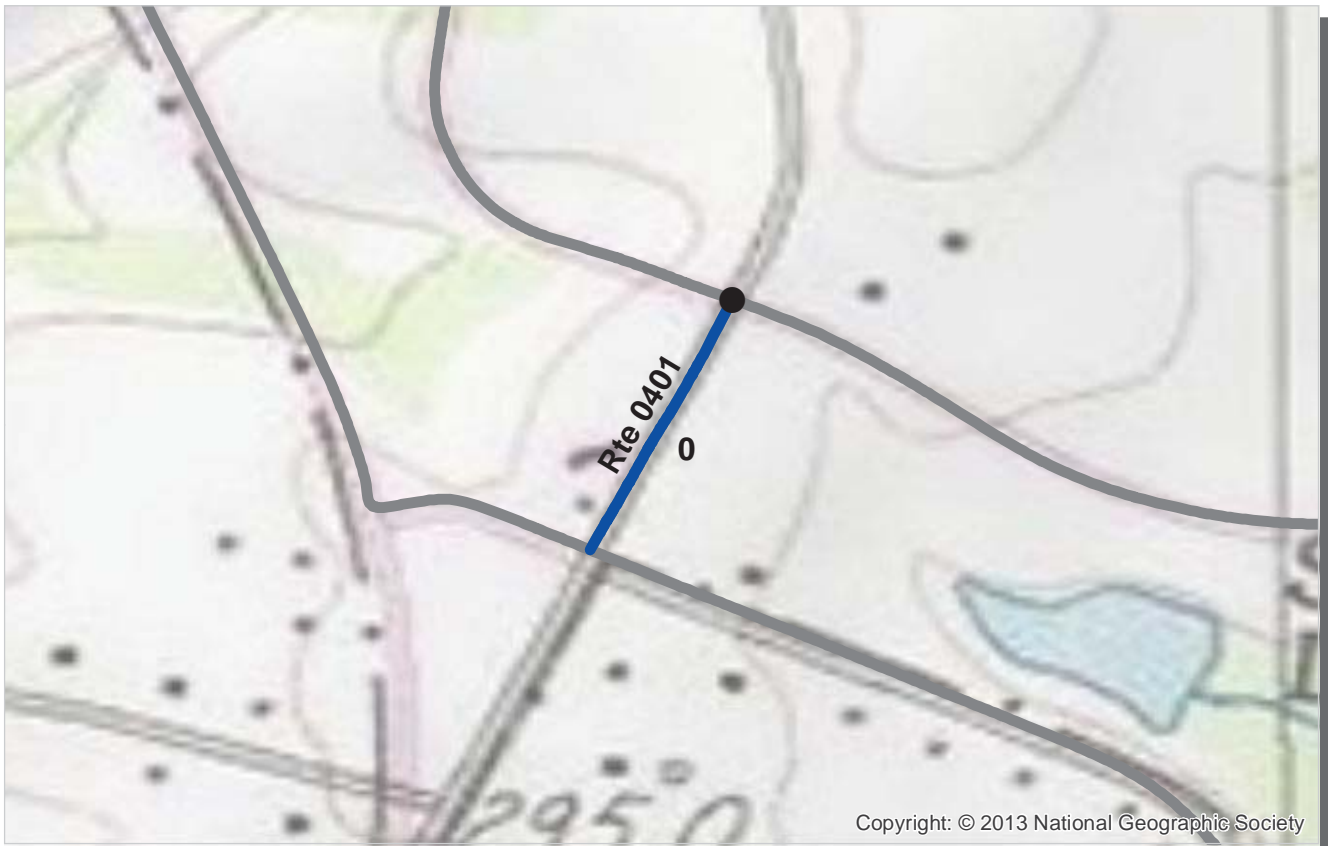
ROUTE: 0401 MAINTENANCE AREA ACCESS ROAD

Section Number	0				
Section Length (mi)	0.13				
Cross Section Information					
Number of Lanes	2				
Paved Width (ft)	20				
Lane Width (ft)	10				
Roadway Condition Information					
SCR (Surface Condition Rating)	98				
PCR (Pavement Condition Rating)	98				
Distress Index Values					
Structural Crack Index	100				
Transverse Cracking Index	100				
Patching Index	100				
Rutting Index	98				
Roughness Condition Index (RCI)	NC

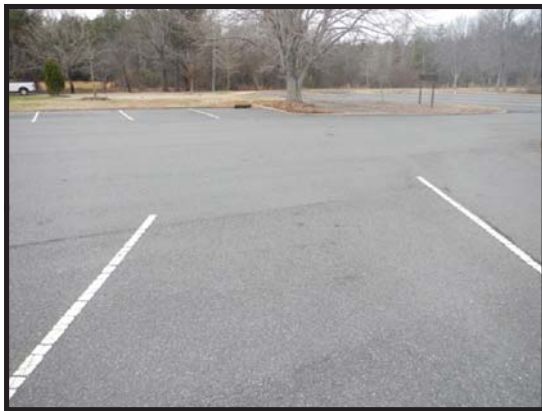
Route Number	Public / NonPublic	Date Visited	Area (sq ft)	Lane Miles *	Surface Type
0900	PUBLIC	2/20/2013	63,053	1.09	AS
Culverts	Drop Inlets	Gates	Curb & Gutter	Curb	PCR
0	11	0	CONCRETE CURB AND GUTTER	CONCRETE CURB	GOOD/90

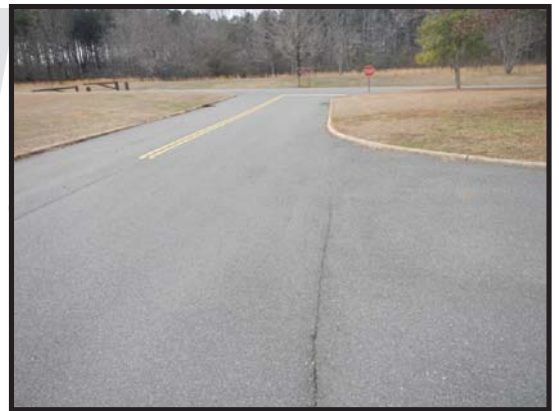
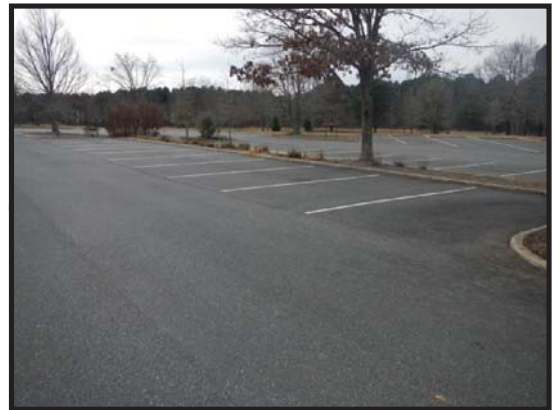
Route 0902

Route Number	Public / NonPublic	Date Visited	Area (sq ft)	Lane Miles *	Surface Type
0902	NONPUBLIC	2/20/2013	13,380	0.23	AS
Culverts	Drop Inlets	Gates	Curb & Gutter	Curb	PCR
0	0	0	NO CURB AND GUTTER	NO CURB	EXCELLENT/97

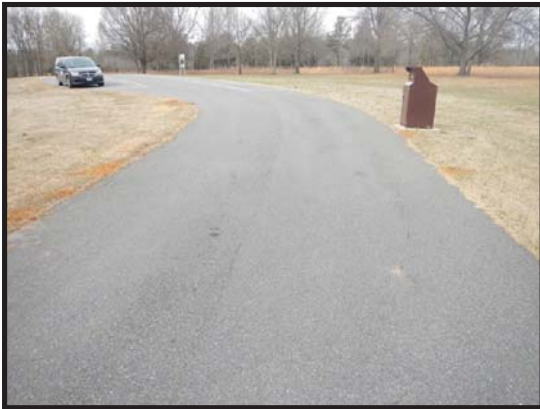
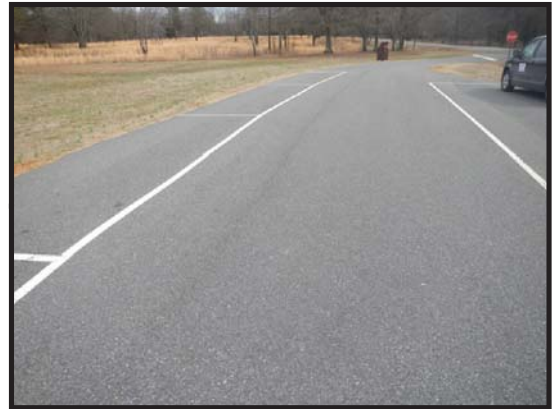
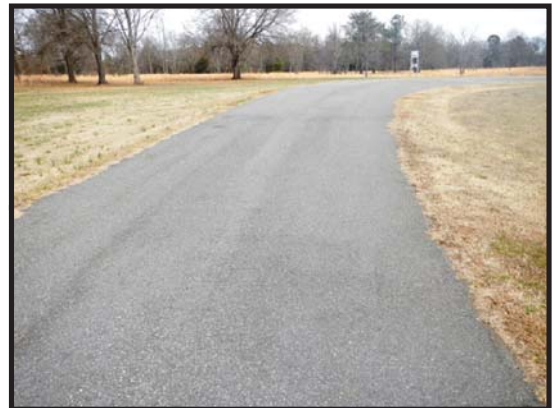
Route 0903

Route Number	Public / NonPublic	Date Visited	Area (sq ft)	Lane Miles *	Surface Type
0903	PUBLIC	2/20/2013	6,998	0.12	AS
Culverts	Drop Inlets	Gates	Curb & Gutter	Curb	PCR
1	0	0	NO CURB AND GUTTER	NO CURB	GOOD/90

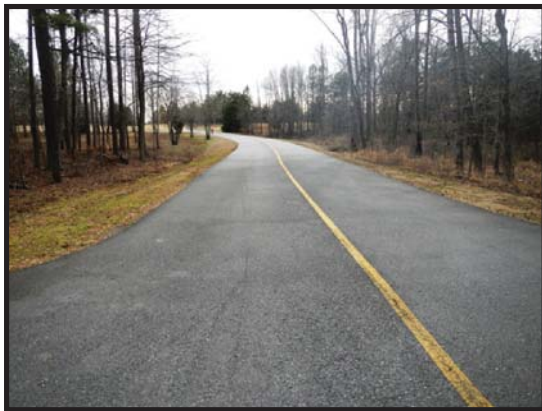
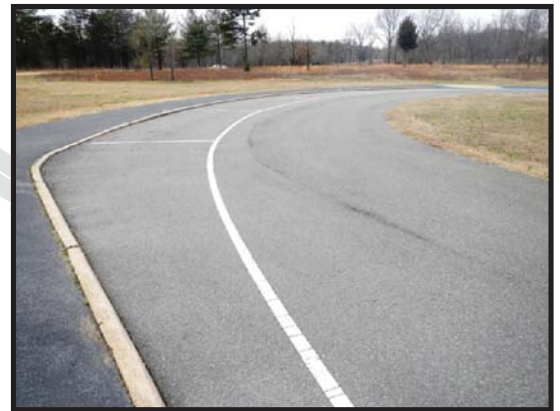
Route 0904

Route Number	Public / NonPublic	Date Visited	Area (sq ft)	Lane Miles *	Surface Type
0904	PUBLIC	2/20/2013	19,620	0.34	AS
Culverts	Drop Inlets	Gates	Curb & Gutter	Curb	PCR
0	0	0	NO CURB AND GUTTER	CONCRETE CURB	GOOD/90

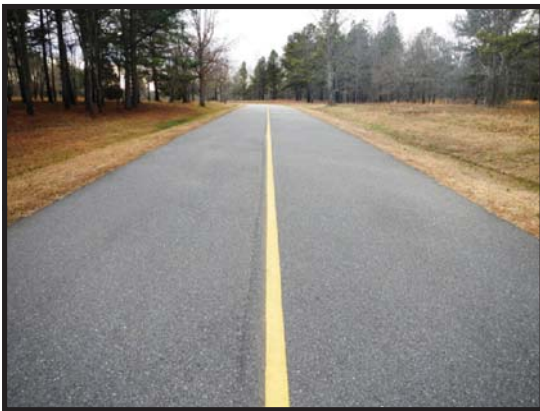
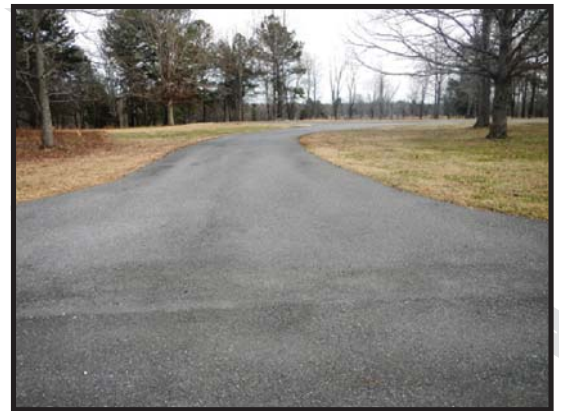
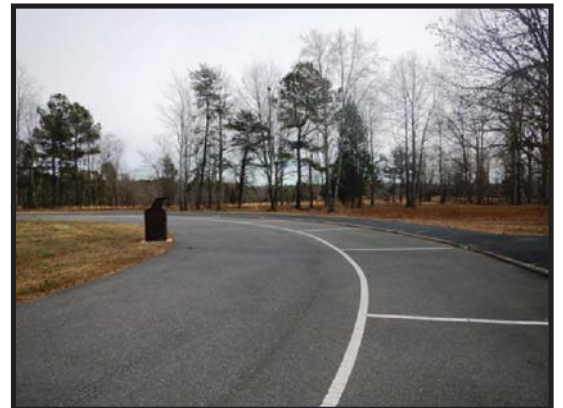
Route 0905

Route Number	Public / NonPublic	Date Visited	Area (sq ft)	Lane Miles *	Surface Type
0905	PUBLIC	2/20/2013	21,612	0.37	AS
Culverts	Drop Inlets	Gates	Curb & Gutter	Curb	PCR
1	0	0	NO CURB AND GUTTER	CONCRETE CURB	GOOD/90

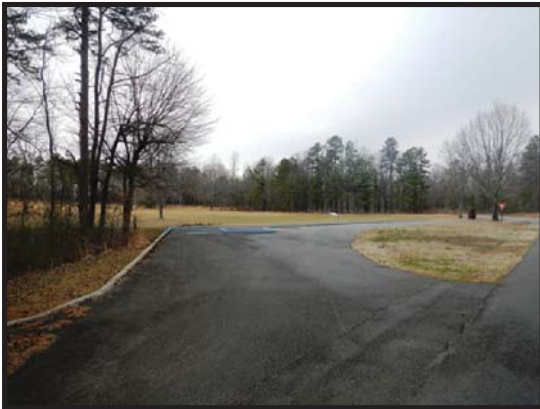
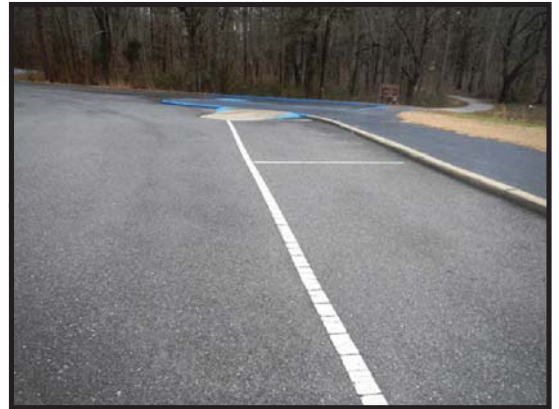
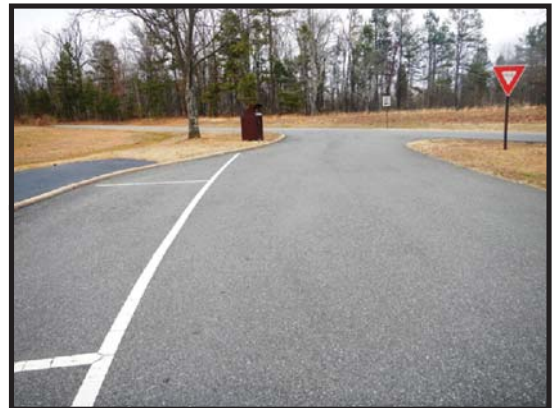
Route 0906

Route Number	Public / NonPublic	Date Visited	Area (sq ft)	Lane Miles *	Surface Type
0906	PUBLIC	2/20/2013	6,047	0.10	AS
Culverts	Drop Inlets	Gates	Curb & Gutter	Curb	PCR
0	0	0	NO CURB AND GUTTER	CONCRETE CURB	GOOD/90

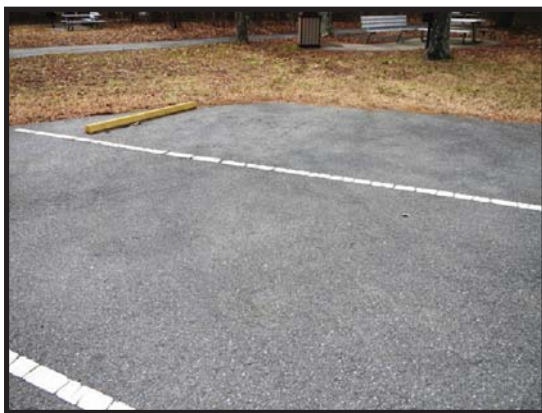
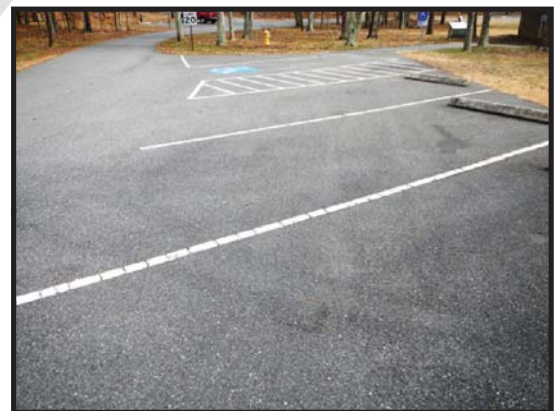
Route 0907ZZ

Route Number	Public / NonPublic	Date Visited	Area (sq ft)	Lane Miles *	Surface Type
0907Z	PUBLIC	2/20/2013	3,271	0.06	AS
Culverts	Drop Inlets	Gates	Curb & Gutter	Curb	PCR
0	0	0	NO CURB AND GUTTER	NO CURB	GOOD/90

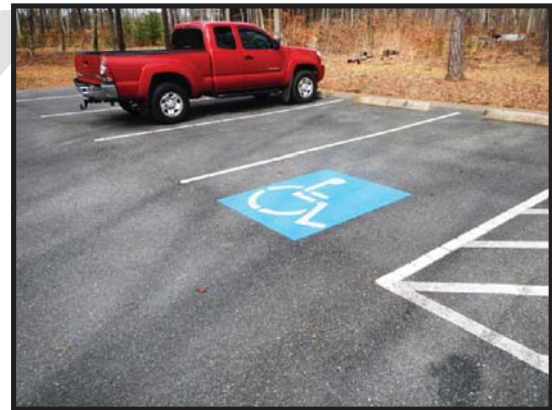
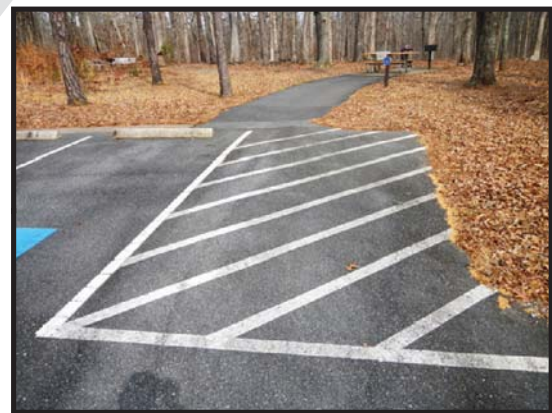
Route 0908Z

Route Number	Public / NonPublic	Date Visited	Area (sq ft)	Lane Miles *	Surface Type
0908Z	PUBLIC	2/20/2013	1,493	0.03	AS
Culverts	Drop Inlets	Gates	Curb & Gutter	Curb	PCR
0	0	0	NO CURB AND GUTTER	NO CURB	GOOD/90

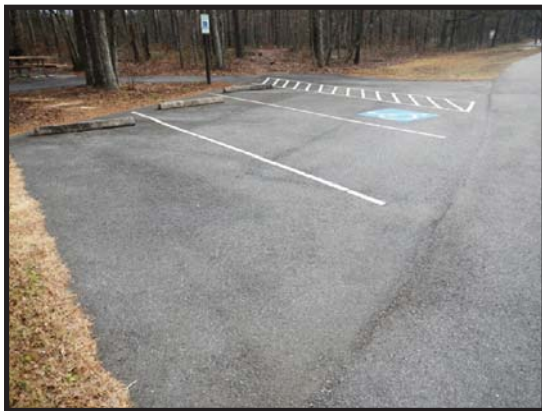
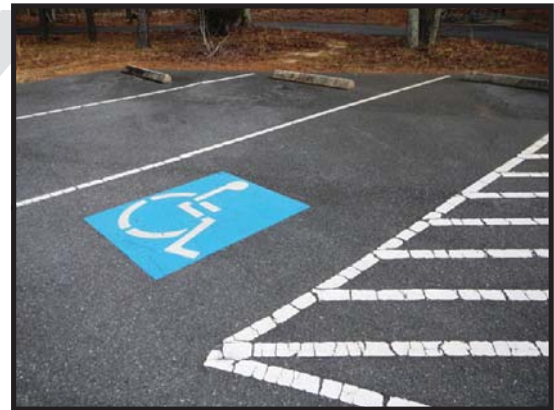
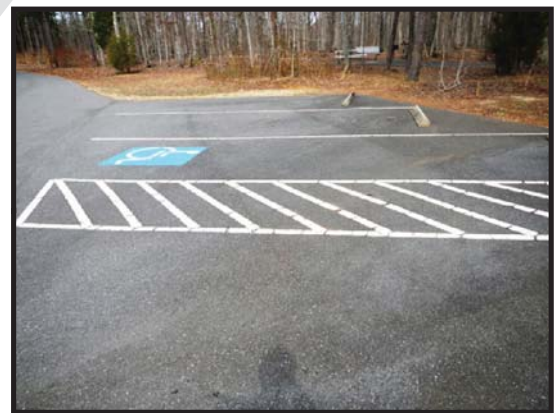
Route 0909Z

Route Number	Public / NonPublic	Date Visited	Area (sq ft)	Lane Miles *	Surface Type
0909Z	PUBLIC	2/20/2013	1,376	0.02	AS
Culverts	Drop Inlets	Gates	Curb & Gutter	Curb	PCR
0	0	0	NO CURB AND GUTTER	NO CURB	FAIR/73

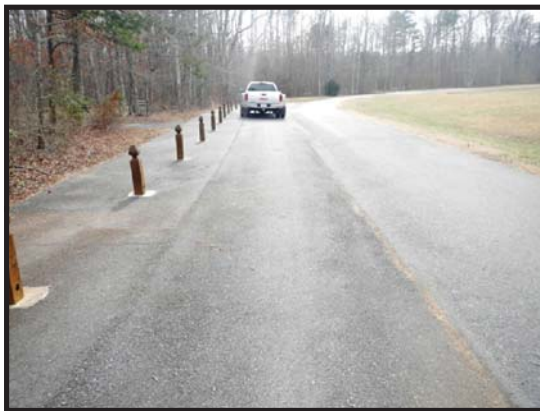
Route 0910Z

Route Number	Public / NonPublic	Date Visited	Area (sq ft)	Lane Miles *	Surface Type
0910Z	PUBLIC	2/20/2013	3,065	0.05	AS
Culverts	Drop Inlets	Gates	Curb & Gutter	Curb	PCR
0	0	0	NO CURB AND GUTTER	NO CURB	GOOD/90

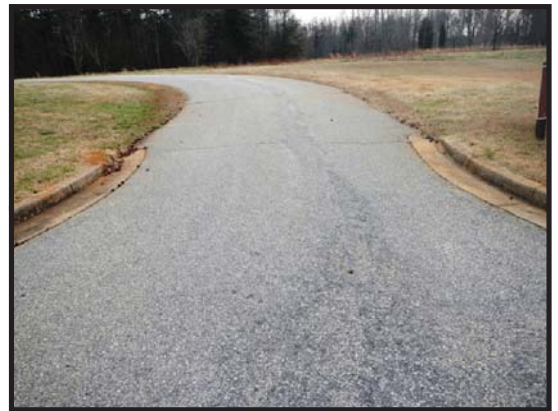
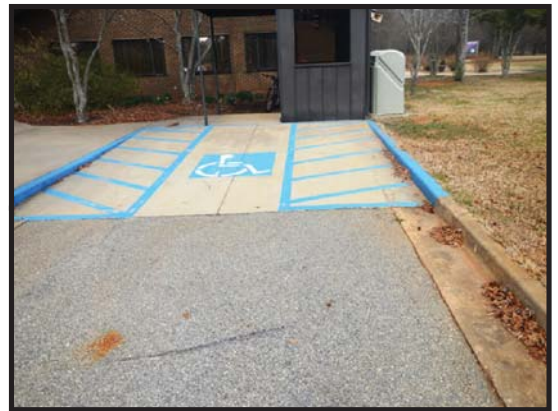
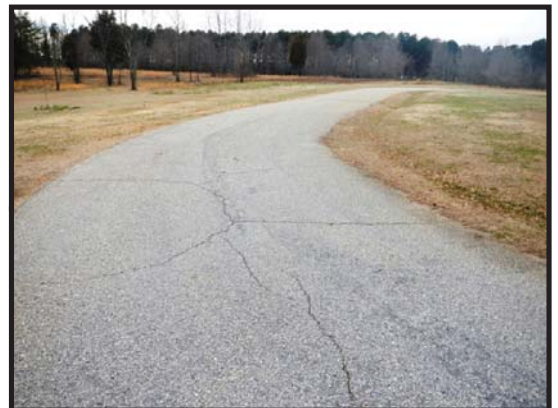
Route Number	Public / NonPublic	Date Visited	Area (sq ft)	Lane Miles *	Surface Type
0913	NONPUBLIC	2/20/2013	6,300	0.11	AS
Culverts	Drop Inlets	Gates	Curb & Gutter	Curb	PCR
0	0	0	CONCRETE CURB AND GUTTER	CONCRETE CURB	FAIR/73

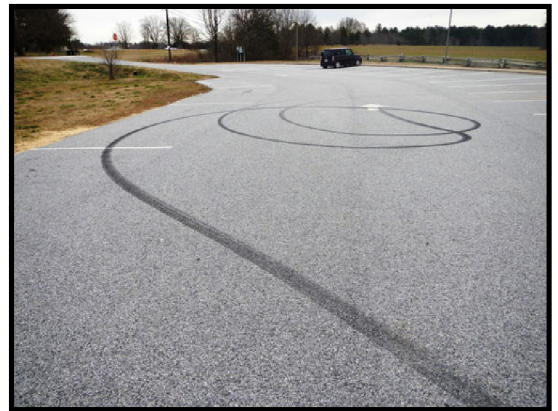
Route 0916

Route Number	Public / NonPublic	Date Visited	Area (sq ft)	Lane Miles *	Surface Type
0916	NONPUBLIC	2/20/2013	3,406	0.06	AS
Culverts	Drop Inlets	Gates	Curb & Gutter	Curb	PCR
0	0	0	NO CURB AND GUTTER	WOOD CURB	POOR/45

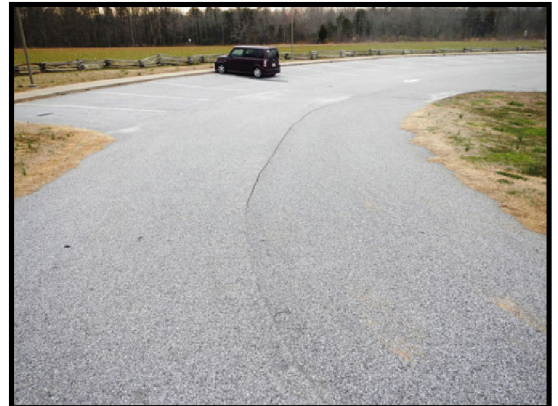
Route 0914

Route Number	Public / NonPublic	Date Visited	Area (sq ft)	Lane Miles *	Surface Type
0914	PUBLIC	2/20/2013	18,180	0.31	AS
Culverts	Drop Inlets	Gates	Curb & Gutter	Curb	PCR
1	0	0	NO CURB AND GUTTER	NO CURB	GOOD/90

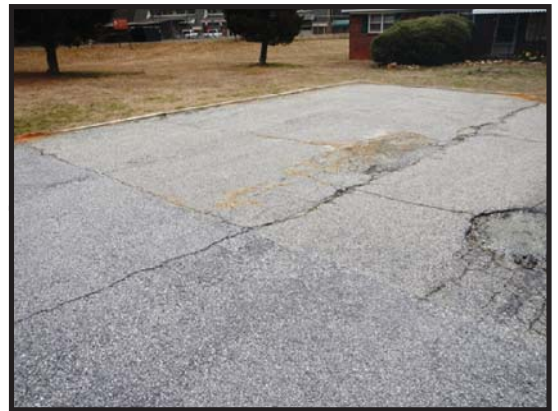
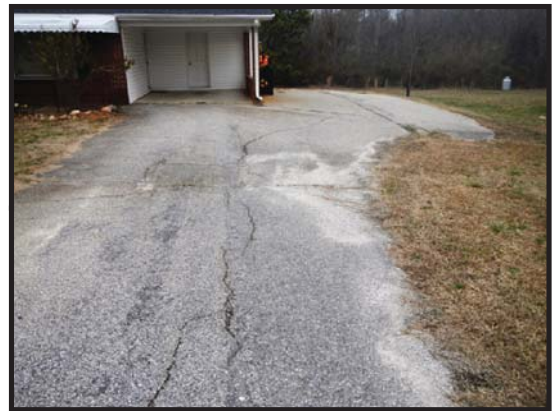
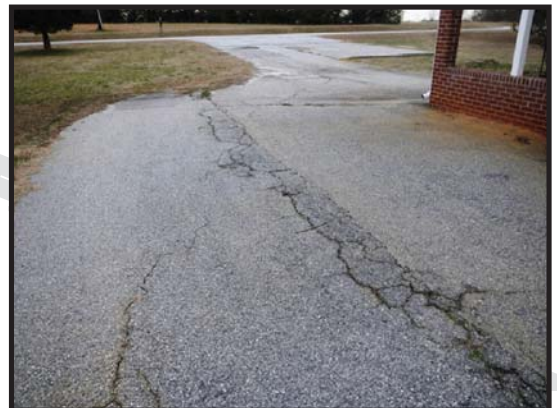
Route 0917

Route Number	Public / NonPublic	Date Visited	Area (sq ft)	Lane Miles *	Surface Type
0917	NONPUBLIC	2/20/2013	1,851	0.03	AS
Culverts	Drop Inlets	Gates	Curb & Gutter	Curb	PCR
0	0	0	NO CURB AND GUTTER	NO CURB	POOR/45
