Federal Lands Highway Road Inventory Program

Road Inventory and Condition Assessment

Eleanor Roosevelt National Historic Site ELRO

Cycle 5 Report

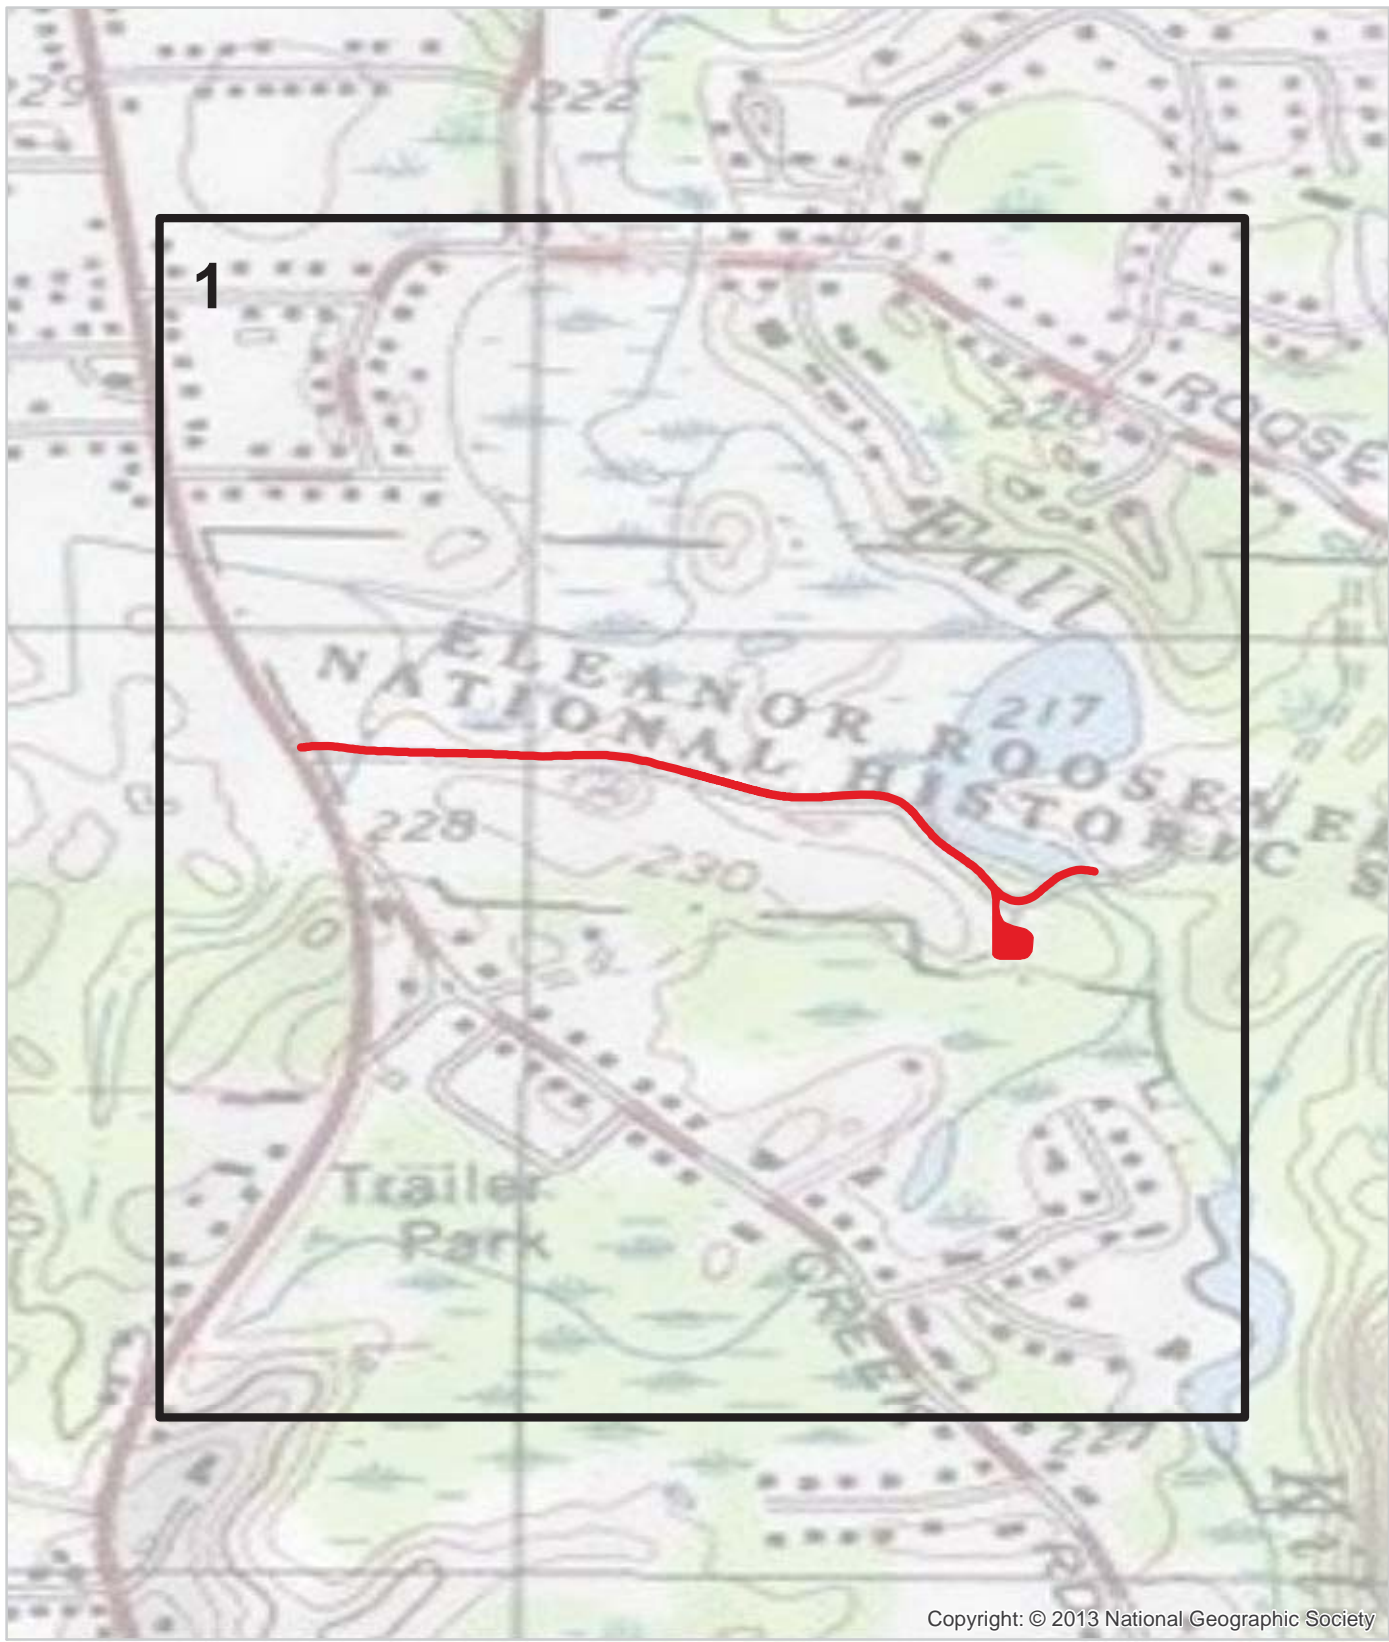
Eleanor Roosevelt National Historic Site
Route Location Map
Key Map

Cycle 5 Collected Routes

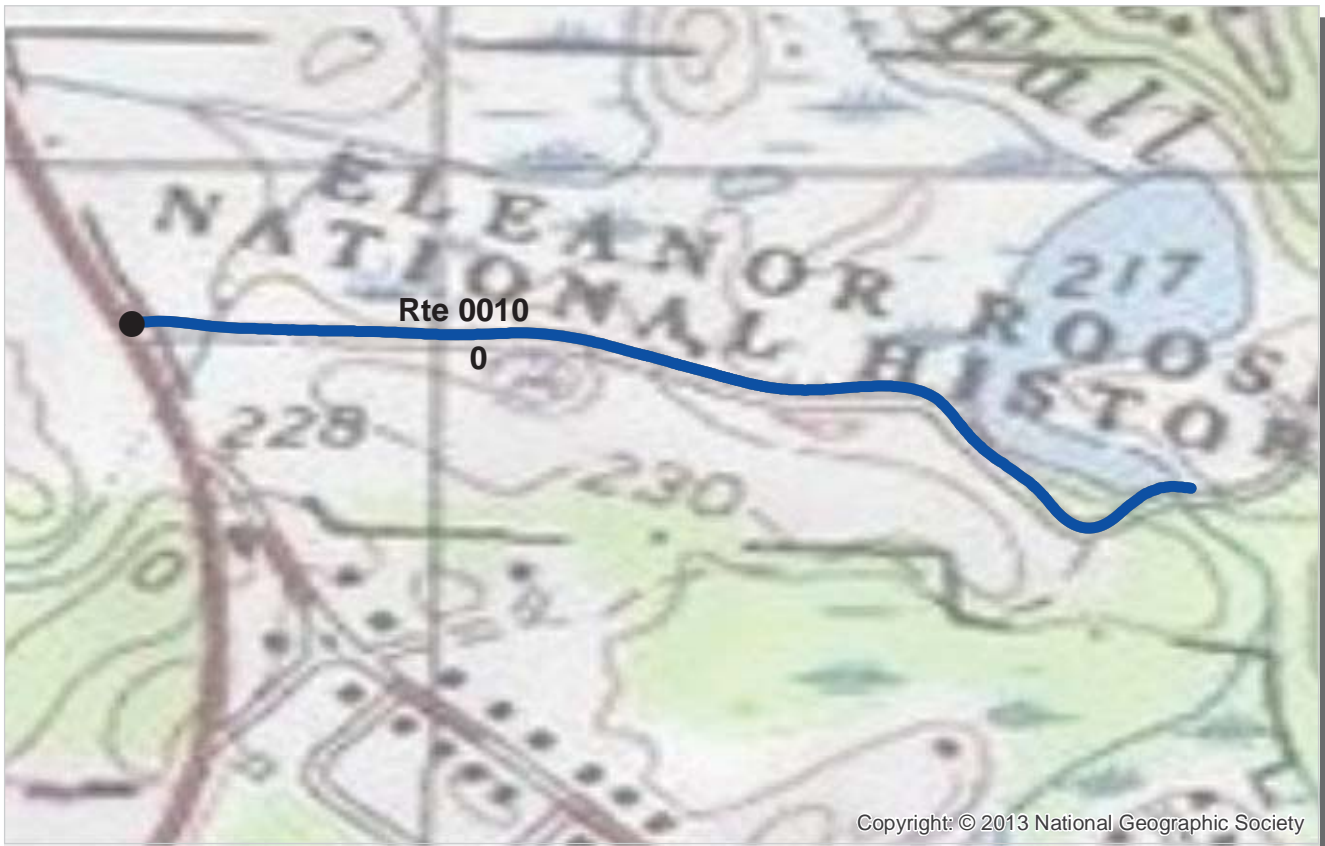
ROUTE: 0010 MAIN ENTRANCE ROAD

PCR Poor ■ Fair ■ Good ■ Excellent ■ No Data ■
 (0 - 60) (61 - 84) (85 - 94) (95 - 100)

* If the PCR rating is not available for a section, the SCR rating will be displayed. See appendix for definitions and formulas.

Section Number	0				
Section Length (mi)	0.44				
Cross Section Information					
Number of Lanes	2				
Paved Width (ft)	16				
Lane Width (ft)	8				
Roadway Condition Information					
SCR (Surface Condition Rating)	95				
PCR (Pavement Condition Rating)	95				
Distress Index Values					
Structural Crack Index	98				
Transverse Cracking Index	98				
Patching Index	100				
Rutting Index	95				
Roughness Condition Index (RCI)	NC

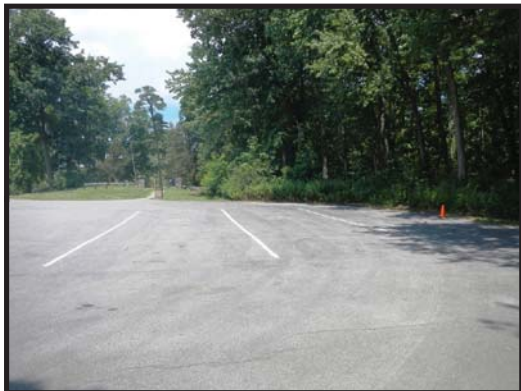
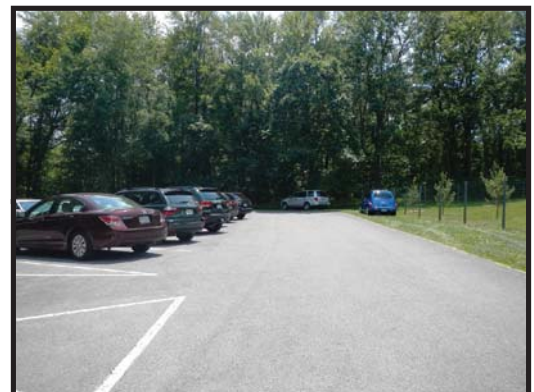
Route Number	Public / NonPublic	Date Visited	Area (sq ft)	Lane Miles *	Surface Type
0900	PUBLIC	7/1/2012	13,375	0.23	AS
Culverts	Drop Inlets	Gates	Curb & Gutter	Curb	PCR
0	0	0	NO CURB AND GUTTER	NO CURB	GOOD/90
