Federal Lands Highway Road Inventory Program

Road Inventory and Condition Assessment

Fire Island National Seashore FIIS

Cycle 5 Report

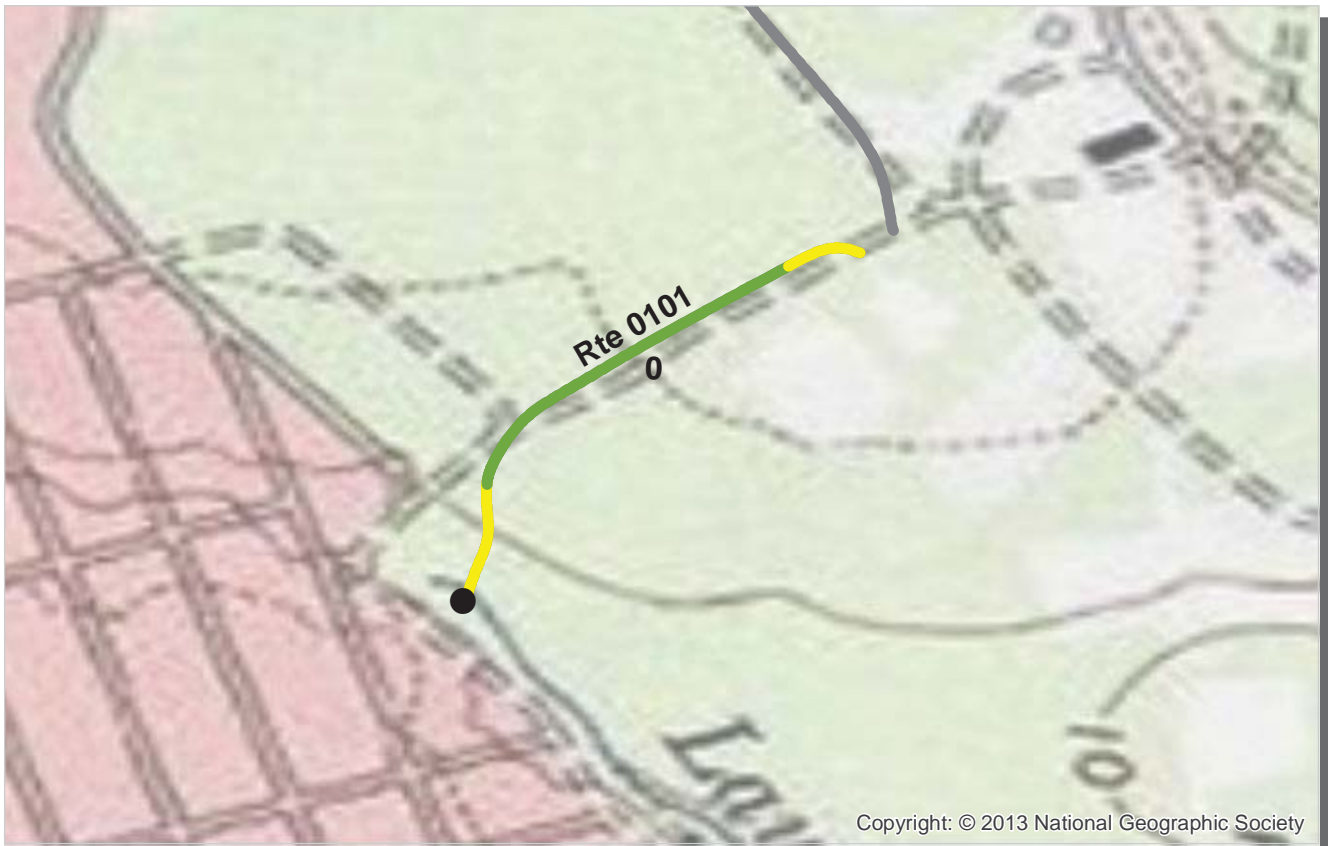
ROUTE: 0101 MAIN ENTRANCE

Section Number	0				
Section Length (mi)	0.25				
Cross Section Information					
Number of Lanes	1				
Paved Width (ft)	11				
Lane Width (ft)	11				
Roadway Condition Information					
SCR (Surface Condition Rating)	84				
PCR (Pavement Condition Rating)	84				
Distress Index Values					
Structural Crack Index	93				
Transverse Cracking Index	84				
Patching Index	100				
Rutting Index	90				
Roughness Condition Index (RCI)	NC

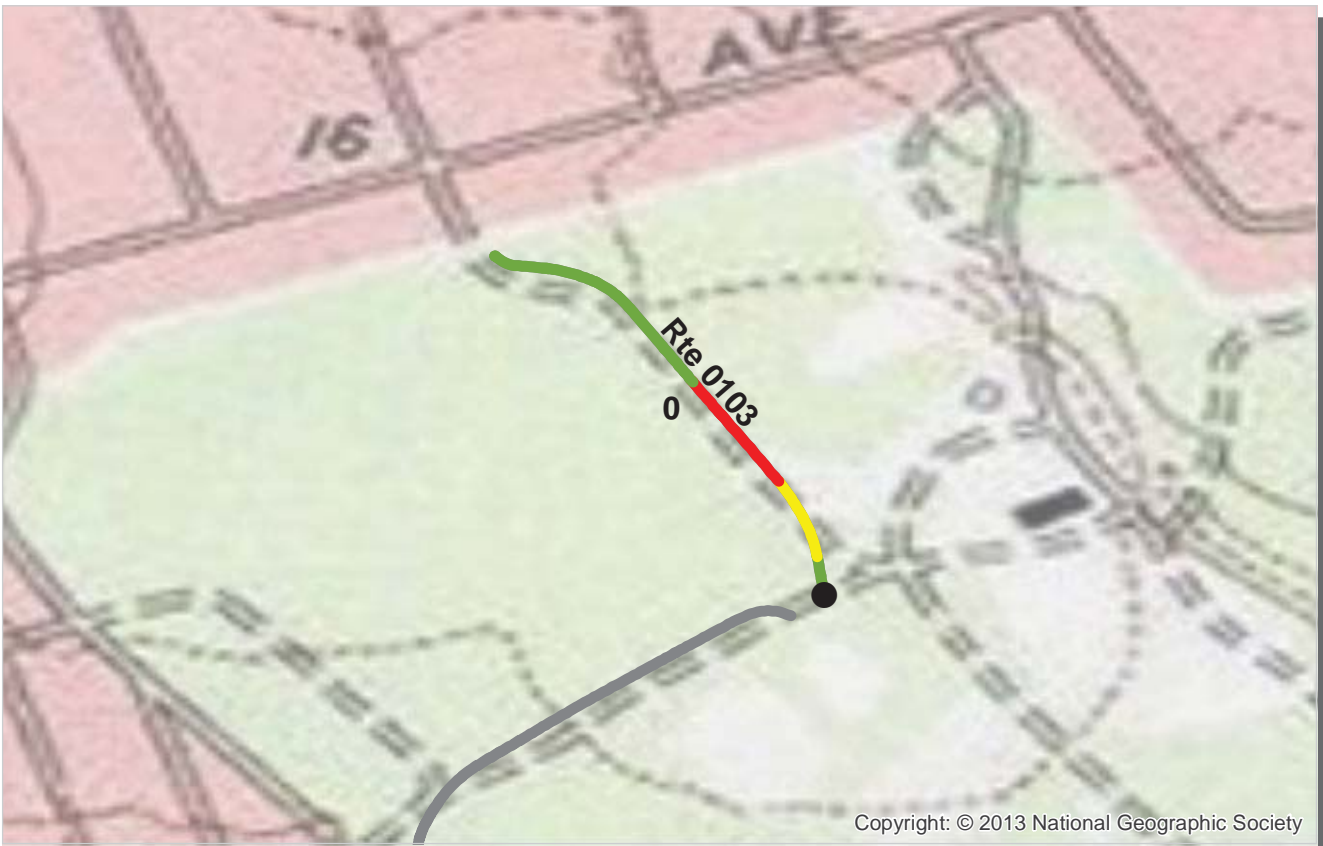
ROUTE: 0103 MAIN EXIT

Section Number	0				
Section Length (mi)	0.22				
Cross Section Information					
Number of Lanes	1				
Paved Width (ft)	10				
Lane Width (ft)	10				
Roadway Condition Information					
SCR (Surface Condition Rating)	73				
PCR (Pavement Condition Rating)	73				
Distress Index Values					
Structural Crack Index	96				
Transverse Cracking Index	73				
Patching Index	100				
Rutting Index	93				
Roughness Condition Index (RCI)	NC

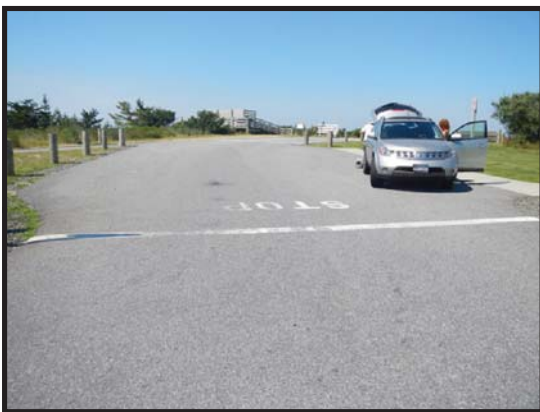
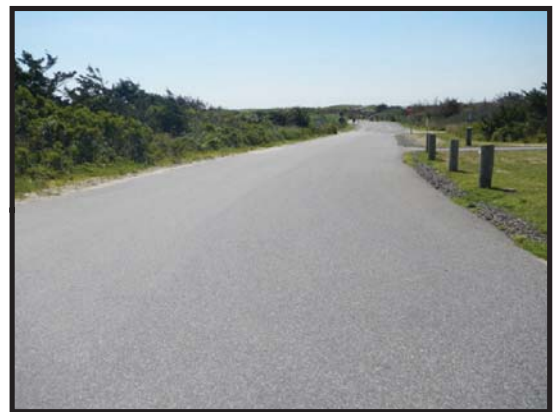
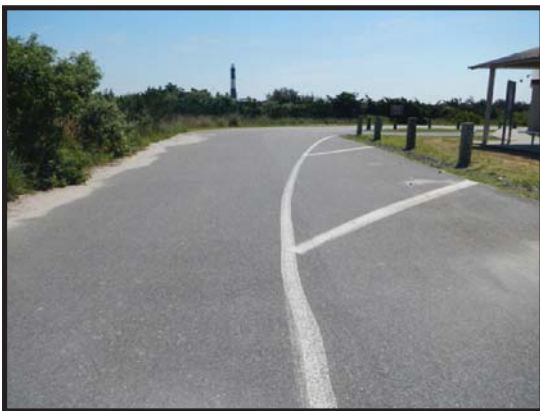
WEST ENTRANCE PAVED ROAD
FROM ROBERT MOSES CAUSEWAY
TO ROUTE 0100 (WEST ENTRANCE UNPAVED ROAD)

Route Number	Public / NonPublic	Date Visited	Area (sq ft)	Lane Miles *	Surface Type
0010	PUBLIC	6/30/2012	15,474	0.27	AS
Culverts	Drop Inlets	Gates	Curb & Gutter	Curb	PCR
0	0	0	NO CURB AND GUTTER	NO CURB	GOOD/90

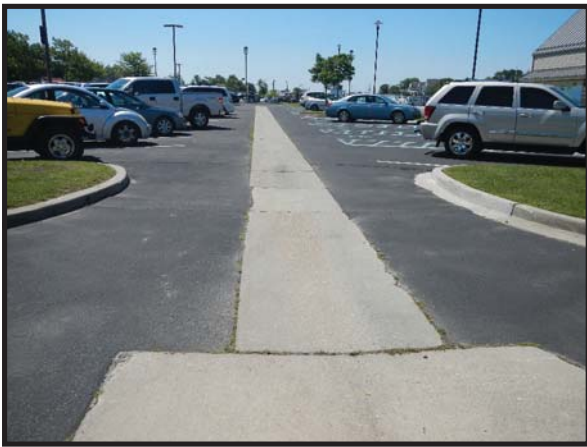
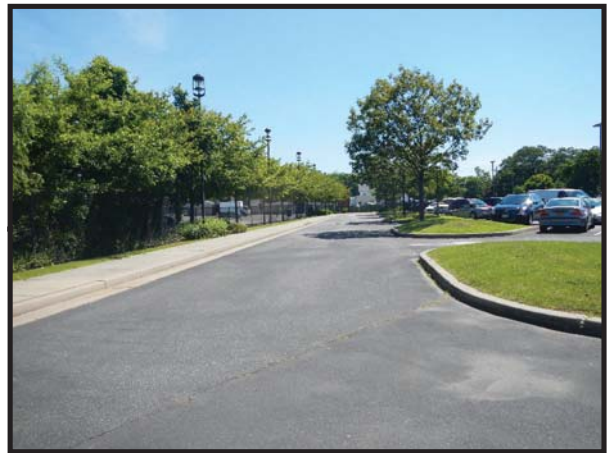
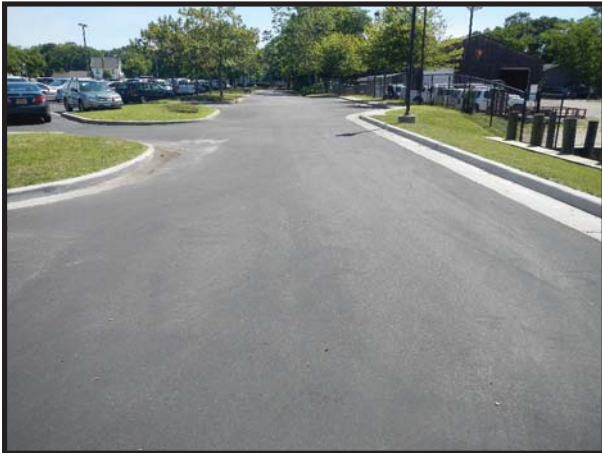
Route Number	Public / NonPublic	Date Visited	Area (sq ft)	Lane Miles *	Surface Type
0900	PUBLIC	6/30/2012	82,932	1.43	AS
Culverts	Drop Inlets	Gates	Curb & Gutter	Curb	PCR
0	1	2	CONCRETE CURB AND GUTTER	CONCRETE CURB	GOOD/90

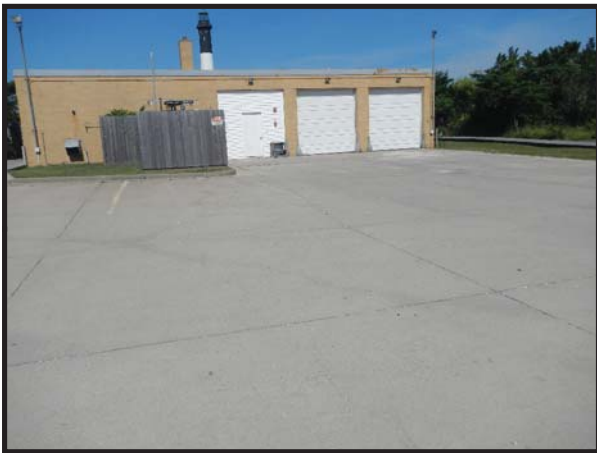
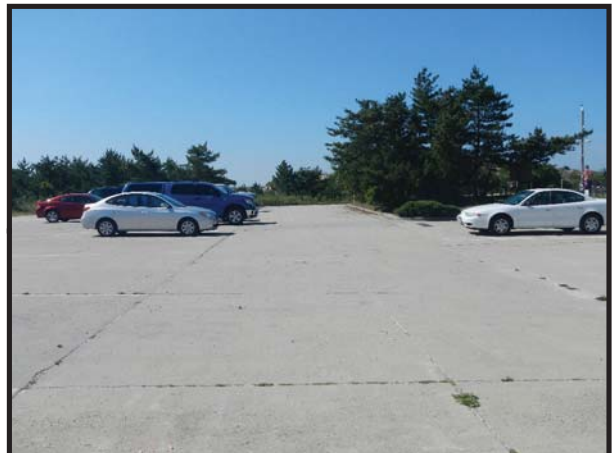
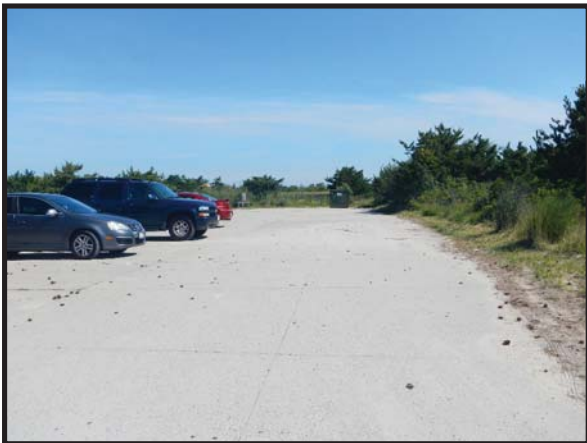
Route 0901

Route Number	Public / NonPublic	Date Visited	Area (sq ft)	Lane Miles *	Surface Type
0901	NONPUBLIC	6/30/2012	20,041	0.35	CO
Culverts	Drop Inlets	Gates	Curb & Gutter	Curb	PCR
0	0	0	NO CURB AND GUTTER	CONCRETE CURB	FAIR/73

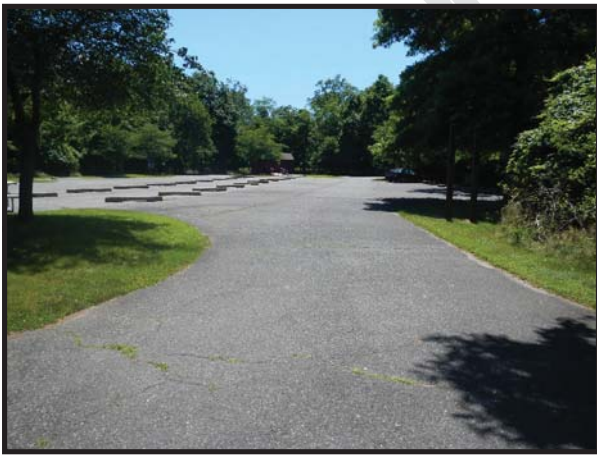
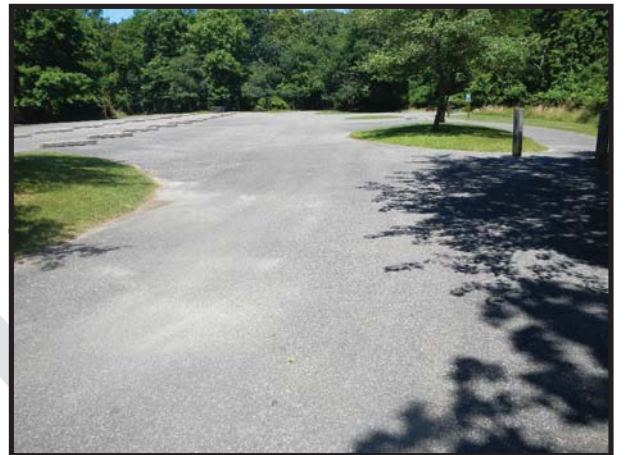
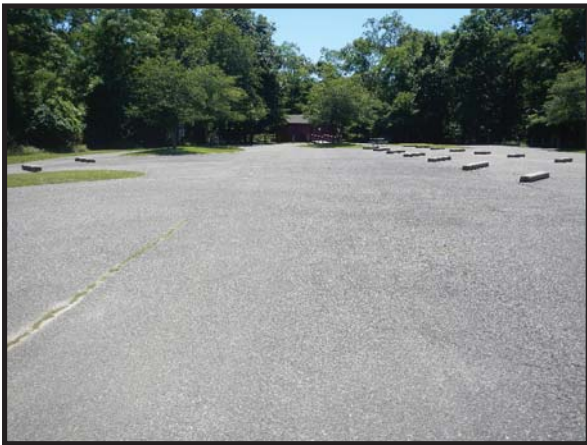
Route 0902

Route Number	Public / NonPublic	Date Visited	Area (sq ft)	Lane Miles *	Surface Type
0902	PUBLIC	6/30/2012	31,516	0.54	AS
Culverts	Drop Inlets	Gates	Curb & Gutter	Curb	PCR
0	0	0	NO CURB AND GUTTER	NO CURB	FAIR/73

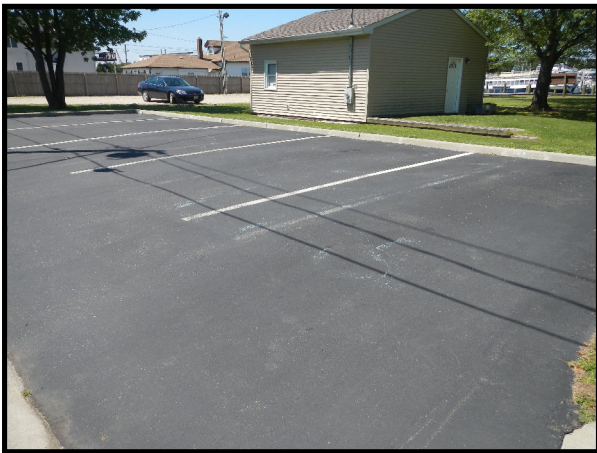
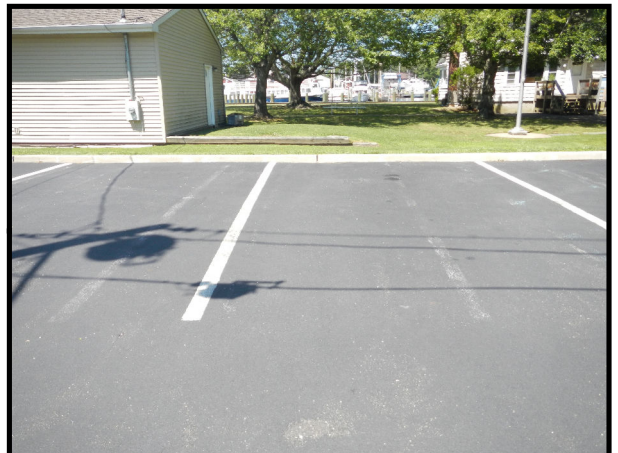
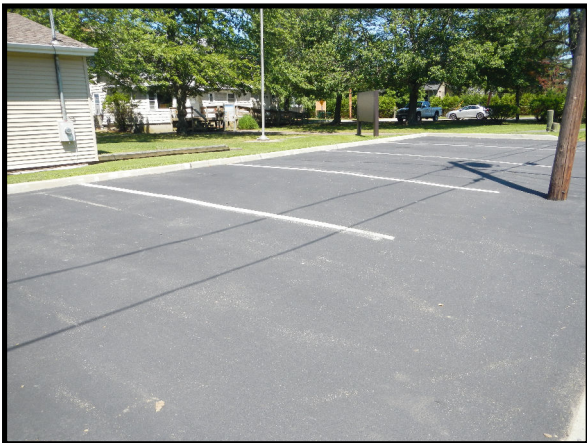
Route 0905

Route Number	Public / NonPublic	Date Visited	Area (sq ft)	Lane Miles *	Surface Type
0905	NONPUBLIC	6/30/2012	1,235	0.02	AS
Culverts	Drop Inlets	Gates	Curb & Gutter	Curb	PCR
0	0	0	NO CURB AND GUTTER	CONCRETE CURB	EXCELLENT/97

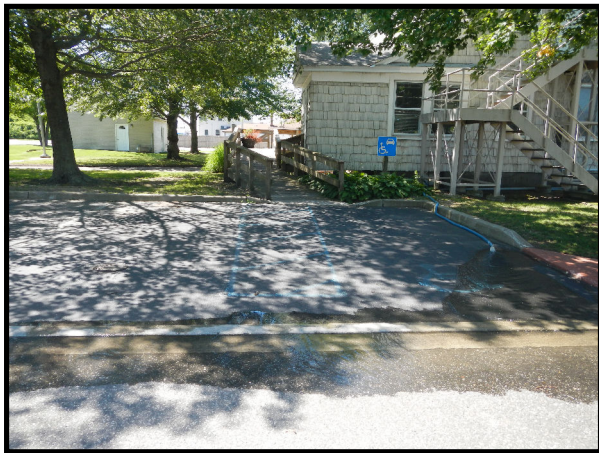
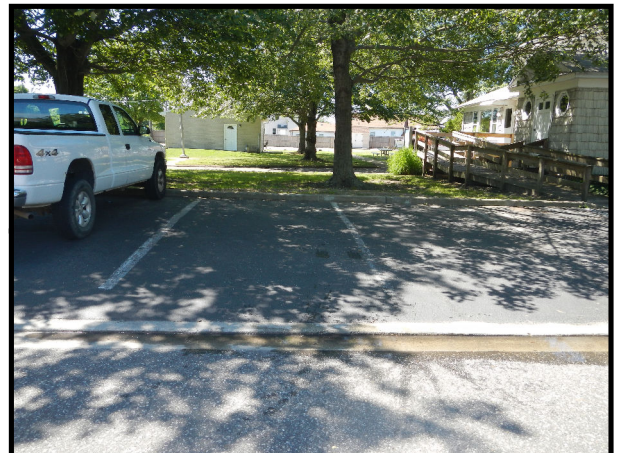
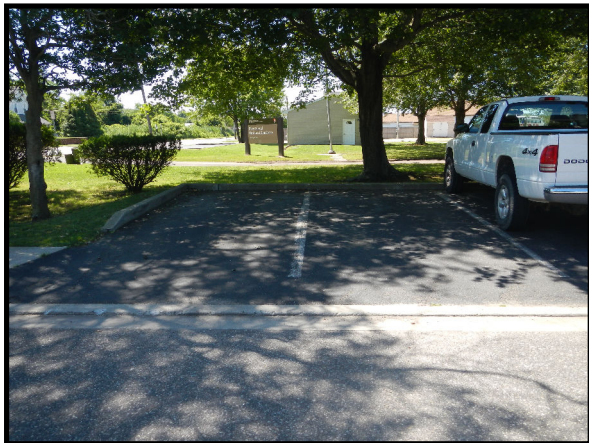
Rte 0906

Route Number	Public / NonPublic	Date Visited	Area (sq ft)	Lane Miles *	Surface Type
0906	PUBLIC	6/30/2012	1,133	0.02	AS
Culverts	Drop Inlets	Gates	Curb & Gutter	Curb	PCR
0	0	0	NO CURB AND GUTTER	CONCRETE CURB	GOOD/90
